HIGHER VELLY FARM, HARTLAND, TORRIDGE, DEVON

Results of a Desk-Based Assessment,
Historic Building Recording &
Archaeological Monitoring

Report No.: 160106
Date: 06.01.2016
Author: E. Wapshott
P. Webb

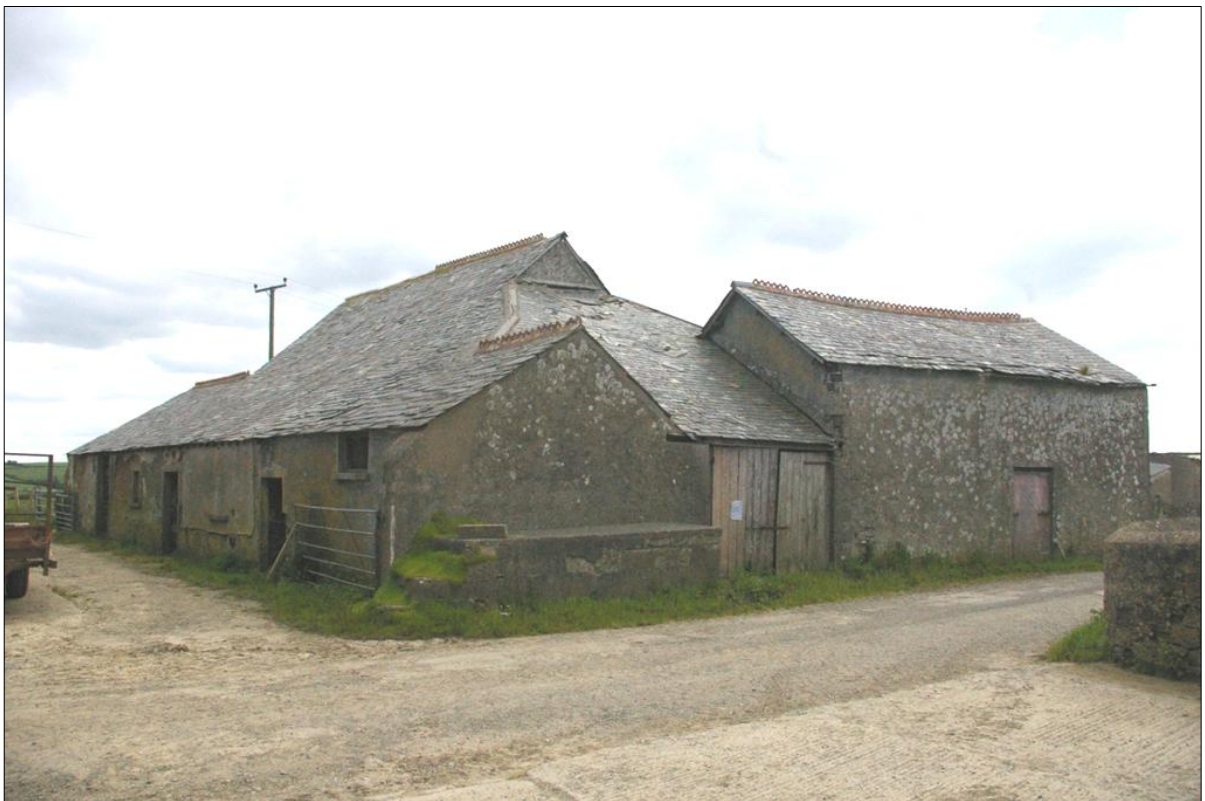
Figure 7: View of the Higher Velly barn complex; viewed from the north-west.

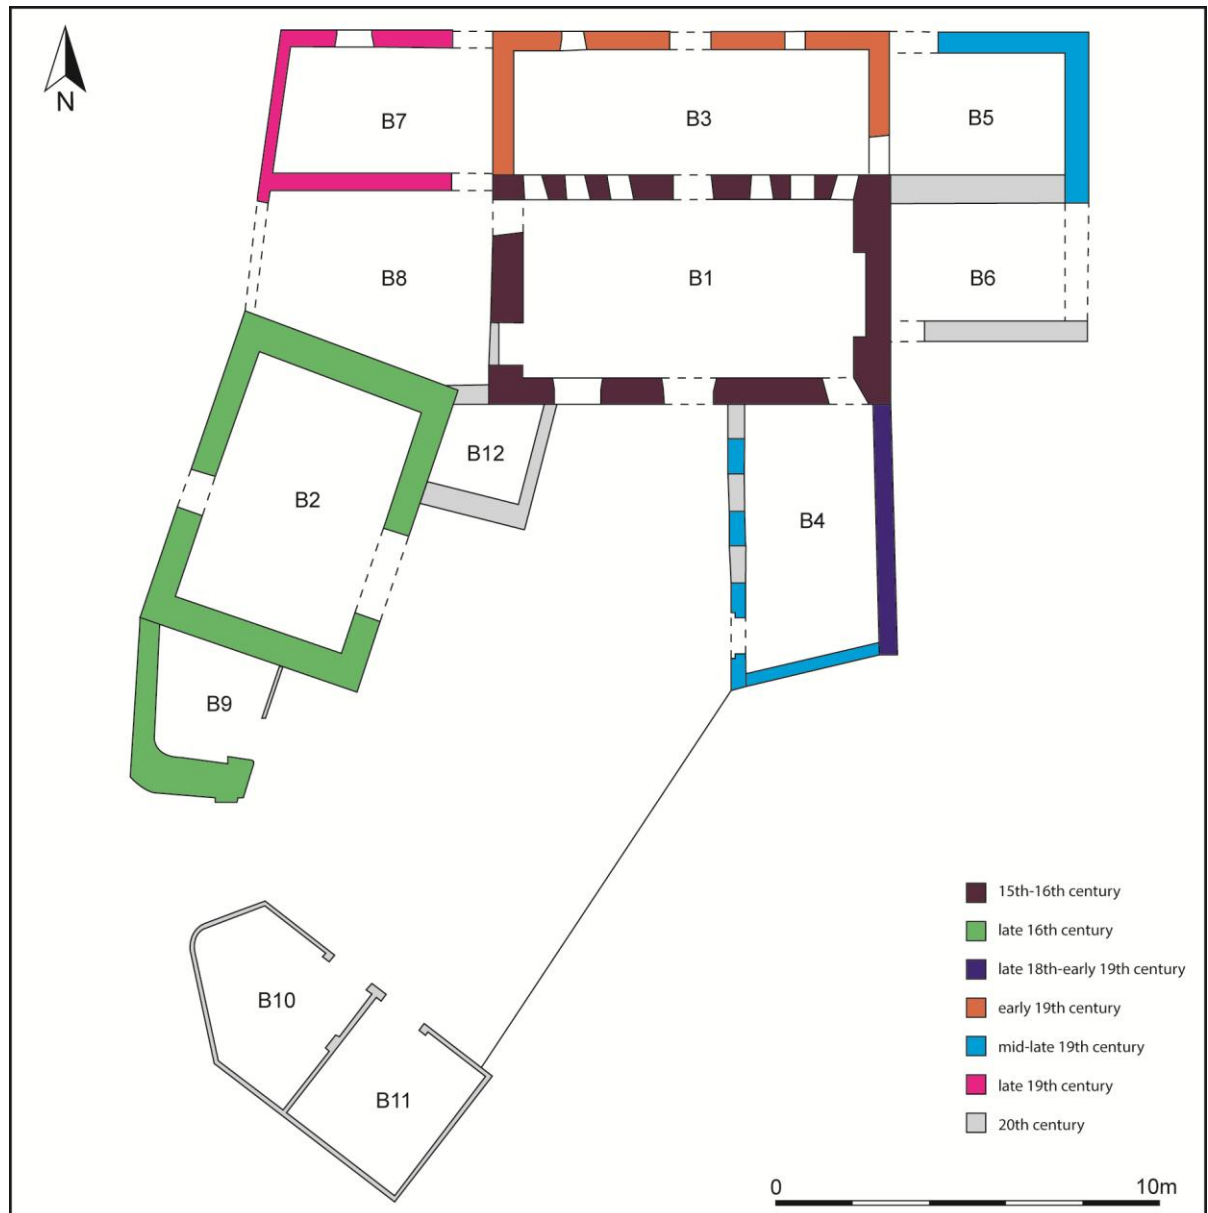
The earliest building fabric is found within Building 1 (B1 on Figure 8), forming the north side of the courtyard. The building comprises a former pigsty, with loft above and is of two storeys, of five bays, and built of irregularly coursed stonework of dressed and squared blocks. The stonework is clay bonded, with a cement render covering the south and west walls. A feature of this building is the quality of the dressed blocks and the densely packed nature of the stonework. The building has received a significant raise (Figure 9), creating the first floor, using a mixture of cob and rubble. It has also undergone numerous alterations, including: the forcing of doorways, feed chutes, and the

blocking of earlier openings. The building has a later king-post roof structure and slate roof. Several changes of function have converted it from a domestic service building, possibly a kitchen block, to a dwelling, and subsequently to its agricultural use.

Figure 8: Plan of Higher Velly building complex showing phasing of ground floor wall construction.

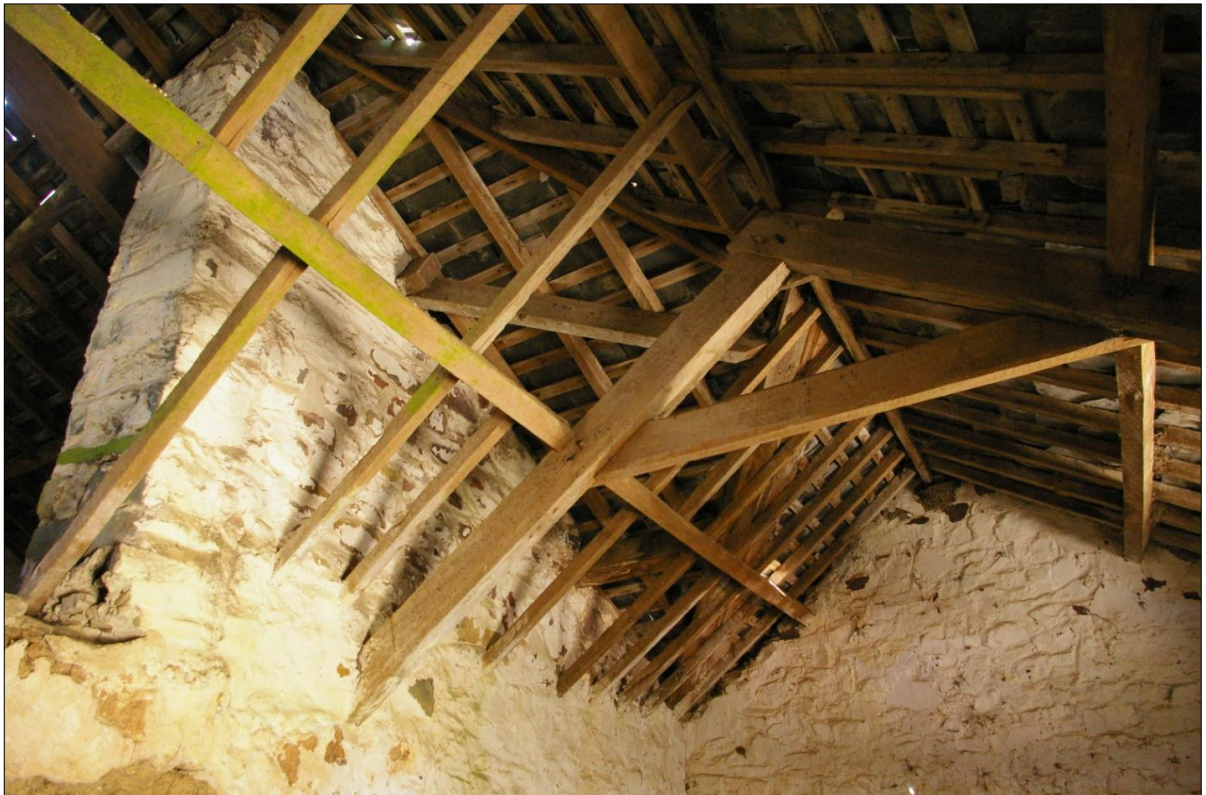
Figure 15: Detail of the roof structure within B7, showing the earlier double-pitch roof replaced with a single-pitch cat-slide roof; viewed from the east-north-east.

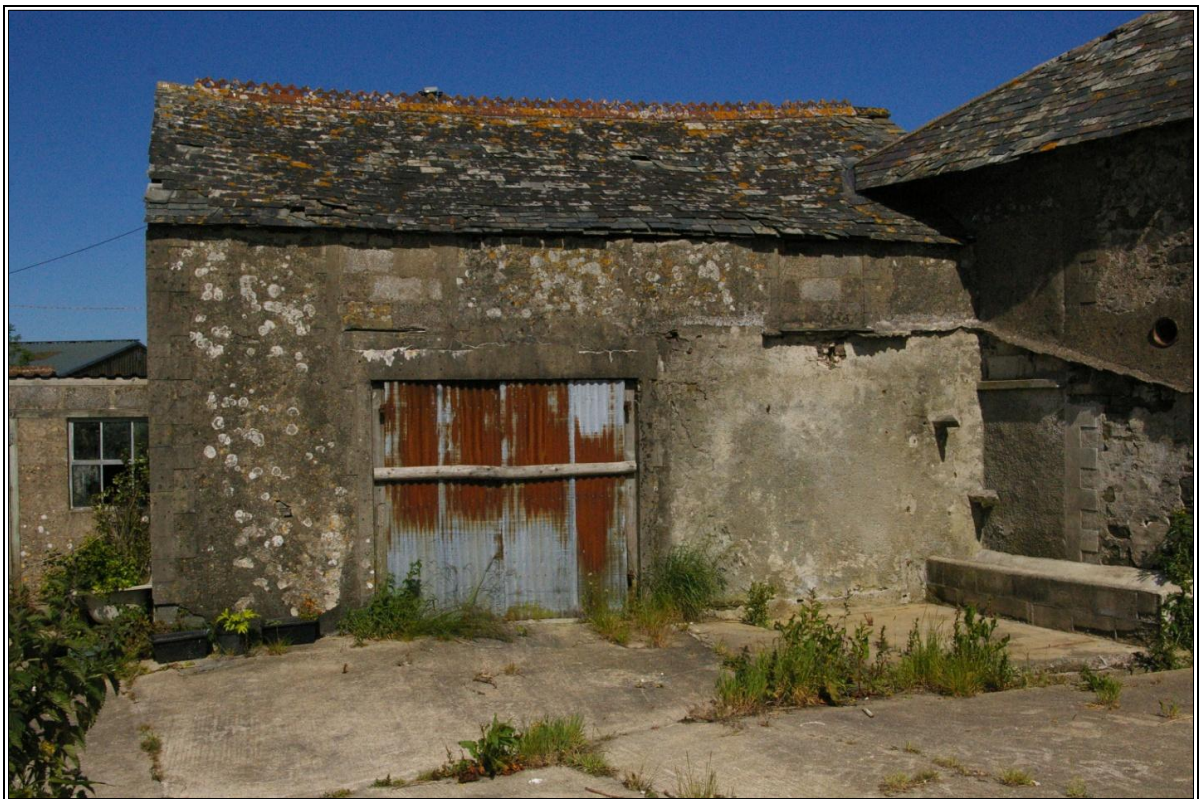
Figure 16: East wall of B2 showing remnants of roof structure to B12; viewed from the south-east.

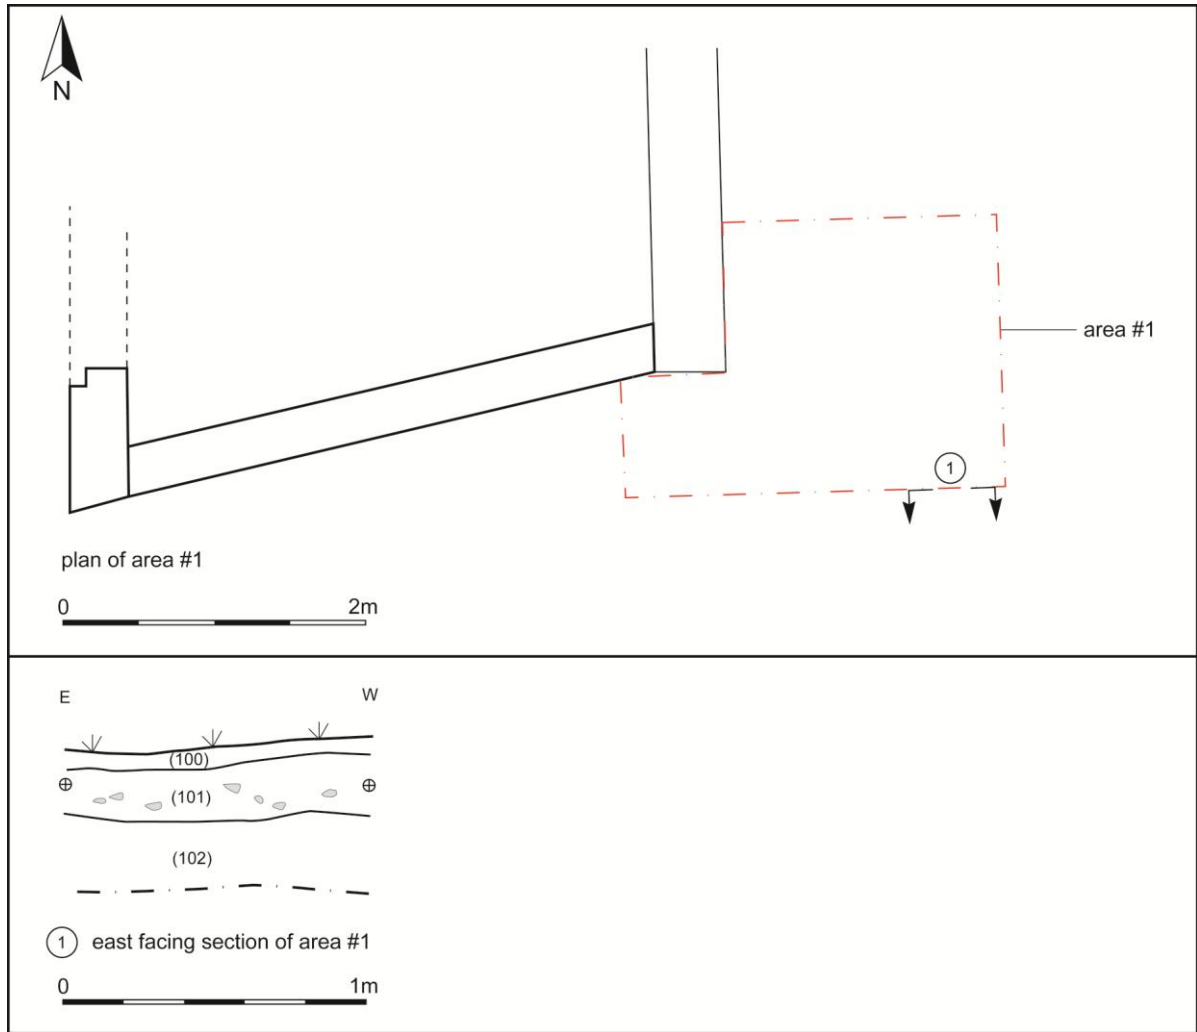
Area #1 was excavated to assess the foundations of the east and south walls of building B4 due to the leaning nature of the east wall. It was 'L'-shaped in plan, located surrounding the exterior south-east corner of the structure, measuring 1.8m north-south × 2.5m east-west, and was excavated to a depth of 0.5m. The stratigraphy consisted of: topsoil (100); grey-brown silt-clay-loam, overlying subsoil (101); grey-brown soft-friable silt-clay, and natural (102); sub-angular stone within blue-grey clay (Figure 18).

No archaeological features were identified within the area, with the building footings continuing to a depth of 0.5m below the ground surface, though no foundation cut was identified.

Figure 18: Area #1 plans and sections

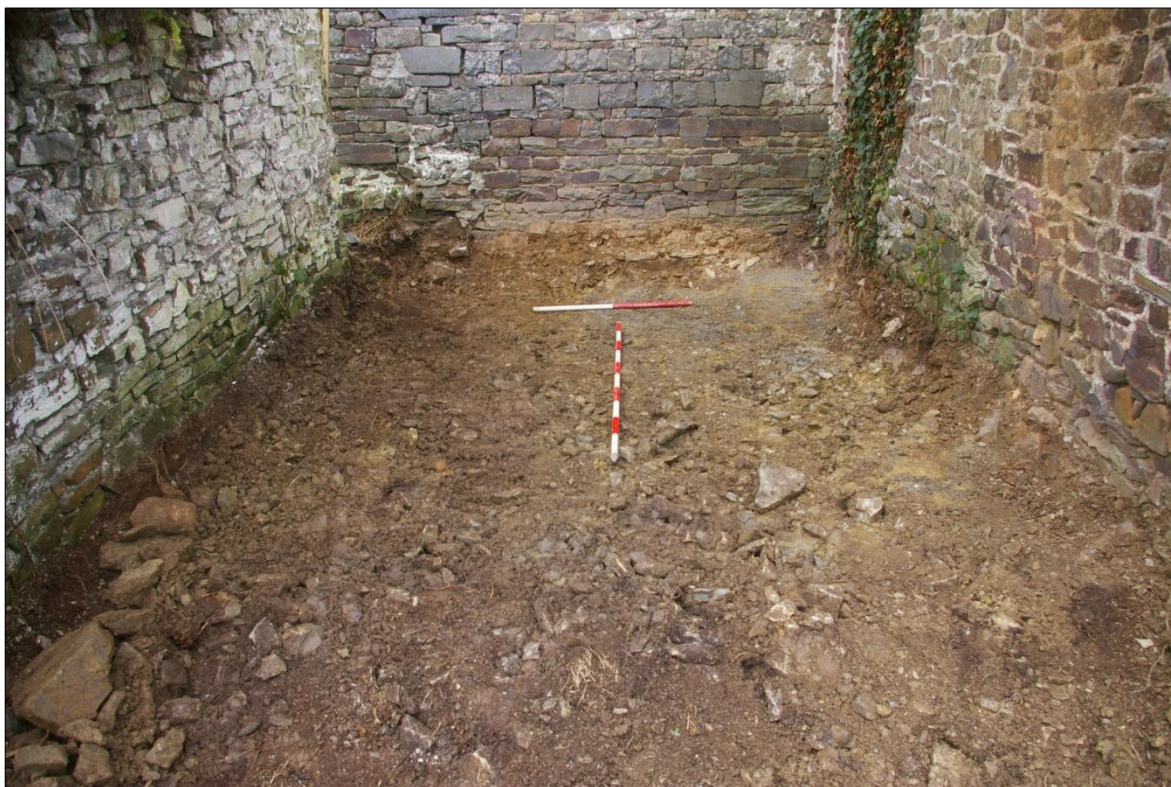
The only features identified within this area comprised the foundation cuts for the standing walls (Figures 19-20), cut into the natural to a depth of 0.1m. Of these, [202] was orientated east-west; and [205] orientated north-south, measuring up to 1m from the extant walls, and both containing yellow-brown silt-clays (204), (207), abutting the stone built walls.

Figure 19: Post-excavation plan view of Area #2; viewed from the east (1m and 2m scales).

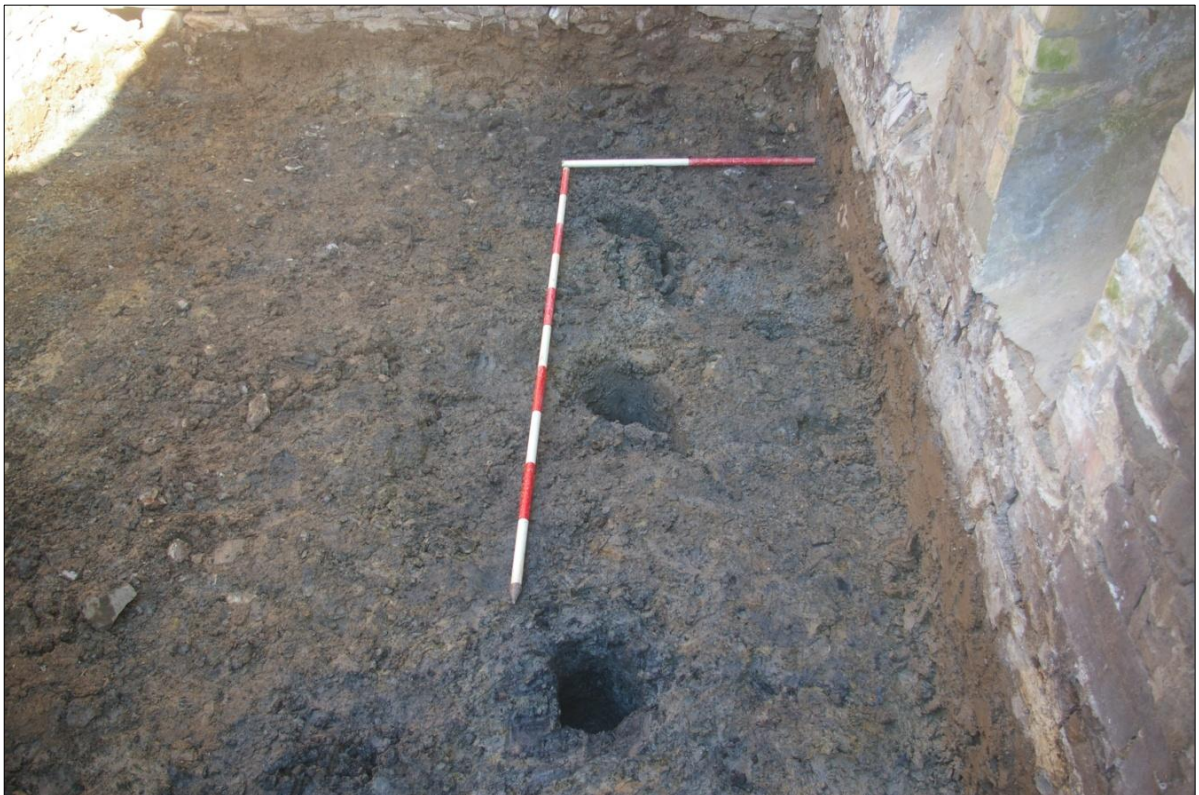
Alongside the foundation cut [429] for the north wall of building B1 eleven post-holes were identified (Figures 22-23). Wall foundation cut [429] was orientated east-west and measured 0.2m wide, containing fill (431) grey-brown soft clay abutting wall {430}. Of the post-holes, nine: [405], [407], [409], [411], [413], [415], [417], [419]) formed a linear alignment approximately 0.5m north of the exterior of the north wall of building B1; and two [421], [423] were located opposite the doorway (central to the wall). All of the post-holes were sub-circular in plan, measuring between 0.2-0.3m in diameter × up to 0.42m in depth with vertical sides, sharp break of slope and flat base. All contained the remains of a wooden post set within dark grey soft clay. These post-holes all cut re-deposited natural layer (404) and had been sealed by layer (403).

Figure 22: Plan view of east end of post-alignment, Area #4; viewed from the west (1m and 2m scales).

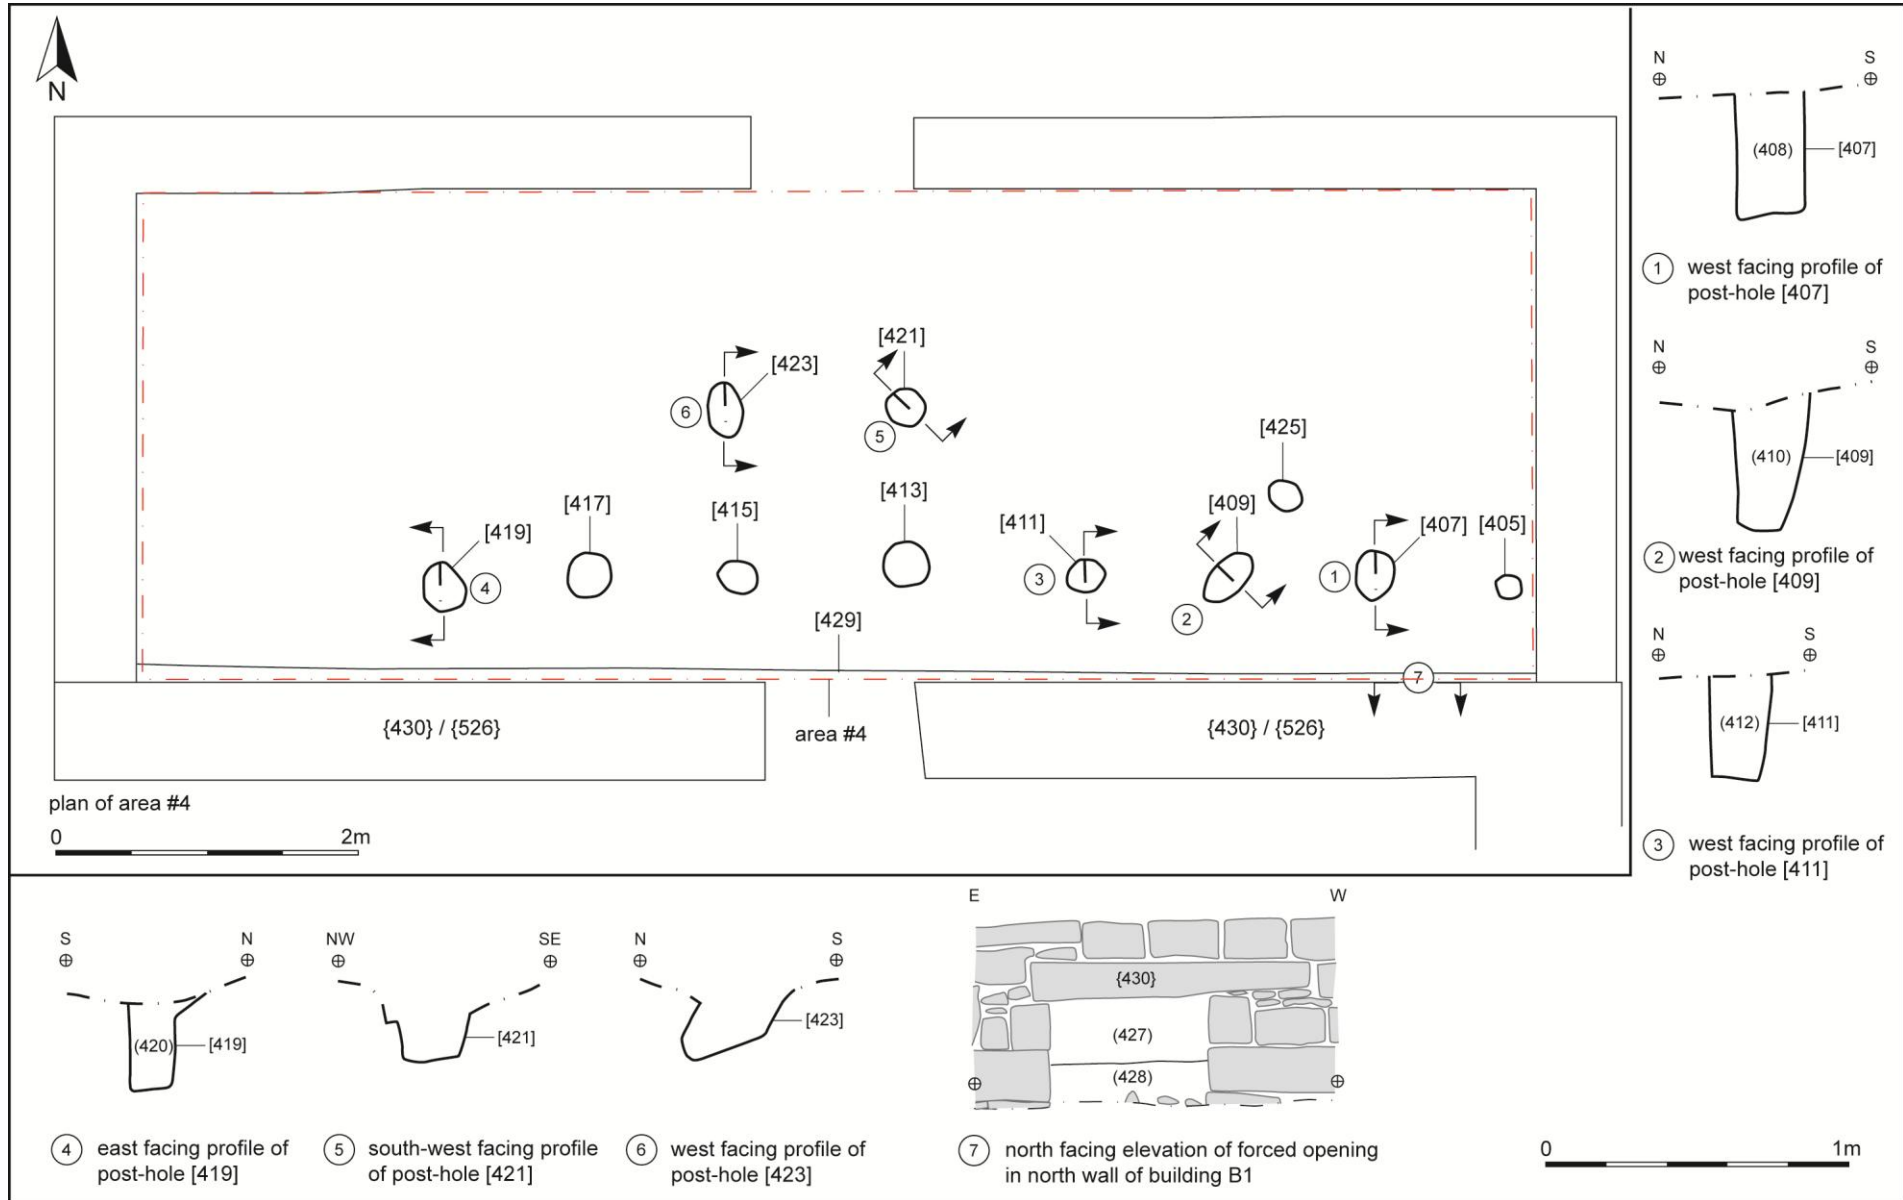
Figure 23: Area #4 plans and sections.

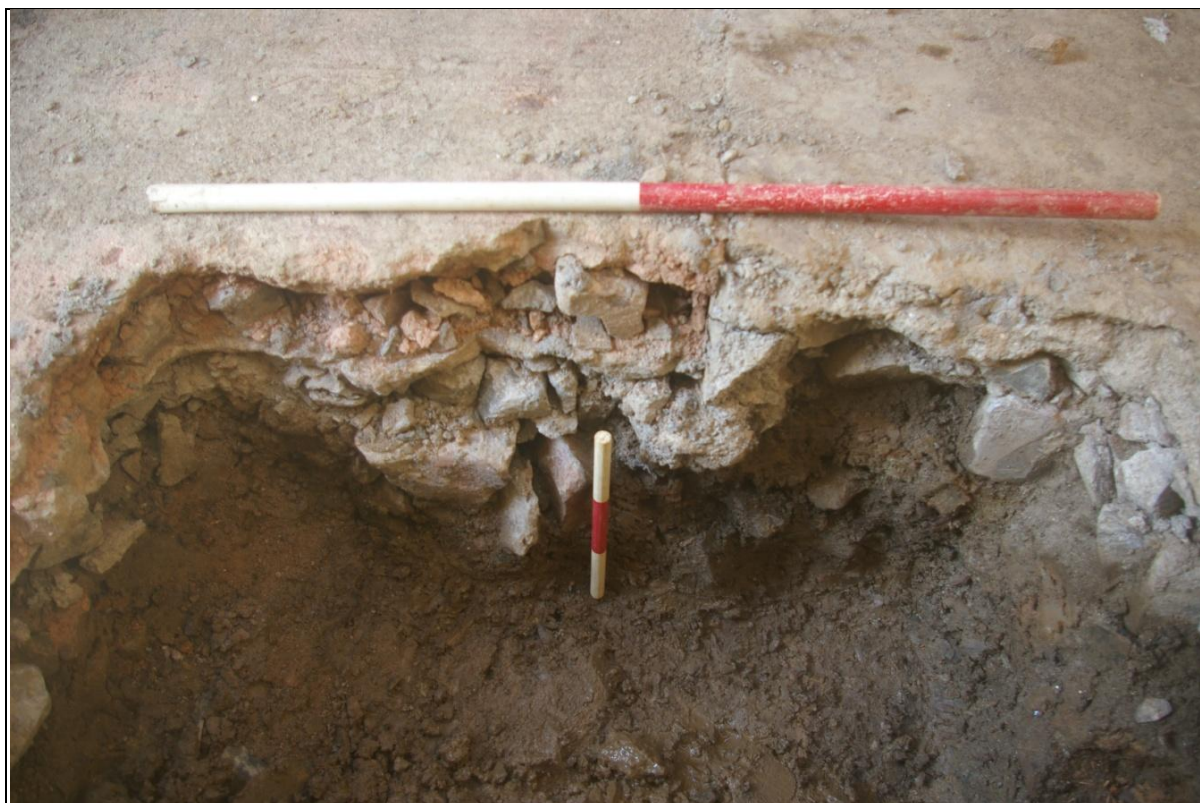
An initial test-pit measuring 1m×1m was excavated to allow for part of the existing east wall of building B1 to be shored-up. The stratigraphy comprised: the existing concrete floor surface (500), (503); underlying aggregate bedding layers (501), (502), (504); layers (505), (506), (507), and (508); comprising grey-brown silt-clays with common to frequent sub-angular irregular stones; and re-deposited layer (509); brown clay (Figure 24).

Figure 24: East facing section of test pit, Area #5; viewed from the east (0.3m and 1m scales).

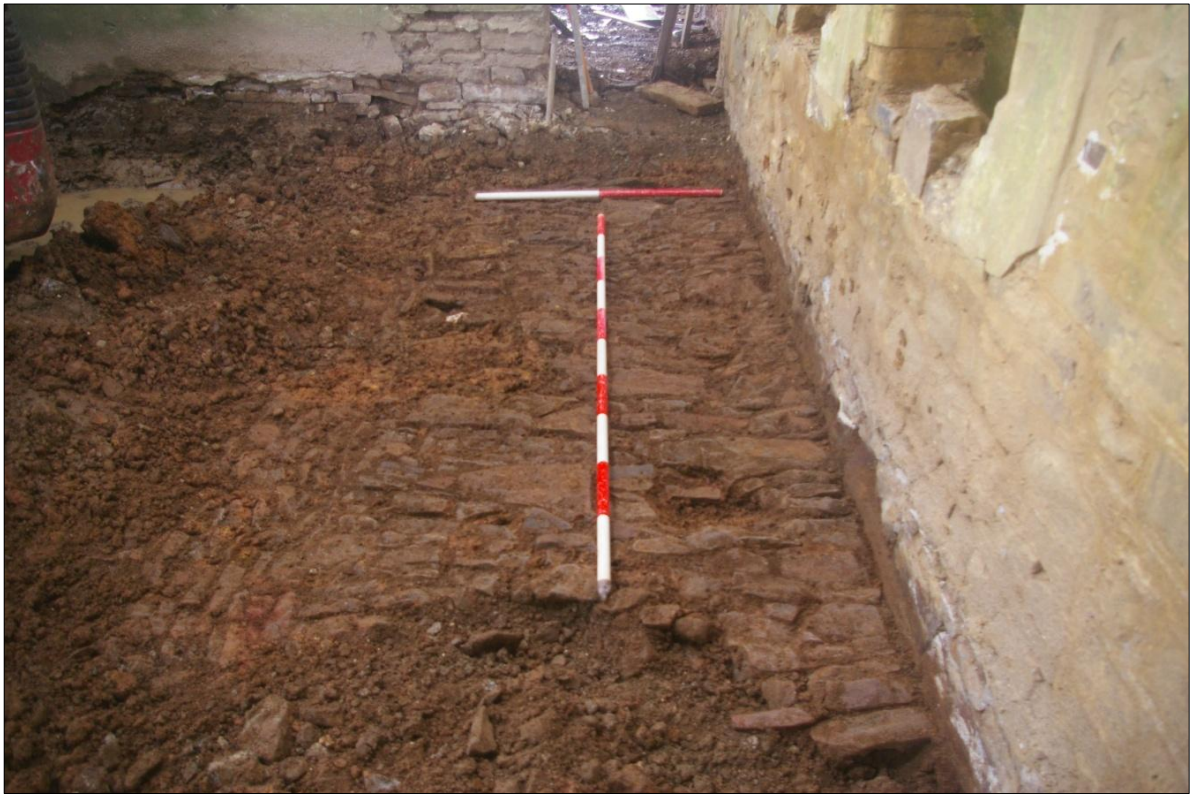
Cobble surface (520) only partially survived in the north-west corner of Area #5 (Figures 25,26), covering an area measuring 2.9m×1.5m on an east-west alignment. It comprised angular to sub-angular stones 0.1m-0.3m set to a depth of 0.05m with an earth bond, and had been laid upon a base layer (521) of grey-brown soft silt-clay 0.05m thick. Set within the cobbles were a small number of larger, more irregularly shaped stones (and voids suggesting the removal of such stones) which may have formed post-pads, though there is no conclusive evidence for this.

Figure 25: Post-excavation plan view of cobble surface (520), Area #5; viewed from the east (1m and 2m scales).

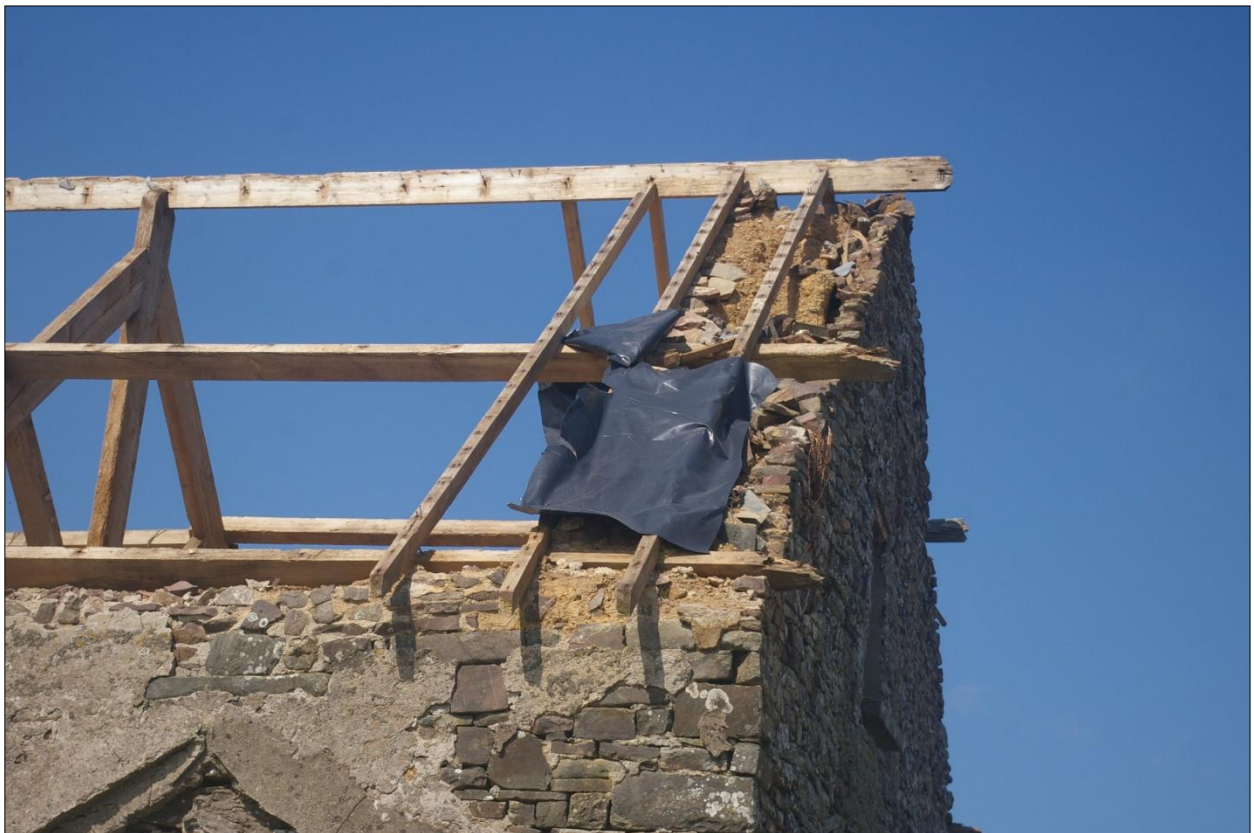
Detail of construction of east gable end of building 1; viewed from the south-east.

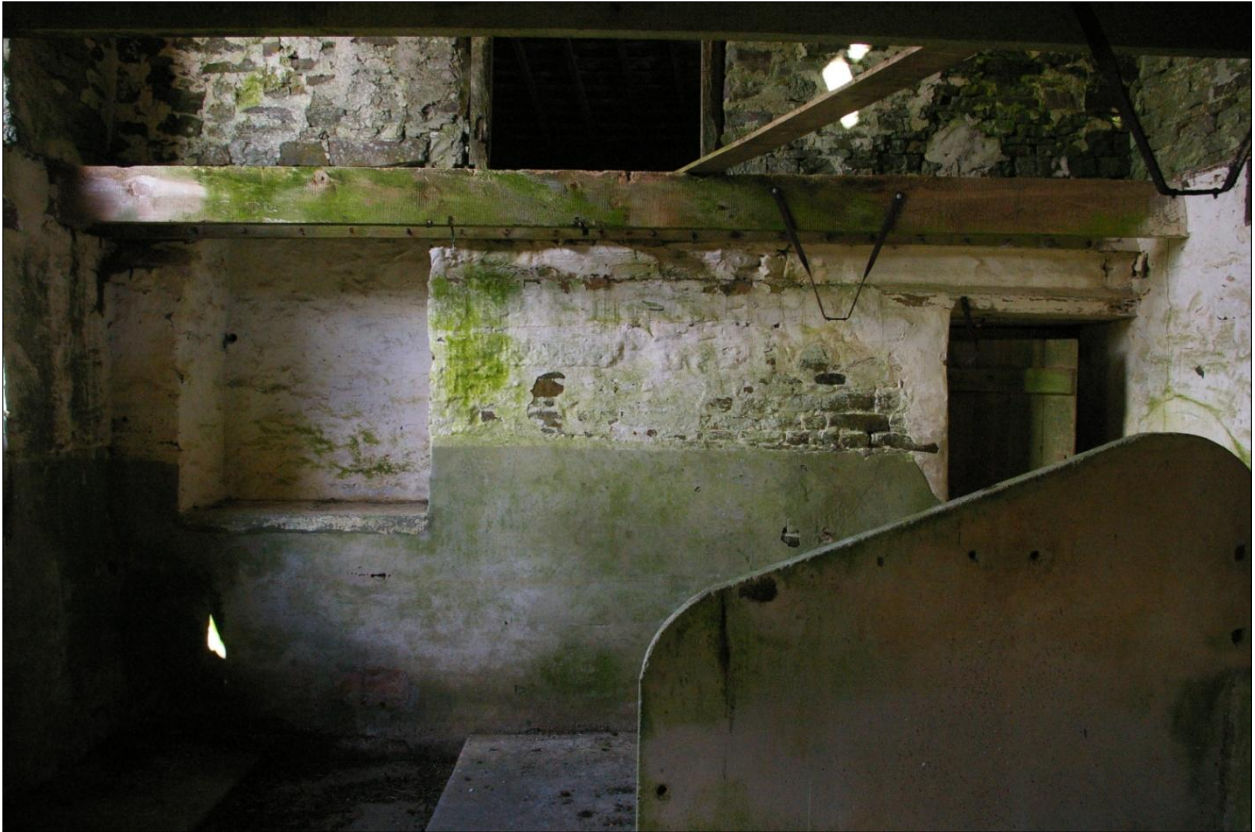
The west wall of Building 1, internal face, showing the blocked window at ground floor level; viewed from the east.

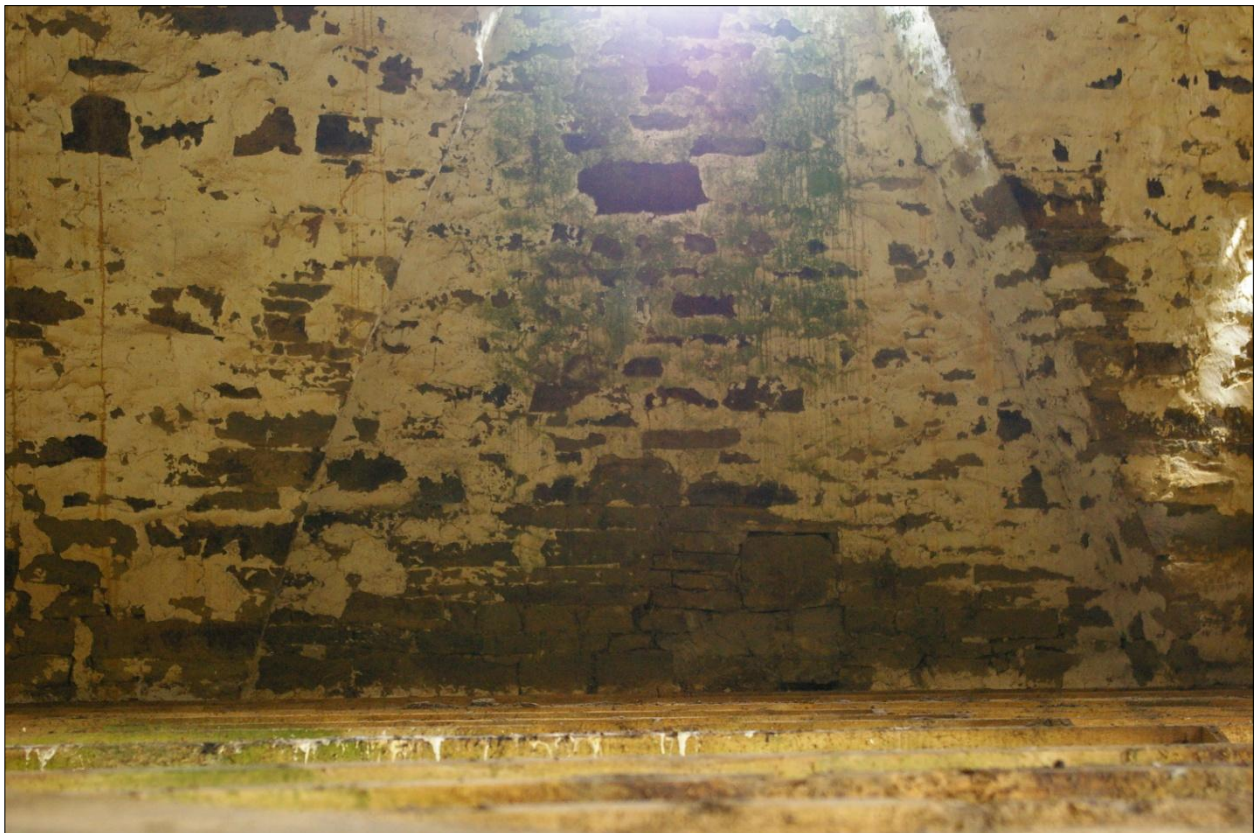
The east gable wall of Building 1, internal face, at first floor level, showing detail of the possible chimney stack structure, viewed from the north-west.

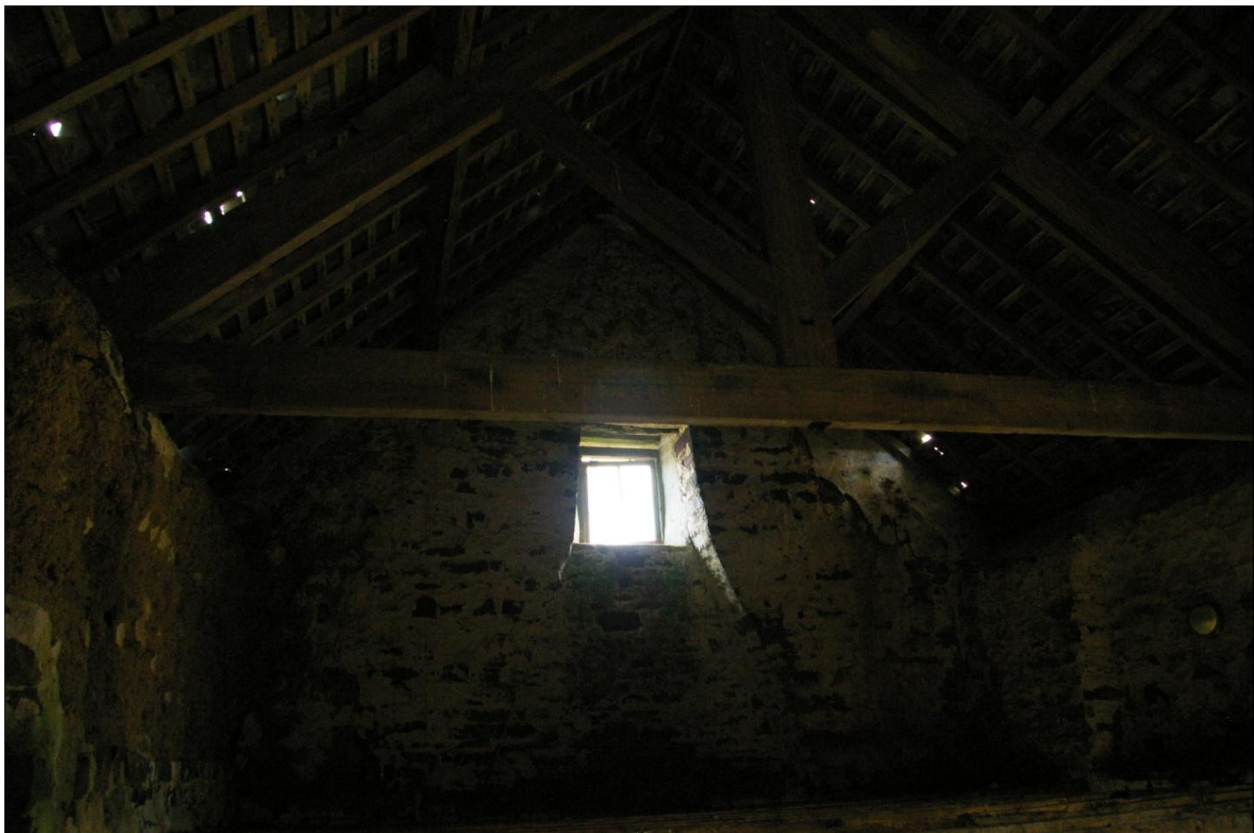
The east gable wall of building 1, internal face at first floor level, showing detail of the window forced into the chimney stack; viewed from the north-west.

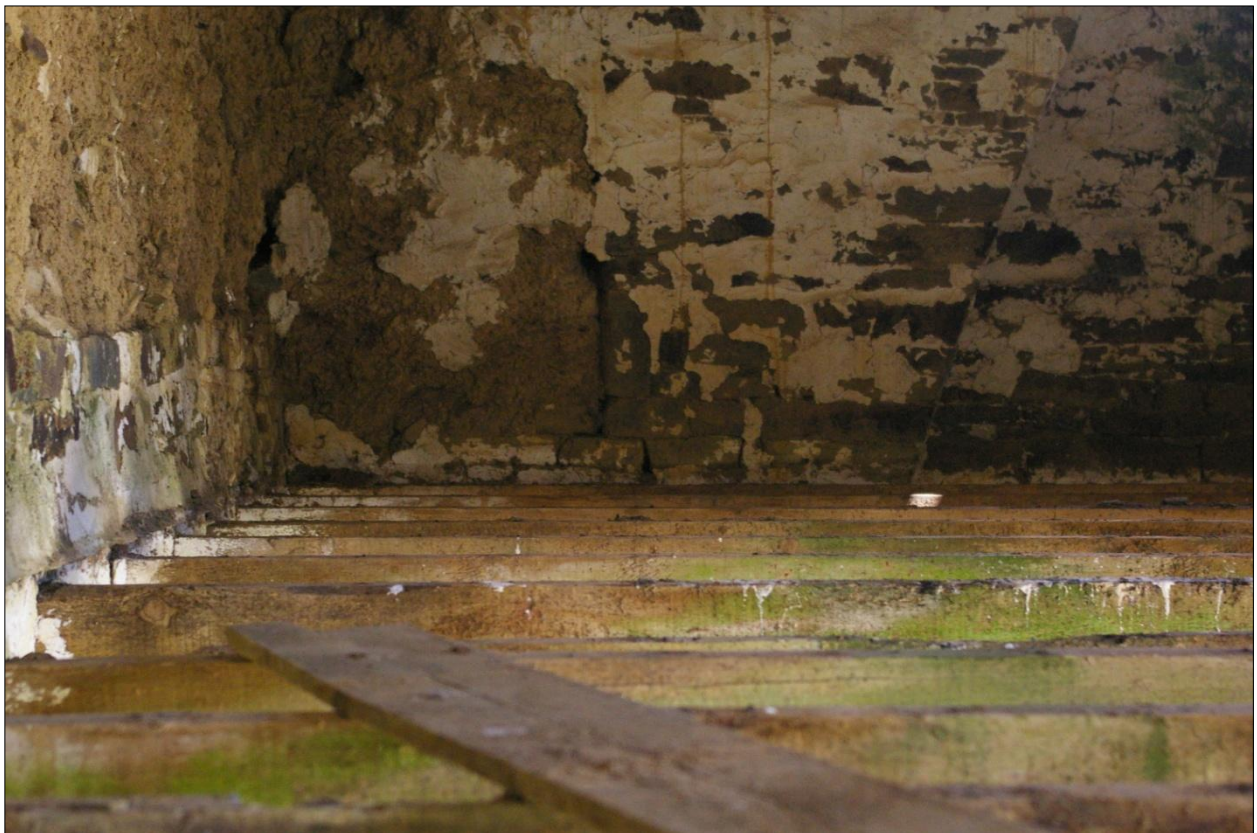
The east gable wall of Building 1, internal face, at first floor level, showing detail of the chamfered reveal/edge visible to the north of the chimney stack in the east wall of Building 1; viewed from the west.

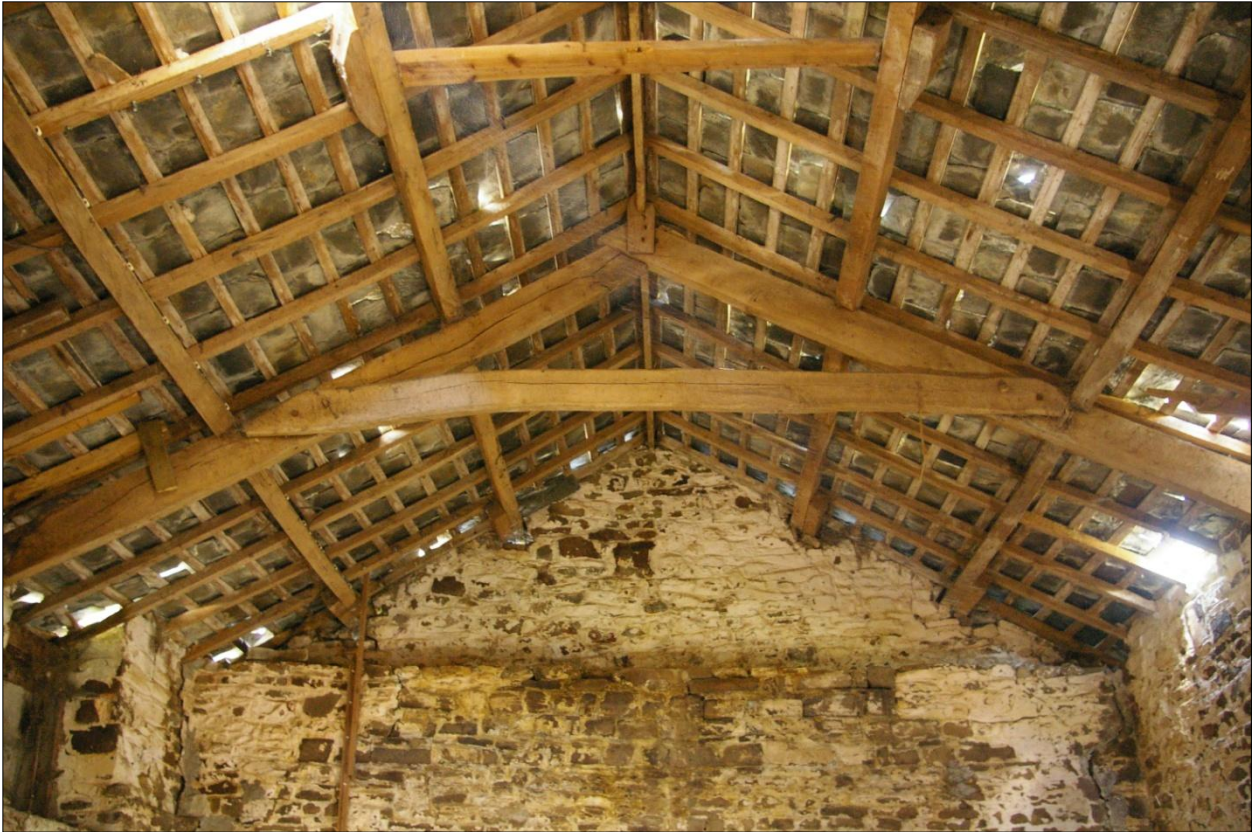
The pegged and bolted A-frames within Building 2; viewed from the north.

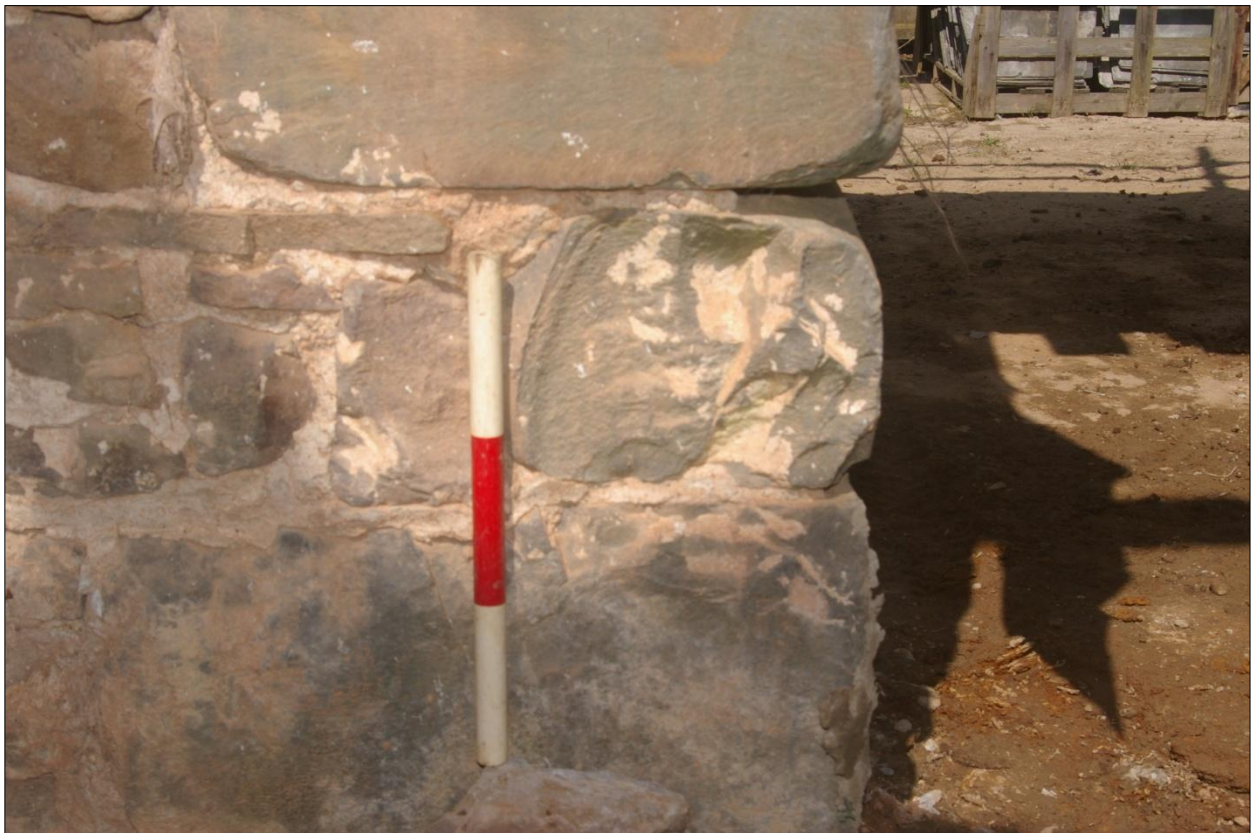
Detail of possible ecclesiastical stone set within north doorway of building 3; viewed from the south (0.3m scale).

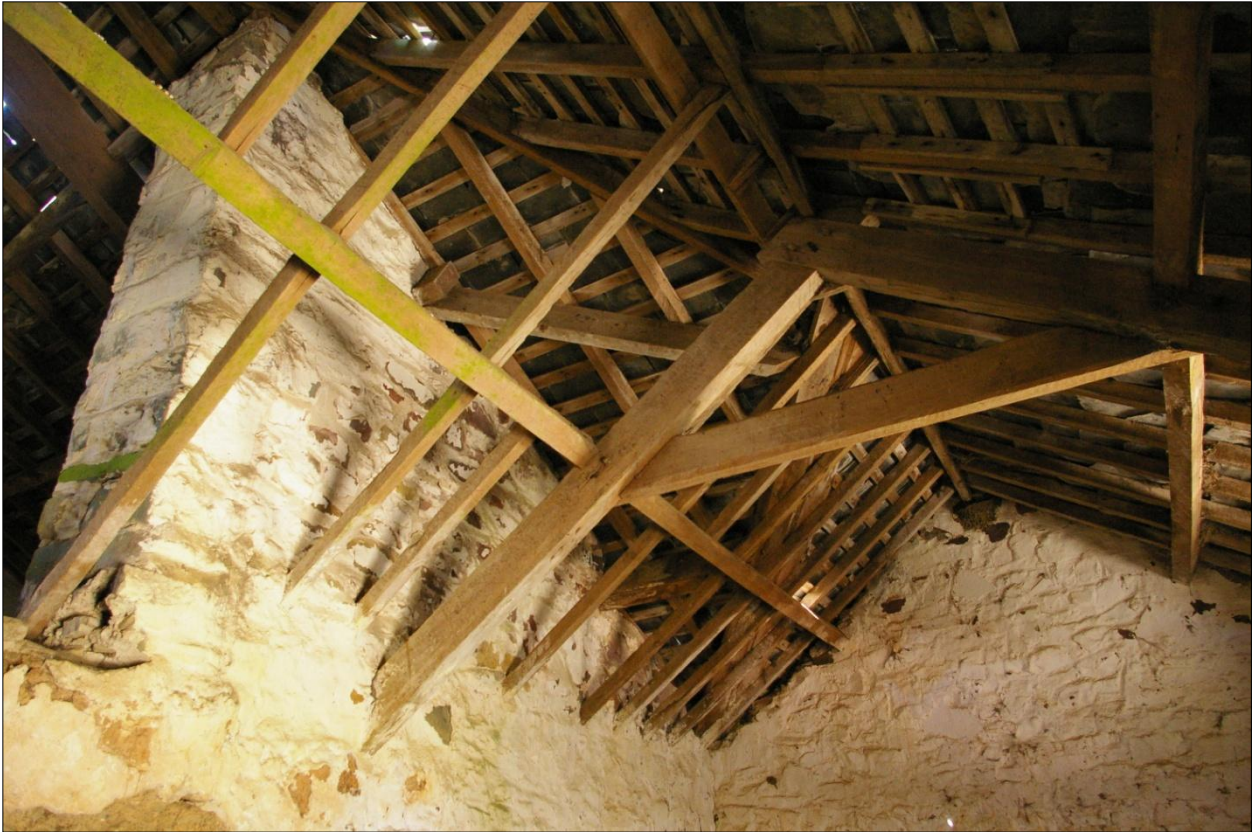
The pegged and bolted A-frame roof within Building 7, which survives within the modern roofing, which runs over the top; viewed from the north-east.

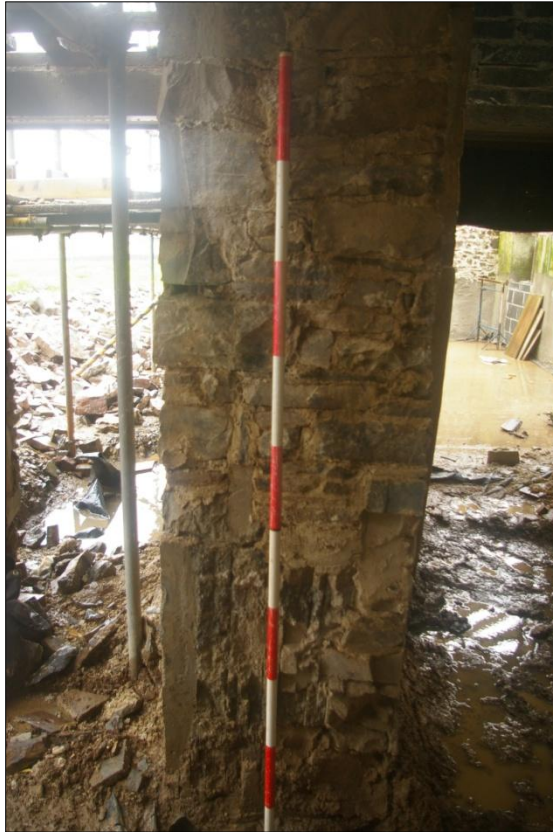
Recent forced opening through east wall of B1 showing recent wall repairs, Area #5; viewed from the north (2m scale).

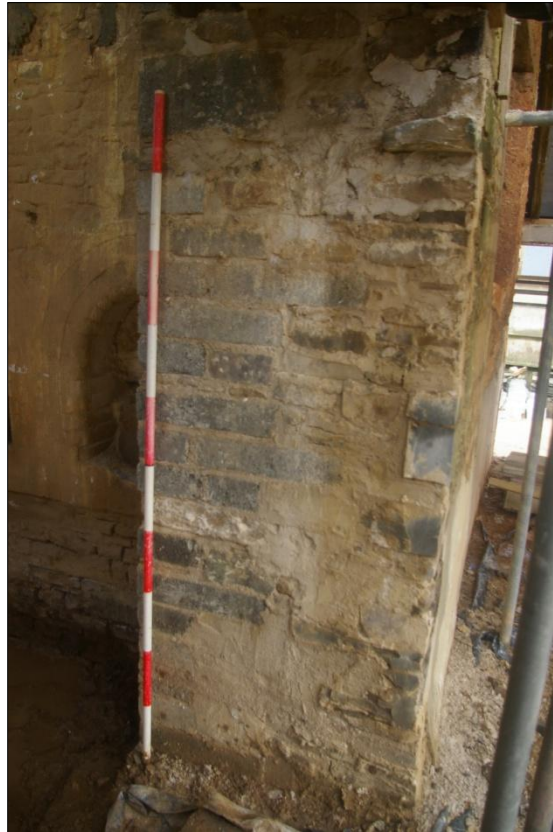
Detail of recent repairs after forced opening through east wall of building B1, north end, Area #5; viewed from the south-east (2m scale).
