HIGHER VELLY FARM, HARTLAND, TORRIDGE, DEVON

Results of a Desk-Based Assessment,
Historic Building Recording &
Archaeological Monitoring

Report No.: 160106
Date: 06.01.2016
Author: E. Wapshott
P. Webb

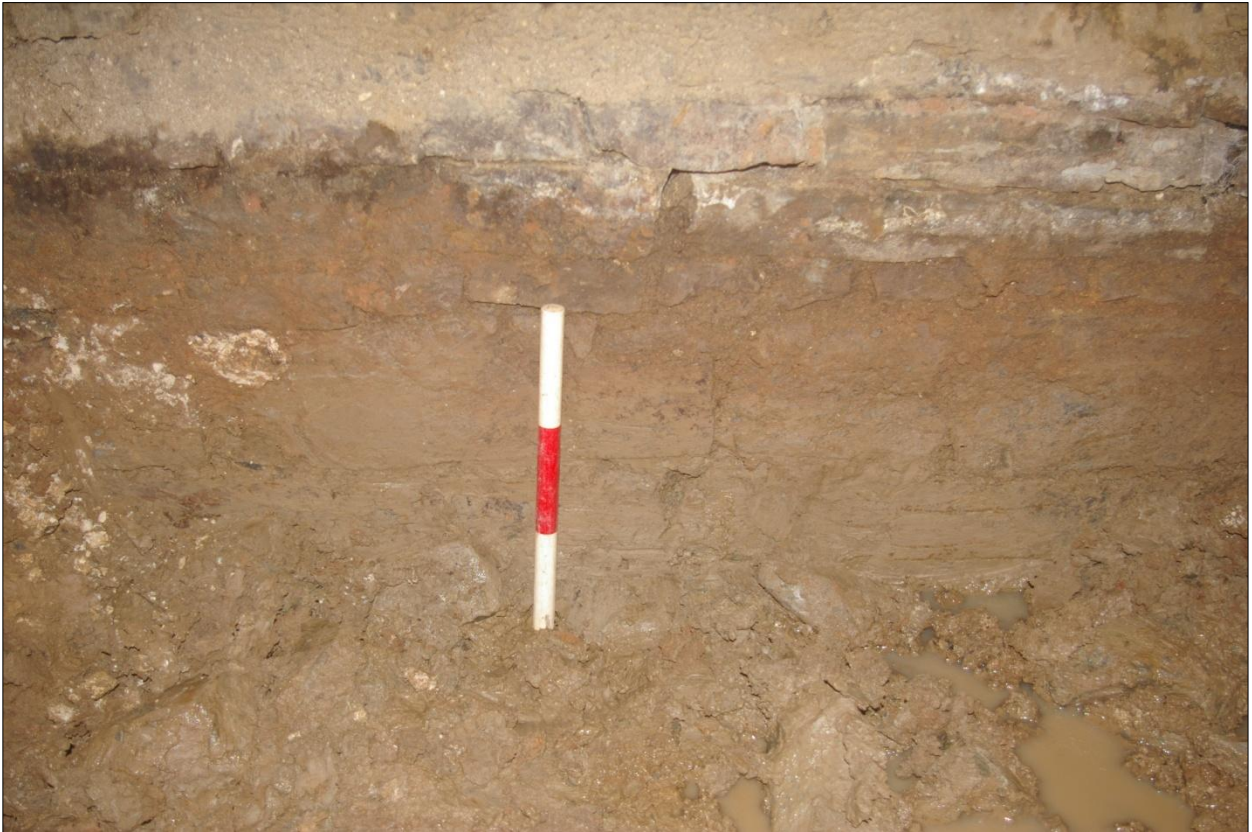
Detail of lower wall foundations of north wall, building B1, Area #5; viewed from the south (0.3m scale).

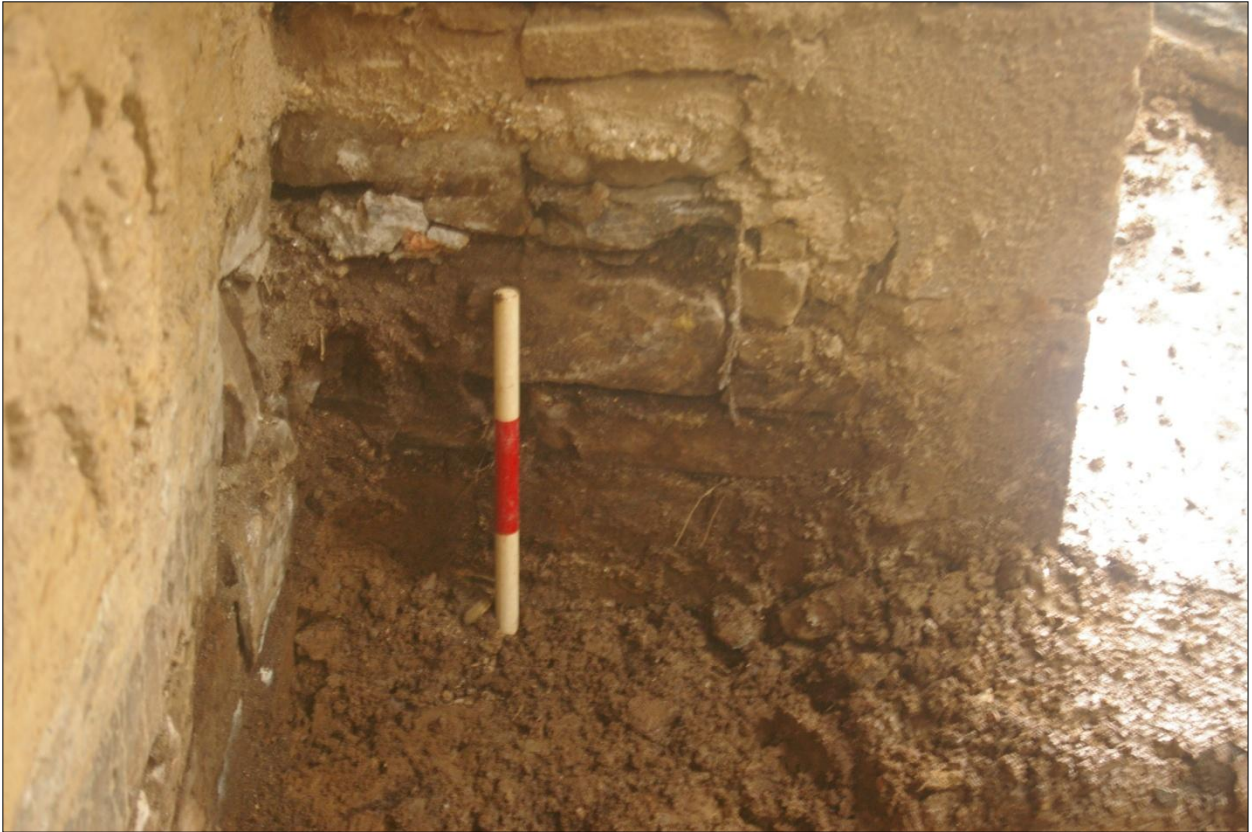
Detail of lower wall foundation of east wall, building B1, north end, Area #5; viewed from the west (0.3m scale).

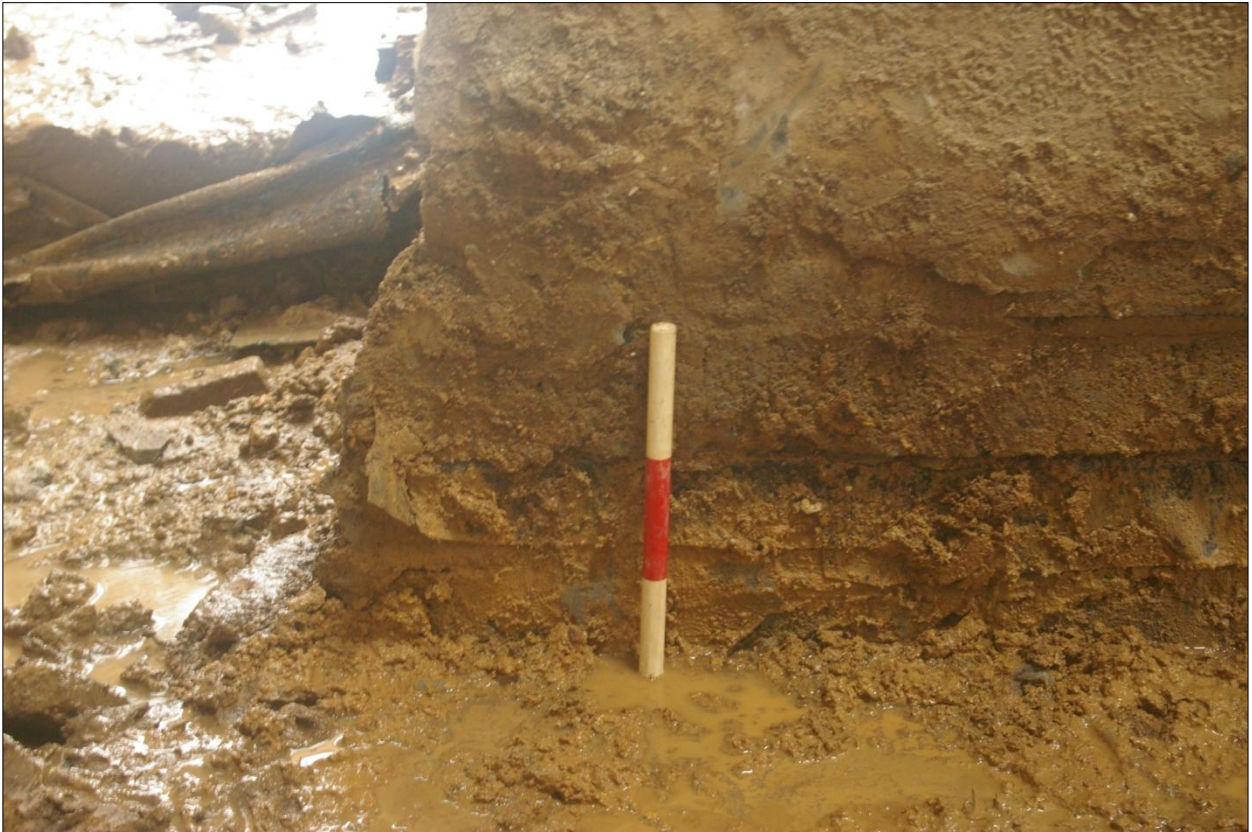
Detail of lower wall foundation of east wall, building B1, south end, Area #5; viewed from the west (0.3m scale).

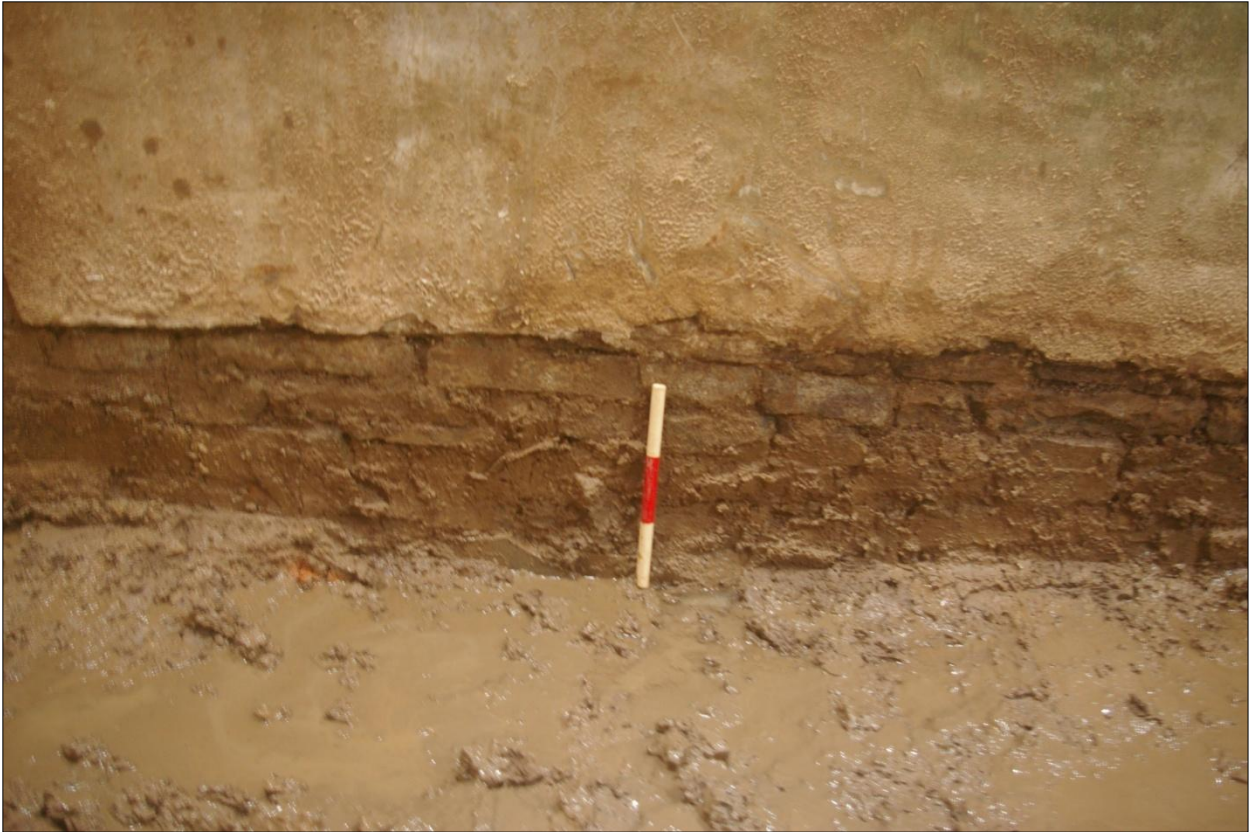
Detail of lower wall foundations of south wall building B1, Area #5; viewed from the north (0.3m scale).

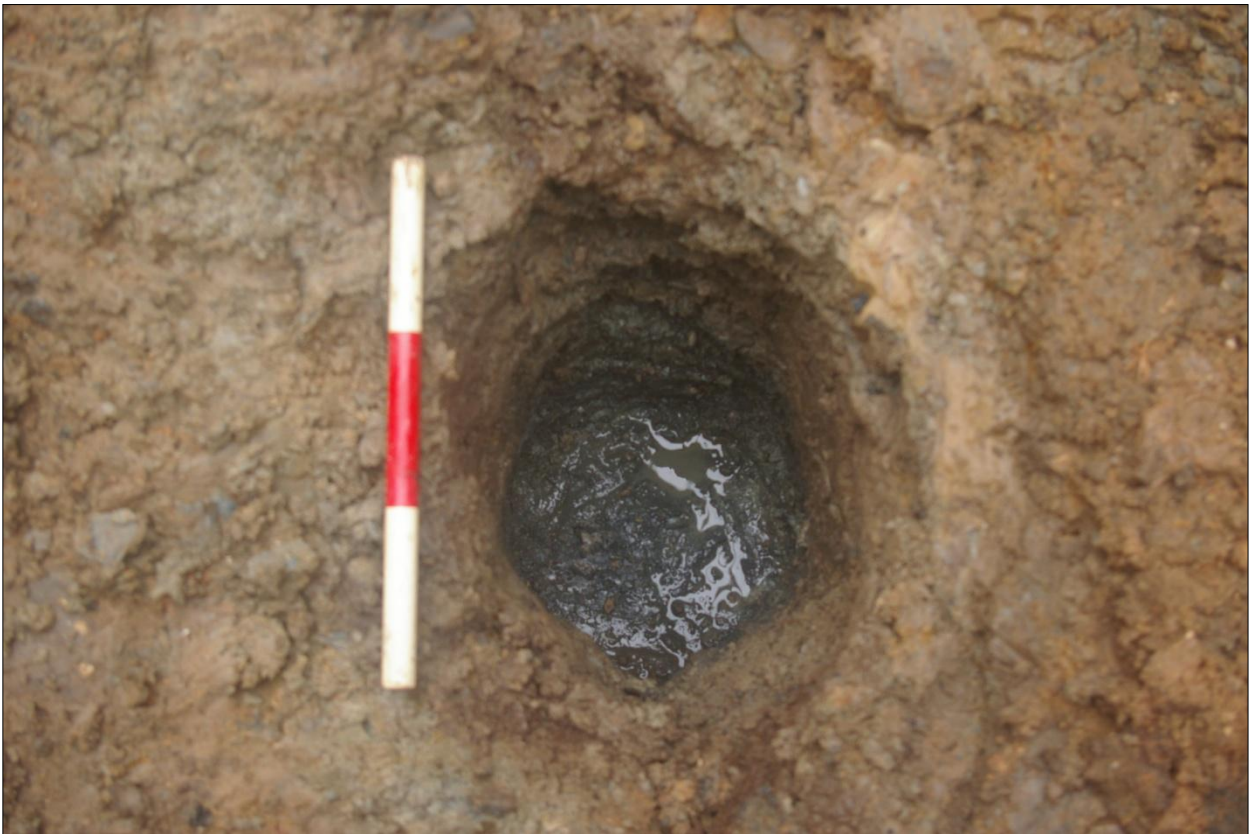
Post-excavation plan view of post-hole [620], Area #6; viewed from the south (0.3m scale).

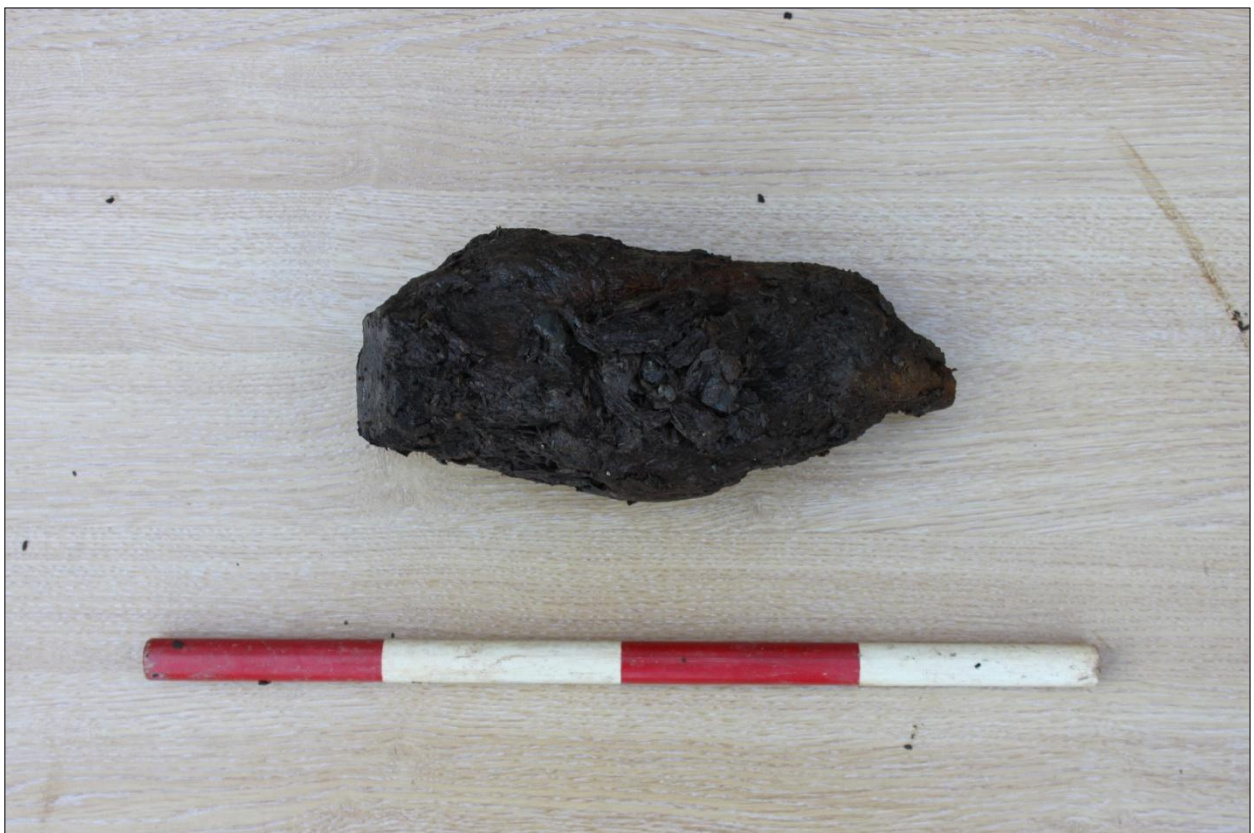
View of post recovered from within post-hole [421] (0.4m scale).
