LAND at BACK LANE AUGHTON LANCASHIRE

Results of a Revised Desk-Based Assessment, Walkover Survey & Historic Visual Impact Assessment

> Report No.: 150811 Date: 11.08.2015 Author: E. Wapshott B. Morris

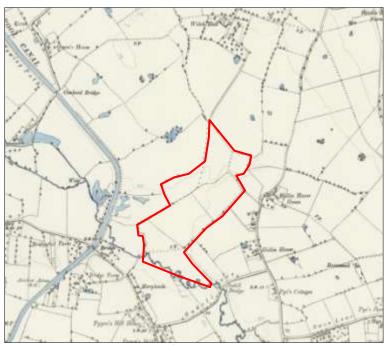
Figure 6: Extract from the OS 1st edition 6" map (1:63,360) surveyed 1891-92, published 1894 (Lancashire Sheets XCI.NE & XCI.SE).

By 1893 (Figure 6, Lancashire Sheets XCI.NE & XCI.SE, 1:63,360) a number of the historic field boundaries shown on Figure 5 had been lost and the fields enlarged. *Wood Meadow, Wood Croft* and *Field next to Six Acre Park* had been thrown together, the boundary separating *Gravel Hey* and *Gravel Fields* removed, and the Sudell Brook canalised. By the mid 1920s (OS 3rd revision 1926, not illustrated) almost all of the fields shown on Figure 5 as belonging to Thomas Blundell had been amalgamated and the internal ditches or hedgerows removed (see Figure 8, Lancashire Sheets XCI.NE & XCI.SE, 1:63,360). Substantial boundary loss across the whole area occurs between the 1950s and the 1970s (OS National Grid 1974, 1:10,000, not illustrated).

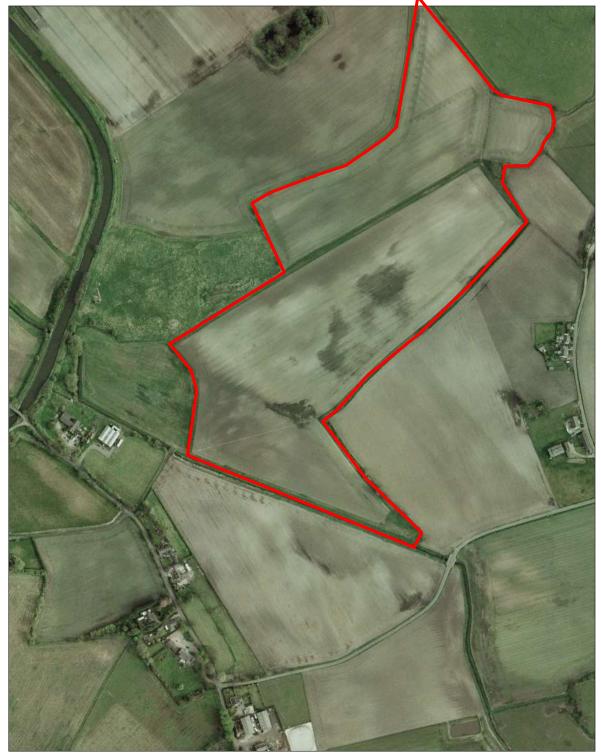
Figure 11: A recent (2005) aerial photograph, showing crop- and soilmarks (© Infoterra Ltd. & Bluesky) (the site is indicated).

A review of the online and readily-available aerial photographs was undertaken, but this demonstrated that recent aerial photographs were not particularly helpful. The only clear cropmarks are large, irregular and diffuse and presumably relate to either palaeo-channels or areas of differential waterlogging (Figure 11). Aerial photographs subsequently provided [11.08.15] by the Lancashire HER shows the western end of the site and the fields adjacent to the west to contain a series of cropmarks (Figure 12 and Figure 13), including what are clearly palaeochannels (relating to the pre-canalisation course of the Sudell Brook), but also what could be relict field boundaries (or possibly land under-drainage) and a small circular double-ditched enclosure or ring-ditch. The diffuse character of some of these crop- and soilmarks makes it difficult to be conclusive, but it does indicate this part of the site has archaeological potential.

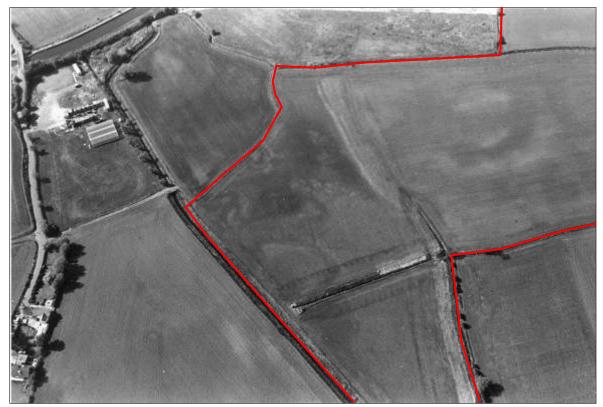
Figure 12: Aerial photograph (viewed from the south, looking north) supplied by Lancashire HER (2816-N1663). The red-line boundary of the site is shown.

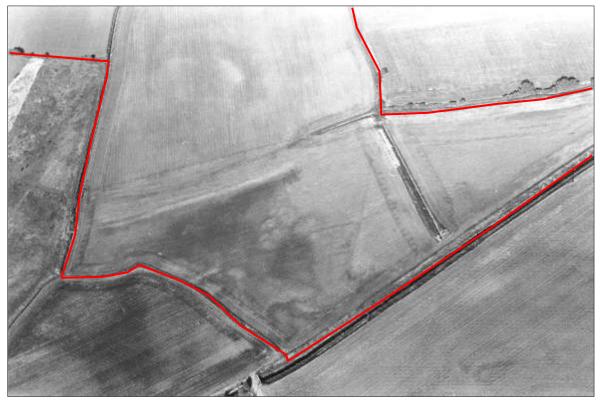
Figure 13: Aerial photograph (viewed from the west, looking east) supplied by Lancashire HER (2816-N1666). The red-line boundary of the site is shown.

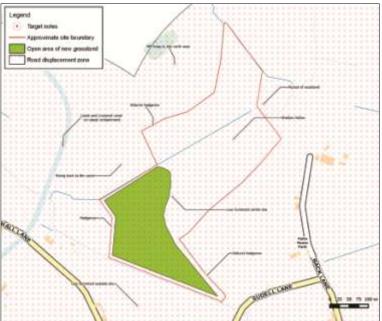
Proposed layout (above) and eco-diversity zone (below).

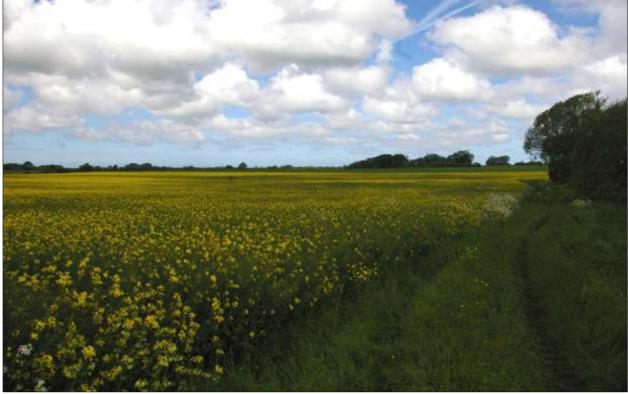
View up and across the fields from the south-east corner, along the footpath; from the south-east.

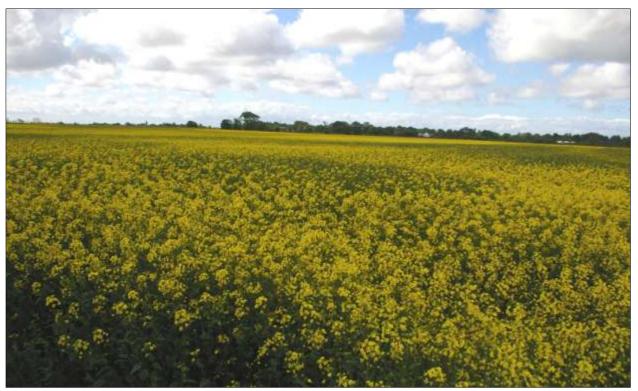
View across the south field; from the east.

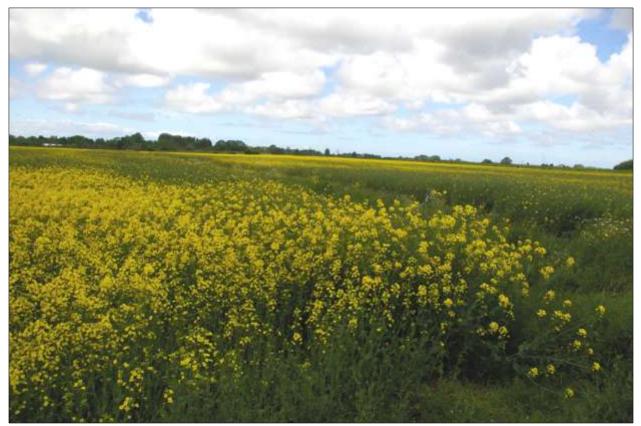
View across both fields, and the drainage ditch that divides them; from the east.

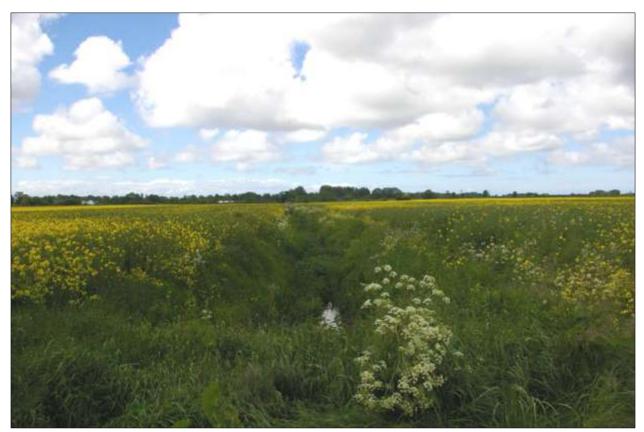
View along the drainage ditch that divides the two fields; from the east-north-east.

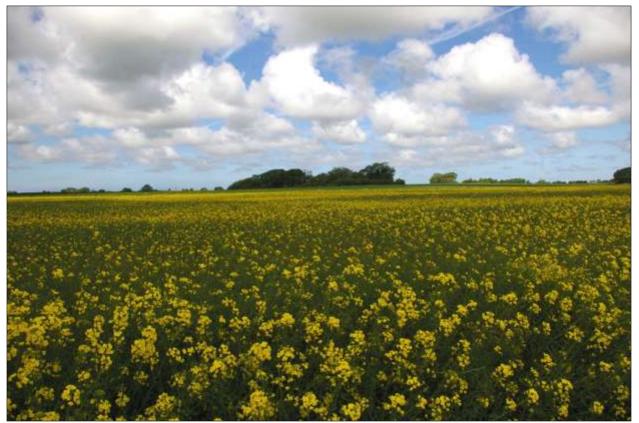
View across the north fields, looking across to a copse of trees around former gravel pits; from the south-east.

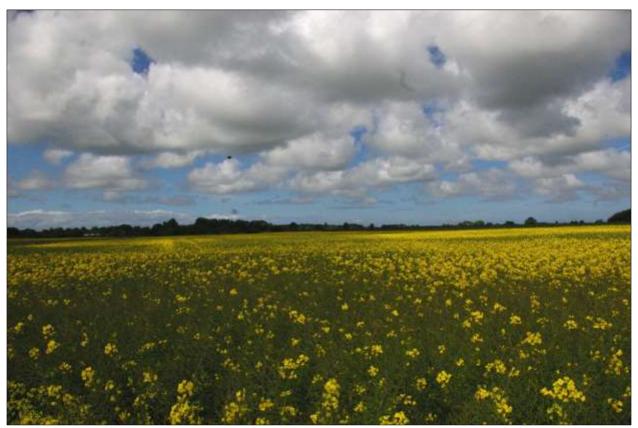
View across the north field; from the east.

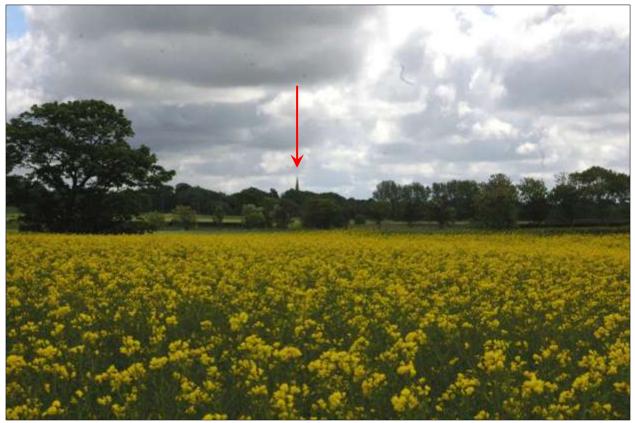
View to the spire of Aughton Church (indicated) from the site; from the west.

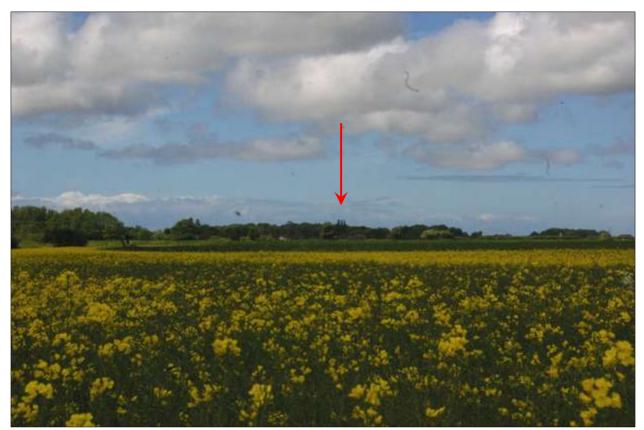
View to the tower, parapet and finials of the Catholic Church of Our Lady, Lydiate (indicated), across the fields; from the east.

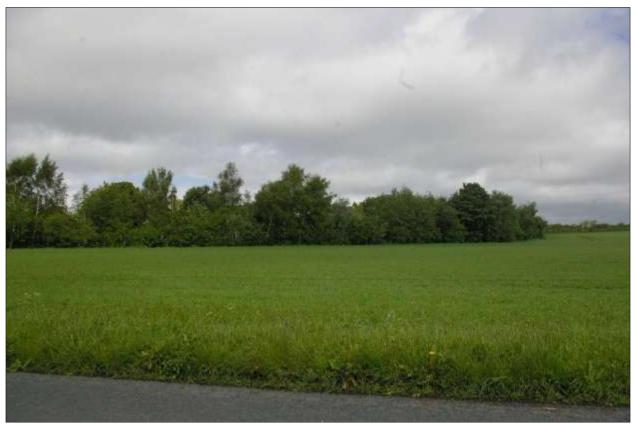
Downholland Hall, viewed from Black-a-Moor Lane across the fields showing screening from trees; from the south-south-west.

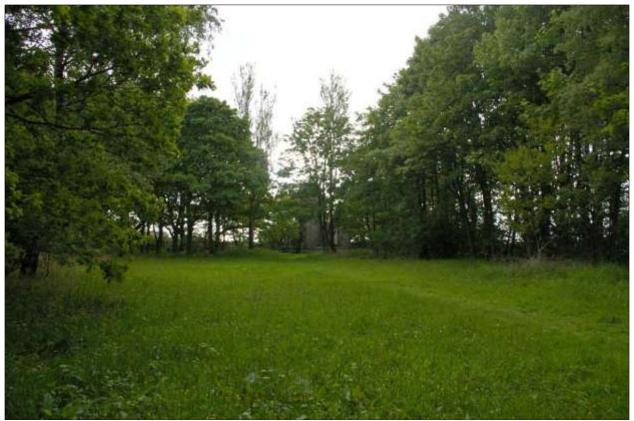
St Katherine's Chapel in Lydiate, set amongst its dense copse of trees; from the east-south-east.

Designation: GII*/SAM (chapel yard) Condition: fair Description: Ruined chapel, of late 15th or early 16th century. Plan of five-bay nave, south porch and west tower. Diagonal buttresses and remains of cornice to nave. Perpendicular-style south windows with transoms, tracery remaining to central windows between weathered buttresses. Porch at western end now has only lower parts of walls remaining and Tudor arched headed inner entrance. Blank north wall with buttresses. East end has walls flanking window up to springers. Tower of three stages with drip moulds and diagonal buttresses, with four-centred internal tower arch on half-octagonal responds. One of two surviving private chapels in southern Lancashire.
