# LAND at STOKE BARTON FARM, HARTLAND, DEVON

Results of a Desk-Based Assessment,  
Impact Assessment & Evaluation Trenching

Report No.: 151015  
Date: 15.10.2015  
Authors: P. Webb  
E. Wapshott  
S. Walls

*This report presents the results of a desk-based assessment, walkover survey, impact assessment and evaluation trenching carried out by South West Archaeology Ltd. (SWARCH) on land at Stoke Barton Farm, Stoke, Hartland, Devon in advance of the proposed construction of a single house.*

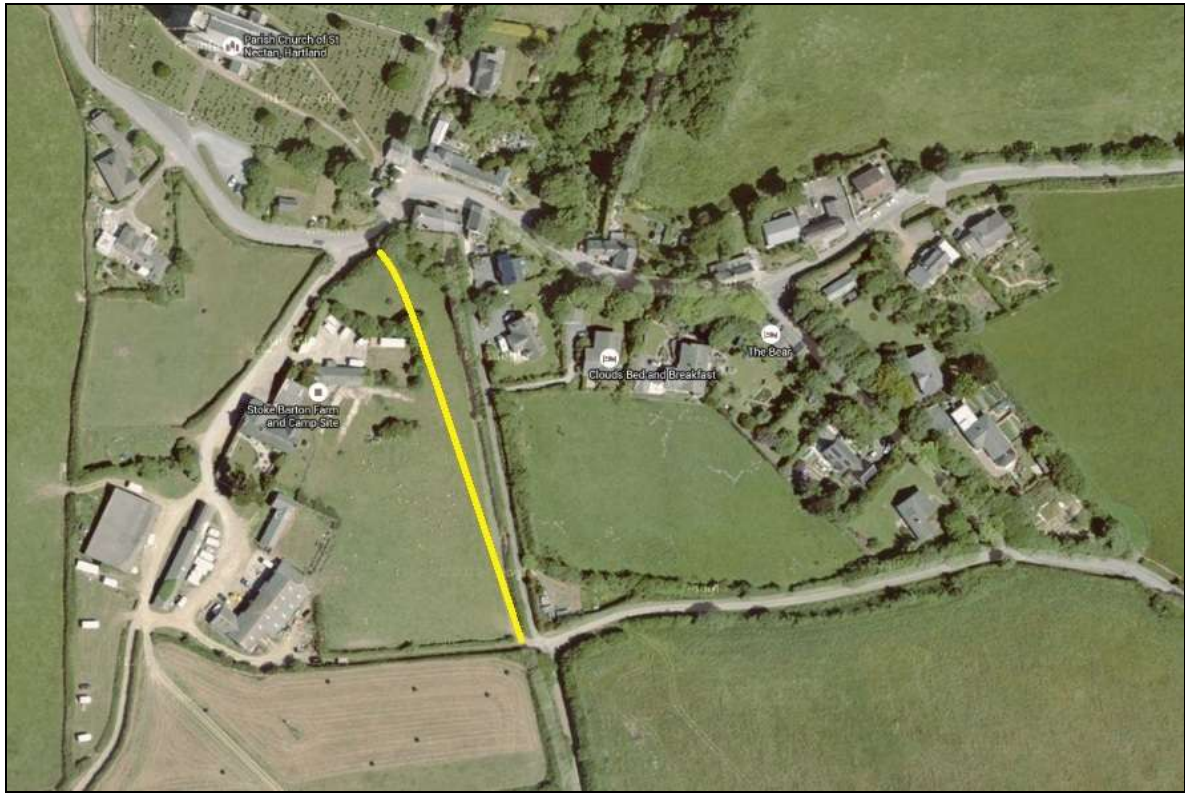
Figure 5: Aerial Photograph Showing the orientation of the identified hollow way in yellow (Google Maps).

association with a septic tank identified in the evaluation trenching. This area is enclosed by a curving hollow, which rises on an arcing-parallel to the farm track, through the fields, framing the farmstead on its east side. This hollow may relate to a possible former hollow-way or routeway (see Figure 5). There are no other visible earthworks or standing building remains.

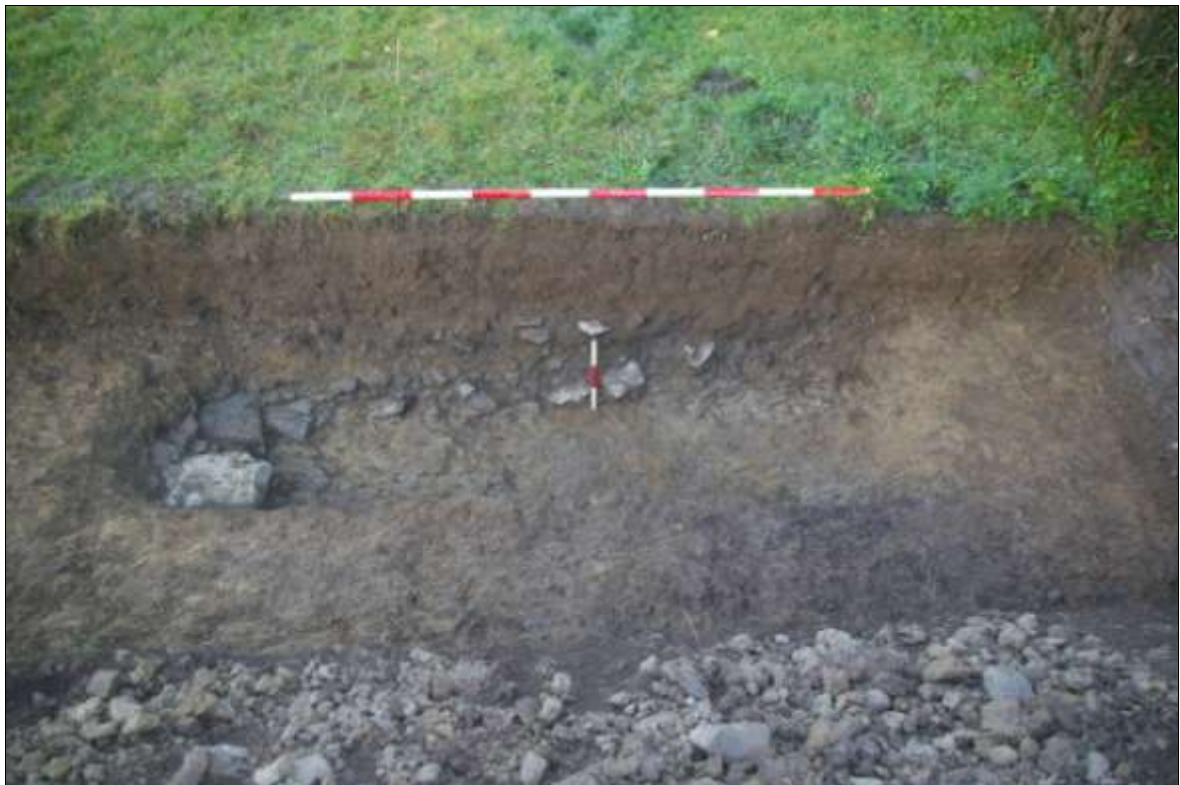
Figure 7: North-east facing section of [103]; viewed from the north-east (0.3m and 2m scales).

A single archaeological feature, ditch [103] (Figures 7-8), was identified at the northern end of the trench. It was orientated north-east to south-west and measured 1m wide x 0.44m deep with moderately steep northern side and stepped southern side, sharp break of slope and flat base. It contained three fills: (104), (105), and (106); grey-brown silt-clays with charcoal flecks and medium-large angular stone inclusions. A concentration of medieval pottery was recovered from the upper fill, (104), of this feature, though single examples of post-medieval glass and non-metallic slag were also recovered from its fills.

The presence of a relatively large assemblage of medieval pottery (approximately half of the finds) from the assemblage, primarily from the upper fill (104) of ditch [103], though including the fills of drains across the site, indicates the presence of medieval activity on or near the site, though none of the finds are from primary deposits.

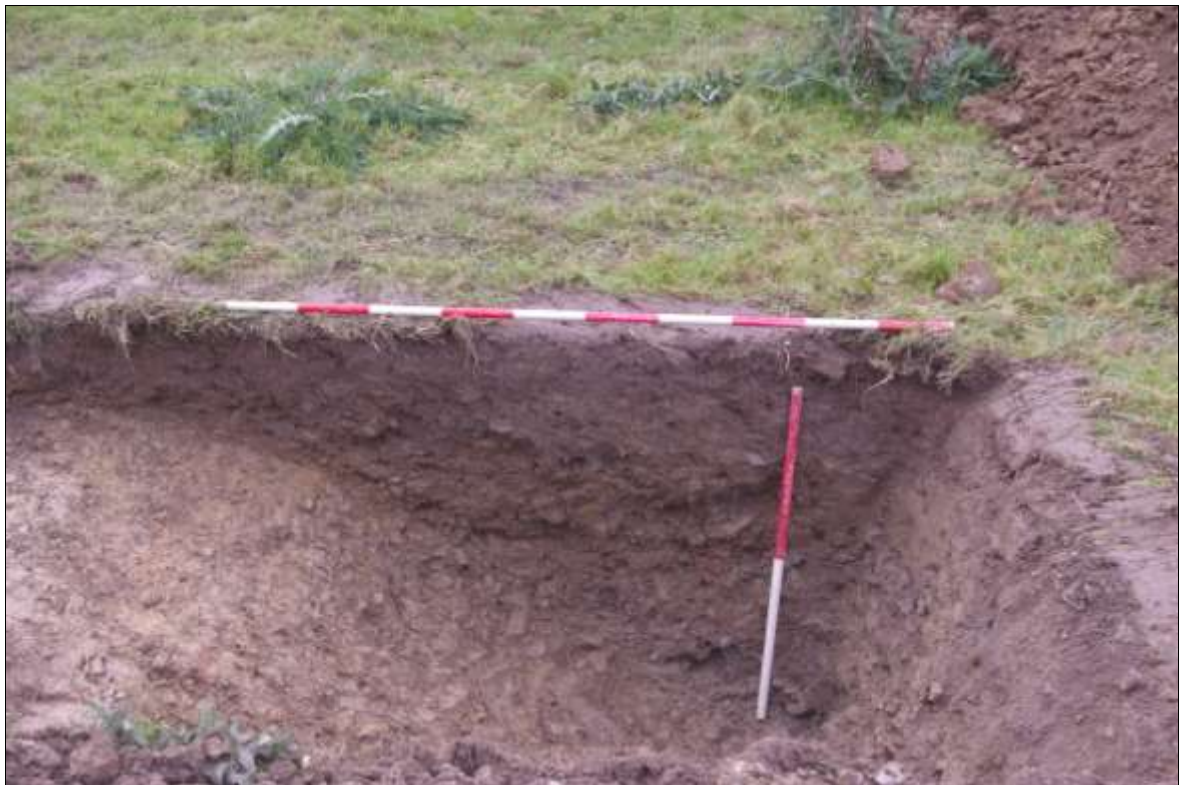
Figure 11: North facing section of ditch [403]; viewed from the north (1m and 2m scales).

Five features were identified within the trench: ditch/hollow-way [403], and gully [407], and drains [409], [411], and [413] (Figure 11). Ditch/hollow-way [403], located at the western end of the trench, formed the eastern edge of a depressive earthwork running north to south across the site, measuring 2.4m+ wide x 0.86m deep within the trench, with moderately steep eastern side, clear break of slope and flat base (Figure 12). It contained three fills: (404), (405), and (406); brown-grey clay to silt-clays with frequent angular stone inclusions. Post-medieval North Devon Wares were recovered from this feature.

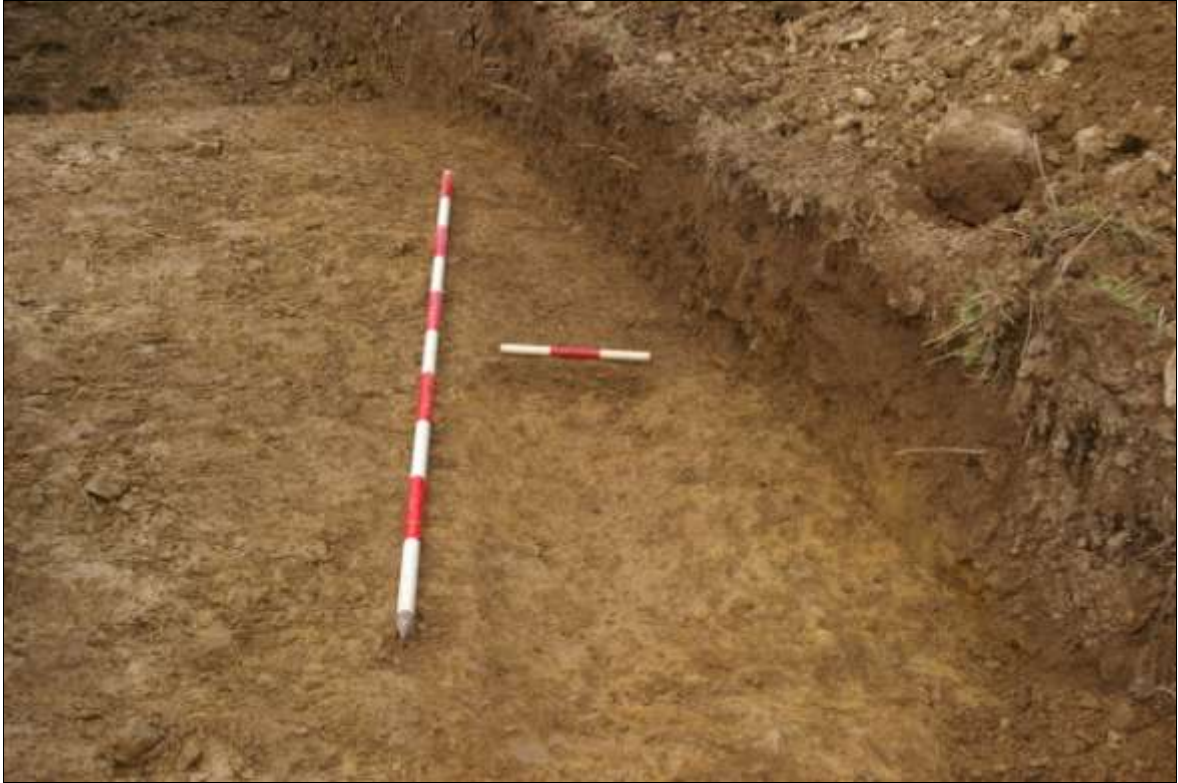
Figure 12: Post-excavation view of gully [407]; viewed from the south-east (0.3m and 2m scales).

Gully [407] was located towards the western end of the trench, immediately to the east of [403] and orientated approximately north-west to south-east, butt-ending towards the centre of the trench (Figure 13). It measured 3.2m x 0.38m wide x 0.08m deep with steep sides, clear to sharp break of slope and flat base. It contained a single fill: (408); a grey-brown silt-clay. No artefacts were recovered from this feature.

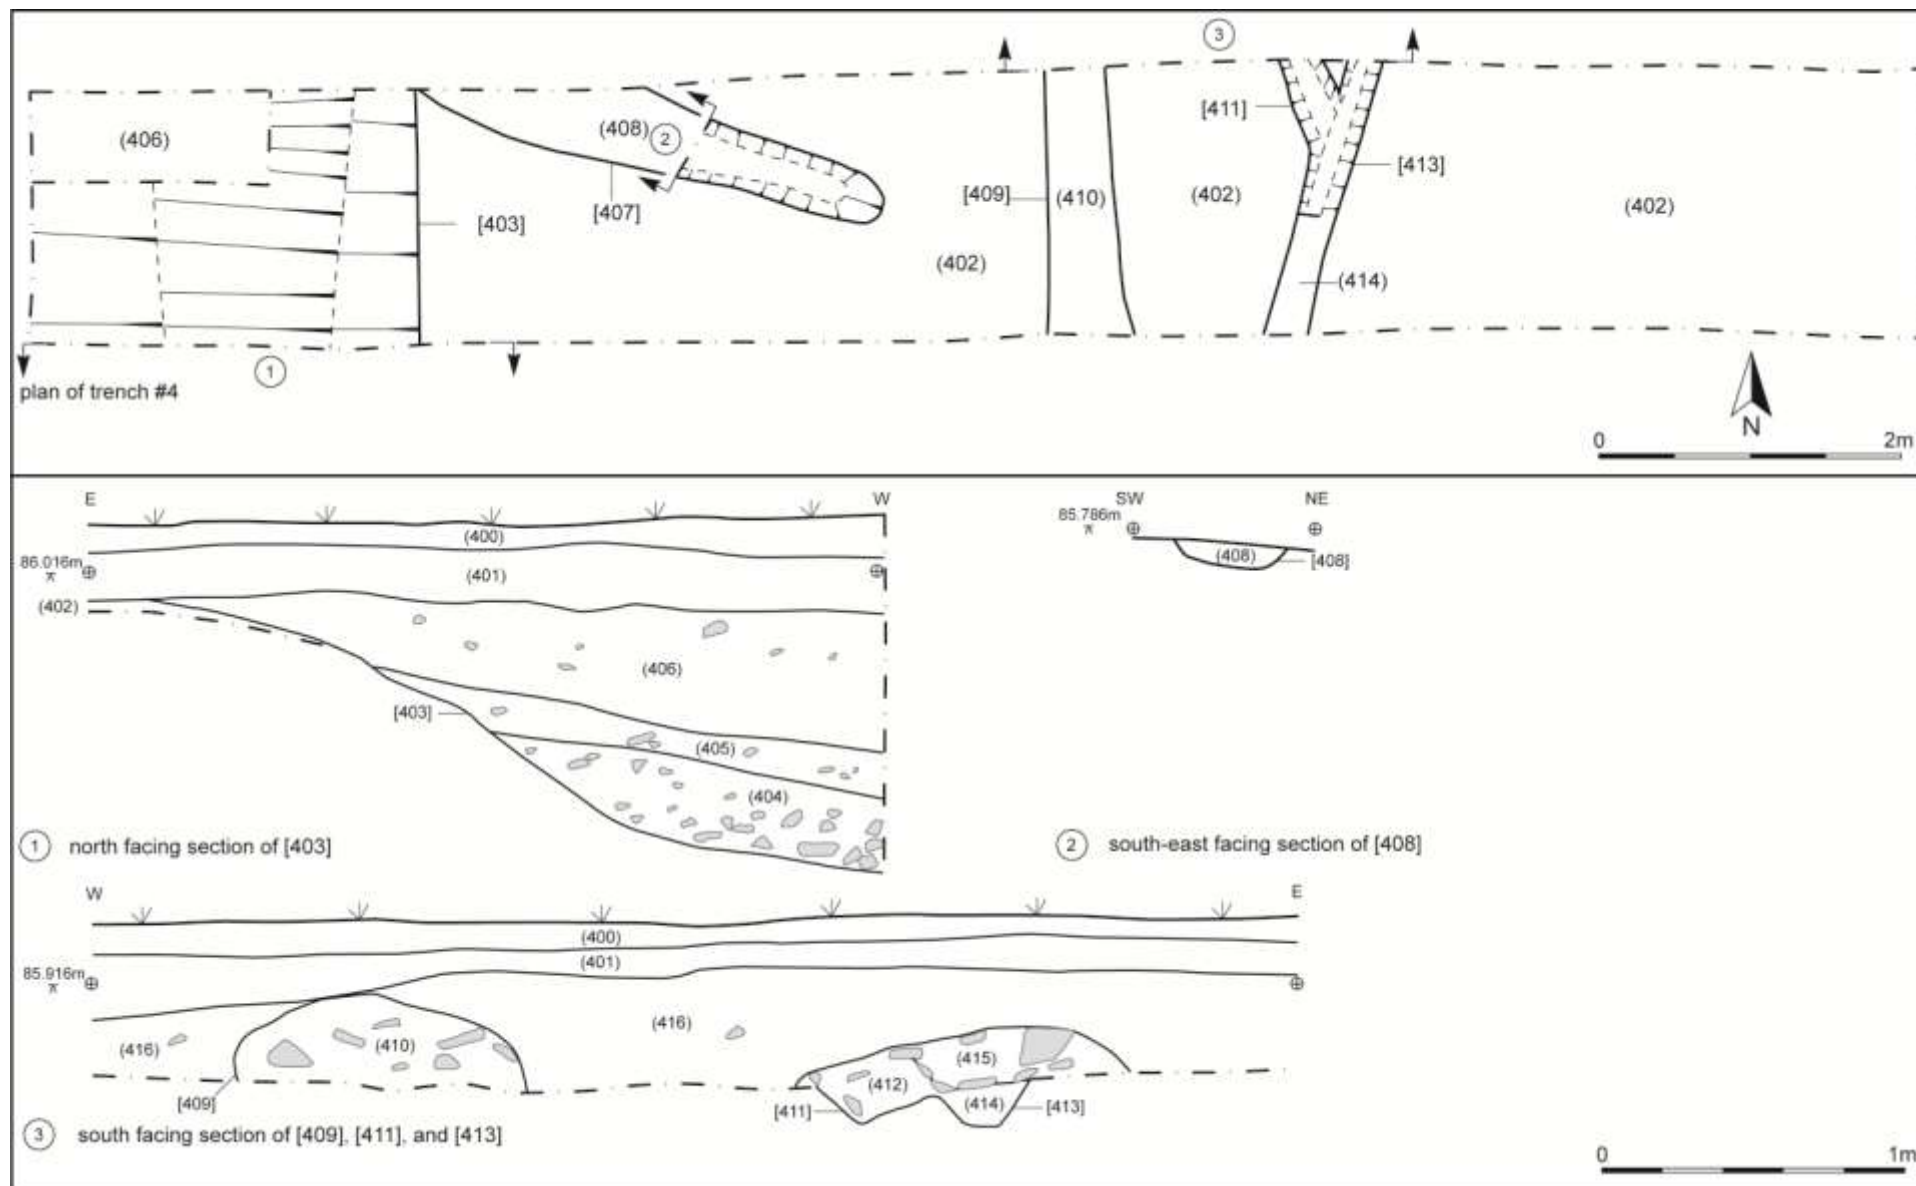
Figure 15: Trench #4 plans and sections.

Trench #4, located towards the eastern limits of the site to identify features which may be disturbed by the building foundations, and to examine the linear depression running north to south across the site, was orientated east to west, measured 12.75m x 1.6m wide and excavated to a depth of 0.5m. The stratigraphic sequence comprised topsoil (400); a grey-brown silt-clay 0.13m thick, overlying lower topsoil (401); a grey-brown silt-clay 0.20-0.24m thick, which overlay the natural clay. Finds recovered from the topsoil included post-medieval pottery, and CBM fragments.

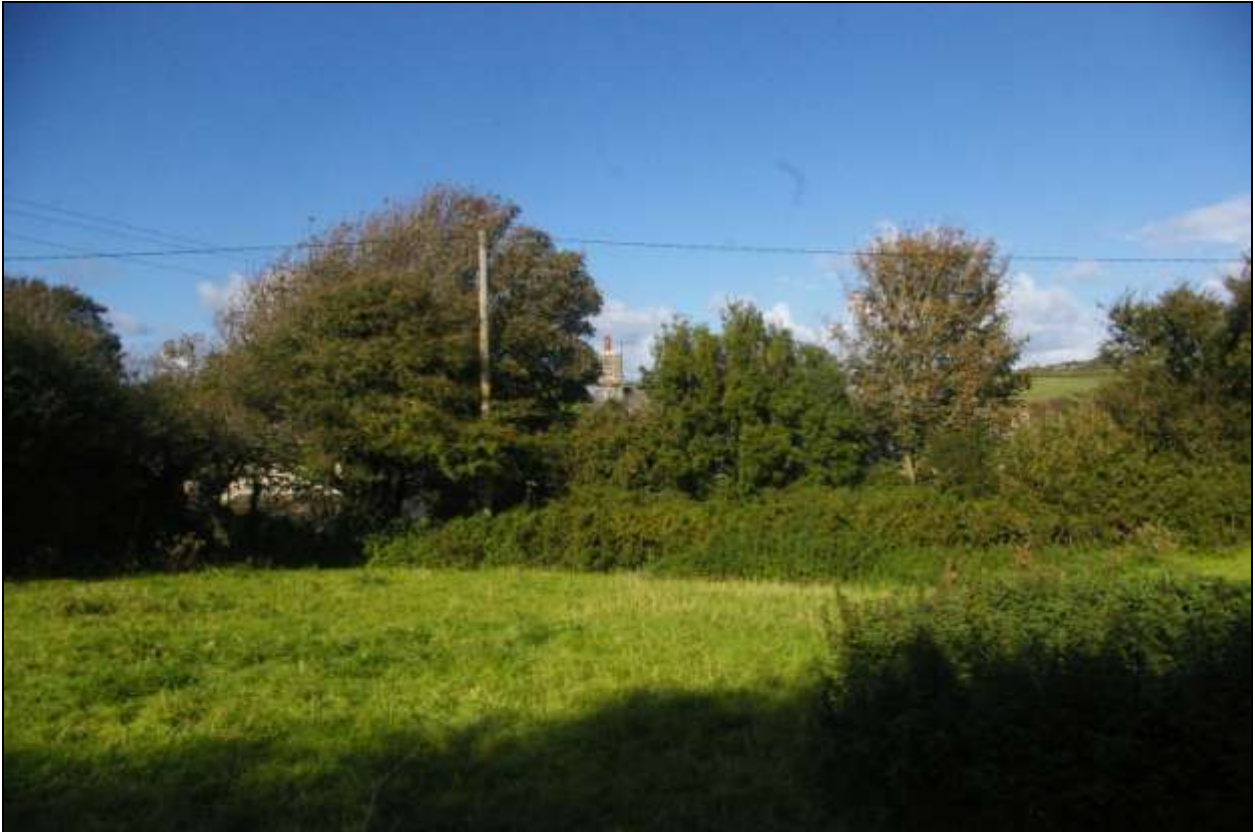
View across the development site to Church House, showing the proximity of the Listed Building but also the local blocking which mitigates any impact; from the south.

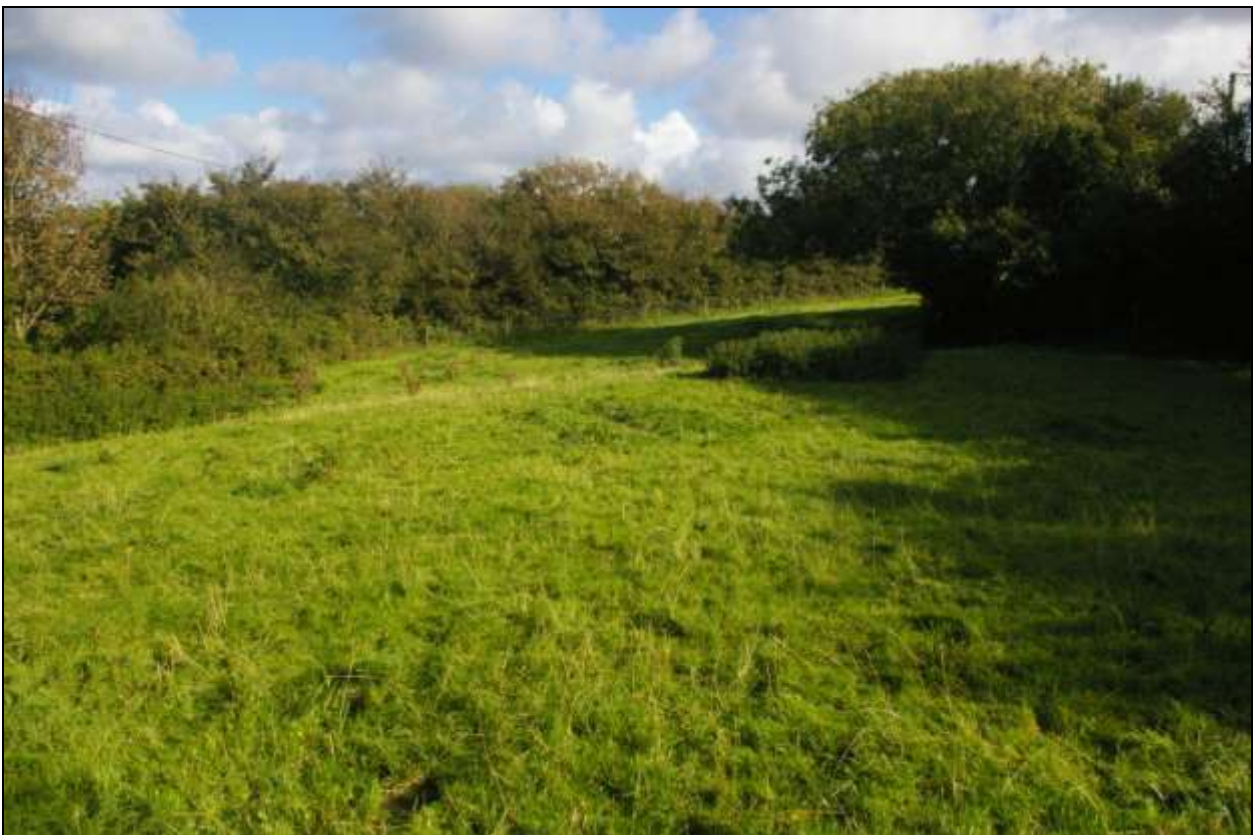
View across the raised terraced area within the field; from the west.

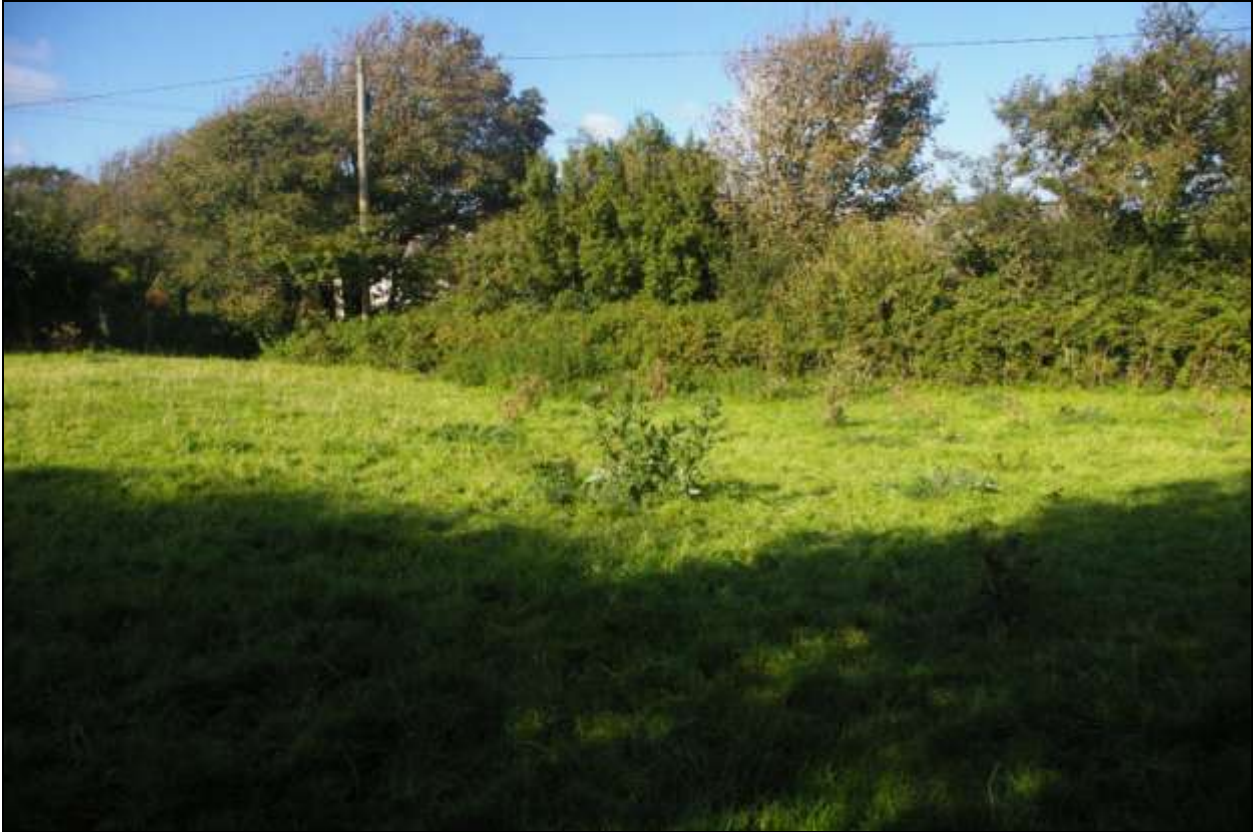
View down the hollow-way, which drops across the field towards Church House; from the south-south-east.

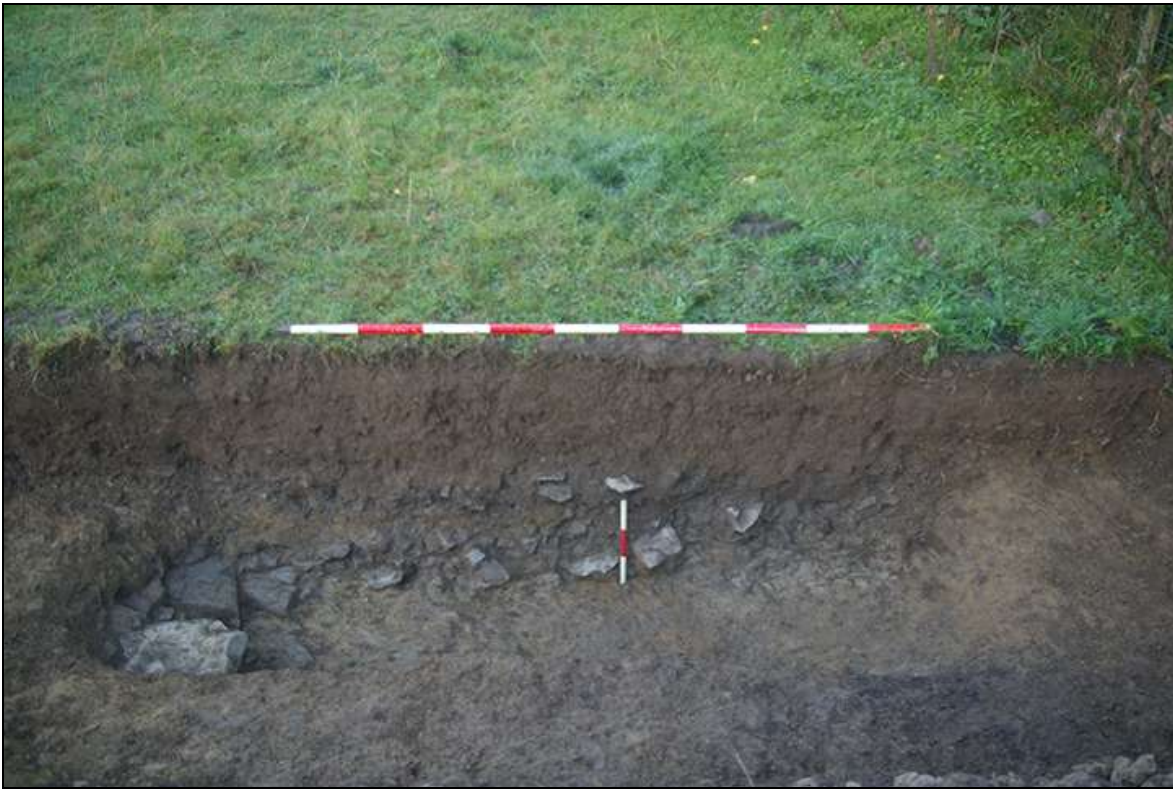
East facing section of [103] Trench #1; viewed from the east (0.3m and 2m scales).

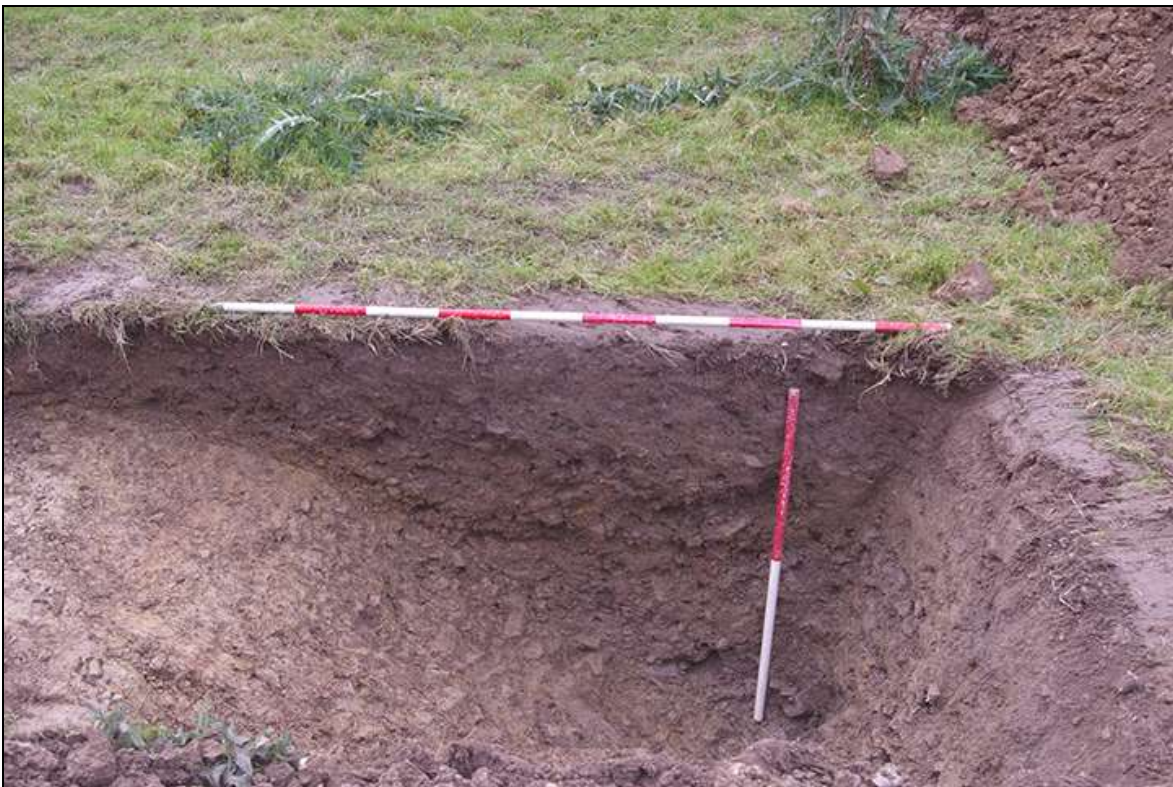
North facing section of [403], Trench #4; viewed from the north (1m and 2m scales).

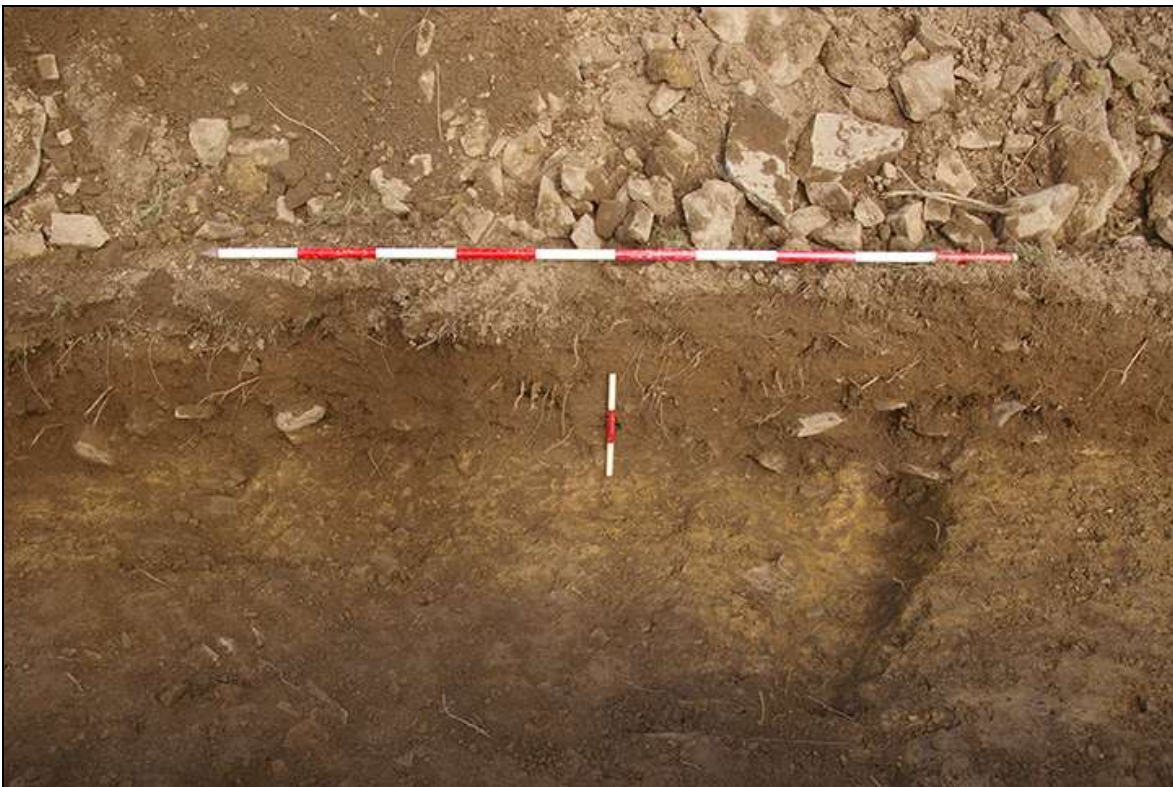
South facing section of [409], [411], and [413] Trench #4; viewed from the south (0.3m and 2m scales).

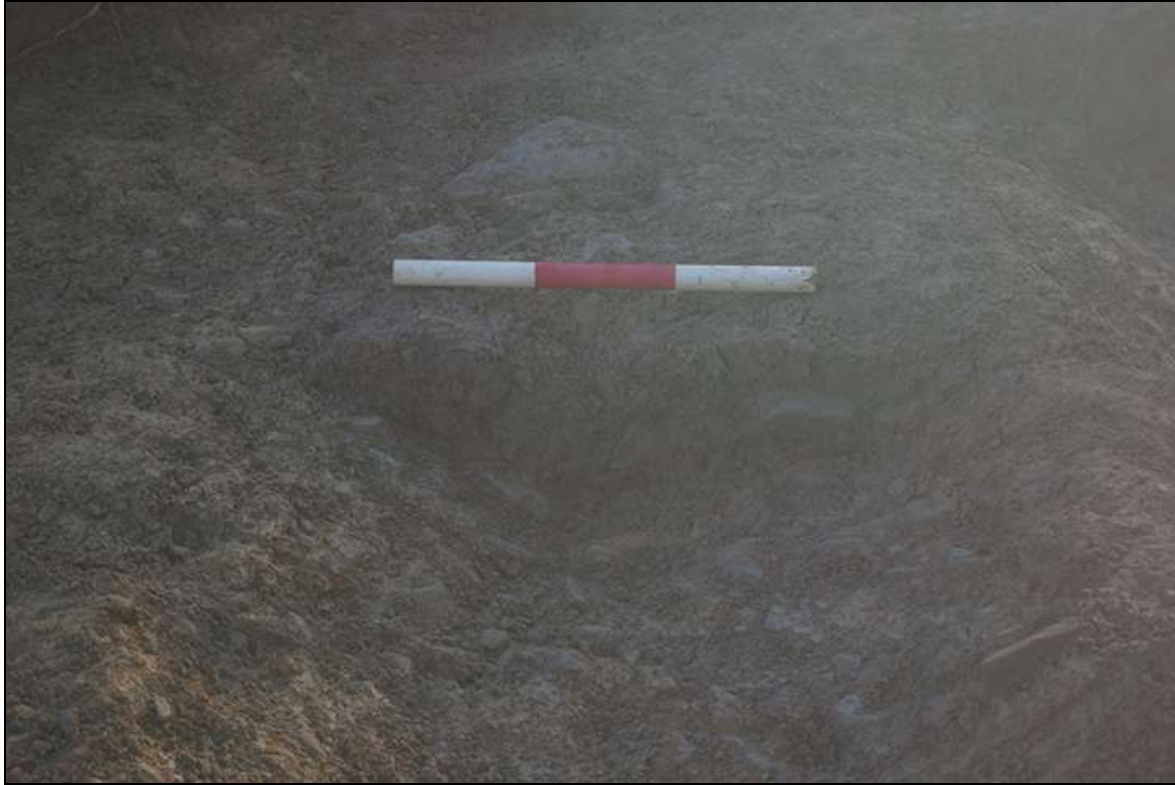
West facing section of [503] Trench #5; viewed from the west (0.3m scale).

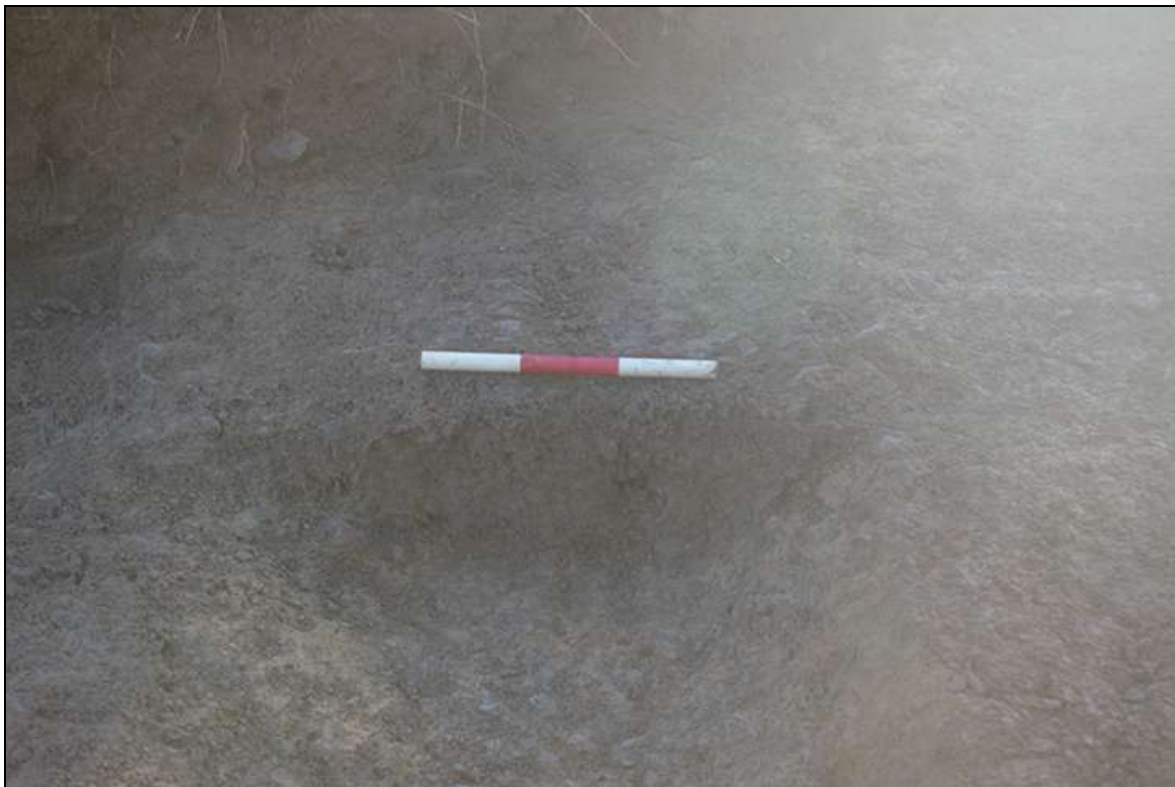
West facing section of [505] Trench #5; viewed from the west (0.3m scale).

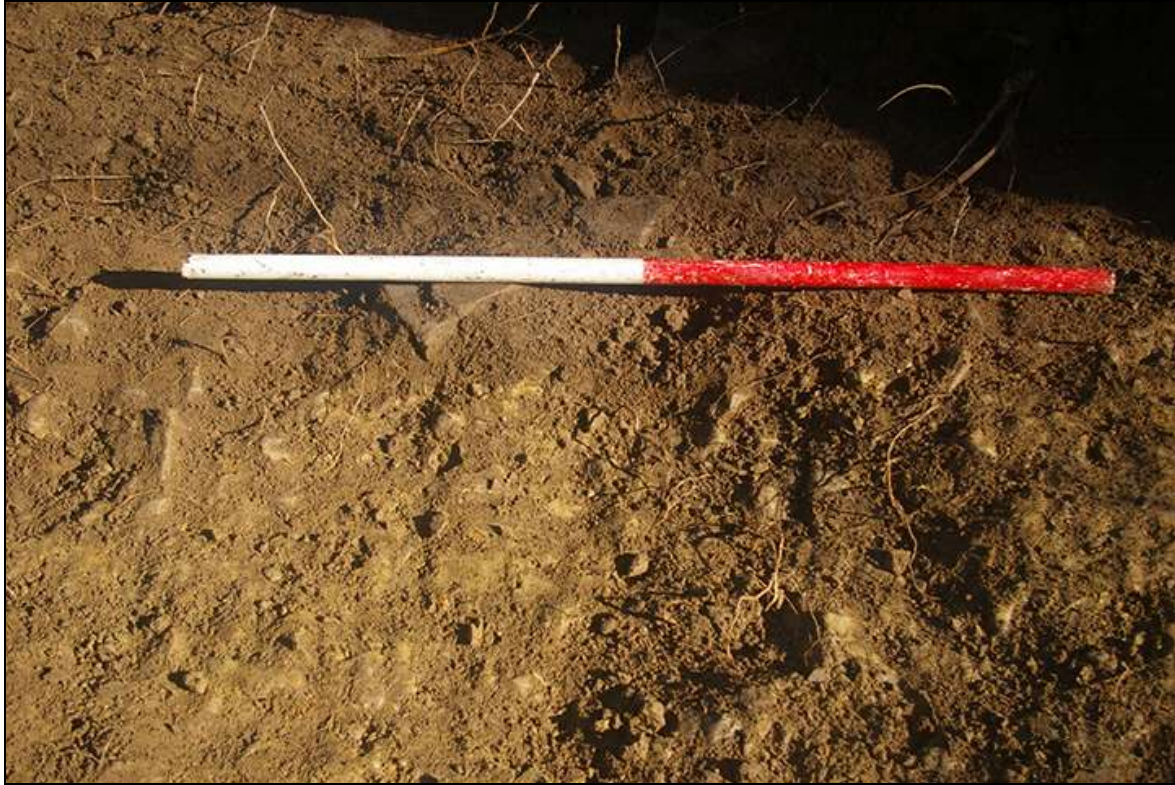
South facing section of [508] Trench #5; viewed from the south (1m scale).
