# BLAGDON MANOR CLAWTON DEVON

Results of a Historic Building Appraisal  
& Impact Assessment

Report No.: 150807  
Date: 07.08.2015  
Authors: E. Wapshott

**SWARCH project reference:** ABM15  
**National Grid Reference:** SX 36889 96980  
**Project Director:** Dr Samuel Walls  
**Fieldwork Managers:** Dr Samuel Walls  
**Project Officer:** Dr Samuel Walls  
**Historic Building Survey:** Emily Wapshott  
**Impact Assessment:** Emily Wapshott  
**Report:** Emily Wapshott  
**Report Editing:** Natalie Boyd; Dr. Samuel Walls  
**Graphics:** Joe Bampton

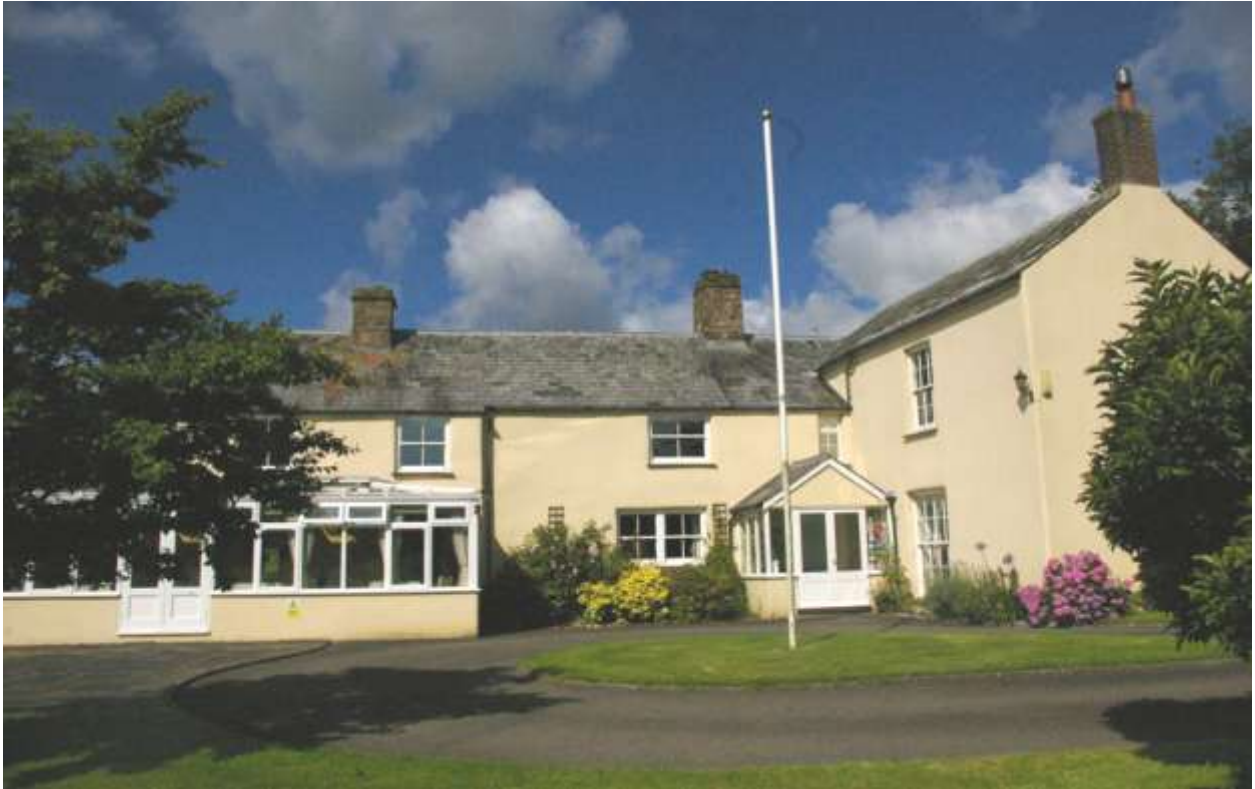
The house has an asymmetrical, two-storey, four-window front (east) elevation, with 19<sup>th</sup> century horned-sash windows. There is a massive stone axial stack to the north and a smaller stone axial stack to the south. The roof is of slate with a leaded ridge. To the south end of the elevation a modern conservatory has been added within the last 15 years; this encloses the window and door openings to the south of the elevation. The 19<sup>th</sup> century door noted in the Listing survives. A part-glazed 20<sup>th</sup> century porch stands in the left return of the cross-wing, replacing an earlier porch (of Marland brick, as noted in the Listing). The cross wing has a single sash window to ground and first floor on its south elevation.

The east elevation of Blagdon Manor; viewed from the east-south-east.

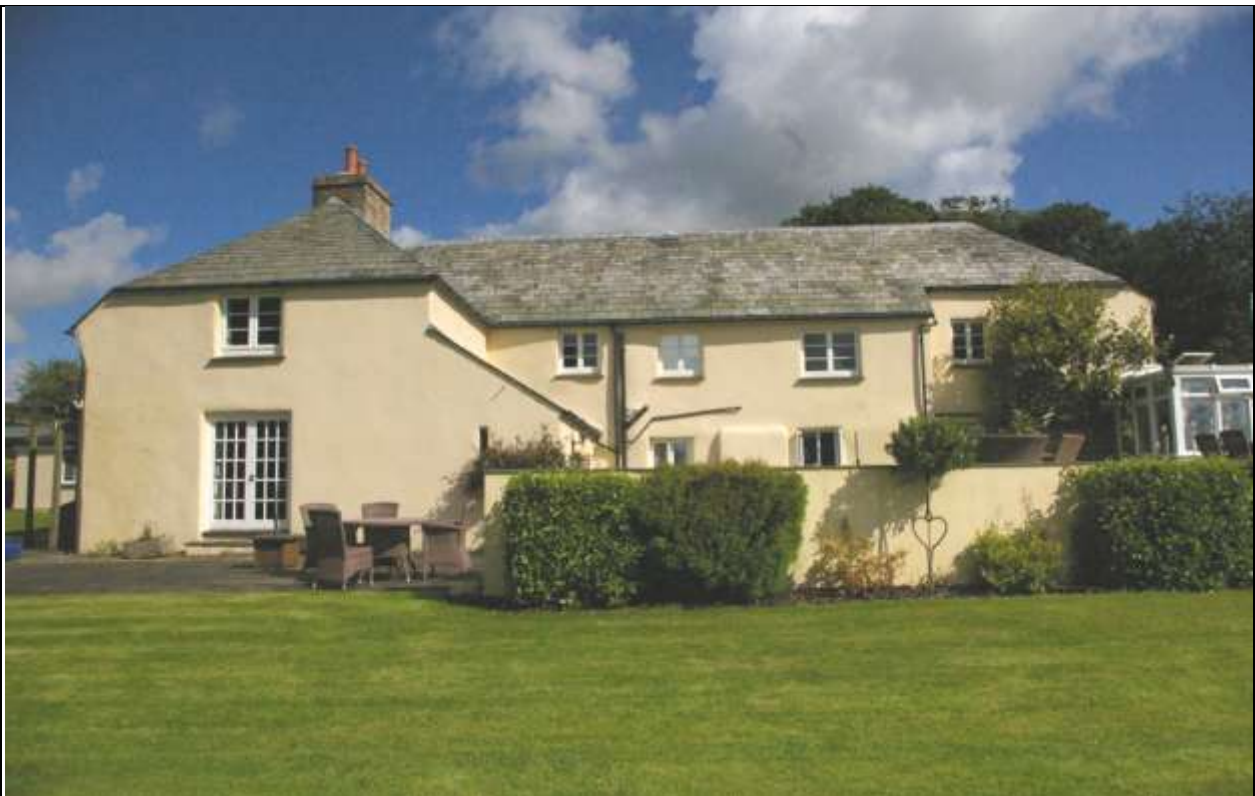
The south elevation is an asymmetrical, two-storey, five-window range. To the east, the elevation drops back, enclosed partly by the large modern conservatory, where the building has been remodelled. To the west there is the projecting hipped gable of the west range, abutted by a lean-to on its eastern side. The windows are a mix of 19<sup>th</sup> century and modern casements, with modern French windows in the projecting gable to the west. The roof is of slate with a leaded ridge.

The south elevation of Blagdon Manor; viewed from the south-south-east.

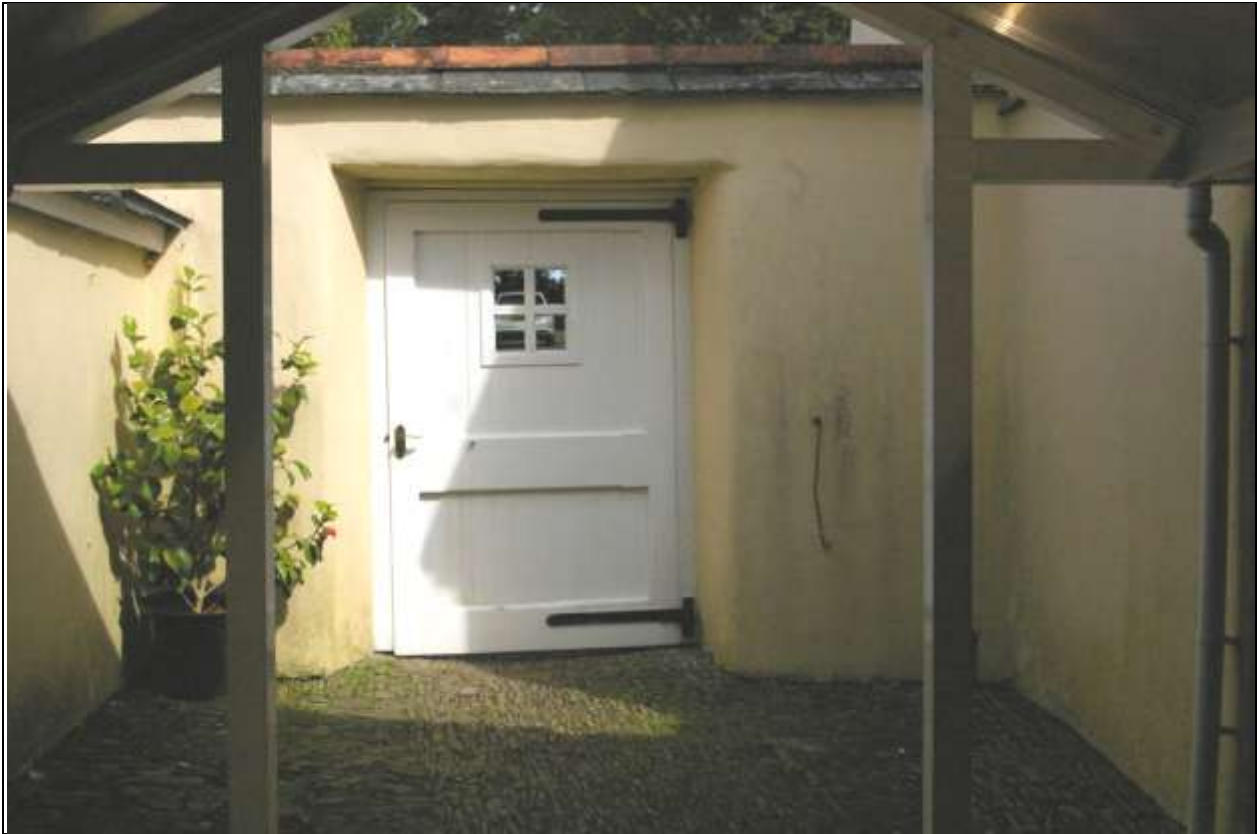
The north elevation of the west range is gabled, with a stone stack, as described in the Listing. The courtyard is bounded by a wide c.2m high cob wall with slate coping, set with a large modern plank door. The courtyard is covered by a modern conservatory-style canopy. The east range within the courtyard is partly slate hung, as is the stair projection. The north elevation of the cross-wing is an asymmetrical two-window range; a large canted bay window and wide tripartite sash window to the ground floor, with two sash windows to the first floor, all horned, and of 19<sup>th</sup> century date. There is a lean-to to the west end, with modern plank boarded double doors. The roof is of slate with a leaded ridge, hipped to the west, forming an elongated cat-slide roof over a small lean-to. There is an east gable-end brick chimney stack and a brick stack within the slope of the lean-to roof to the west.

The door into the courtyard; viewed from the south.

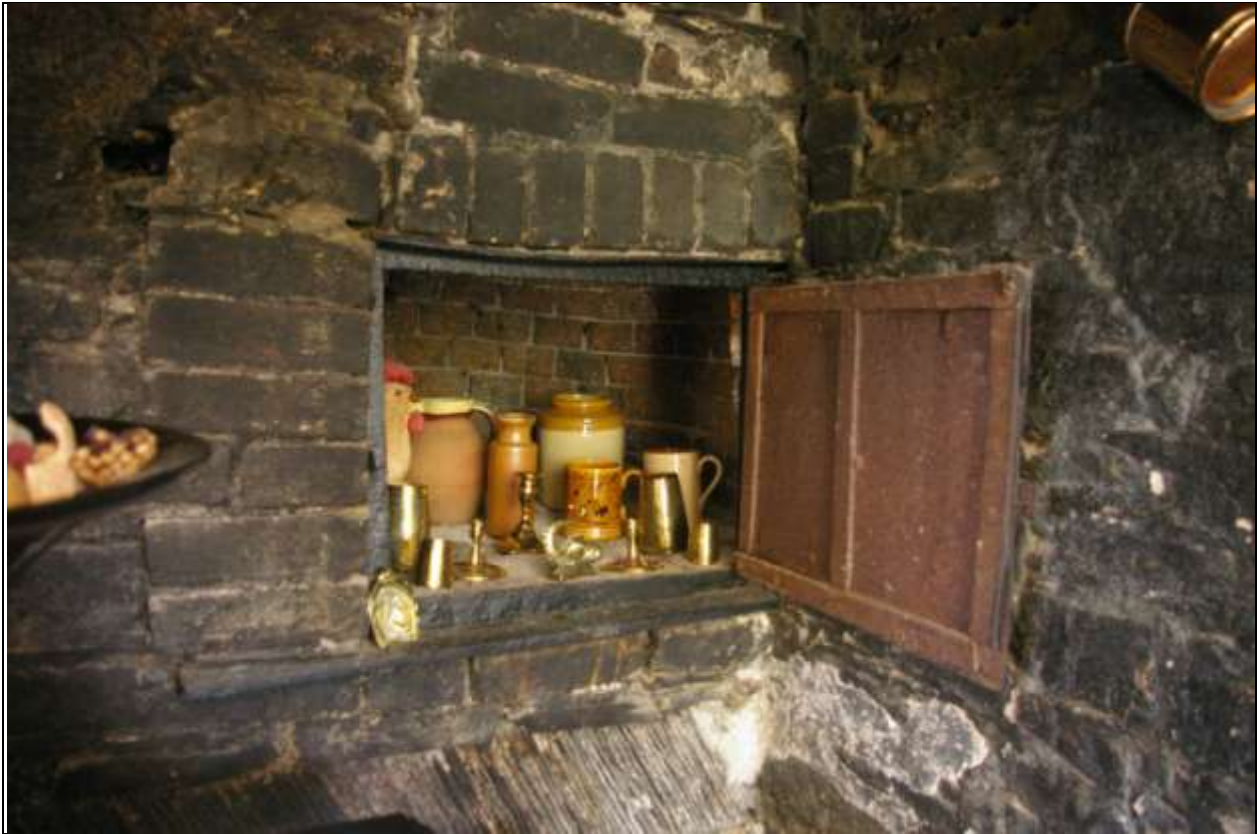
View of the brick-built bread oven; viewed from the south-west.

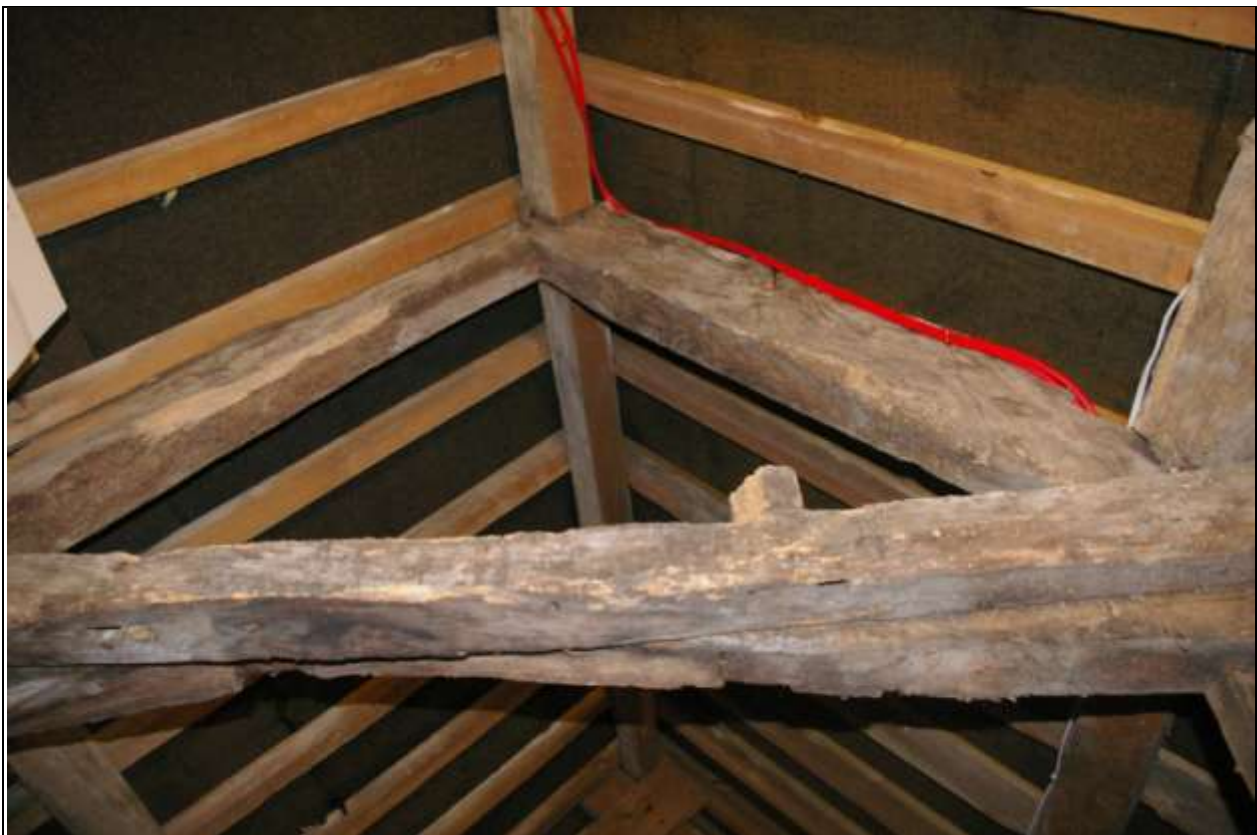
The south range may retain an element of a roof structure from the later 17<sup>th</sup> or even very early 18<sup>th</sup> century. This range appears to be an infill between the two earlier parallel ranges. No significant features, other than the covered well, survive in this range but it is important as indicative of the complex development of Blagdon.

View of part of one of the surviving A-frame two-part truss blades pegged at the top. A collar with spiked joints is braced across the A-frame, with a later additional rough-cut and irregular beam for strength; the collar has sockets for a partition. One original large square-set purlin socketed into the south truss blade. Viewed from the west.
