THE OLD STATION MASTER'S HOUSE FOWEY CORNWALL

Results of Historic Building Recording

> Report No.: 151106 Date: 06.11.15 Authors: N. Boyd C. Humphreys E. Wapshott

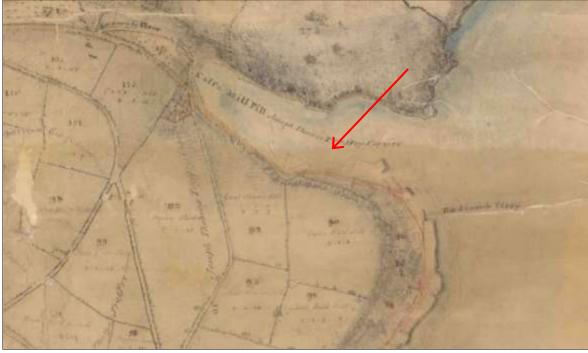
Figure 3: Extract from the Fowey Tithe Map of 1840, showing the Caffa Mill area. The approximate location of the site is indicated (CRO).

The earliest cartographic source available to this assessment is the 1840 Fowey Tithe Map. At this date the land on which the Old Station Master's House was to be built had yet to be reclaimed from the estuarine muds. The map notes Caffa Mill Pill was under the ownership of Joseph Thomas Treffrey Esquire, a notable Cornish entrepreneur and industrialist, who lived at Place.

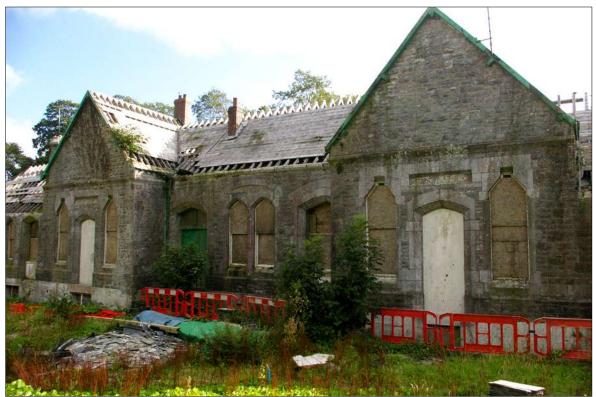
Figure 6: The north elevation of the building; from the north-west.

Set-back wings flank the central portion of the elevation. The east wing is the longer range, of two storeys, with wide Gothic arched sashes to either side of two identical narrow Gothic arched sashes to the centre. The large window and door openings are framed by dressed limestone reveals, with slight shallow stepped cavetto moulding. The smaller windows have dressed stone quoin reveals. The stepped detail at first floor recurs, as on the south elevation, and the plinth projects at basement level. The elevation is rendered to the east end and at basement level. A large window appears to have been forced into the wall, at basement level, now boarded shut.

To the west end the wing is shorter and not as far set-back. There is a narrow doorway to the west, at first floor height, within dressed limestone reveals, with shallow stepped cavetto moulding. To the east is a two-light Gothic arched sash window, also with dressed stone quoin reveals. The stepped detail at first floor recurs, as on the south elevation, and the plinth projects at basement level, where it is rendered. A small window appears to have been forced in at basement level at the east end of this wing.

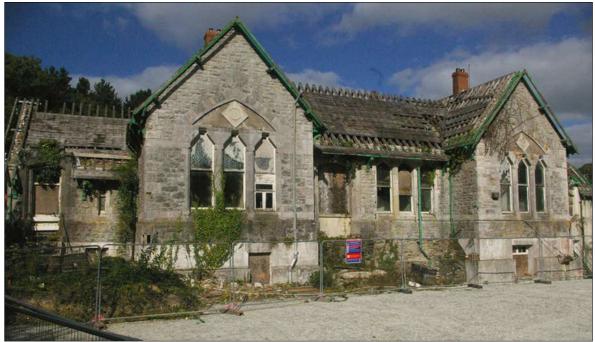
Figure 7: The south elevation of the building; from the south-west.

The central range is framed by two projecting gables, with deep overhanging eaves. The gables are symmetrical, each with a large three light window to the centre, of Caernarfon shouldered arch style, all windows of sash form. Above the windows are depressed Gothic arches and an inset lozenge panel with carved roundel. The gables have rusticated quoins and the windows are framed by dressed limestone reveals. To the centre of each projecting gable at basement level there is a large square window opening, set into the wide plinth base. The lower portions of both gables are rendered. Both gables have doorways entering the basement on their outside edge. In the west gable, the door is accessed via steps.

Between the gables a main door is offset to the west, with dressed limestone reveals of stepped cavetto form, as seen in other doorways. This doorway is now boarded and blocked. To the east side is a large three-light window of Gothic arched sashes, set in dressed limestone reveals in the form of quoins, as seen elsewhere in the building. The render on the lower portion of the building has been removed here and the steps or walkway to the doorway have been lost. The lower portion can be seen to be of killas rubble stone in a lime mortar, not designed to be seen.

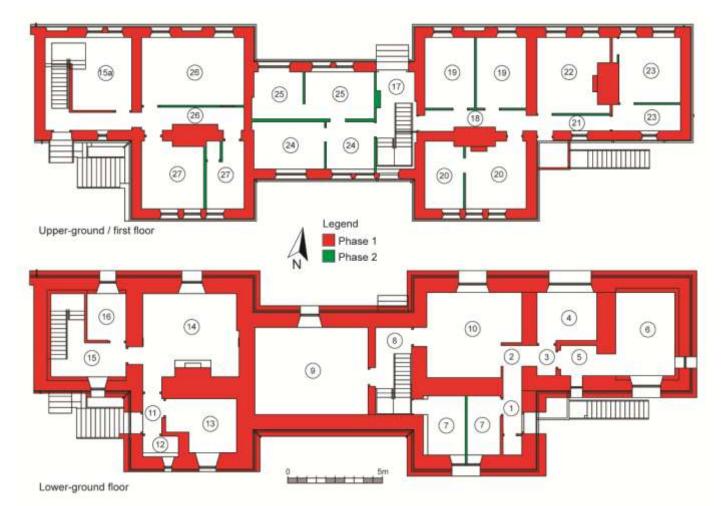
Figure 8: Phased plans of the Old Station Master's House (based on supplied drawings).

Bathrooms and kitchens were inserted and modern plasterboard partitions were put up in larger rooms to divide the space or provide access corridors. Rooms that were affected by this are: 7, 17, 19, 20, (21, 22), 23, 24, 25, 26 and 27 and all the partitions are shown on the phased building plan. Mid 20th century tiled/stone effect fireplaces were also added to some rooms (14, 20, 22, 25).

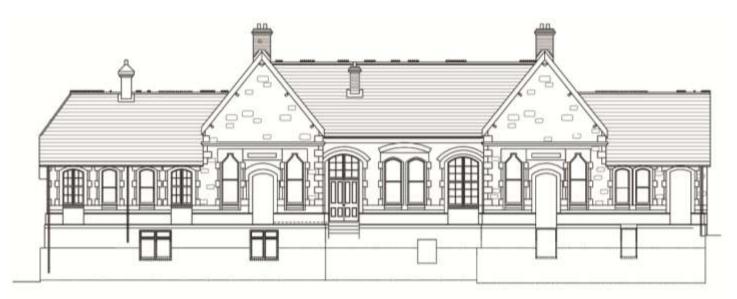
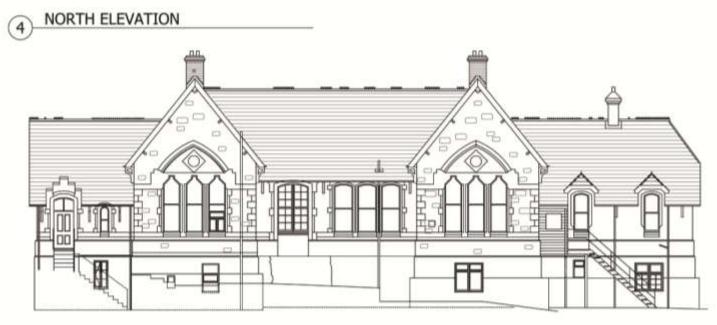
SOUTH ELEVATION

Figure 9: Elevations drawings (supplied by architect).

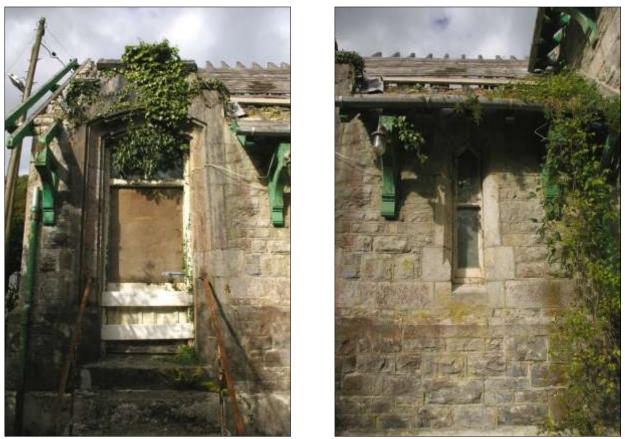
Detailed view of the doorway (left) and the narrow arched sash (right) in the west wing; from the south.

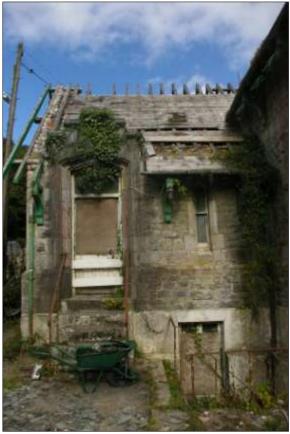
The west wing of the building, with separate door access; from the south.

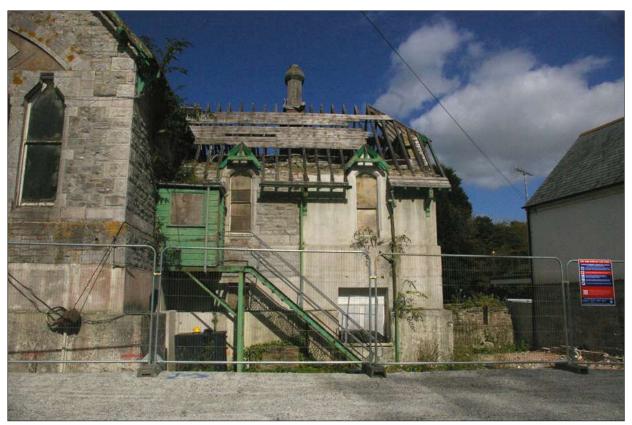
The east wing of the building; from the south.

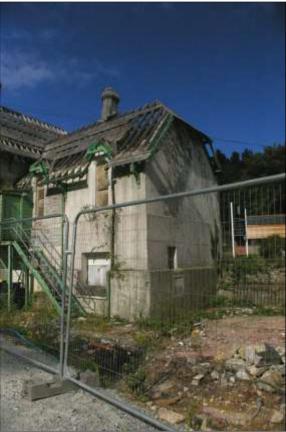
Left: Detailed view of the eastern projecting gable on the south elevation; from the south. Right: The east wing of the building; from the south-east.

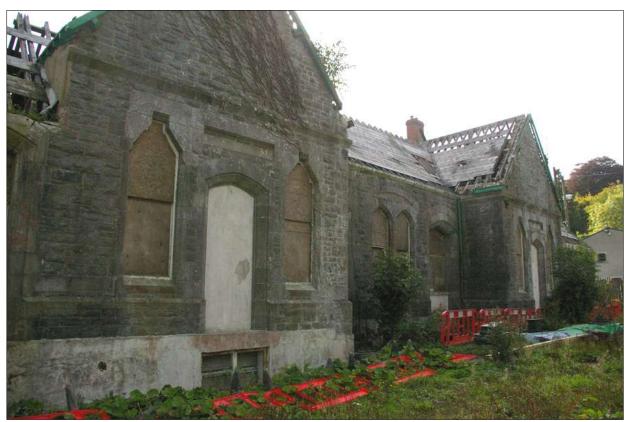
The north elevation of the building; from the north-east.

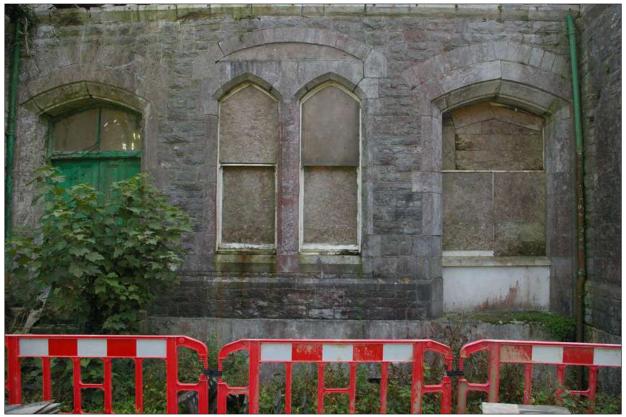
The north elevation of the central part of the building with paired double doorways, that to the west now blocked; from the north.

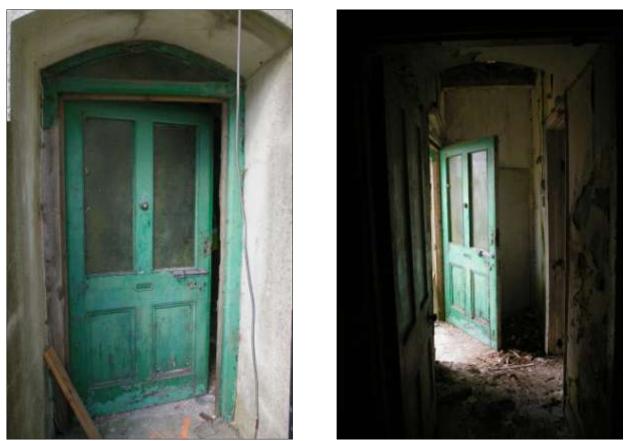
Left: Door into Room 1; entering into the east side of the basement; from the east-south-east. Right: Room 1, the lobby, within the east side of the basement, showing the cupboard behind the door and the frame of the door which divides the lobby area; from the north.

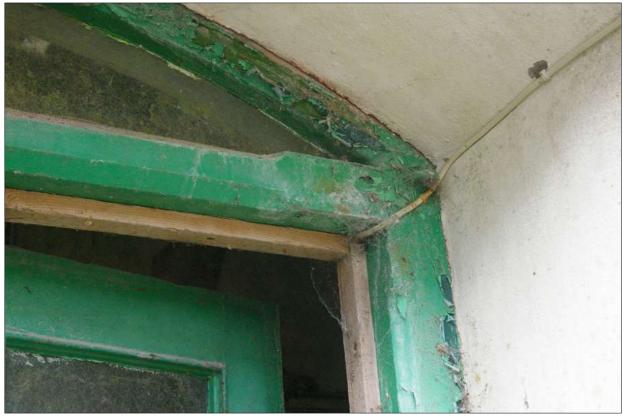
Heavy chamfered frame with arched single pane of glass above; from the south-east.

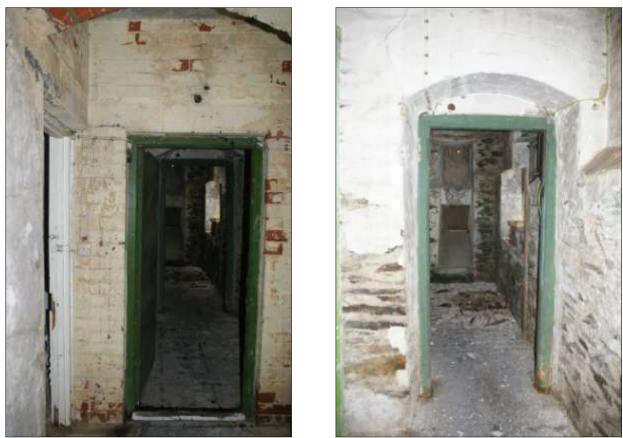
Left: Room 3, another lobby/room, serving Rooms 5 and 6; from the west. Right: Brick segmental arch; to Room 6, the former coal chute and boiler room; from the west.

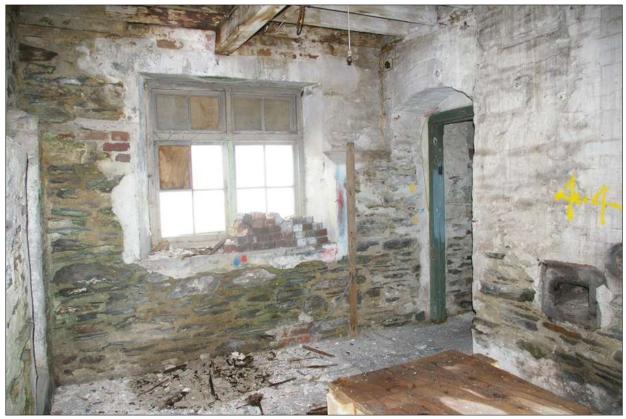
Room 6, the former coal chute and boiler room, with a further timber transom window, as in Room 4, and exposed stone walls; from the north-east.

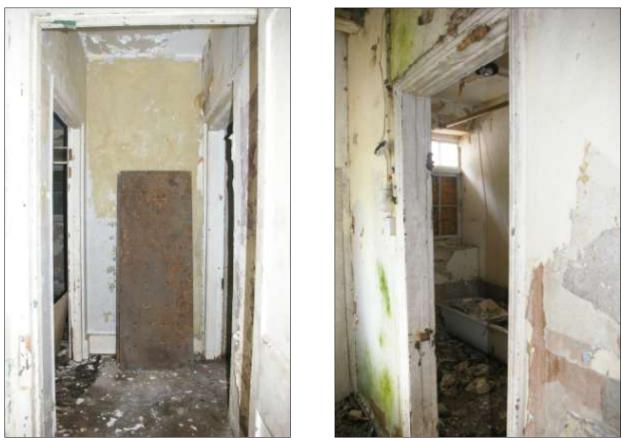
Left: Room 2, a secondary part of the lobby, showing doorways 3 and 4 and surviving skirting boards; from the south. Right: The bathrooms of Room 7. The modern partition cuts the transom timber window, which is the same as that Rooms 4 and 6; from the north-east.

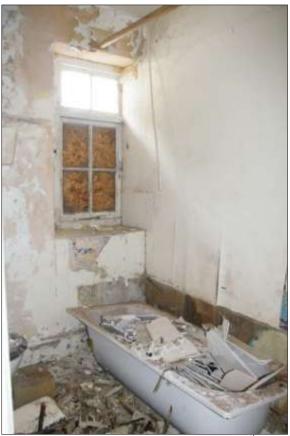
Room 7, divided into two bathrooms in the 20th century; from the north-east.

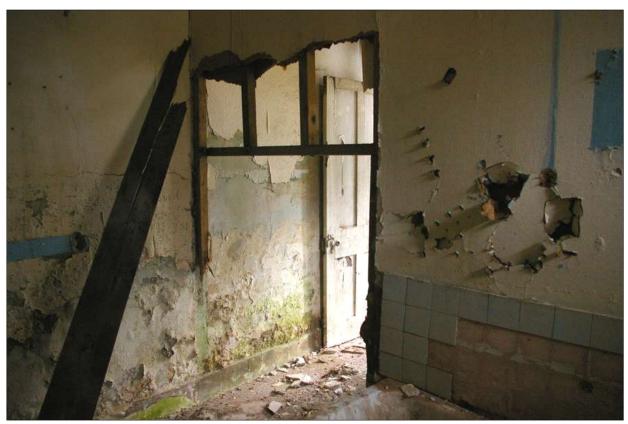
Room 7, the modern timber framed partition; from the south-west.

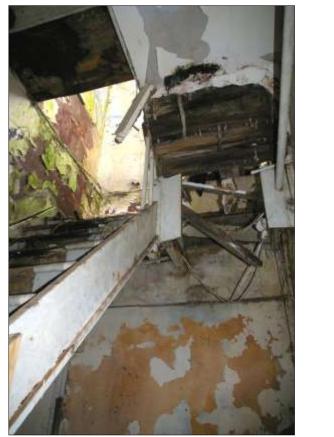
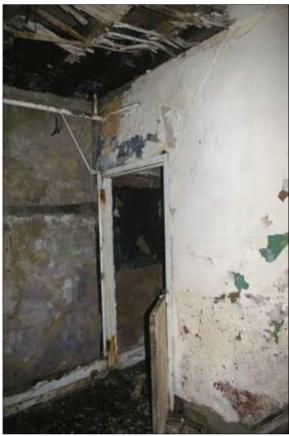
Left: The staircase in the centre of the basement, Room 8, leading to the 1st floor central hallway; from the north-west. Right: Room 10, set with a modern frame, but some surviving beaded skirting to the walls; from the south-west.

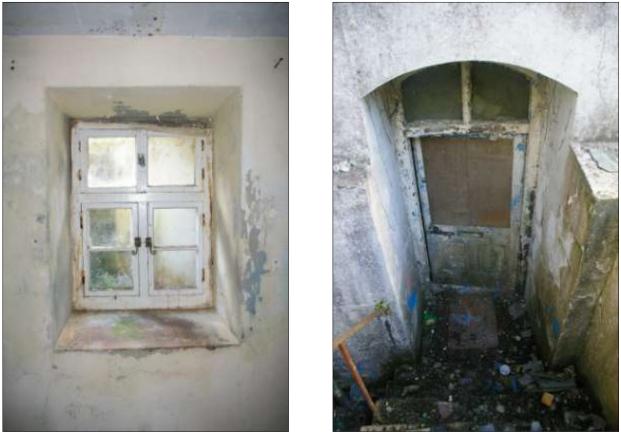
Left: The window in Room 9. A heavy timber transom, with fixed single-pane opening casements above and two-pane opening casements below. The window has brass locks and coiled latches; from the south. Right: Access leading to Room 11, a lobby, leading into the separate west side of the basement; from the west.

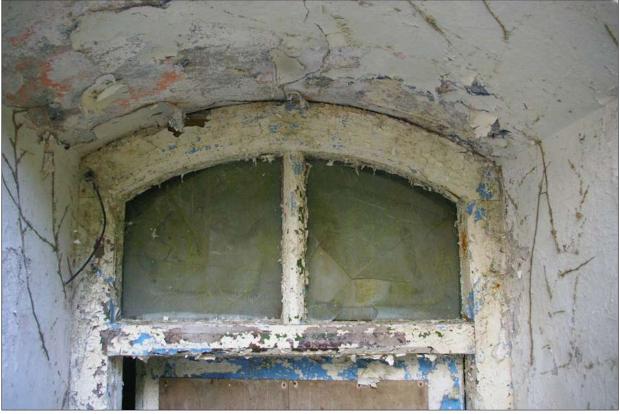
Heavy chamfered frame with two-pane mullioned arched light above; from the west.

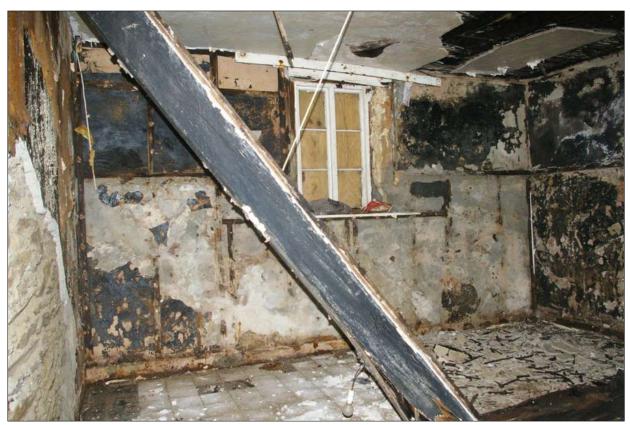
Room 14, showing excessive water ingress and damage; from the south-west.

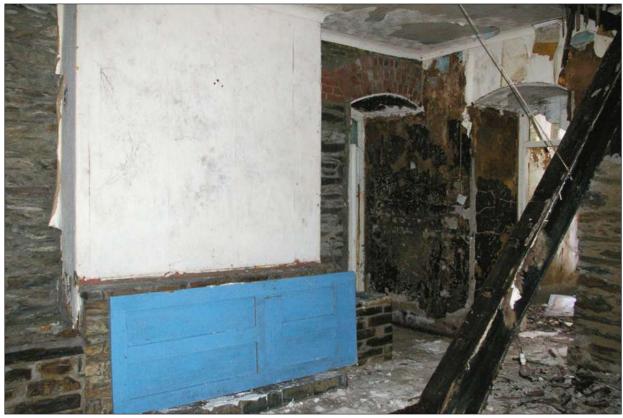
The large stack within Room 14 and arched doorway to Room 15; from the north-east.

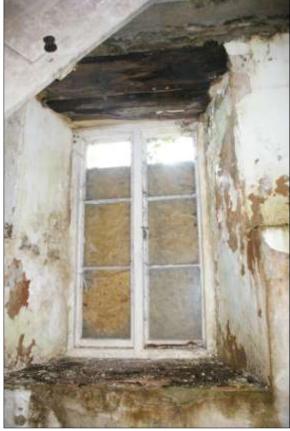
Left: Room 14; from the north-west. Right: Window in the south wall of Room 15; from the north-west.

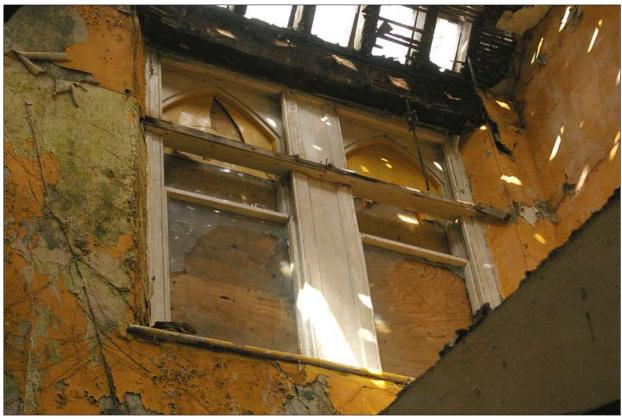
Arched sash windows in the north wall of Room 15; from the south-west.

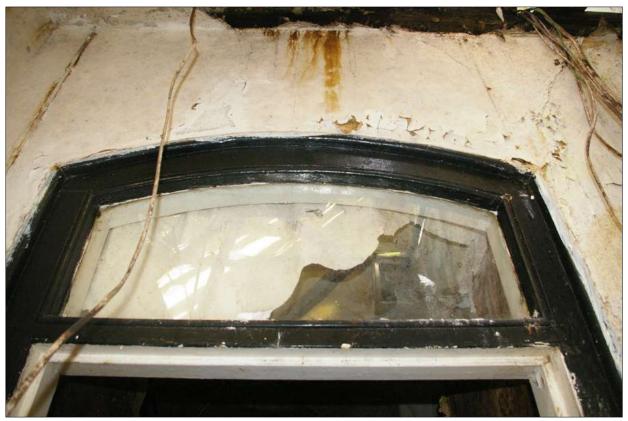
Detail of door between Rooms 14 and 15, with its narrow beaded frames instead of the chamfered frames seen elsewhere in the building; from the west.

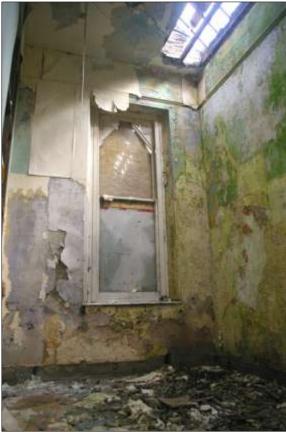
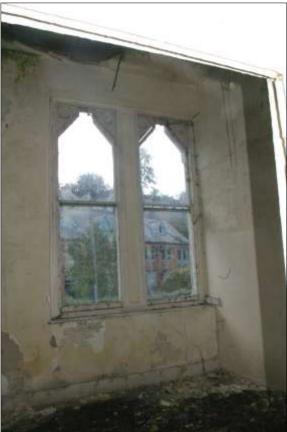
Left: Window within Room 19; from the south-east. Right: Room 20, showing a modern partition cutting the three-light sash window; from the north-east.

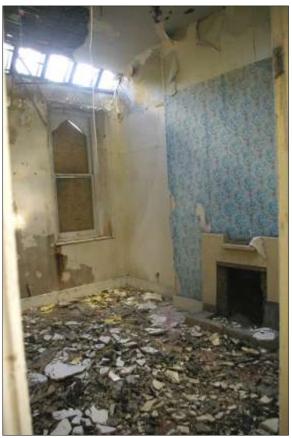
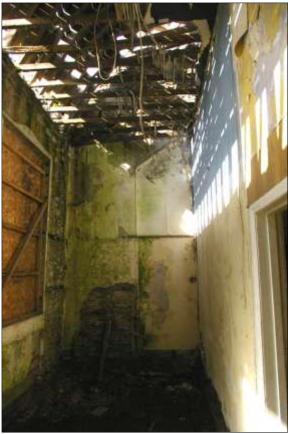
Left: Room 22, with arched sash single light window; from the south-west. Right: Arch detail in the west wall of Room 24 (part of the arch is in Room 25); from the east.

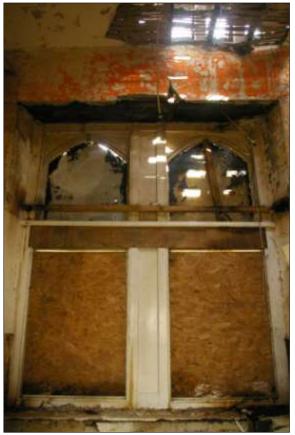
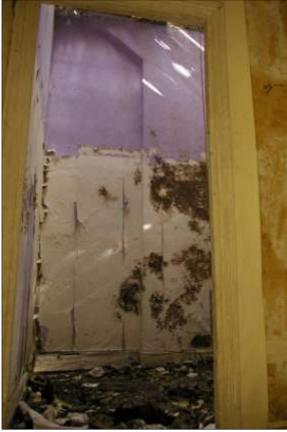
Left: Two-light arched sash window in Room 15; from the south. Right: Arch detail in the west wall of Room 25; from the east.

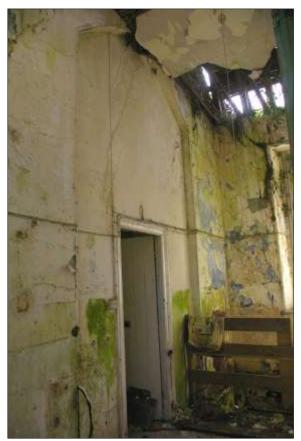
Arch detail, within Room 17, which matches Rooms 24 and 25, once an open space; from the north-west.
