# TREGEW FARMHOUSE FLUSHING, MYLOR CORNWALL

Results of a Desk-Based Assessment &  
Limited Historic Visual Impact Assessment

Report No.: 150716  
Date: 16.07.2015  
Author: B. Morris

*This report presents the results of a desk-based assessment and historic visual impact assessment (HVIA) carried out by South West Archaeology Ltd. on land at Tregew Farm, Flushing, Mylor in Cornwall, as part of the pre-planning submission for a proposed barn conversion and small residential development.*

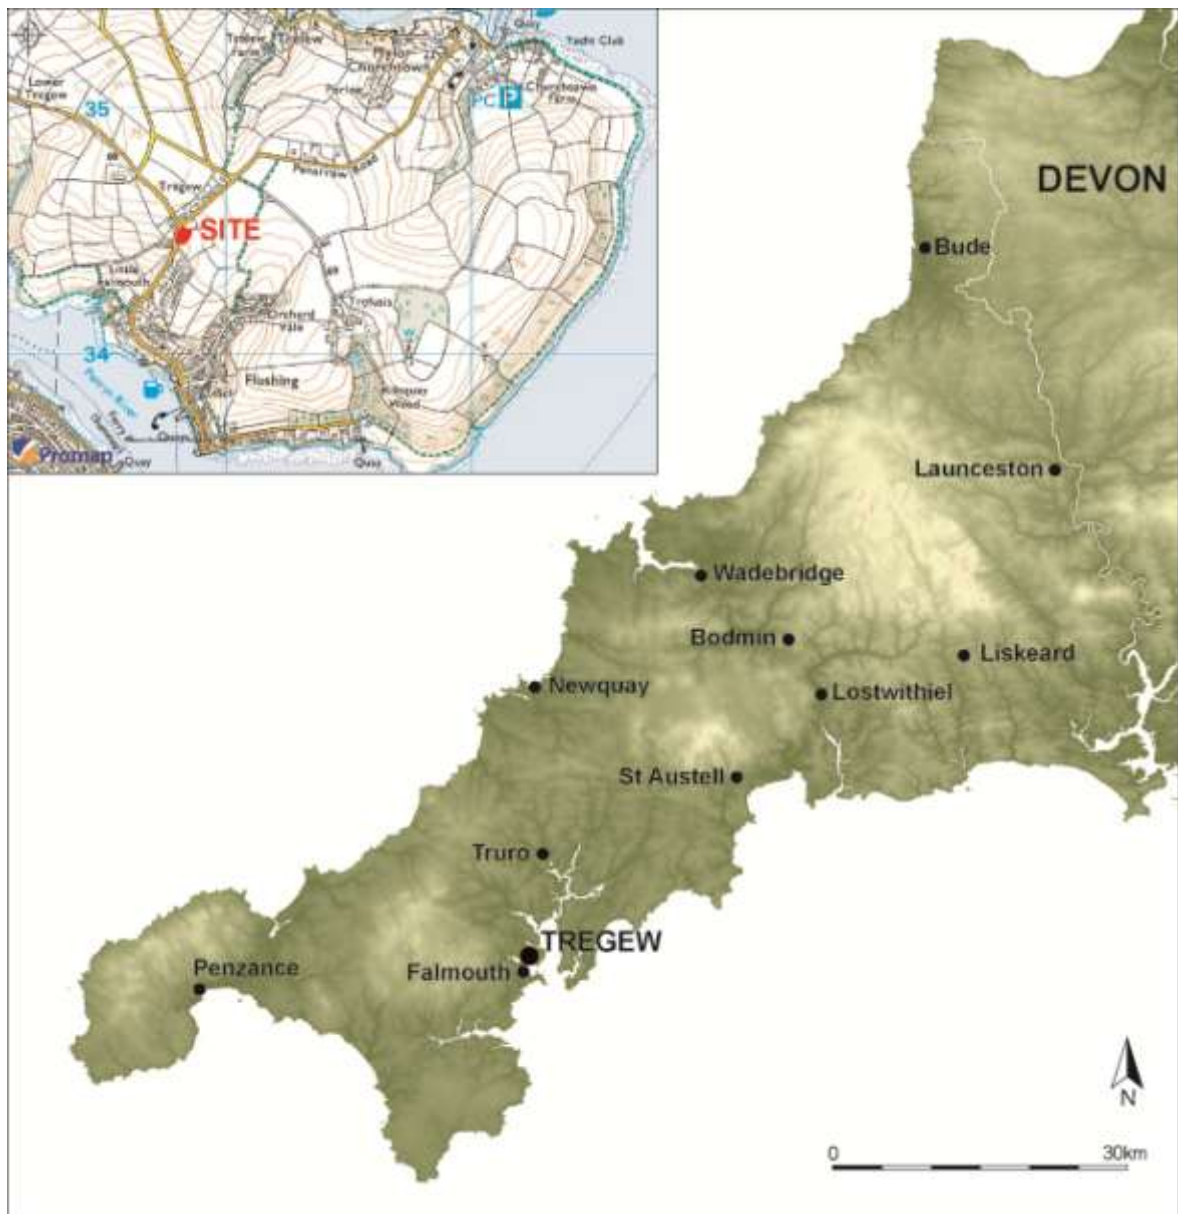
Figure 1: Site location (the proposed site is indicated).

This report presents the results of a desk-based assessment and historical visual impact assessment (HVIA) carried out by South West Archaeology Ltd. (SWARCH) on land at Tregew Farm, Flushing, Mylor in Cornwall (Figure 1). The work was commissioned by Russell Dodge of WestCountry Land Ltd. in order to establish the historic background for the site and assess the potential impact of a proposed housing development with barn conversions on the setting of the Grade II Listed farmhouse.

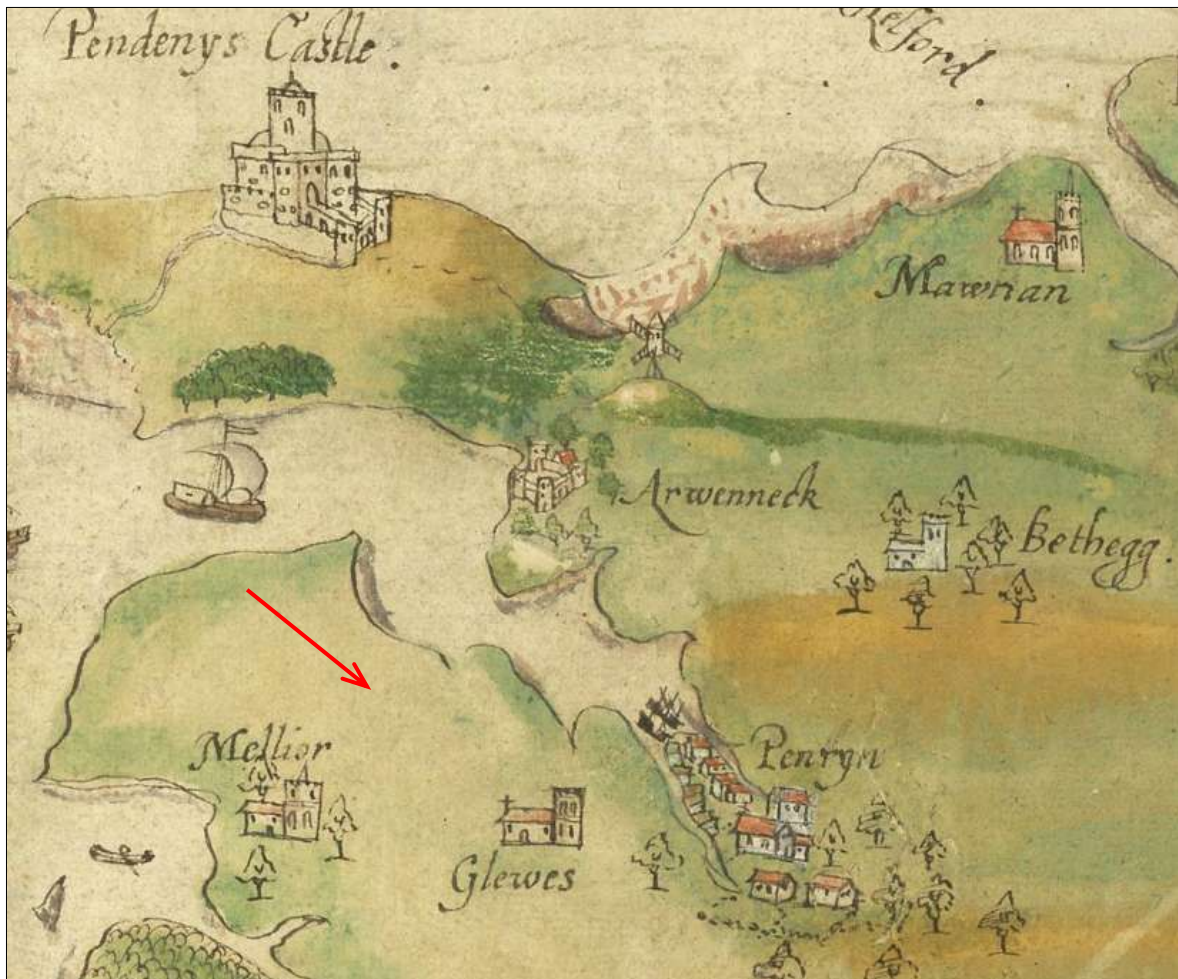
Figure 2: Extract from a 1590s map of the Haven (BL). The approximate location of Tregew is indicated.

While there are a number of early county maps for Cornwall, none of these sources show the landscape around Tregew in any meaningful detail (e.g. see Figure 2). However, the site is located close to Falmouth Haven, and Elizabethan concerns for the security of the harbour mean that there are a number of good early maps, if not entirely reliable.

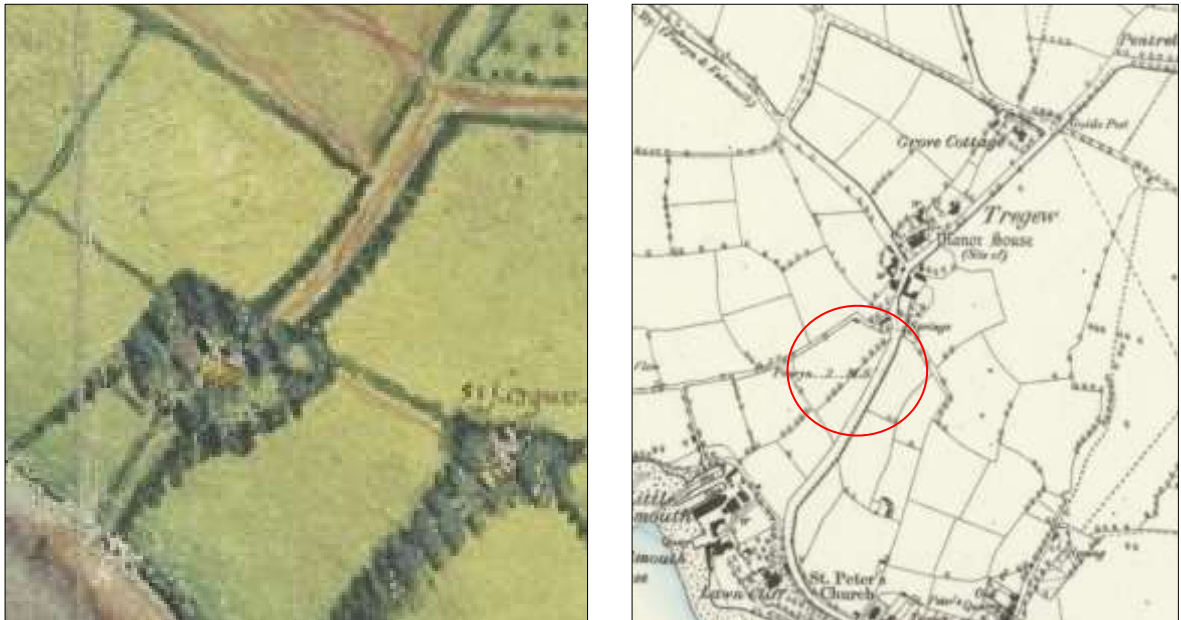
Figure 4: Comparison between the 1595 Burghley map and the 1888 OS map. If the Burghley map is reliable, then it might suggest the manorial enclosure lay to the south of the current hamlet (as indicated).

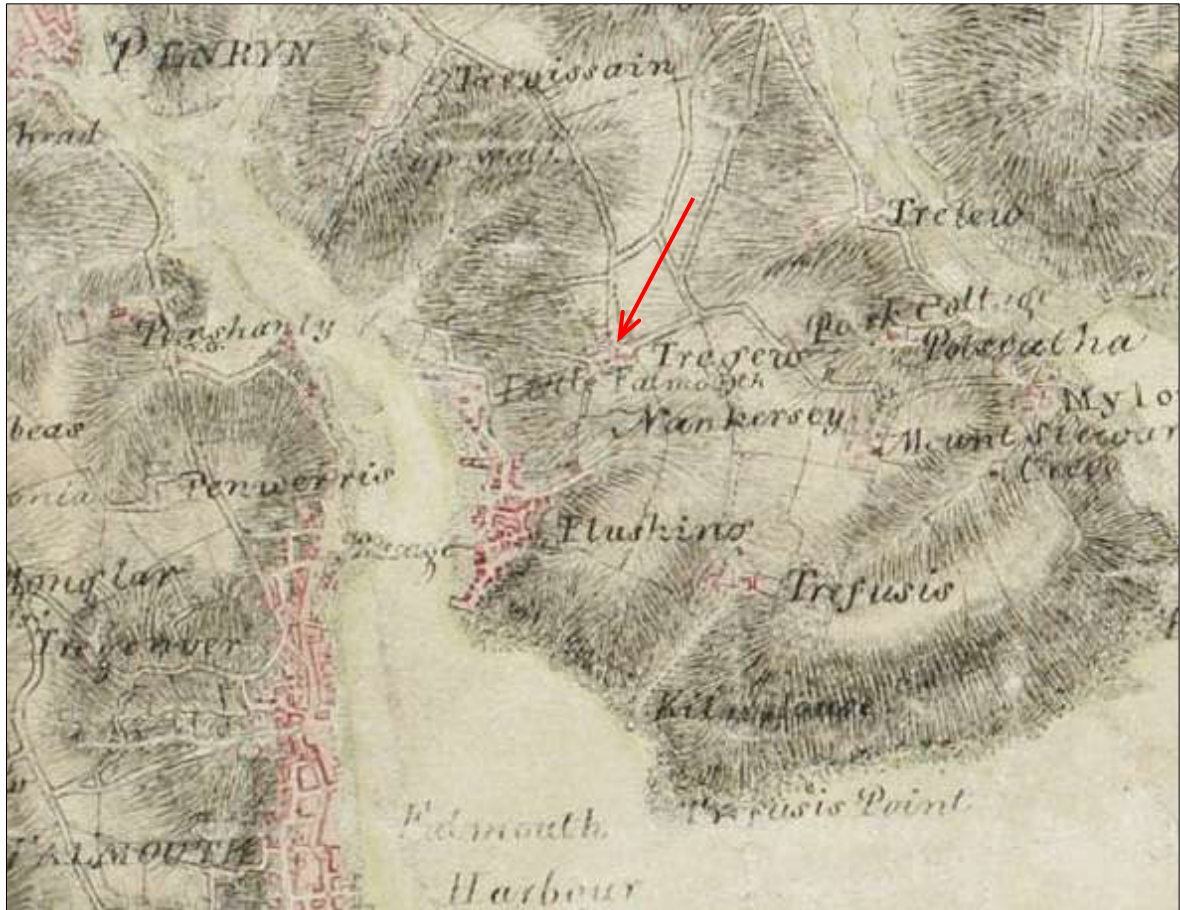
Figure 5: Extract from the 1811 OS surveyor's draft map for the area. The location of Tregew is indicated.

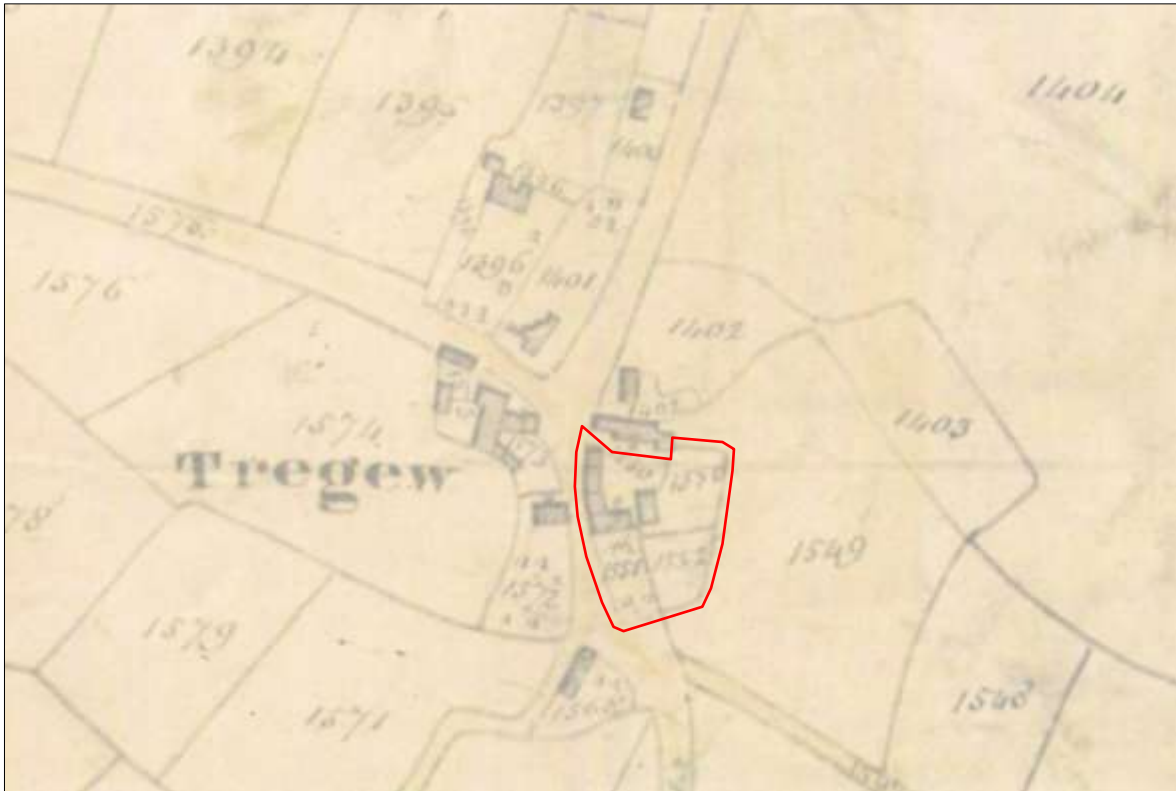
Figure 6: Extract from the 1840 Mylor tithe map; the site is indicated (CRO).

The first detailed field map available to this study is the 1840 Mylor tithe map. The land belongs to the Trefusis Estate, owned by Lord Clinton (aka the Trefusis family of Trefusis). It is of interest that all the dwellings shown are described as tenements in (the Manor of) Tregew, with little indication of any building of any particular status. The sole exception is the reference to field no.1402, which is described as 'house, garden and court'. Field no.1402 lies just north of the farmhouse at Tregew Farm, but the ligature indicates the farmhouse belongs with the farm buildings to the south (plot no.1550). Field no.1402 was a separate tenement containing its own dwelling (this structure survives as an outbuilding within the garden of the farmhouse), with little apparent evidence of status.

The lands attached to each of the tenements within the settlement are very mixed, implying there was once a common open field system in place. The fields south-west of the hamlet (accessed via Dark Lane), on morphological grounds (i.e. laid out either side of a lane, with gently-curving boundaries), appear the most likely candidates. The Burghley map shows a large area of unenclosed open land (presumably 'Tregew Downs') north of the settlement; this had been enclosed by 1811, but the arrangement of the roads, and the larger and more regular fields shown on the 19<sup>th</sup> century maps in this area are indicative of late enclosure. The much larger fields, with long, curving boundaries that surround Trefusis to the east, strongly suggest the presence of a polite landscape that encompassed most of the south-eastern part of the peninsula.

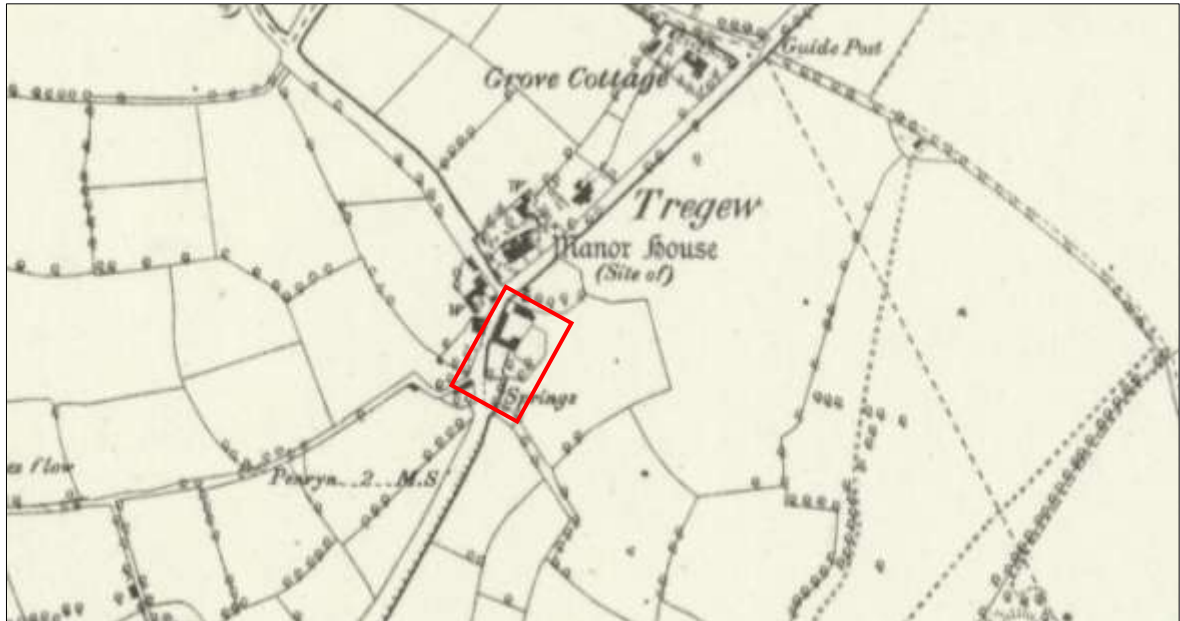
Figure 7: Extract from the OS 1<sup>st</sup> edition map, surveyed 1878, published 1888 (CRO).

All the subsequent OS maps note the presence of a ‘manor house’ just south of Tregew House. There is nothing in the documentary record or the cartographic record to indicate there was a manor house at this location, and Tregew Manor appears to have been attached to Trefusis from an early date. Change within the local landscape from the later 19<sup>th</sup> century onwards is relatively limited. Some field boundary loss occurred, and the house of Mrs Tilly had been replaced with a larger villa by 1878. By 1906 a pump (‘P’) is noted at the southern end of the hamlet, and in 1938 the houses along Tregew Close are planned or under construction. The first of the modern barns is shown on the 1970s OS maps, and the bungalows on Tregew Road are shown from the 1960s.

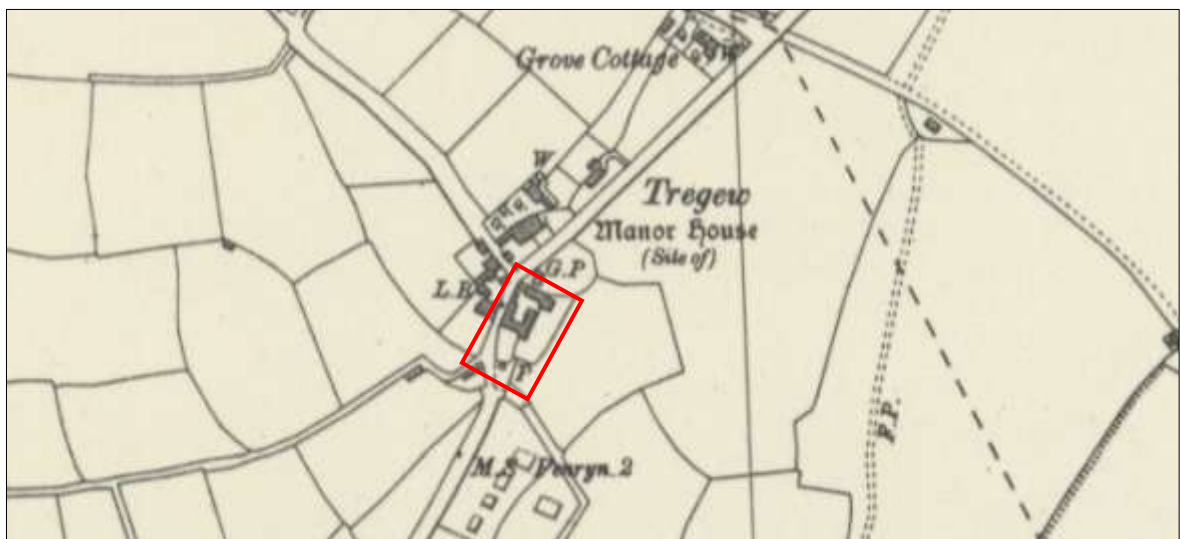
Figure 9: Extract from the OS revised map, surveyed 1938, published 1945 (CRO).

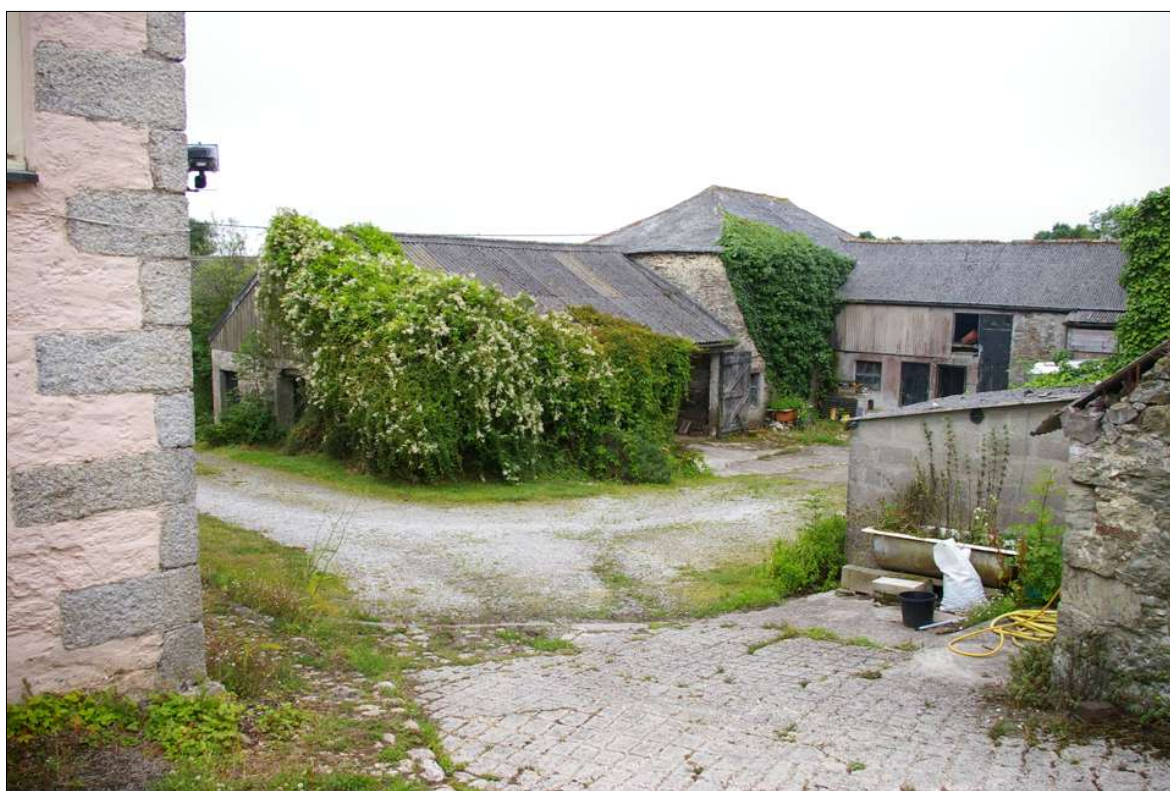
The original access to the farmyard was via a gate in the north-west corner, which is opposite the road junction; the ground slopes quite steeply down into the yard from this gateway, but the yard itself slopes fairly gently to the south. The yard surface is a mix of concrete (in the gateway and in front of B3) and white gravel. A pavement of quartz pebbles runs down from the gateway in front of the house, now partly replaced or skimmed with concrete.

Figure 11: Looking down into the yard from the original access; from the north-west.

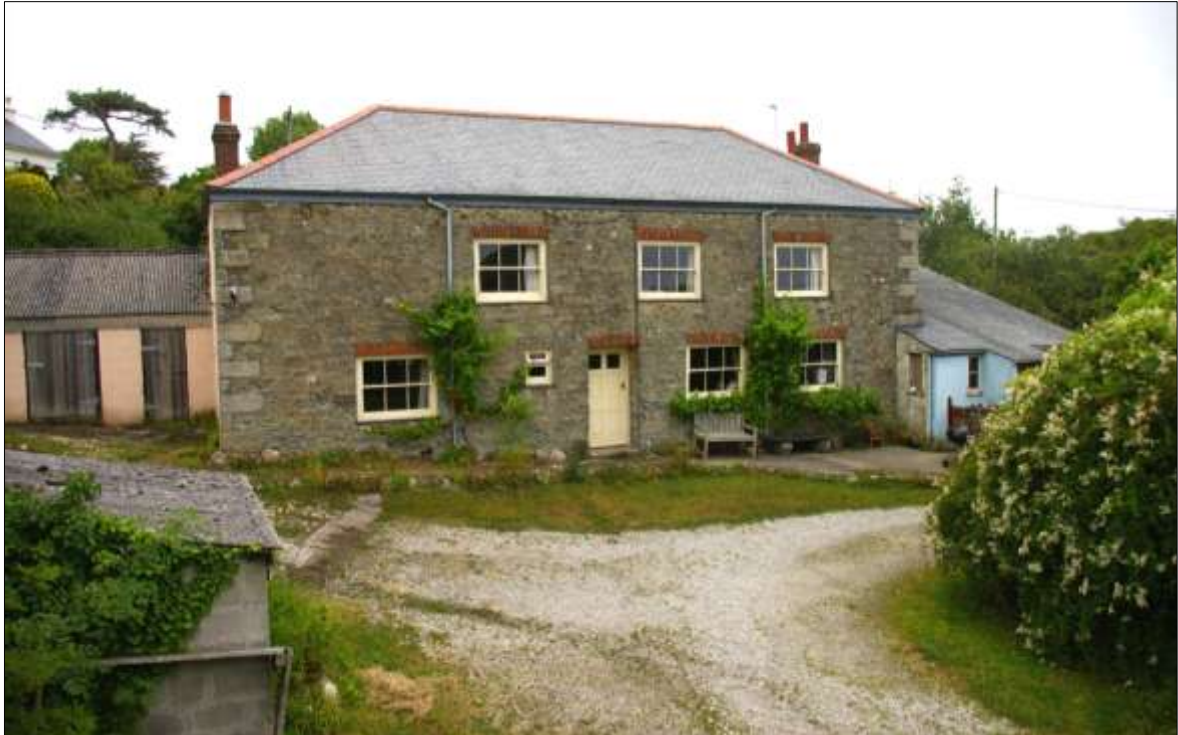
Tregew Farmhouse is a large, ostensibly late 18<sup>th</sup> century building containing good period interior fittings. It stands on the left as you enter the farmyard from the original gateway. The principal elevation faces south, across the farmyard, and is built of squared coursed stone rubble with squared granite quoins to the corners. There is a central door, with two broad windows to the right and one to the left, and three windows at first-floor level. The windows and doors have flat segmental arches of brick. A small window (cloakroom/toilet) has been forced through left of the door. The Listing indicates the roof was (in 1986) of slurried scantle slate; this was replaced in the late 1990s with regular rectangular slates. The interior was not inspected, but is apparently little different from the description in the Listing, which notes the survival of good late 18<sup>th</sup> century fittings. The Listing concludes: *'A most interesting very complete farmhouse with an unusual plan'*. However, the rear (north) elevation shows evidence for a raise, and it seems plausible that this is an earlier building that was extensively renovated in the late 18<sup>th</sup> century and the south elevation rebuilt at this date.

Figure 12: The south elevation of the farmhouse, viewed from the top of the steps outside of B2; viewed from the south-west.

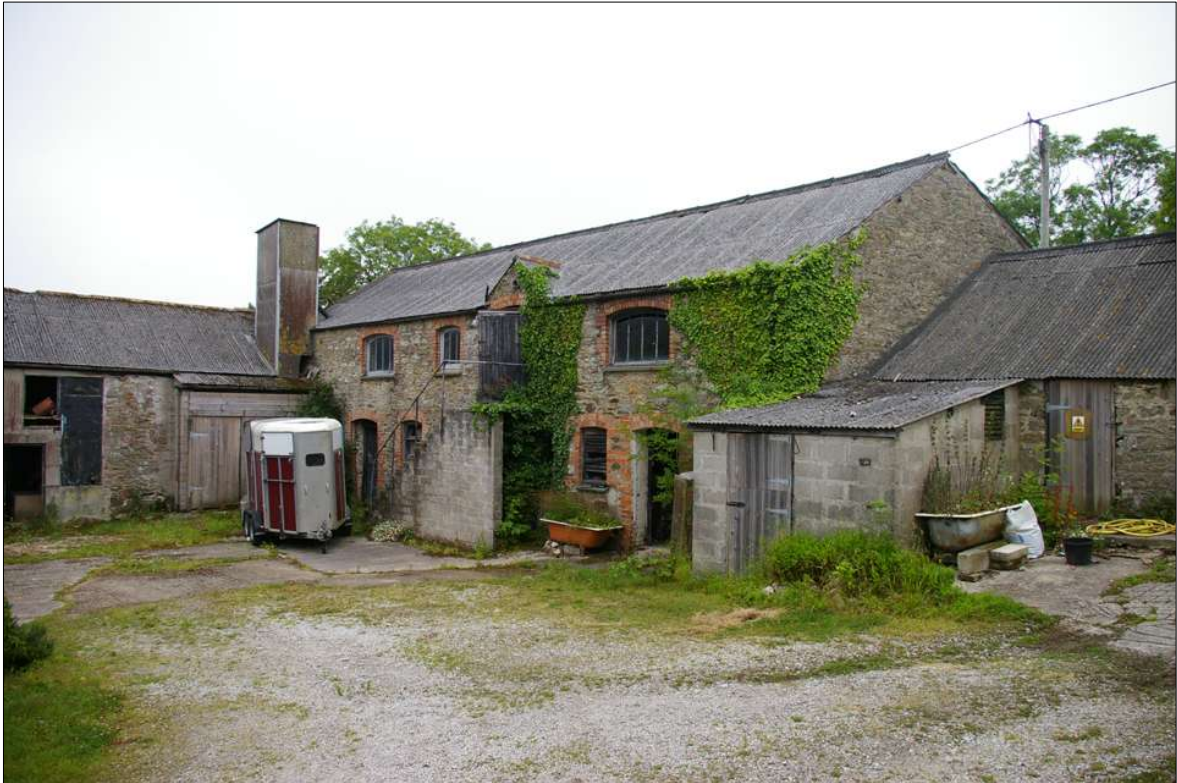
B2, the former stables, is a long two-storey range flanking the western side of the yard, between it and the road. It is of stone rubble, with gables, and a replacement asbestos sheet roof. The east elevation features a number of doors and windows, at first and ground floor level, with brick arches and reveals. In the centre there is a loading door at first-floor level, with a dormer above for a hoist. A set of concrete steps rises to this loading door. There is an internal stone wall, but few internal fittings remain. The roof is carried on simple half-lapped bolted trusses of later 19<sup>th</sup> century date. Buildings are shown at this location on the tithe map, and it seems probable the

east elevation was rebuilt in a modern (i.e. late Victorian) style and the building re-roofed at that date.

Figure 13: B2 viewed from the north-east; B1 and B6 to the right, B3 to the left.

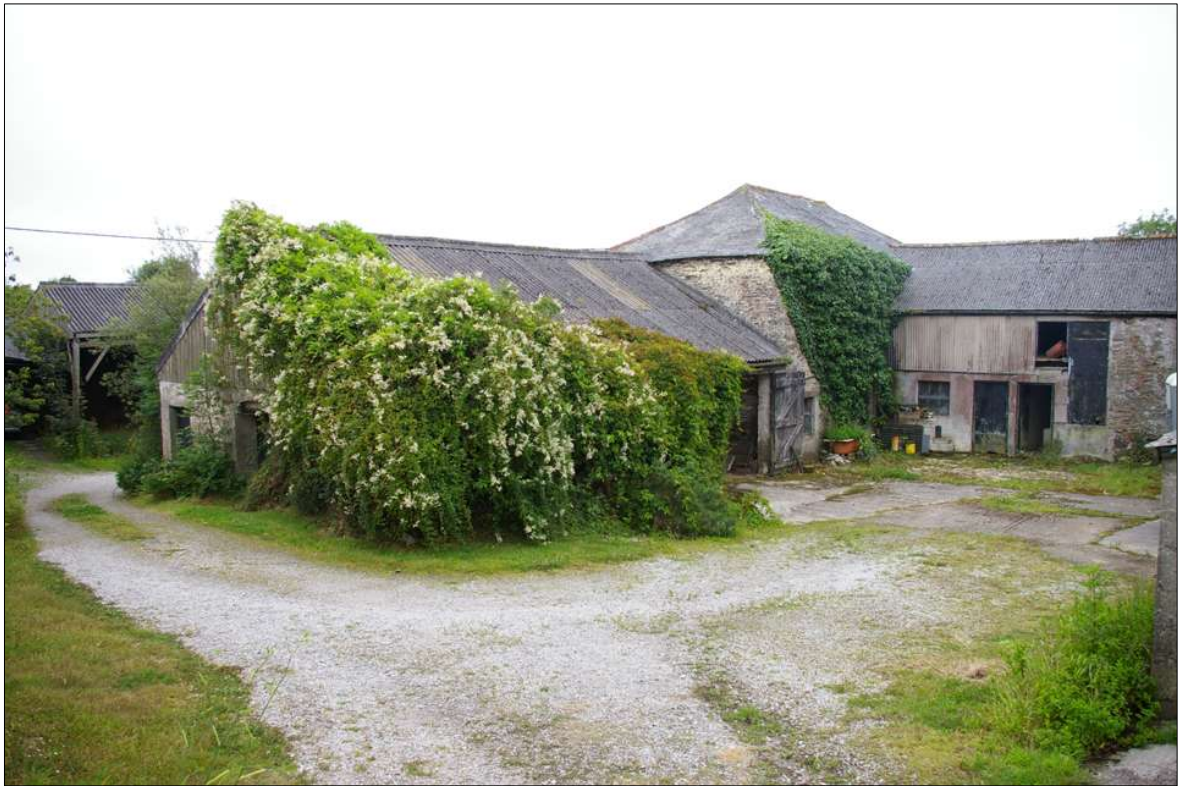
B5 is a single-storey square building abutting B4 to the north. The walls are of stone rubble with some brick reveals observed, and many blocked or forced openings. The walls have been raised with shuttered concrete and the roof is of modern timber construction. The height of the original

walls and the width of the current building would suggest the floors have been raised, and that it was originally a narrower structure with an outshut and catslide roof where the internal wall was removed.

Figure 14: B5 (centre) and B4 (right), viewed from the north-west.

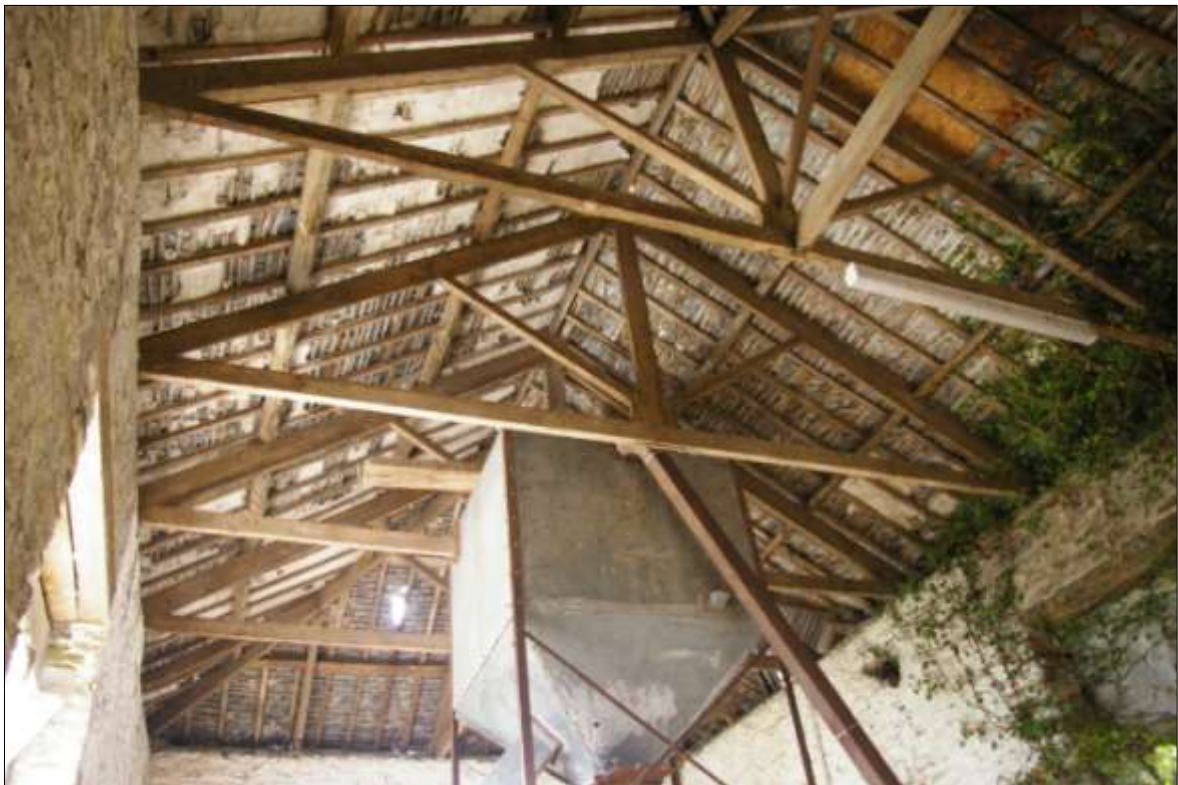
B4 is a two-storey rectangular building in the south-east corner of the yard. It is of stone rubble, with a hipped slurried scantle slate roof carried on pegged kingpost trusses with queen struts. This is the only surviving scantle roof observed within the hamlet. The internal floor has been removed and the ground floor is open to the roof. A large steel hopper is suspended from steel girders above the middle of the room. Each wall contains a series of blocked and forced openings at ground and first-floor level, and there was at least one internal stone wall. The removal of the internal structure would appear to have contributed to the failure of the walls in several places. The character of the stonework would suggest it is the oldest complete structure on site.

Figure 15: The interior of B4, showing the kingpost with queen-strut roof.

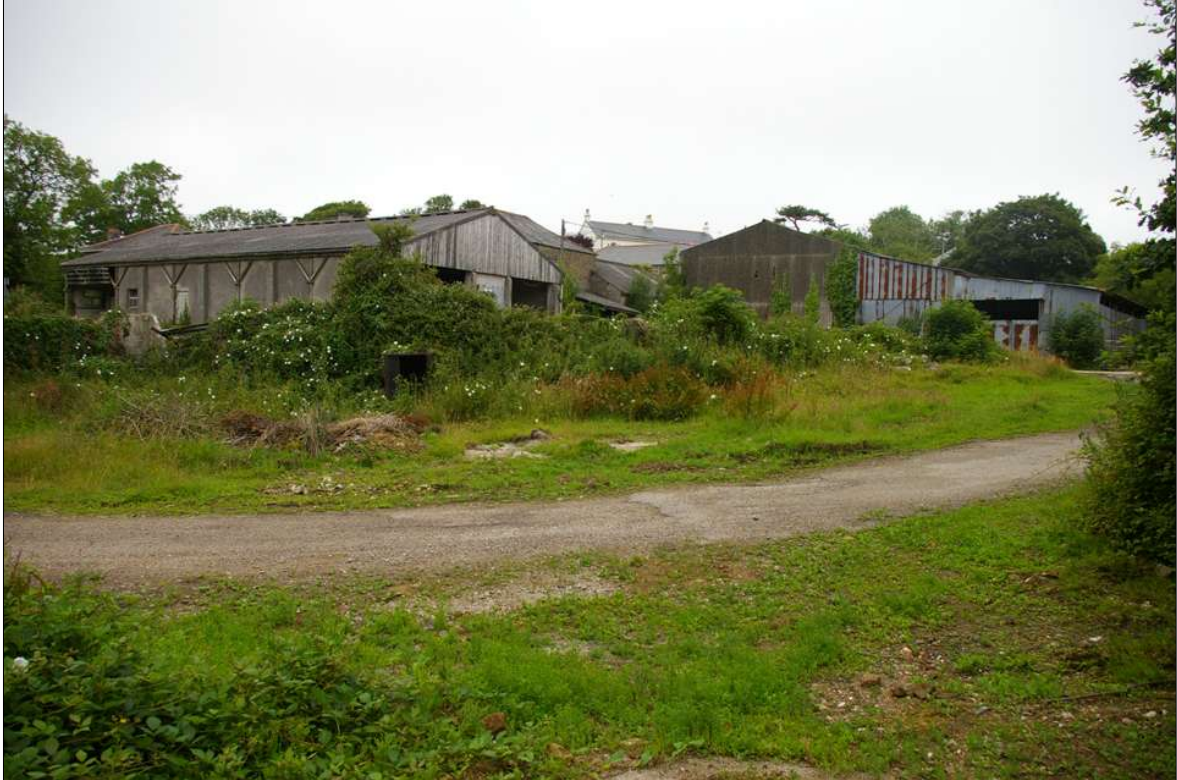
Figure 16: The farmstead viewed from the south, showing B8 (left) and B9 (right).

The other modern (20<sup>th</sup> century) structures on site lie south and west of the historic farmyard. B8 is located immediately to the south of B3; it is a large timber-framed structure with walls of skimmed concrete block with internal concrete block subdivisions. It lies within a yard with a concrete surface, with a tangled mass of steel gates to the east; this yard has been built up and levelled with subsoil material derived from buildings works elsewhere in Flushing.

B9 is a complex of barns to the east of the historic farmyard, all of timber construction. B10 lies beyond B9 to the east, and is another, but more recent, timber framed building. B8-B10 have roofs of 'big six' asbestos sheeting, and utilise Yorkshire boarding as cladding.

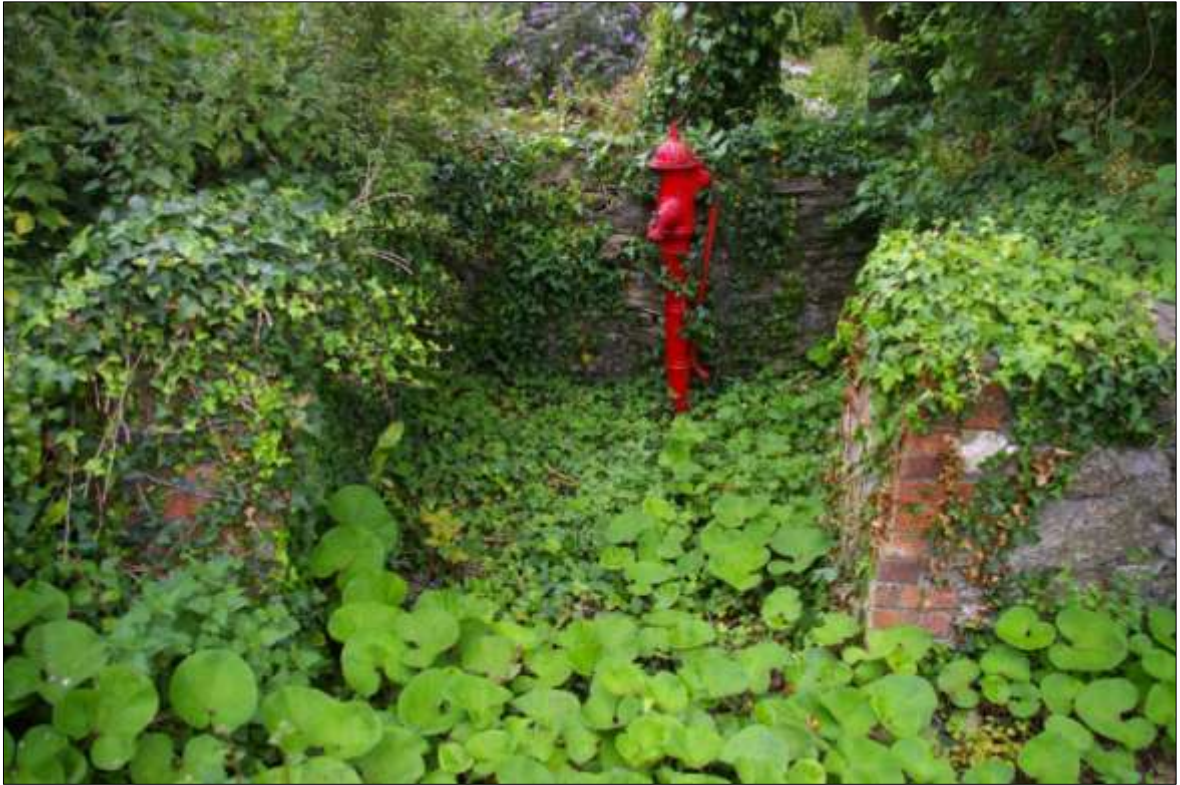
South of the farm buildings is an area of former yard; access to the farmhouse runs through this area. Twisted metal and the remains of another concrete structure survive in this area. Around the edge, and particularly to the south, this area has become very overgrown. Next to the access onto Tregew Road there is a small walled enclosure (c.3m across), of stone rubble with brick reveals; it contains a metal pump (painted red).

Figure 17: The walled pump at the southern end of the site; viewed from the west.

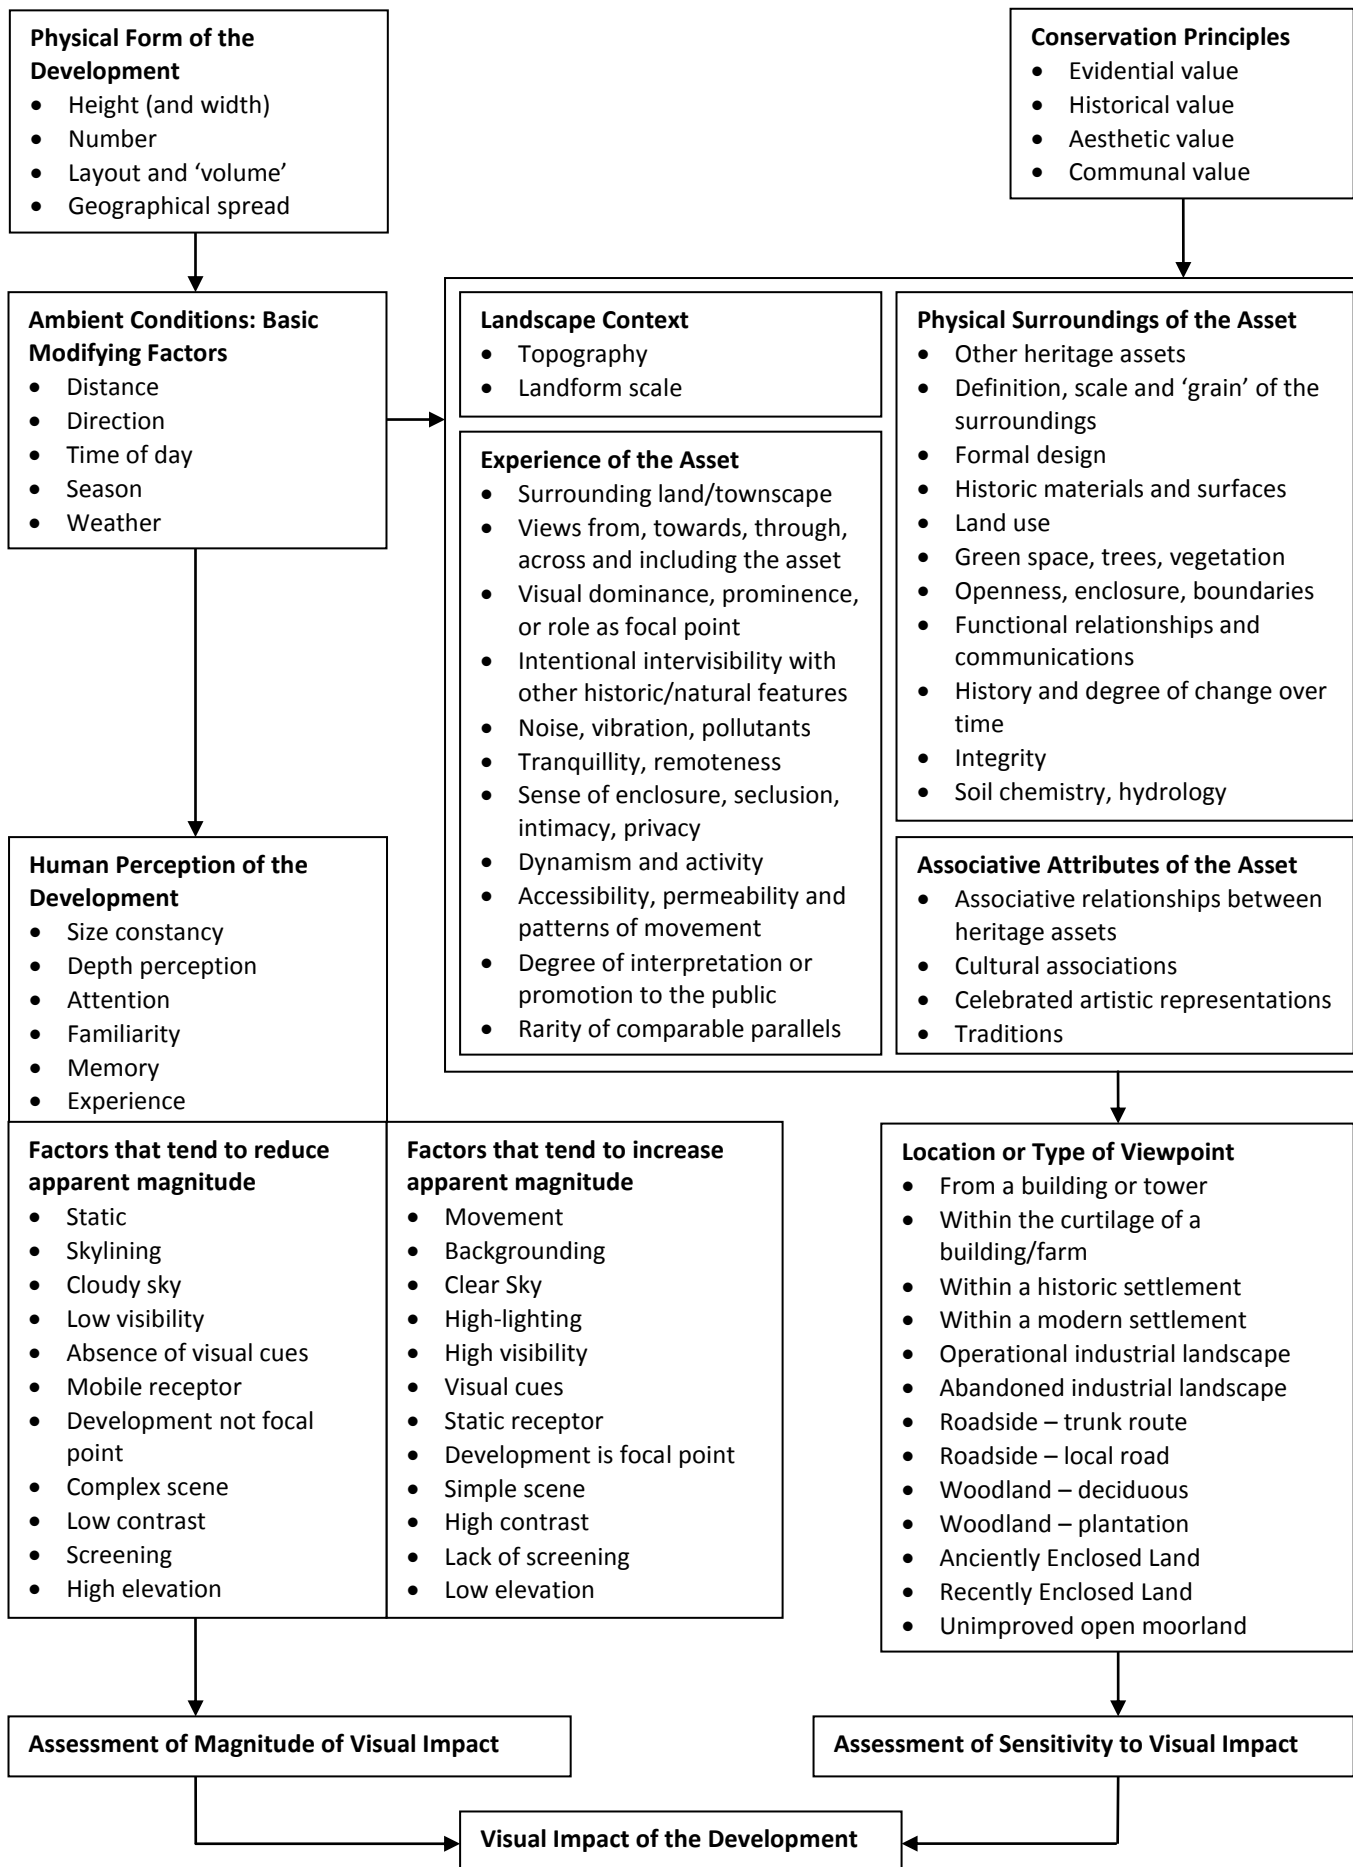
Table 3: The conceptual model for visual impact assessment proposed by the University of Newcastle (2002, 63), modified to include elements of *Assessment Step 2* from the Setting of Heritage Assets (English Heritage 2011, 19).

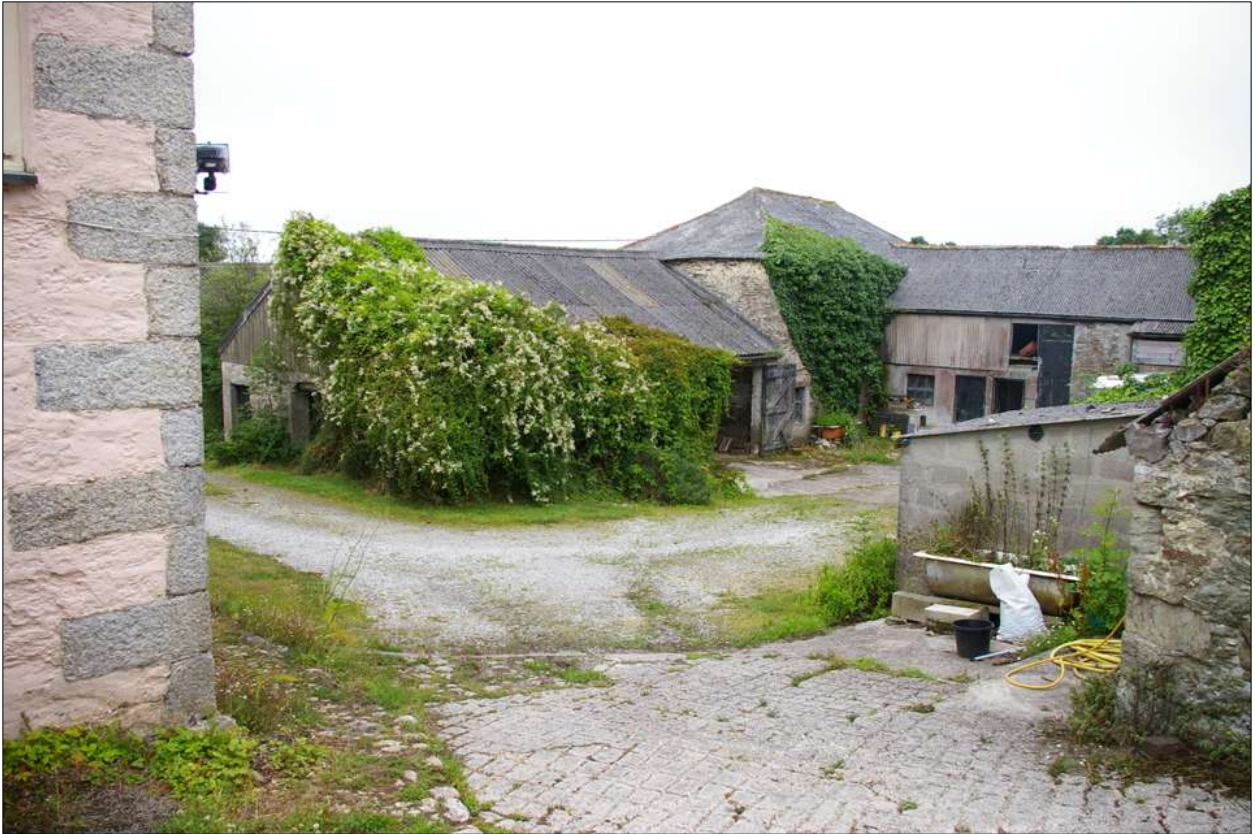
Looking down into the yard from the original access; from the north-west.

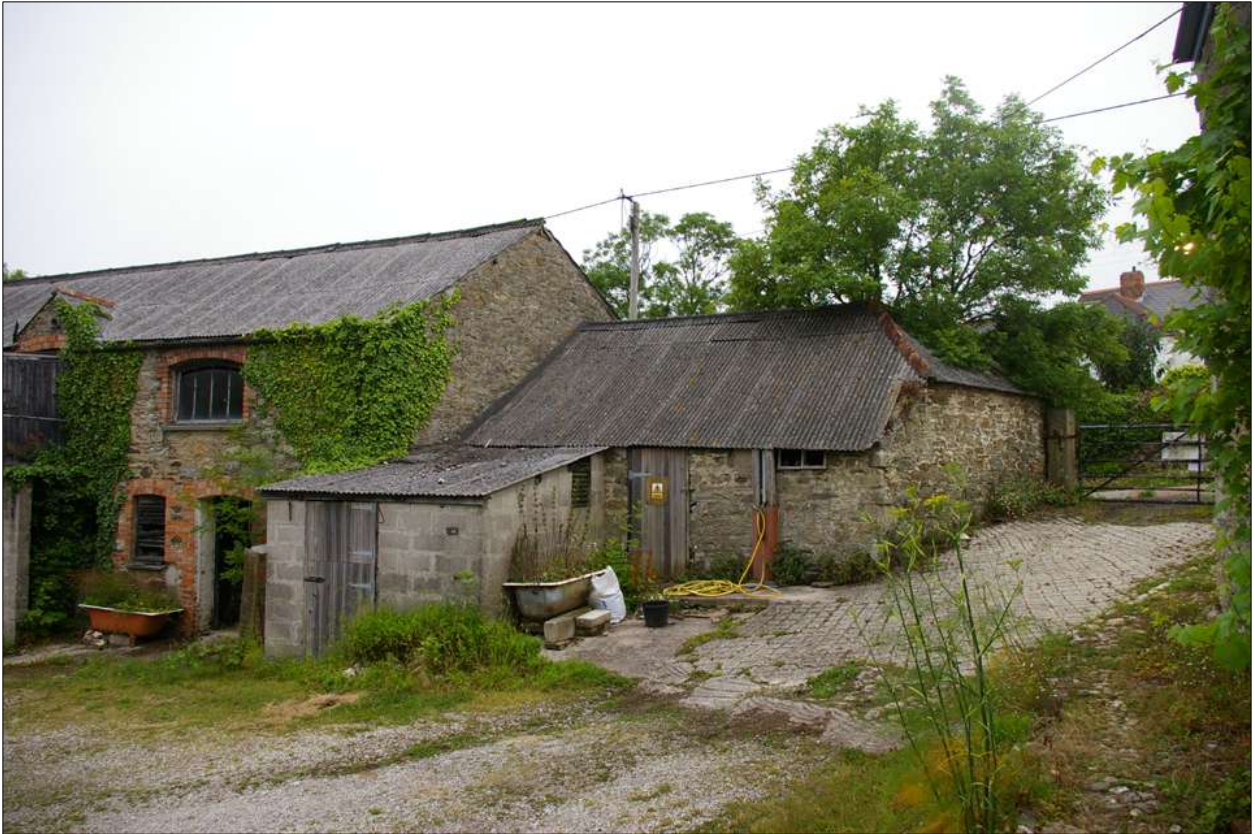
B1 and B6, in the north-west corner of the farmyard; viewed from the east.

B1 is a small mono-pitch outshut at the northern end of B2 and next to the original entrance. It has walls of stone rubble with a replacement asbestos sheet roof, and was originally open-fronted (cart shed?) (interior not inspected).

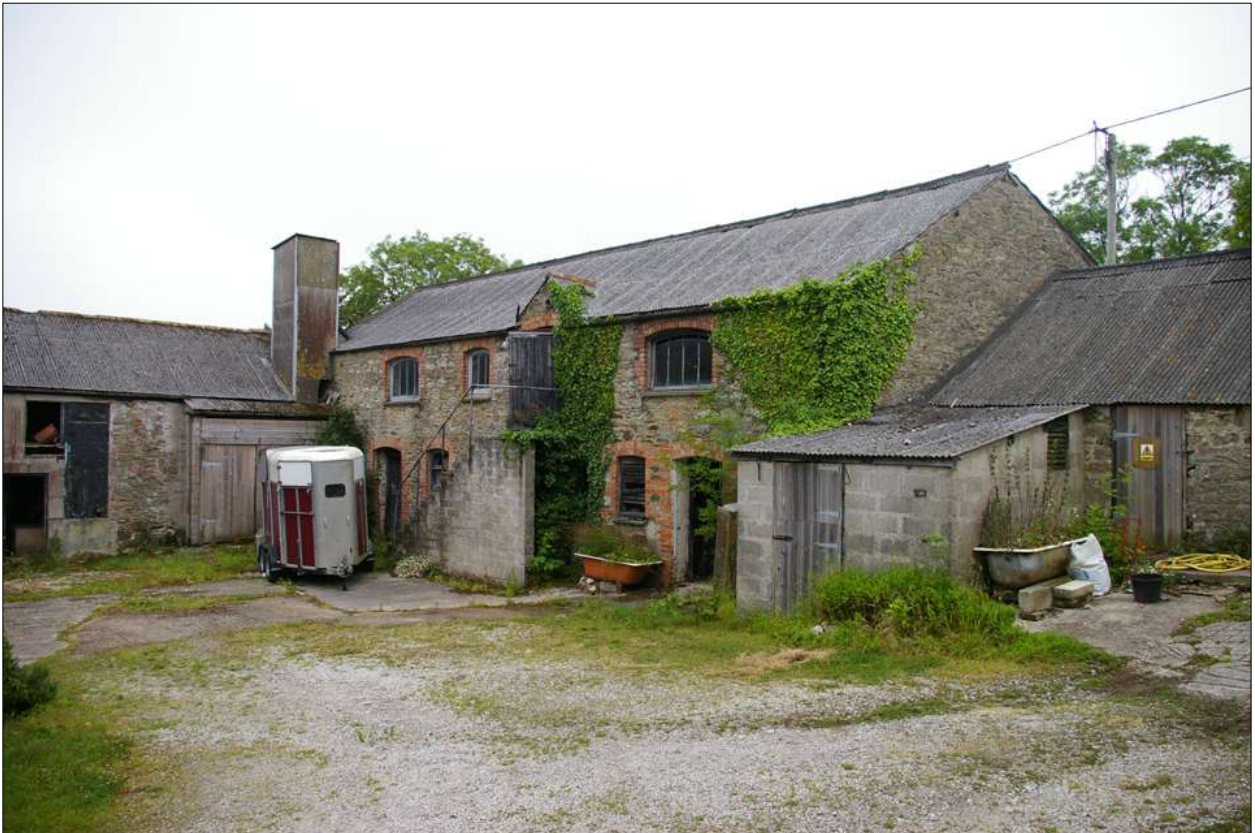
B2, viewed from the north-east.

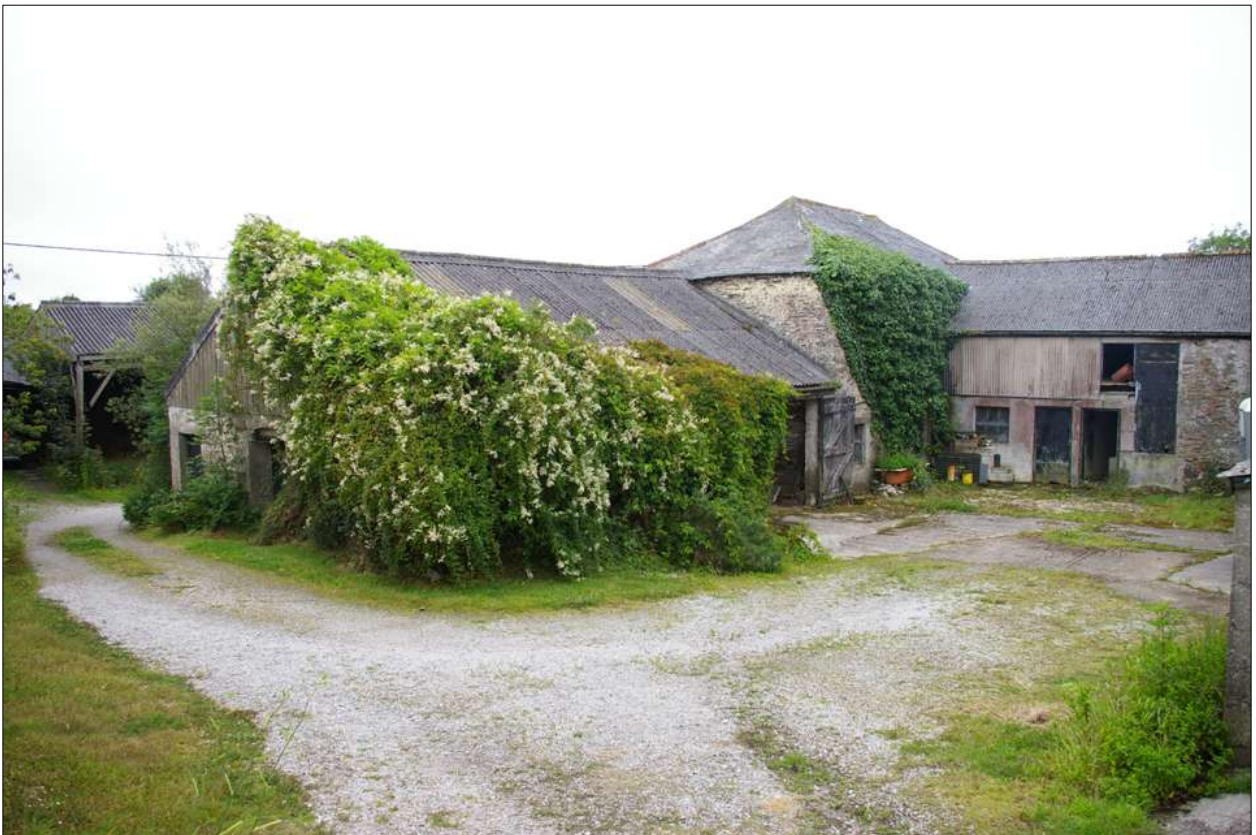
B4 and B5, viewed from the north-west.
