# TREGEW FARMHOUSE FLUSHING, MYLOR CORNWALL

Results of a Desk-Based Assessment &  
Limited Historic Visual Impact Assessment

Report No.: 150716  
Date: 16.07.2015  
Author: B. Morris

*This report presents the results of a desk-based assessment and historic visual impact assessment (HVIA) carried out by South West Archaeology Ltd. on land at Tregew Farm, Flushing, Mylor in Cornwall, as part of the pre-planning submission for a proposed barn conversion and small residential development.*

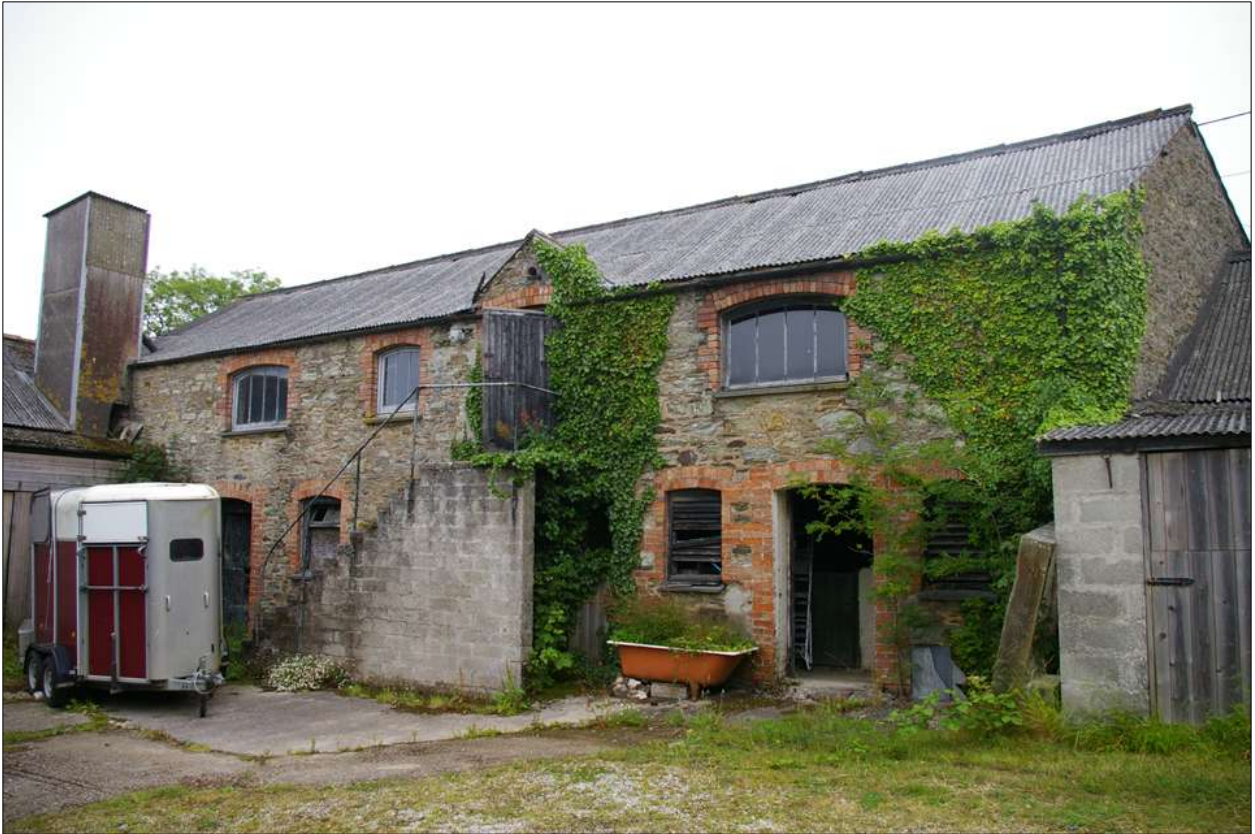
Detail of the east elevation of B2; viewed from the north-east.

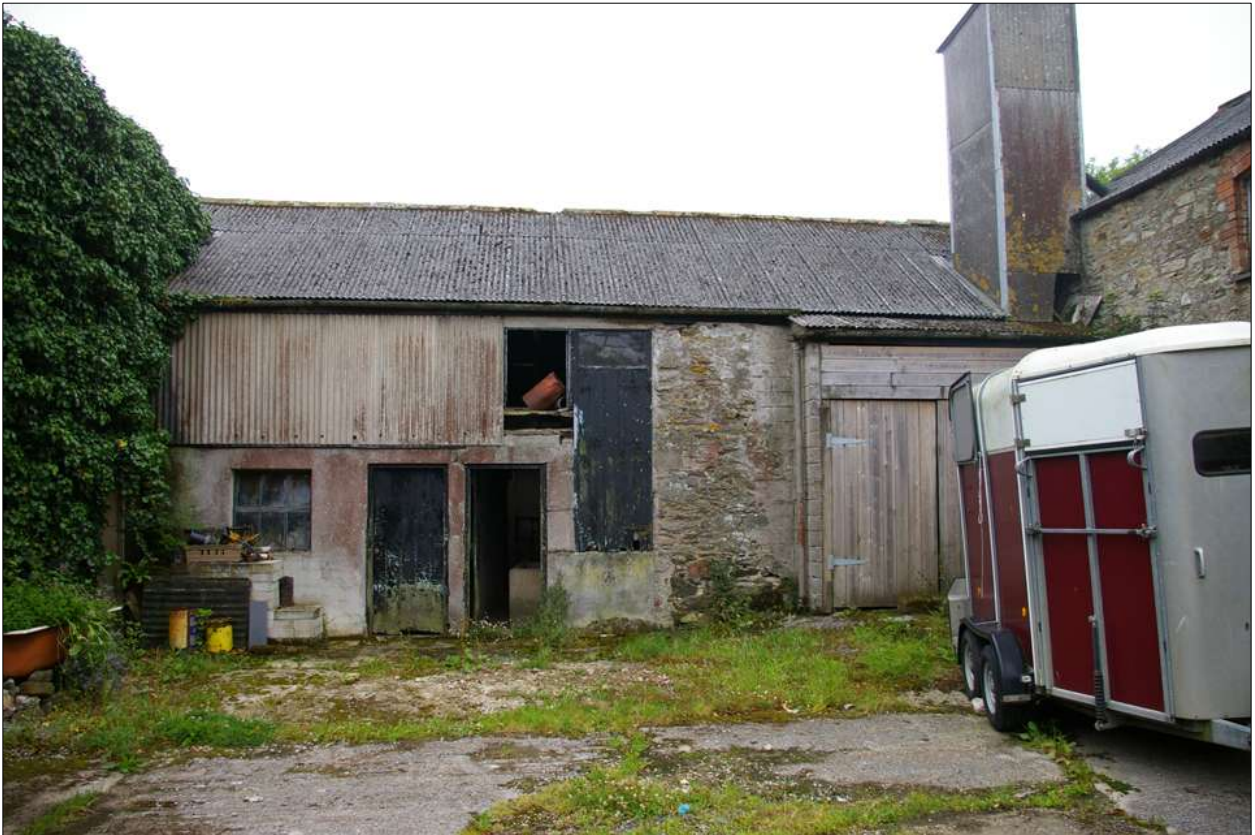
Detail of the north elevation of B3; viewed from the north.

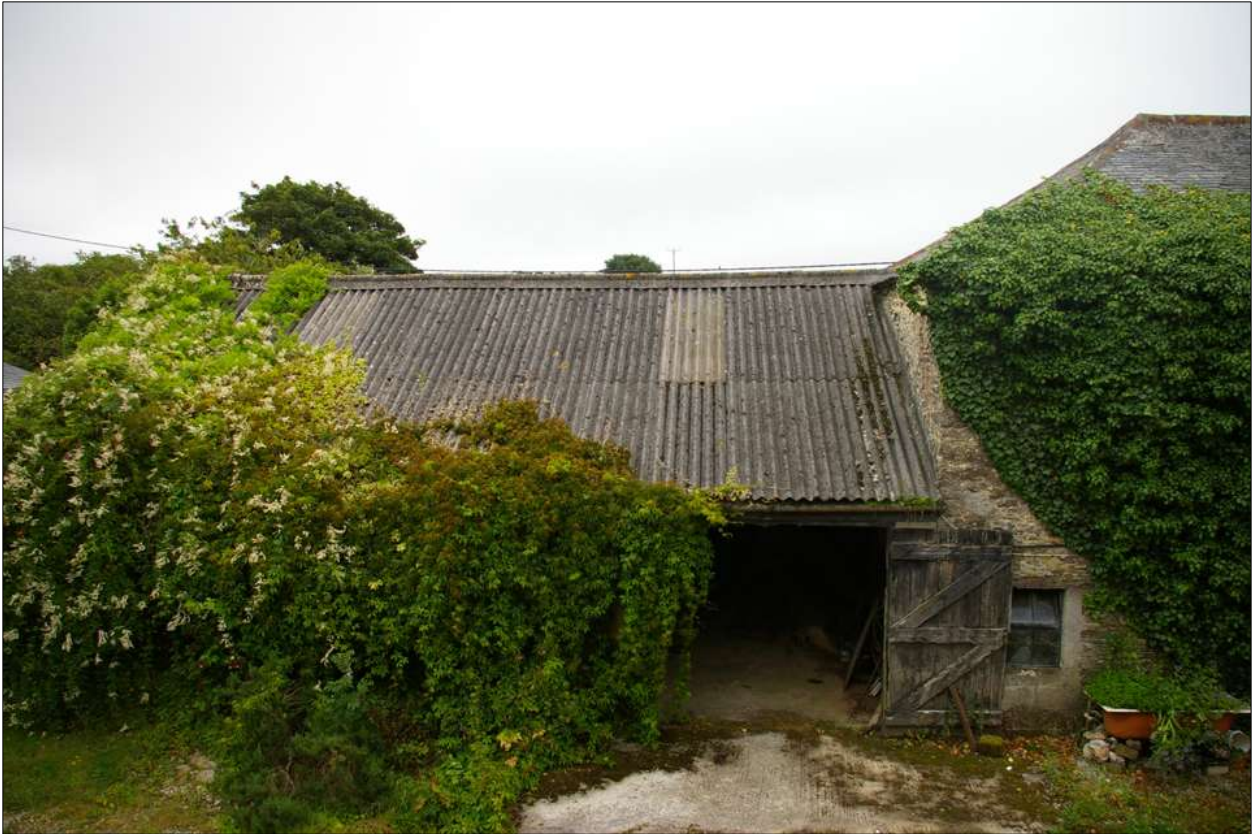
Detail of the west elevation of B5; viewed from the west.

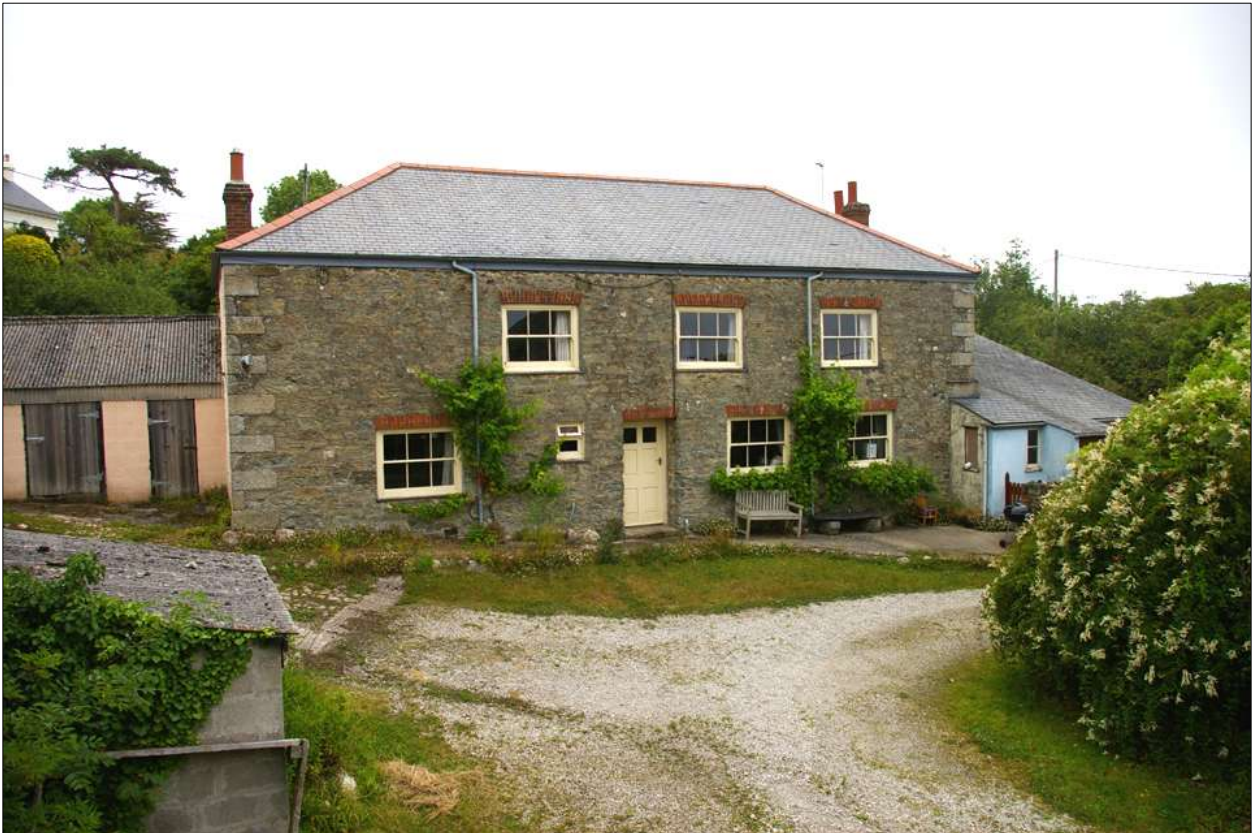
The south elevation of the farmhouse, viewed from the top of the steps outside of B2; viewed from the south-west.

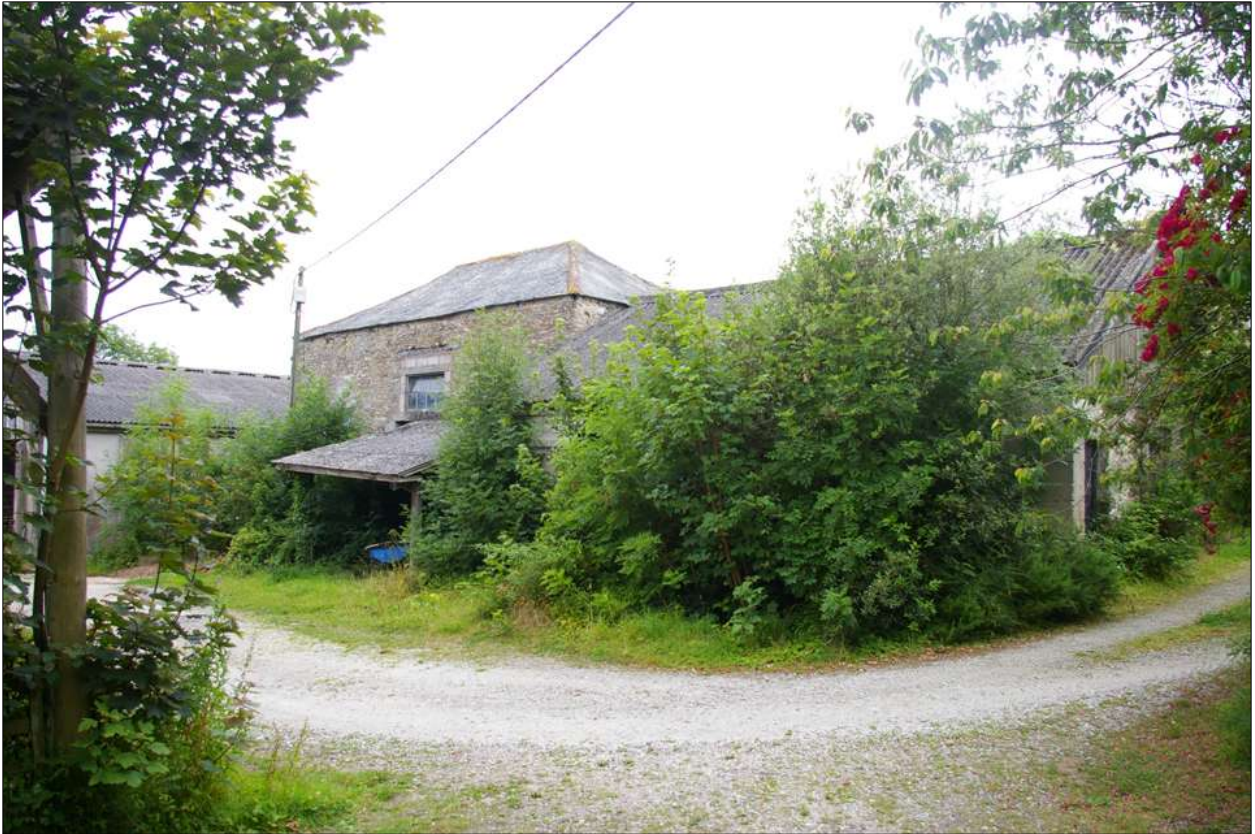
The east elevation of B4 and B5, viewed from the north-east.

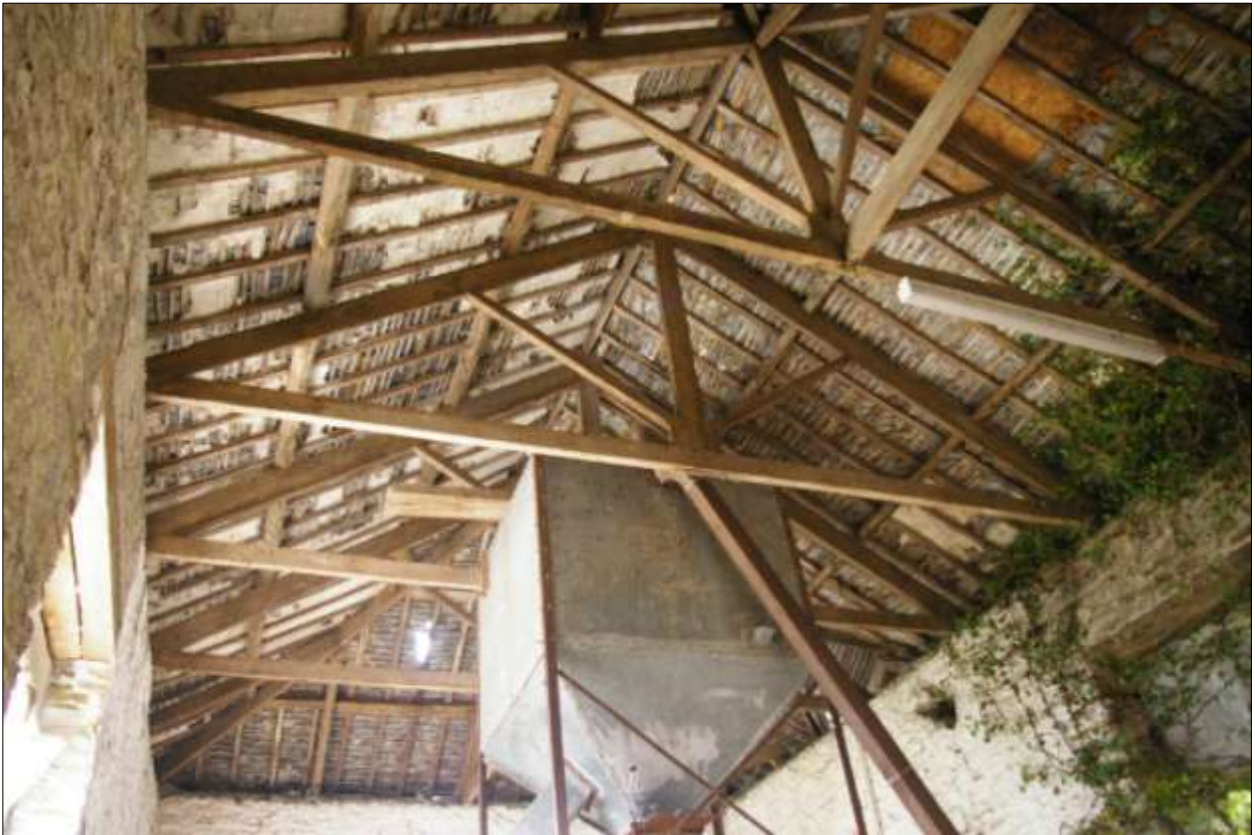
The interior of B4, showing the kingpost with queen-strut roof.

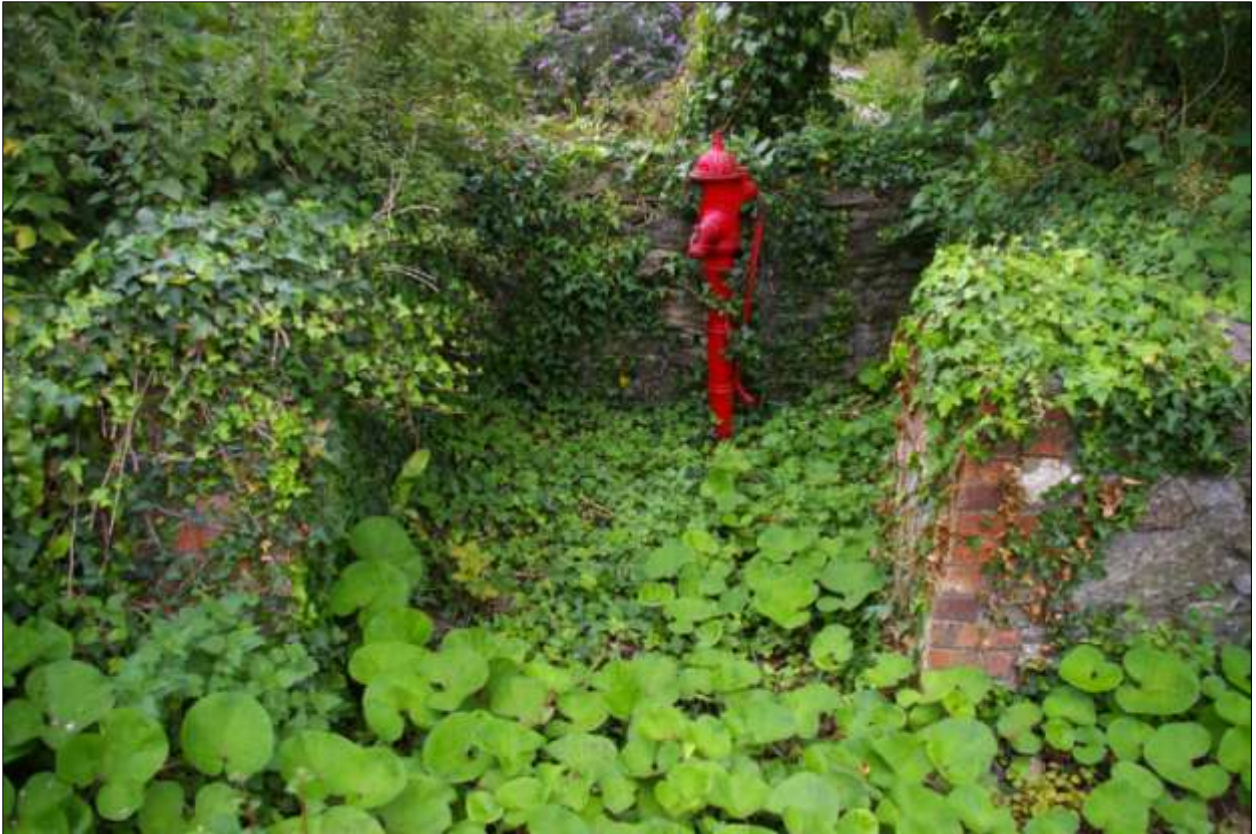
The walled pump at the southern end of the site; viewed from the west.

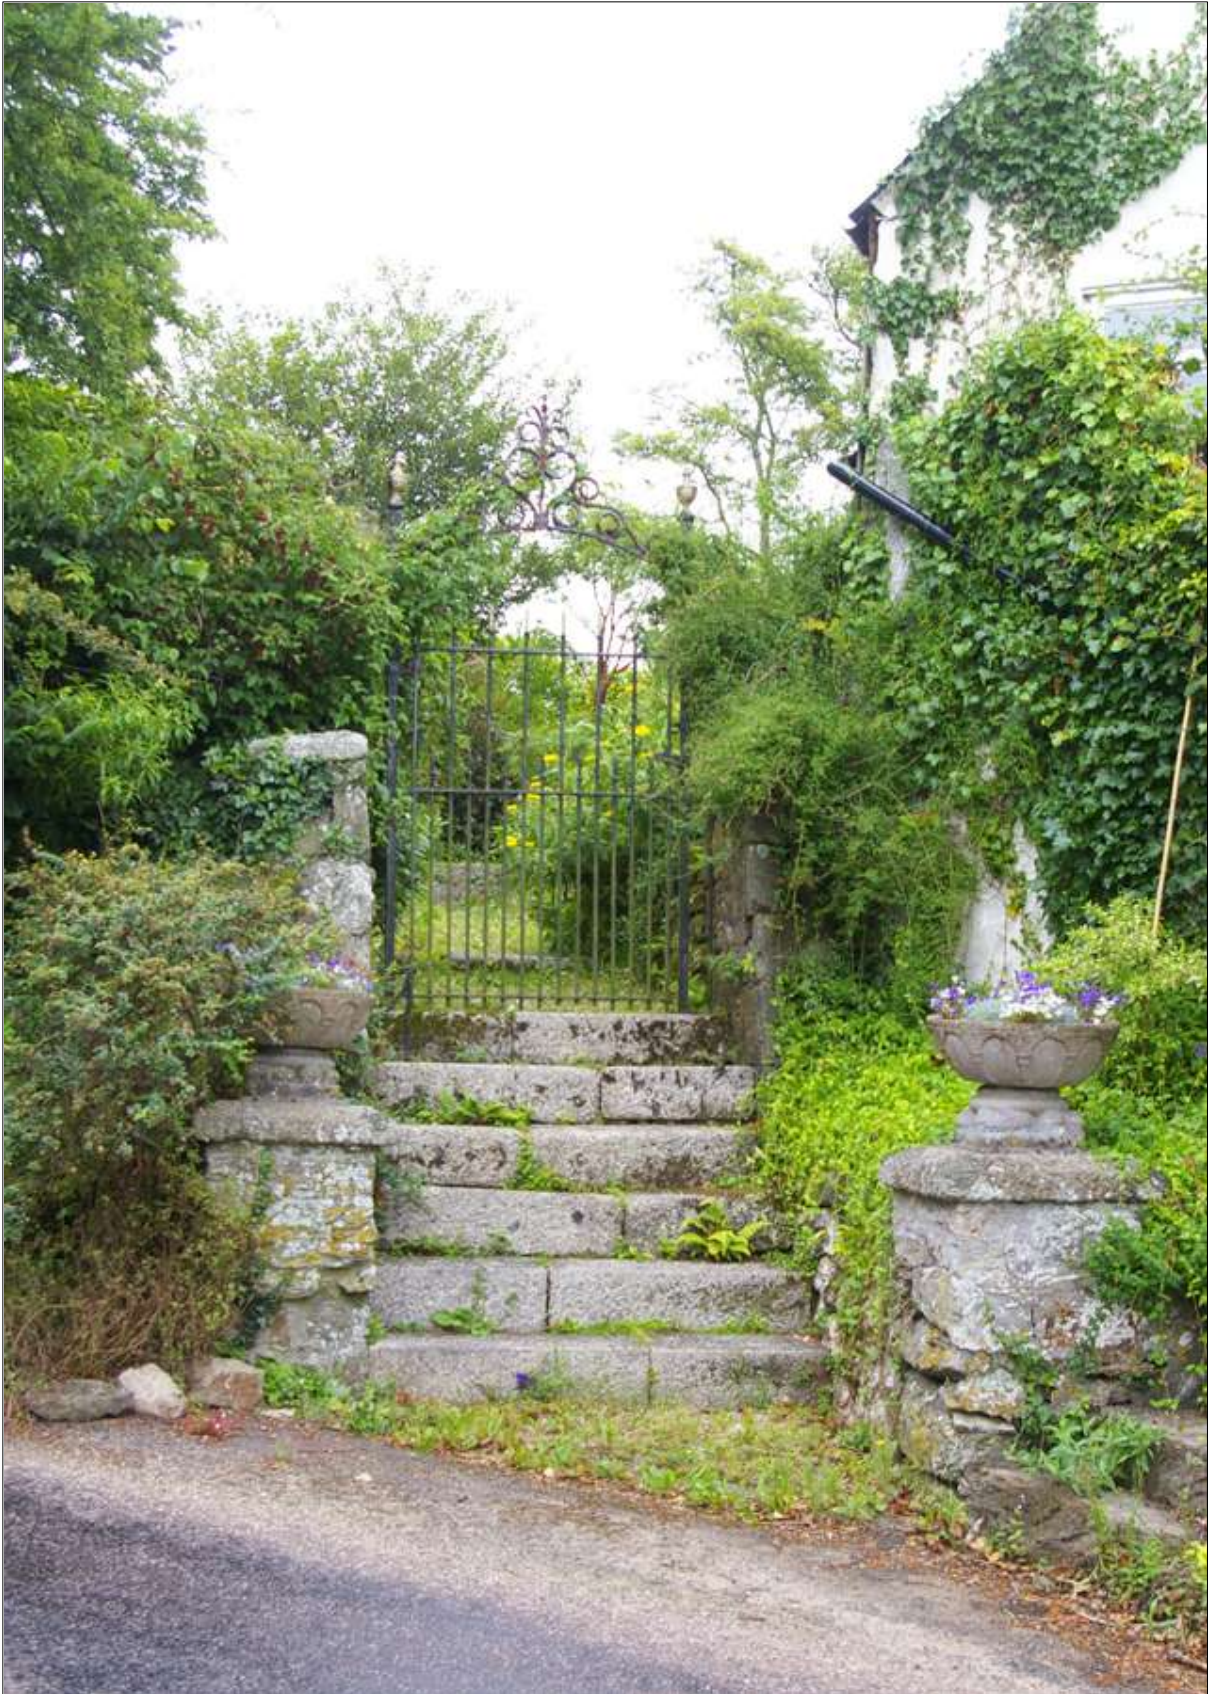
The GII steps/gate piers to Tregew House; viewed from the south.
