THE MANOR HOUSE COMPLEX AND THE FARMERS ARMS, WOOLSERY, DEVON

Desk Based Assessment &
Historic Building Recording

Report No.: 150415
Date: 15.04.2015
Author: E. Wapshott
V. Hosegood

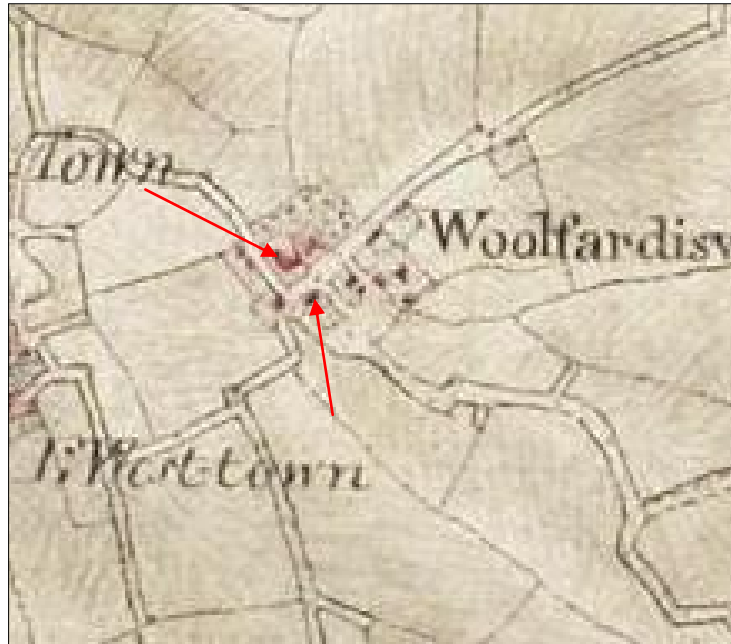
Figure 3: Extract from the 1804 Surveyors Draft OS map. The sites are indicated.

The first useful source in this study is the Surveyors Draft OS map dating to 1804 (Figure 3). Although the detail is not clear on this map and the scale and accuracy is questionable, it does show the extent of the development of the village in this period. The manor house and the pub are depicted and there is a small scatter of buildings bordering the road to the west of the house as well as to the south and east of the church.

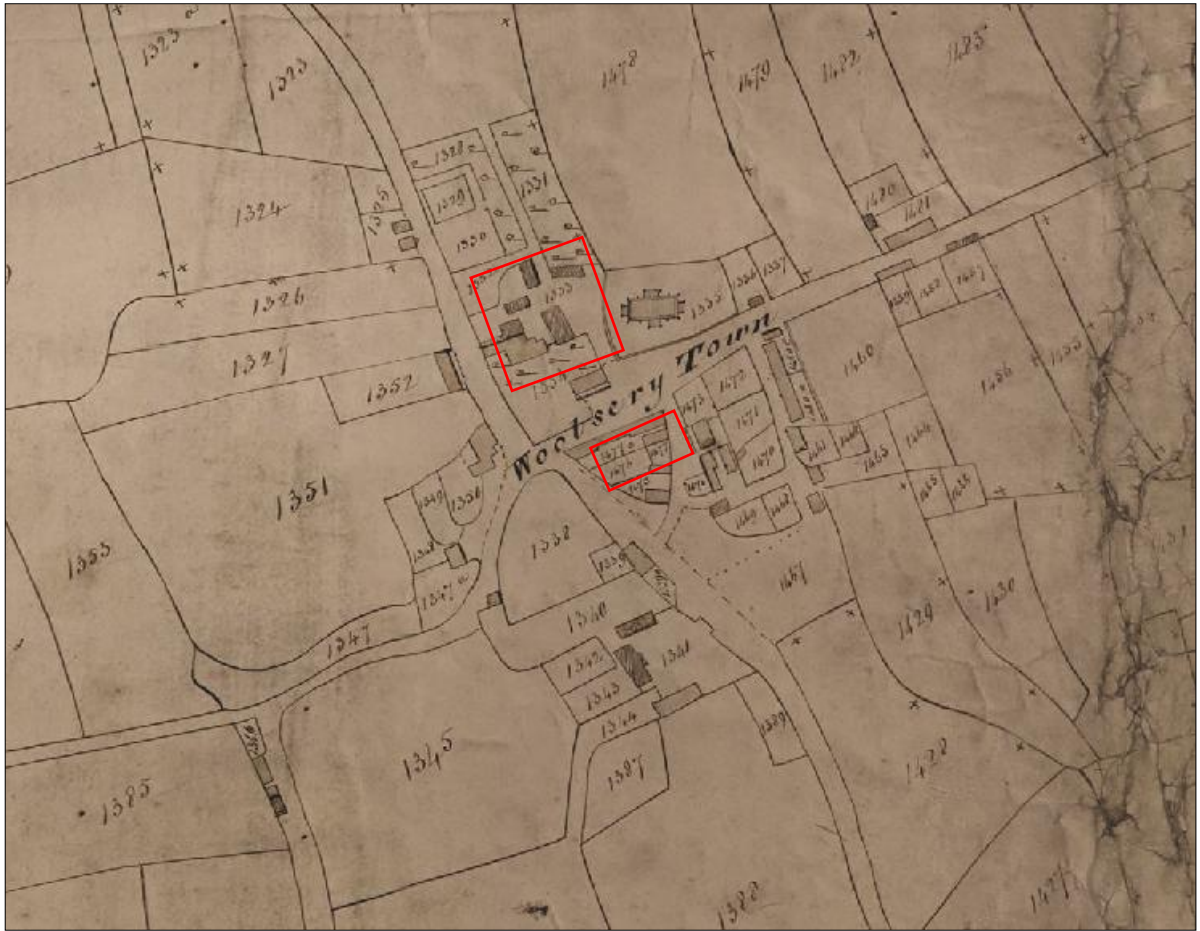
Figure 4: Extract from the 1840 Woolserly Tithe map (the house and pub are indicated).

The Woolsery tithe map of 1840 details the buildings (Figure 4) hinted at on the 1804 Surveyors Draft. The only notable changes between the two maps are further houses to the very south of the village and the buildings to the north of the manor, which are not obvious on the 1804 map and so may have been developed between these two maps. The tithe apportionment (Table 1), suggest that the Farmers Arms (1477a) was in 1840 a *house and court*(yard) owned and occupied by Edward Lee. The Manor House and the surrounding land and buildings are owned and occupied by, Bartholomew Prust; which supports the documentary sources. The land to the north and south of the manor is mainly in use as gardens, lawns and orchards, while the scatter of buildings to the north of it are labelled *houses and grounds* suggesting that there was more than one dwelling present at this time.

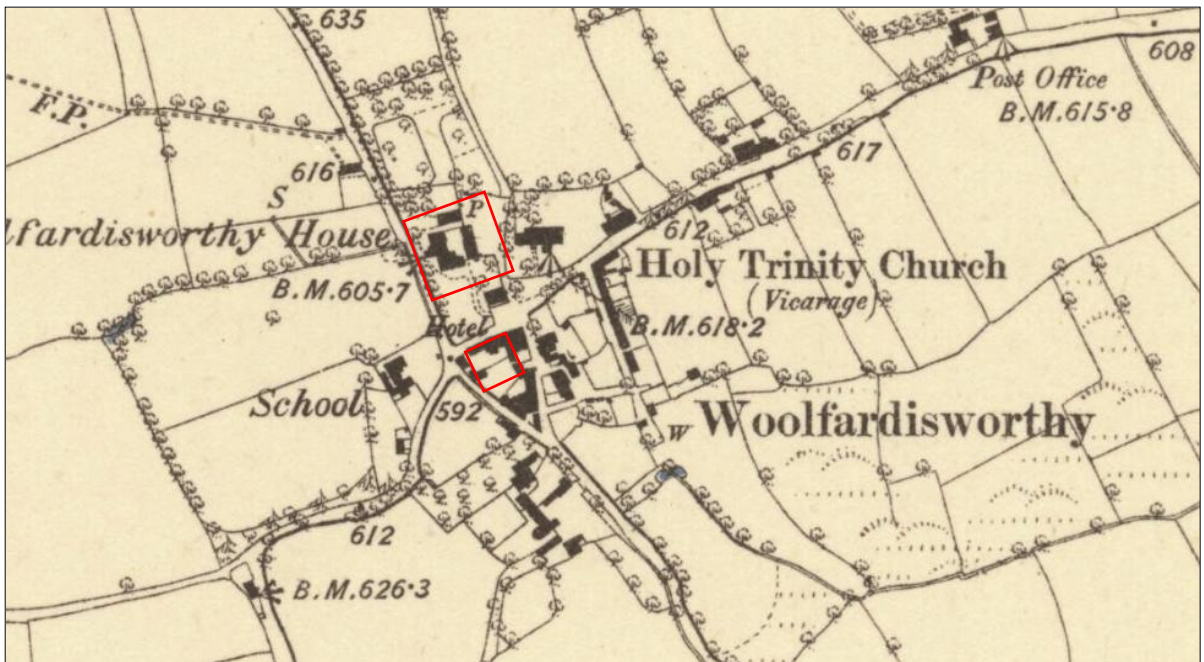
Figure 5: Detailed Extract from 1st Edition OS map of 1887, the house is indicated.

There are a few small changes between the First Edition OS of 1887 (Figure 5) and the tithe map. The plan of the building in the area occupied by the pub differs slightly to that apparent on the tithe, suggesting that it had undergone some changes, particularly to the south. The same is true for the Manor House; it had been extended northwards on the western side by this date, perhaps incorporating a former outbuilding. The number of buildings to the north of the Manor House had reduced from the five apparent on the tithe to two on the First Edition. There are also numerous differences in the wider village, for example a school has been built in the south-west corner of the village, in 1840 this land belonged to the Prust's and there had been a house fronting onto the road. There is no major development between 1840 and 1888 and there are no major changes between the First and Second Edition (1906) OS maps (see Figure 6).

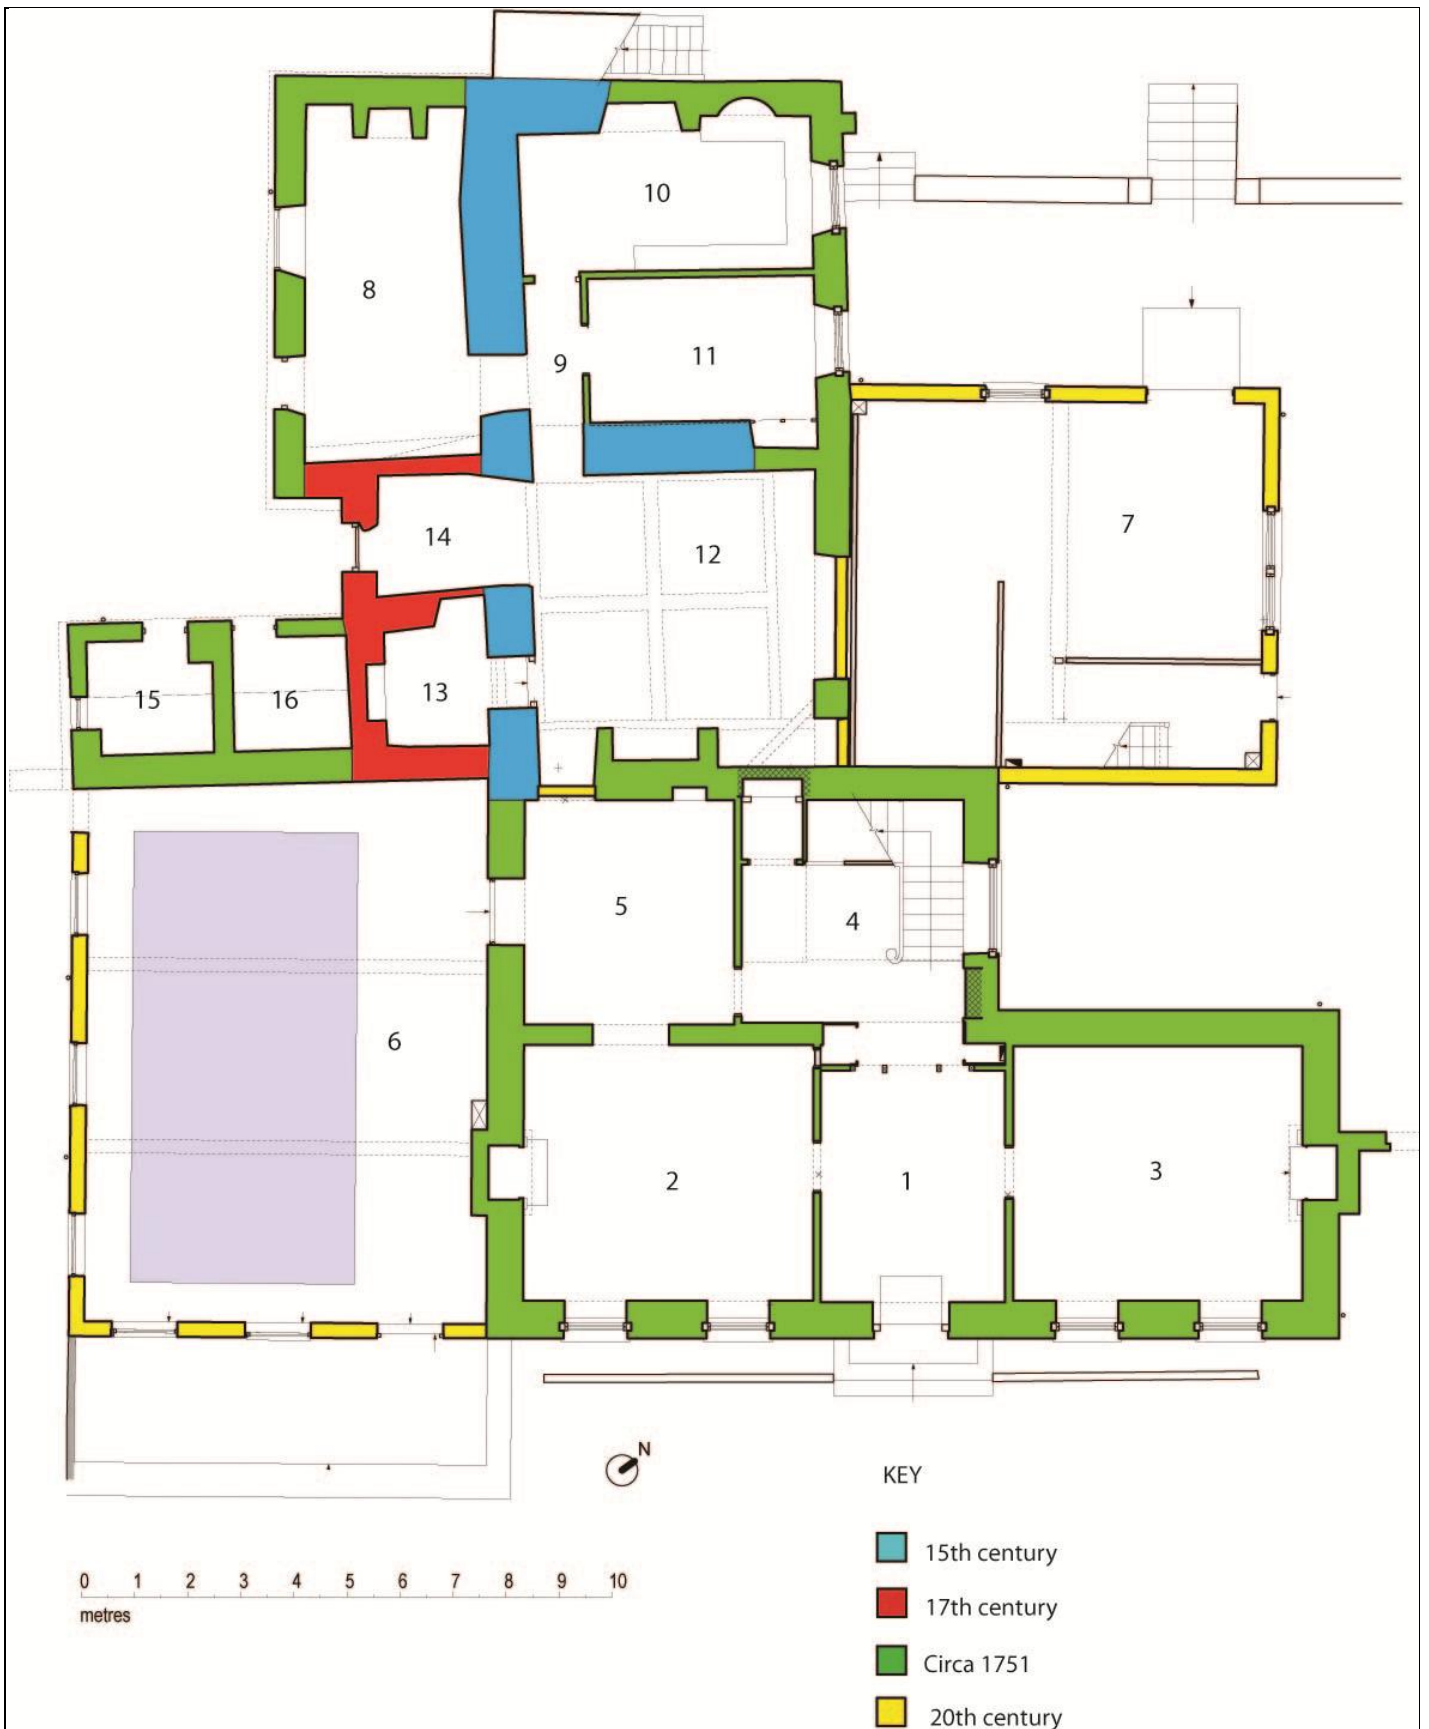
Figure 7: Phased ground floor plan of the Manor House.

3.2.7 Phasing

Medieval (late 15th-early 16th century)

The building was most likely of a typical regional form, a three cell and cross passage house, with an open hall, to the south of the cross passage. The building lay on a north-south alignment, set into the slope, which rises to the north. The building was of one and a half storeys, the hall open to the roof, with a central open hearth.

Evidence for this phase is: the thick stone medieval walls of the open hall, cross passage and end room, to the south and west of the Service Range; the medieval smoke-blackened roof truss, with yoke. The south end of the medieval building, the inner room, was either demolished or partially incorporated into the later main Front Range.

17th century

The cross-passage house received an extensive remodel. This phase represents considerable financial outlay and investment in the building and the new fashionable additions all respect the main street facade of the house at the time, i.e. the west elevation.

The open hall was floored, with a fine moulded cross-beam roof, new roof trusses were inserted to the north side of the hall structure carrying a plaster barrel vault formed over the new first floor room. A small stone stair turret was then built against the south-west corner of the hall, to provide access to the new first floor room. A double height porch was built to the west side of the cross passage, facing the main street, served by a newly forced opening at first floor level. This porch was probably open to the ground floor, with a small room above. Between the porch and stair turret a large axial chimney stack (or projecting oriel window) may have been constructed to serve the rooms formed by the closing of the open hall.

Evidence for this phase is: the cross-beam ceiling, scar of the barrel vault; the extant 17th century trusses; moulded stone plinth to the exterior face of the west wall; roll moulded timber beam in the lean-to and blocked forced doorway at first floor height. The stair turret survives structurally only; the porch survives in part within the later lean-to structure which abuts the building to the west.

18th century (c.1751)

This represents a significant rebuild and repair phase, alongside the considerable construction of the main Front Range. Again this phase represents significant financial outlay and investment in the building, the occupants again moving decidedly with the architectural fashions of the time.

There was an extensive remodel of surviving parts of the medieval and 17th century building to form a service wing, the open hall becoming the main kitchen, the end room divided to form a dairy and housekeeper's room. A long lean-to was built along the west side, possibly for a scullery, incorporating the remains of the projecting porch. The east wall of the building at the north end was wholly rebuilt.

The newly constructed Front Range may have incorporated the remains of the inner room of the medieval building. The south extension is built in a classical style, with fine quality fittings, such as the stair, cornicing and moulded architraves, panelling, sash windows etc.

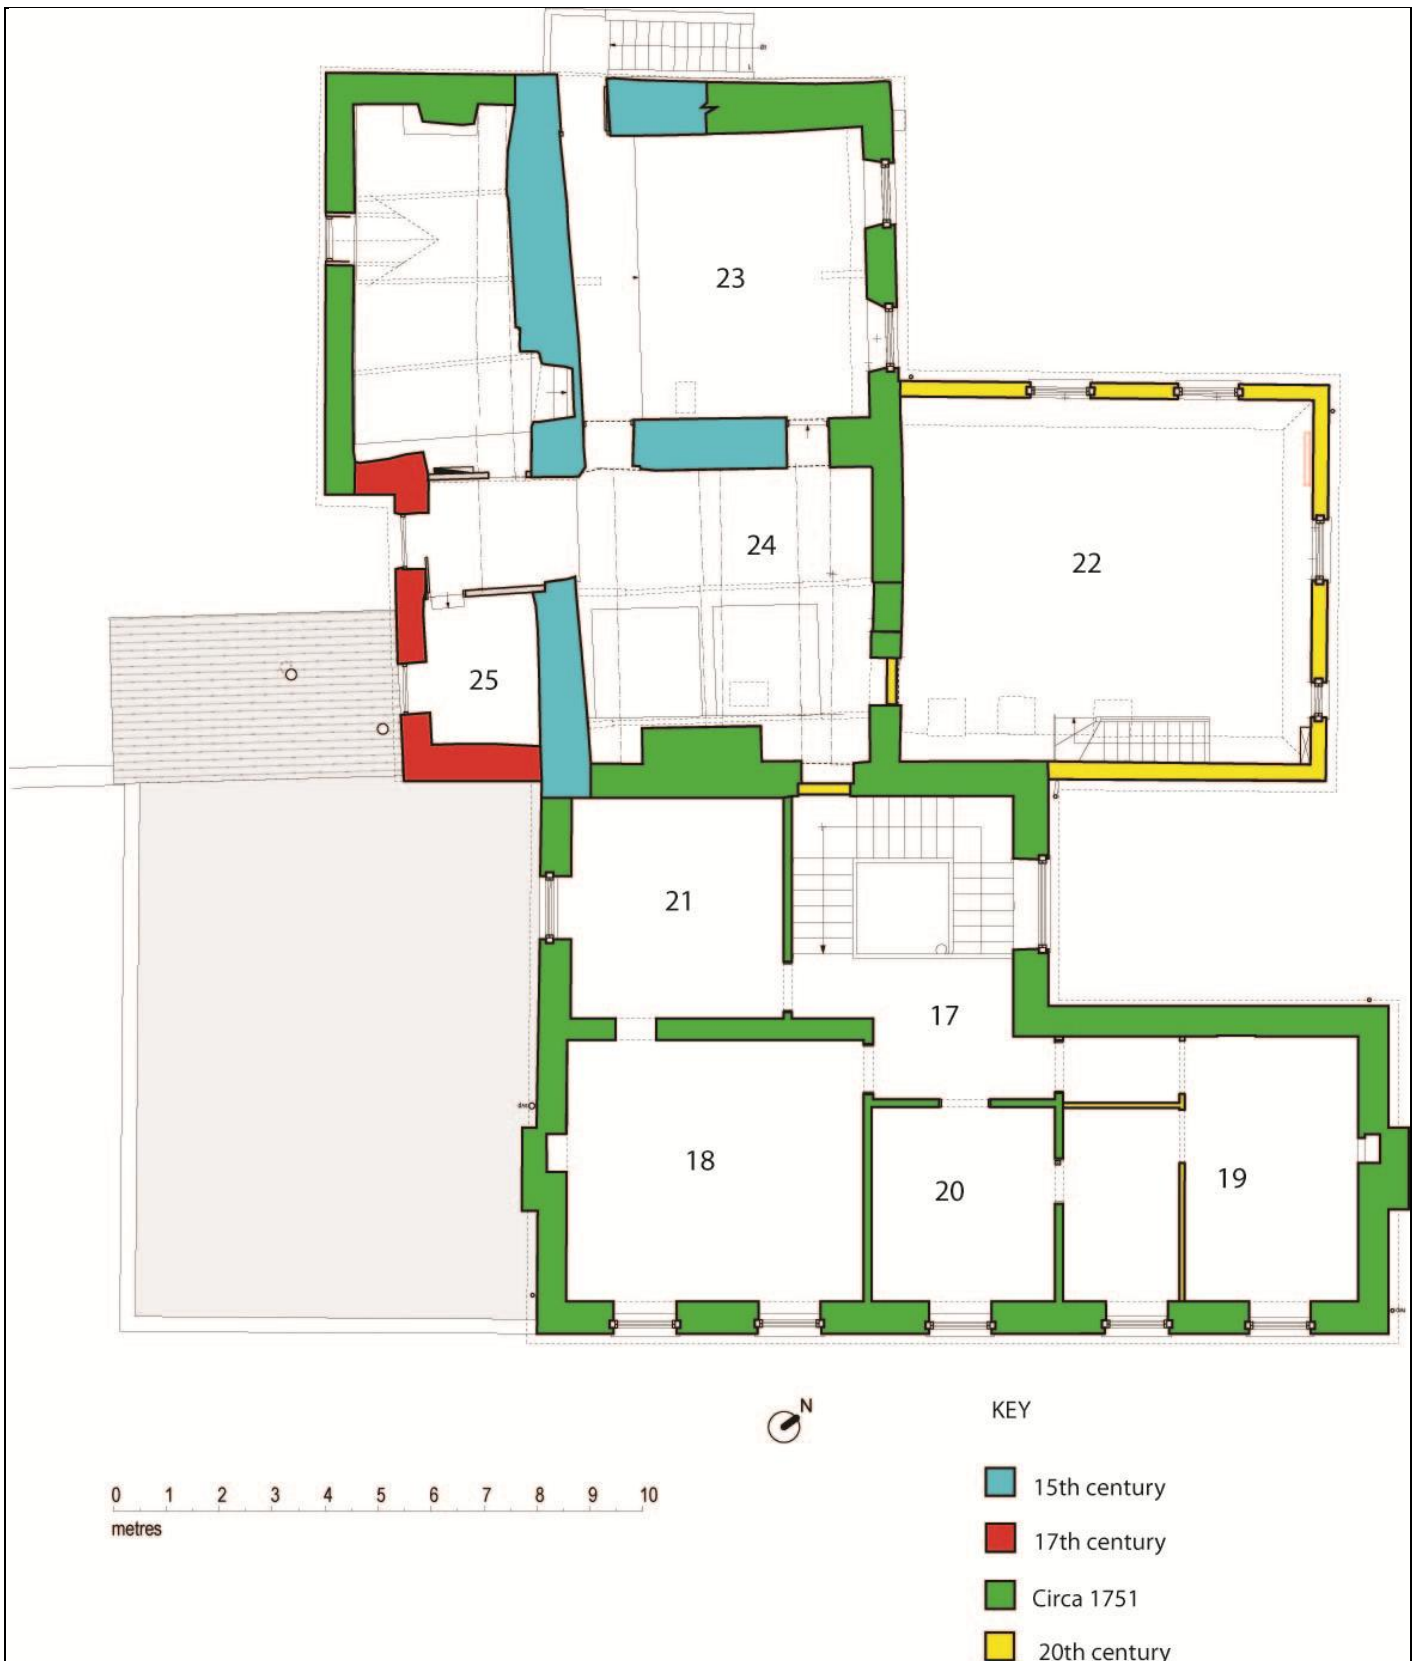
Figure 8: Phased first floor plan of the Manor House.

The stair in the Front Range raises three flights to the large first floor landing, which serves four bedrooms. Rooms 18 and 19 each have two sash windows in panelled casements, and are heated by small fireplaces, offset within the gable end stacks. Bedroom 19 has been partially divided by modern timber partitioning. A smaller, unheated bedroom (Room 20) stands between the two larger rooms, with a single hornless sash window in a panelled casement. A heated bedroom (Room 21) is to the west, over the morning room, with a hornless sash in a panelled casement in the west wall.

The first floor of the Service Range can now only be accessed via the exterior stair on the north elevation. This enters a large room (Room 23) located over the dairy and housekeeper's rooms. It is lit by two large 19th century sashes (with 2x2 panes) in the east wall, with boarding beneath. There is deep moulded skirting and two doorways lead into the former open hall to the south. The former open hall is now only partially floored (Room 24); open to the roof, with a smoke-blackened truss to the south and a 17th century truss to the north. On the north wall there is the scar of a plaster barrel vault ceiling and associated sockets. There is a brick stack with a blocked fireplace on the south wall. There is a cupboard west of the stack and to the east a narrow blocked doorway with timber lintel.

To the west of the hall are the remains of the oriel window/lateral stack, which has an opening to the south into the stair turret, and north into the lean-to. The un-floored lean-to has a blocked doorway at first floor level to the east. The stair turret has a forced opening in its eastern wall, which is also now blocked. There are two exterior store rooms attached to the west of the stair turret (these are discussed with the outbuildings).

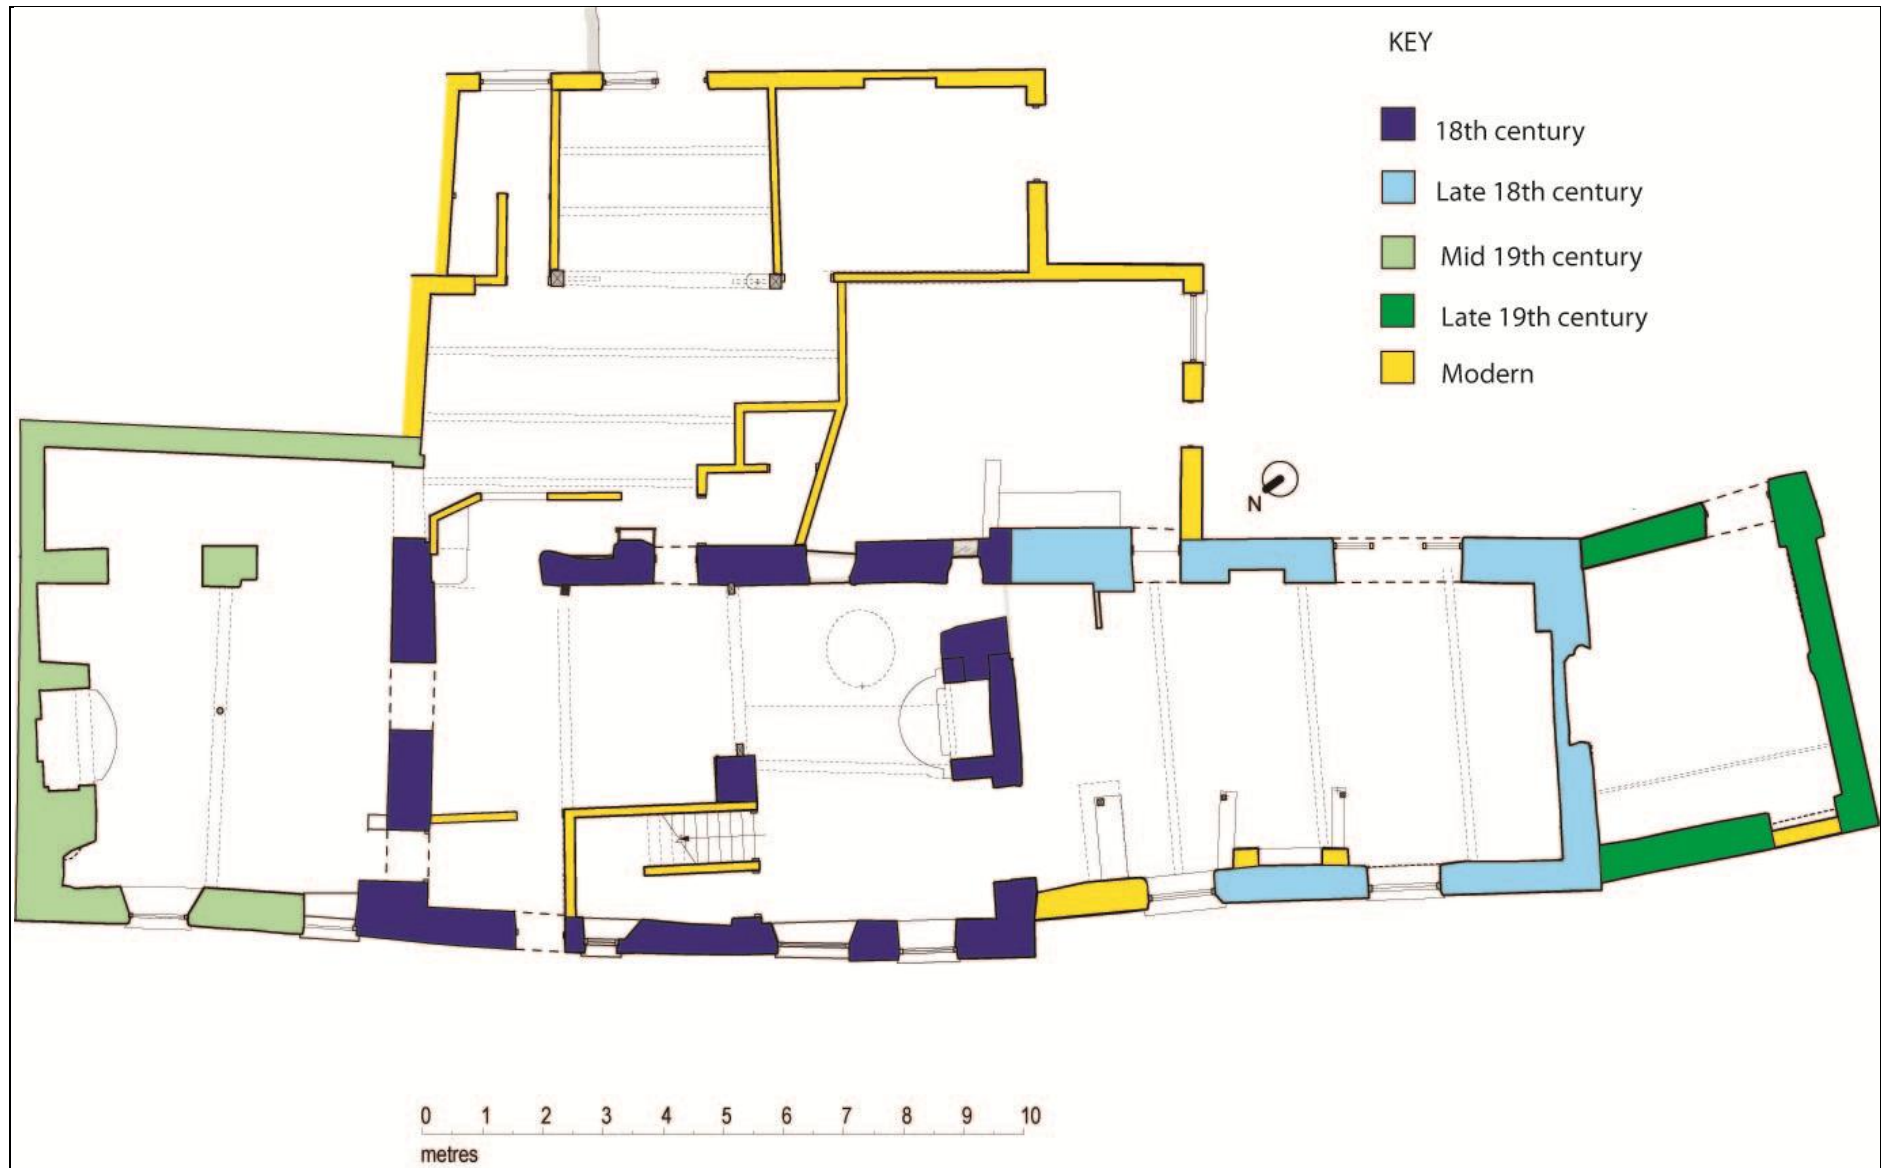
Figure 9: Phased ground floor plan of the Farmers Arms

Late 19th century (remodel of earlier barn)

This represents a phase of remodelling, potentially of the barn apparent on the tithe map to the west end of the range of buildings. This barn was truncated and demolished at the west end. A new west gable was built with a loading door, framed by ceramic bricks typical of the late 19th century.

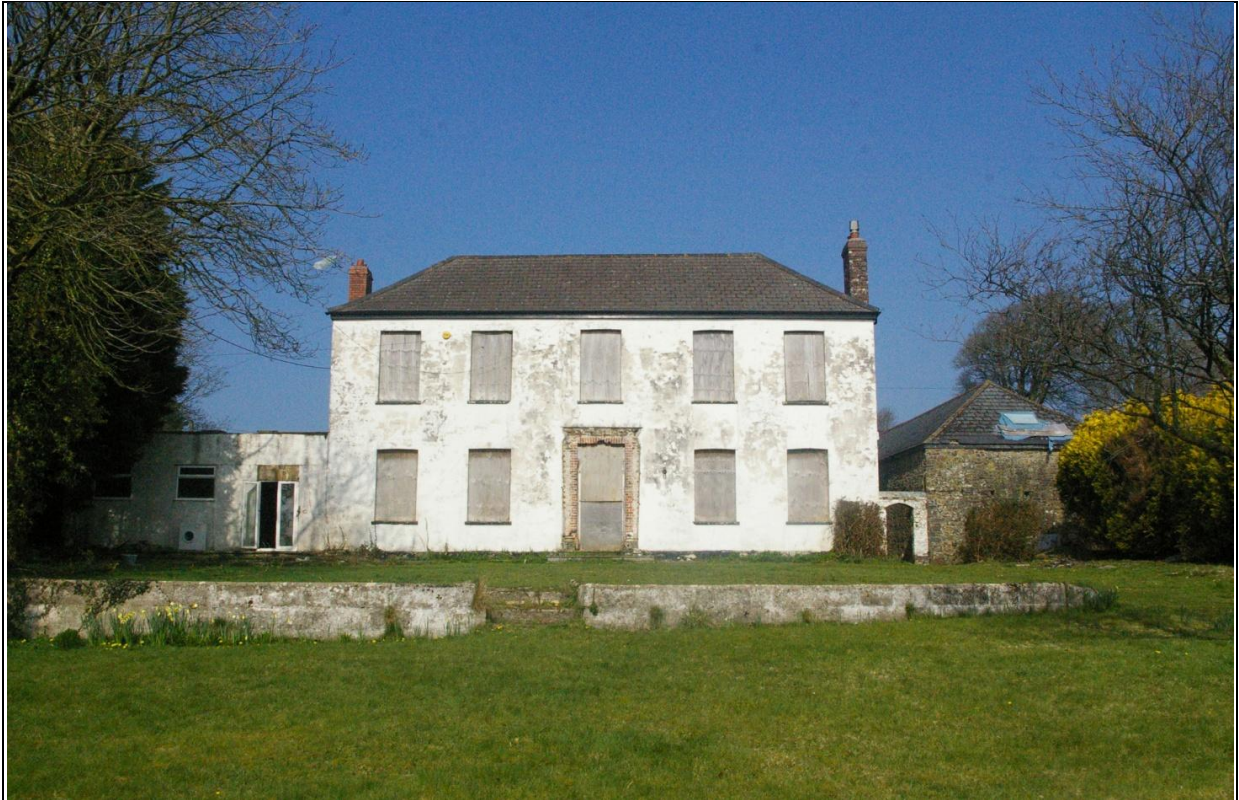
The Manor House has a principal rendered south facade; a two storey, symmetrical, five-window range (the windows are externally boarded) with a central entrance, under a hipped slate roof, with a brick gable end stack to the west and a stone gable end stack to the east.

The front facade of the Manor House; from the south.

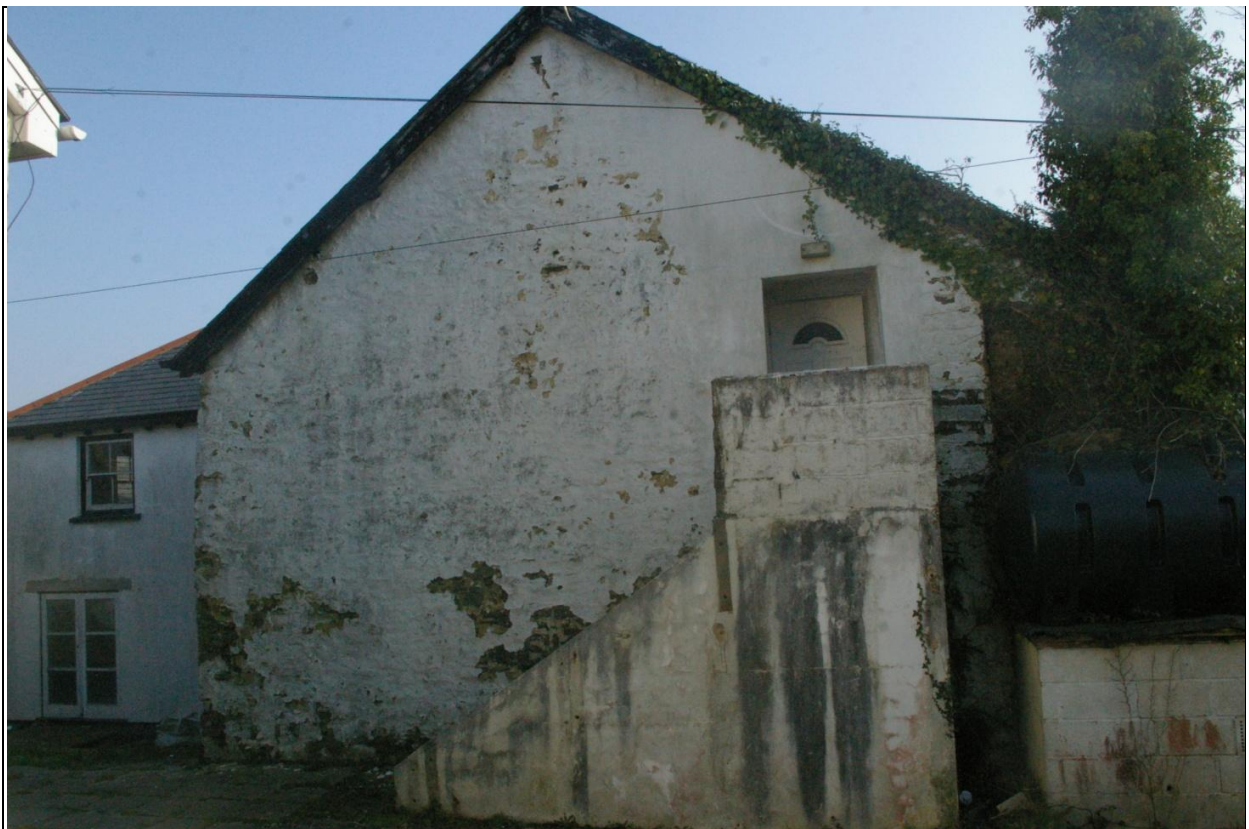
The north elevation is partly set into the bank to the north. It is of low, two storey height, gabled, with barge boards. Built of painted slate/shale stone rubble with roughly dressed quoins and abutted by a set of modern rendered concrete block steps which rise to the first floor from the east, serving a doorway forced into the elevation. Part of this wall is 'battered', with a pronounced slope as the elevation rises.

The north gable end elevation of the Manor House; from the north, north-west.

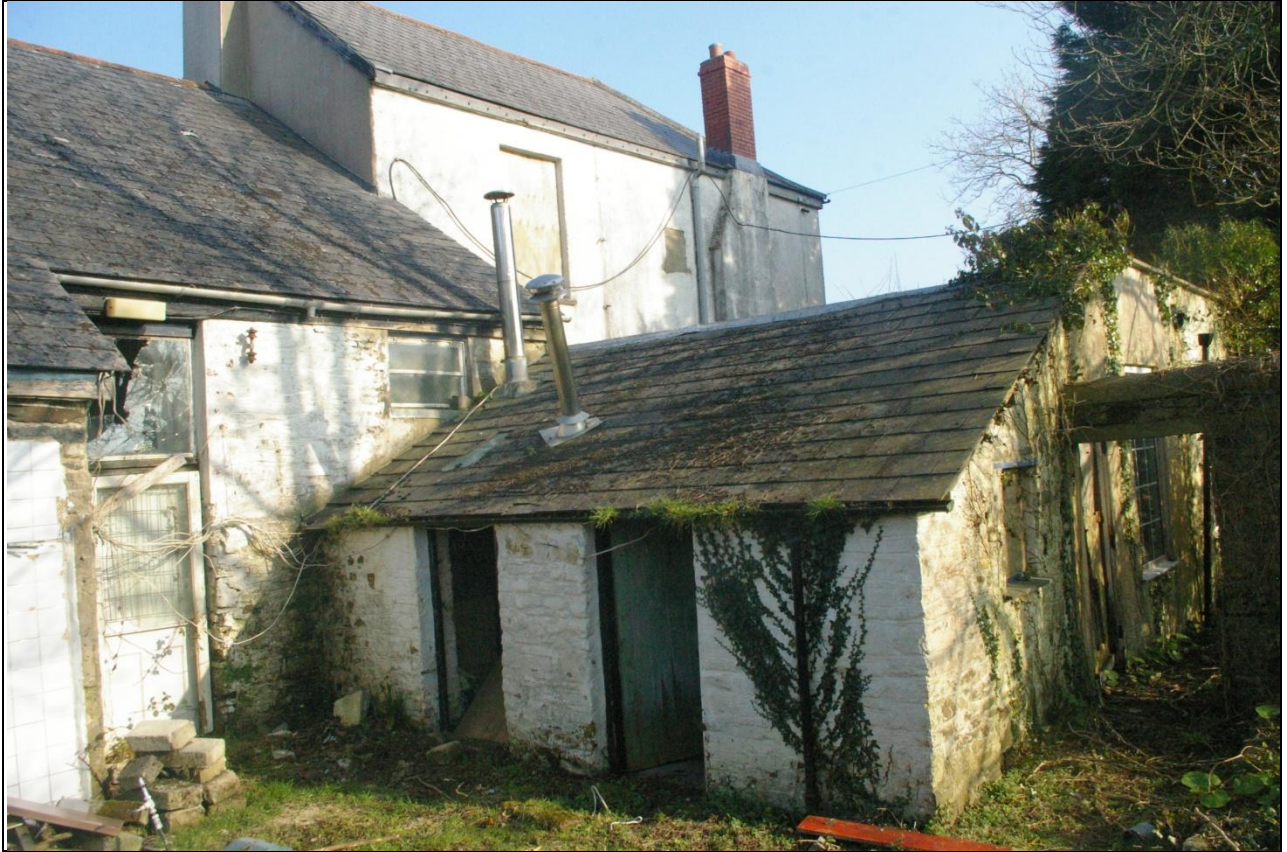
The outbuilding adjoining the Manor House to the west is built in a local vernacular style out of slatestone and shale rubble, with roughly dressed stone quoins and a single pitch slate roof. The outbuilding is of single storey, with two centrally positioned doors providing access to the two small rooms. There is a small single window opening in the west wall, with a slate sill.

The outbuilding adjoining to the west, the forced opening to the centre and the abutting tall south wing of the Manor House; from the north-west.

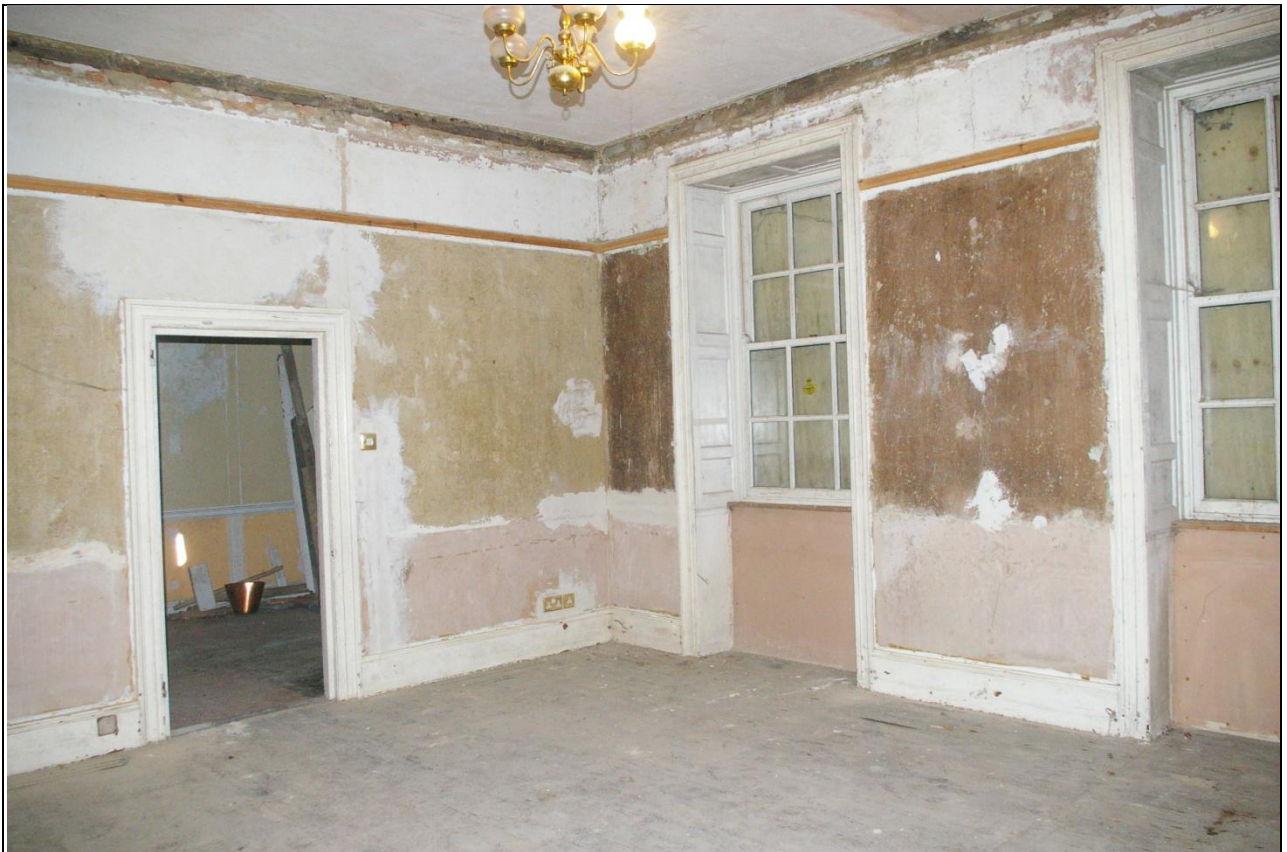
The dining room in the Manor House, showing panelled casements; from the north-west.

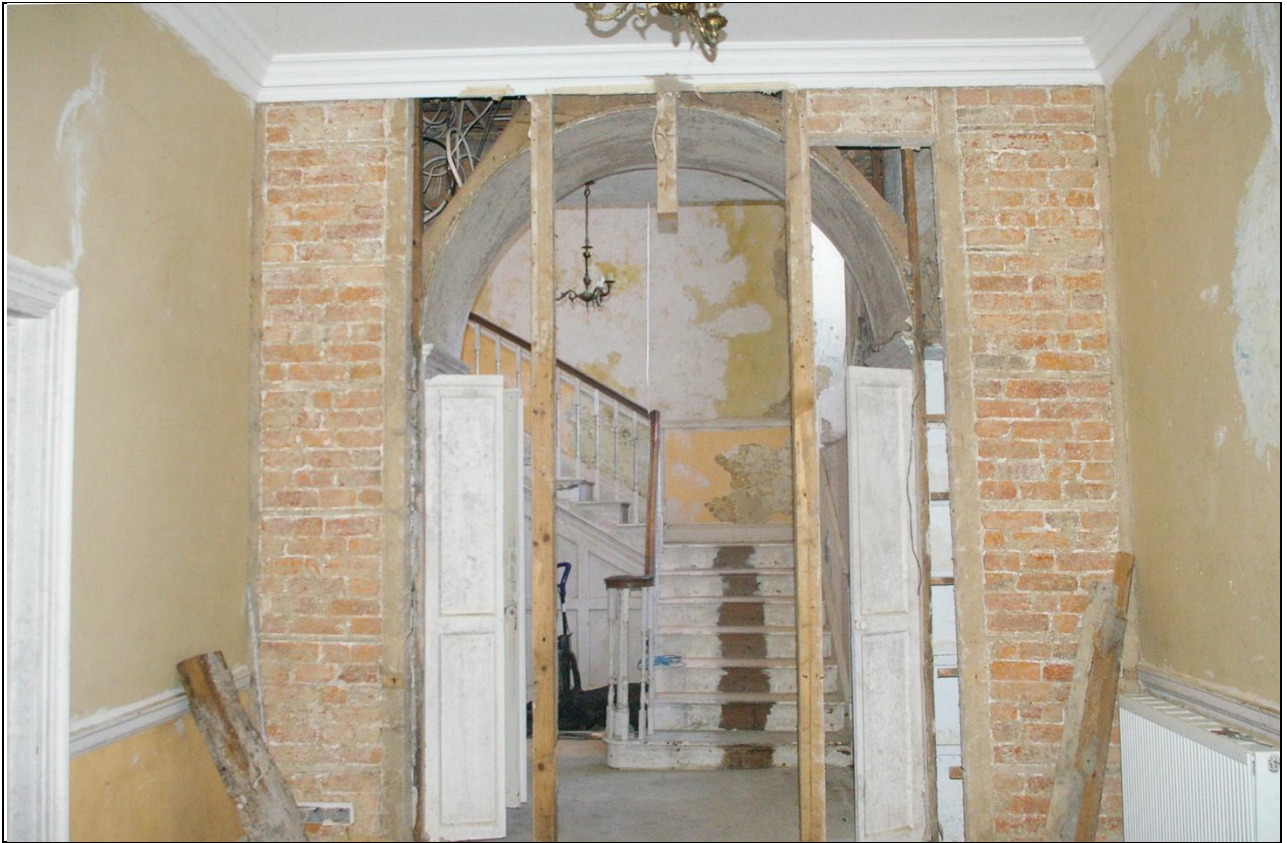
A large archway in the north wall of the vestibule, set with panelled cupboards, leads to the offset rear stair hall, with sweeping three-flight stair, with polished timber handrail and moulded stair plate. The stair hall has a high ceiling with decorative cornice, and is lit by a round arched double height, hornless, (16 x 12 pane) sash window in the east wall. A doorway under the stairs leads to another door, which links to the kitchen in the Service Range. A small morning room to the rear left (west), is accessed via the stair hall, with a tall beaded opening to the west wall, now set with a small offset glazed door and a blocked fireplace in the north wall framed by a small arched alcove to the east and an arched blocked doorway to the west.

The archway to the stair hall, from the vestibule; from the south.

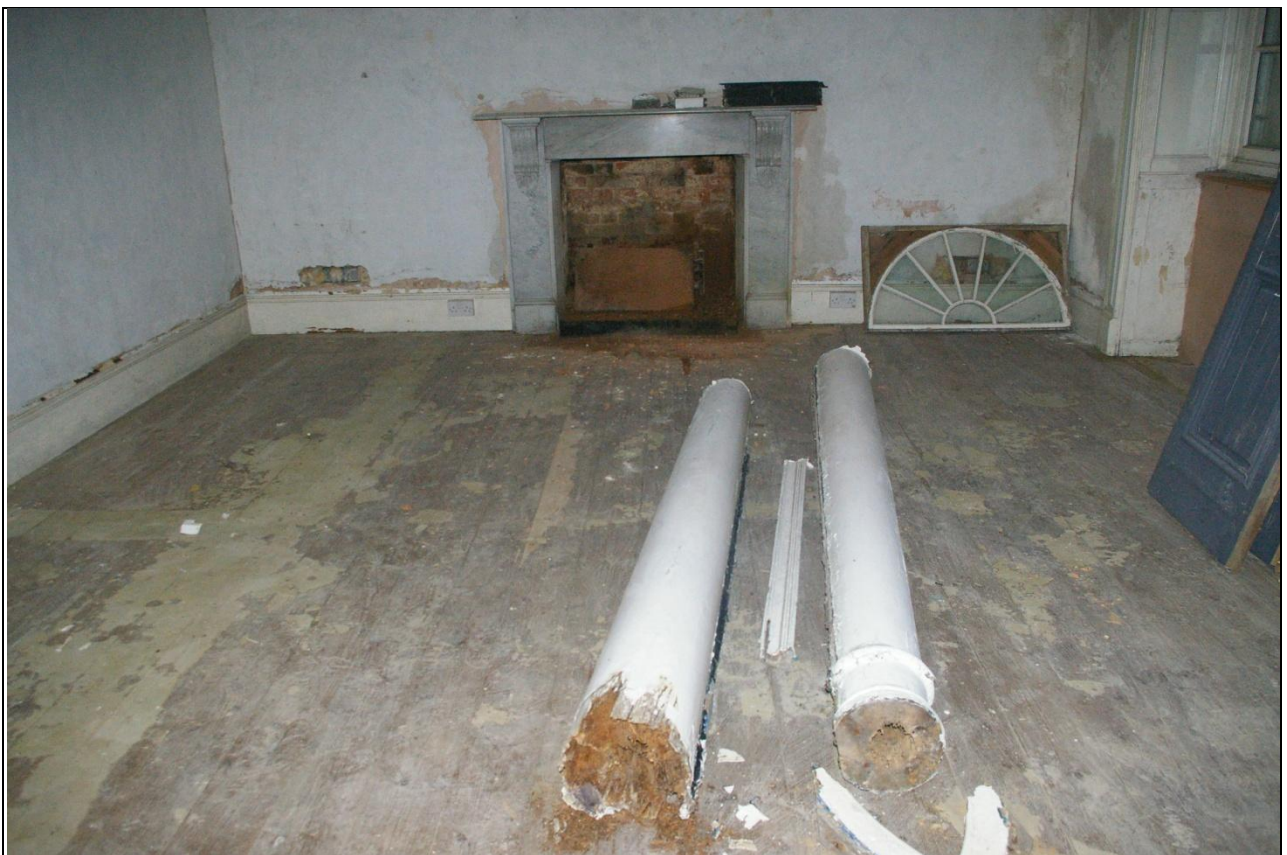
The Front Range (south) is entered through a central doorway, formerly under a porch, with Doric columns and round arched fanlight (these architectural details are 'stored' inside the building). A wide central vestibule serves the two main reception rooms to left and right, a dining room and drawing room, both with high ceilings, decorative cornices, tall sash windows in panelled shuttered casements and fireplaces.

The fireplace in the drawing room at the Manor House and the former Doric columns and fanlight stored here; from the west.

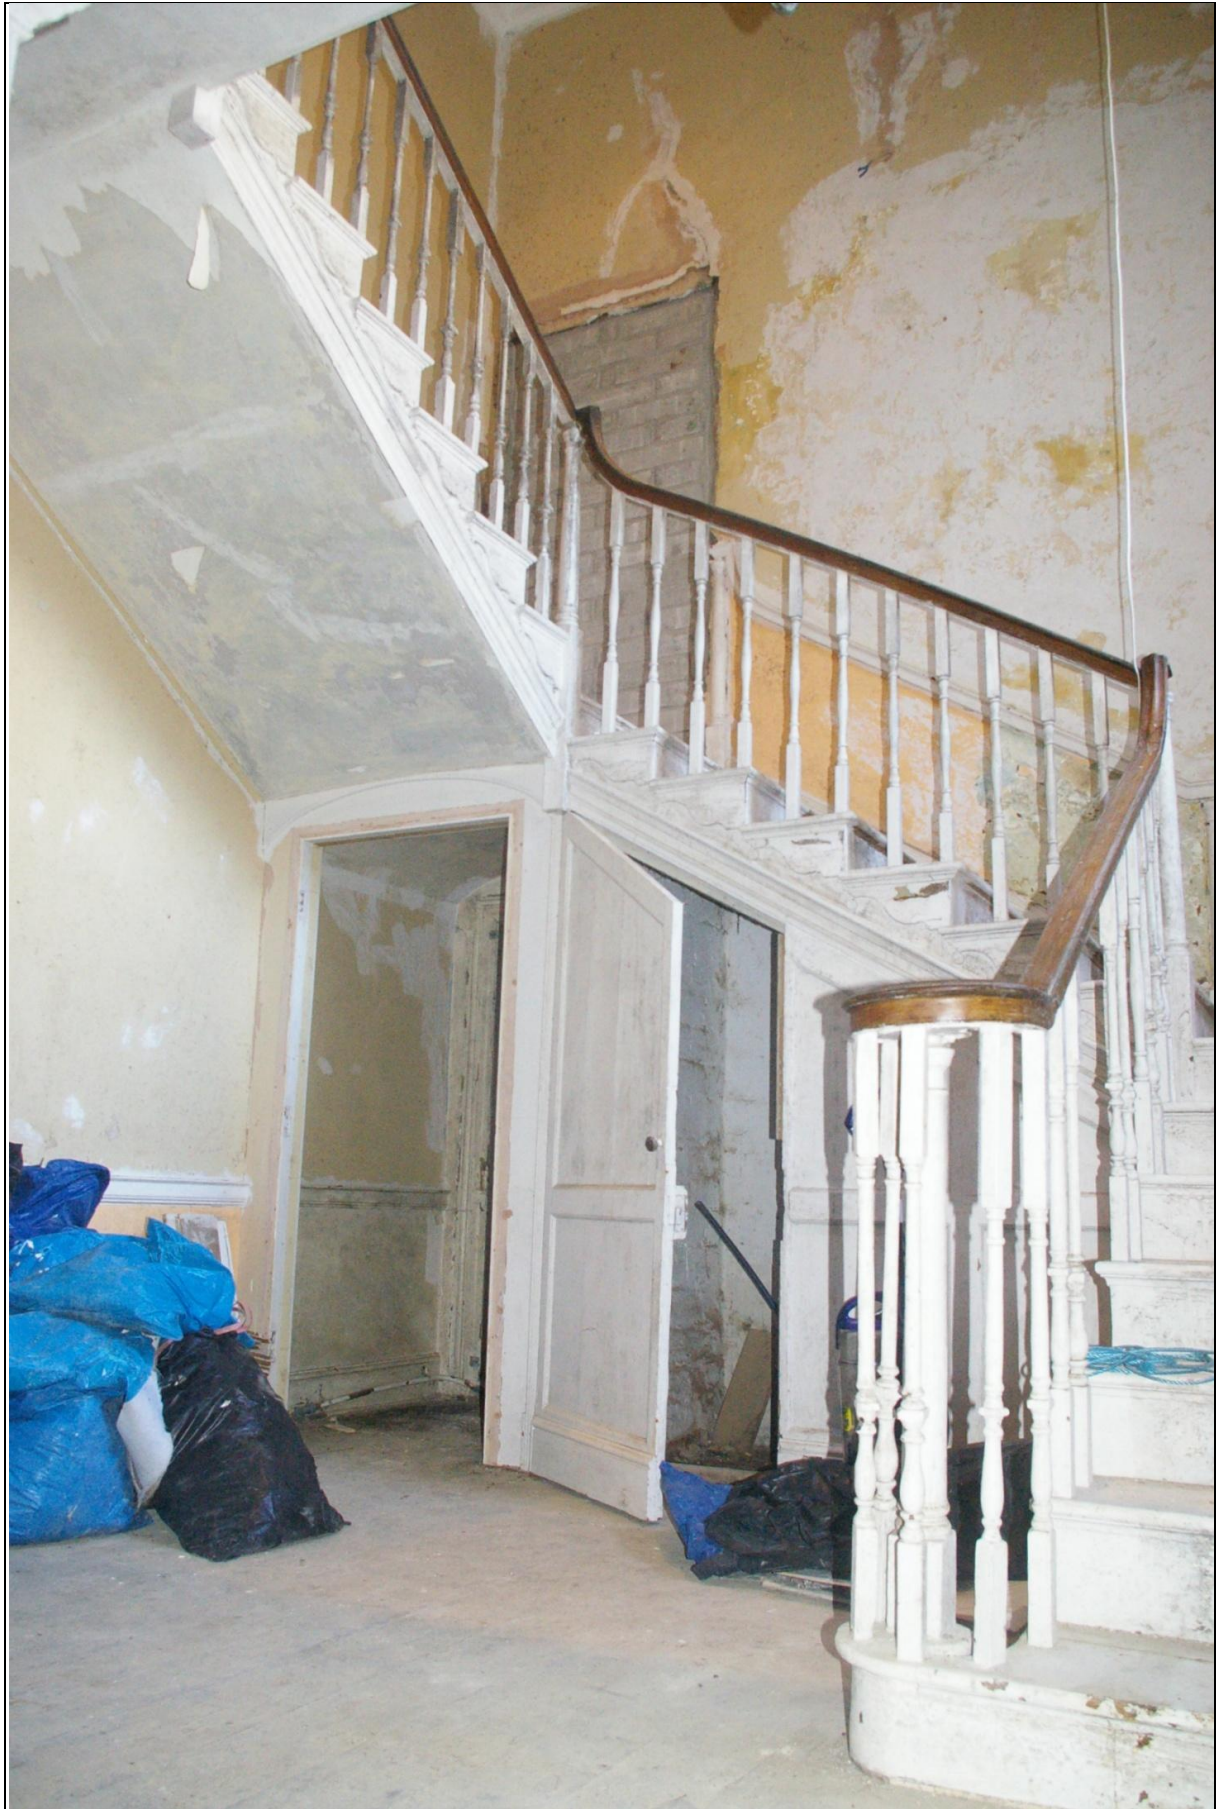
The stair in the Manor House; from the south-east.
