THE MANOR HOUSE COMPLEX AND THE FARMERS ARMS, WOOLSERY, DEVON

Desk Based Assessment &
Historic Building Recording

Report No.: 150415
Date: 15.04.2015
Author: E. Wapshott
V. Hosegood

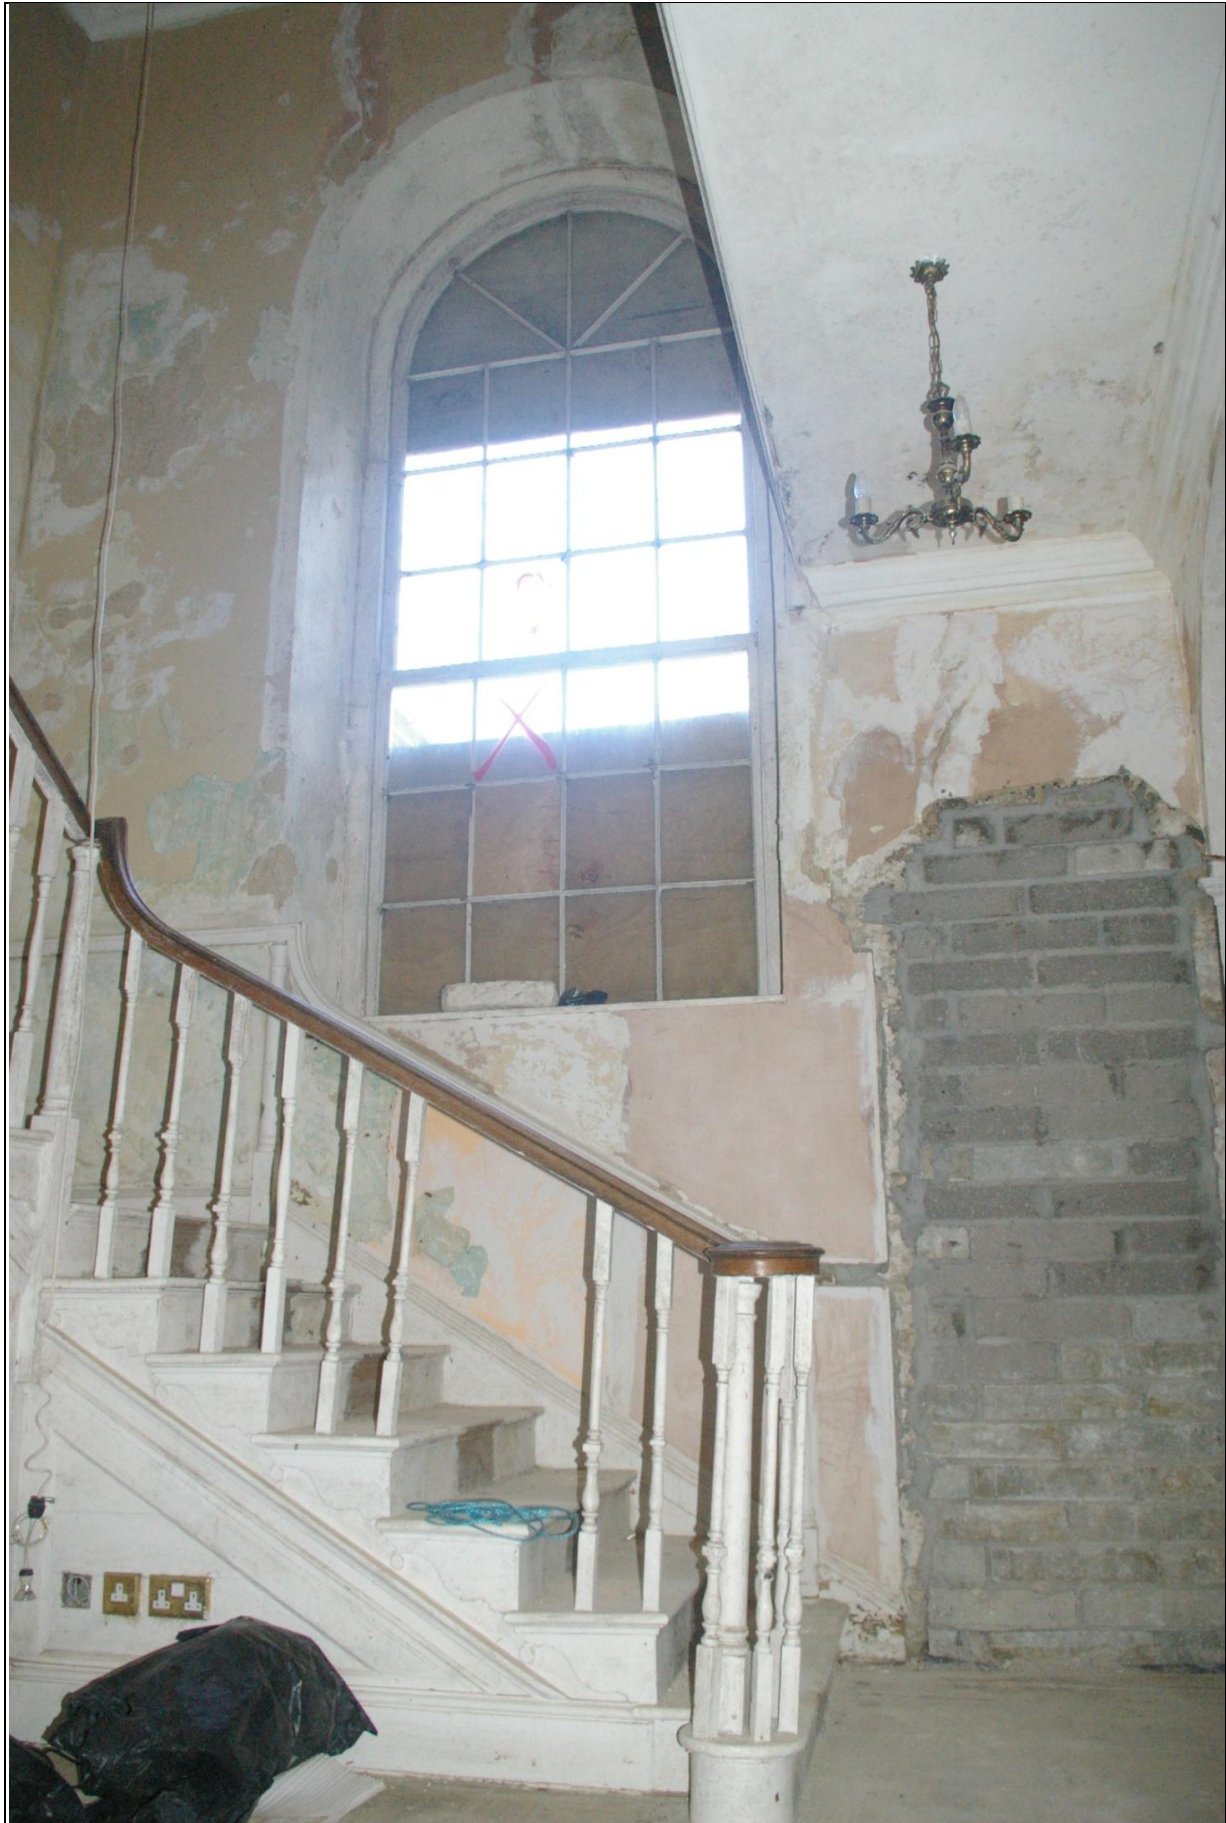
The tall arched stair window; from the south-west.

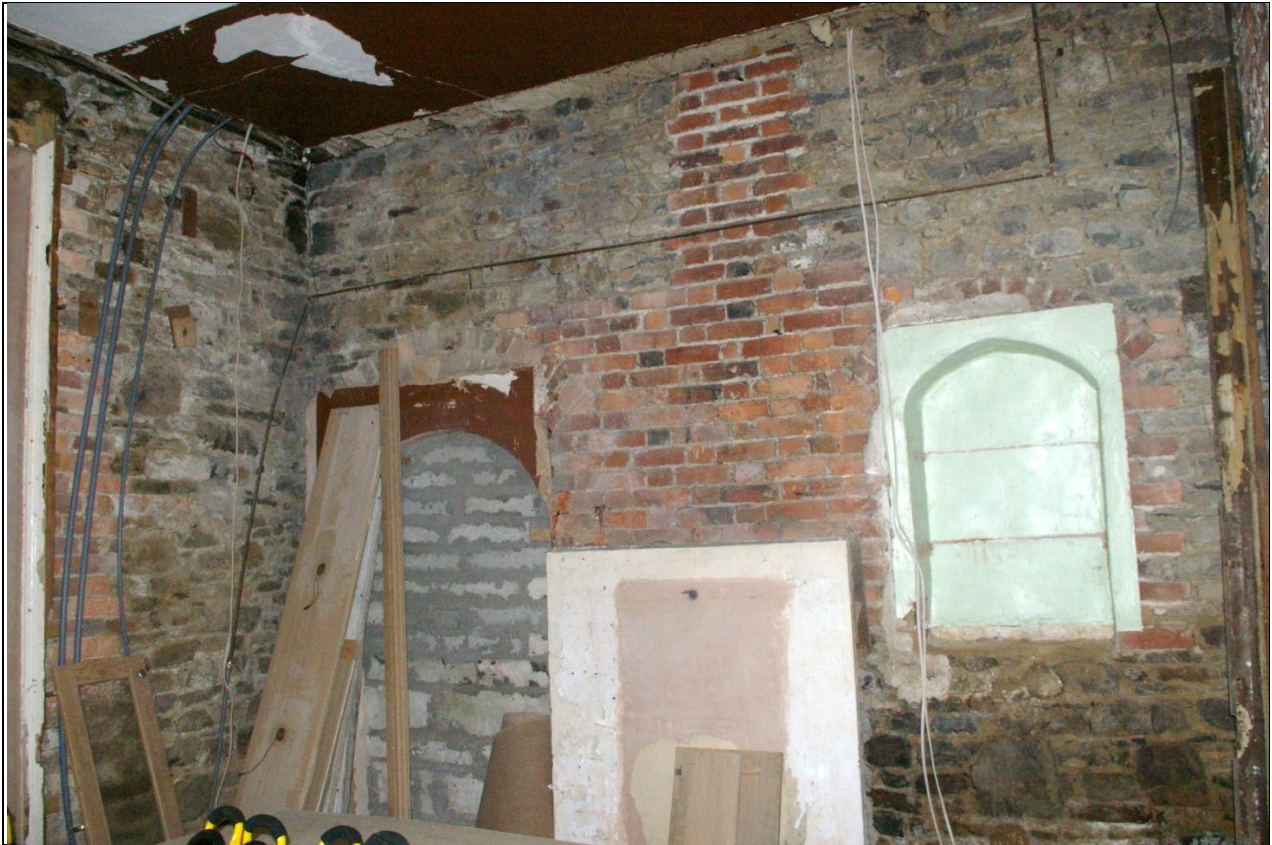
The alcove, blocked fireplace and blocked doorway in the north wall of the morning room, in the Manor House; from the east, south-east.

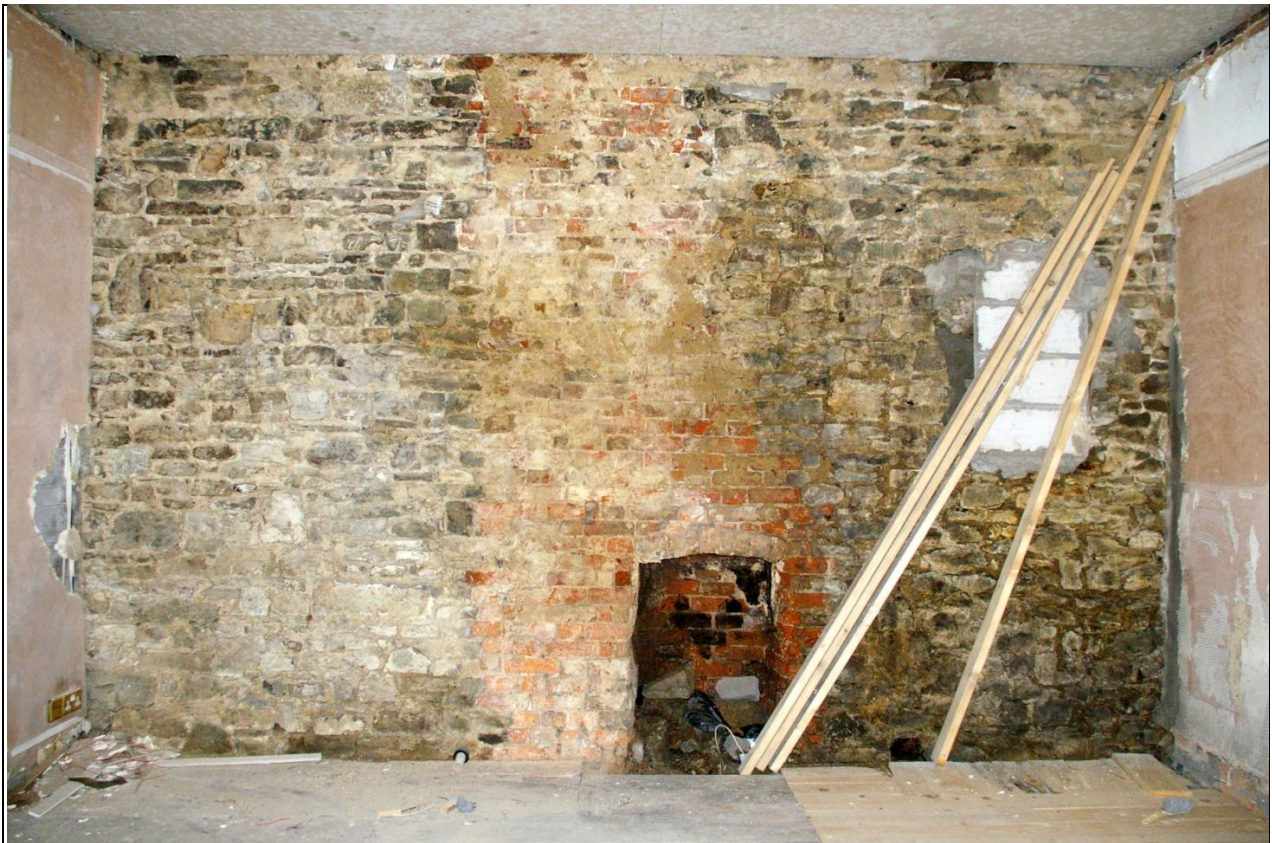
The small fireplace and blocked window or alcove in the west wall in the front bedroom to the left in the Manor House; from the east.

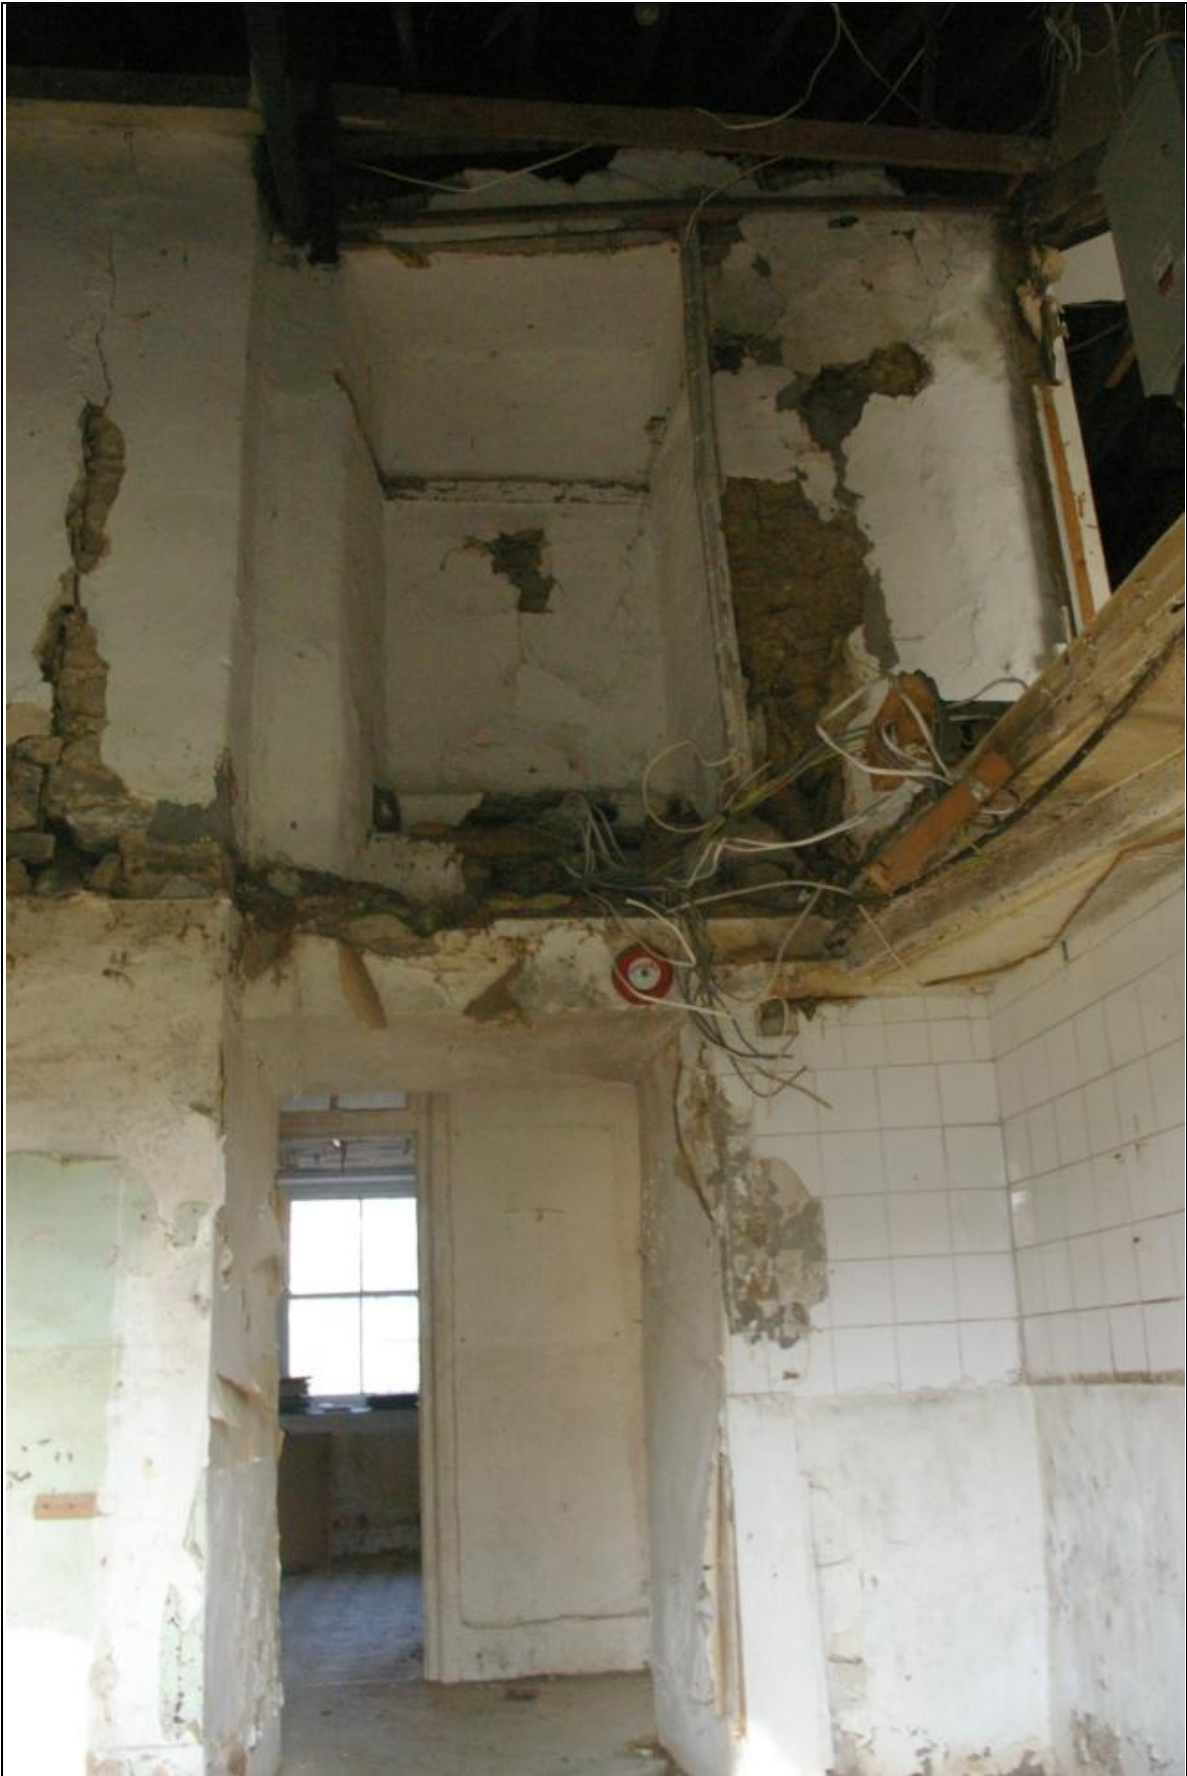
Two doorways within the lean-to, one to the former cross-passage on the ground floor, the other on the first floor to the former porch; from the west.

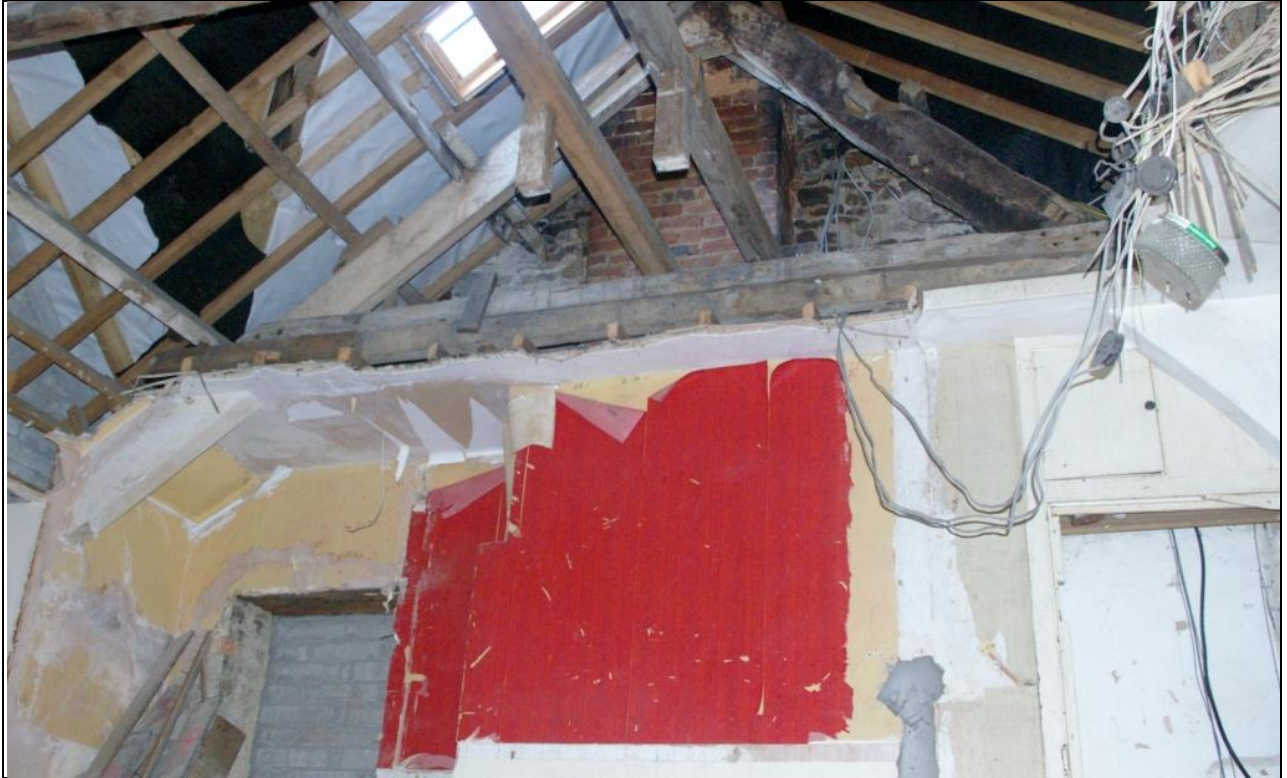
The open hall was floored, with a fine moulded cross-beam roof, new roof trusses were inserted to the north side of the hall structure carrying a plaster barrel vault formed over the new first floor room. A small stone stair turret was then built against the south-west corner of the hall, to provide access to the new first floor room. A double height porch was built to the west side of the cross passage, facing the main street, served by a newly forced opening at first floor level. This porch was probably open to the ground floor, with a small room above. Between the porch and stair turret a large axial chimney stack (or projecting oriel window) may have been constructed to serve the rooms formed by the closing of the open hall.

The historic trusses within the roof structure above the former open hall; from the north-west.

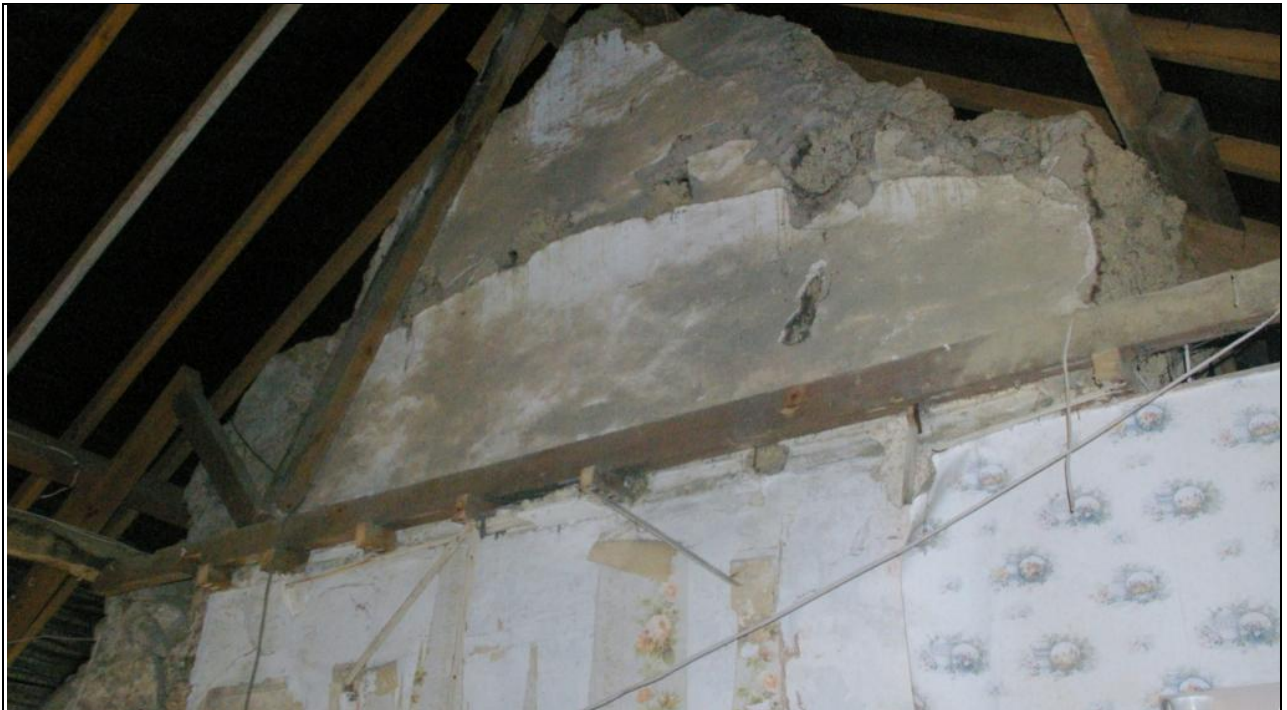
The scar from the former barrel vault in the upper north wall of the former open hall; from the south-east.

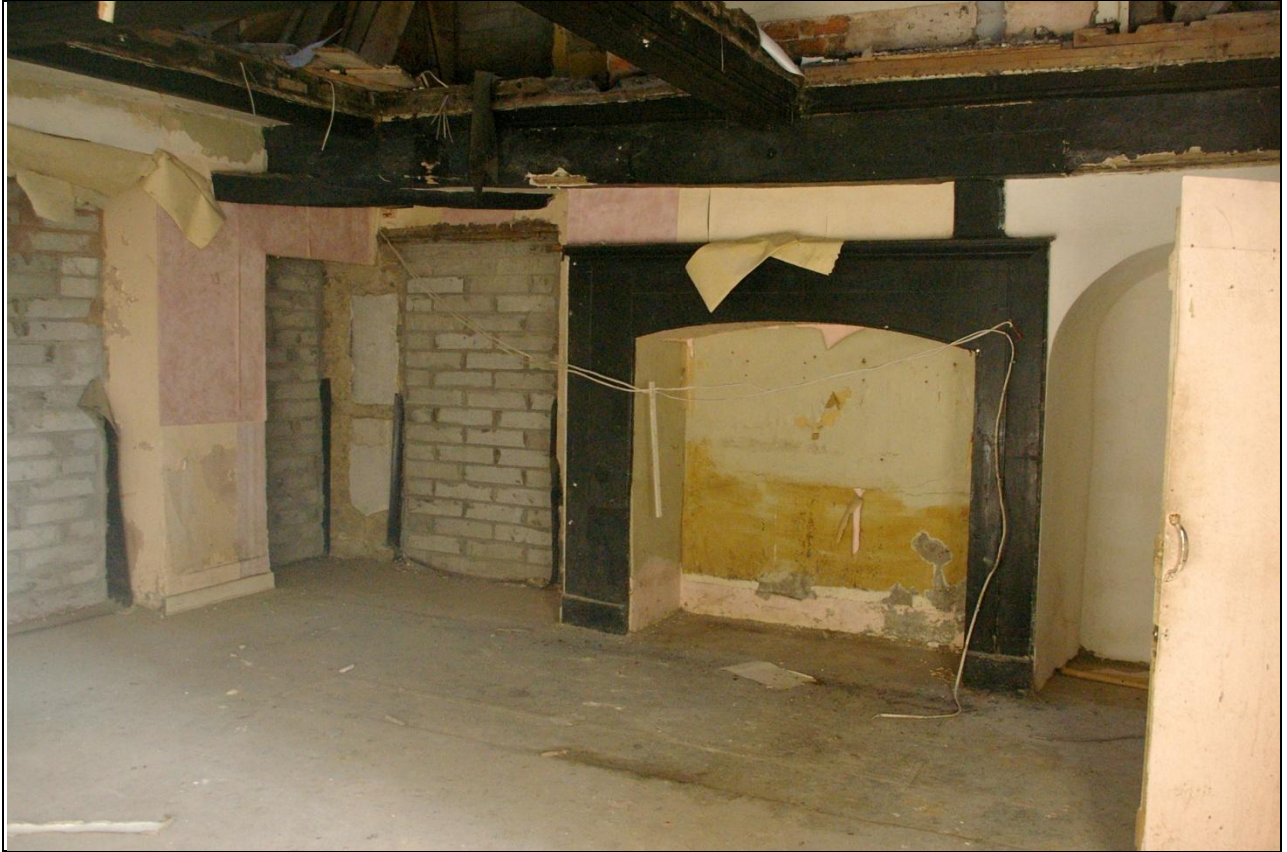
There was an extensive remodel of surviving parts of the medieval and 17th century building to form a service wing, the open hall becoming the main kitchen, the end room divided to form a dairy and housekeeper's room. A long lean-to was built along the west side, possibly for a scullery, incorporating the remains of the projecting porch. The east wall of the building at the north end was wholly rebuilt.

The 18th century kitchen fireplace in the former open hall, on the ground floor, in the service range; from the north-west.

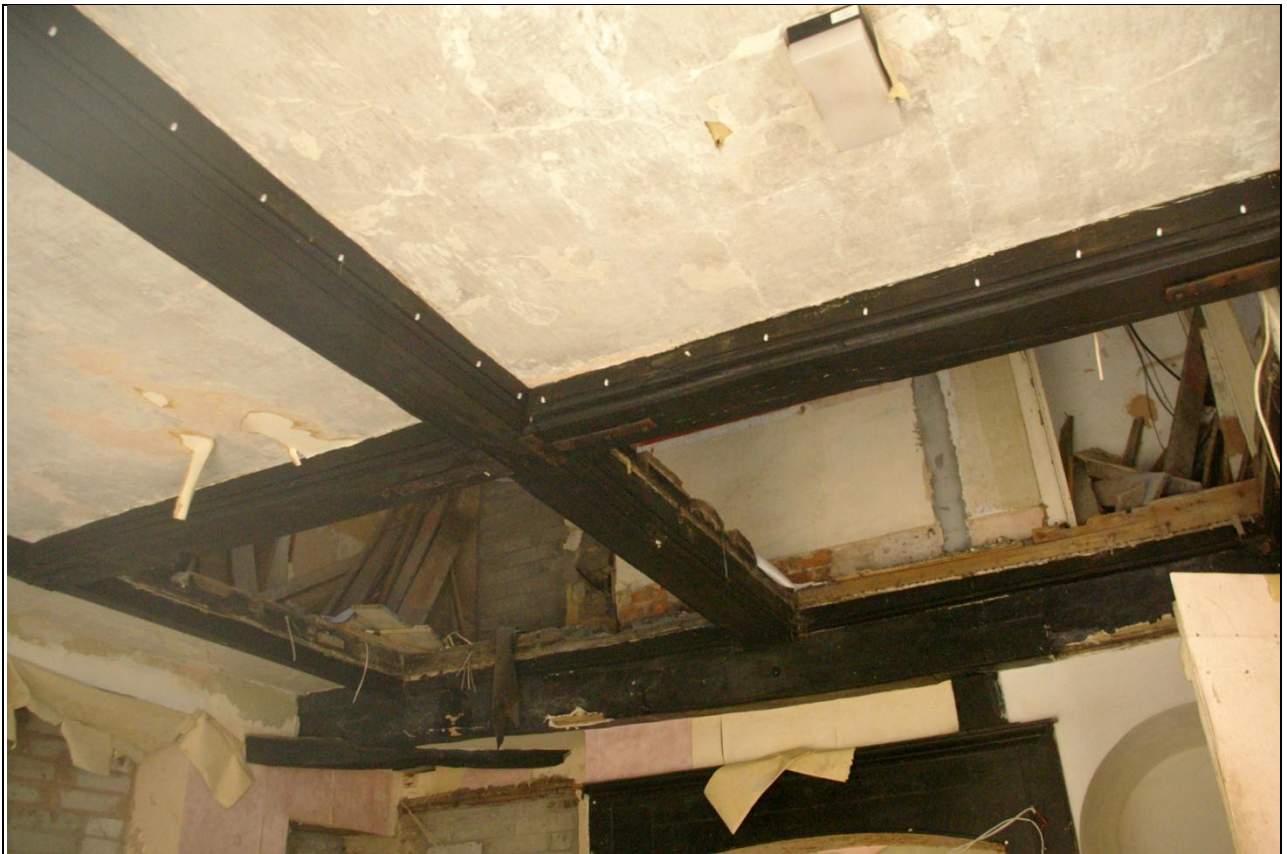
The cross beam roof, inserted into the open hall in the 17th century; from the north-west.

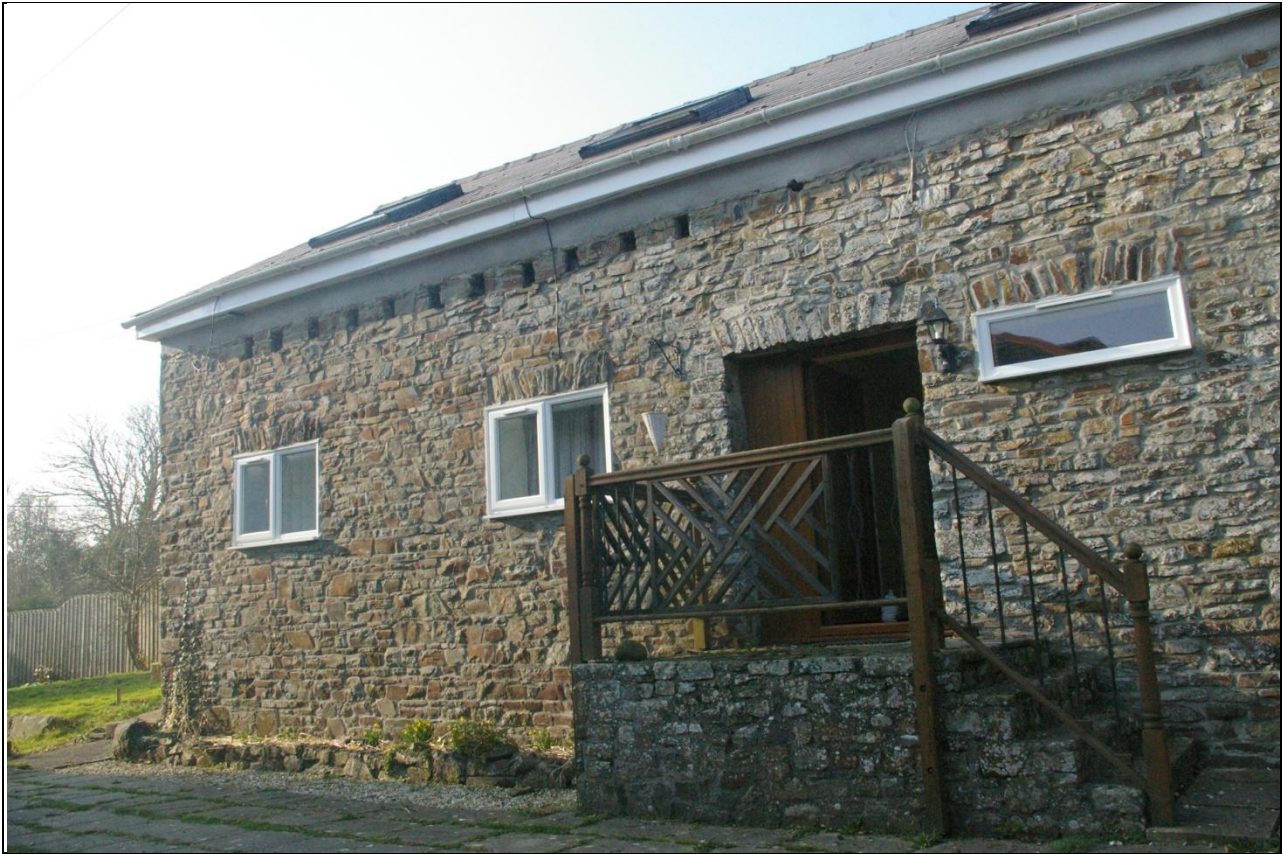
A small slatestone building with a modern slate roof, rectangular in plan on an east-west alignment set to the north of the Manor House. The building is set into the bank, to the north. The south elevation of the building faces the manor house and appears to have been refaced or heavily repaired during its conversion to a cottage. There are three modern window openings and a central wide doorway opening, served by a set of stone steps. The elevation has been raised, the roof wholly replaced. There are a row of sockets or small holes at the eaves, to the west, which may be for pigeons or doves. The west elevation is rendered, with a small modern window at ground floor level to the north. The west gable end has a timber sliding door to a store at the north side, a small

The outbuilding to the north of the Manor House; from the south-east.

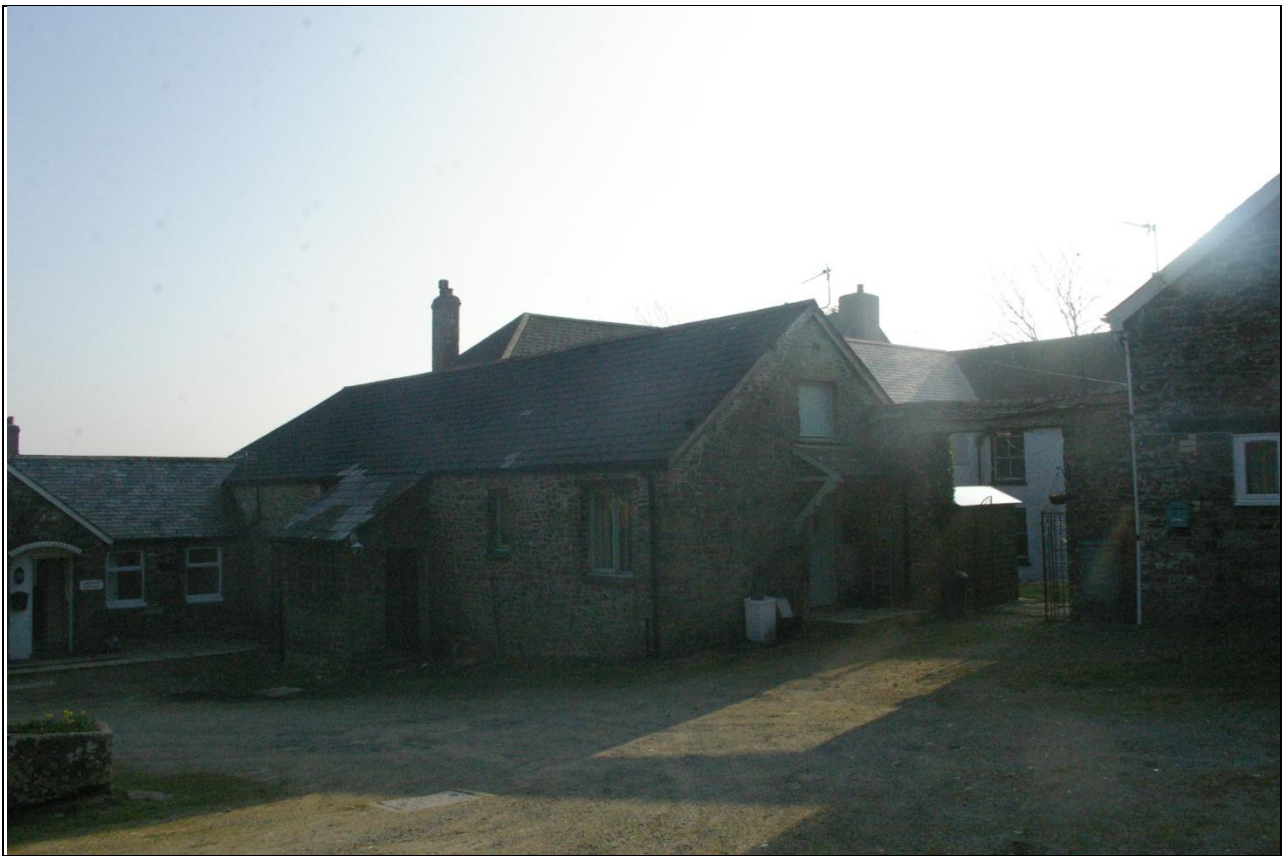
The farmyard of buildings to the east of the Manor House, showing the context and setting; from the north-east.

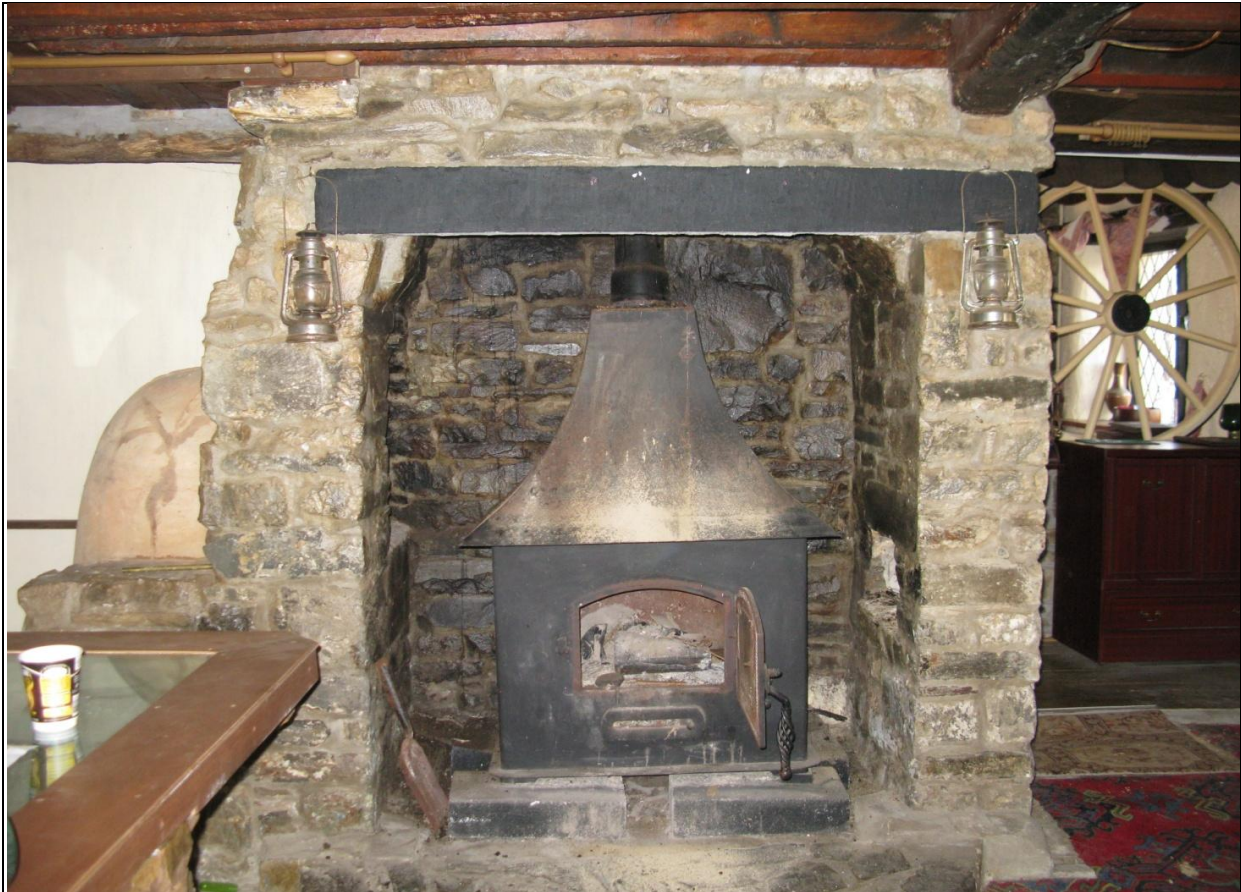
Fireplace in west gable end stack in the Farmers Arms, with replaced concrete lintel; from the east.

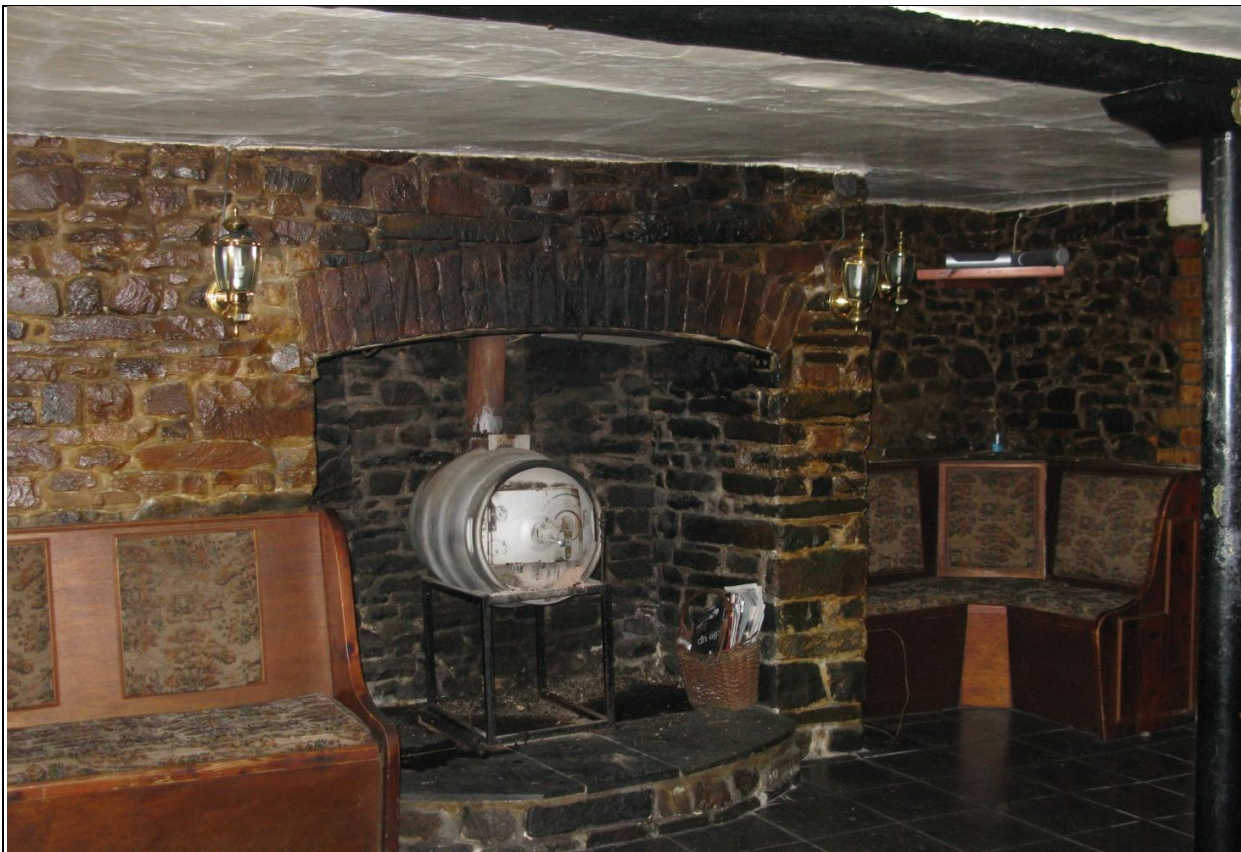
The east gable stack in the 19th century infill building; from the west-north-west.

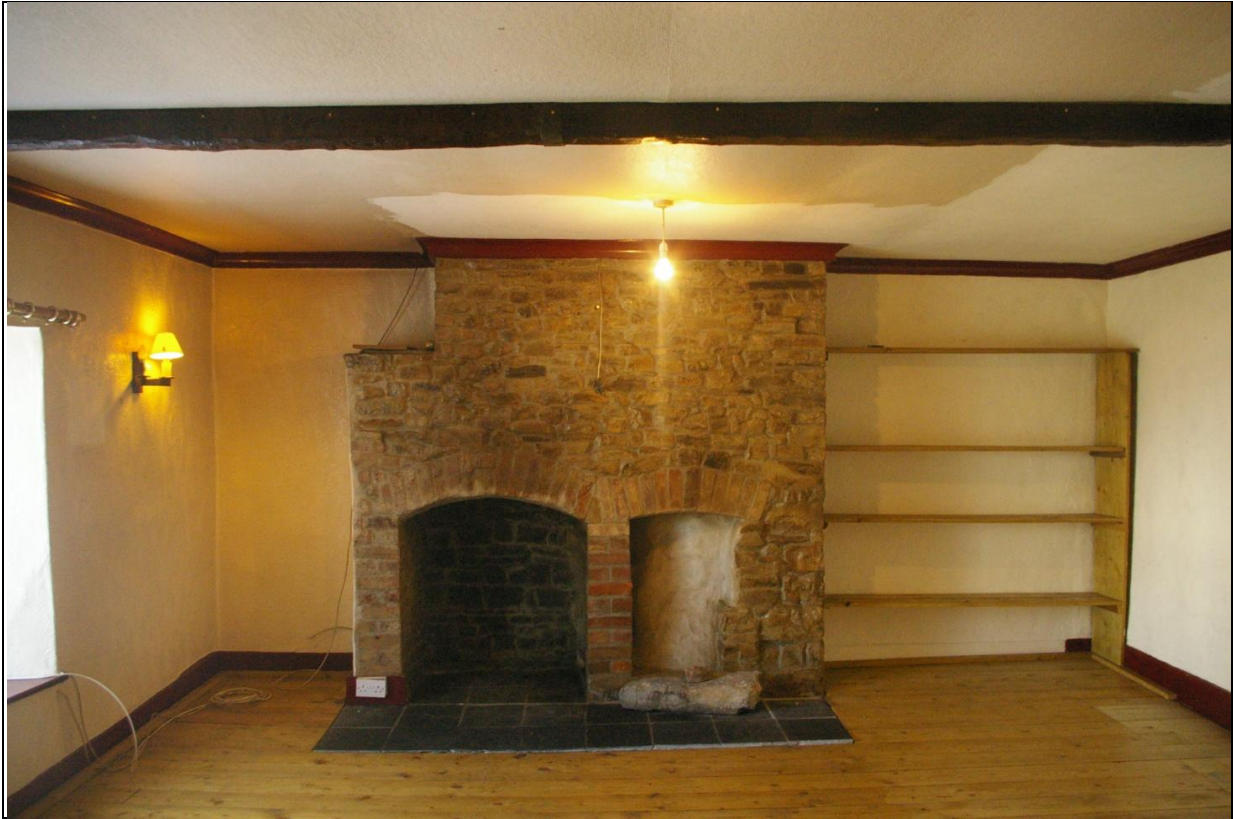
The first floor stone stack with two hearths in the 19th century infill building; from the west.

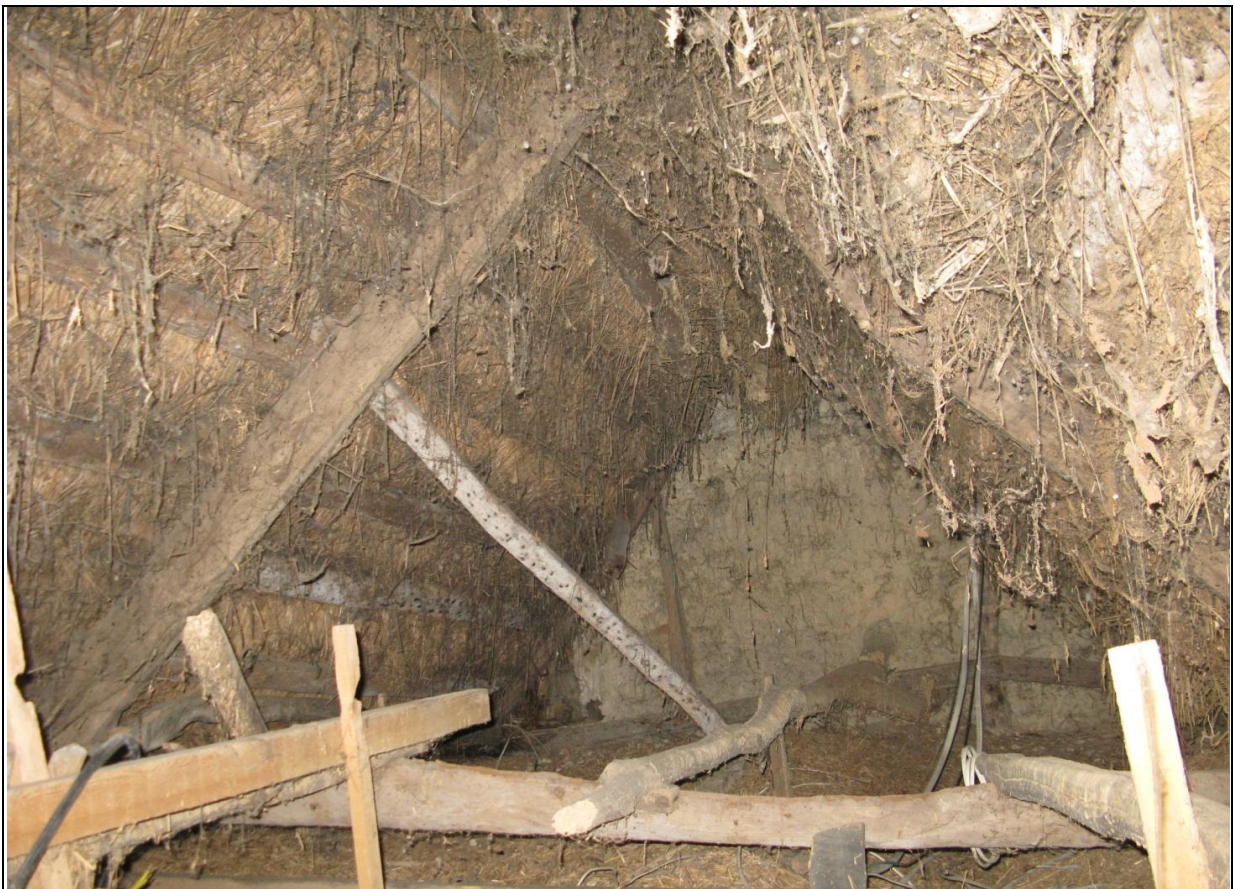
The thatch roof with A-frame trusses and multiple purlins; from the south-west.

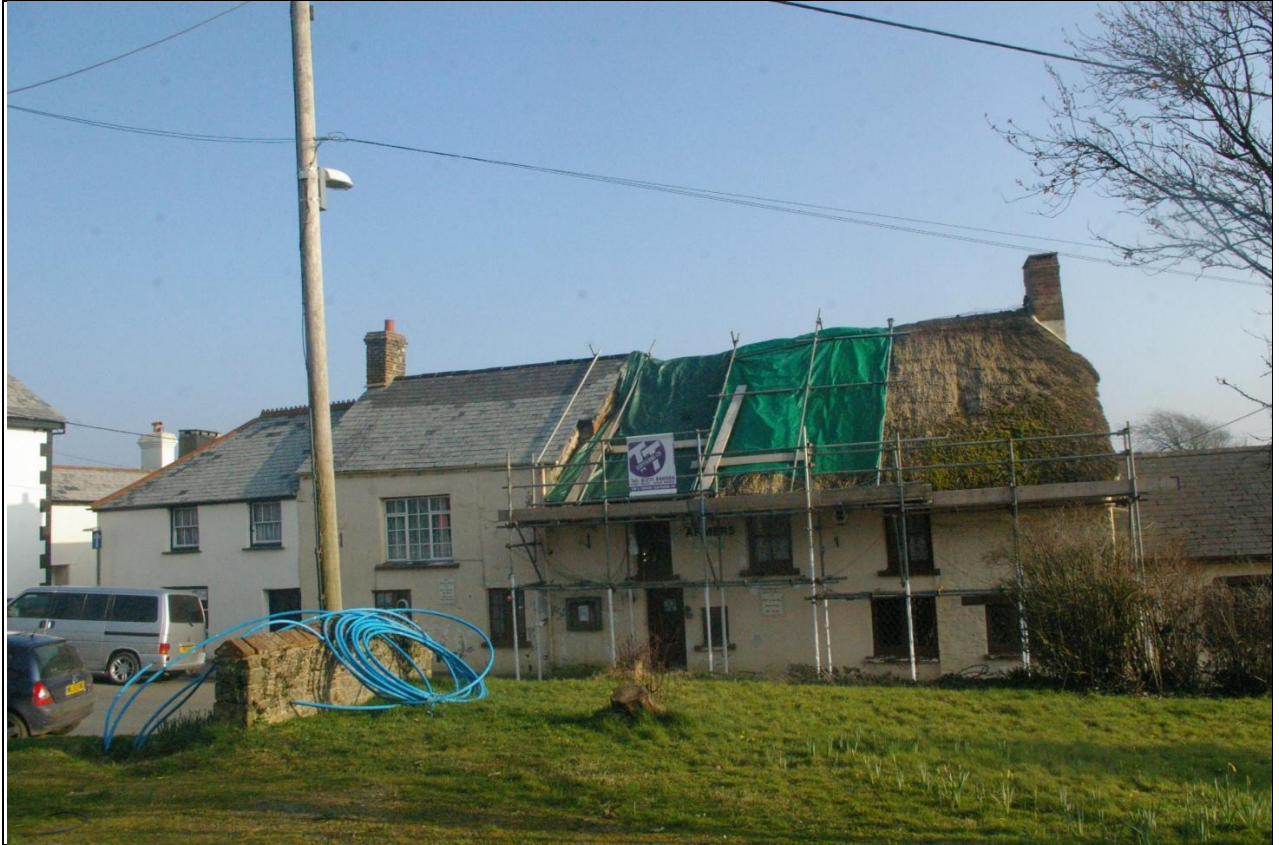
The Farmers Arms and 19th century infill building viewed from the lawned gardens of the Manor House; from the north, north-west.

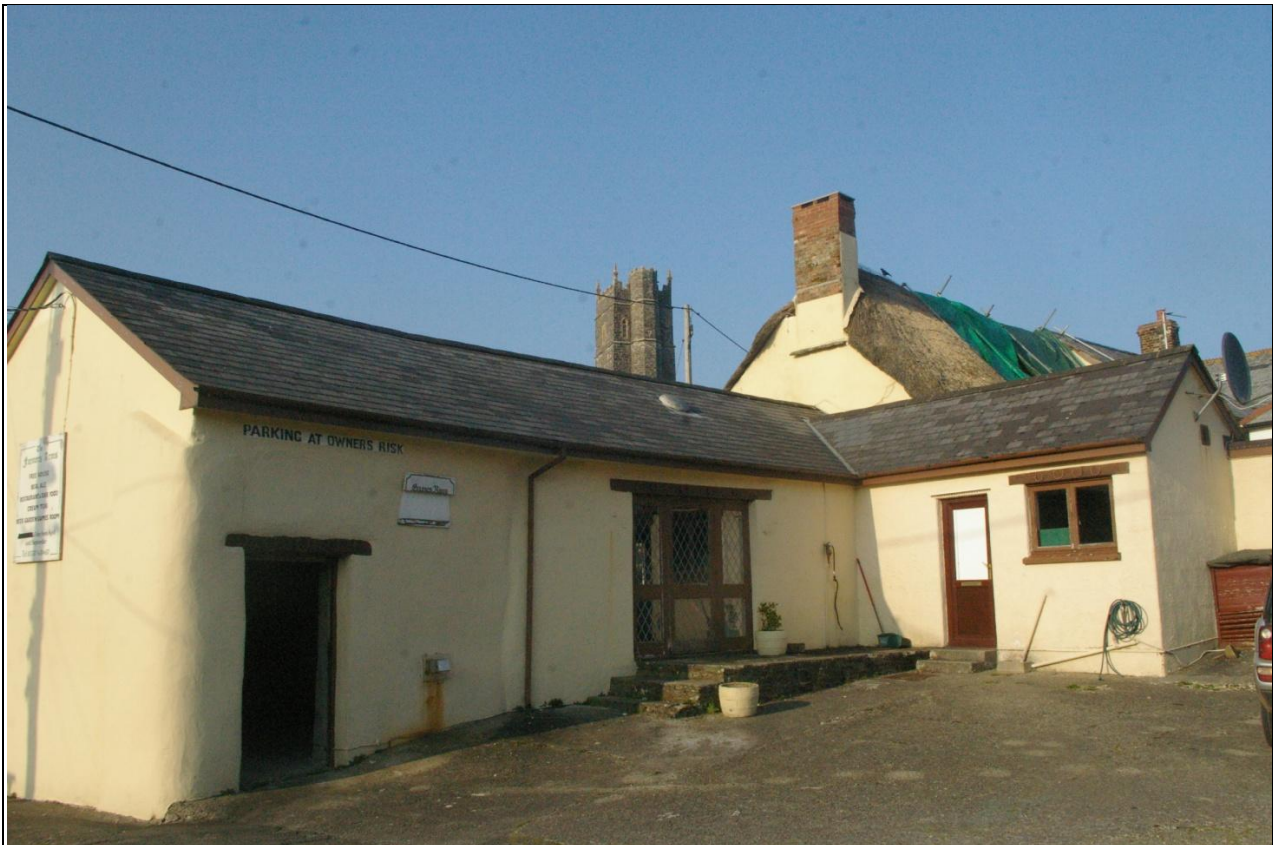
The Farmers Arms and barns from the south side, showing proximity to the church; from the south-west.
