Devon County Council Historic Environment Record

Civil Parish & District: Kingskerswell, Teignbridge	National Grid Reference SX 857 682		Number:	
Subject: Limited archaeological evaluation at Kingskerswell Manor House, Foredown Lane, Kingskerswell, Devon. Photo attached? YES				
Planning Application no: n/a		Recipient museum: n/a		
OASIS ID: southwes1-226631		Museum Accession no: n/a		
Contractor's reference number/code: KMH	Dates fieldwork undertaken: 3 rd Novem			aken: 3 rd November 2015

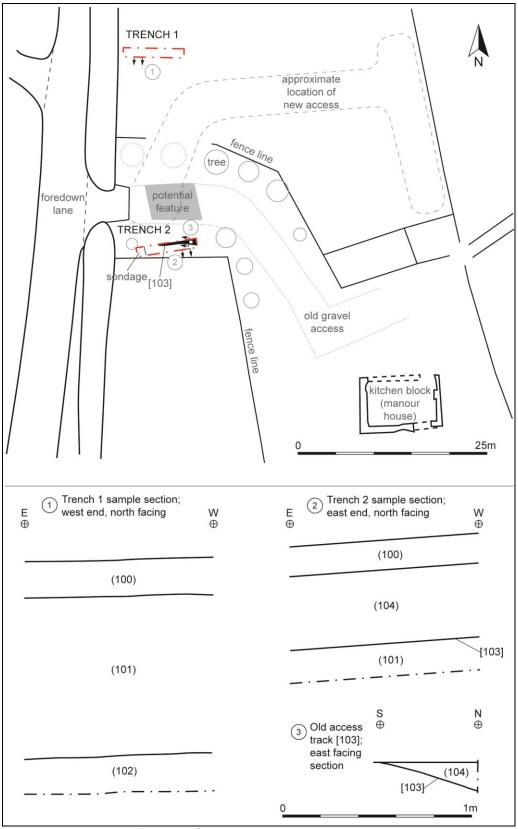
Figure 1: Site plan and section drawings.

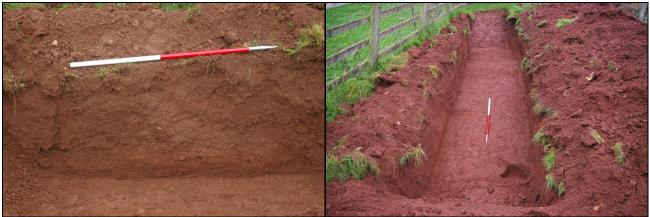
Trench #1 was excavated to a depth of c.1.25m. It revealed no archaeological features or significant remains. Trench #2 was excavated to a depth of c.0.7m, with a sondage at its west end excavated to a depth of 1.10m. A large amount of root disturbance, including extant roots and organic material, was evident between the layers in the trench. A cut [103] pertaining to the old access track was identified; it had an even gentle slope and contained made ground (104): a friable mid reddish-brown clay-silt with occasional to moderate small stones.

Figure 2 (left): North-facing sample section at the east end of Trench #2; viewed from the north (1m scale). Figure 3 (right): Trench #2, post-excavation; viewed from the east (1m scale).

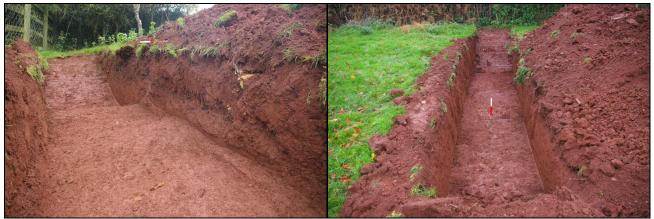
Figure 4 (left): Oblique shot of south-facing section of Trench #2, showing the root-disturbed horizon; viewed from the south-east (1m scale).

Figure 5 (right): Trench #1, post-excavation; viewed from the east (1m scale).

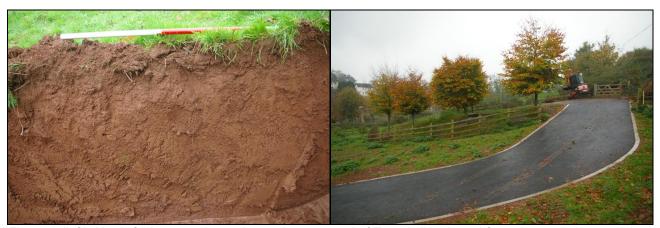
The potential ditch identified in previous reports (SWARCH report no.110216) would appear to have been the made-ground deposit, with tip lines relating to the older, but still modern, man-made slope/access to the manor. The ground here has been landscaped and made-up by c.2m. No significant archaeological features or deposits were present.

Figure 6 (left): North-facing sample section at the west end of Trench #1; viewed from the north (1m scale). Figure 7 (right): New road/access, showing landscaped ground, with up to c.2m difference to either side of the fence-line; viewed from the north (no scale).
