Hartland Lower Brownsham House

Hartland

Lower Brownsham Farm is Grade II Listed, located in the hamlet of Brownsham in North Devon. The National Trust own the property and have identified it as in need of an historic building survey in order to record and analyse the origin, construction and development of the buildings and therefore better inform their maintenance and interpretation without compromising the buildings historic features or conservation value.

Record of the building in 2015

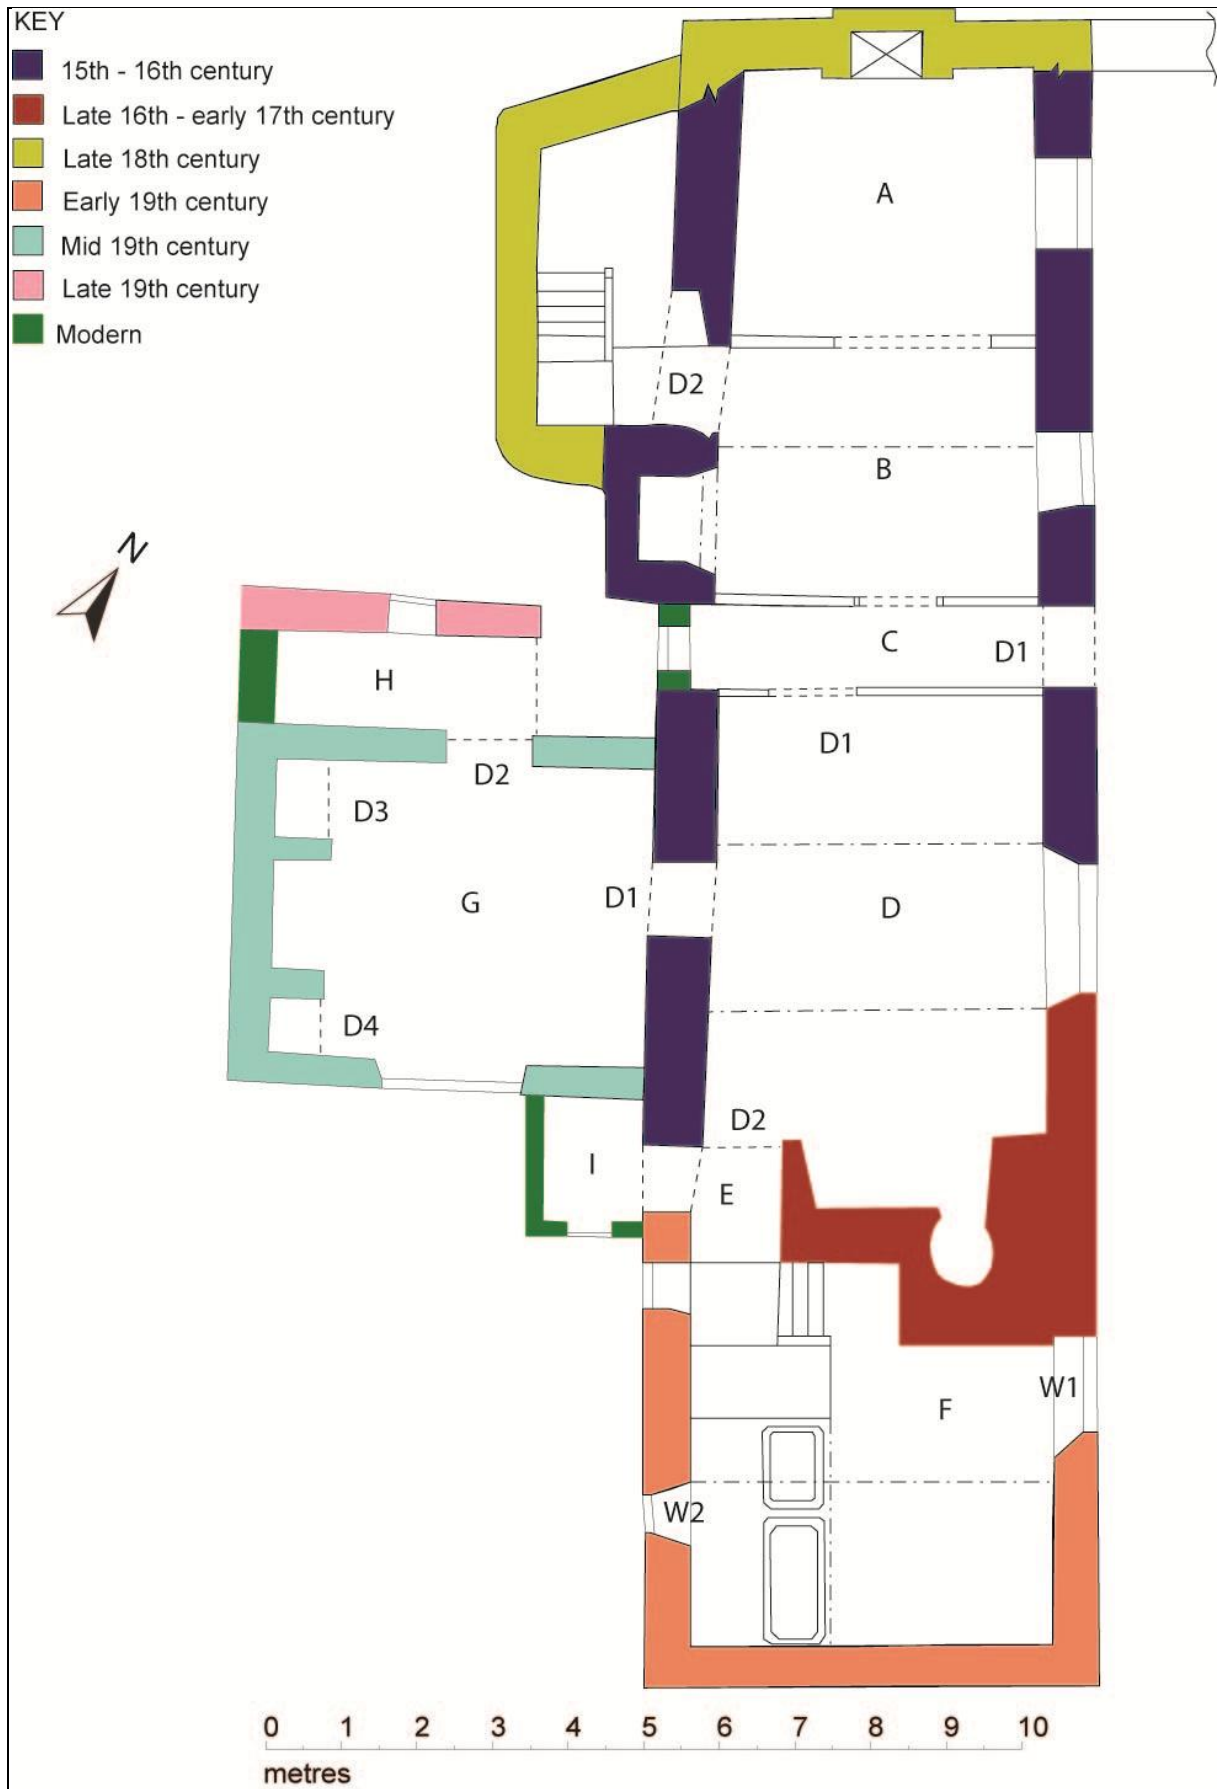
Figure 2: Phased plan of ground floor (from the 2015 survey).

Phase 1: Possible longhouse consisting of rooms A, B, C & D. Room A the inner room; rooms B & C heated by a lateral stack probably with adjacent stair turret, and room D being the 'lower'

Phase 2: The lower end of the building; room D, is raised to full two storey and converted to domestic use and heated by a gable end stack and the cross-passage C is formed.

Phase 3: The gable end of the inner room A is rebuilt with a chimneystack and the adjacent stair turret is rebuilt.

Phase 4: A three storey extension added to the south end of the building, consisting of a ground floor dairy and salting room.

Phase 5: Rear extension built as kitchen, removing cooking function (shown on the 1844 Hartland Tithe map (fig. 7).

Phase 6: Room H added as an outhouse and food preparation (i.e. butchery) room.

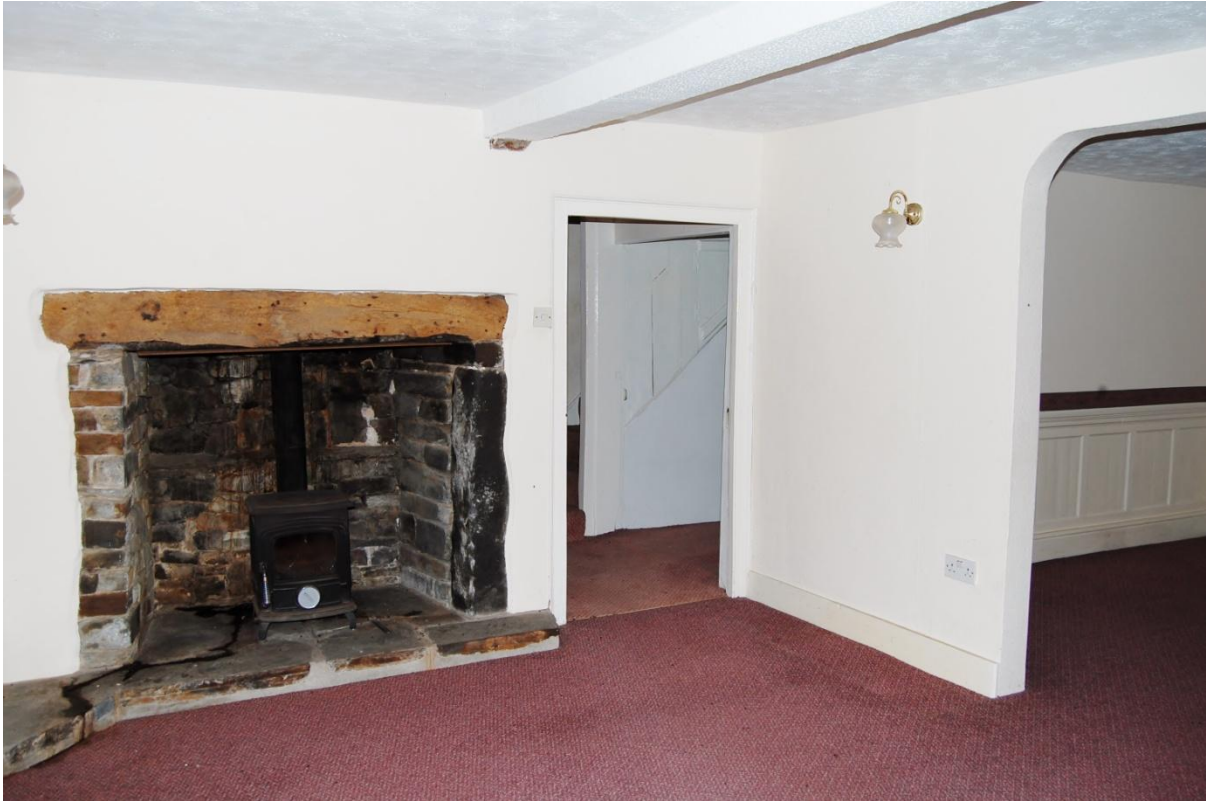
Figure 5: Fireplace and stair turret in Room B; from the north-east (from the 2015 survey).

Ceiling is artexed with transverse beam. Part of partition with Room A removed (see plan). The partition that ran in front of the fireplace has been removed. The fireplace has a stone monolith on right hand side and has semi dressed stone to the left. The timber bressumer appears contemporary; however the detailing is odd in that the stop sits over the left hand cheek suggesting the opening has been reduced. Therefore there could be another stone upright to the left that is currently hidden. Four panel 18th or 19th century doorway to right of fireplace leads to stair turret. There is a part exposed timber corbel below the cross beam. Door to stair turret four panel 2x2, rim lock with brass knob and early L shaped hinges. Window as Room A but 4x2. Panels below sill raised and fielded with window seat. Possibly early 18th century, but may be a late use of raised and fielded panels.

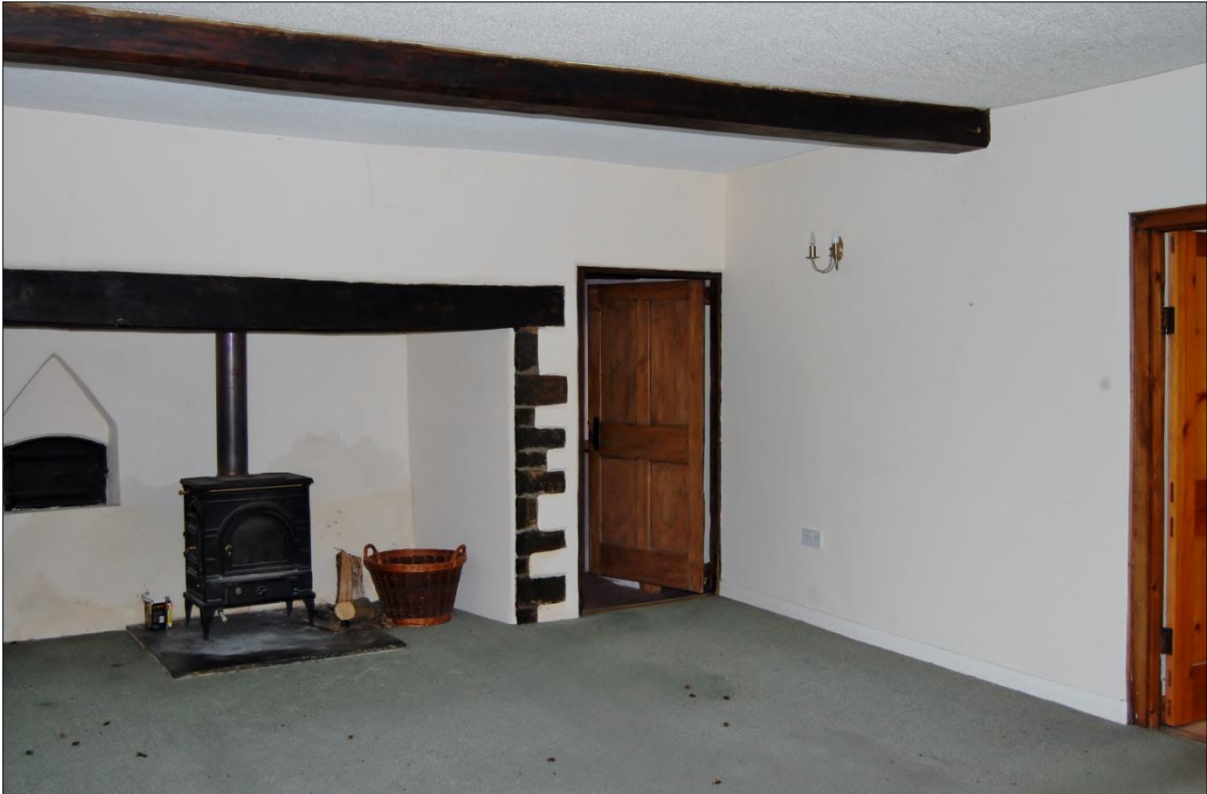
| Room D | Open, wood lintel with tiny chamfer and run-out stop. Jamb and rear plastered and painted white, fronts on jamb stones only showing. Log burner on large slate slab. Cloam oven in rear, iron door with long hinges on pins, wrought iron latch. 17c. |

Figure 6: Room D, showing the fireplace; from the north (from the 2015 survey).

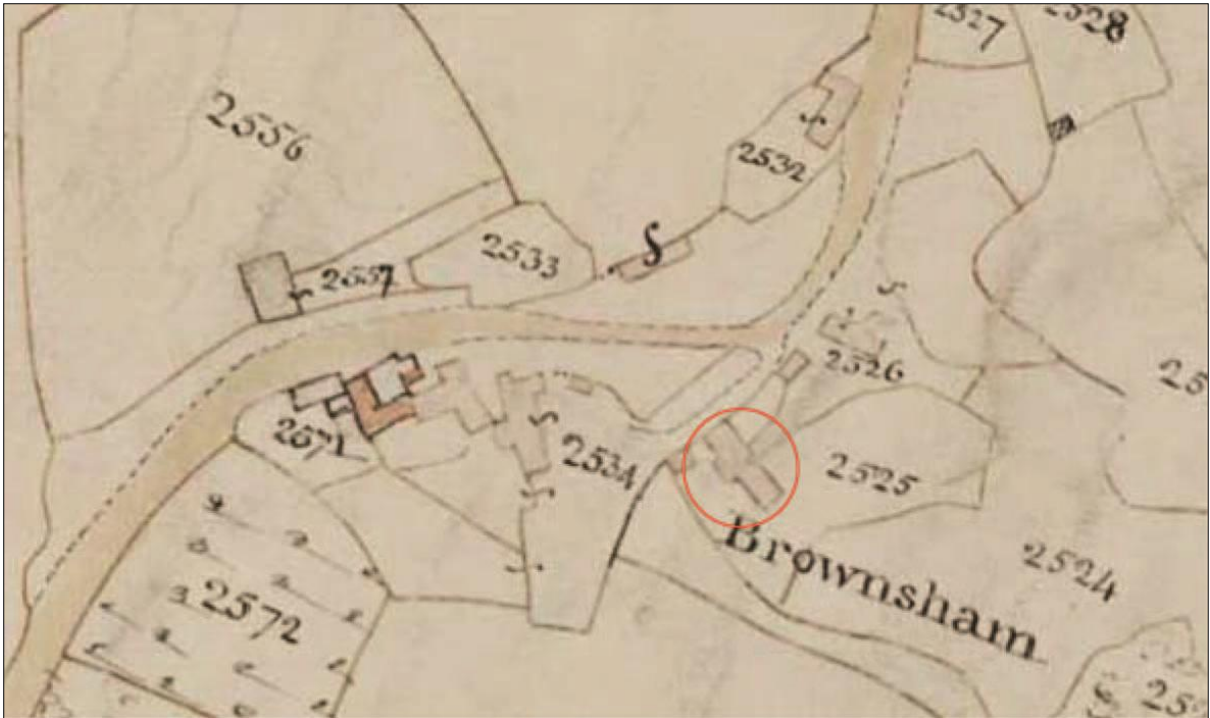
Figure 7: Extract from the Tithe map of 1840

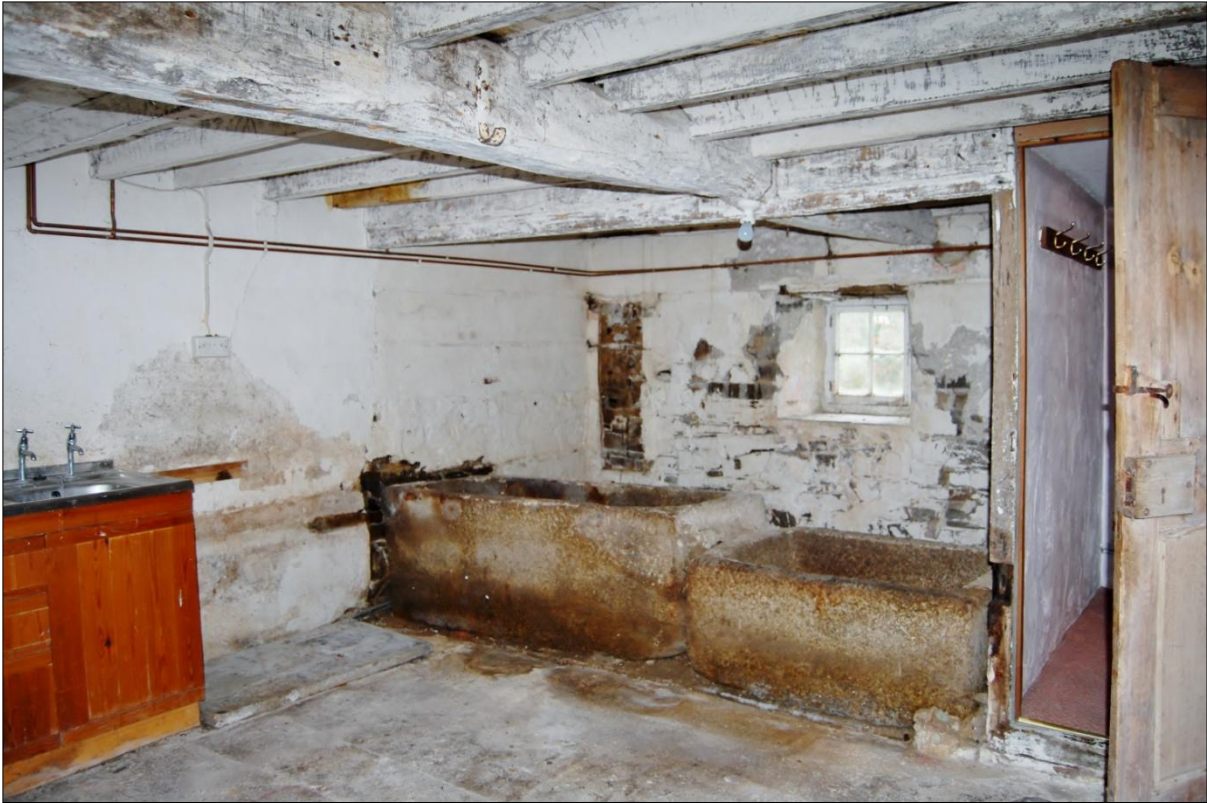
The eastern part was a dairy with slate shelving along south-east and south-west walls, 5-10 cm thick, resting on wood supports. All the slate has now been removed. Wide wooden shelves were on the north-east wall and suspended from the beam and joists, these were removed in 1986.

The salting room had two stone troughs in it and a two panel door opening from passage E. The stone salting troughs are still in situ but the screen that separated them from the dairy has been removed. Hanging hooks are still in situ. There appears to have been a pump (now removed) on south wall as the wall was painted around it.

Figure 9: The dairy, including the stone salting troughs; from the north; taken during 2015 survey.

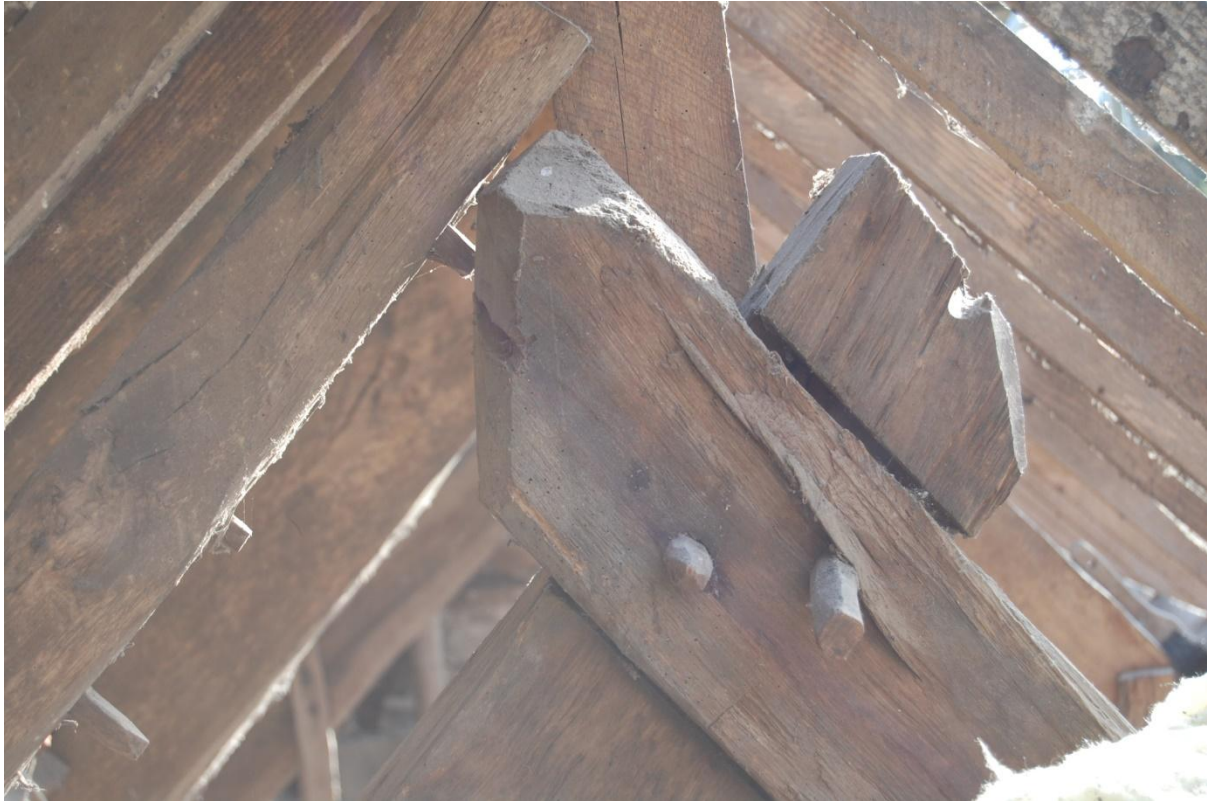
Truss 3: As truss 2 with apex deeply notched. Reused pegged timber on North-East side, held out to support purlins and connecting with ridge support.

The roof is accessed through an opening in the bathroom ceiling (Room L). There is clear evidence of several roof construction phases and an earlier roof construction still exists within the current system. The earliest roof covering was most probably thatch, now slate, with lime torching still existing on underside of slates.

Trusses 1 and 2 above Room A were not accessible and Truss 3 and 4 had A frames that were smaller and chunkier than trusses 4, 5 and 6. The apex joint was also different between the two types; trusses 3 and 4 being halved and pegged at the apex; trusses 4,5 and 6 having a mortice and tenon joint at the apex. All purlins and rafters were modern timber across the entire roof.

Figure 10: Internal Roof Structure showing apex of truss 3.
