65 MEDDON STREET

BIDEFORD

Results of a Desk-Based Assessment, Building Recording and
Archaeological Monitoring and Recording

South West Archaeology Ltd. report no. 160712

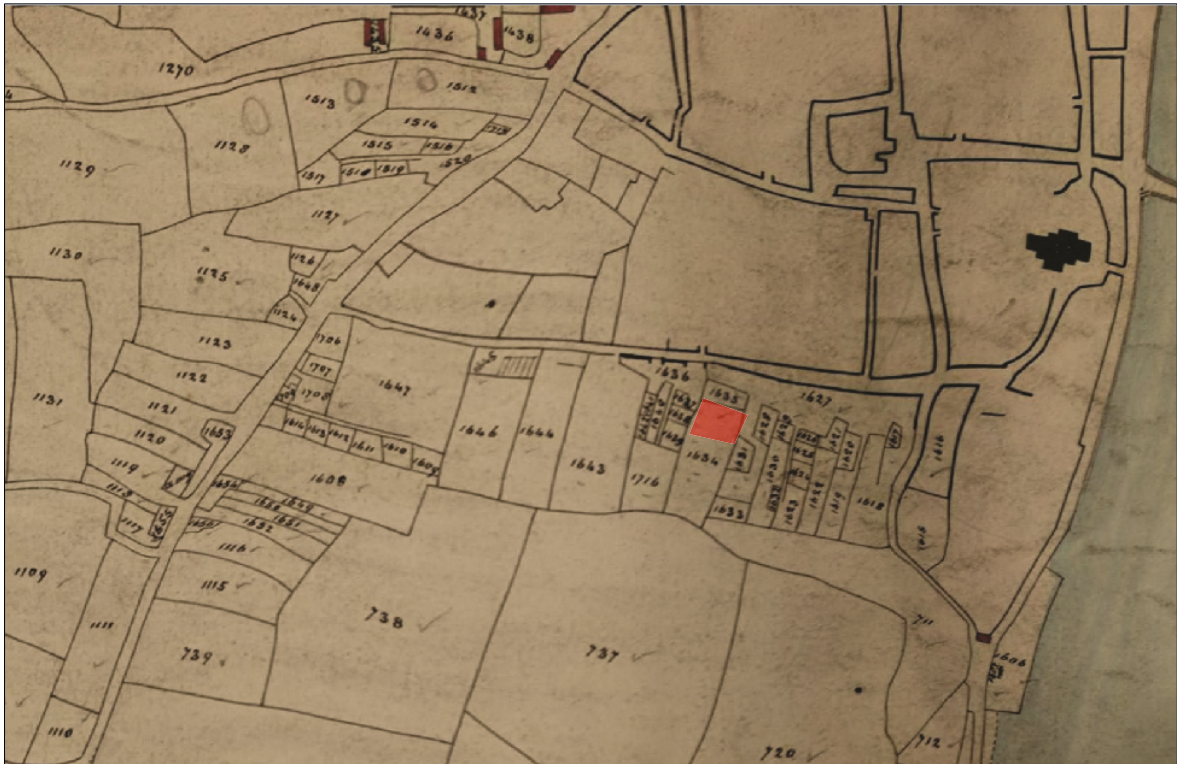
The 1839 Tithe Map (Figure 3) gives a more detailed interpretation of the landscape surrounding the site, though it contains very limited detail of the town itself, the only building depicted being St. Mary's Church, to the north-east of the site. The Tithe Map indicates that plots surrounding the development site are primarily of a form similar to burgage plots associated with domestic structures (a detail not present on the earlier map) following the roads, though with some larger plots symptomatic of the presence of larger properties. It indicates the development site as being situated as part of plot 1634, with a further plot (1635) forming its northern boundary against the buildings along Meddon Street. To the south of the site, the wider fieldscape can be seen to revert to the large regular Post-Medieval field system. No apportionment data was available for land ownership within the town, though the fields to the south are under the ownership of John Dyke and occupancy of John Grant.

FIGURE 3: EXTRACT FROM THE BIDEFORD TITHE MAP DATED 1839 (THE APPROXIMATE LOCATION OF THE SITE IS INDICATED).

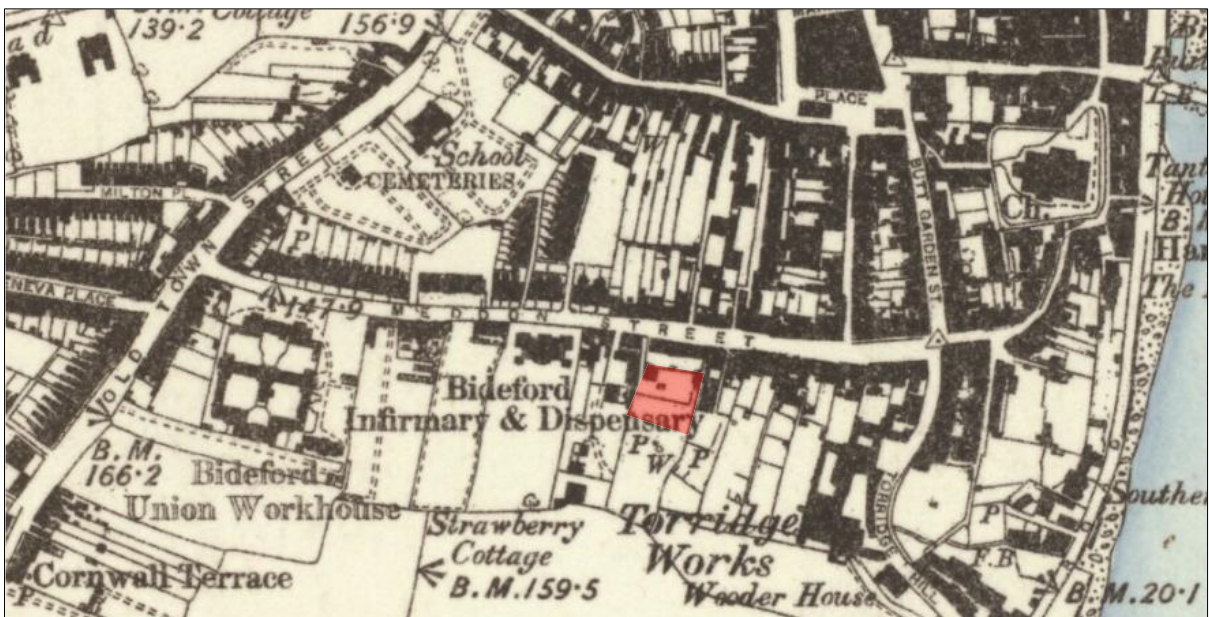
The 1888 OS 1st edition map (Figure 5) provides an even greater level of detail. It shows that relatively significant amount of urban development has occurred since the earlier maps, with field boundary rationalisation associated with the development of the Workhouse, though also on a wider scale. The site is shown to include parts of two plots. The northern portion of the site at this time contained buildings in both the north-east and north-west corners, with a further small building to the centre. The southern portion forms part of a larger 'garden' at this time, and this appears to potentially still be accessed from the plots to the west, as an unmade track/footpath is shown. There appears to have been a 'pump' located in this garden, with a further pump and well in the plot to the east.

FIGURE 5: EXTRACT FROM THE 1888 ORDNANCE SURVEY 1ST EDITION MAP (THE APPROXIMATE LOCATION OF THE SITE IS INDICATED).

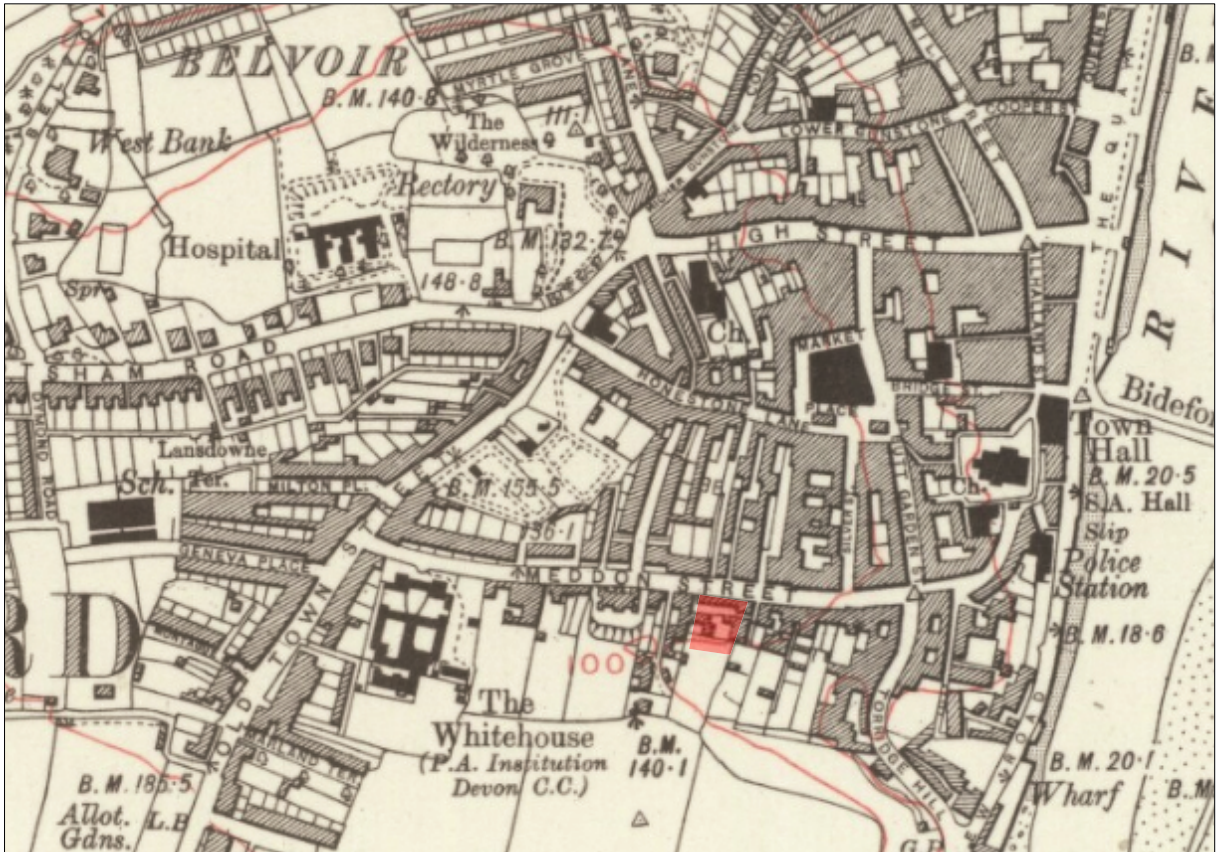
Later 20th century OS mapping shows very limited development of Bideford in proximity to the proposal site, the most significant changes being the move of the Infirmary from its location to the west of the development site, to a new location further to the north-west, near West Bank (Figure 7). By the mid 20th century there had been no identifiable development of the site; and it is not until the post-war period that there is significant development and expansion of Bideford, the estates to the south of the proposal site being constructed in the 1980s.

FIGURE 7: EXTRACT FROM THE 1935 ORDNANCE SURVEY MAP (THE APPROXIMATE LOCATION OF THE SITE IS INDICATED).

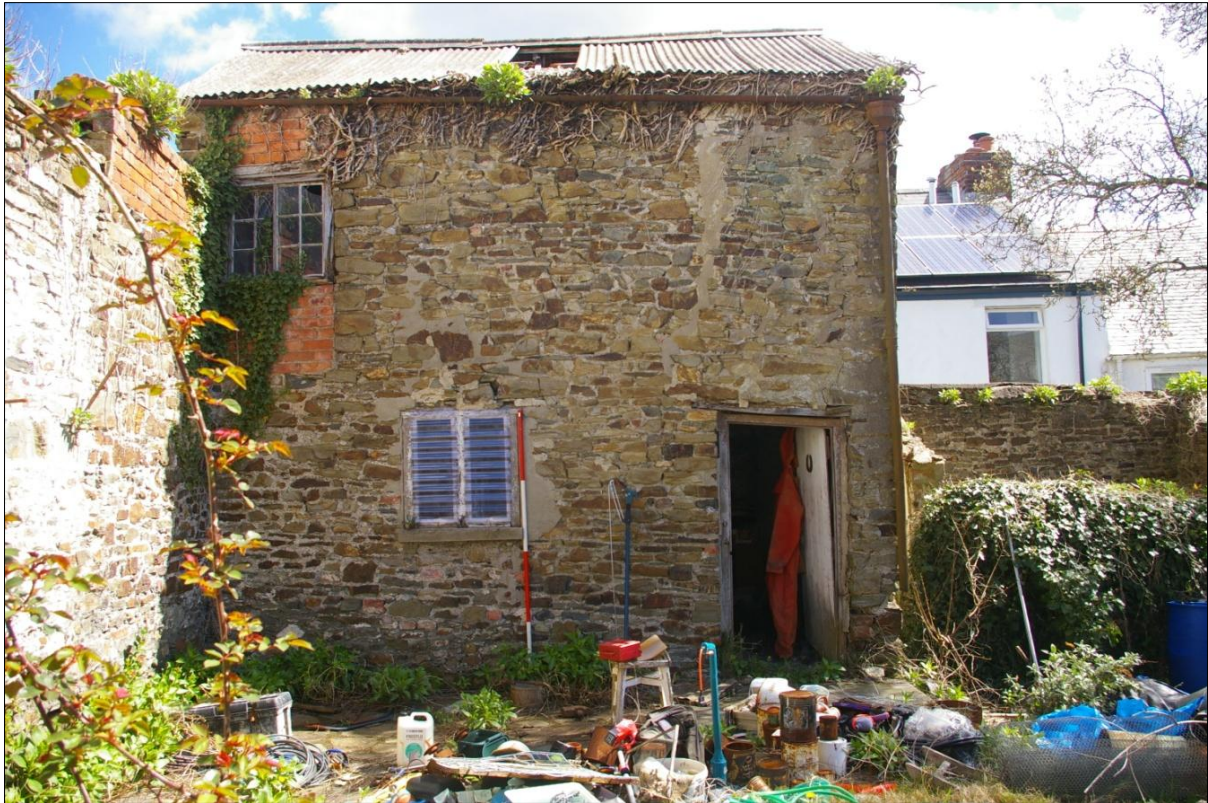
The west elevation of the barn (Figure 10) shows a significant structural crack towards the southern end, running from the eaves down to the doorway, indicating that the south-west corner of the building has failed. The crack has been heavily patched with cement.

The construction of the lower storey is of closely packed coursed local slate-stone and mud-stone types bonded by a white/grey lime mortar. The upper floor is of a more irregular rubble build using noticeably more, but looser, mortar of grey/beige colour and with greater frequency of coal and mica/grit inclusions.

There is a ground floor doorway at the south end, set in a narrow beaded wooden frame, with pegged joints. The door is constructed from varying widths of board and is ledged to the rear. A ground floor window is located centrally in the elevation, comprising a wide timber pegged frame, central mullion and fixings for shutters. It is now blocked by corrugated plastic sheeting. A first floor loading door is located to the northern end of the elevation, blocked with brickwork and set with a re-used timber two-light sliding 'Yorkshire' sash window with bead moulding.

FIGURE 10: WEST ELEVATION OF THE MAIN OUTBUILDING SHOWING THE STRUCTURAL CRACK TO THE SOUTH, AND BLOCKED LOADING DOOR TO THE NORTH; VIEWED FROM THE WEST (2M SCALE).

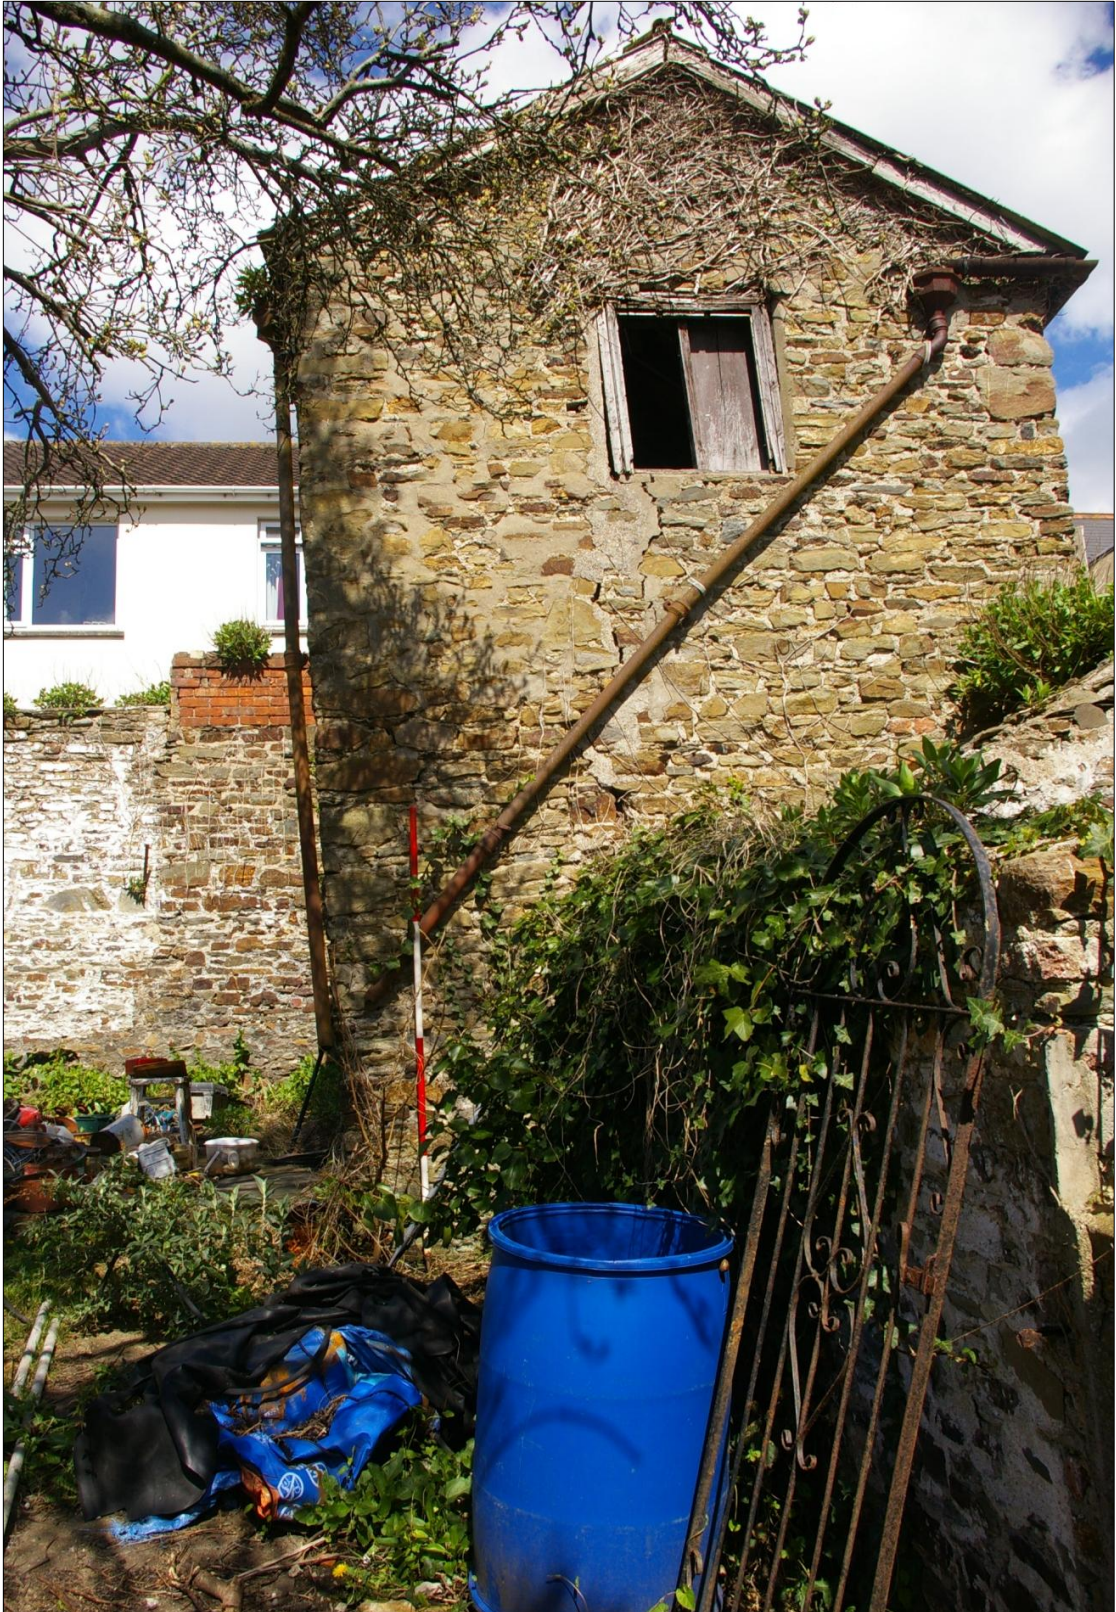
The south elevation comprises the gable-end of the building. As with the west elevation there is a significant structural crack towards the west end, extending from the first floor window down to the south-west corner. The crack and area around it have been heavily patched with cement. The double pitch and corrugated fibre sheeting of the roof is again evident, though timber barge boards are also present to this elevation. The cast iron guttering continues, with a diagonal down-pipe running down from the north-east to the south-west.

The ground floor of the elevation contains (potentially older) stonework of tightly packed and roughly coursed small, flat slate- and mud-stone, though the eastern side of this elevation is partly obscured by the rendered face of the adjacent outside toilet. The first floor of the elevation appears cohesive with the upper floor of the west elevation, being constructed from looser rubble stonework, with heavy use of lime mortar. There is one opening, set partly into the gable apex on the first floor.

This comprises a small window/loading door with a wide timber frame, pegged joints and surviving board shutters.

FIGURE 11: SOUTH ELEVATION OF THE MAIN OUTBUILDING, SHOWING THE WOODEN FRAMED WINDOW AND STRUCTURAL CRACK TO THE WEST; VIEWED FROM THE SOUTH (2M SCALE).

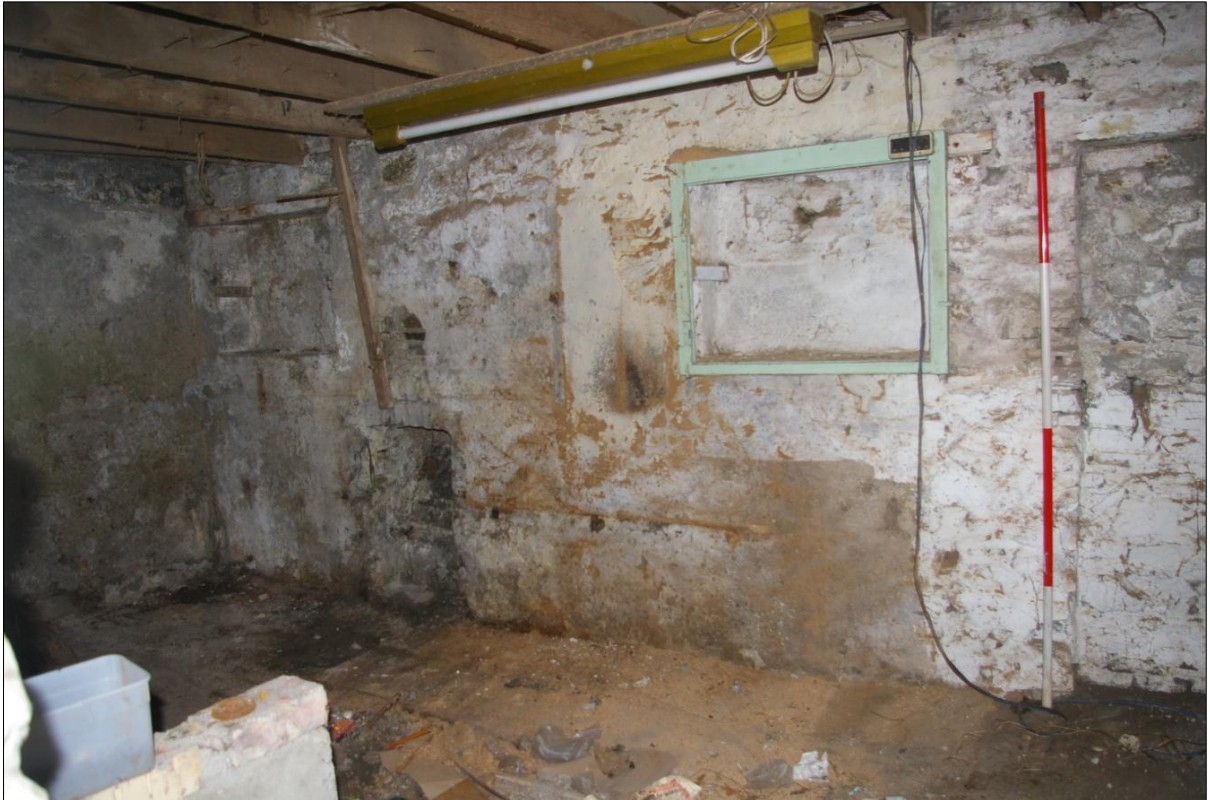
As with the north elevation, the building has been built up against an earlier wall: the roughly coursed eastern site boundary wall constructed of tightly packed slate-stone and bonded by a rich, creamy lime mortar. Damage to the lower levels of the wall indicates that a possible clay bond was used in its construction. The wall is much patched and repaired, with large sections heavily re-pointed in cement. Internal inspection of the wall identified blocked windows, a door and a fireplace to both the ground and first floors, suggestive of an earlier domestic dwelling once being located on the site.

FIGURE 12: DETAIL OF THE INTERIOR ELEVATION OF THE EAST WALL, SHOWING THE BLOCKED DOORWAY, BLOCKED WINDOWS AND FIREPLACE; VIEWED FROM THE SOUTH-WEST (2M SCALE).

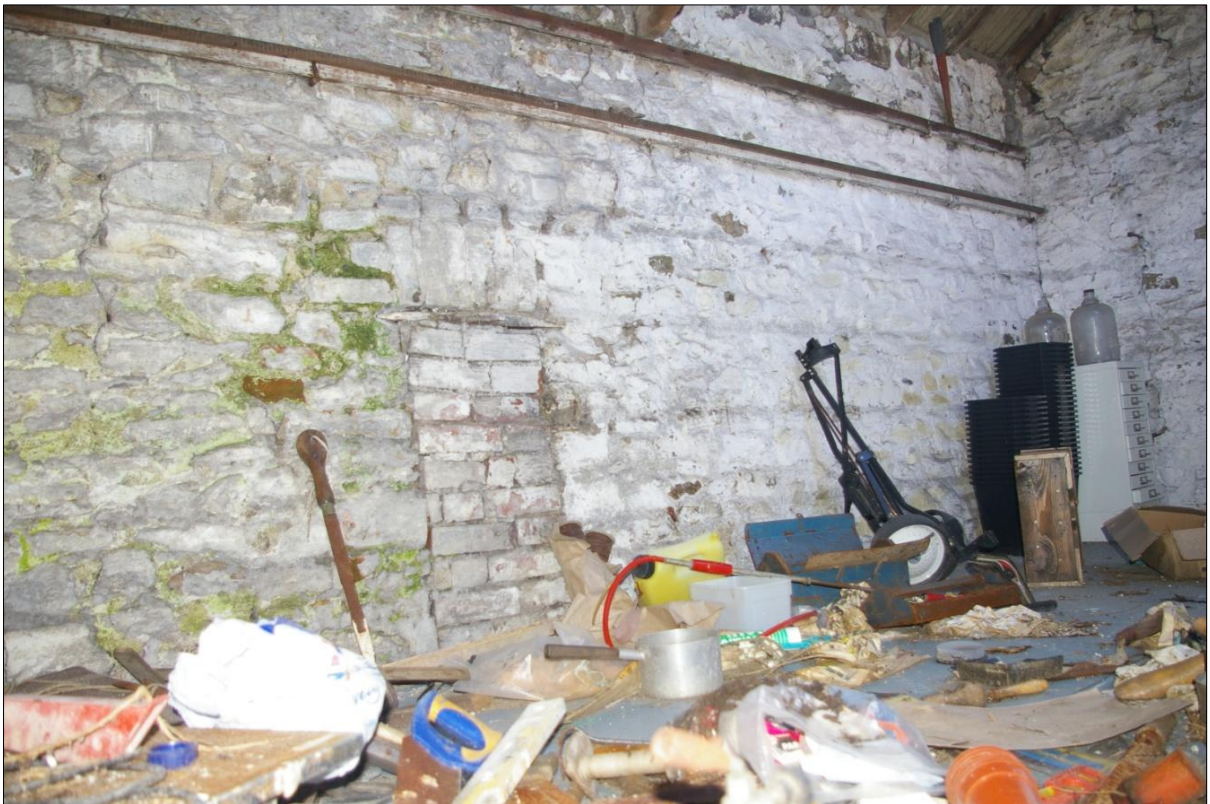
The whitewashed stone walls continue up from the ground floor into the loft space, the floor of which comprises a mix of re-used boards and chipboard sheets over predominantly narrow 20th century timber joists, with two 19th century larger set timber joists surviving to the north end. A narrow off-set central fireplace in the east wall utilises the same stack identified on the ground floor. The fireplace has a shallow handmade brick relieving arch and rough stone quoins to the sides, and has been blocked by brickwork. There is a 20th century 'A'-frame roof structure.

FIGURE 13: DETAIL SHOWING THE FIREPLACE IN THE EAST WALL OF THE LOFT SPACE; VIEWED FROM THE NORTH-WEST (NO SCALE).

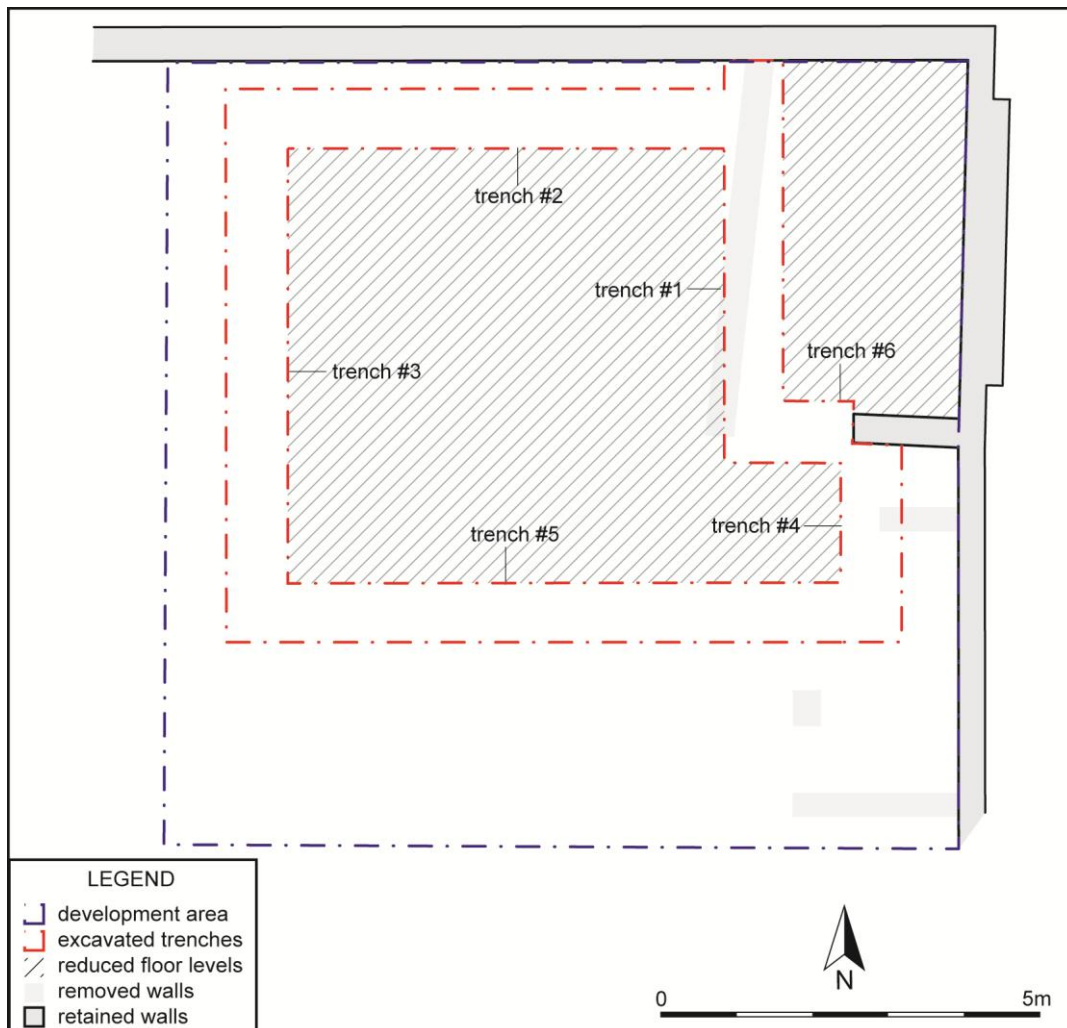
Archaeological monitoring and recording was conducted during groundworks associated with the conversion and extension of buildings at No. 65 Meddon Street, within an area covering approximately 110m² in the north-east corner of the property. The excavation comprised the reduction in level of the footprint of the new building and interior of the barn structure; and the excavation of 6 foundation trenches (see Figure 14) to depths of up to c.1m. All groundworks were carried out by tracked 360° excavator fitted with a 1.20m wide toothless grading bucket under strict archaeological supervision.

FIGURE 15: PLAN OF EXCAVATED AREAS.

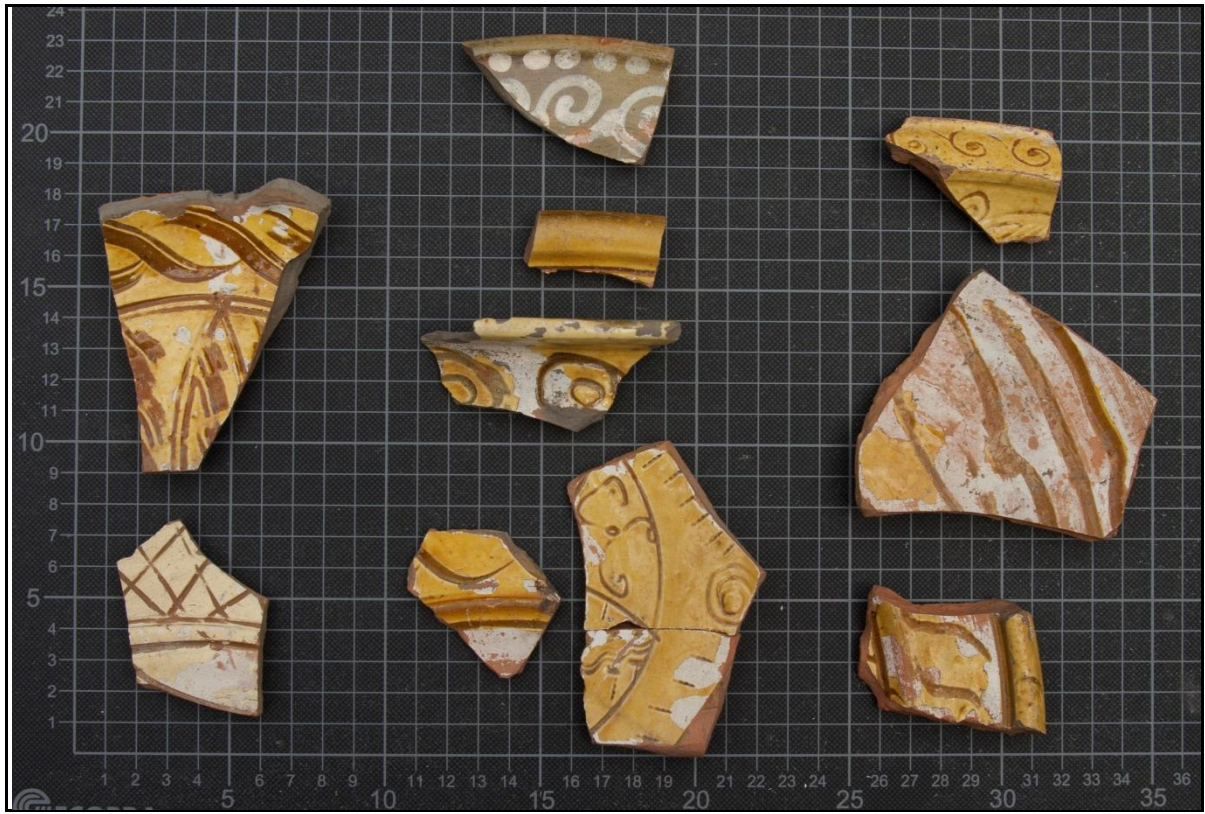
and the assemblage contains primarily local North Devon wares (see Figure 16), with a very small number of other fabrics represented. For a full and detailed list see Appendix 2.

FIGURE 17: PHOTOGRAPH OF SOME OF THE SGRAFFITO SHERDS, FROM VARIOUS CONTEXTS, THAT WERE RECOVERED FROM THE SITE.

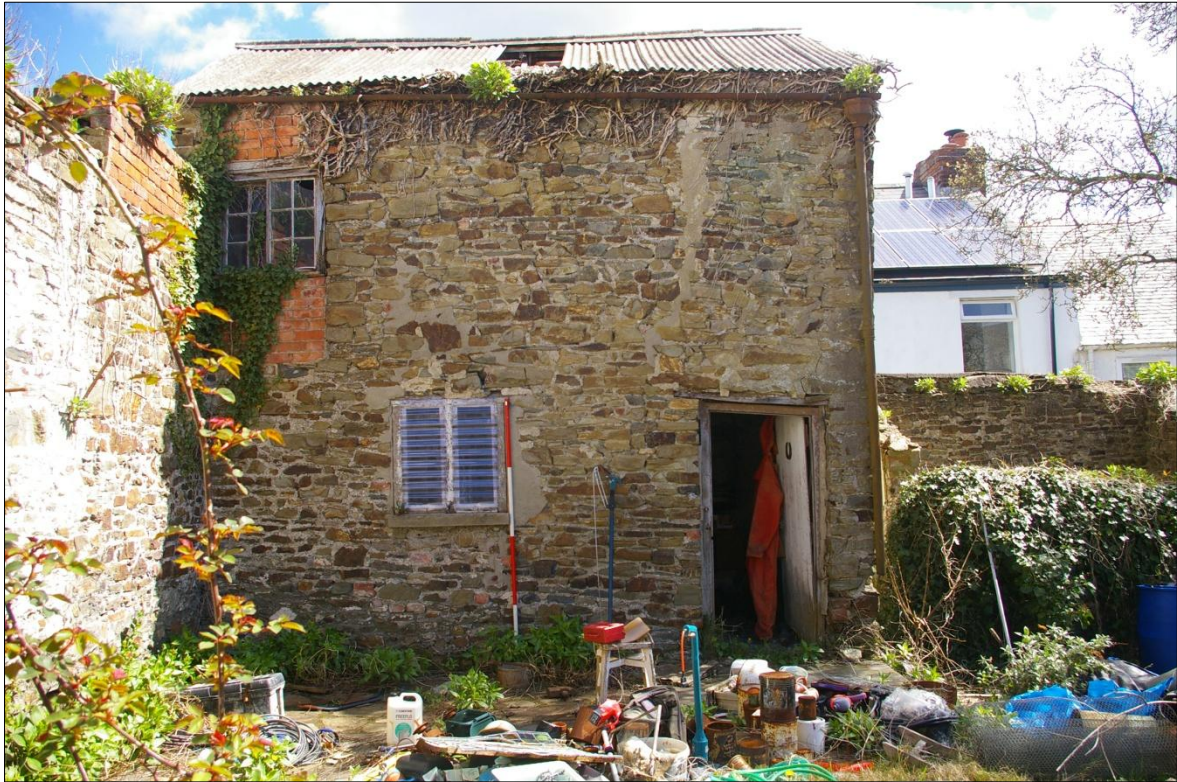
WEST ELEVATION OF THE BARN; VIEWED FROM THE WEST (2M SCALE).

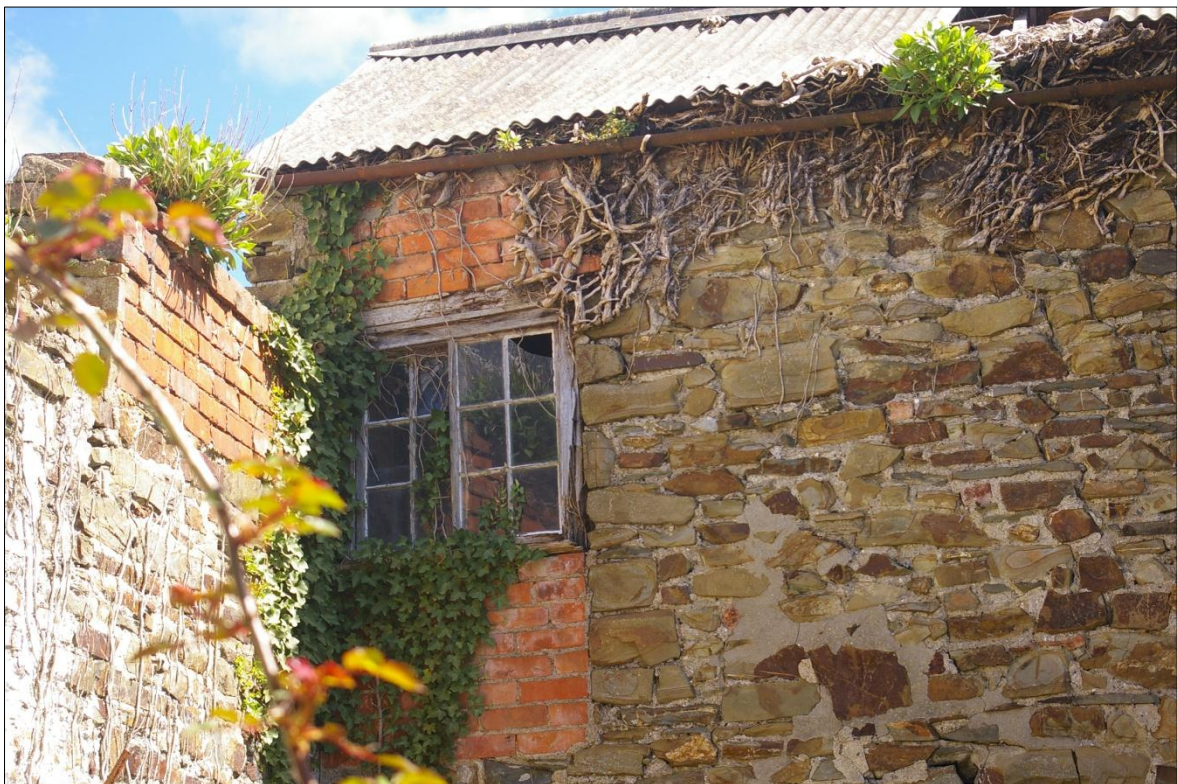
DETAIL OF THE WEST ELEVATION OF THE BARN, SHOWING THE SLIDING 'YORKSHIRE' SASH SET INTO THE BLOCKED LOADING DOOR; VIEWED FROM THE WEST-SOUTH-WEST (NO SCALE).

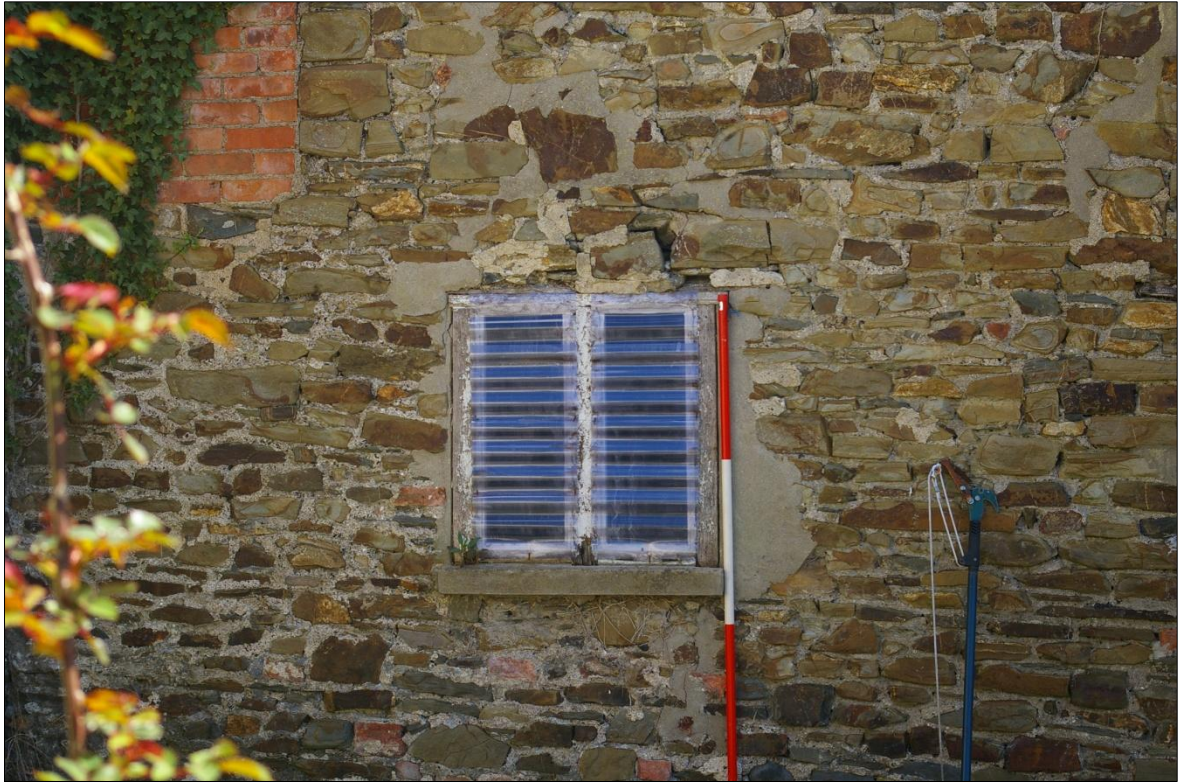
DETAIL OF THE WEST ELEVATION OF THE BARN, SHOWING THE GROUND FLOOR TIMBER WINDOW; VIEWED FROM THE WEST (2M SCALE).

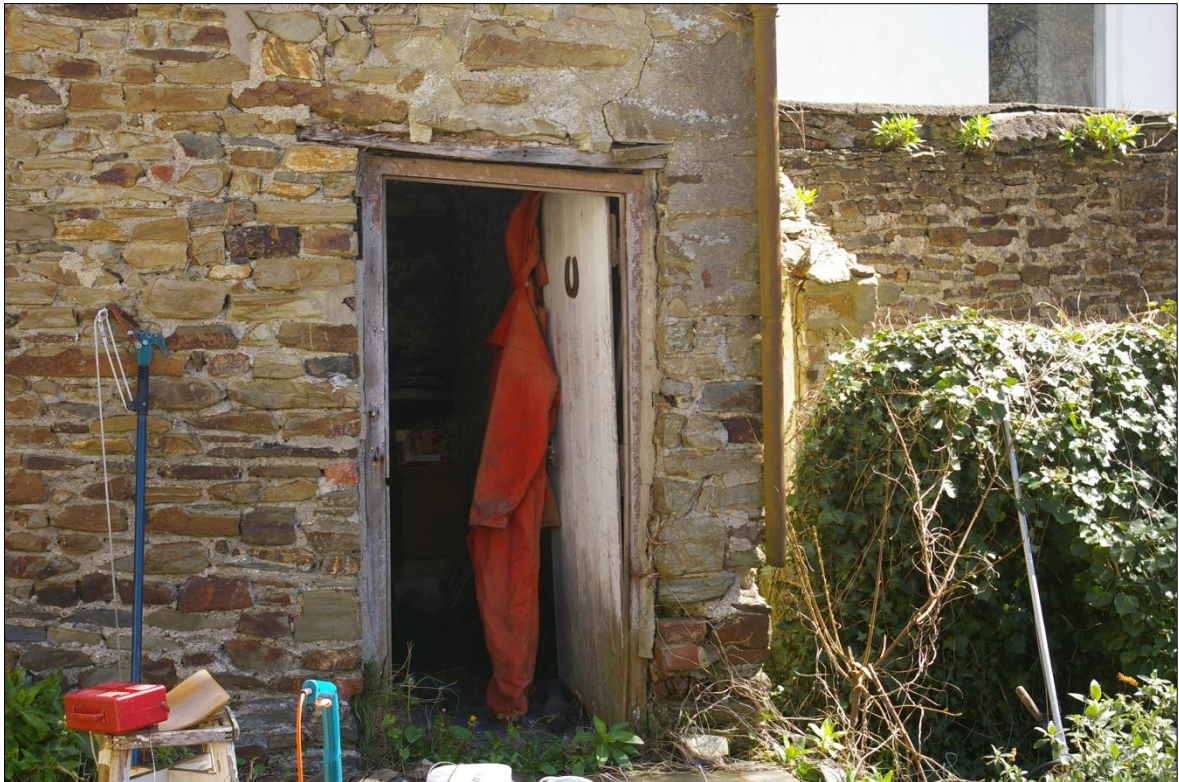
DETAIL OF THE WEST ELEVATION OF THE BARN, SHOWING THE DOORWAY IN THE SOUTH-WEST CORNER; VIEWED FROM THE WEST (NO SCALE).

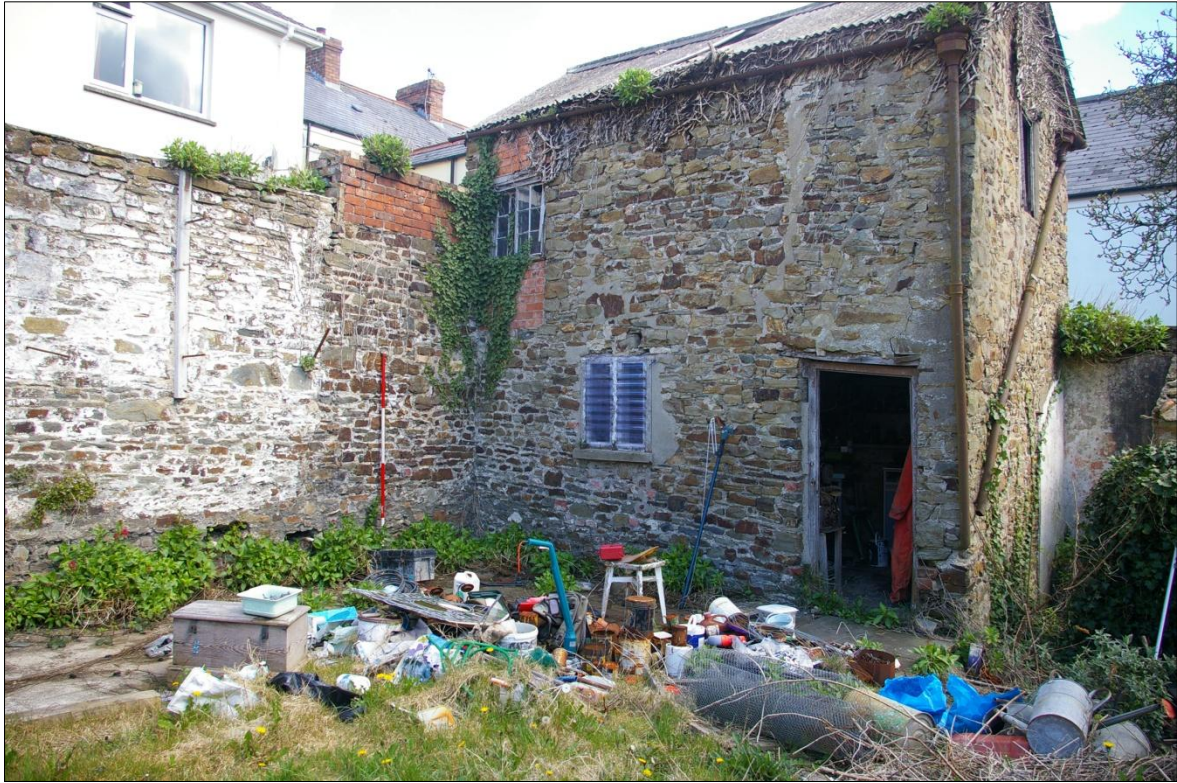
THE WEST ELEVATION OF THE BARN AND ADJACENT NORTH PLOT WALL; VIEWED FROM THE SOUTH-WEST (2M SCALE).

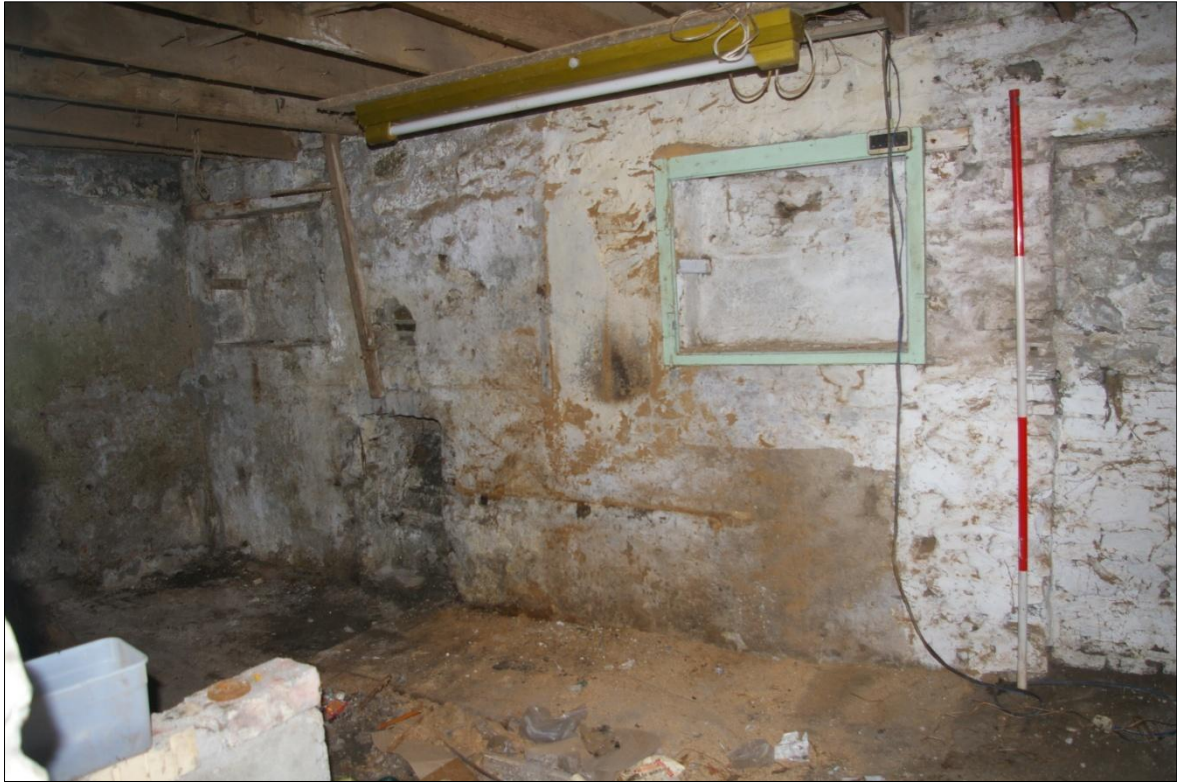
INTERIOR OF THE BARN, SHOWING THE INTERNAL FACE OF THE EAST BURGAGE PLOT WALL WITH DETAILS OF THE BLOCKED DOOR, WINDOWS AND FIREPLACE; VIEWED FROM THE WEST (2M SCALE).

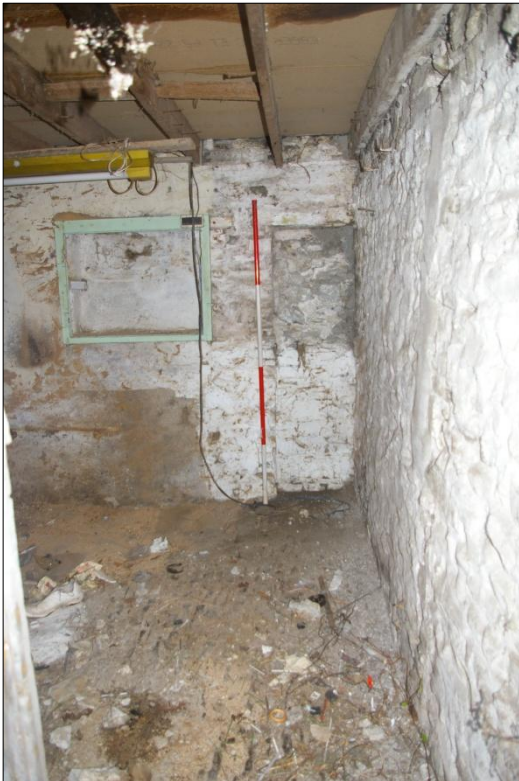
(LEFT) DETAIL OF THE INTERNAL FACE OF THE EAST WALL OF THE BARN, SHOWING THE BLOCKED DOORWAY AND COBBLED SURFACE AT THE SOUTH END; VIEWED FROM THE WEST (2M SCALE).

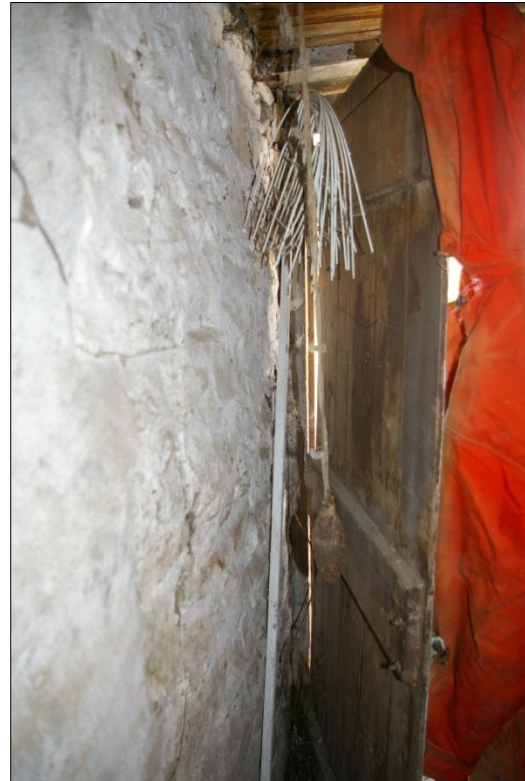
(RIGHT) DETAIL OF THE PLANK DOOR TO THE BARN, LEDGED TO THE REAR; VIEWED FROM THE NORTH-EAST (NO SCALE).

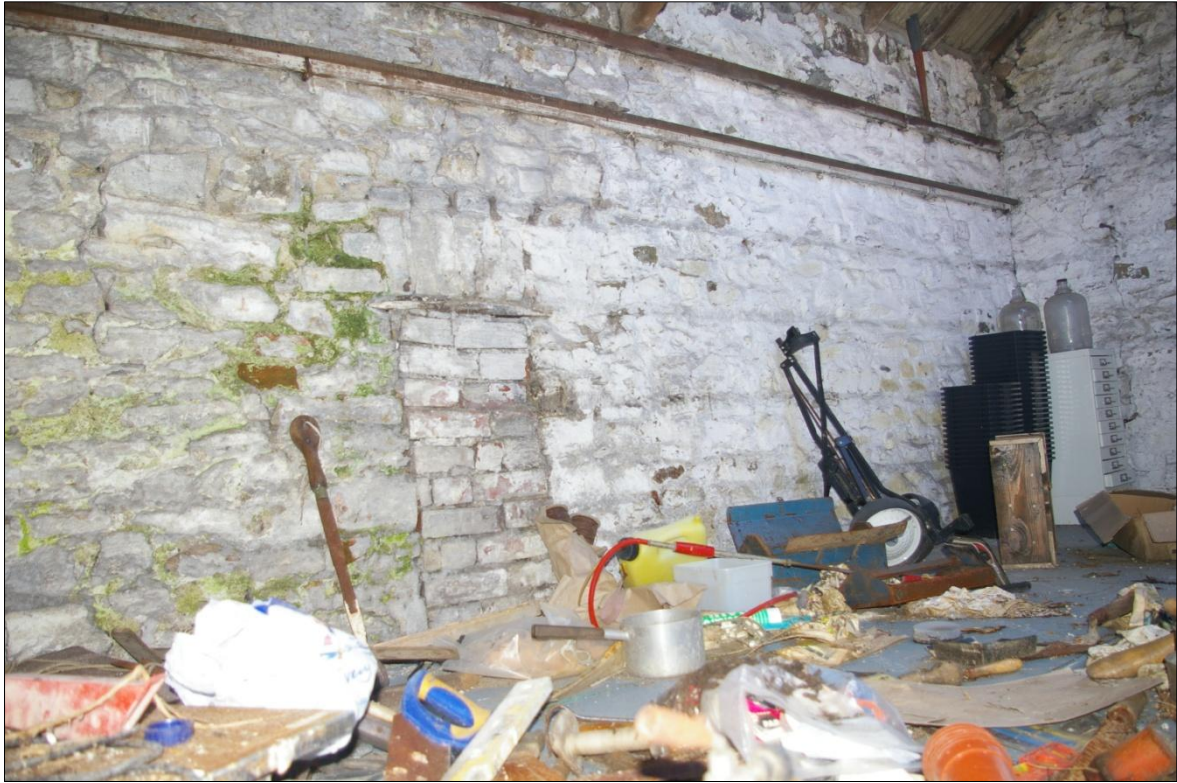
DETAIL OF THE INTERNAL FACE OF THE EAST WALL OF THE BARN, SHOWING THE BLOCKED FIREPLACE; VIEWED FROM THE NORTH-WEST (NO SCALE).

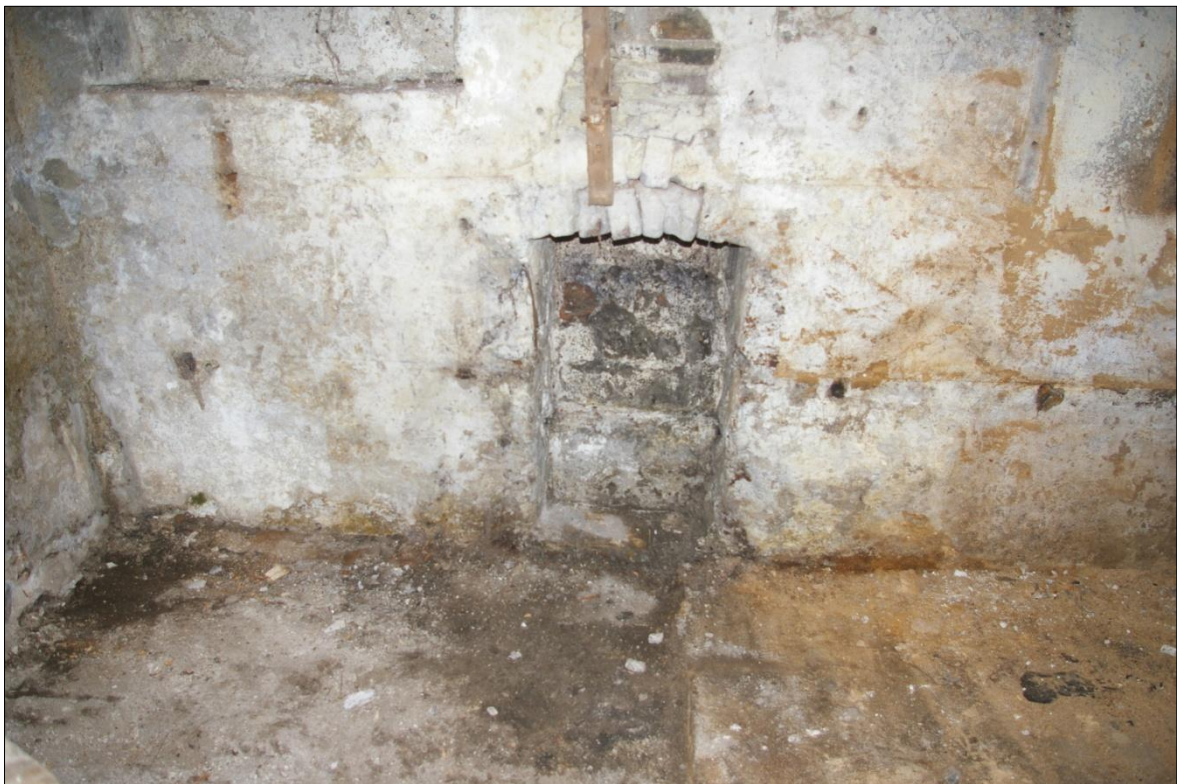
DETAIL OF THE INTERNAL FACE OF THE EAST WALL OF THE BARN, SHOWING THE SMALL FIREPLACE WITH STONE DRESSED JAMBS TO THE SIDE, AND SMALL HANDMADE BRICK SEGMENTAL ARCH, FOLLOWING REMOVAL OF BLOCKING; VIEWED FROM THE WEST (NO SCALE).

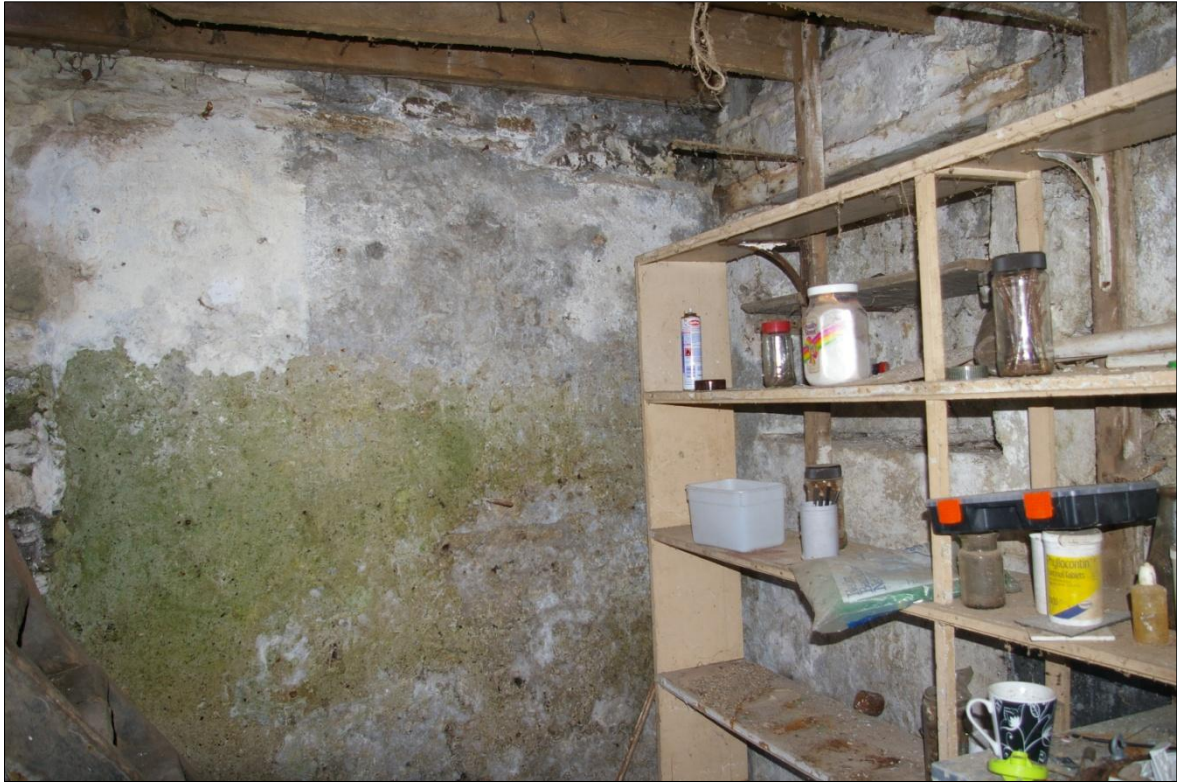
THE INTERNAL FACE OF THE NORTH WALL OF THE BARN, SHOWING THE SURVIVING LIME PLASTER WITH WHITEWASH; VIEWED FROM THE SOUTH-WEST (NO SCALE).

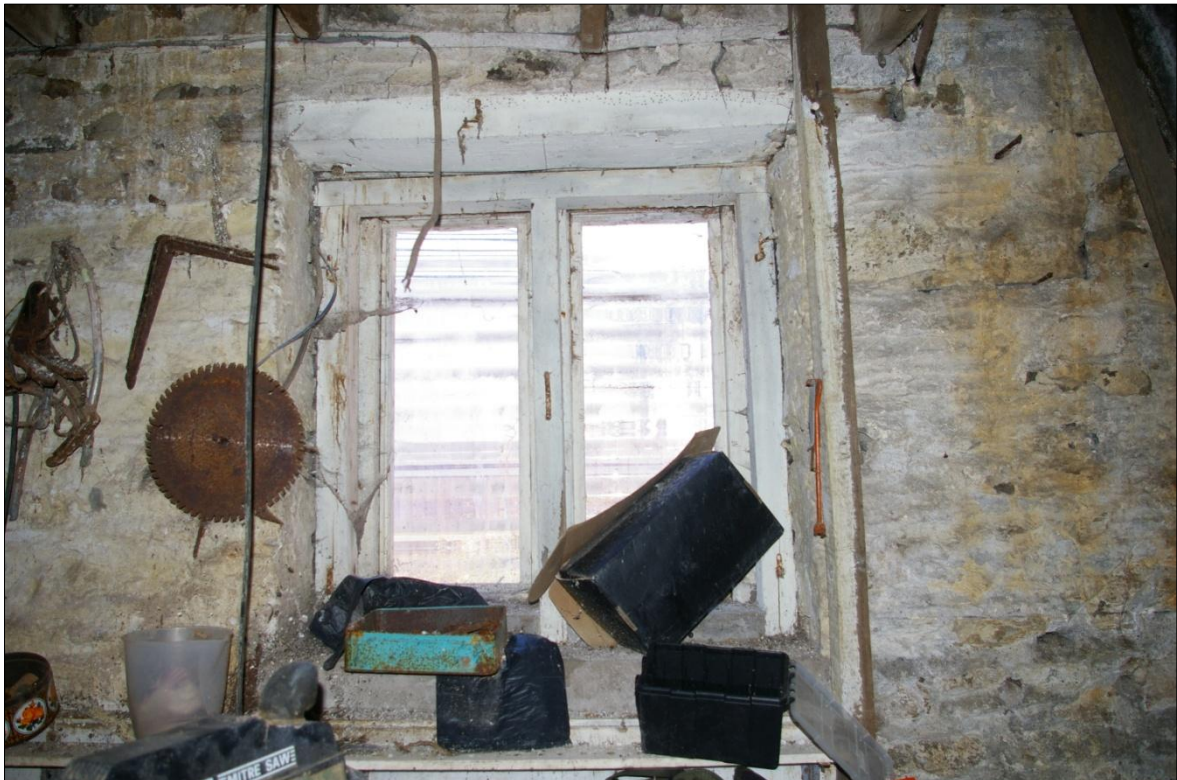
DETAIL OF THE INTERNAL FACE OF THE WEST WALL OF THE BARN, SHOWING THE CENTRAL GROUND FLOOR WINDOW; VIEWED FROM THE EAST (NO SCALE).

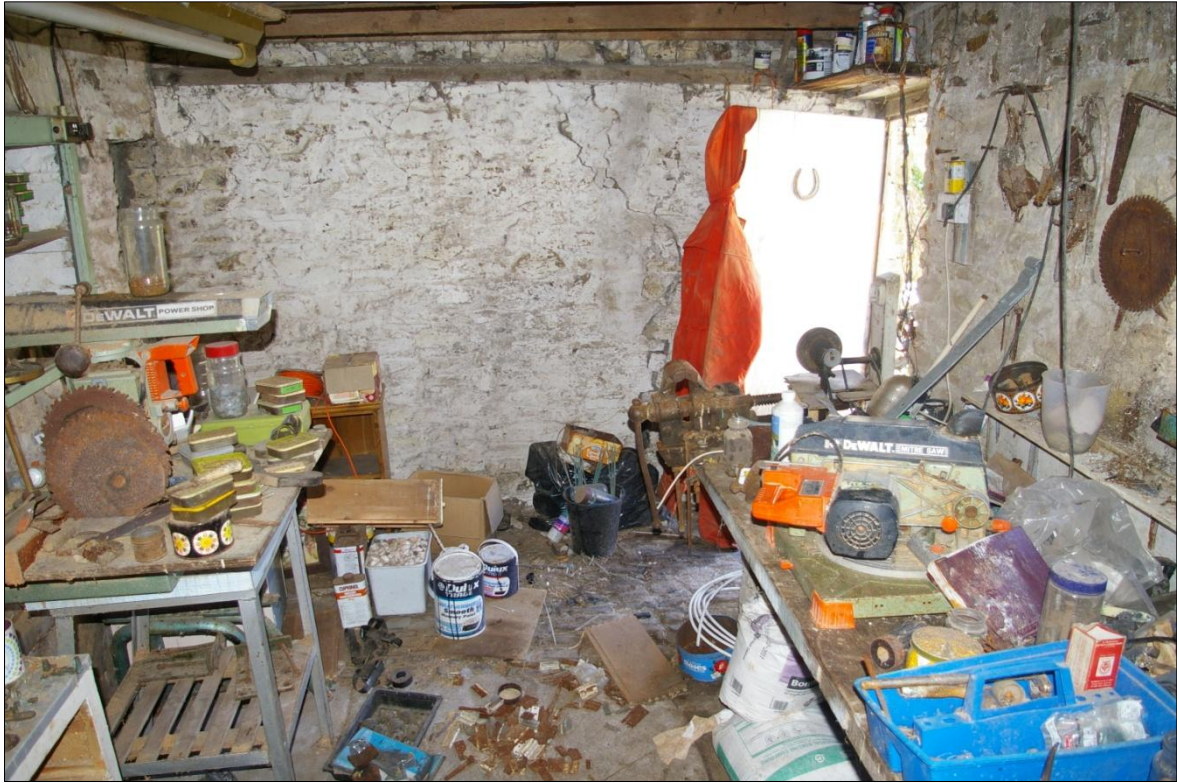
THE INTERNAL FACE OF THE SOUTH WALL OF THE BARN; VIEWED FROM THE NORTH (NO SCALE).
