65 MEDDON STREET

BIDEFORD

Results of a Desk-Based Assessment, Building Recording and
Archaeological Monitoring and Recording

South West Archaeology Ltd. report no. 160712

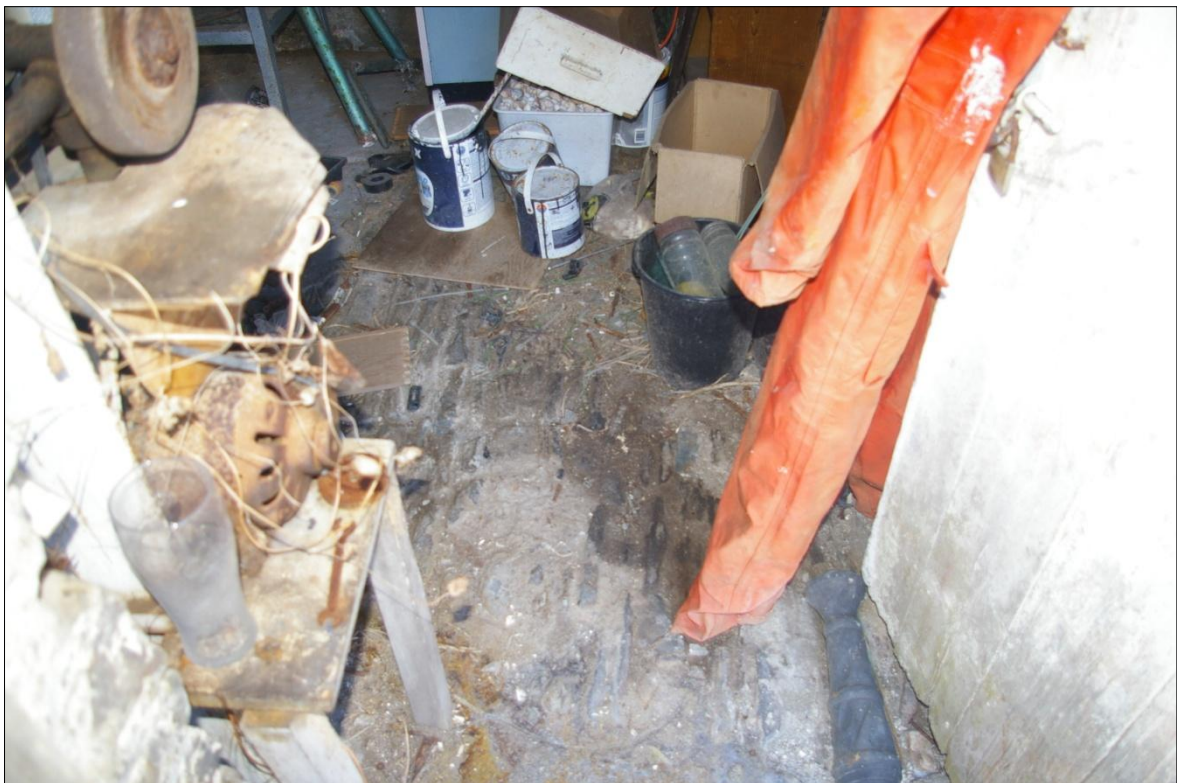
DETAIL OF THE SURVIVING COBBLE FLOOR IN THE EXISTING DOORWAY TO THE BARN; VIEWED FROM THE WEST (NO SCALE).

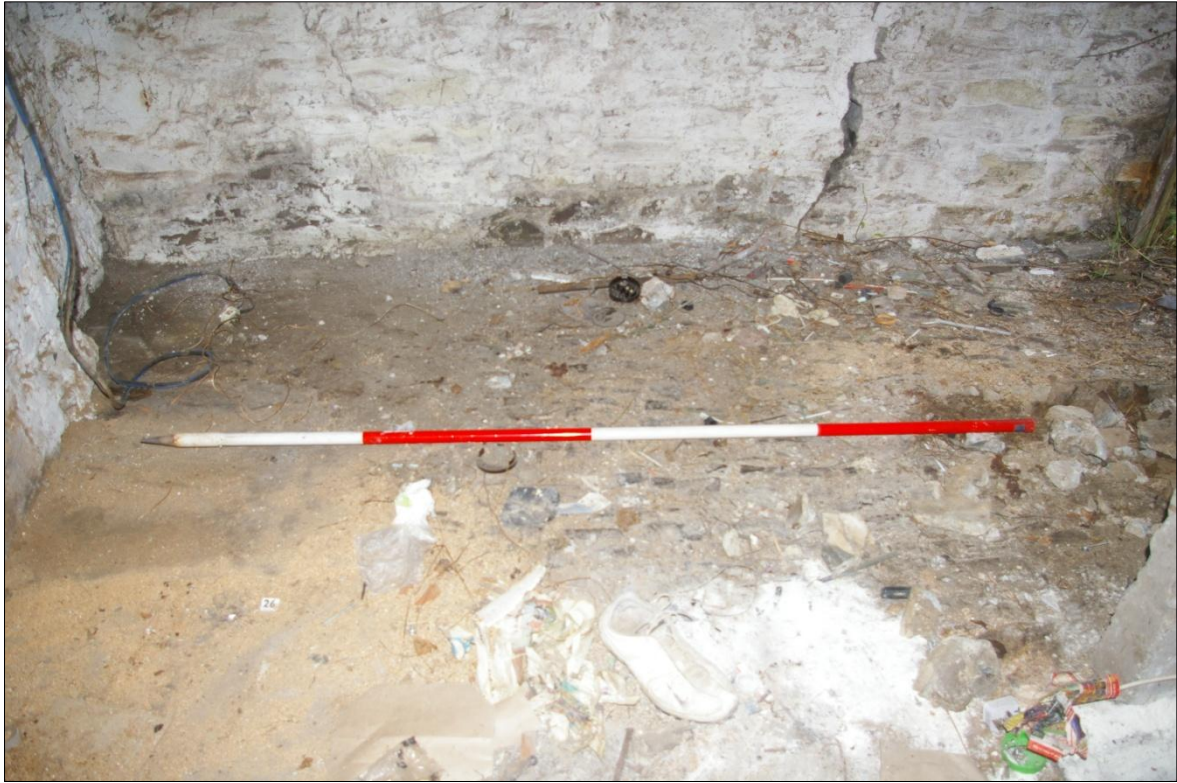
DETAIL OF THE COBBLE FLOOR WITHIN THE BARN BETWEEN THE BLOCKED AND CURRENT DOORWAYS; VIEWED FROM THE NORTH (2M SCALE).

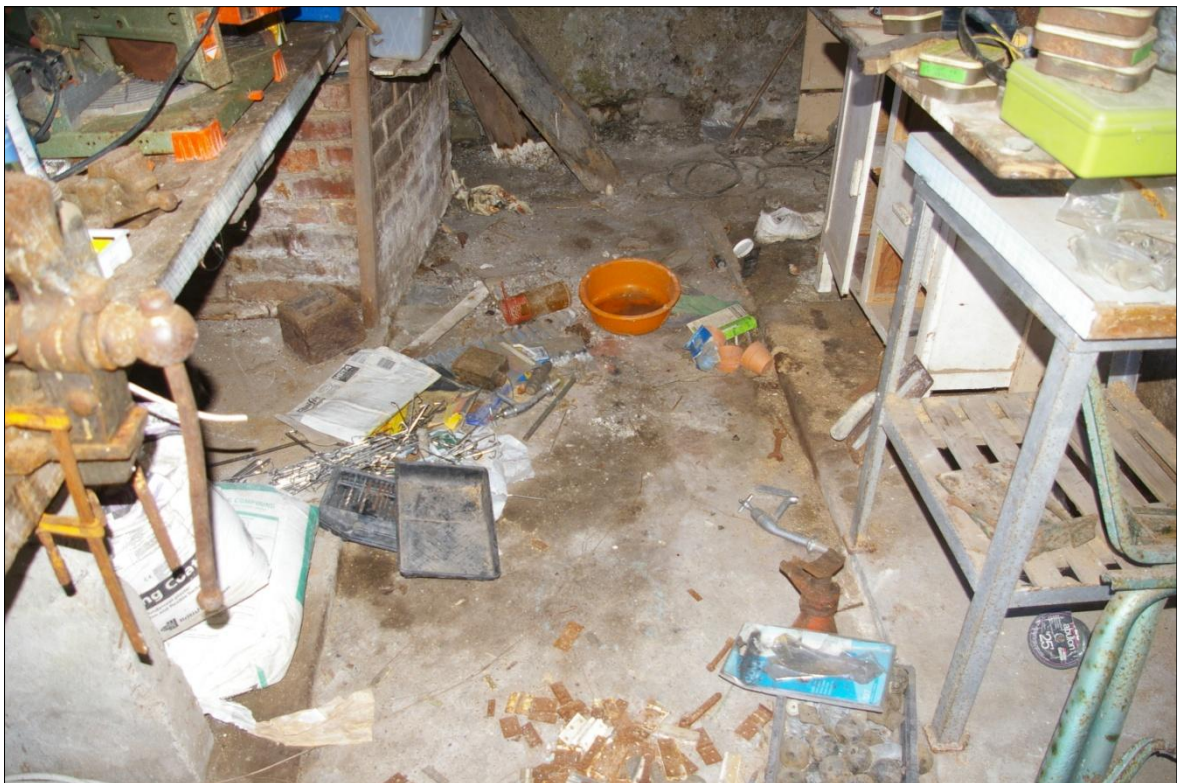
DETAIL OF THE MAIN SURVIVING CONCRETE FLOOR WITHIN THE BARN, SHOWING THE RAISED PLATFORMS AGAINST EACH SIDE WALL; VIEWED FROM THE SOUTH (NO SCALE).

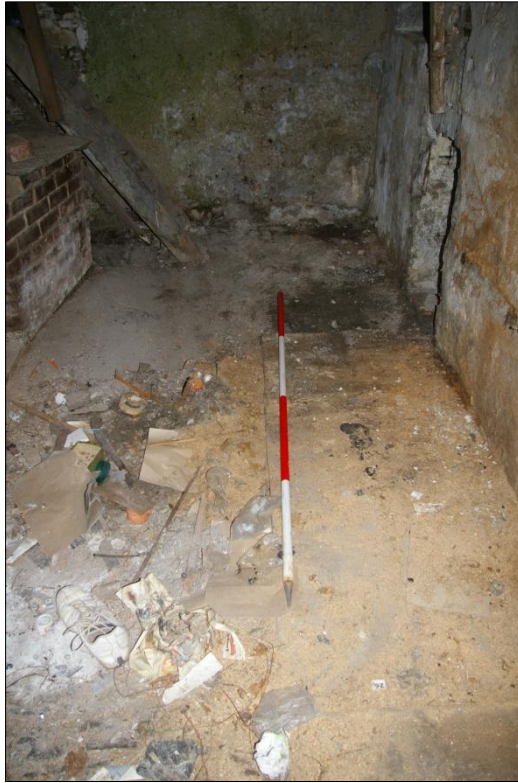
DETAIL OF THE CENTRAL REPAIRED SECTION OF CONCRETE FLOOR, WITH THE EARLIER LIME-CRETE REPAIR TO THE NORTH; VIEWED FROM THE SOUTH (2M SCALE).

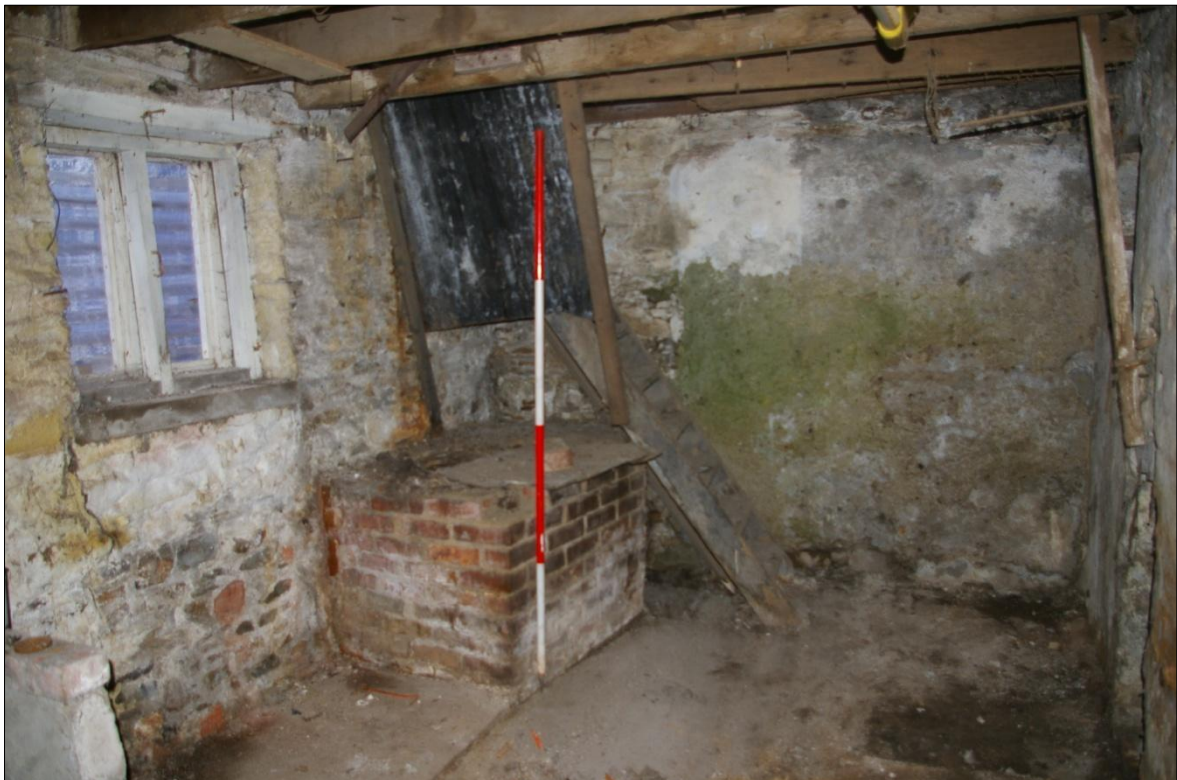
THE BRICK BUILT COPPER IN THE NORTH-WEST CORNER OF THE BARN, WITH WOODEN STAIRS RISING TO THE LOFT ABOVE; VIEWED FROM THE SOUTH-EAST (2M SCALE).

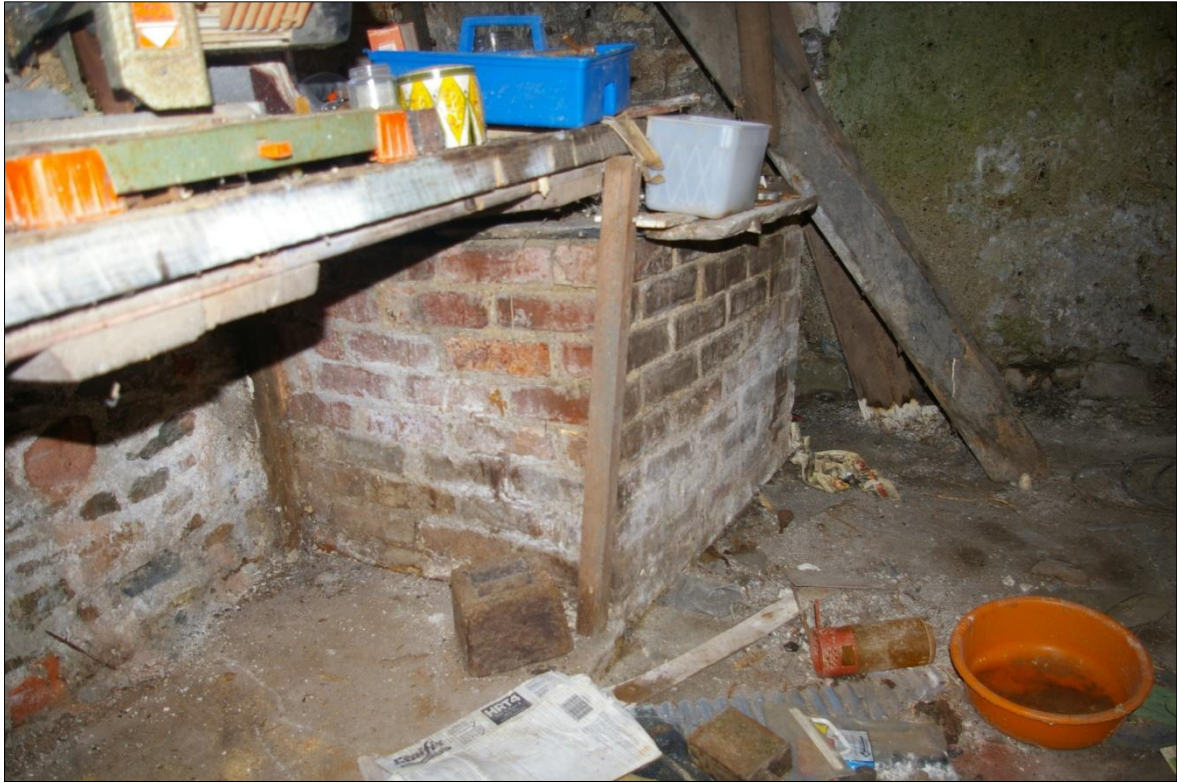
DETAIL OF THE BRICK BUILT COPPER IN THE NORTH-WEST CORNER OF THE BARN; VIEWED FROM THE SOUTH-EAST (NO SCALE).

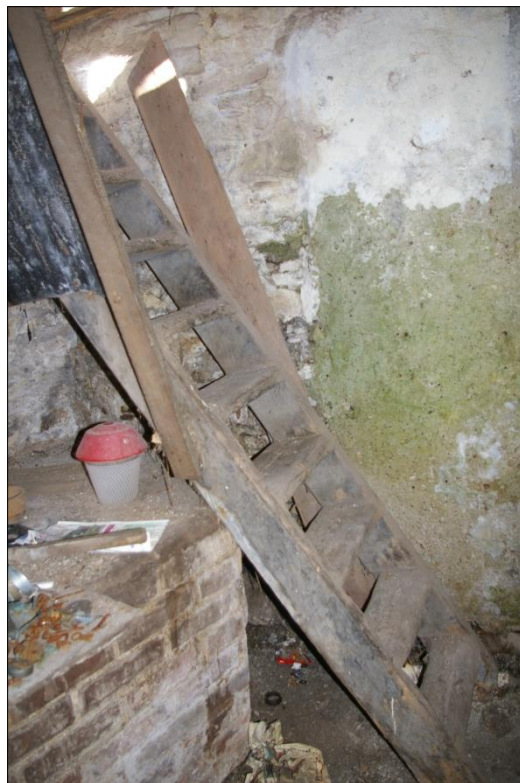
THE TIMBER STEPS IN THE NORTH-WEST CORNER OF THE BARN LEADING TO THE LOFT; VIEWED FROM THE SOUTH-EAST (NO SCALE).

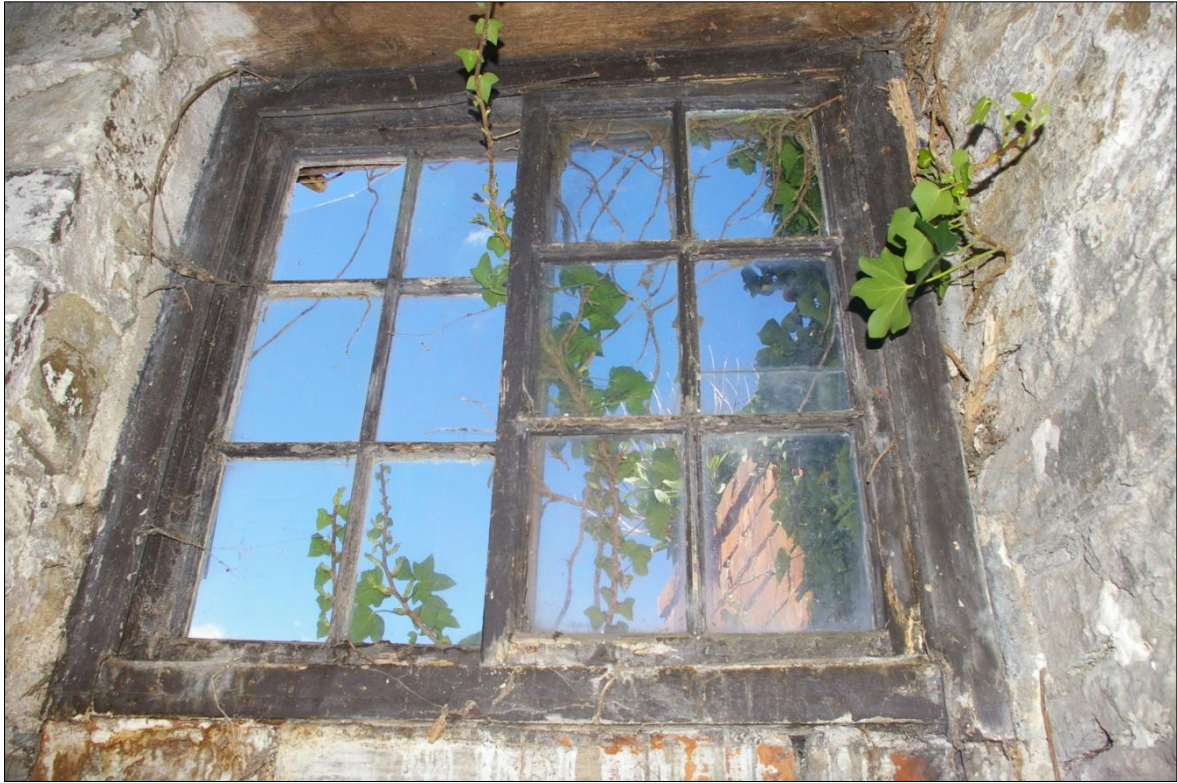
INTERNAL DETAIL OF THE SLIDING SASH WINDOW WITHIN THE BLOCKED LOADING DOOR IN THE WEST WALL OF THE BARN; VIEWED FROM THE EAST (NO SCALE).

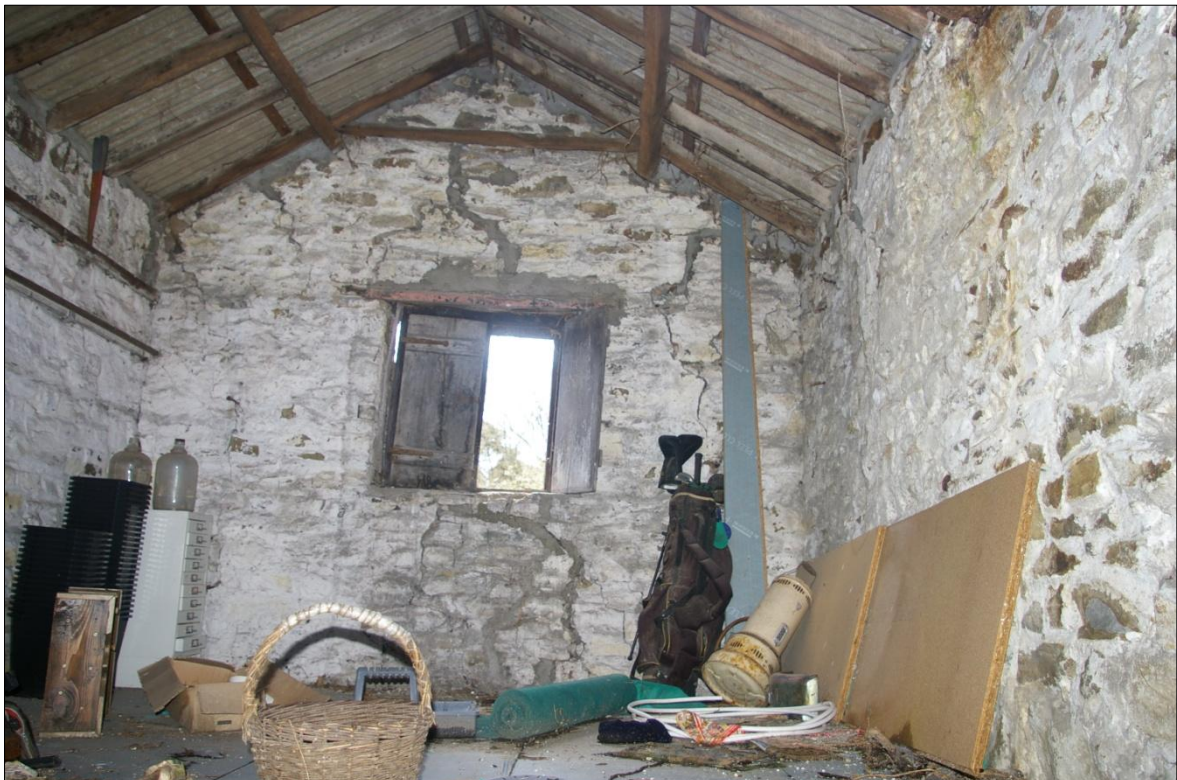
THE LOFT SPACE WITHIN THE BARN, SHOWING THE SURVIVING TIMBER WINDOW WITH PLANK SHUTTERS AND THE WHITEWASHED WALLS; VIEWED FROM THE NORTH (NO SCALE).

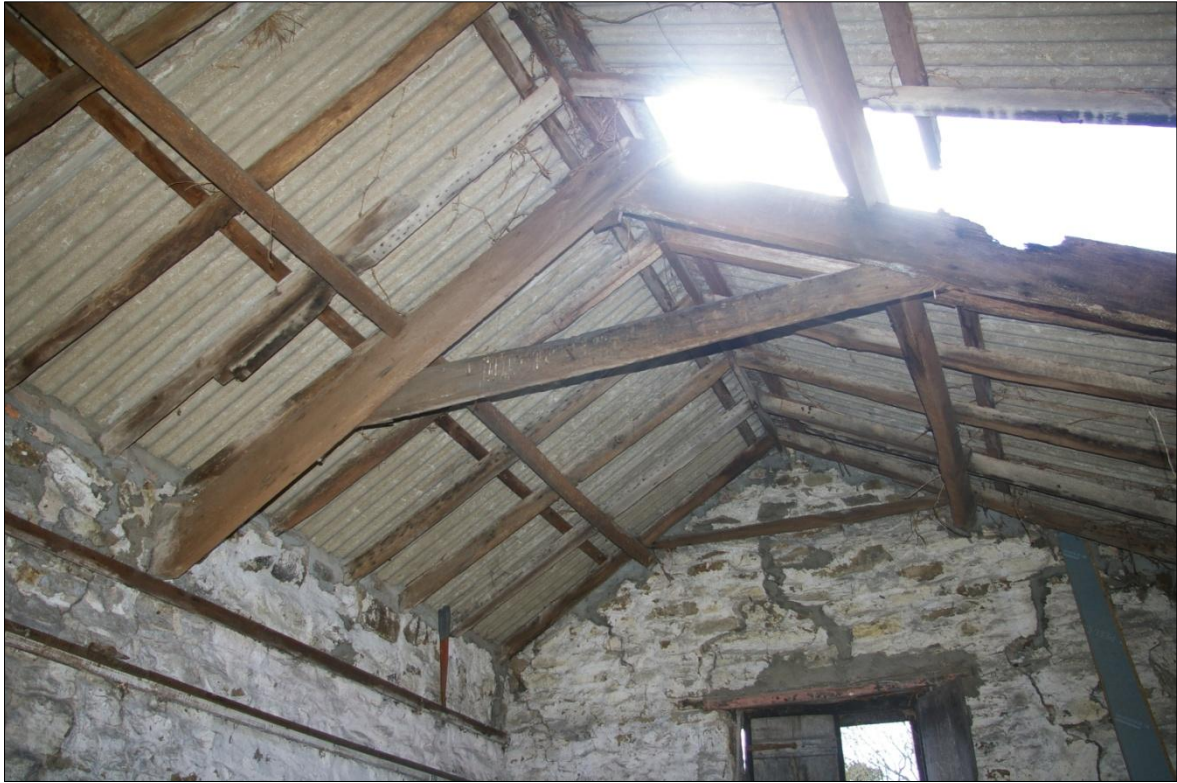
DETAIL OF THE 'A'-FRAME WITHIN THE 20TH CENTURY ROOF STRUCTURE OF THE BARN; VIEWED FROM THE NORTH-WEST (NO SCALE).

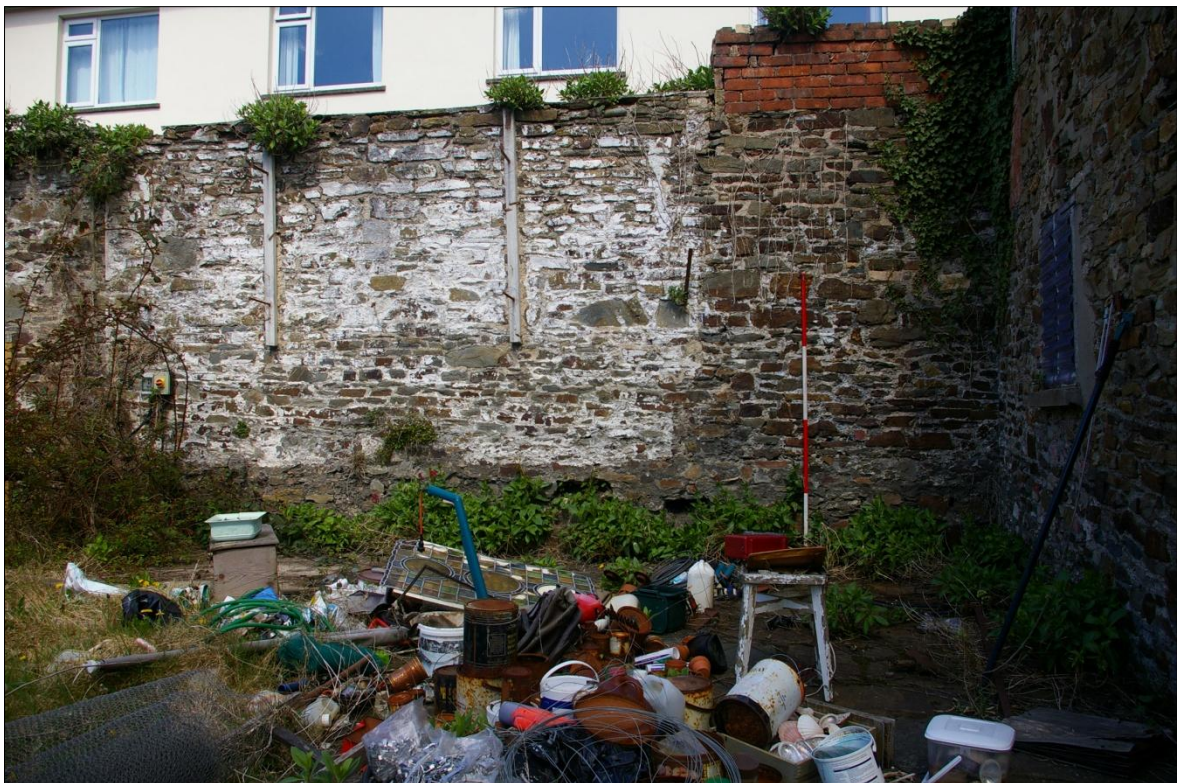
THE PLOT WALL TO THE NORTH OF THE SITE; VIEWED FROM THE SOUTH-SOUTH-EAST (2M SCALE).

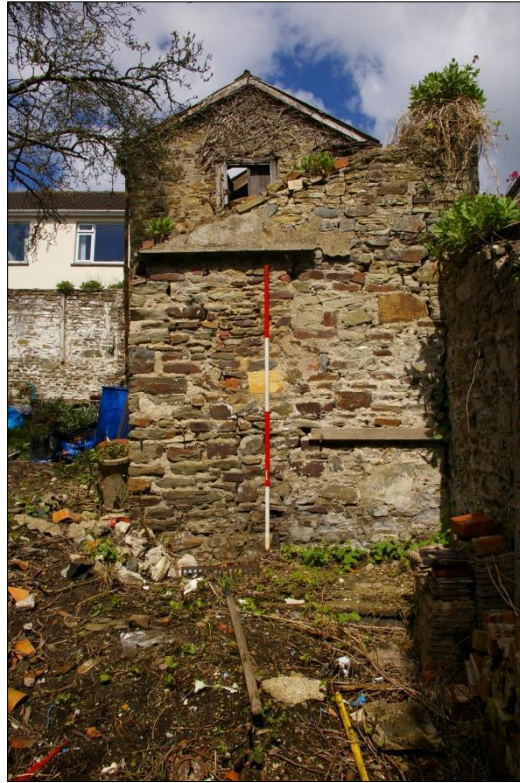
SOUTH ELEVATION OF THE OUTBUILDING, SHOWING DETAIL OF REMAINS OF A POSSIBLE TEMPORARY STRUCTURE; VIEWED FROM THE SOUTH (2M SCALE).

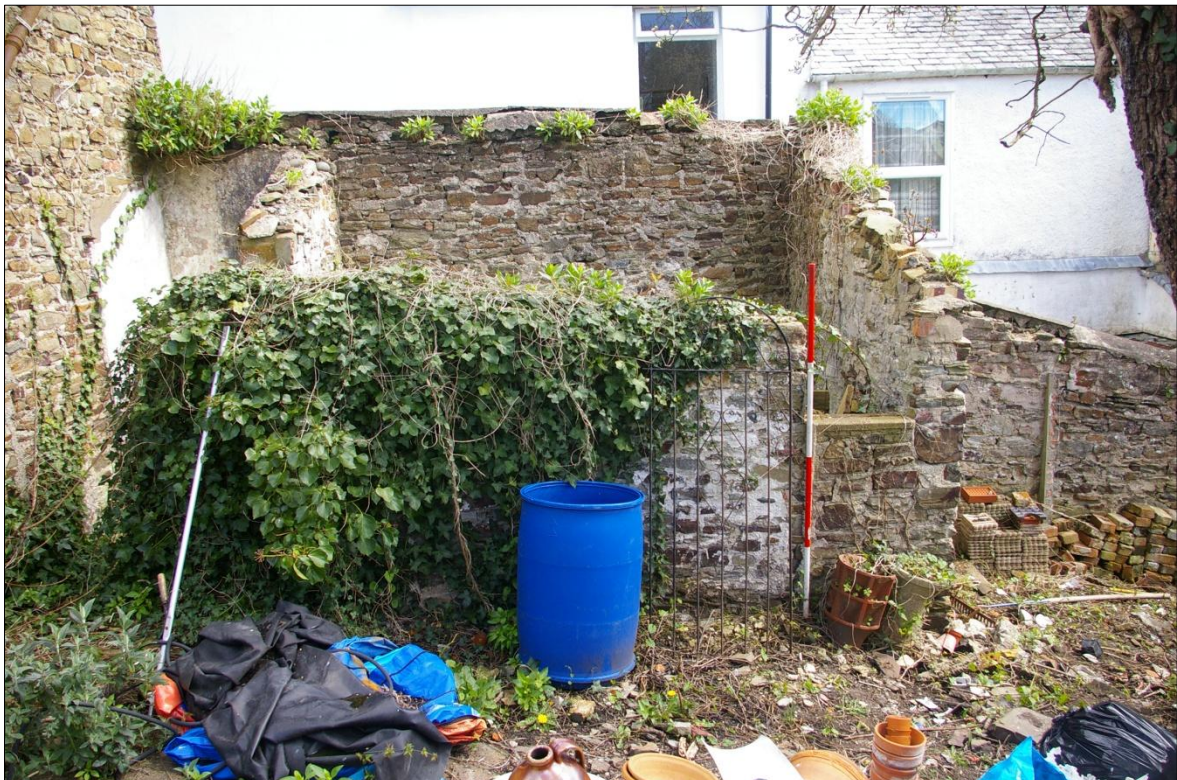
WEST ELEVATION OF THE OUTBUILDING; VIEWED FROM THE WEST (2M SCALE).

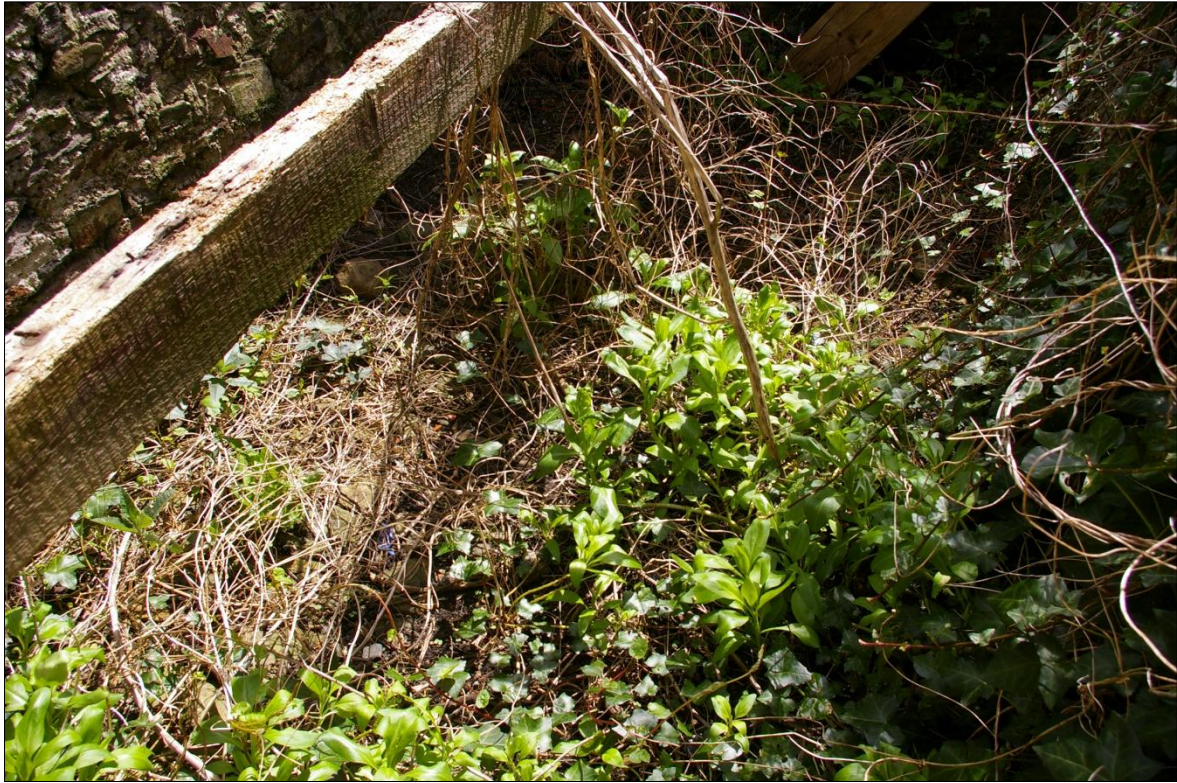
DETAIL OF THE INTERIOR OF THE OUTBUILDING, SHOWING THE TIMBER FITMENTS AND COBBLED FLOOR; VIEWED FROM THE NORTH-WEST (NO SCALE).

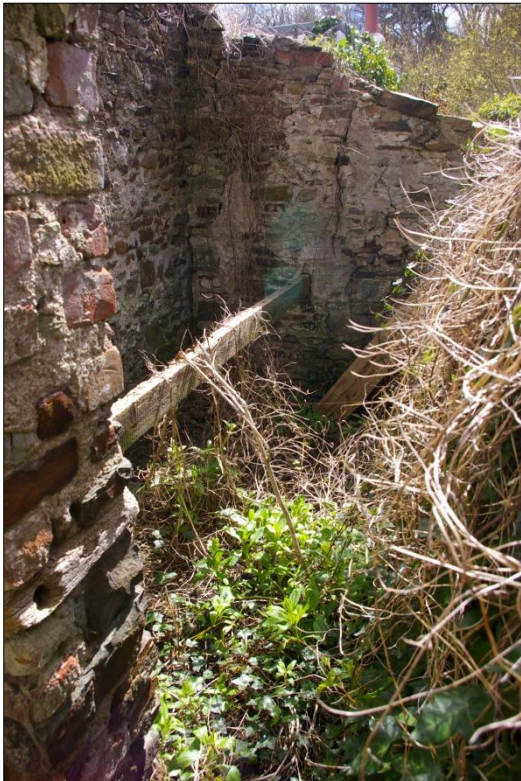
(LEFT) INTERIOR OF THE OUTBUILDING, SHOWING TIMBER FITMENTS FROM THE USE OF THE SITE AS A PLANT NURSERY; VIEWED FROM THE NORTH-WEST (NO SCALE).

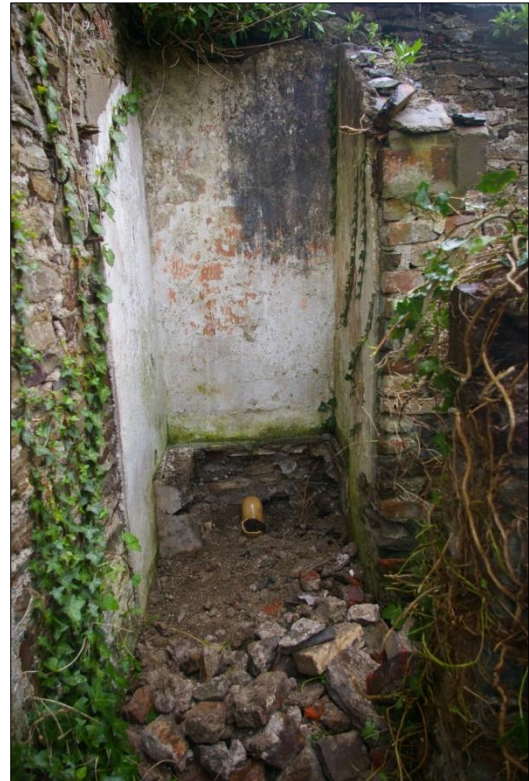
(RIGHT) THE INTERNAL VIEW OF THE OUTSIDE TOILET FORMED BETWEEN THE BARN AND THE OUTBUILDING; VIEWED FROM THE WEST (NO SCALE).

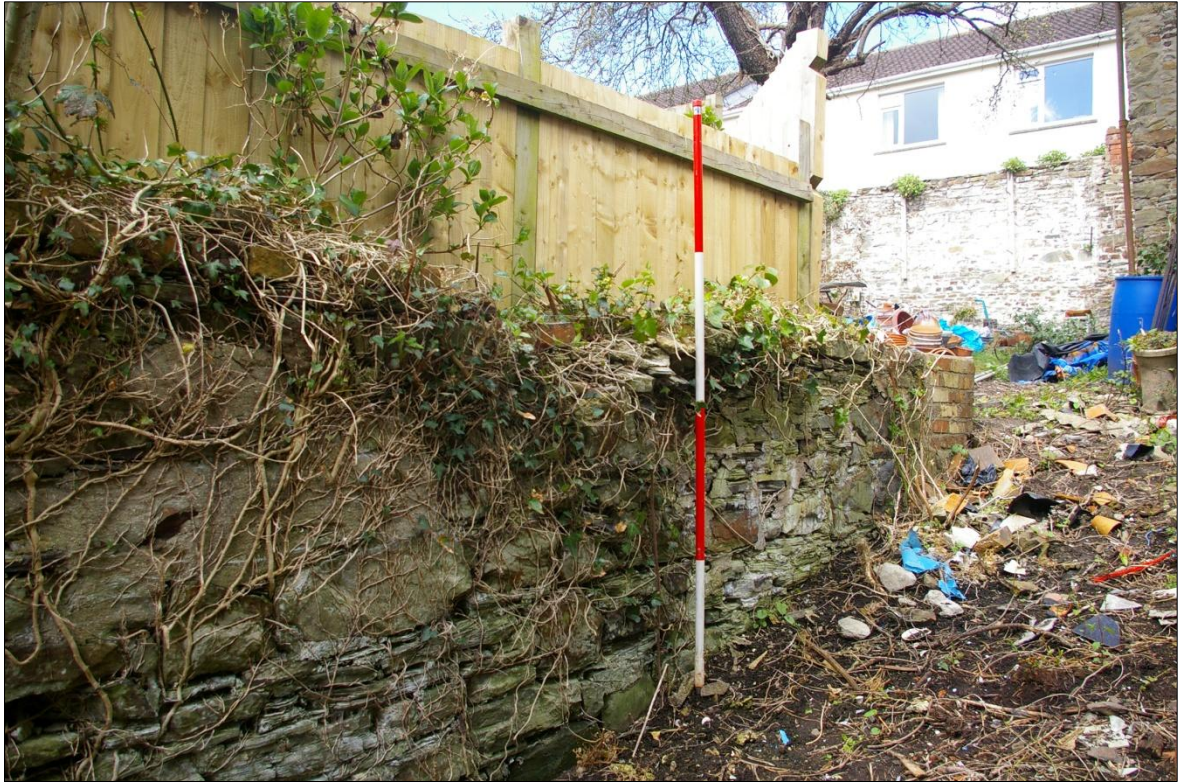
THE LARGE SLATE-STONE WALL TO THE SOUTH-WEST OF THE DEVELOPMENT SITE, FORMING A RETAINING WALL TO THE LEVEL LAWN AREA; VIEWED FROM THE SOUTH-EAST (2M SCALE).

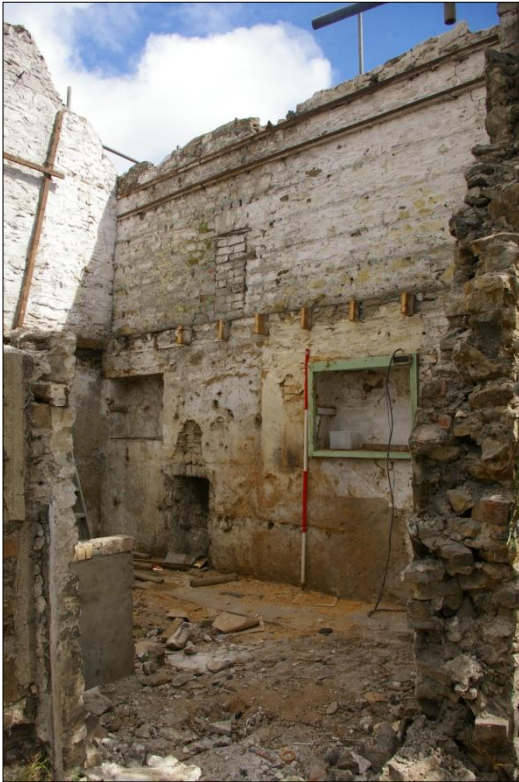
(LEFT) THE INTERNAL FACE OF THE EAST WALL OF THE BARN, FOLLOWING REMOVAL OF THE ROOF, INTERNAL FITTINGS AND PARTIAL DEMOLITION OF THE SOUTH AND WEST WALLS; VIEWED FROM THE SOUTH-WEST (2M SCALE).

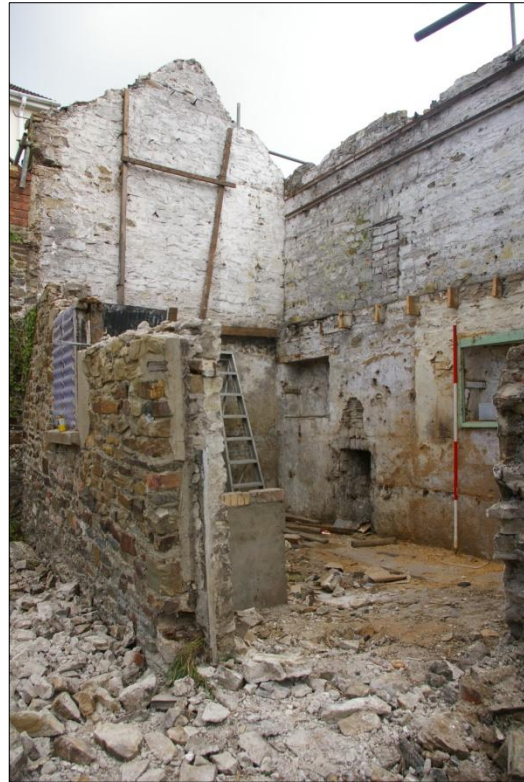
(RIGHT) THE INTERNAL FACE OF THE NORTH AND EAST WALLS OF THE BARN FOLLOWING PARTIAL DEMOLITION; VIEWED FROM THE SOUTH-WEST (2M SCALE).

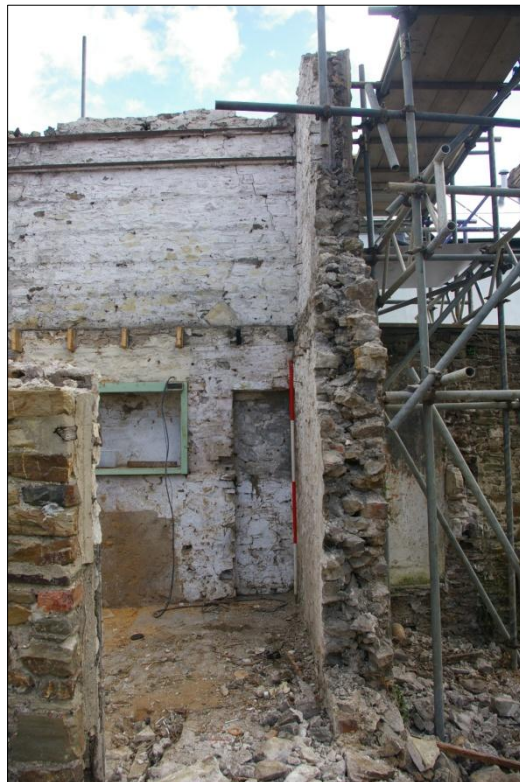
DETAIL OF THE PHASING OF THE BARN STRUCTURE, SHOWING THE SOUTH WALL OBSTRUCTING THE EARLIER BLOCKED DOORWAY IN THE EAST WALL; VIEWED FROM THE WEST (2M SCALE).

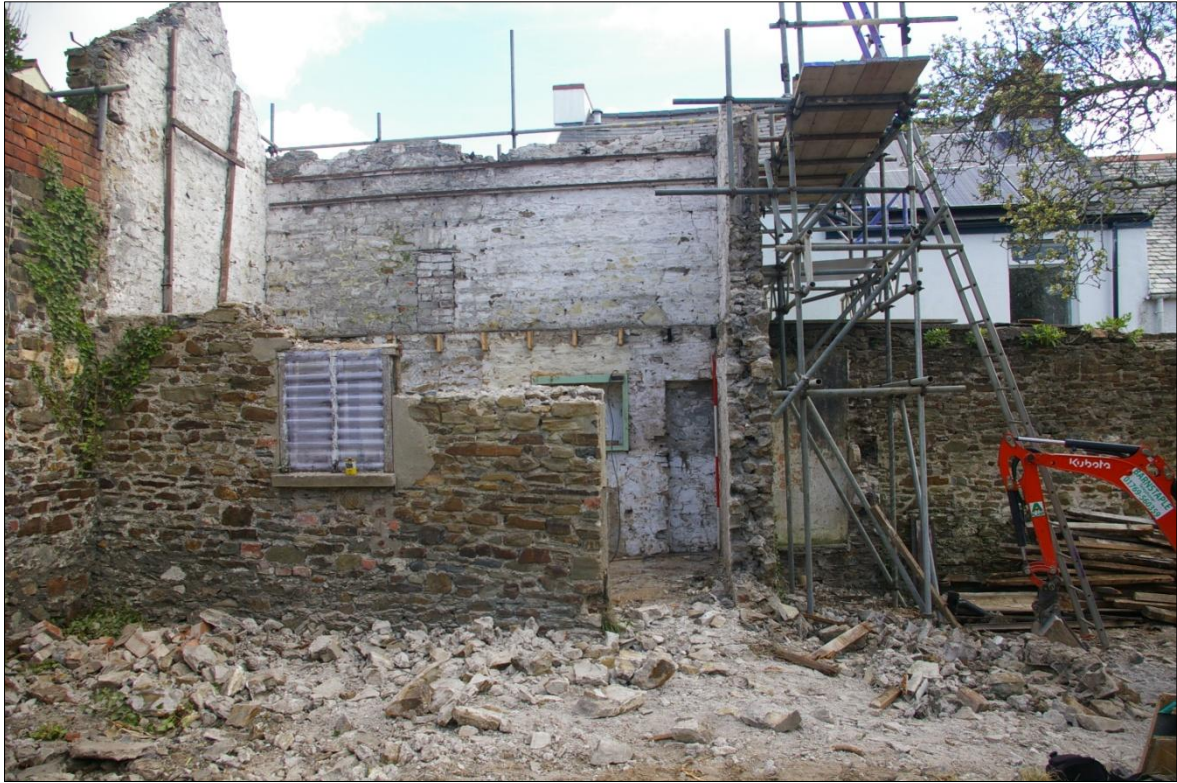
THE BARN STRUCTURE FOLLOWING PARTIAL DEMOLITION OF THE SOUTH AND WEST WALLS; VIEWED FROM THE WEST (2M SCALE).

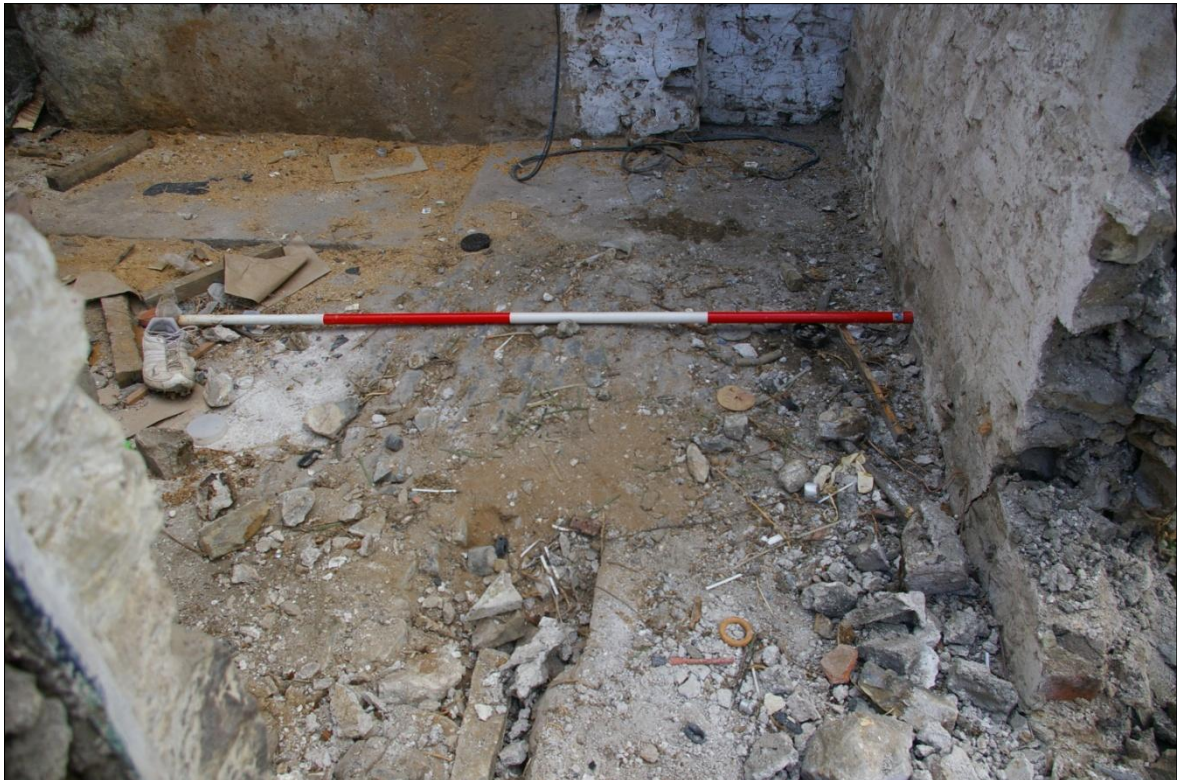
THE COBBLED FLOOR AT THE SOUTHERN END OF THE BARN BUILDING; VIEWED FROM THE WEST (2M SCALE).

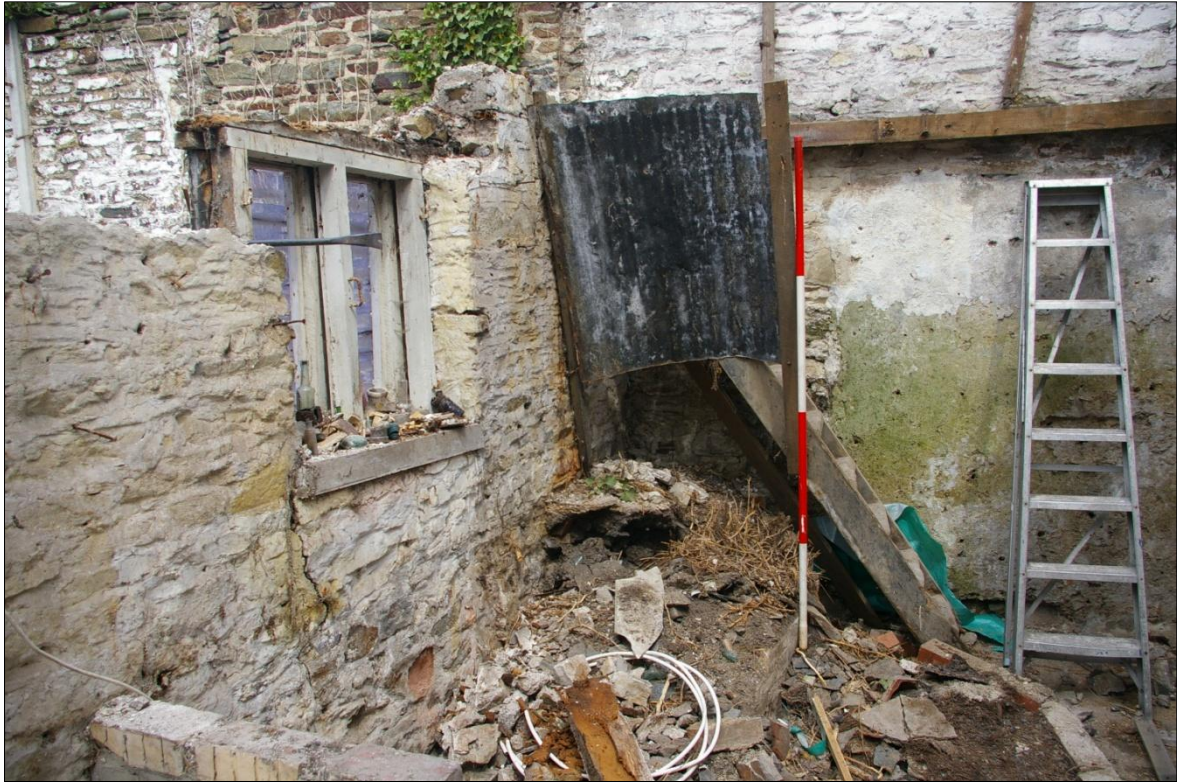
DETAIL FOLLOWING THE REMOVAL OF THE BRICK COPPER, SHOWING ITS EXTENSIVE BACK-FILLING WITH 19TH CENTURY RUBBISH; VIEWED FROM THE SOUTH (2M SCALE).

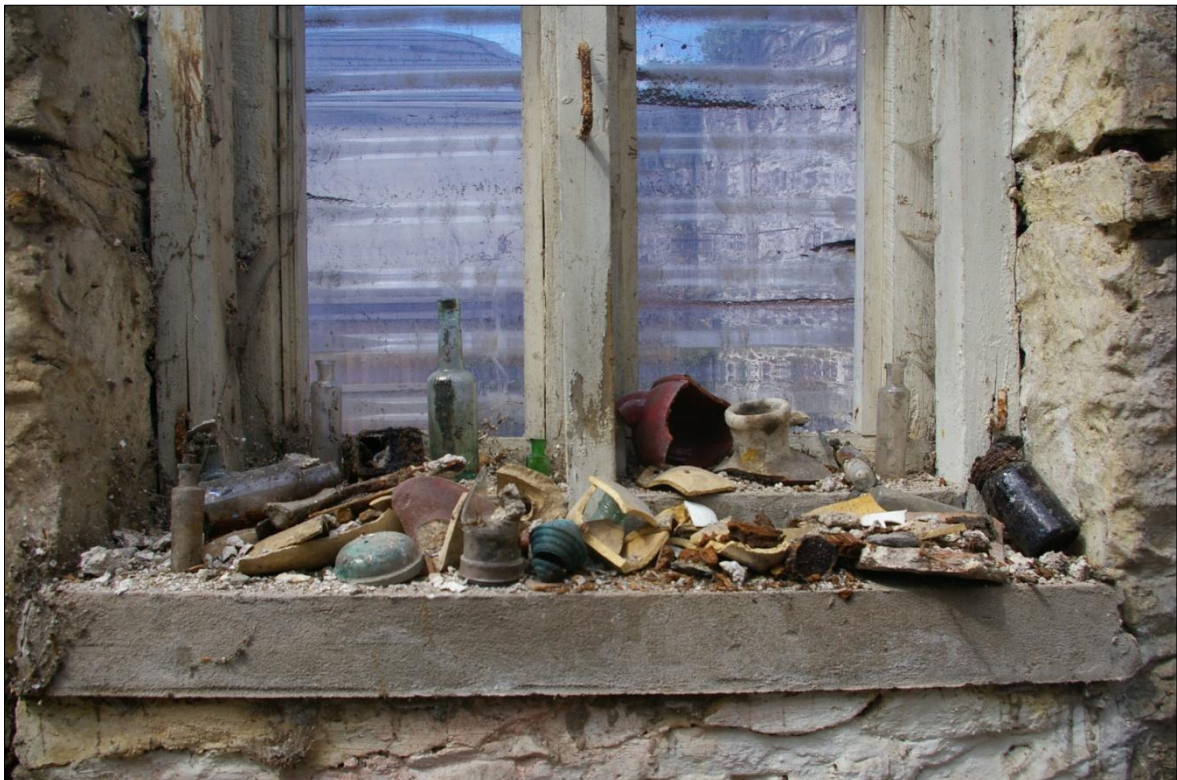
A SAMPLE OF THE 19TH CENTURY STONEWARE POTTERY AND GLASS BOTTLES RECOVERED FROM THE BACK-FILLED COPPER STRUCTURE; VIEWED FROM THE EAST (2M SCALE).

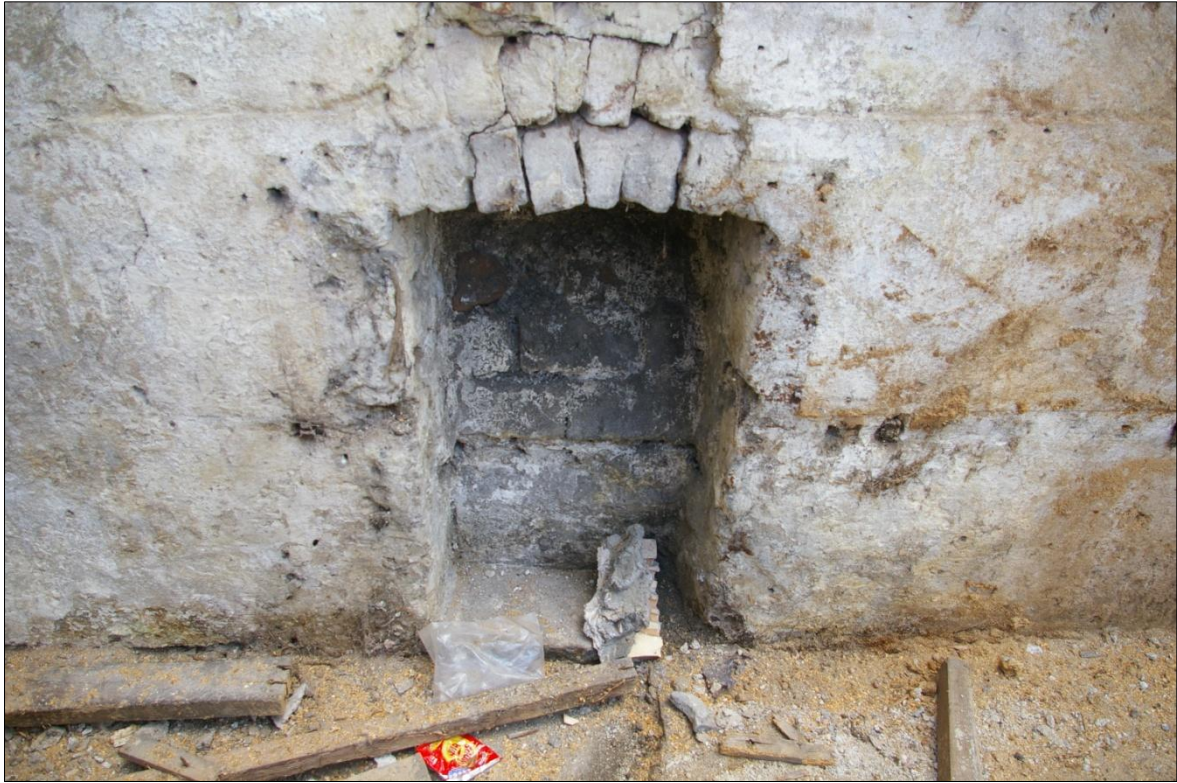
DETAIL OF THE GROUND FLOOR FIREPLACE WITHIN THE EAST WALL OF THE BARN STRUCTURE; VIEWED FROM THE WEST (NO SCALE).

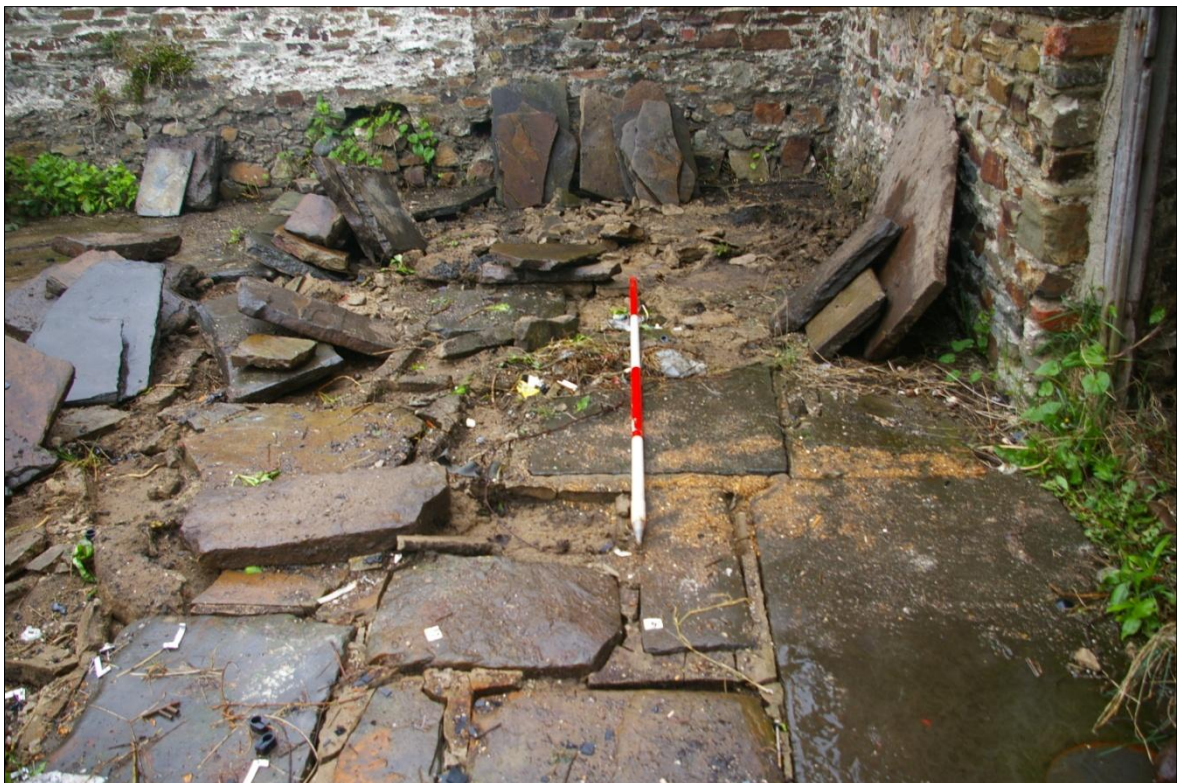
THE PATIO AREA TO THE WEST OF THE BARN DURING EXCAVATION, SHOWING THE SAND BEDDING LAYER BENEATH; VIEWED FROM THE SOUTH (2M SCALE).

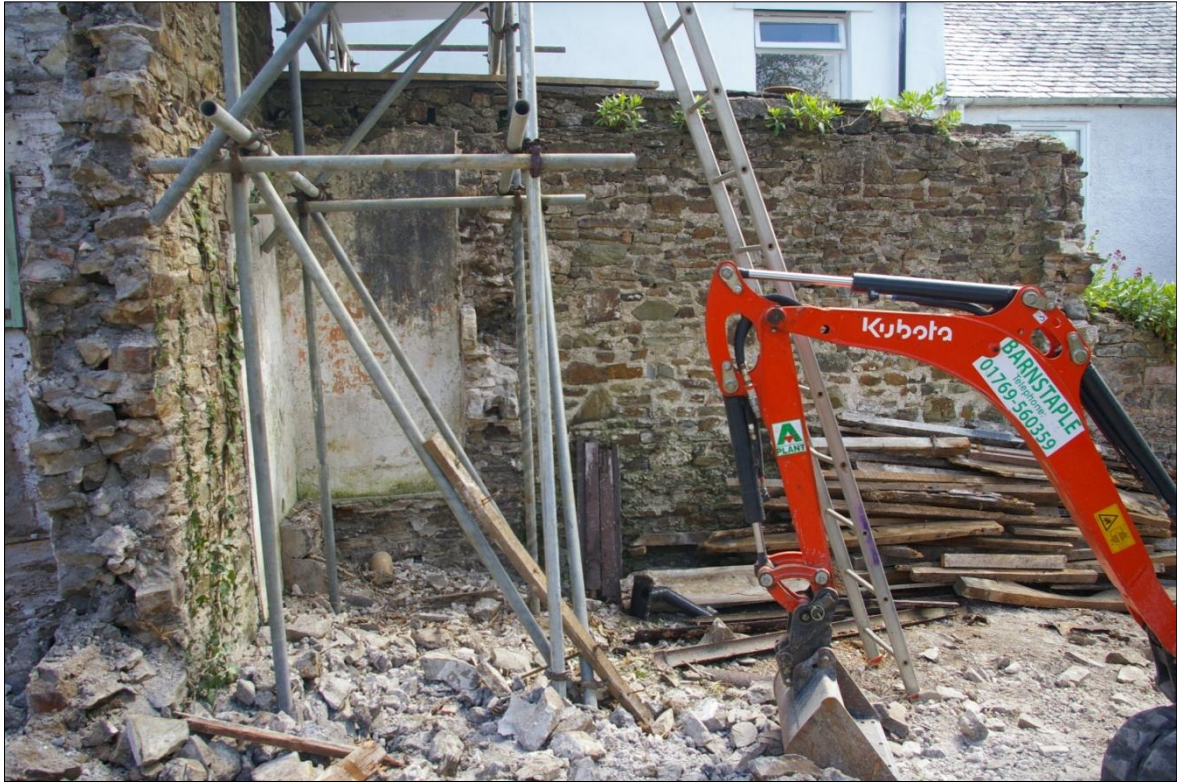
THE OUTSIDE TOILET BETWEEN THE BARN AND THE (NOW DEMOLISHED) OUTBUILDING; VIEWED FROM THE WEST (NO SCALE).

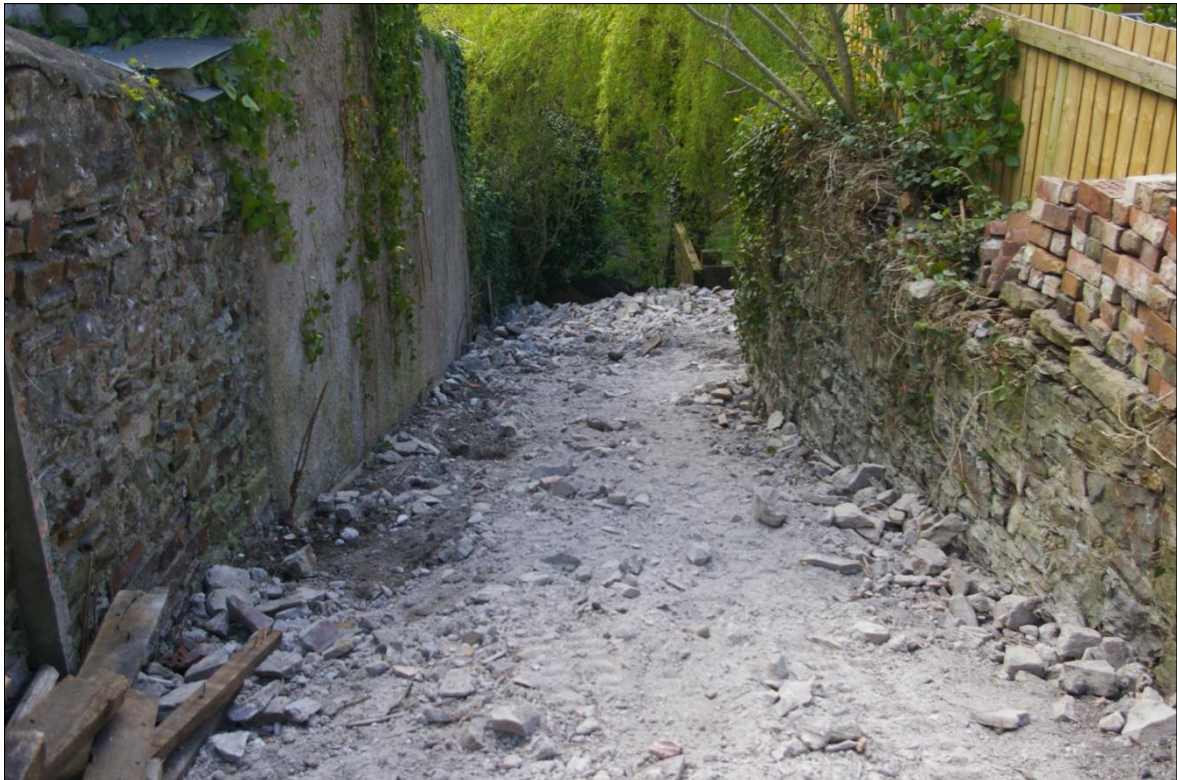
To the south-west of the small outbuilding is an 'L' shaped section of wall, the eastern portion on a north-south alignment; the southern on an east-west alignment. It currently acts as a retaining wall, supporting the built-up area to the west which forms a level lawn at the top of the steep south-facing slope. The wall is of coursed large squared mud-stone blocks and densely packed poor quality shale, with a clay/lime bond. The northern end has been repaired or replaced by a section of brickwork, whilst there is evidence of the corner being of dressed blocks. The western run of the wall has been increasingly repaired and heavily patched towards the west, this end having been demolished to allow a driveway to access the wooded garden area to the south. This wall may form an earlier building or plot wall, reflecting early site terracing/levelling.

VIEW TO THE SOUTH OF THE SITE, BETWEEN THE EASTERN PLOT WALL AND THE POSSIBLE PLOT DIVISION ACTING AS A RETAINING WALL TO THE LAWN AREA TO THE WEST; VIEWED FROM THE NORTH (NO SCALE).
