**121 BOUTPORT STREET
BARNSTAPLE
NORTH DEVON
DEVON**

Results of a Historic Building Assessment

South West Archaeology Ltd. report no. 160204

By C. Humphreys & B. Whitlock
Report Version 01
03 February 2016

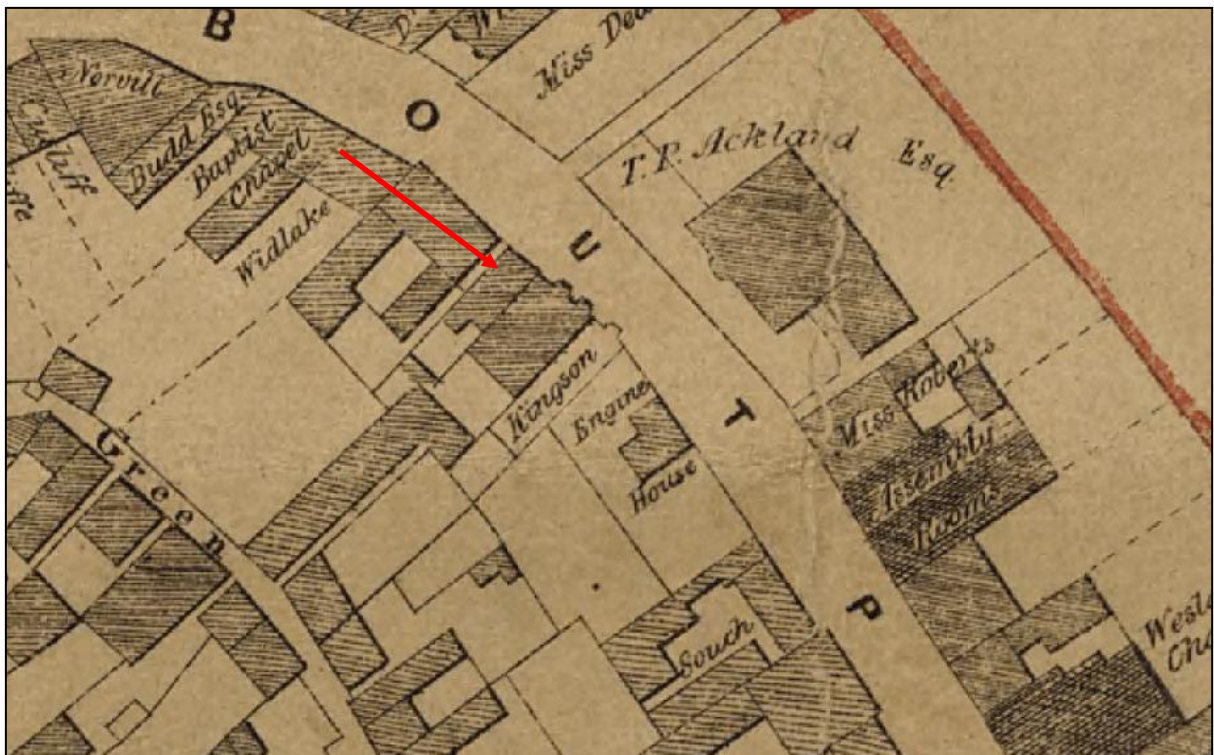
Figure 2: Extract from the 1843 Barnstaple Town Plan.

The Barnstaple Town Plan of 1843 shows a building in the location of the present 121 Boutport Street with a small yard to the rear. To the west and adjacent to the building there appears to be a passage giving access to the yards behind 122.

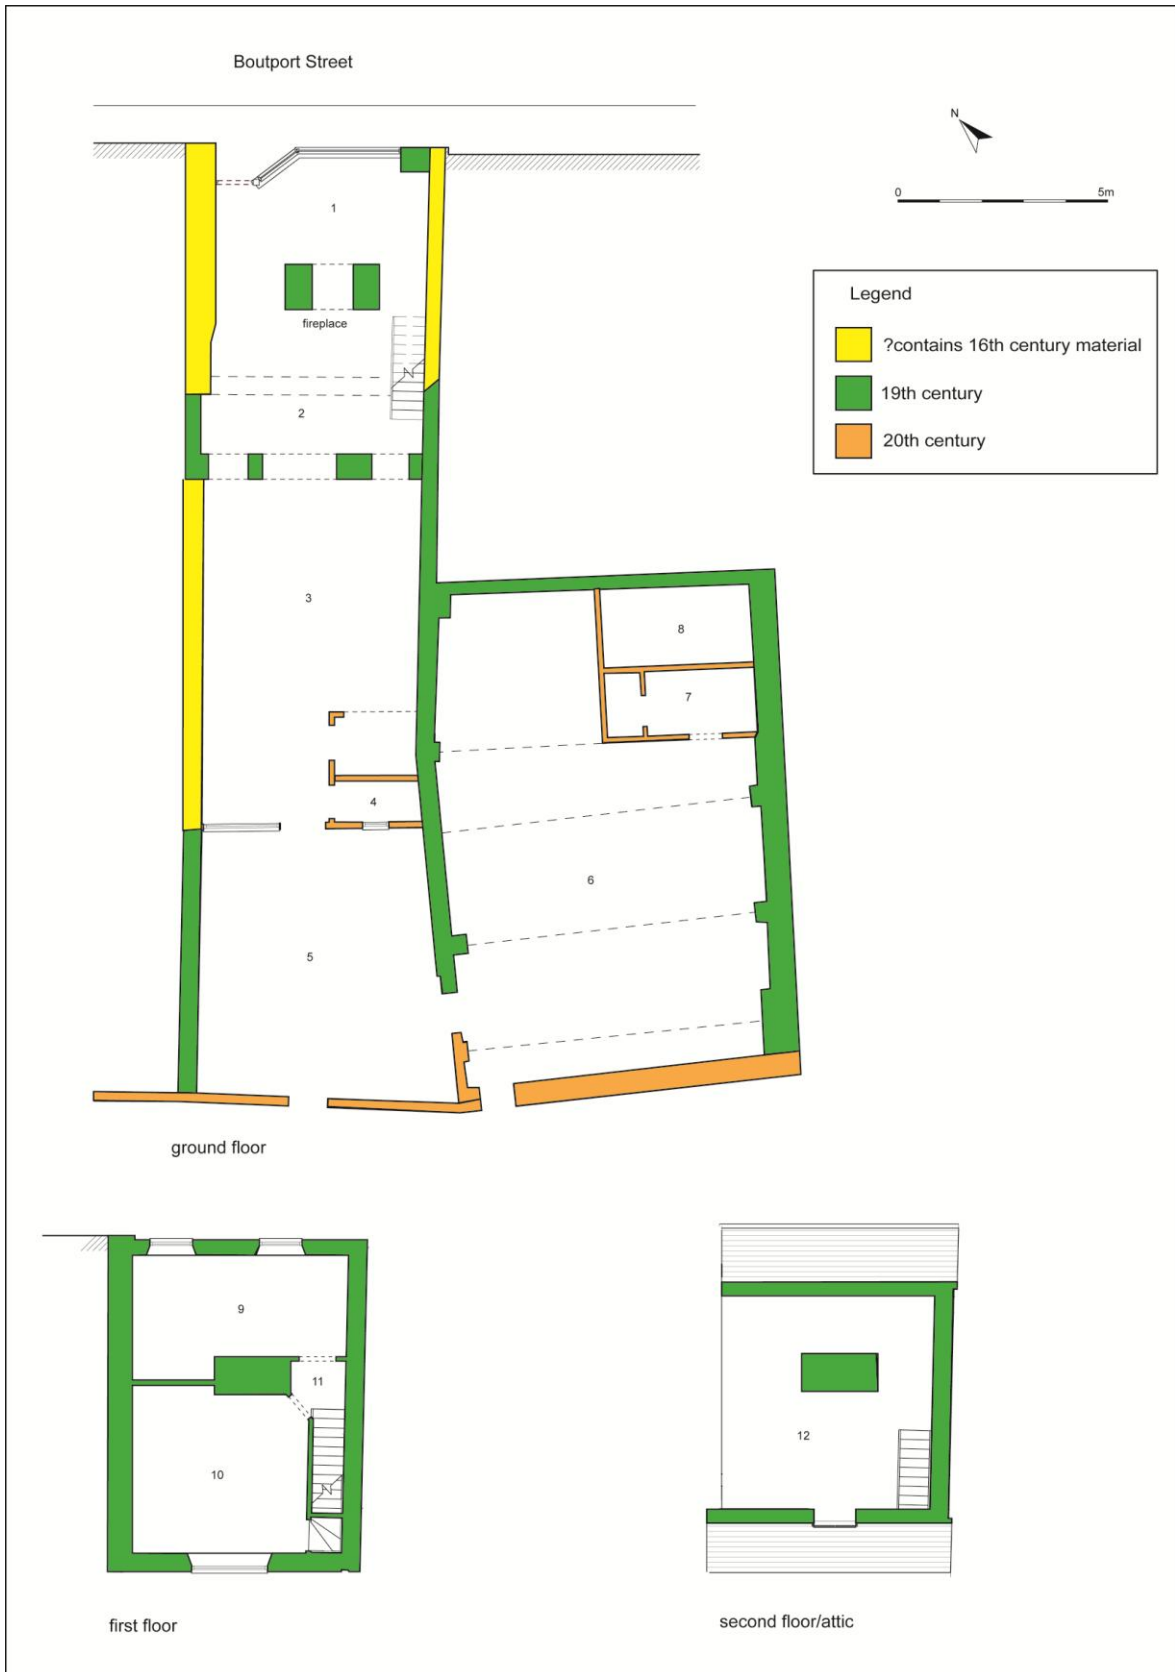
Figure 7: Phased plan showing room numbers.

The building underwent a thorough makeover in the mid 19th century. The front wall is rebuilt with a shop front and the rear wall is rebuilt outside the earlier line. A brick chimney stack is inserted towards the centre of the new building and the roof height is raised using a new pine structure. This allowed the attic to be used for further accommodation that is accessed from the first floor by a narrow stair. Only the rooms on the ground and first floor were heated.

An extension is added to the rear of the building replacing the structure shown on the early maps of which no details are apparent in the extant structure. The rear yards are covered and during the construction of the Green Lanes Shopping Centre in the 1980s the rear wall of the yard is removed and replaced with modern brick.

All partitions are removed on the ground floor and the stair is replaced. The base of the chimney stack is almost completely removed and the first floor fireplace openings are blocked.

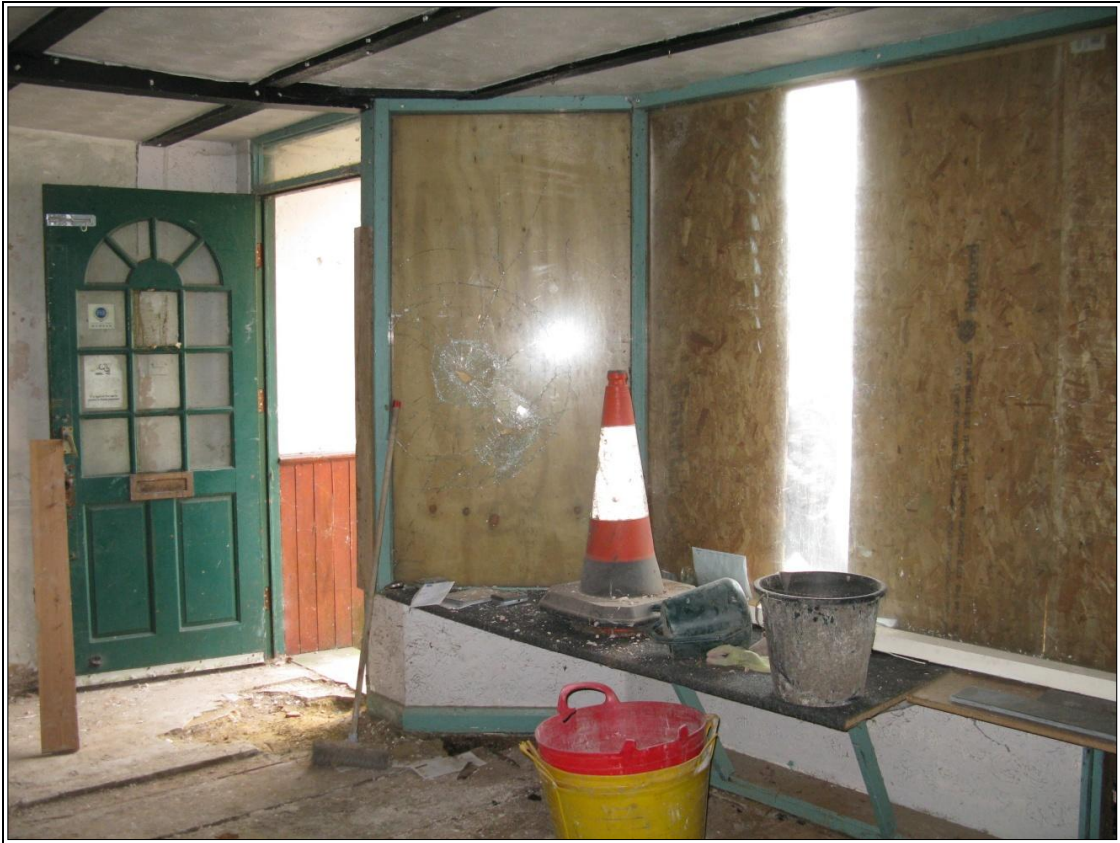
Figure 8: Rear of shop window.

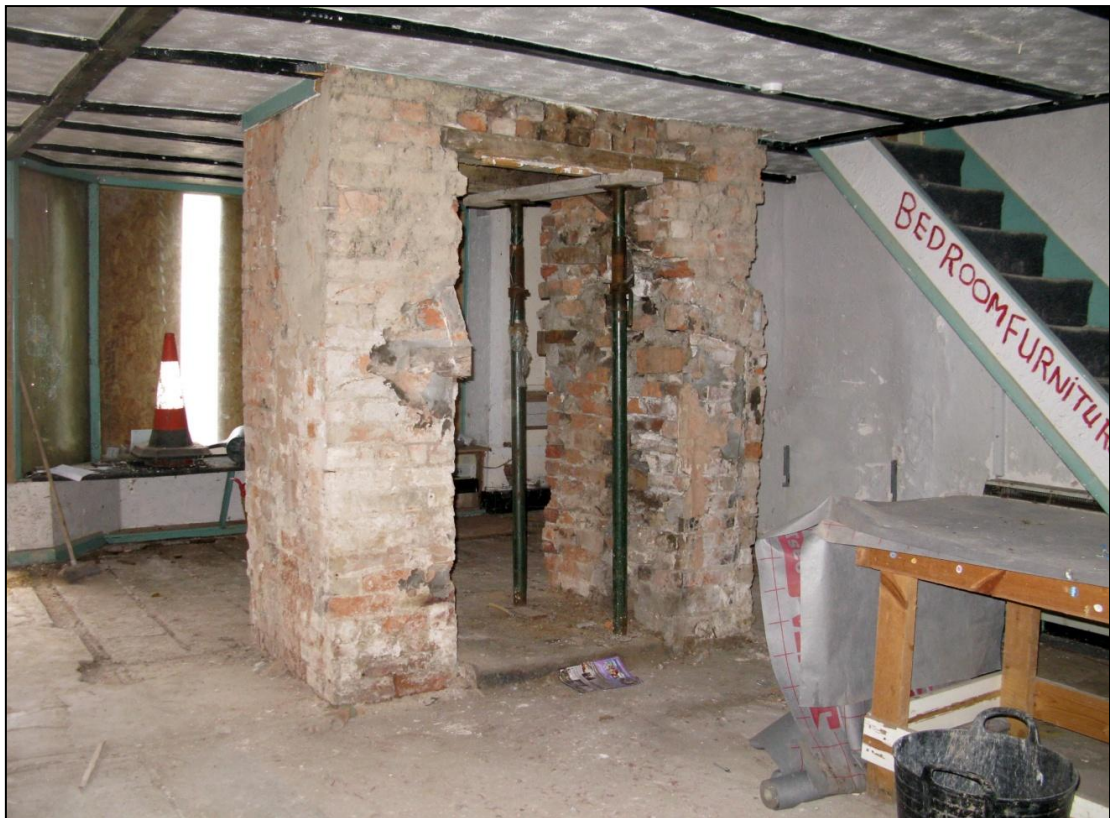
Figure 9: Rooms 1 & 2 showing partially dismantled stack.

The brick chimney stack that rises between Rooms 1 and 2 is of 19th century date. The building appears to have had fireplaces to heat Rooms 1 and 2 on the ground and Rooms 9 and 10 on the first floor. All historic fireplaces have been removed. The fireplace openings on the ground floor would have both had segmental brick arches; in both cases these and the timber lintels have been mostly removed causing the structure to become unsound. The east side of the fireplace has been reduced, possibly due to the removal of a partition wall between Rooms 1 and 2. The fireplace openings on the first floor have been blocked and there are no openings on the second floor.

The removal of the fireplaces and the lower part of the chimney stack; the cutting through and removal of the segmental arches and lintels, has allowed this structure to become unstable. The remaining structure has very little architectural merit and with the removal of the ground floor partitions has lost most of its original context.

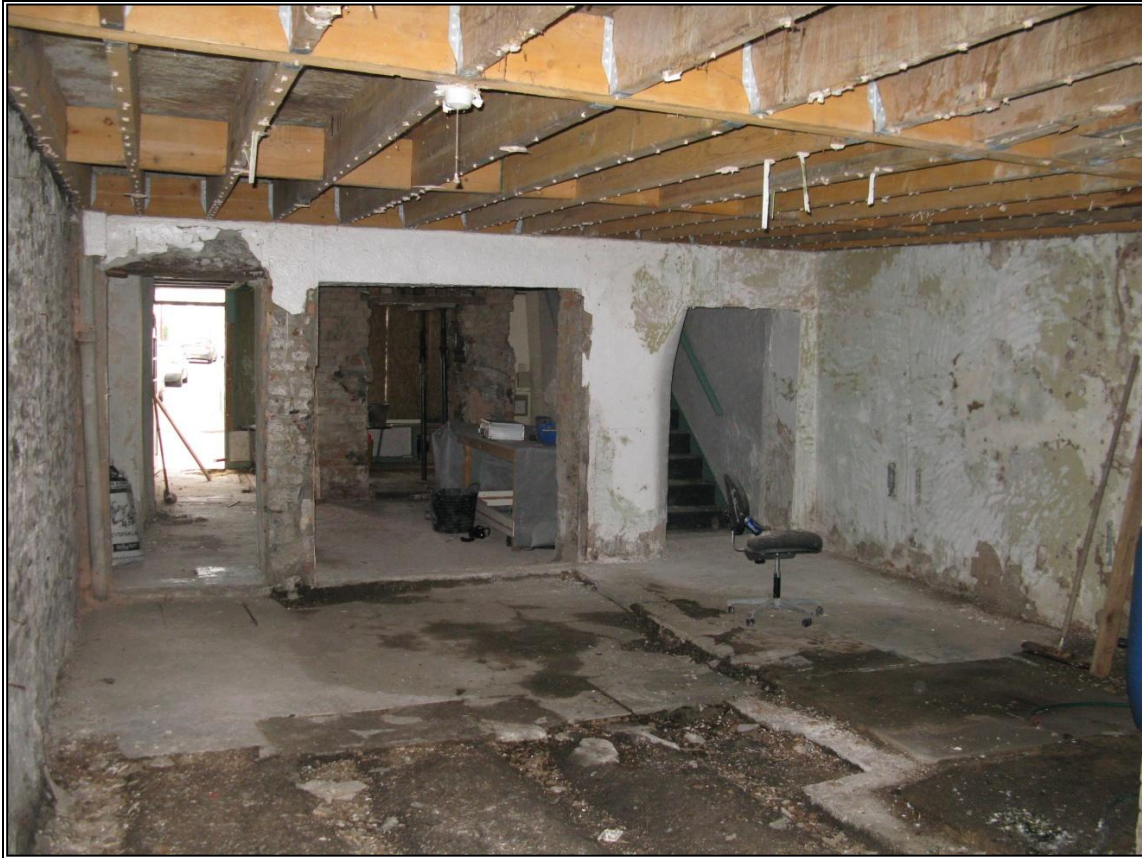
Figure 10: Room 3 from the south.

Most of the ground floor has concrete or other modern floors except an area of slate towards the centre of the rear extension (Room 3). The first floor has random width pine boards of 19th century date in the stair lobby (Room 11) and in Room 9. The other boards are of modern 6 inch pine.

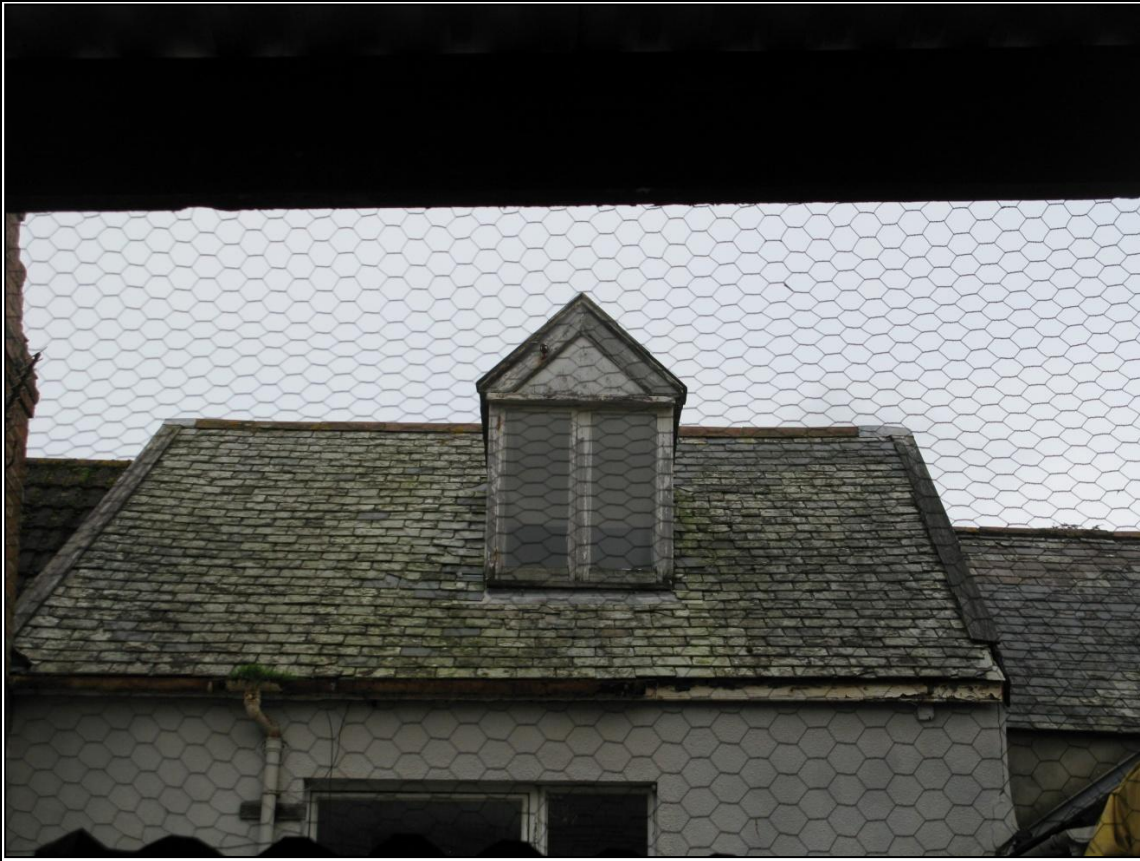
Figure 12: Rear elevation.

The ground floor of the rear elevation is enclosed by later extensions, has three openings and appears to be mostly of brick construction. The first floor has a single metal casement window set in painted pebble dash walls. The roof is of slate and has a single, slightly offset, gabled dormer with glazed sides.

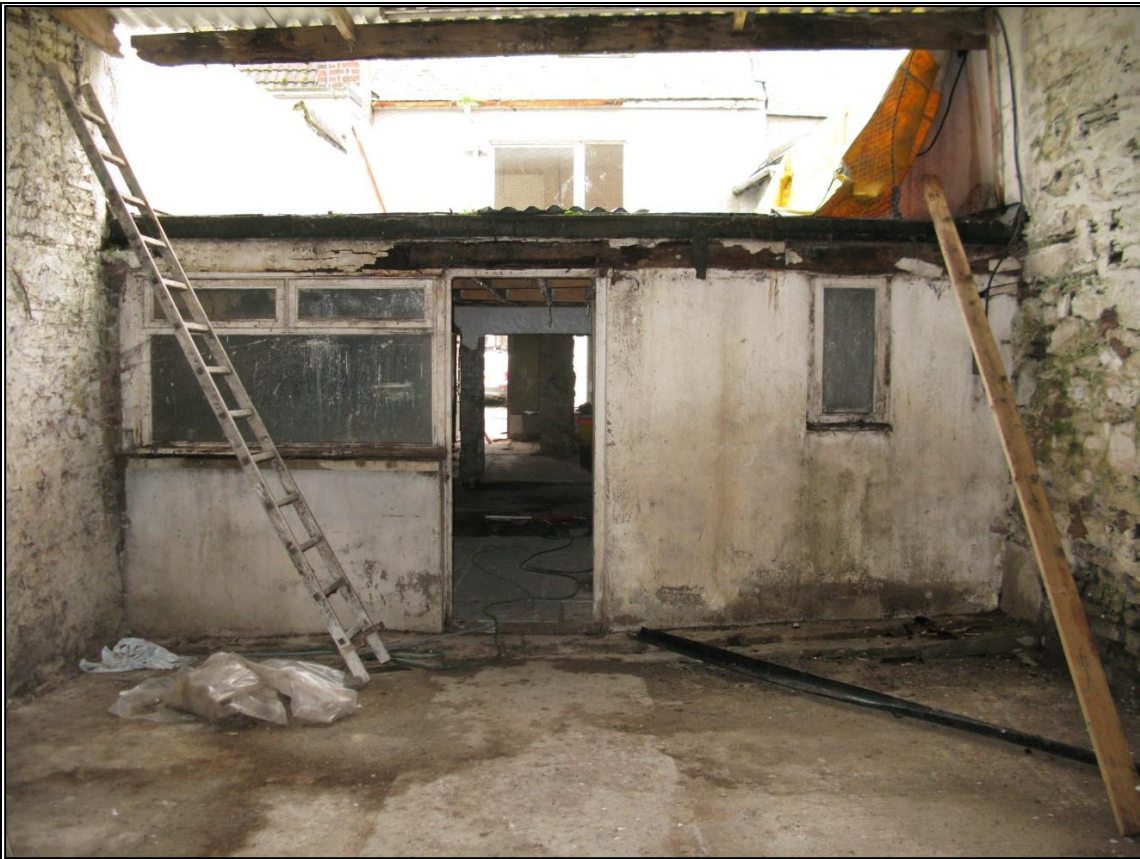
Figure 13: Elevation of rear extension.

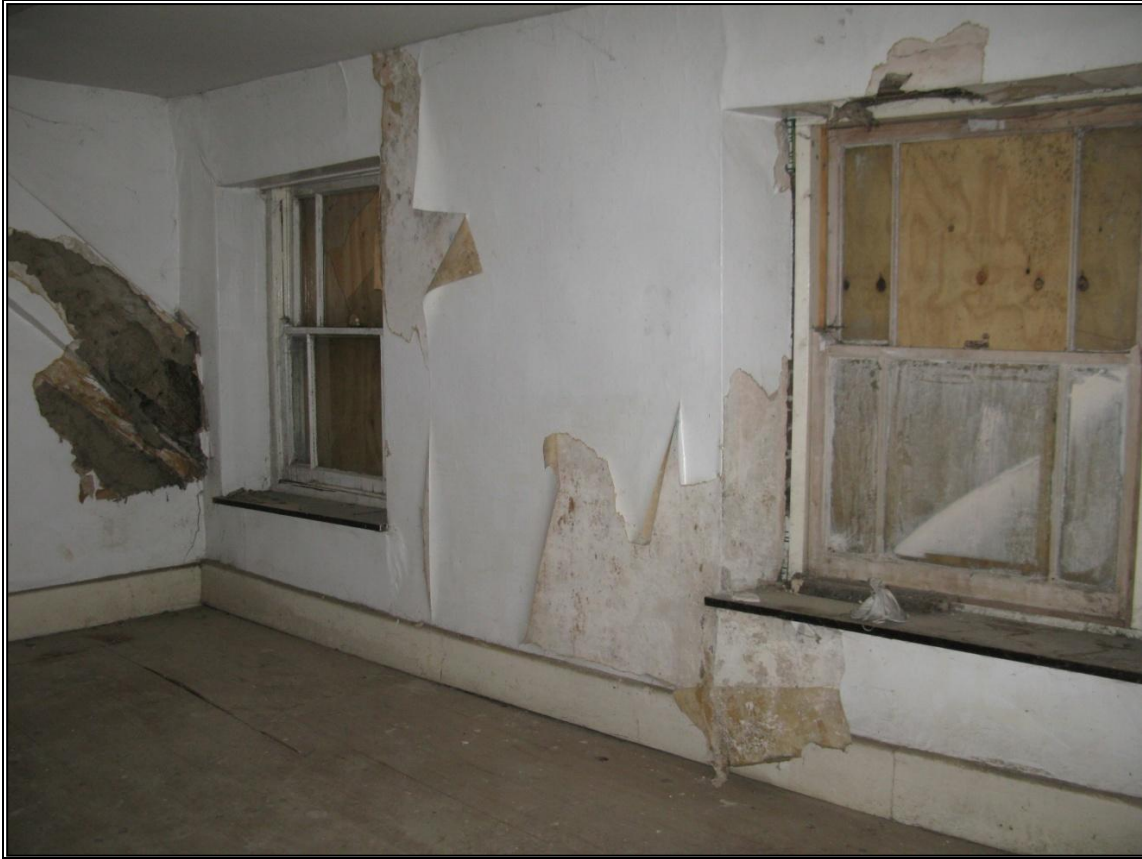
The most interesting feature of the building is the 16th century roof truss embedded in the wall between this building and 122 Boutport Street, the apex of which is approximately 1.5m below the current ridge. The feet of this truss can be seen meeting the front wall in Room 9 and approximately a metre from the rear wall of Room 10, where it meets a straight join. This clearly demonstrates the rebuild of the rear wall.

Figure 14: First floor sash windows and foot of early roof truss in the west wall.

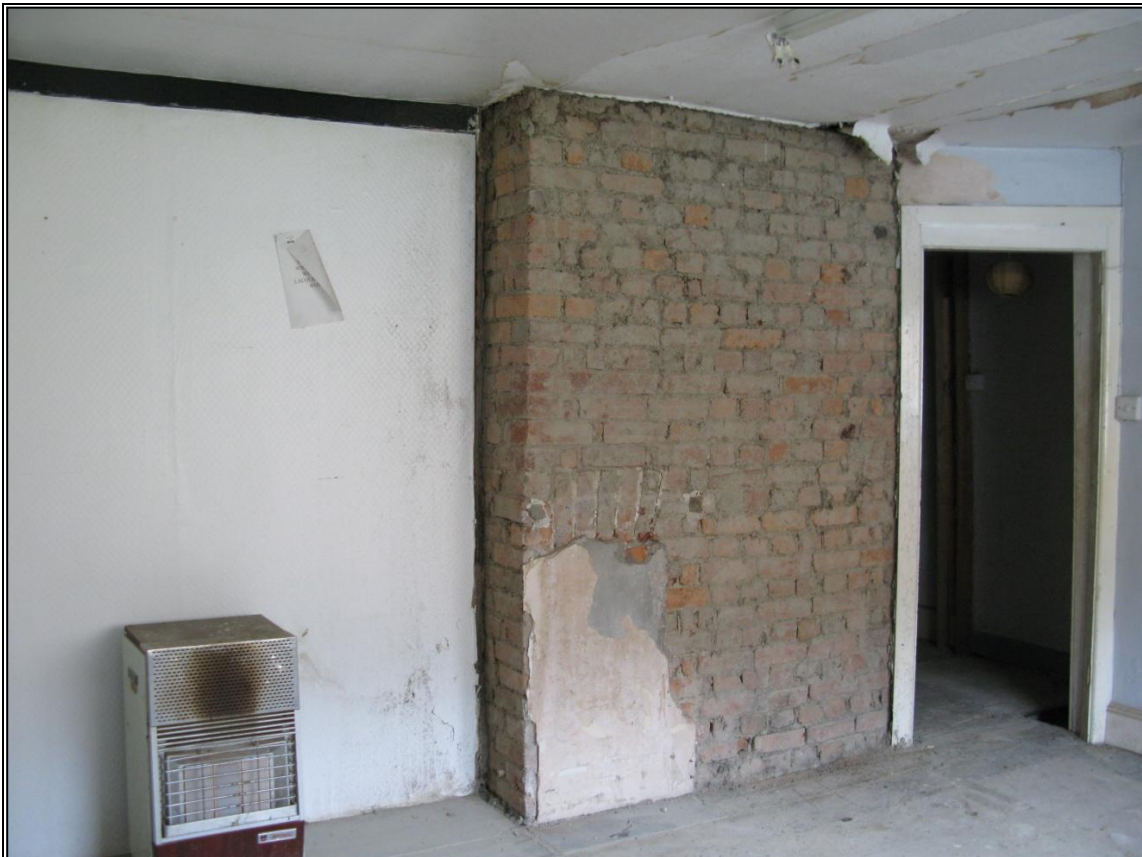
Figure 15: Chimney stack in Room 9 showing blocked opening.

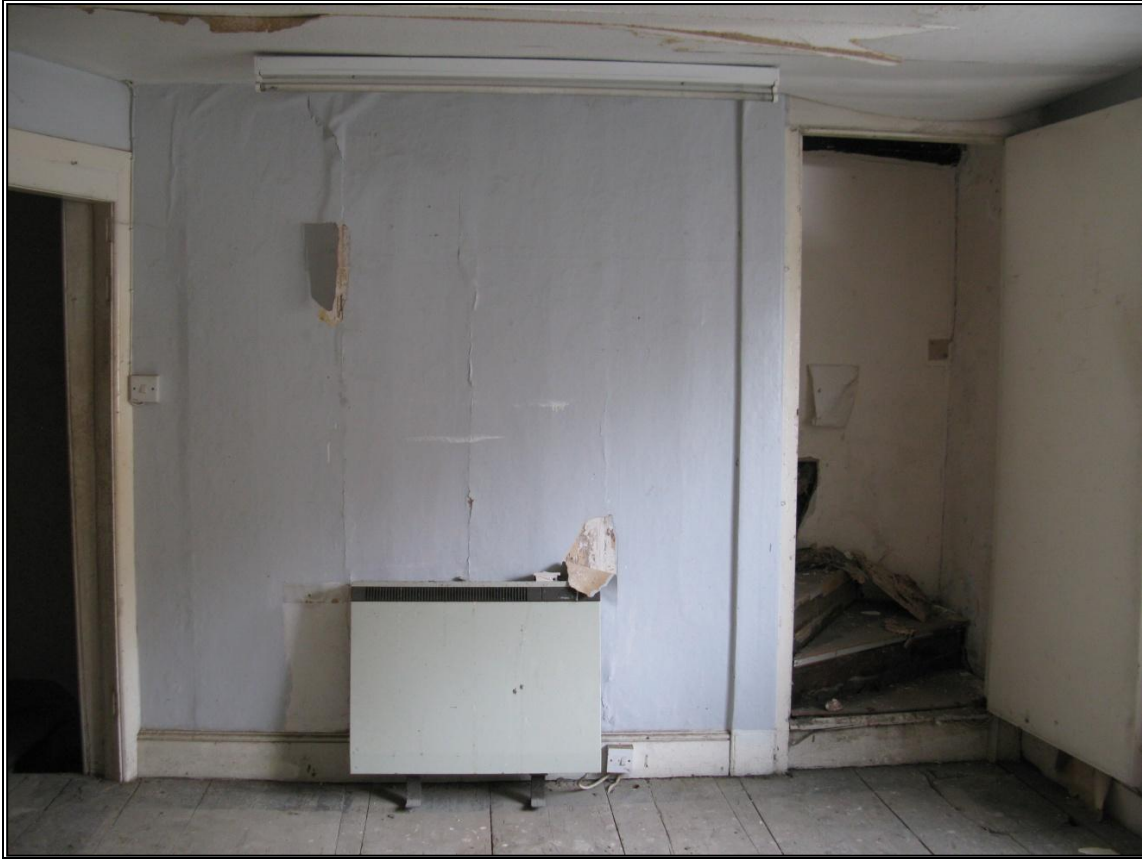
The ground floor stair is modern, and the stair to the attic is of 19th date and is enclosed by random width beaded edge pine boards of a similar period.

Figure 16: Attic stair in Room 10.

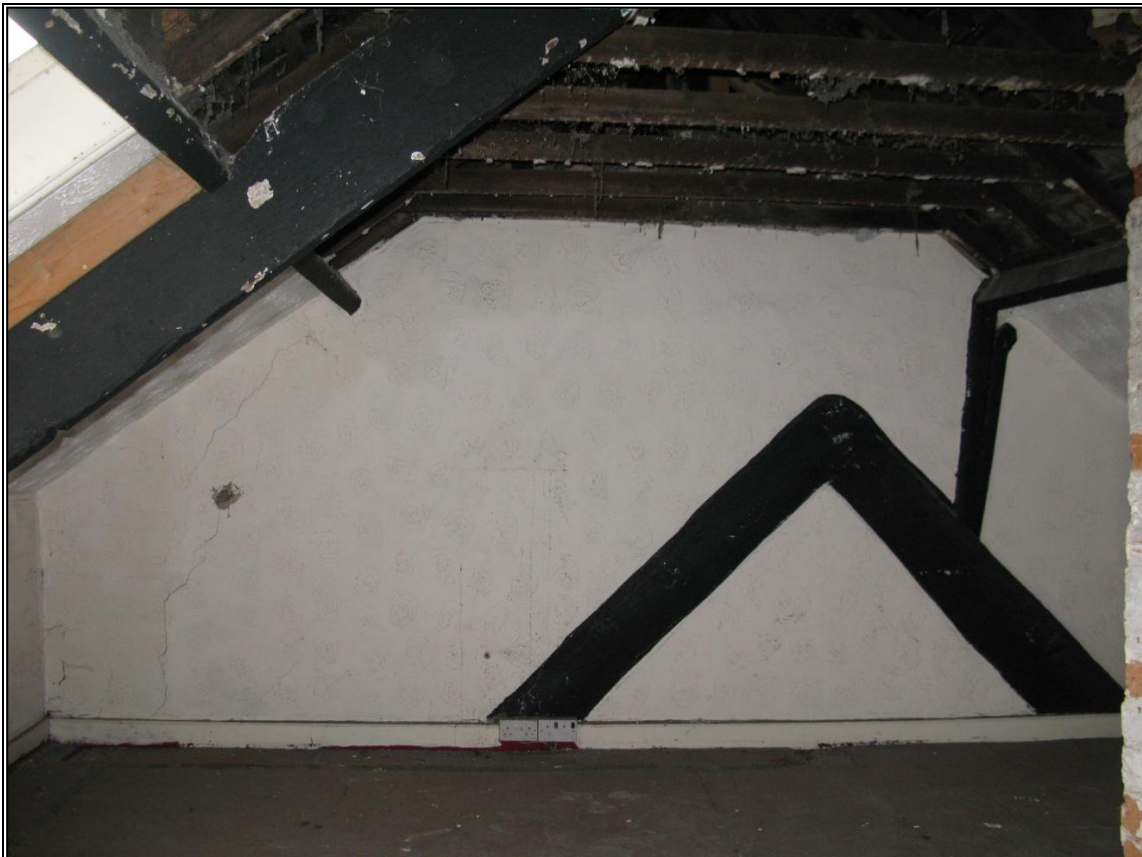
The building is not of significance as a 19th century structure, however the 16th century roof truss embedded in the wall between 121 and 122 is an important indicator of the date for the particular development of this part of the town of Barnstaple.

Figure 17: Early roof truss set in wall between 121 and 122 Boutport Street.
