9 HIGH STREET GREAT TORRINGTON DEVON

A Record of the Gable of the East Elevation

Report No.: 241215
Date: December 2015
Authors: Colin Humphreys
Bryn Morris

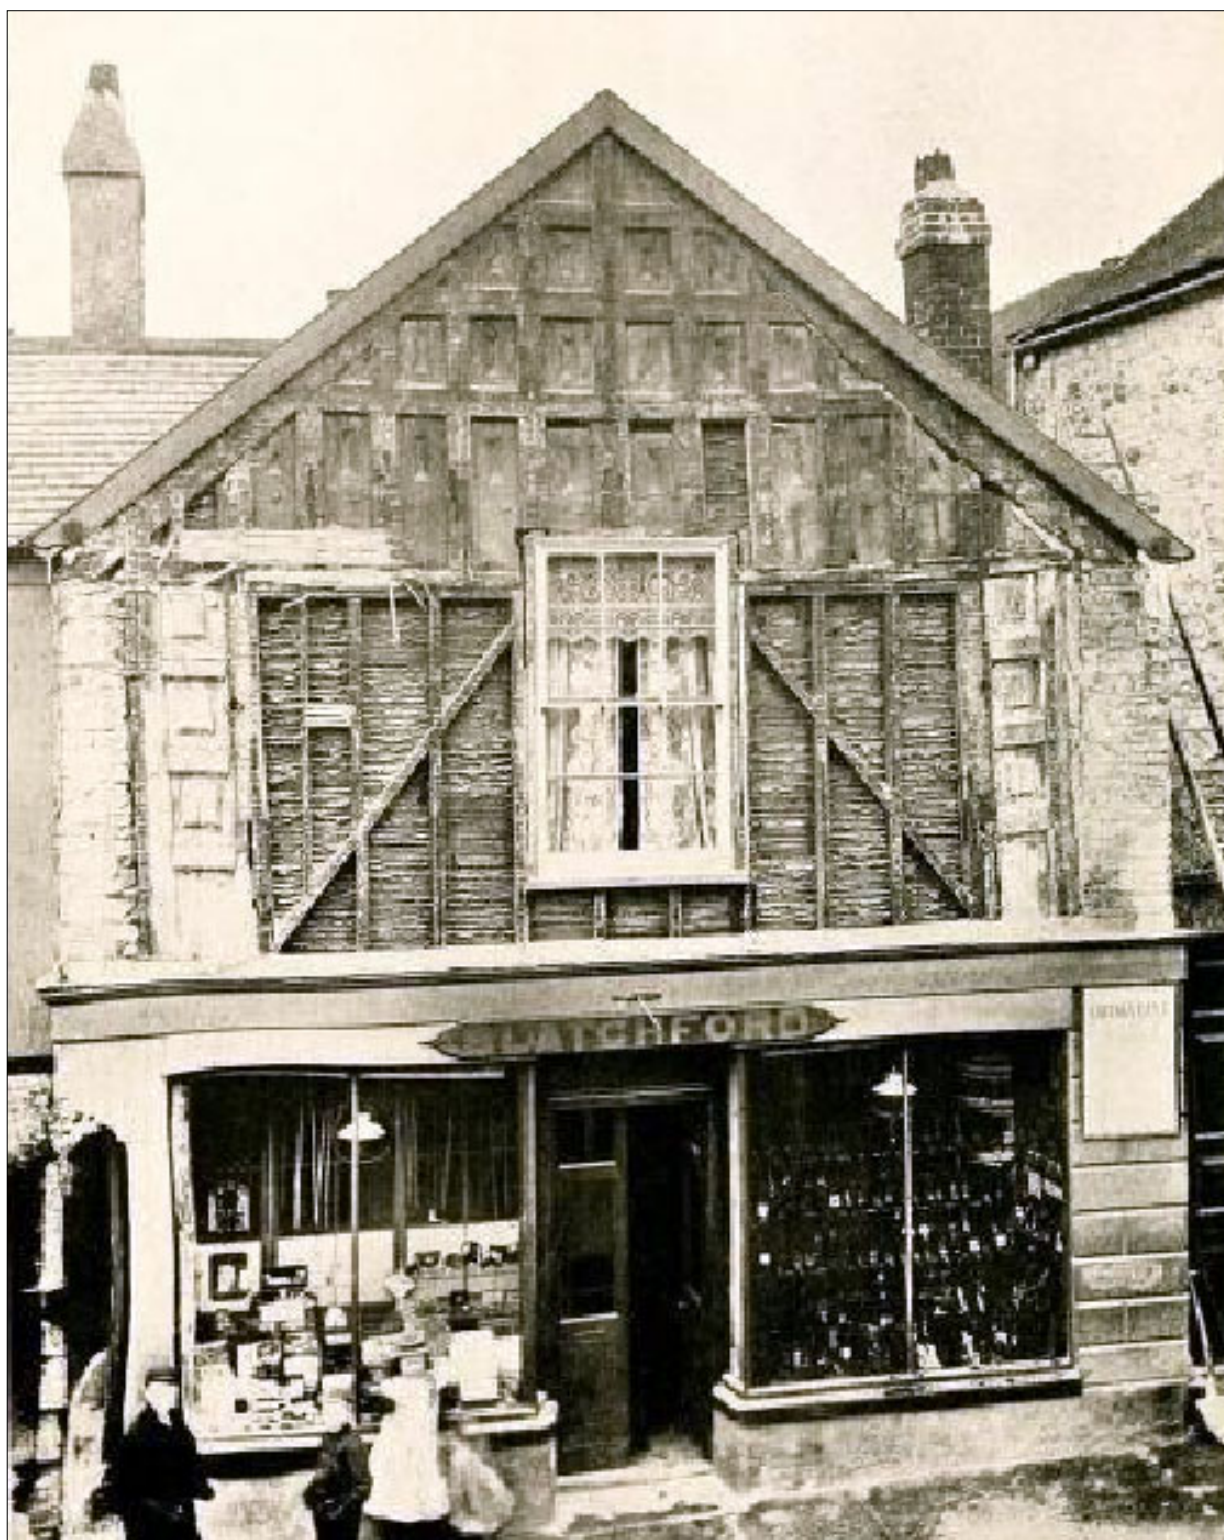
The uniqueness of this building was recognised in the early 20th century when a Mr. George Doe photographed the street elevation and commented on the excellent condition of the structure (fig 3 and appendix 1).

Figure 3: Photograph taken in 1903 by George M. Doe, see appendix 1.

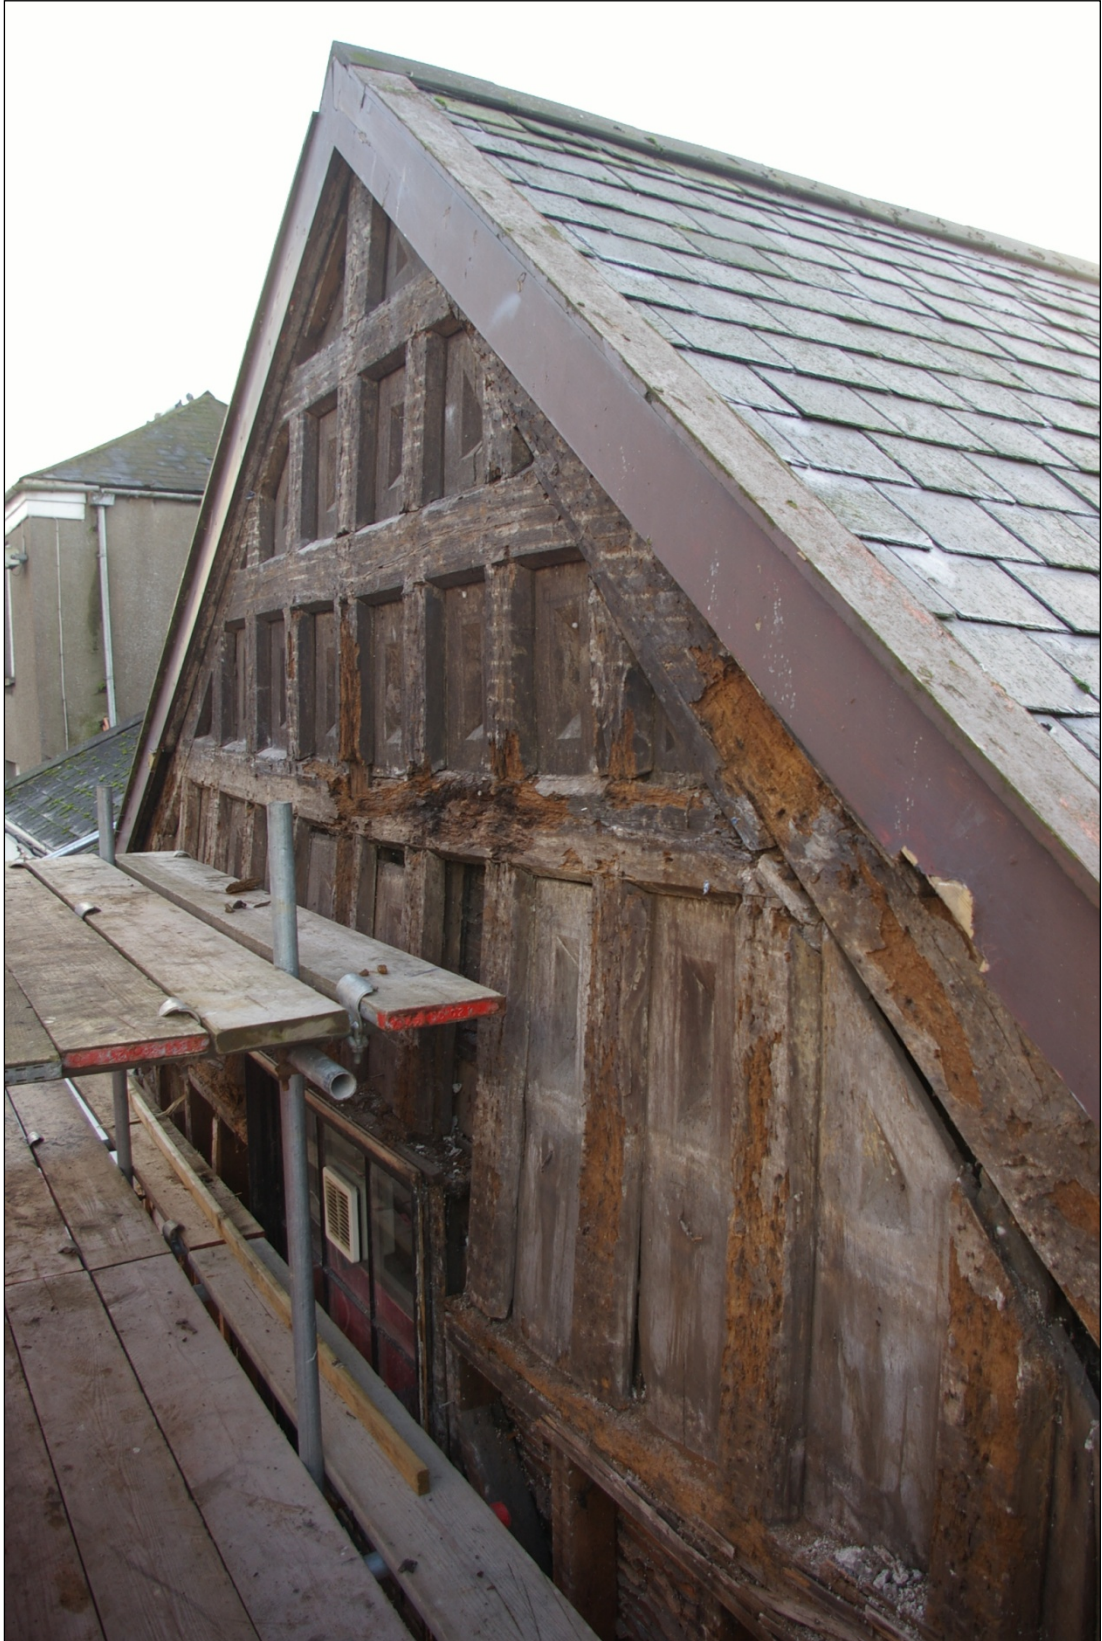
Figure 4: The gable photographed from the north east.
