# LAND at WAKEY HILL SOLPORT and STAPLETON The CITY of CARLISLE CUMBRIA

Results of a Desk-Based Assessment & Historic Visual Impact Assessment

South West Archaeology Ltd. report no. 160209

By E. Wapshott & S. Walls  
Report Version DRAFT01  
09 February 2016

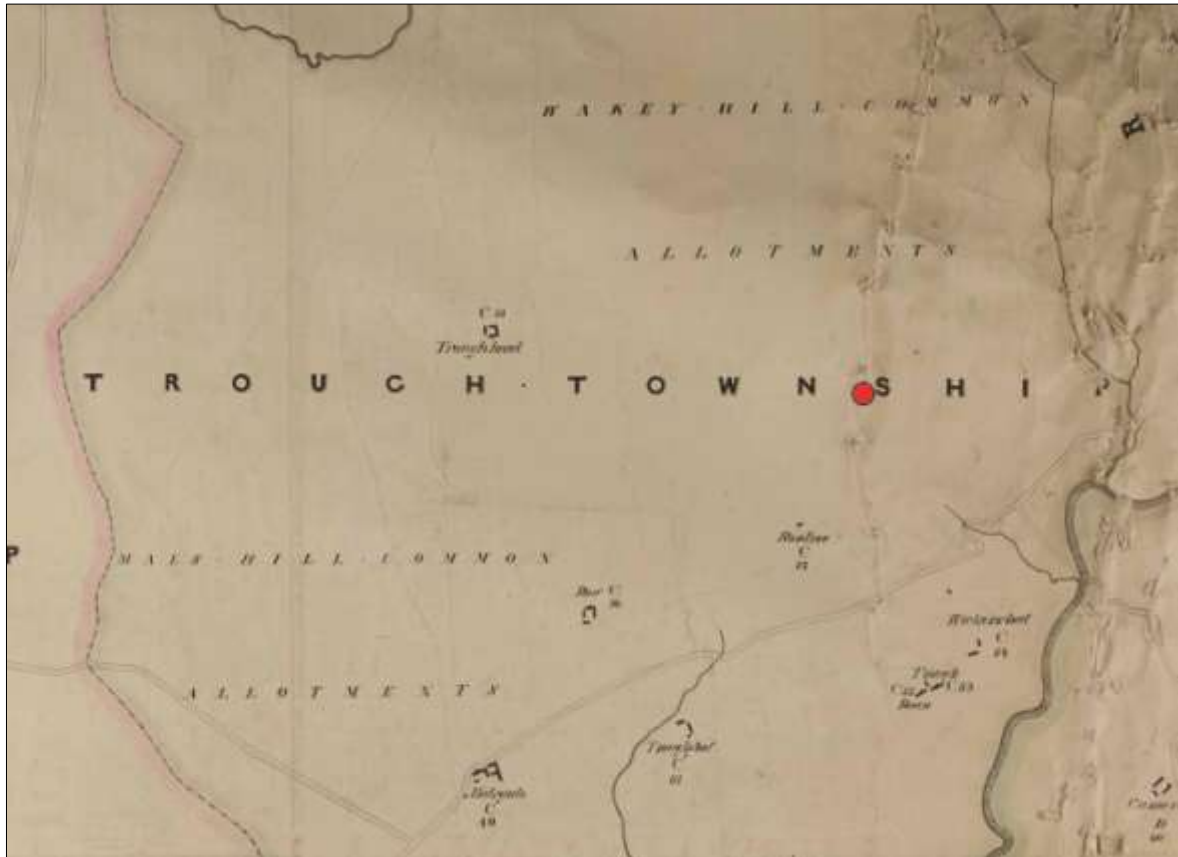
Figure 3: Extract from the 1845 Stapleton tithe map; the approximate location of the turbine is indicated.

It is not until the mid-19<sup>th</sup> century that the first detailed cartographic material of the area is available; namely the 1845 Stapleton tithe map and apportionment (Cumbria Record Office QRE/1/105; see Figure 3 ). This shows the wider landscape in broad detail: a fieldscape of largely post-medieval enclosure and farmsteads. The proposal site at this time is located within an area recorded as *Wakey Hill Common Allotments*, and as such the land is divided and apportioned between individual tenements and not under the ownership of an over-arching landlord.

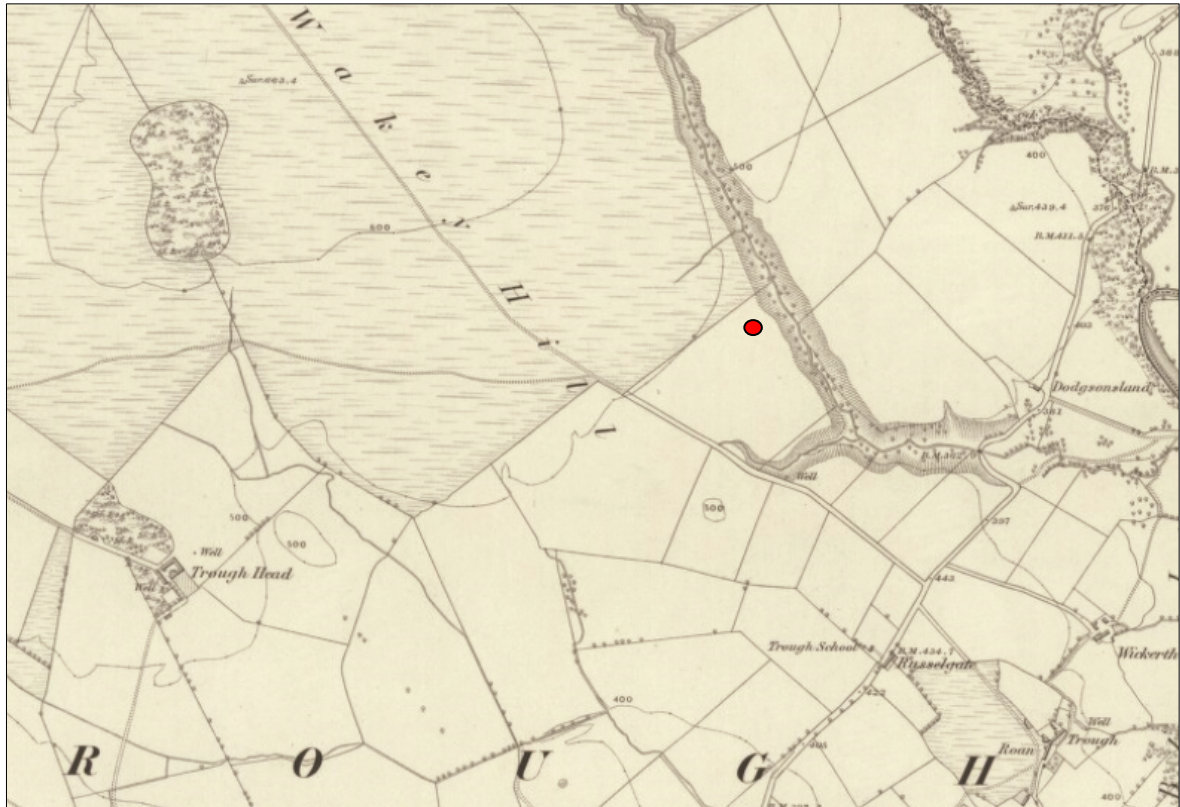
Figure 4: Extract from the 1868 1st Edition Ordnance Survey map for Cumberland (sheet VII) surveyed 1863; the approximate location of the turbine is indicated.

The 1<sup>st</sup> edition Ordnance Survey map of 1868 (Figure 3) indicates that little or no development had occurred in the years following enclosure. The field systems retained a pattern of small regular enclosures associated with post-medieval enclosure. Alongside this was larger enclosure associated with later mostly 19<sup>th</sup> century enclosure. To the north of the site the former common is depicted as moorland. A small area of woodland plantation is shown near the summit of Wakey Hill.

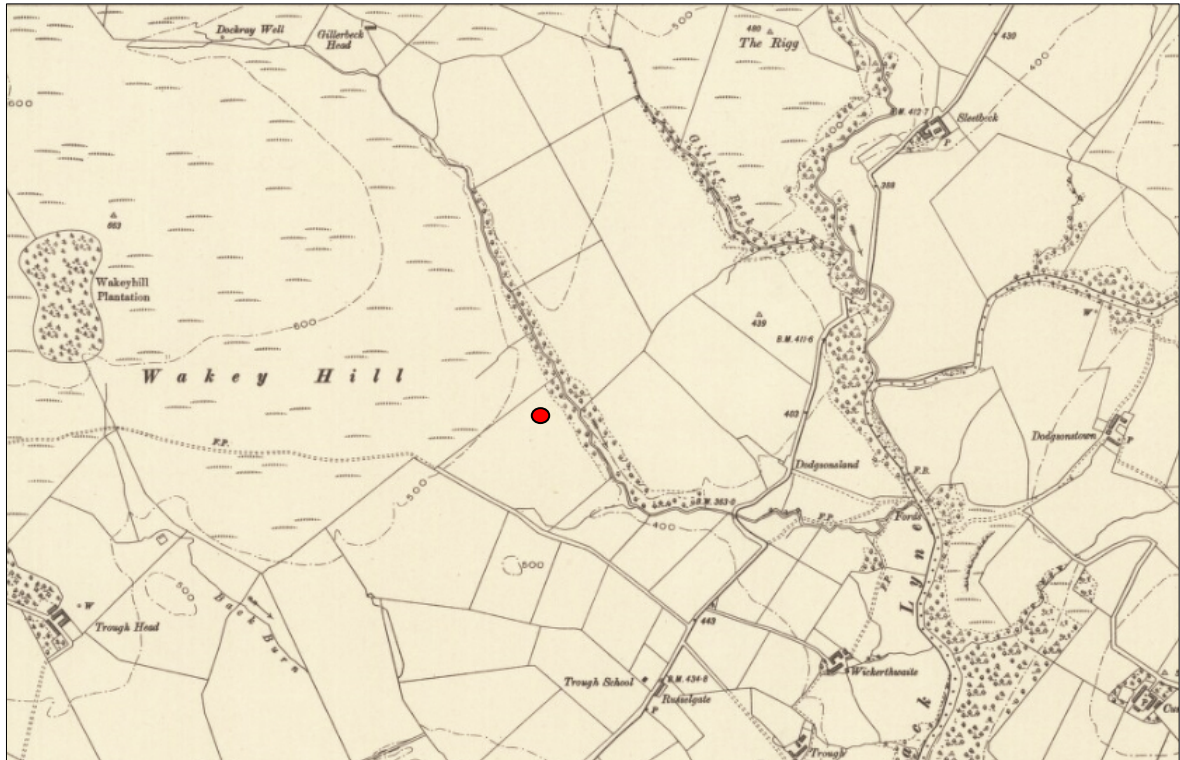
Figure 5: Extract from the 1901 2nd Edition Ordnance Survey map of Cumberland (sheet VII) revised 1899; the approximate location of the turbine is indicated.

By the time of the second edition OS Map of 1901 (Figure 4) there are very few changes, there only being the addition of a small enclosure within the field to the north-east of Trough Head, against the boundary with *Back Burn*. The proposal site is still at this time surrounded by enclosed fields to the south and open moorland to the north; the Wakeyhill Plantation also remains a small area on the summit.

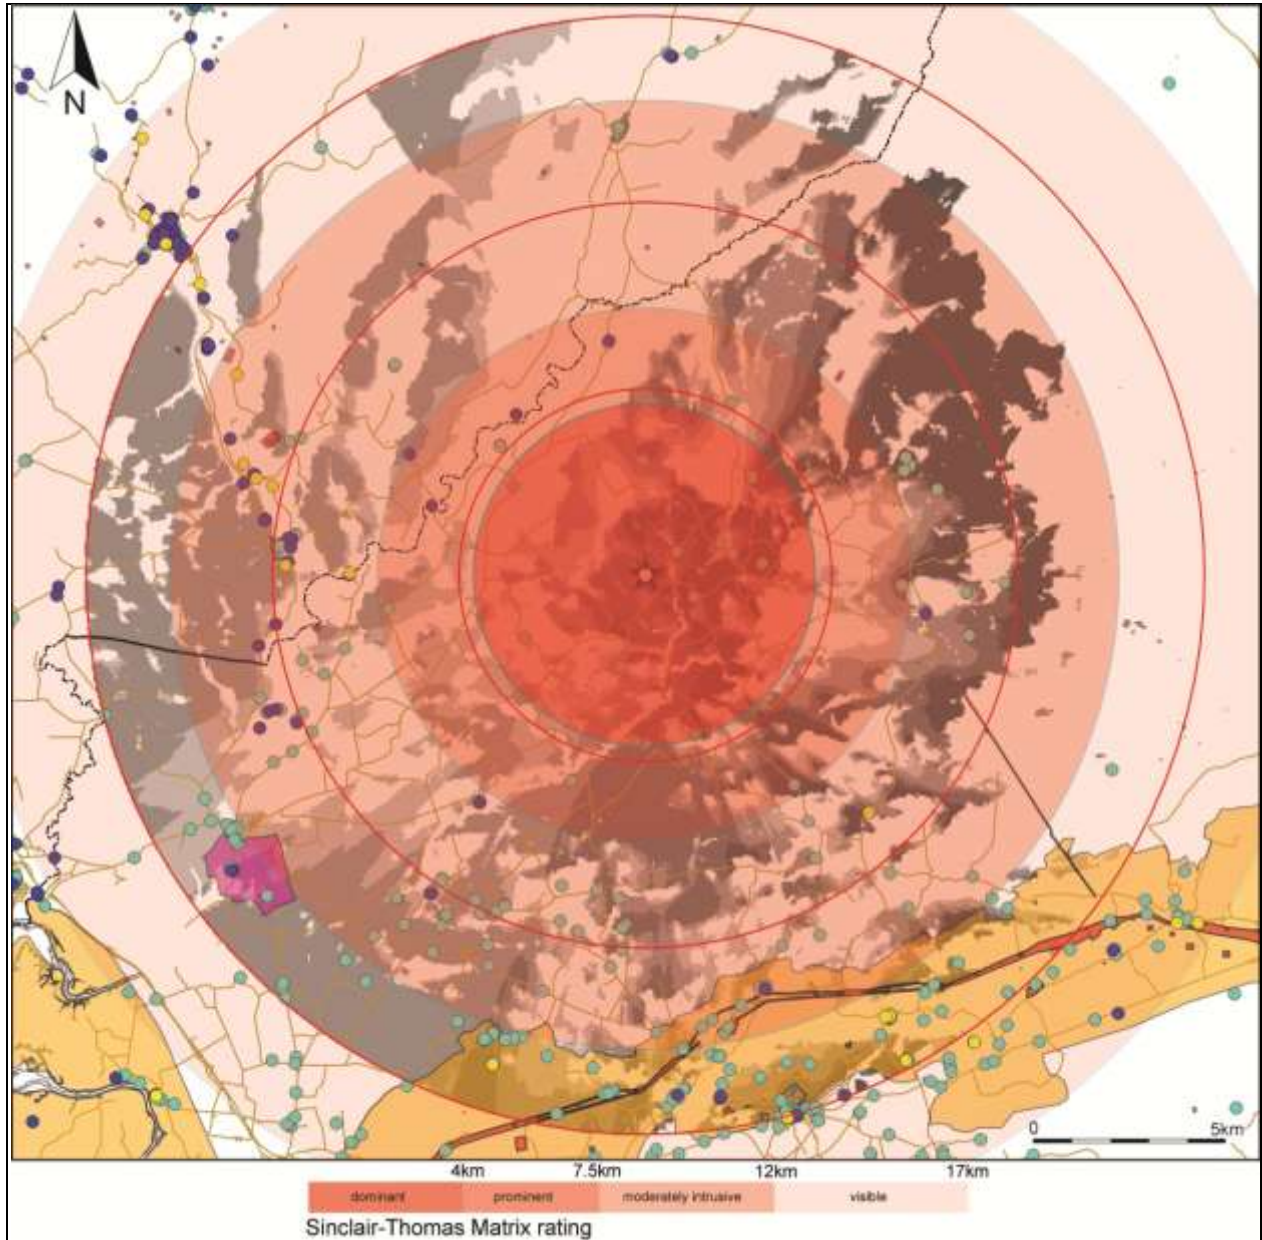
Figure 9: Distribution of designated heritage assets within the ZTV of the proposed wind turbine within 15km, in relation to the Sinclair-Thomas Zones, and based on an observer height of 2m (data as in Figure 8).

The ZTV was mapped to a total distance of 15km from the proposed site by Cleanearth Energy (Figure 8-9). The visibility of the proposed development would diminish with distance, and may be locally blocked by intervening buildings within settlements and by hedgerbanks, woodlands and natural topography. Theoretical visibility has been assessed as the visibility to the blade tip (105m). Up to 4km Listed Buildings (of all grades) and Scheduled Monuments (SAMs) were

There are two Grade II Listed assets/groups of assets within 1km, within 5km of the proposal site are a further ten Grade II Listed structures/groups mostly farm buildings and a single SAM. There are numerous higher value assets between 5-10km from the turbine, the Frontiers of the Roman Empire World Heritage Site and Registered Battlefield at Solway Moss.

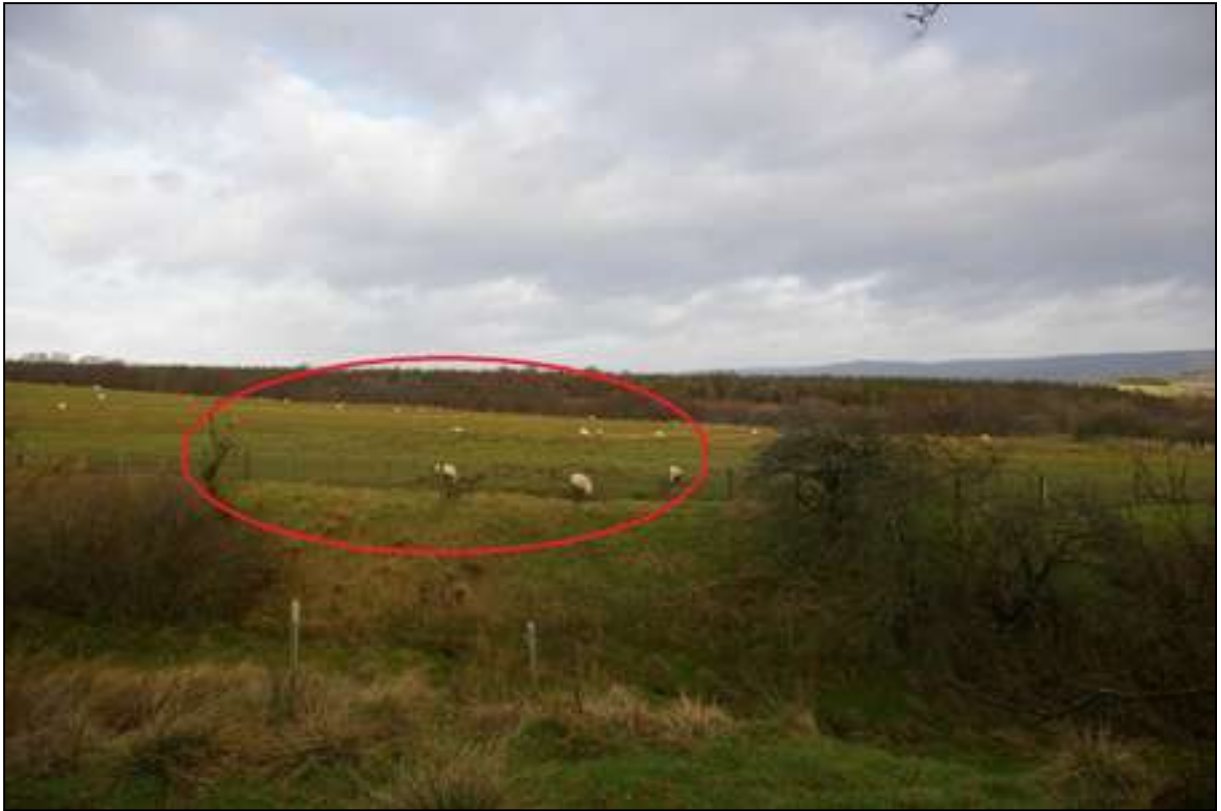
As above, annotated.

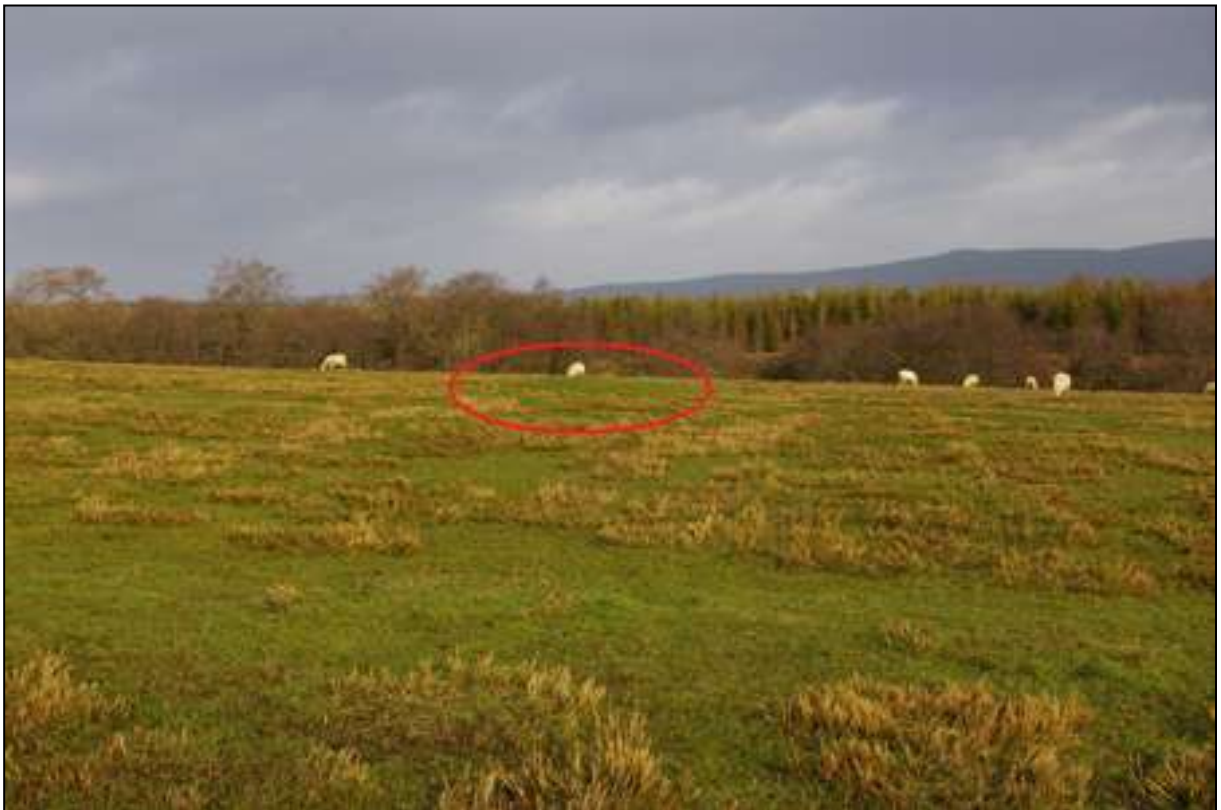
As above, annotated.

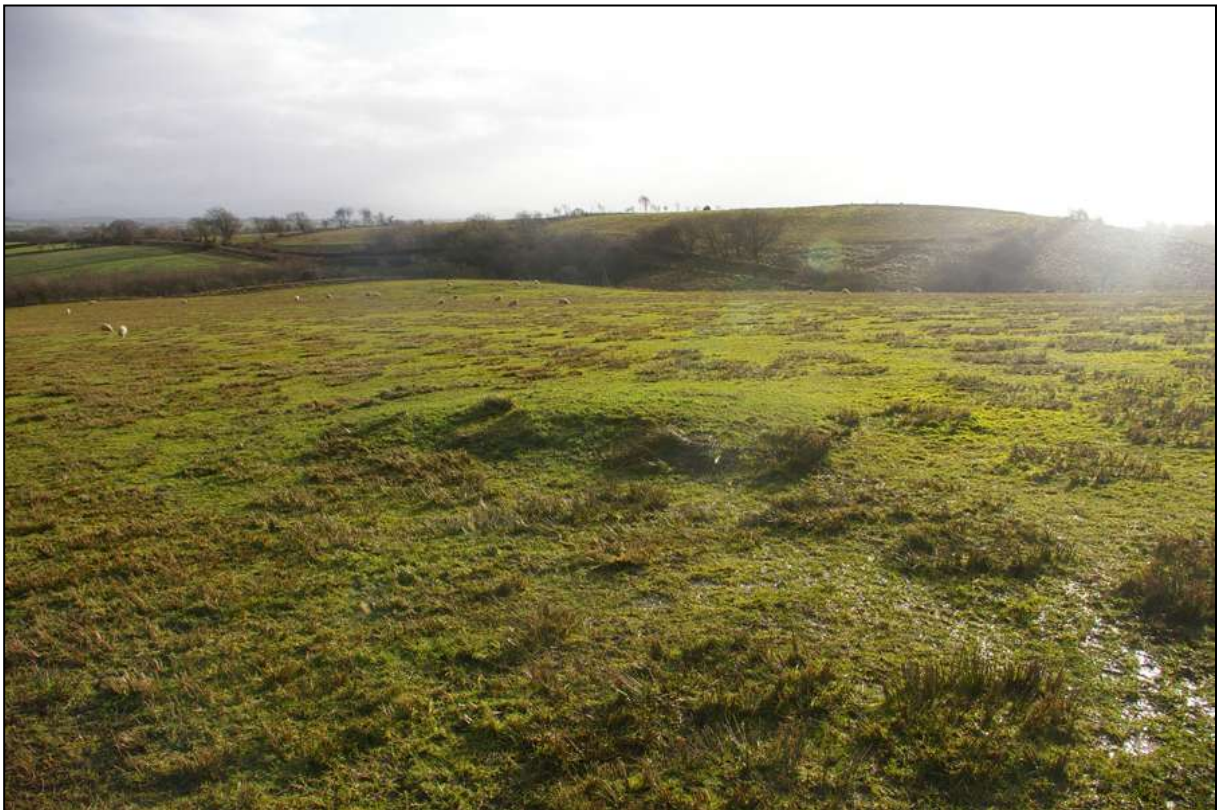
View of the largest and best preserved of the mounds viewed; from the west.

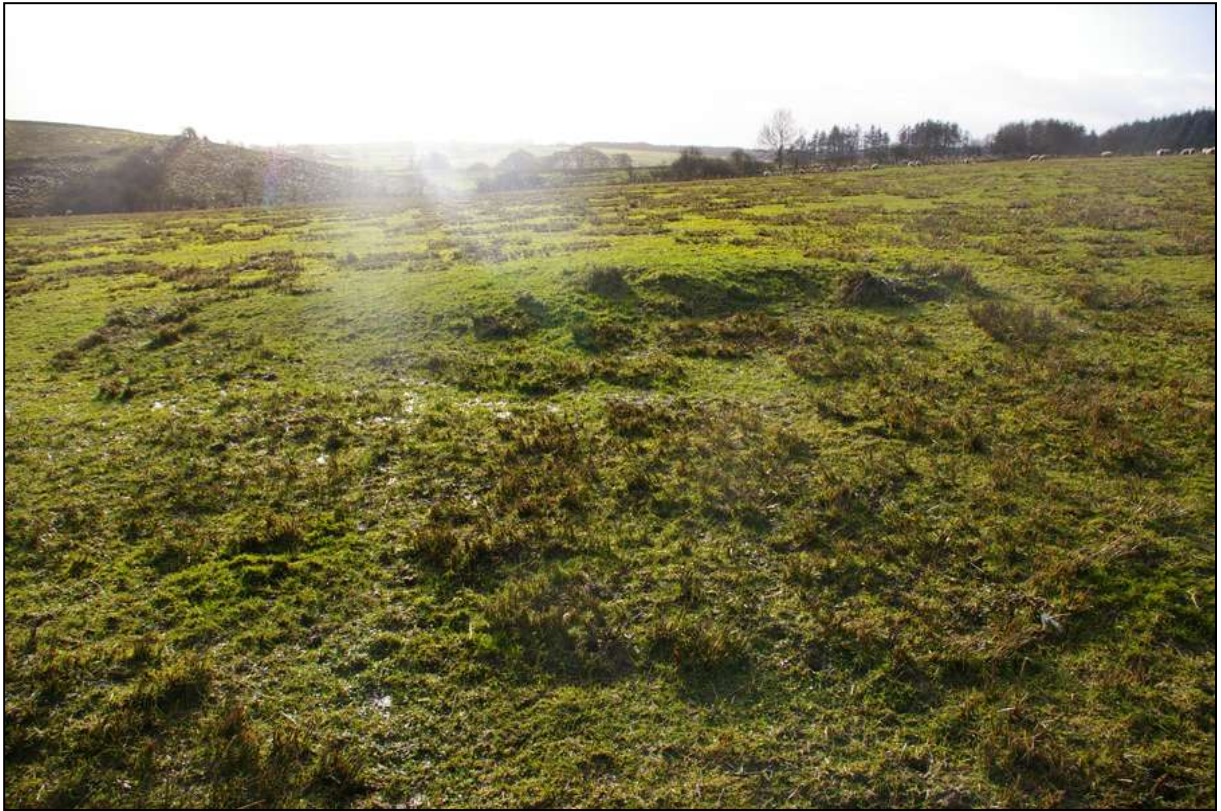
View of the largest and best preserved of the mounds viewed; from the north, north-east.

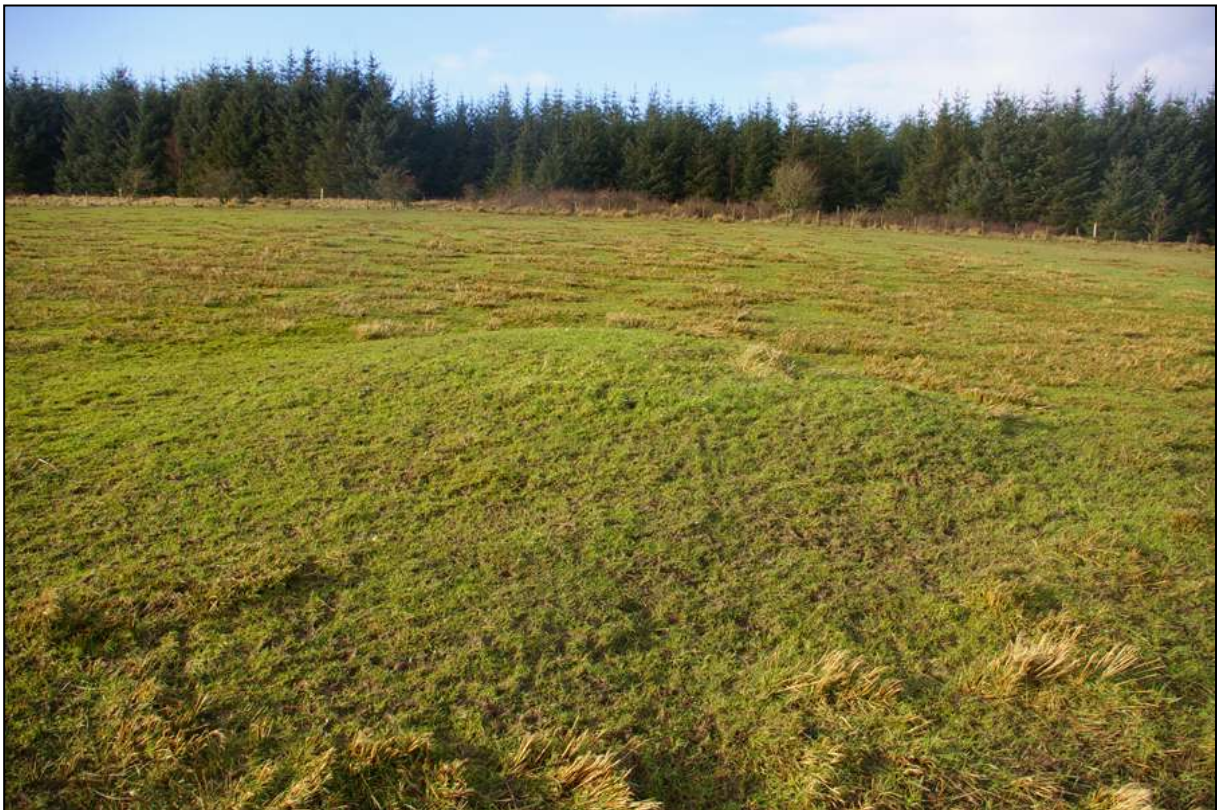
View of the largest and best preserved of the mounds viewed, from its slumped side; from the east.
