**LAND OFF OLD MINE LANE
ST ANN'S CHAPEL
CALSTOCK
CORNWALL**

Results of a Desk-Based Assessment, Walkover Survey,
Archaeological Evaluation & Revised Historical Impact Assessment

South West Archaeology Ltd. report no. 170707

By E. Wapshott, B. Morris & P. Webb
Report Version: Final
7th July 2017

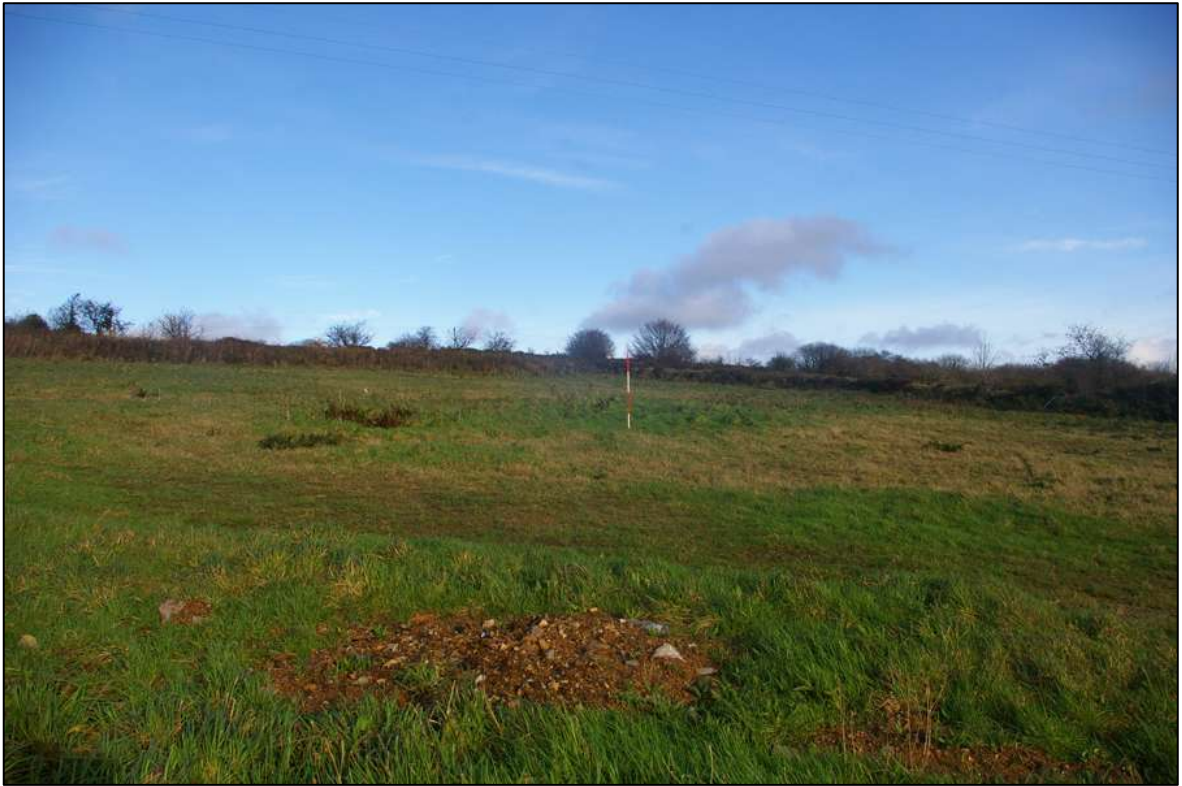
FIGURE 9: THE NORTH-EAST CORNER OF THE PROPOSED DEVELOPMENT SITE; VIEWED FROM THE SOUTH-WEST (SCALE 2M).

whole field stripped of turf/vegetation OR covered with the topsoil generated by the adjacent housing development. It is likely, based on these observations, that any upstanding archaeological features (i.e. the earthwork noted on the historic OS maps) would have been flattened or perhaps buried.

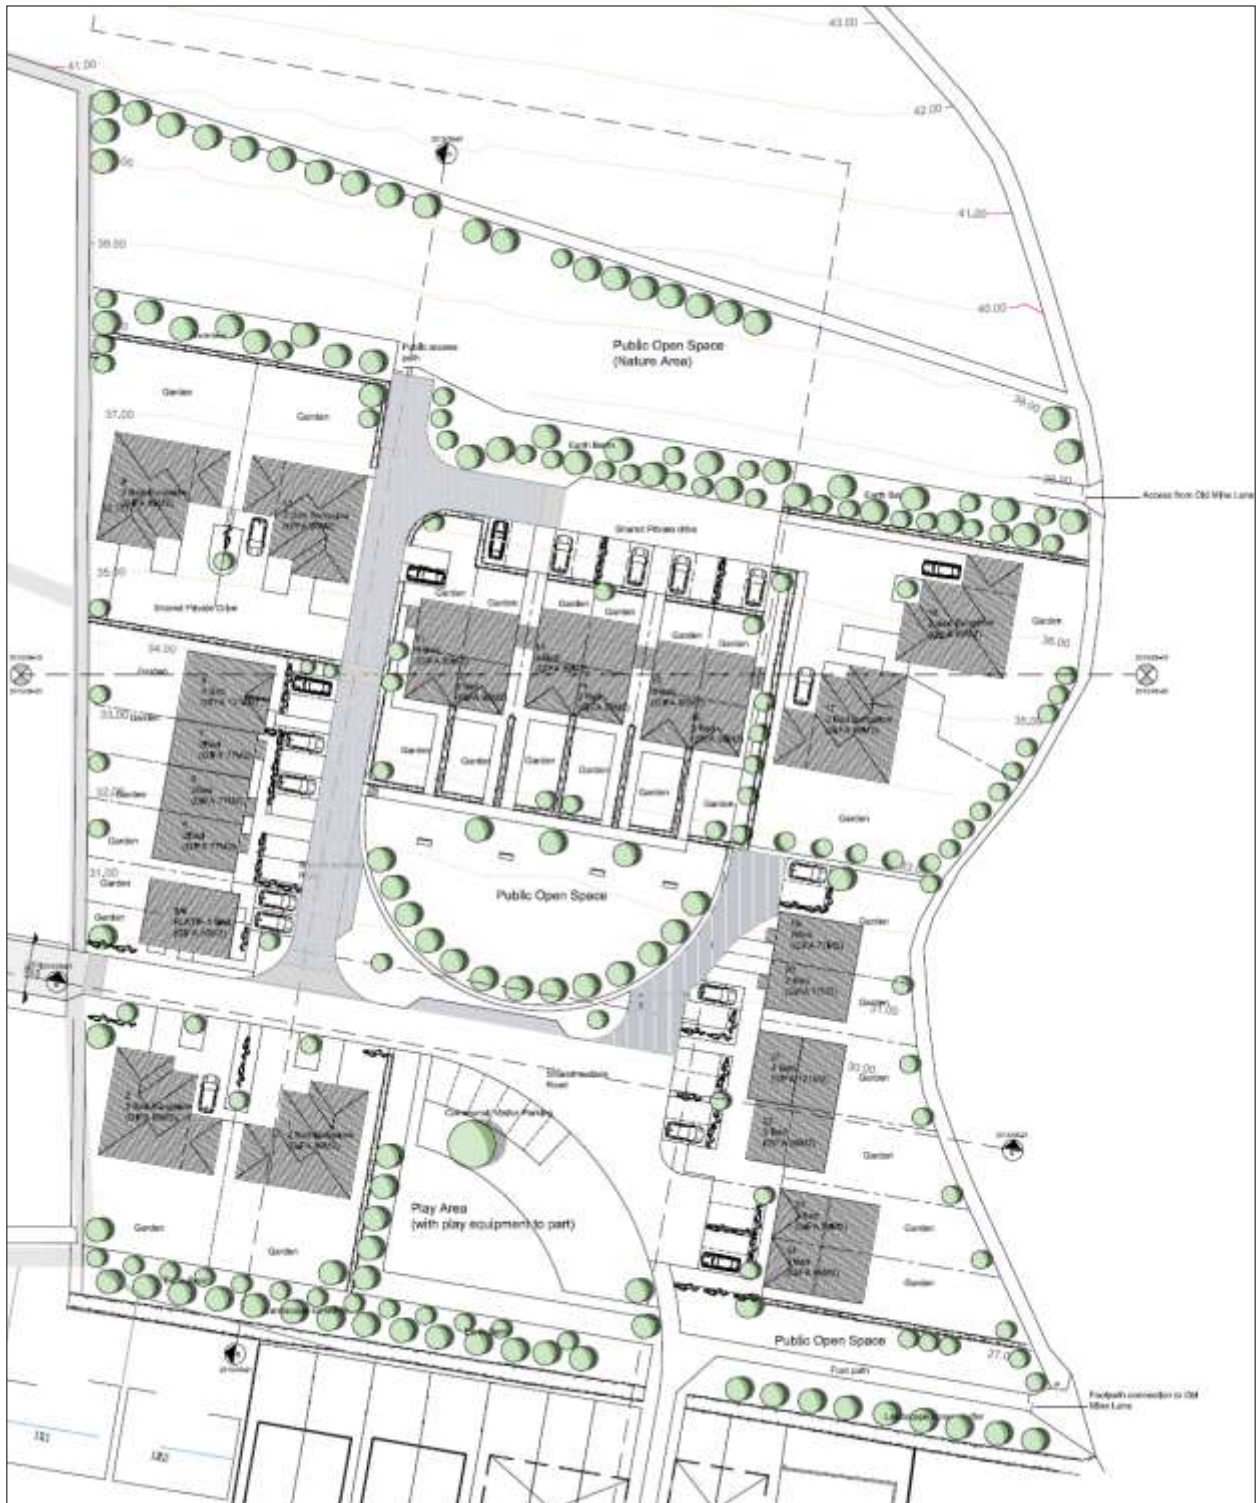
APPENDIX 1: ORIGINAL LAYOUT

Original layout (2015.06-18P1 Outline scheme 6 site layout.pdf)

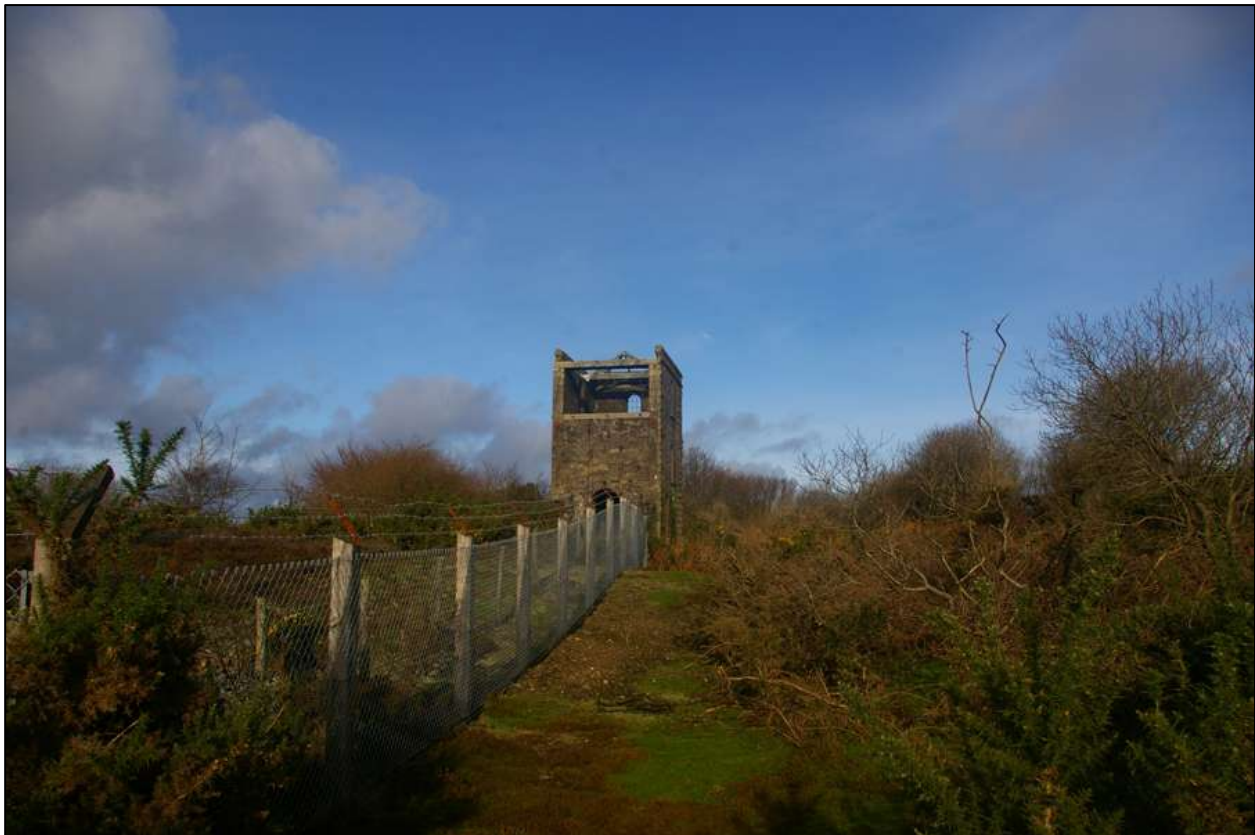
The enginehouse next to the fenced off mine shafts on the open moorland; viewed from the south-south-west.

<p>fittings have decayed or have been removed. It is associated with stone and concrete platforms with iron pintles where machinery would have been mounted. All the other associated structures have been lost, and the spoil heaps extensively re-worked.</p>
<p><i>Topographical Location and Landscape Context:</i> The enginehouse is located on the break of slope, just to the west of the summit of Hingston Down. The land falls away fairly gradually to the east, south and west, more quickly to the north. The landscape context is the mining landscape and wider Tamar Valley WHS.</p>
<p><i>Principal Views:</i> Views from the site are limited by vegetation to the south. In winter it is visible through the trees from the north, but is otherwise most prominent from the south and south-east. There are views to the south, towards St Ann's Chapel along Old Mine Lane; and west, towards Kit Hill, with its associated relict burial landscape. There are wide landscape views towards the engine house, which is a visible component of the ridge skyline.</p>

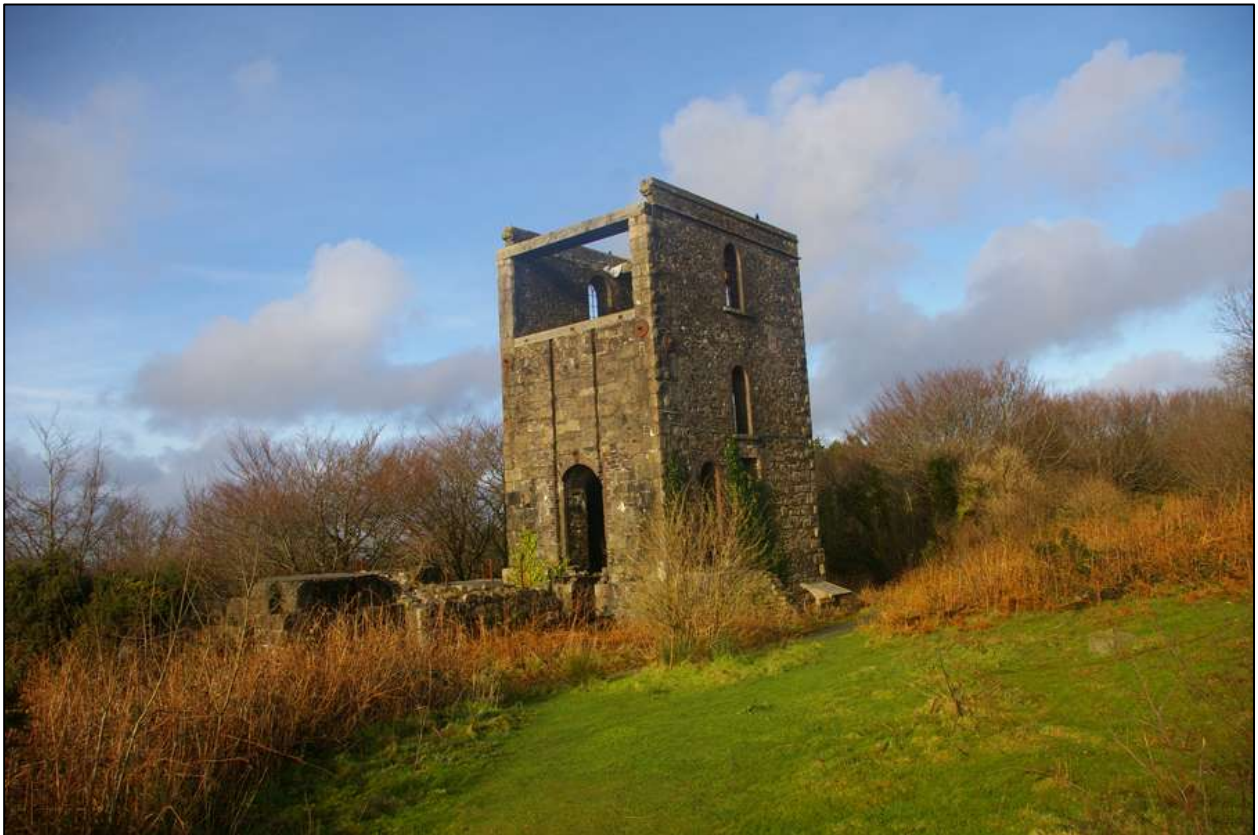
The enginehouse and part-ruined buildings, on the moorland, a Grade II Listed building; viewed from the south-south-east.
