Devon County Council Historic Environment Record

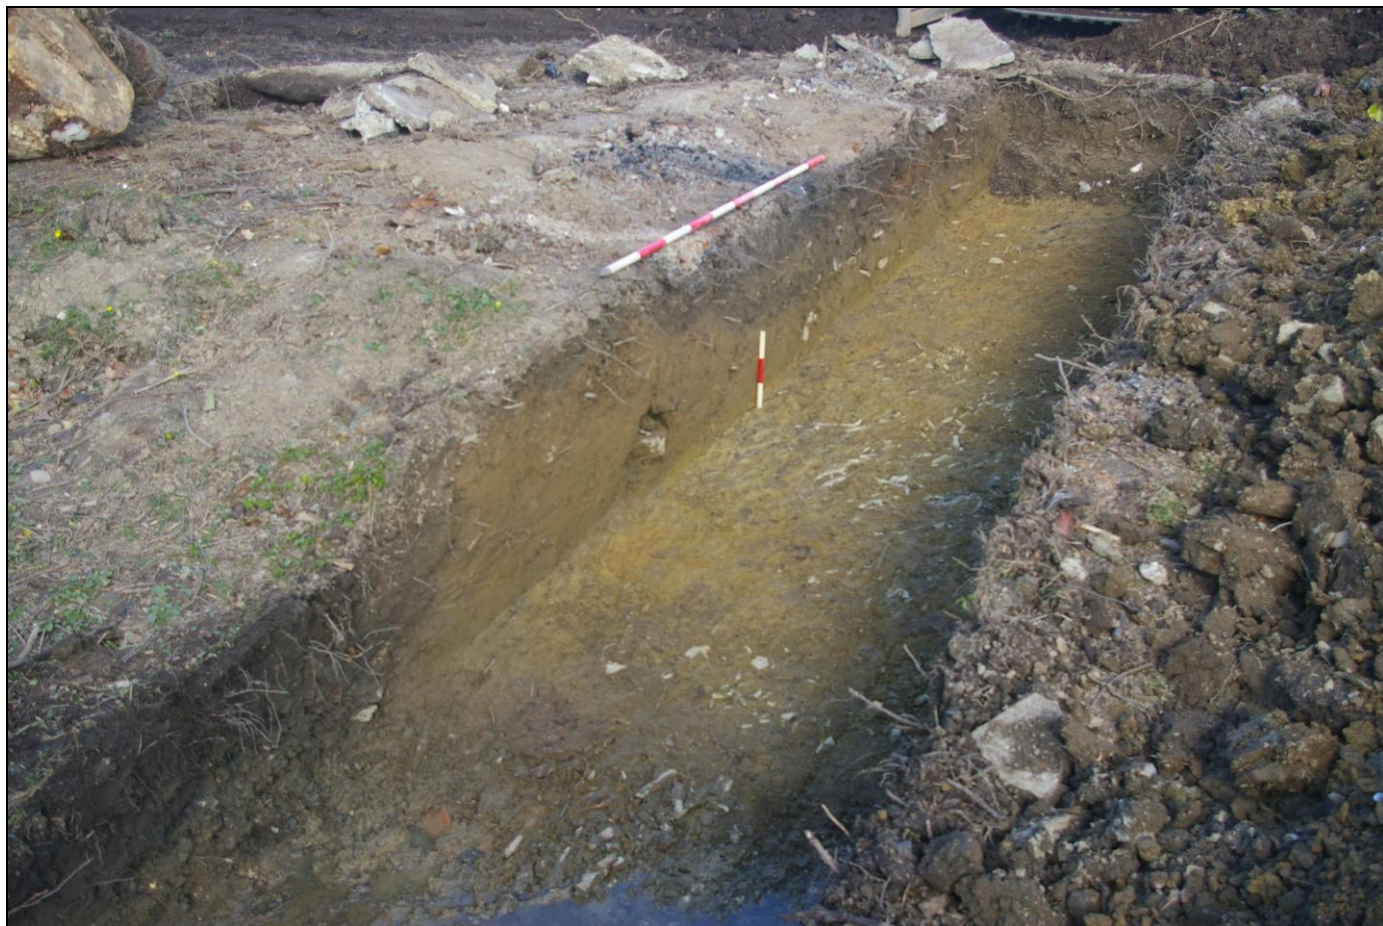
Figure 2: South-east facing section of trench 3, showing the terracing cut at its western end; viewed from the south (0.3m and 2m scales).

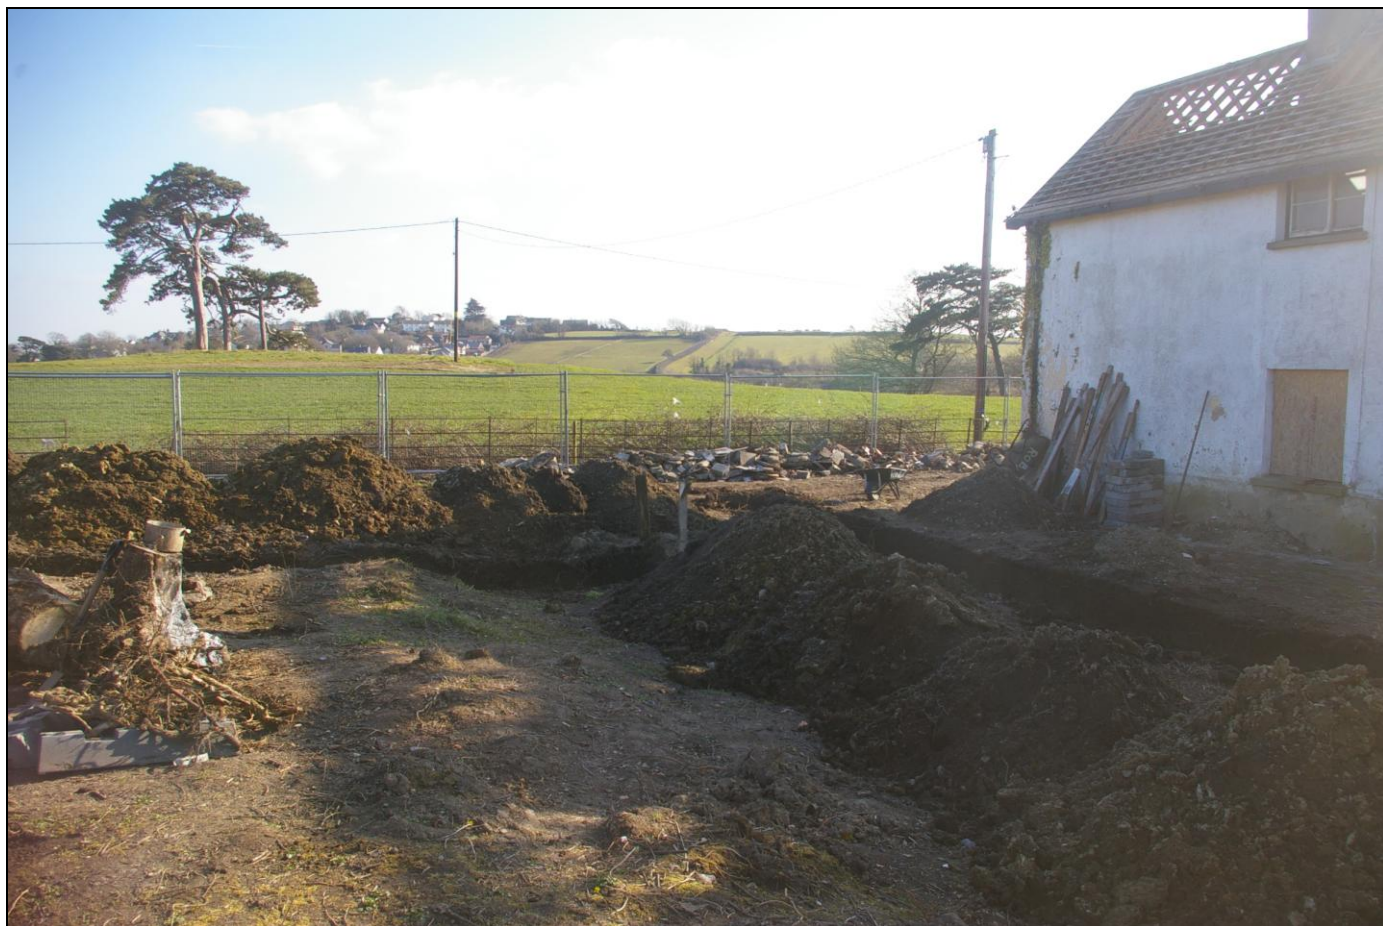
Figure 3: View of the site, showing the 'bank' of the terrace cut for the existing Lenwood Cottage (foreground); viewed from the north (no scale).
