LANIVET TO LAKE VIEW PIPELINE

LANIVET CORNWALL

Results of a Desk-Based Assessment

Lanivet to Lake View Pipeline, Lanivet, Cornwall Results of a Desk-Based Assessment

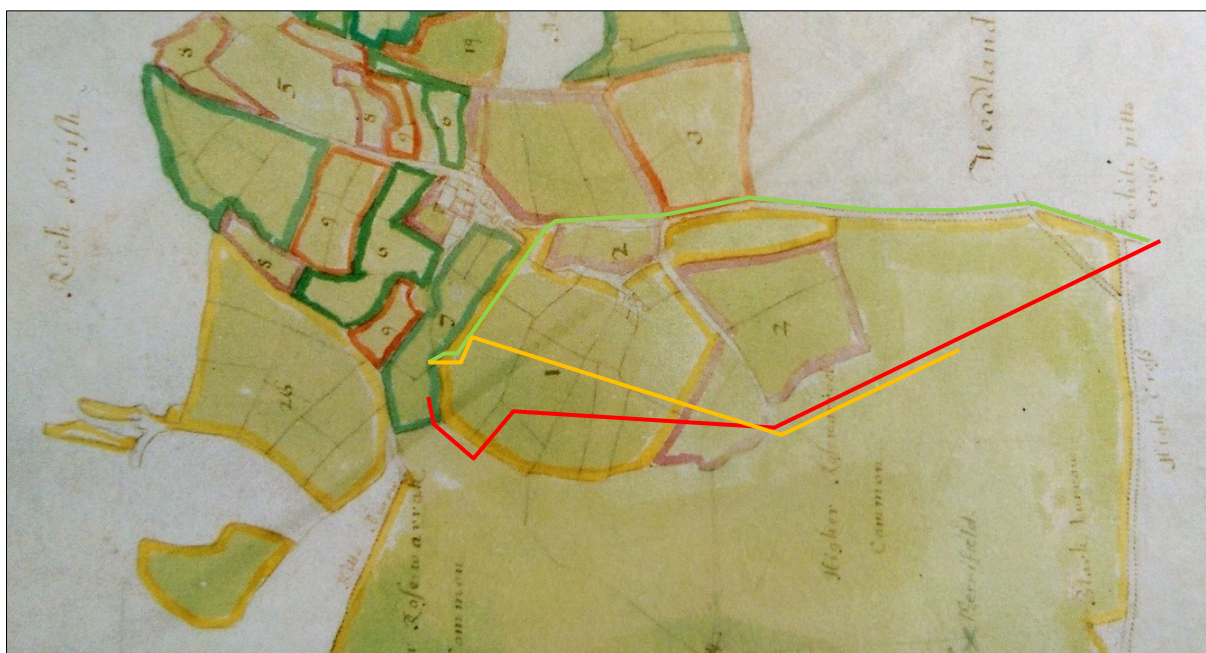
FIGURE 2: EXTRACT FROM THE 'GENERAL SCHEME OF THE MANOR OF TREMORE AND ROSEWARRICK' IN THE LANHYDROCK ATLAS (NT) (THE APPROXIMATE PIPELINE ROUTE IS INDICATED).

The earliest useful cartographic source is the late 17th century Lanhydrock Atlas, which shows the lands held from the Lanhydrock estate in considerable detail. It provides both general outline of fieldscape (Figure 2) and a more detailed depiction of the lands of tenements at Higher and Lower Rosewarrick (Figure 3); the land being shown as under a combination of arable cultivation and pasture. The outline map shows that the proposed pipeline routes run through predominantly common land, through Woodland Common to the east and south, passing into Higher Rosewarrick Common before entering fields associated with Tremore and Rosewarrick manor. It indicates that the bulk of the fields were part of Colling's Tenement, though also including a significant number of fields fell within Prinn's Tenement, and small numbers of fields belonging to Benet's and Bourn's Tenements.

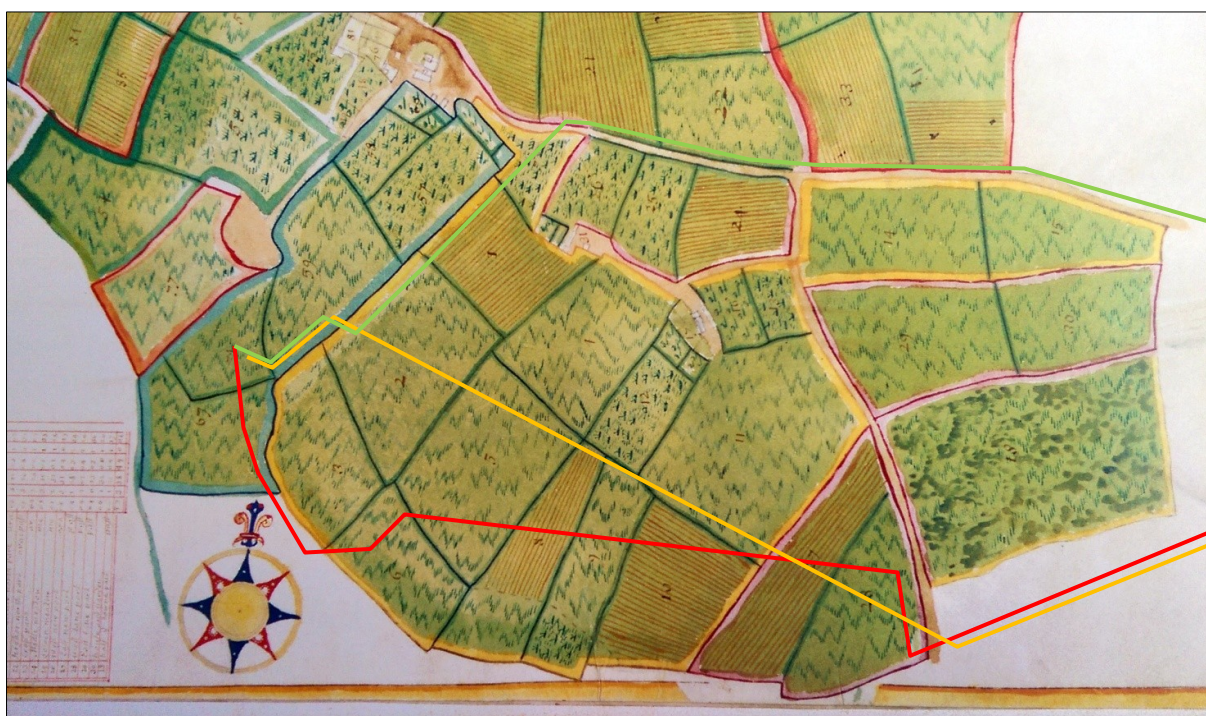
FIGURE 3: EXTRACT FROM THE 'TENEMENTS AT HIGHER AND LOWER ROSEWARRICK, ROSEBINE AND PENSTRACE' MAP IN THE LANHYDROCK ATLAS (NT) (THE APPROXIMATE PIPELINE ROUTE IS INDICATED).

The more detailed field plan provides details of the land associated with the various tenements. The field boundaries are shown as a combination of gently-curving boundaries, indicating that the fields were derived from medieval strips, with straight boundaries belonging to post-medieval enclosures. The majority of the field names are prosaic, primarily locational or topographic. The proposed pipeline would, from the western edge of unenclosed land, pass through *East* and *West New Park* belonging to Rowland Prinn's Tenement; and *Lower New Park*, *Hill Park*, *Rain's Park*, *Lower West Park* and *West Park Moor*, the lands of Fran Robartes at Rosewarrick. The alternative routes also pass through *Lower South Park* of Fran Robartes land; *West Meadow*, *Hill Meadow* and *Under Park* belonging to Benet's Tenement; *Great North Park*, *Lower Middle North Park*, *Higher North Park* of Rowland Prinn's Tenement; and *Hig Park* of Prinn's Tenement in Penstrace.
