ST ERTH MULTI MODAL HUB

ST ERTH CORNWALL

Results of a Desk-Based Assessment, Walkover & Geophysical Survey

South West Archaeology Ltd. report no. 160324

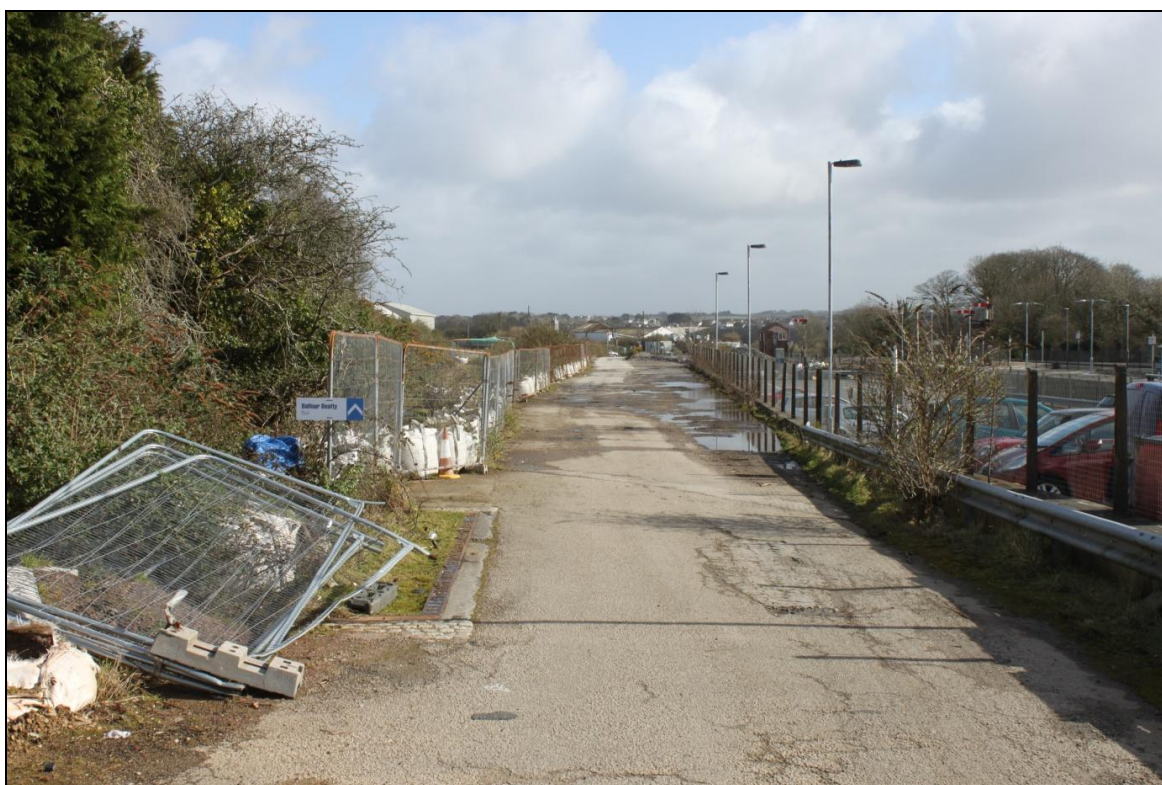
condition, and should be retained if possible. To the north is a wide tarmac road flanked to the north by the footprints of two post-1932 buildings currently visible (Figure 9). One of these is a concrete pad, with the long side set at c.45° to the wharfs and cut into the hillside to the north-west. There are also piles of rubble in this area, probably from the demolished buildings. There is a further c.5m long concrete pad near the entrance. The northern boundary of this area is an earthen hedge bank. Remnants of concrete blocks cut into this bank, in the vicinity of the building footprint. This boundary suggests that a fairly substantial terrace had been cut into the hillside to enable the construction of this area of railway sidings and wharfs.

FIGURE 9: THE FORMER WHARFS, THE PROPOSED NORTHERN CAR PARK; VIEWED FROM THE WEST.

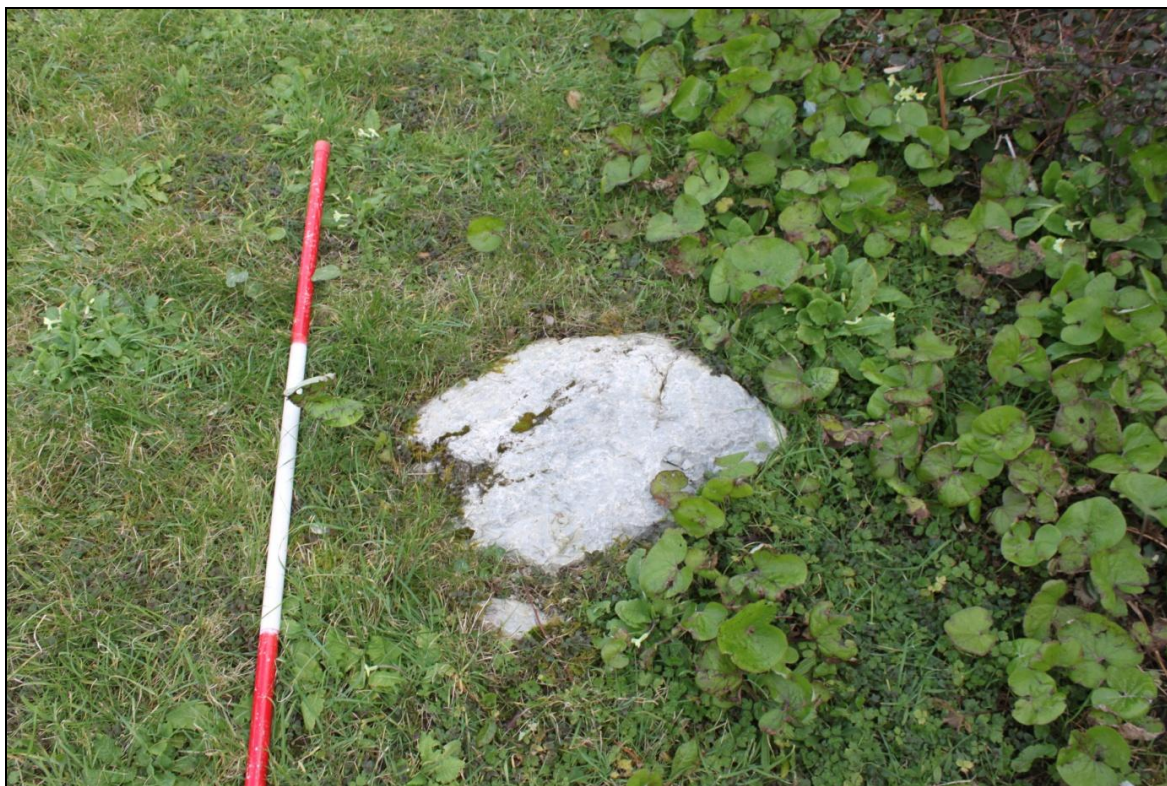
probably eroded out of the nearby bank, is visible set into the grass by the road verge on the south (Figure 10); this may be the 'cup marked stone' noted on the HER, but no obvious marks were visible. This is set some distance from the road and would be unlikely to be impacted by the proposals.

FIGURE 10: POSSIBLE CUP-MARKED STONE ON GRASS VERGE TO THE SOUTH OF THE A30; VIEWED FROM THE SOUTH-WEST (2M SCALE).

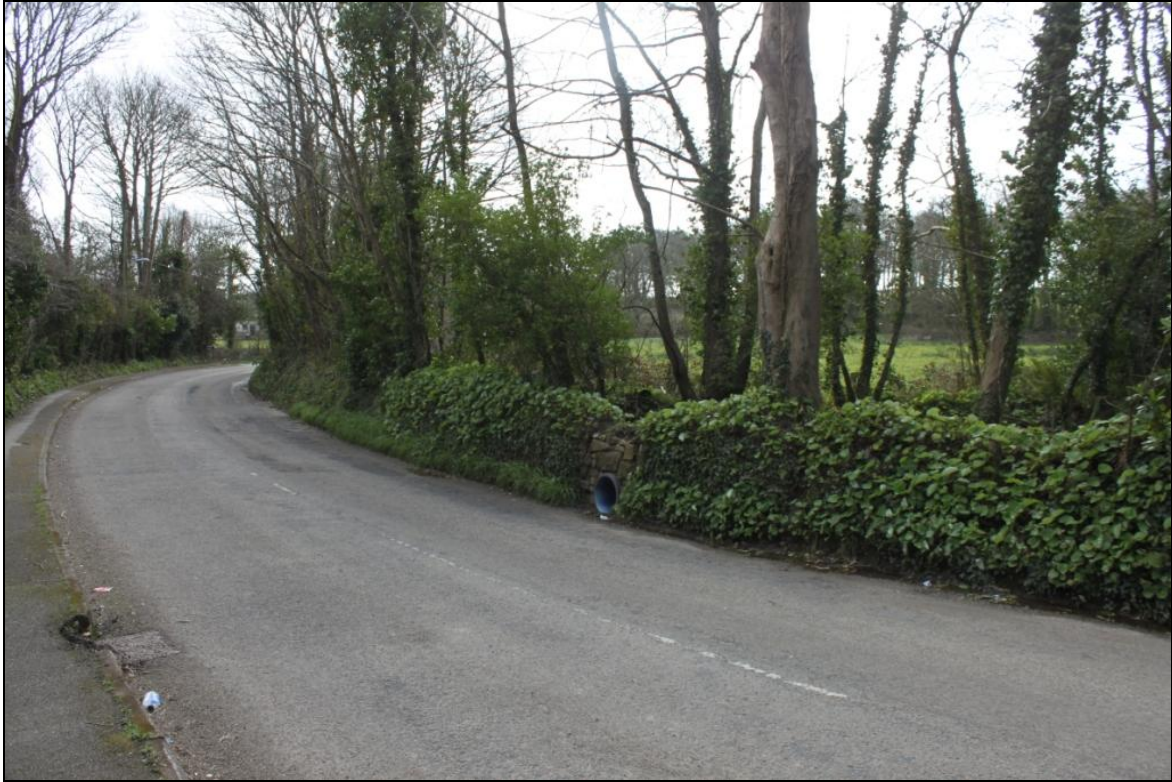
For the length of road running through the woods and up to Treloweth, which already has a narrow pavement on its eastern side, it would appear that in general the eastern boundary is largely 19th century or 20th century in date, and that if any road widening is required it is these boundaries which should be moved back. The western boundary (in general) along this length is comprised of a more substantial stone faced hedgebank lined with trees (see Figure 11). There are some areas of recent repair, but in general this boundary appears to have not altered substantially since at least 1840. Also of note on the western side of the road are the granite gate posts to the framing the track by the pumphouse, these are quite fine, suggesting that they have probably been moved to this location from elsewhere, perhaps nearby Treloweth in the late 19th century.

FIGURE 11: TRELOWETH LANE AS IT PASSES THROUGH TRELOWETH WOODS, NOTE THE LOWER EASTERN HEDGE BANK FLANKING THE PAVEMENT, VIEWED FROM THE NORTH-WEST (NO SCALE).

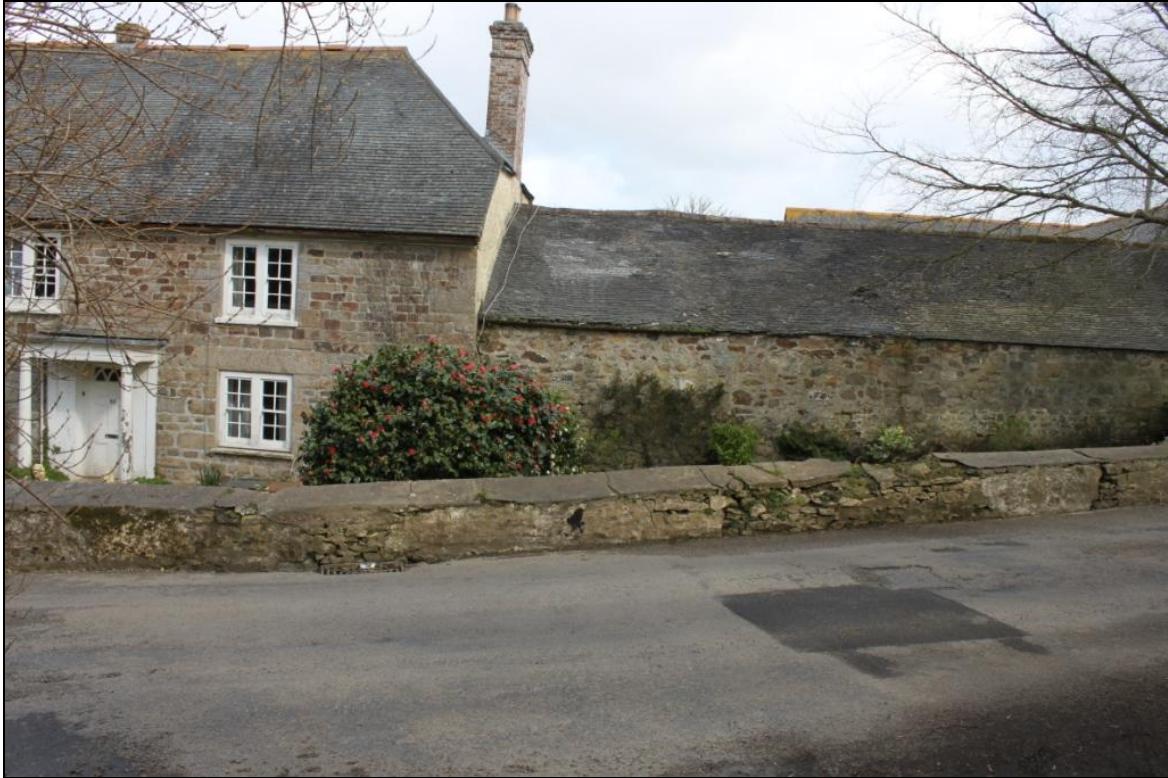
Treloweth Lane as it runs through the hamlet of Treloweth is currently quite narrow and flanked on either side by stone walls and or stone faced hedgebanks. The farmhouse, cartshed, stables and garden walls to Treloweth farmhouse are also Grade II Listed and need to be carefully considered within any proposed works. The Listed structures appear externally to be in relatively good condition, but the garden wall appears to be deteriorating in places, and has been subject to some unsympathetic cement repairs (see Figure 12). Any works in this area should consider the opportunity to improve the condition and appearance of these garden walls.

FIGURE 12: TRELOWETH FARMHOUSE (NO.10) AND PARTS OF ITS GRADE II LISTED GARDEN WALLS, NOTE THE CRACKS AND DAMAGE, VIEWED FROM THE SOUTH-WEST (NO SCALE).

The proposed development should be seen as an opportunity to stabilise and improve the condition of some of the designated and un-designated assets which are within the proposal area. The majority of these would focus upon the Grade II Listed and other railway structures, as there are various issues which need addressing, such as loss of brick coping to the bridge and platforms, deterioration of the metal railings, etc.

The proposed construction of a pavement within the hamlet of Treloweth and any associated road widening needs to be carefully considered to minimise the impact on the setting and character of the Grade II Listed structures. The garden wall to No. 10 (Treloweth Farmhouse) could be stabilised and repaired where necessary, as it has some slight damage, and has been subject to some un-sympathetic repairs in the past. If the stone wall opposite No. 10 needs to be re-moved it should be re-built in a similar style, using the same materials where possible.

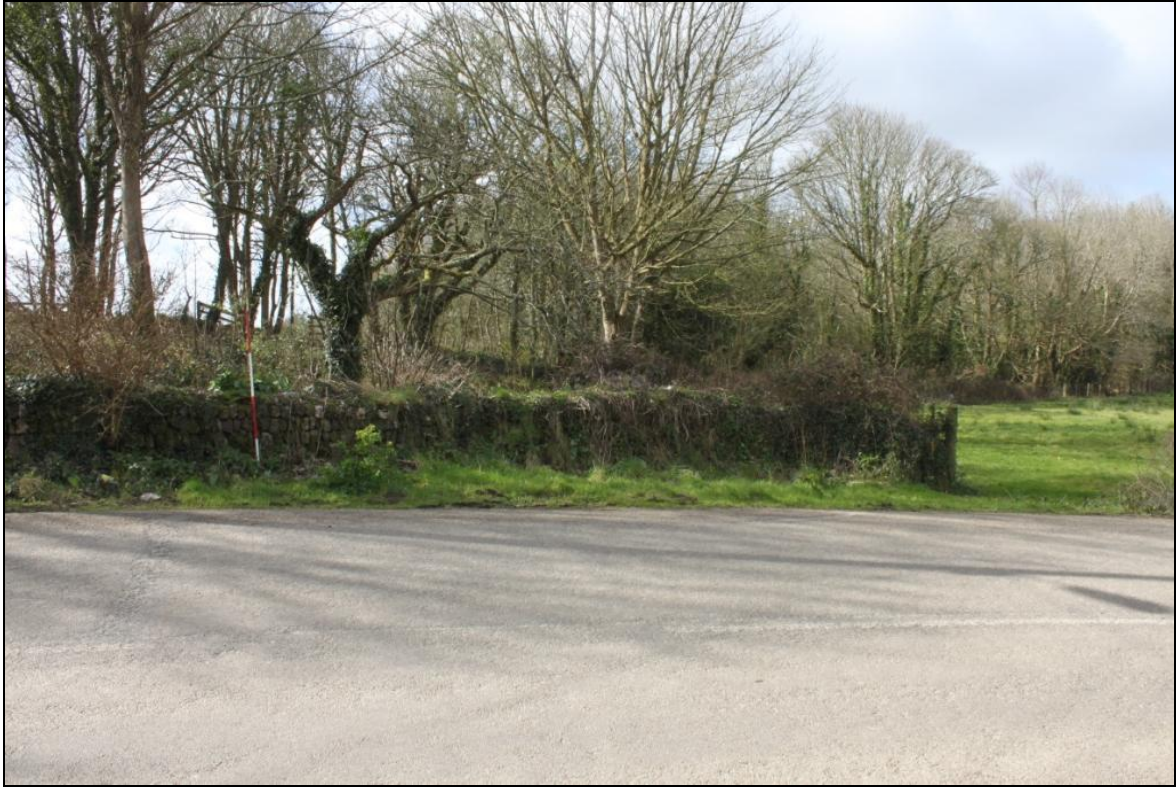
Given the presence of these Grade II Listed garden walls any widening would have to occur largely therefore along the western side of the road. The western boundary immediately opposite No. 10 (Treloweth farmhouse) is of coursed blocky stone, with a late 19th century appearance (Figure 13). A narrow gateway (for a footpath) has been forced in the wall and includes a re-used granite post and a re-used granite window sill. It is recommended that any road widening along this stretch, would re-instate the wall in a similar build-style utilising the existing fabric, where possible.

FIGURE 13: WESTERN BOUNDARY OPPOSITE TRELOWETH FARMHOUSE (NO. 10), VIEWED FROM THE EAST (2M SCALE).

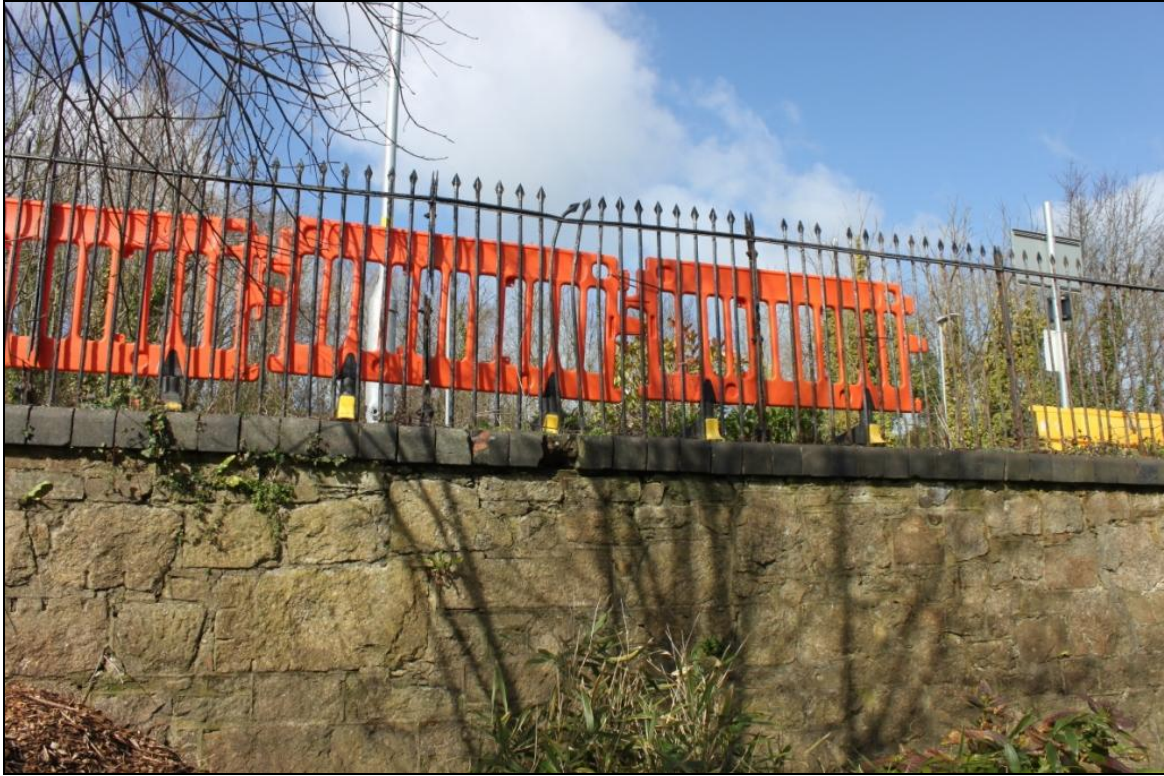
The churchyard slopes gently from south-east to north-west, and comprises a neatly maintained lawn with a sprinkling of specimen trees. The east boundary is a modern fence and hedge line. The west boundary has recently been cut back, with a wooden post fenceline and fallen fence with some trees beyond, leaving a narrow path between the two fencelines. The north boundary comprises the retaining wall for the platform, which consists of large granite blocks and rubble stone capped with engineer bricks, and topped by a wrought iron fence. The condition of this wall, in particular the fence and brick capping, is deteriorating (see Figure 16). The western end of the wall has been repaired/covered in concrete.

FIGURE 16: DAMAGED RAILING AND BRICK CAPPING TO THE PLATFORM, VIEWED FROM THE SOUTH IN THE KINGDOM HALL GARDEN (NO SCALE).

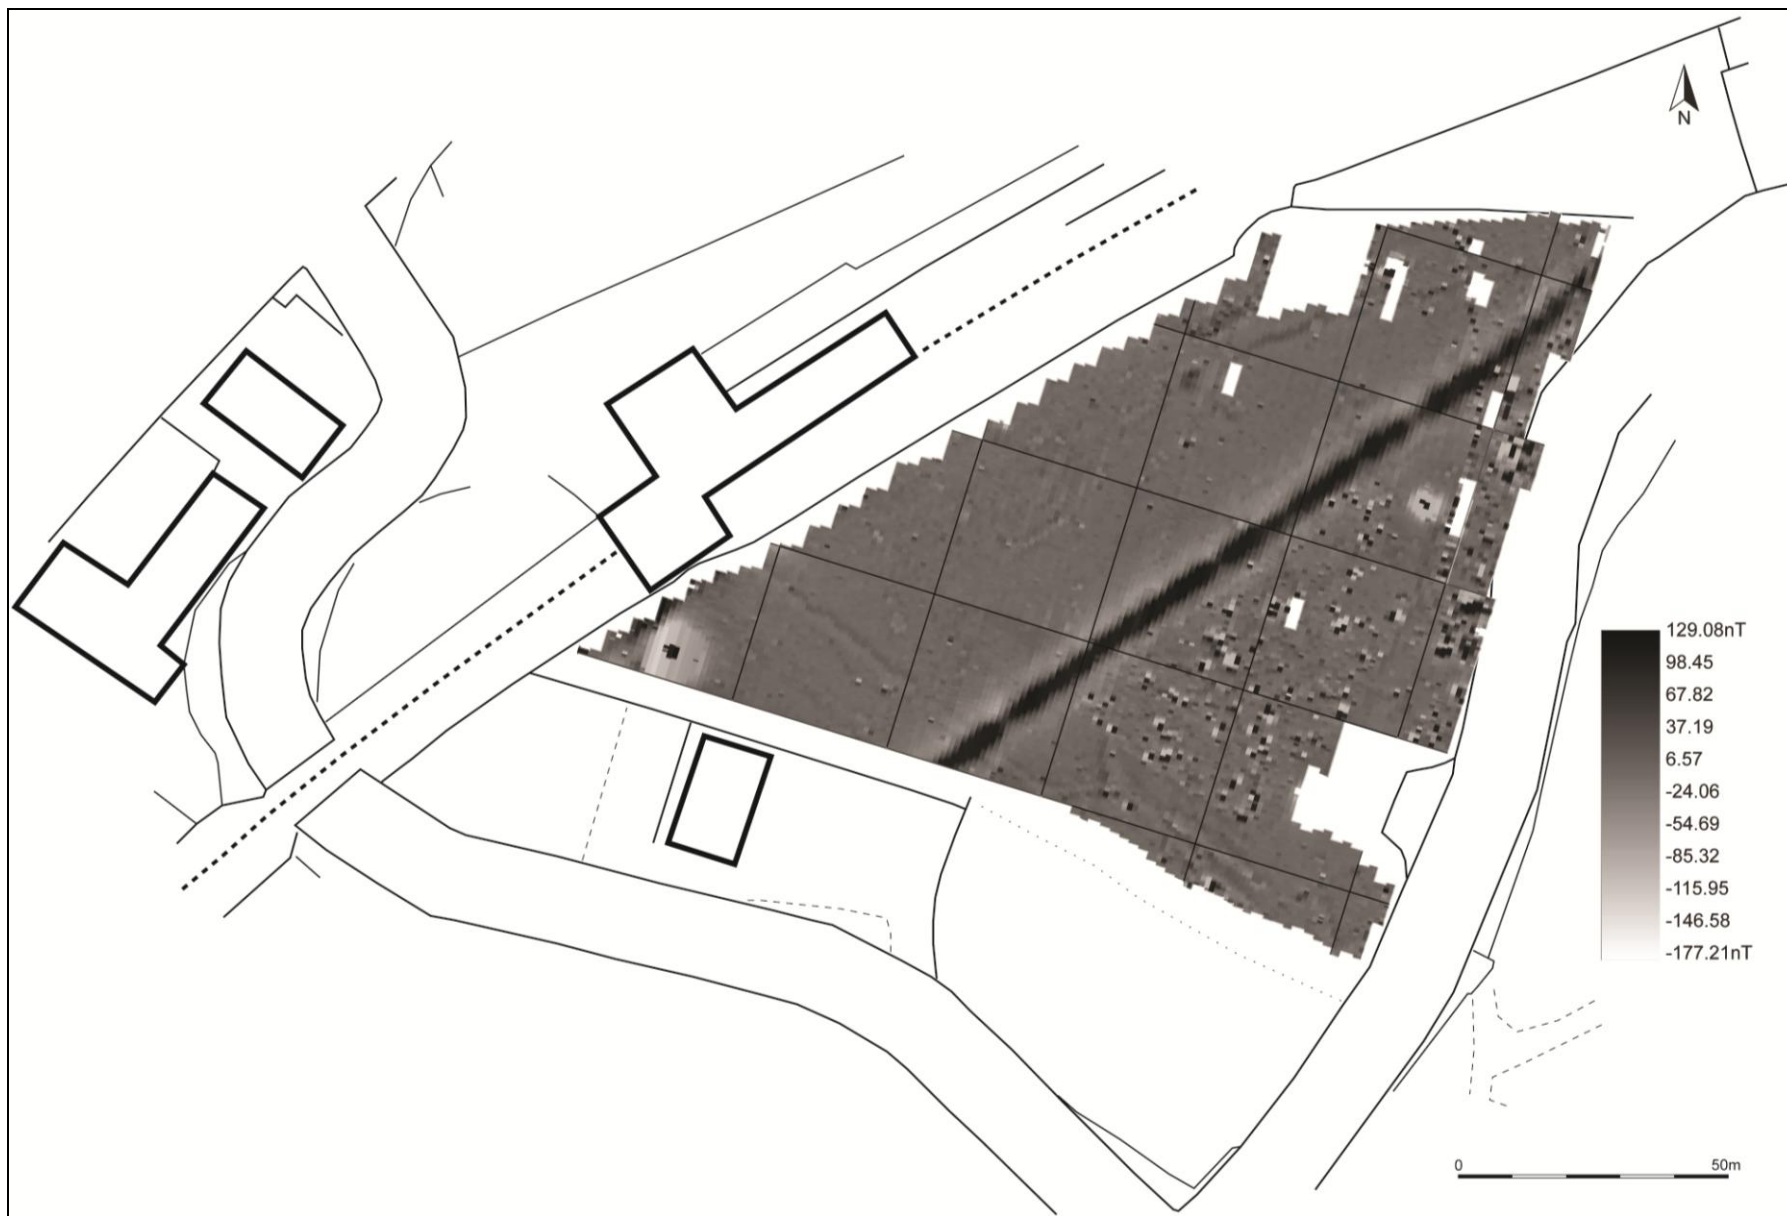
Figures 17 and 18 with the accompanying Table 2 show the analyses and interpretation of the geophysical survey data. Additional graphic images of the survey data and numbered grid locations can be found in Appendix 3.

FIGURE 17: SHADE PLOT OF GRADIOMETER SURVEY DATA (MINIMAL PROCESSING).

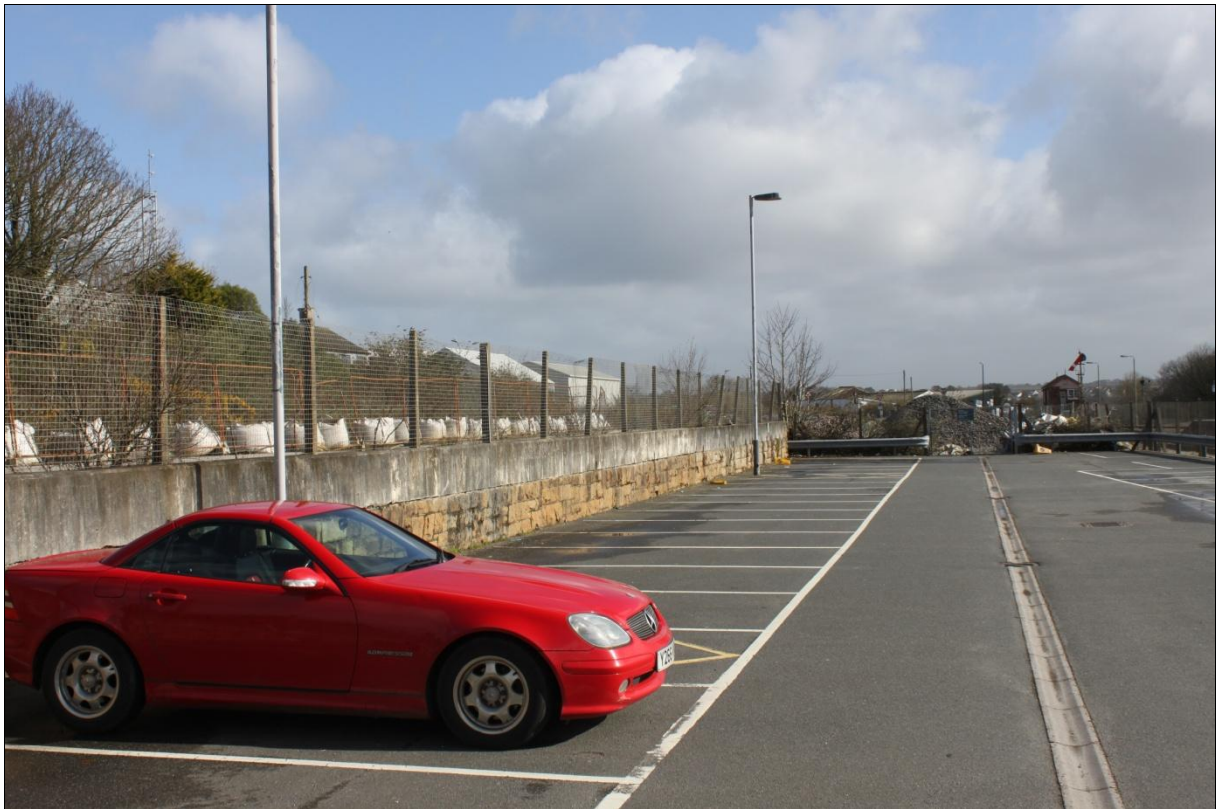
Northern car park and retaining wall; viewed from the south-west.

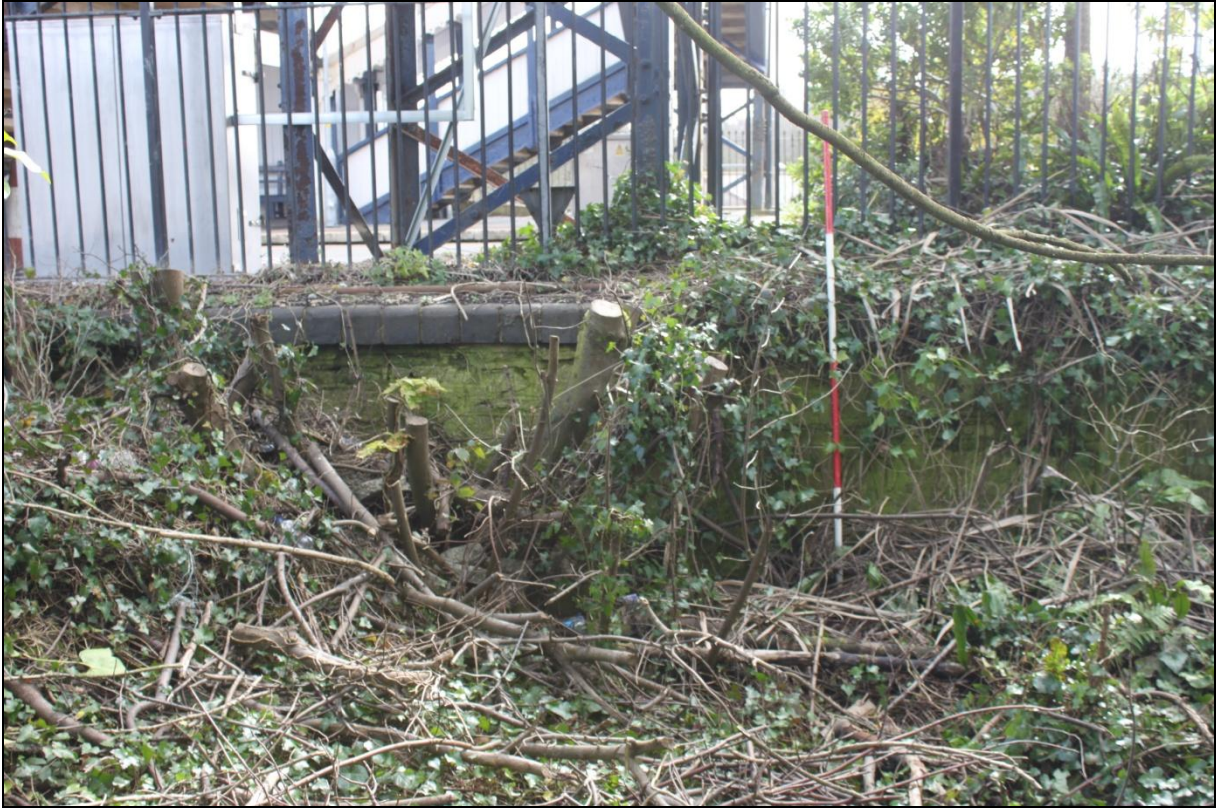
Retaining wall to platform in scrub area, eastern end; viewed from the north (2m scale).

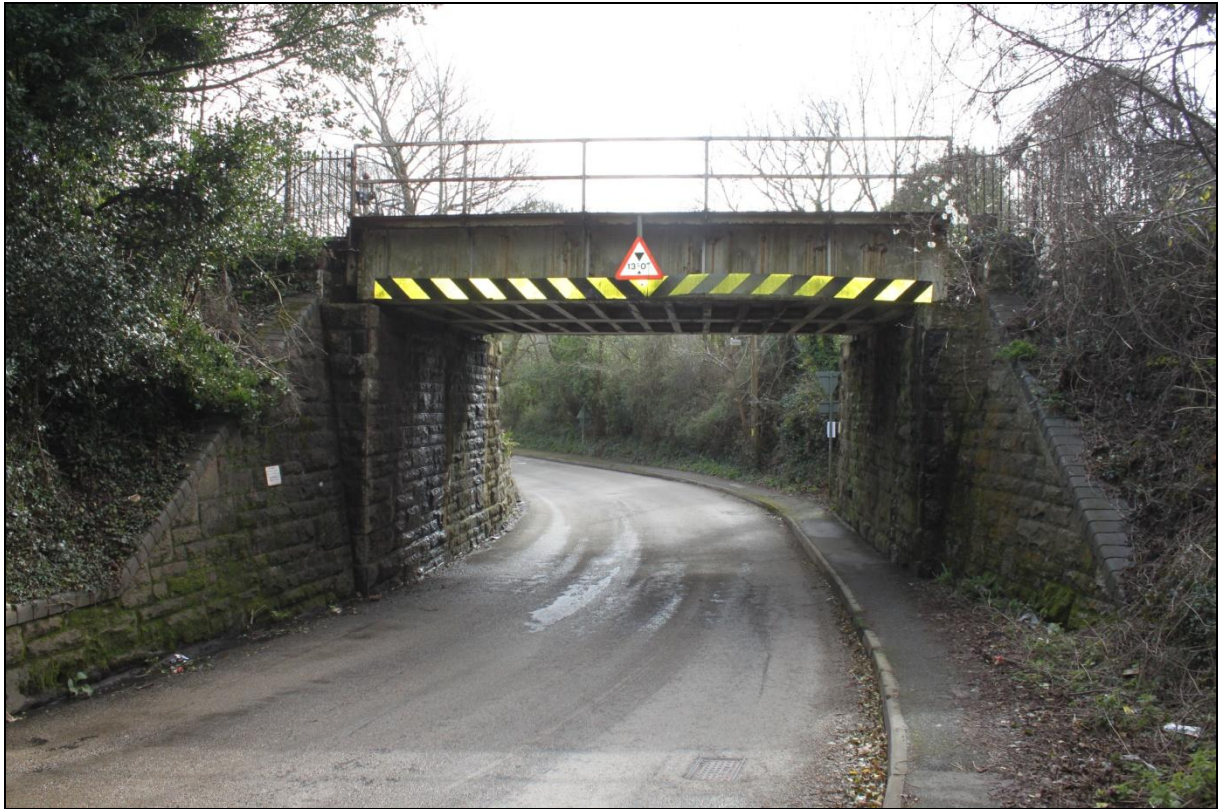
From an historic and archaeological perspective, there is very little of note in this area. The only feature of merit is a late 19th century railway bridge, which would benefit from some repair and maintenance work, as some of the black engineering bricks capping the sides have become loose, others are missing, and parts are obscured by hill wash. As part of the proposed development, the pavement will be moved to the other side and will cut into the earth bank to the north, but this has no archaeological implications.

Railway bridge; viewed from the north-west.

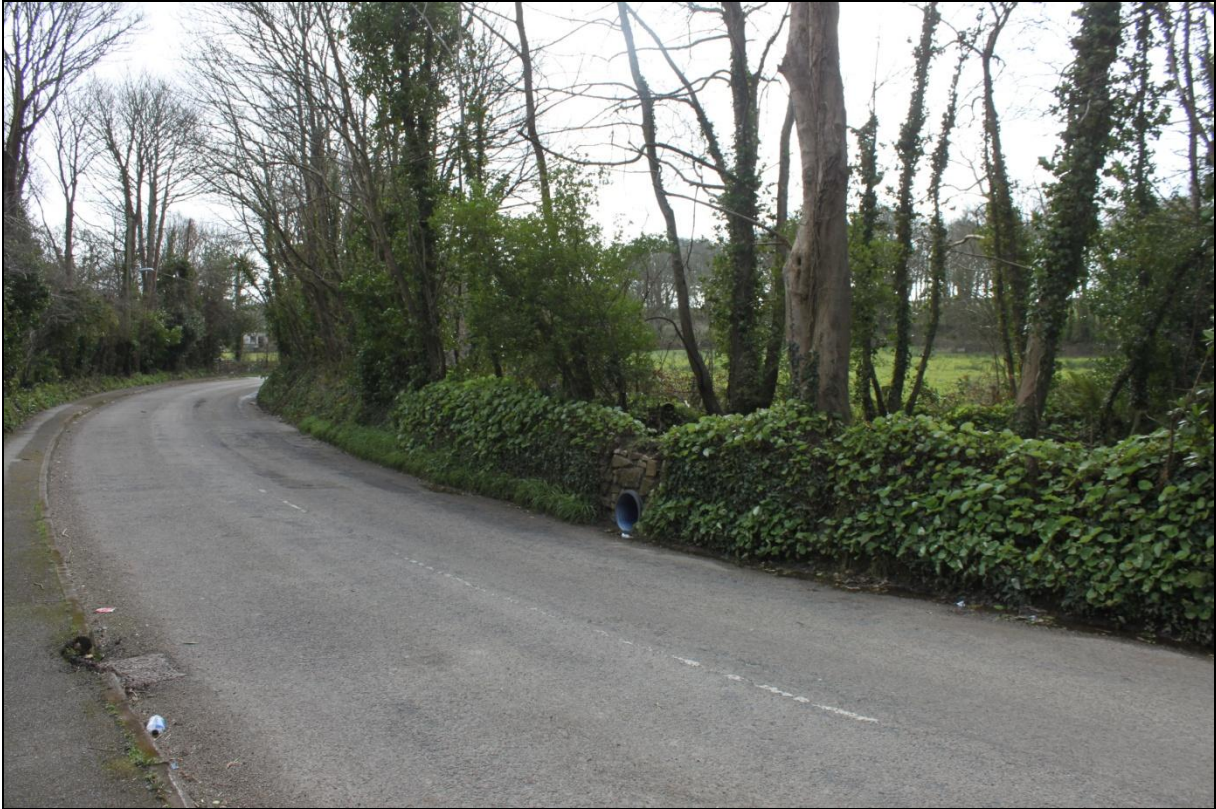
Recent drain/repair in southern/western boundary to road; viewed from the north.

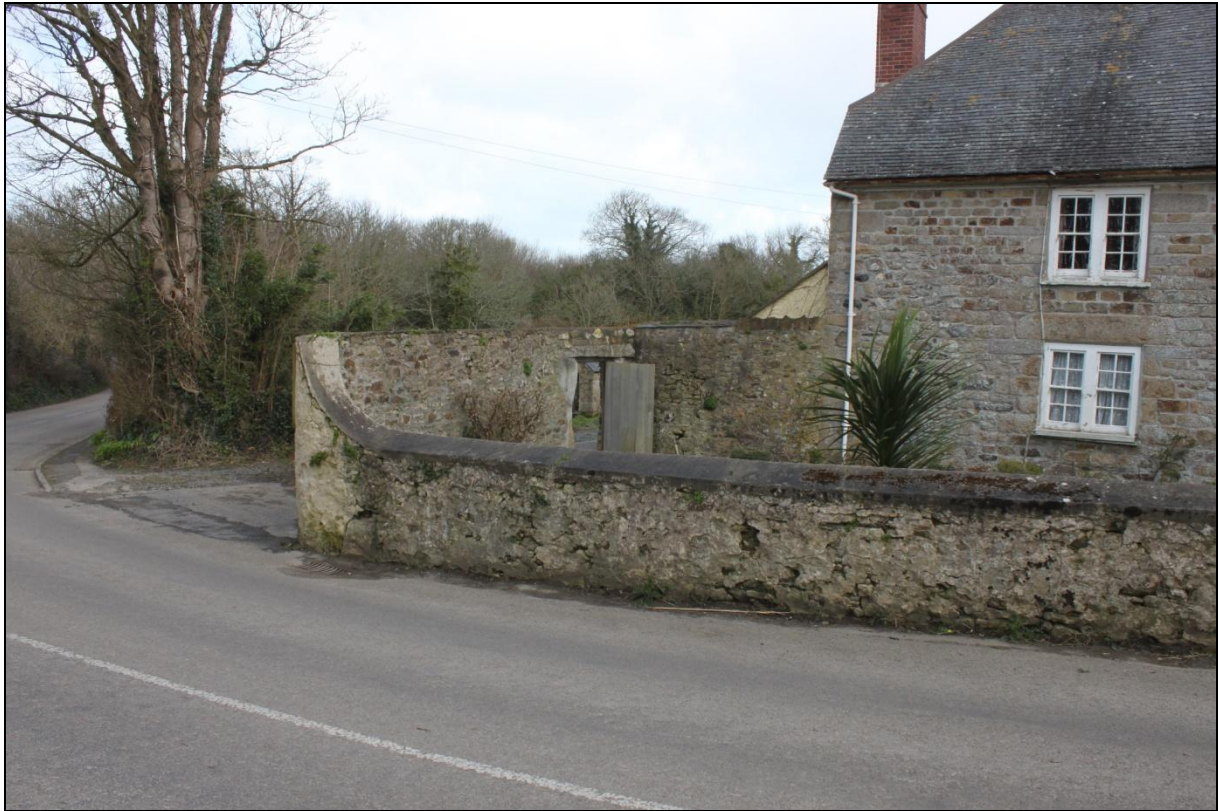
Grade II Listed boundary walls to Treloweth Farmhouse; viewed from the south.

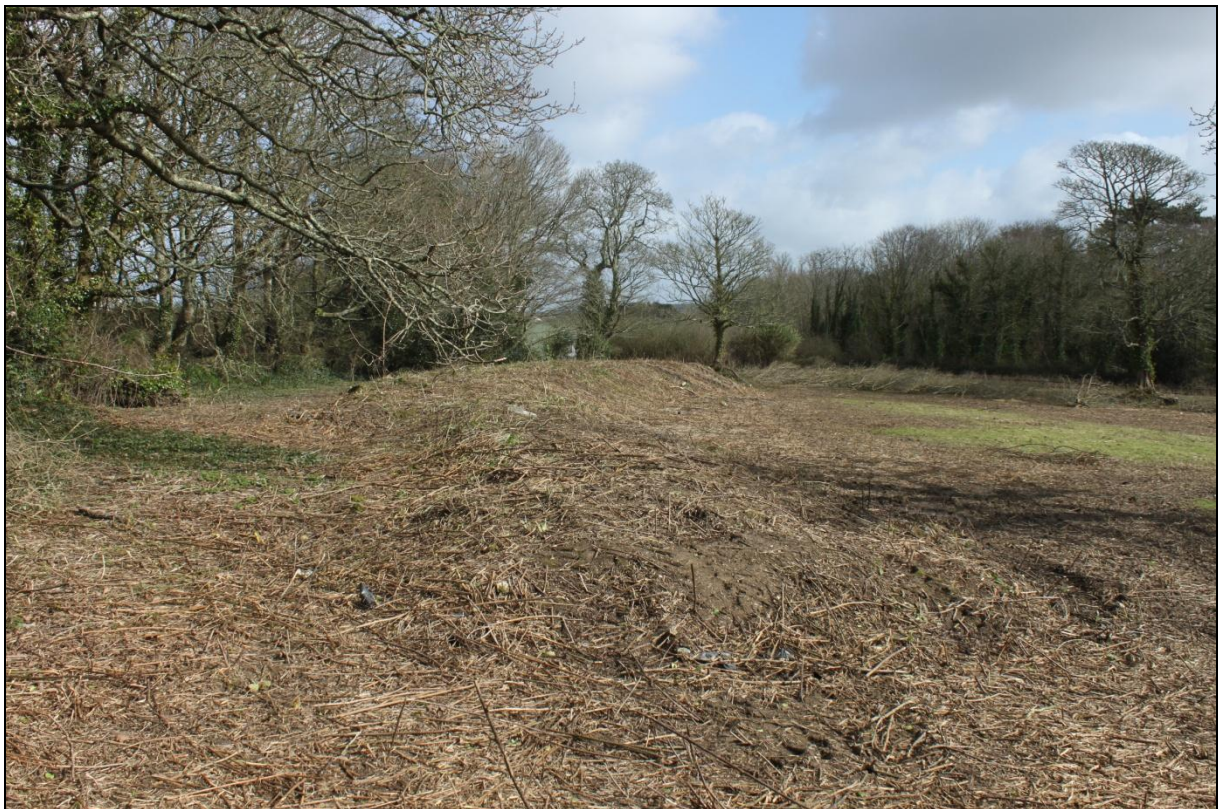
Earthen bund (containing contaminated soil) to east of field; viewed from the north-west.

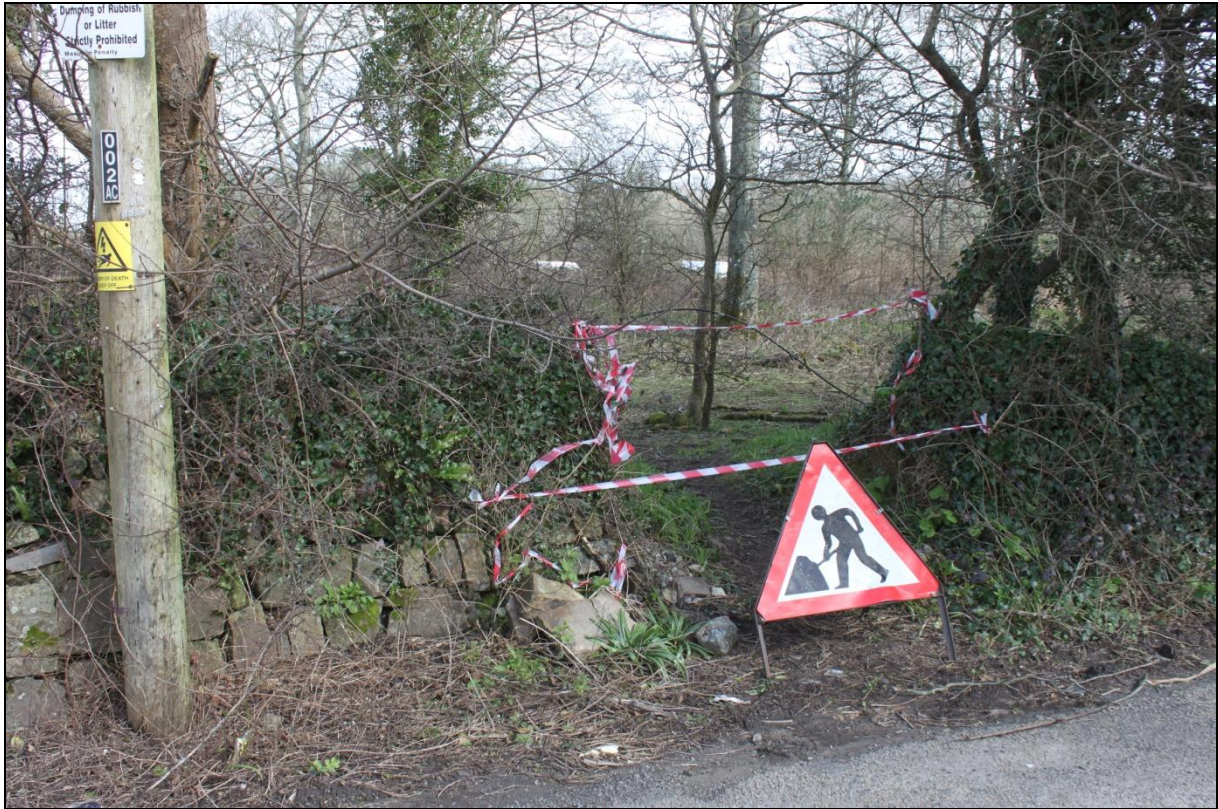
Forced gate in west boundary; viewed from the south-west.

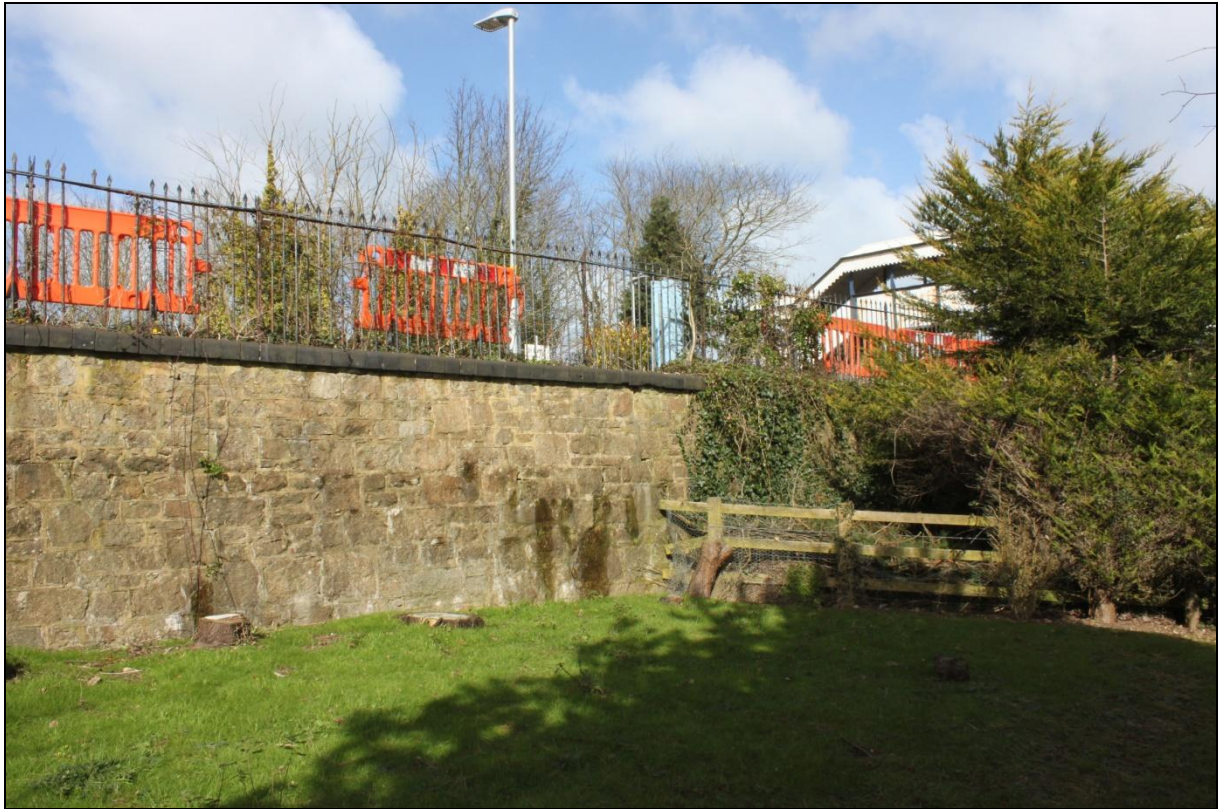
Platform retaining wall in Kingdom Hall plot; viewed from the south.

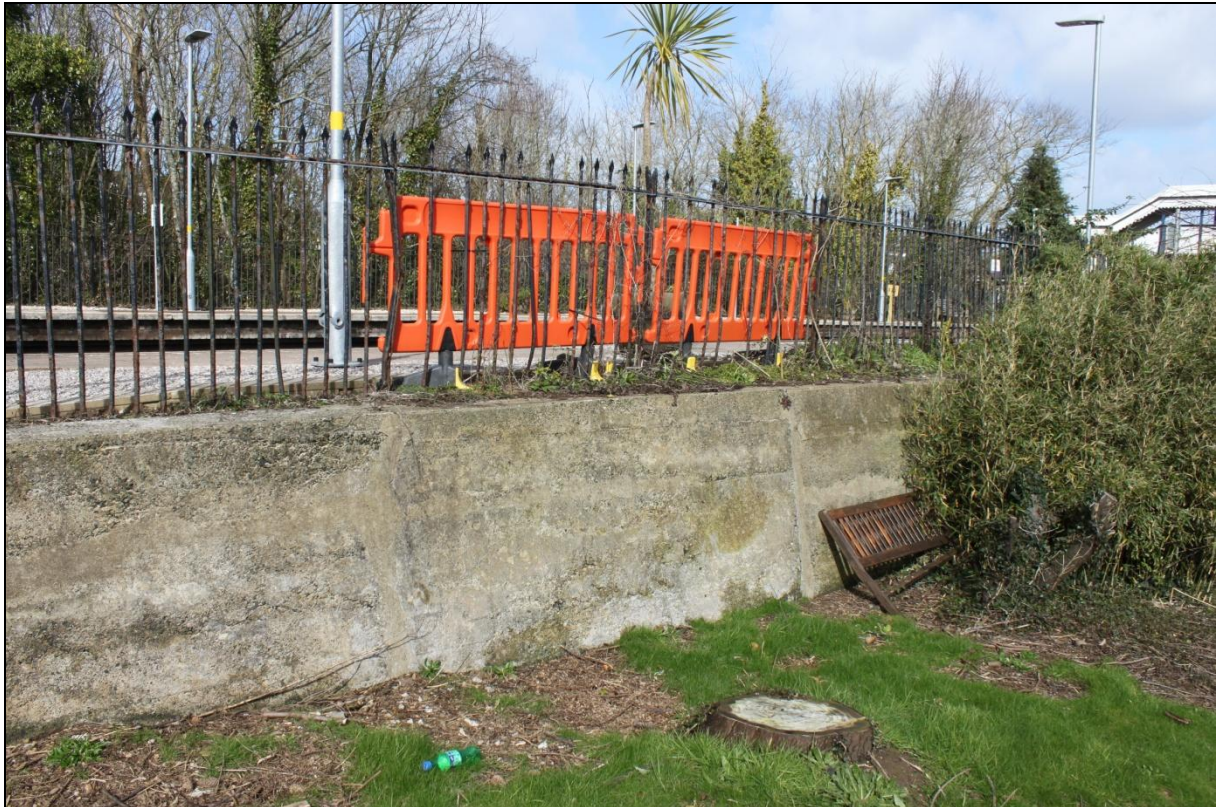
Repairs at western end in Kingdom Hall plot; viewed from the south.
