# LAND AT UNION CORNER FALMOUTH CORNWALL

Results of a Desk Based Assessment  
& Archaeological Gradiometer Survey

Report No.: 151123  
Date: 23.11.2015  
Author: J. Bampton

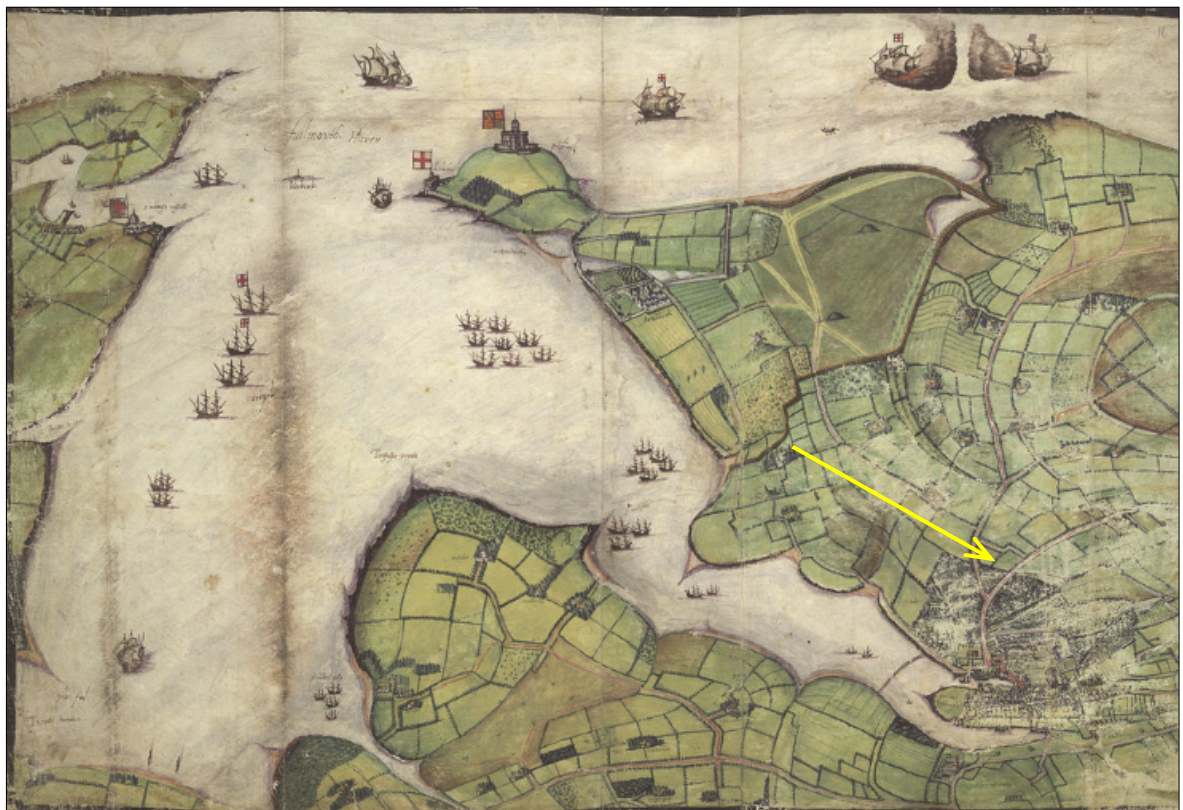
Figure 2: Extract from the Burghley Atlas of 1579 (BL) (the approximate location of the site is indicated).

The earliest useful map depicting the site is Lord Burghley’s Atlas of 1579, which depicts the site as lying within an enclosed fieldscape, and one which still includes unenclosed strip fields.

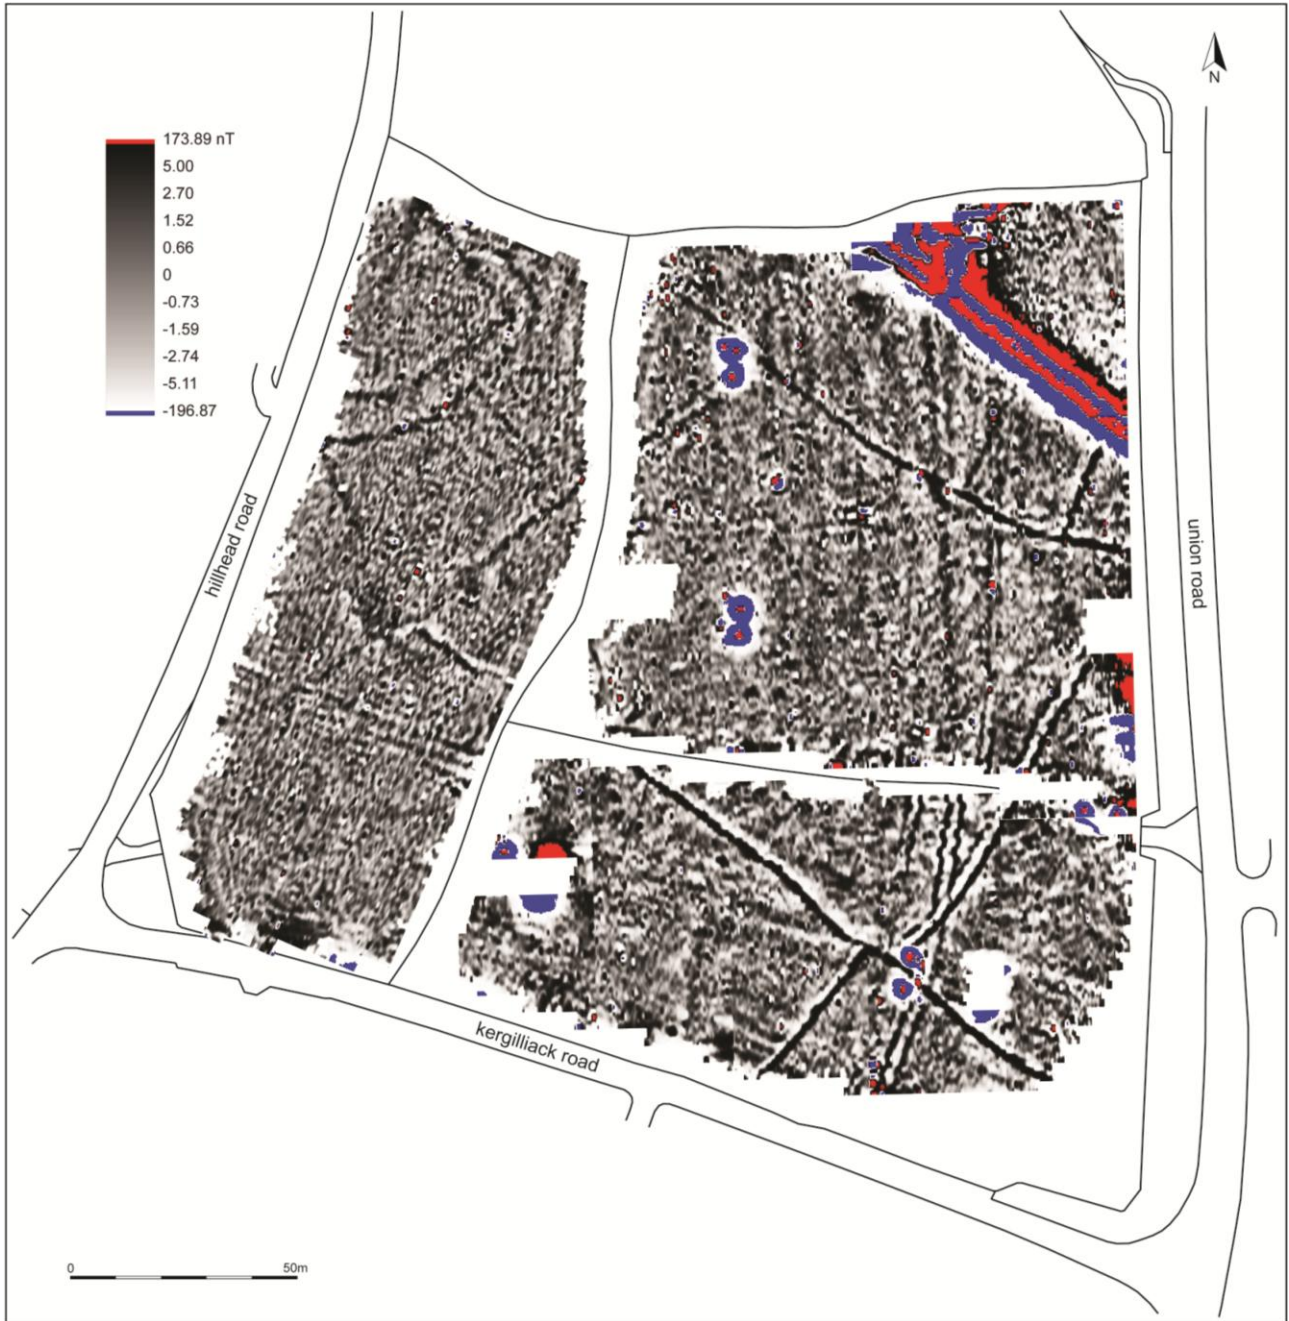
Red-grey-blue shade plot of gradiometer survey data.

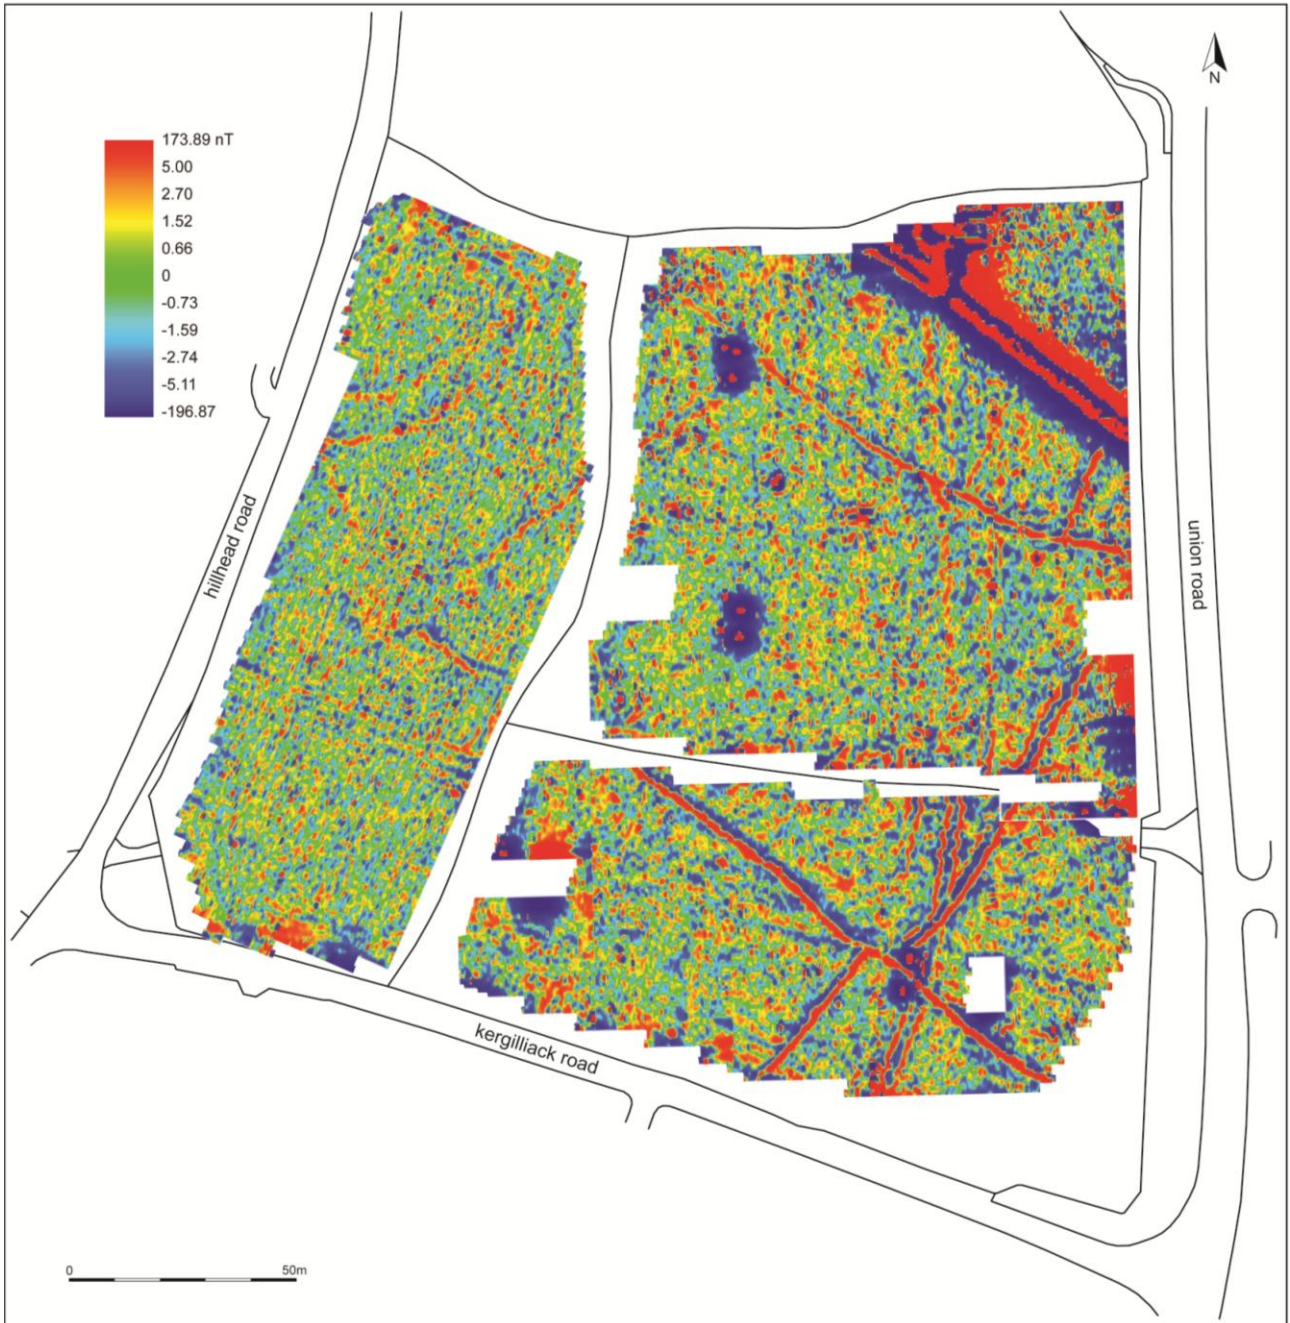
Red-Blue-Green(2) shade plot of gradiometer survey data.
