LAND at BIRCH ROAD LANDKEY DEVON

Results of Desk-Based Assessment &
Geophysical Survey for Phase 2 Development

Report No.: 160623
Date: 23.06.16
Author: J. Bampton
P. Webb

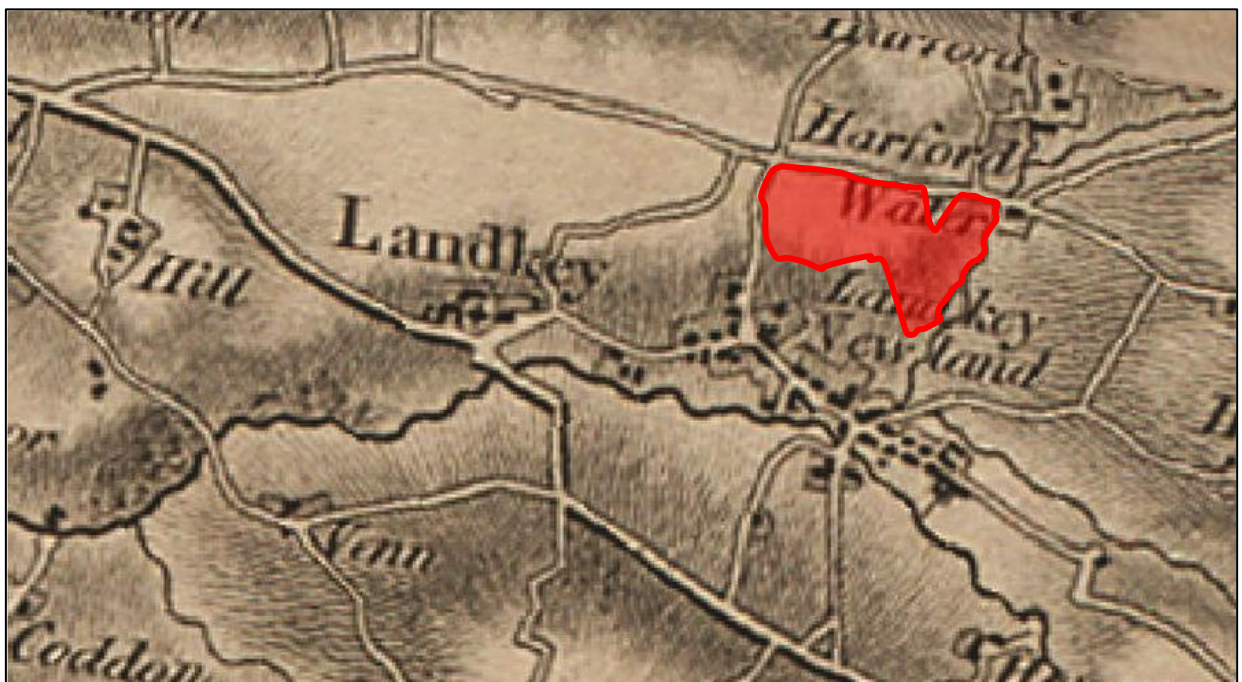
Figure 2: Extract from Donn's map of 1765 (DHC) (the approximate extent of the site is outlined in red).

The first map depicting this area is Donn's map of 1765. This shows the major settlements, roads and watercourse running from Harford Water to Landkey Newland. The church at Landkey is also indicated. It would appear that the site is not occupied with any structures at this time.

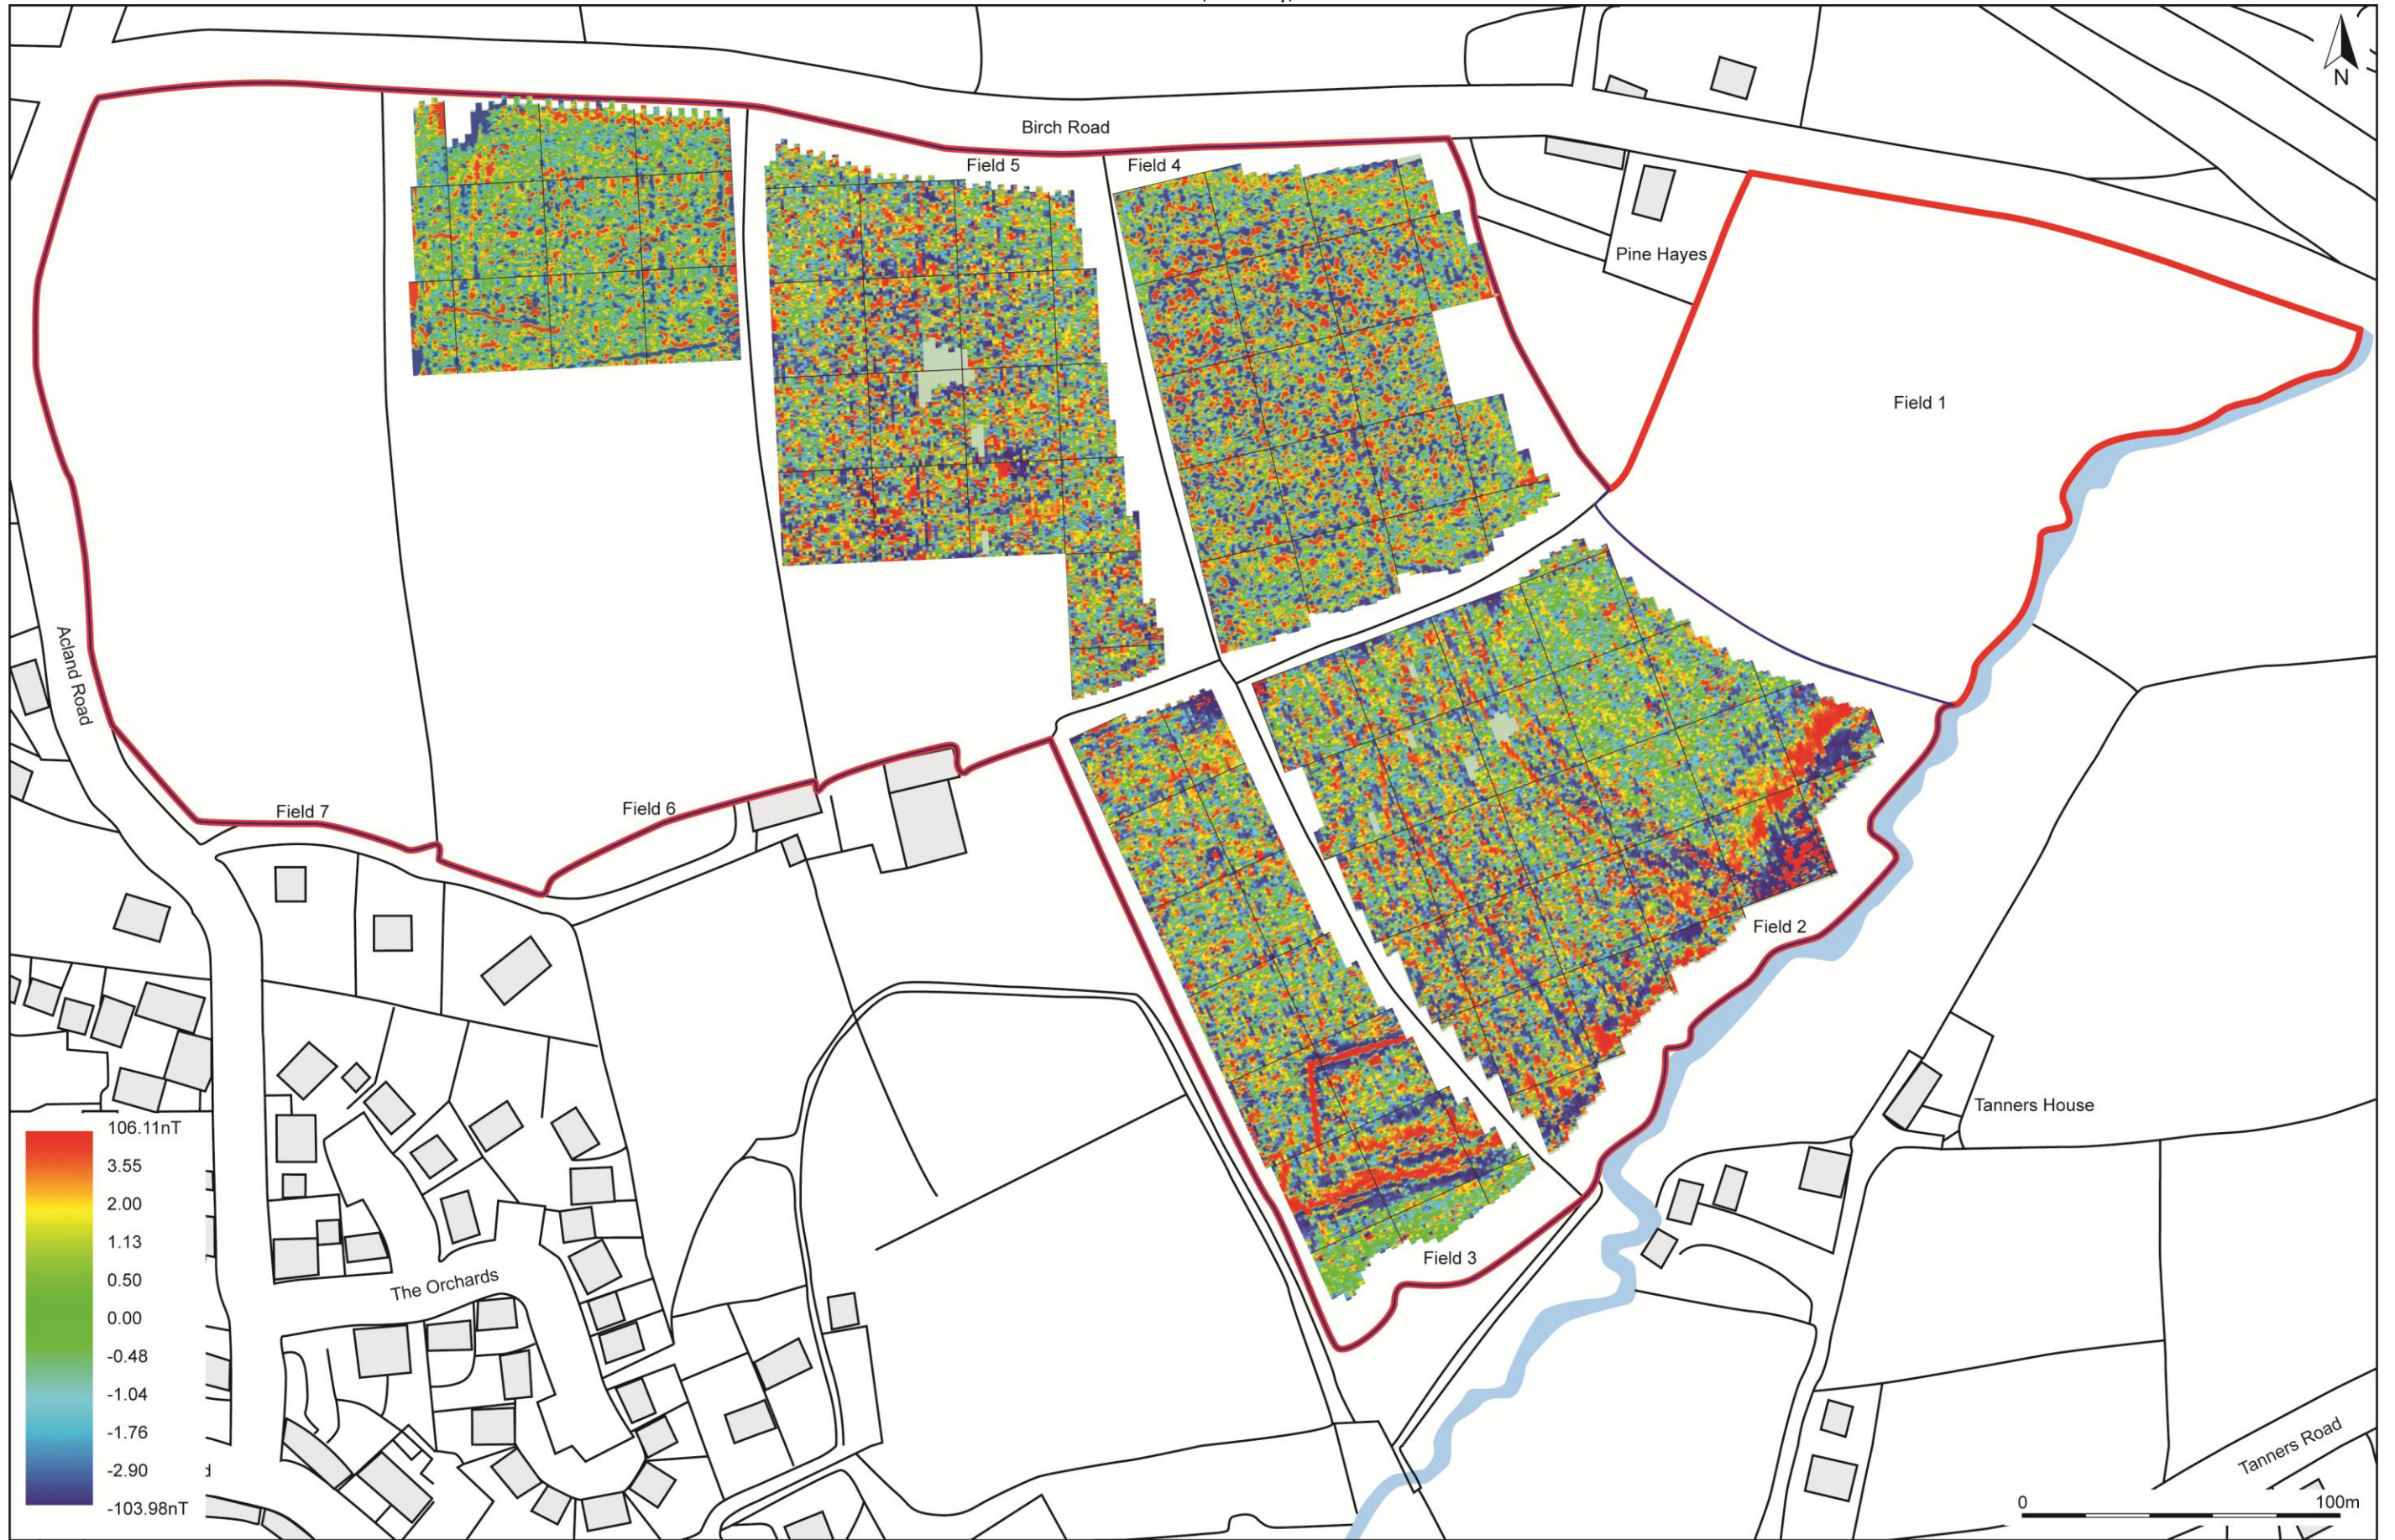
Figure 10: Red-Blue-Green (2) shade plot of gradiometer survey data; gradiated shading.

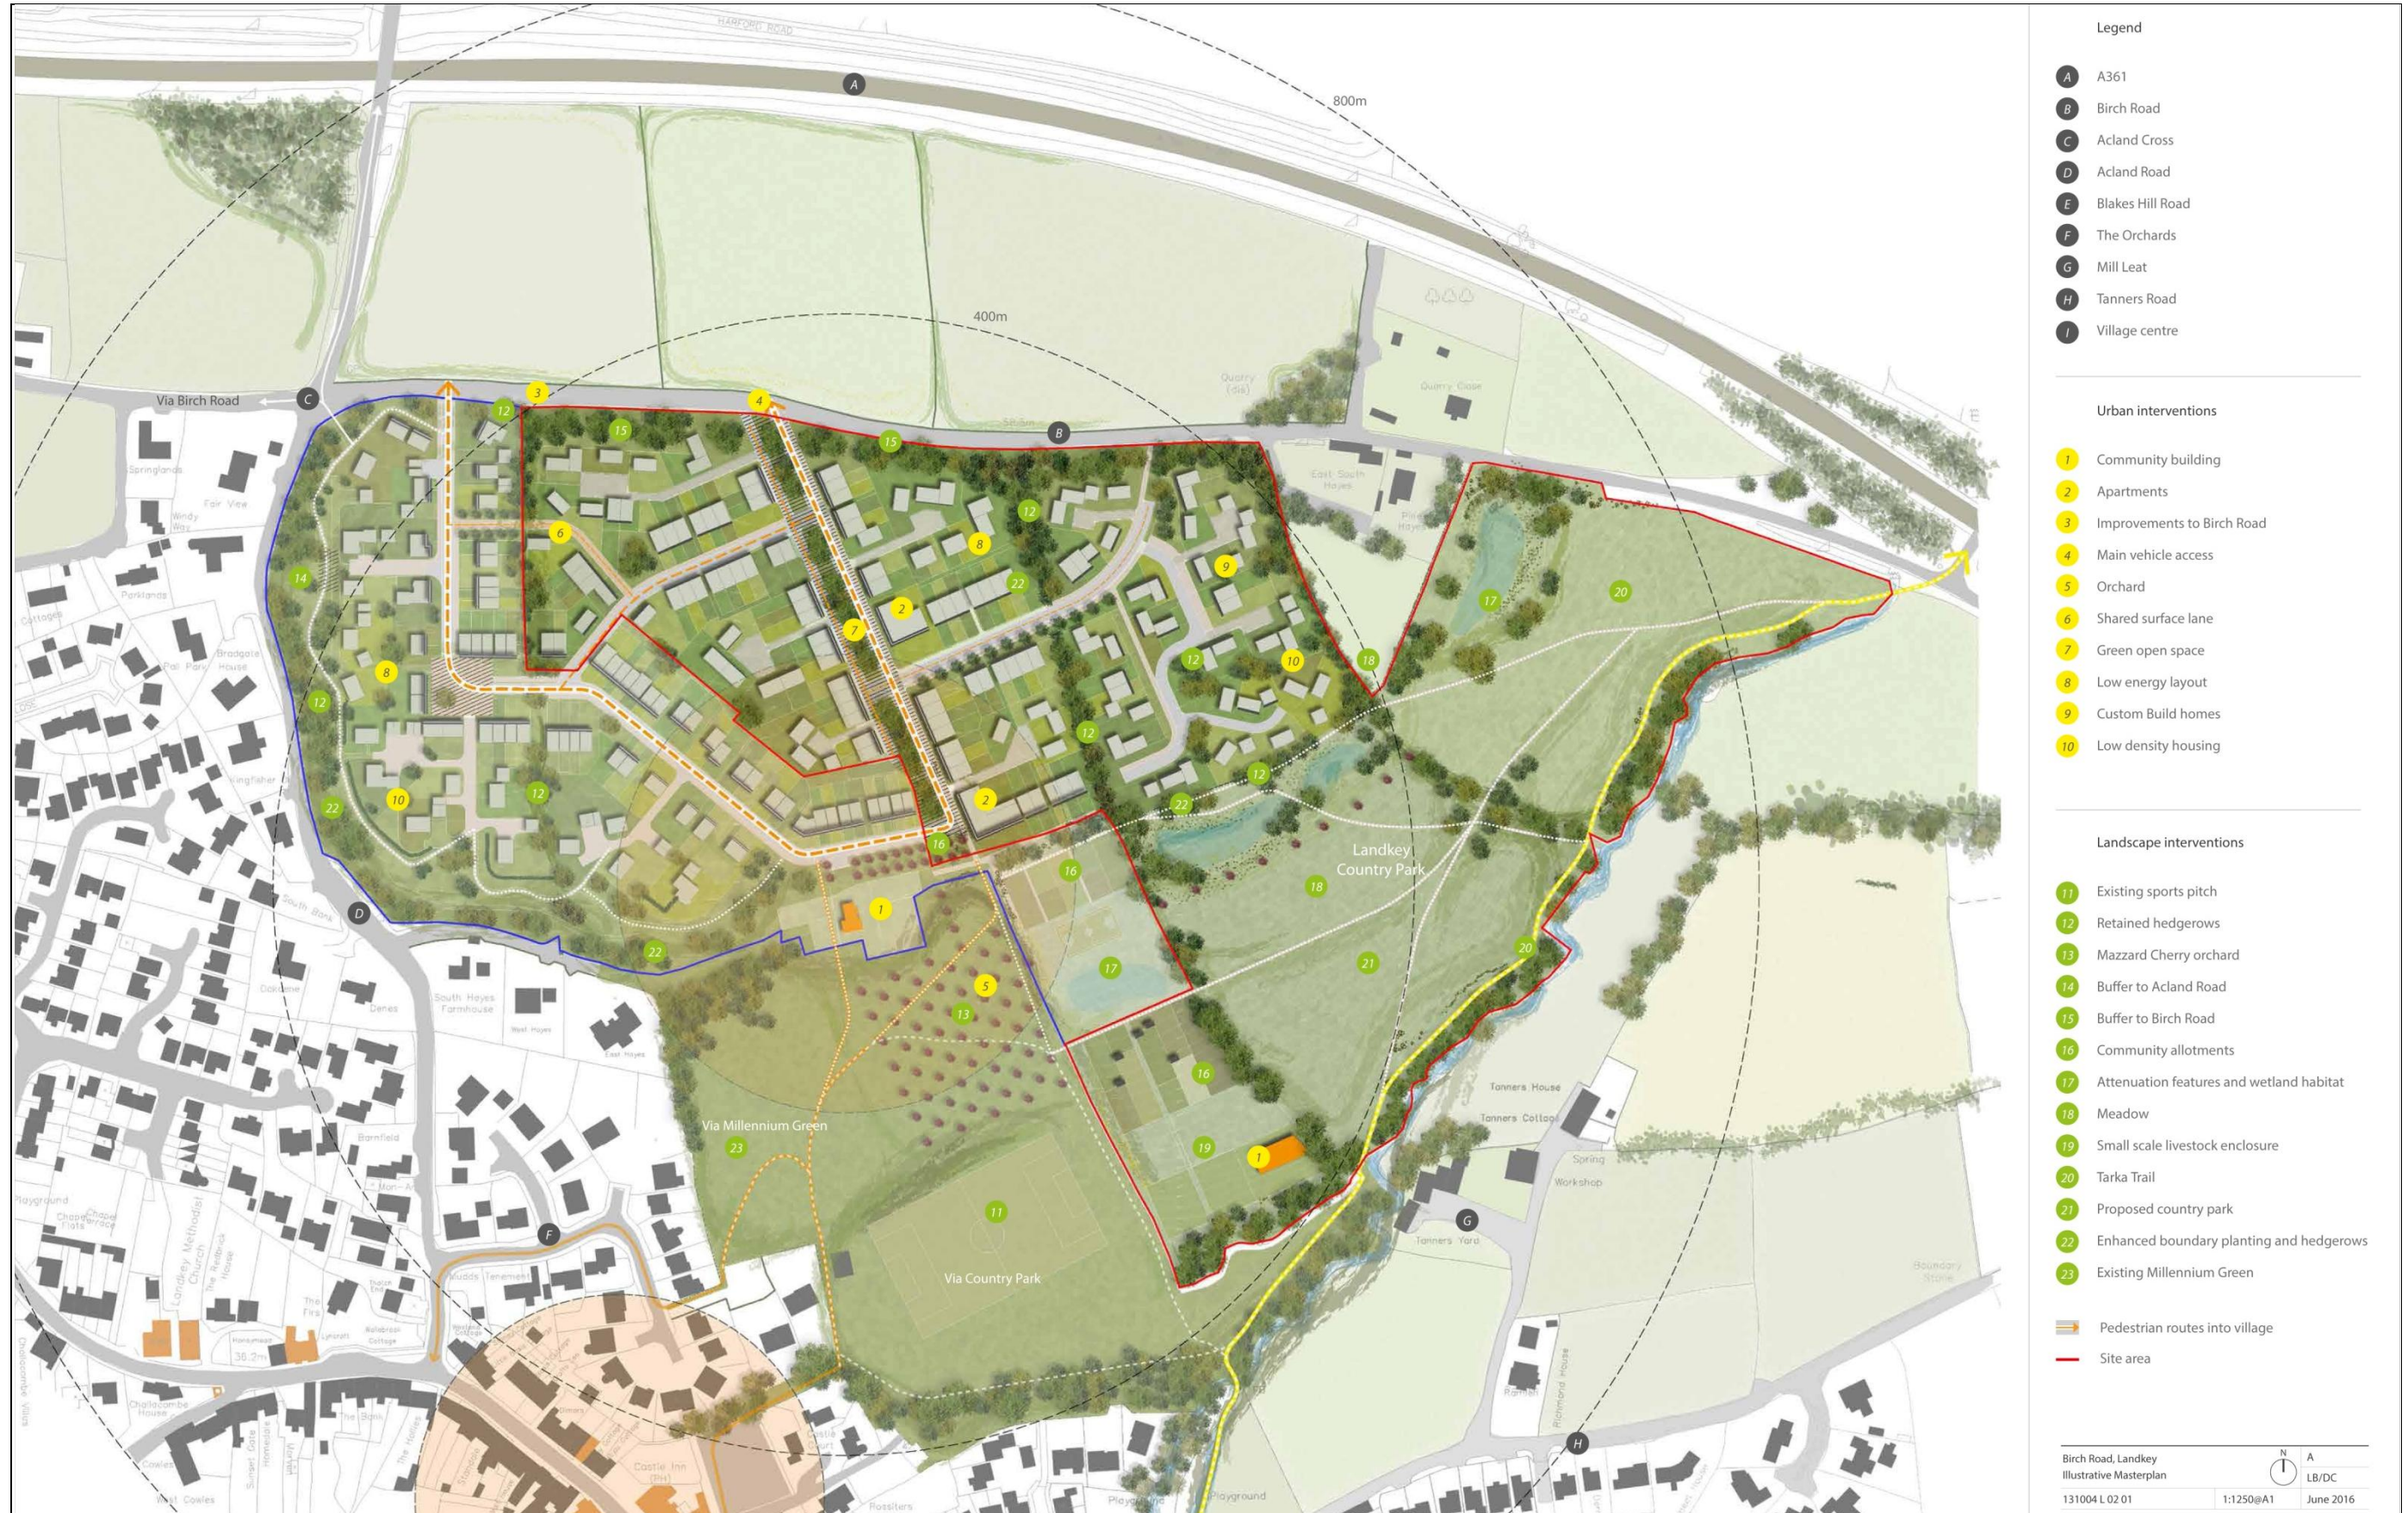
Figure 12: Site Master Plan showing proposed layout.
