LAND AT EDGAR ROAD WAINHOUSE CORNER BUDE CORNWALL

Results of a Geophysical Survey

South West Archaeology Ltd. report no. 160702

By P. Webb
Report Version: Final
2ND July 2016

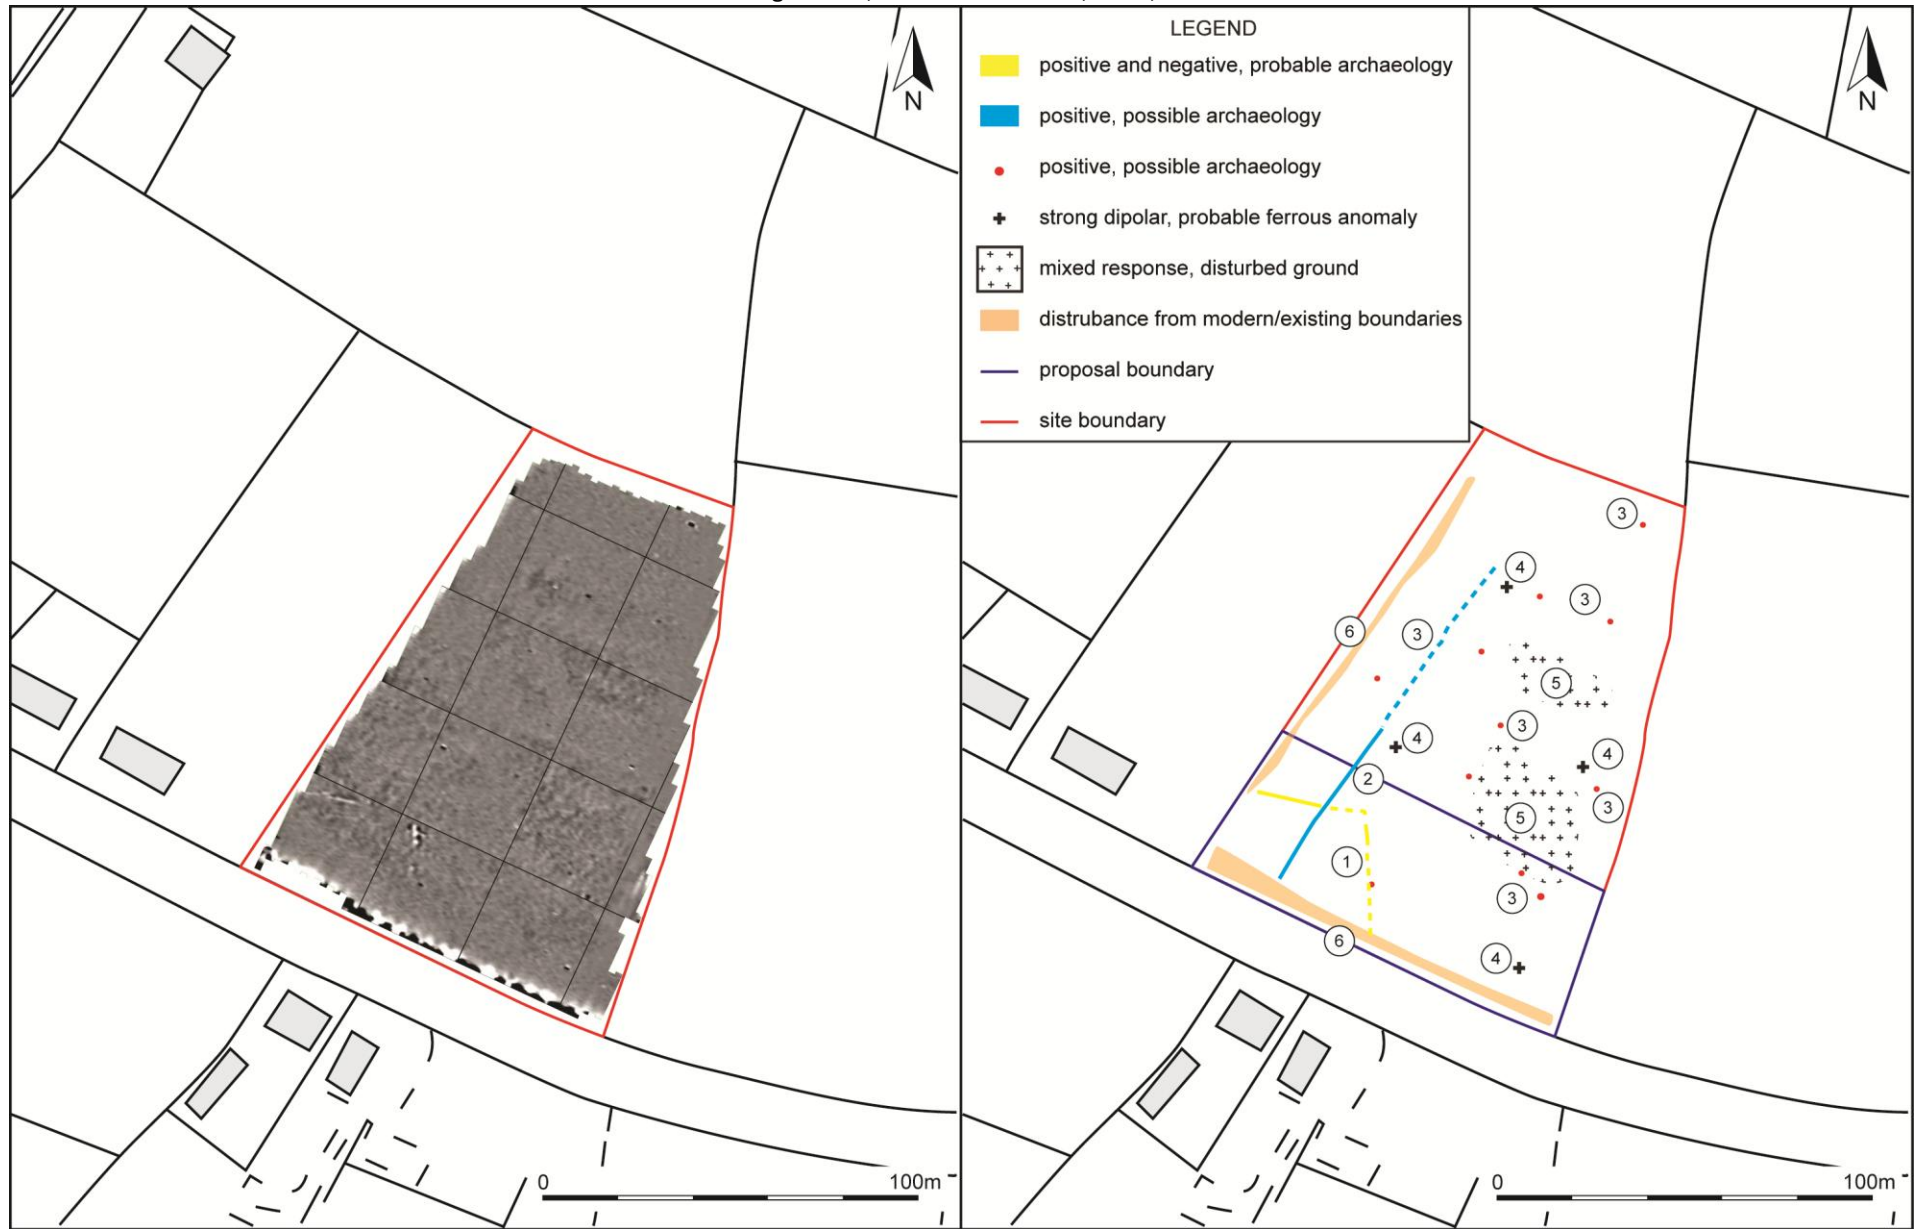
FIGURE 2: SHADE PLOT OF GRADIOMETER SURVEY DATA; MINIMAL PROCESSING (LEFT); INTERPRETATION OF GRADIOMETER SURVEY DATA (RIGHT).

Table 1 with the accompanying Figure 2 show the analyses and interpretation of the geophysical survey data. Additional graphic images of the survey data and numbered grid locations can be found in Appendix 2.

Anomaly group	Class and Certainty	Form	Archaeological Characterisation	Comments
1	Moderate negative with associated positive, probable	Recti-linear	Possible enclosure	A possible rectilinear enclosure in the south-west corner of the site. Responses vary between +36nT and -42nT. Elements appear bipolar suggesting there may be a modern service pipe.
2	Weak positive, possible	Linear	Possible historic field boundary	A linear anomaly, possibly forming a removed historic field boundary, perhaps related to Medieval strip fields. Weak positive responses of up to 11nT.
3	Positive, possible	Sub-oval/ amorphous	Pits	At least ten discreet anomalies, c.<+40nT. Indicative of cut features such as pits or tree-throws.
4	Dipolar, possible	Sub-oval	Metallic deposit	A series of large dipolar response (up to +60/-35nT) indicative of metallic deposits. Likely to be associated with metallic artefacts.
5	Weak mixed, possible	Spread	Disturbance	Two amorphous spreads of weak mixed positive and negative responses (up to +/-12nT). Possibly associated with heavily disturbed ground.

6	Strong positive and negative, probable	Linear	Existing field boundaries	Responses reflecting proximity to existing field boundaries. Readings of up to +125/-92nT.

The survey identified six groups of anomalies: Group 1 represents a possible small rectangular enclosure, or modern service pipe. Group 2 may represent an historic field boundary, possibly part of a medieval strip-field system. Group 3 represents possible pits or tree-throws. Group 4 represents ferrous anomalies, likely buried agricultural artefacts. Group 5 represents two areas of weak magnetic mixed responses indicative of ground disturbance. Group 6 represents interference related to the existing field boundaries.

Group 1 are negative with positive anomalies forming a small rectangular enclosure in the south-west corner of the site. This enclosure is not marked on the OS mapping, although the northern east to west orientated linear approximately aligns with a historic boundary in fields to the west. The primarily negative nature of the response indicates that it may be a low bank-like feature. However, there are elements of bipolarisation which may indicate the presence of a modern service pipe.

Group 2 constitutes a weak linear positive anomaly indicative of a ditch feature. It runs parallel to the existing north to south boundaries, and is likely to have formed a boundary as part of a Medieval strip-field system.

Group 3 is composed of at least ten discrete positive anomalies. These are generally caused by in-filled cut features and could be pits of archaeological origin. However, they could equally be indicative of naturally occurring tree-throws or geological features.

Group 4 are four discrete dipolar anomalies. They are moderately strong responses and may indicate metallic objects, which given the agricultural nature of the site may be agricultural in origin.

Group 5 comprises two areas of mixed magnetic positive and negative responses. The weakness of the anomalies indicates that they relate to areas of disturbed ground. Their location is consistent with slight ridges either side of a depression in the field, also the approximate location of the possible ploughed-out barrow. These results indicate that if a barrow did exist it has been almost completely destroyed.

Group 6 are two positive and negative linear anomalies along the boundary of the site. They are strong responses and reflect interference caused by proximity to the existing field boundaries which contain metal fencing.

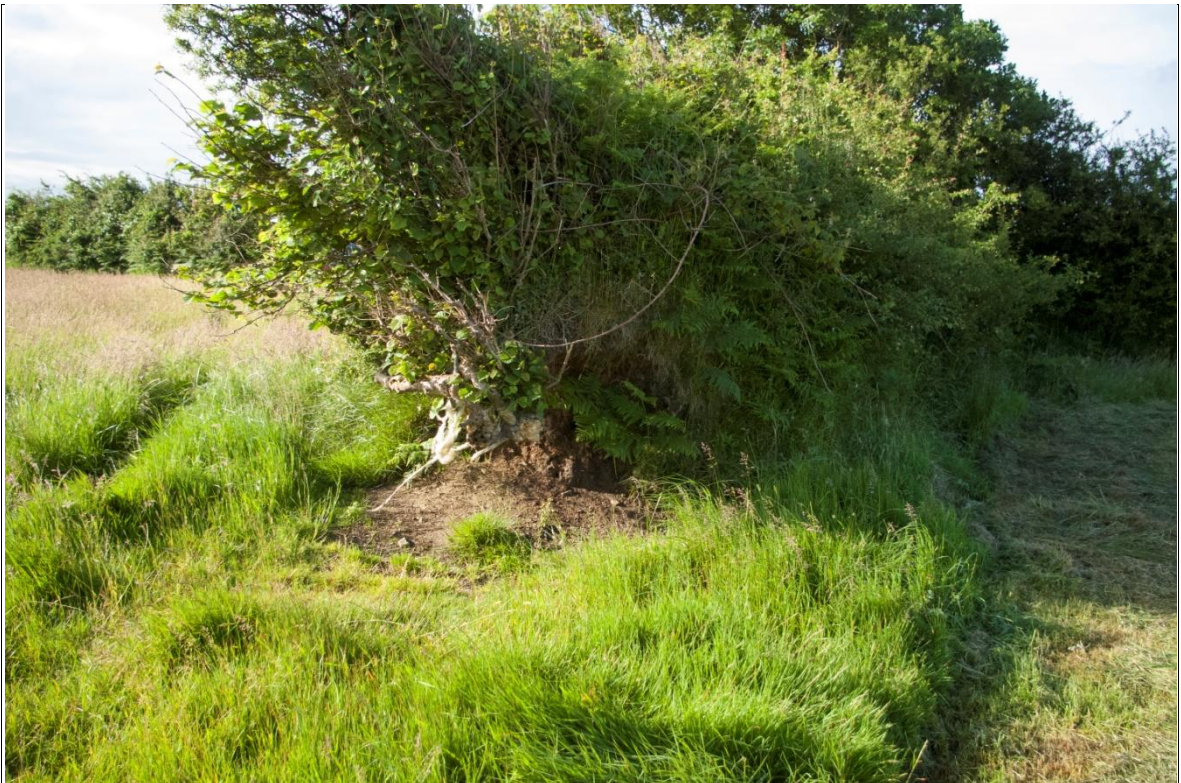
DETAIL OF THE HEDGEBANK FORMING THE EASTERN SITE BOUNDARY; VIEWED FROM THE NORTH-NORTH-WEST.

The site was bounded on its north, east and south sides by hedgebanks, and on its west side by a wooden post and wire fence. The hedgebanks were all overgrown, containing hawthorn, brambles and fern. The entrance was located at the south-east corner and formed by a break in the east hedgebank boundary. A crop of grass had recently been cut on the site. Some slight topographic variation of the site was identified centrally in the site towards the eastern boundary, in the approximate location of the un-designated barrow site. A compliment of supporting photographs of the site can be seen in Appendix 1.

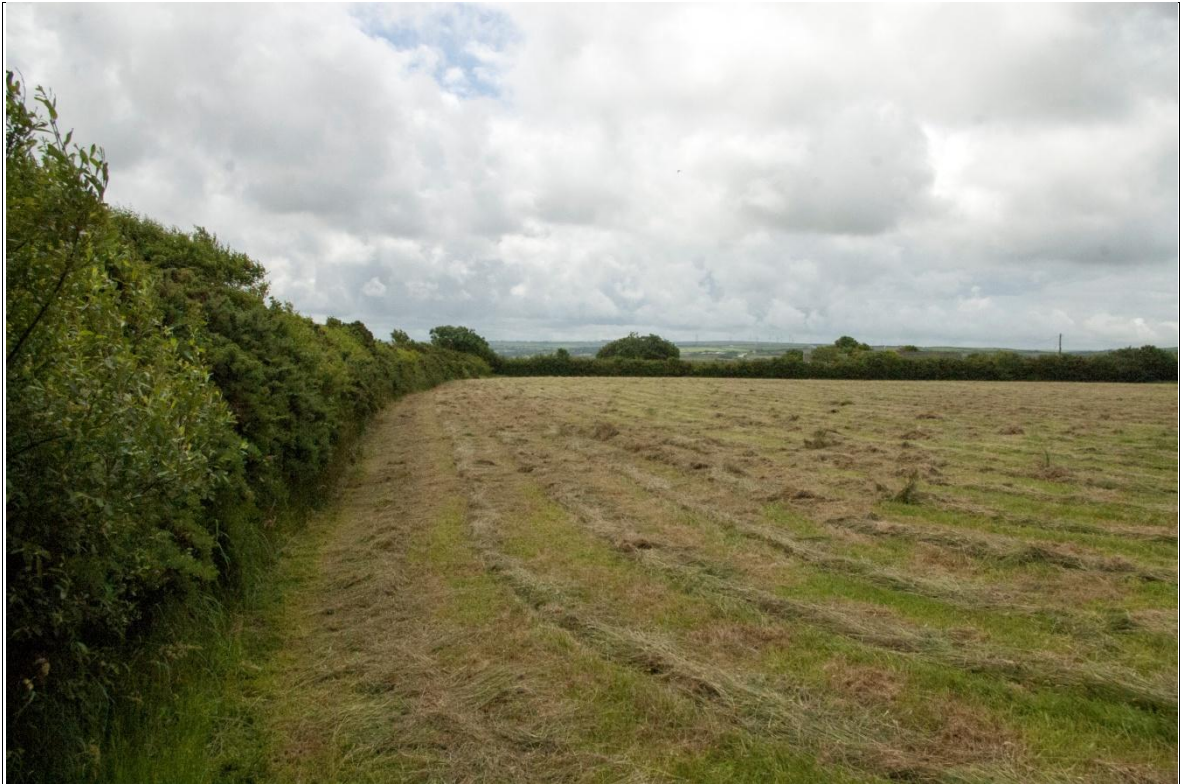
VIEW ALONG THE EASTERN FIELD BOUNDARY, ACROSS THE LOCALE OF THE SUSPECTED PLOUGHED-OUT BARROW; VIEWED FROM THE NORTH.

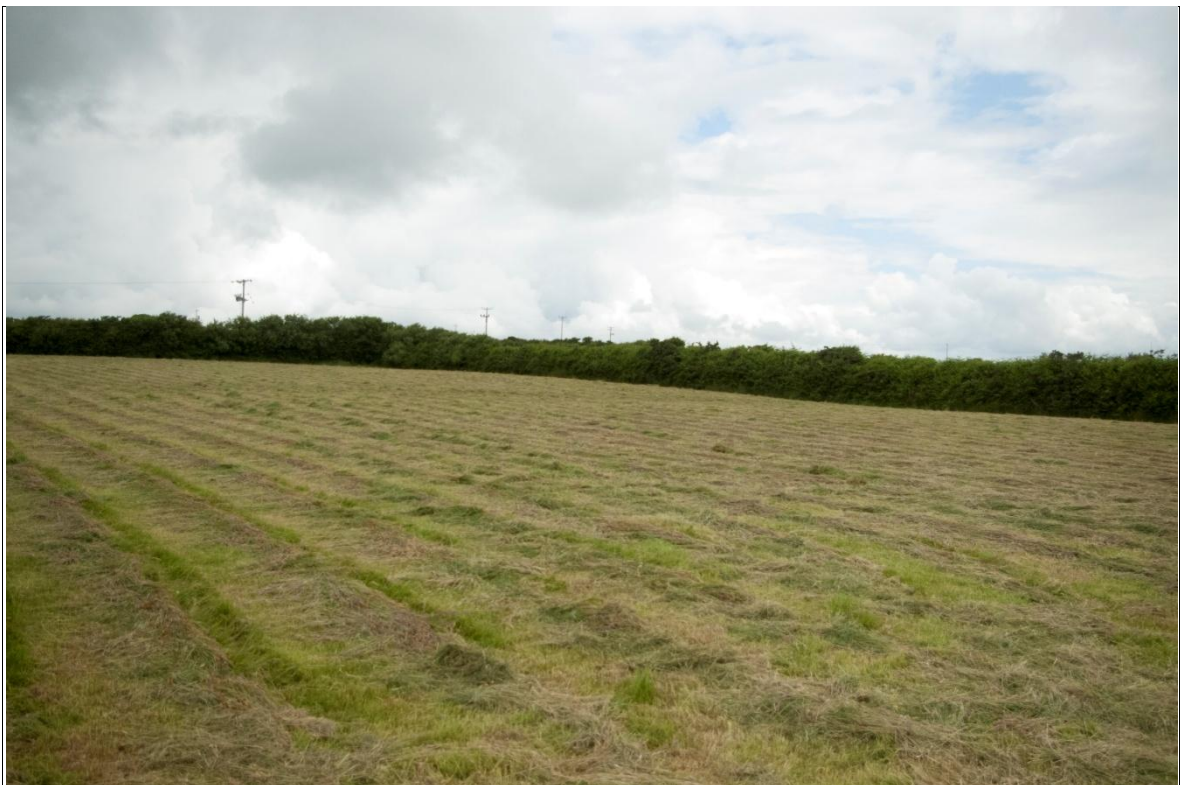
THE WIDER FIELD TO THE NORTH OF THE PROPOSAL SITE, SHOWING THE SLIGHT DEPRESSION BETWEEN TWO RIDGES AGAINST THE EASTERN SITE BOUNDARY; VIEWED FROM THE SOUTH-WEST.

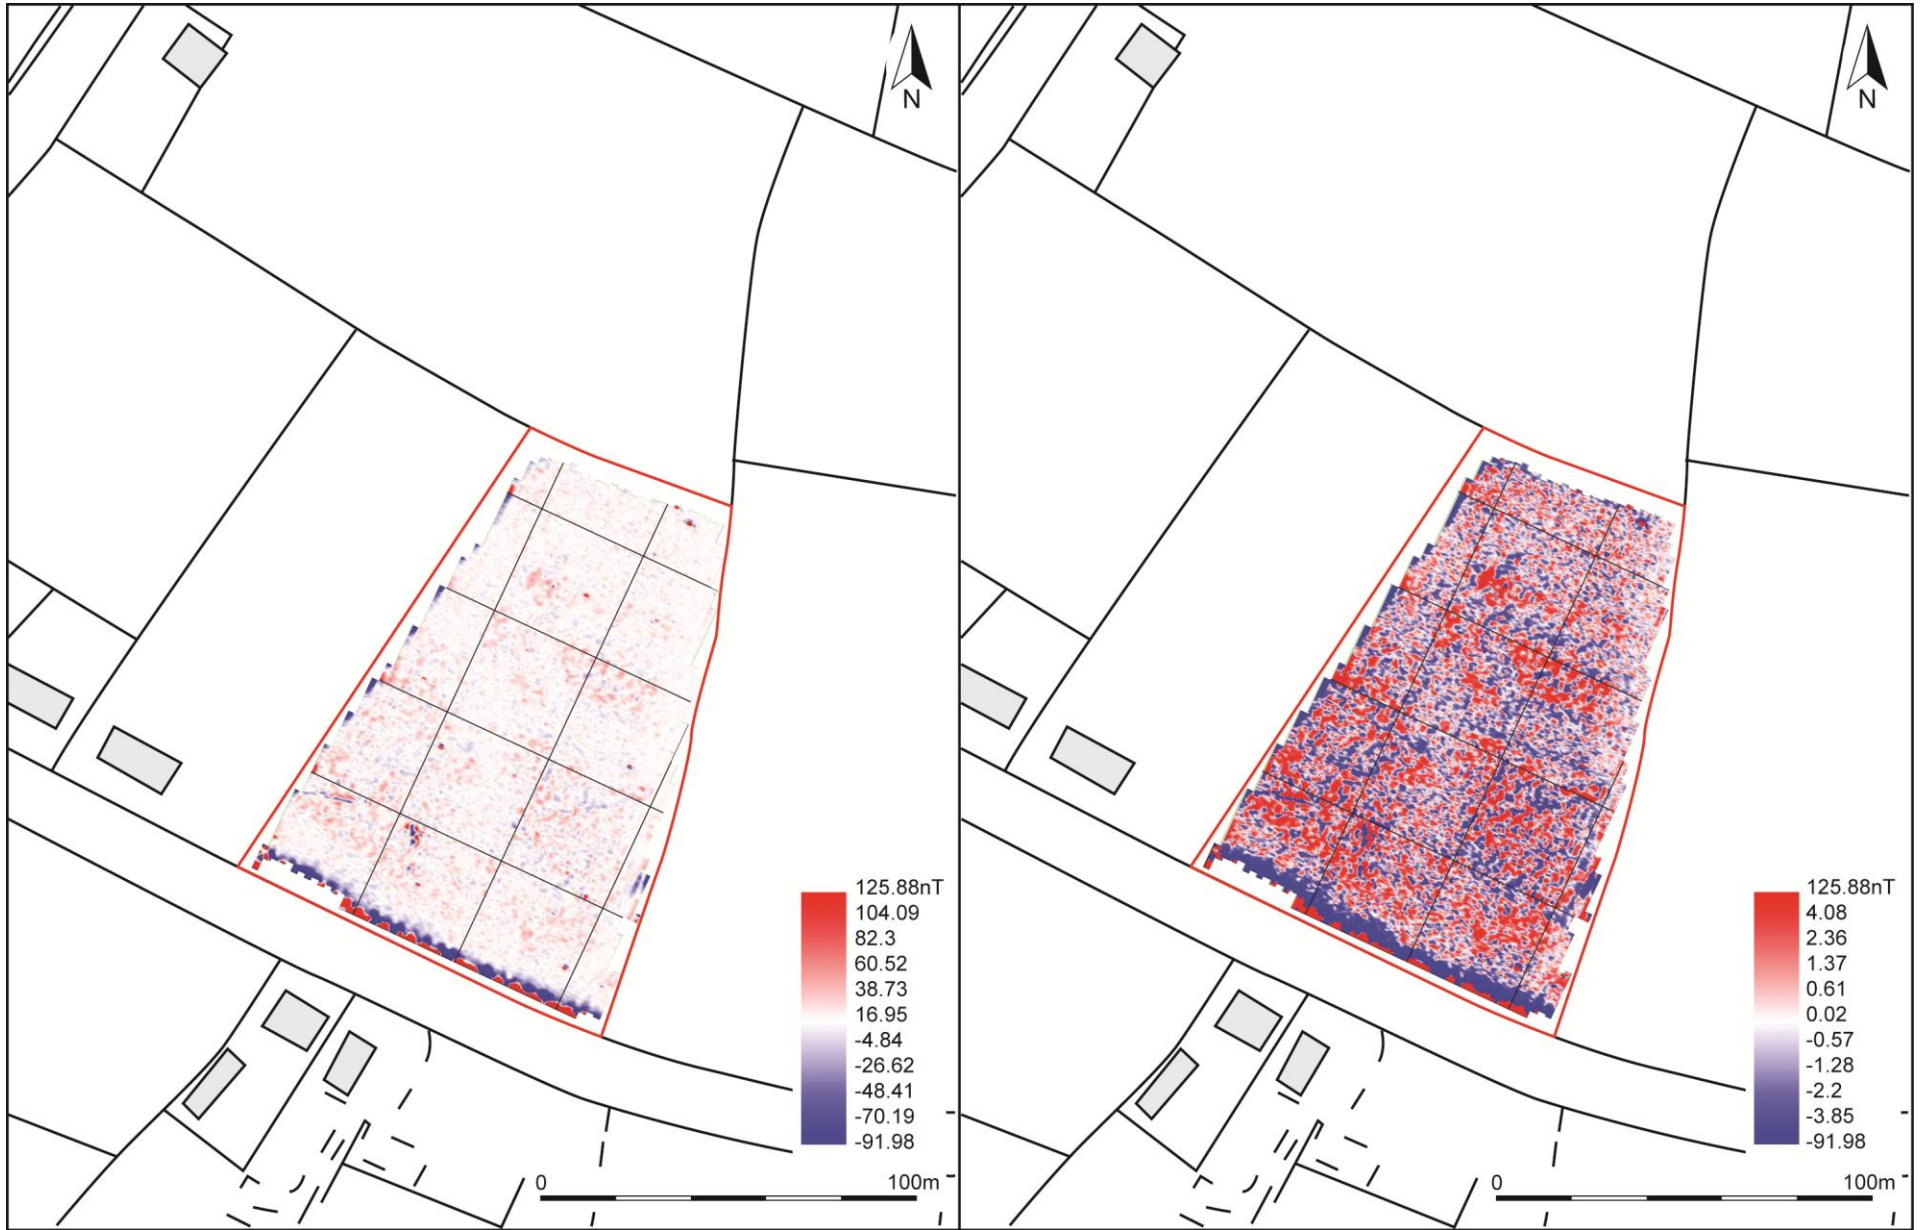
FIGURE 6: RED-WHITE-BLUE SHADE PLOT OF GRADIOMETER SURVEY DATA: GRADIATED SHADING (LEFT); BAND WEIGHT EQUALISED, GRADIATED SHADING (RIGHT).
