# WHITE ROCK COTTAGE SIMONSBATH EXMOOR SOMERSET

REVISED Desk-Based Assessment &  
Historic Building Recording

South West Archaeology Ltd. report no. 151105

By T. Green, C. Humphreys, B. Morris & E. Wapshott  
Report Version 05  
05 November 2015

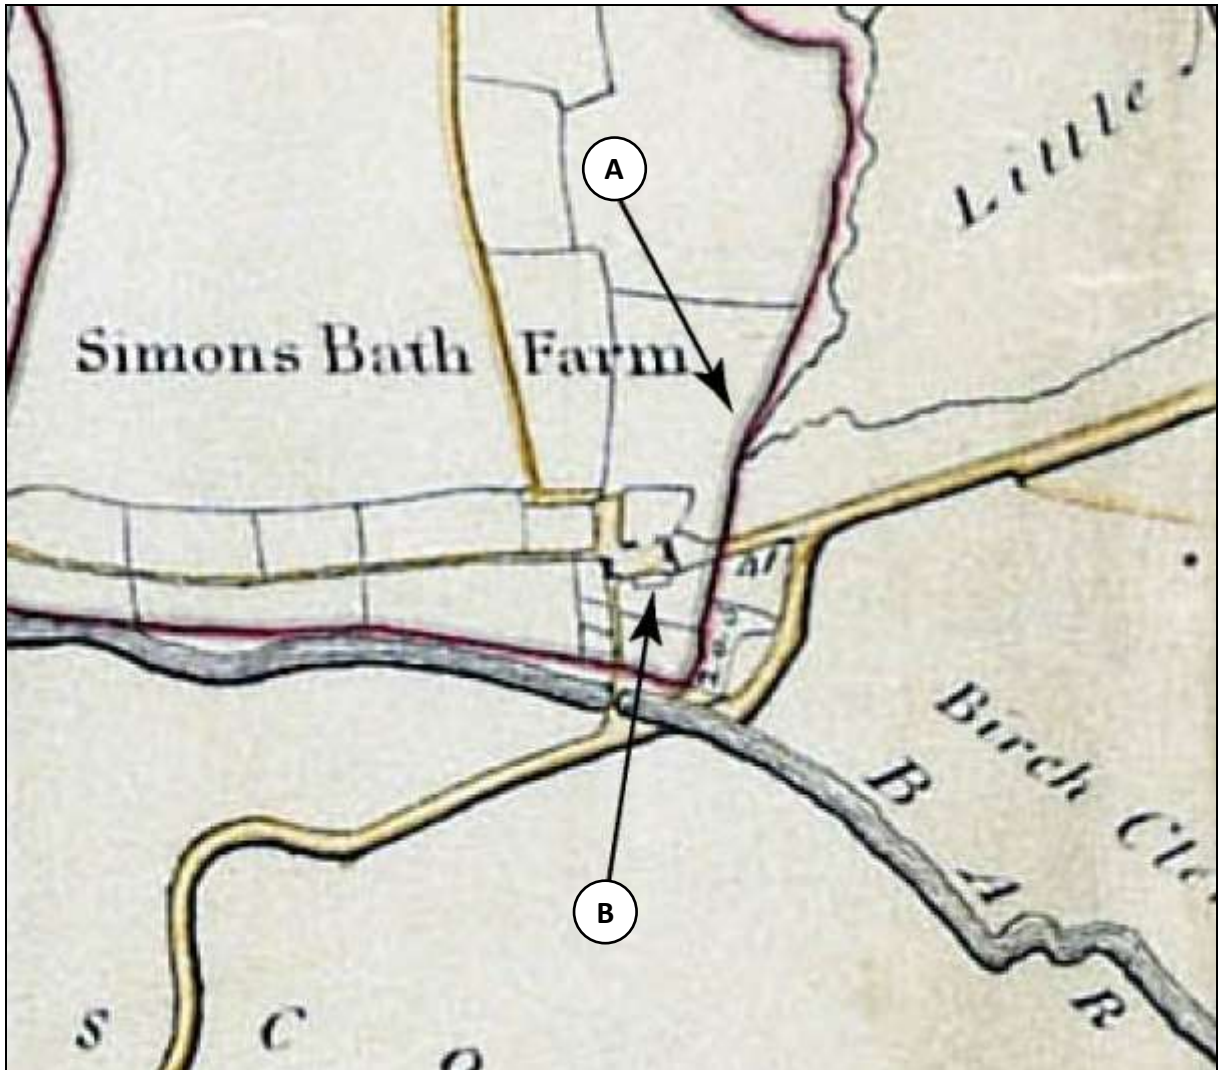
Figure 2: Extract from the Exmoor Enclosure map of 1818. Arrowed are A: the approximate location of White Rock Cottage, B: Simonsbath House (Somerset Archives and Local Studies).

It is evident from the Exmoor enclosure map of 1818 (Figure 2) that at this date there were no buildings (at least none recorded) at the location of White Rock Cottage. Mr Thomas Timmins is listed as living at White Rock Cottage, Exmoor, in 1830 (Savage 1830, iii), and his son (Thomas Theophilus Timmins) was baptised in Exford Church in 1822, where it is noted Mr Timmins was a land surveyor resident at Simonsbath. Thomas senior went on to have two further children, in 1824 and 1826; his wife Mary died in 1828 and is buried at Exford. From this we may surmise White Rock Cottage was extant by 1822. The earliest detailed record of the White Rock Cottage is found in an estate inventory of 1833 (SHC: A/BAZ/1/6). Among the appointments and features at Simonsbath the list includes 'White Rock Cottage etc.'. Apart from Simonsbath House itself, White Rock Cottage was the only residential building listed. The 'etc.' after the name of the cottage is expanded to list the contents of the 'Gardener's Tool House' as well as the features and contents of 'White Rock Garden'. Since the cottage was there in 1830, it is probably safe to assume that it was built in the early 1820s, presumably to house staff attached to Simonsbath House. Considering the associated list of gardening equipment, it seems most likely that it was to be the Head Gardener's cottage. In fact Burton (1994, 24) states that before 1840 the cottage was occupied by a land surveyor and gardener.

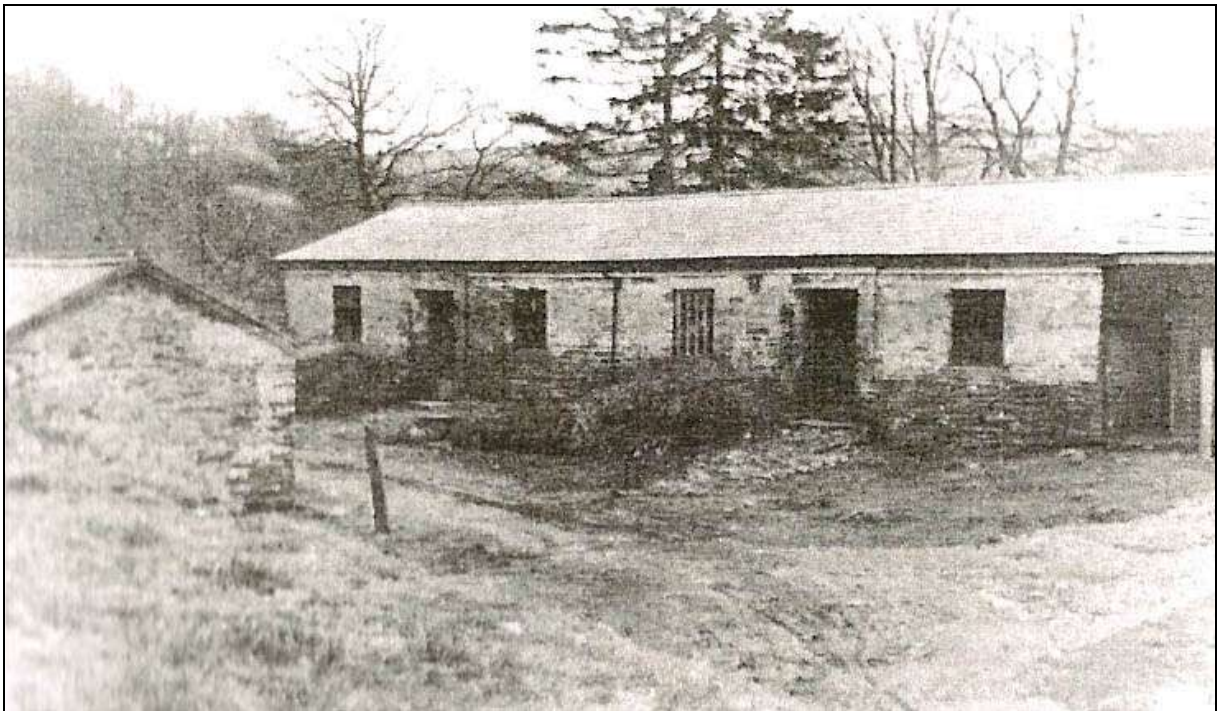
Figure 6: Early 20<sup>th</sup> century photograph of the Upper Stables (Caroline Garrett 2004).

The maps of 1888 and 1902 as well as the early 20<sup>th</sup> century photograph seen in Figure 6 show that opposite the 'stables' stood a small rectangular building. The cartographic record and extant remnants of the structure indicate that this was built over the leat which runs beside the car park access track. The leat is shown on the OS maps as canalised and may have been culverted to pass beneath the building. The purpose of the building is unknown.

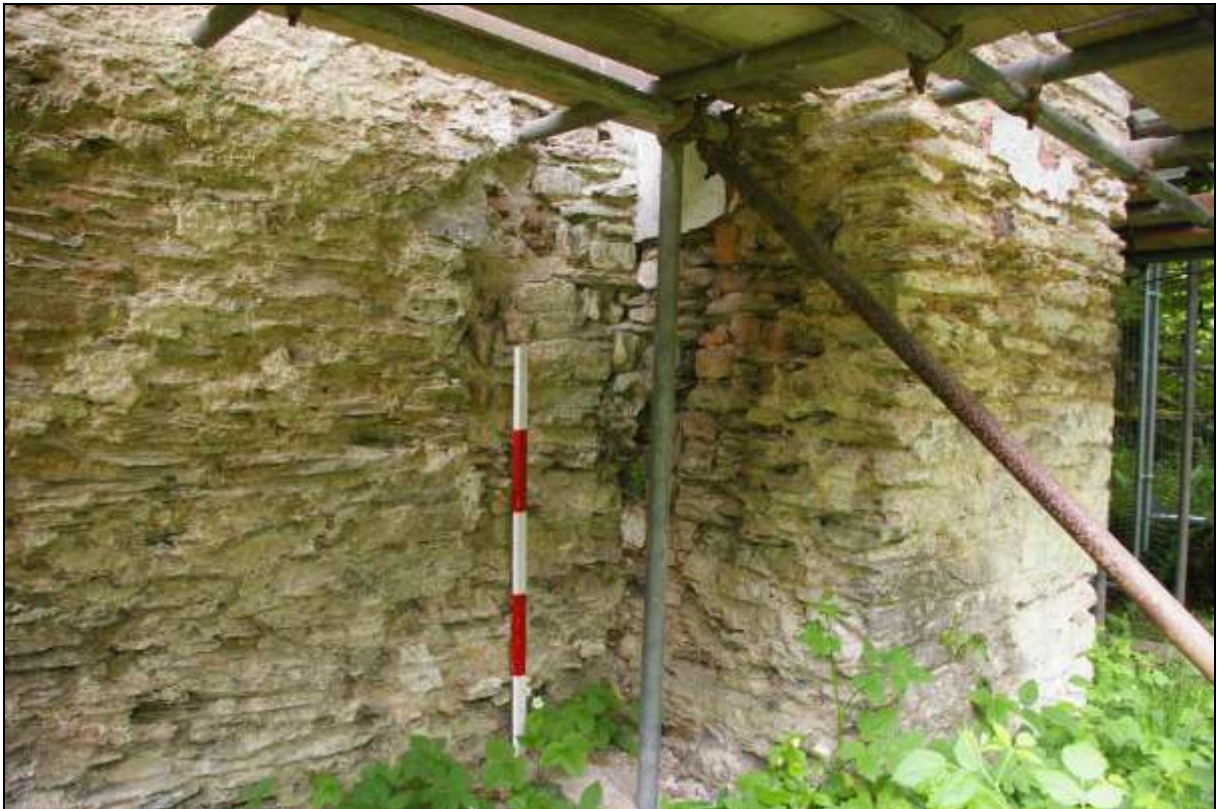
void. This vent is built into a small blocked rectangular opening, presumably a former window opening. The elevation has a large chimney stack, off-set to the north side; this is a large square-profiled structure which projects considerably from the elevation and is not tied into the wall. The stack narrows just above the roof line with a slate drip course to the north and south sides. To the south of the stack at the base it appears damaged and partially hacked away, as does the gable wall, with the burnt stone and brick lining to a chimney visible; this could represent the removal and blocking of a bread oven (Figure 8). At the southern end of this elevation, the removal of the render demonstrated the gable wall abuts the southern wall; the south wall stops abruptly, and originally appears to have continued to the east, indicating that this part of the structure has been truncated.

Figure 8: View of the disturbed stonework next to the eastern chimney stack (scale 1m).

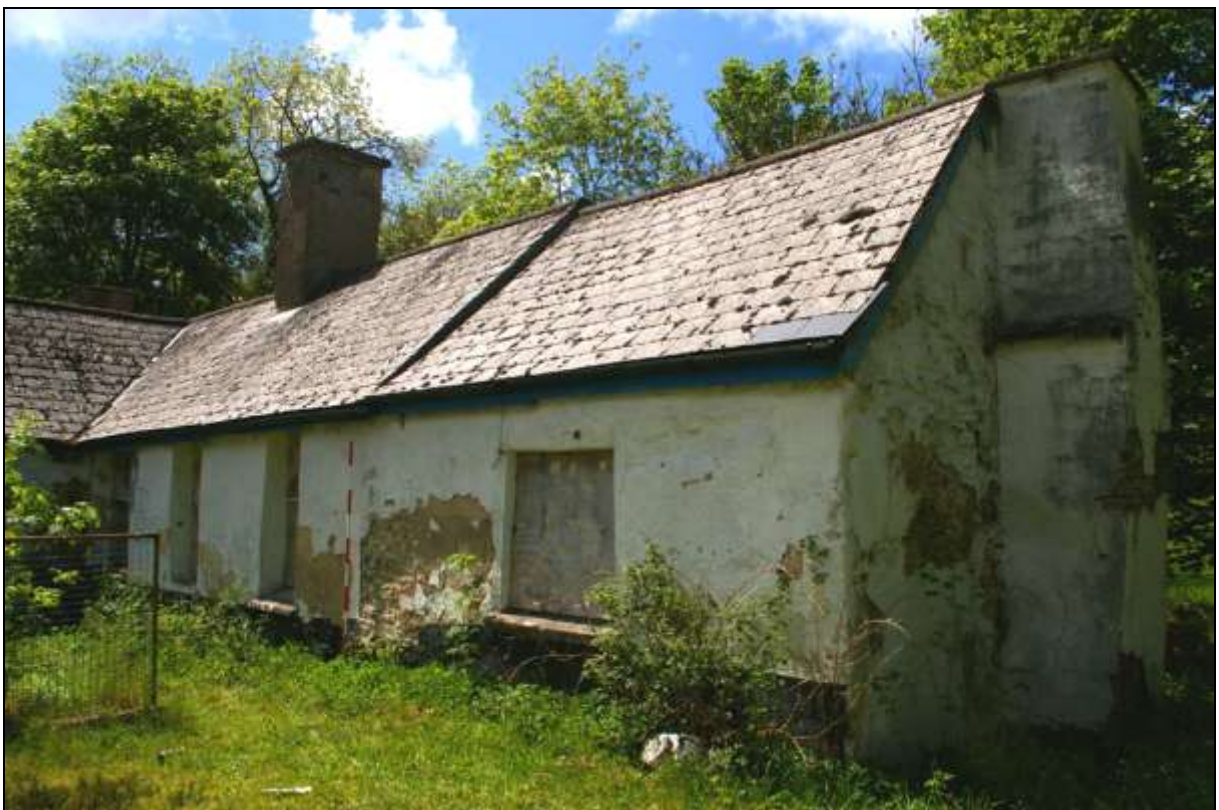
The south elevation of the main range and the eastern single-celled structure are of stone rubble, single-storey in height, rendered in a variety of smooth and textured lime and patched with cement, with an upper  $\frac{3}{4}$  painted white, with the lower  $\frac{1}{4}$  portion painted black, possibly tarred. The removal of the render demonstrated the southern wall of R1 abuts the main range. The roof is pitched, of composite slates with terracotta ridge tiles and blue painted timber fascia boards. To the east, the roof over R1 is of a different pitch to R2-R6.

Figure 9: The eastern end of the south-facing elevation of the main range in 2012, viewed from the south-east (scale 2m).

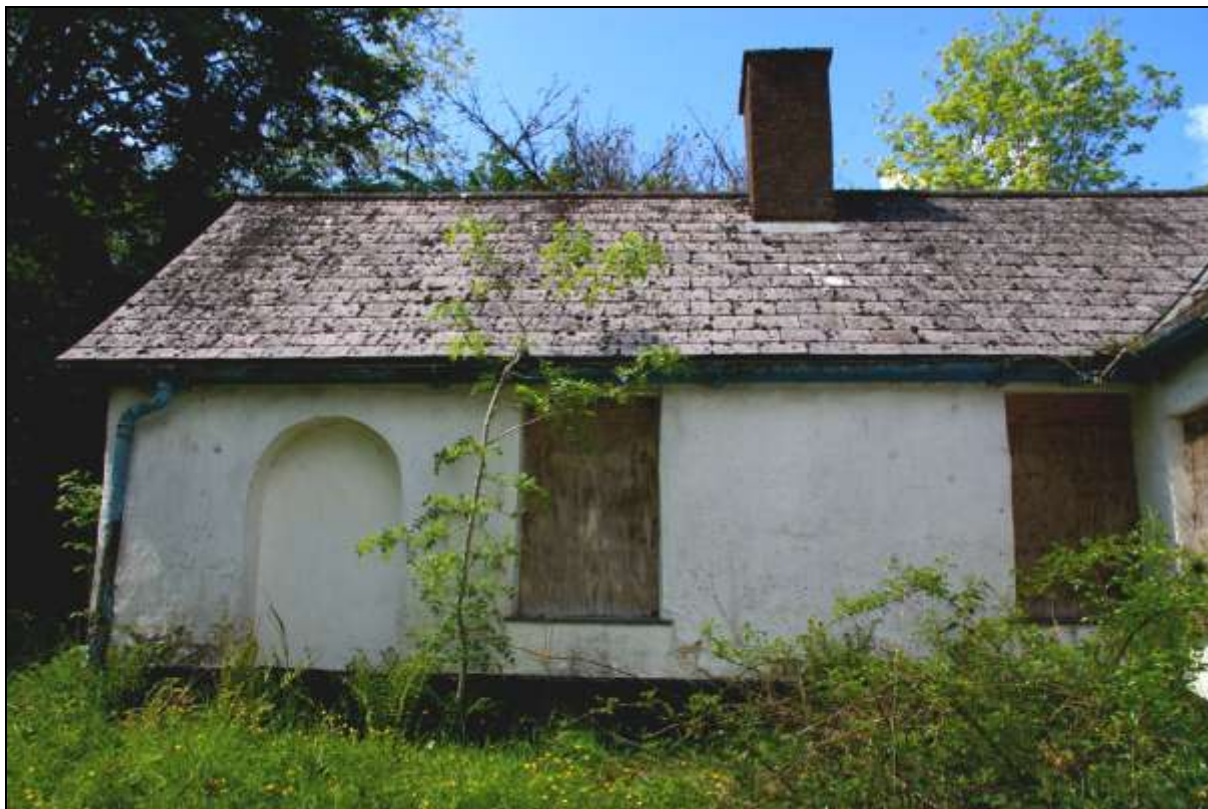
To the west are two large, tall hornless sash windows with narrow slate sills; these windows sit within window openings that have been widened and raised, but even though the windows are secondary, the casements are the only ones in the building of any historical value. To the west end is what appears to be a blocked doorway with a round-headed arch, surviving as a niche in the elevation, with cast iron guttering and a cast-iron downpipe.

Figure 10: The western end of the south-facing elevation of the main range in 2012, viewed from the south.

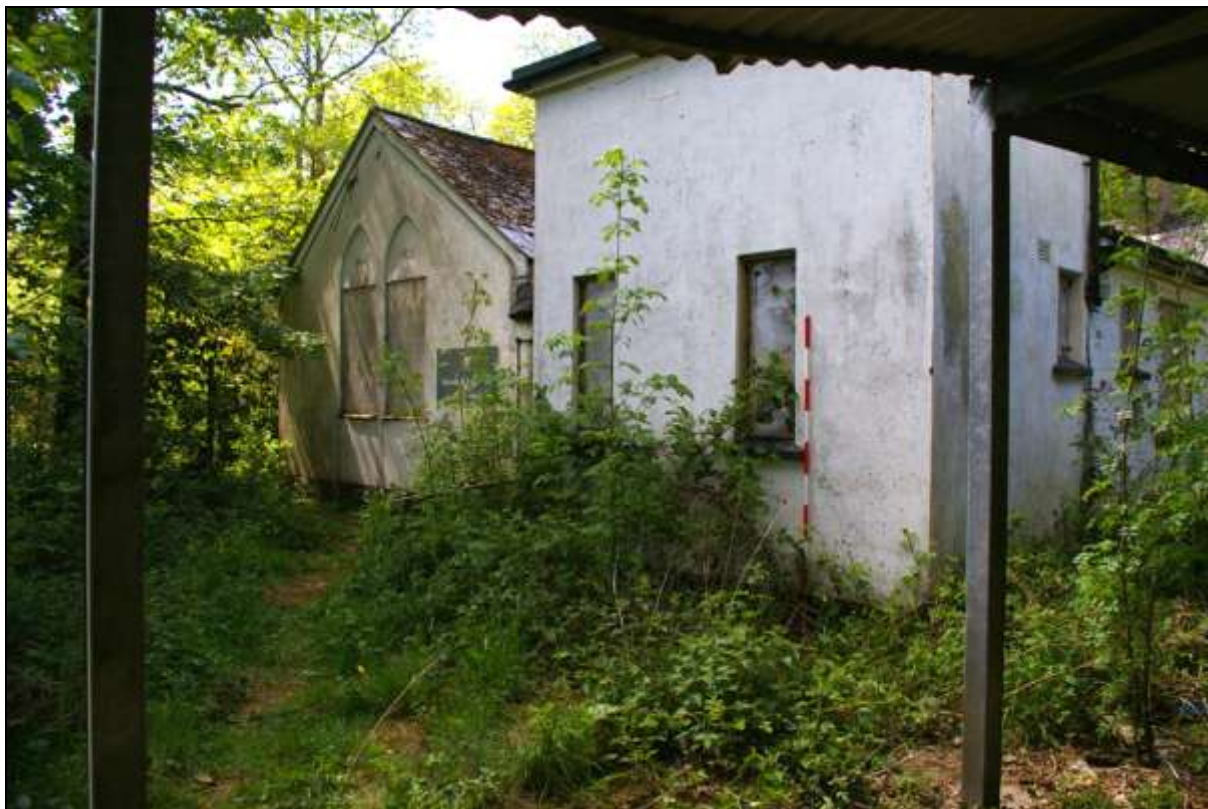
Figure 11: The south-facing elevation of the school hall and 20<sup>th</sup> century water tower in 2012, viewed from the south-east (scale 2m).

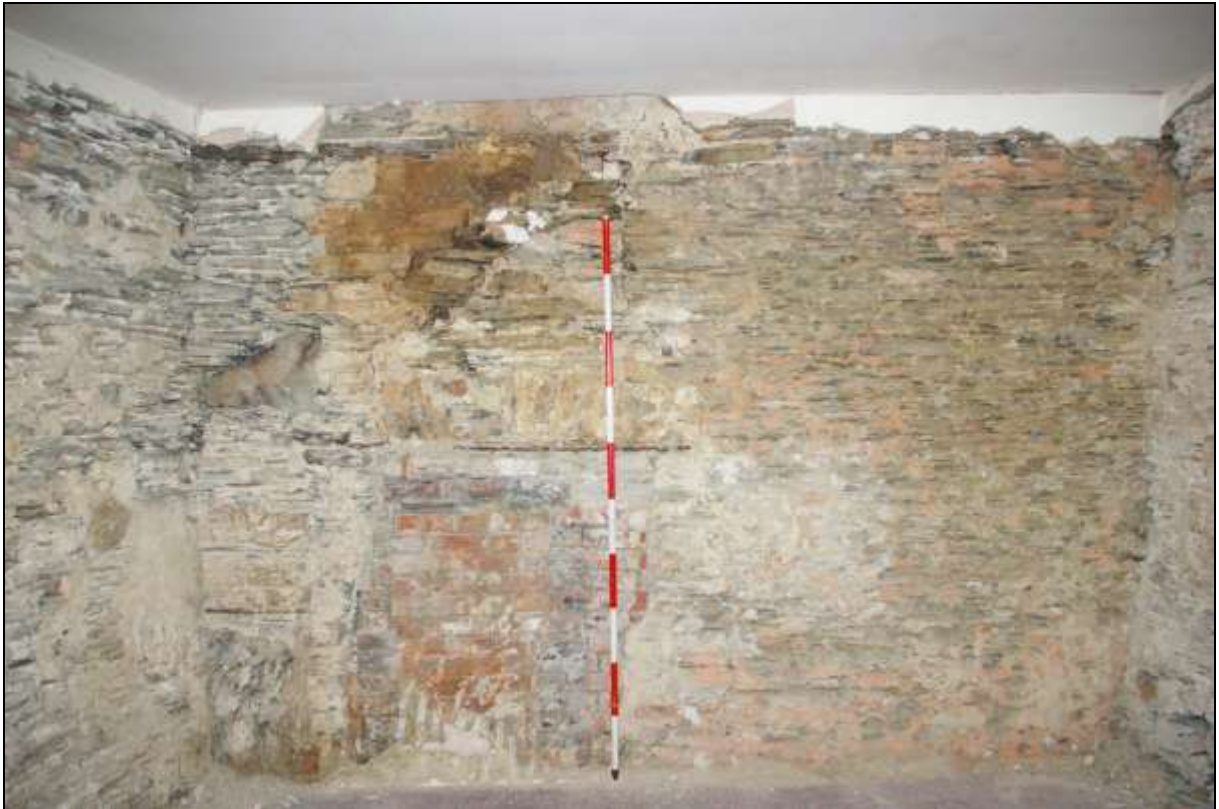
Figure 12: East wall of R1 in 2015, showing the thin timber lacing (top) and the blocked fireplaces and disturbed flue stonework; viewed from the west (scale 2m).

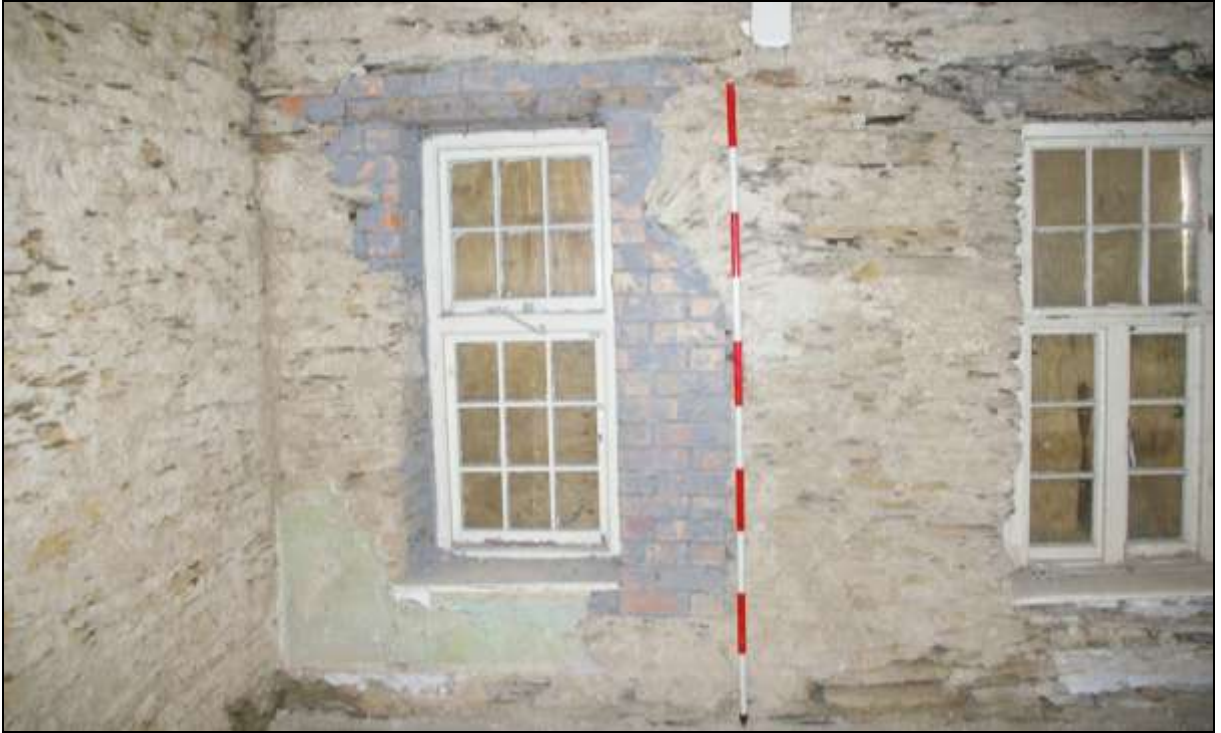
Figure 13: The south wall of R2 in 2015, showing the blocked round-headed arched doorway with forced window; viewed from the north (scale 2m).

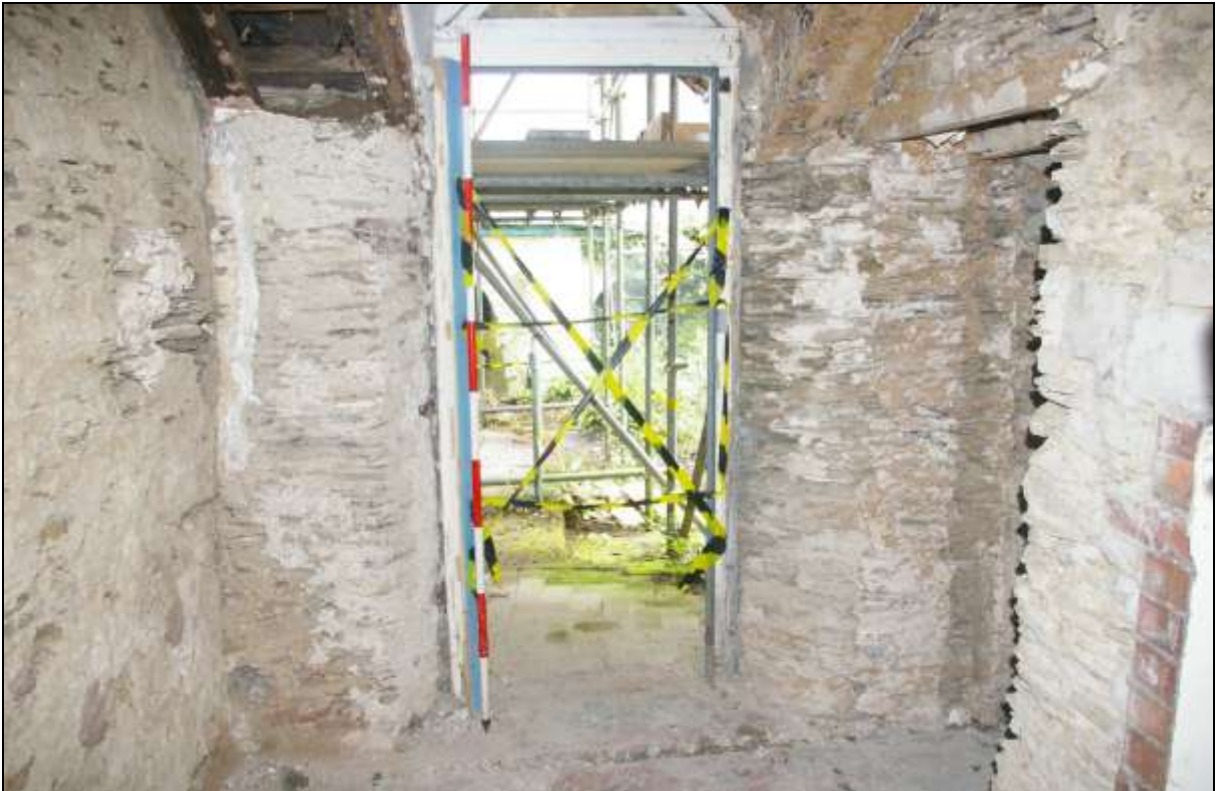
Figure 14: The external door to R9 in 2015, with blocked window splay to the left; viewed from the east (scale 2m).

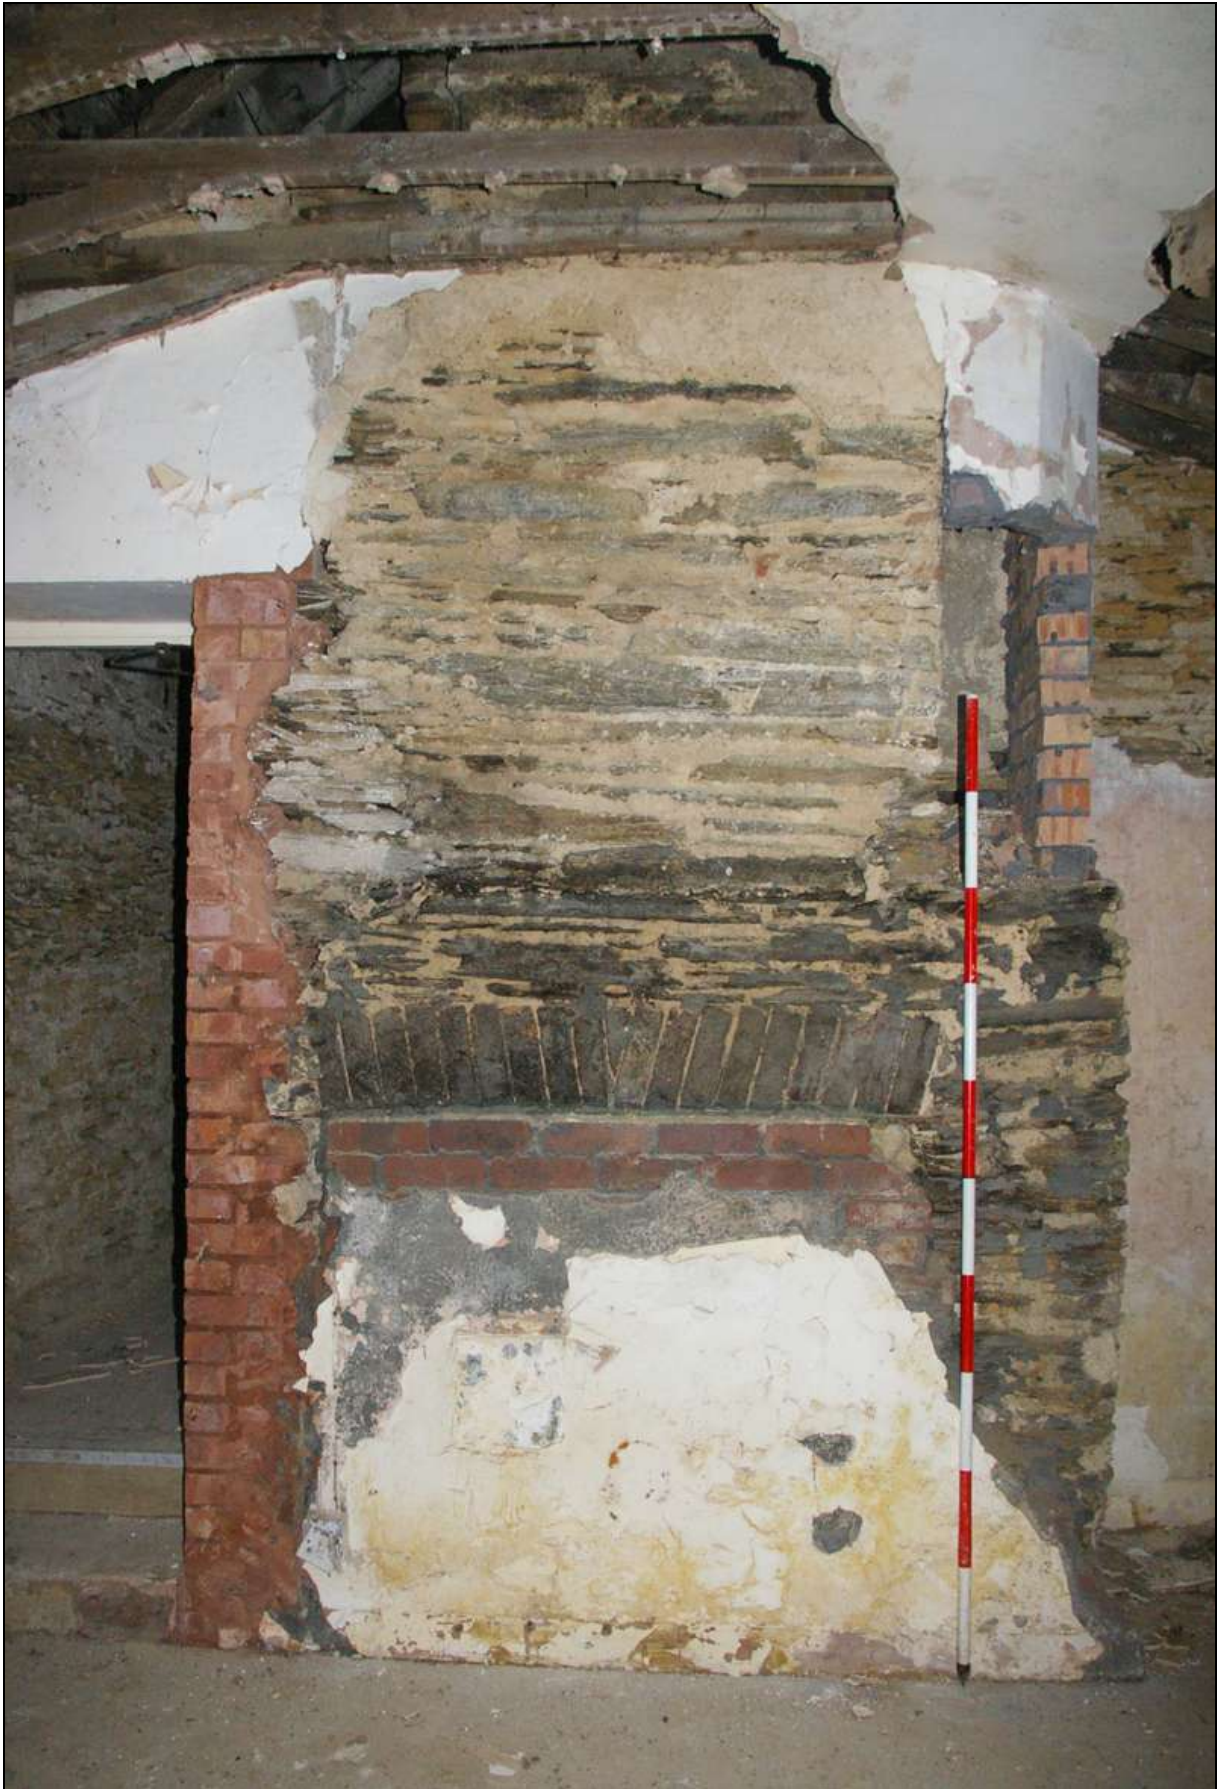
Figure 15: The stack in R3 in 2015, showing the blocked fireplace with segmental arch, the rebuilt upper stack with dressed stonework, and the forced doorway to the left; viewed from the west (scale 2m).

- Chimney stack on east wall with blocked fireplace. The upper portion of the stack appears to have been repaired or rebuilt using dressed stones similar to those seen in the stable block. The lime mortar used has a noticeably-different yellowish hue.
- The fireplace in the stack has a blue-brown brick segmental arch, with cut brick keystone. This is over an iron lintel. The fireplace has then been blocked with two phases of modern brickwork, the hearth initially being reduced in size before being blocked, then plastered over (similar construction to fireplace in R3).
- Large area forced into the south side of the stack, rebuilt in modern brickwork, forming a hollow area or chamber. No access for smoke or from fire. Purpose/function unclear.

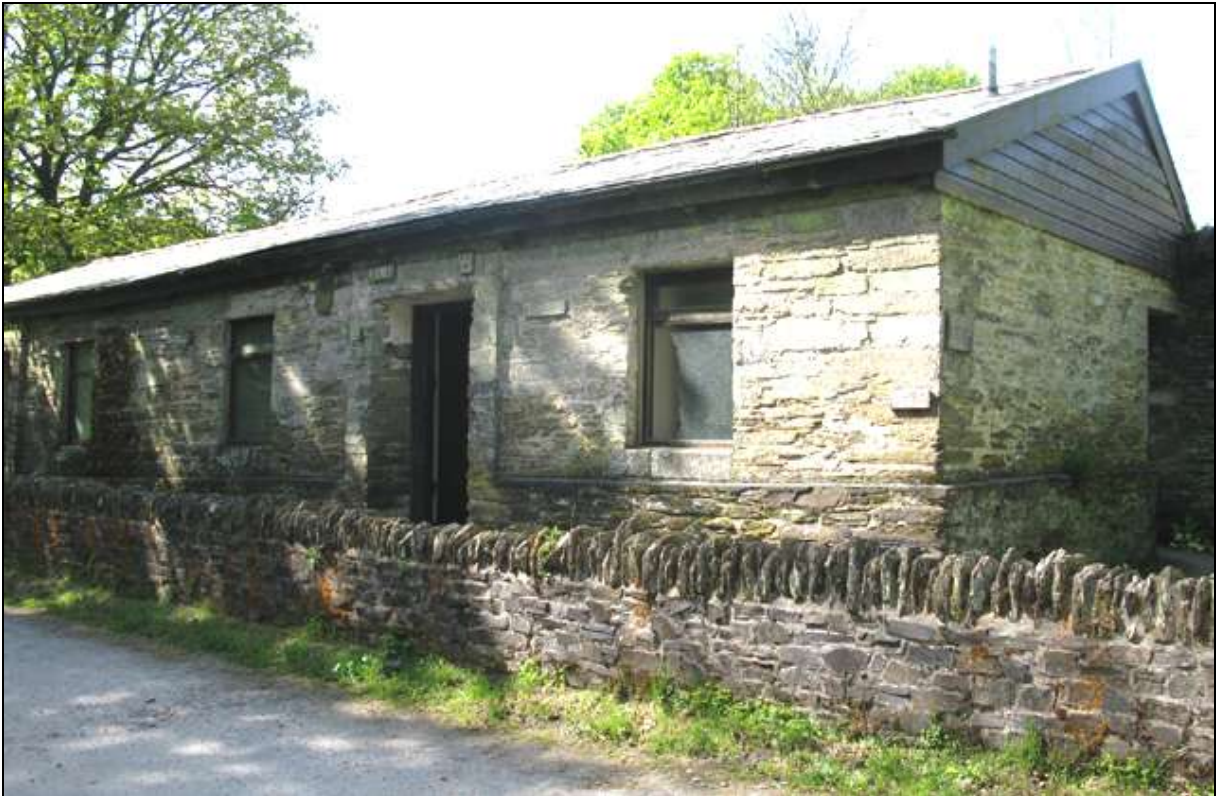
The west-facing elevation contains no openings or structural details. The gable elevations are also very simple: the north-facing elevation contains a single door, forced through, for the male toilets, and the south-facing elevation contains a single window at eaves height. The east-facing elevation, in contrast, contains six openings: two doors and four windows, arranged symmetrically, all with stone lintels. The stonework around the two doorways projects slightly, and incorporates large iron hinges and catches. The windows have dressed hard purple sandstone sills, but have the appearance of being forced through or otherwise modified. They contain modern timber two-light windows. Sawn or dressed stone is used sporadically around the doorways and in an unbroken single line below the eaves. In the centre of the elevation is a vertical stack of dressed stones within the build of the wall, perhaps marking the position of an internal partition. Abutting the northern gable are the ruined walls of an open-fronted extension.

Figure 18: The east-facing elevation of the toilet block in 2012; from the north.

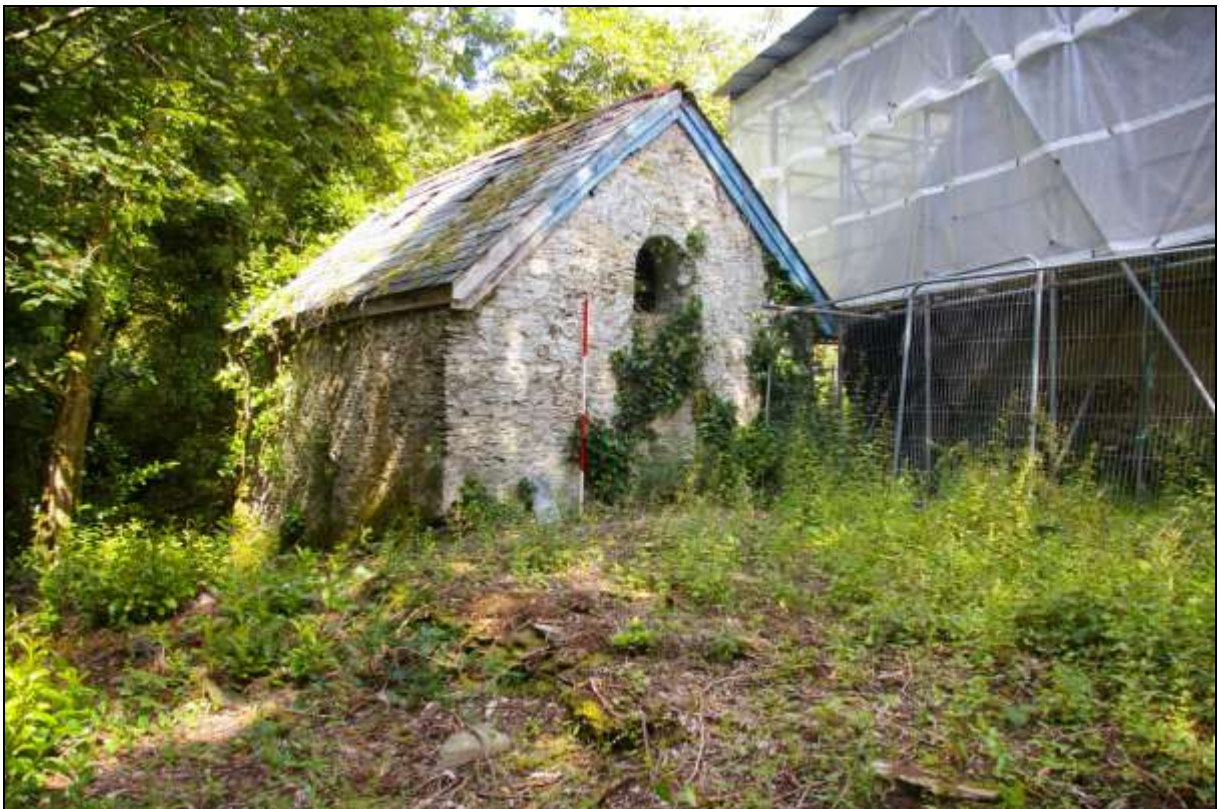
South-west of the main building is a small two-storey single-cell outbuilding. Built of stone rubble with a pitched slate roof, this structure is fairly plain, with two round-headed doorways in the east elevation, and a small round-headed window in the south elevation. The interior was originally accessed by a door in the east wall, with a window to the south; when a wall was built internally (to create a privy?) the window was forced through as a door. In the west elevation at its southern end, there is a suggestion that the south wall of the outbuilding was built abutting an existing low wall, and there is a platform adjoining to the south, shown as a flowerbed in historic photographs.

Figure 20: The south and west elevations of the outbuilding in 2015, with the former flowerbed in the foreground (scale 2m).

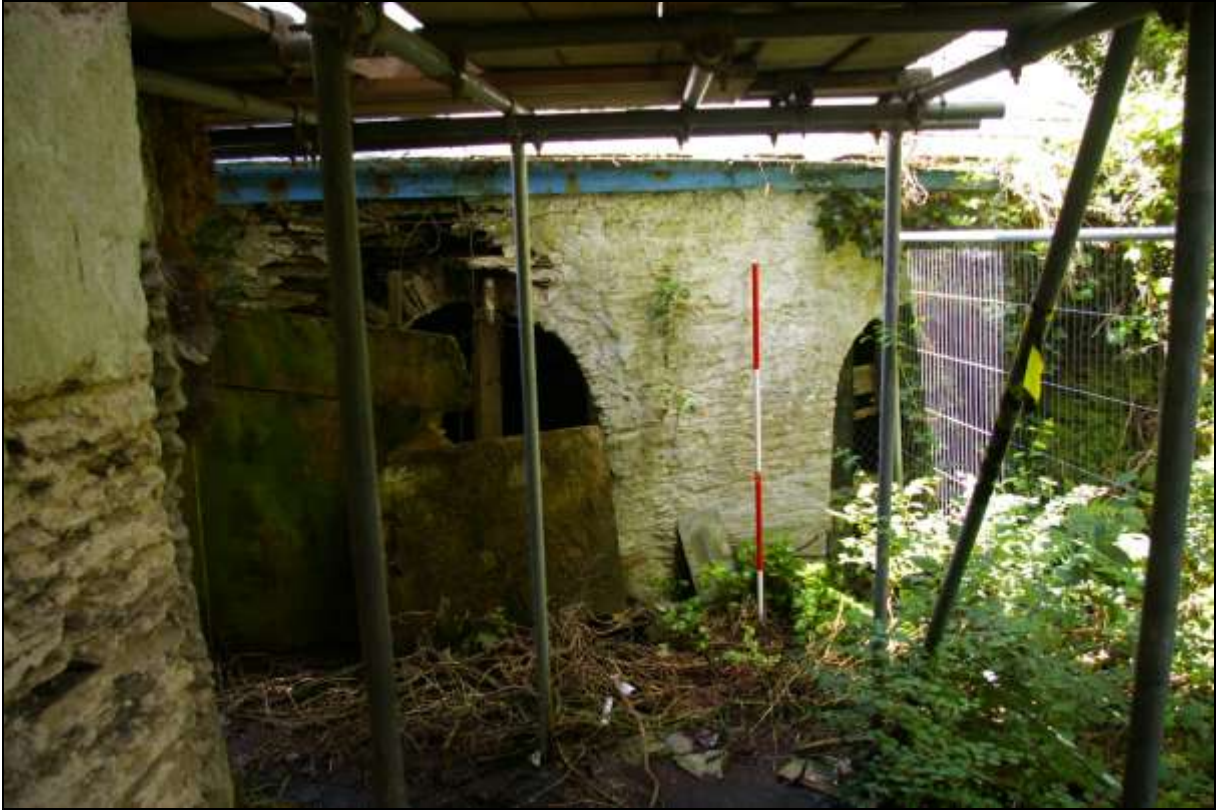
Figure 21: The east elevation of the outbuilding in 2015, viewed from the east (scale 2m).
