# ANDERTON FARMHOUSE LAUNCELLS CORNWALL

Results of a Desk- Based Assessment &  
Building Survey

Report No.: 150422  
Date: 22.04.2015  
Authors: C. Humphreys  
E. Wapshott  
V. Hosegood

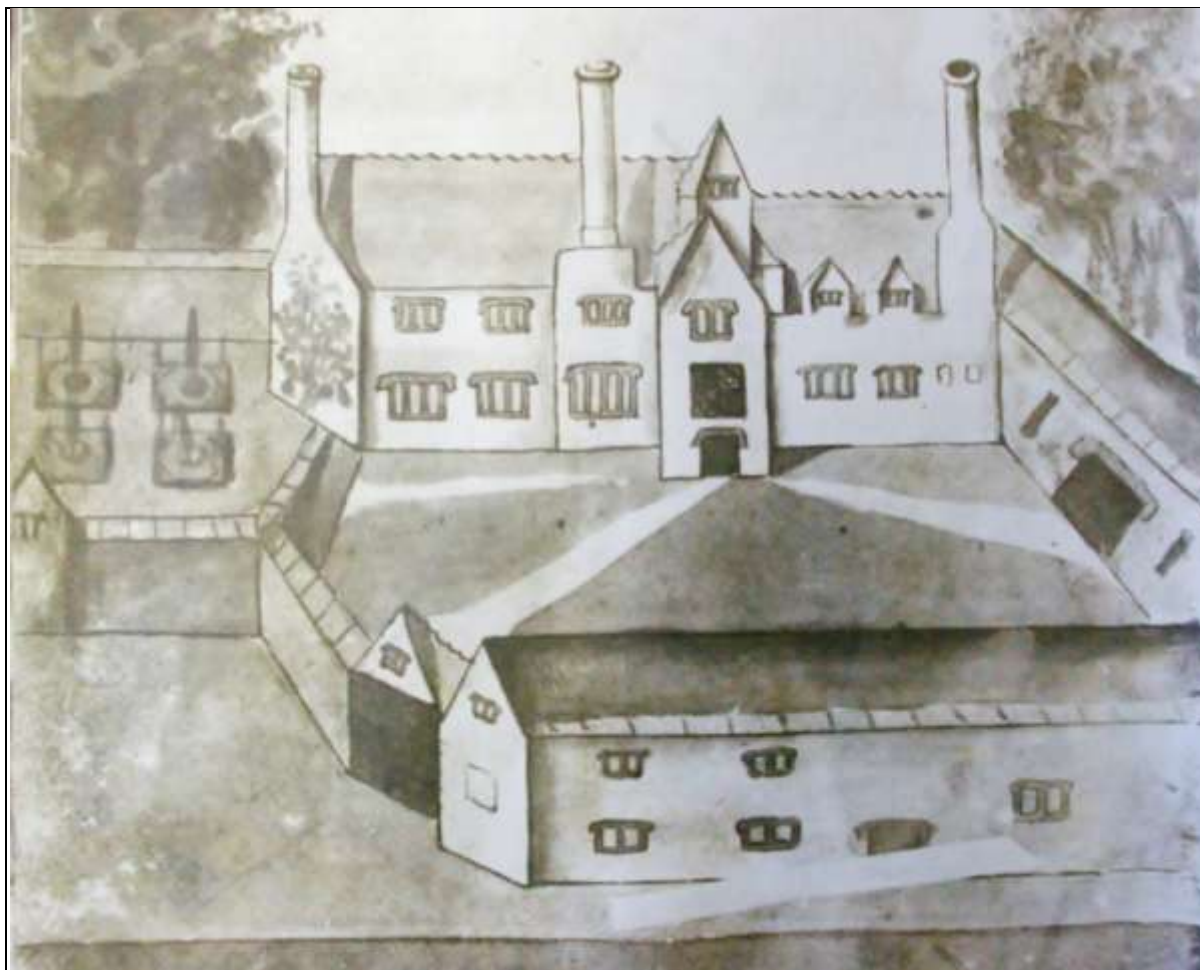
Figure 3: Extract from the Spoure Book, showing Anderton House (CRO).

The former manorial status of Anderton, means that there is a rich documentary history of wills and leases connected to the various families which have held Anderson from the 16<sup>th</sup> century. Most notable in understanding the history and development of the present building is the Spoure Book (c.1694), which includes a 'draught of Anderson House' (see Figure 3). The illustration depicts a large house framed to the front by a courtyard of buildings and with formal walled gardens to the side. The house which is shown is two storeys, with a projecting two/three storey porch, and adjacent hall projection (presumably for grand windows). The roof appears to have been shown as tiled or slated with a decorative ridge. There are axial stacks at each end of the house, with a further lateral chimney, which presumably relate to a lateral stack on the rear elevation. The porch appears to have possibly had a stained glass window at first floor level. The window openings to either side of the porch appear to be very different, with those to the left clearly larger, it should be noted that the height of the roofline also appears lower to the right.

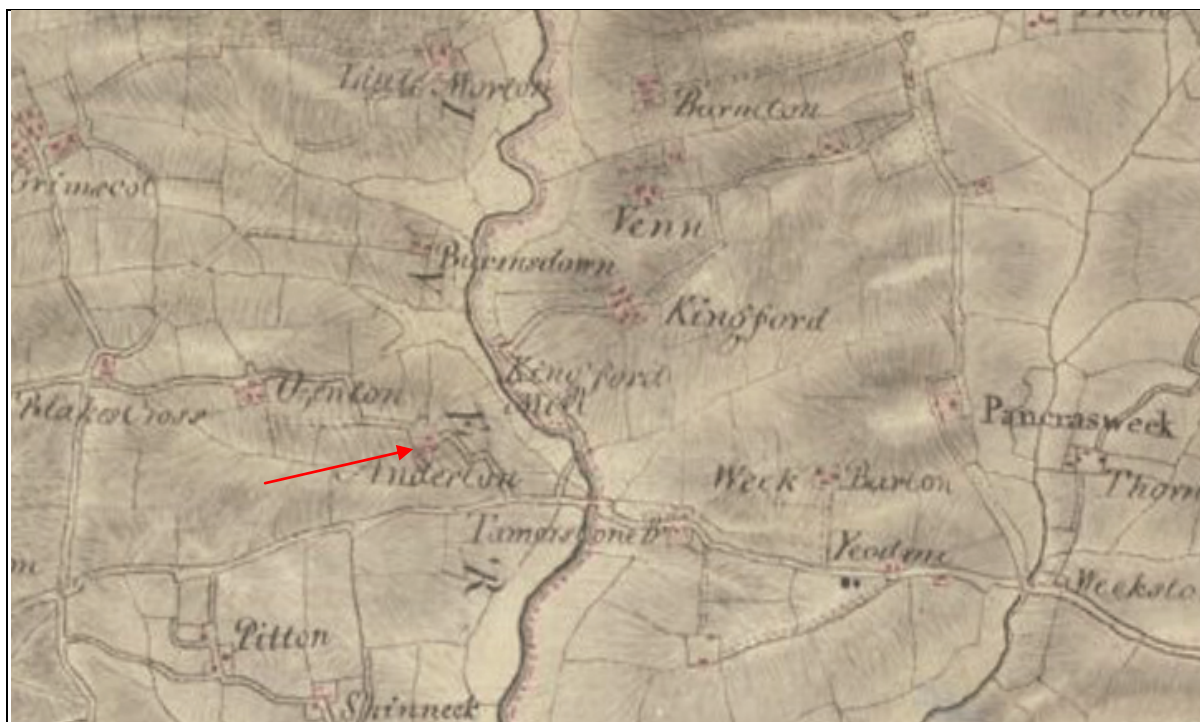
Figure 4: Extract from the Holsworthy Ordnance Survey Surveyors Draft, c.1813 (CRO).

The earliest detailed map available to this study is the First Series OS Surveyors Draft (1813) (Figure 4). Anderton is marked on the map, and, although the detail is unclear, a group of (three?) buildings along with an access route, which continues towards Ossington can be seen. The building group does not appear to resemble that depicted in the Spoure Book. The fieldscape does not appear to be very accurate, although the construction of the Bude Canal (c.1819-1823) may have resulted in significant changes.

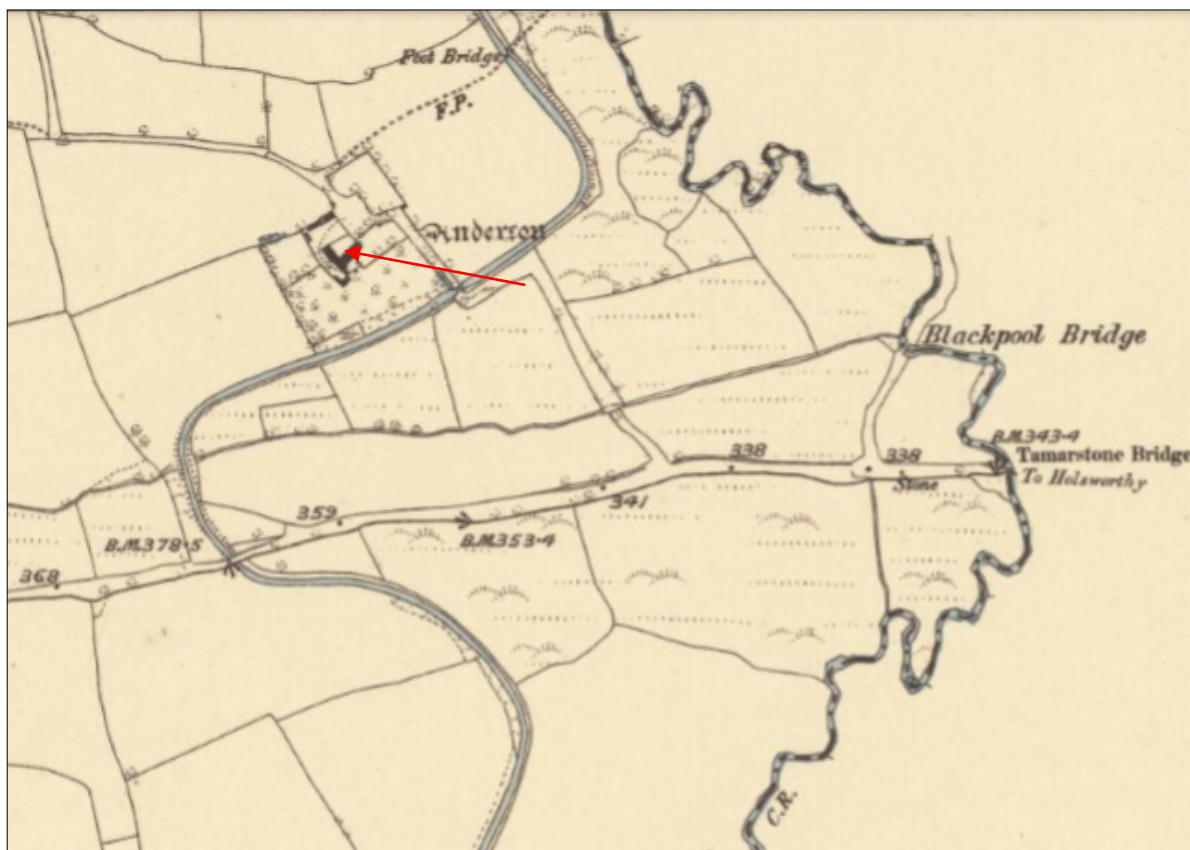
Figure 6: Extract from the Ordnance Survey 1<sup>st</sup> Edition 1884 (the site is indicated).

The Ordnance Survey 1<sup>st</sup> edition map of 1884 suggests that the agricultural building to the north of the farmhouse had been demolished, although there is presently a building in this location. This building had formed a courtyard on the tithe map and may have been depicted in the foreground of the picture in the Spoure Book. The other noted change is that the agricultural building located furthest to the north on the tithe map had been extended to the east, with a possible outshot or separate building running south from the western end of the range. Presumably these additions were as direct replacements for the presumably unroofed (rather than demolished) structure. There are no other notable changes to the farmhouse or surrounding buildings. Nor are there any further changes (except in the field pattern) on the Ordnance Survey 2<sup>nd</sup> edition map of 1907.

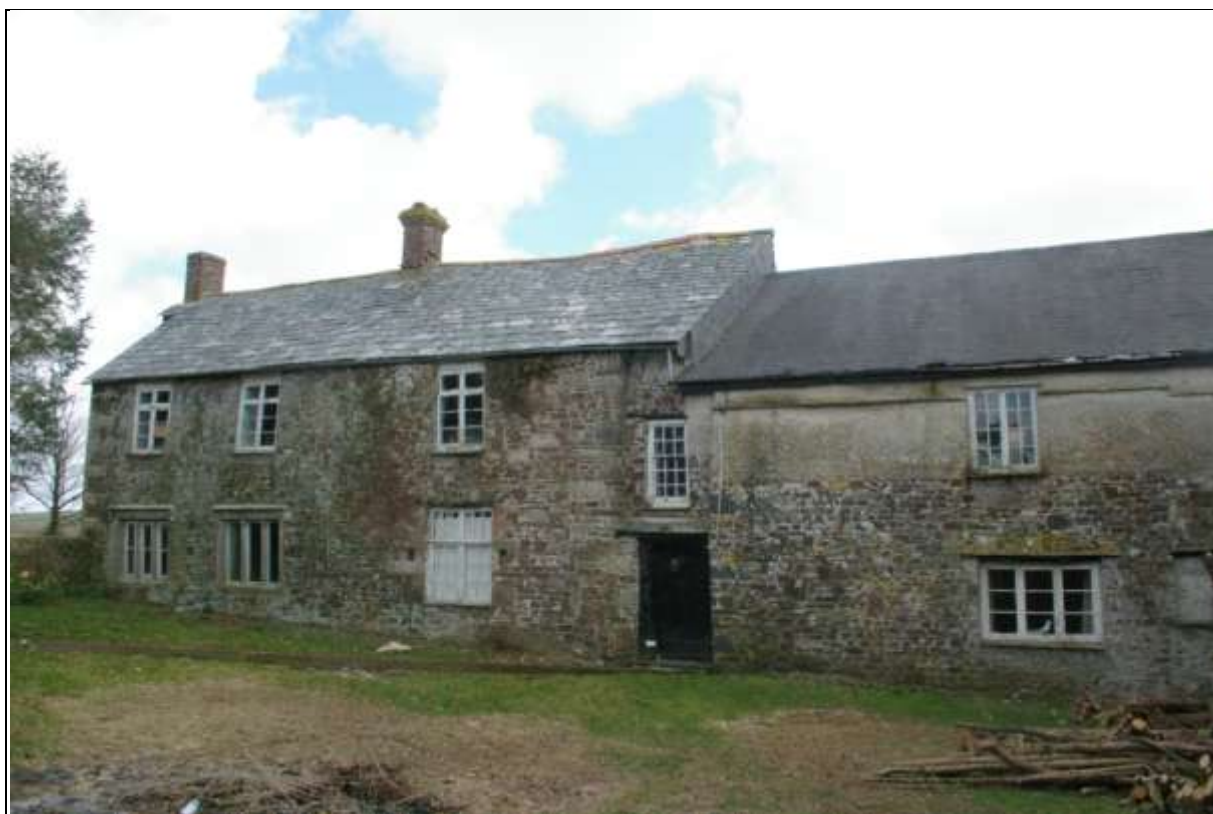
Figure 9: Shot of the north elevation, viewed from the north-east.

The north elevation is the principal facade; it is of asymmetrical plan, exhibiting multiple phases of rebuilt stonework and some cob. The east end of the north elevation is of dressed, squared rubble stonework. This is set with two surviving hollow-chamfered three-light stone mullioned windows on the ground floor and two mullioned and transomed timber casement windows, to the first floor. The former hall and room above, to the centre of the elevation, are served by two large mullioned and transomed timber casement windows, with an axial stack above, rebuilt in brick. The entrance to the cross passage, west of the former hall, under a slate overhang, has a fine doorframe, with ovolo-moulded jambs, with urn stops and the front door has incised geometric decoration between

heavy studwork. Above the cross passage, a hornless sash window is set into a former first floor door opening. A central two-storey porch and off-set hall projection have been demolished here, leaving significant wall scars. To the west end, a three light mullioned timber casement window serves the ground floor and a narrow timber casement serves the first floor. There is a short projecting range to the west, with a ground floor timber casement window and blocked window to the first floor, abutted by a barn, which projects north.

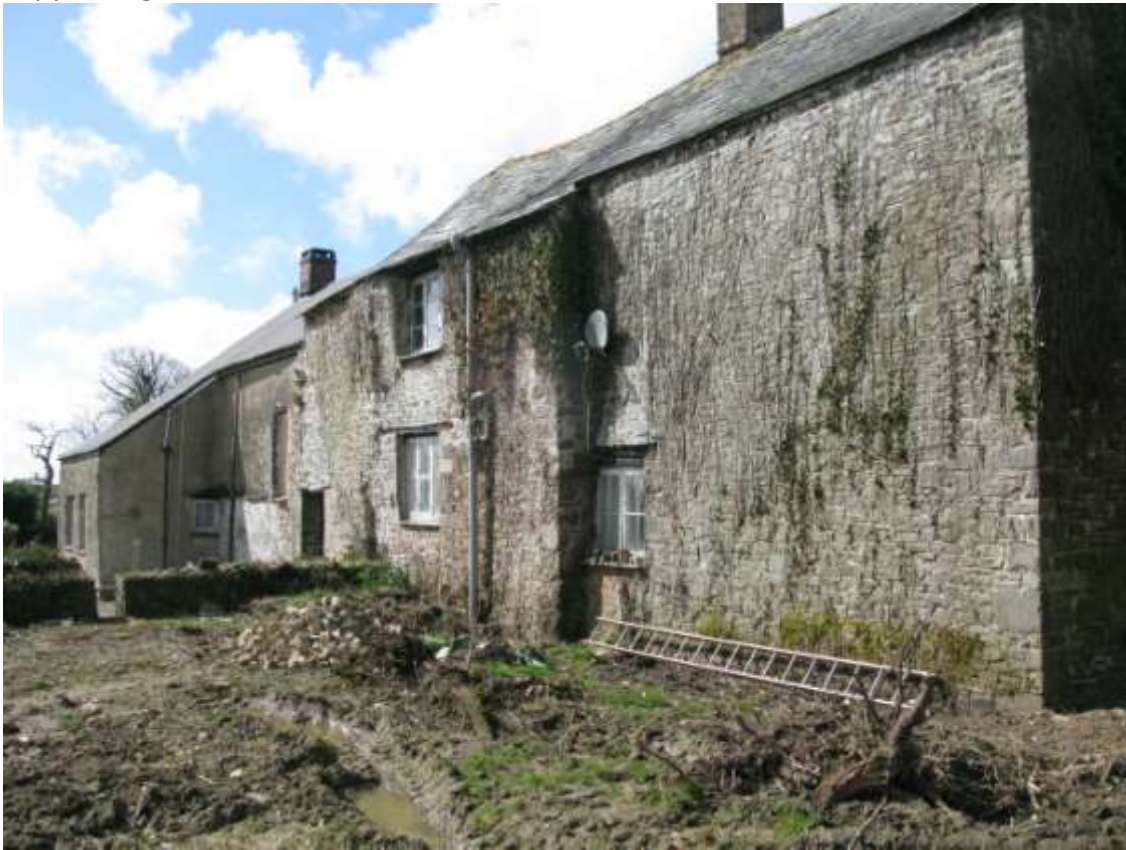
The south elevation is asymmetrical; it exhibits multiple phases of repaired stonework and cob. The east end of the building exhibits squared, dressed rubble stone on the ground floor, a blocked doorway set with a timber window. At first floor level the wall has been rebuilt in looser rubble. A central portion of rough rubble stonework, projects, with a timber mullioned casement window to both ground and first floor. There are significant wall scars, which suggest a structure has been demolished. The south end of the cross passage is served by a modern plank door in a narrow timber frame. On the first floor at the west end one large, hornless sash window, has been forced into a cob section of wall; the reveals rebuilt in brick. The west end is enclosed by a single-storey extension.

The south elevation of the house; from the south east.

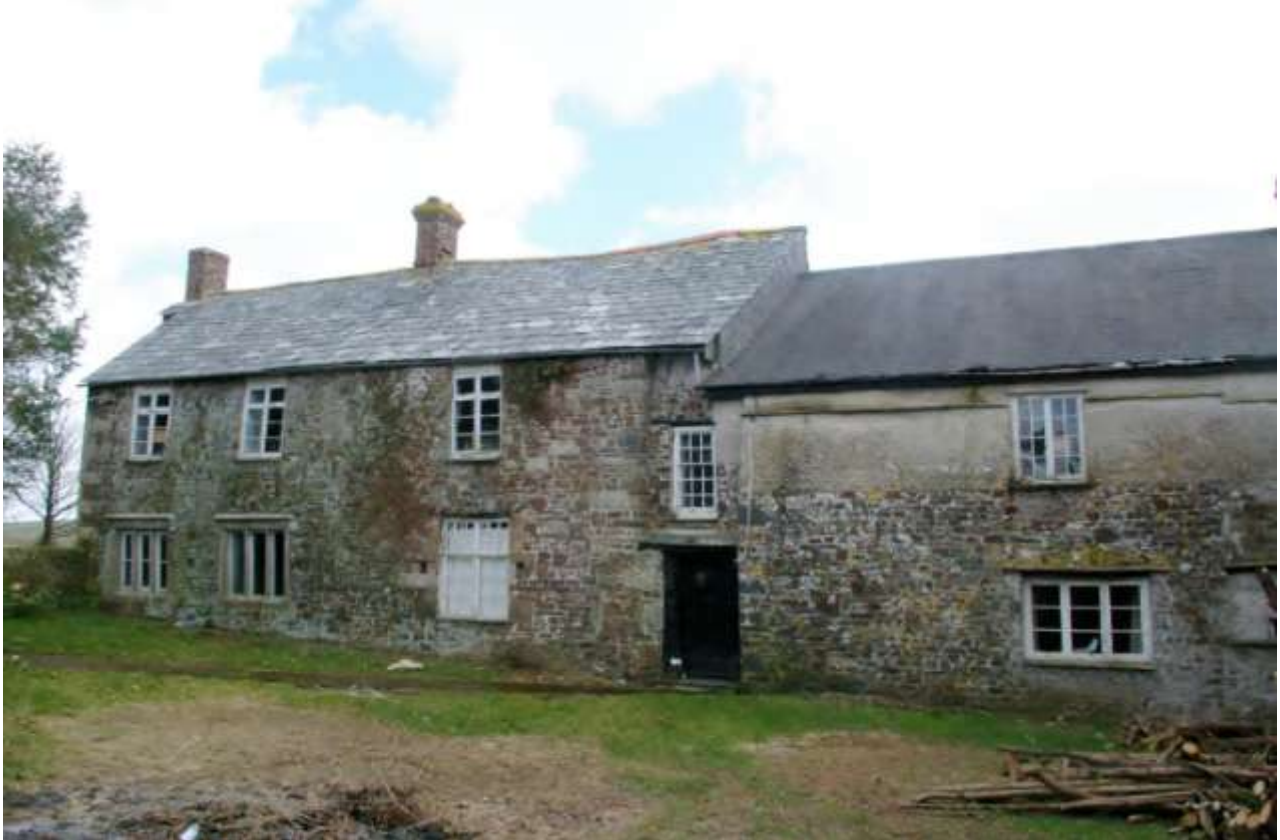
The north elevation; from the north west.

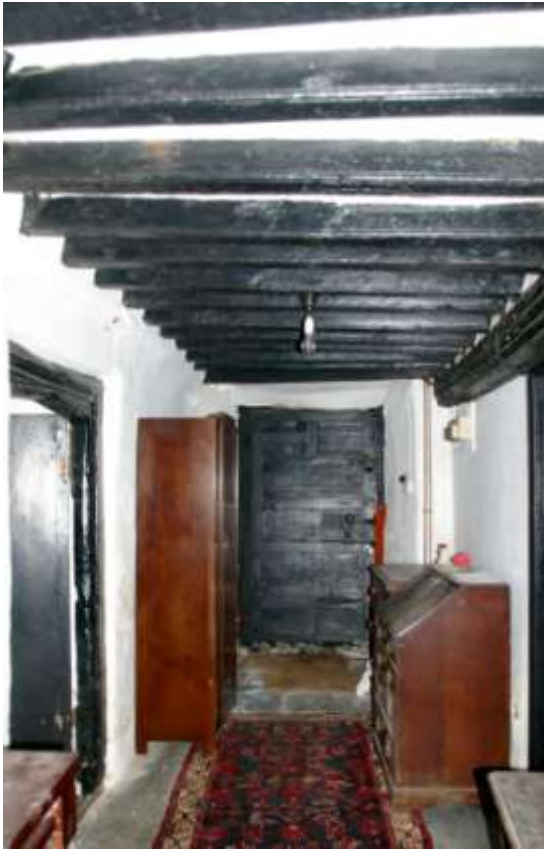
The farmhouse is entered through the north elevation, into the cross passage (Room 1). Ovolo moulded ceiling joists span the ceiling of the passage. To the east they are set into an earlier roll moulded beam, over a lathe and plaster partition (possibly containing the medieval hall screen). To the west they are set into a chamfered beam set within a substantial stone wall. There are two doors to the east; the first of which is a plain four panel door in a narrow beaded frame. The second, at the south end of the passage, is a modern plank door which opens into a cupboard, originally the south-west corner of the former open hall and thus contains part of the moulded cornice. The southern end of the cross passage has a modern plank door. The door to the west is a shallow four-centred arch, with foliate carved spandrels; the jambs are tenoned into the soffit. The door is a ledged plank door on L-H hinges.

The cross passage; from the south.

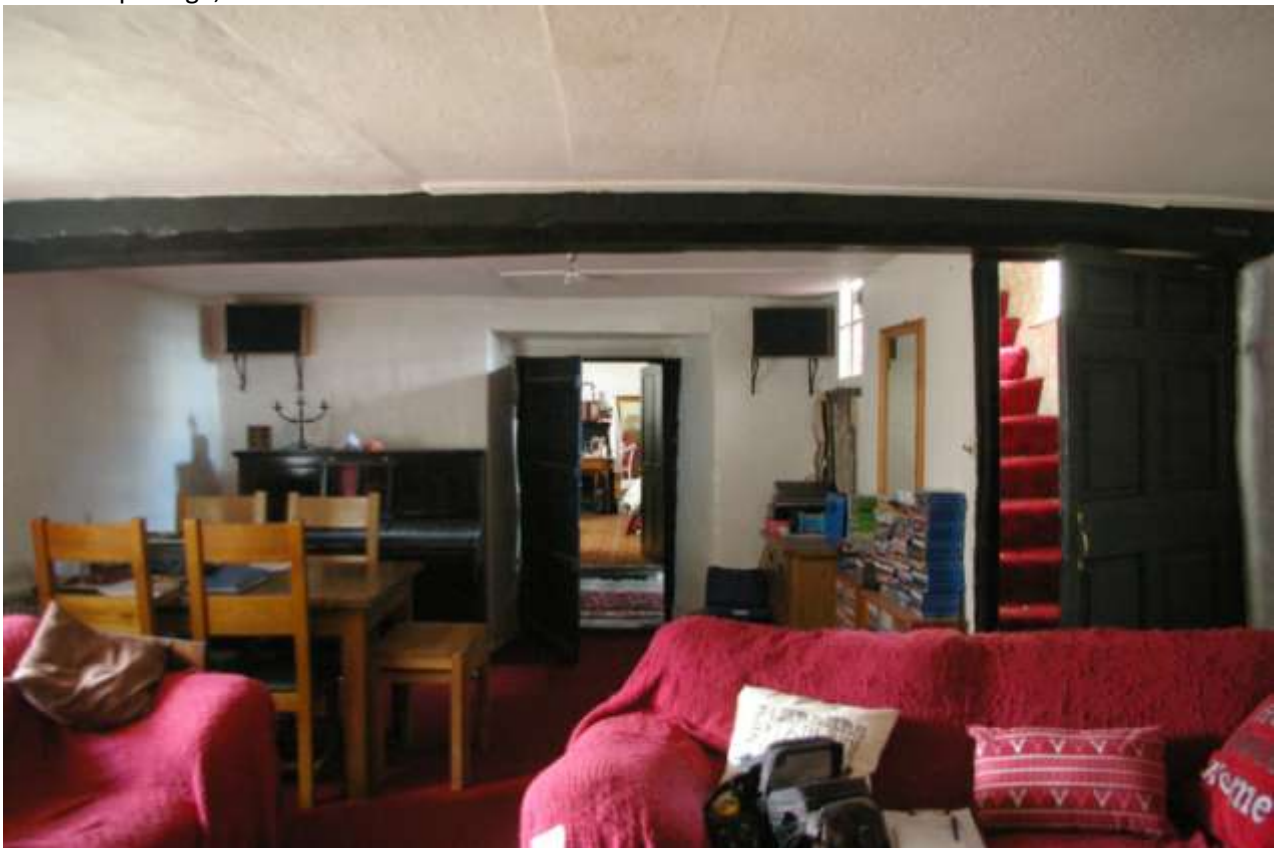
The room to the west (Room 2) is lit from the north via a large, timber three-light mullioned casement window. A heavy chamfered beam spans the centre of the room with a narrower beam to the west, flat to one side, both on a north-south alignment. The room is heated by a large gable-end stack to the west; an open fireplace with narrow chamfered timber bressumer over, squared rubble stone reveals and raised modern slate hearth. It has two ovens, one a cloam oven with funnel-shaped opening, one with a cast-iron door. A door with two raised and fielded panels, to the north of the stack, leads through into a hallway. Off the hallway to the north is a small room with window to east and blocked window to north. To the south, the modern kitchen (Room 3) wraps around the west gable end of the building.

The western room on the ground floor; from the west.

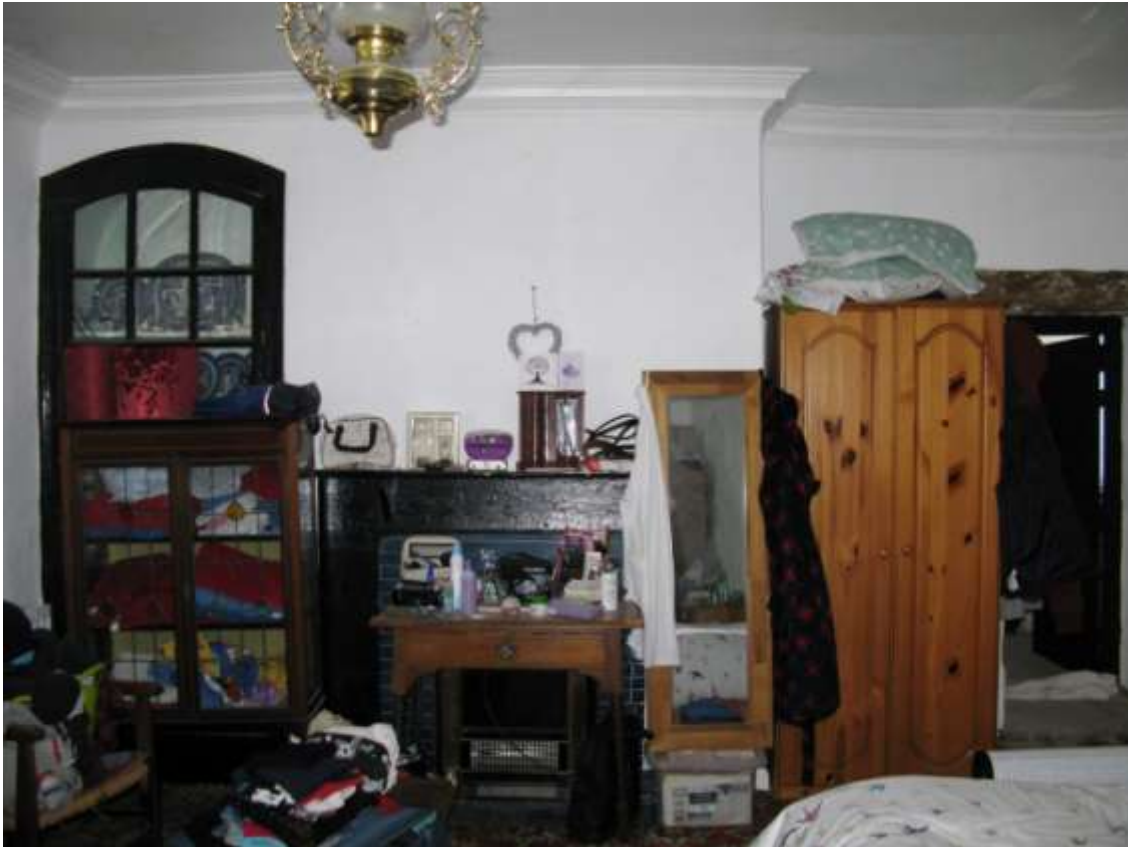
The room to the east of the cross passage (Room 4) is the former open hall. This room is lit from the north and south. The full height window to the north has wide sloping reveals and the large southern window has sloping reveals and timber sill. The high ceiling is of lathe and plaster; a deep moulded cornice runs around the room and respects the projecting stack. An axial stack stands to the north-east corner of the room, the fireplace has a beaded timber surround and mantle shelf. A tall round-arched cupboard is set into the alcove to the left of the fireplace, with glazed fifteen pane door above and a panelled door below, L-H hinges. A doorway, the door with raised and fielded panels, in the south-east corner leads to Room 5.

The ground floor hall, showing the 19<sup>th</sup> century cupboard, 17<sup>th</sup> century corning and original door to the far right of the shot; from the west.

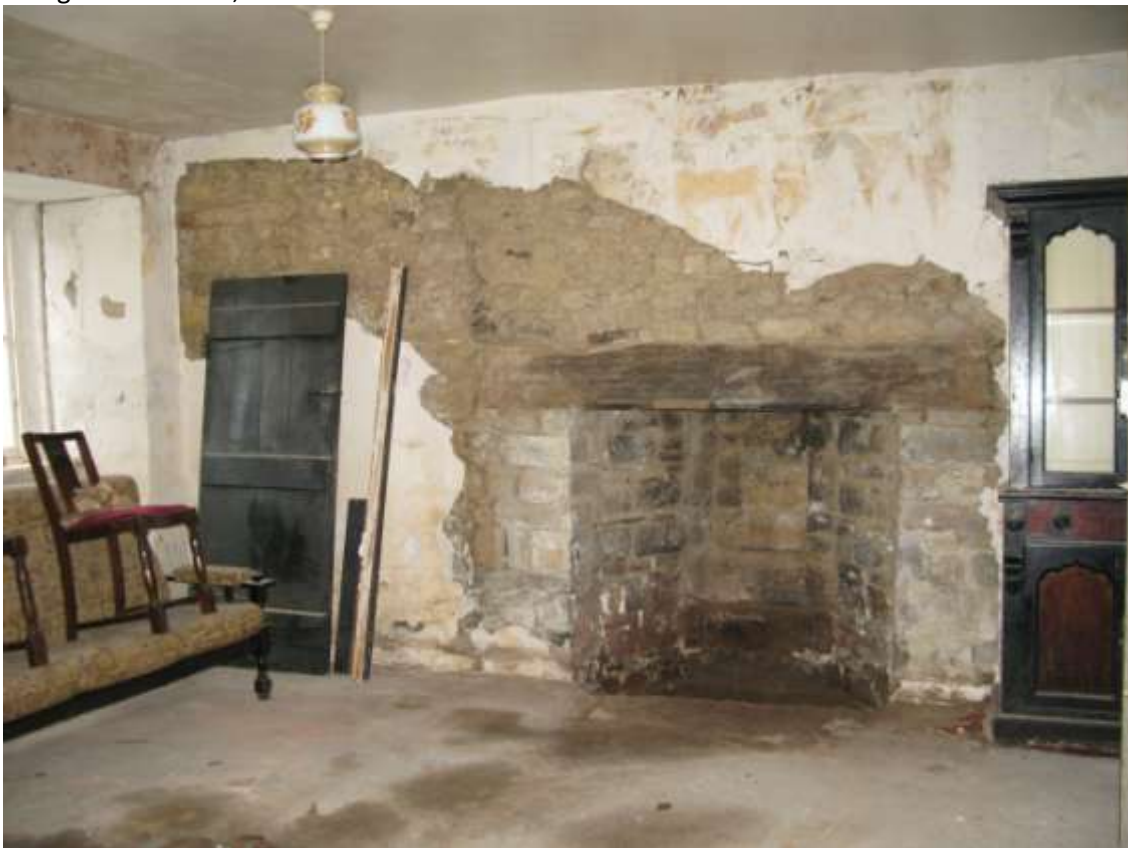
The 'inner room', to the east end of the building (Room 5) is accessed in the south-west corner, lit from the north and south. In the north wall are two large, stone, hollow-chamfered mullioned windows, with panelled window seats and to the south-west, a narrow timber casement window is set in a blocked doorway. The ceiling is much disturbed modern boarding, a fine 17<sup>th</sup> century decorative plaster ceiling having apparently been ripped out in the 1940s. The floor level steps up, with a layer of concrete over two layers of brick paving. The room is heated via a gable-end stack, with square fireplace, framed by dressed stone sloping, angled reveals, chunky bressumer beam over and a low brick hearth. The bressumer is hacked to carry a plaster coating, and a surround and grate have probably been removed. A staircase rises out of this room, against the south wall, accessing the bedroom (Room 6). This stair is enclosed within a modern plank boarded partition.

The 17<sup>th</sup> century fireplace in the eastern ground floor room; from the south west.

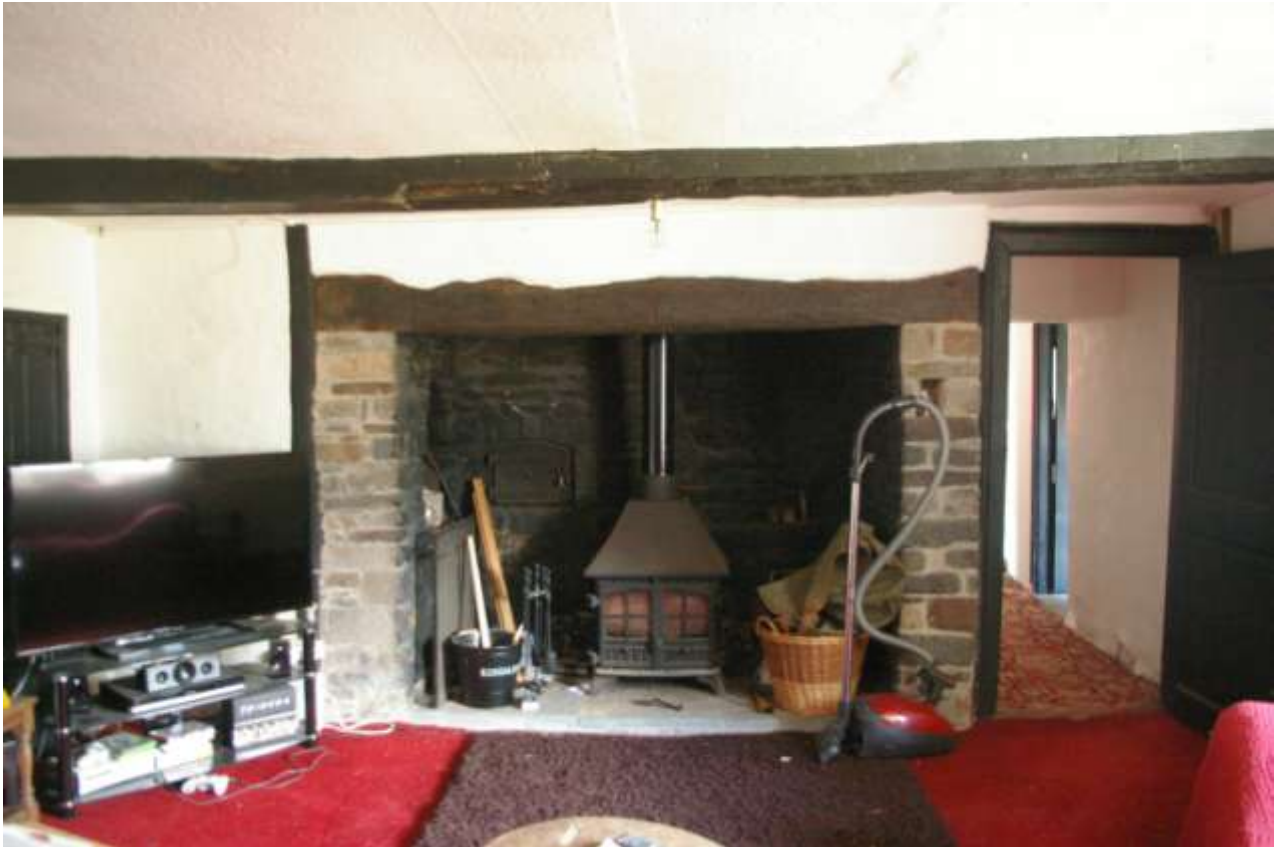
The 17<sup>th</sup> century fireplace in the ground floor hall; from the east.

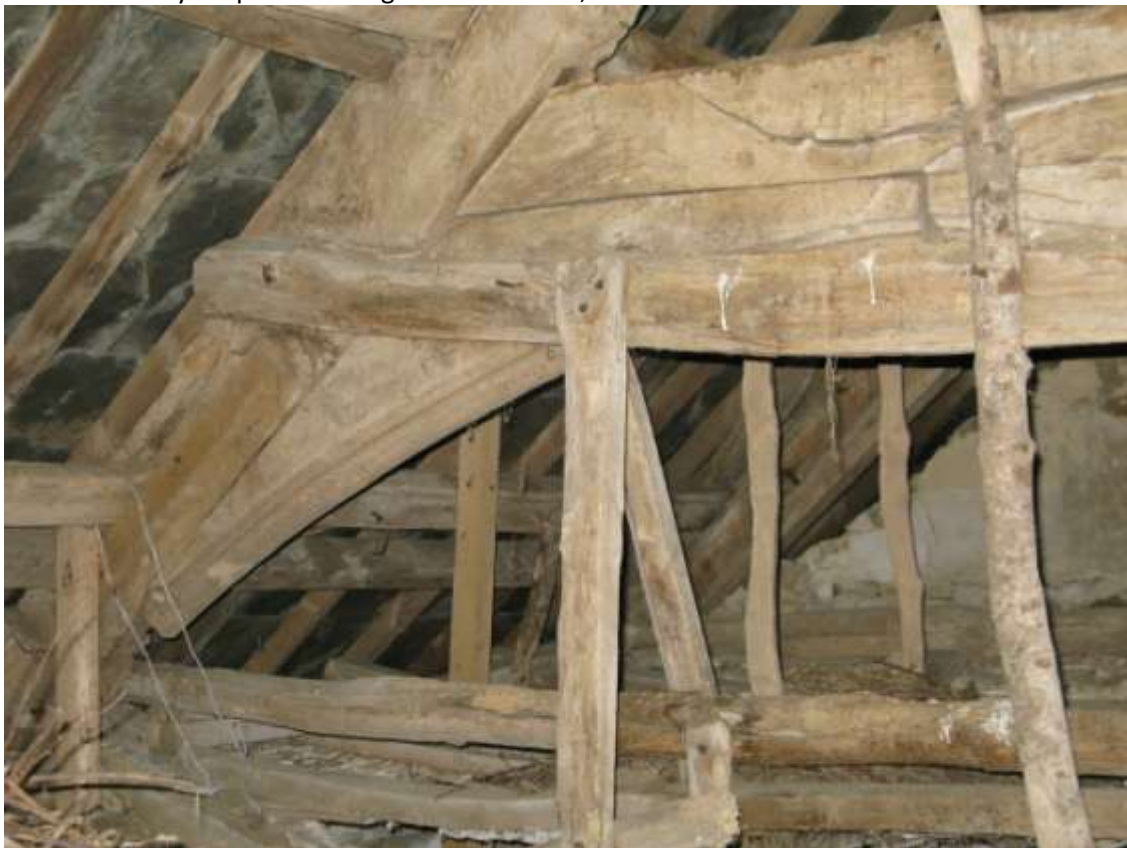
These 15<sup>th</sup> century trusses are of oak and are of substantial size. The arch-bracing on the trusses is ovolo-moulded, the wind-bracing appears to be hollow (or cavetto) chamfered, as are the surviving heavy, square-set purlins. All four trusses have at least one side of arch-bracing remaining, the wind bracing lies loose on the later plaster ceilings in many places but to the east end of the hall, adjacent to the later axial stack, the wind-bracing is in situ, on the north side of the roof, between the second-to-last and last truss.

Detail of the west side of the arch-braced truss; from the south.

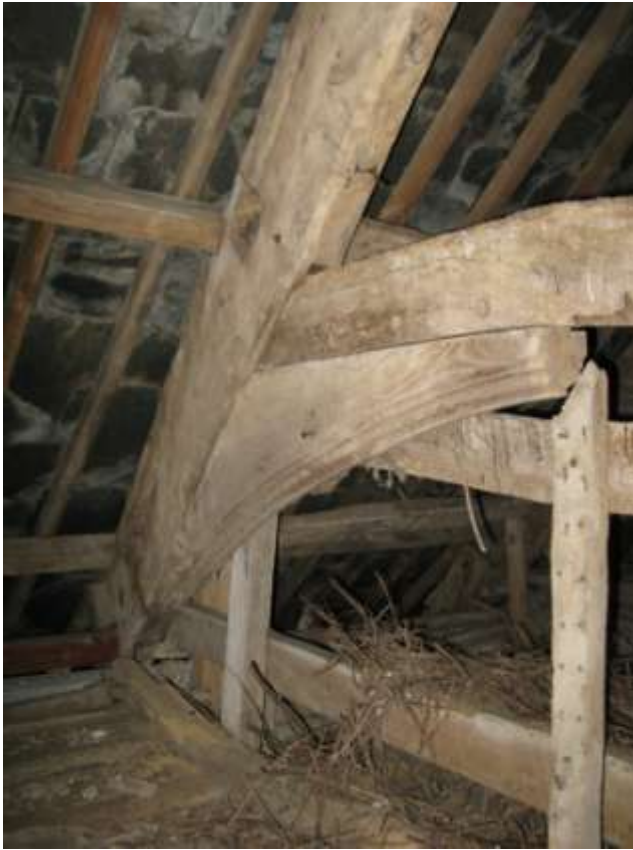
Detail of the section of the arch-braced truss; from the south.
