# BRYNN MILL ROCHE CORNWALL

## Historic Building Recording

Report No.: 20160210  
Date: 10/02/2016  
Authors: B Morris  
M Watts

**SWARCH project reference:** RBM14  
**Planning Application No.:** PA13/07736, PA13/07737  
**OS Map copying Licence No:** 100044808  
**National Grid Reference:** SW9824563322  
**Project Director:** Colin Humphreys  
**Fieldwork Managers:** Bryn Morris  
**Project Officer:** Martin Watts  
**Desk Based Assessment:** Bryn Morris; Martin Watts  
**Building Survey:** Martin Watts  
**Report:** Bryn Morris; Martin Watts  
**Report Editing:** Natalie Boyd; Bryn Morris  
**Research:** Bryn Morris; Martin Watts

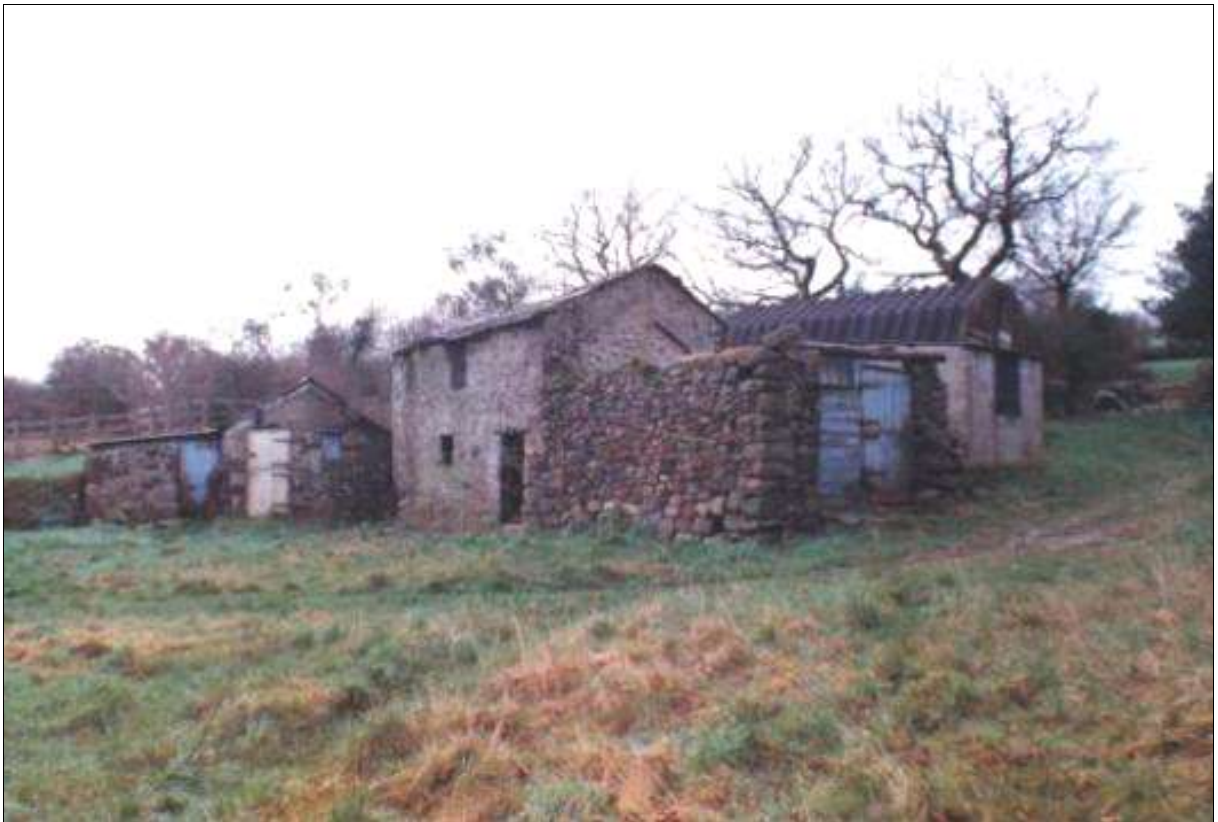
Figure 7: The outbuildings south-west of the Mill, as photographed in 1988, viewed from the north-east. In its clear mix of styles and materials, this structure is probably very similar to the earlier phases of the Mill (photo: courtesy of M. Watts).

To the west of the mill and cottage are the overgrown remains of the rubble stone walls of some small outbuildings built into the slope. These were not closely investigated; they appear to have been ancillary buildings, probably for animals, forming an essential part of any smallholding. A photograph taken in 1988 shows some of these buildings in a more intact condition (Figure 7).

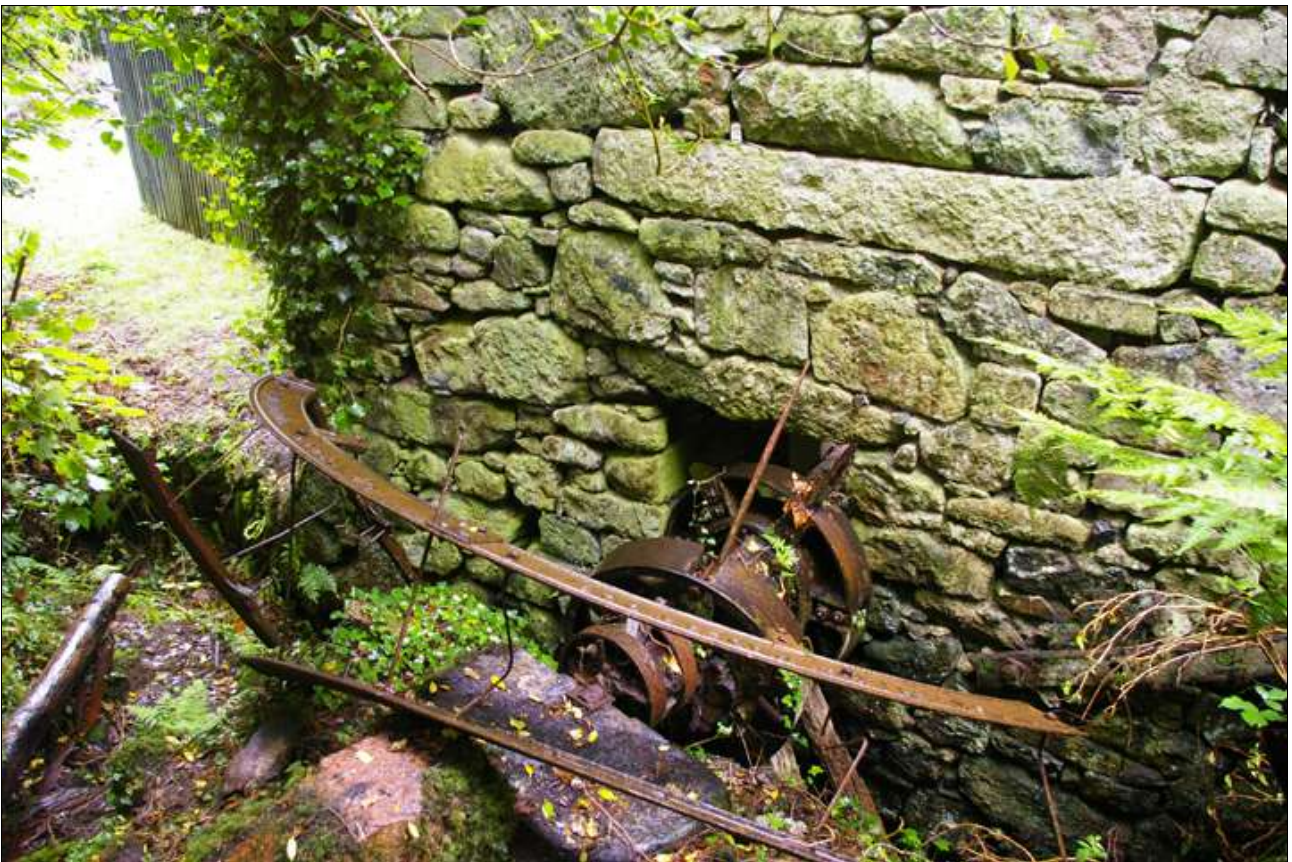
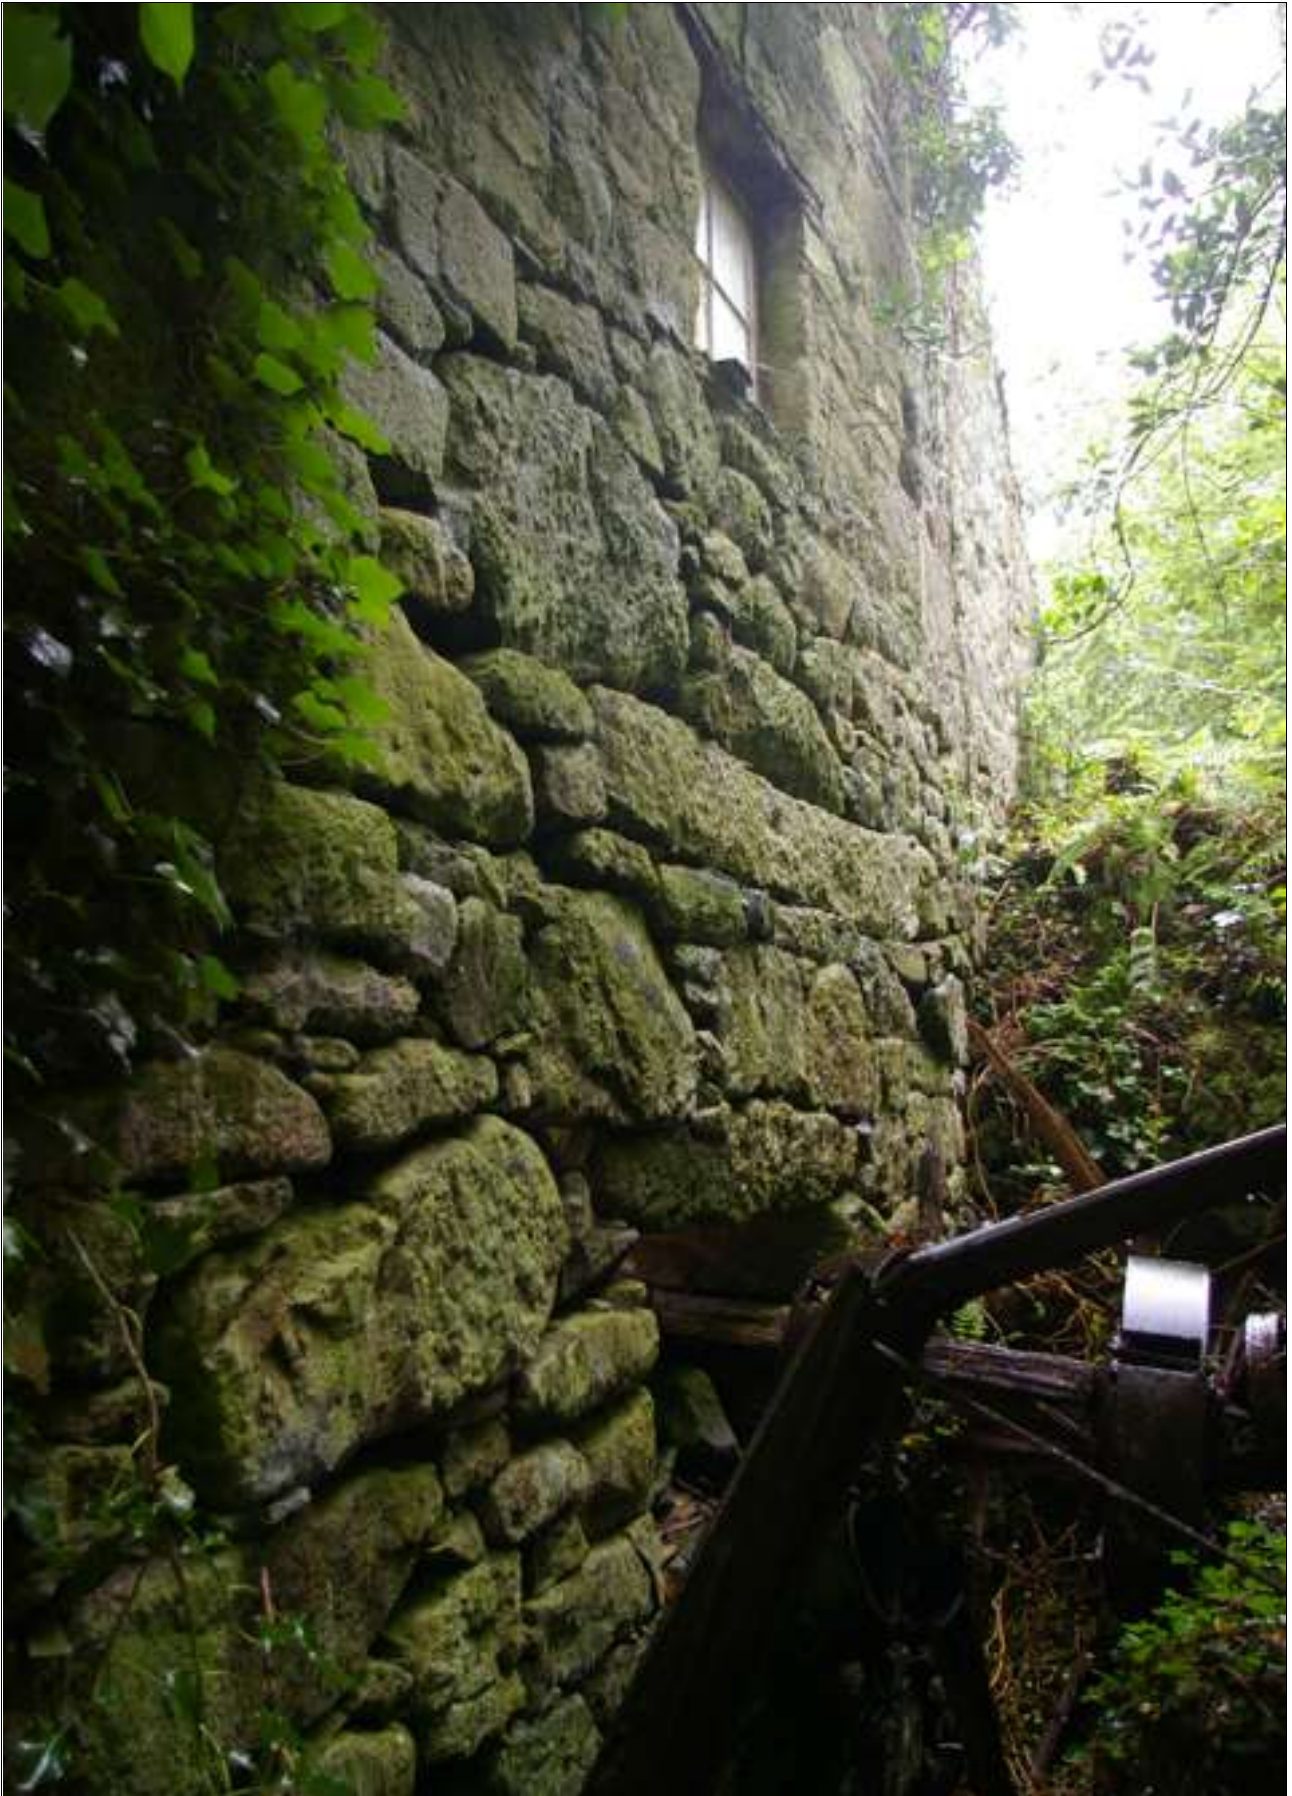
The iron shroud rings and naves are collapsing into the wheelpit, the timber wheelshaft is broken and incomplete and the timber arms and buckets have rotted away. A break in the outer shroud ring was noted in 2014 and there has been marked deterioration since then, with further collapse and breaks in the shrouds.

The wheelpit, showing the collapsed wheel *in situ*; viewed from the north.

As above, viewed from the east.

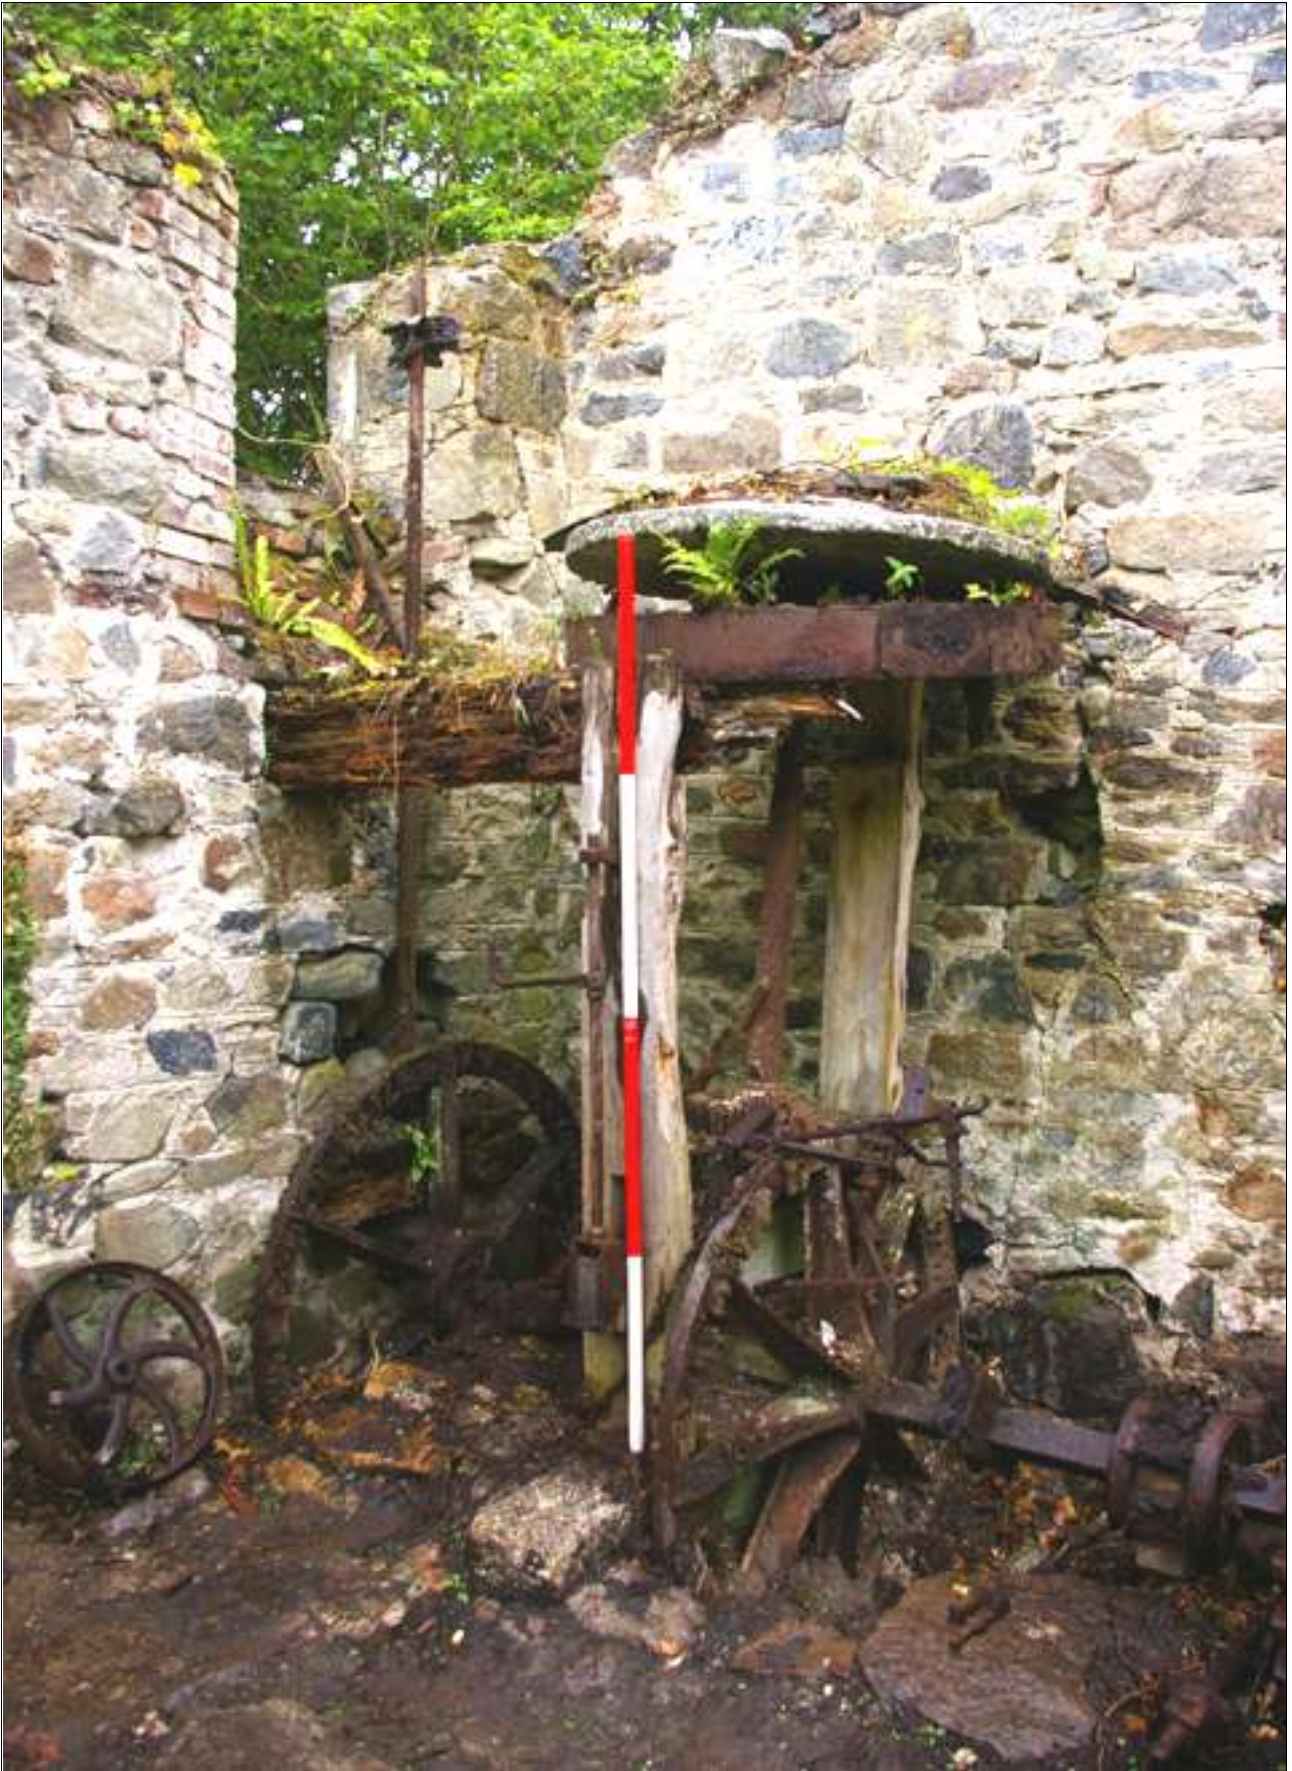
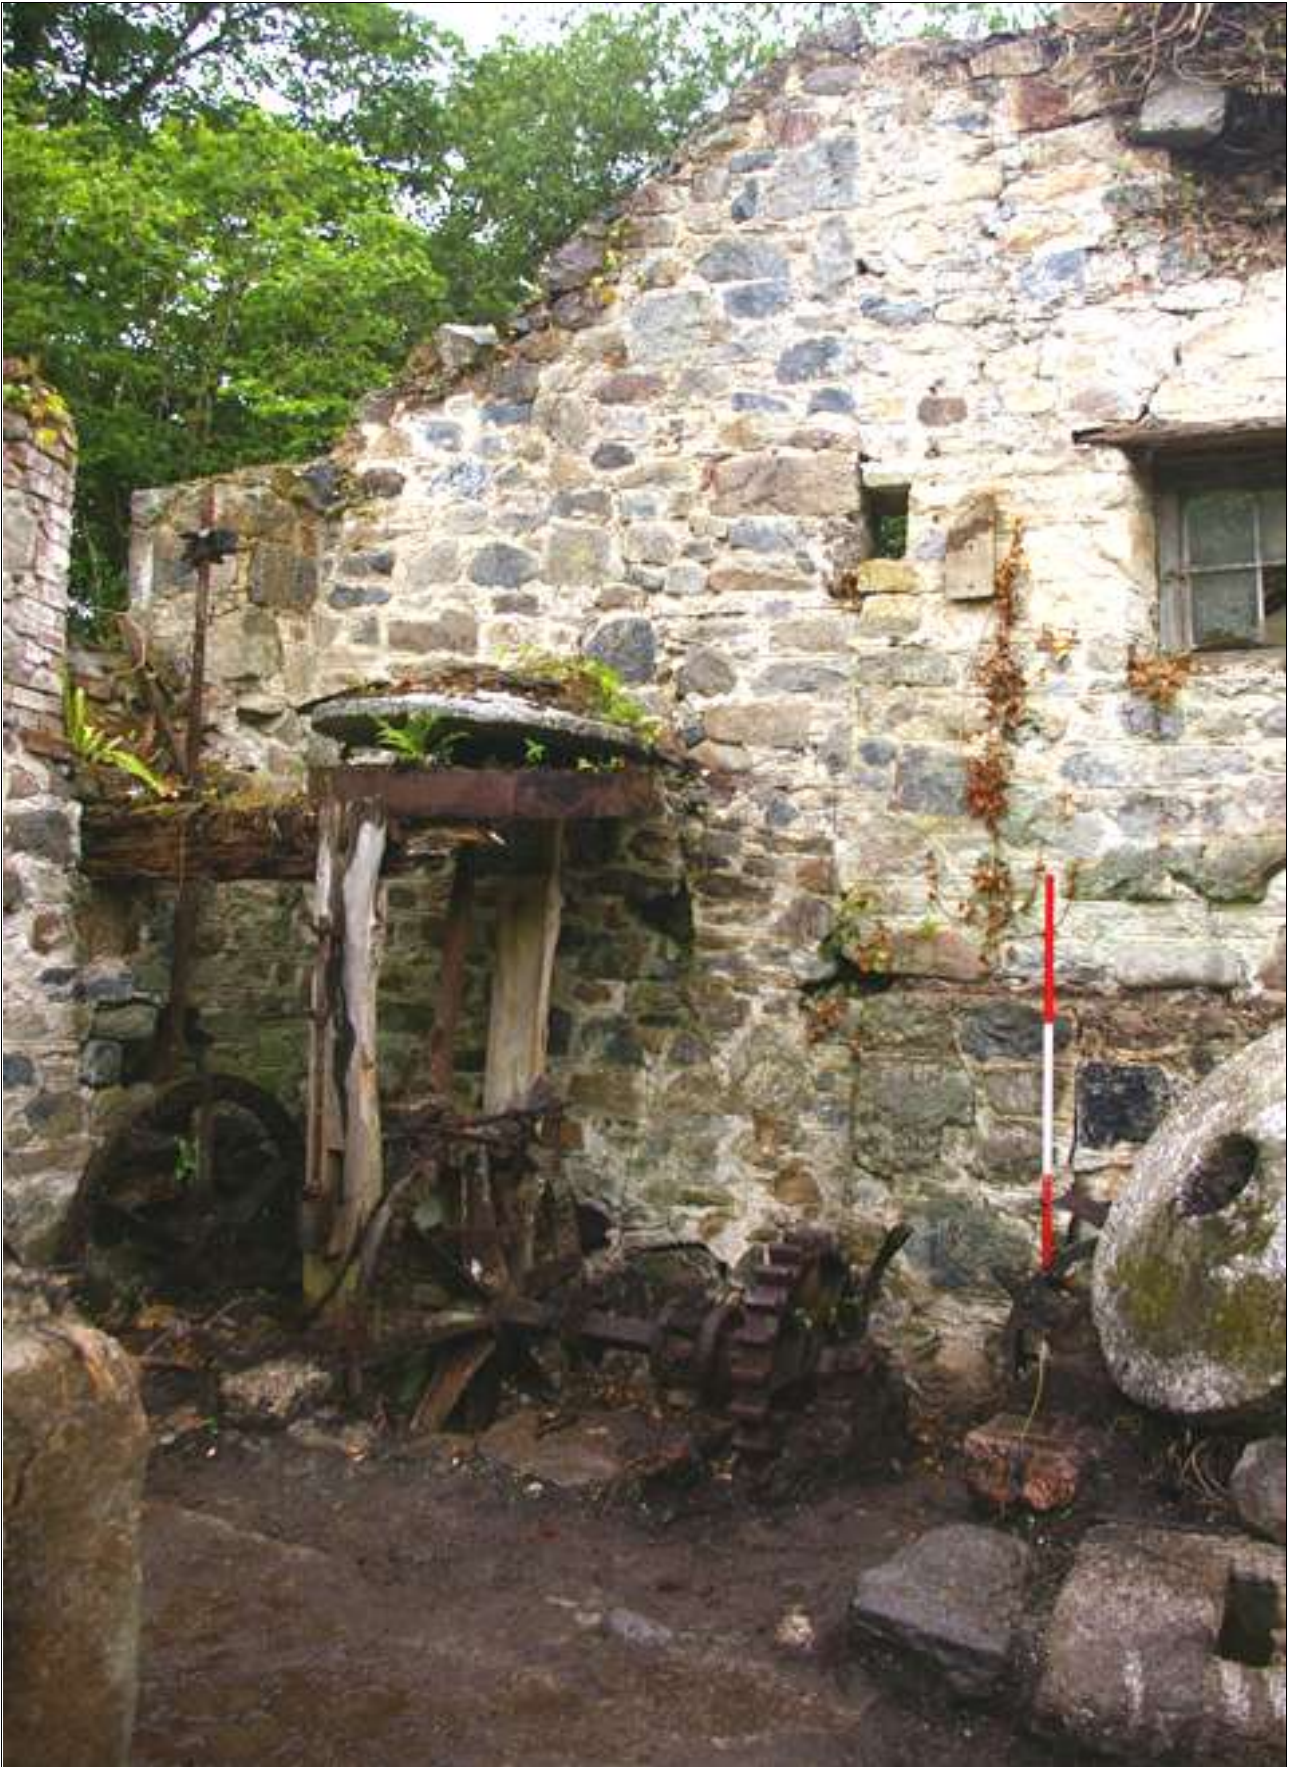
The upstream layshaft, driving gears and millstones; viewed from the south-east (scale 2m).

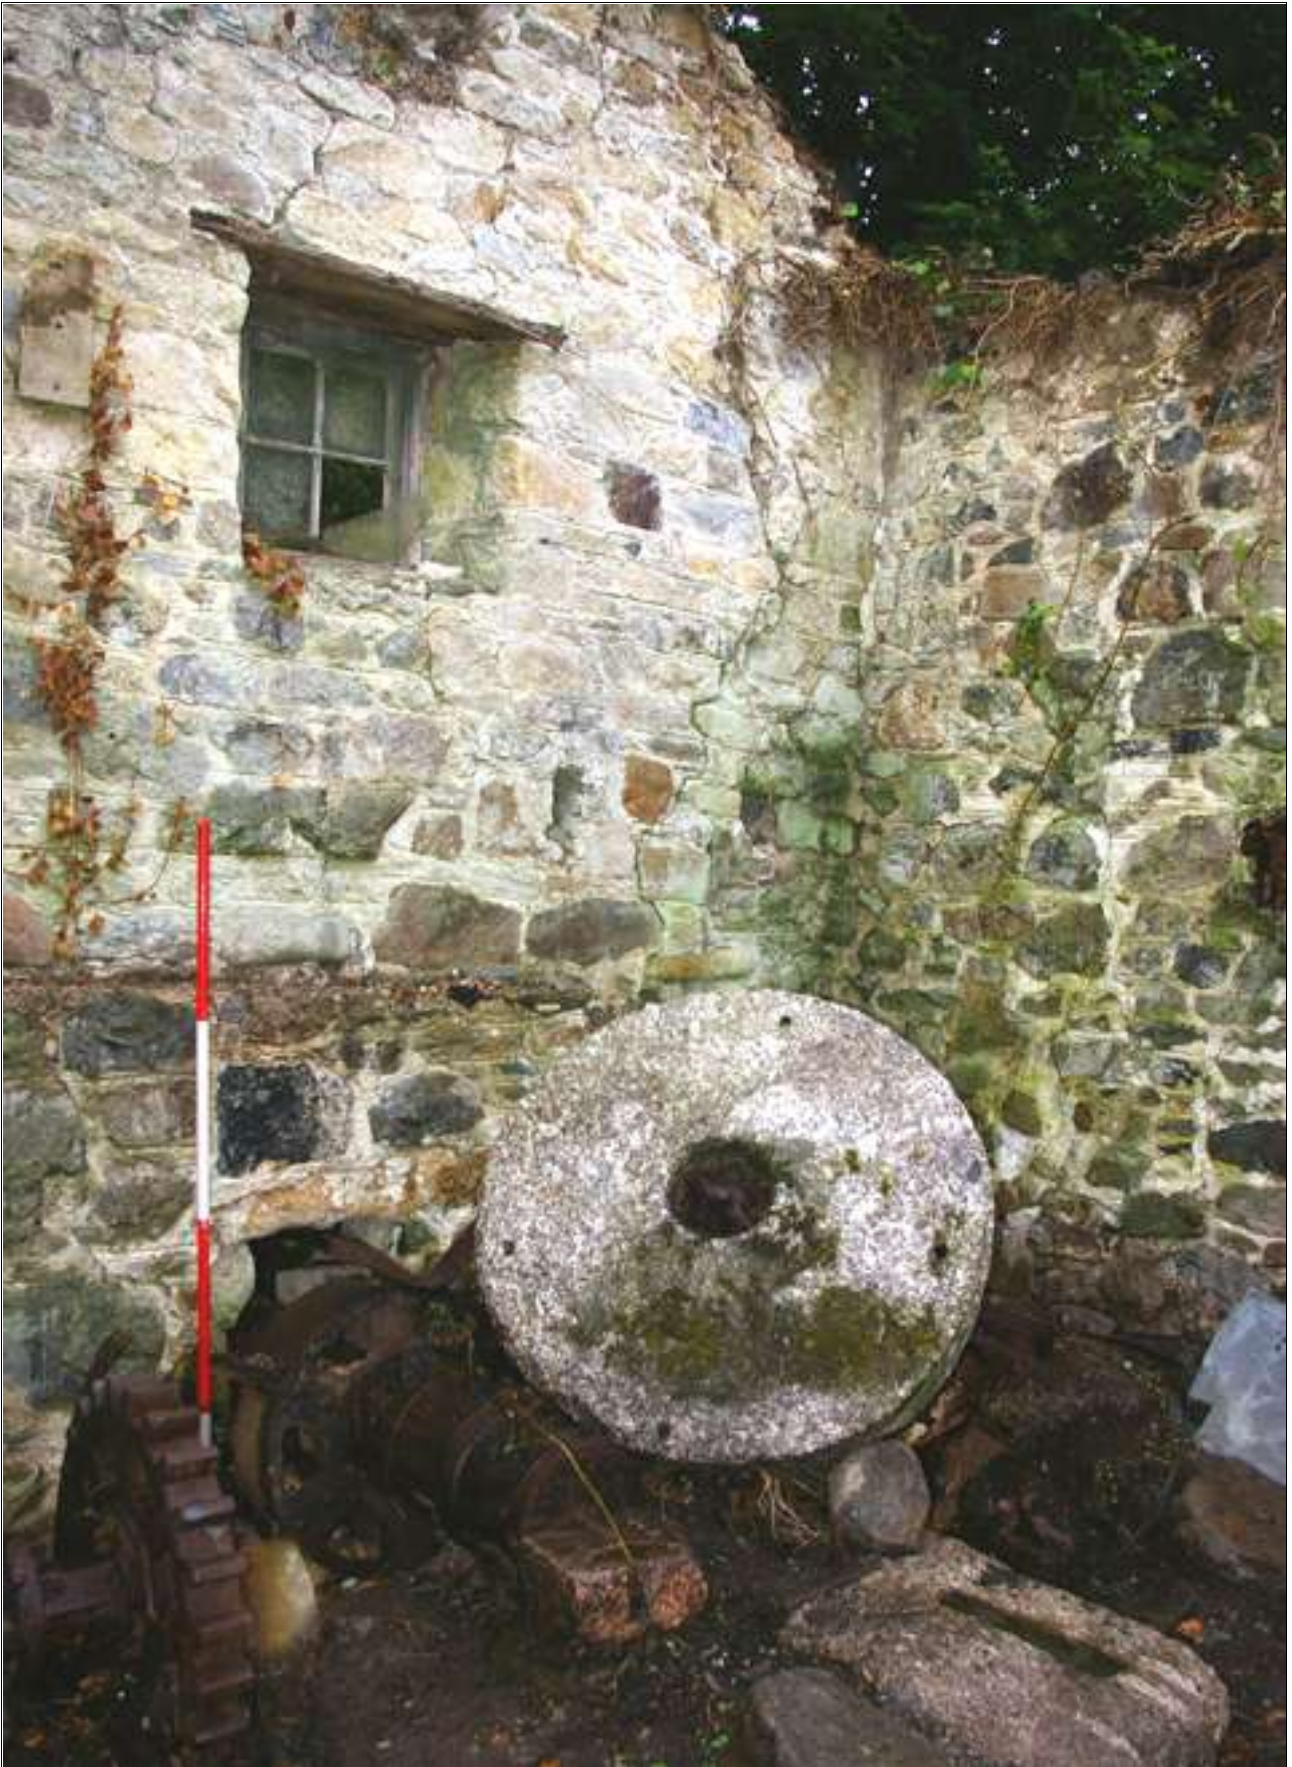
On the downstream side of the pitwheel is the remains of a broken and decayed timber layshaft, its upstream end partly obscured by the millstones. This shaft was about 1.37m long, apparently tapering towards its downstream end. In 1988 it was described as 'crudely circular' in section. At its upstream end the shaft carries a cast-iron spur pinion which meshed with the pitwheel. This is a single casting 0.64m overall diameter, with a circular centre and 4 radial arms which carry a 10cm gear face with 19 teeth of 10cm (4in) pitch. It is mounted 20cm from the upstream end of shaft and was bolted through the timber arms of the millstone drive gear. Details of upstream end bearing and disengaging mechanism (which were noted by Alan Stoyel in 1988) could not be seen, the timbers having rotted away. The shaft formerly carried a compass-arm gear [two arms crossing at right angles to each other, halved into each other within the thickness of the shaft and wedged in place], which has also rotted away. It is possible that some fragments of this gear may be found during further clearance of this area. In 1988 it was described as 'a wooden, compass-armed, contrate [i.e. unbevelled] wheel of approximately 54" diameter x 5" wide, with a 6" face. There are 4 arms. Cogs have 3½" pitch and 3" face.' The exact number of cogs was not recorded, but from the dimensions given would be of the order of 44. This gear had two circumferential iron bands binding it, one 5cm (upstream/west) and the other 7cm wide, similar to that on pitwheel. The gudgeon on the

The downstream layshaft and millstones; viewed from the south-west (scale 2m).

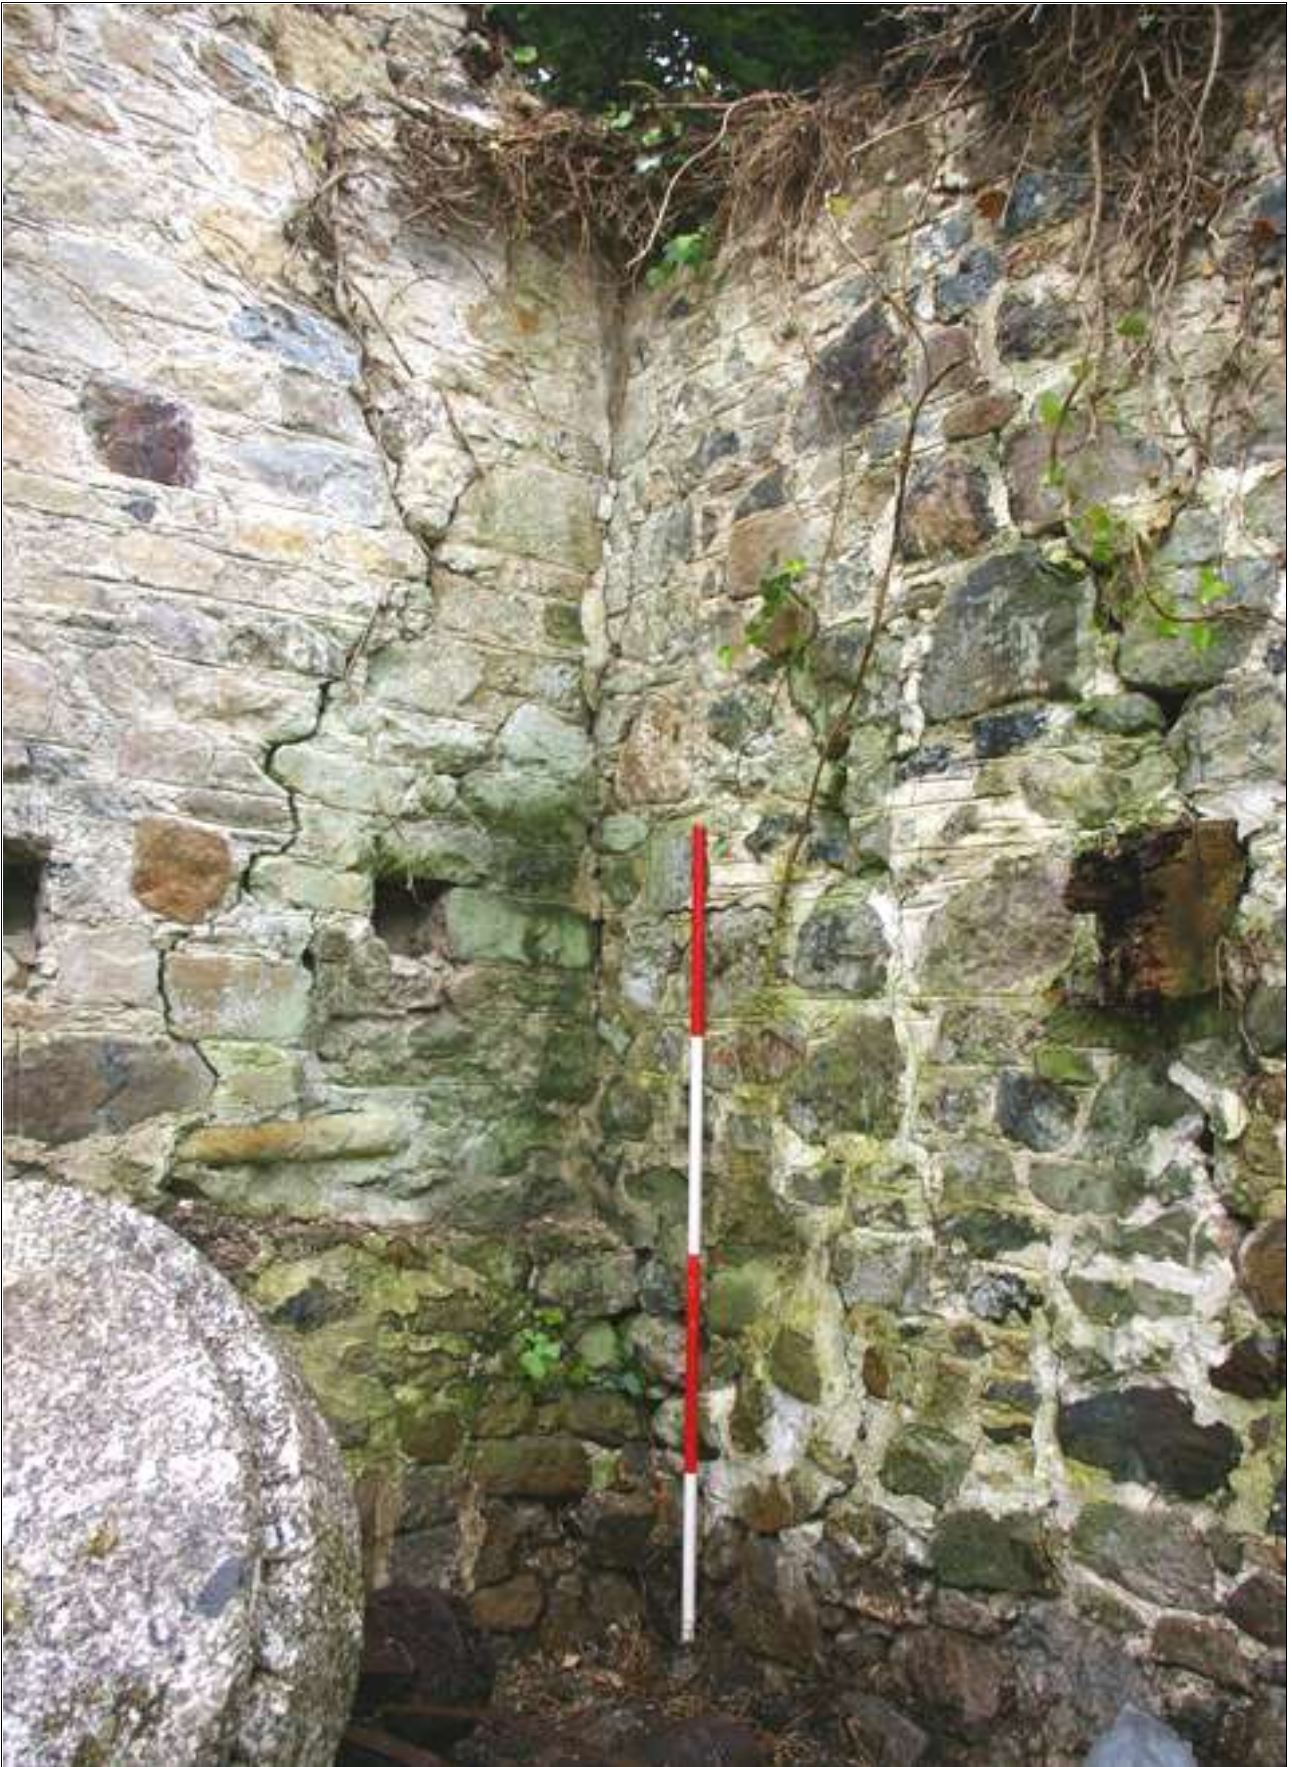
The north-east corner of the Mill, showing structural cracks; viewed from the south-west (scale 2m).

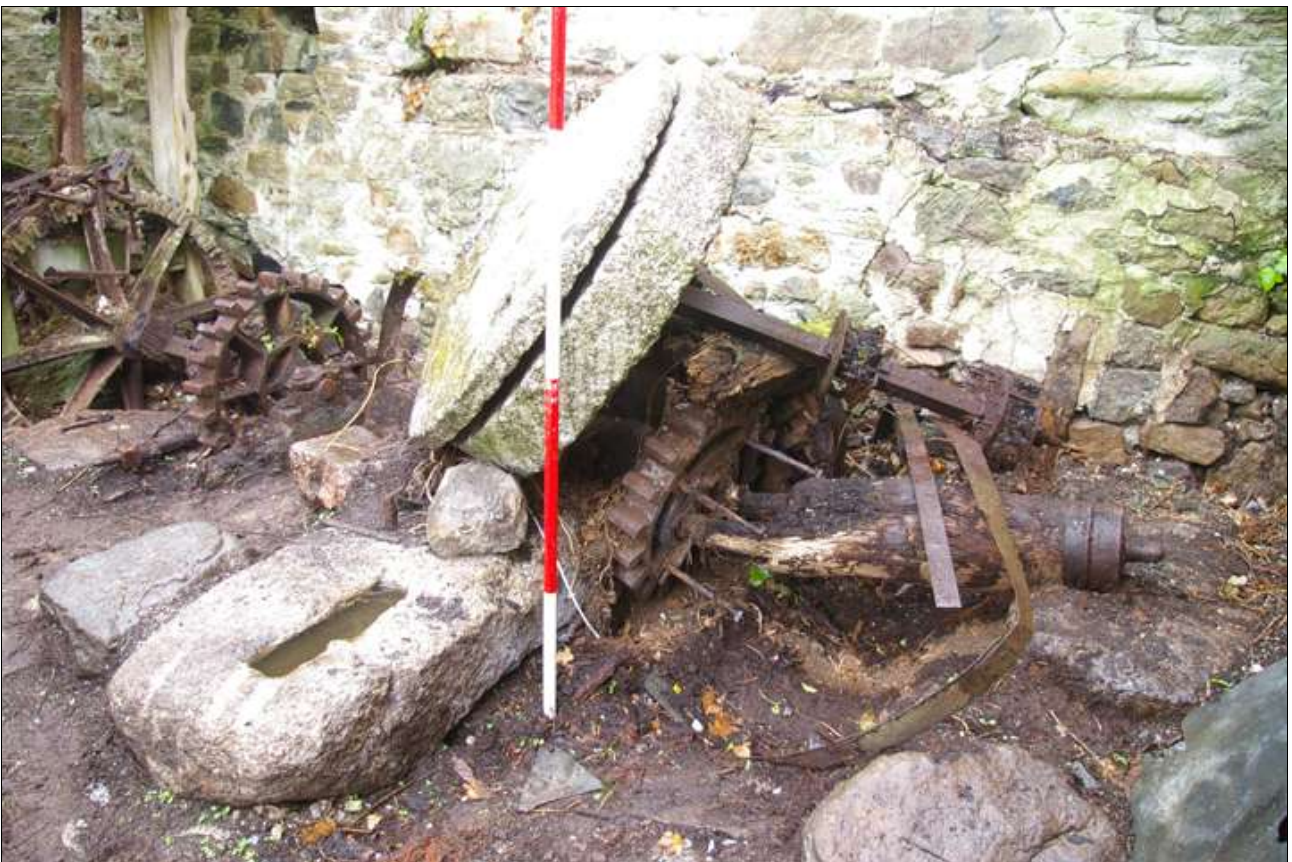
These are lying at an angle over the upstream end of the downstream layshaft, the bridge posts and hurst timbers which supported them having completely rotted away. Both stones are of granite with domed backs; the bedstone is about 1.17m diameter and 18.5cm thick, with a flat back. The runner (top) stone is the same diameter with a 23cm circular eye; it is worn to 6cm thick at the periphery and is 18.5cm thick at eye. It has four holes bored into its back. These are set about 10cm in from periphery and just over 2.5cm diameter. Three are evenly spaced, on quarters, the fourth being slightly offset. These may have been for pegs used to locate a second stone, or disc of stone, to add weight to the worn runner stone, to increase its working life. The runner is mounted on a bridge rynd, which located in a circular iron mace. There is a square projection on the top of the rynd, on which the foot of the damsel was located.

The collapsed downstream iron spur gear and millstones; viewed from the south-east (scale 2m).

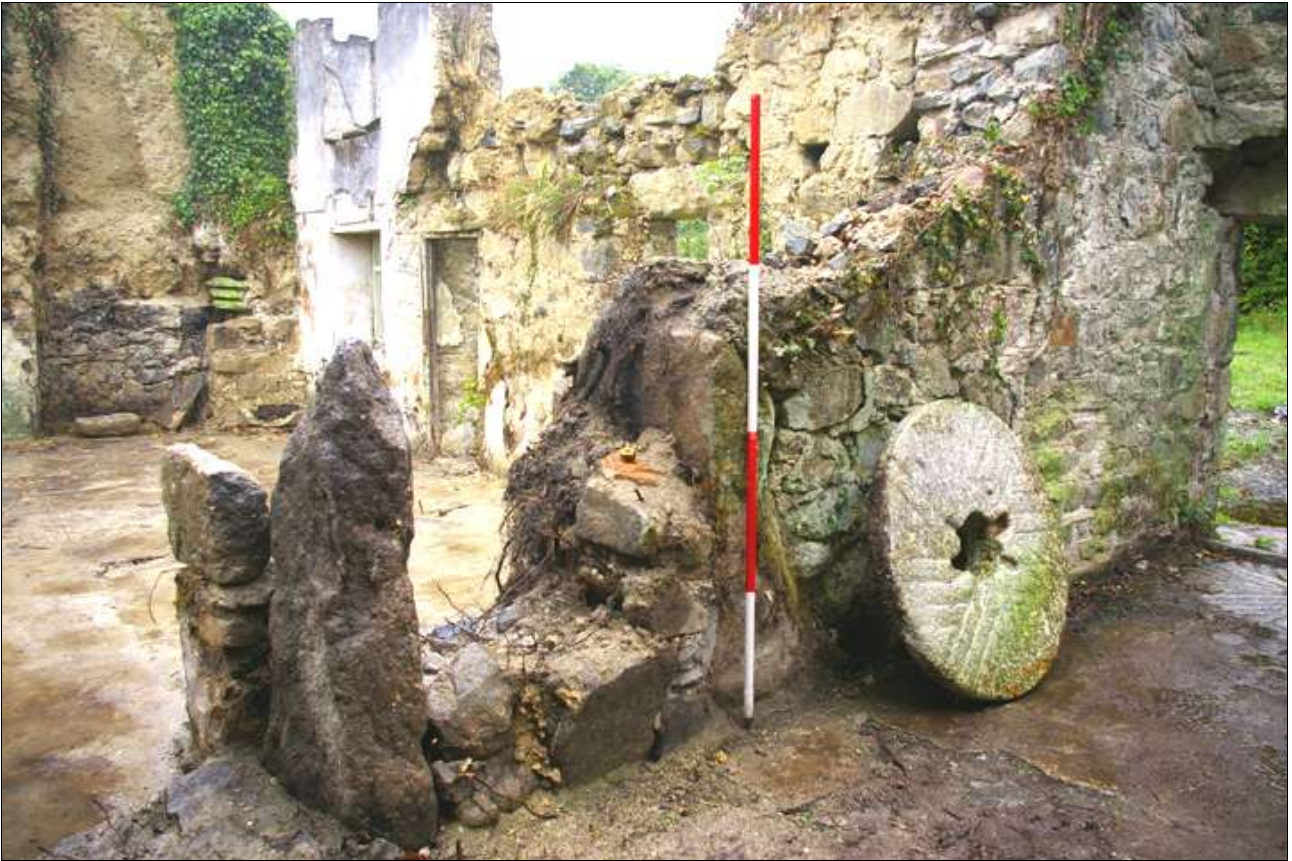
The south wall of the mill, showing the blocked orthostat doorway; viewed from the north-east (scale 2m).

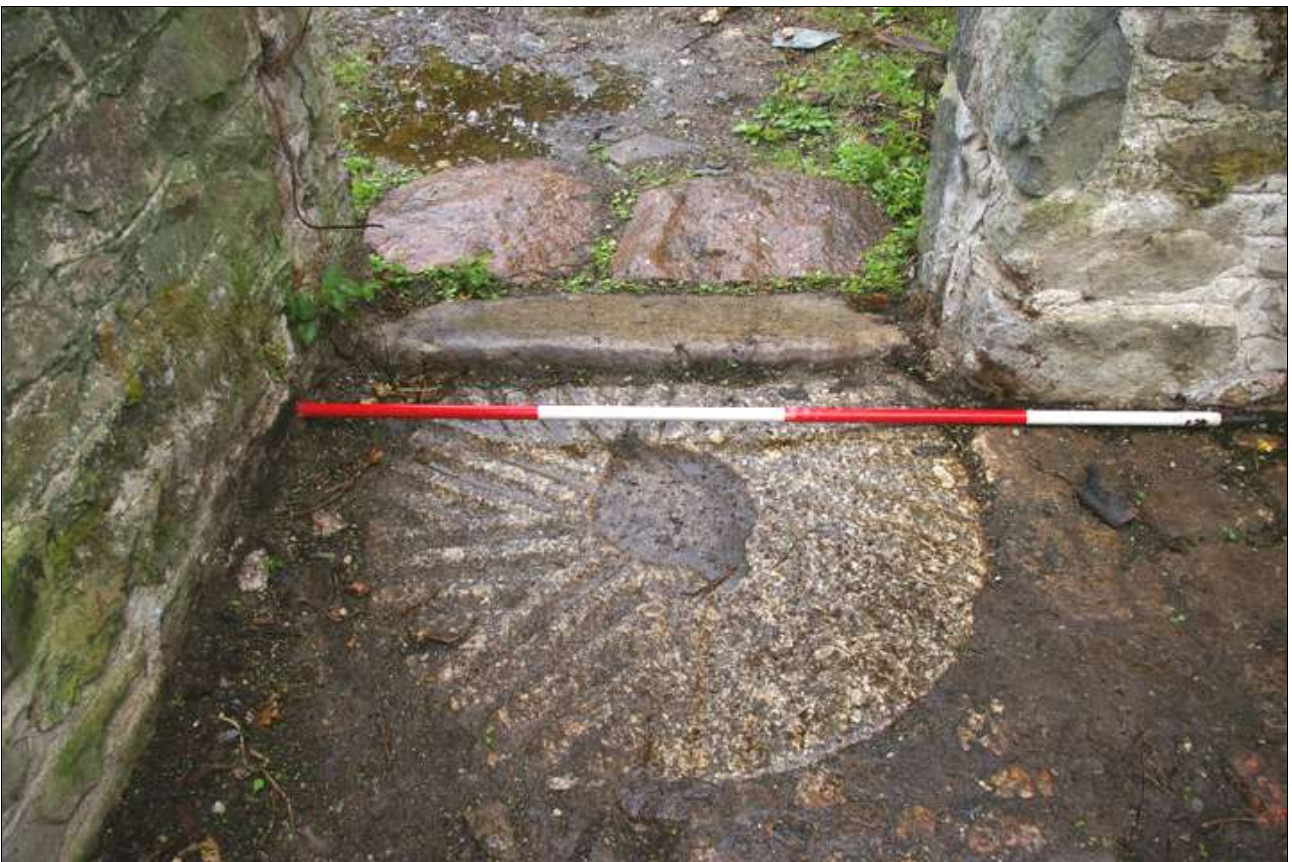
The worn millstone set into the floor just inside the western doorway into the mill; viewed from the east (scale 2m).

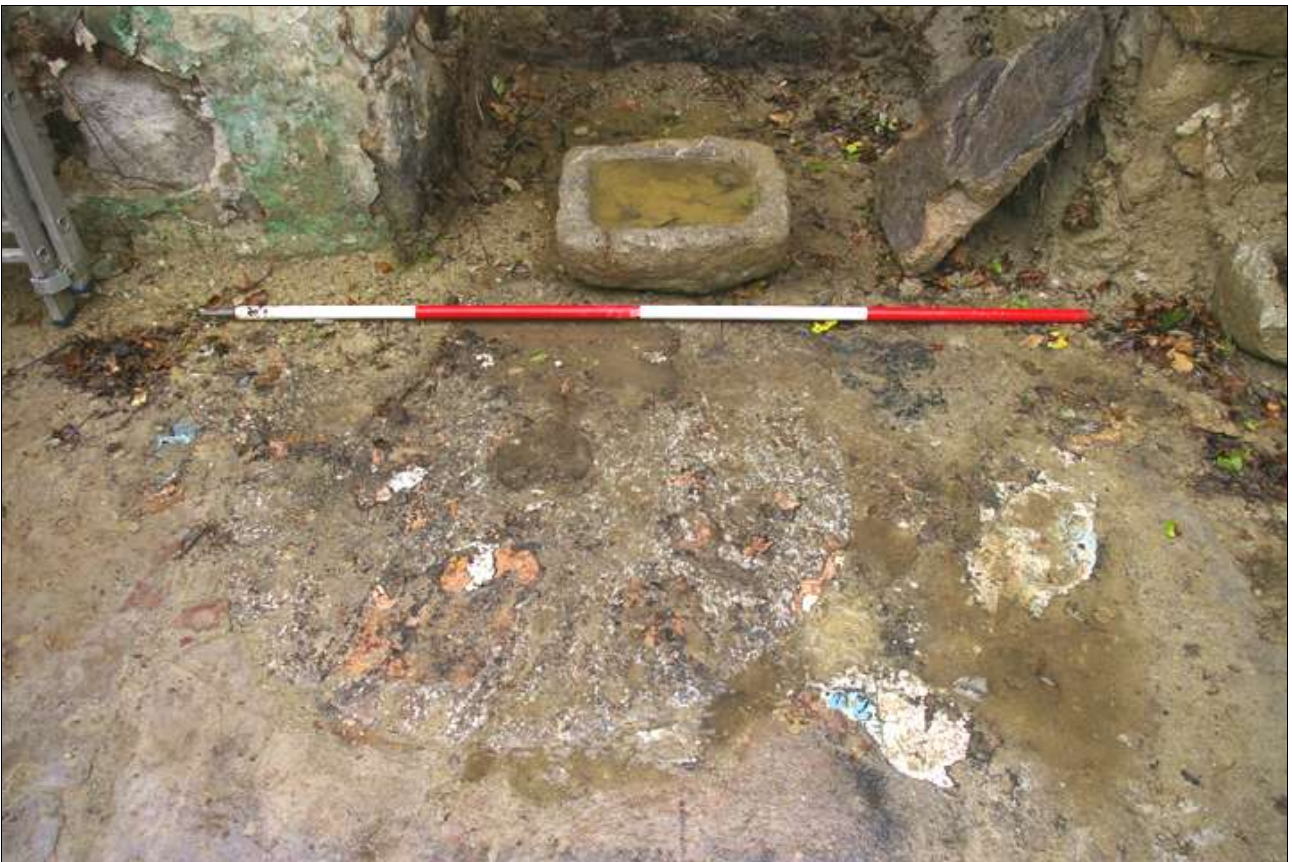
Plans made in the 1980s indicated a two-room layout, with ground-floor fireplaces at both ends and a central stair to the first floor. The chimney serving the fireplace at the north end had been removed and roofed over before 1988. Following the clearance of the interior, the floor was revealed to be of concrete, with the remnants of linoleum adhering to the surface, with scars for narrow studwork walls defining the two small rooms. In the middle of the floor, and adjacent to the southern fireplace, parts of worn granite millstones had been set into the floor.

The worn millstone set into the concrete floor of the cottage, in front of the southern fireplace; viewed from the north (scale 2m).

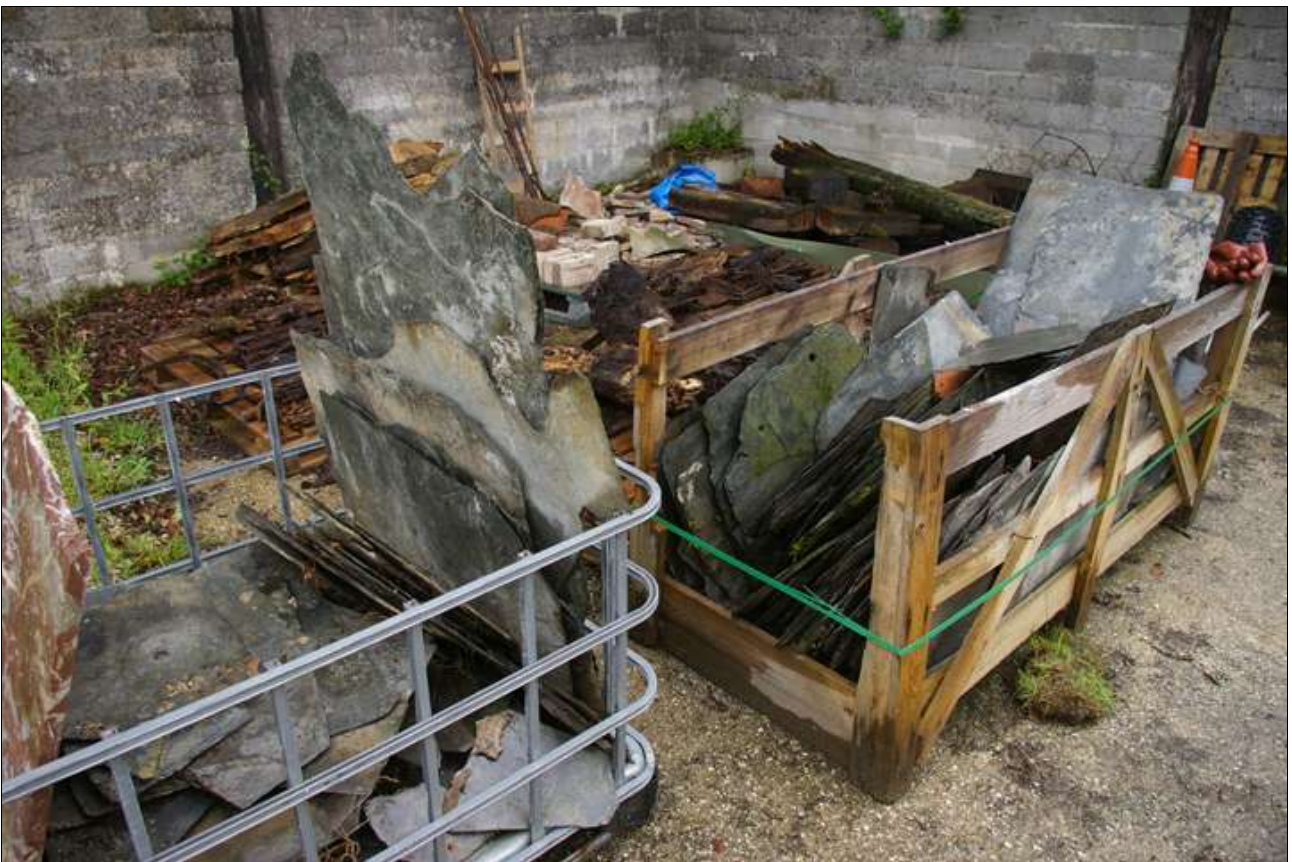
The roof of the mill has collapsed; no details of the roof structure survive, but it had a roof of large and irregular (scantle) slates. From survey drawings made in the 1980s, the pitch of the mill roof was about 30 degrees. The external walls of the mill stand to eaves level, but structural cracks are visible in the north and east elevations. The west (front) elevation, and the upper part of the north elevation, is of rubble stone bedded in lime mortar. The other walls are clay bonded and pointed with mortar. There are some massive stone blocks, mainly on the north (wheelpit) side. The south (internal) wall contains two large sub-rounded 'orthostats' that frame a blocked doorway. The walls are built of a highly heterogeneous mixture of local slatestone, sandstone, granite rubble and other fine-grained igneous rocks. Granite is used for lintels and some quoins.

The irregular scantile slates recovered during the clearance of the debris inside the Mill.

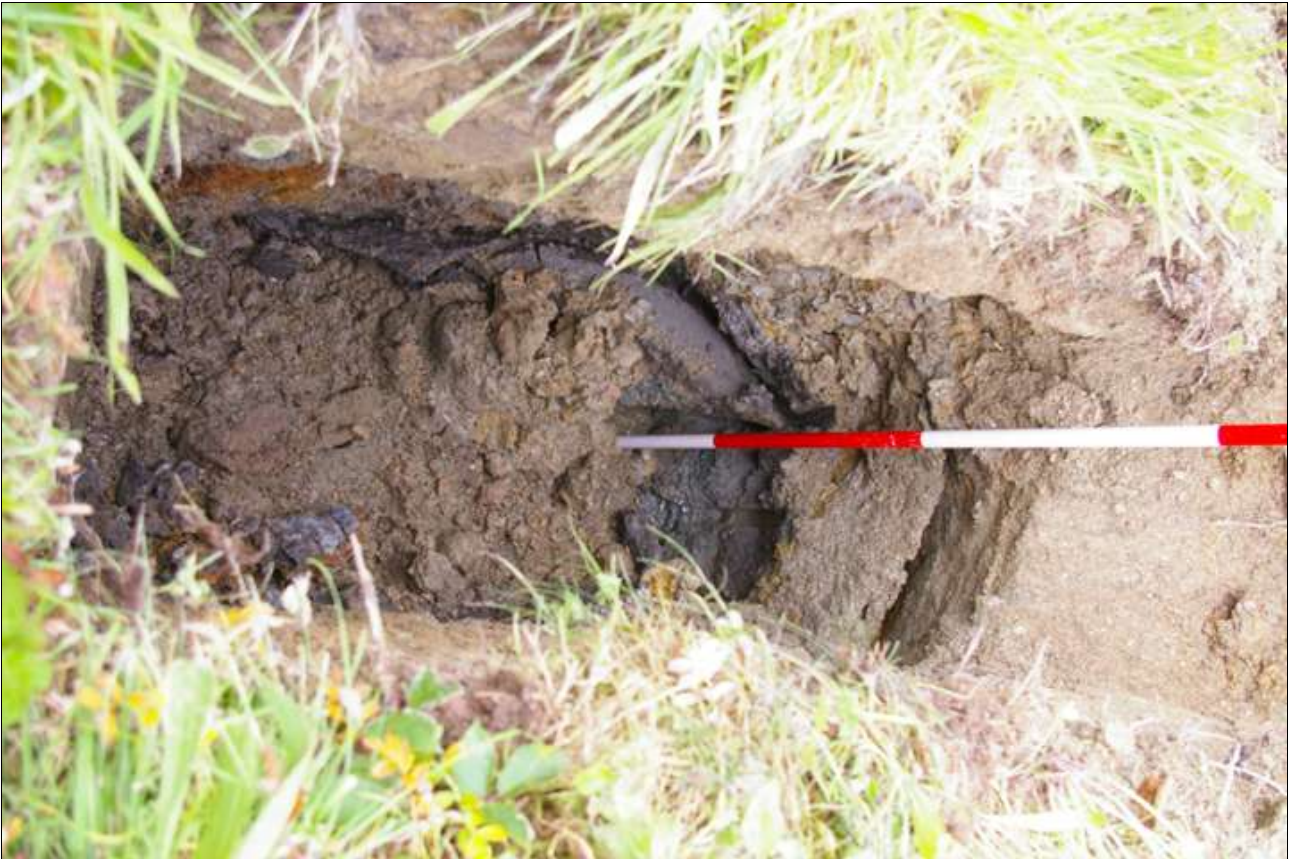
Geotechnical pit #2, viewed from the south (scale 2m); note the dark grey humic silty-clay in the partly-collapsed pit.

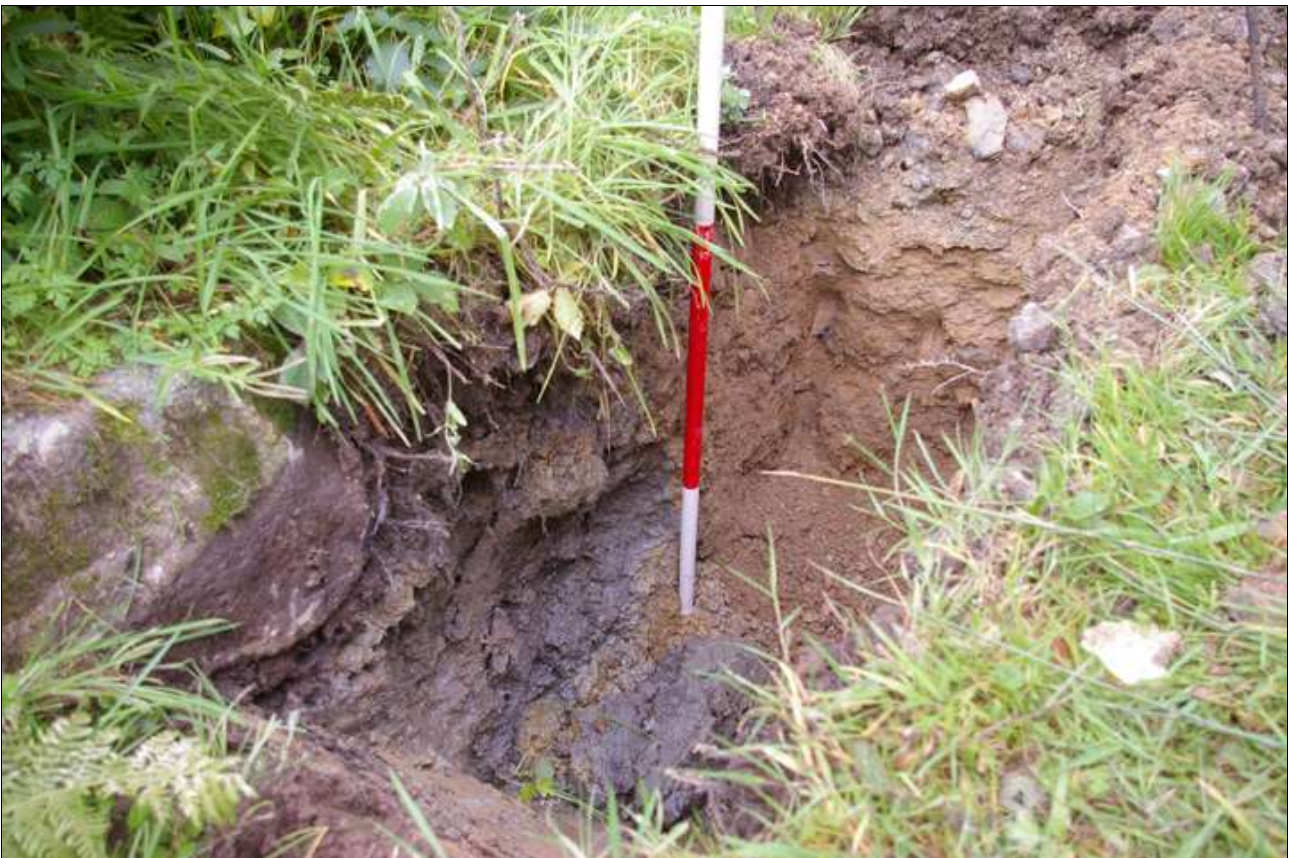
Geotechnical pit #1, viewed from the south-east (scale 2m); this pit just clips the edge of the feature containing the dark grey humic silty-clay.
