# BRYNN MILL ROCHE CORNWALL

## Historic Building Recording

Report No.: 20160210  
Date: 10/02/2016  
Authors: B Morris  
M Watts

**SWARCH project reference:** RBM14  
**Planning Application No.:** PA13/07736, PA13/07737  
**OS Map copying Licence No:** 100044808  
**National Grid Reference:** SW9824563322  
**Project Director:** Colin Humphreys  
**Fieldwork Managers:** Bryn Morris  
**Project Officer:** Martin Watts  
**Desk Based Assessment:** Bryn Morris; Martin Watts  
**Building Survey:** Martin Watts  
**Report:** Bryn Morris; Martin Watts  
**Report Editing:** Natalie Boyd; Bryn Morris  
**Research:** Bryn Morris; Martin Watts

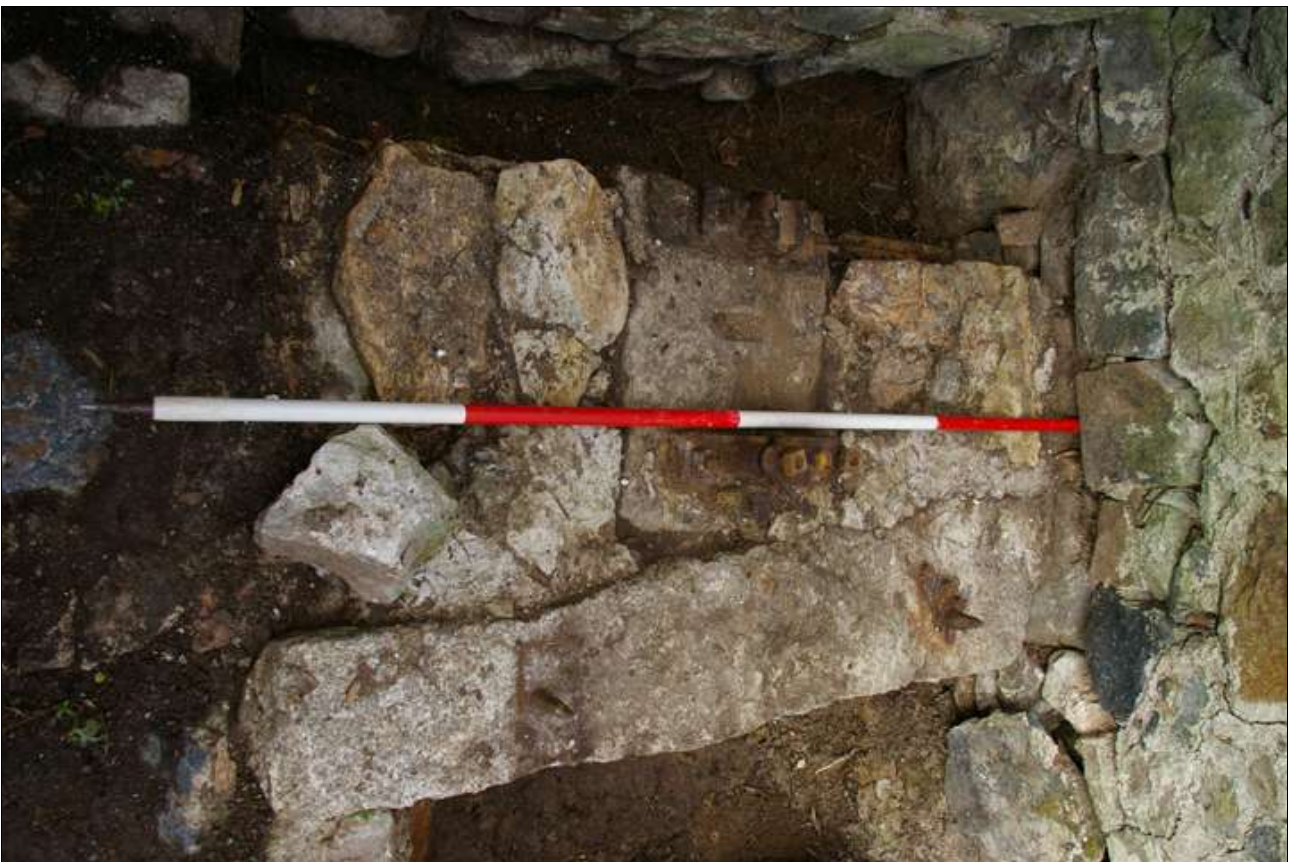
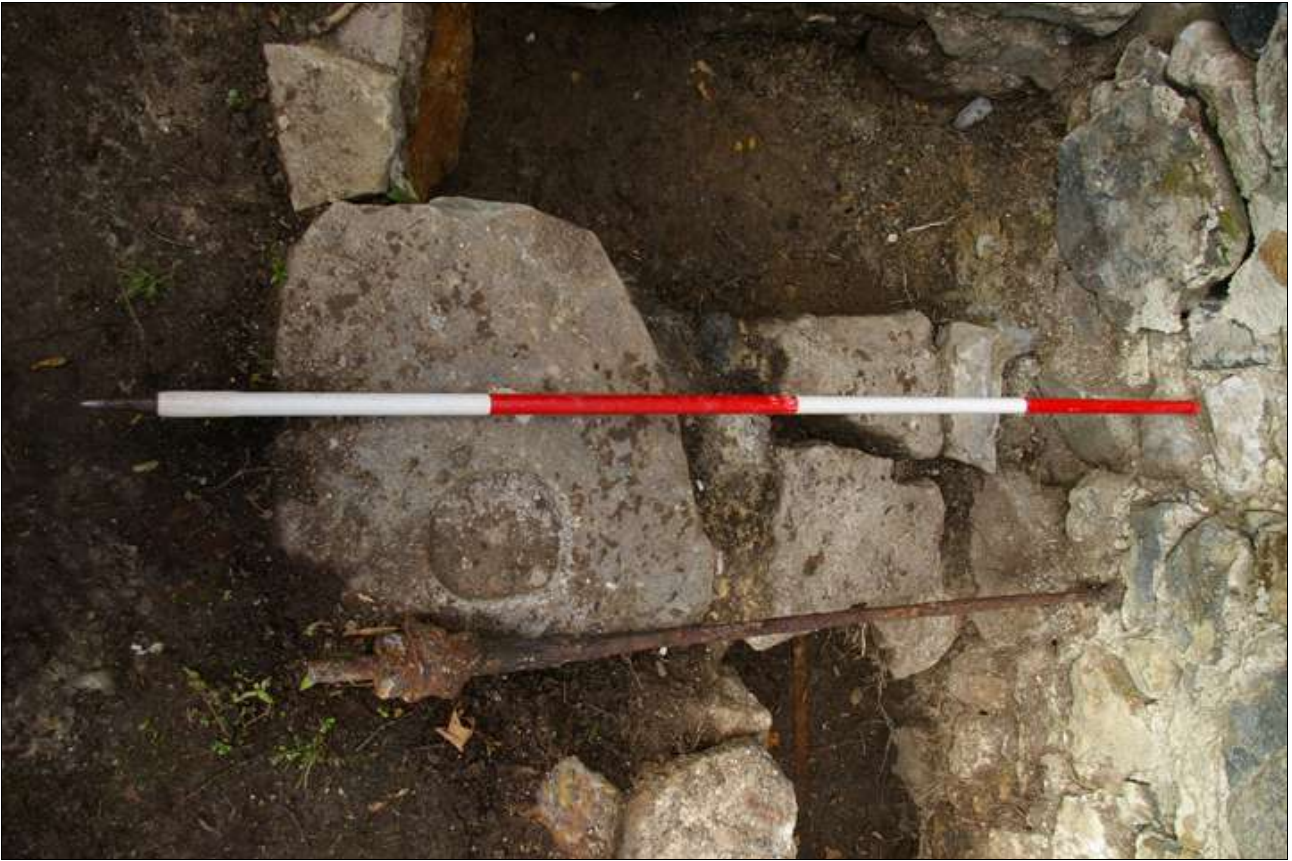
The stone blocks and iron mounts for the upstream layshaft and driving gears; viewed from the south (scale 2m).

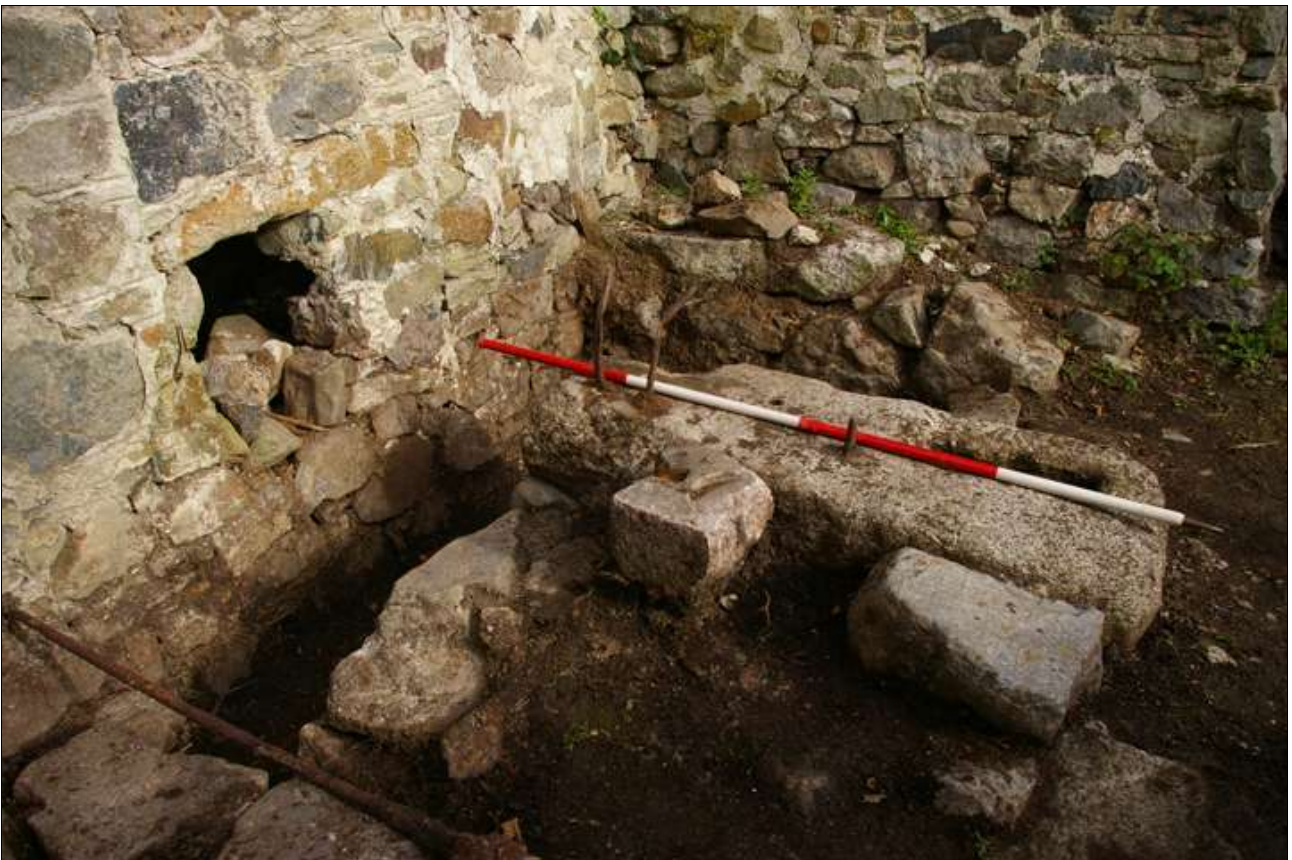
The stone blocks and iron mounts for the downstream layshaft and driving gears, viewed from the south-west (scale 2m).

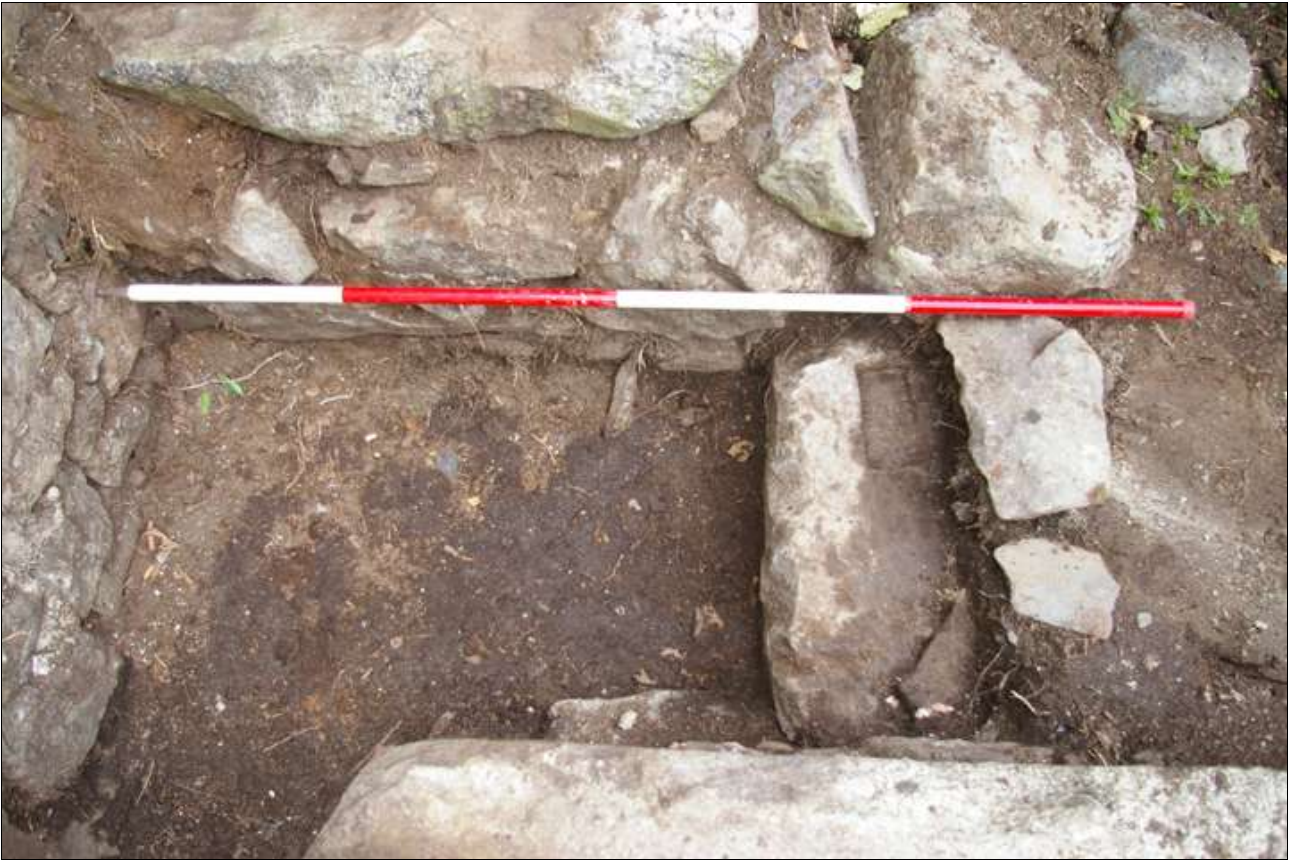
The 'step down' into the eastern cog pit, showing the re-used stone with socket; viewed from the west (scale 2m)

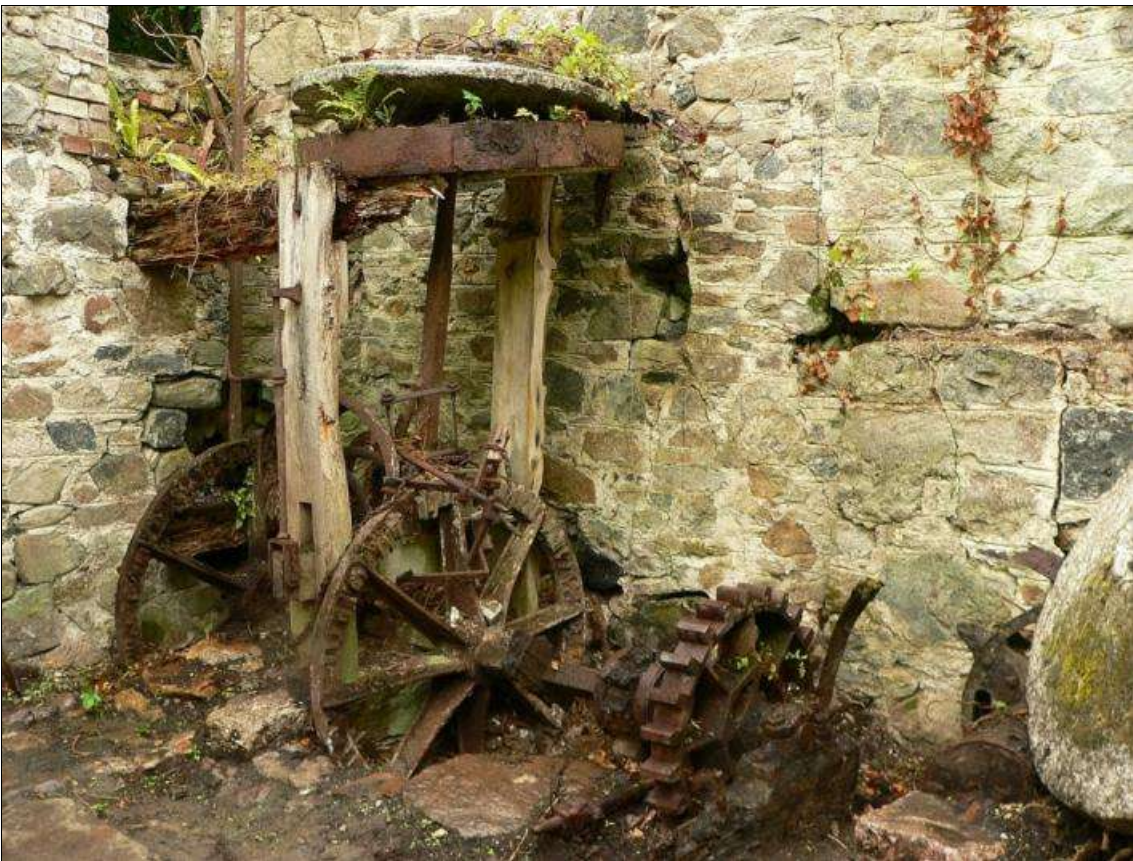
Upstream layshaft, driving gears and millstones, looking north-west (photo: M Watts).

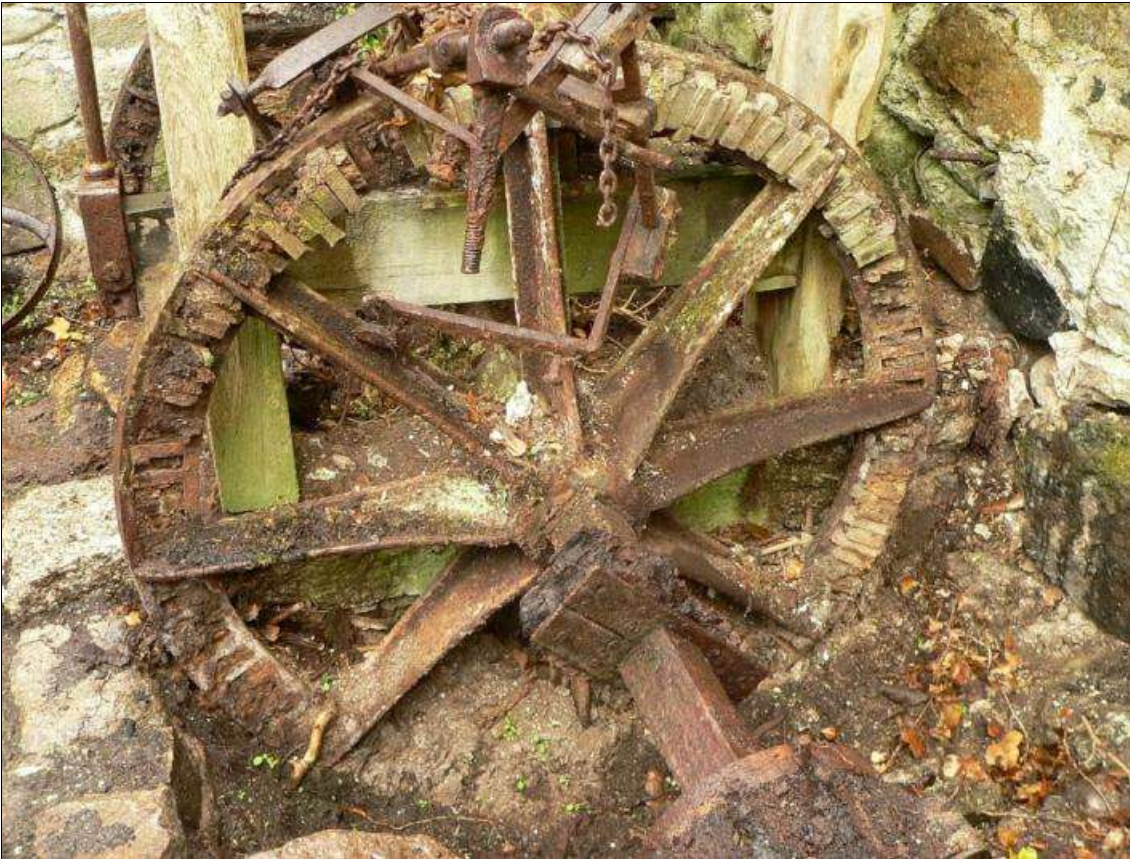
Bevel gear drive to upstream millstones (photo: M Watts).

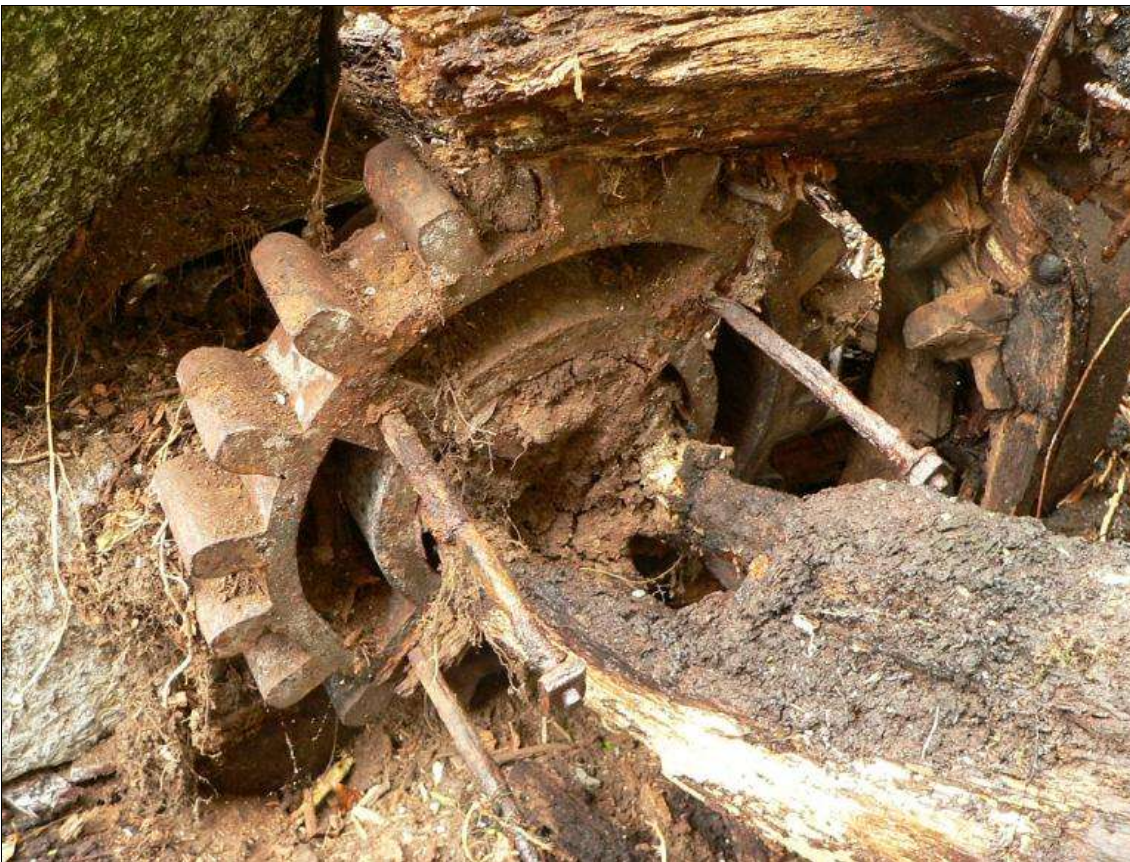
Remains of downstream layshaft, with iron spur pinion (driven by pitwheel) and bolts for securing it to arms of stone drive gear (rotted away) (photo: M Watts).
