**DEVONIA
HIGH BICKINGTON
TORRIDGE
DEVON**

Historic Building Recording and Archaeological Monitoring & Recording

South West Archaeology Ltd. report no. 180501

1st May 2018

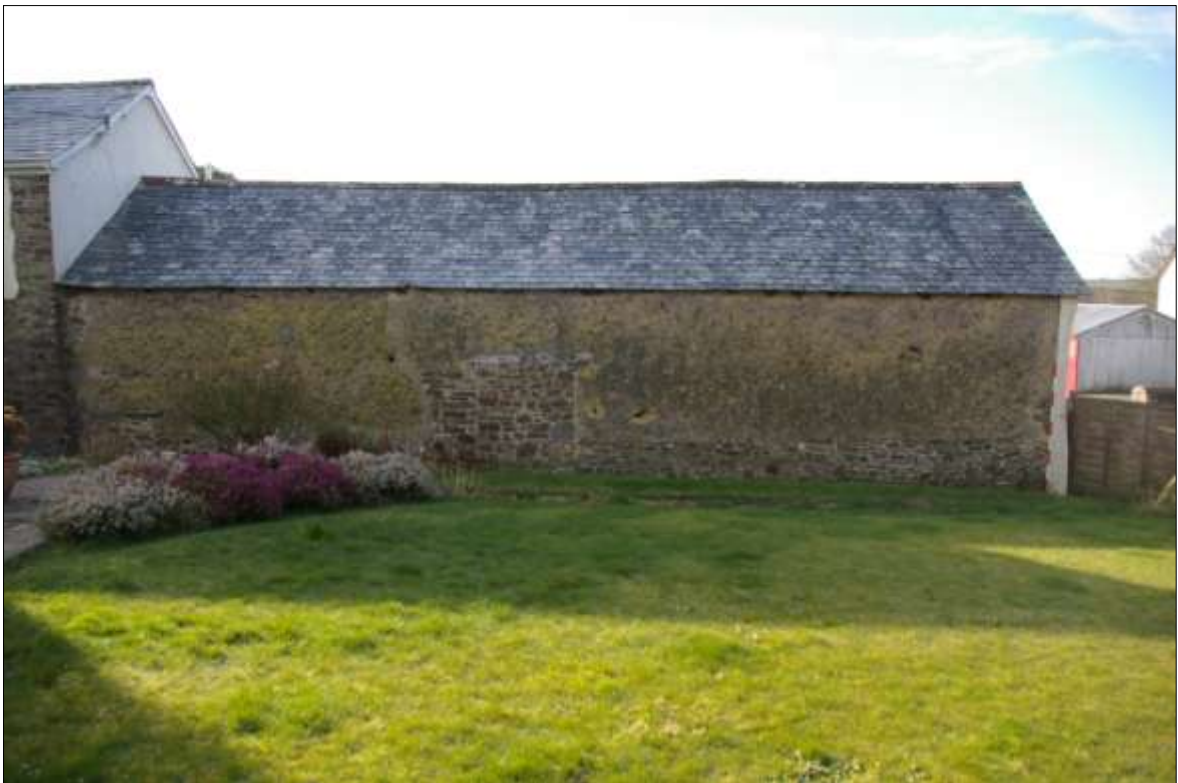
FIGURE 7: THE EXTERNAL ELEVATION OF THE NORTH WALL OF B1 SHOWING PHASES OF THE STONE AND COB CONSTRUCTION, WITH BLOCKED DOORWAY TOWARDS THE CENTRE; VIEWED FROM THE NORTH (2M SCALE).

The north wall is not externally rendered and provides the most detailed evidence for the building's functional chronology (Figures 10 and 11). It is constructed of cob on a fine regularised rubble stone base, exhibiting several distinct phases of alteration and repair, including a blocked central doorway. There is a clear build raise of a more yellow coloured cob raising the height of the wall, which is also visible internally on the southern wall. The stonework is of a form and quality which indicates an older post-medieval building, possibly late 17th or 18th century in date, rather than being of the looser rubble found in 19th century structures. A series of large round socket holes in the western half of the north wall indicate a former loft intended to carry significant weight; whilst a single smaller socket is evident to the east.

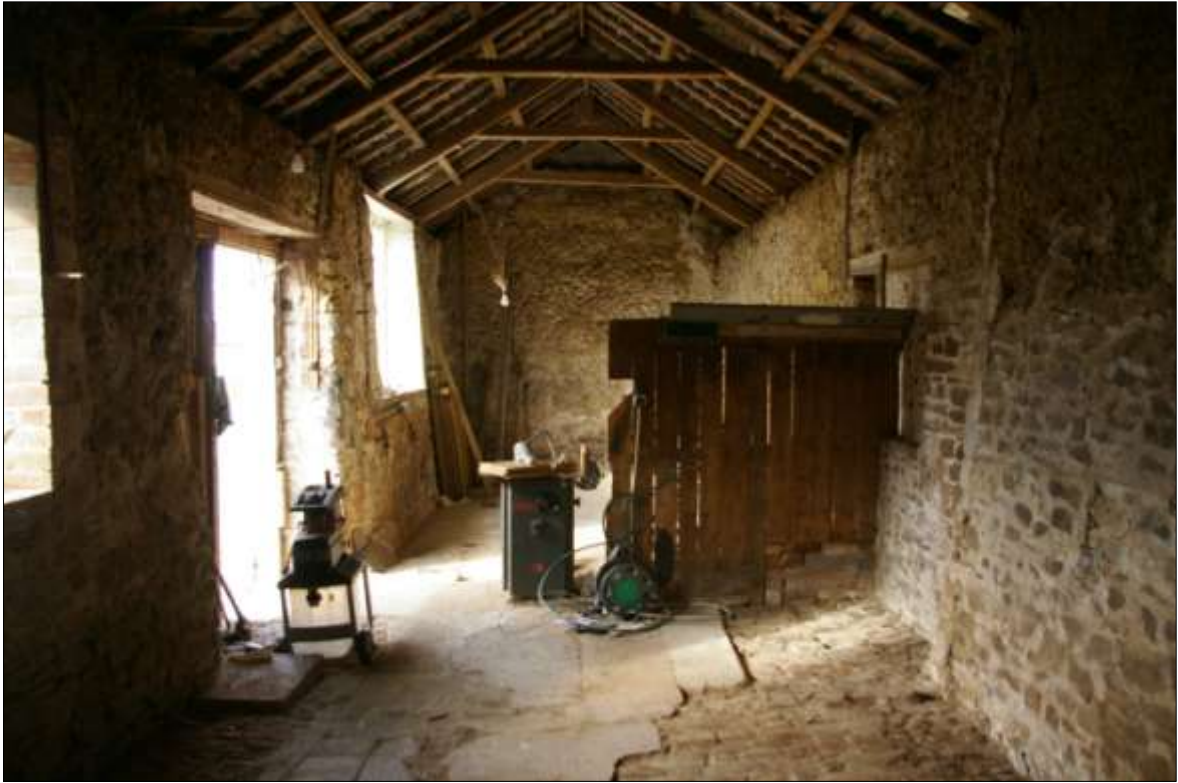
FIGURE 8: THE INTERIOR OF B1, SHOWING EVIDENCE OF ITS LATEST USE AS A WORKSHOP; VIEWED FROM THE EAST.

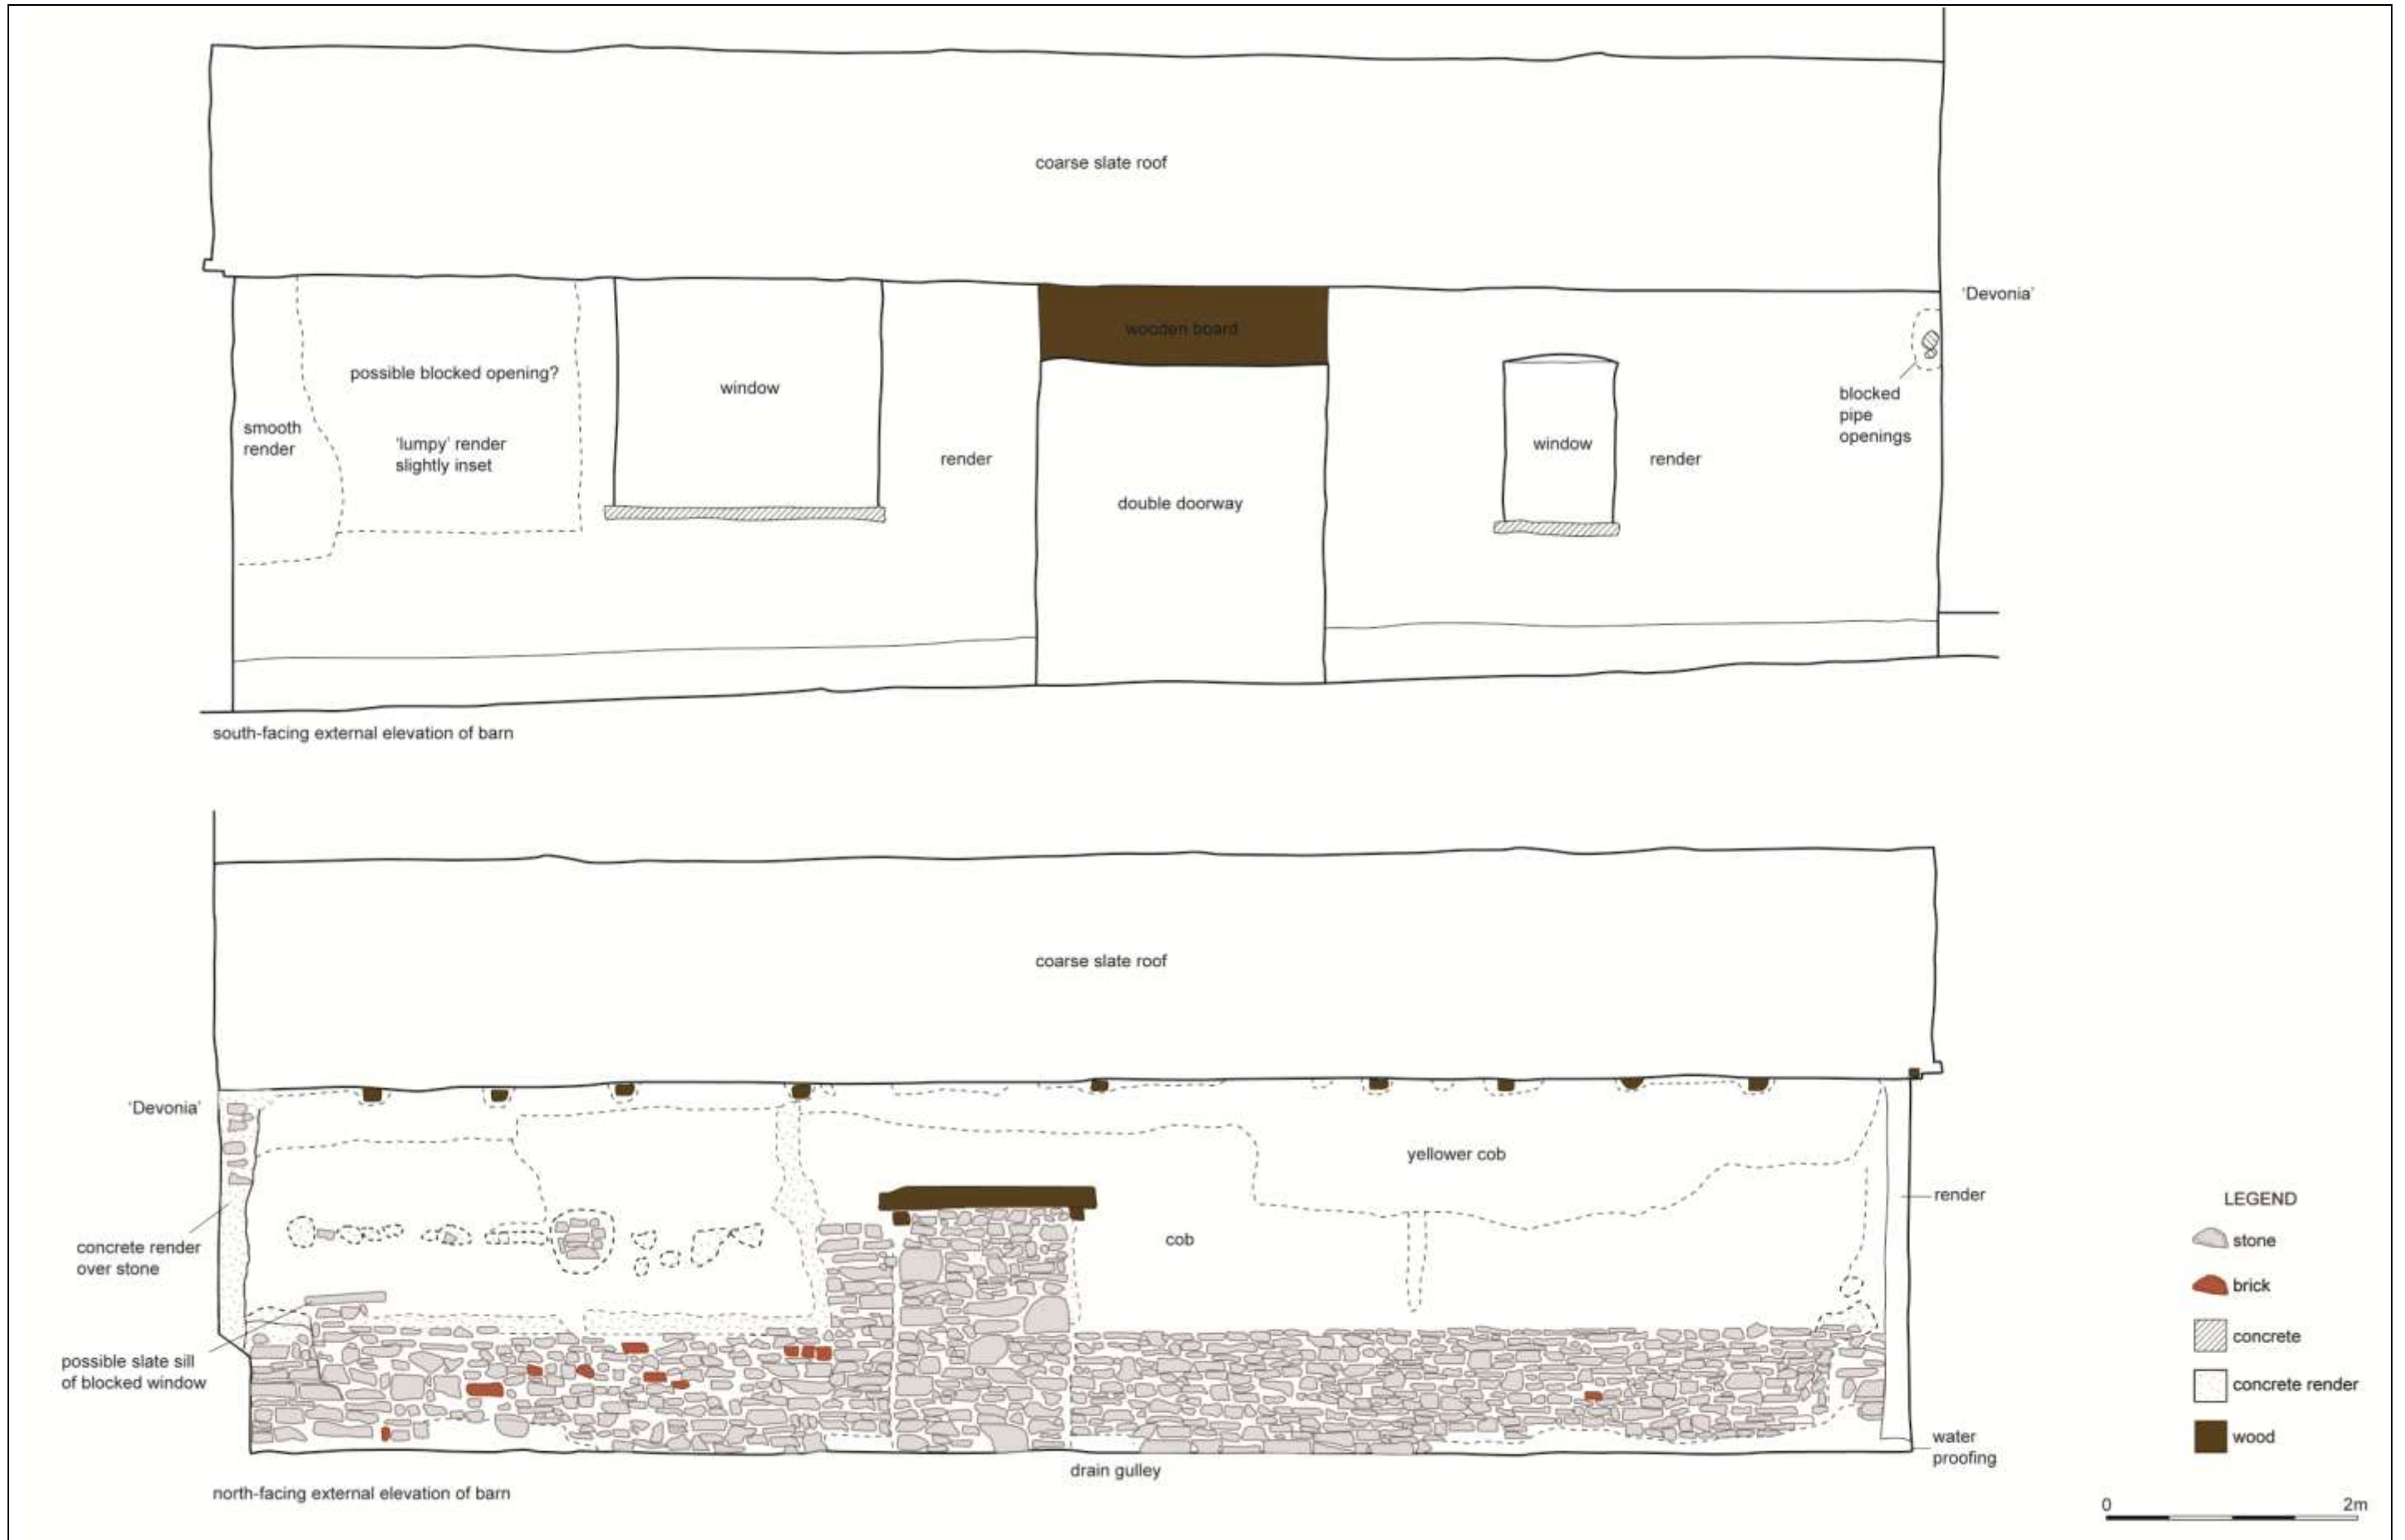
FIGURE 10: EXTERNAL ELEVATIONS OF B1 SHOWING DETAIL OF CONSTRUCTION.

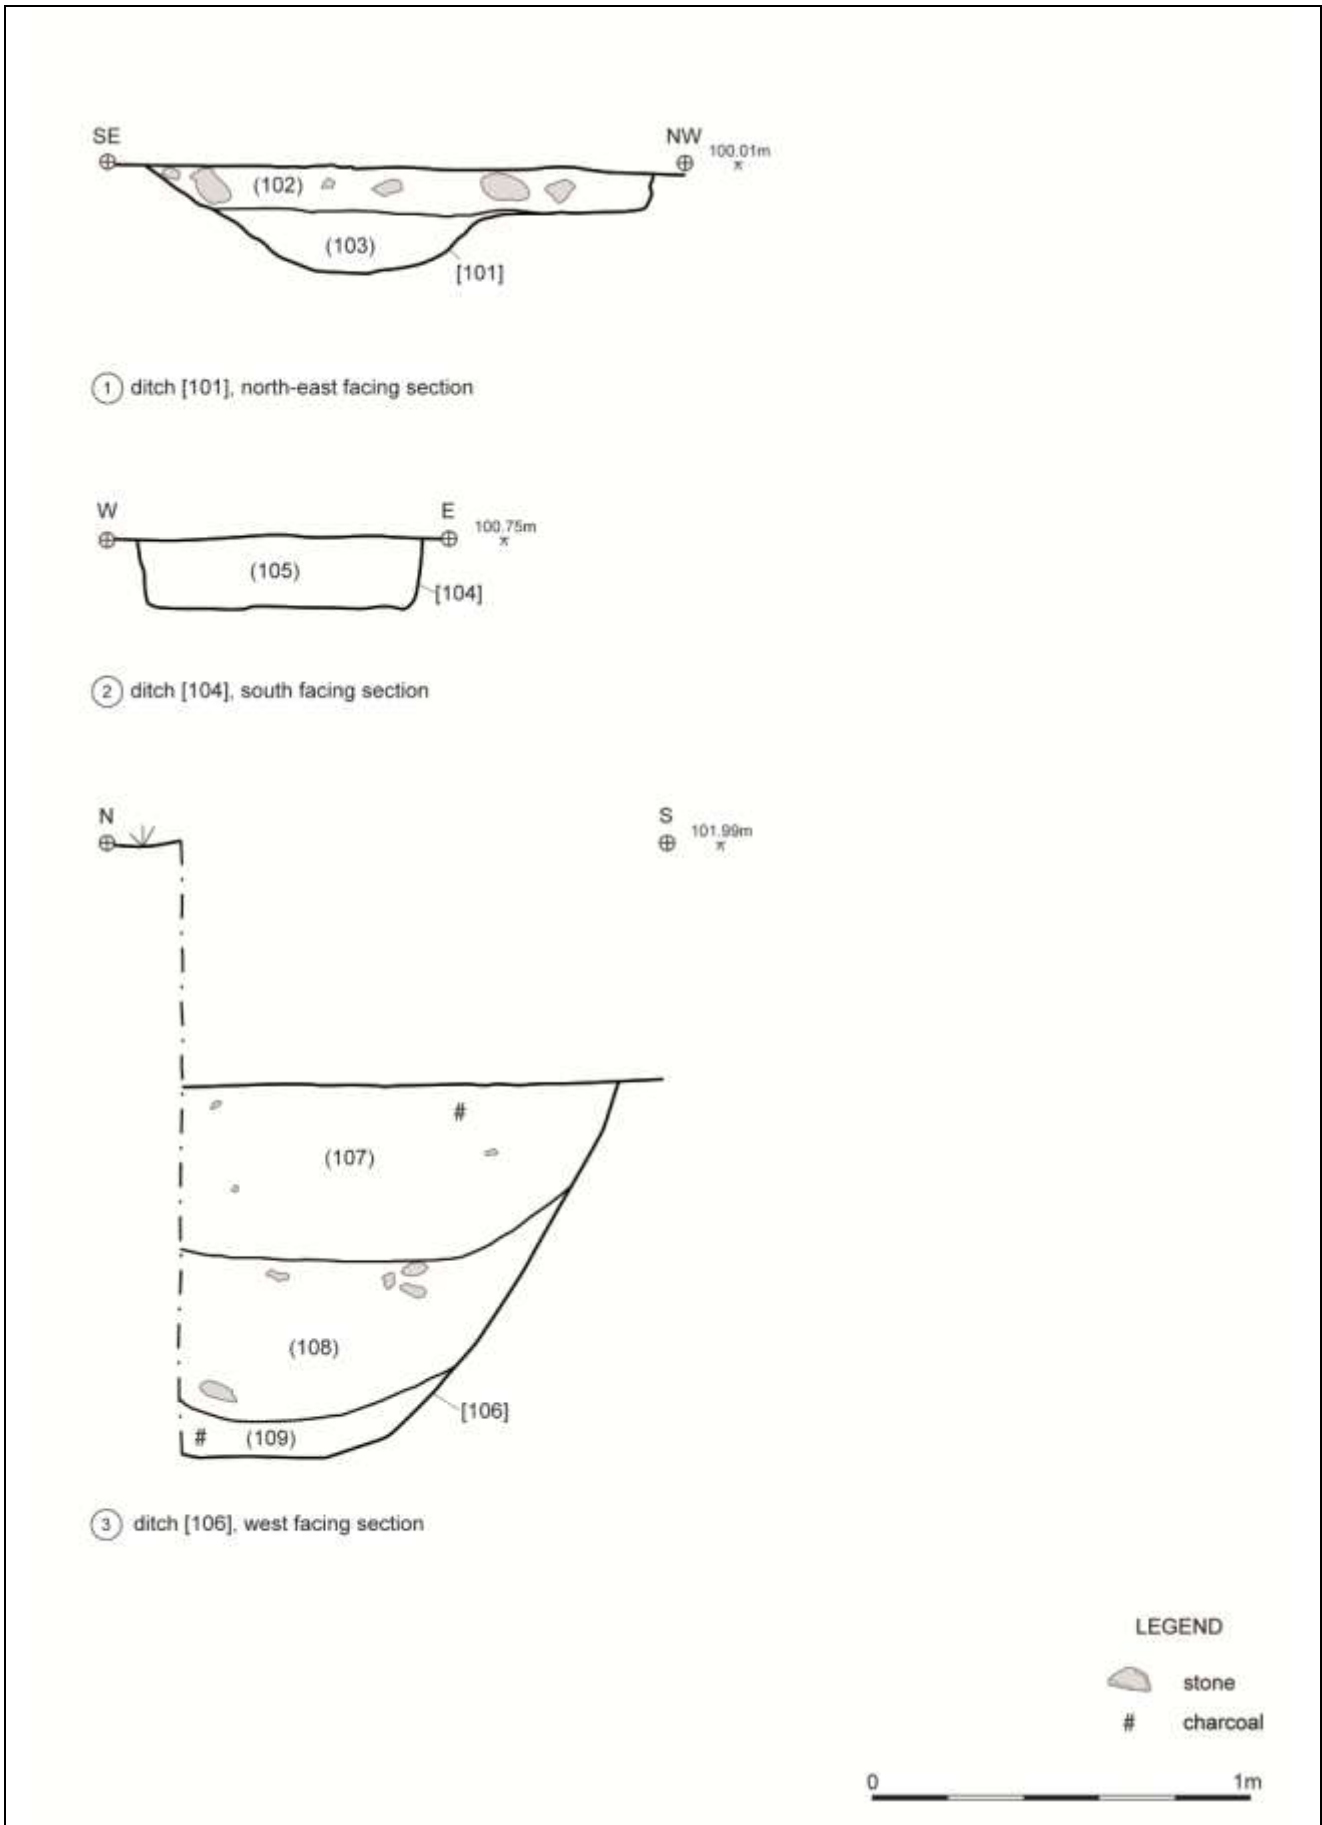
FIGURE 16: SECTIONS OF ARCHAEOLOGICAL FEATURES. HEIGHTS BASED ON AN ARBITRARY TBM OF 100.00M AOD.

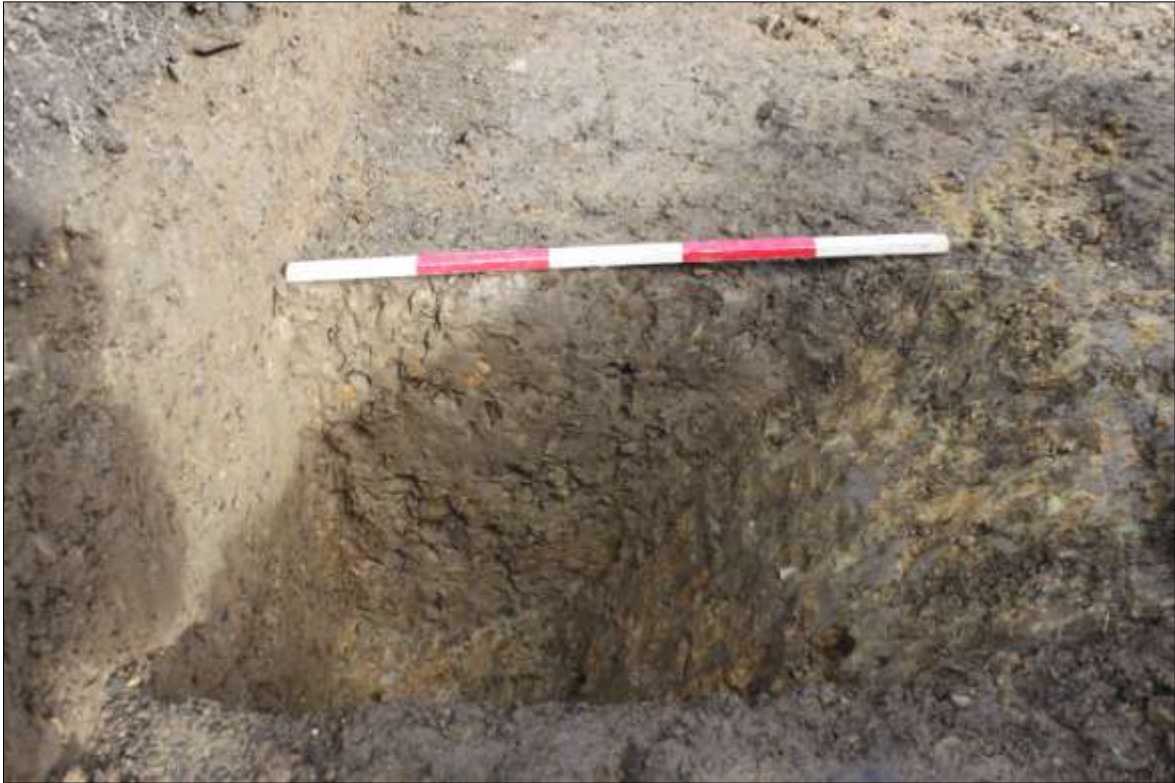
FIGURE 17: DITCH [106]; WEST FACING SECTION; VIEWED FROM THE WEST (2M SCALE).

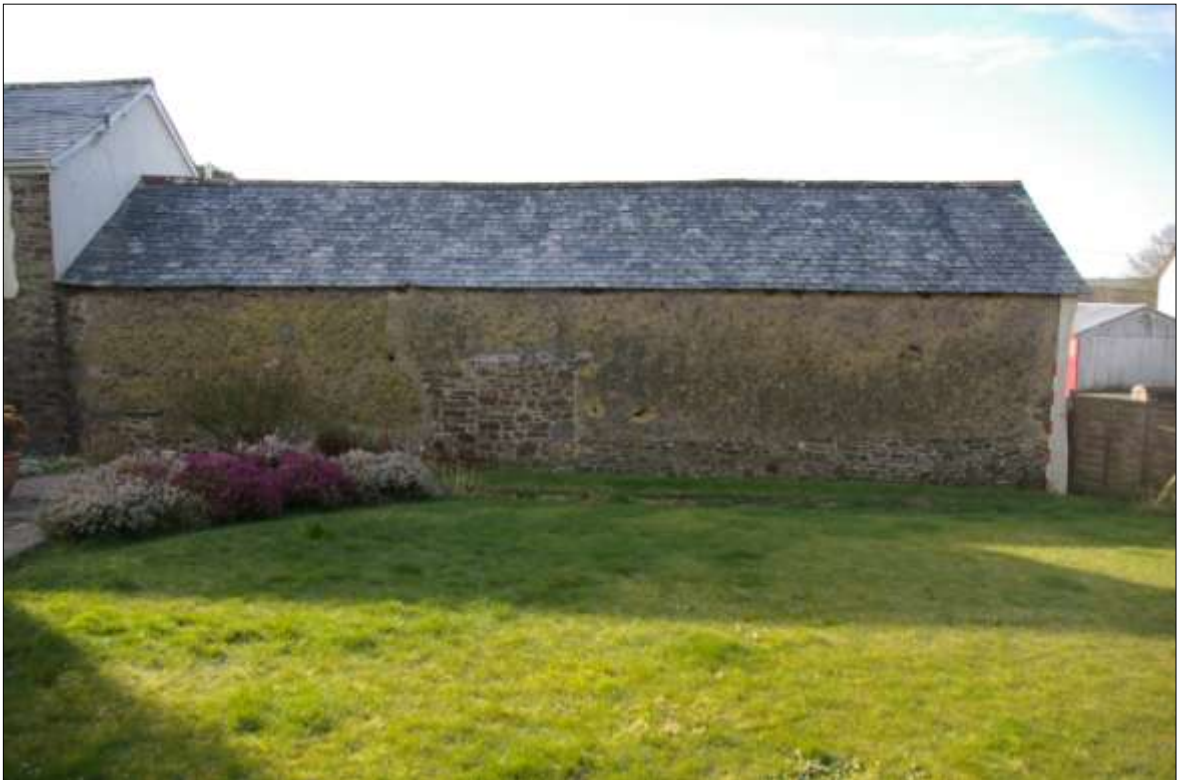
10. THE NORTH EXTERNAL ELEVATION OF B1; VIEWED FROM THE NORTH (2M SCALE).

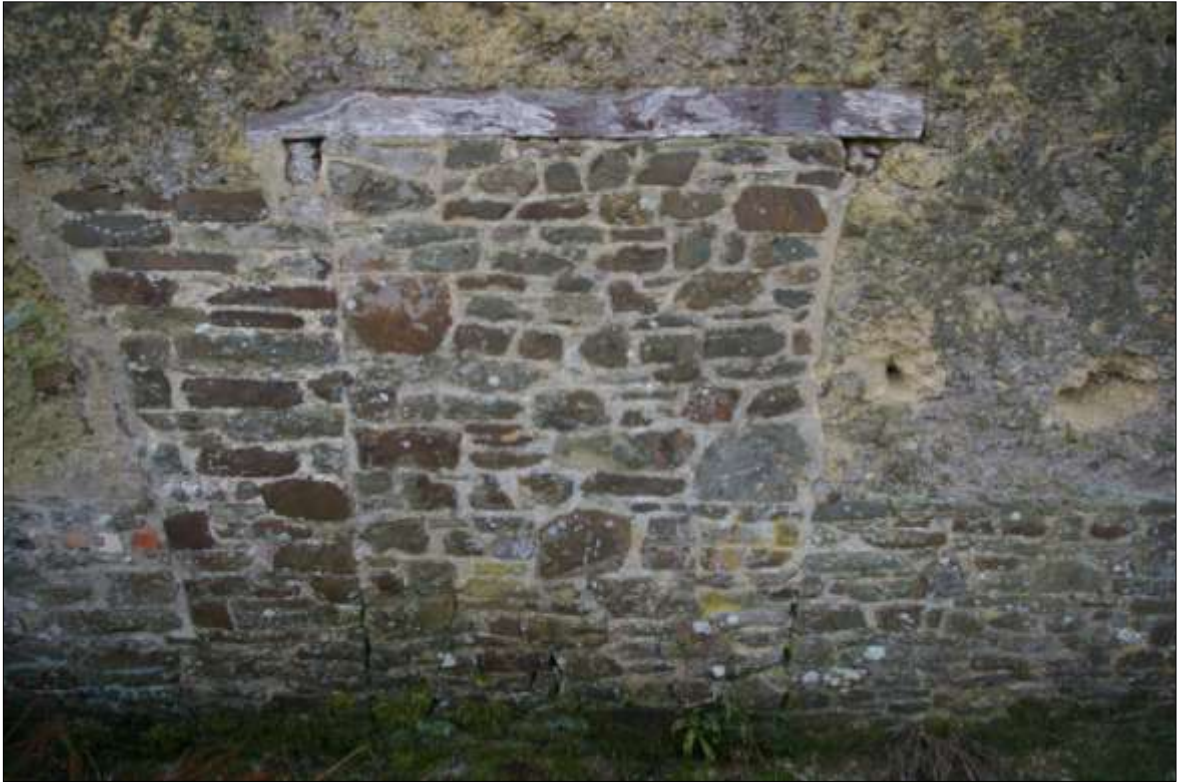
11. DETAIL OF THE BLOCKED DOOR OFF-CENTRE IN THE NORTH EXTERNAL ELEVATION OF B1; VIEWED FROM THE NORTH (NO SCALE).

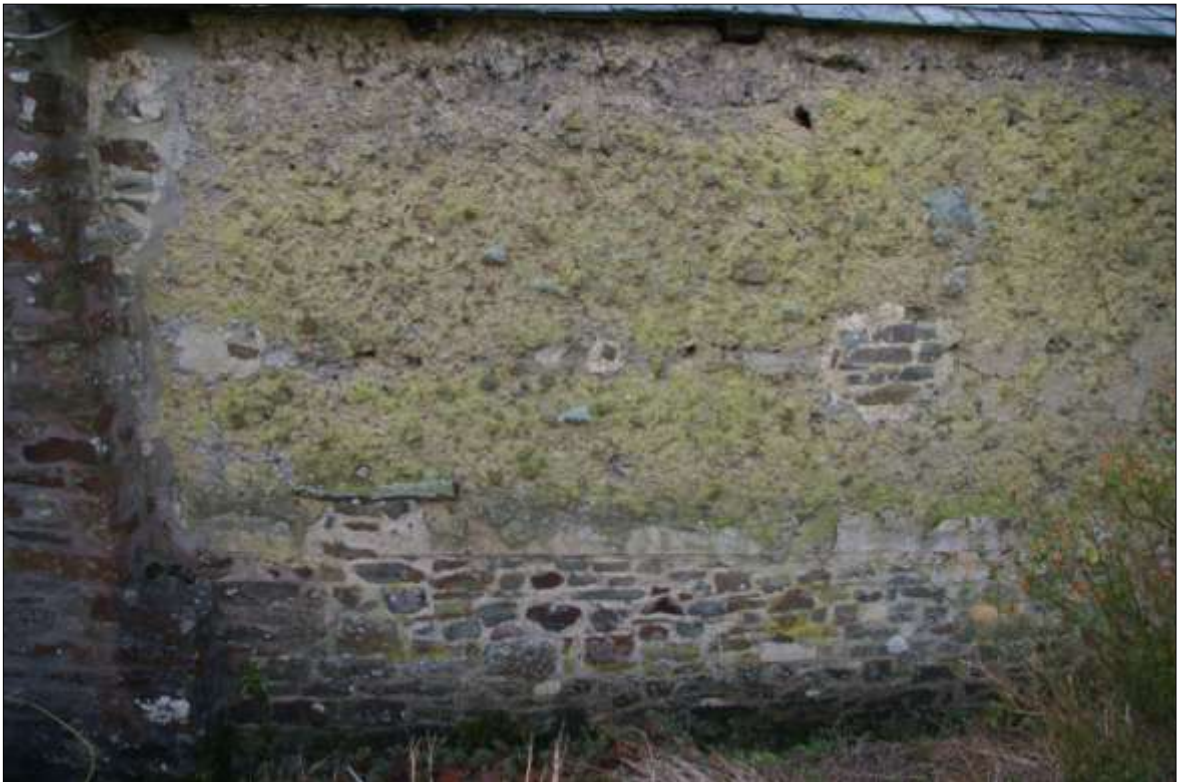
12. DETAIL OF THE DISTURBED COB AND LOOSER RUBBLE 'INFILL' AT THE EASTERN END OF THE NORTH EXTERNAL ELEVATION OF B1; VIEWED FROM THE NORTH (NO SCALE).

The walls and roof at the very eastern end of B1 where it abuts Devonia may date to this phase, and appear as a significant repair or alteration (possibly resulting from the extension of Devonia) having been constructed of looser rubble stonework with more clay based cob. This repair or extension is why the earlier structure of B1 appears to abut the 19th century gable of Devonia. The roof at this point also used poorer quality rafters, probably fashioned on site.

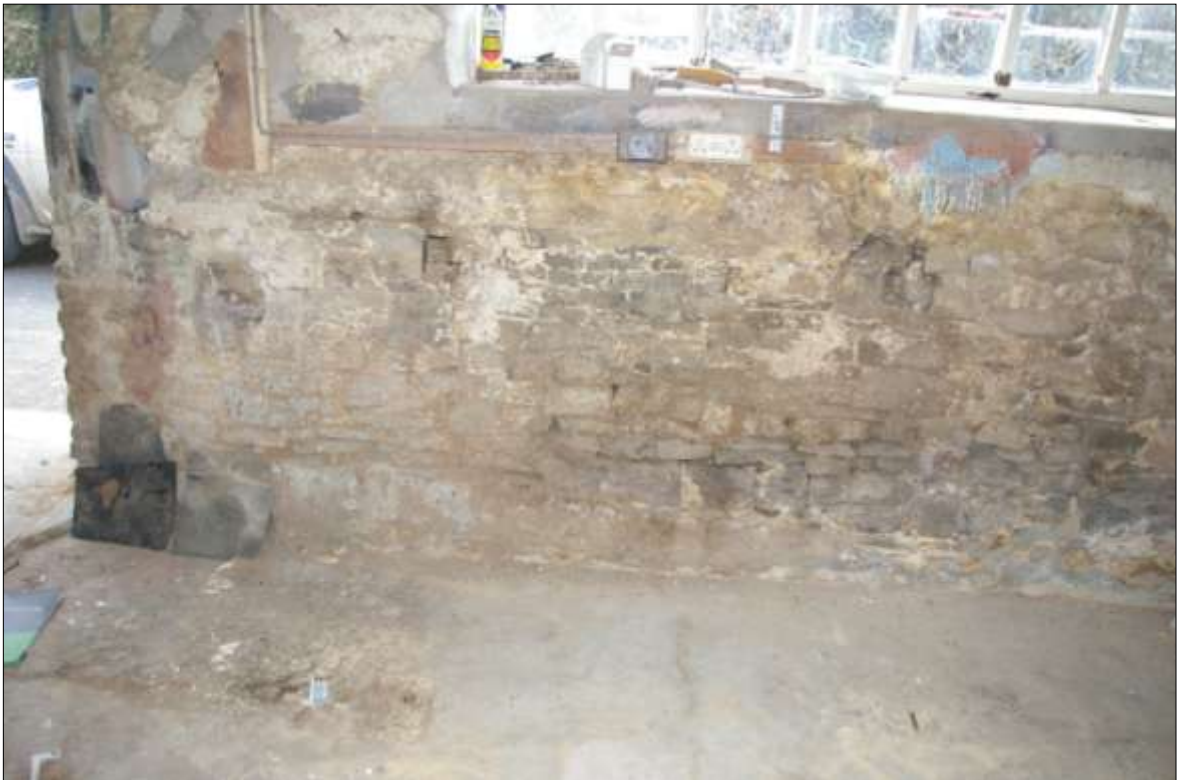
16. DETAIL OF THE INTERNAL ELEVATION OF THE SOUTH WALL OF B1 SHOWING DETAIL OF THE GOOD QUALITY SHAPED BLOCKY SEMI-COURSED EARLY POST-MEDIEVAL STONEMWORK BENEATH THE LARGE WINDOW; VIEWED FROM THE NORTH (NO SCALE).

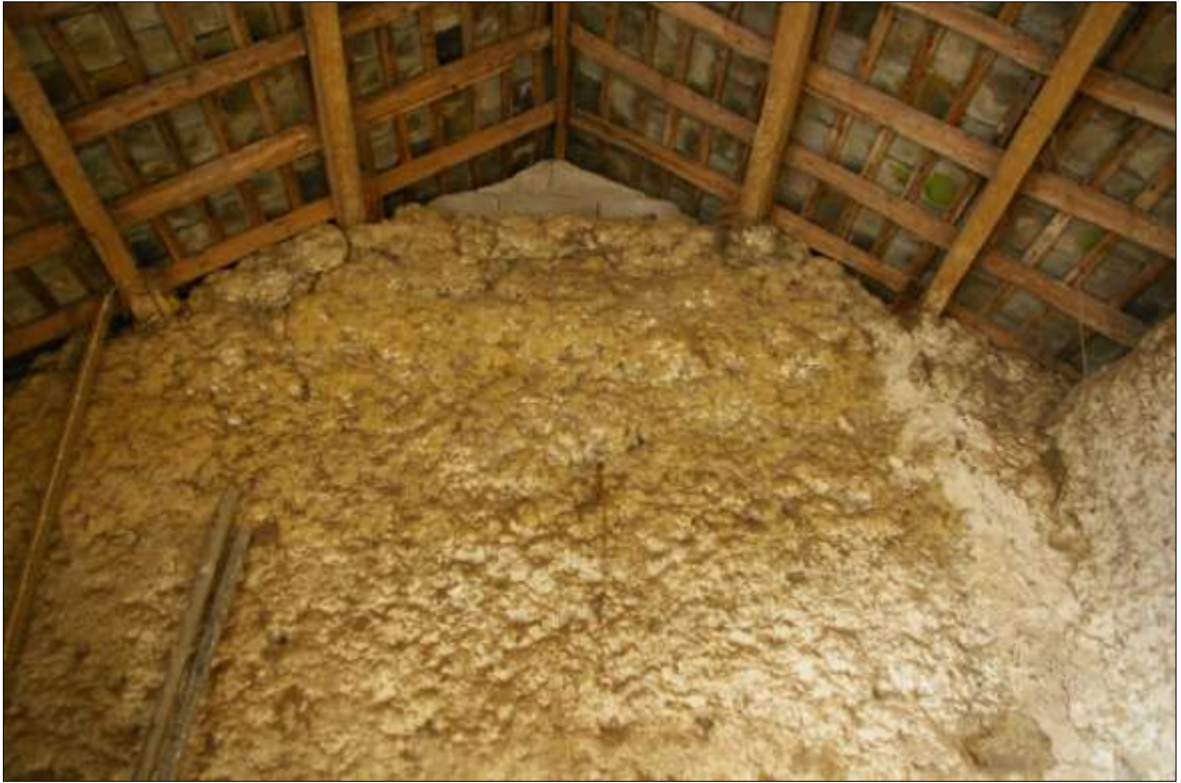
19. DETAIL OF THE INTERNAL WEST GABLE END OF B1 SHOWING THE UPPER REBUILT COB, IN A DIFFERENT MARKEDLY YELLOW COLOUR AND THE DEEP BATTERED SLOPE, POSSIBLY CAUSED BY COB SLUMPING DUE TO POORER QUALITY; VIEWED FROM THE EAST (NO SCALE).

At some point after the original construction of B1, the west gable wall was rebuilt. Whilst this was likely carried out in the same materials, it was crudely undertaken and the failure to adequately tie this wall into the rest of the building has resulted in significant slumping of the cob, and there are clear build lines in both the cob and stonework.

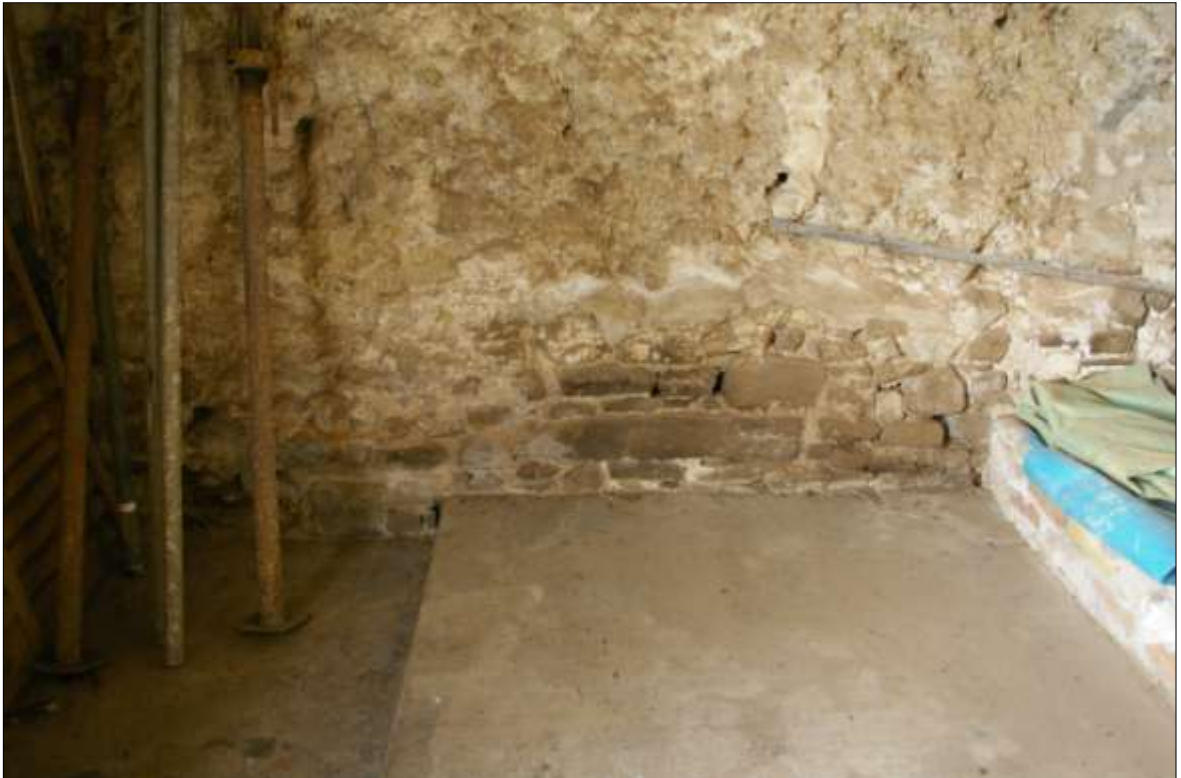
20. DETAIL OF THE LOW AND POORLY BUILT LOOSE RUBBLE TO THE BASE OF THE WEST GABLE WALL OF B1; VIEWED FROM THE EAST (NO SCALE).

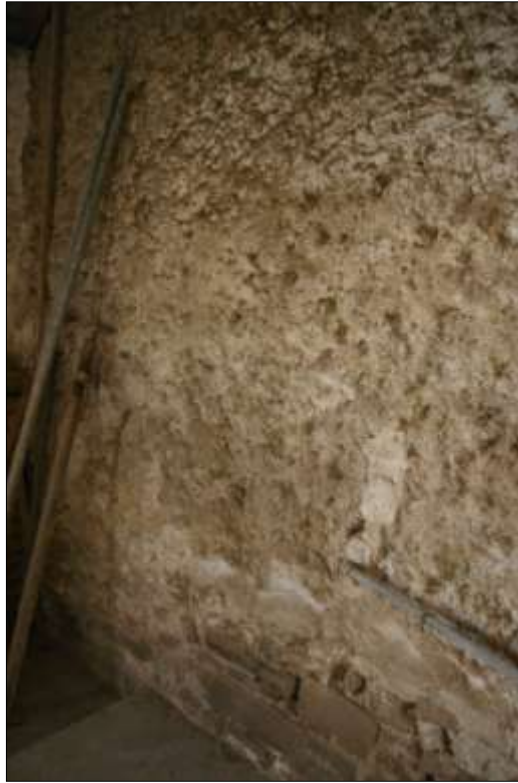
21. DETAIL OF THE INTERNAL ELEVATION OF THE WEST GABLE WALL OF B1 SHOWING THE SLUMPING OF THE COB AND CLEAR BUILD LINES; VIEWED FROM THE NORTH-EAST (NO SCALE).

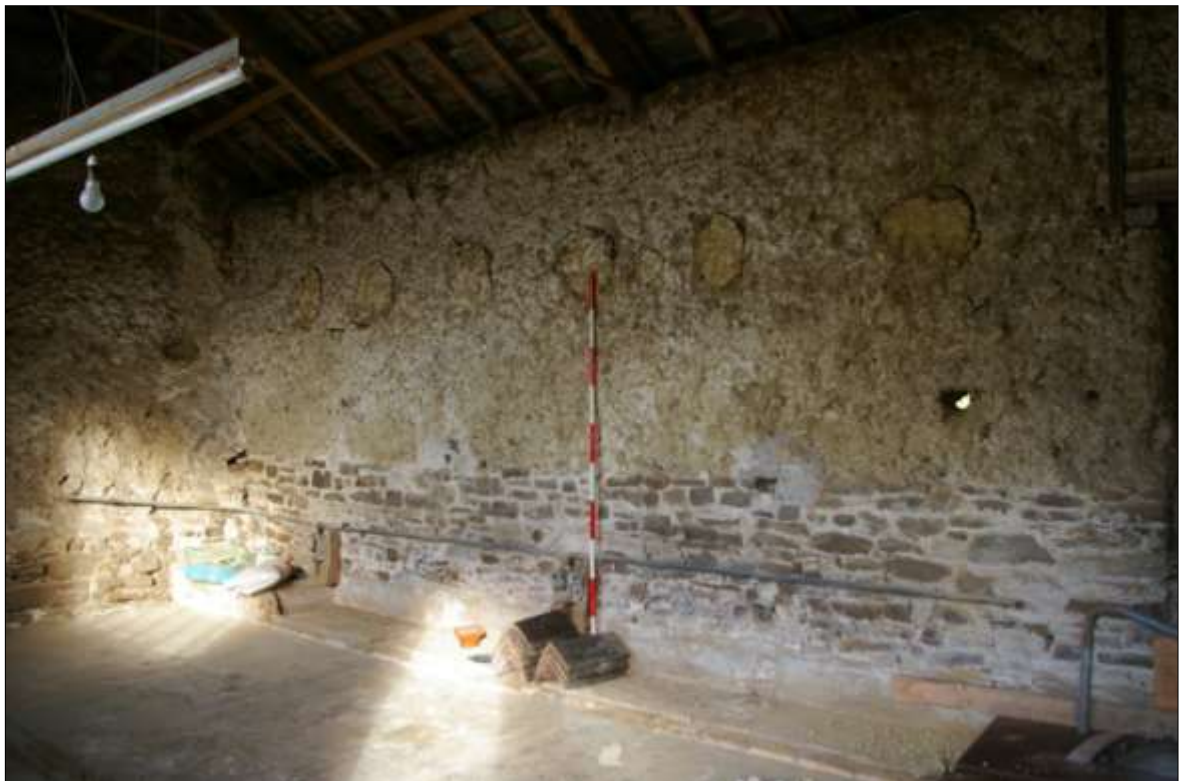
22. INTERNAL SOUTH ELEVATION OF THE NORTH WALL OF B1, WEST END, SHOWING THE INFILLED LARGE SOCKET HOLES FOR HEAVY BEAMS TO SUPPORT A LOFT FLOOR, EXPECTED TO CARRY A HEAVY LOAD; VIEWED FROM THE SOUTH-EAST (2M SCALE).

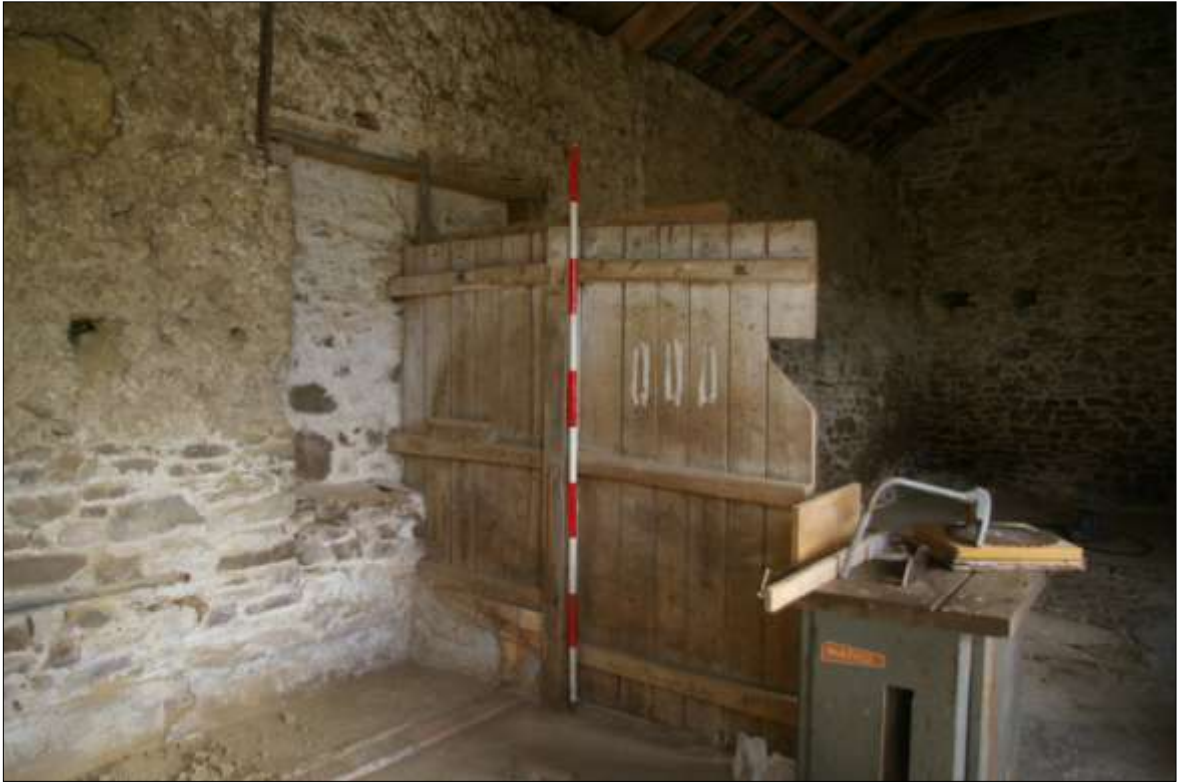
23. DETAIL OF THE TWO PHASES OF BLOCKING OF THE DOOR WITHIN THE NORTH WALL OF B1, AND THE TIMBER PARTITION SCREEN CURRENTLY DIVIDING THE INTERIOR SPACE WITHIN THE OUTBUILDING; VIEWED FROM THE WEST (2M SCALE).

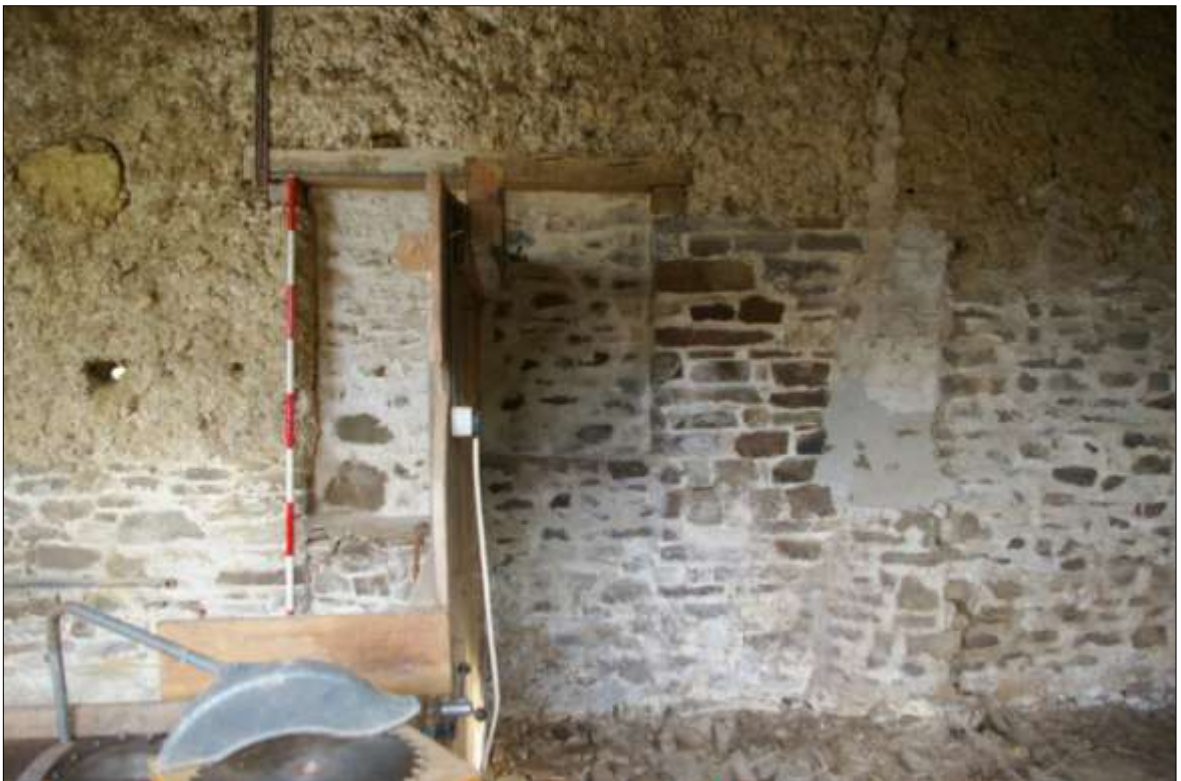
24. DETAIL OF THE BLOCKED DOORWAY IN THE NORTH WALL OF B1, SHOWING DETAIL OF THE TAPERED OPENING, WIDER TO BOTTOM; VIEWED FROM THE SOUTH (2M SCALE).

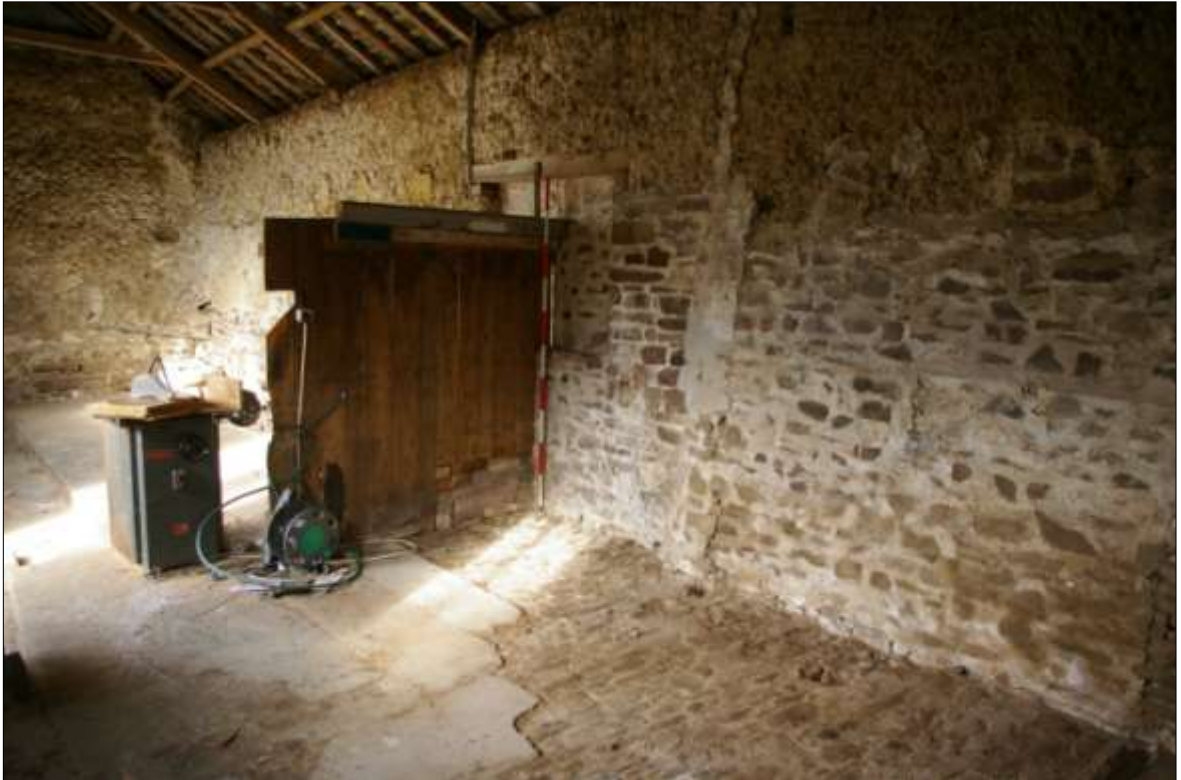
25. DETAIL OF THE COMPLEX PHASES OF BLOCKING OF THE DOORWAY WITHIN THE NORTH WALL OF B1 AND THE TIMBER SCREEN WHICH CURRENTLY DIVIDES THE INTERIOR SPACE OF THE OUTBUILDING; VIEWED FROM THE SOUTH-EAST (2M SCALE).

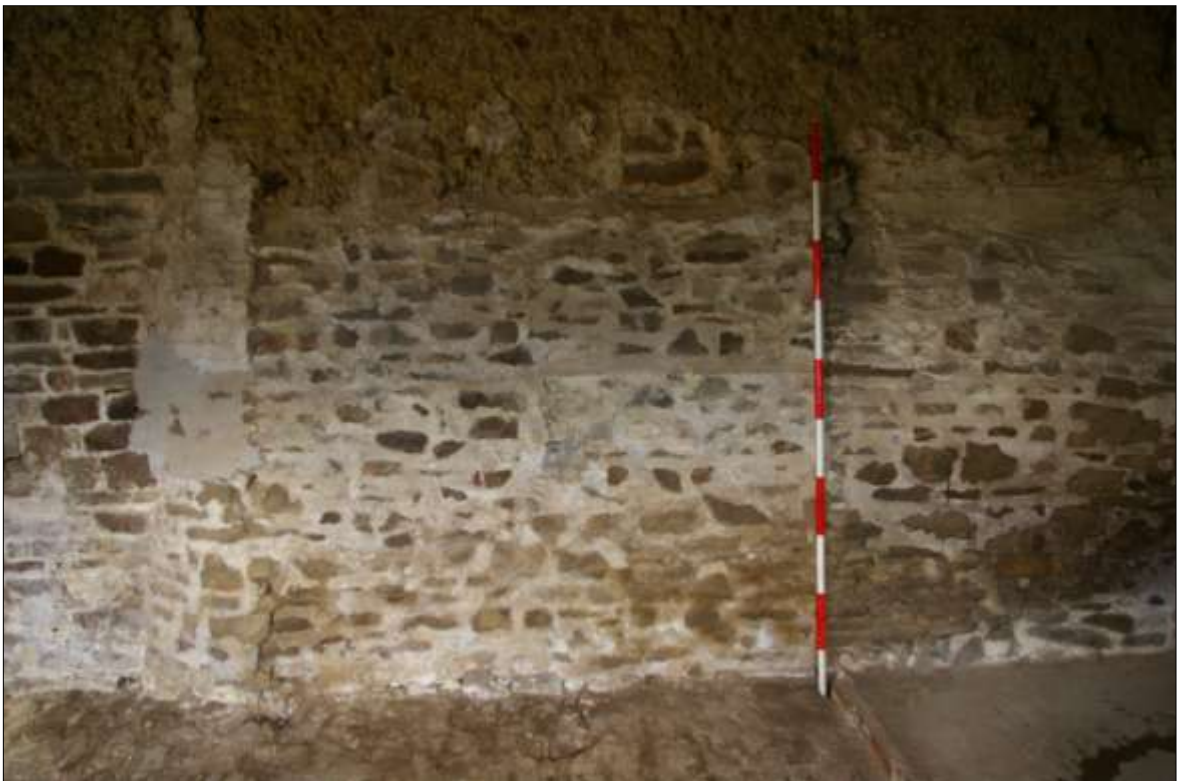
26. DETAIL OF THE INTERNAL ELEVATION OF THE NORTH WALL OF B1, WEST END, SHOWING MARKED PHASING, REBUILD AND INDICATION OF ALTERED USE; VIEWED FROM THE SOUTH (2M SCALE).

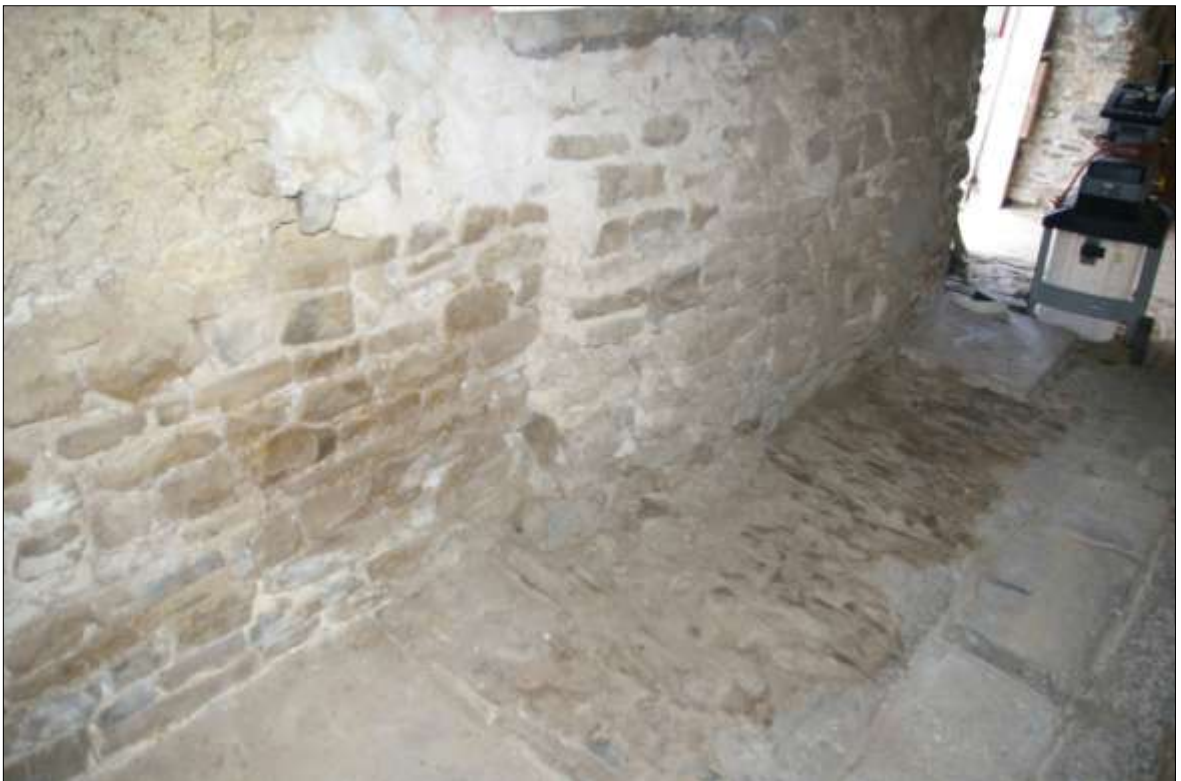
28. DETAIL OF THE CLEAR BUILD LINE IN THE INTERNAL ELEVATION OF THE SOUTH WALL OF B1, WHERE THE GOOD BATTERED STONWORK ENDS AND IS ABUTTED BY A SHORT STRETCH OF 19TH CENTURY CHARACTER RUBBLE; VIEWED FROM THE NORTH-EAST (NO SCALE).

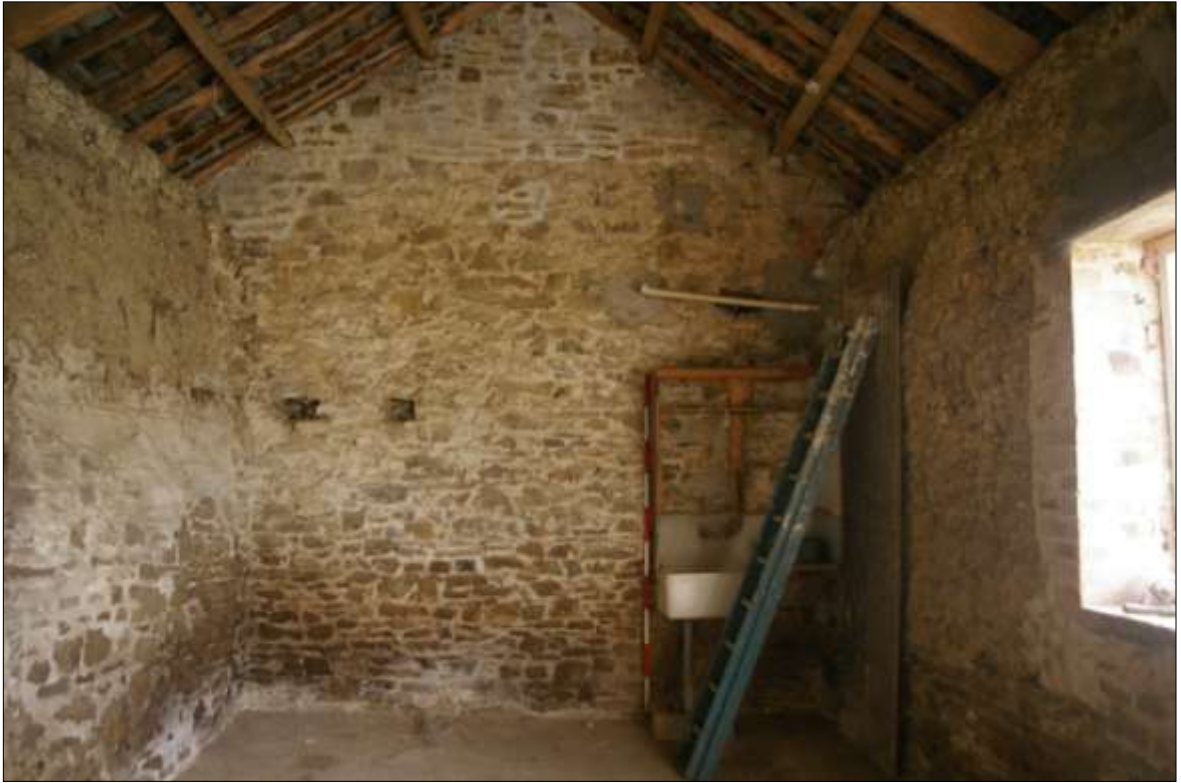
29. THE WEST GABLE OF DEVONIA, FORMING THE EAST WALL OF B1, SHOWING THE MESSILY REBUILT RUBBLE STONE; VIEWED FROM WEST (2M SCALE).

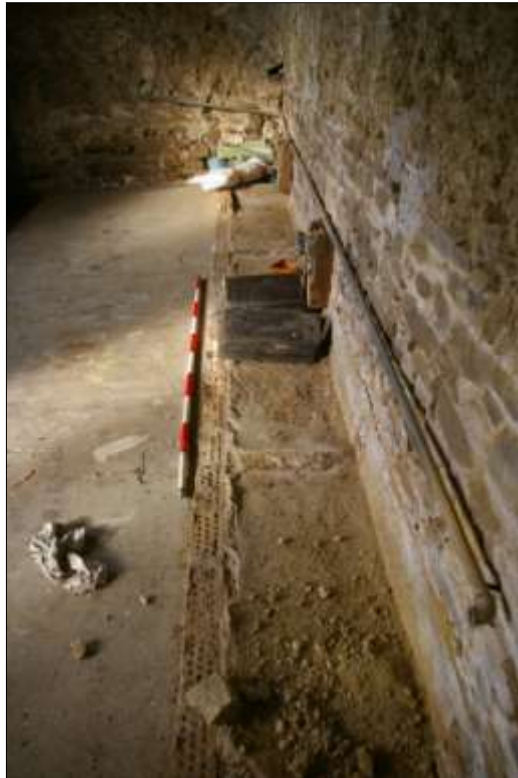
30. DETAIL OF THE BRICK AND LIME/CEMENT MIX BUILT CATTLE TROUGH, USING A MIX OF RECYCLED BRICKS, SOME HANDMADE, WITH RAISED CONCRETE PLINTH INDICATING THE WEST END OF THE OUTBUILDING WAS USED FOR A TIME AS A MILKING PARLOUR IN THE EARLY 20TH CENTURY AND POSSIBLY EARLIER; VIEWED FROM THE EAST (2M SCALE).
