**DEVONIA
HIGH BICKINGTON
TORRIDGE
DEVON**

Historic Building Recording and Archaeological Monitoring & Recording

South West Archaeology Ltd. report no. 180501

1st May 2018

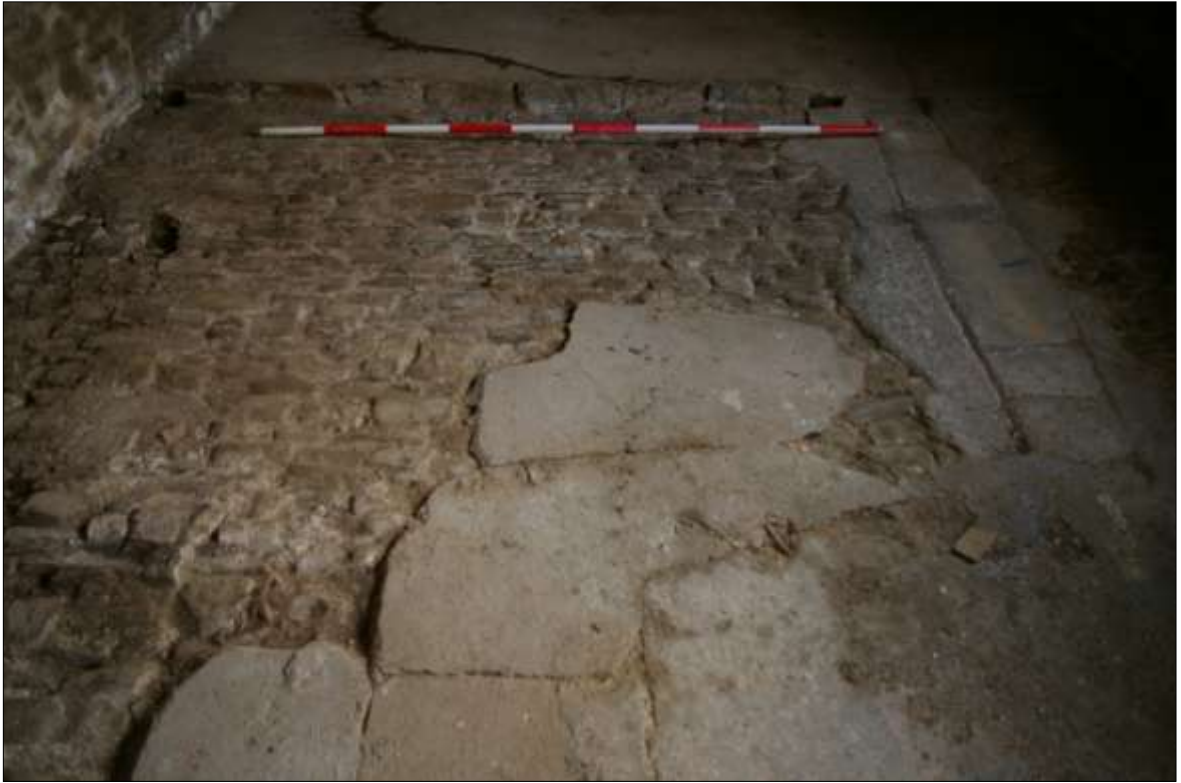
31. DETAIL OF THE CONCRETE SCREED AND ORIGINAL GOOD QUALITY COBBLE FLOORS TO THE EAST OF B1, SHOWING PARTITION SLOTS AND SOCKETS; VIEWED FROM THE WEST (2M SCALE).

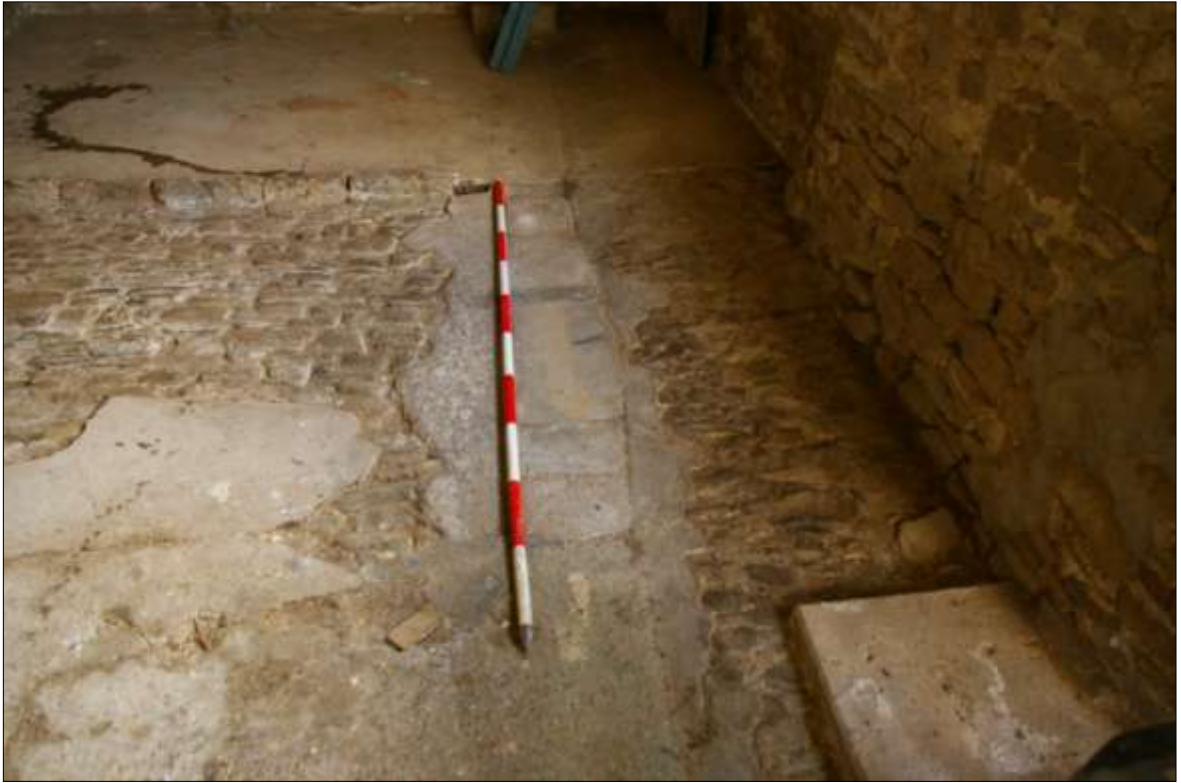
33. DETAIL OF THE DRAIN CUTTING THE COBBLED FLOOR WITHIN B1; VIEWED FROM THE WEST (2M SCALE).

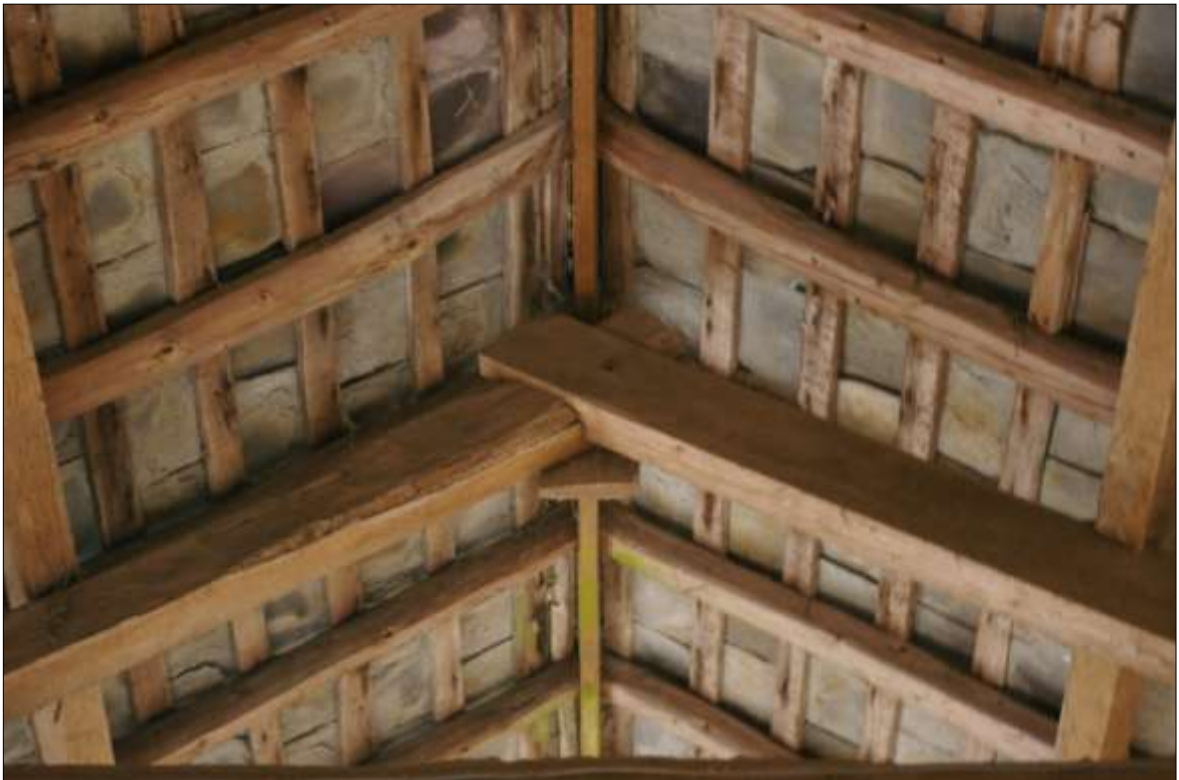
36. DETAIL OF THE ROOF STRUCTURE WITHIN B1 SHOWING THE APEX OF THE TRUSS AND HOW THE RIDGE PLANK, RAFTERS AND BATTENS BELONG TO A MORE MODERN ROOF RESTING ON THE TRUSSES AND ARE NOT CONTEMPORARY, THE TRUSS APEX NOT SUPPORTING IT; VIEWED FROM THE EAST (NO SCALE).

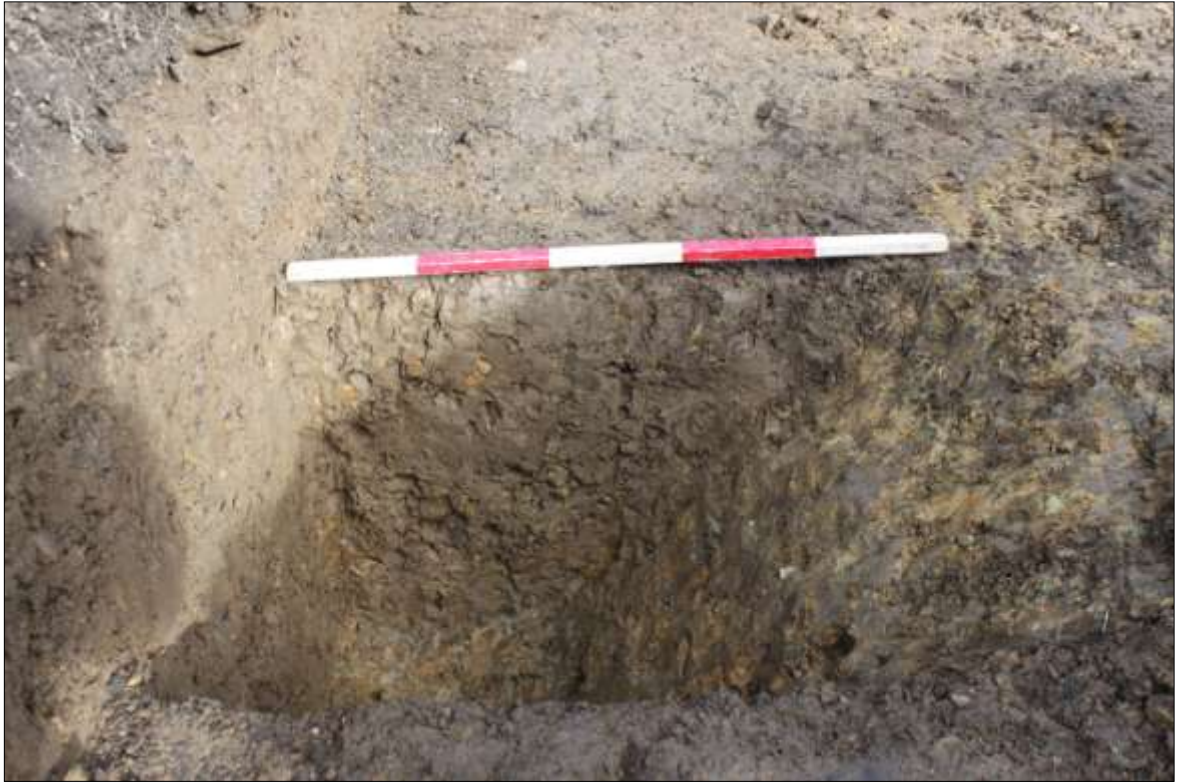
11. DITCH [106] WEST FACING SECTION; VIEWED FROM THE WEST (1M SCALE).

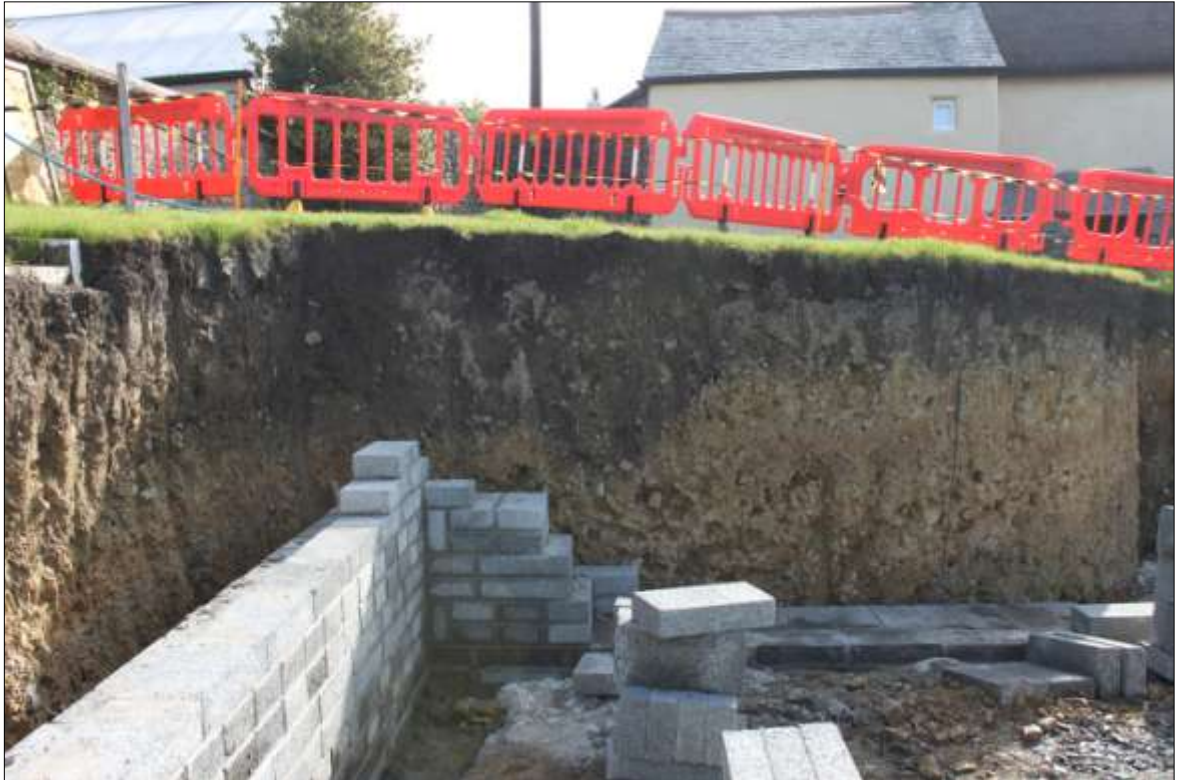
14. EAST FACING SITE SECTION FOLLOWING FULL SITE EXCAVATION, SHOWING DITCH [106] CONTINUING BEYOND THE LIMITS OF EXCAVATION; VIEWED FROM THE WEST (NO SCALE).
