ADJOINING LAND AT CANAL RISE/SOUTHFIELDS BRIDGERULE TORRIDGE DEVON

Results of a Desk-Based Assessment & Archaeological Evaluation

South West Archaeology Ltd. report no. 170508

By B. Morris & L. Lichtenstein
Report Version: FINAL
21st April 2017

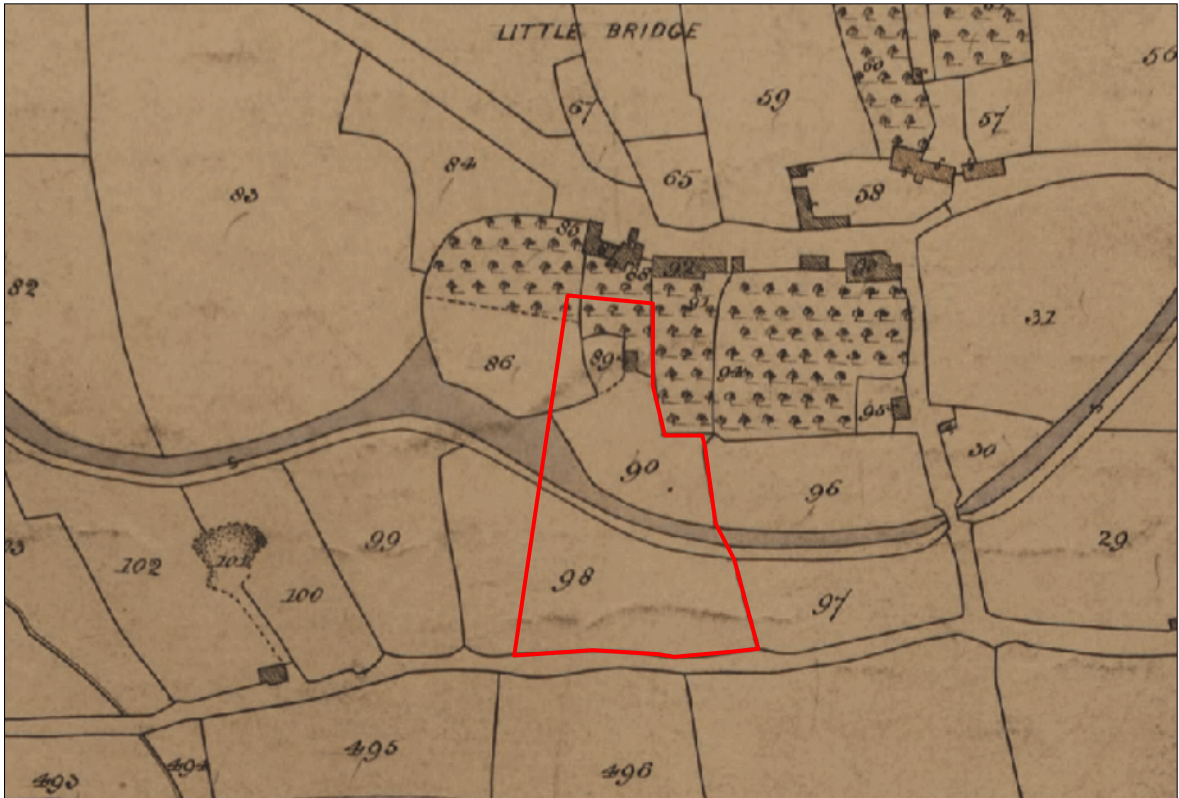
FIGURE 3: EXTRACT FROM THE 1842 TITHE MAP (DHC) (THE LOCATION OF THE SITE IS INDICATED).

The Bridgerule (West) tithe map of 1842 (Figure 3) is the first detailed cartographic resource available to this study. It shows the settlement of *Little Bridge* and the Bude Canal in some detail. The layout of the settlement, together with the slightly-curving form of the field boundaries, might indicate the houses were built along one edge of a series of open field strips. The fields closest to the houses are depicted as orchards, and the near-circular shape of Field no.86 is of clear morphological interest. The field names are entirely prosaic and reflect the close proximity of the site to a farming settlement (i.e. the profusion of mowhays etc.). It is of interest that the

The Bridgerule (West) tithe map of 1842 (Figure 3) is the first detailed cartographic resource available to this study. It shows the settlement of *Little Bridge* and the Bude Canal in some detail. The layout of the settlement, together with the slightly-curving form of the field boundaries, might indicate the houses were built along one edge of a series of open field strips. The fields closest to the houses are depicted as orchards, and the near-circular shape of Field no.86 is of clear morphological interest. The field names are entirely prosaic and reflect the close proximity of the site to a farming settlement (i.e. the profusion of mowhays etc.). It is of interest that the road is shown crossing the canal, implying at this date the existence of a bridge rather than a viaduct (see below).

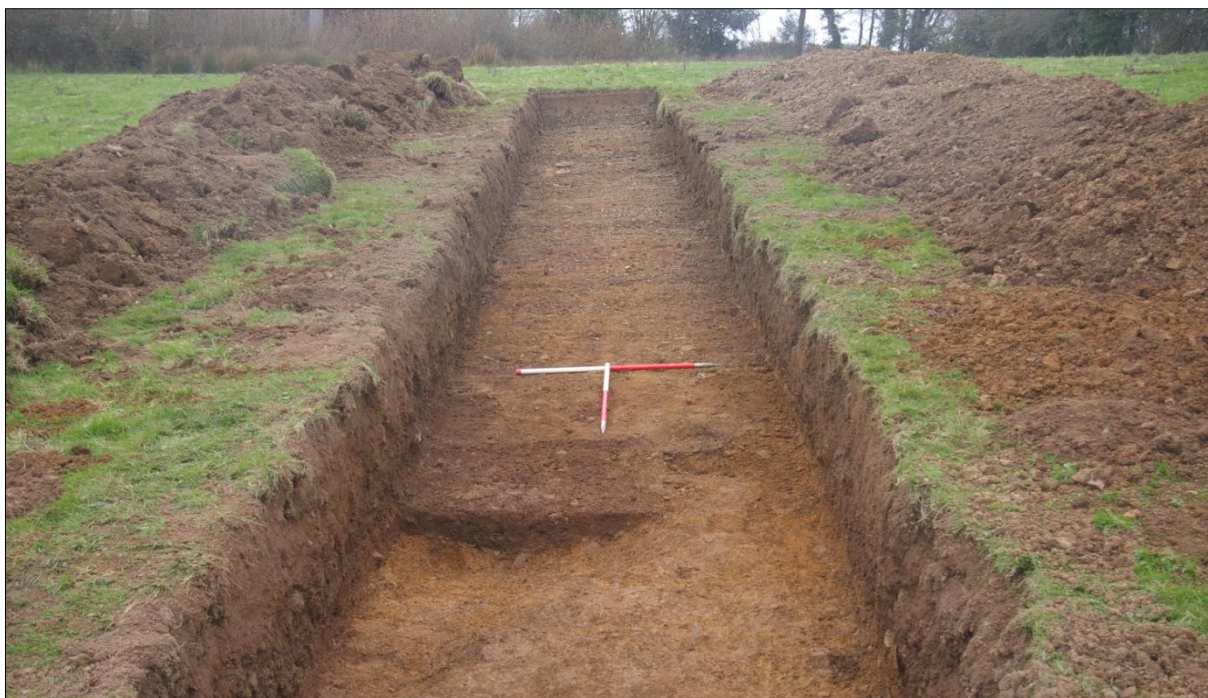
FIGURE 9: TRENCH 1 WITH PIT [103]; VIEWED FROM THE SOUTH-EAST (SCALES 1M & 2M).

Trench 1 was located in the south-western part of the site and was 20m long. This trench contained a single feature, shallow pit [103] (Figure 9 and Figure 12). Pit [103] was a sub-circular feature c.2.95m in diameter and 0.23m deep with gradually-sloping sides and concave base. It contained a single fill (104), a loose mid greyish-brown silty clay with frequent charcoal and frequent small-medium sub-rounded stone inclusions; some of the stones were heat affected. There were no finds.

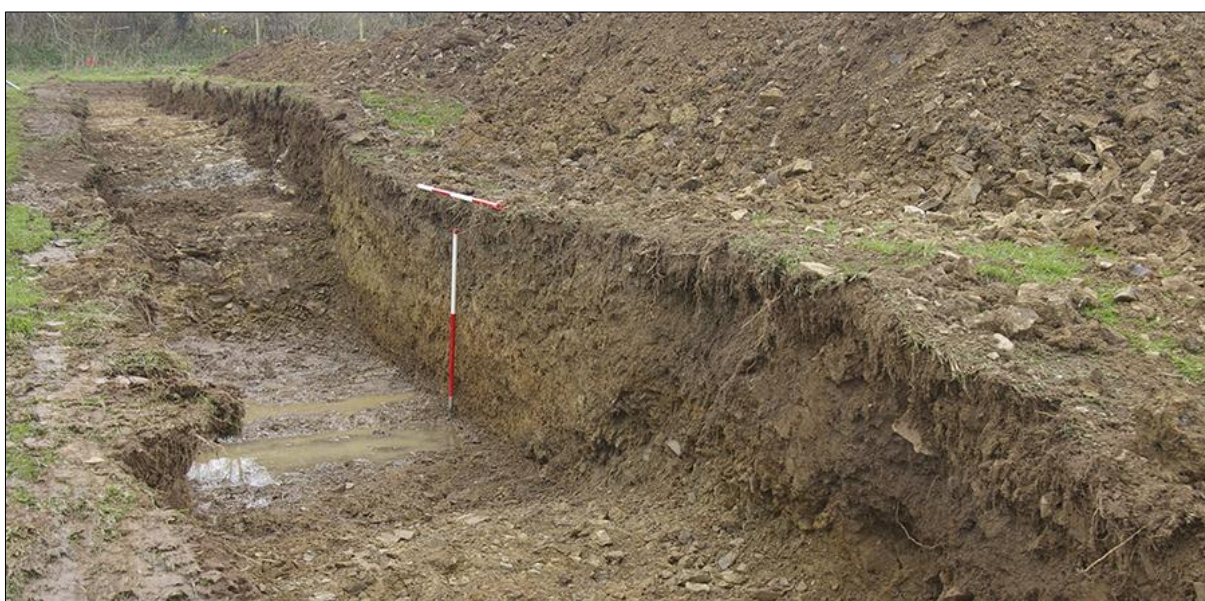
FIGURE 10: CANAL [203], OBLIQUE SHOT FROM THE SOUTH-WEST, LOOKING NORTH-NORTH-EAST (SCALE 1M & 2M).

Trench 2 was located just west of Littlebridge Cross and was 50m long; it was located to target the former Bude Canal line. The only features in this trench related to the Canal: its channel [203] with a bank to either side {221} {222}, and a small ditch [218] and bank {219} beyond the bank on the southern side. The southern bank also probably functioned as a towpath (Figure 10 – Figure 12).

The Canal channel [203] was located in the centre of the trench and it was orientated east-west. It measured c.8.0m wide and was up to 1.50m deep. Its profile was somewhat asymmetric, with a steeply-sloping northern edge and a more gradual southern edge; its base was broad and slightly concave. It contained eight fills (206)(207)(208)(209)(210)(211)(212)(217). Basal fill (206) was a very thin layer of compact blue-grey clay, most probably accumulated whilst the canal was in use or possibly a waterproof lining intended to prevent leakage. This fill produced some fragments of oyster shell (14g). Fill (207) was a compact mid greyish-brown silty clay with occasional medium-sized sub-angular stone inclusions, and may be from the initial silting of the feature. The other fills were variably-stony grey to yellowish brown silty clays or clayey silts capped with a modern topsoil (217); it seems likely these represent dumped deposits and that the Canal channel was deliberately infilled. Fill (212) produced ×1 sherd of white refined earthenware (later 19th century).

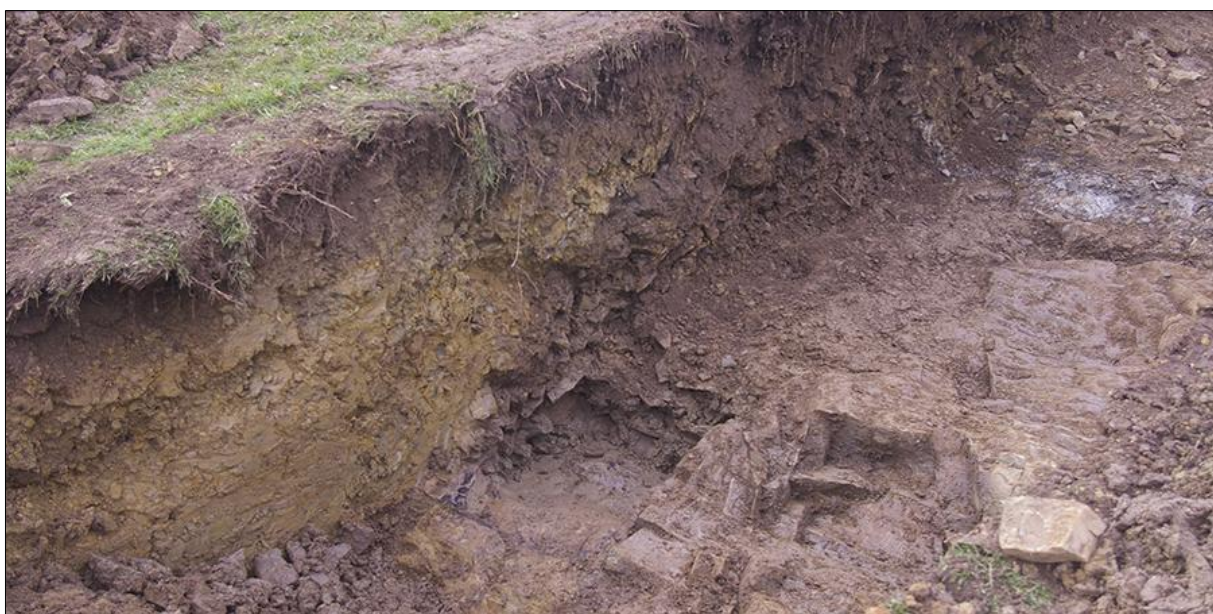
FIGURE 11: BEDROCK UNDERNEATH THE NORTHERN BANK {221} OF CANAL [203]; VIEWED FROM THE SOUTH-EAST (NO SCALE).

The banks to either side of the main channel were visible as clear earthworks in the field. Prior to their construction the topsoil and subsoil had been stripped down to the level of the natural, presumably to counter leakage and ensure greater stability. The banks appear to have been created by piling up excavated material from the central channel. The northern bank {221} was sat on the top of the natural bedrock, and consisted of a single layer of compact mid greyish-brown clayey silt with

abundant poorly-sorted small to very large stones. The southern bank {222} was slightly different construction and was comprised of three layers: (204) a compact mid brownish-grey silty clay redeposited natural with abundant small to very large sub-angular stone inclusions; (205) a compact mid greyish-brown clayey silt with occasional medium sub-angular stone inclusions; and (216) a compact dark greyish-brown clayey silt with abundant medium to large stone inclusions. These stones formed a distinct layer on top of the bank, and this was presumably the towpath.

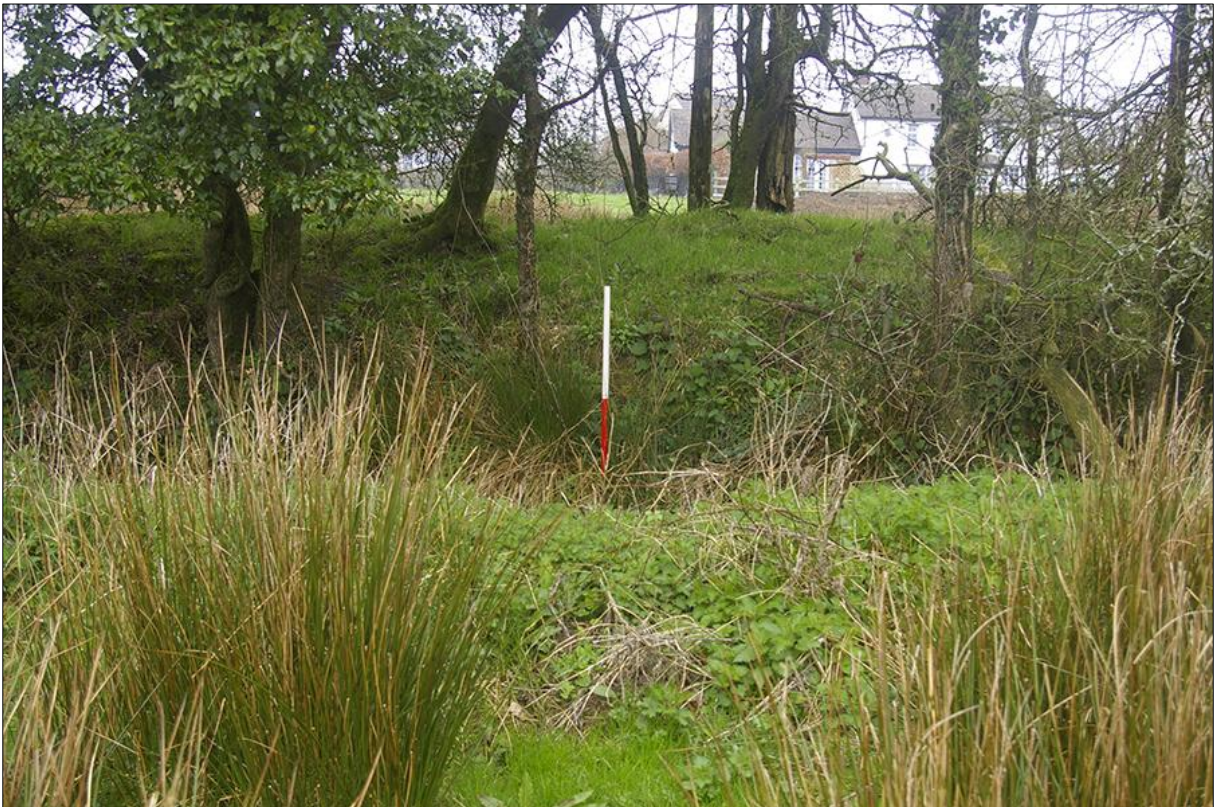
SOUTHERN CANAL BANK {222}, FLANKING DITCH [218] AND BANK {219}; VIEWED FROM THE SOUTH (SCALE 1M).

A small ditch [218] flanked the southern side of the southern bank {222}, with its own bank {219} on its downslope side. It was c.1.5m wide and up to 0.35m deep with a U-shaped profile. It appeared to be contemporary with [203], presumably to carry any leaking or excess water from the canal. The ditch contained two fills: (215) a compact mid grey clay with occasional medium to large stone inclusions; this fill may have weathered from the southern bank {222} while it was still in use. Fill (220) was compact mid brownish-grey clay silt with occasional stone fragments, interpreted as relatively recent and deliberate backfilling. Bank {219} ran parallel to ditch [218] and was comprised of compact mid greyish-brown clayey silt with occasional stone inclusions.

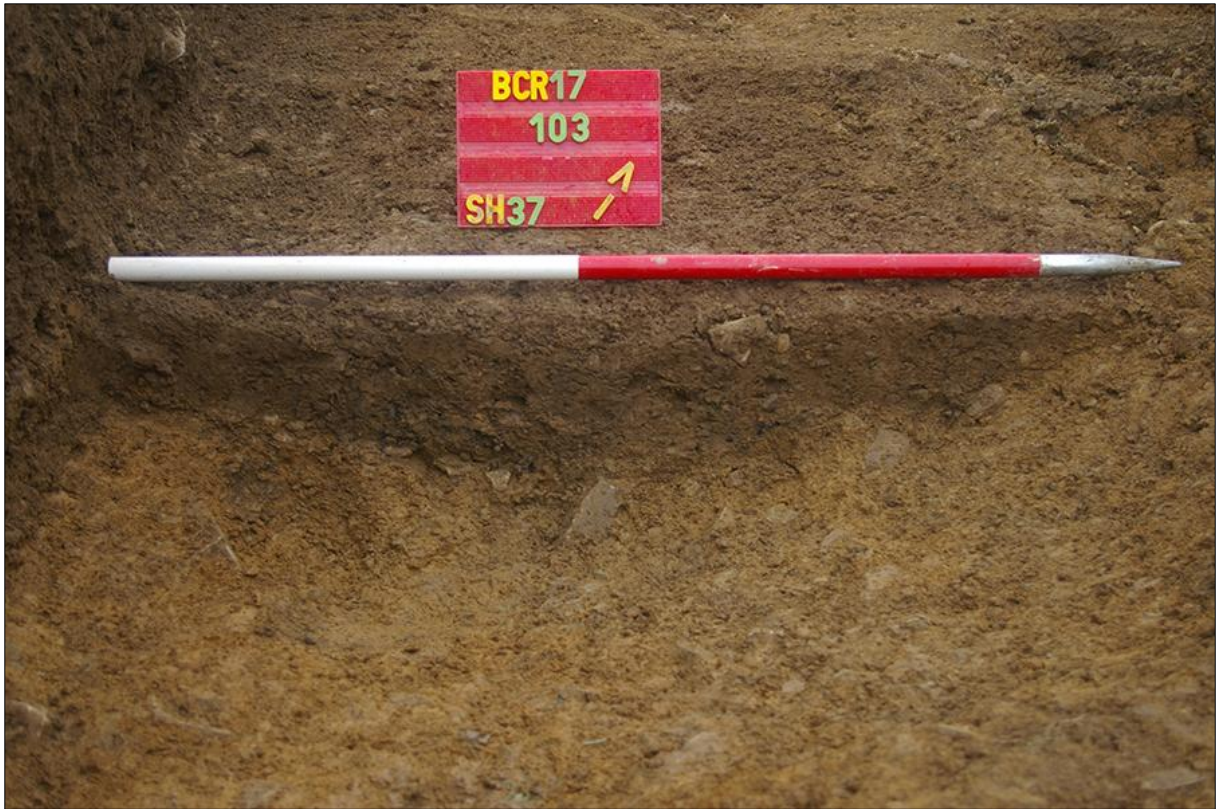
PIT [103], SOUTH-EAST FACING SECTION (SCALE 1M).

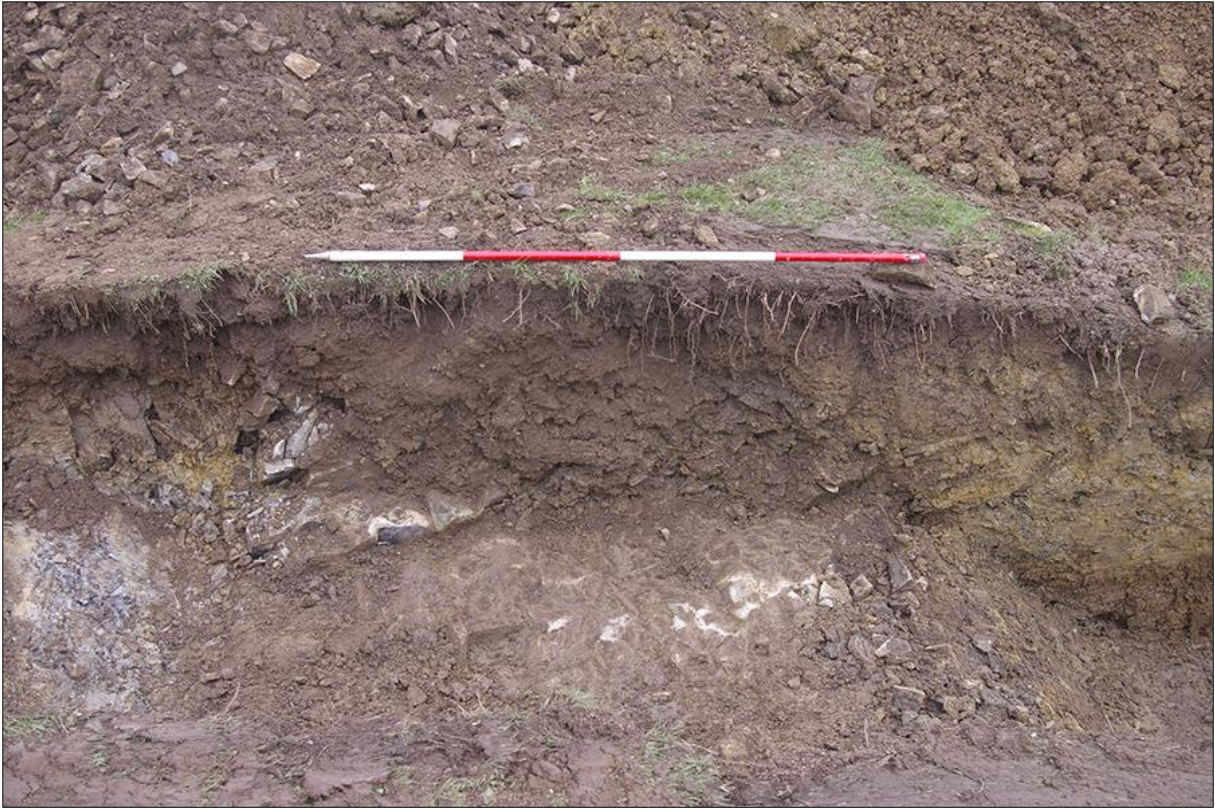
CANAL [203], WEST-FACING SECTION OF NORTHERN BANK {221} (SCALE 2M).

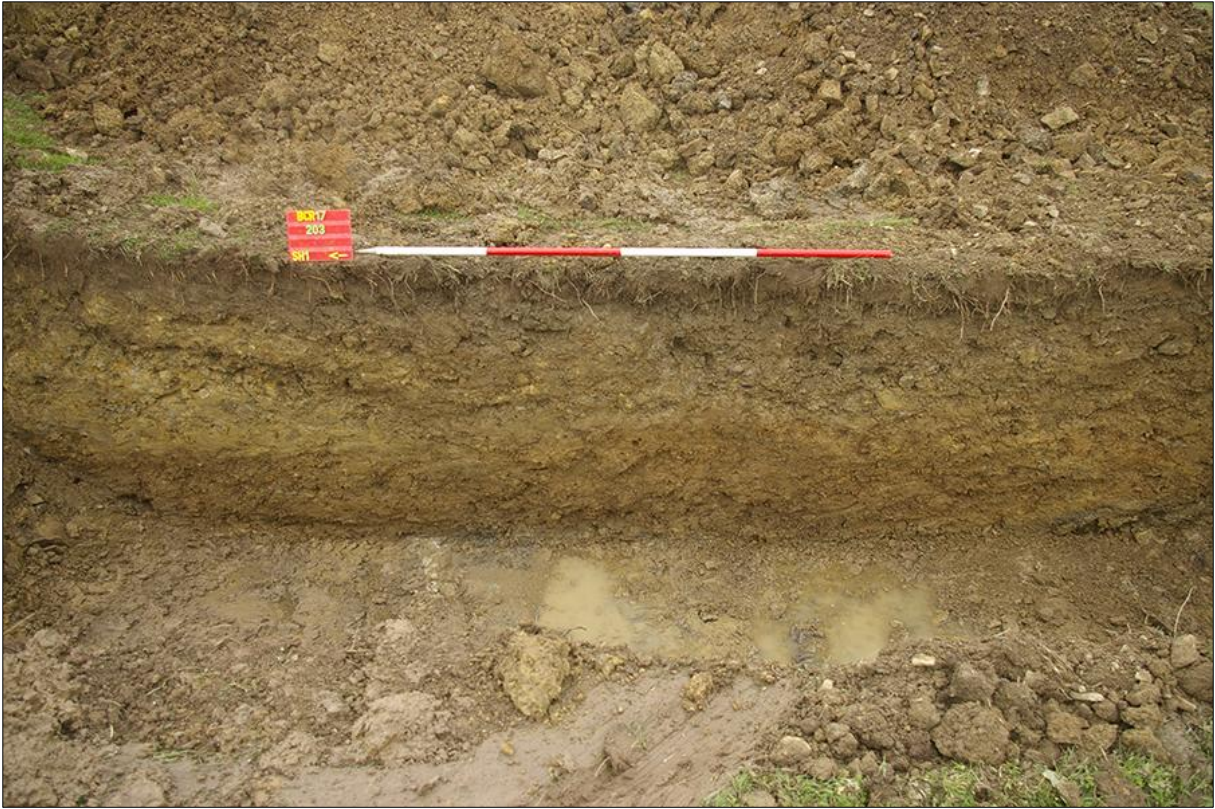
CANAL [203], CENTRAL WEST-FACING SECTION (SCALE 2M).

The topsoil and subsoil was removed from the footprint of the Canal and the banks that flanked it to either side, a corridor up to 15m wide. The Canal channel, c. 6.75m wide, was dug down the centre of this corridor and the variably-stony material used to build up the banks to either side. The northern (upslope) bank {221} consisted of a single dump of material, but the southern (downslope) bank {222} contained a sequence of deposits capped with very stony material or metalling. This variation would reflect the fact that the downslope bank would always be the most vulnerable structurally, and that the towpath ran along this bank (as indicated on historic OS maps). Beyond the downslope bank was a second, much smaller bank {219} and ditch, probably intended to carry any water leaking through or overtopping the Canal bank safely to existing drainage channels. It is of interest that the topsoil and subsoil from the Canal corridor was largely removed, and presumably this must have been disposed of in the local area.

The primary fill (206) of the channel was a thin layer of blue-grey clay which can be interpreted as puddled clay intended as waterproofing. The next fill (207) should probably be interpreted as primary silting, but the thickness of this layer (even accounting for compaction) would suggest the Canal – in use for 66 years – was subject to periodic cleaning. As the bulk of the material filling the channel consists of fairly clean redeposited natural, this would imply the Canal was infilled quite quickly after it fell out of use. This redeposited material could be derived from clearing the relict field boundaries on the site (which disappear from the historic OS maps by 1906), or, if a longer chronology can be justified, from housing development in the local area during the first half of the 20th century. The evidence for discrete layers, but the lack of stabilisation horizons, would suggest episodic infilling over a short period of time.

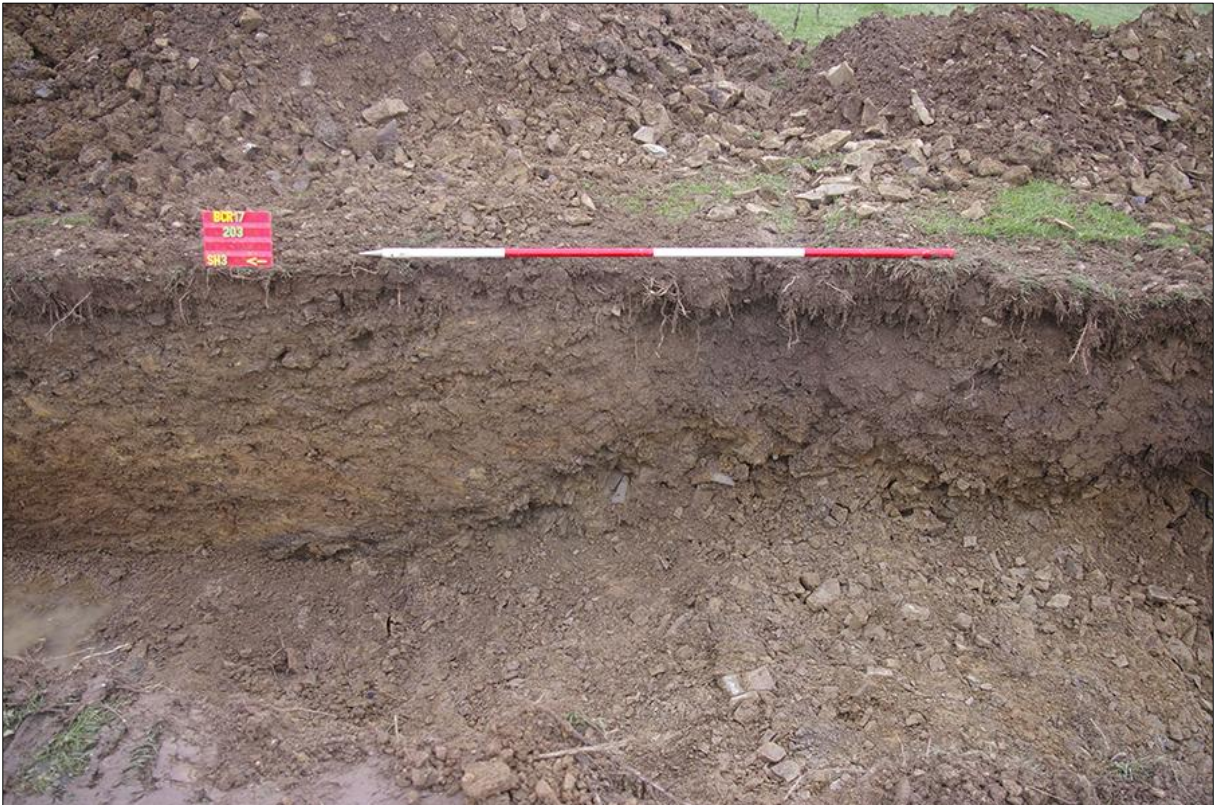
CANAL [203], WEST-FACING SECTION, SOUTHERN END, SHOWING SOUTHERN BANK {222} (SCALE 2M).

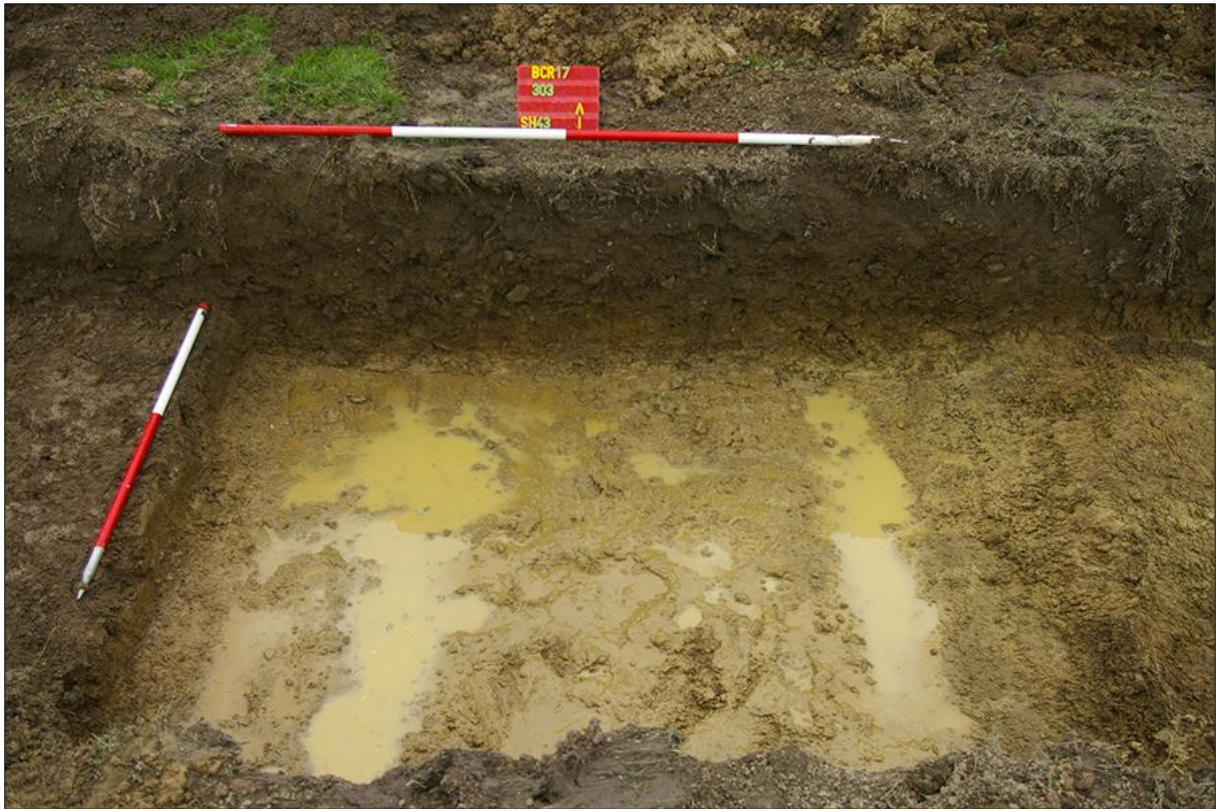
PIT [303], SOUTH-FACING SECTION; VIEWED FROM THE SOUTH (SCALE 1M & 2M).

Trench 3 was located towards the western edge of the site and was orientated north-east to south-west; it was 15m long. A single feature was identified in this trench. Pit [303] was oval in plan, c.2.6m in diameter and 0.23m deep with gradually-sloping sides and flat base (FIGURE). It contained a single fill (304), a firm dark brownish-grey clayey silt with occasional stone inclusions. It was cut by a land drain on its south-west side. There were no finds.

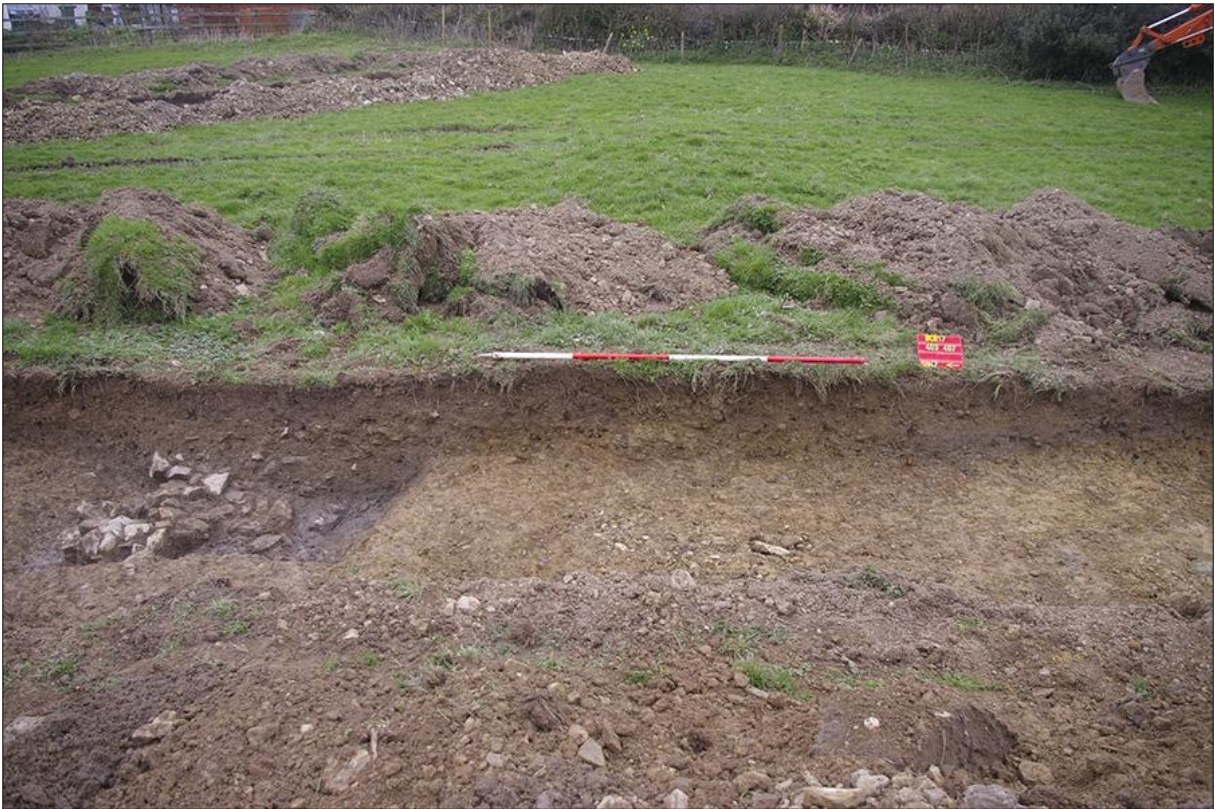
DITCH [403], BANK {407} AND RUBBLE {412}, WEST-FACING SECTION (SCALE 2M).

Ditch [403] was aligned approximately east-to-west and measured 1.8m wide and 0.65m deep with moderate to steeply-sloping sides and a concave base. It contained four fills (404)(405)(406)(412), all variably stony friable or soft mid greyish-brown or grey silty clays; Fill (412) was particularly stony. Fill (404) produced one fragment (3g) of clay tobacco pipe stem and seven (1104g) probable roof slate fragments (one pierced). It also produced a single fragment (16g) of animal bone. Bank {407}, comprised a single soft mid brown silty clay layer, was located on the southern side of ditch [403] and was clearly visible as an earthwork. Bank {407} was cut by a modern ceramic land drain [413].

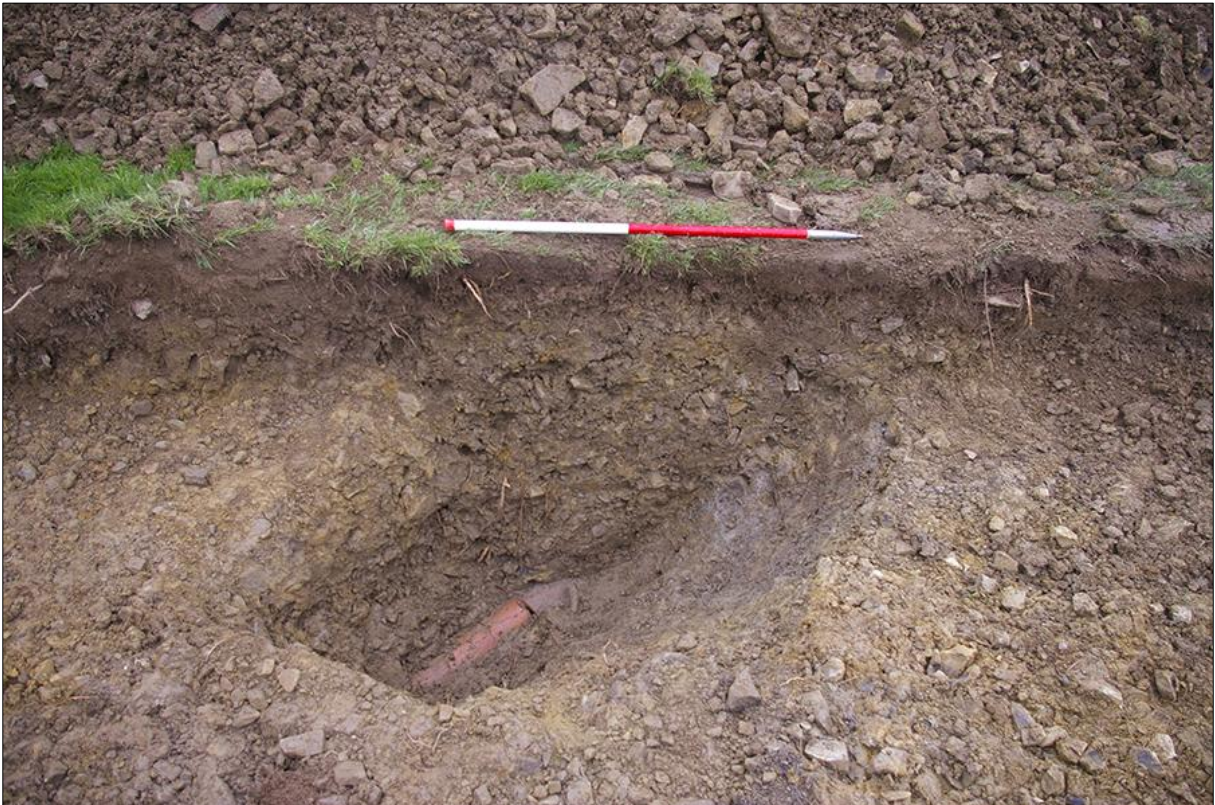
LAND DRAIN [503] AND DITCH [515], NORTH-FACING SECTION; VIEWED FROM THE NORTH (SCALE 1M).

Ditch (515) was at least 1.5m wide and 0.5m deep. It was located towards the eastern end of the trench, and was orientated approximately north-east to south-west. It contained two fills: (516) a compact light brownish-grey sandy clay with frequent stone inclusions, and (517) a compact light brownish-grey sandy clay with frequent stone inclusions. Fill (516) produced ×2 sherds (6g) of co-joining North Devon medieval coarseware. The eastern side of [515] was cut by a land drain [503]. The backfill of this drain (504) produced ×1 sherd (11g) of 16th century North Devon calcareous ware, ×1 fragment (23g) of modern brick, ×1 (95g) fragment of double-pierced slate and ×1 (7g) iron nail.

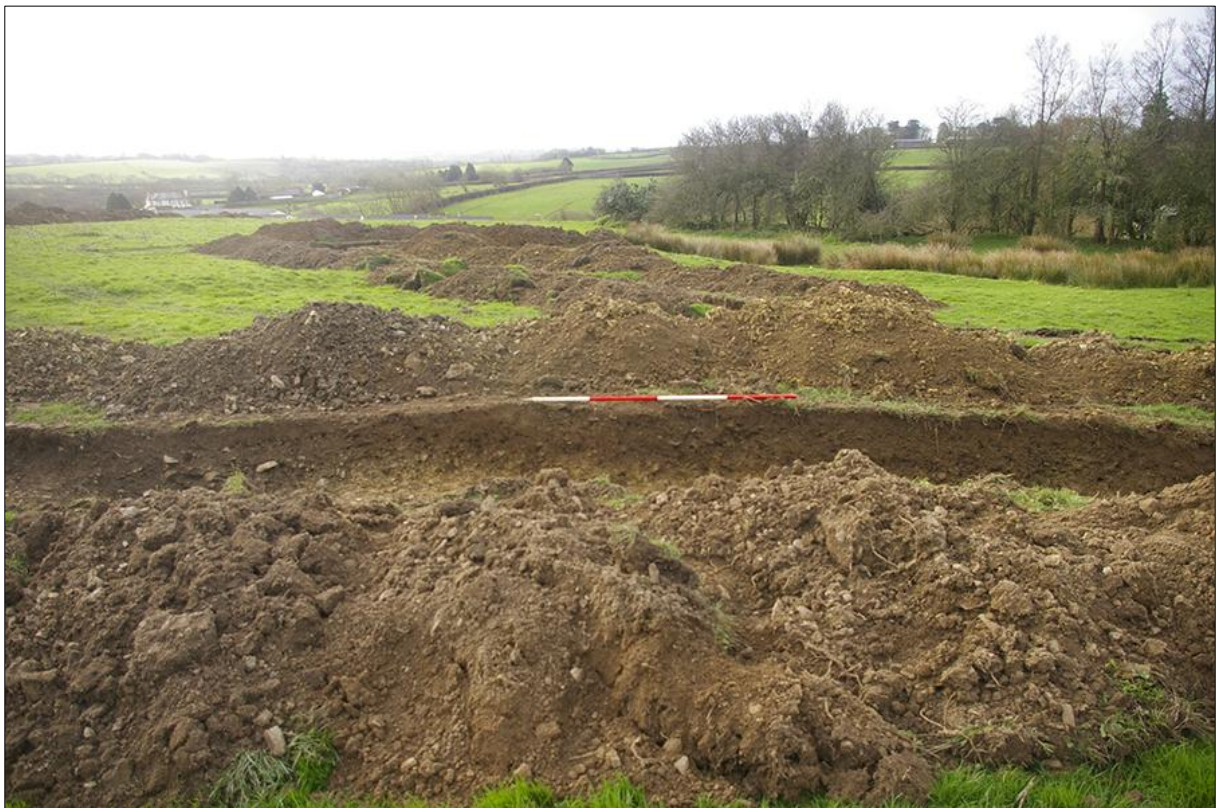
DITCH [505] AND BANK [511], NORTH-FACING SECTION; VIEWED FROM THE NORTH (SCALE 2M).

Ditch [505] was located towards the middle of the trench and was associated with a bank {511} and a modern land drain [513]. It aligned approximately north-north-west to south-south-east and measured 1.72m wide and 0.70m deep with moderate to steeply-sloping sides and a concave base. It contained six fills (506)(512)(507)(508)(509)(510), all variably stony soft or friable mid greyish-brown clayey silts or silty clays. Fill (506) produced ×2 sherds (6g) of post-medieval North Devon calcareous pottery, ×1 sherd (2g) medieval coarseware, and ×2 (16g) pieces of flint. The associated bank {511} was located on the western side of ditch [505] and was clearly visible as an earthwork. It comprised a single deposit of friable mid brown clayey silt with abundant sub-angular and angular stones. The bank produced ×1 sherd (11g) North Devon medieval coarseware. It was cut by a land drain [513].
