SHIRCOMBE FARMHOUSE BROMPTON REGIS SOMERSET

Results of a Desk Based Appraisal,
Historic Roof Assessment & Archaeological Monitoring

Report No.: 141016
Date: 16.10.2014
Author: E. Wapshott
S. Walls

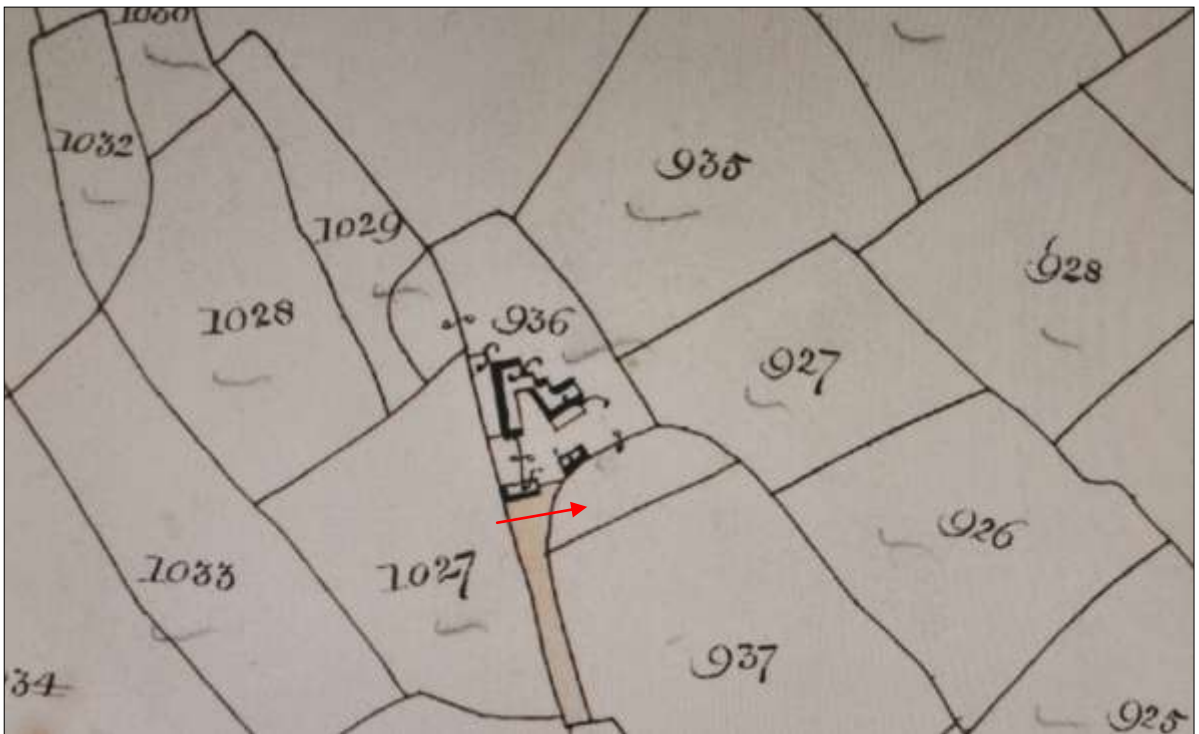
Figure 3: Detailed extract from the tithe map showing detail of the buildings at Shircombe Farm. The approximate location of the present farmhouse is arrowed.

The first detailed cartographic source available for this study is the 1841 tithe map (Figures 3-4). The buildings apparent on this map display little resemblance to the buildings which are present today. In fact the present farmhouse does not appear to have existed at this date, as it should be shown within the detached (un-numbered) enclosure above the field numbered 937. The small building which abuts this un-numbered enclosure is not depicted on later cartographic sources, but would be located at the approximate western end of the present house. It is possible that this building was the farmhouse at this date, with the un-numbered field forming the garden.

The access track appears in the same location as it is today and there is a small rectangular building located at the end of this track. This building does not appear to relate to the East Barn, however which should be shown below (to the east) of this building, and follow an opposing orientation. The larger group of buildings may represent the present South Barn, Mill and North Barn, although the building to the north is depicted on a slightly different alignment to the present North Barn.

The accompanying tithe apportionment suggests that Shircombe and the fields surrounding the farm were all owned by Stuckley Lucas of Baronsdown, and leased to a William Carter. The apportionment describes the enclosure numbered 936 as *House, Barns and Gardens*, suggesting that there was a house on the site. However, it should be noted that in a transcription of the 1841 census there is a William Carter, living at a Great Thurcombe Farm, although it is not clear if the name Great Thurcombe actually refers to Shircombe.

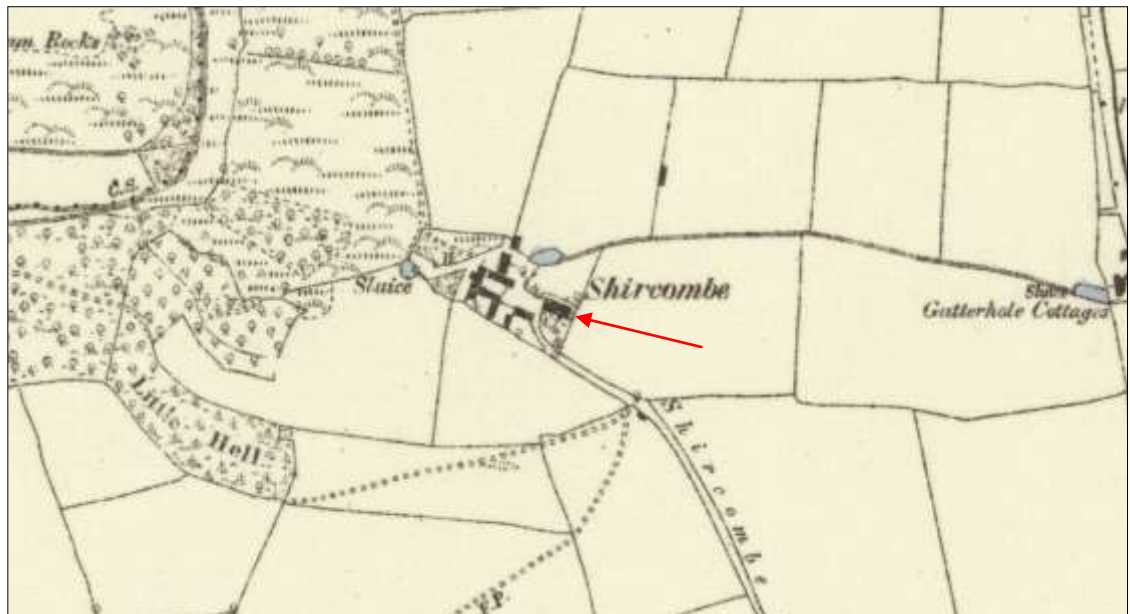
Figure 4: Extract from the 1st edition OS map of 1889. The farmhouse is arrowed.

The farmhouse is depicted as a rectangular building with a small projecting (porch) to the south. There are footpaths depicted to both the south and north of the house, providing

The First Edition Ordnance Survey Map of 1888 more closely resembles the buildings as they are today (Figure 4). The North Barn, Mill and South Barn are depicted, as is the farmhouse and the East Barn for the first time. The forge also appears to be shown as a very small structure against a field boundary. It appears that many of the other smaller buildings, such as the building set along the track to the south-east, and in the fields to the north-east have since been demolished.

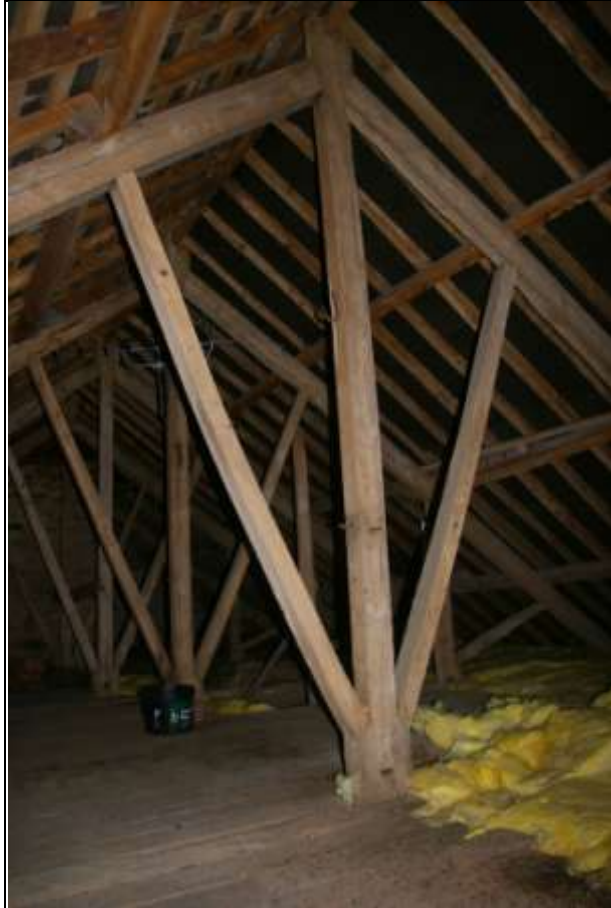
Figure 7: Detail of one of the trusses, king post, with long fine queen struts; from the south-east.

The roof is ten bays in length, with nine king post trusses, with queen struts and aisle posts. The queen struts are of note for being unusually fine. The truss blades are morticed into the head of the kingpost. The queen struts also have mortice and tenon joints to the truss blades and the base of the kingpost. The kingpost is fixed with an iron bolt to the tie beam (see Figure 7).

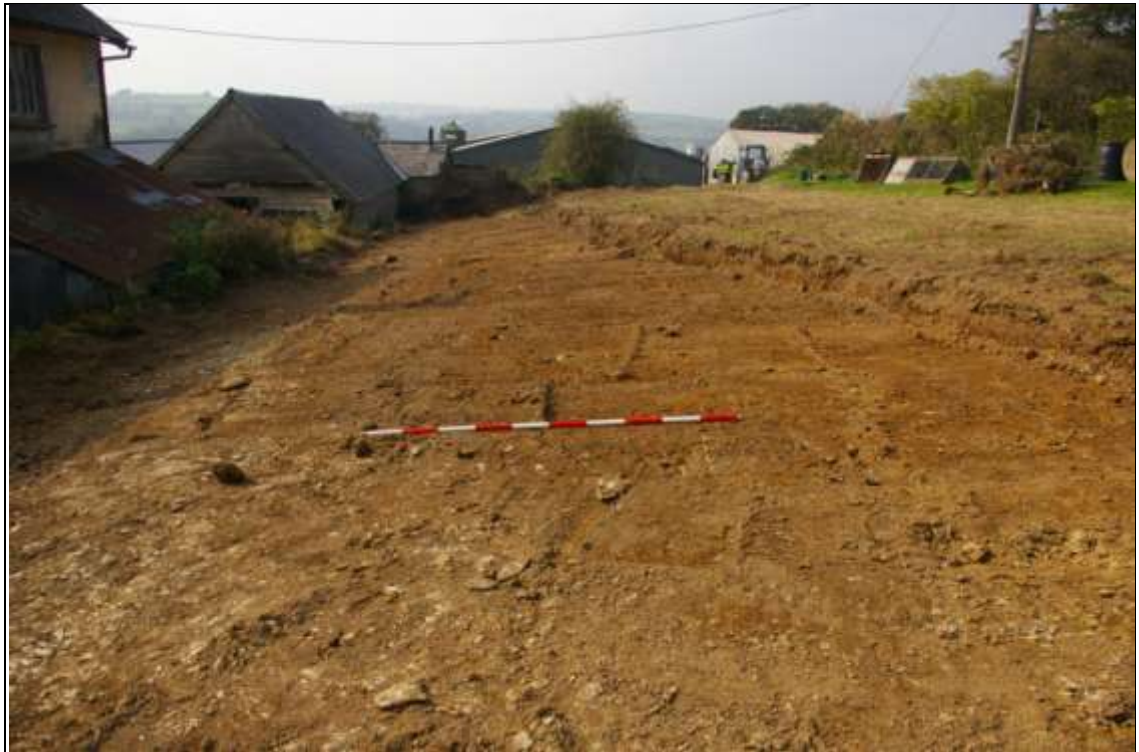
Figure 9: Area 1, viewed from the east; 2m scale.

No archaeological features were viewed although geological variations, bands of yellow sandy-silt and orange-brown clay-silt soils were noted running through the blue-grey coloured degraded shillet which formed the majority of the natural (Figure 9).

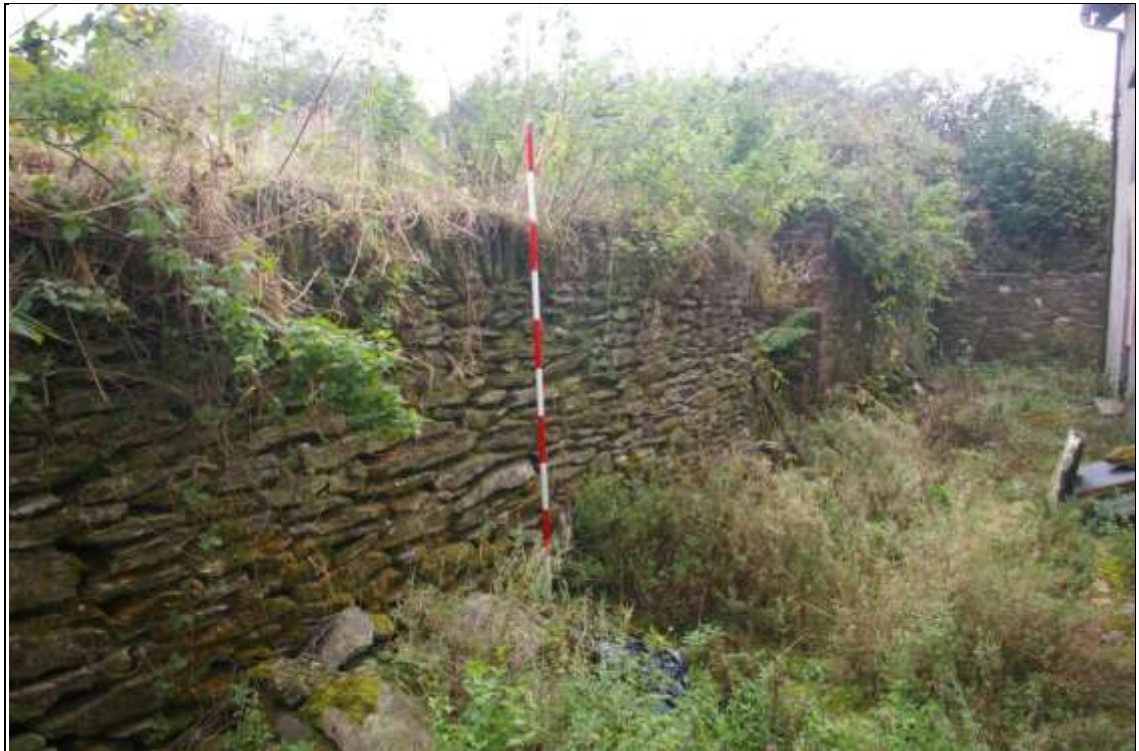
Figure 10: The northern retaining wall before demolition, viewed from the south-west (2m scale).

As part of these ground works the stone revetment walling which surrounded the northern side of the house was demolished and the levels behind pulled back to a depth of approximately 2m. The demolition of the wall was monitored and it was clear that the rear was loosely mortared in lime, in places, with almost a dry-stone character to some of the stonework, stacked in herringbone form. An 18.3m length of wall was being reduced and a profile through the wall was drawn for the section which was removed (Figures 10-12).

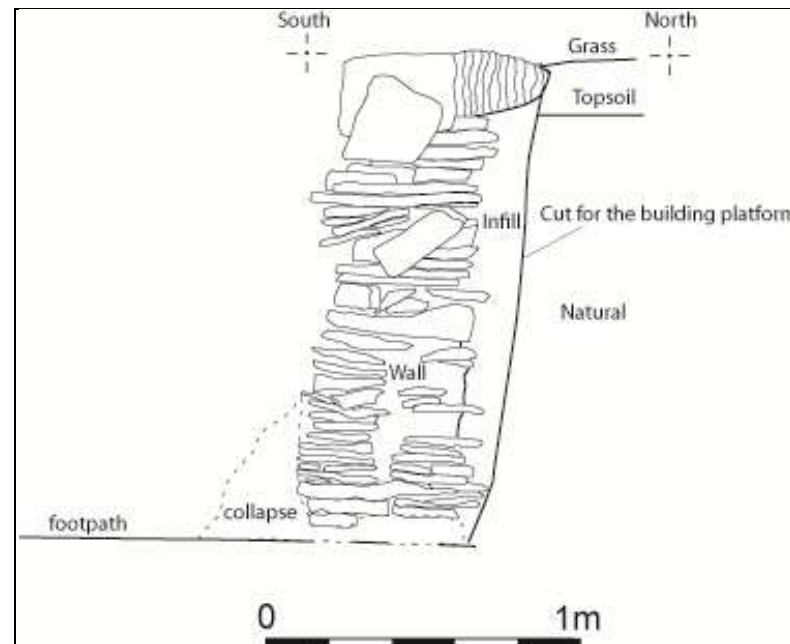
Figure 12: Section through the demolished garden wall.

The edge of the cut for the terrace, onto which the farmhouse had been built, was exposed c.0.3m behind the stone revetment walling which surrounded the northern side of the house. The terrace cut directly into the natural. The ground between the wall and the cut for the platform had been in-filled with a mixture of dark yellow-brown silt loam topsoil and re-deposited natural. A small number of finds were recovered from this deposit including 5x

glass lemonade and ginger-beer bottles, 5x sherds of white refined earthenware fragments. No pre-19th century artefacts were recovered, suggesting the building terrace dated from, or had been significantly enlarged, during the 19th century rebuilding of the farmhouse.

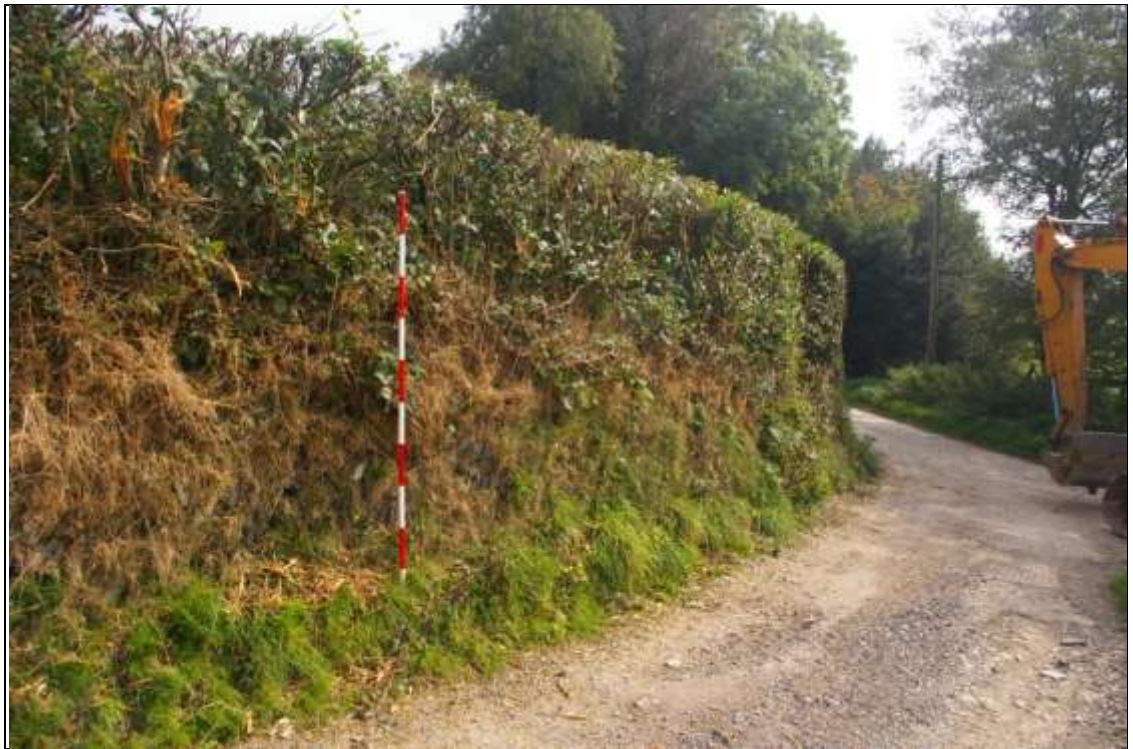
Figure 13: The stone faced laurel hedge, prior to removal, viewed from the north (2m scale).

An open area of c.30m long and 12-10m wide to the east and narrowing to 4-2m to the west was stripped within the garden. The mature laurel hedge was removed and the dry-stone herringbone face to the bank on which this sat was truncated. The stone section of hedgebank was photographed and recorded, before removal (Figures 13-15).

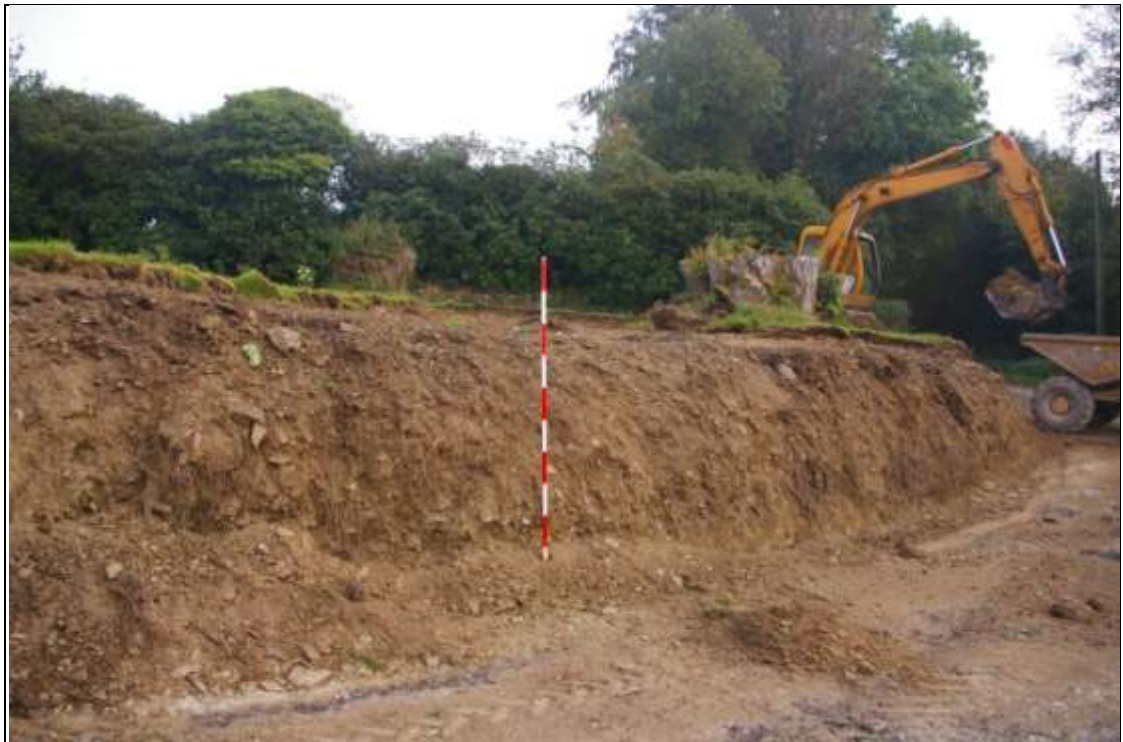
Figure 15: Area 2, the made ground to the front of the garden, with bank and hedge removed, with 2m scale; from the west-north-west.

The ground to the western side, which formed a pronounced curve to the lawned front garden, could be seen to be 'made' ground, of redeposited shillet mixed with brown silty topsoil (Figure 15). To the east the natural rotted shillet was exposed. Just under the grass lawn a very shallow linear feature could be seen which aligned with the front door and projecting porch on the south elevation, this feature was too shallow to record, merely being a smear of darker topsoil pushed into the re-deposited natural. This probably represented the remains of a garden path leading from the front door.

The reduction of levels in this area of made ground area was monitored, but no features were seen during the reduction of the levels. No features were seen cutting into the natural. The natural ran uphill to the north and east, as expected following the natural slope of the hillside. No finds were recovered within the made-ground to date the levelling of the hillside.

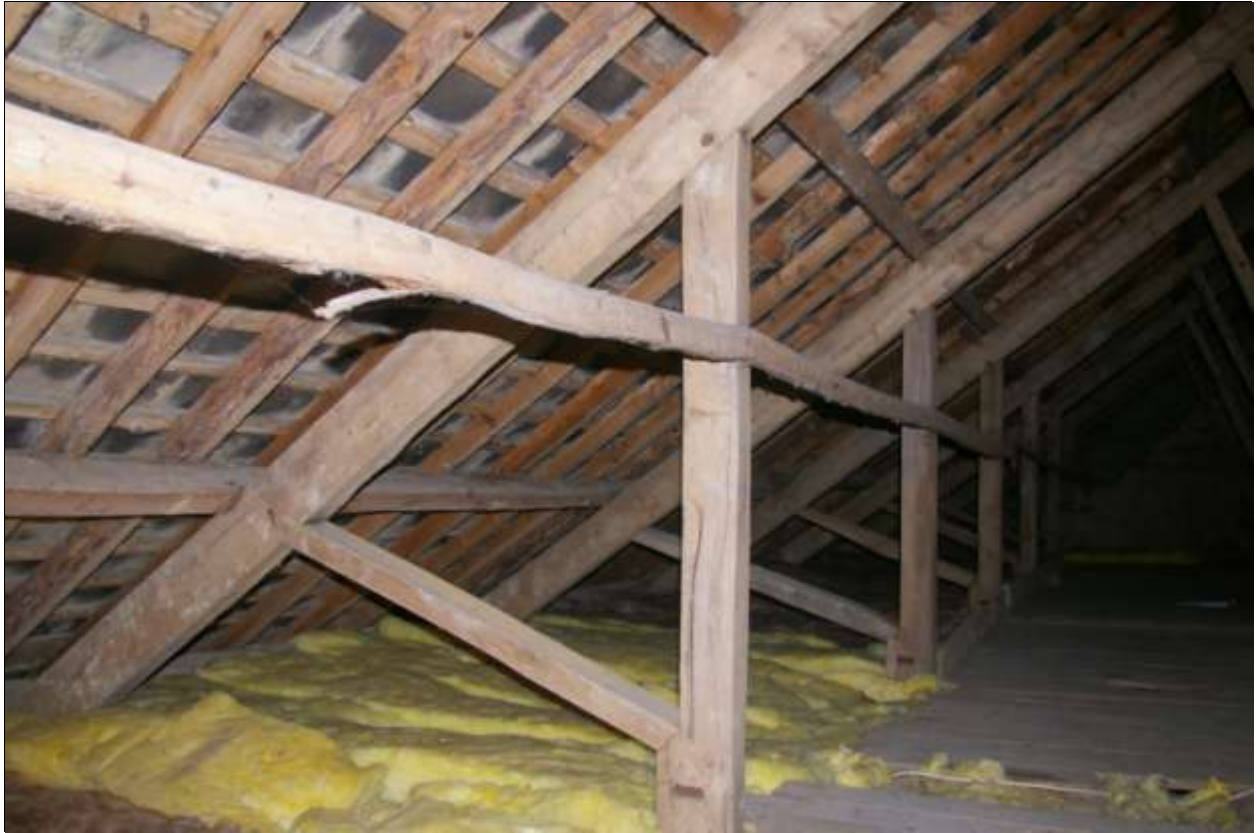
The aisle posts have pegged joints into the truss blades. Additional struts brace the aisle posts. The overlapping ridge pole is set on edge, socketed into the head of each kingpost; some lengths of the ridge pole are modern pine plank replacements. There are three sets of overlapping purlins to each pitch, the purlins are of roughly square profile. Some of the lengths of purlin have been replaced with modern tanalised pine timbers.

The aisle posts, with additional struts and the later hand-rail; viewed from the north-east.

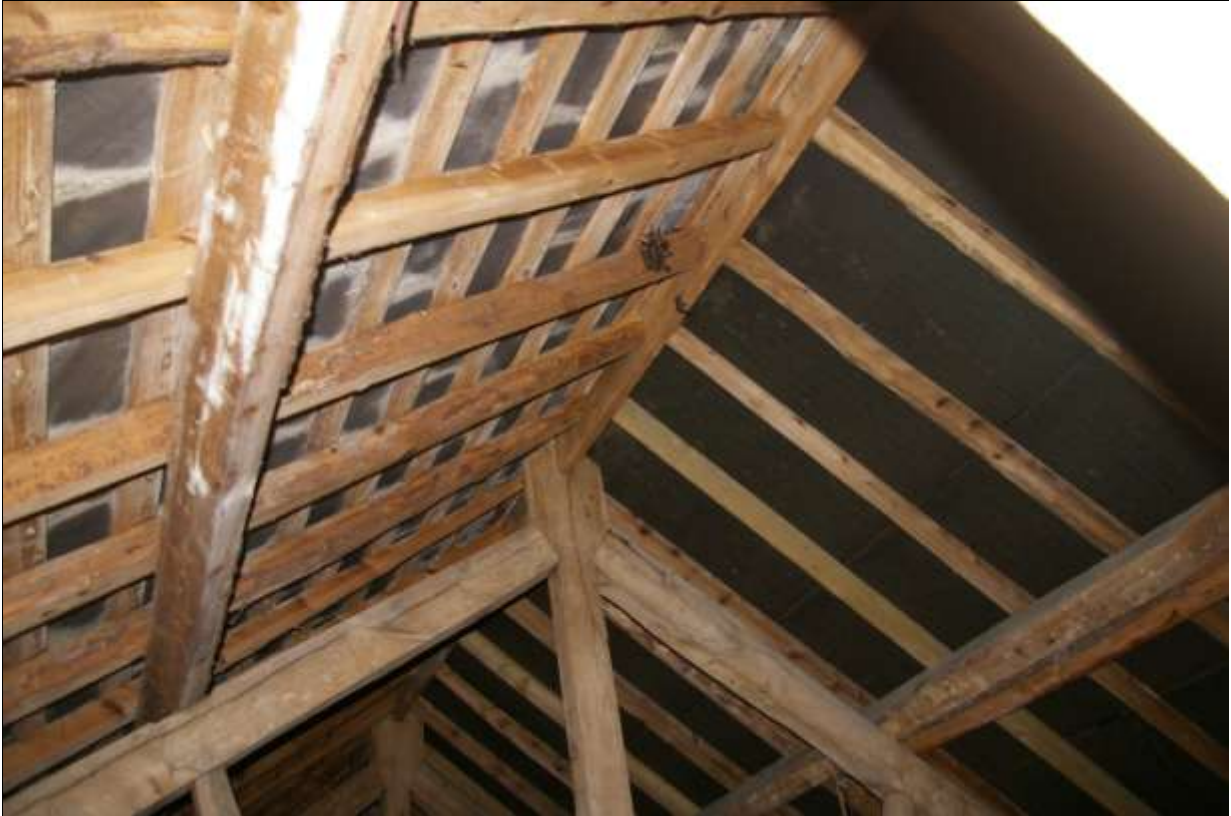
Detail of the ridge pole and upper sets of purlins; from the south-east.

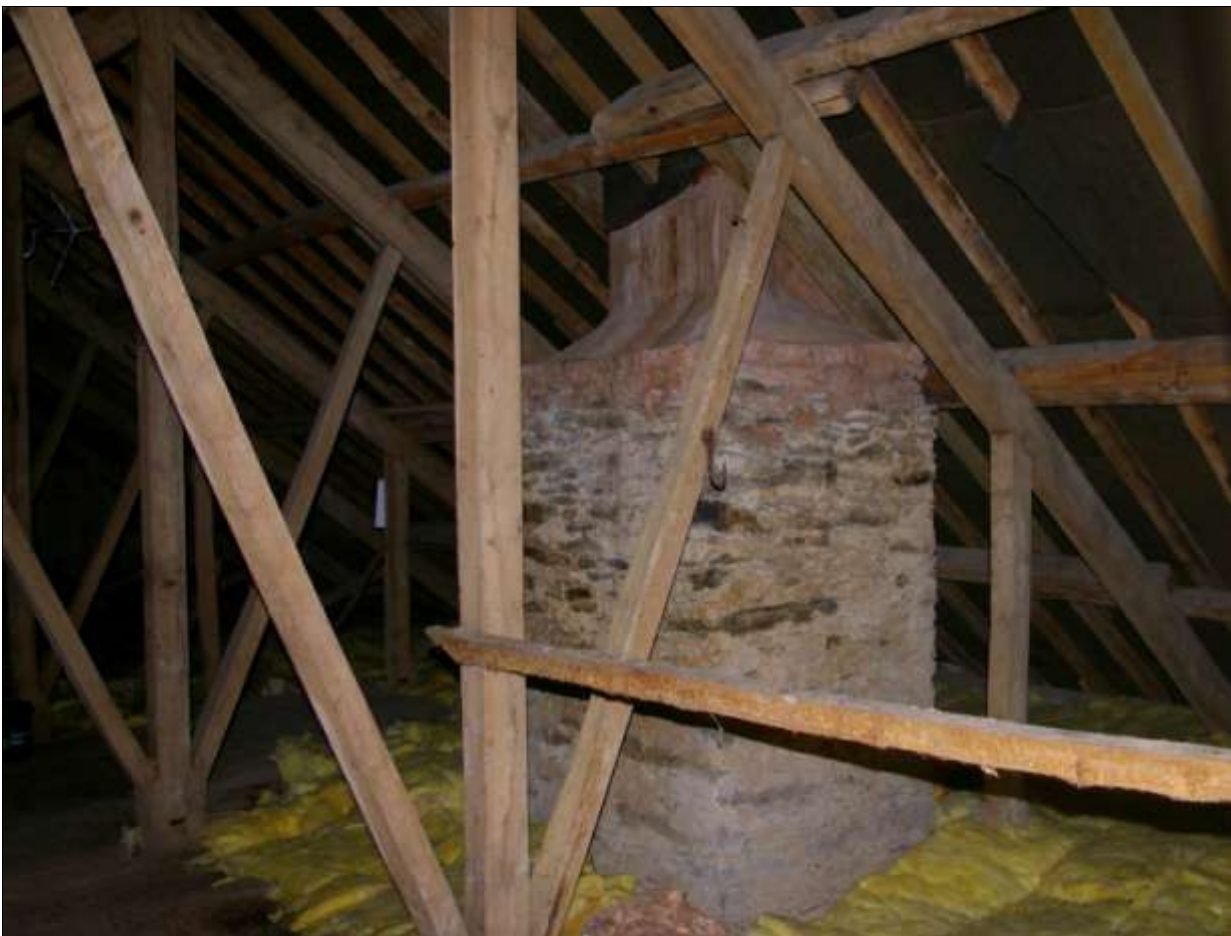
The gable end stack is contiguous with the 19th century east gable wall. The central, formerly lateral, stack is from an earlier structure of probable 17th century date, although it has been repointed and raised. The axial stack to the western end is of a mid-late 18th century date.

The central square stack, of 17th century date; from the south-east.

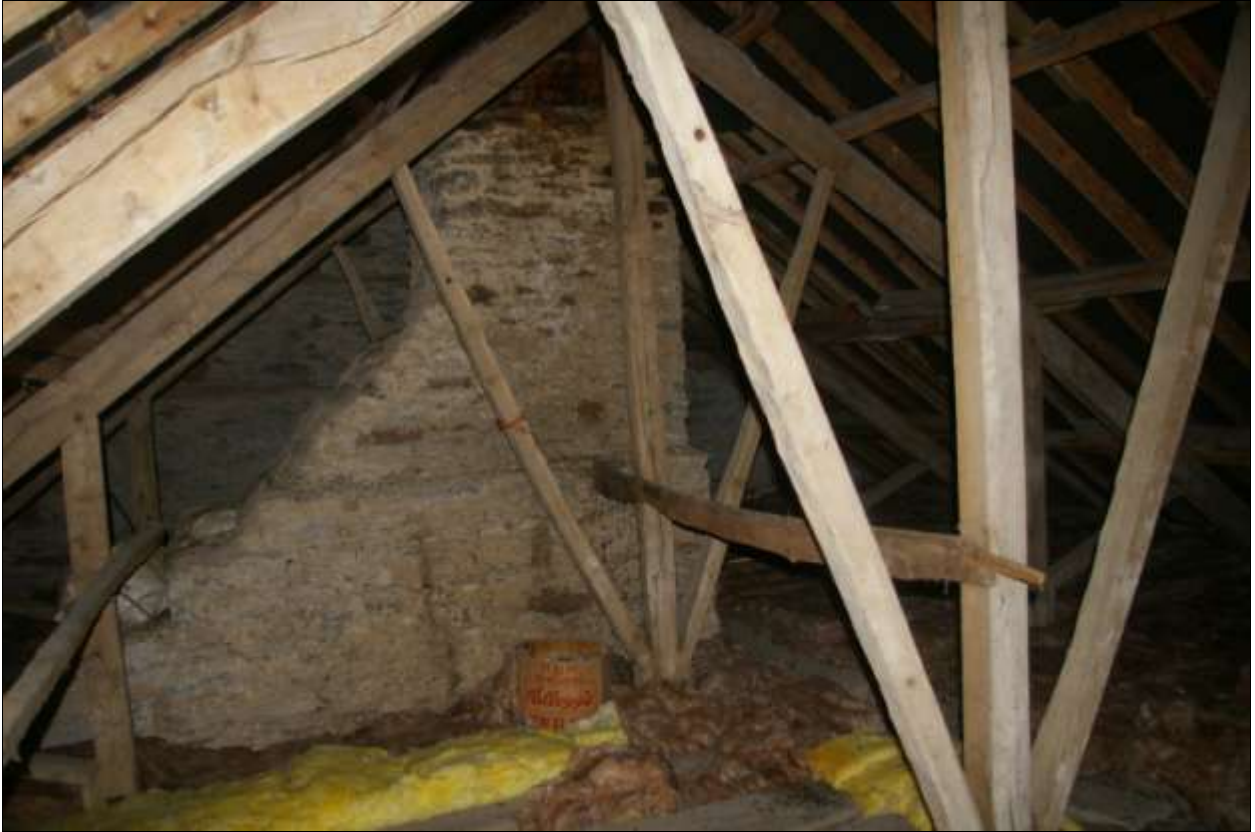
The western axial stack, with projecting built oven flue to the south side; from the south-east.

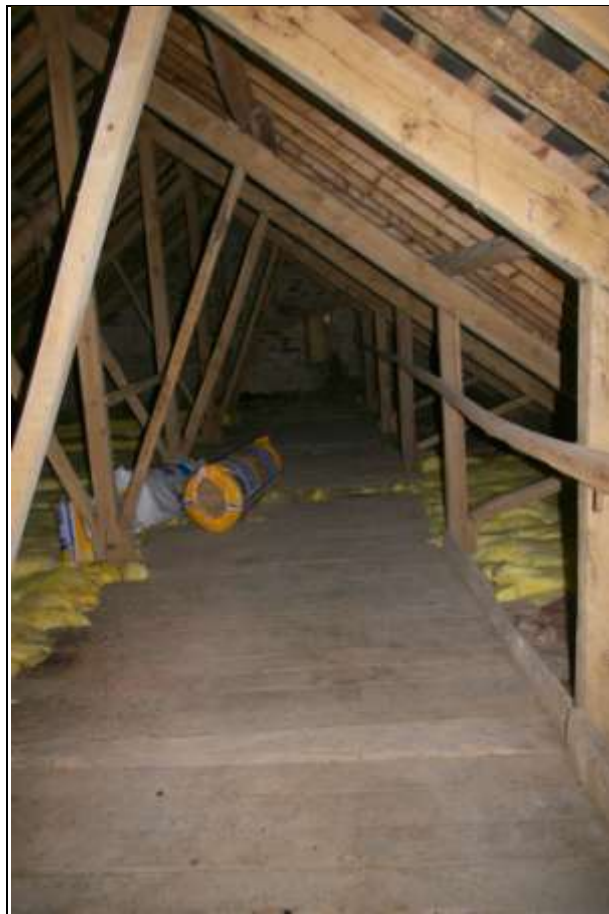
View along the boarded section of flooring; from the west.

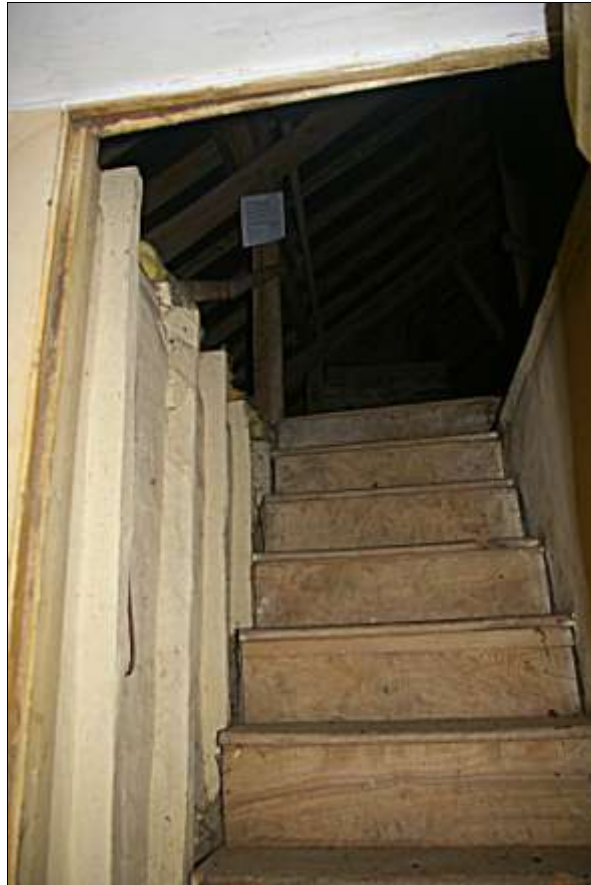
The roof is accessed via a narrow stair within one of the Bedrooms (Room 7), via a ledged plank door (Figure 6). The walls are of lath and plaster, with timber framing, and the stairs have narrow plank risers and treads. The central and southern part of the roof is boarded for access, with a mixture of wide and narrow, even width floorboards. A rail has been nailed to the aisle posts along the boarded section, to keep people off the lath and plaster first floor ceilings. The whole roof is covered with modern fibreglass insulation.

The lath and plaster and timber framing of the loft stair, with timber plank treads and risers; from the west-south-west.

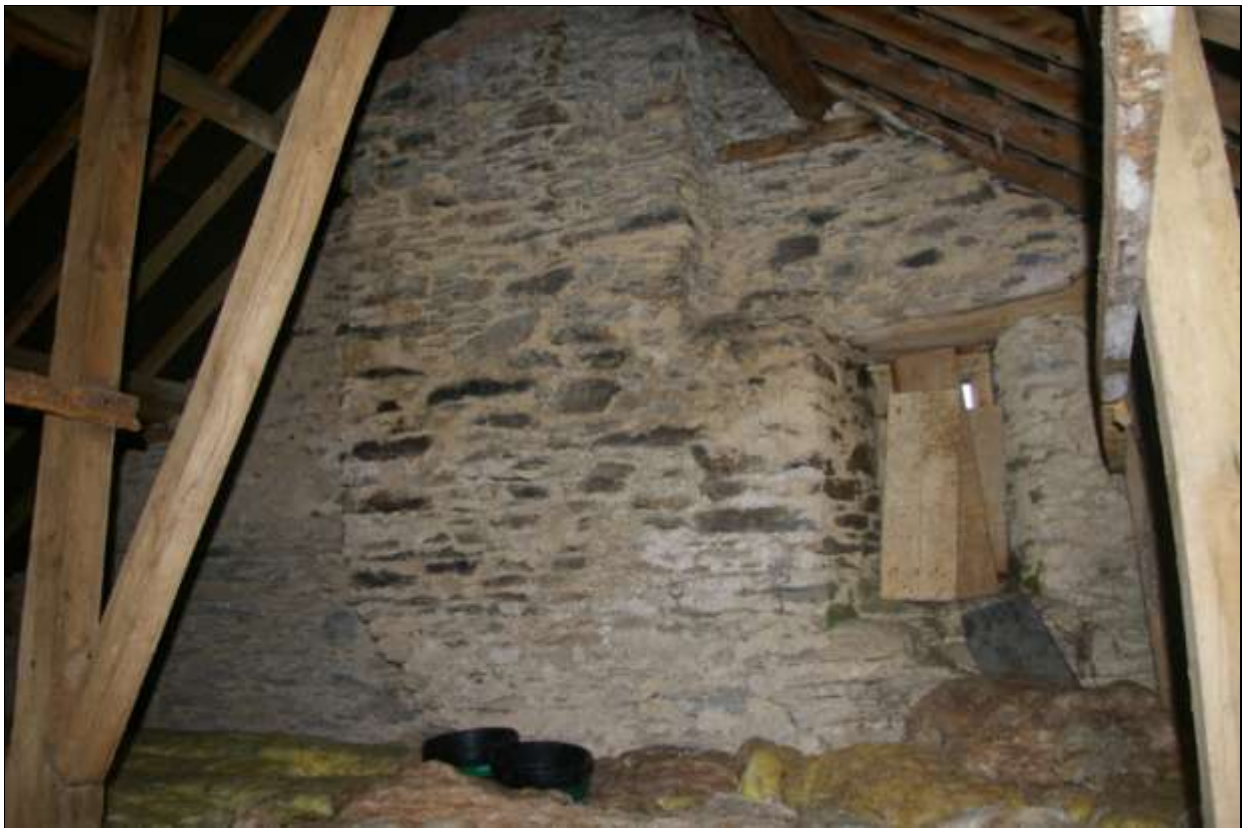
There is a small narrow window set in the east gable end wall, this is has a wide sloping reveal to the south and is set against a chimney stack to the north. It has a narrow roughly-cut timber lintel and a timber pegged frame, although the window is now partially blocked with planks.

The east gable end wall, with chimney stack and small window; from the south-west.

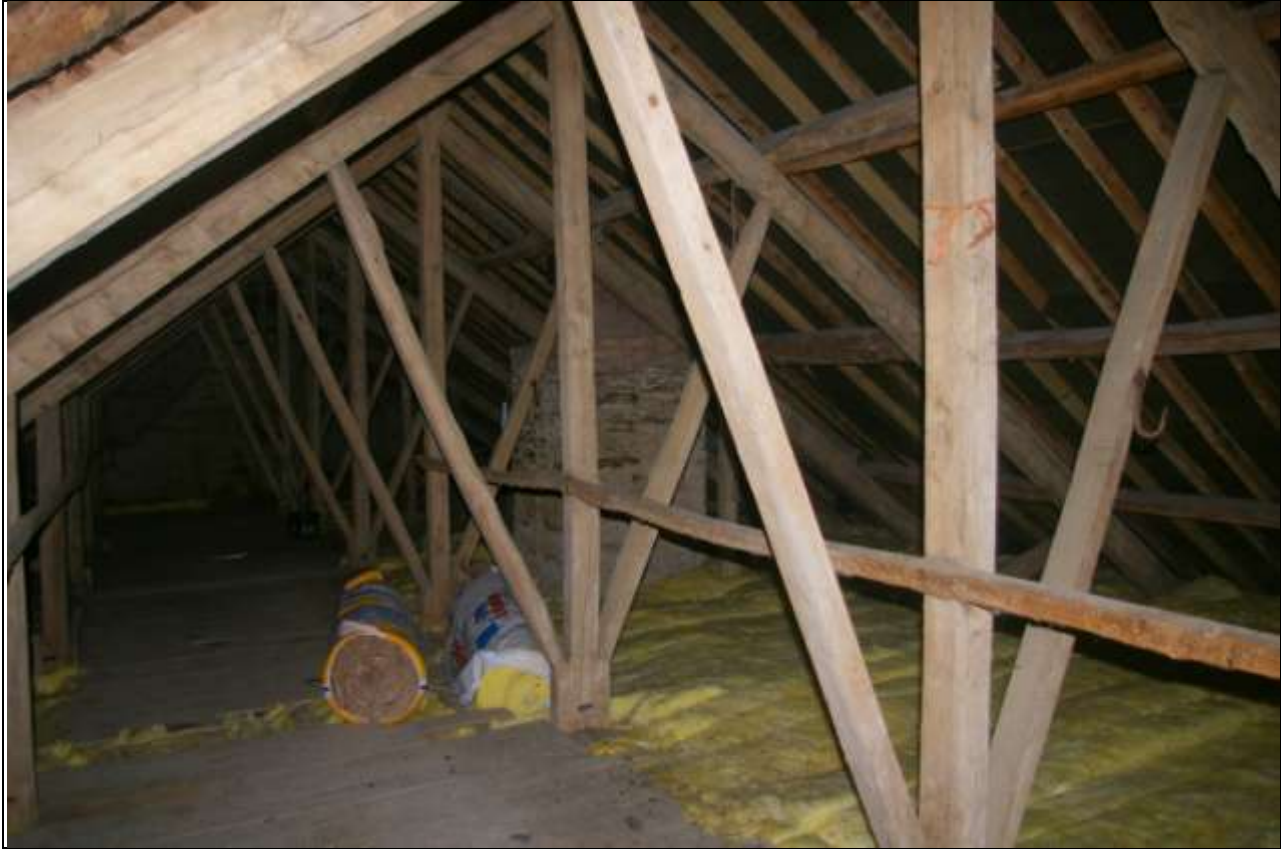
View down the length of the roof; from the east-south-east.

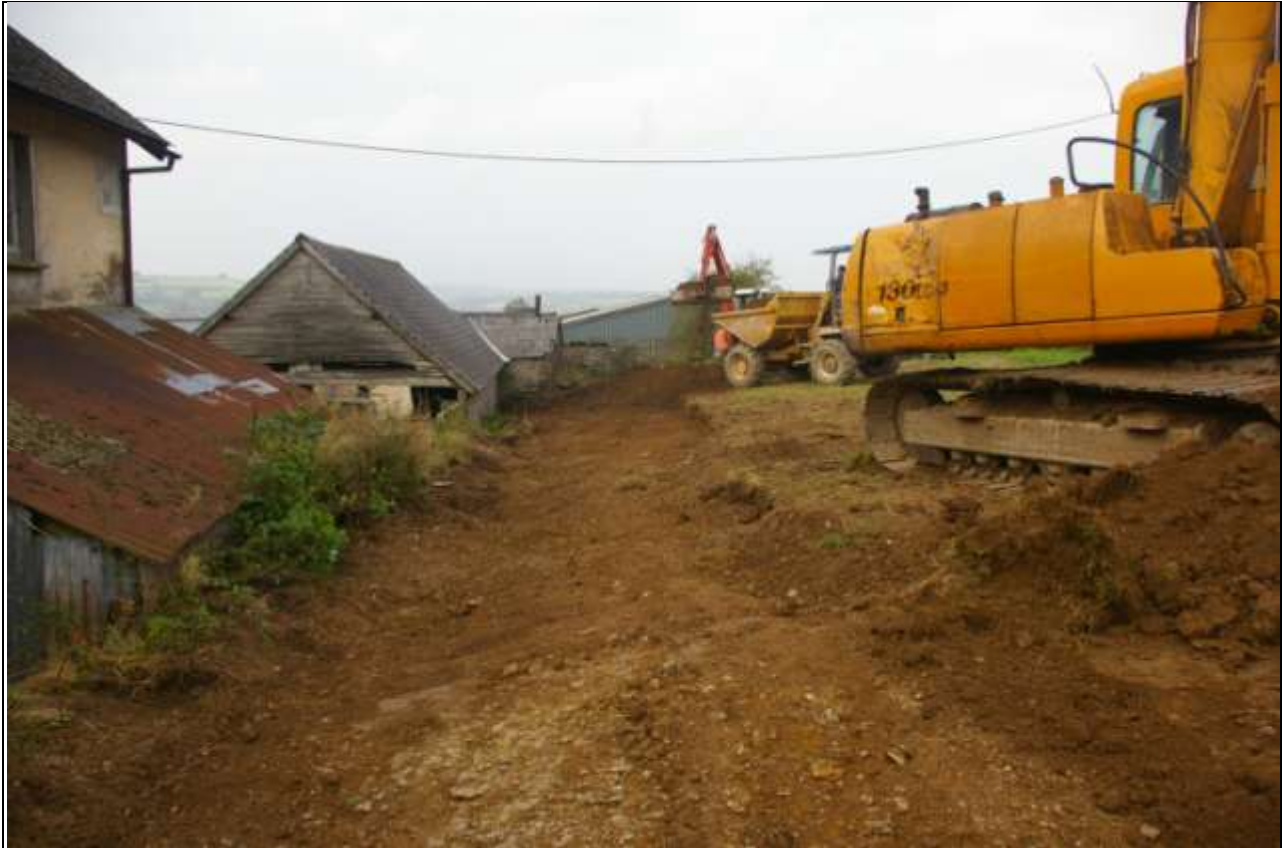
View down Area 1, the open stripped area, with top soil removed; from the east.

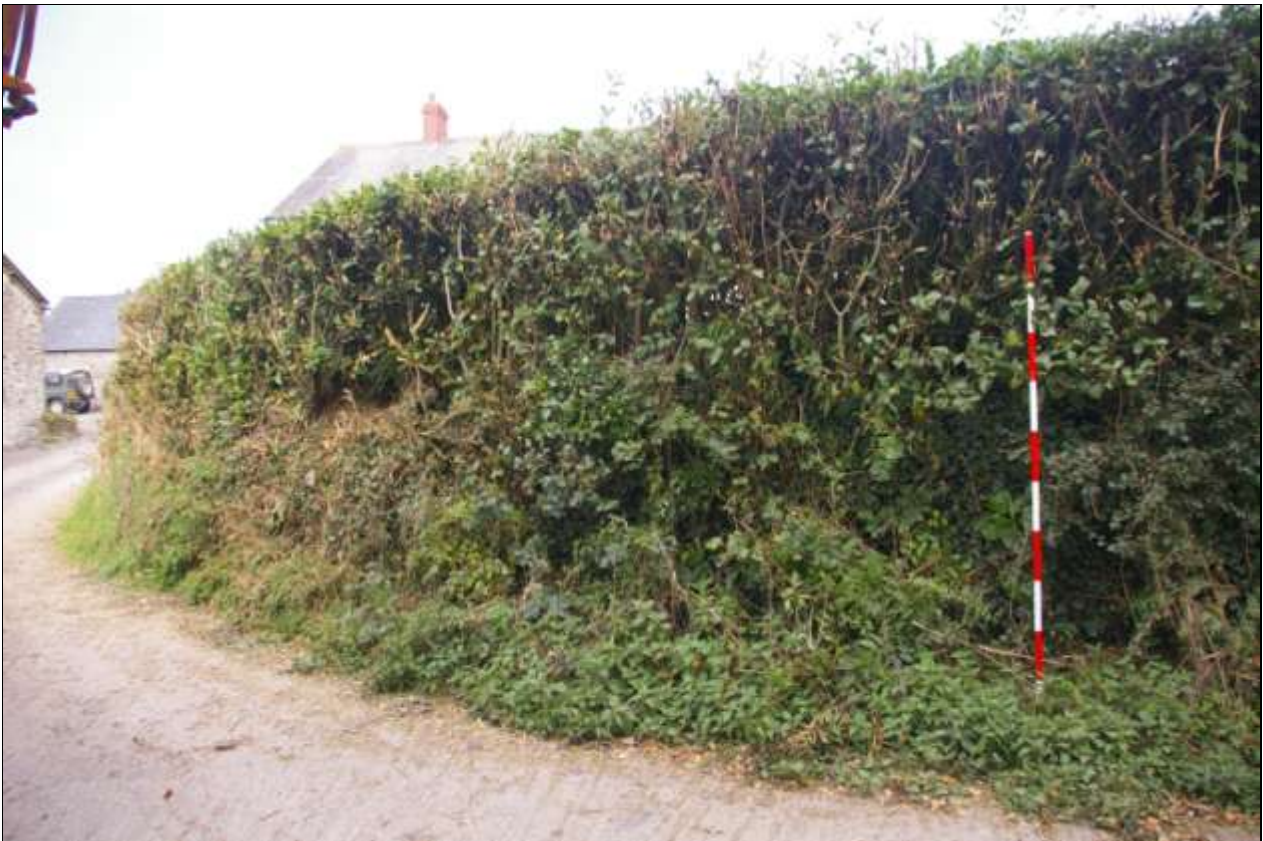
Area 2, view around the curving garden revetment bank, with 2m scale; from the south-south-east.

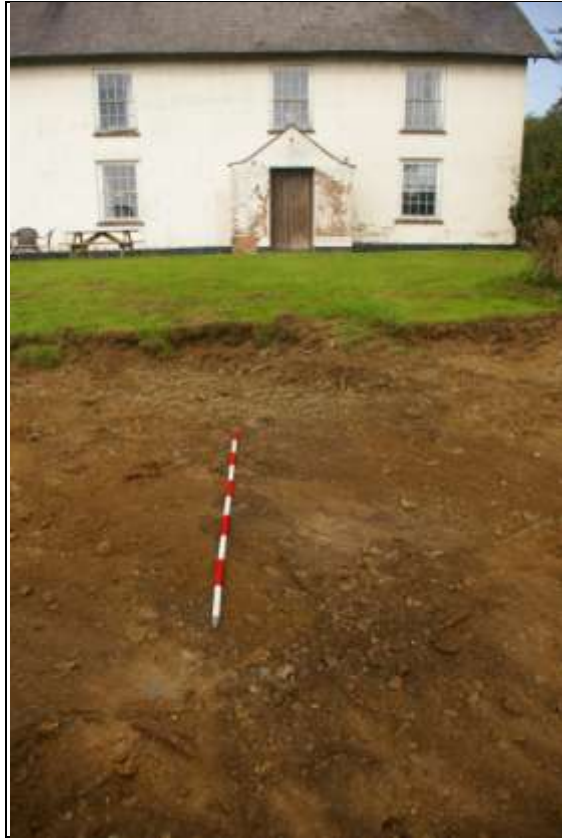
Area 2, the very ephemeral feature/smear of topsoil, the remains of a garden path, with 2m scale; from the south.

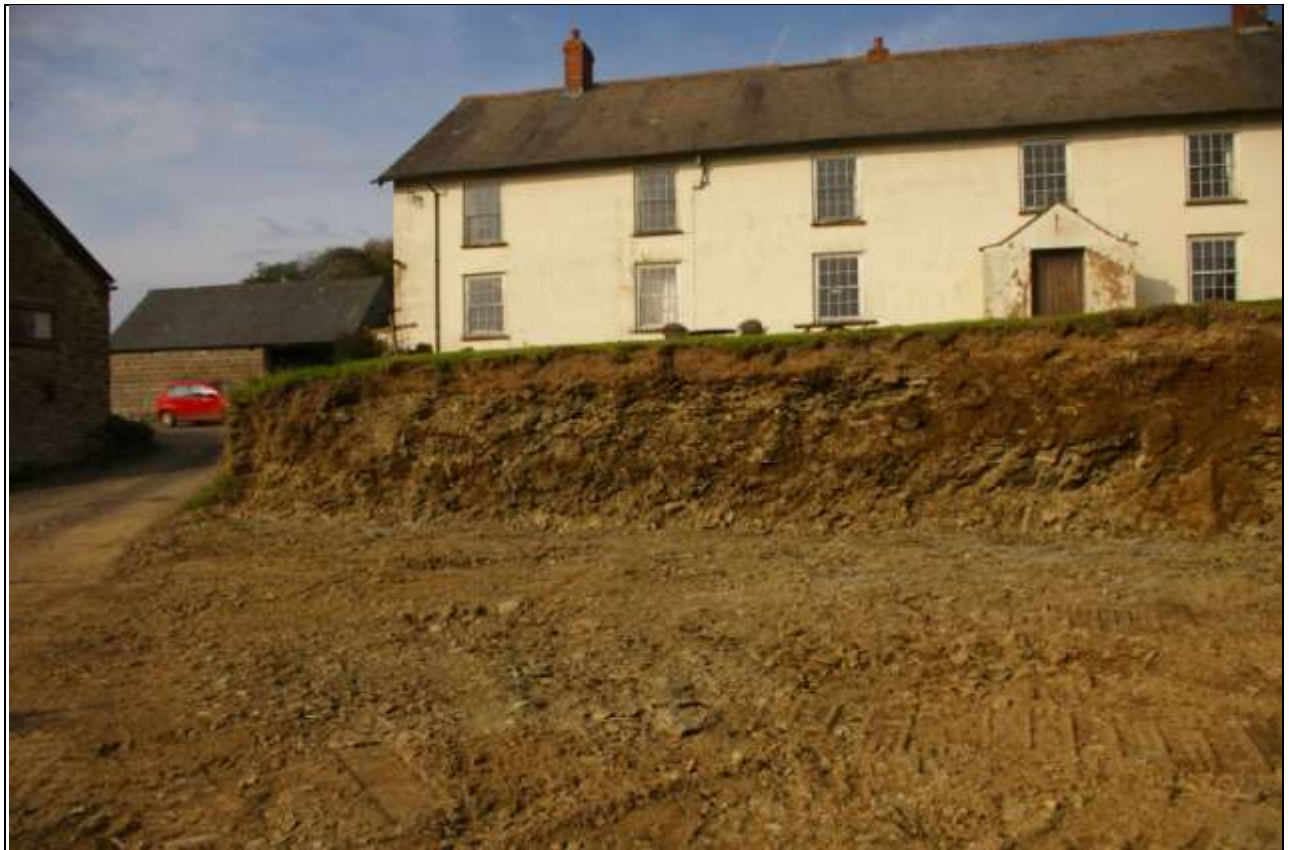
The view of the mostly made ground to the west of Area 2, using redeposited rotted shillet which can be seen mixed with topsoil overlying the natural rotted shillet; from the south-south-east.

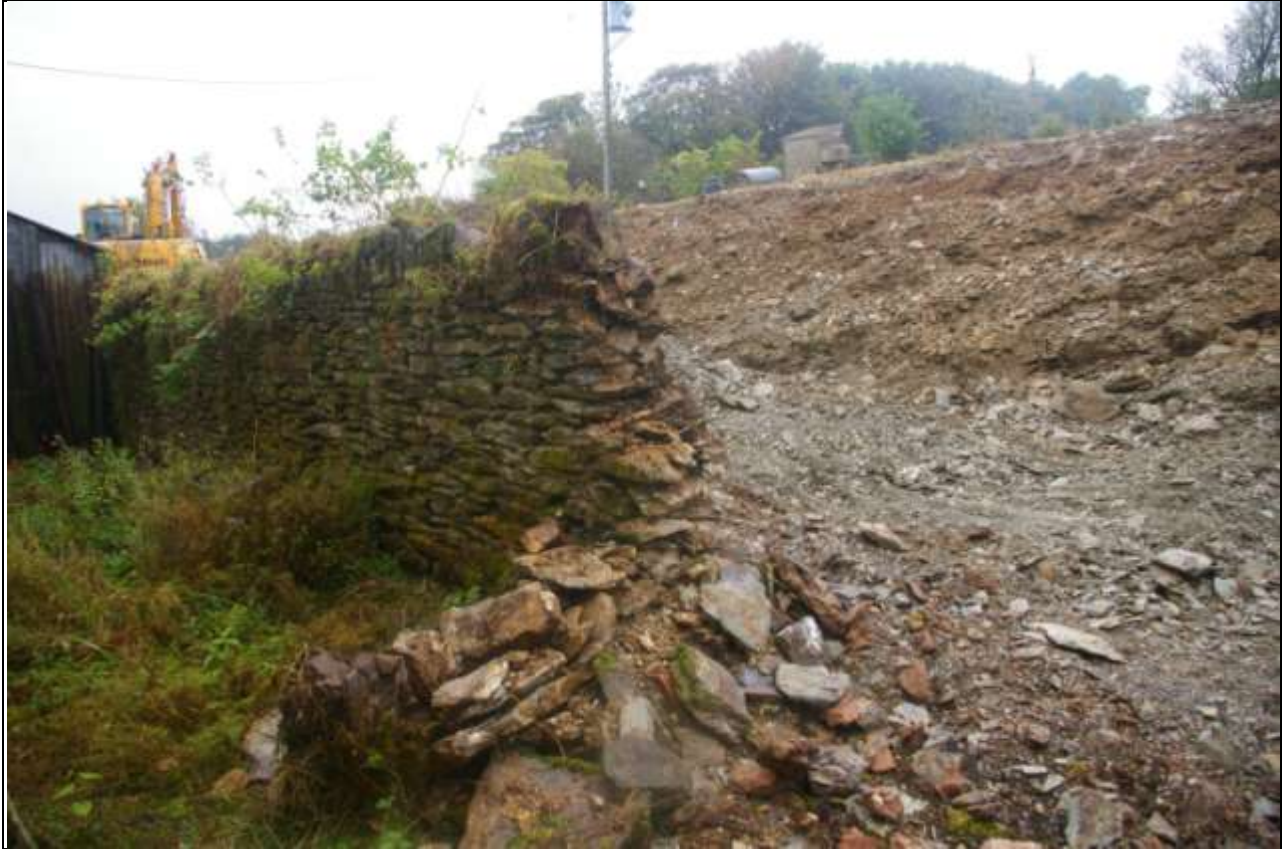
View of Area 1, the rear revetment wall and area excavated behind; from the south-east.
