BINHAMY MOATED SITE

Conservation Management Plan

By F. Balmond and S. Walls
Report Version FINAL
9th March 2017

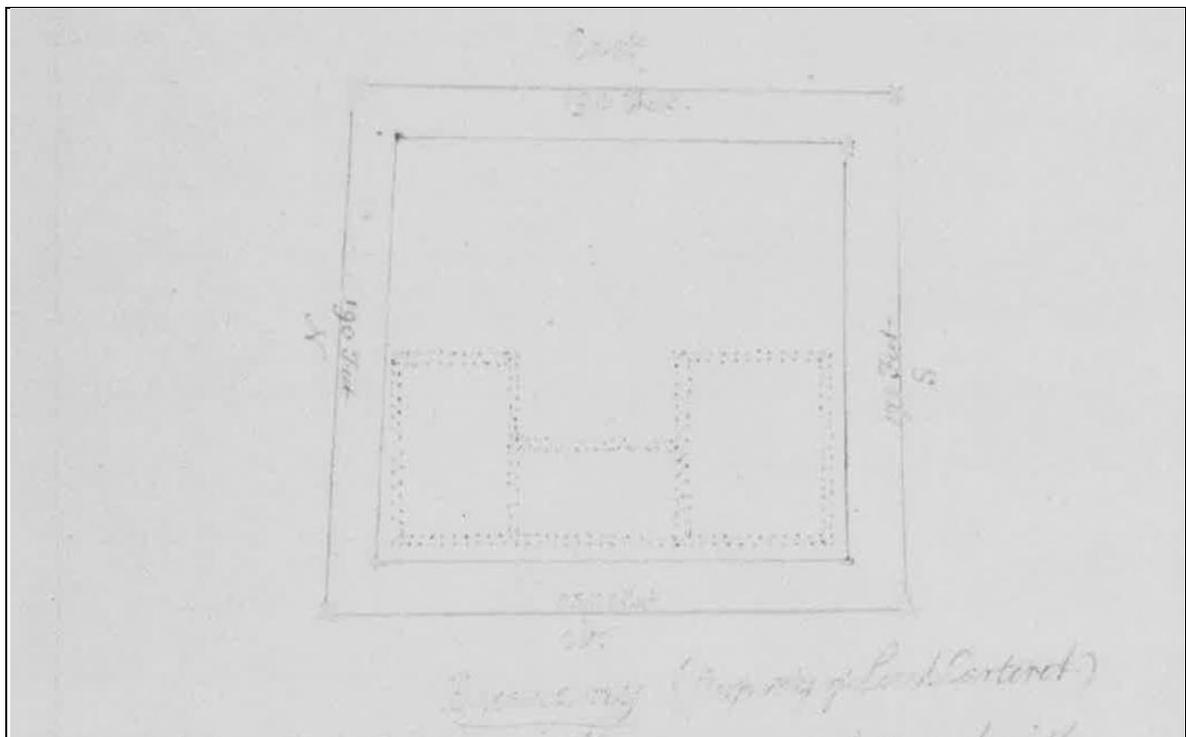
FIGURE 2: 1813 PLAN OF RUINS OF BINHAMY CASTLE. BRITISH LIBRARY SHELFMARK: CARTOGRAPHIC ITEMS ADDITIONAL MS. 9462.FOL.13. (AFTER WRIGHT 2015). NOTE THAT NORTH IS TO THE LEFT OF THE PICTURE.

Binhamy moated site is sited between the river Neet and the coast, on a low ridge. It consists of a sub-rectangular platform c.0.3ha in extent defined by a mostly dry moat c.10m wide and c.2.2m deep (see Appendix 1 for the full scheduling text). The moat has a partial inner bank, and there are outer banks formed of up-cast material on three sides. The interior contains mounds, hollows and some fragmentary walling. The site is thought to be the site of 'Bynnamy' or 'Binamy Castle', built in the early 14th century by Ralph de Blanchminster, Lord of the Manor of Stratton, with a license to crenellate acquired in January 1335. It appears to have changed ownership a number of times, being referred to as the Seat of Sir J Colshill by William Worcester and the 'Ruyned aunient seate of the Grenviles' by Norden c.1600 (Figure 3) (Cornwall HER, Appendix 1). In the post-medieval period the site was used as an orchard, and listed as *Blawmangers Orchard* in the 1840 tithe apportionment; the field to the north was listed as *Blawmangers Plot*. A plan of the ruined buildings drawn by Wrey J'ans and dated 1813 exists in the British Library (Figure 2).

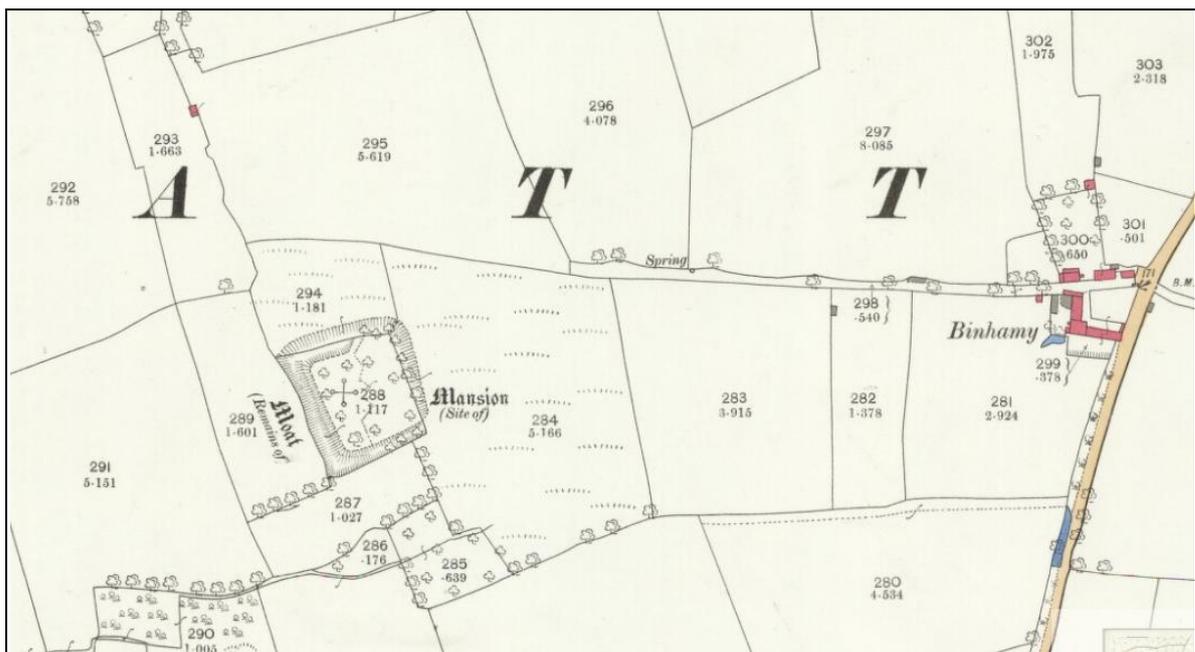
The site is depicted as tree covered on the Ordnance Survey map 1st Edition (Figure 4). By the 1933 revision of the Ordnance Survey map, a number of long buildings have appeared on and around the monument (Figure 5). It is possible the remaining agricultural building to the north of the site is the sole remnant of these structures.

FIGURE 4: EXCEPT FROM 1ST EDITION ORDNANCE SURVEY MAP (SURVEYED 1883). BINHAMY MOATED SITE IS VISIBLE ON THE LEFT OF THE IMAGE.

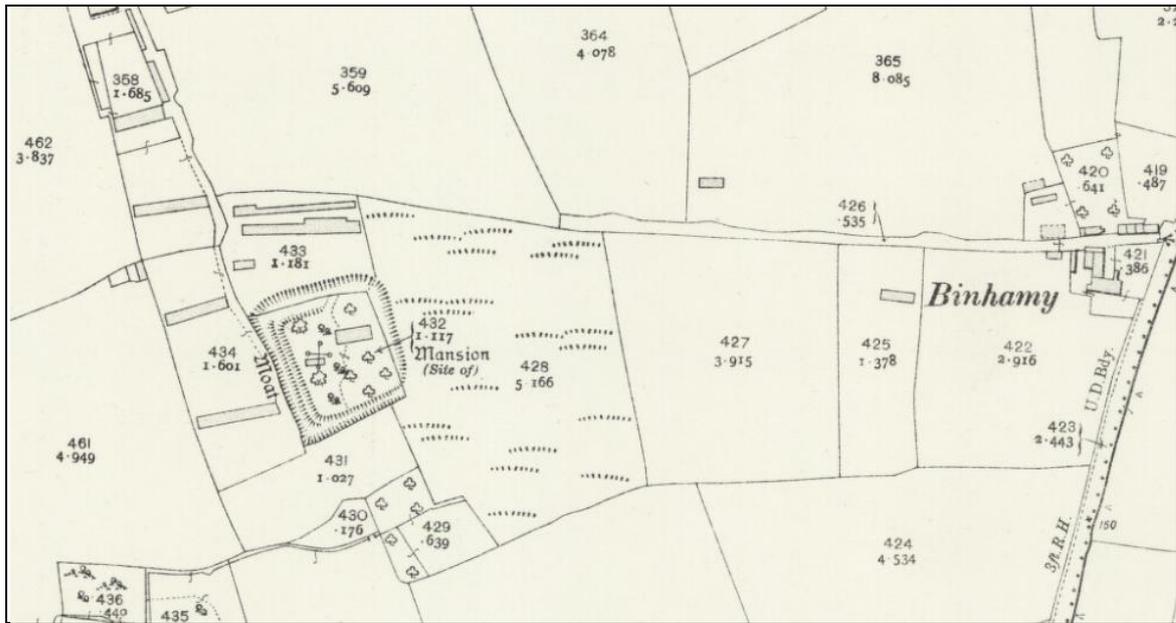
FIGURE 5: EXCEPT FROM 1933 ORDNANCE SURVEY 25INCH MAP. BINHAMY MOATED SITE IS SHOWN ON THE LEFT OF THE IMAGE WITH TWO BUILDINGS DEPICTED INSIDE THE AREA OF THE MOAT.

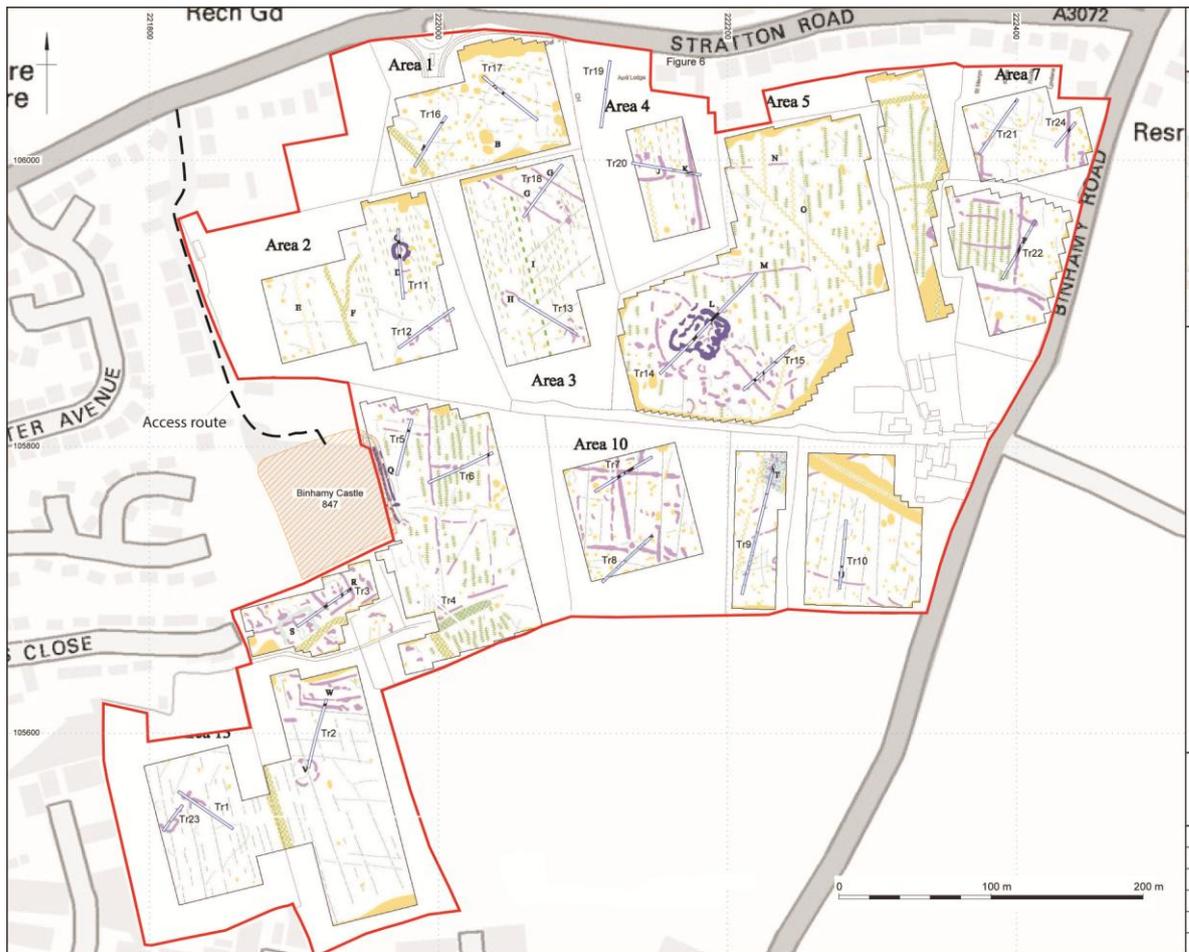
Evaluation trenching has been undertaken by Wessex Archaeology (2013) across the area to the east of the moated site, targeting the geophysical anomalies identified in the GSB survey (see Figure 6). This evaluation confirmed the presence of a potential ring ditch, but found that the majority of archaeological features revealed appear to correspond to post-medieval field boundaries and concluded that the archaeological potential of the area to the east of the site was *low*, and no further work appears to have taken place. A small rectangular enclosure to the south of the moated site, although undated, produced a small quantity of pegged slate, suggestive of activity contemporary with the medieval manor.

FIGURE 6: PLAN SHOWING THE EVALUATION TRENCHES AND GEOPHYSICS RESULTS FOR THE ADJOINING DEVELOPMENT AREAS (AFTER: WESSEX ARCHAEOLOGY 2013: 40). BINHAMY CASTLE IS INDICATED, AS IS THE PROPOSED ACCESS.

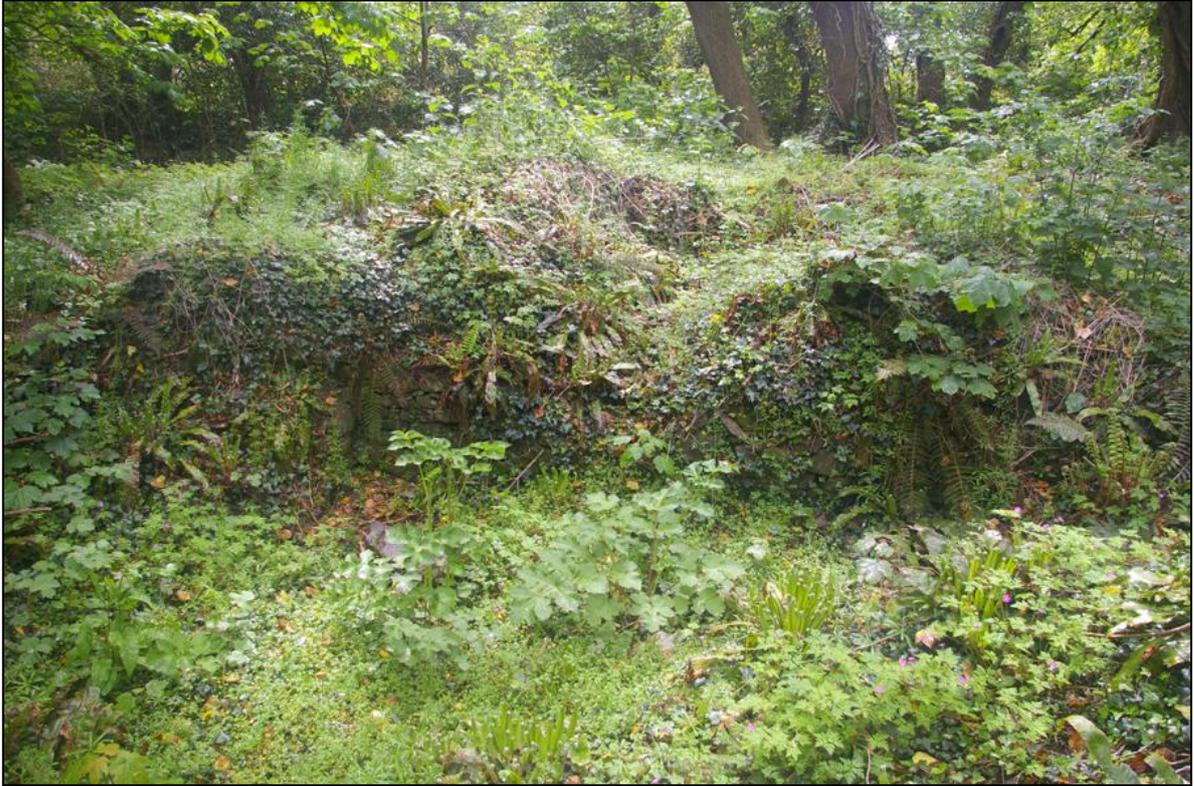
Binhamy Moated Site has been assessed by Historic England as ‘generally unsatisfactory [condition] with major localised problems’ as a result of permitted development and has been placed on the Heritage at Risk register. The site is covered in hazel and hawthorn scrub, with brambles, nettles, ivy and wild garlic. There are numerous mature trees growing within the enclosure and along the outer ditches and banks, the most dominant species being sycamore. A number of walls survive to a low height (e.g. Figure 7). These are thought to relate to the medieval manor house which once stood on this site. The natural woodland growth has created both a mature canopy and a dense undergrowth, with some more open areas noted primarily where the remains of buildings are best preserved, possibly due to below-ground structures restricting the growth of vegetation, and also in part through the informal management.

FIGURE 7: REMAINS OF STONE WALLING TO THE SOUTH-WEST OF THE SITE, A SMALL SQUARE STRUCTURE, POSSIBLY A TOWER, GARDEROBE OR STAIR TURRET, WHICH STANDS SLIGHTLY HIGHER THAN THE ADJOINING WALL OF A BUILDING; VIEWED FROM THE EAST.

AIM: Based on an archaeological assessment of the standing structure a plan for any additional conservation work should be formulated. This will need approval and consent from Historic England. A timetable for any works should be created and appropriately skilled personnel employed. Consolidation of any loose stonework is recommended before permitting public access to the site.
