South West Archaeology Ltd. Report no 180502

Land at Kitwell Street, Uffculme, Mid Devon, Devon Results of Archaeological Monitoring and Recording

By B. Morris & P. Webb Report Version: FINAL 2nd May 2018

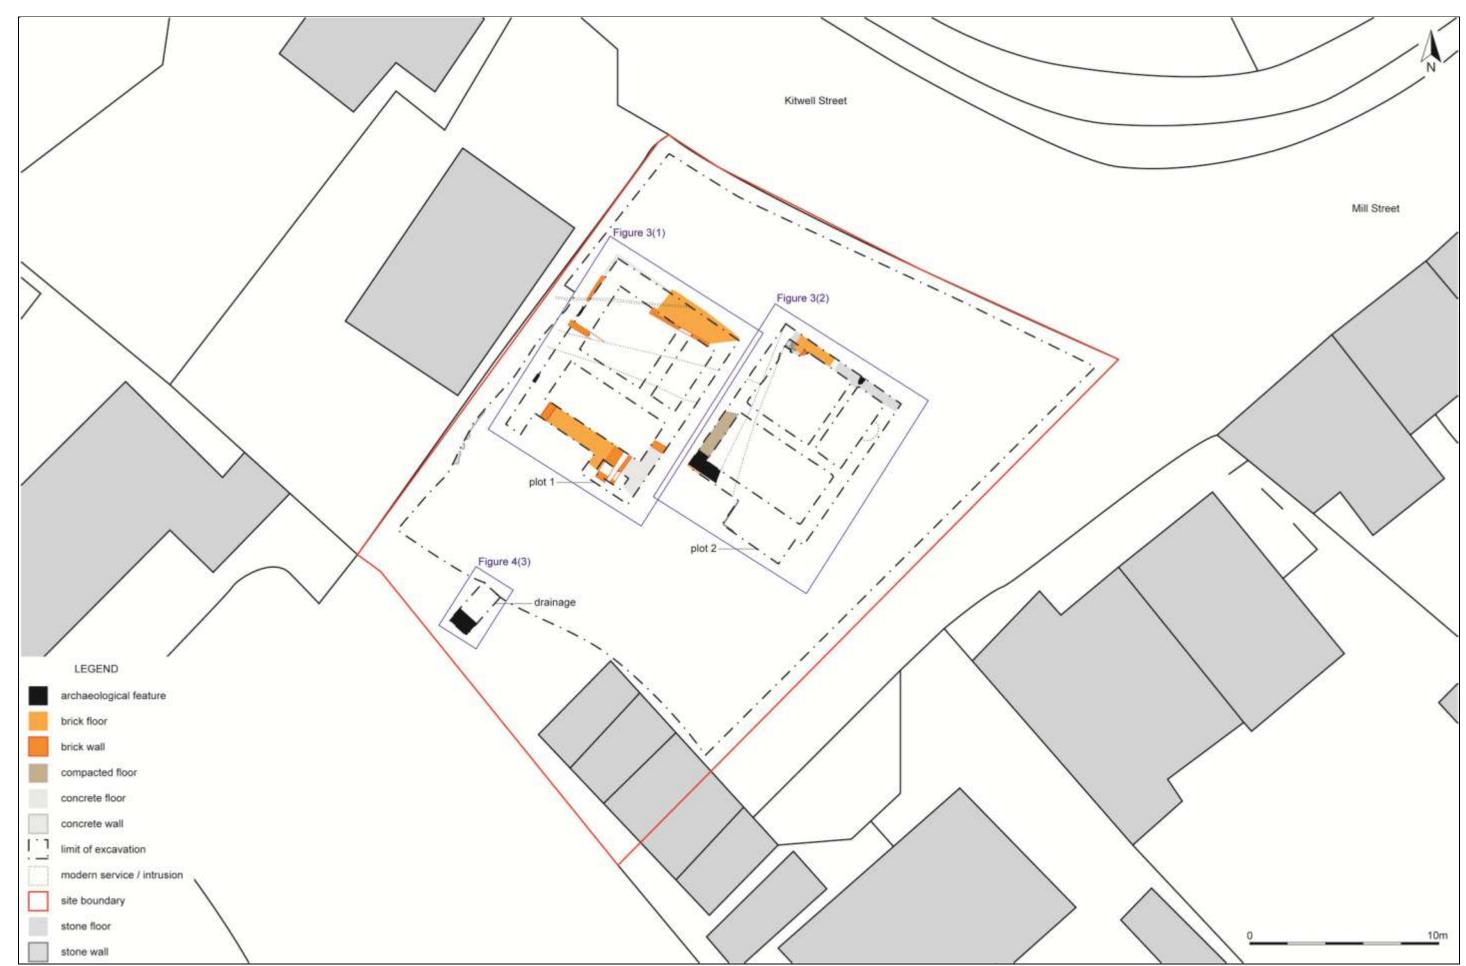
FIGURE 2: SITE PLAN SHOWING LIMIT OF EXCAVATION AND FEATURES.

A single ditch, [106] was identified at the southern end of the site within the drainage (soak-away) trench and likely forms part of a former boundary across the site (Figures 2, 4). It was orientated approximately north-west to south-east and measured 0.80+m wide and 0.45m deep with gentle sloping north-east side and slightly concave base. It contained a single fill: (107), a grey-yellow-brown clay-silt. No finds were recovered from this feature.

Four drains, [111], [119], [144], and [151] were located running at various angles across the site (Figures 2-4). Most of these were modern, reflecting the most recent phases of development of the site. The earliest, drain [119] was located towards the northern end of plot 1. It was orientated north-west to south east and measured 0.50m wide and 0.50m deep with vertical sides and flat base. It comprised a central ceramic drain surrounded by red brick construction {139} with an overlying backfill (120), grey-brown silt. This feature had been cut by drain [111]. No finds were recovered from this feature.

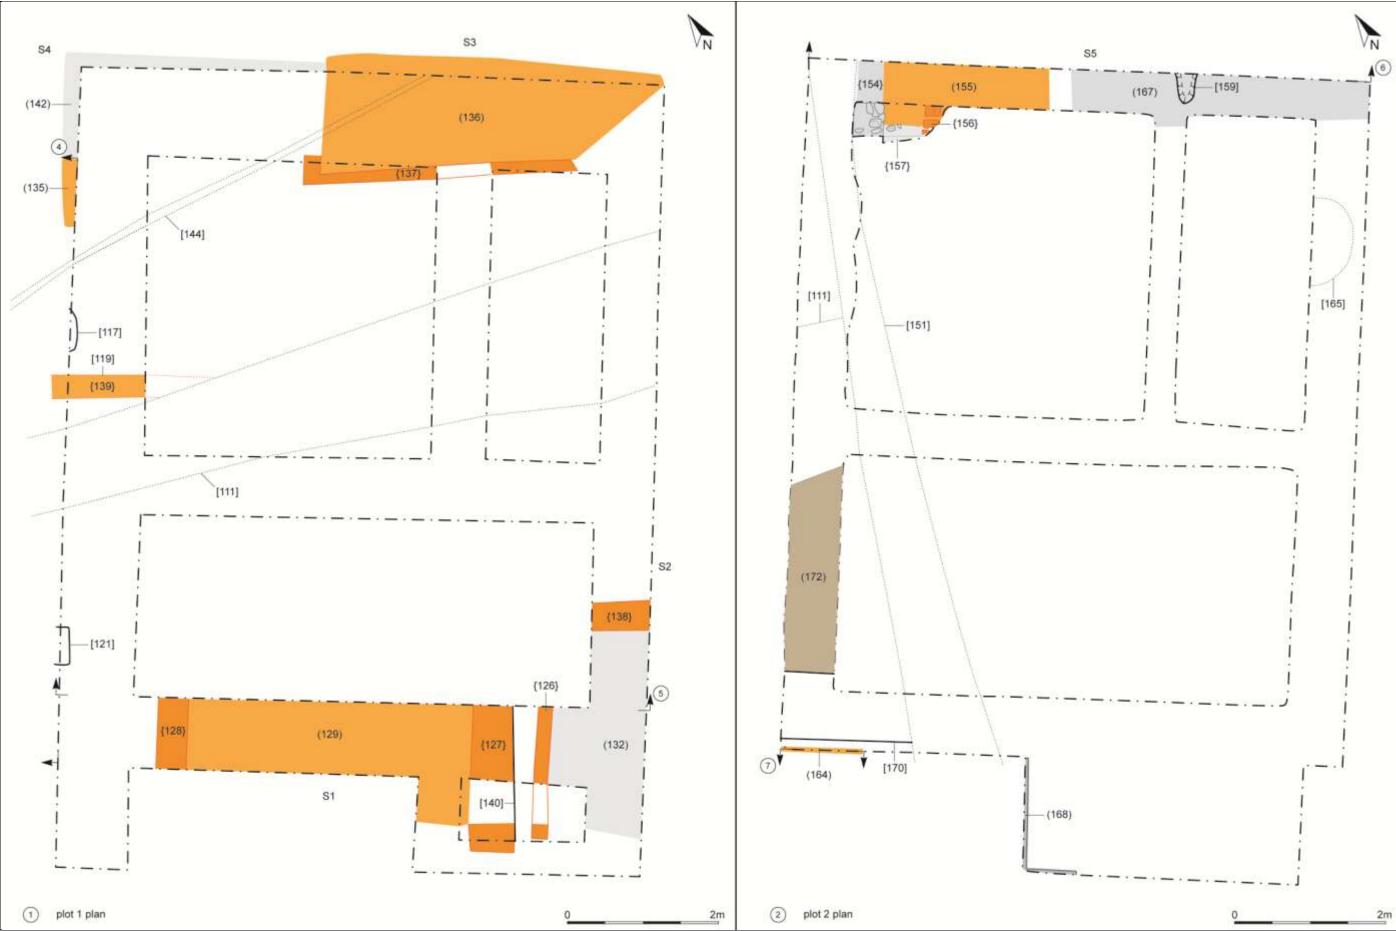
FIGURE 3: BUILDING PLOT PLANS SHOWING ARCHAEOLOGICAL FEATURES.

Ten floor surfaces, (129), (132), (135), (136), (142), (155), (164), (167), (168), and (172) were identified during the excavation (Figures 2-4). These surfaces formed a combination of internal floors and external yards to a series of structures (S1-S5) reflecting the later historic development of the site and often appeared to be associated with walls (see below). They were constructed of a mix of brick, concrete, and stone; the concrete surfaces commonly replacing earlier brick surfaces.

Eight walls, {126}, {127}, {128}, {137}, {138}, {154}, {156}, and {157} were identified during the excavation (Figures 2-4), many of which were associated with floor surfaces (see above). Wall {126} formed a possible boundary wall separating structure S1 from an external yard area (132). Walls {127} and {128} represented the remains of a demolished structure (S1) on the site and define a rectangular room, $c.2+m\times4.20m$ wide, towards the south-west corner of the site, surface (129) forming the floor. Wall {137} formed the south-west corner of a rectangular structure (S3), $c.3.50+m\times1.50+m$ wide, and bounded floor (136) towards the north-east corner of plot 1. Wall {138} represented a wall running approximately north-west to south-east and is likely to have formed the southern wall of a structure (S2) adjacent to S1. Wall {154} formed the western wall of a rectangular structure (S5), $c.6.50+m\times1+m$ along the northern edge of plot 2 and appeared to be associated with floor (155).

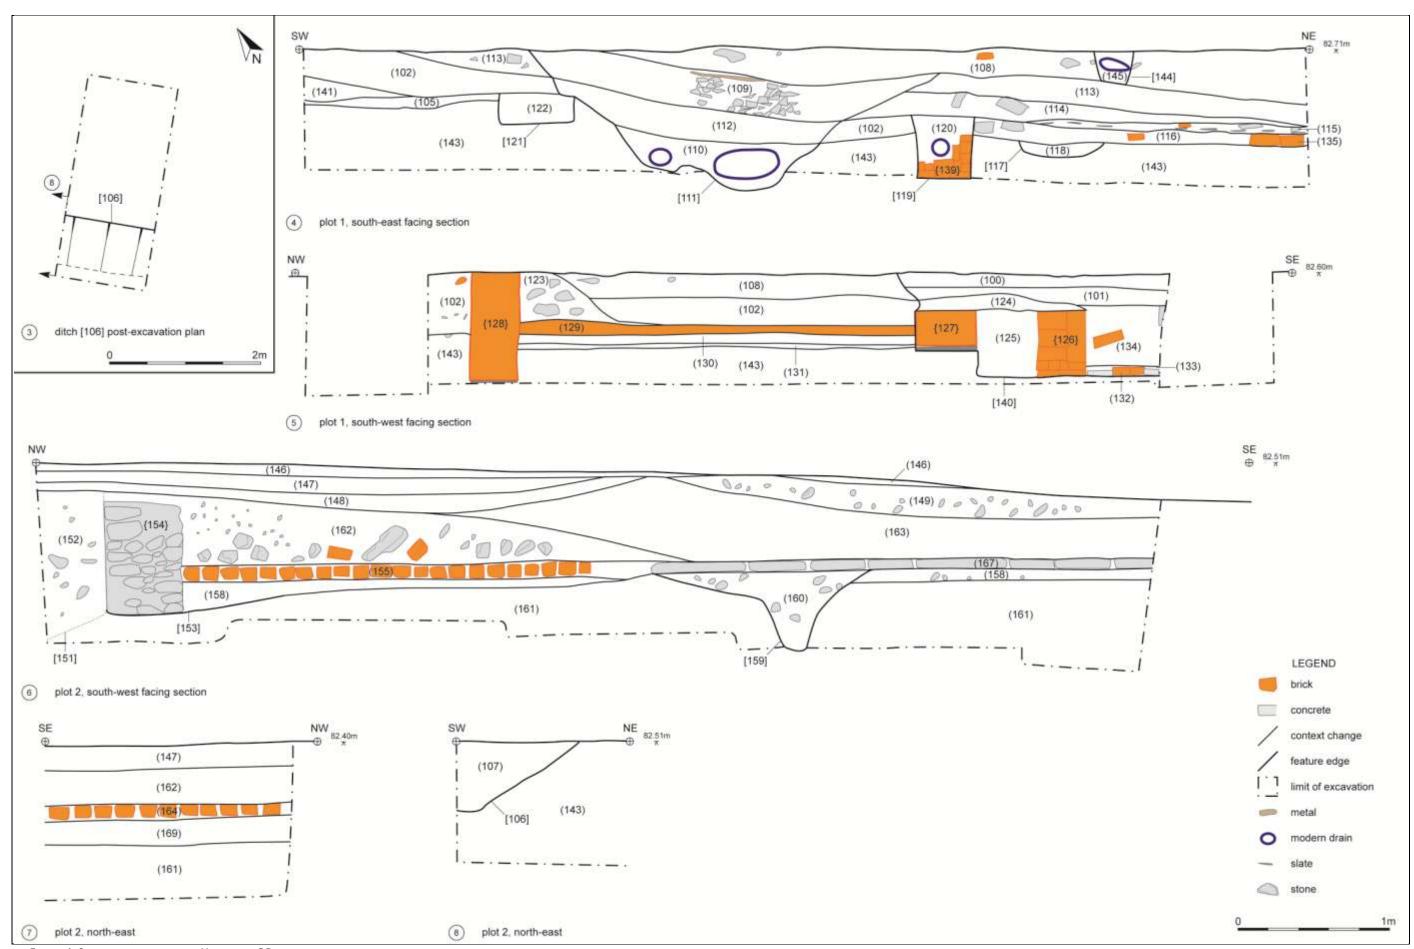
FIGURE 4: SITE PLANS AND SECTIONS. HEIGHTS AT OD.

Two pits, [159] and [165] were located towards the north-eastern corner of plot 2 (Figures 2-4). They reflect mixed functions from different phases of the site, [159] associated with structural development; and [165] with later use of the site. The exposed portion of [159] appeared sub-oval in plan, measuring 0.40+m × up to 1.50m wide and 0.50m deep on a north-east to south-west orientation. It had a shallow to moderate upper profile, dropping steeply to a narrow base; and contained a single fill: (160), green-grey sand-silt. Finds recovered from this feature included a single sherd of post-medieval North Devon gravel free pottery.

One wall robber trench [170]; and two possible wall robber trenches [117], and [121] were identified across the site (Figures 2-4) and represent the demolition and removal of various phases of structure from the site: [170] the removal of what was probably a boundary wall; [117] the demolition southwestern wall of structure S4; and [121] the demolition of the north-eastern wall of structure S1.

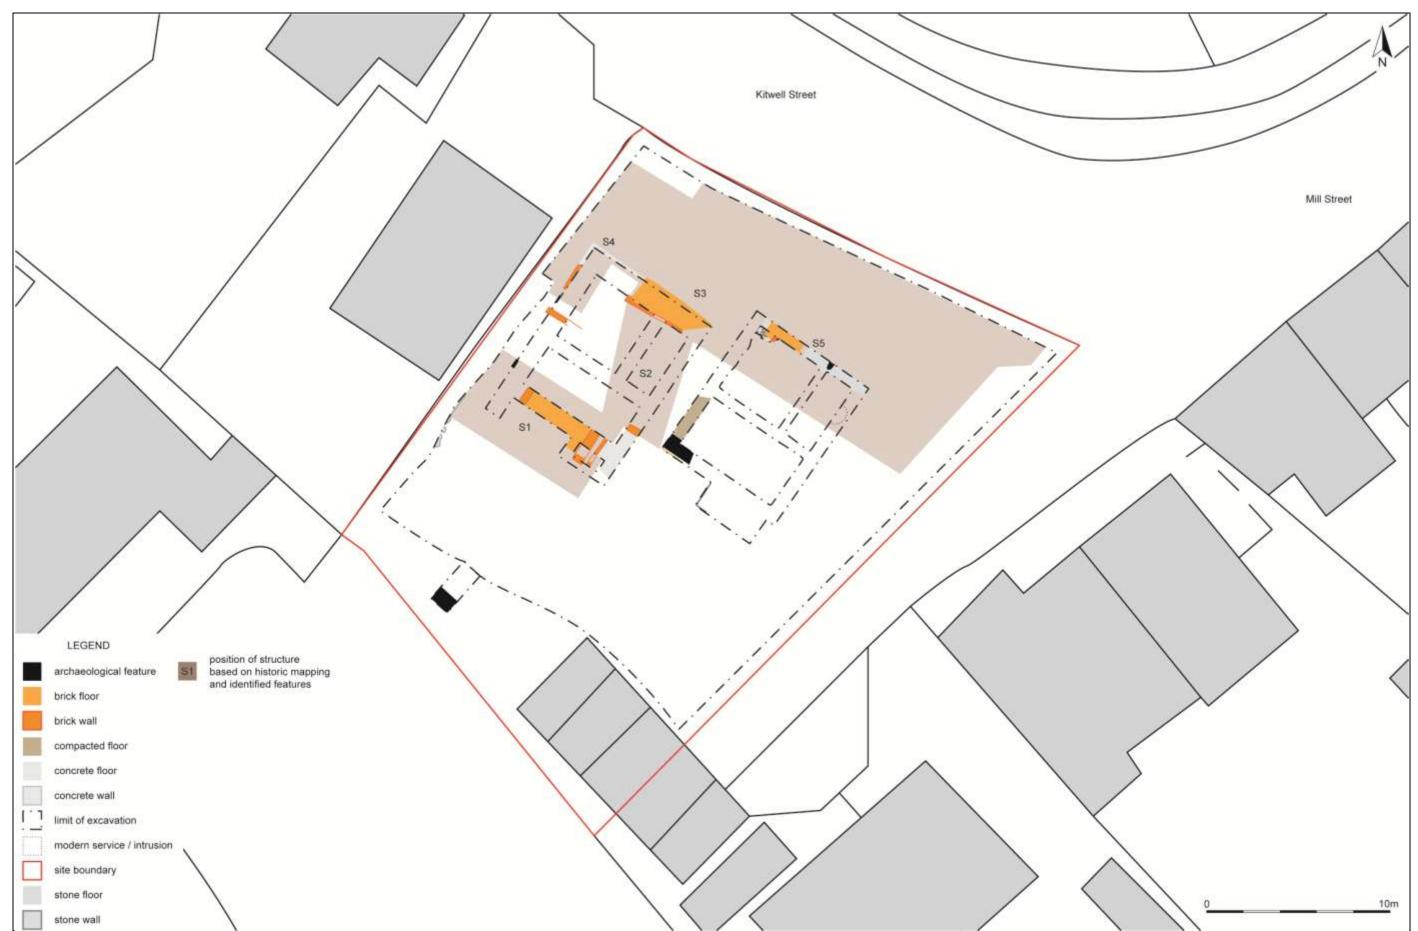
FIGURE 5: SITE PLANS SHOWING IDENTIFIED FEATURES IN RELATION TO STRUCTURES IDENTIFIED ON HISTORIC MAPPING.

The archaeological monitoring and recording revealed five broad phases of activity on the site, some of which may have overlapped and which are reflected in the historic mapping (Figure 5):

- Phase 1: Medieval to post-medieval removed boundary
- Phase 2: Post-medieval-mid 19th century structural remains
- Phase 3: 19th century re-development with structural remains
- Phase 4: early 20th century re-development with structural remains
- Phase 5: late 20th century demolition and re-development

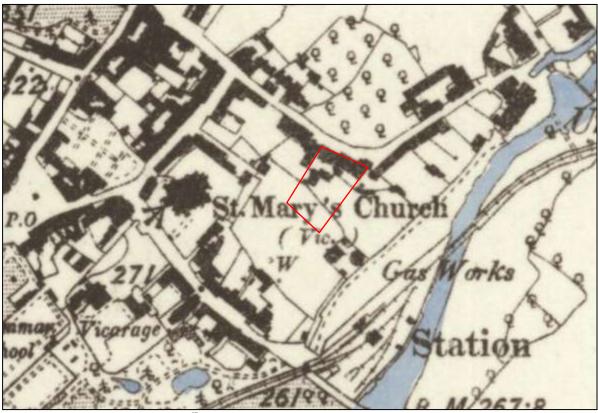
EXTRACT FROM THE ORDNANCE SURVEY 1ST EDITION MAP OF 1888. THE APPROXIMATE SITE IS INDICATED (NLS).

The late 19th century mapping of the site indicates that there had been significant re-development, the buildings recorded on the tithe map appearing to have either been removed or extended. Structure S1, formed of walls {127} and {128}, and floor (129), all of brick construction appears as a replacement structure within the plot following the (partial?) demolition of the tithe building within plot no.2608, and forms part of a room within the building. The position of possible wall robber cut [121] would suggest that it is likely to have formed the northern wall of this structure. Structure S2, formed by brick wall {138}, was also constructed at this time; whilst structure S3 appears as an extension to the building S5, for which floor surface (155) appears to represent part of the redevelopment of the structure. At the same time brick floor surface (135) formed part of the redevelopment of structure S4.

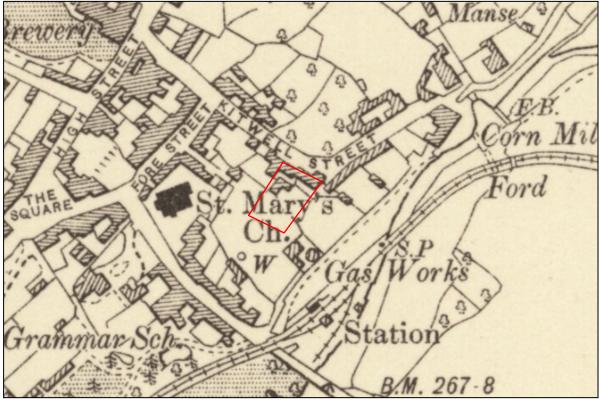
Extract from the Ordnance Survey $\mathbf{1}^{\text{st}}$ Edition map of 1906. The approximate site is indicated (NLS).

The early 20th century saw further development of the structures on the site, most notably with the demolition of structure S2; brick floor surface (135) being replaced by concrete surface (142) within structure S4. Part of the brick floor within S5 also appears to have been replaced, stone slab surface (167) being laid over the same bedding layer. Associated with this was pit [159] which cut through the bedding layer but was sealed by the slab floor, perhaps indicating the removal of a structural feature.

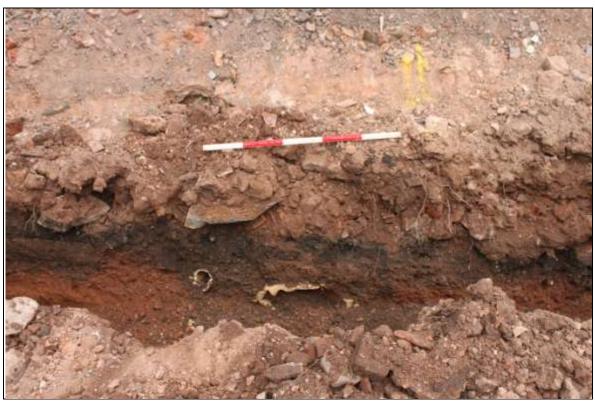
Drain [111] was located across the centre of plot 1 site running approximately north-west to south-east. It measured 3.40m wide and 1.20m deep with moderate to steep sloping sides and undulating base. It contained three fills: (109), (110), and (112), yellow-brown and grey-brown clay-silts with rubble inclusions, along with two ceramic drains. No finds were recovered from this feature.

House plot 1, north-west foundation trench, south-east facing section of service trench [111]; viewed from the south-east (1m scale).

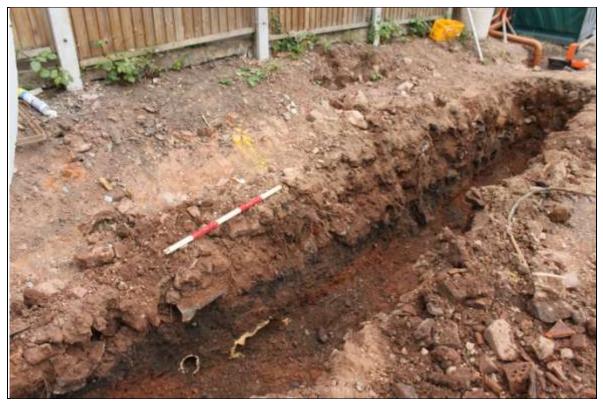
House plot 1, south-east facing section of north-west foundation trench, oblique, showing service trench [111]; viewed from the south (1 m scale).

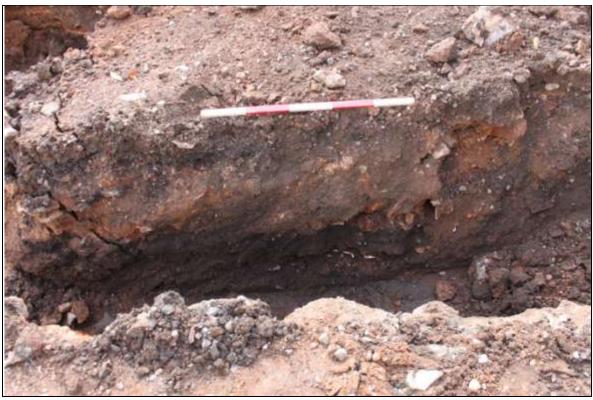
House plot 1, mid foundation trench, north-east facing section of service trench [111]; viewed from the north-west (1m scale).

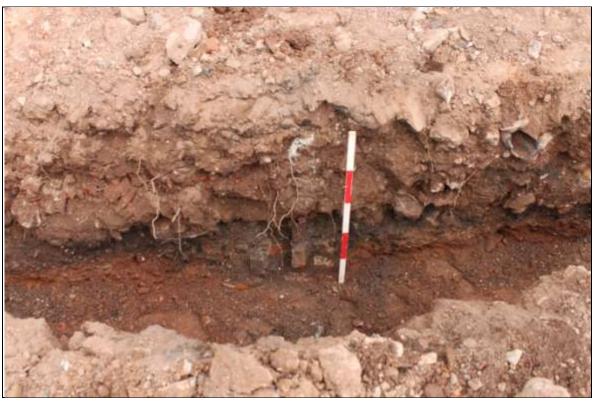
HOUSE PLOT 1, SOUTH-EAST FACING SECTION OF DRAIN [119]; VIEWED FROM THE SOUTH-EAST (1M SCALE).

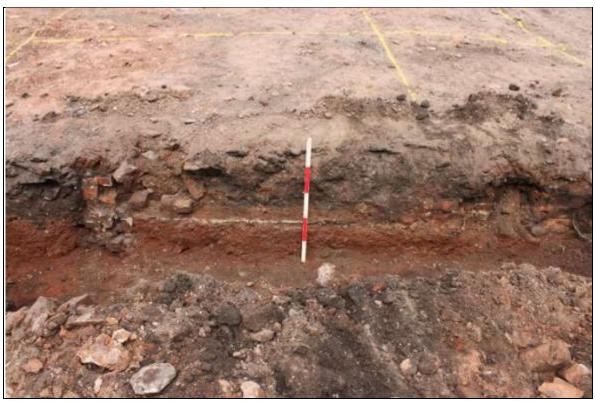
Floor (129) was located at the south-western end of plot 1 and was exposed for a length of 1.60m, measuring 3.25m wide. It was constructed of red and pinkish bricks 0.10m thick with traces of white lime mortar; and had been set on bedding layer (130), pinkish brown sand-silt and (131), compacted white lime mortar. This formed the internal floor surface of structure S1.

House plot 1, south-west facing section of walls $\{126\}$, $\{127\}$, and $\{128\}$, and floor (129); viewed from the south-west (1 M scale).

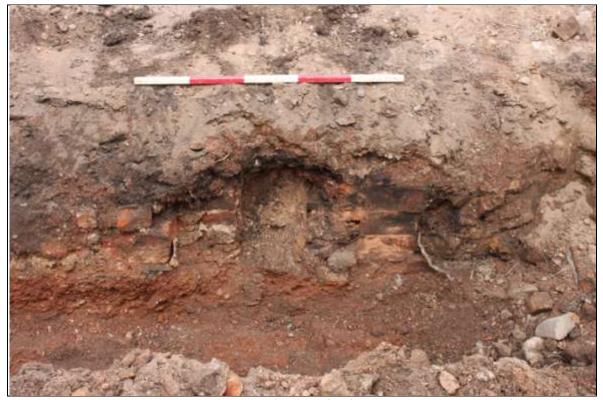
Wall $\{126\}$ was a linear structure located towards the south-east corner of plot 1 on a north-east to south-west alignment. It was exposed for a length of 1.80m, measuring 0.40m wide and surviving to a height of 0.55m. The wall was constructed of red brick, and was abutted by floor surface (132). These were both set within possible terrace cut [140] measuring 1.80+m × 1+m and 0.20m deep with vertical sides and flat base.

To the west, wall {127} was exposed on the same north-east to south-west alignment for a length of 1.80m, and measured 0.50m wide, surviving to a height of 0.34m. It was constructed of red brick with off-white lime mortar and was set on a bedding of slates. This wall was abutted by floor surface (129) and formed south-eastern wall of structure S1. To the west, wall {128} was exposed for a length of 0.90m, and measured 0.40m surviving to a height of 0.90m. It was constructed of red brick with white lime mortar over a bedding of slate; and formed the north-western wall of structure S1.

House plot 1, south-west facing section of walls $\{126\}$ and $\{127\}$; viewed from the south-west (1m scale).

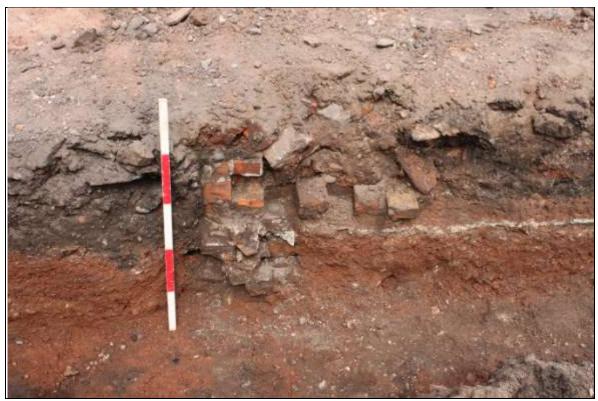
HOUSE PLOT 1, SOUTH-WEST FACING SECTION OF WALL {128} WITH DEMOLITION RUBBLE TO THE EAST; VIEWED FROM THE SOUTH-WEST (1M SCALE).

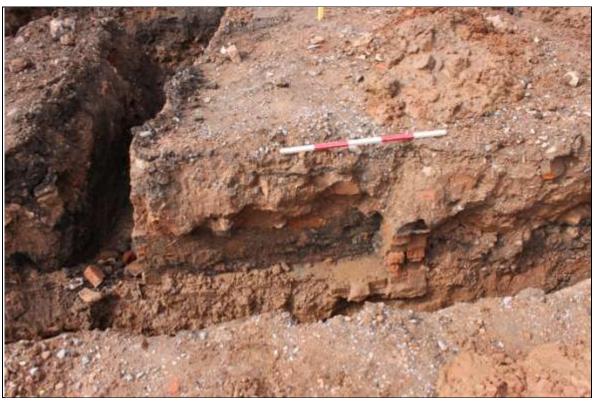
Wall $\{137\}$ was located towards the northern edge of plot 1. It was predominantly set on a northwest to south-east orientation, turning at its north-western end to run towards the north-east, and was exposed for a length of 3.70m, measuring 0.25m wide and surviving to a height of c.0.50m. The wall was constructed of red brick with an off-white lime mortar. This wall formed the south-western corner of structure S3.

HOUSE PLOT 1, NORTH-EAST FACING SECTION OF WALL {137} WITH FLOOR (138); VIEWED FROM THE NORTH-EAST (1M SCALE).

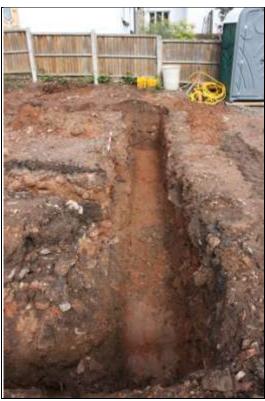
HOUSE PLOT 1, VIEW ALONG NORTH-EAST FOUNDATION TRENCH SHOWING WALL {137} WITH FLOOR (138); VIEWED FROM THE SOUTH-EAST (1M SCALE).

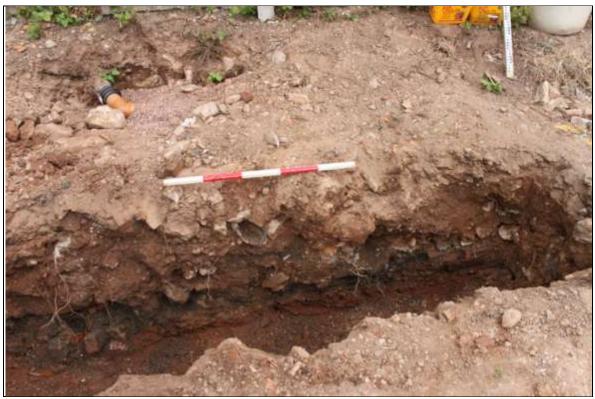
At the northern end of plot 1 drain [144] was orientated approximately east to west and measured 0.30m wide and 0.18m deep with steep to near vertical sides and flat base. It contained a single fill: (145), yellow-brown clay-silt and rubble. No finds were recovered from this feature.

HOUSE PLOT 1, SOUTH-EAST FACING SECTION OF SERVICE TRENCH [144]; VIEWED FROM THE SOUTH-EAST (1M SCALE).

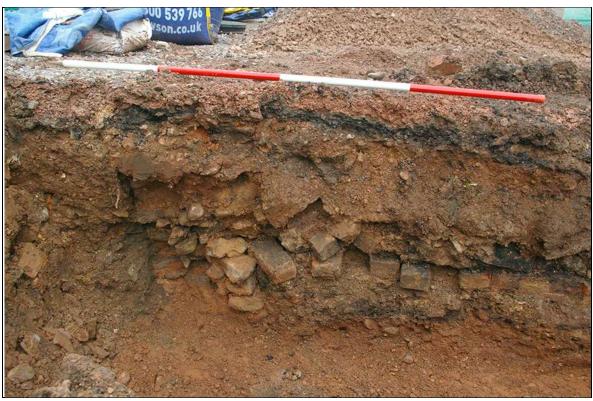
At the northern end of plot 2, floor surface (155) formed a probable rectangular area measuring 2.10m ×0.80+m on a north-west to south-east orientation. It was constructed of pale red handmade bricks 0.10m thick which had been blackened by either a burning episode or coal storage. This surface is likely to have formed an internal floor to structure S5. To the east, a further floor surface (167), irregular flagstones up to 0.50m in size and 0.08m thick may have replaced floor (155) or may reflect the division of the structure into rooms.

At the north-western corner of plot 2 wall {154} was exposed for a length of 1m, measuring 0.50m wide and surviving to a height of 0.75m. It was constructed of rounded and sub-rounded river cobbles with a pink-buff-brown lime mortar. This wall had been set within construction cut [153], measuring 0.90m wide and 0.10m deep with moderate to vertical sloping sides and flat base. Where the wall had not filled the cut, this had been filled with floor bedding layer (158). The feature formed the north-western wall of structure S5.

HOUSE PLOT 2, SOUTH-EAST FACING SECTION WALL {154} AND FLOOR SURFACE (155); VIEWED FROM THE SOUTH-WEST (2M SCALE).

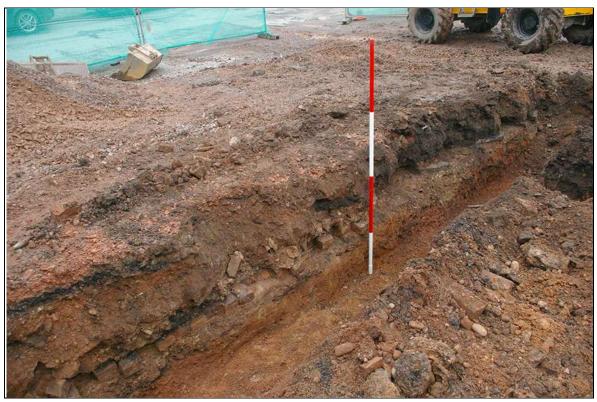
House plot 2, south-west facing section of north-west foundation trench, oblique, showing floor surfaces (155) and (167); viewed from the west (2m scale).

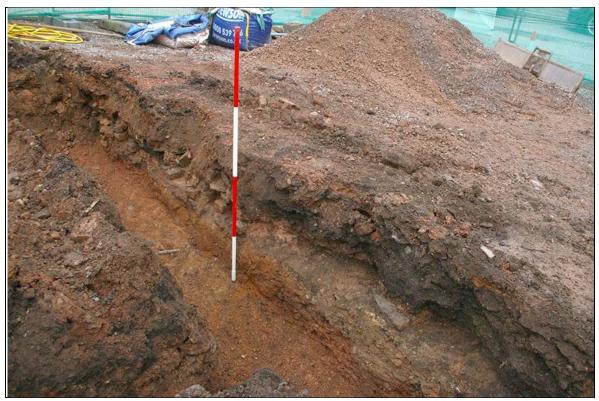
House plot 2, south-west facing section of north-west foundation trench, oblique, showing floor surfaces (155) and (167); viewed from the south (2m scale).

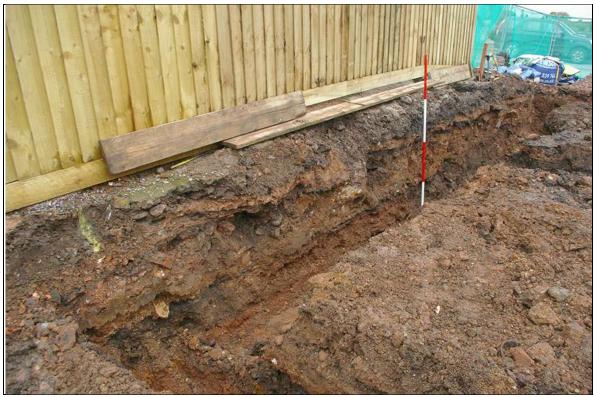
Robber trench [170] was located towards the southern end of plot 2 on a north-west to south-east orientation. It was identified for a length of *c*.2.50m and measured 0.80m wide and 0.30m deep with near vertical sides and flat base. It contained a single fill: (171), mixed brown-grey and yellow-brown silts. It is likely to represent the removal of a former boundary wall to the south-east of structure S2.

House plot 2, south-east facing section of north-west foundation trench, oblique, showing robber cut [170]; viewed from the south (2M scale).

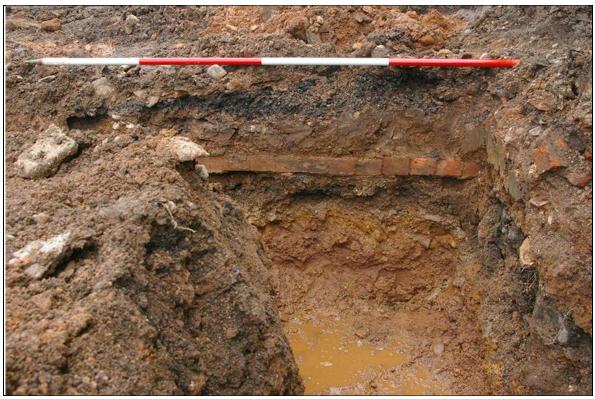
Floor (164) was identified within the section at the southern end of plot 2, extending to the south beyond the limits of excavation. It formed a probable rectangular area orientated north-west to south-east measuring 1+m and was constructed of red brick. This feature is likely to have been an external brick surfaced yard area.

HOUSE PLOT 2, NORTH-EAST FACING SECTION OF FLOOR SURFACE (164); VIEWED FROM THE NORTH-EAST (2M SCALE).

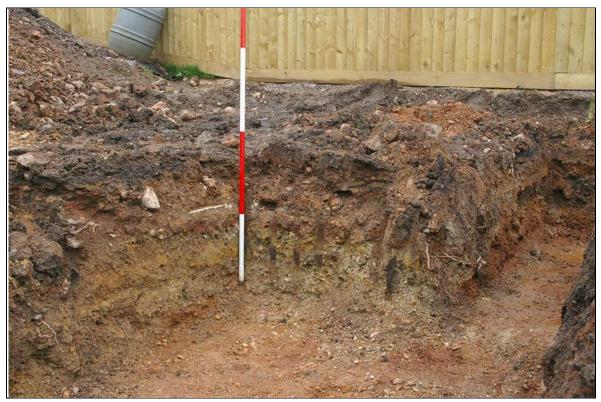
House plot 2, North-East and South-East facing sections showing floor surface (168), oblique; viewed from the East (Part 2m Scale).

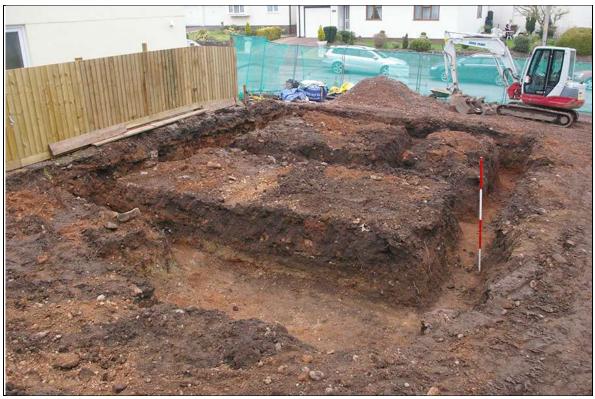
HOUSE PLOT 2, SITE SHOT SHOWING FOUNDATION TRENCHES AND SOIL LAYER (163); VIEWED FROM THE SOUTH (2M SCALE).
