# Cornwall & Scilly Historic Environment Record Site Recording form

<b>Site Name:</b> Land rear of Marlborough Lodge, Silverdale Road, Falmouth, Cornwall	<b>Planning Ref:</b> PA17/02543
<b>Grid ref (10-fig):</b> SW 79988 31888	<b>OS Map No:</b> OSGB36
<b>Parish:</b> Falmouth	<b>OASIS Ref:</b> Southwes1_288054
<b>Site Type:</b> Domestic garden	
<b>Period:</b> 19 <sup>th</sup> Century and Modern	<b>Form:</b> Archaeological monitoring and recording event

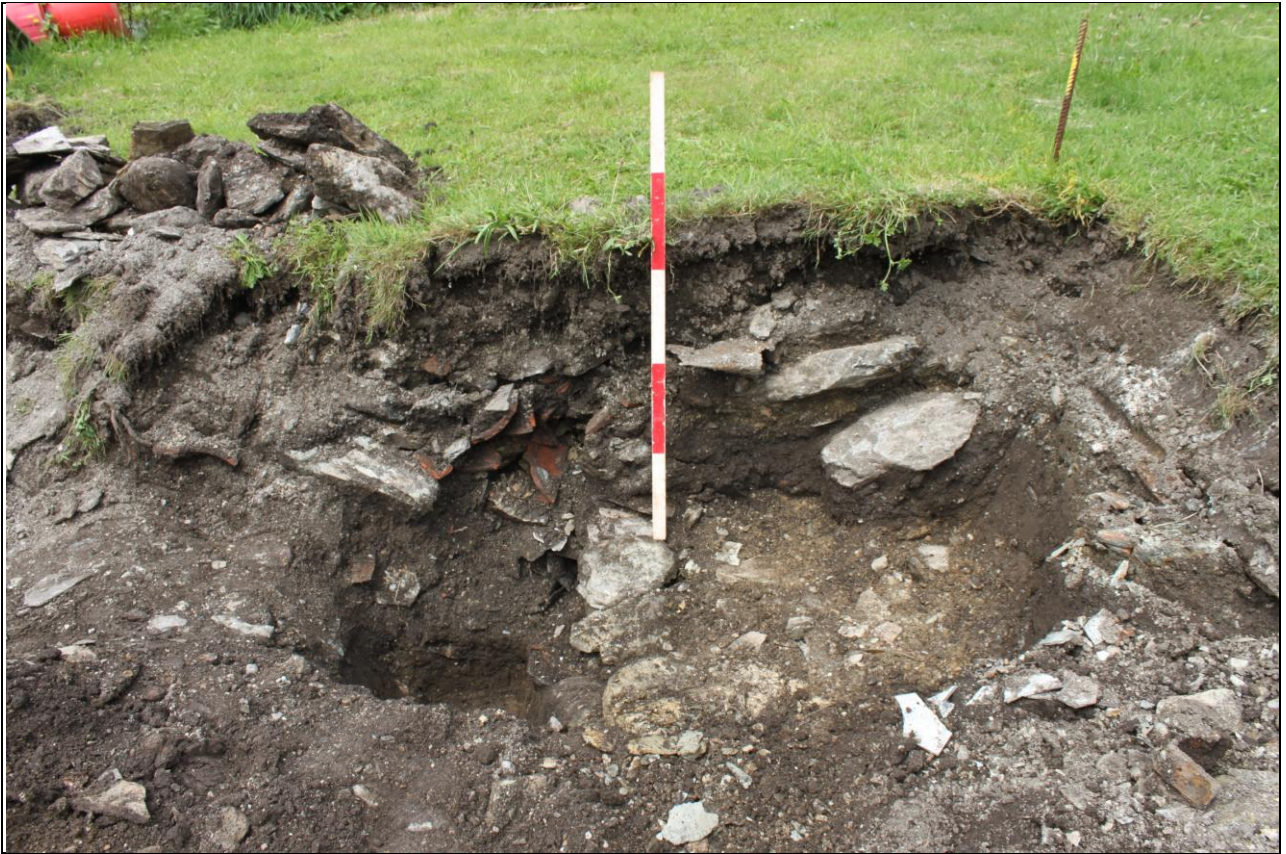
Figure 2: Area A section through footing {109}; viewed from the east (1m scale).

The excavations revealed the very truncated remains of parts of the former buildings which had stood on the site, these typically survived only as single courses of stone or brick, but in general had been almost completely truncated. To the north of Area A, the footings of a stone wall {109} bonded with a yellow clay-silt, proved to survive to a much greater height, up to c.0.45m high. It was cut into the natural and was 0.24m thick; orientated east-west, appearing to turn at its eastern end to the north and beyond the limit of excavation. Only the top of the wall was exposed for the most part, as it survived below the formation level. It appeared that this wall had perhaps been re-used as a retaining wall/garden wall when the plot was levelled, with the gardens to the north seemingly raised and the development area terraced almost flat, probably in the very early 20<sup>th</sup> century. To the north, and abutting the wall, was a deposit of dark brown silt (111) with common brick, pantile, stone rubble and rare iron slag. This was also only exposed in plan, and presumably represents a demolition deposit. The required formation level meant that for about half of Area A, the natural was not exposed, although the excavation of a sondage suggests that what would have presumably once been the yard area had been dug away by cut [107] and backfilled with demolition material consisting of a grey-yellow gritty silt (110) with abundant stone fragments, and occasional brick, pantile and corrugated iron fragments. Flanking the cut for the former yard two brick pads {105} and {107} were exposed, suggesting the former presence of a shippon along the yard's north-east side. The cut of a shallow drain [103] ran along the east (inside) of these pads, and extended to the north for a further 3.3m beyond {105} to the location of where a further pad was probably once located.

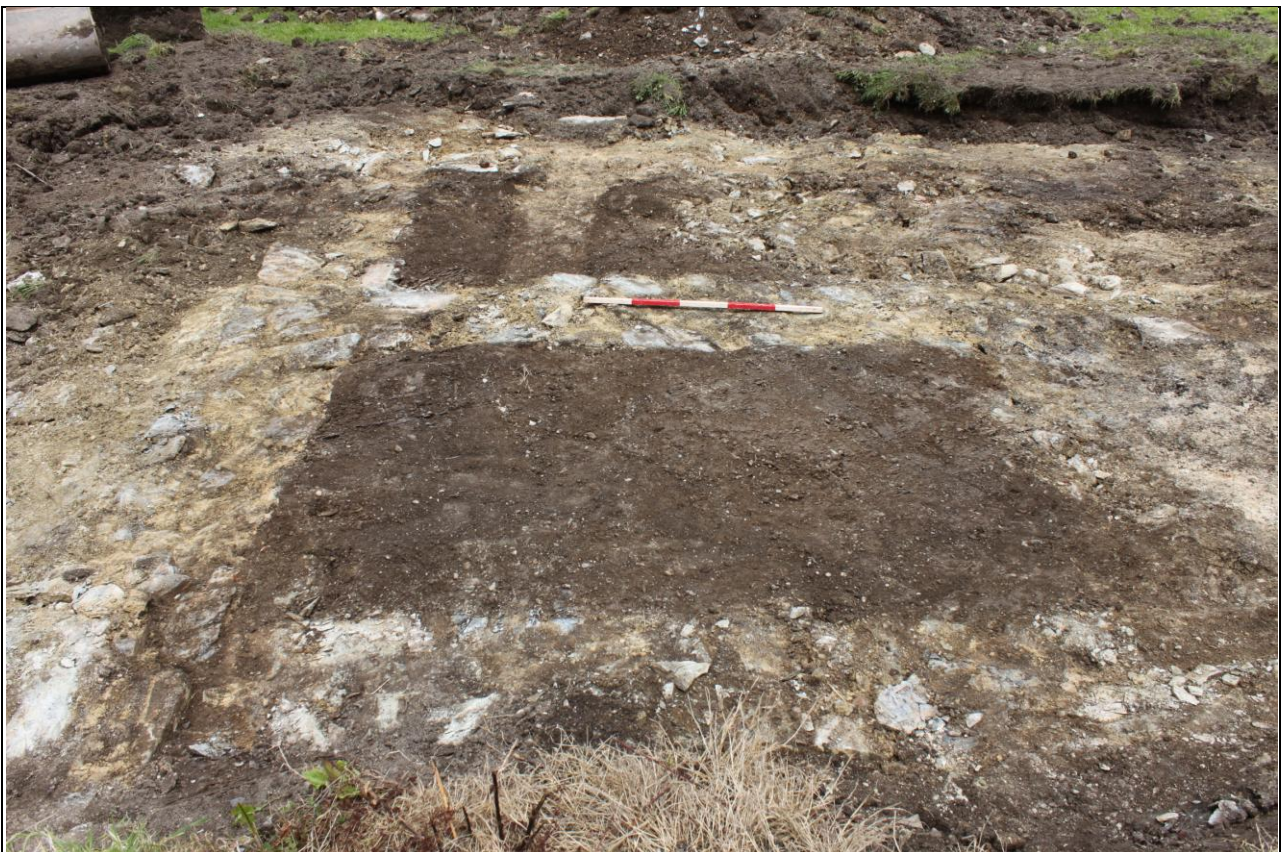
Figure 3: Area B, wall footings {113} and {114}; viewed from the south (1m scale).

Area B exposed the remains of a further building, although this had been even more severely truncated than seen in Area A. To the east of the area was a 0.9m wide stone wall footing {112}, orientated north-south and aligned with brick pads {106} and {105} in Area A. Footing {112} survived only as a slight grey-yellow linear discolouration in the natural with only three sub-angular stones surviving to indicate that it was likely a wall. To the west of footing {112}, but (no longer) adjoining/abutting was evidence of the partial footings for a two roomed stone building formed from {113} and {114}, the surviving single course of footings were 0.65m wide walls of sub-angular stone bonded with a yellow silt-clay. Wall {114} appears to abut wall {113} so may represent a second phase of build. The two rooms of the building were defined by shallow (0.04m deep) deposits of grey-brown gritty silt-clay (116) and (117). The building had been completely truncated to the east.
