MOORLAND VIEW EAST STREET NORTH MOLTON DEVON

Results of Archaeological Monitoring and Recording

South West Archaeology Ltd. Report no 171201

By J. Bampton
Report Version: FINAL
1st December 2017

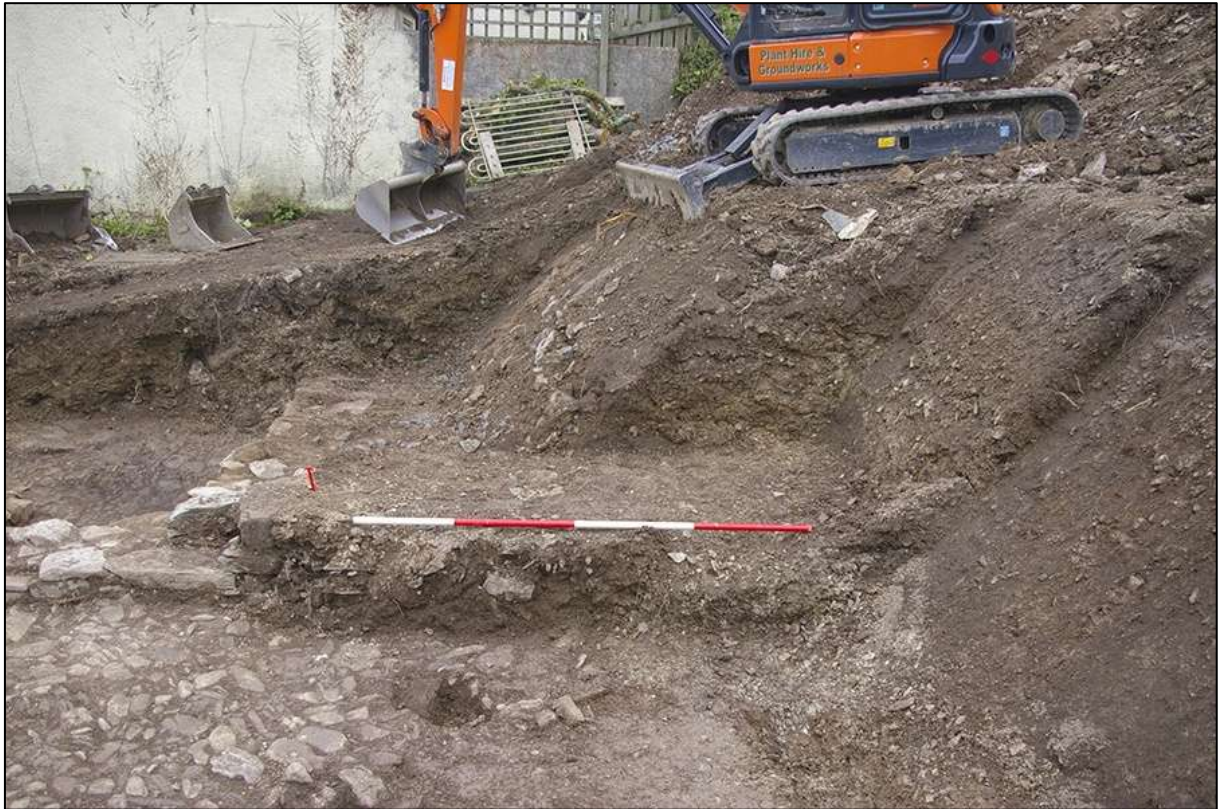
SECTION, NORTH OF WALL {004}; VIEWED FROM THE SOUTH-EAST (2M SCALE).

On the north side of Wall {004} the collapsed or demolished slate roof of the demolished rectangular structure, represented by Layer (022). This overlaid collapse/demolition Layer (039) and was overlaid by the demolition/made-ground Layer (055), which was similar to Layer (054).

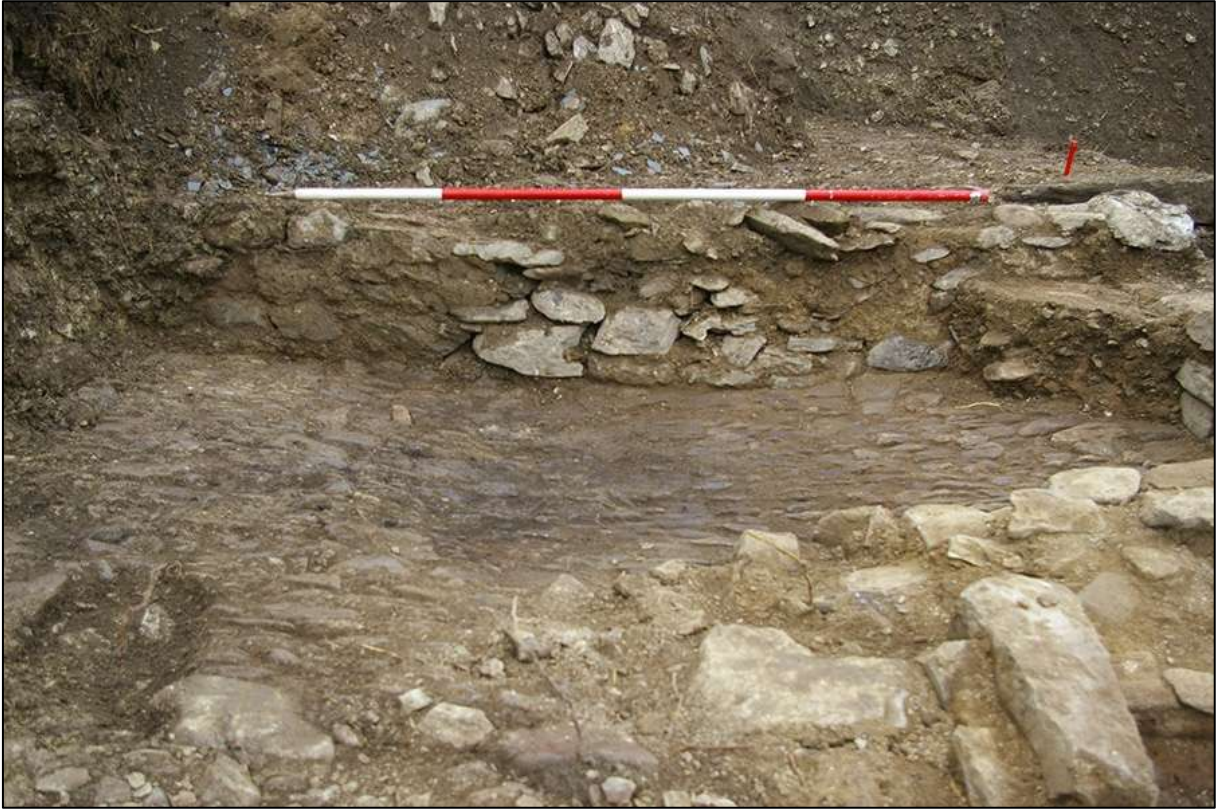
WALL {004}, SOUTH-WEST FACE; VIEWED FROM THE SOUTH-WEST (2M SCALE).

Wall {004} was c.0.50m wide and had dressed internal and external faces, with possible plaster on the internal face. It had a clayey earth bond and was <3.10m long, aligned roughly east-west and formed the north wall of a rectangular room. At its east end, it was tied into Wall {005}. It had no clear construction cut and overlaid made-ground (049) and was overlain by demolition layer (055). It was abutted by cobble floors (013) on its outside and (010) on its inside.

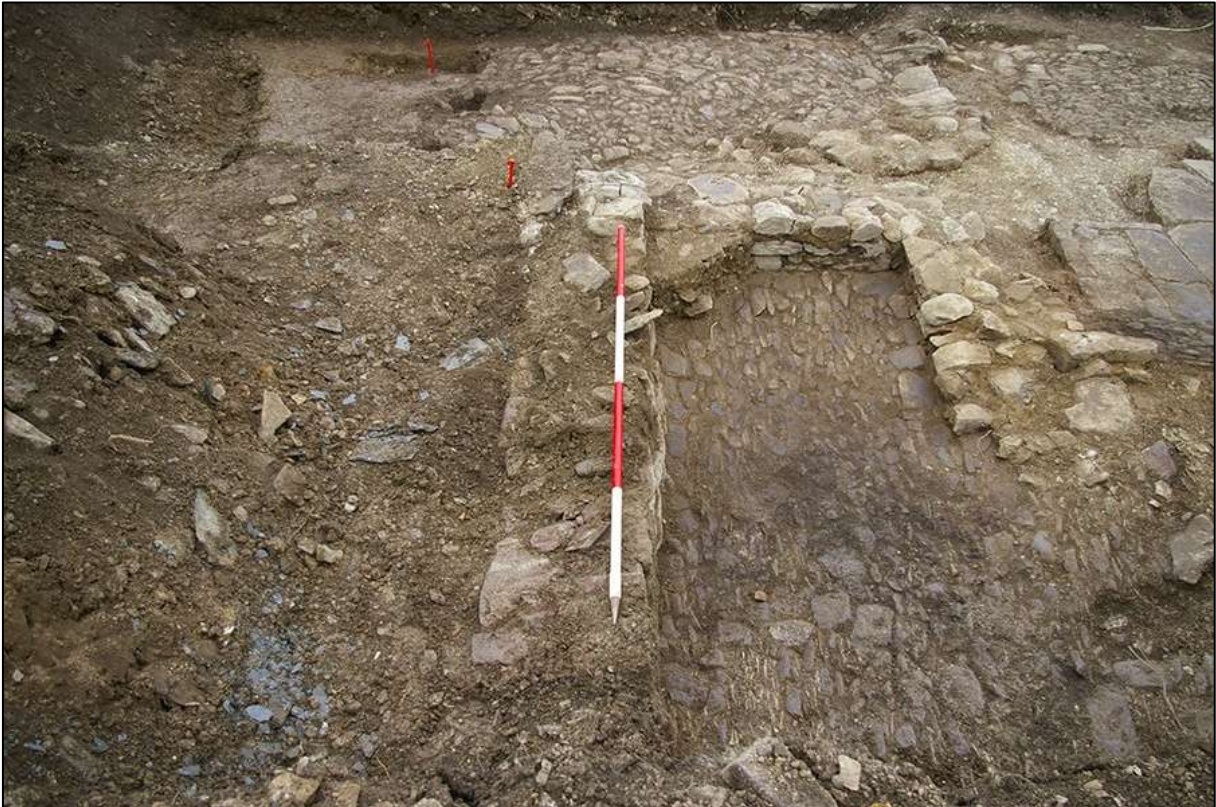
WALL {004}; VIEWED FROM THE NORTH-WEST (2M SCALE).

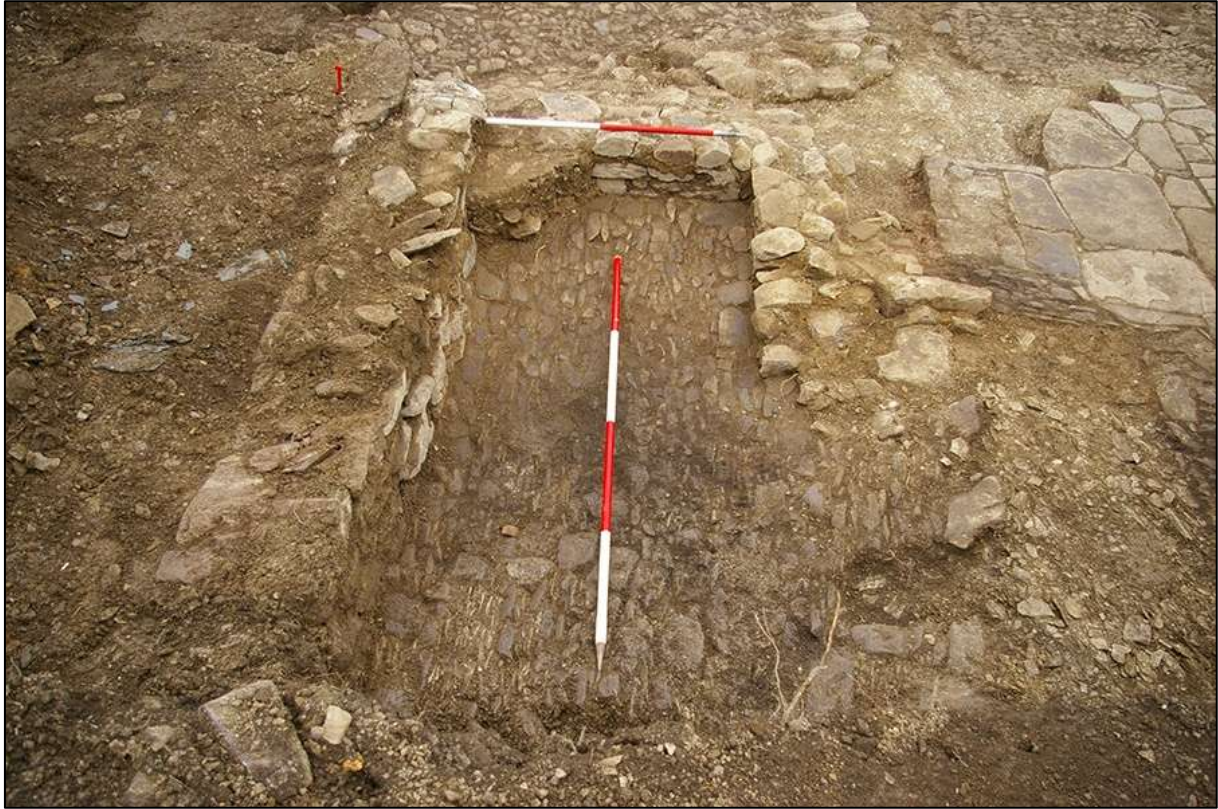
WALL {005} AND COBBLE FLOOR (010); VIEWED FROM THE NORTH-WEST (1M & 2M SCALE).

Cobble surface (010), c.2.80m×1.90m across, was comprised of tightly packed thin cobbles, c.0.08m thick, predominantly aligned east-west, set into a silt-clay matrix/bedding layer (025). It was located within a rectangular structure in the north-west of the excavated area, abutting Walls {004}, {005} and {006}. It overlaid Pit fill (028) and was overlain by a deposit of burnt material, (031), which may have settled into a slight depression/hollow in this floor surface. This was in-turn overlain by demolition layers (021) and (050), which contain the demolition material from Wall {004}.

Wall {005} was c.0.50m wide and had dressed internal and external faces, with possible plaster on the internal face. It had a clayey earth bond and was c.1.50m long, aligned roughly north-south and formed the east wall of a rectangular room. At its north end, it was tied into Wall {004} and at its south end it was tied into Wall {006}. It had no clear construction cut and partially overlaid made-ground (049) and was overlain by demolition layer (055). It was abutted by cobble floors (013) on its outside and (010) on its inside.

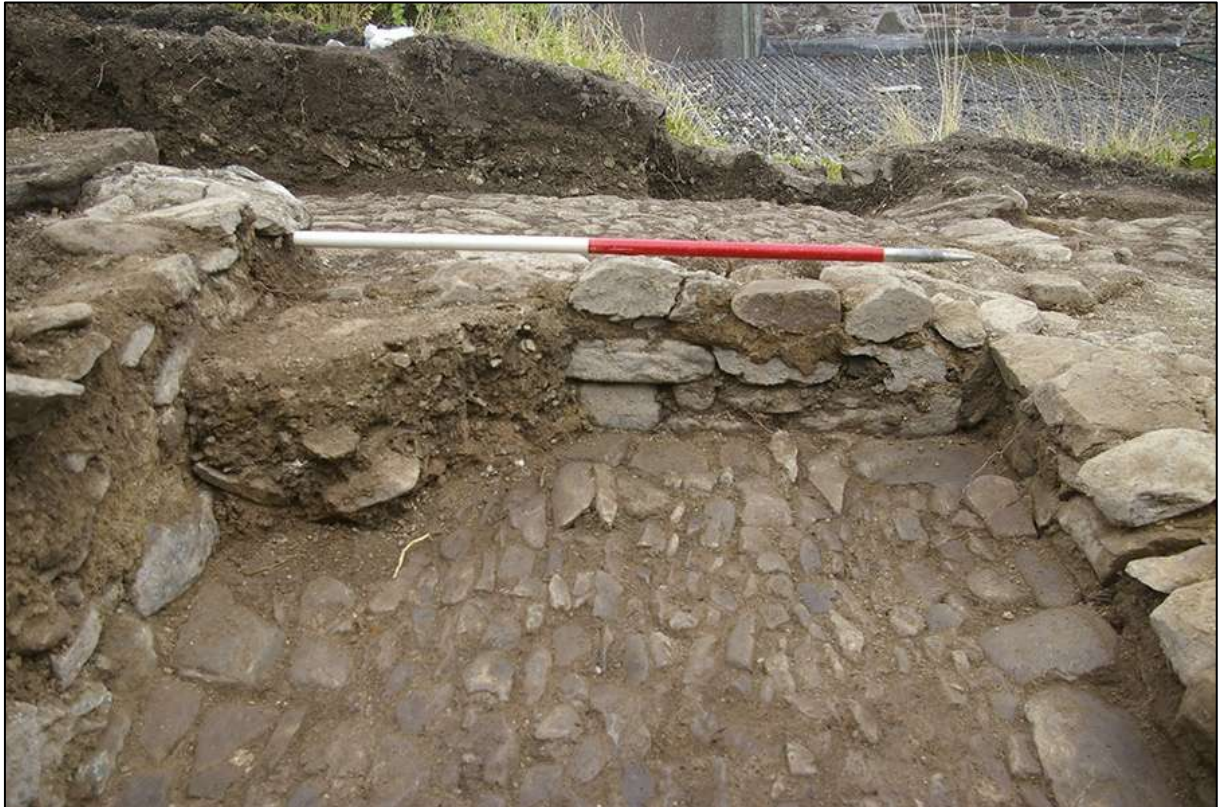
WALL {005}, NORTH-WEST FACE; VIEWED FROM THE NORTH-WEST (1M SCALE).

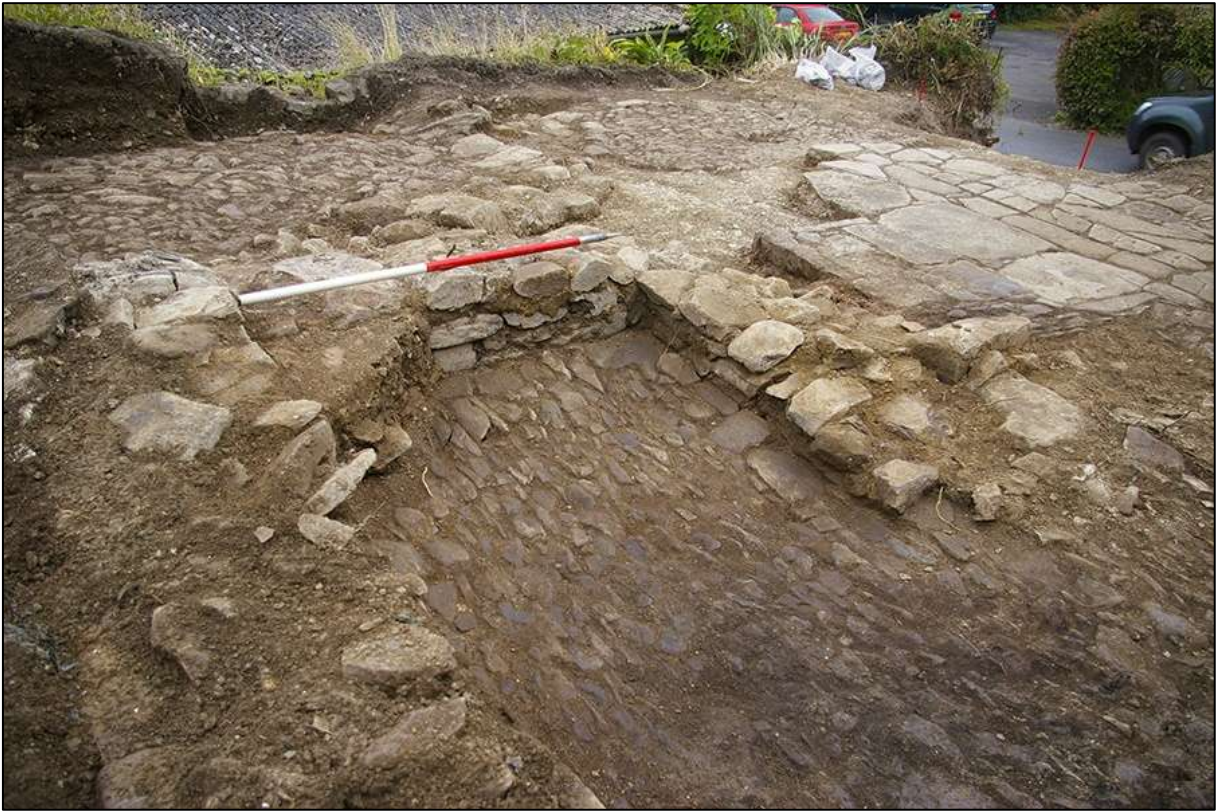
WALLS {004} {005} AND {006}; VIEWED FROM THE NORTH (1M SCALE).

Wall {006} was c.0.66m with a dressed internal face and a damaged/truncated external face. It had a clayey earth bond and was <1.50m long, aligned roughly east-west and formed the south wall of a rectangular room. At its east end, it was tied into Wall {005} and at its west end it was tied into Wall {007}. It had no clear construction cut and overlaid made-ground (049) and was overlain by demolition layer (055). The south-east corner of the wall had been damaged or truncated. It was abutted by the cobbles of floor (011) on its outside and (010) on its inside.

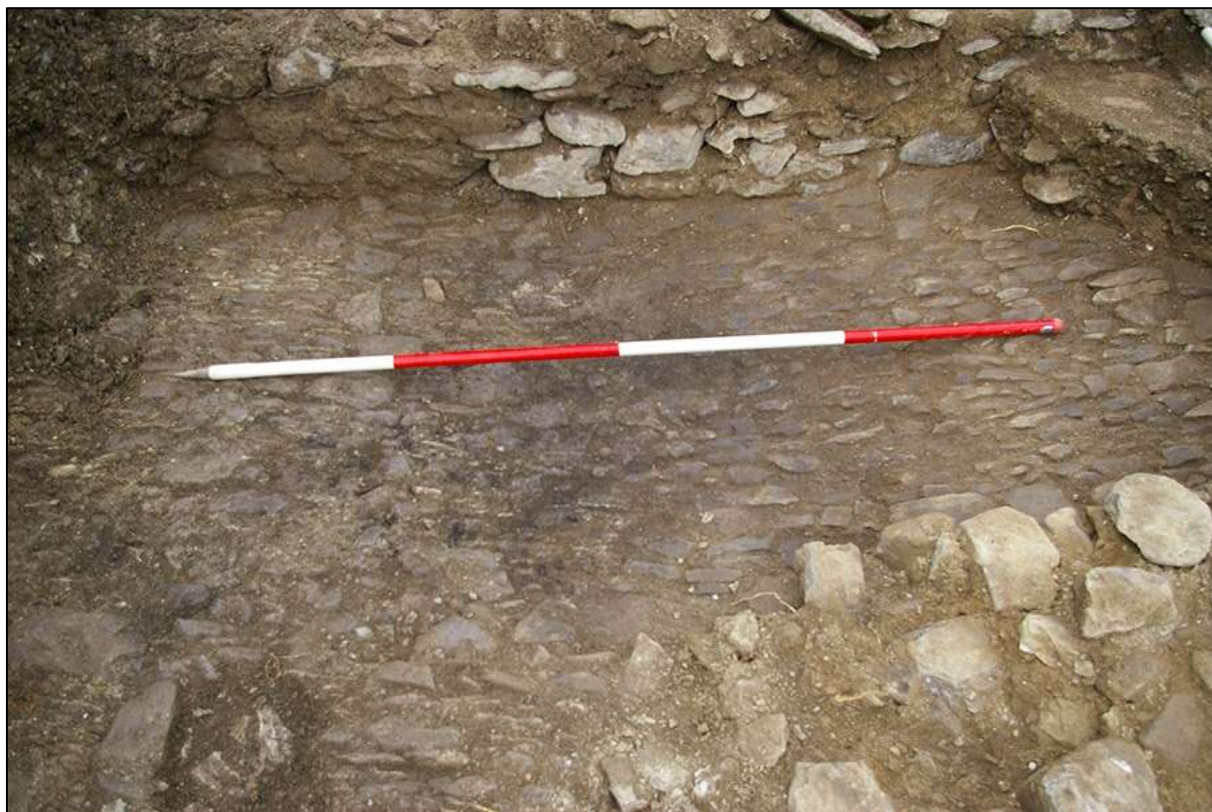
COBBLE FLOOR (010); VIEWED FROM THE SOUTH-WEST (2M SCALE).

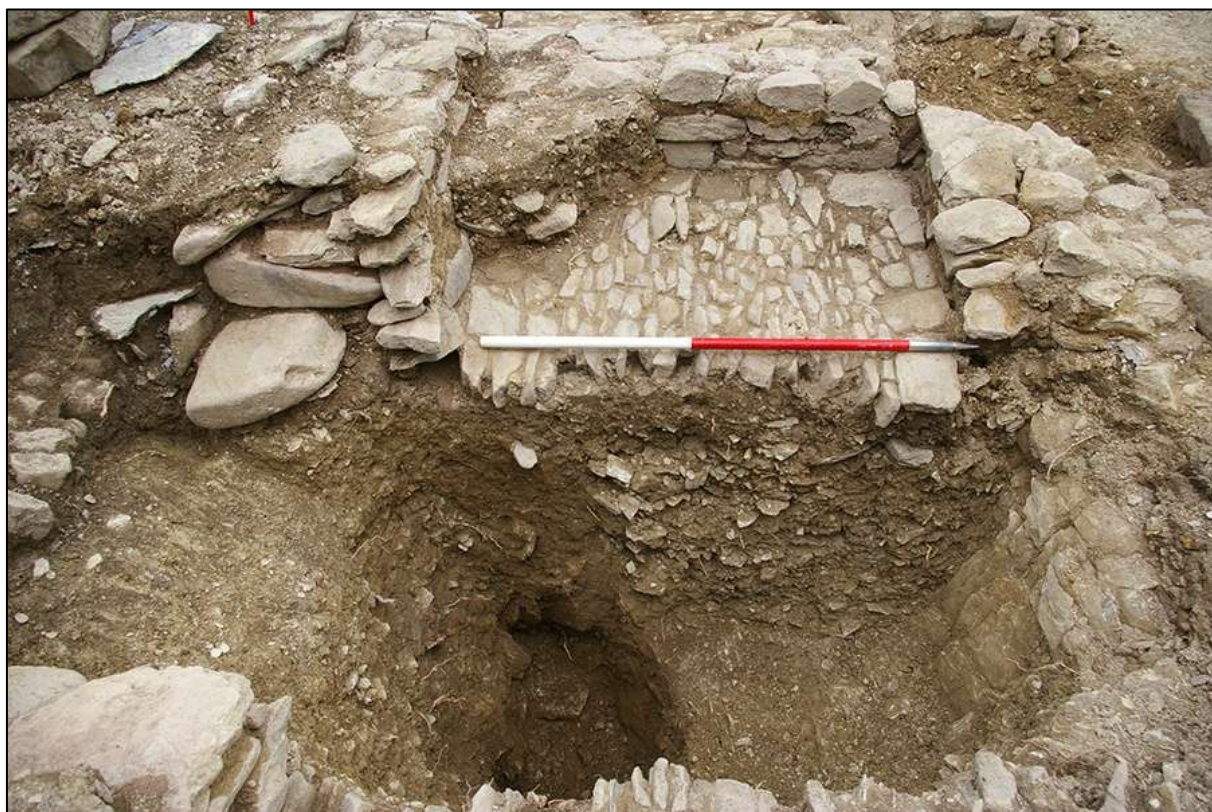
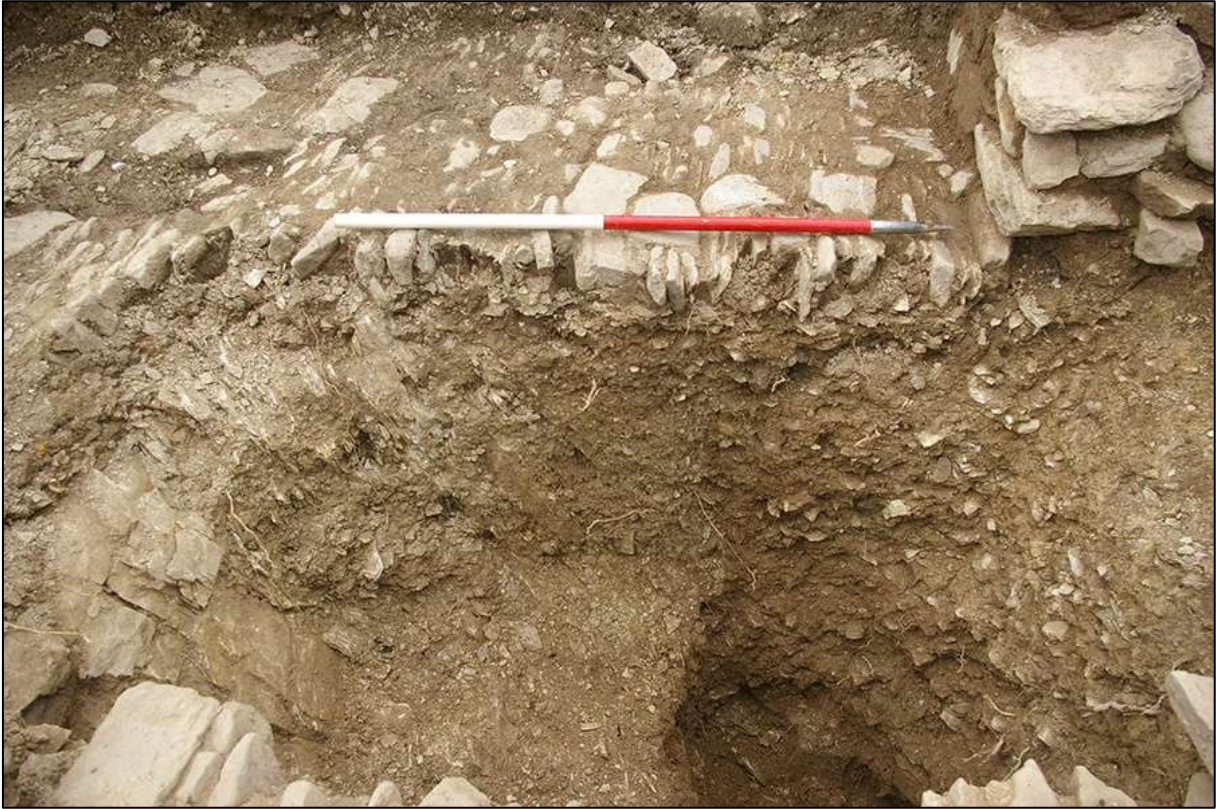
WALL {004}, COBBLE FLOOR (010) AND PITS [026] AND [029]; VIEWED FROM THE NORTH-WEST (1M SCALE).

WALL {004}, COBBLE FLOOR (010) AND PITS [026] AND [029]; VIEWED FROM THE SOUTH-EAST (1M SCALE).

Pit [026], 1.70m×1.25m×0.50m, was sub-rectangular in plan with very steep sides and a flat base. [026] cut pit fill (030) and it contained two fills; (027) and (028), lower and upper respectively that contained medieval and later finds and frequent redeposited natural. Fill (028) was overlain by Made-ground (049).

Pit [029], 1.40m×2.10m×2.4m, was sub-oval in plan with near vertical sides, tapering in to a flat base. It cut the natural and it contained a single fills, (030) of mixed redeposited natural that contained medieval. Fill (030) was cut by [026]. Its relatively clean redeposited natural fill and lack of finds at its base may indicate that it was not used for storage or left open for long.

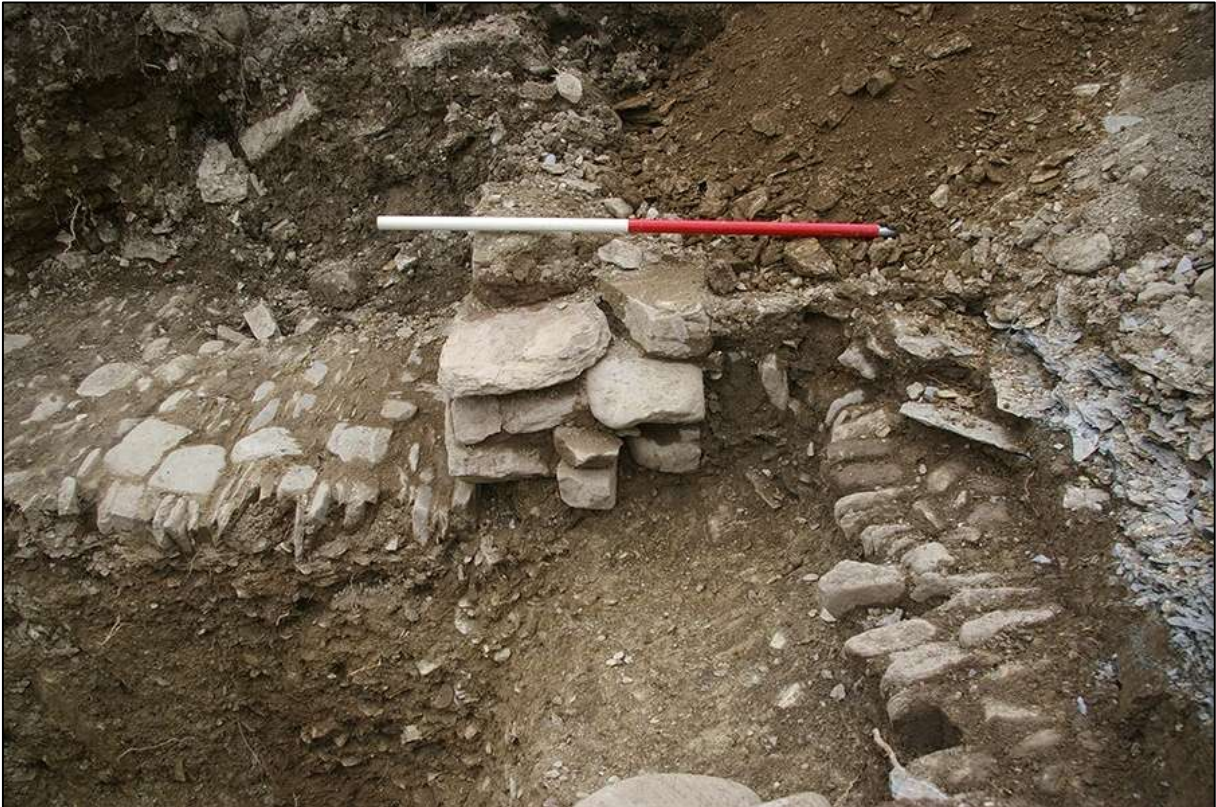
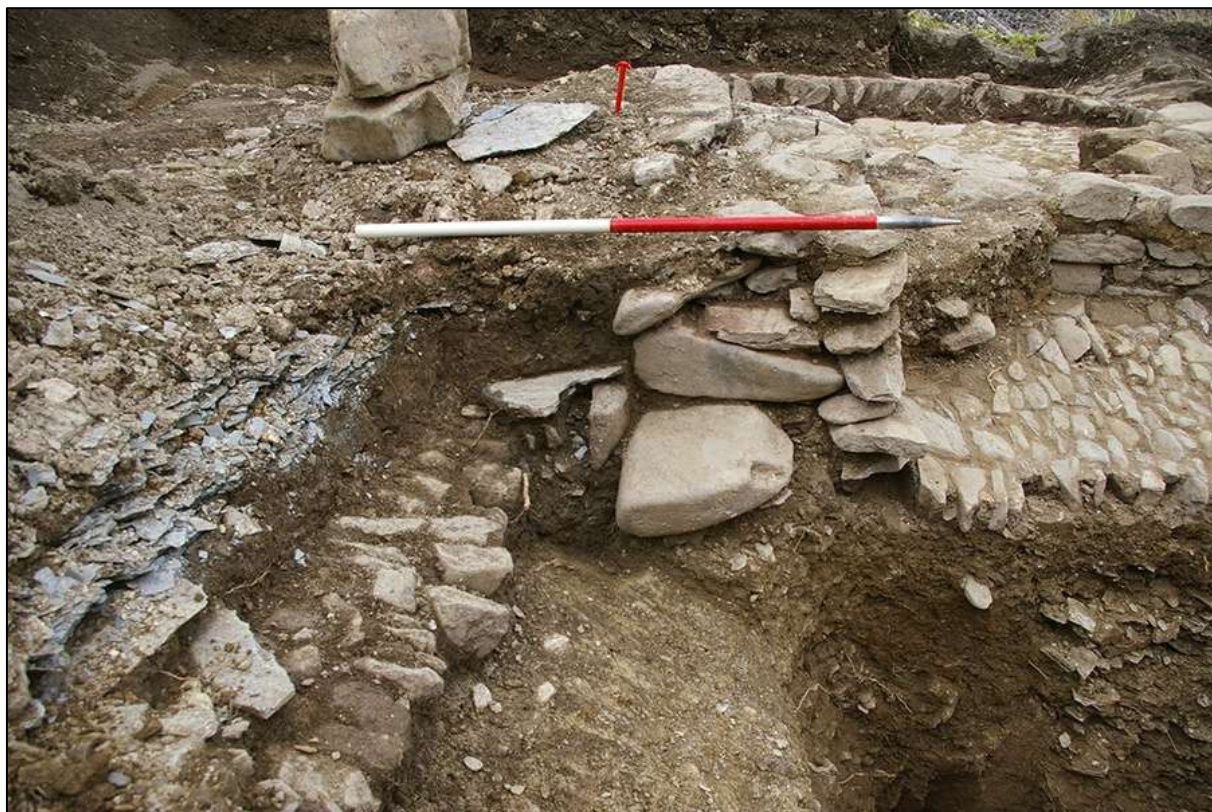
WALL {004}, COBBLE FLOOR (010) AND COBBLE FLOOR (013); VIEWED FROM THE SOUTH-EAST (1M SCALE).

WALL {004}, COBBLE FLOOR (010) AND COBBLE FLOOR (013); VIEWED FROM THE NORTH-WEST (1M SCALE).

Cobble surface (013), c.2.90m×2.90m (c.3.60×3m at its widest points) across, was comprised of less regularly aligned cobbles, c.0.10m thick, possibly radiating out from along its western edge and curving as it sloped gently to the south-east to encourage run-off of surface water. It was located in the north-east quarter of the site. Its cobbles were more varied than those of (010) and (011) and include occasional stones. It was set into a red sandy bedding layer, (042) and overlain by demolition layer (039). It abutted Walls {004}, {005}, {012}, {015} and {040}. (013) At its south end, the cobbles of (013) were set to form a drain, aligned roughly east-west, which would have fed into the culvert defining the south-east boundary of the site and defined by Wall {015}. The south side of this drain included larger curb stones. (013) was cut at its north-end by Postholes [016] and [019].

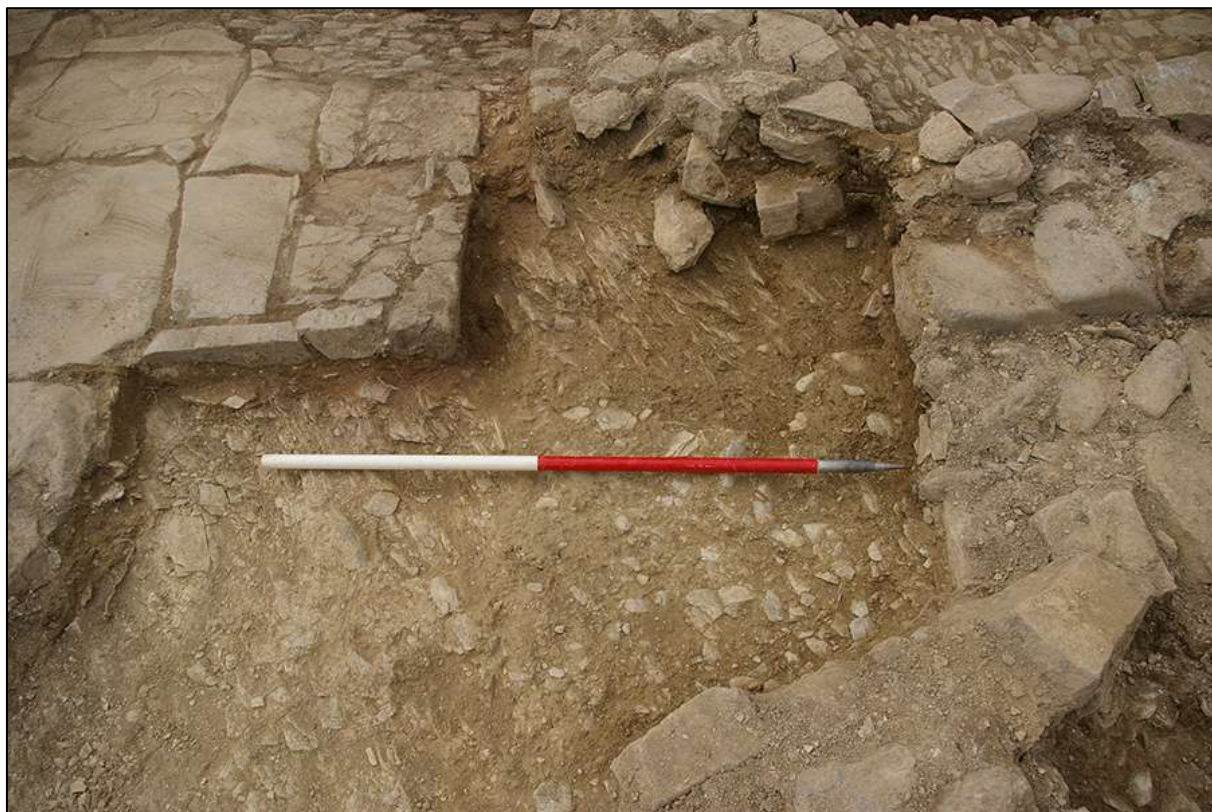
SOUTH END OF WALL {006} AND STONE FLOOR (011); VIEWED FROM THE SOUTH-EAST (1M SCALE).

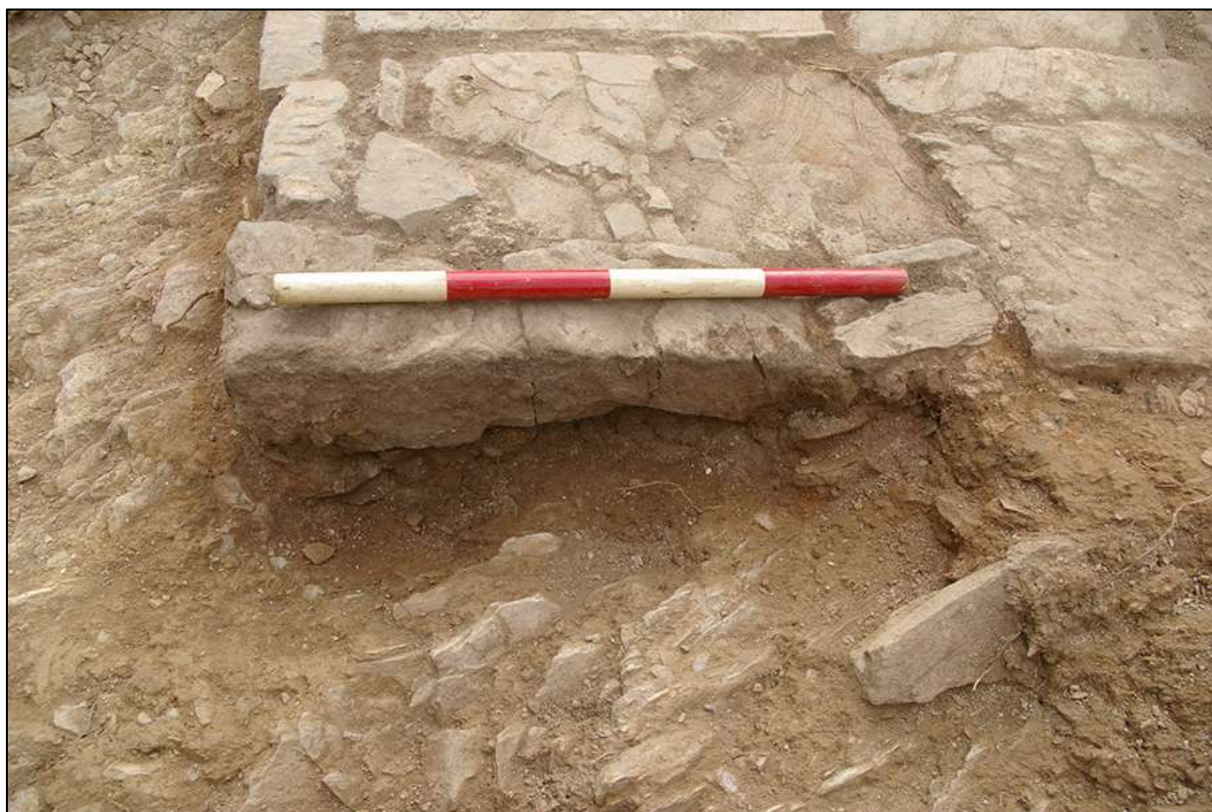
POSSIBLE HEAT AFFECTED PART OF STONE FLOOR (011), ADJACENT TO WALLS {005} AND {006}; VIEWED FROM THE NORTH-EAST (0.40M SCALE).

(011)	<i>Slab floor</i>	Stone slab floor/paving with a plaster/mortar bond sealing and setting slabs (part of (024)?), area 4+m×3m with a possible fire place in its NE section and an adjacent area defined by cobbles	Overlaid (024); Overlain by (023){051}	0.09m	Post-med
{012}	<i>Wall</i>	Possibly part of fireplace, demolished/robbed out, c.0.56m wide, loose stone rubble wall with possible earth bond, possible slight curve to it to SE of cell structure	Overlaid (003); Overlain by (039)	0.17m	Post-med

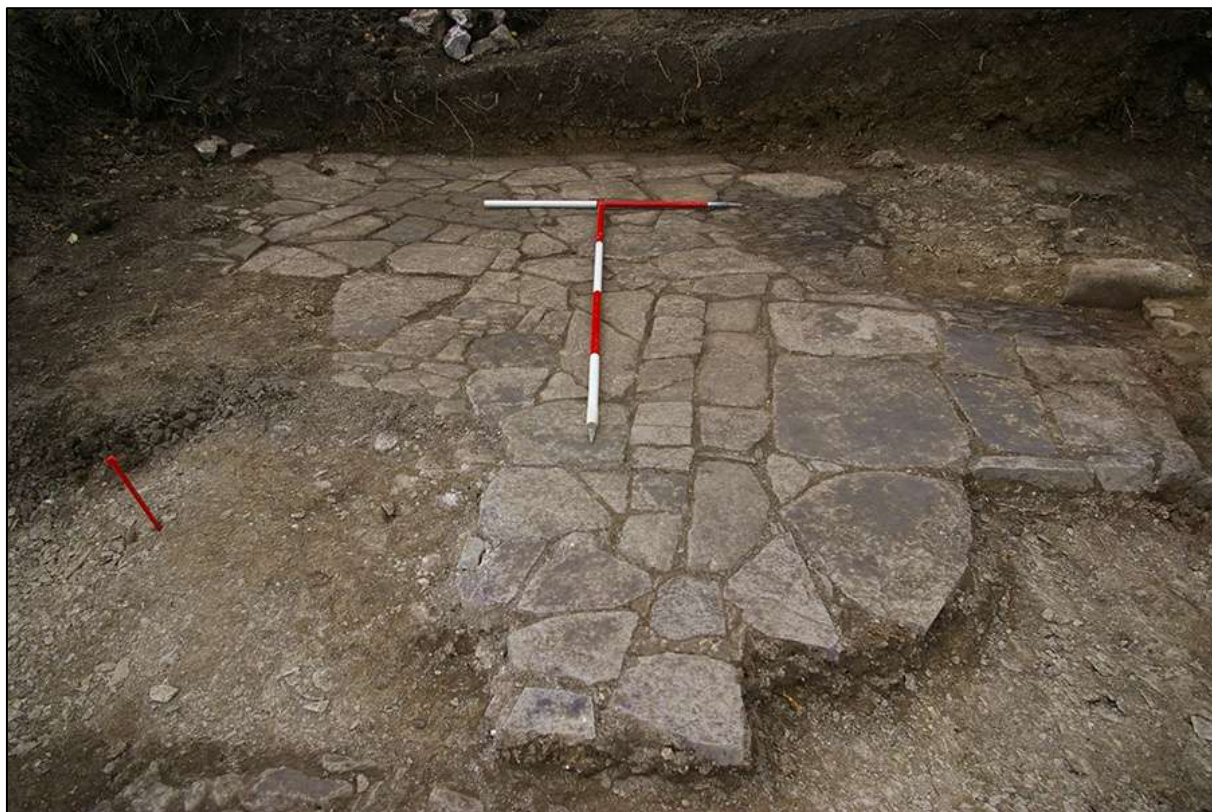
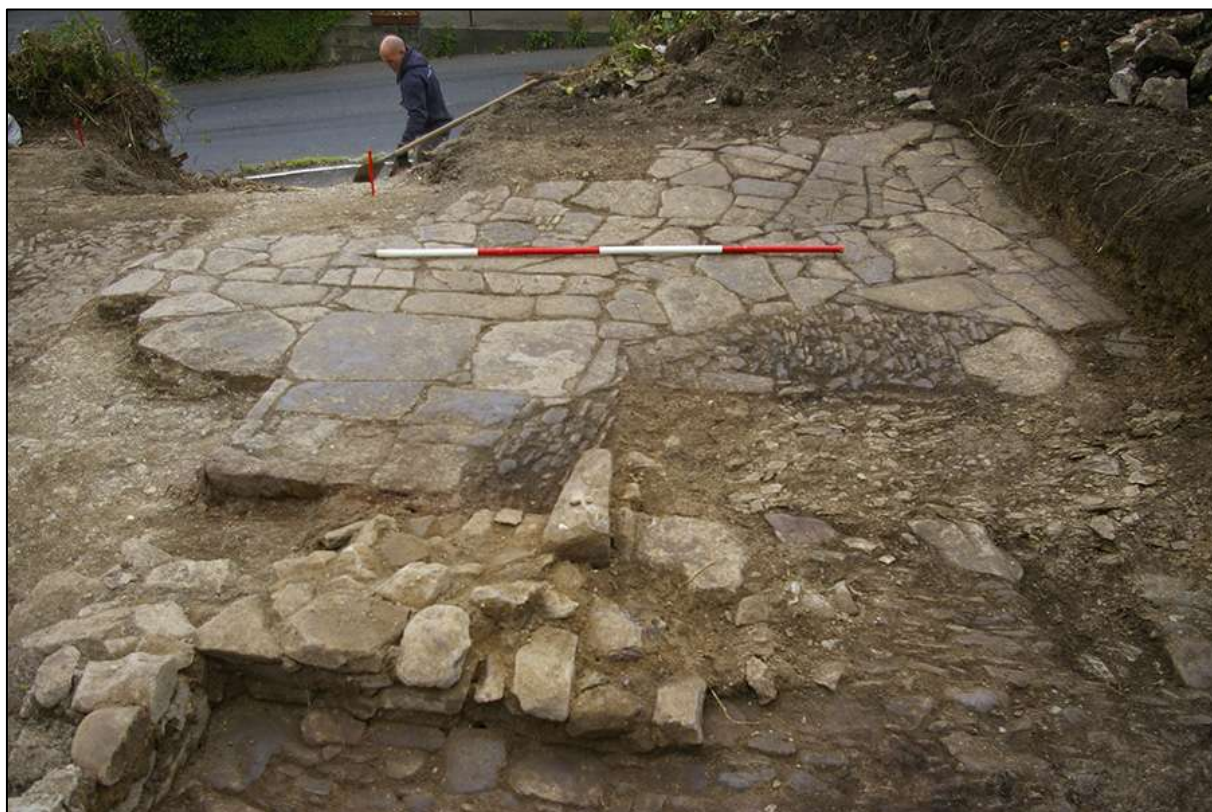
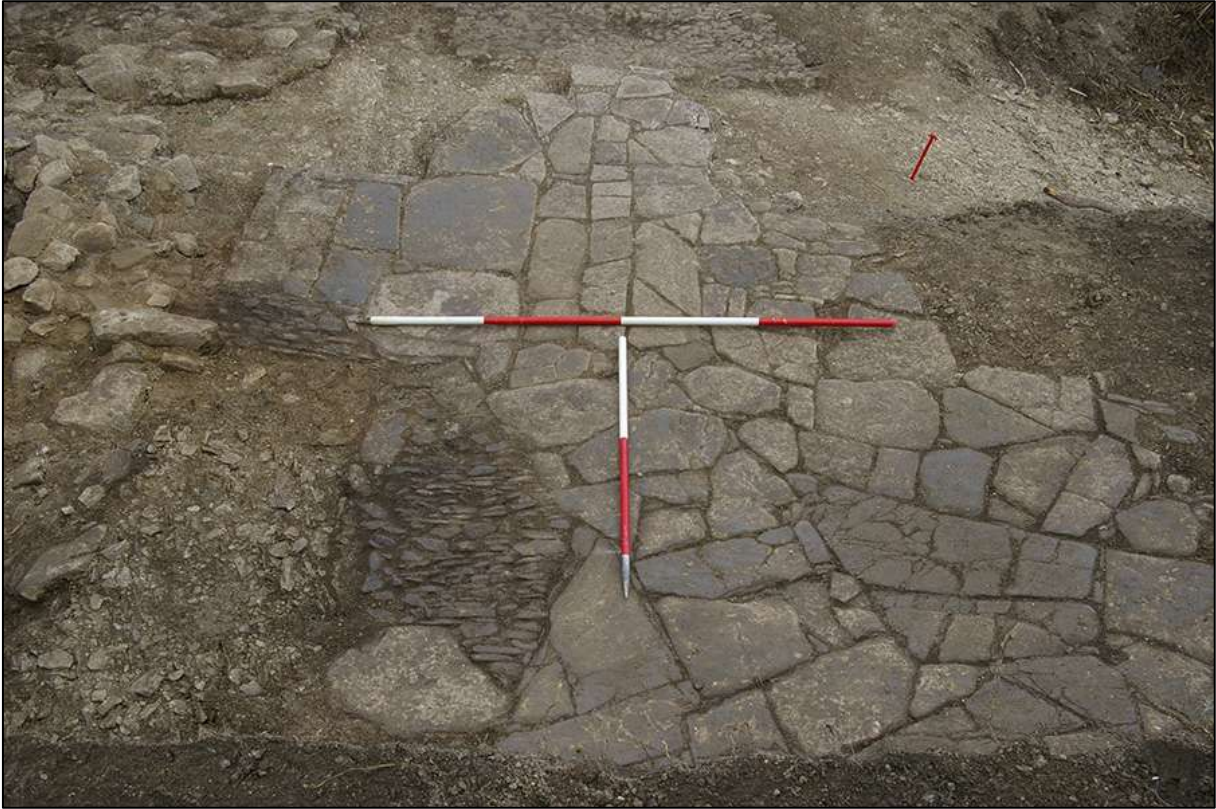
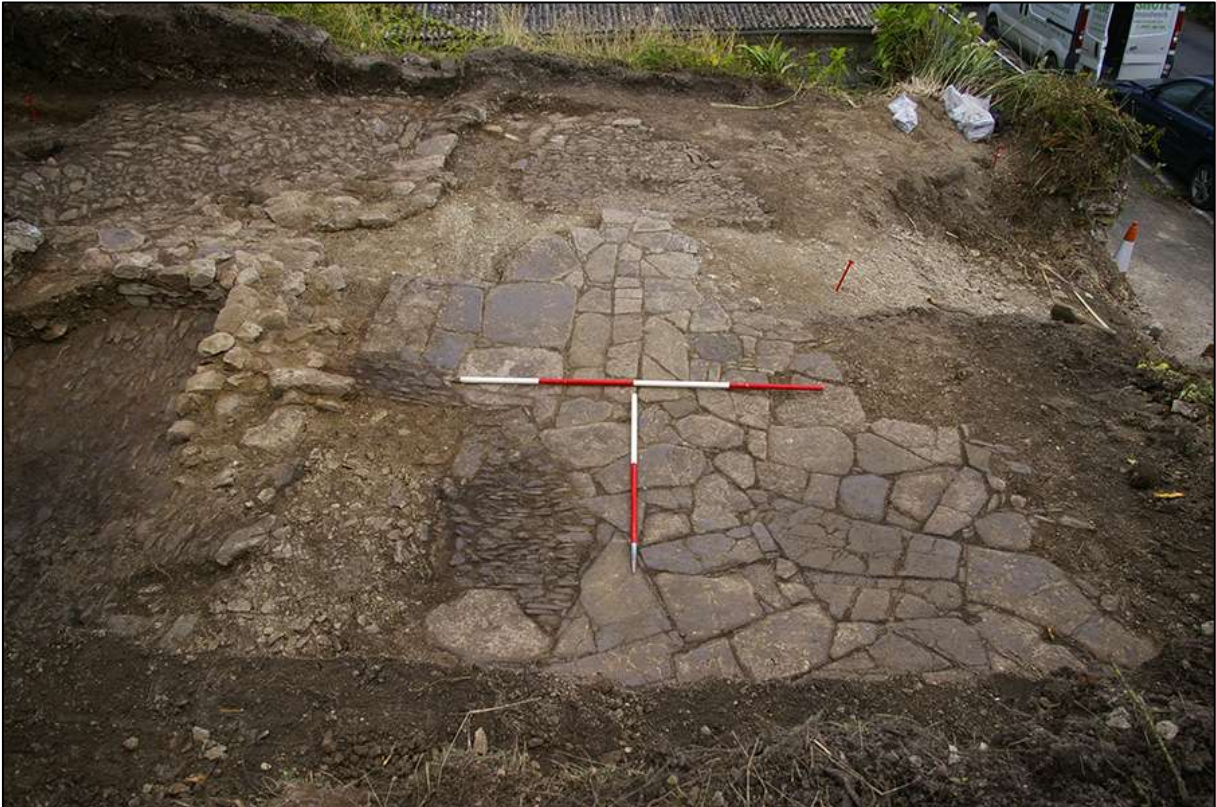
STONE FLOOR (011); VIEWED FROM THE SOUTH-EAST (1M & 2M SCALE).

STONE FLOOR (011); VIEWED FROM THE NORTH-EAST (2M SCALE).

STONE FLOOR (011); VIEWED FROM THE NORTH-WEST (1M & 2M SCALE).

SOUTH HALF OF SITE, STONE FLOOR (011); VIEWED FROM THE NORTH-WEST (1M & 2M SCALE).

Stone slab surface (011), c.4m×3m across, was comprised of stone slabs from c.0.12m×0.18m across to 0.62m×0.50m across and c.0.095m thick, in the south-west quarter of the excavated area. These slabs were set into silty bedding/levelling layer, (024) and a thin lime mortar that filled any small gaps between the stones. These bedding layers overlaid the natural. Two patches of cobbles, similar to (010), although laid roughly north-south, were located in the north end of the floor and both on the edges of areas possibly heat affected. Some patterns in the laying of the stones could be discerned: a two stone wide, east-west alignment extending from the east end of the floor and the squared-off and curbed heat affected north-east portion of the floor. (011) was overlain by demolition layers (023)/(051).

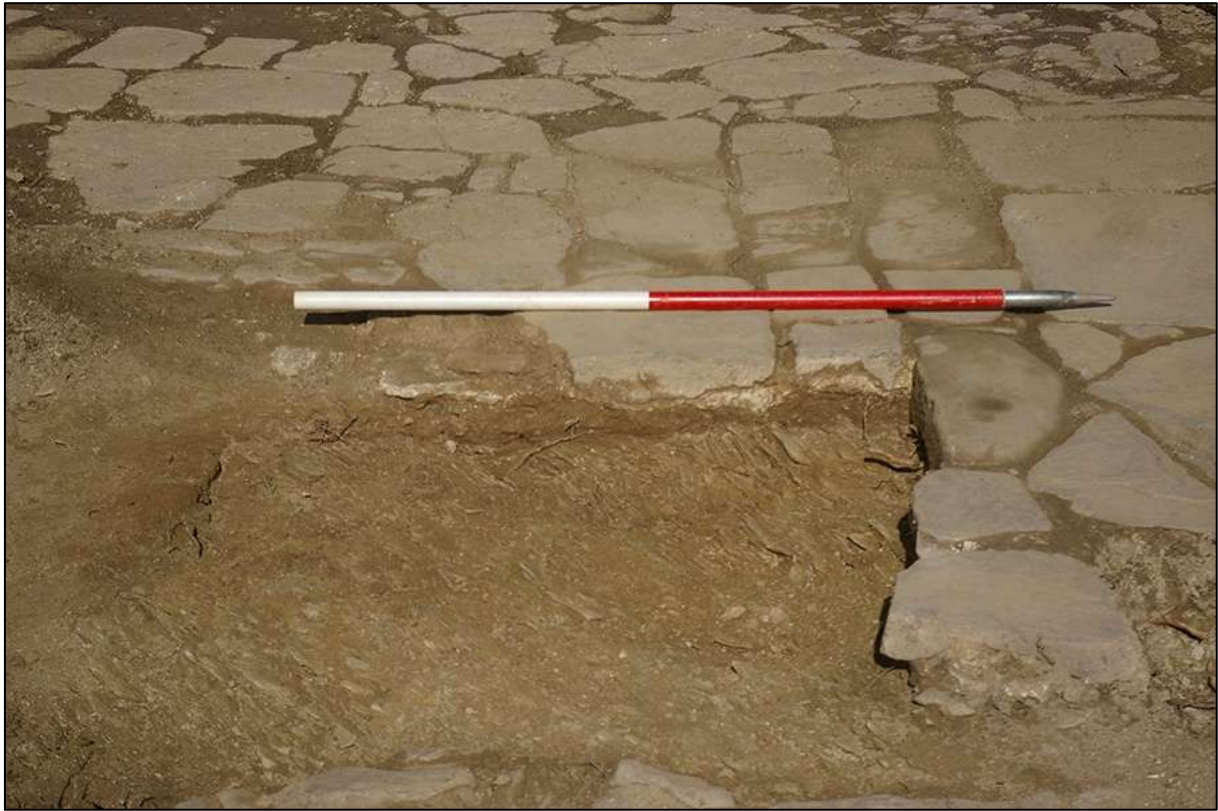
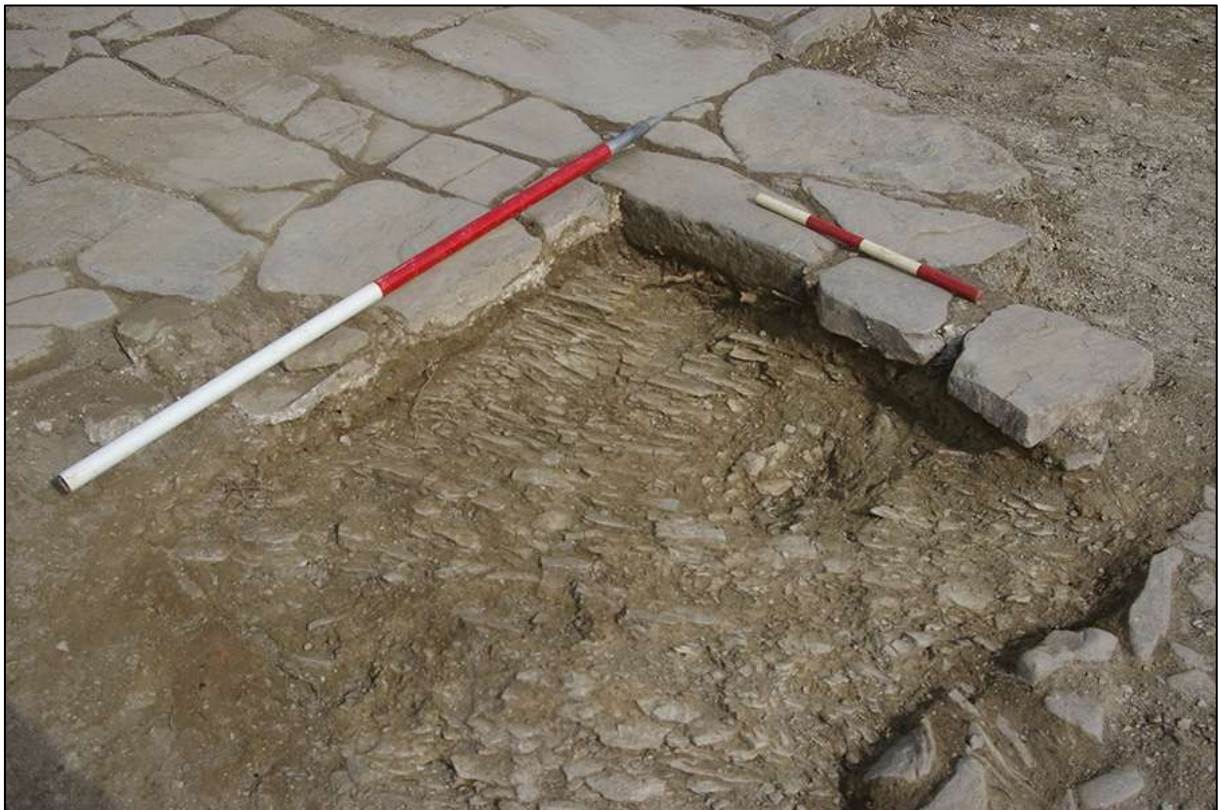
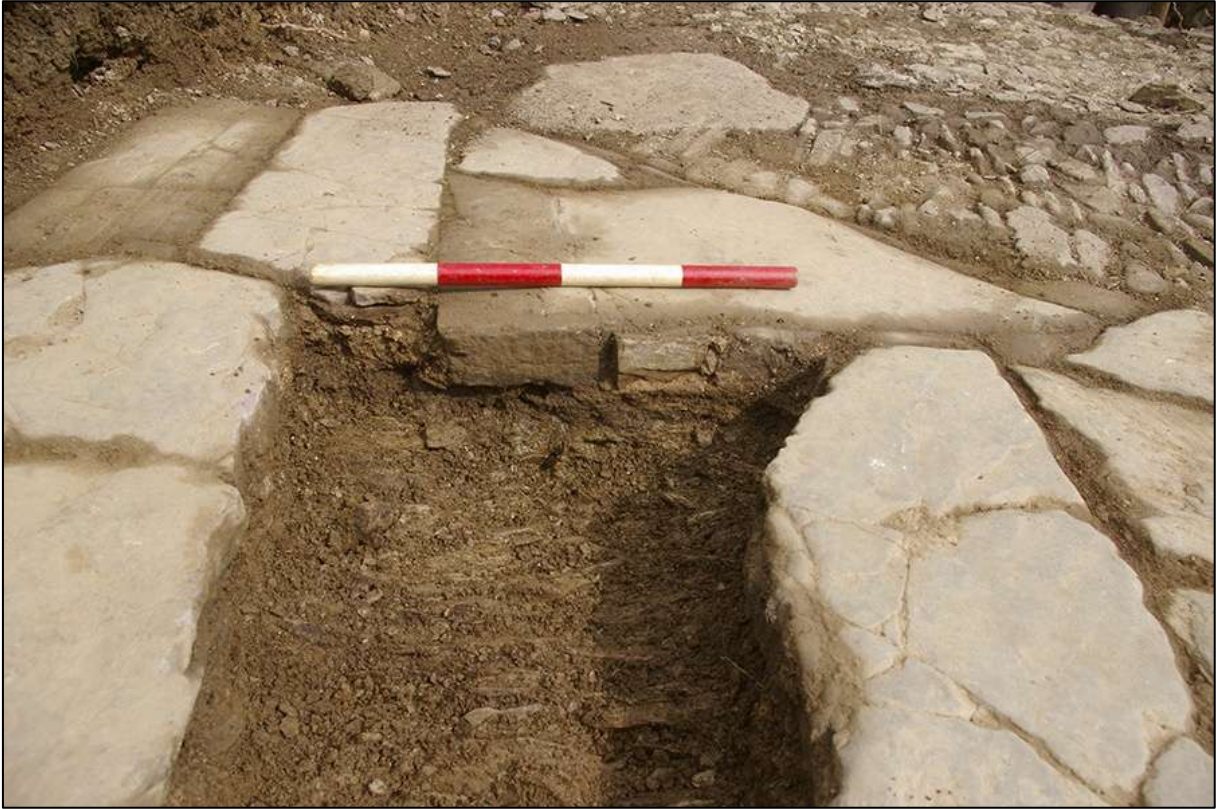
SECTION THROUGH STONE FLOOR (011); VIEWED FROM THE SOUTH-EAST (1M SCALE).

SECTION THROUGH STONE FLOOR (011); VIEWED FROM THE SOUTH (0.40M & 1M SCALE).

SECTION THROUGH STONE FLOOR (011); VIEWED FROM THE SOUTH-WEST (0.40M SCALE).

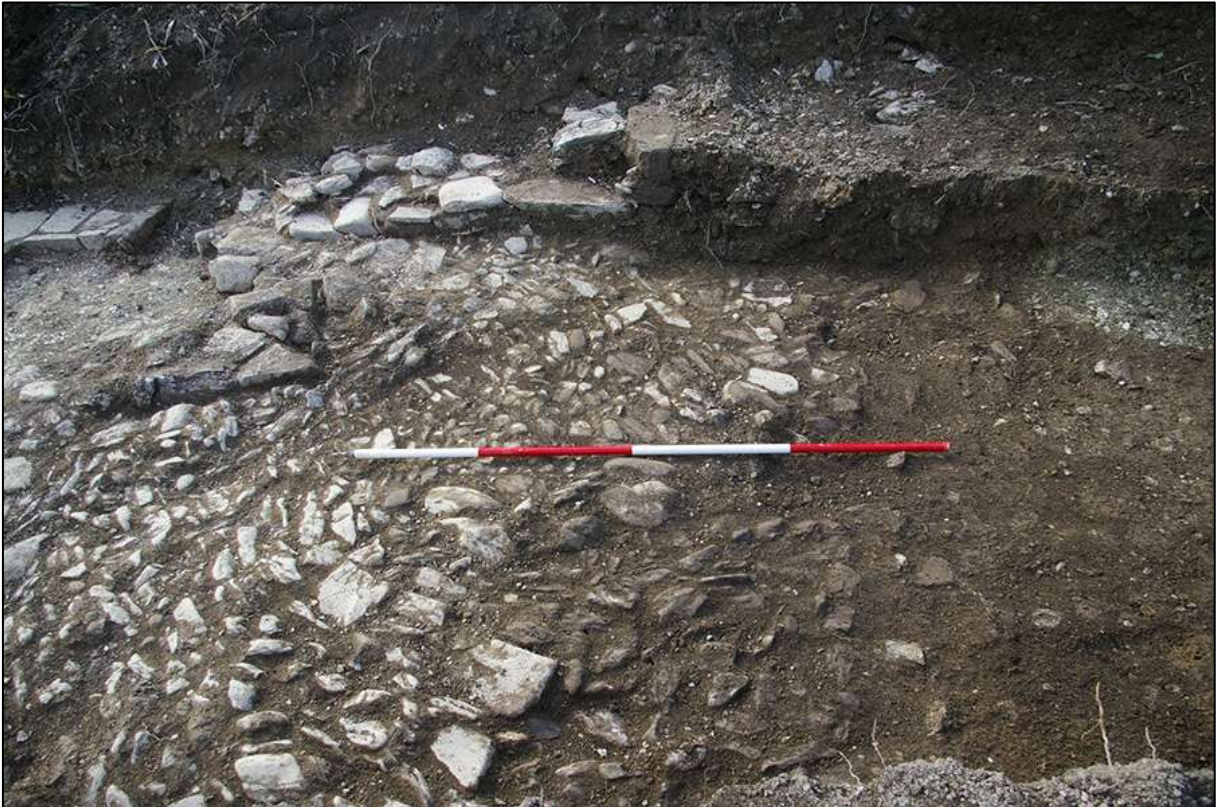
COBBLE FLOOR (013); VIEWED FROM THE SOUTH-EAST (2M SCALE).
