MOORLAND VIEW EAST STREET NORTH MOLTON DEVON

Results of Archaeological Monitoring and Recording

South West Archaeology Ltd. Report no 171201

By J. Bampton
Report Version: FINAL
1st December 2017

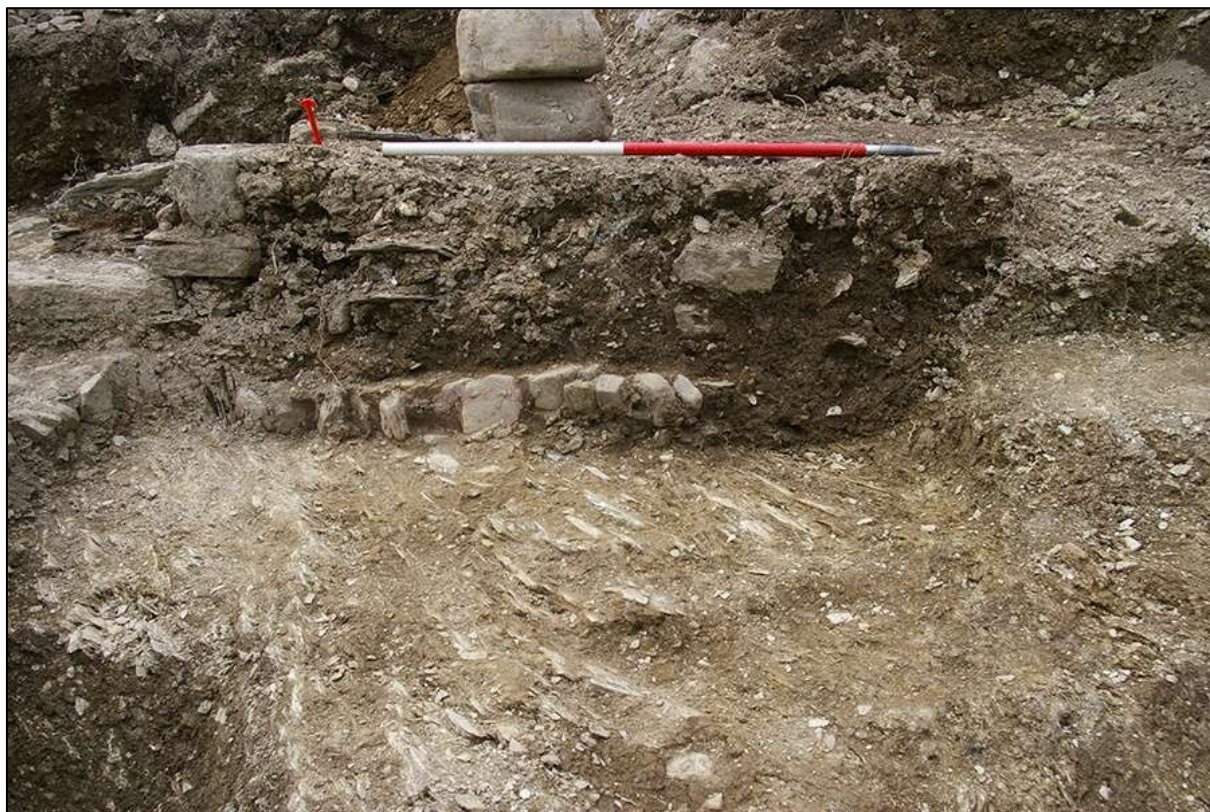
SECTION THROUGH COBBLE FLOOR (013), ABUTTING WALLS {004} AND {040}; VIEWED FROM THE SOUTH-EAST (1M SCALE).

Wall {040} was a stone faced retaining wall, approximately one or two stones thick, c.0.22m wide, pressed into and retaining made-ground (041) and the terraced subsoil and natural at the north end

of the site. It ran along the width of the excavated area to varying degrees of survival to a height of c.0.45-0.80m. It overlaid Made-grounds (045) and (038), was abutted by Cobble floor (013) and was overlain by Demolition layer (039).

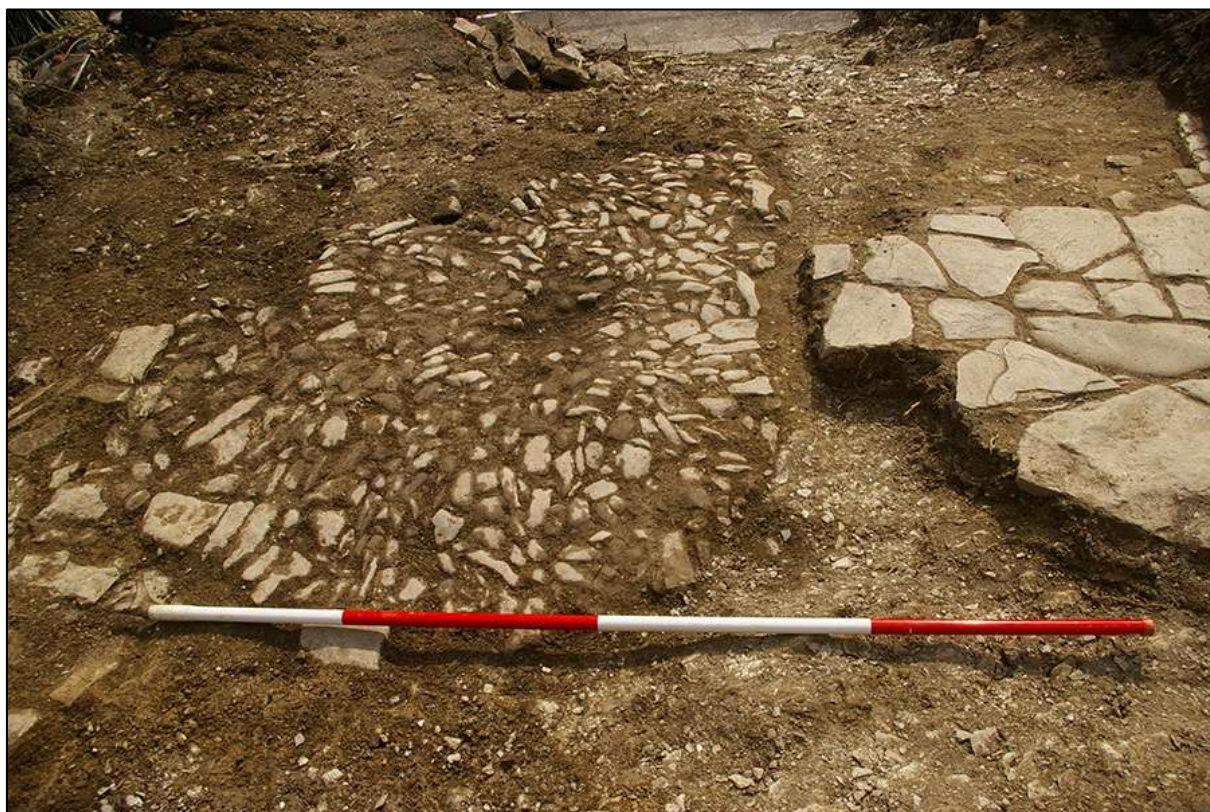
COBBLES (014) AND STONE FLOOR (011); VIEWED FROM THE NORTH-EAST (2M SCALE).

Cobble surface (014), c.2m×2m across, was comprised of a variety of generally small cobbles aligned roughly north-south and east-west in patches across the surface, 0.10m thick. It was located in the south-east quarter of the site. It was tightly packed in some patches and less well consolidated and perhaps damaged in others. (014) had been truncated at its south end and north end, although appeared to be sloping gently towards the curb stones of (013), which did not overlay a lower floor surface. Where (014) appears to be regularly aligned it forms curbs along its east and west edges, respecting (011) and probably the south-eastern boundary of the site. It was set into the natural and was overlain by demolition layers (023) and (032).

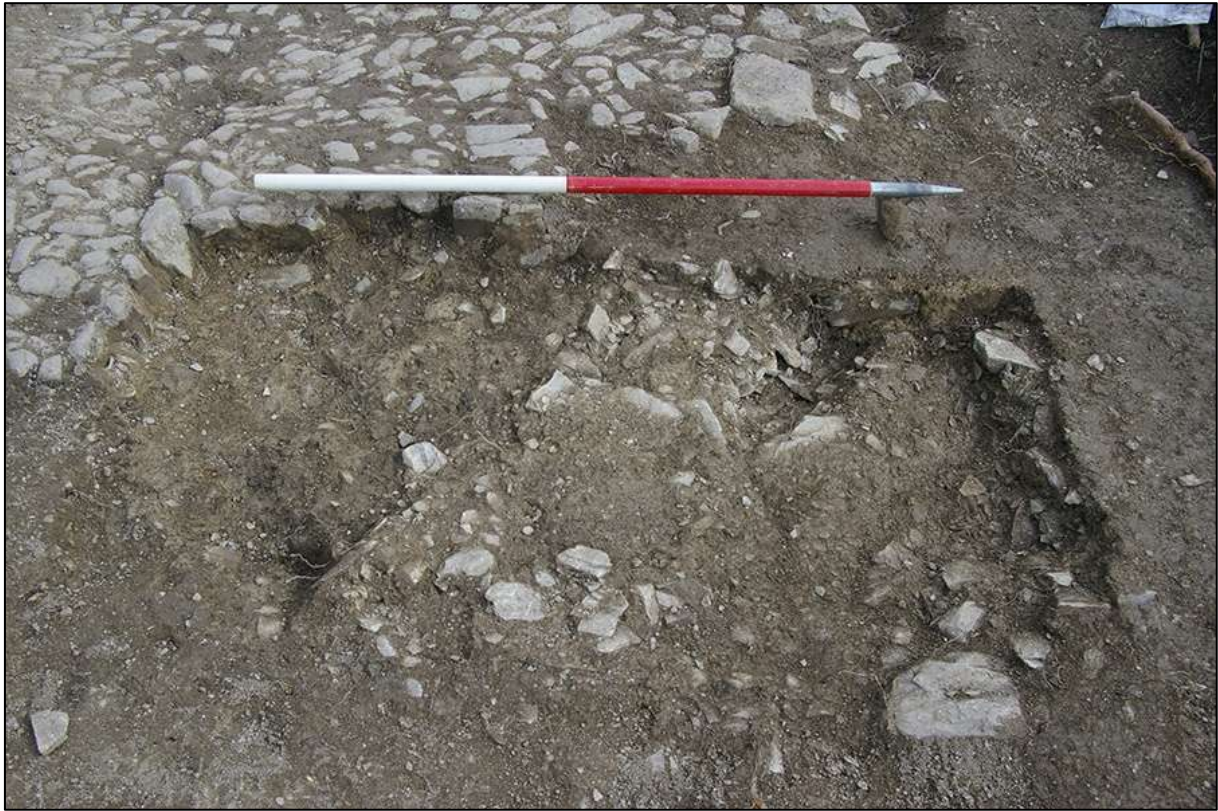
SECTION THROUGH COBBLE FLOOR (014); VIEWED FROM THE SOUTH-WEST (1M SCALE).

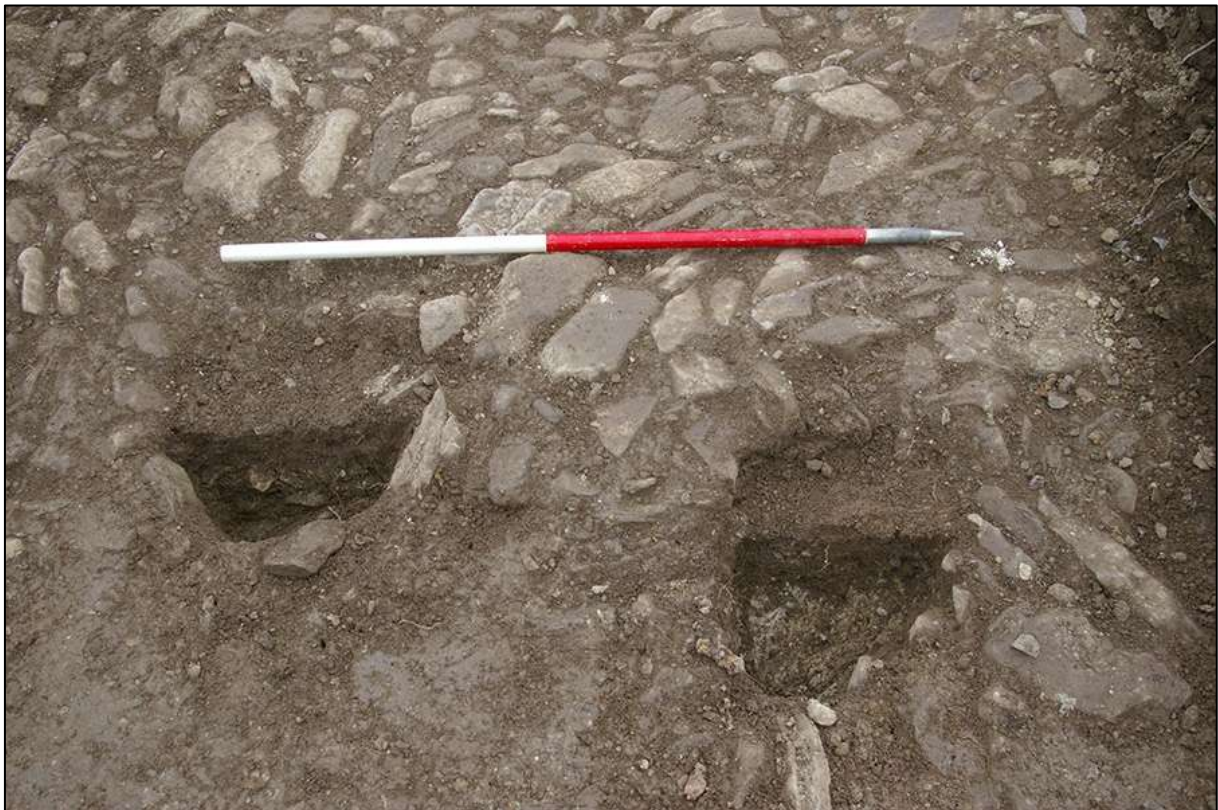
POSTHOLES [016] AND [019]; VIEWED FROM THE NORTH-EAST (1M SCALE).

Postholes [016] and [019] were oval in plan with near vertical sides and flat bases, c.0.35m in diameter and c.0.19m deep. They each cut or were respected by Cobble floor (013) and their respective fills were overlain by (039). Each contained fills that contained 17th-19th century finds; (018) and (020) respectively.

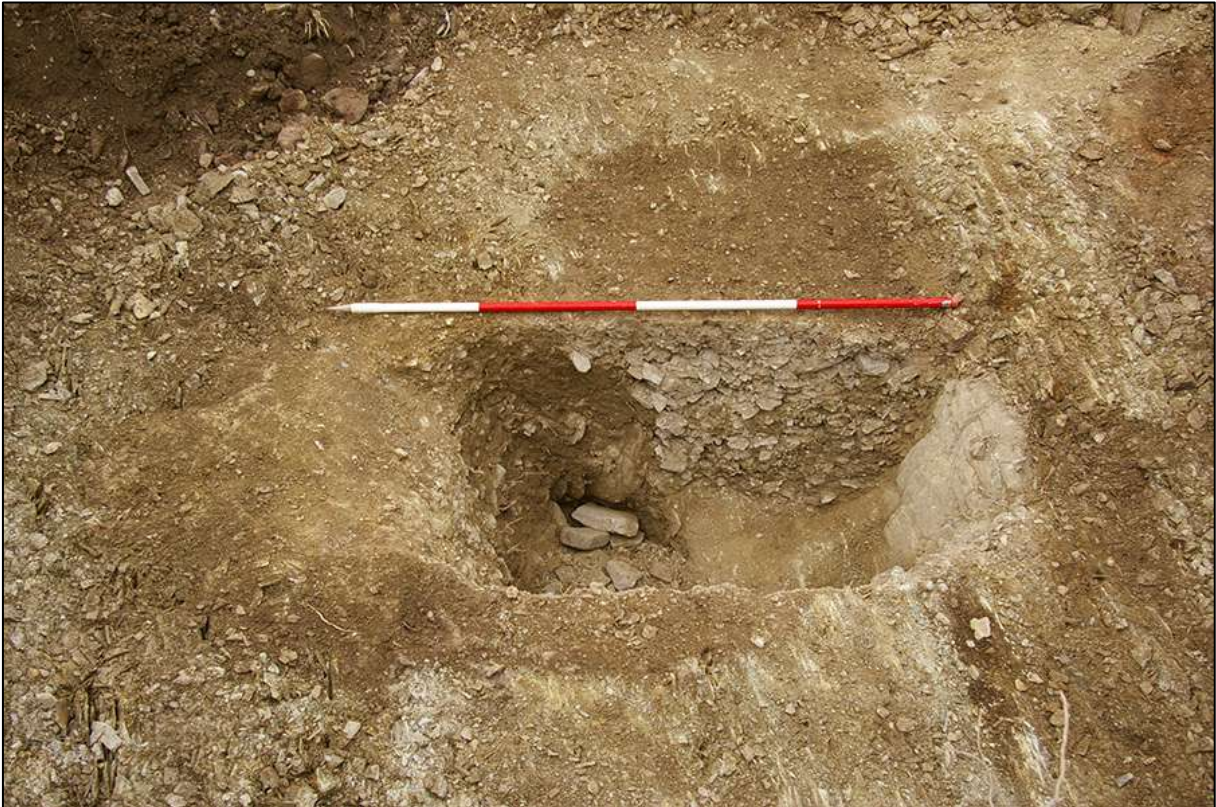
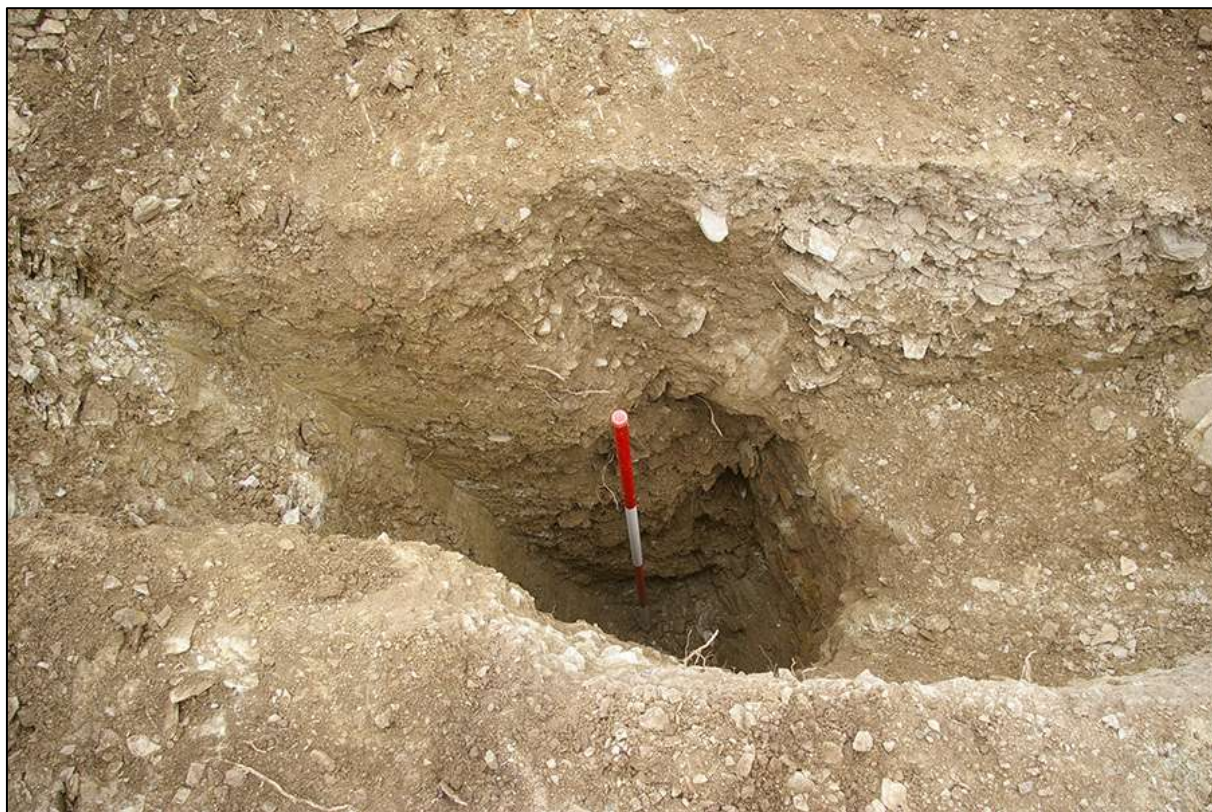
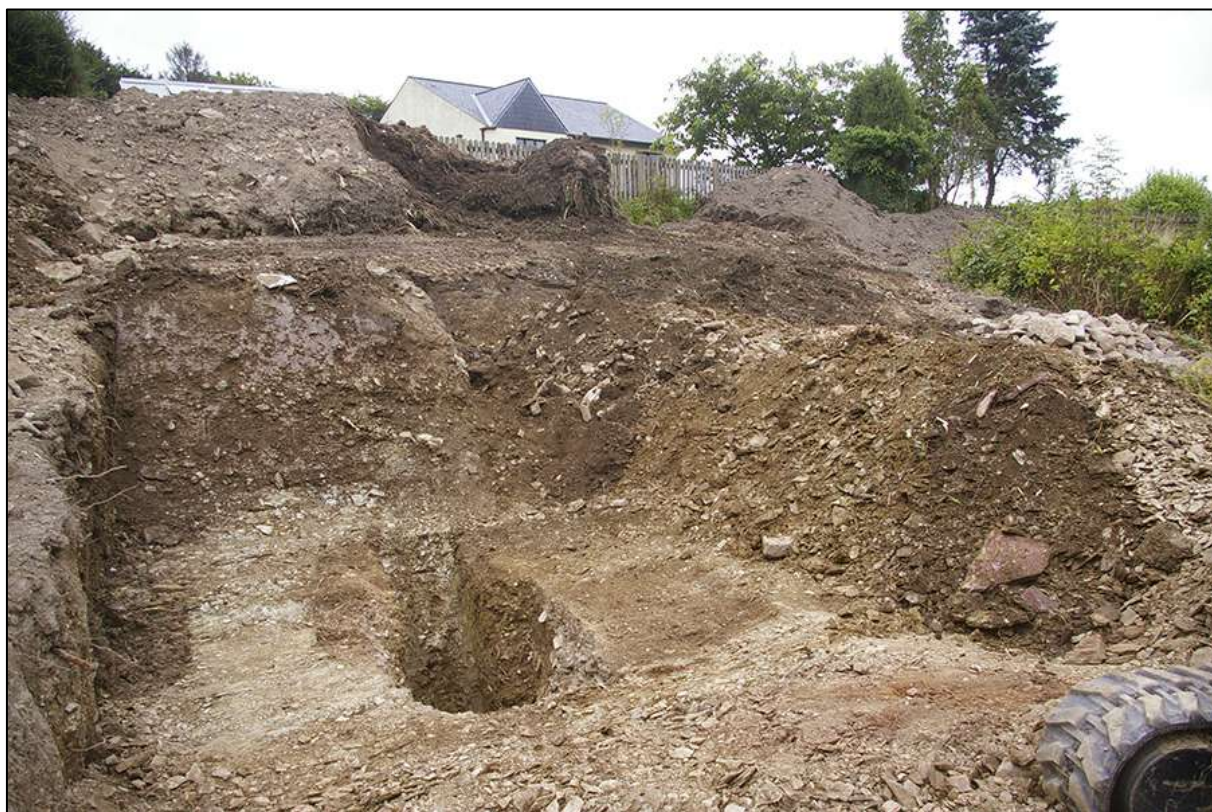
PITS [026] AND [029], MID-EXCAVATION; VIEWED FROM THE NORTH-WEST (2M SCALE).

PITS [026] AND [029]; VIEWED FROM THE NORTH-WEST (2M SCALE).

PITS [026] AND [029], POST-EXCAVATION; VIEWED FROM THE WEST-SOUTH-WEST (NO SCALE).

Pits [026] and [029] (Figures 2-9) were located beneath the demolished rectangular structure in the north-west corner of the excavated area. The earliest of these, [029] contained medieval finds, while [026] contained medieval and post-medieval finds. Their presence caused a slump in Cobble floor (010), which had probably been levelled with Made-ground (049) prior to further subsidence. They were probably related to some kind of prospection.

Pit [026], 1.70m×1.25m×0.50m, was sub-rectangular in plan with very steep sides and a flat base. [026] cut pit fill (030) and it contained two fills; (027) and (028), lower and upper respectively that contained medieval and later finds and frequent redeposited natural. Fill (028) was overlain by Made-ground (049).

Pit [029], 1.40m×2.10m×2.4m, was sub-oval in plan with near vertical sides, tapering in to a flat base. It cut the natural and it contained a single fills, (030) of mixed redeposited natural that contained medieval. Fill (030) was cut by [026]. Its relatively clean redeposited natural fill and lack of finds at its base may indicate that it was not used for storage or left open for long.

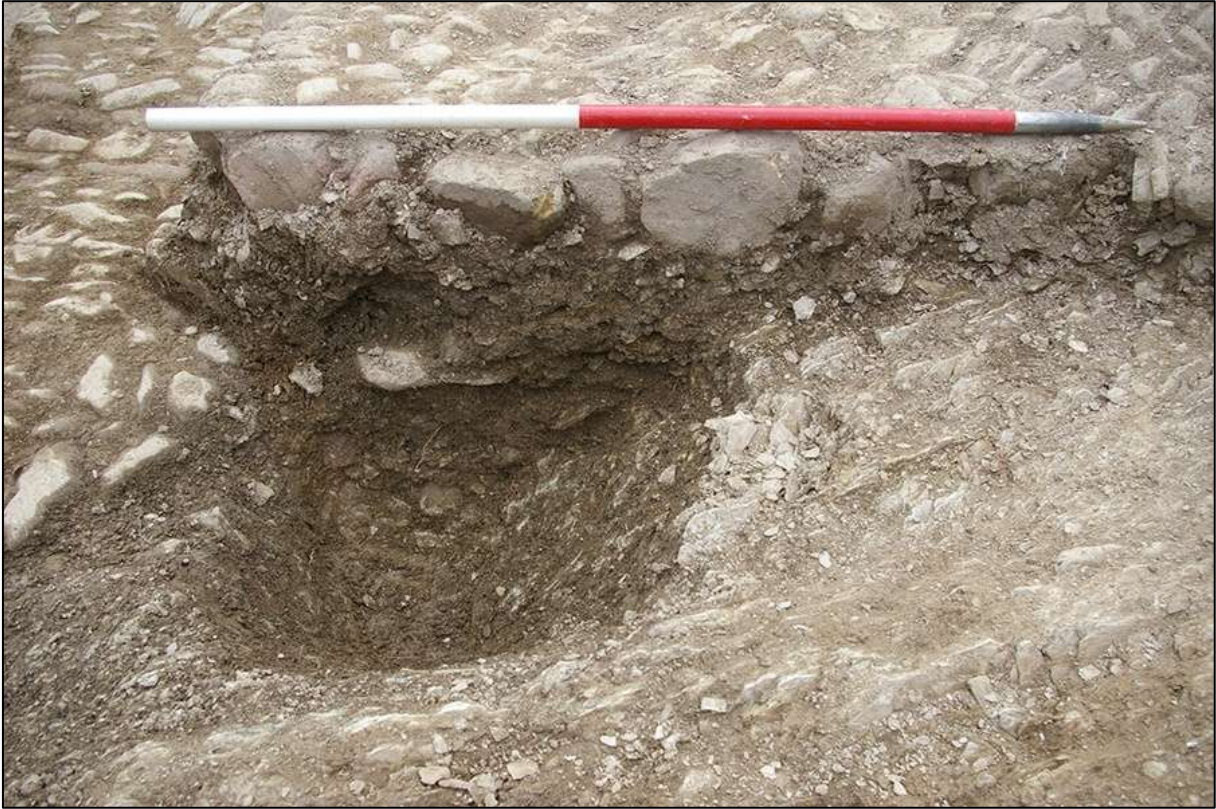
POSTHOLE [034]; VIEWED FROM THE NORTH-EAST (1M SCALE).

Posthole [034] was oval in plan with steep sides and a concave base. It cut- and was located on the west edge of Cobble floor (036) and contained a single fill, (035), which contained post-medieval finds. It was overlain by Made-ground (044).

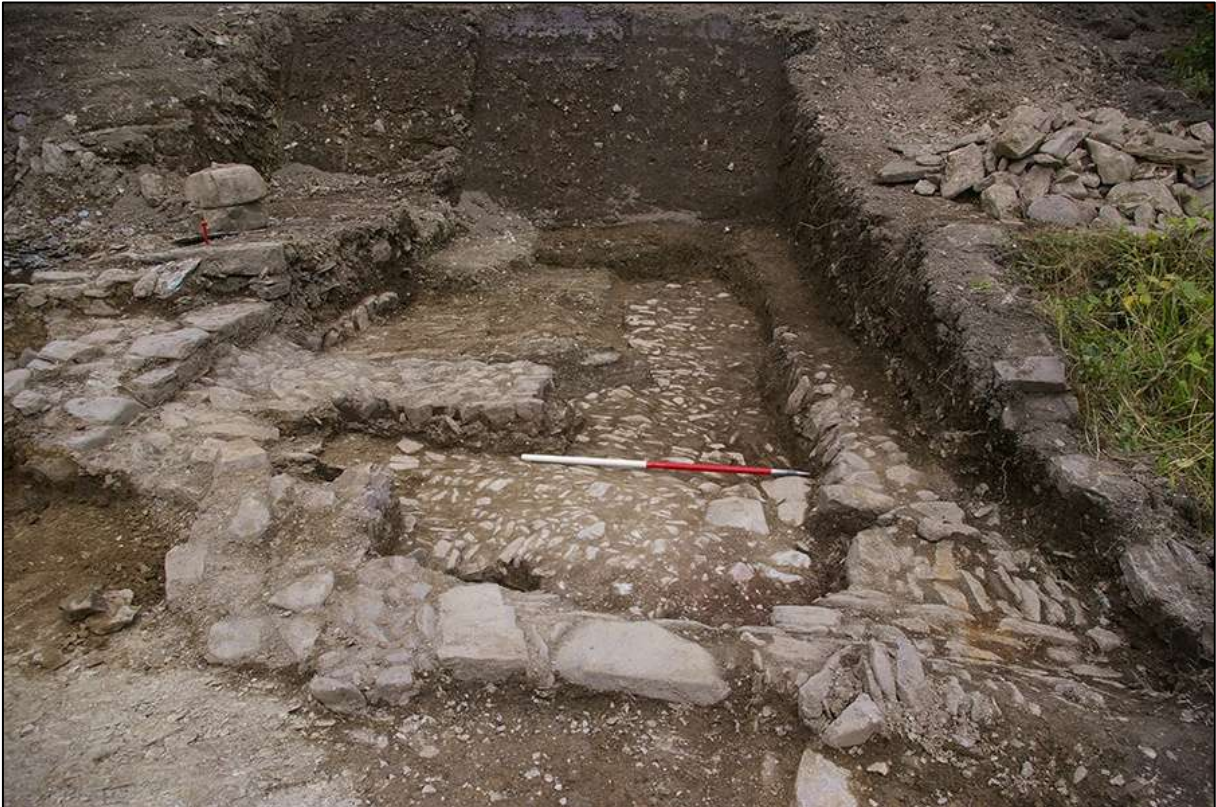
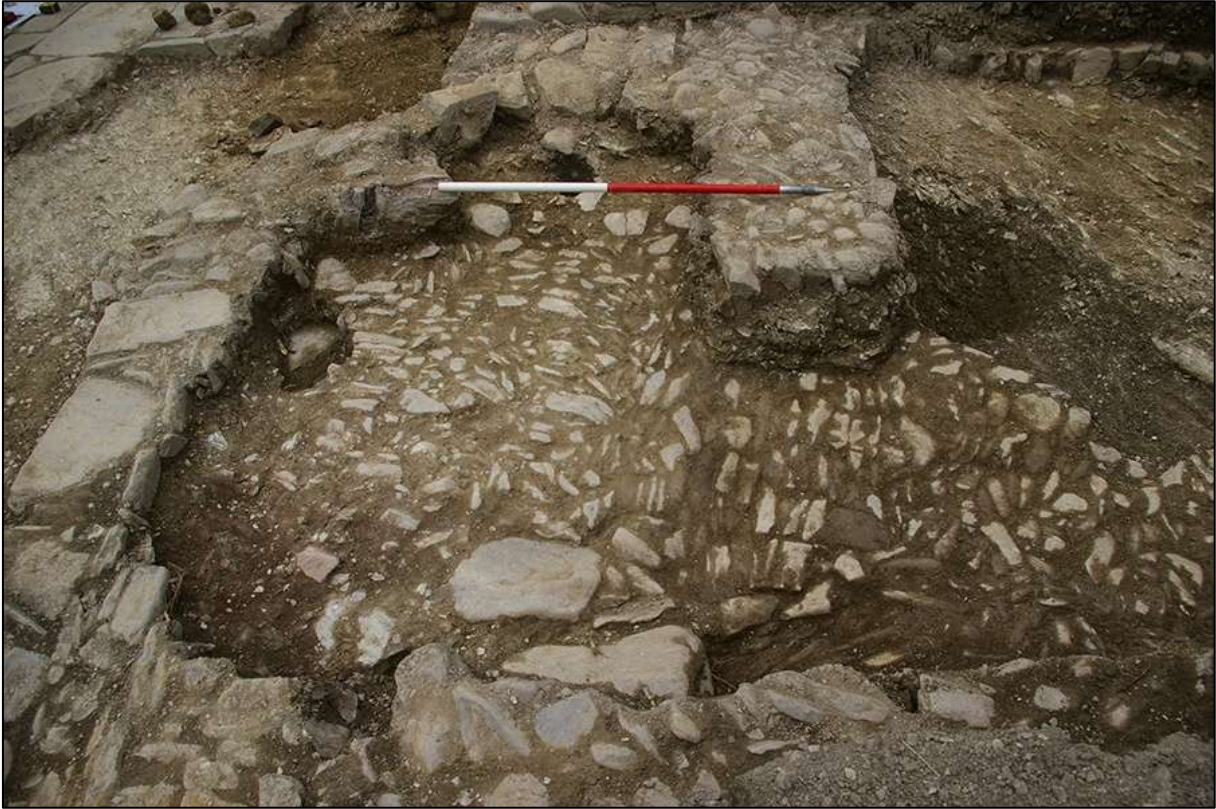
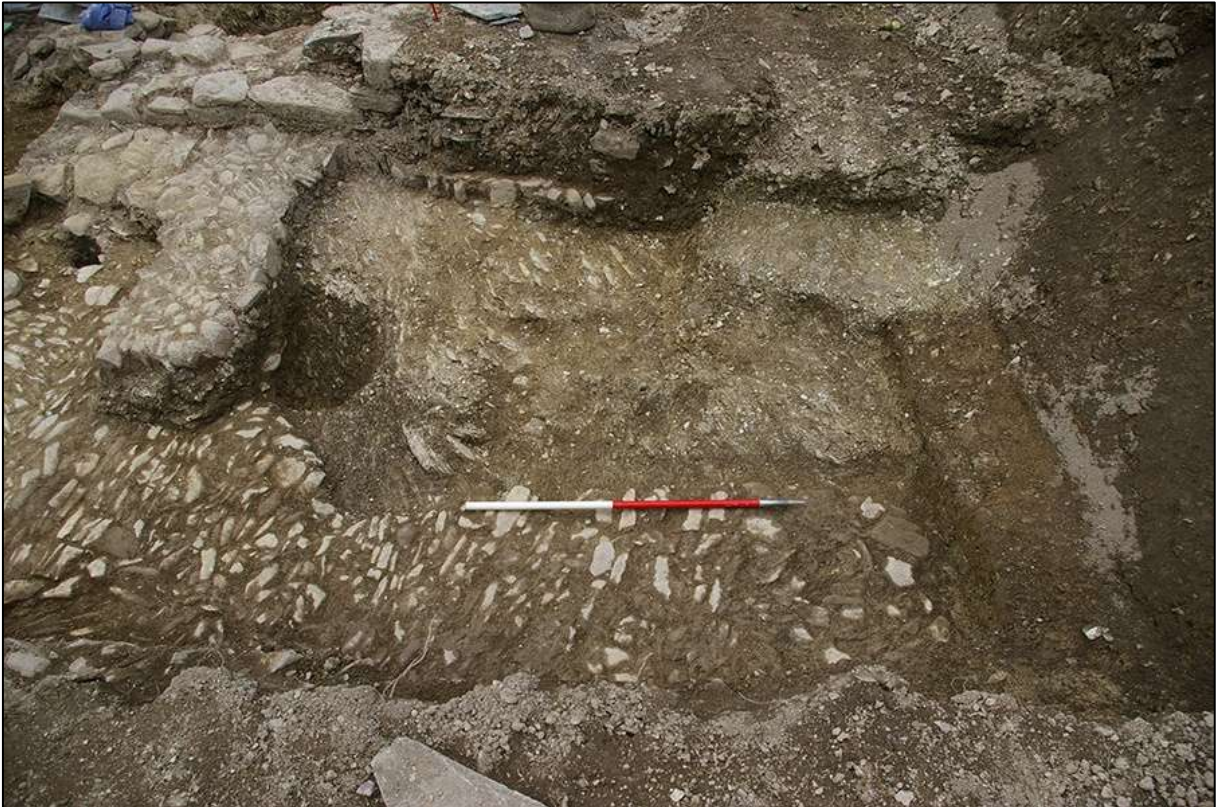
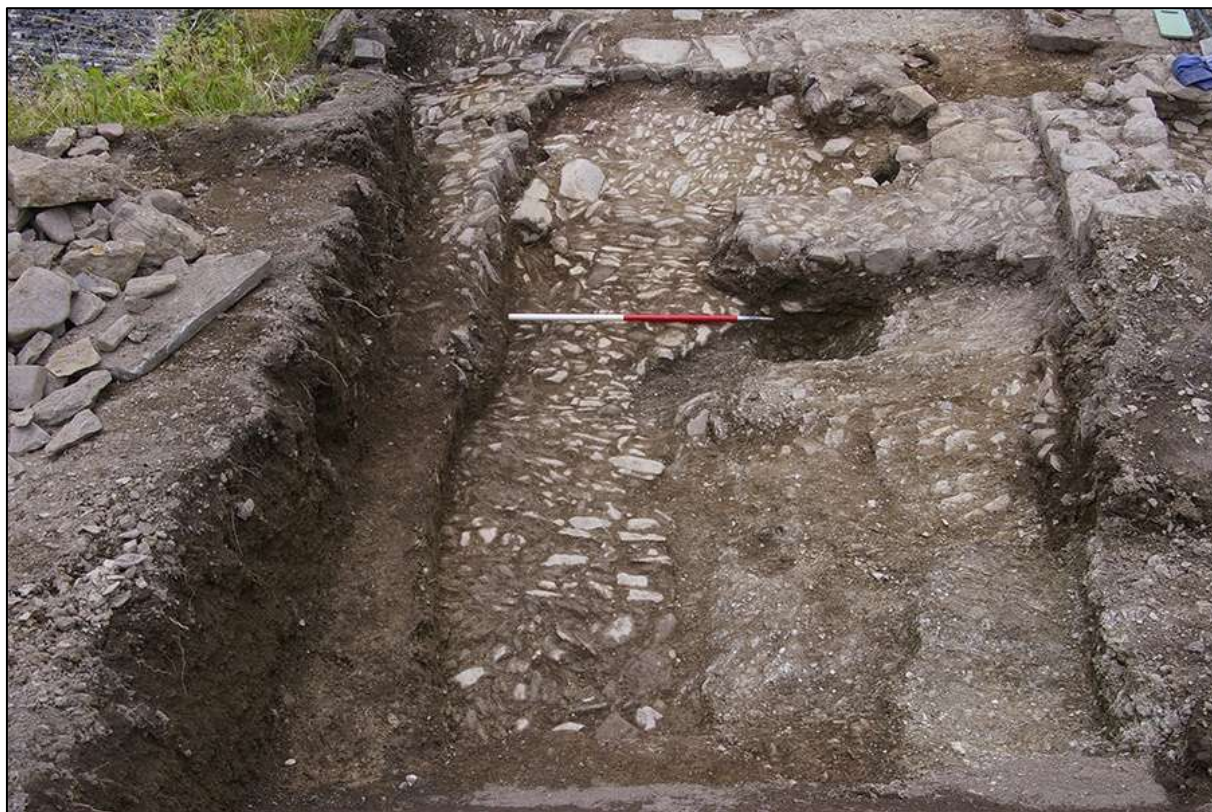
COBBLE FLOOR (036); VIEWED FROM THE SOUTH-WEST (1M SCALE).

COBBLE FLOOR (036); VIEWED FROM THE SOUTH-EAST (1M SCALE).

COBBLE FLOOR (036); VIEWED FROM THE NORTH-EAST (1M SCALE).

Cobble surface (036), c.4.25m long by 0.87-1.70m wide, was comprised of tightly packed relatively small cobbles, c.0.10m thick, set into the natural within the base of a terrace cut, [156] which had moderate stepped and concave sides and a flat base. It was located in the north-east quarter of the excavated area. The cobbles were mostly arranged irregularly, although were set in places to form drains aligned roughly east-west. (036) was either cut by or respected a drain, [047], at its south end. It was overlaid by (013), which had an in-built drain in the same location. (036) was cut by Postholes [034] and [057].

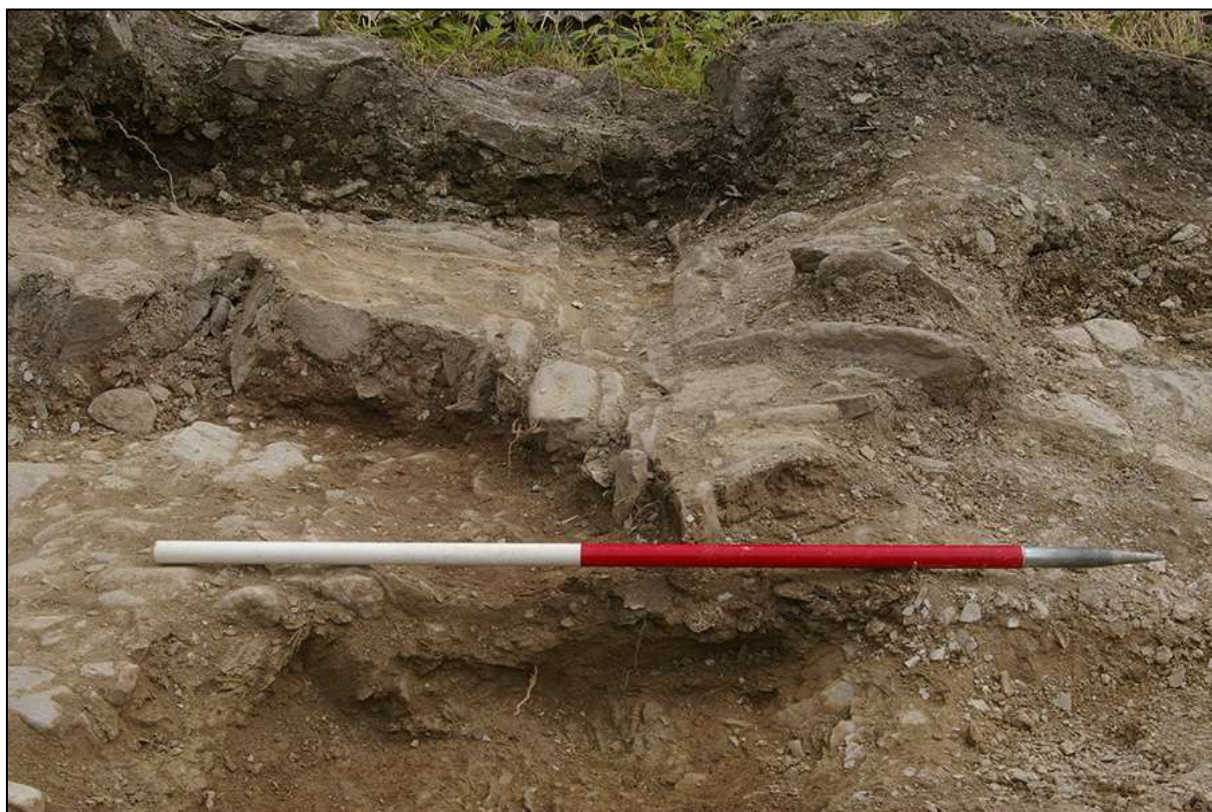
DRAIN [047]; VIEWED FROM THE NORTH-WEST (1M SCALE).

Drain [047] was a linear feature, c.0.70m wide, aligned roughly east-west with gentle-moderate slopes and flattish base. It contained a single fill, (048), which contained post-medieval pottery. It cut or was built into cobble floor (036) and was overlain by Made-ground (045) onto which cobble floor (013) was built, however the drain, which would have fed into the culvert that runs along the south-east edge of the site, was retained as a built gutter feature within the cobble floor, (013).
