# HIGHER HUNNACOTT LANDKEY NORTH DEVON DEVON

Results of Limited Historic Building Recording and Archaeological Recording

South West Archaeology Ltd. report no. 171009

By P. Webb  
Report Version: FINAL  
8<sup>th</sup> September 2017

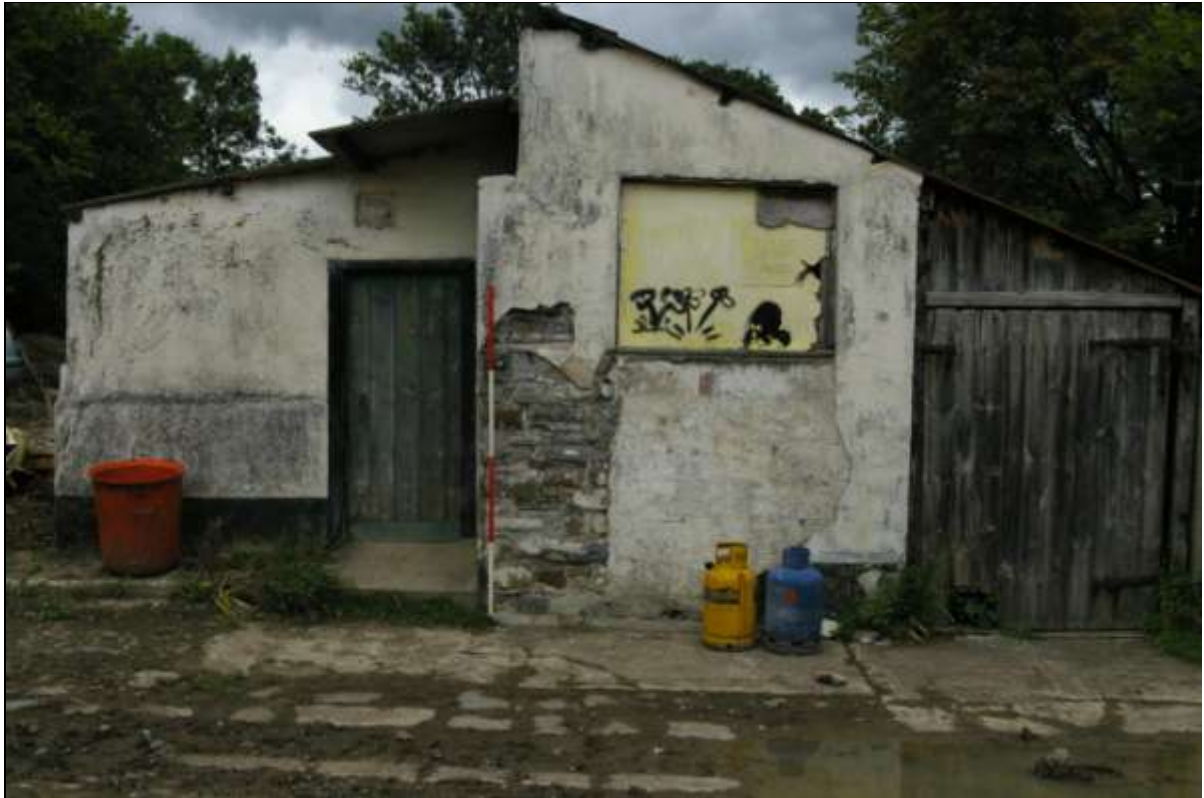
Building 5 (Figures 2, 5) comprises a two cell 'L'-shaped structure towards the northern end of the site on a north-east to south-west orientation. It is predominantly constructed of rendered concrete blockwork; the central dividing wall between the two cells being an earlier phase of dressed angular stone. The structure has a double level pitched corrugated tin roof covering (the eastern cell being to a greater height). The western, smaller, cell appears as a later addition to the eastern cell. Two door openings are visible within the structure: a single opening at the eastern end of the south elevation of the western cell, with timber plank door; and a double door opening with timber door at the east end of the south elevation of the eastern cell. Five window openings are visible in the structure, towards the centre of each elevation of the east cell (the southern being blocked); and single window opening in the north elevation of the west cell. The structure appears to have been used for storage. The earliest phase of this building, the central dividing wall between the two cells, is all that remains of the various phases of 19<sup>th</sup> century construction; the remainder of the building having been re-built in two phases during the late 20<sup>th</sup> century.

FIGURE 5: BUILDING 5 SOUTH-EAST ELEVATION; VIEWED FROM THE SOUTH-EAST (2M SCALE).

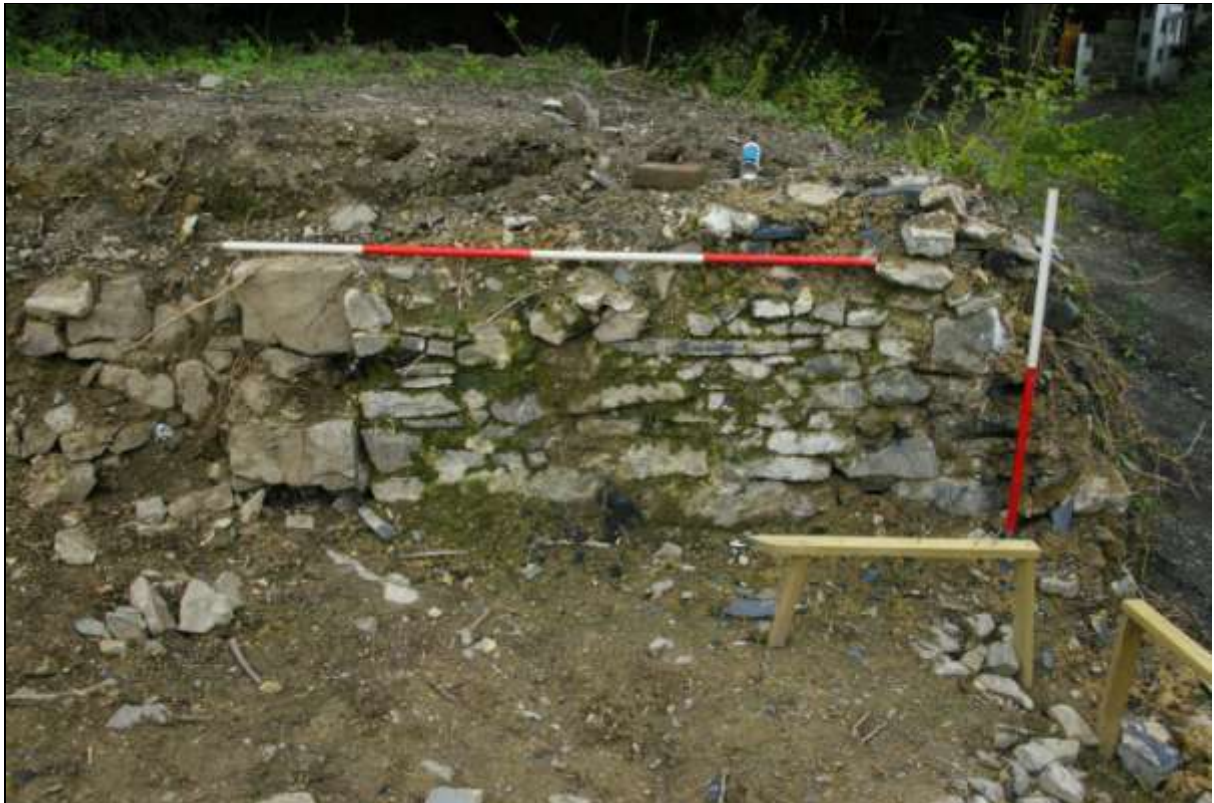
Wall 2 (Figures 2, 7) is a roughly dressed linear stone wall with loose earth bond on a north-east to south-west orientation standing up to c.1m high. It is abutted at its northern end by Wall 1. Two distinct sections are visible along this wall, the southern section being constructed of more homogenous and larger dressed stone blocks, with large stone quoins; indicating two phases of construction to this wall. The location of this wall corresponds with the western elevation of a range of buildings visible on 19<sup>th</sup> century mapping; the construction of the walls suggesting that a northern cell was constructed as a separate phase adding to an earlier structure; the southern end of the wall being lost during the construction/demolition of Building 1.

FIGURE 7: WALL 2 SOUTH-EAST ELEVATION, NORTHERN END, SHOWING TWO ABUTTING PHASES OF WALL CONSTRUCTION; VIEWED FROM THE SOUTH-EAST (1M & 2M SCALES).

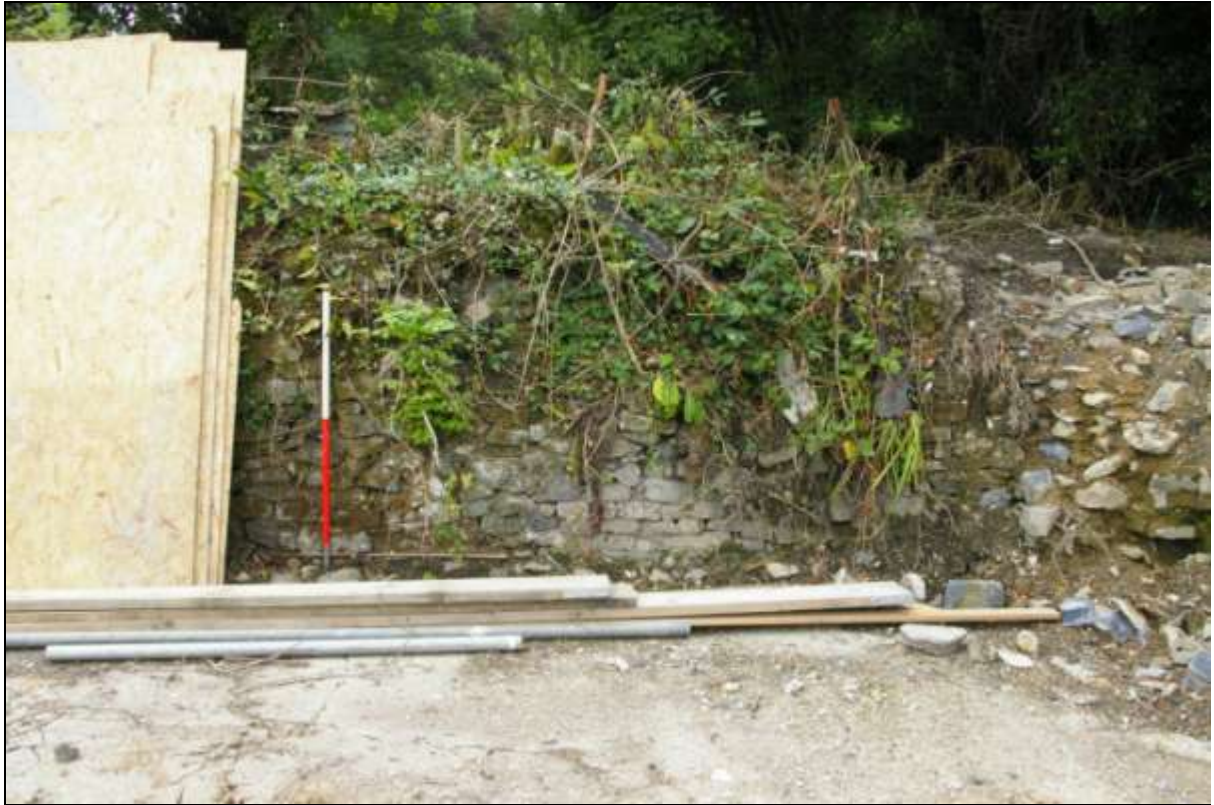
Wall 3 (Figures 2, 8) is a roughly dressed linear stone wall with loose earth bond on a north-west to south-east alignment. It stands to c.1.5m high and currently forms part of the southern boundary to the site. The wall appears 19<sup>th</sup> century in date, historic mapping indicating that it forms the southern wall of the western range of 19<sup>th</sup> century buildings identified in part as Wall 2.

FIGURE 8: WALL 3 NORTH-EAST ELEVATION, WESTERN END; VIEWED FROM THE NORTH-EAST (1M SCALE).

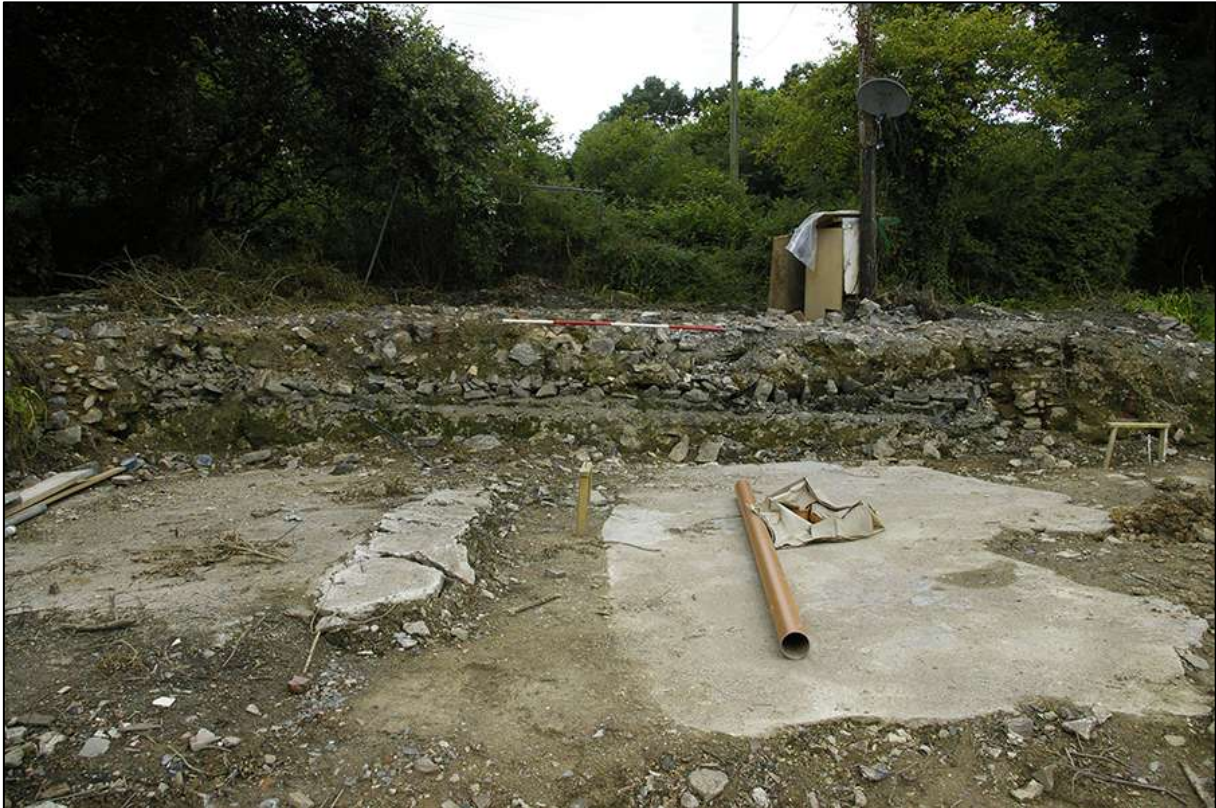
GENERAL SITE SHOT, SHOWING BACKFILL RUBBLE WITHIN BUILDING 1 (BEHIND AND BENEATH SCALE); VIEWED FROM THE SOUTH-EAST (2M SCALE).

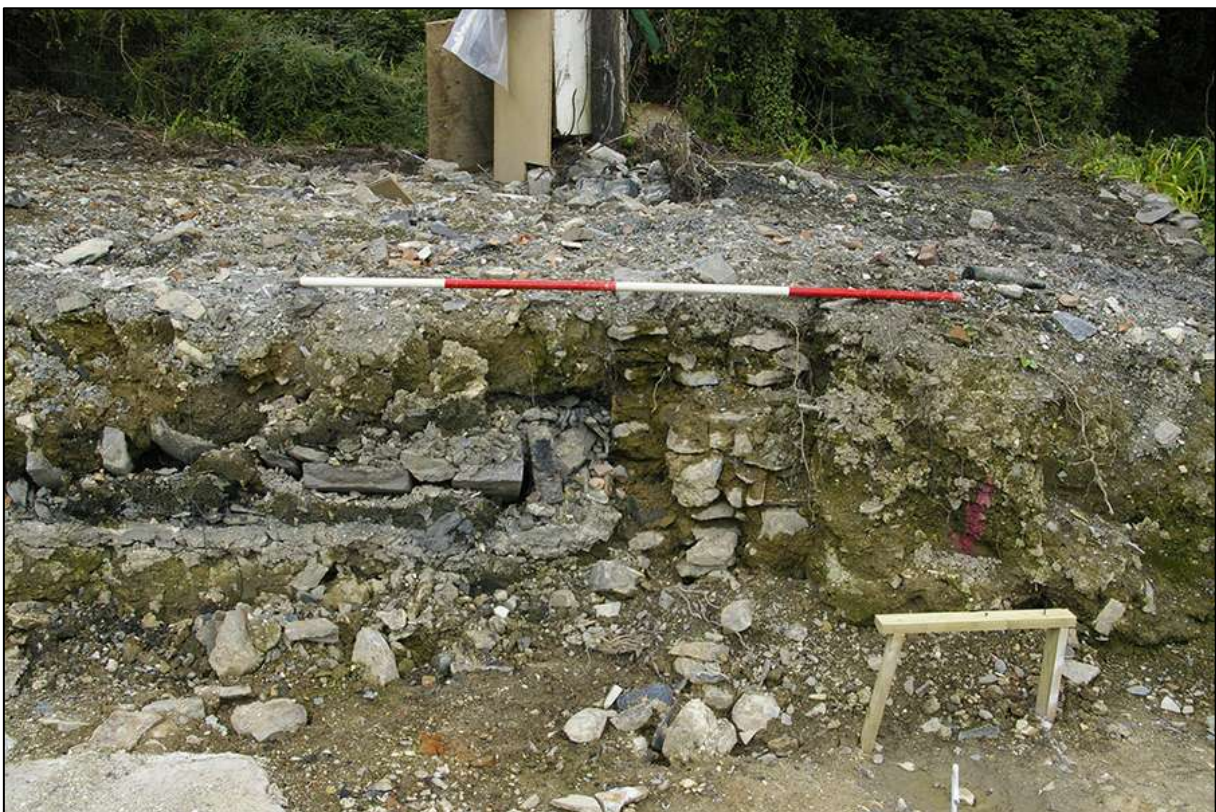
Building 1 (Figure 2) comprises the outline footprint of a loosely 'L'-shaped structure on a north-east to south-west alignment at the south-western corner of the site. Only the east end of the northern wall was visible, of rubble stone construction with traces of earth bond, measuring c.0.70m high and 0.60m wide. No other upstanding remains were identified, the entire footprint having been infilled with demolition rubble, including burnt material. No cartographic evidence of a structure at this location exists until the late 20<sup>th</sup> century; and this is likely to represent the final phase of permanent dwellings on the site, the burnt nature of some of the demolition infill indicating that it was perhaps the building believed to have burnt down in the mid 20<sup>th</sup> century.

BUILDING 1, DETAIL OF WALL CONSTRUCTION WITH ABUTTING BURNT RUBBLE BACKFILL; VIEWED FROM THE SOUTH-EAST (2M SCALE).

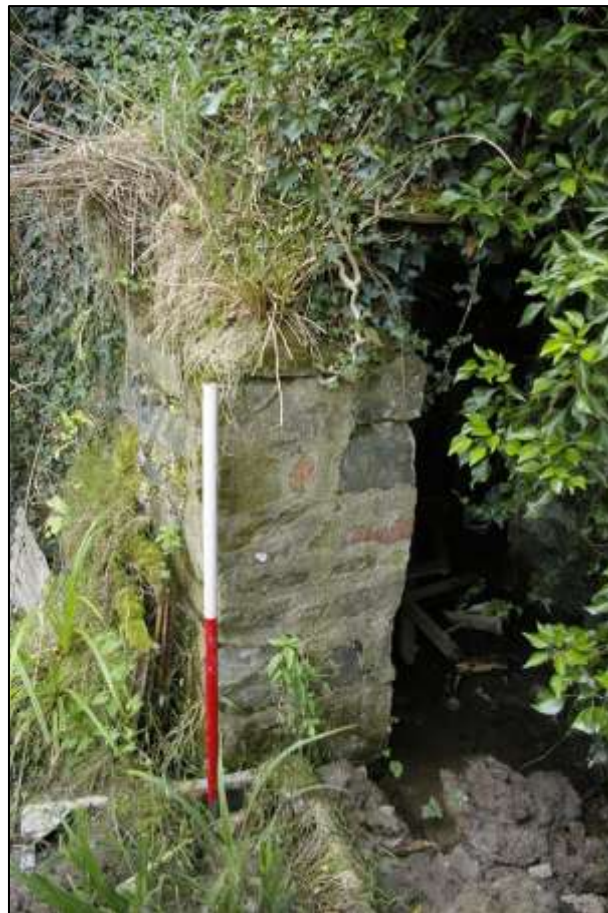
BUILDING 6 DETAIL OF REPAIRS TO NORTH WALL; VIEWED FROM THE NORTH-WEST (1M SCALE).

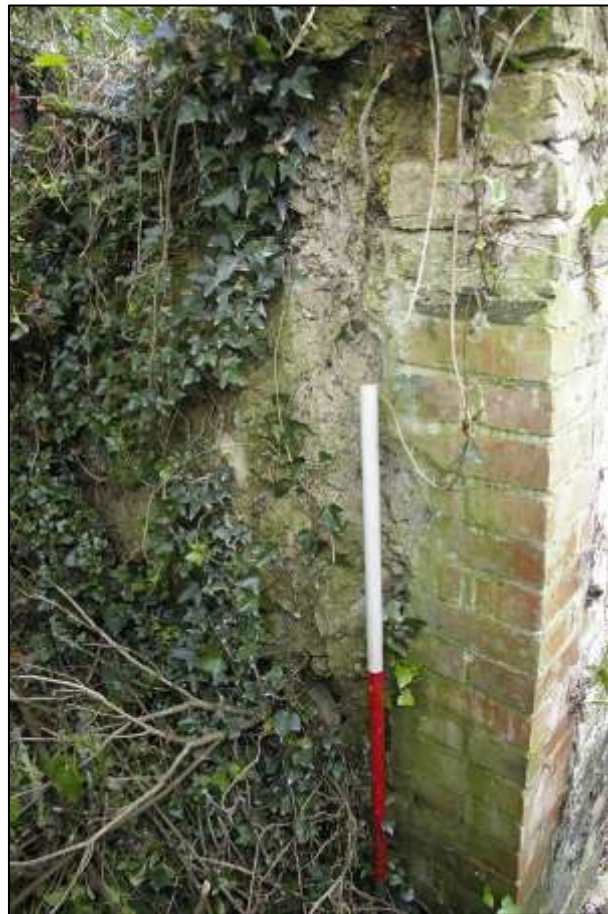
the east of which the upper portion of Wall 4 can be seen to be of cob construction. Brick repairs have been made to the eastern end of the wall, where it forms an opening against the west wall of B3. The north-west return and western end of the main length of wall form the south- and north-western walls of Building 2, being abutted by the 20<sup>th</sup> century walls of the structure. The wall currently forms part of the southern boundary to the site, though historic mapping indicates that it formed the southern and western walls of a range of 19<sup>th</sup> century buildings, of which Building 3 forms the eastern end; the remaining wall having been largely demolished in the early 20<sup>th</sup> century.

WALL 4 DETAIL OF BRICK REPAIRS AT EASTERN END; VIEWED FROM THE EAST (1M SCALE).

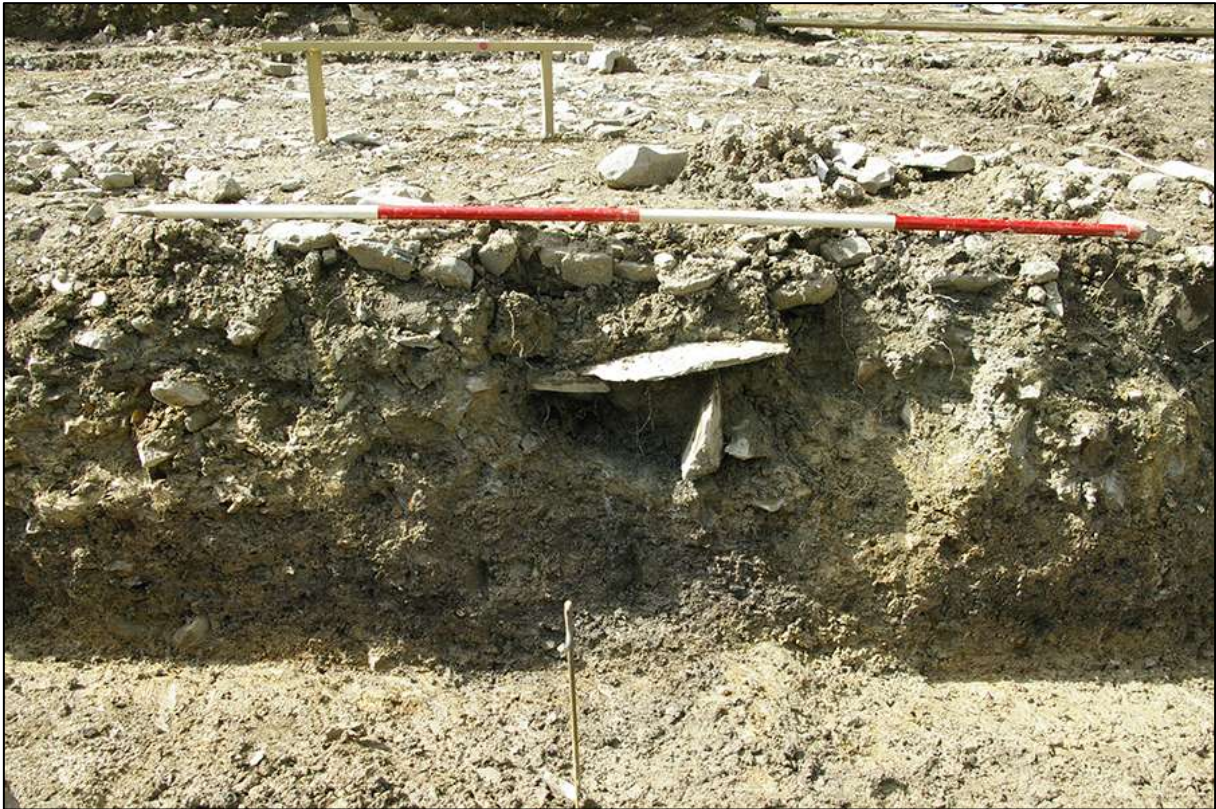
AREA 01 MIDDLE FOUNDATION TRENCH, DRAIN {125} NORTH-EAST FACING SECTION; VIEWED FROM THE NORTH-EAST (2M SCALE).

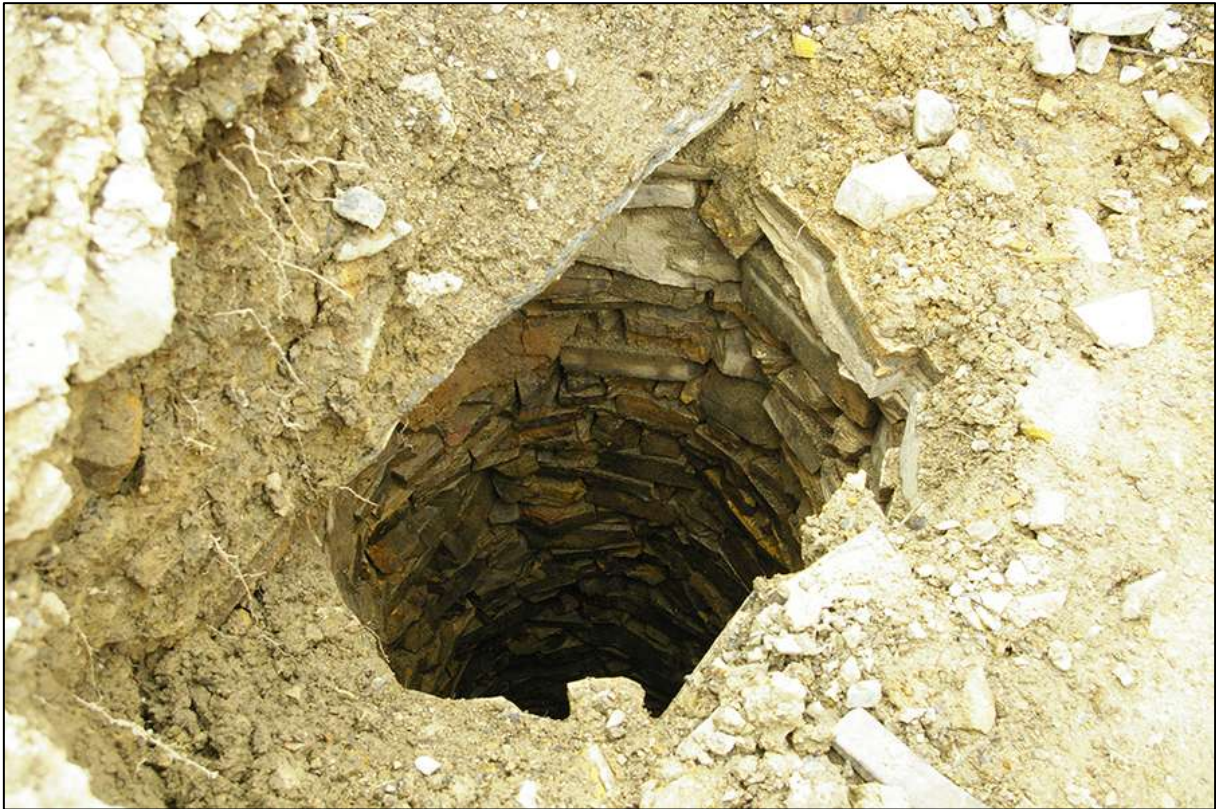
AREA 01 MIDDLE FOUNDATION TRENCH, DETAIL OF WELL {129}; VIEWED FROM THE NORTH-EAST (NO SCALE).

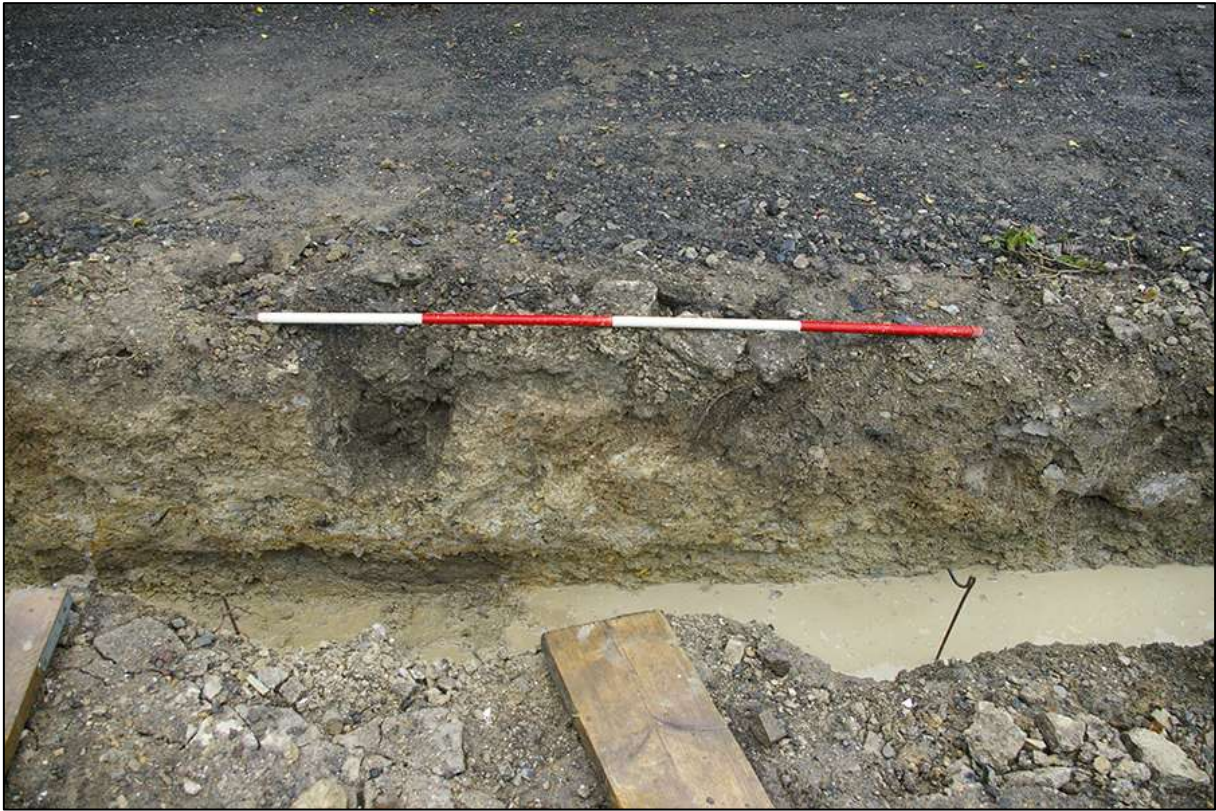
AREA 01 NORTHERN FOUNDATION TRENCH, WALL CUT [145] SOUTH-EAST FACING SECTION; VIEWED FROM THE SOUTH-WEST (2M SCALE).

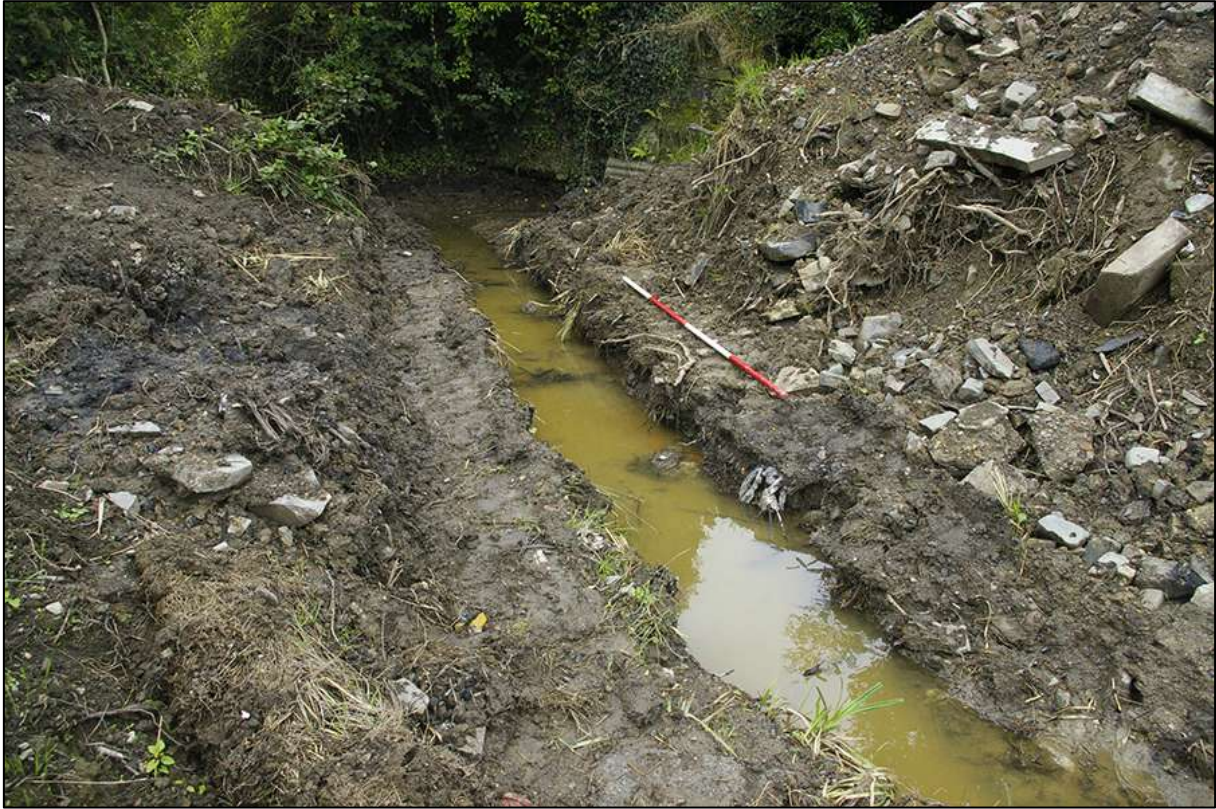
AREA 03, SHOWING LEVEL OF GROUND WATER/FLOODING; VIEWED FROM THE NORTH-WEST (2M SCALE).
