# OLD TRINE MODBURY SOUTH HAMS DEVON

Historic Building Appraisal, Statement of Significance & Impact Assessment

South West Archaeology Ltd. report no. 161223

By E. Wapshott & B. Morris  
Report Version FINAL  
23<sup>rd</sup> December 2016

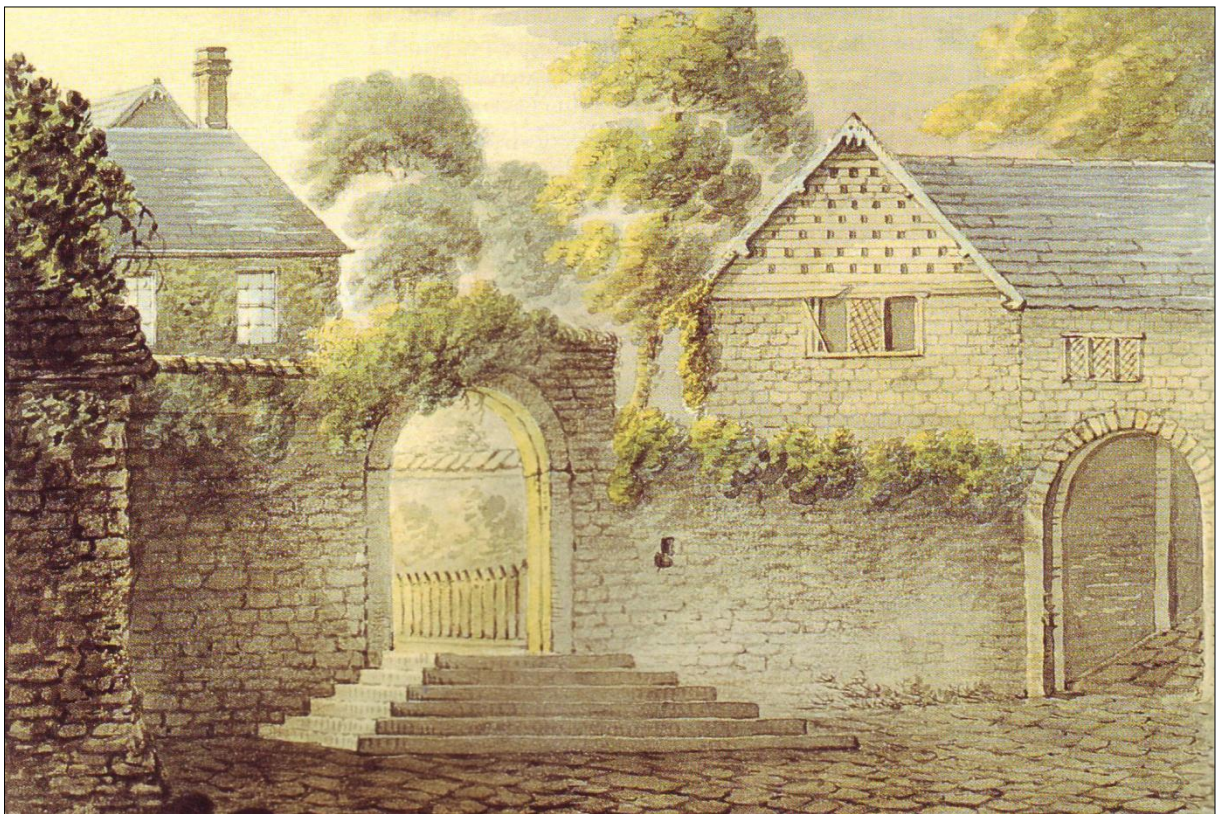
Figure 2: The Rev. John Swete’s watercolour of Traine (undated) (reproduced from Gray 1998, 20; DHC ref: 564M/F5/79). Note the gatehouse to the right is shown as gabled with pigeon holes, and the window is not shown as the two-light casement with granite mullion and lintel. In contrast, the little that can be seen of Old Traine (in the background) is very similar to the extant structure, with the exception of a slightly taller chimney.

A key consideration for Traine is the extent to which it may have been modified by Swete himself. His journals are entitled *Picturesque Sketches of Devon* and he was clearly both well-informed and opinionated. It is very possible Traine and its surroundings may have been arranged to suit his tastes, and this should be borne in mind.

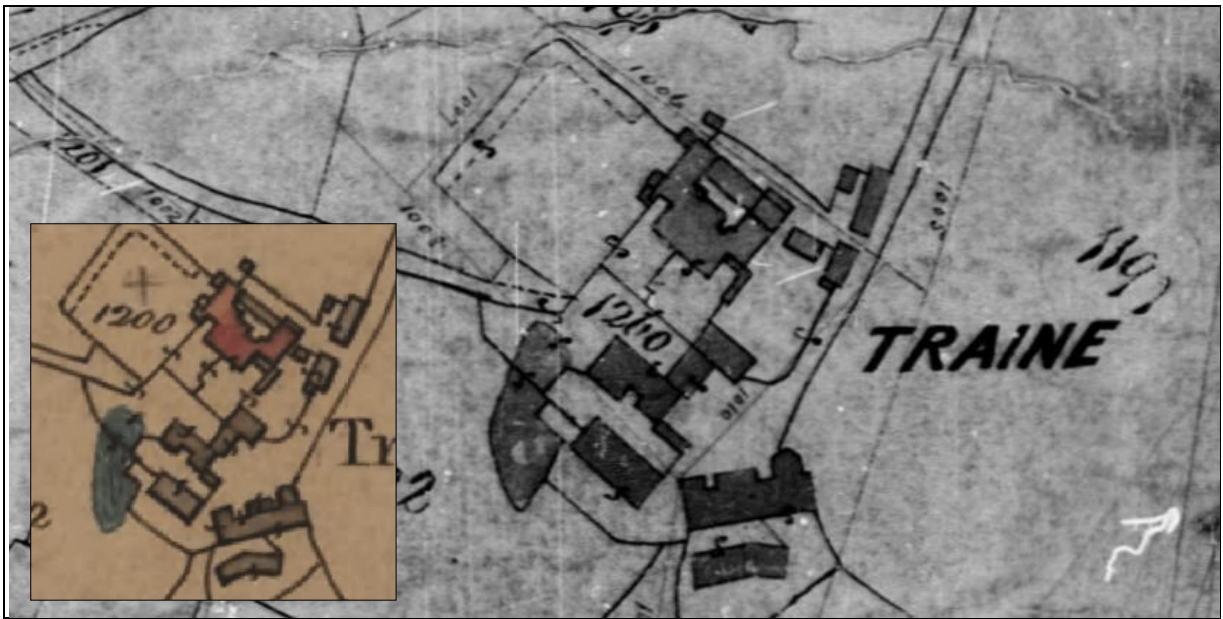
FIGURE 3: EXTRACT FROM THE 1841 MODBURY TITHE MAP 1841; PRO MAP, WITH DHC MAP AS INSET.

The earliest map of the site available to this study is the tithe map of 1841. The PRO and DHC maps are slightly different and show complementary information. The PRO map is clearly more detailed and shows the survey lines; the DHC map is less detailed and seemingly less accurate, but there is a distinction between domestic buildings (in pink) and outbuildings (in grey). Many of the field names to the south and east of Traine feature the element *park*; park is a fairly standard field name element in Devon (like *close*, or *field*) but might hint at a landscape or earlier park associated with the house.

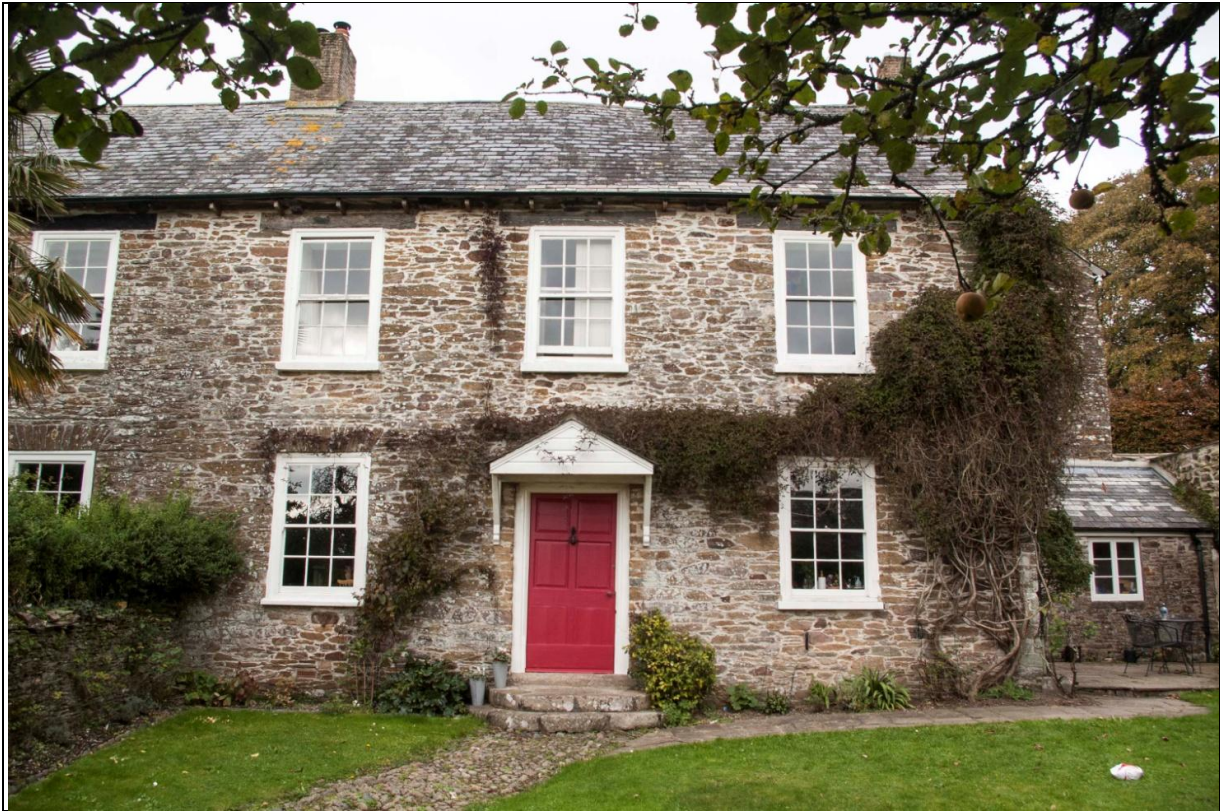
Figure 6: The south front elevation of Old Traine, the eastern of the two dwellings formed from the former hall range in c.1800; from the south.

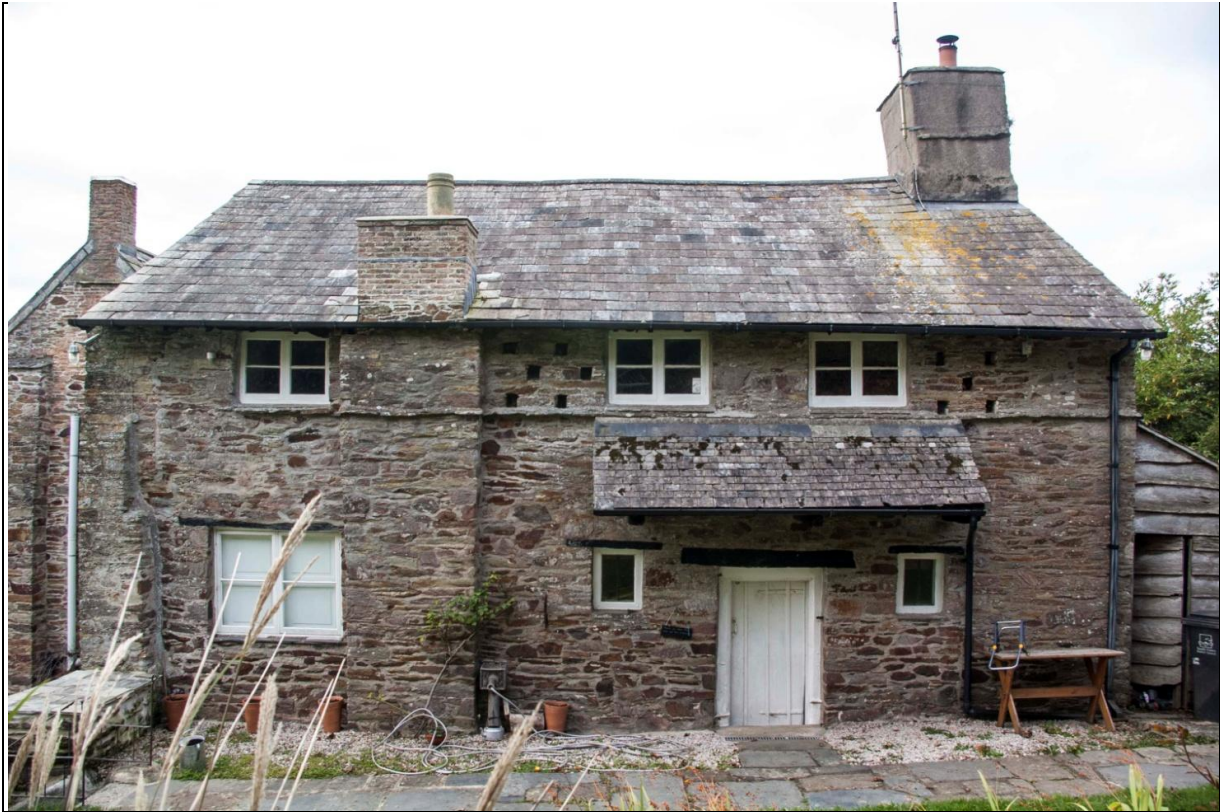
Figure 7: The east elevation of the east range; from the east.

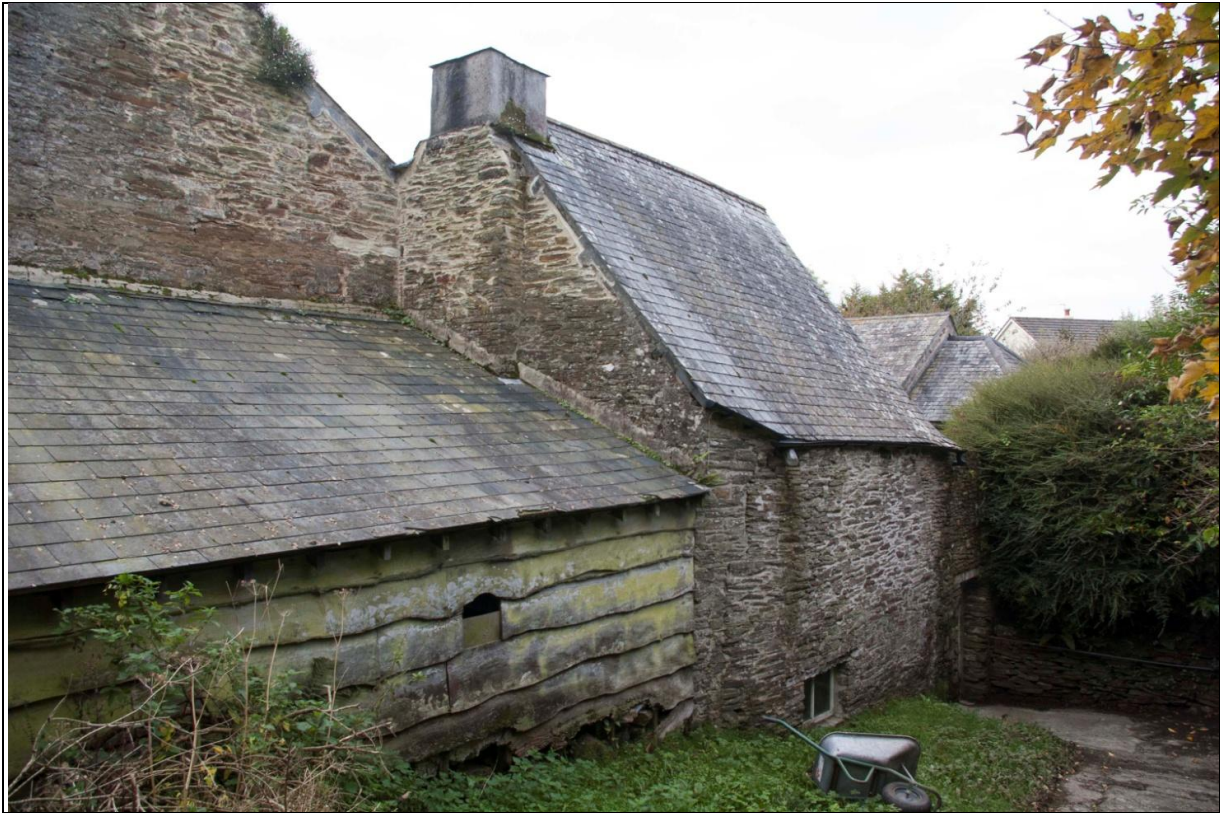
Figure 8: The relationship between the east and north ranges, showing the timber garage/shed, potentially built in place of a demolished stone building; from the north-east.

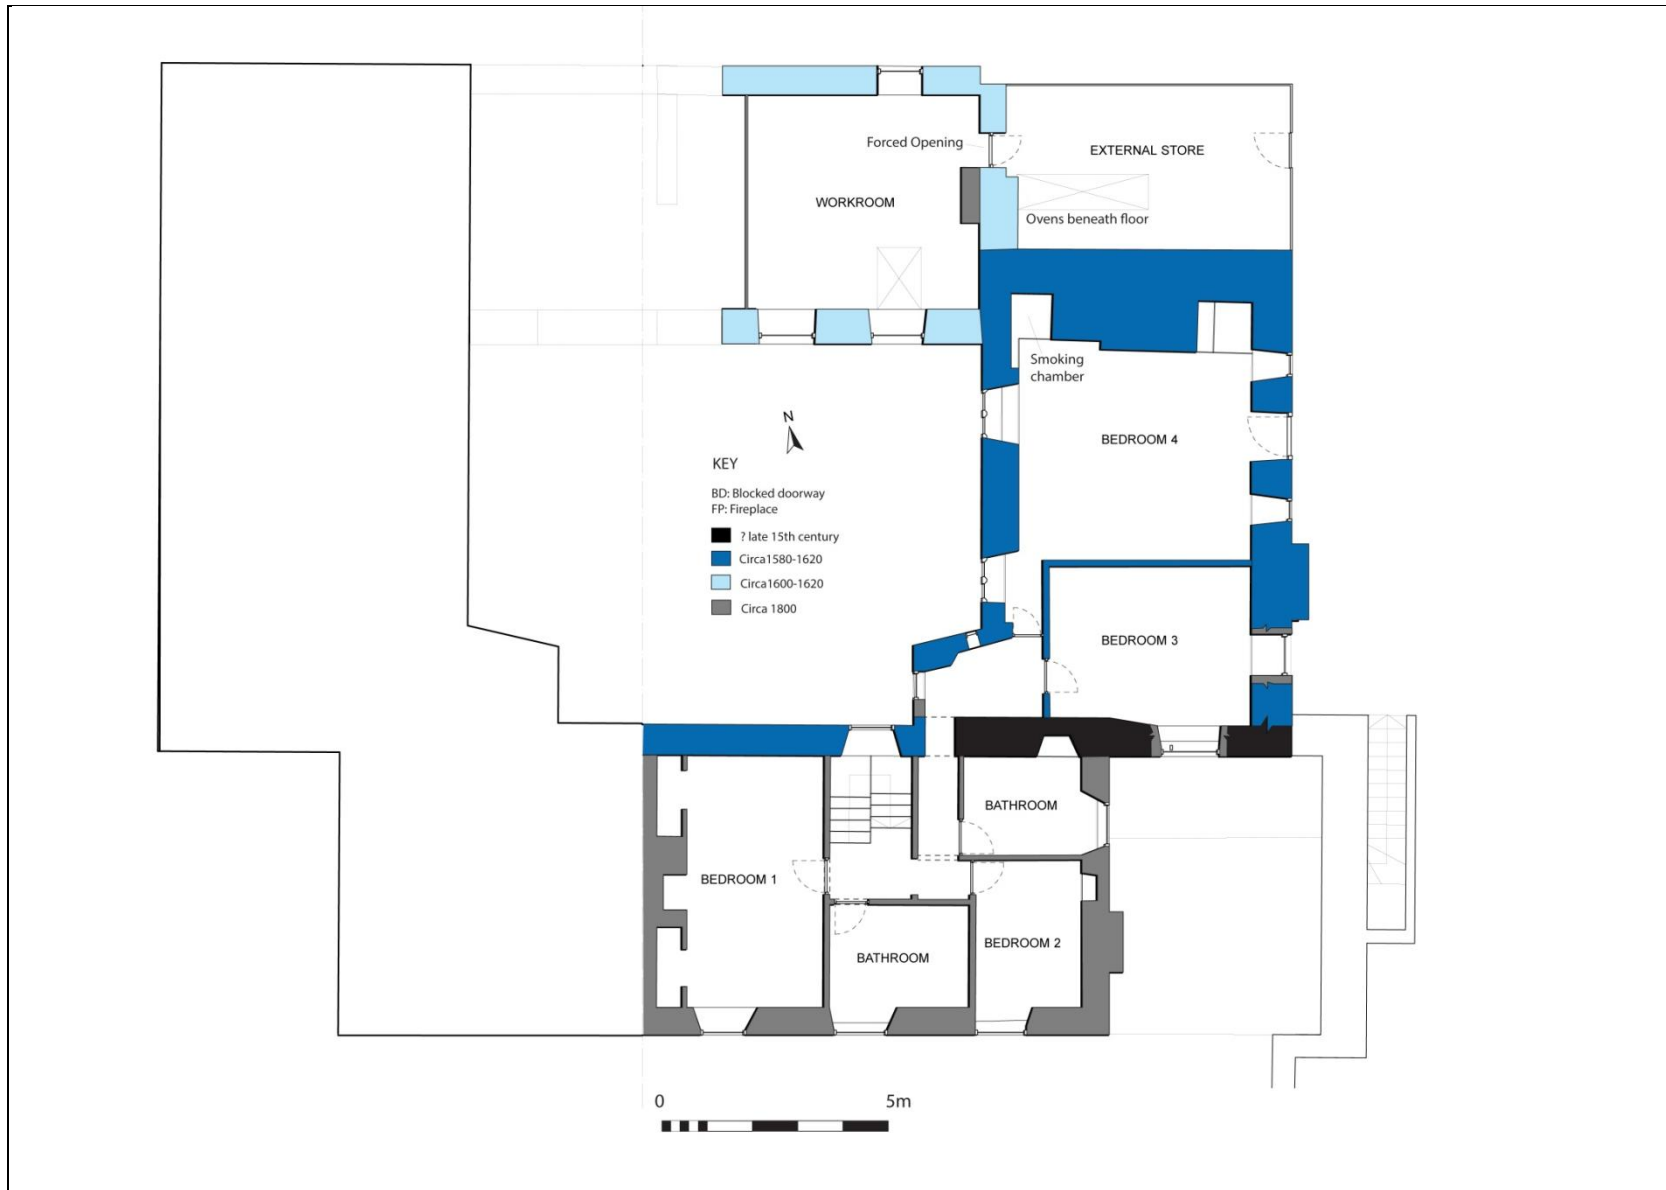
Figure 10: Provisional phasing: first floor (based on supplied drawings).

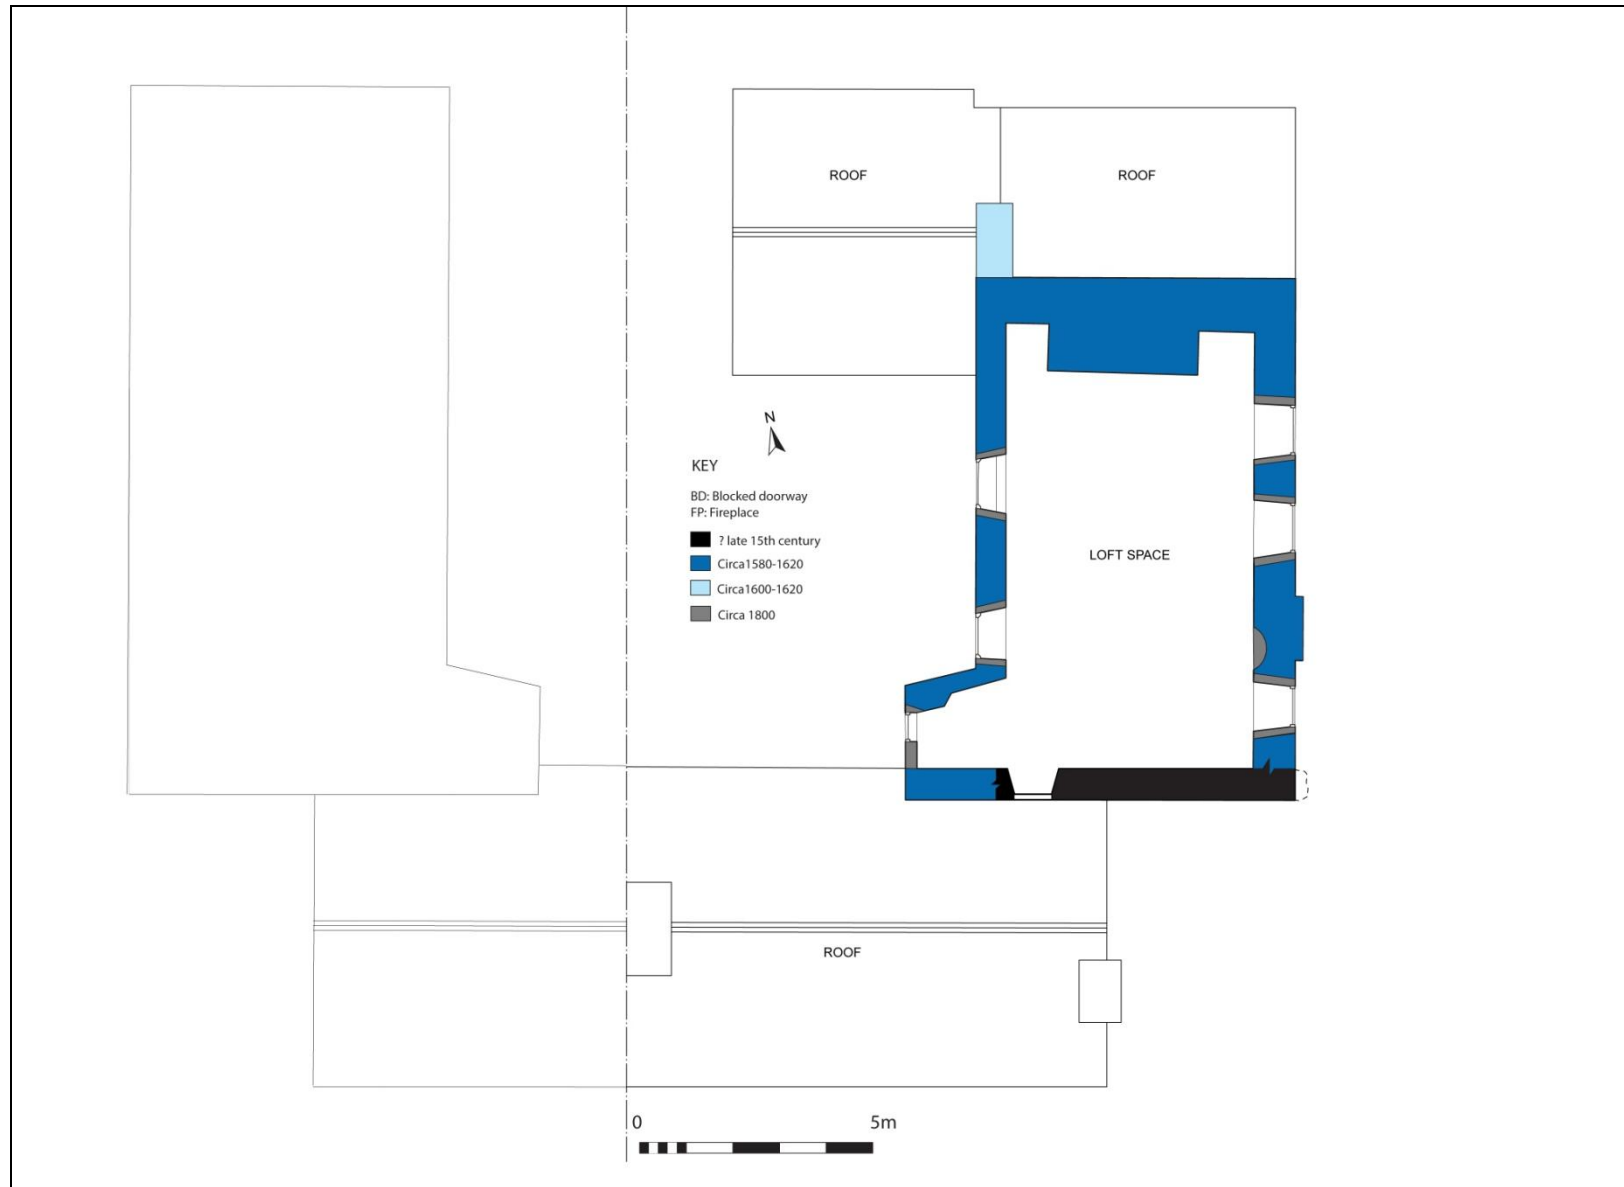
Figure 11: Provisional phasing: second floor (based on supplied drawings).

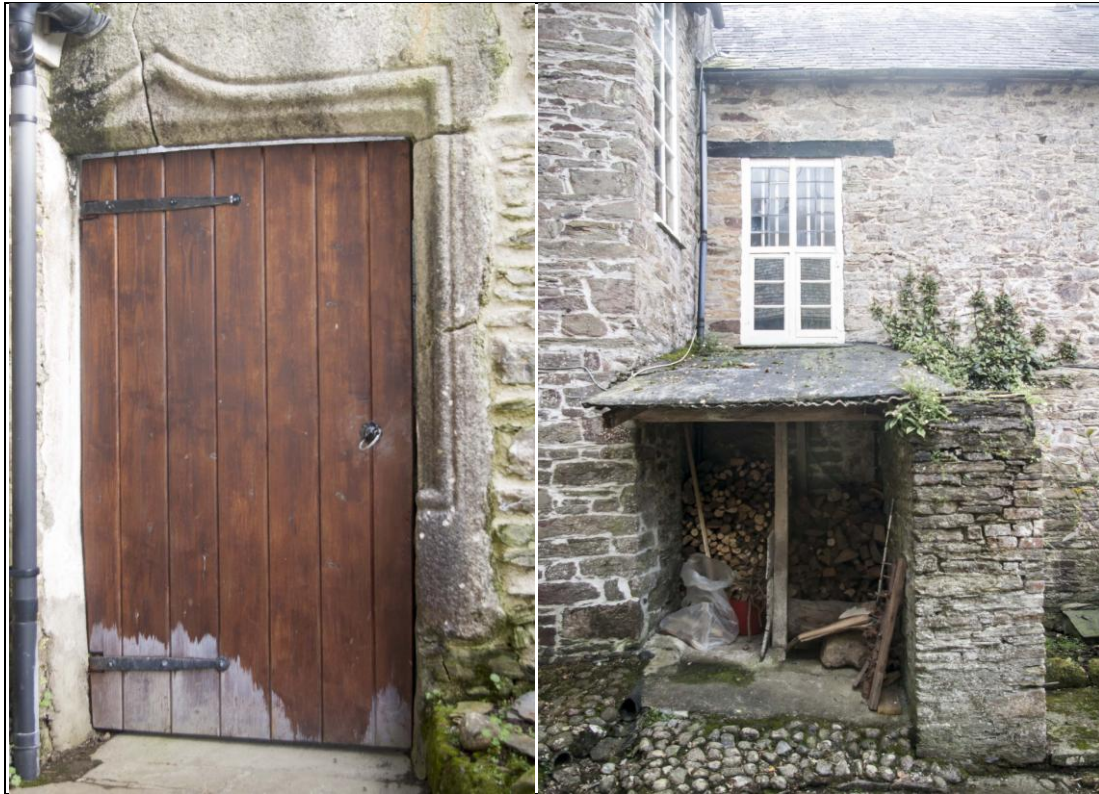
Left: Fireplace surround, 17<sup>th</sup> century, in east garden wall, repurposed as a doorway; from the west-south-west.  
Right: Eastern stair turret, serving south range, abutted by modern log store roof, with 19<sup>th</sup> century wall of demolished lean-to to west (right); from the north.

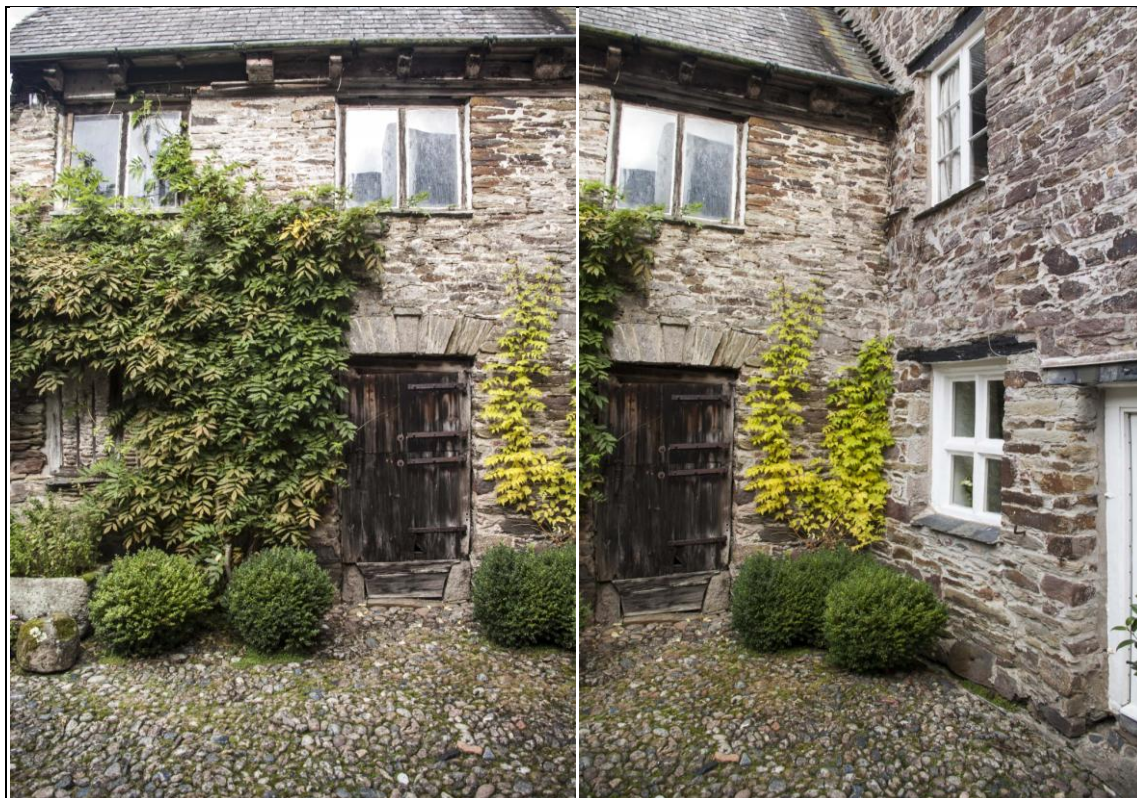
Left: Detail of front elevation of north range, showing dressed details and overhanging decorative eaves structure; from the south.

Right: Detailed view of the adjoining east and north ranges, exhibiting complex phasing; from the south-west.

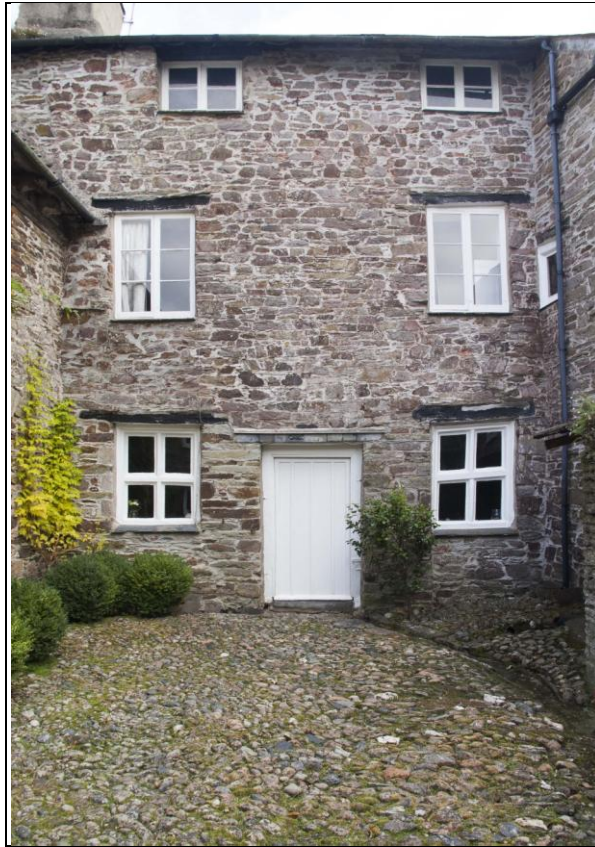
Shot of the western elevation of the east range, facing into the courtyard; from the west.

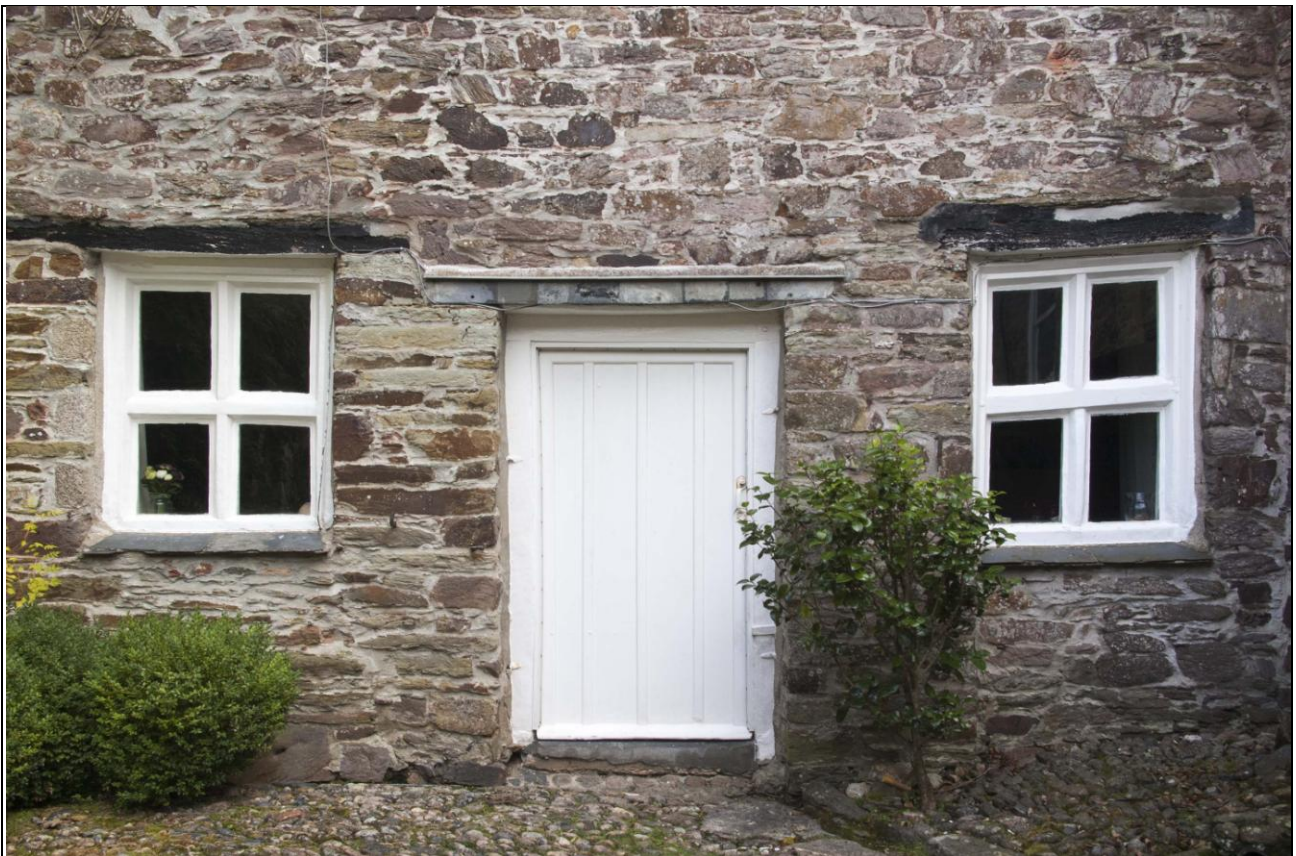
View of the central door and flanking windows, of 17<sup>th</sup> century date, in the ground floor of the east range, facing into the courtyard; from the west.

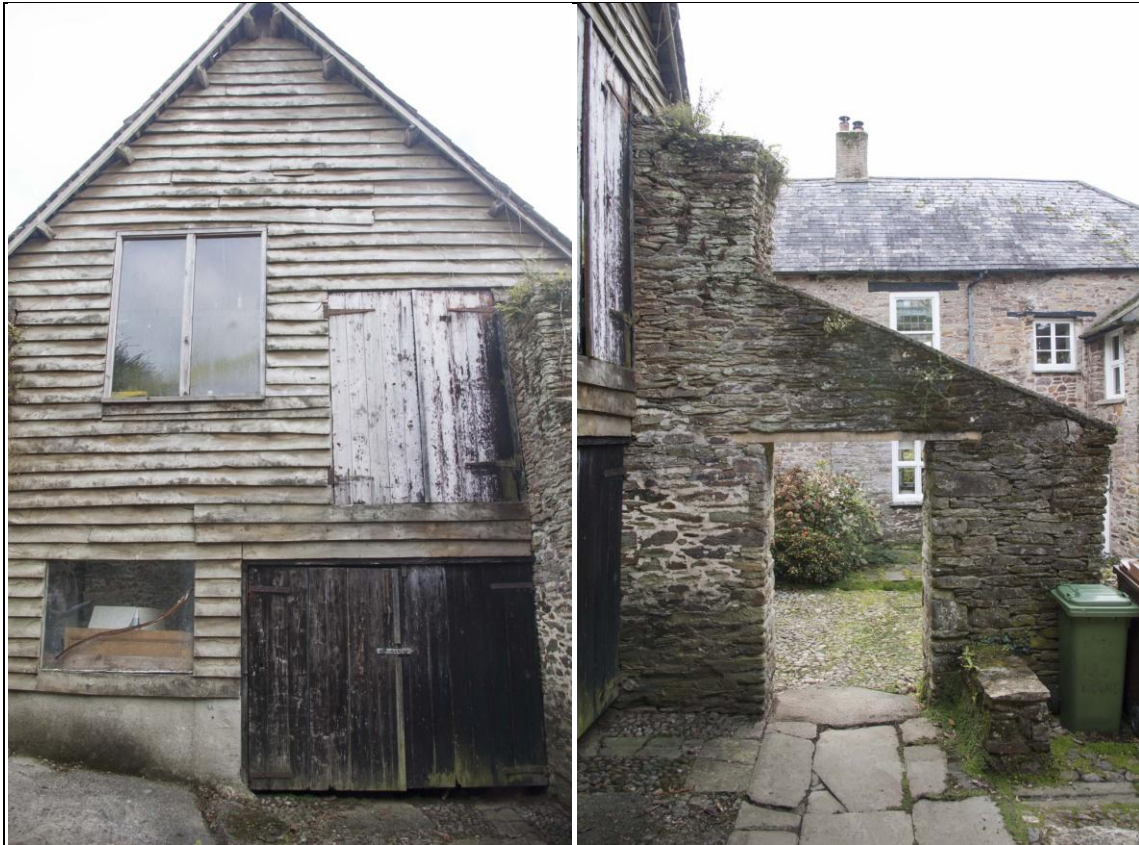
Left: The 1960s timber clad and framed west wall of the standing remains of the north range; from the west.  
Right: The original central door of the north range, within a surviving section of wall; from the north.

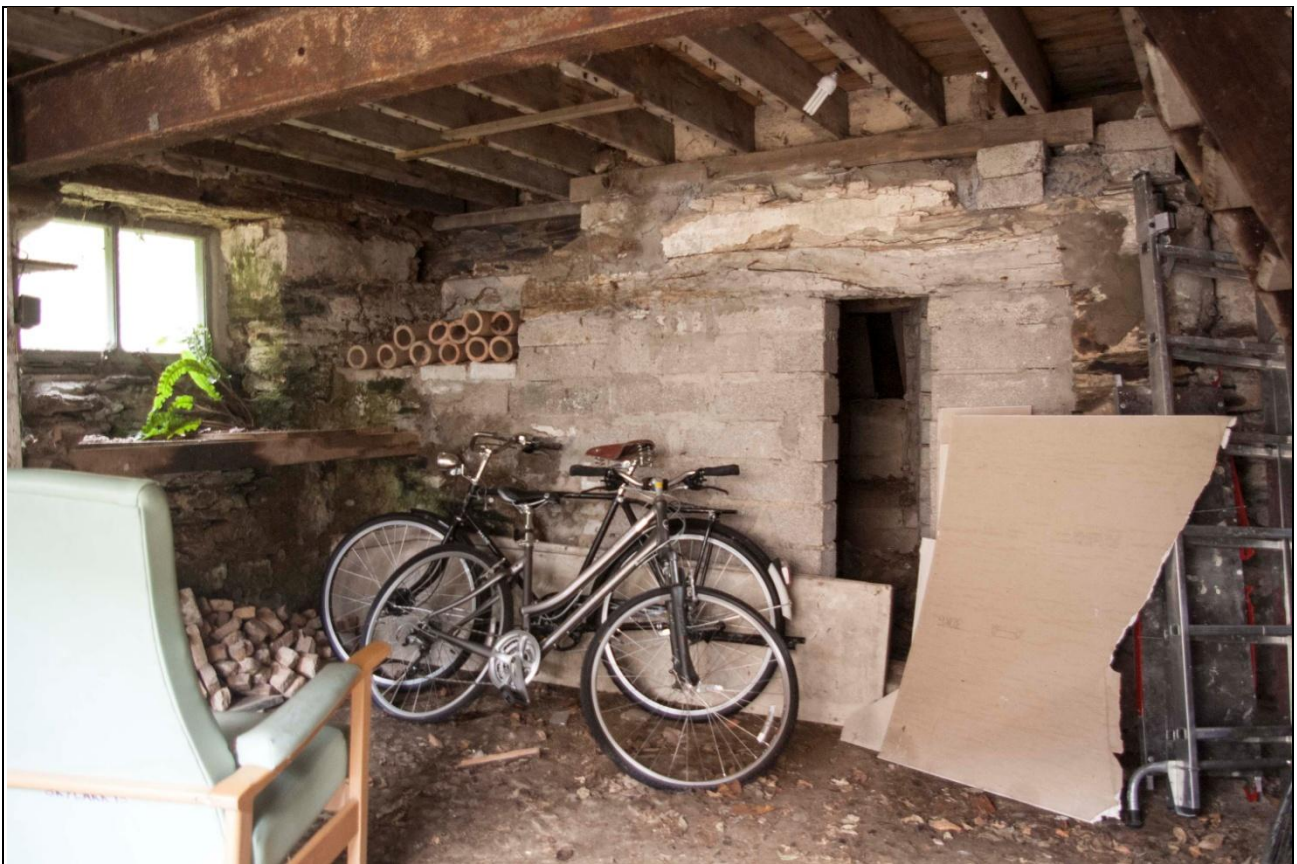
The series of stack and oven structures to the east end of the north range, showing significant intervention in the 1960s; from the south-west.

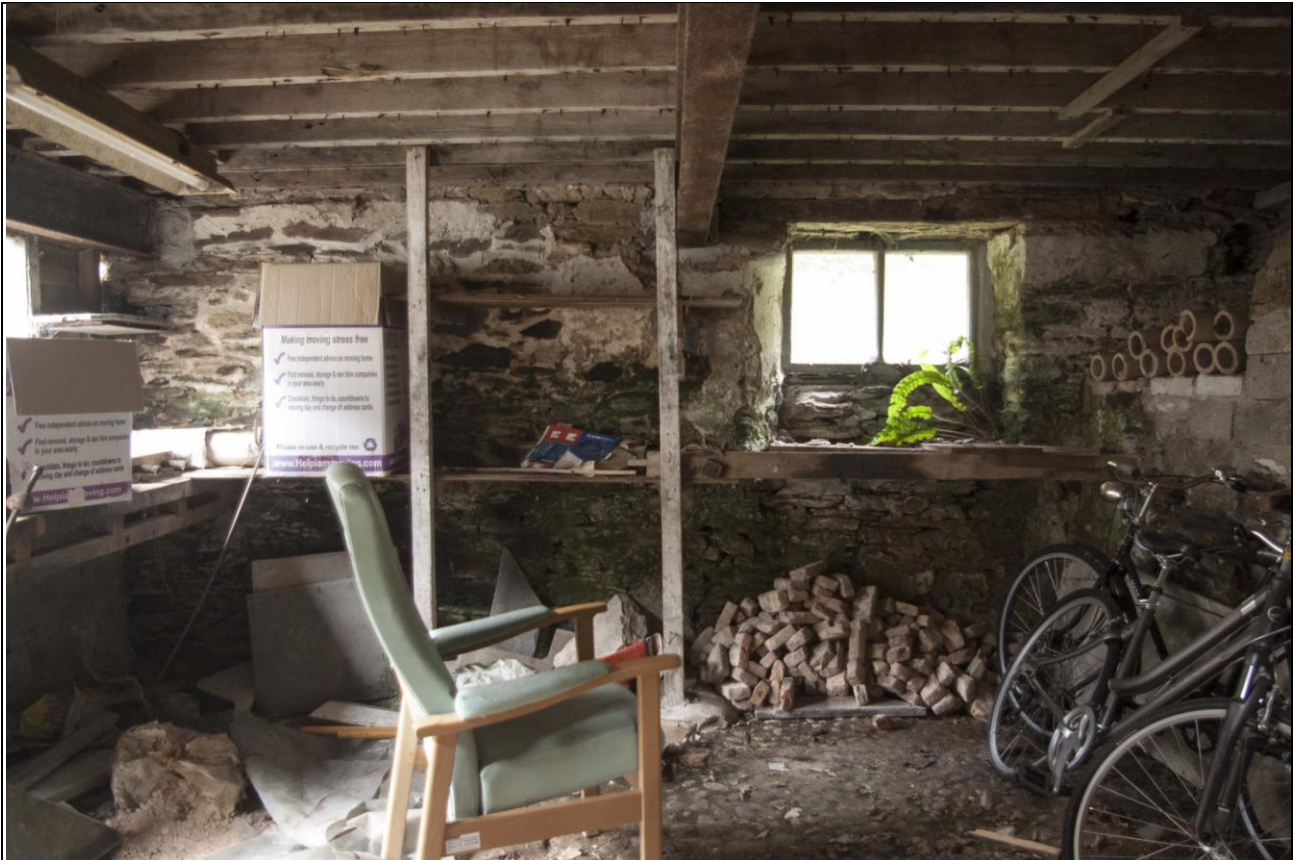
The north wall of the north range, at ground floor level, with a small forced window to the east side; from the south.

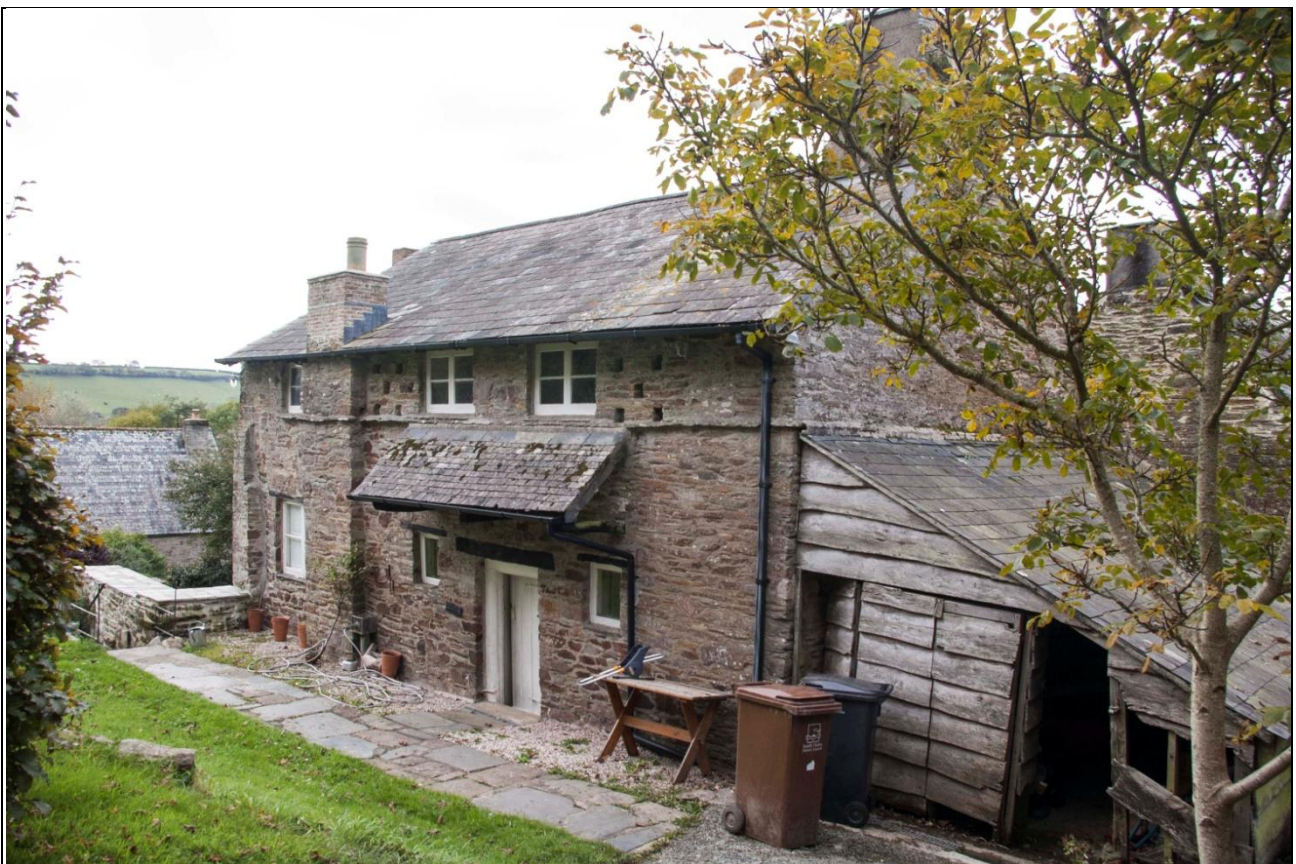
The east elevation of the east range, showing porch, which incorporates surviving sections of pentice, with drip course above, showing it formally ran almost the entire length of the elevation; from the north-east.

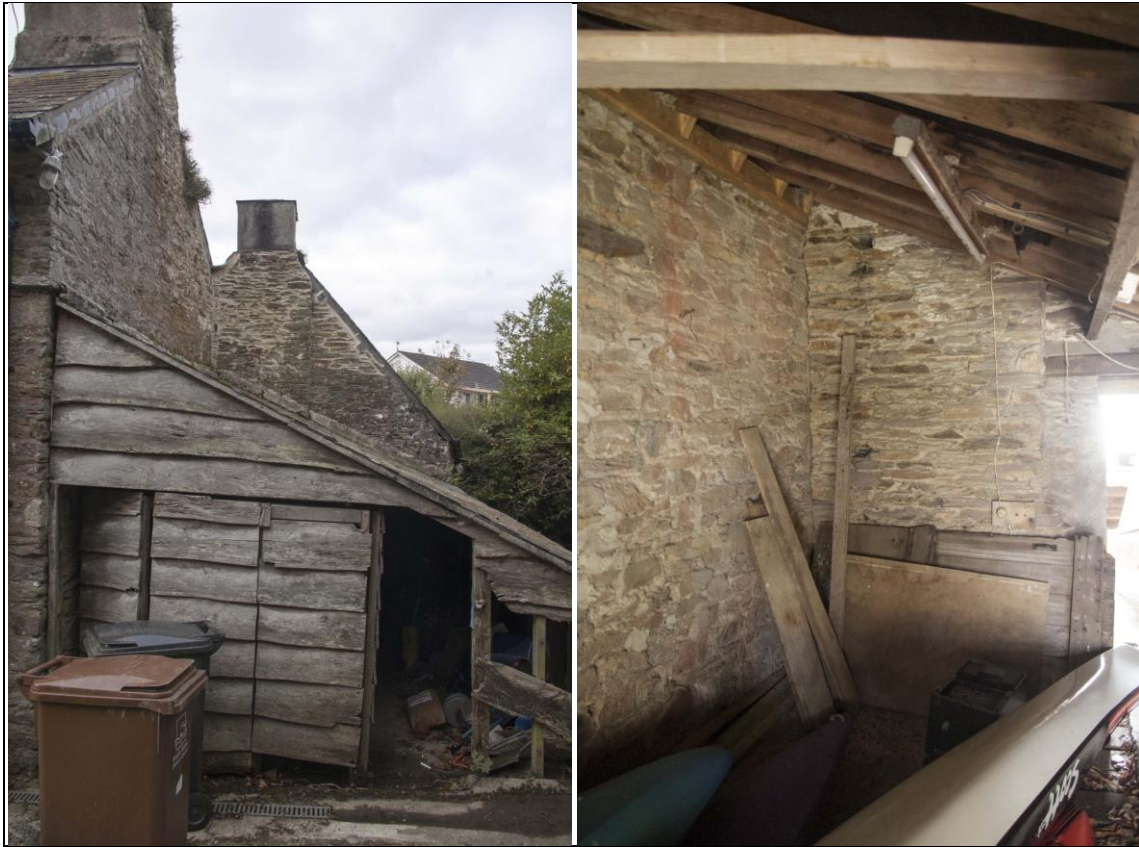
Left: The timber 1960s garage/store; from the east.

Right: View of the relationship between the east and north ranges, as seen within the garage/store; from the east, north-east.

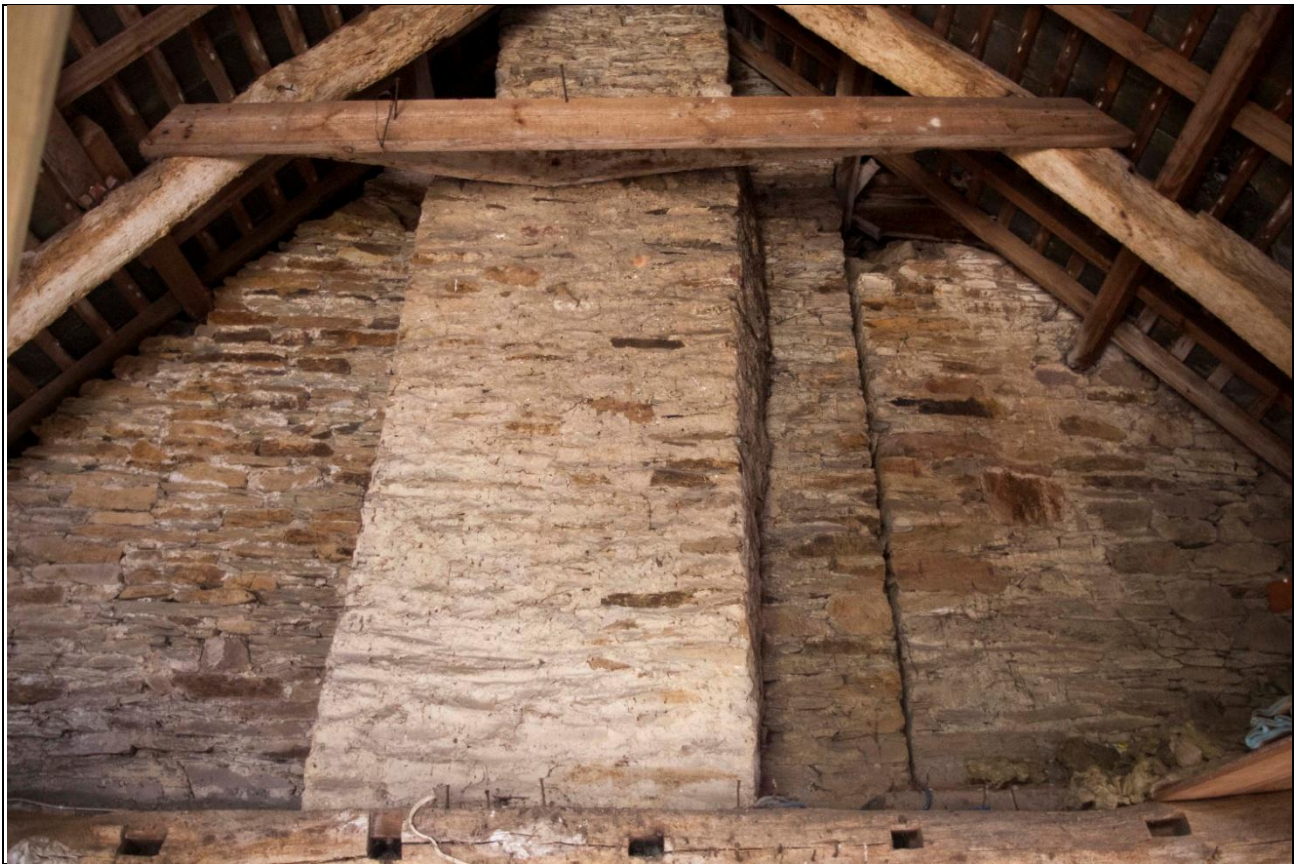
The two clear phases of chimney stack, within the roof of the north range, at the east end; from the west.

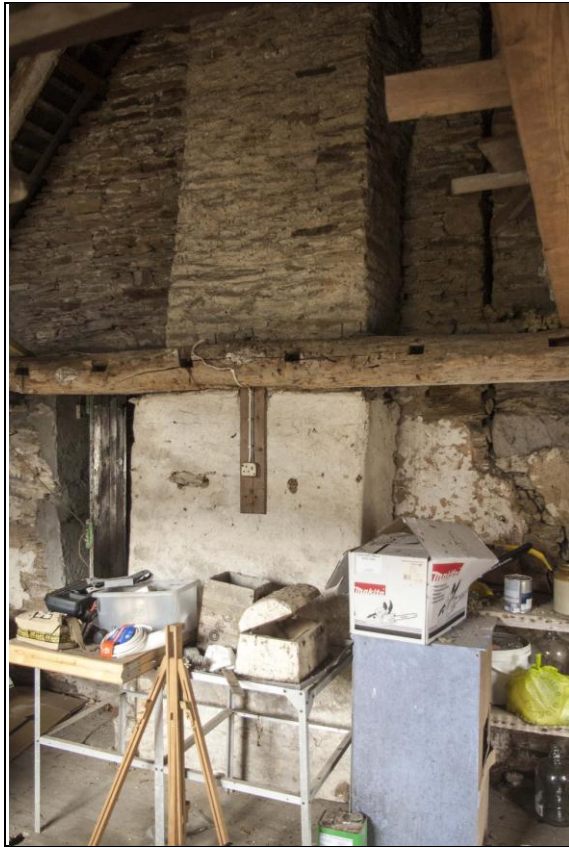
Access to the first floor level of the north range is via a door forced through the east wall north of the stack and braced by beams and metal supports. However, this has severely weakened this corner of the building: below the stack the structure is supported on concrete blocks, and there are large structural cracks. The conversion works would provide an opportunity to address these structural issues and ensure the survival of this range; left in its current state its future is uncertain.

Wider view of the series of stacks and forced door in the east wall of the north range; from the south-west.<sup>3</sup>

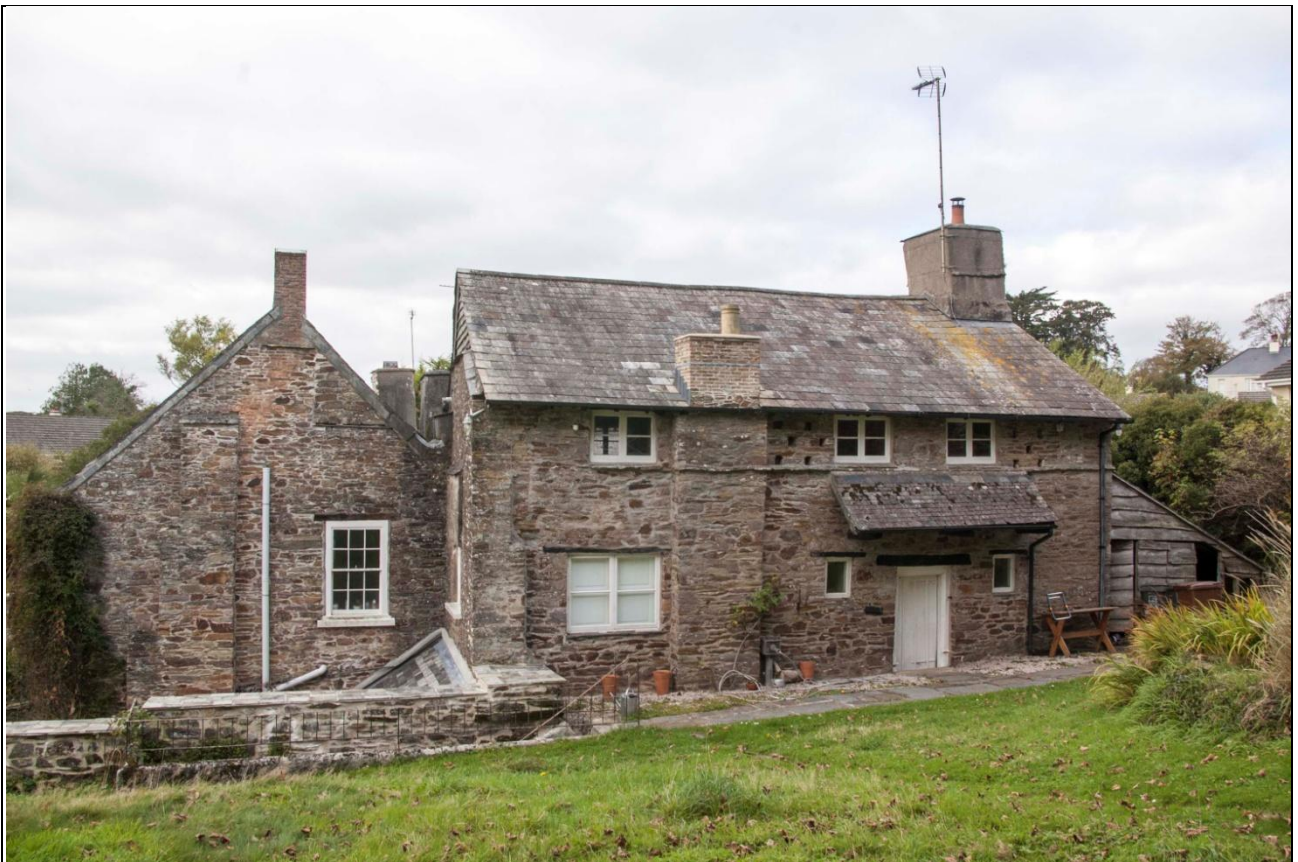
View of the relationship between the east elevation of the east range that of the south range; from the east-south-east.

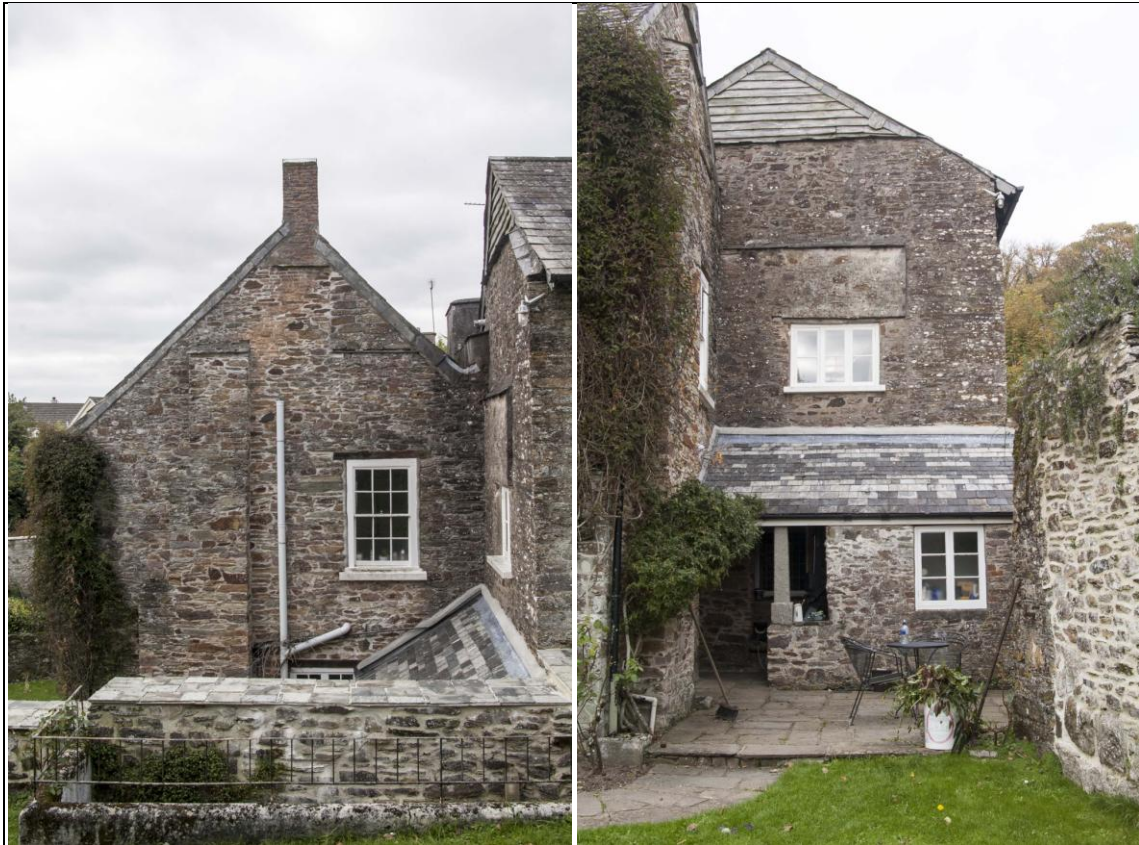
Left: View of the east end of the south range, viewed over the former east wall, now within the garden, showing the truncation of this range in the c.1800 rebuild; from the east.

Right: The south elevation of the east range which exhibits at least three phases of build; from the south.
