# OLD TRINE MODBURY SOUTH HAMS DEVON

Historic Building Appraisal, Statement of Significance & Impact Assessment

South West Archaeology Ltd. report no. 161223

By E. Wapshott & B. Morris  
Report Version FINAL  
23<sup>rd</sup> December 2016

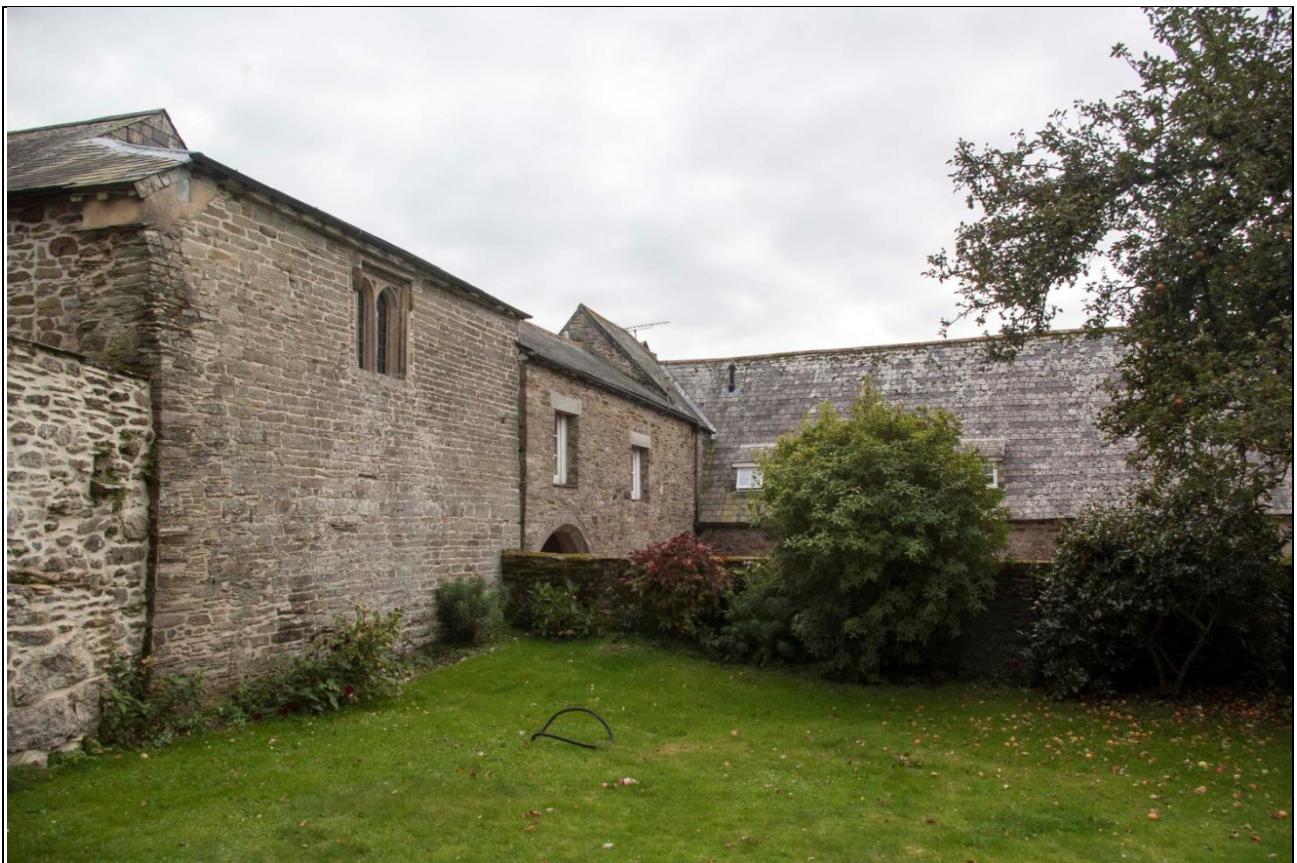
The stables and 'gatehouse' range to the south-east of Old Trine, exhibiting some very high quality fragmentary building remains, with ashlar stonework; from the north-north-west.

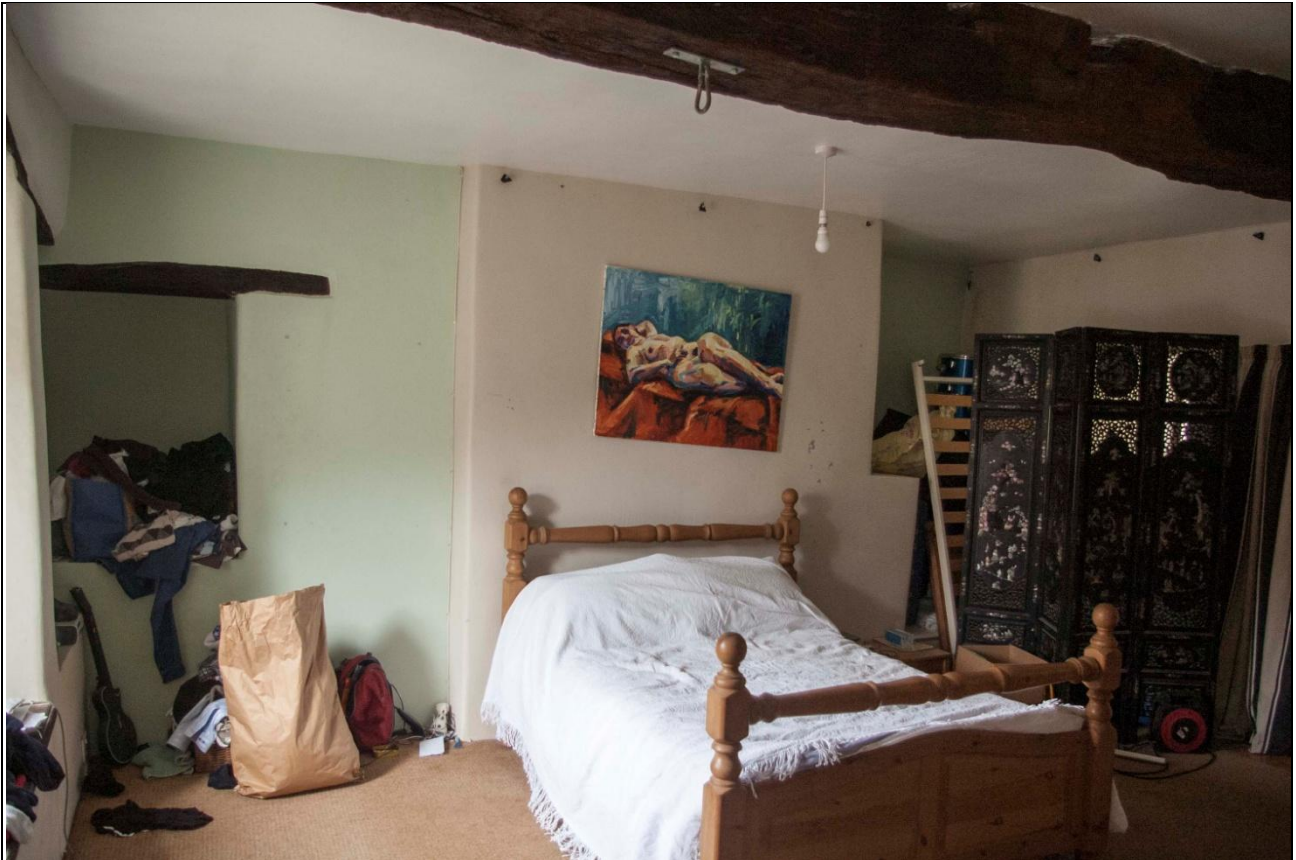
Shot of the stack, top of the oven to right and smoking cupboard to left in the first floor of the east range; from the south-west.

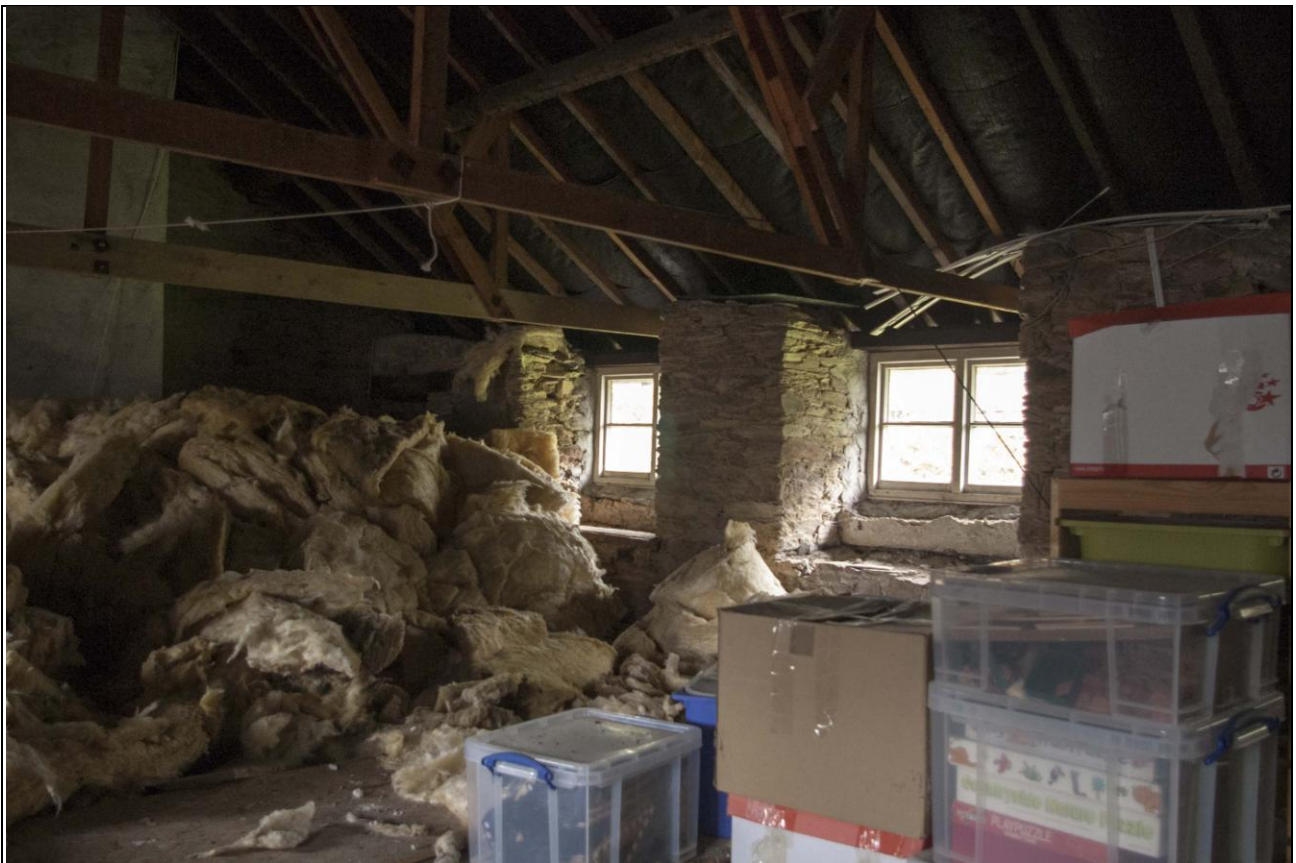
View of the inserted later casements, on the second floor of the east range, showing the conversion from storage to servant accommodation, probably in c.1800; from the south-west.

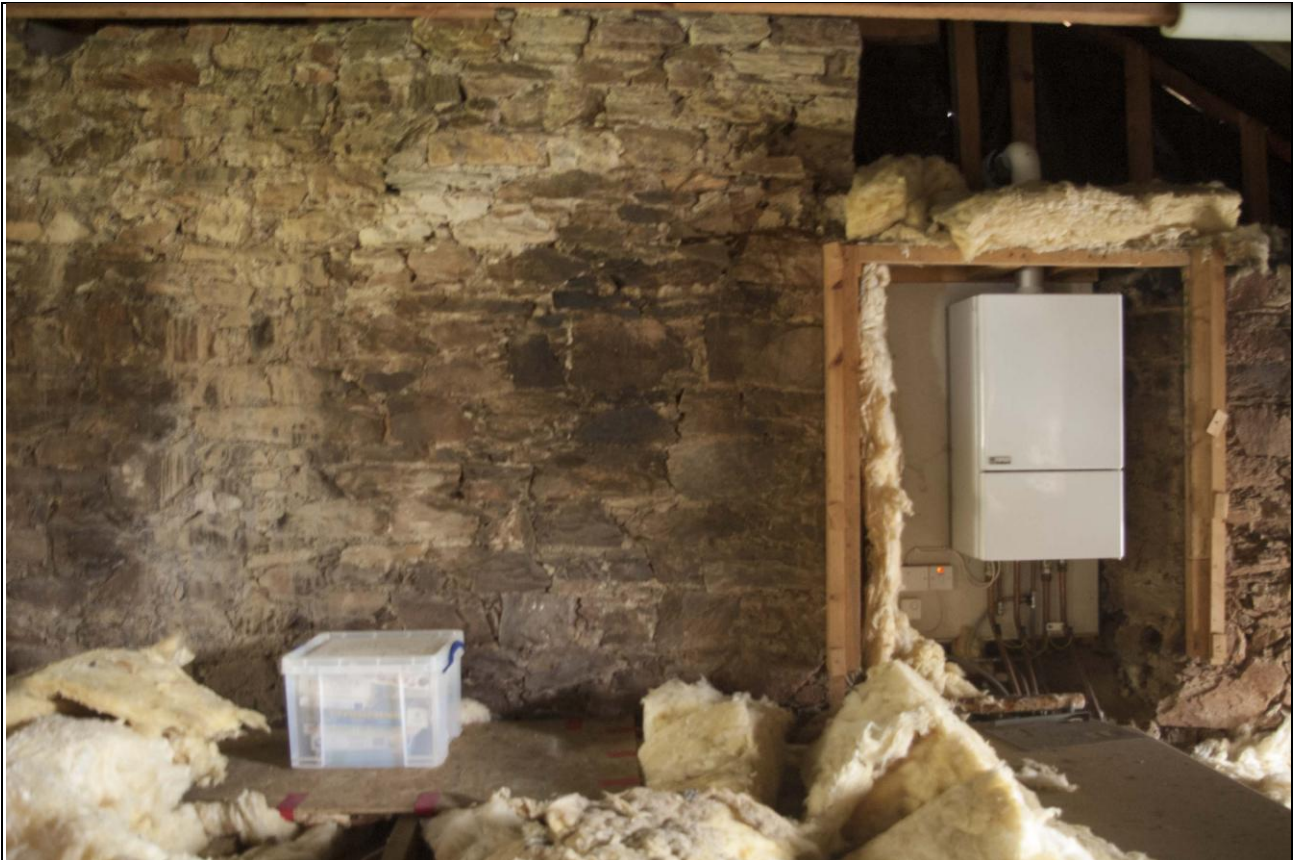
View of the section of medieval walling to the south end of the east range, showing large blocked window, with dressed quoins, now blocked by boiler; from the north.

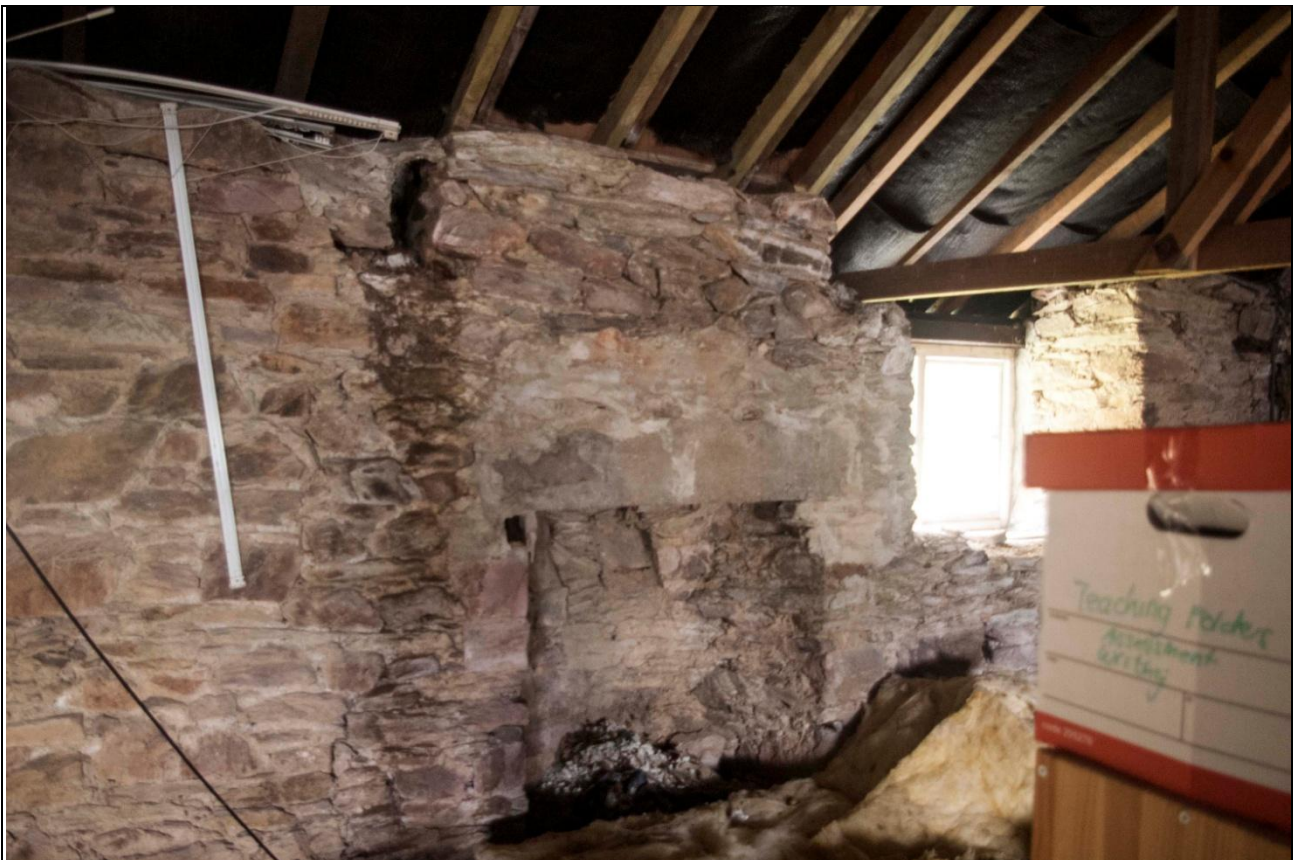
View of the stack and forced fireplace, with rounded hearth, within the second floor of the east range, of c.1800 date; from the north-west.

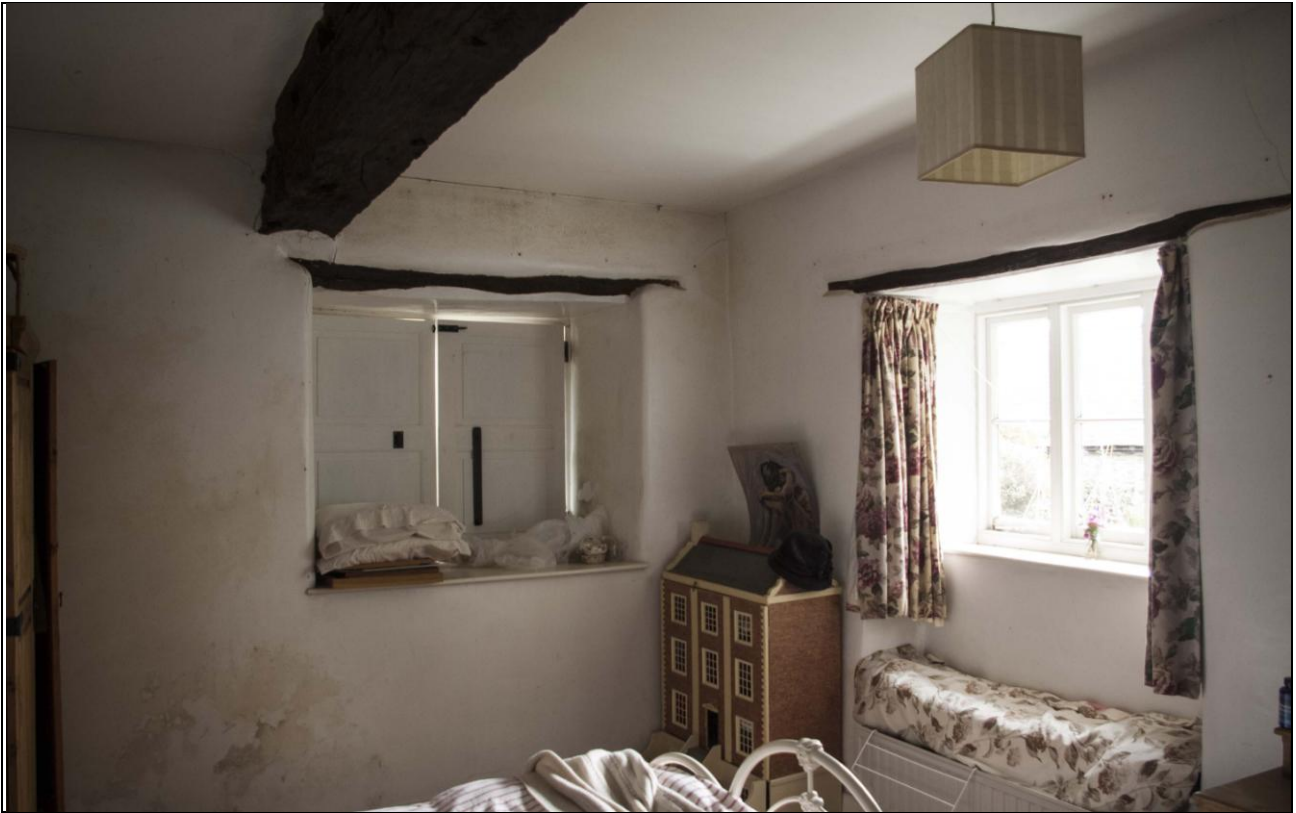
View of the forced window to the east and a further window to the south set within larger blocked opening, in the south-east corner of the east range, within the small bedroom; from the west-north-west.

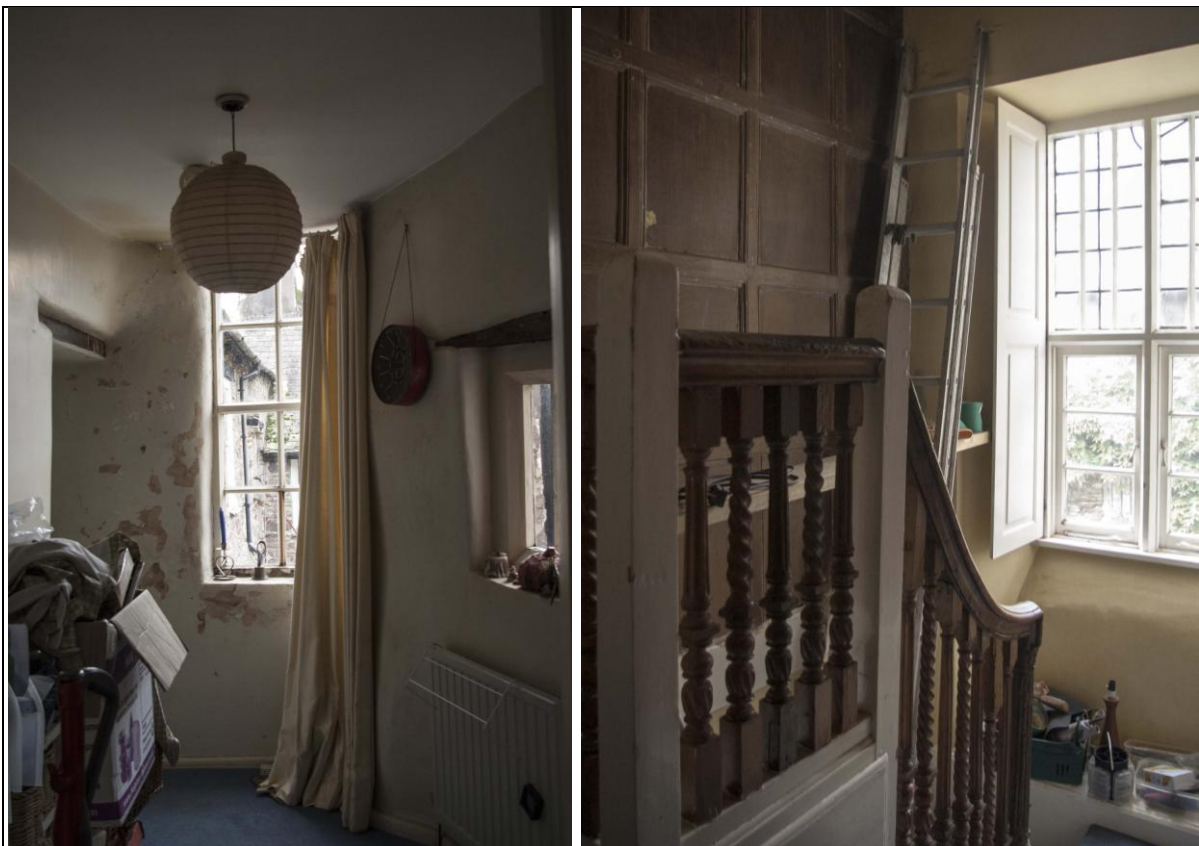
Left: View of the east stair turret at first floor level, opened up, with stair removed; from the east.  
Right: View of the first floor landing in the south range, with sections of fine moulded handrail and turned balusters of 18<sup>th</sup> century date, set within a later plain frame of c.1800, with basic chamfered block newel posts. Once belonging to a grand stair, now removed or reset, possibly not even original to the house; from the south-east.

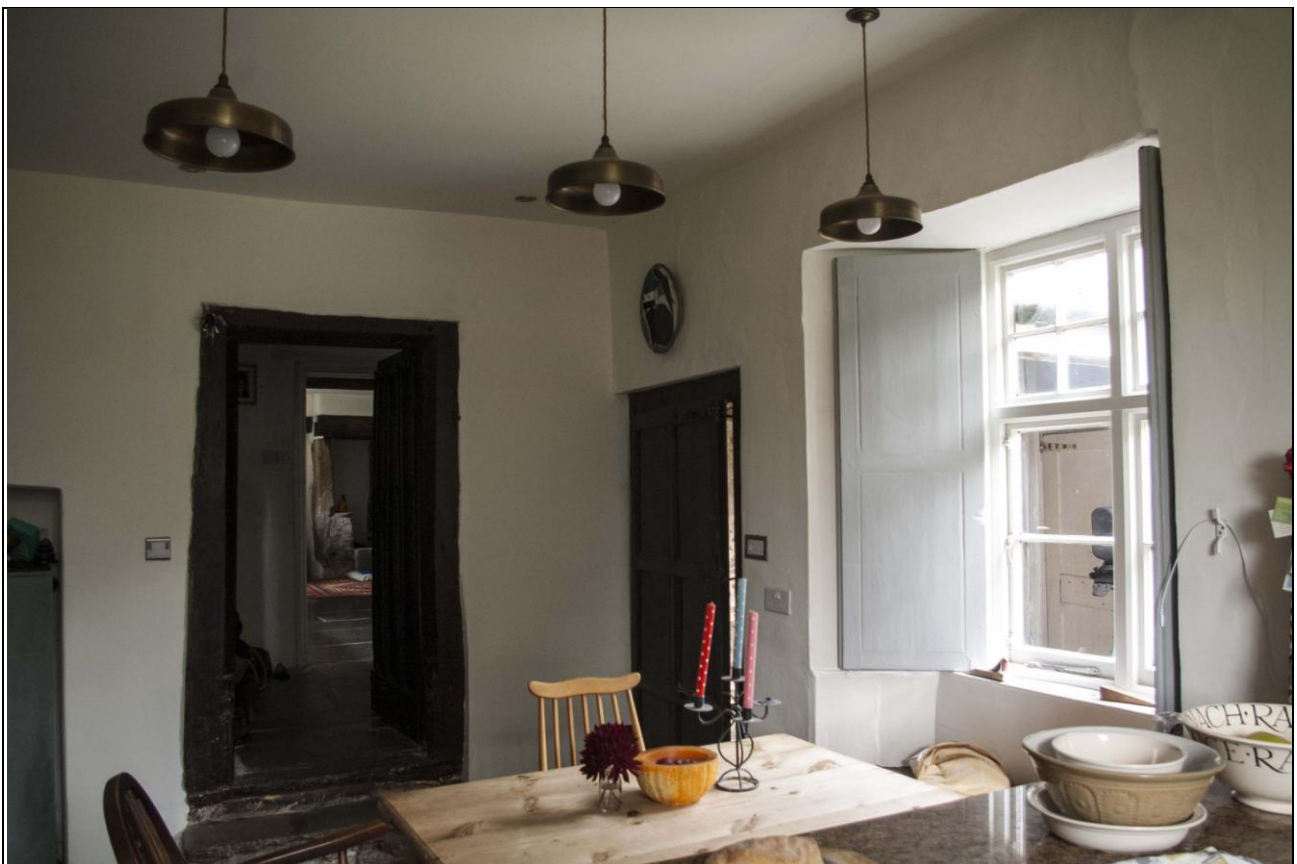
The kitchen in the south range, with transom window, reset 17<sup>th</sup> century door to exterior and original doorway and door to the east stair turret in the north wall; from the south-west.

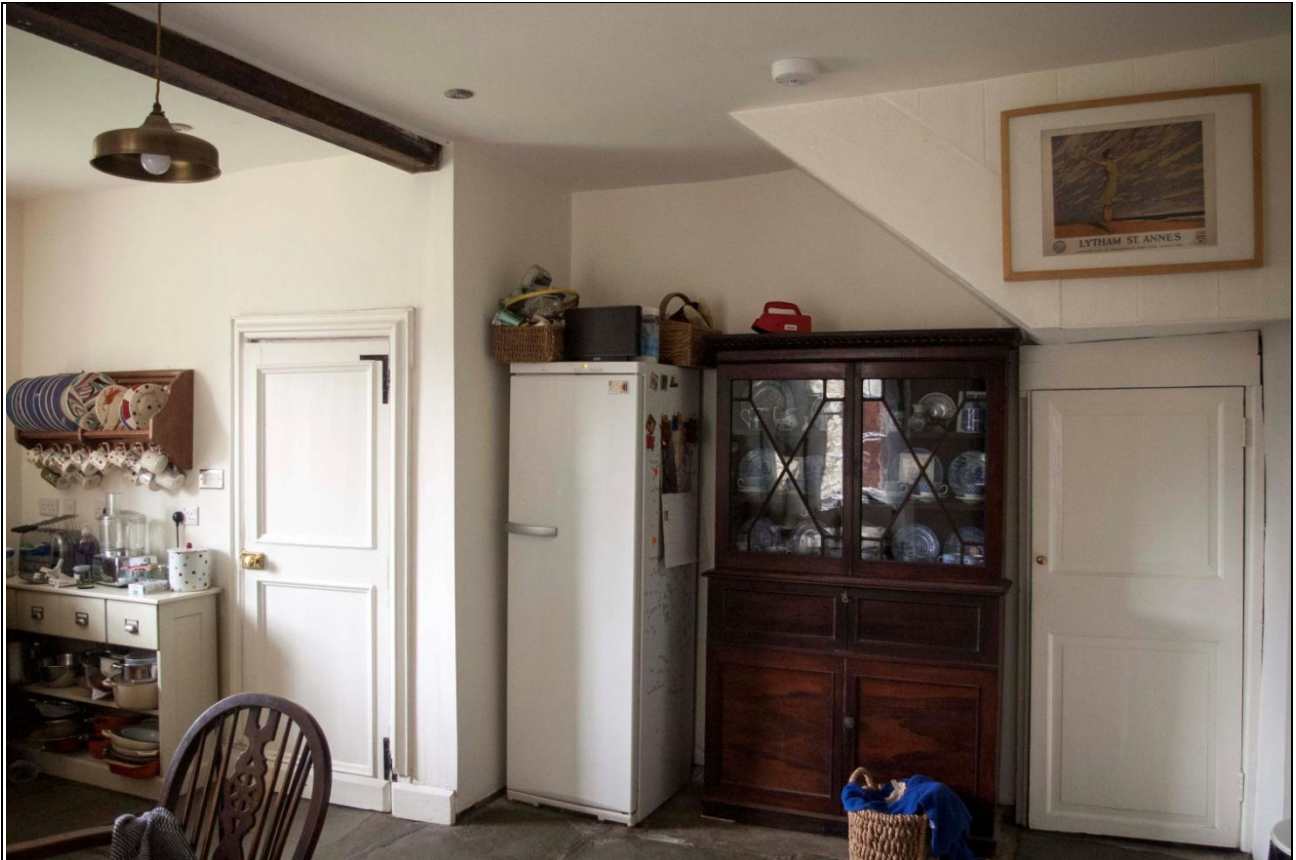
View of the kitchen in the south range, with reused two panel 17<sup>th</sup> century door to under stair cupboard and a reset bolection moulded door and frame to the hallway; from the north-east.

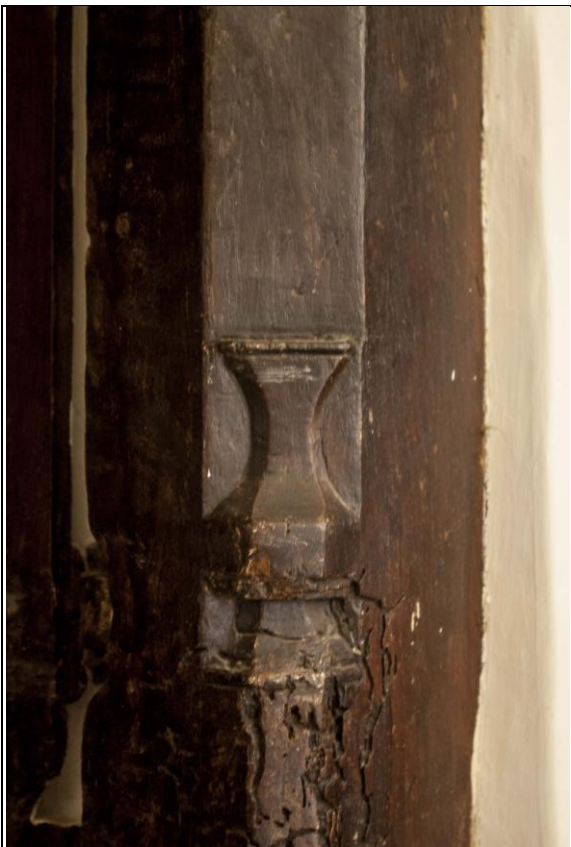
Left: Detail of the vase shaped stops on the 17<sup>th</sup> century door to the east stair turret, as seen within the kitchen.

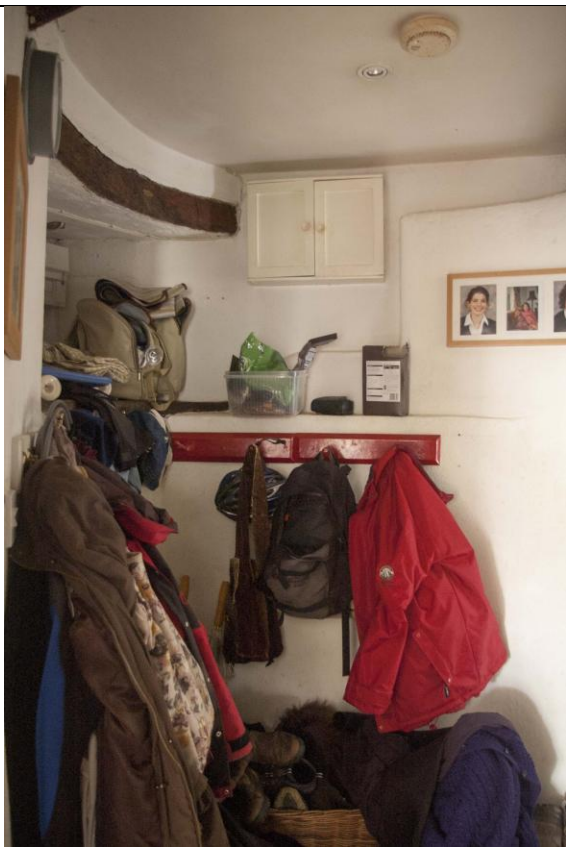
Right: Detail of east stair turret and blocked ground floor window, with stair now removed; from the south-south-east.

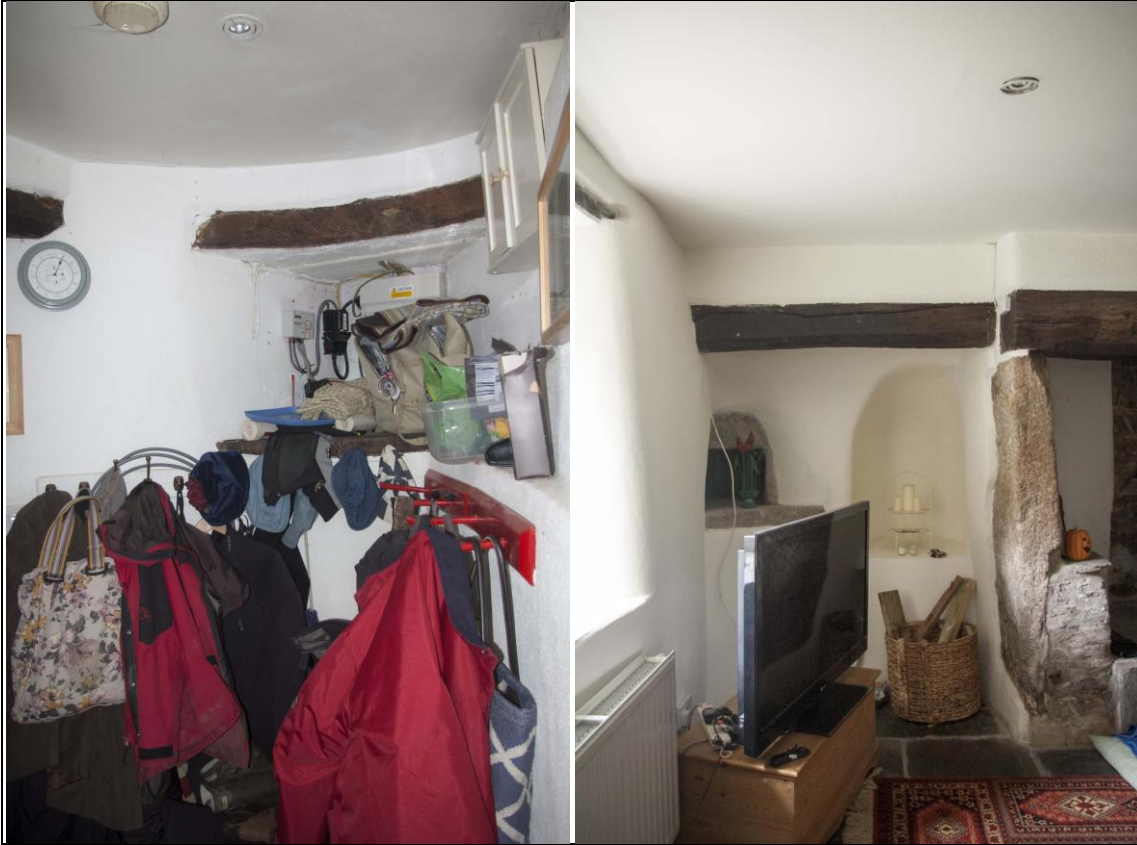
Left: View of the blocked window at ground floor level in the east stair turret; from the north-east.  
Right: Detailed view of oven and smoke chamber to the north wall of the east range; from the south.

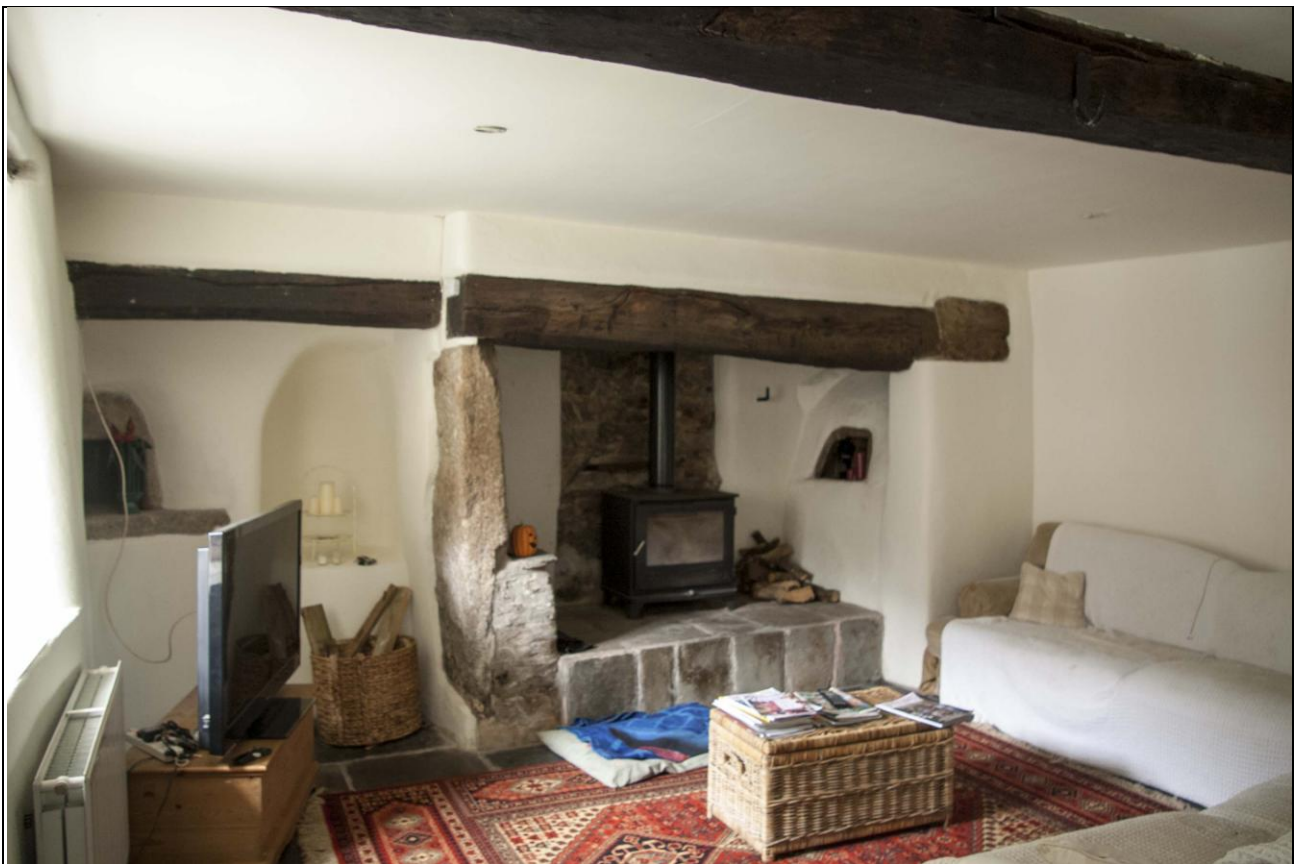
The hearth, ovens and smoke chamber, of 17<sup>th</sup> century date, in the north wall of the east range, note the massive cut off beam to the east side, suggestive of an earlier (medieval) open smoke bay.

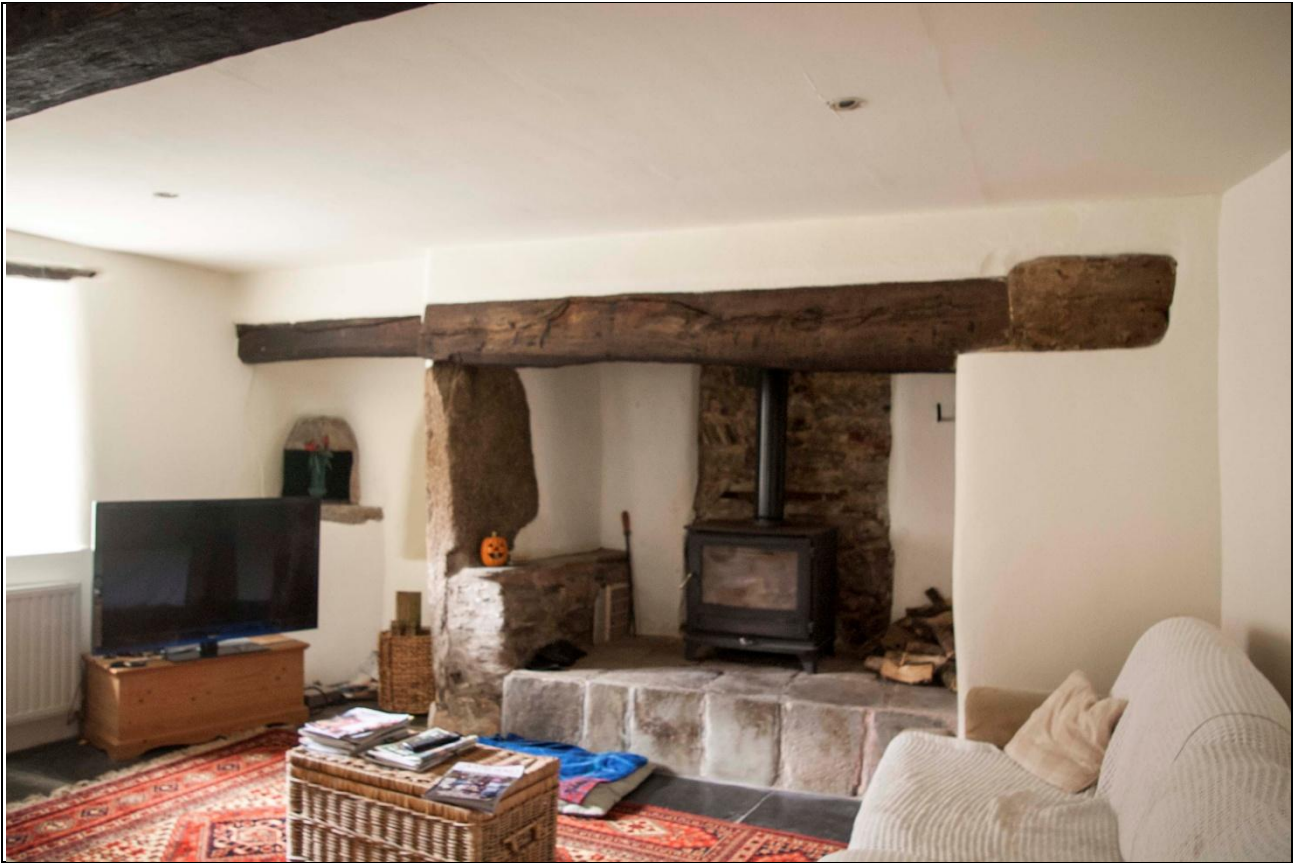
View of the open hearth, ovens and smoking chamber; from the south-east.

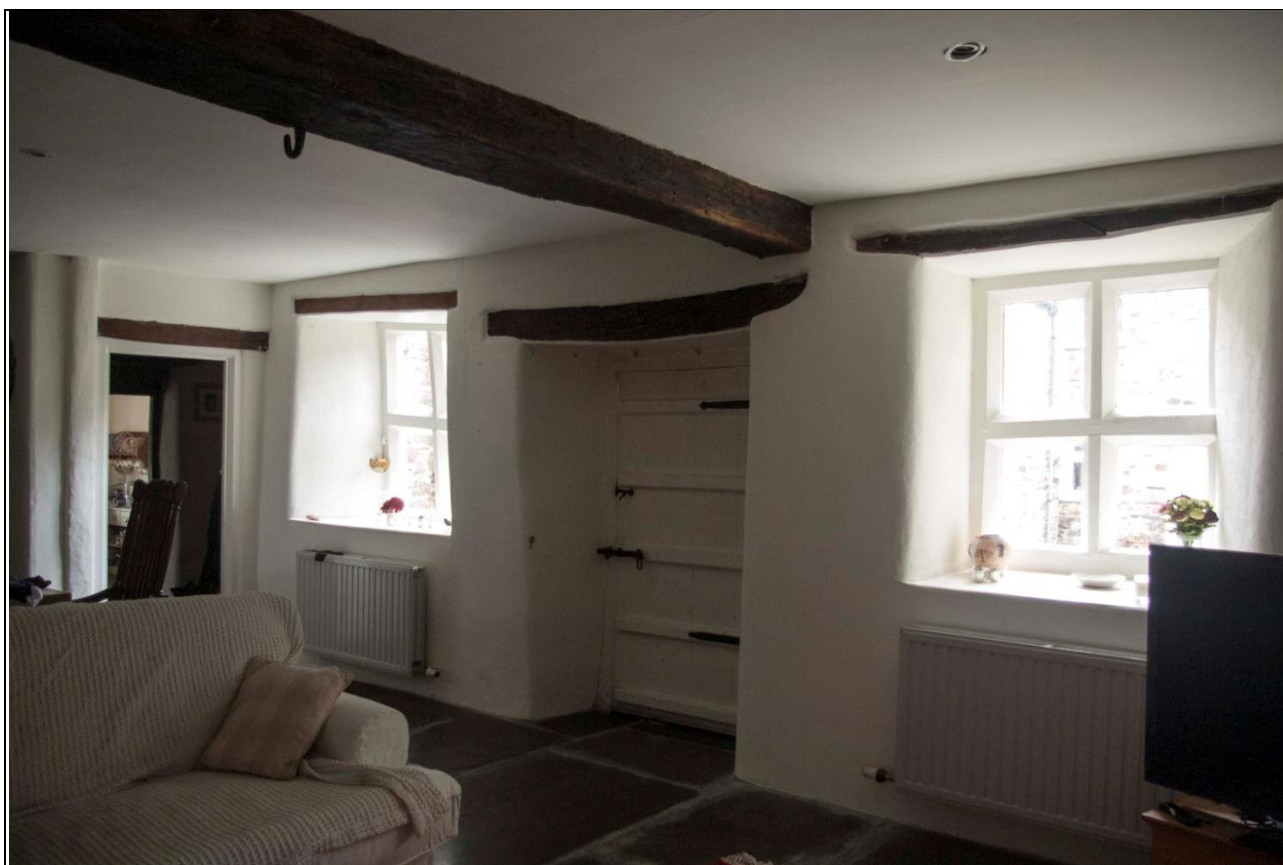
View of the west wall of the east range, at ground floor level, interior face, showing the door and flanking windows and massive first floor ceiling beam; from the north-east.
