# THE RECTORY CORONATION ROAD BLEADON NORTH SOMERSET

Results of a Desk-Based Assessment and Evaluation Trenching

South West Archaeology Ltd. report no. 170928

By F. Balmond and S. Walls Report Version FINAL 19<sup>th</sup> October 2017

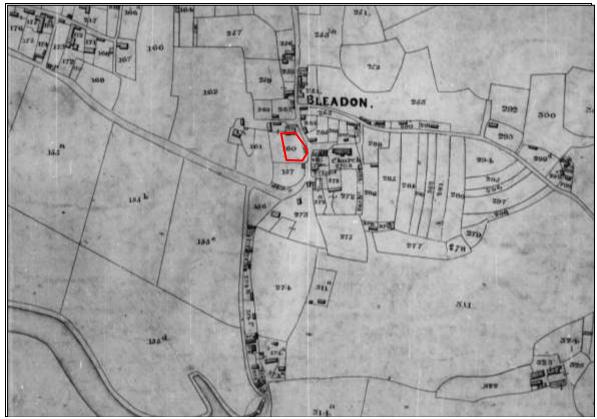
FIGURE 2: EXCERPT FROM THE 1843 BLEADON TITHE MAP. THE LAND PARCEL CONTAINING THE SITE IS INDICATED (TNA).

The Bleadon tithe map of 1843 (see Figure 2) depicts a clear mixture of field patterns, with strip fields visible to the east of the settlement and to the north-west, adjoining the settlement at Purn. The land just north of the River Axe is recorded in the tithe apportionment as a wharf, with a pub known as the Ship and Castle located adjacent to the wharf. A series of small houses and fields are visible from the centre of Bleadon leading down the eastern side of the road to the wharf.

The Rectory is depicted along with some associated buildings fronting onto Rectory Lane, presumably a coach house and stables. The garden extended further to the west at this date and a small building is shown to the east of the site flanking Coronation Road.

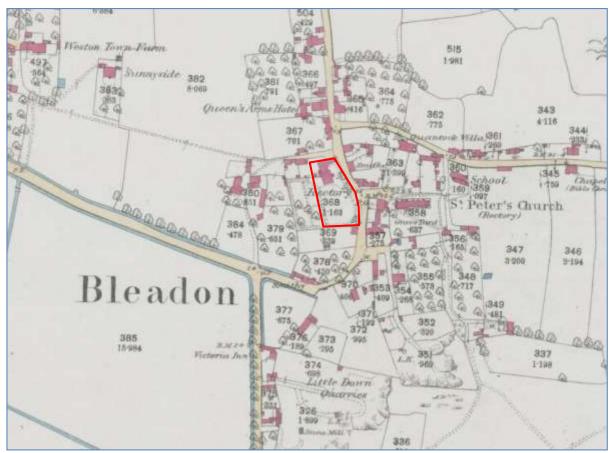
FIGURE 3: EXTRACT FROM THE FIRST EDITION OS 25 INCH MAP OF 1884, THE SITE IS INDICATED.

The Ordnance Survey First Edition Map of 1884 shows a subdivision of part of larger garden plot depicted on the tithe map, in the location of the approximate current boundary. Both parts still appear to have been linked at the northern end and to belong to the Rectory. A garden path is visible running around the outside edges of both gardens, but it is not clear if the garden was terraced into platforms by this time.

The Rectory building is a different shape to the current rectory and more complicated than shown on the tithe map. It appears to have been extended to the north after the tithe map (and Rev. Williams). The associated structures fronting onto Rectory Lane have also been altered by this date, as they form one conjoined range fronting onto the road, rather than an L-shaped arrangement, in fact the southern part of the western building which fronts Rectory Lane appears to have been removed by this date. The western parts of these buildings may have been in a separate ownership by this date as there are no gates depicted linking the now separated yard/garden in which it is located to the Rectory's ownership, although a gate is depicted on later maps. The small building shown within the gardens adjoining Coronation Road is no longer depicted.

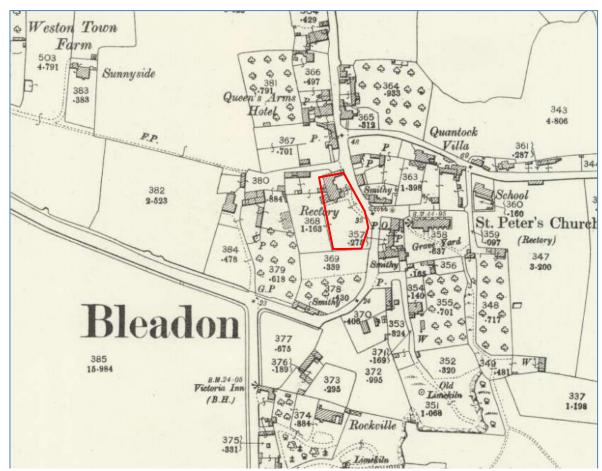
FIGURE 4: EXTRACT FROM THE SECOND EDITION OS MAP OF 1902, THE SITE IS INDICATED

The Ordnance Survey Second Edition map of 1902 shows little change to the site from the first edition although extensions have been added to the south-western and south-eastern sides of the rectory. The structure on the south-west side appears to be a glasshouse or conservatory. The garden paths and mostly not depicted, with the exception of a drive(?) and (presumably paved) path/patio to the immediate south of the rectory. To the immediate south of the rectory garden, the house owned at the time of the tithe by Joseph Wollen, had been demolished by 1902.

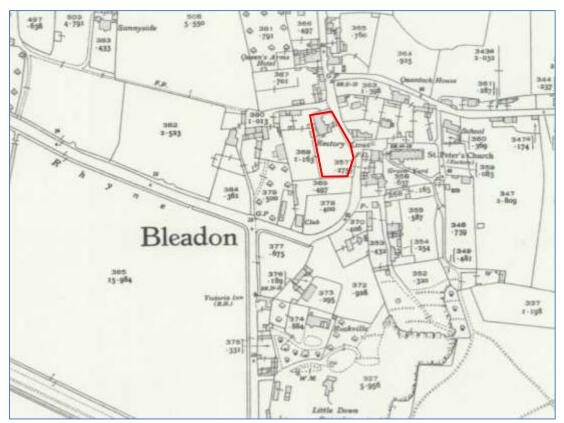
Figure 5: Extract from the 1936 revised 25 inch OS Map, the site is indicated.

Little change appears to have occurred to Bleadon Rectory between the second edition Ordnance Survey map of 1902 and the 1936 revised edition. No further extensions have been added to the Rectory and the gardens all appear to have remained within the same ownership. The 1936 map does show that the Smithy to the south of the site had been demolished and replaced by a *Club* (now The Coronation Hall), with the former plots to the south re-arranged as part of these changes.

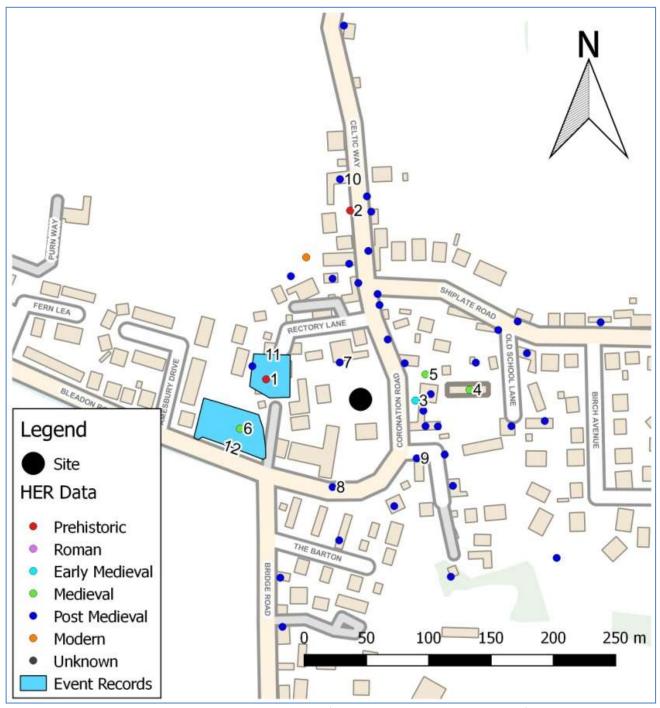
FIGURE 6: MAP OF HERITAGE ASSETS IN CLOSE PROXIMITY TO THE SITE (DATA SUPPLIED BY NORTH SOMERSET HER)

No.	HER No.	Name	Record	Description						
1	MNS2844	Prehistoric Occupation and Burials	Excavation	Evaluation Trenching at Whitegate Farm uncovered evidence from the late prehistoric, medieval and modern periods. Prehistoric activity related to a group of pits, ditches and postholes. Pottery indicated these were of late Bronze Age date. One pit contained a human skull. Human bones were found in two other pits						
2	MNS8334	Prehistoric Burial	Documentary	The HER records a prehistoric burial at this site. It is unclear where this information comes from and the sources given relate to the building at this site (Toms Cottage), it is therefore possible that this record is erroneous.						
3	MNS1548	Manor House?	Documentary	A manor is recorded in a surviving charter of 956, with the boundaries delineated. It was granted by King Eadwig to Aethelwold then in 1053 to Winchester Cathedral.						
3	MNS1549	Saxon Church	Documentary	The 956 description of the manor mentions a church stead on the boundary. It is therefore likely a Saxon church predated the current church, the earliest part of which is the Norman font.

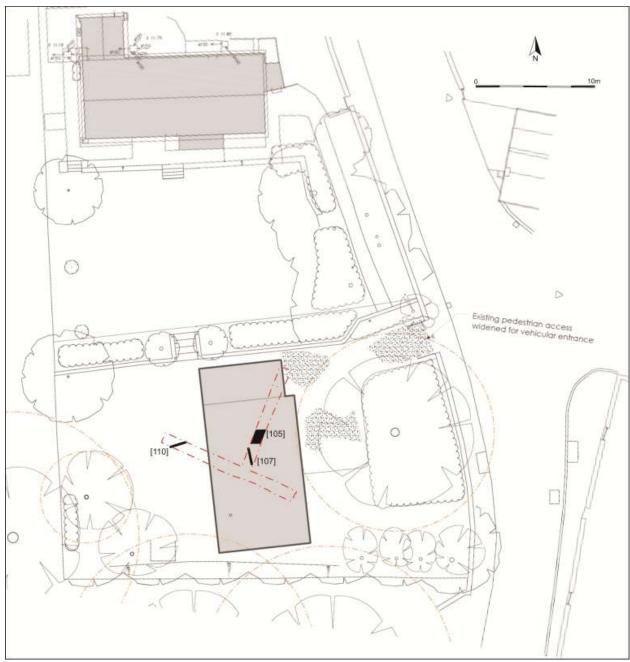
FIGURE 7: TRENCH PLAN, SHOWING THE LOCATION OF THE TRENCHES OVER THE PROPOSED DEVELOPMENT FOOTPRINT.

Two evaluation trenches (totalling 21m in length) were excavated by a machine fitted with a 0.95m wide toothless bucket (Figure 7). All works were under the supervision of the Archaeologist and Ecologist.

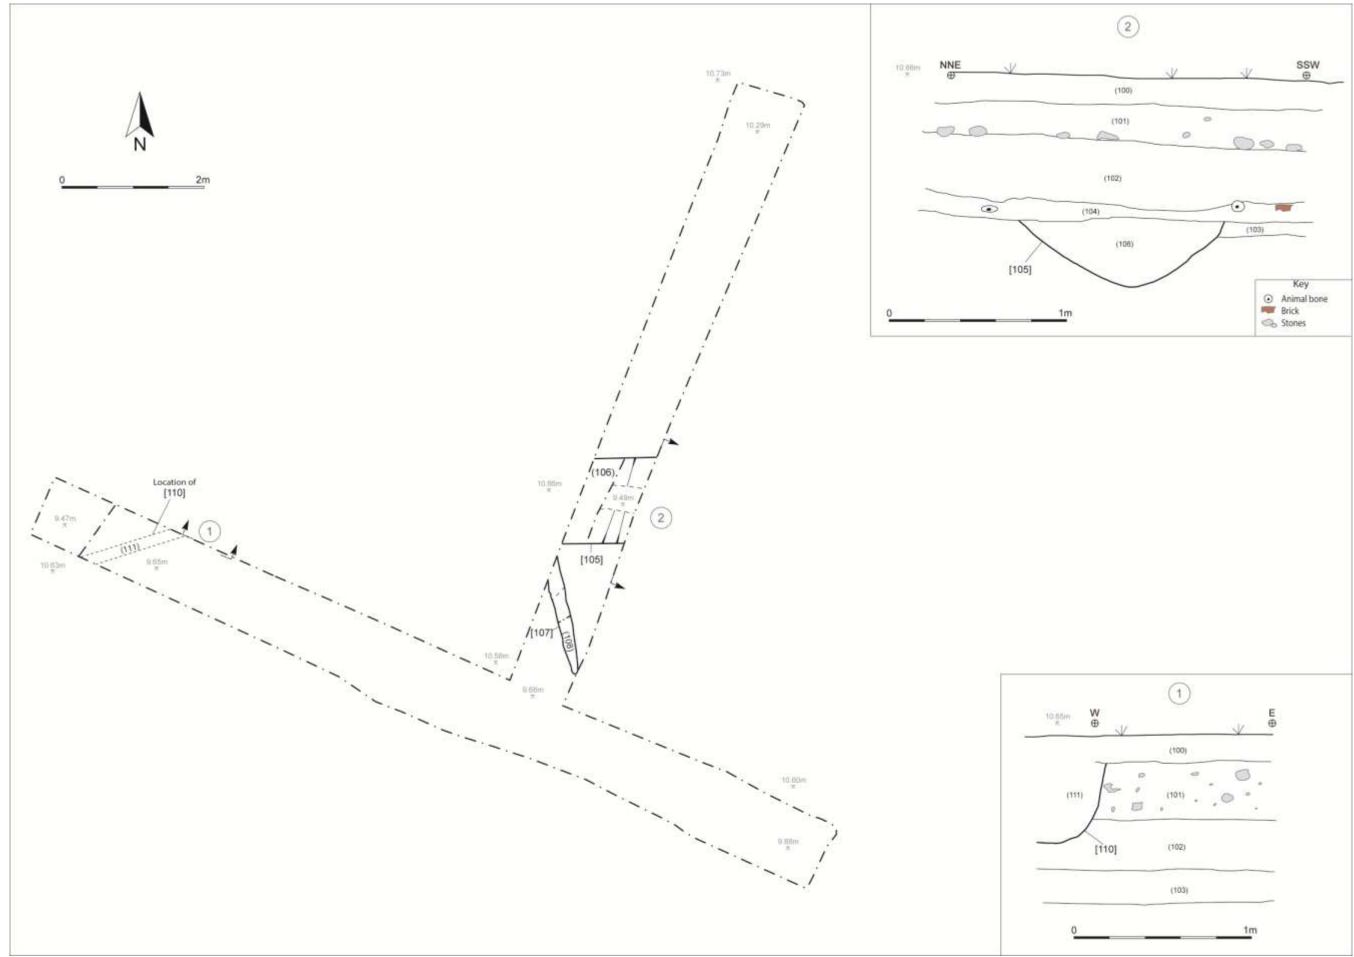
FIGURE 8: DETAILED TRENCH PLAN AND SECTIONS. ALL LEVELS ARE ABOVE ORDNANCE DATUM.

The trenches revealed a relatively consistent stratigraphy of modern topsoil (100) of dark brown fine silt-clay (0.15m thick), which overlies a layer of mixed stone and brick rubble and redeposited natural (101), which varied in thickness from 0.35-0.2m, getting thinner to the north and east. The rubble layer (101) overlay a c.0.3m think layer of clean soft mid-brown slightly clayey-silt (102), which contained rare small sub-angular stones, but was relatively clean. Deposit (102) may represent a buried topsoil horizon. Deposit (102) overlay a thin and mixed layer (up to 0.08m thick) of dark grey ash (104), which contained abundant animal bones (mostly cattle and pig), which petered out to the north and west. Deposit (104) produced a large number of finds, many of which were not retained but included the remains of several saucepans, glass and animal bones of late Victorian/ early 20<sup>th</sup> century character. This deposit overlay a thin clean yellow-brown silt loam (103) with occasional/rare small sub-angular stones. This directly overlies the natural, compact yellow clay with occasional sub-angular stones.

Three features were noted within the evaluation trenches, although these all cut from high up in the stratigraphic sequence, and probably all related to 19<sup>th</sup> to 20<sup>th</sup> century drainage or garden features (see Figure 8).

The evaluation trenching trenches revealed that the site had been significantly landscaped, with the ground terraced and then raised, mostly likely in the late 19<sup>th</sup> or early 20<sup>th</sup> century. There is limited archaeological potential and it seems unnecessary for any further archaeological works to be required for this proposed development.

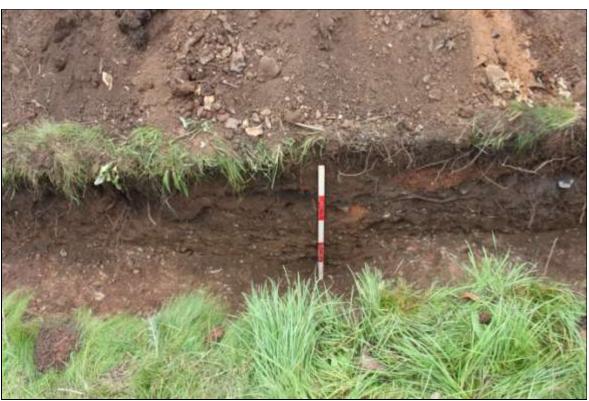
FIGURE 9: DITCH [105], VIEWED FROM THE WEST (1M SCALE).

Ditch [105], was 1.25m wide and 0.22m deep with gently sloping sides and concaved based, orientated east-west (Figure 9). It was filled with a dark grey silt-clay (106) with common to occasional sub-angular stones. Ditch [105] cut through deposit (103).
