BARNSTAPLE MUSEUM EXTENSION

RESULTS OF ARCHAEOLOGICAL MONITORING & RECORDING

SOUTH WEST ARCHAEOLOGY LTD. REPORT NO. 181024

BARNSTAPLE MUSEUM EXTENSION, THE SQUARE, BARNSTAPLE, NORTH DEVON

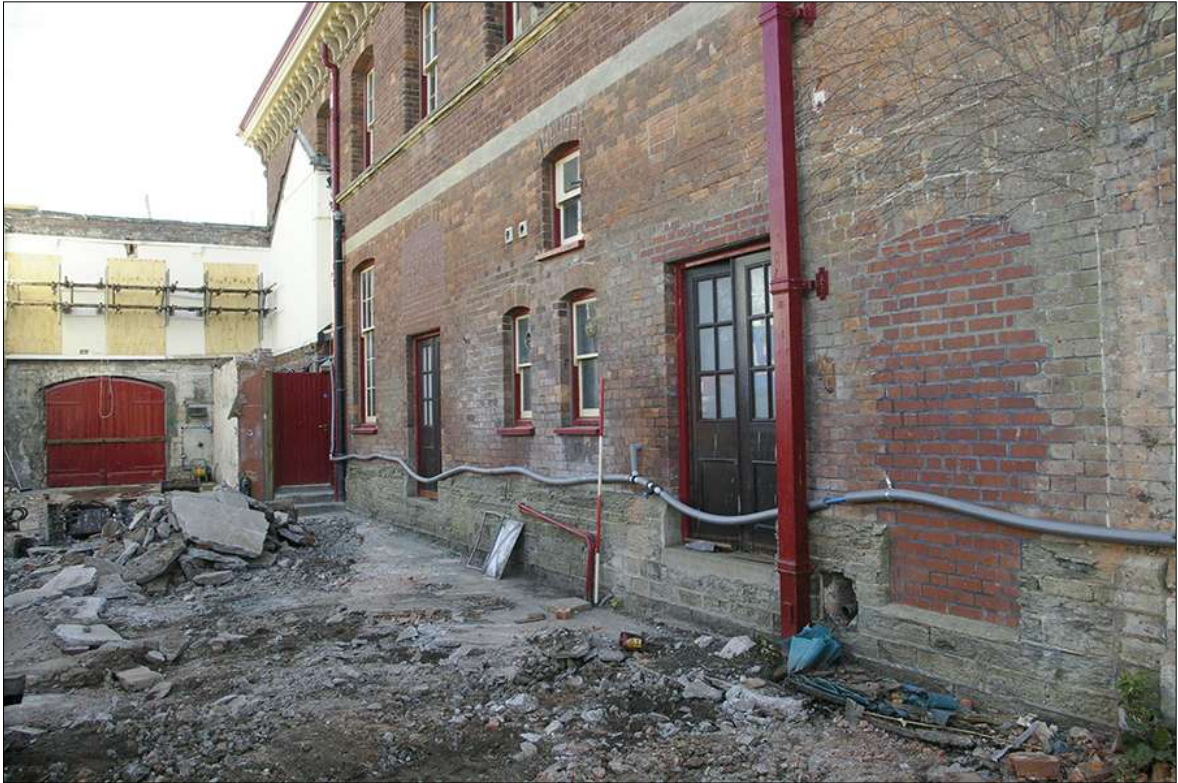
The north-western wall of the existing museum building, recorded as wall {400}, formed the south-eastern limit of the development. It was orientated approximately north-east to south-west, measuring c.21.50m long and c.6m high; and was constructed of red brick with stone dressings and foundation courses with a concrete and lime mortar bond. This was abutted at its north-western corner by wall {522} which formed the frontage of the attached former coach house structure, aligned north-west to south-east; and measuring c.5.50mxc.0.30m wide and c.4m high. It was constructed in the same red brick with stone dressing style as the museum building. At the north-western end of this, wall {521} formed a north-east to south-west orientated return measuring c.6.75mxc.0.60-0.90m and standing to c.6m high. It was constructed of red brick on concrete foundations c.0.30m thick. An additional brick skin {457}, 0.20m wide, had been added to the north-eastern end of this wall during the later 20th century. This was set on concrete foundations {458}, 0.70m wide and c.0.25m thick within construction cut [463]. Internally the former coach house structure had a concrete floor surface (523) c.0.10m thick.

3. GENERAL SITE VIEW SHOWING DEMOLITION WORKS WITH EXISTING MUSEUM BUILDING {400}; FROM THE SOUTH-WEST (2M SCALE).

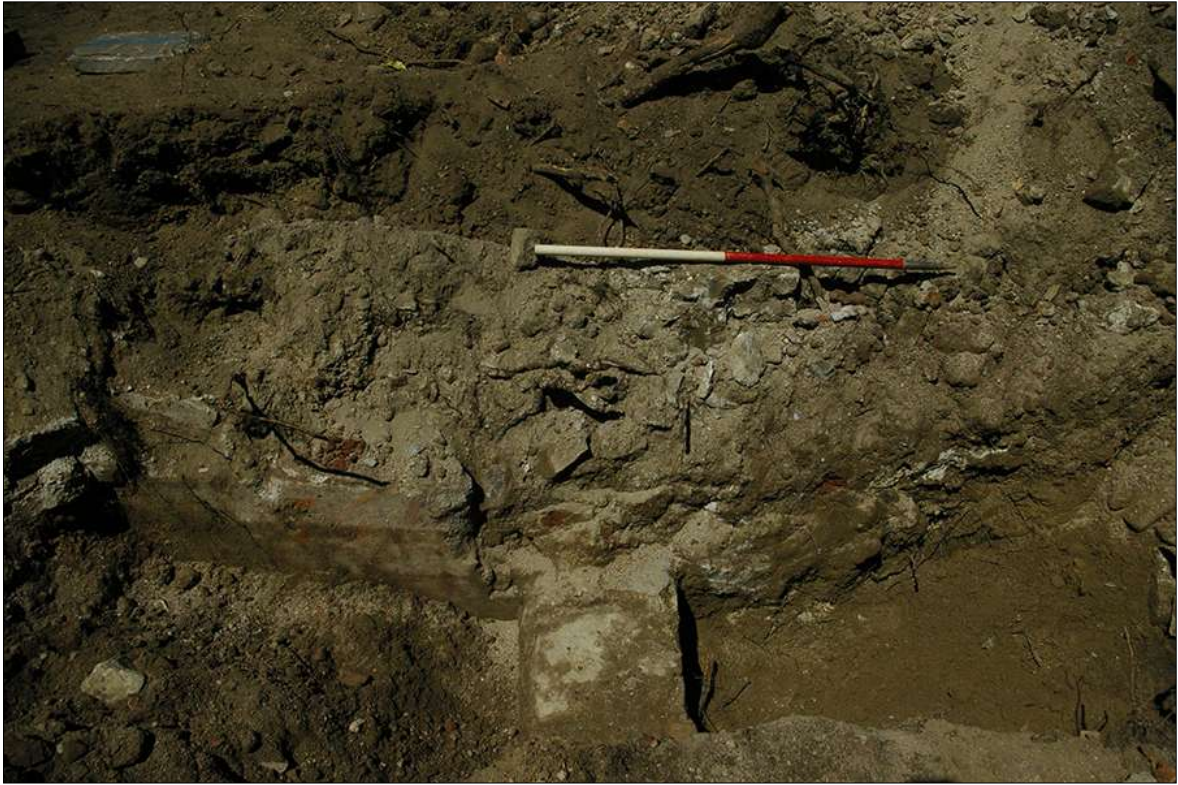
Towards the southern end of the development site, wall {410} was orientated approximately north-east to south-west, and was exposed for a length of 1.50m. It measured 0.55m wide and survived to a height of c.1m. It was constructed of angular stone blocks with concreted mortar, with brick repairs. At the southern end, a higher possible north-west to south-east return appears likely to have continued as wall {506}. This ran for a length of 1.30m and measured 0.50m wide, exposed for a height of 0.20m. It was constructed of angular stone blocks with levelling slates, brick and lime mortar bond.

5. AREA 04A, WALLS {410}, {411}, {412} AND {413}, SOUTH-EAST FACING SECTION; FROM THE SOUTH-EAST (1M SCALE).

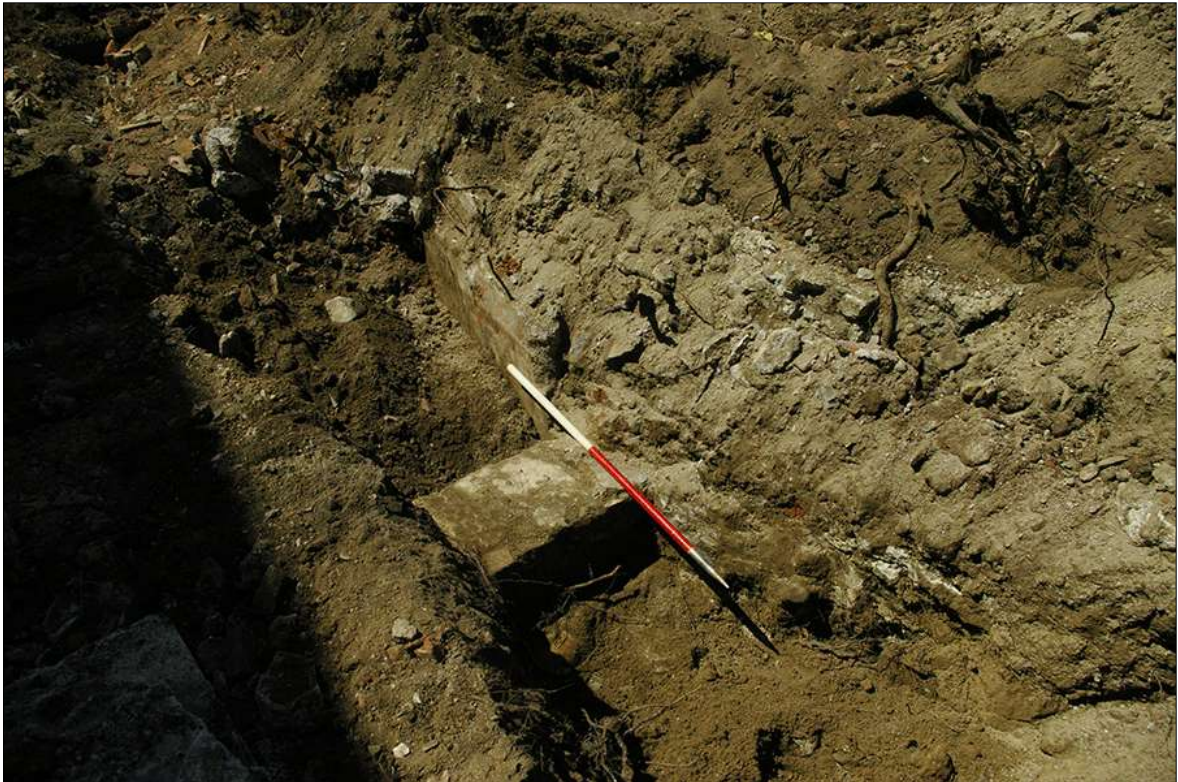
6. AREA 04A, WALLS {410}, {411}, {412}, AND {413} POST-EXCAVATION; FROM THE NORTH-EAST (1M SCALE).

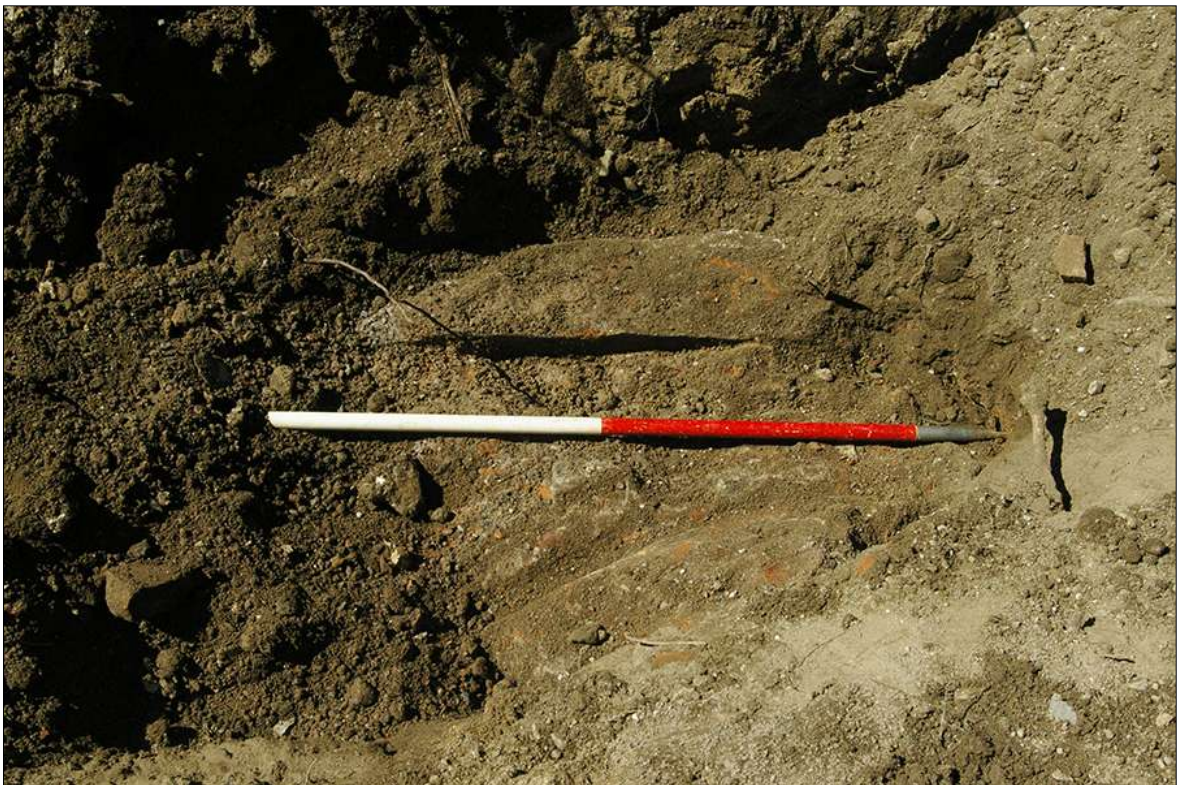
8. AREA 04A, WALL {412}; FROM THE SOUTH-EAST (1M SCALE).

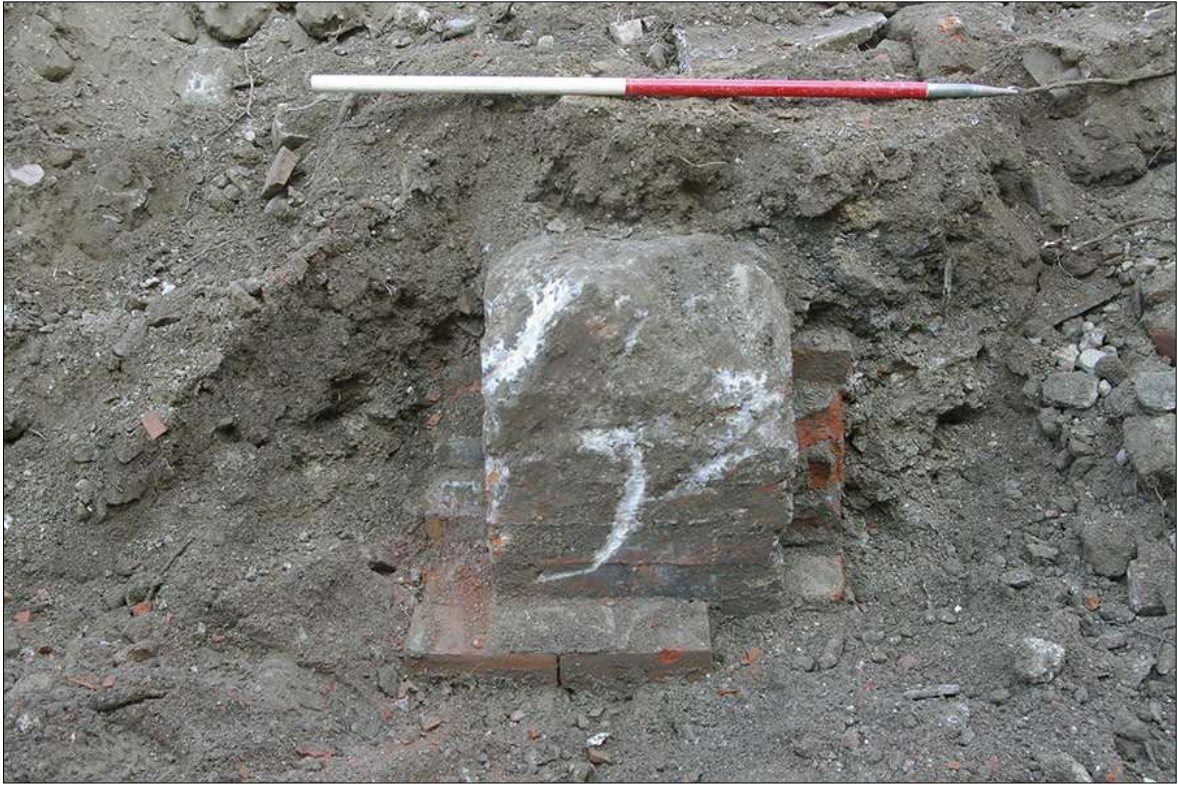
9. AREA 04A, WALL {419}, SOUTH-EAST FACING PROFILE; FROM THE SOUTH-EAST (1M SCALE).

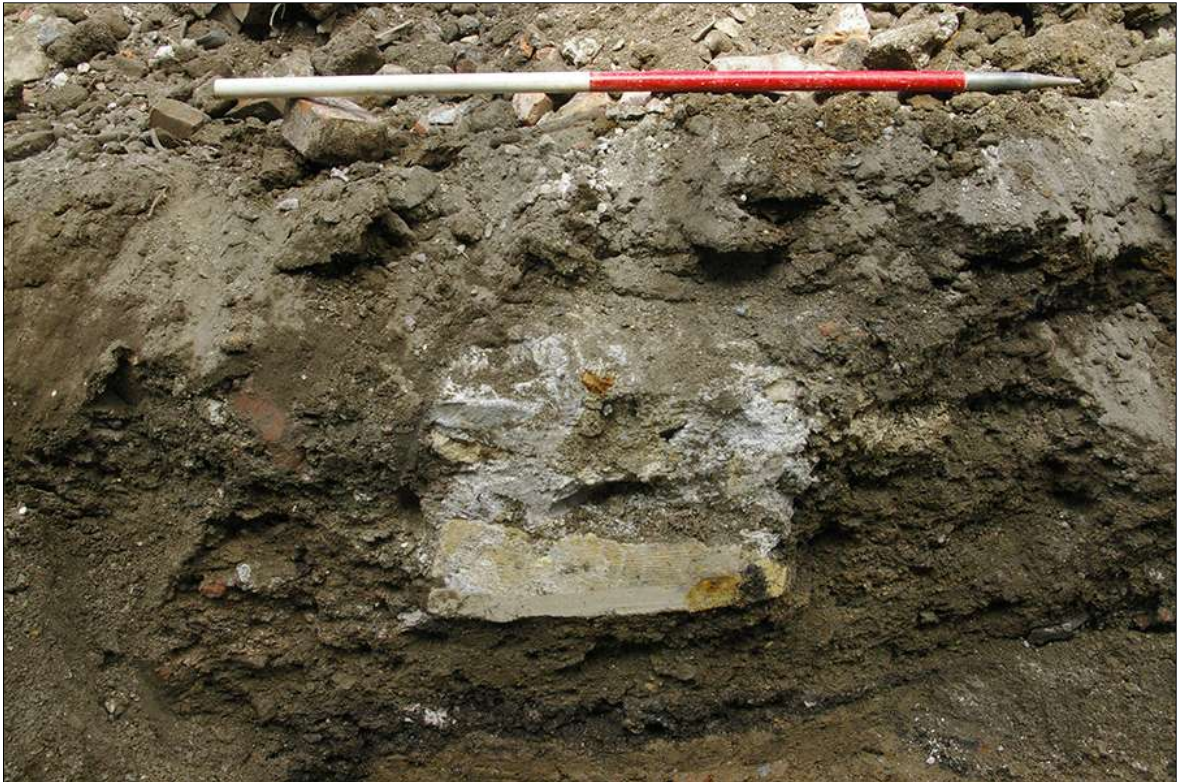
Towards the centre of the site wall {420} had been largely demolished, surviving only as lower wall foundations, the remainder appearing as a line of loose rubble orientated approximately north-west to south-east for a length of c.2m and measuring 0.45m wide. The wall itself appears to have been constructed of lower courses of angular sandstone with a limecrete bond, measuring up to 0.40m high; and had been set within construction cut [436], measuring 0.70m wide and 0.14m deep with vertical sides and flat base. An additional fill, (437), compacted mortar fragments and grey-brown silt formed the base for the wall within the cut.

10. AREA 04A, WALL {420}, SOUTH-EAST FACING PROFILE; FROM THE SOUTH-EAST (1M SCALE).

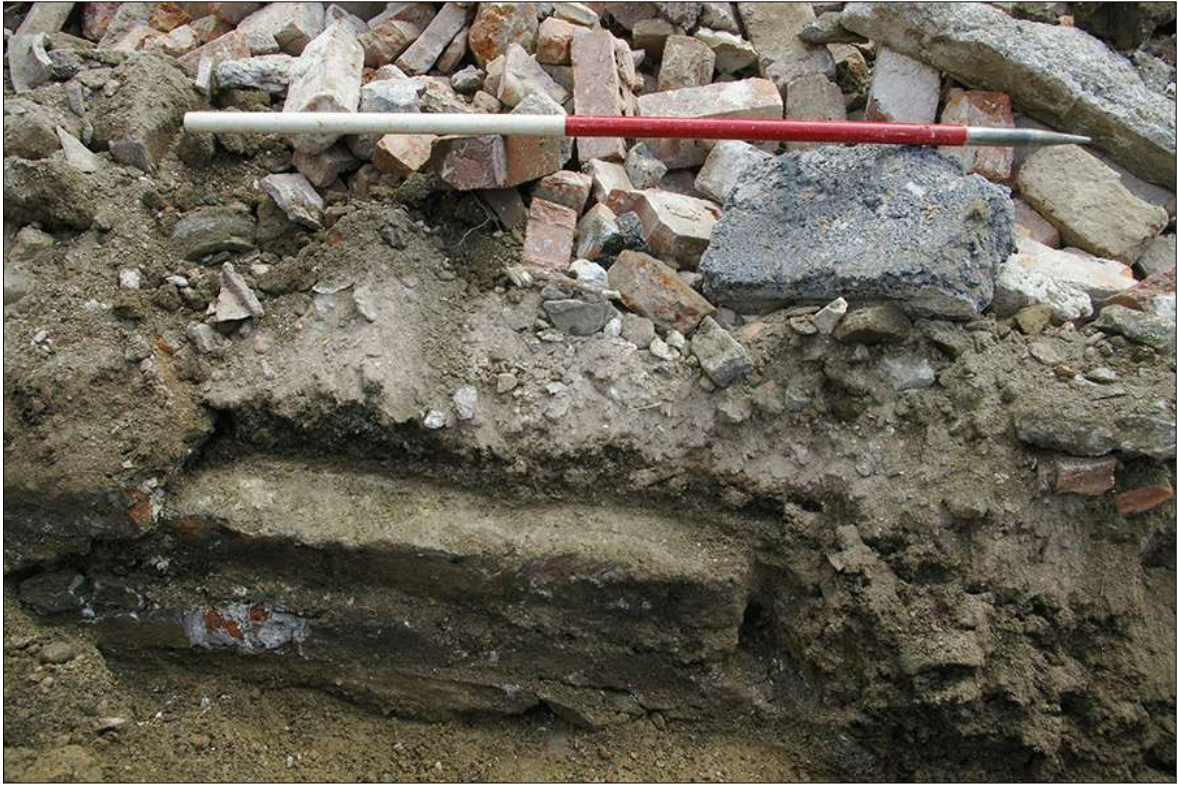
Wall {421} was located to the east of {420}, and survived for a length of c.2m on an approximate north-east to south-west alignment, measuring 0.20m wide and 0.24m high. It was constructed of red brick with a white cement mortar. This wall was set within construction cut [441], measuring 0.20m wide and 0.26m deep with vertical sides and flat base. Other than the wall, the cut contained two fills: upper backfill (442), brown sand; and wall bedding layer (443), brown loose sand with slate. To the north-west, wall {531} formed a possible return of this wall, orientated approximately north-west to south-east; constructed of red brick with concrete mortar and survived as a single brick thickness of wall, perhaps indicating an internal division.

11. AREA 04A, WALL {421}, NORTH-WEST FACING ELEVATION; FROM THE NORTH-WEST (1M SCALE).

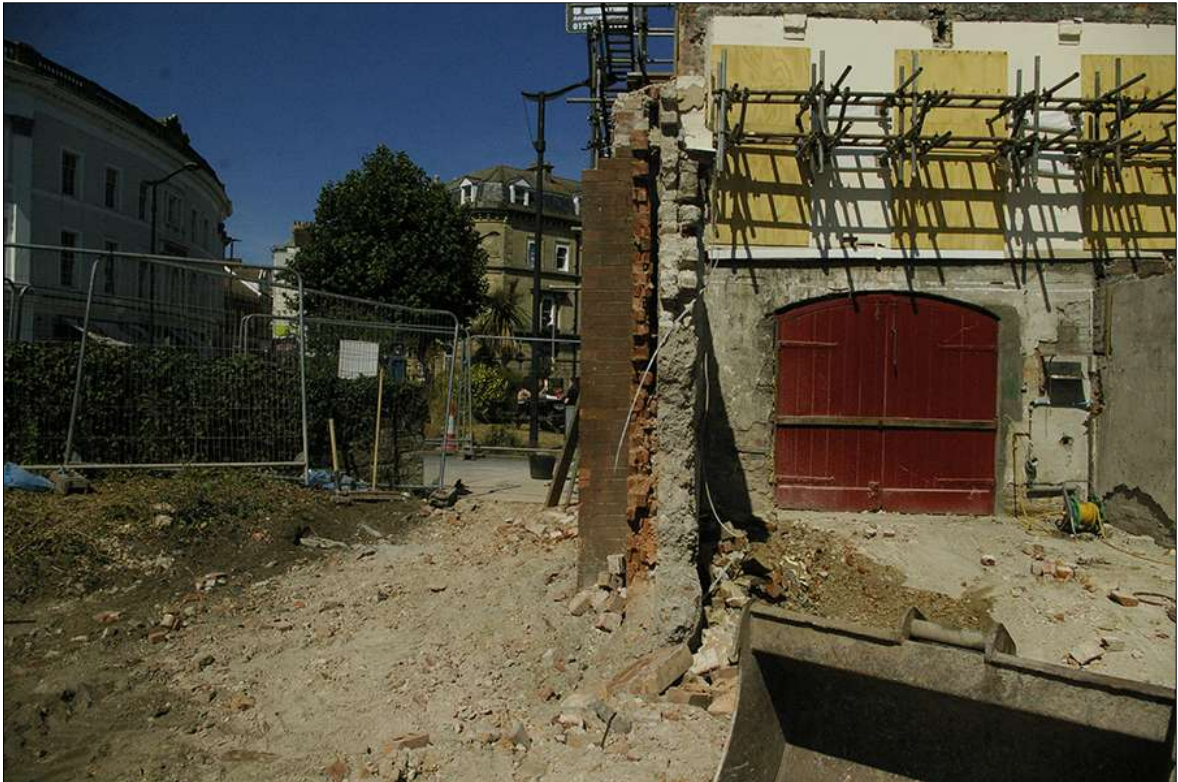
12. AREA 04B, WALL {521} SHOWING BRICK SKIN {457}; FROM THE SOUTH-WEST (NO SCALE).

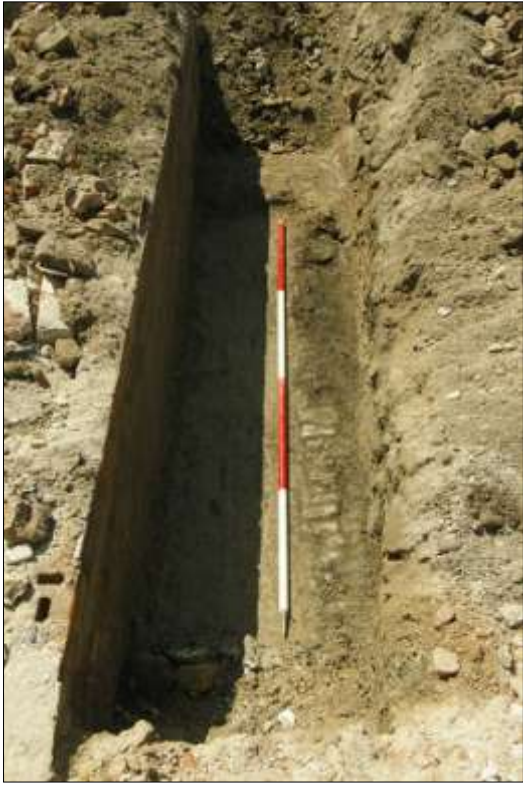
(455)	Layer	Cobble surface – fairly tightly packed sub-angular rounded cobbles, c.0.10m in size, set within bedding layer of mid slightly yellow-brown loose sand. Cobbles orientated approximately north-west to south-east. Only small rectangular area exposed, measuring c.1.95m×0.20m.	Overlain by (454)	-	18 th -19 th century?

13. AREA 04B, COBBLE SURFACE (455); FROM THE NORTH-EAST (2M SCALE).

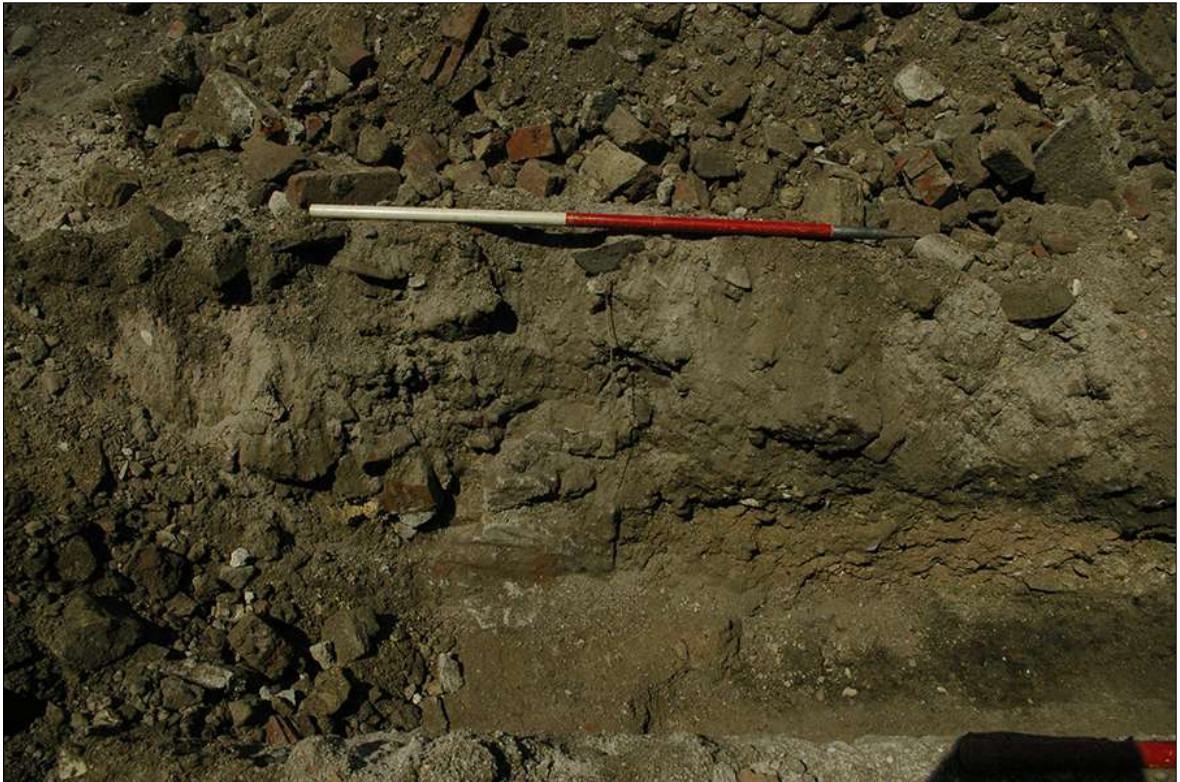
Towards the north-eastern end of the site, wall {449} was orientated approximately north-west to south-east, surviving for a length of 1.50m and measuring 0.54m wide and 0.40m high. It was constructed of red brick with a concrete mortar, with concreted brick and tile foundations {470}. These were set over what appeared to be an earlier phase of wall construction, {471} measuring c.1.50m × 0.60m wide and set within construction cut [525]. This had been backfilled against the wall by (526), brown silt. The south-eastern end of wall {471} had been rendered in white plaster

16. AREA 04B, WALL {449}, SOUTH-EAST FACING PROFILE; FROM THE SOUTH-EAST (1M SCALE).

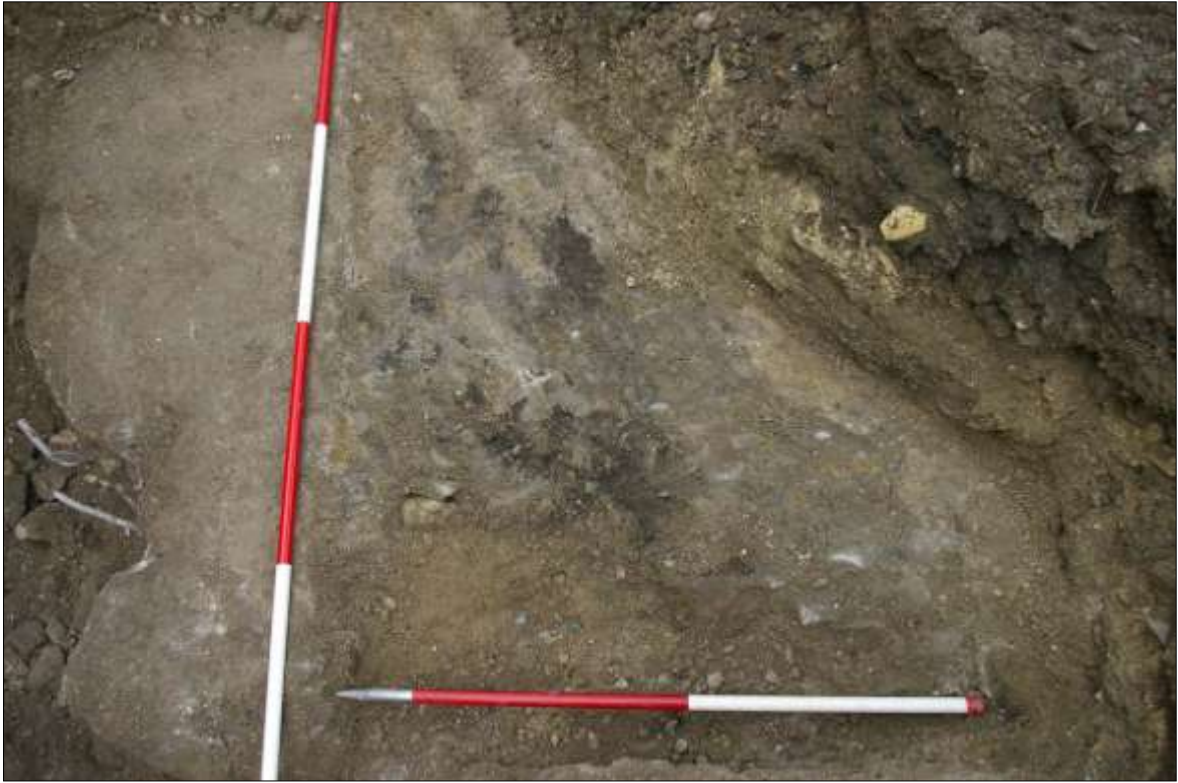
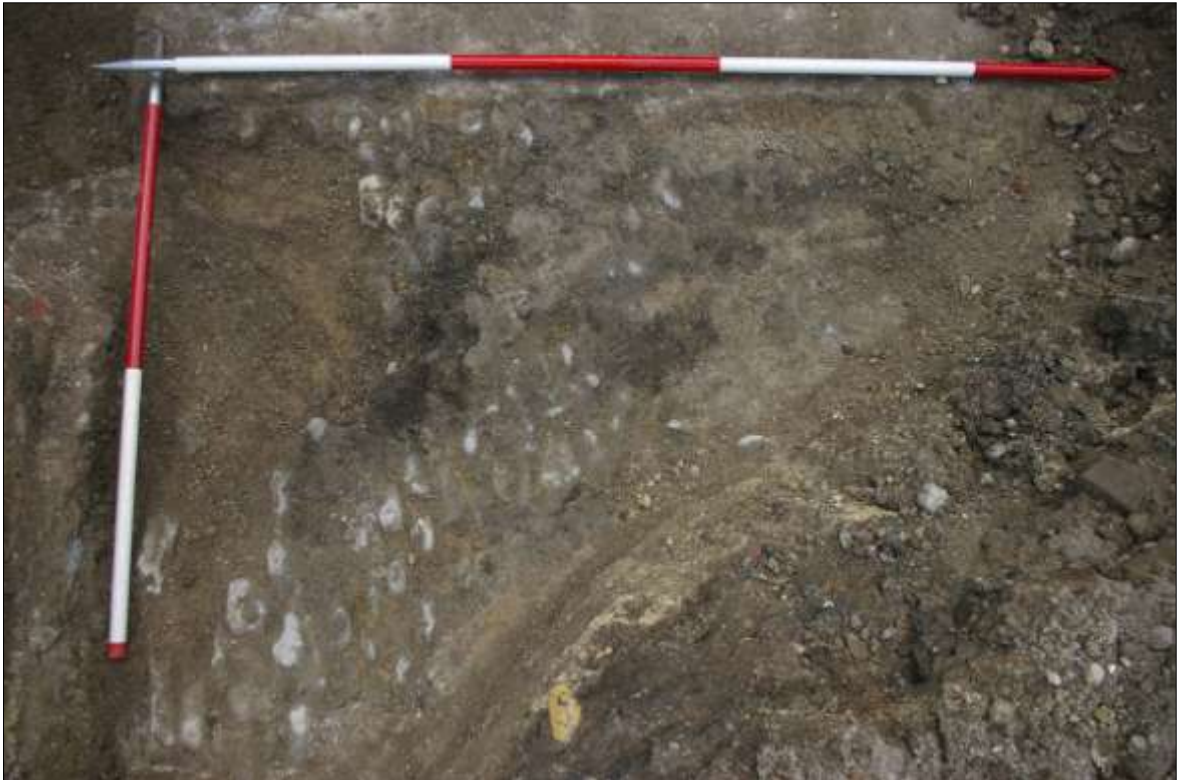
23. AREA 04B, COBBLE SURFACE (465); FROM THE NORTH-WEST (1M & 2M SCALES).

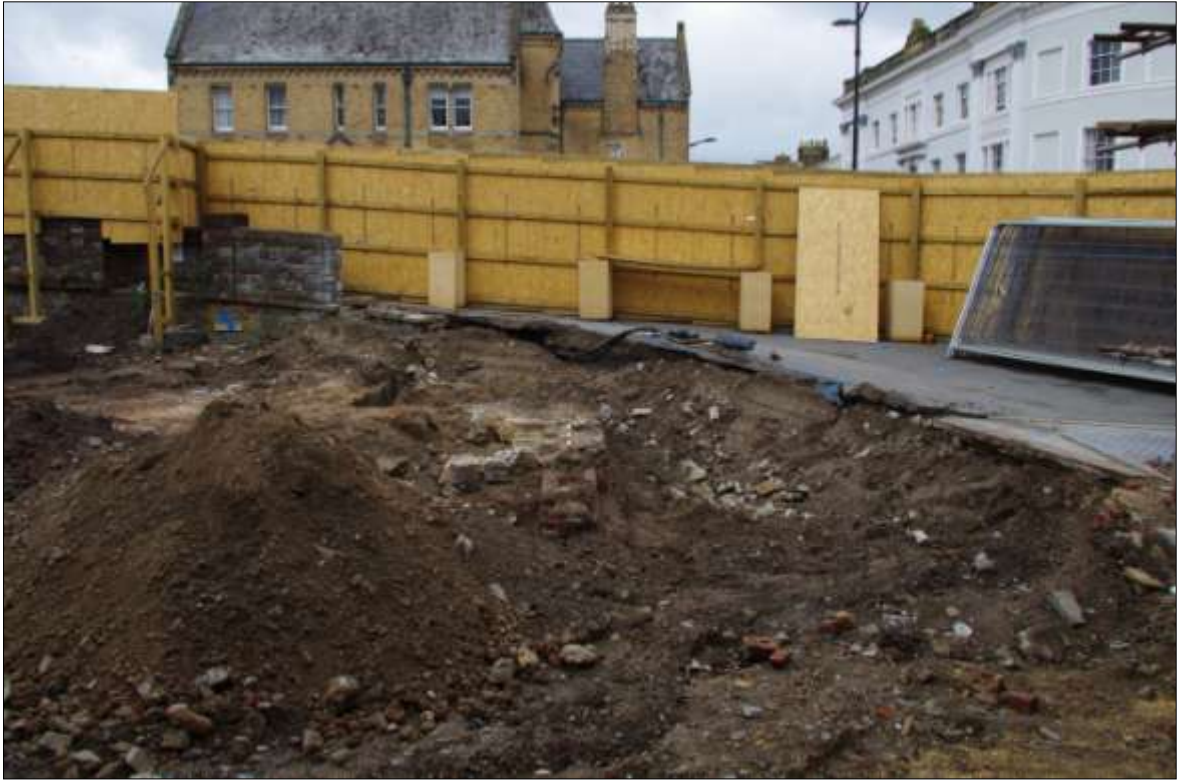
To the north-west, wall {474} may have formed a continuation of {449}, following the same alignment for an additional 3.35m, but measuring 0.60m wide, an extra brick course width to the north-eastern face perhaps reflecting less damage to this section of the wall. This was set on foundations {473}, concreted mortar with brick and tile. This was abutted to its south-western edge by wall {475}, orientated north-east to south-west and surviving for a length of c.1m and measuring 0.40m wide. It was constructed of red brick with cement bond. Approximately 1m to the north-west wall {477} ran parallel to {475}, surviving for a length of c.1m and measuring 0.45m wide. This too was constructed of red brick with cement bond. It is likely that these sections of walls continued to the south-west as {478} (2.20m×0.40) and {479} (1.25m×0.45m), both following the same alignment and constructed of red brick with cement bond. It is possible that the gaps between the walls {475} and {478} and {477} and {479} represent doorways off a central corridor. Between these was {476}, a lower set yellow sandstone slab over purple brick measuring c.1×0.20m, which may have been a step down towards a lower section of building. The spacing and alignment of this group of walls, along with the suggestion of there being a step suggests that formed a corridor within the building.

33. AREA 06, MID-EXCAVATION SHOWING WALLS {472}, {474}, {475}; FROM THE SOUTH-EAST (1M SCALE).

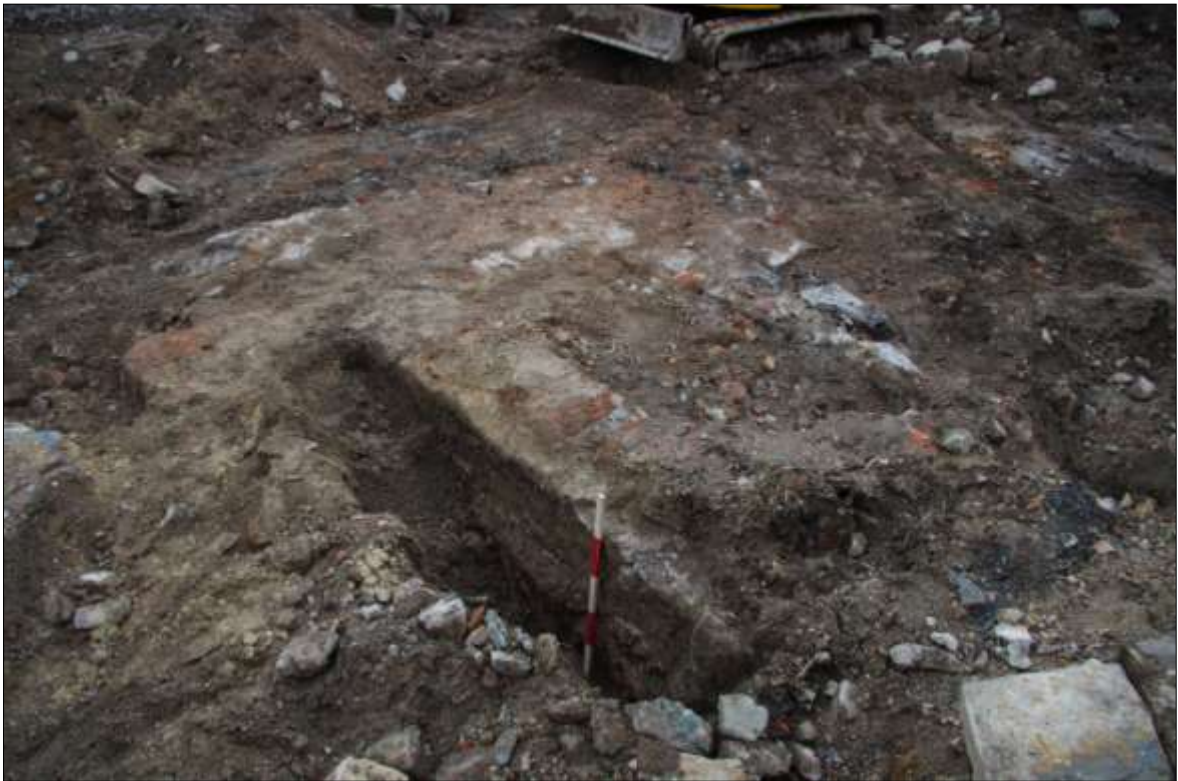
Abutted by the southern end of the possible corridor was a further group of walls: {480}, {481}, {482}, {483}, and {484}. These formed a rectangular structure orientated approximately north-west to south-east measuring c.3m×2m, the walls measuring 0.20-0.25m wide and surviving to c.0.20m high. The main wall structures {481}, {483}, and {484} had been constructed of red brick with cement bond, and appeared to have been set on stone foundations {480}, and {482} c.0.30m deep and up to 0.40m wide. A stone slab (485), orientated north-west to south-east and measuring 0.70m×0.50m was situated just off centre against the exterior of the south-western wall {483}, and may indicate the position of a threshold or form the surviving remains of a stone slab floor.

38. AREA 06, WALLS {480}, {481}, {482}, {483}, AND {484}; FROM THE NORTH (1M SCALE).

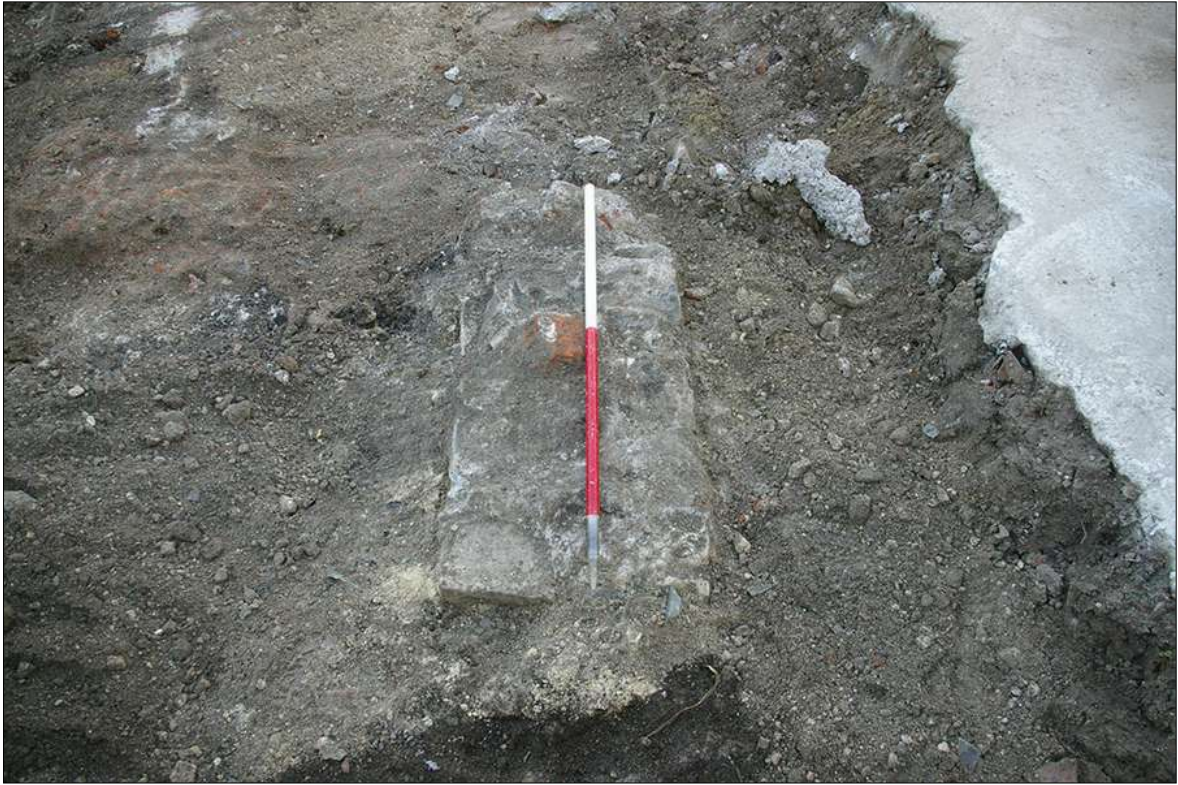
Beneath these was a further group of stone and brick walls. The latest of these, {488} was orientated approximately north-west to south-east and survived for a length of 1.20m, measuring 0.50m wide and exposed to a height of 0.15m. It was largely constructed of angular stone with white limecrete mortar bond and had brick repairs. This abutted the north-eastern end of linear wall {489}, orientated approximately north-east to south-west; measuring 2m×0.60m wide and constructed of red brick with a white lime mortar. At its south-western end this wall returned to run to the north-west as {490}, measuring 2.50m×0.60m wide.

39. AREA 06, WALL {488}; FROM THE SOUTH-EAST (1M SCALE).
