Devon County Council Historic Environment Record

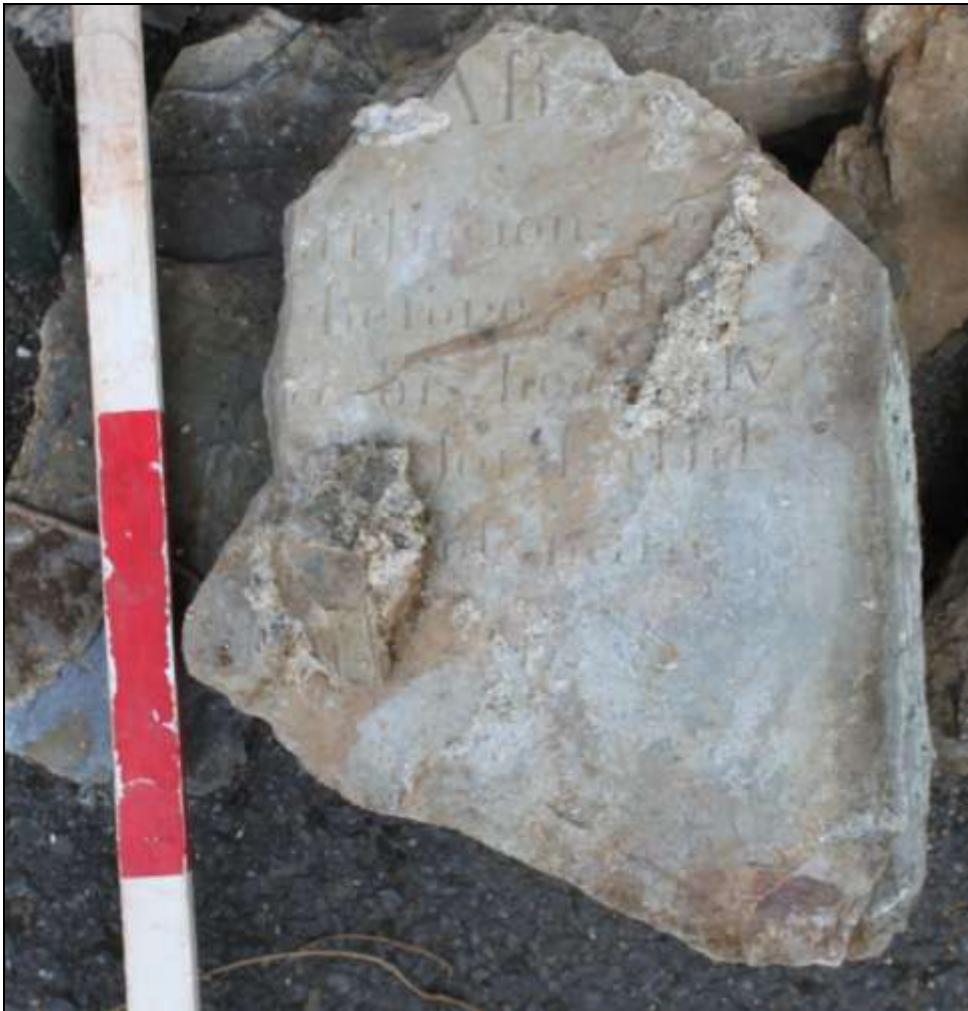
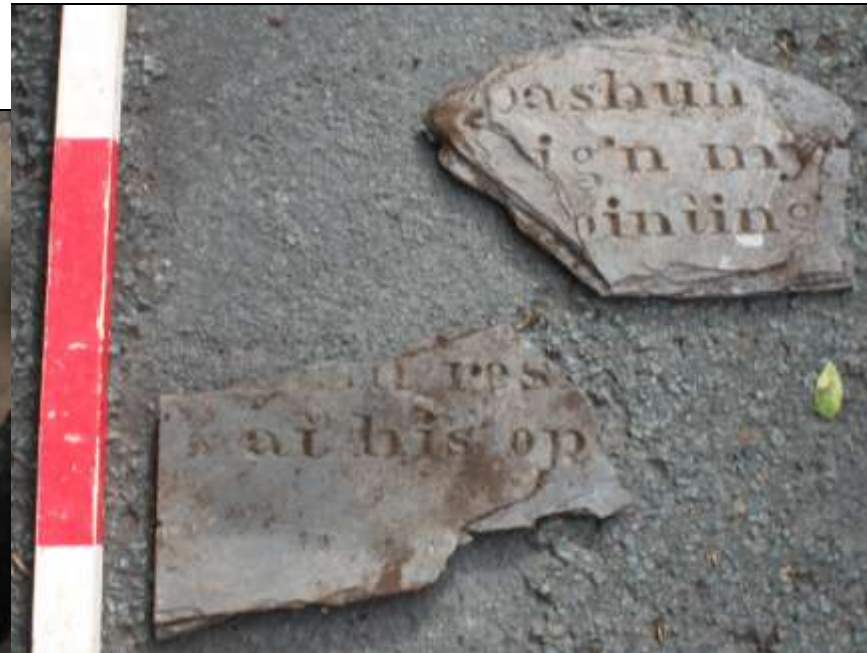
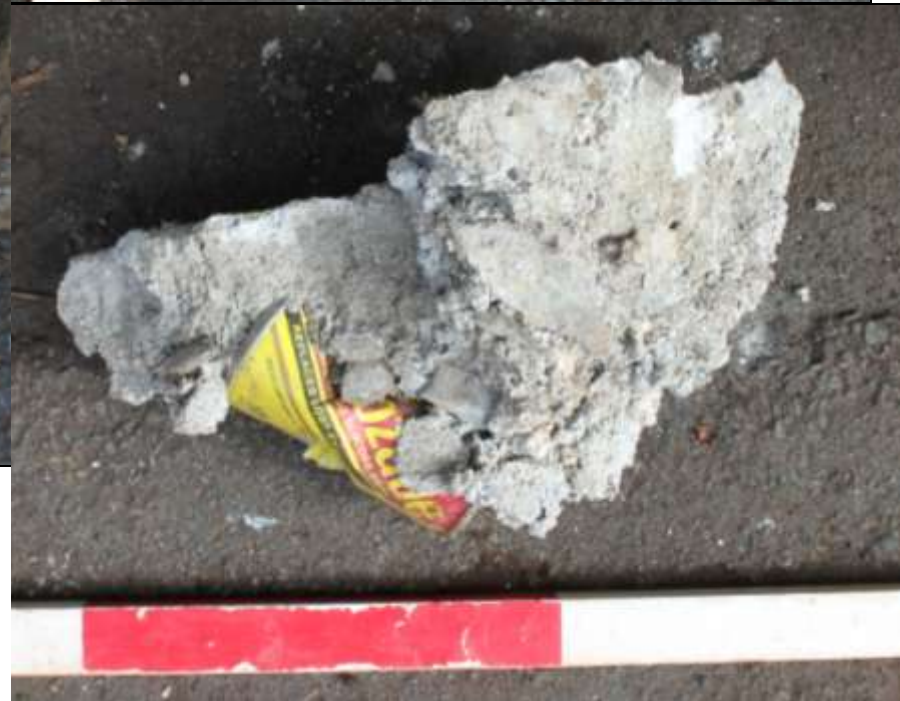
Figure 2: Left and top right: Photos of the fragments of grave stones recovered from within the build (1m scales). Bottom right: Lucozade drinks can incorporated into a phase of recent (1990s?) repairs (1m scale).

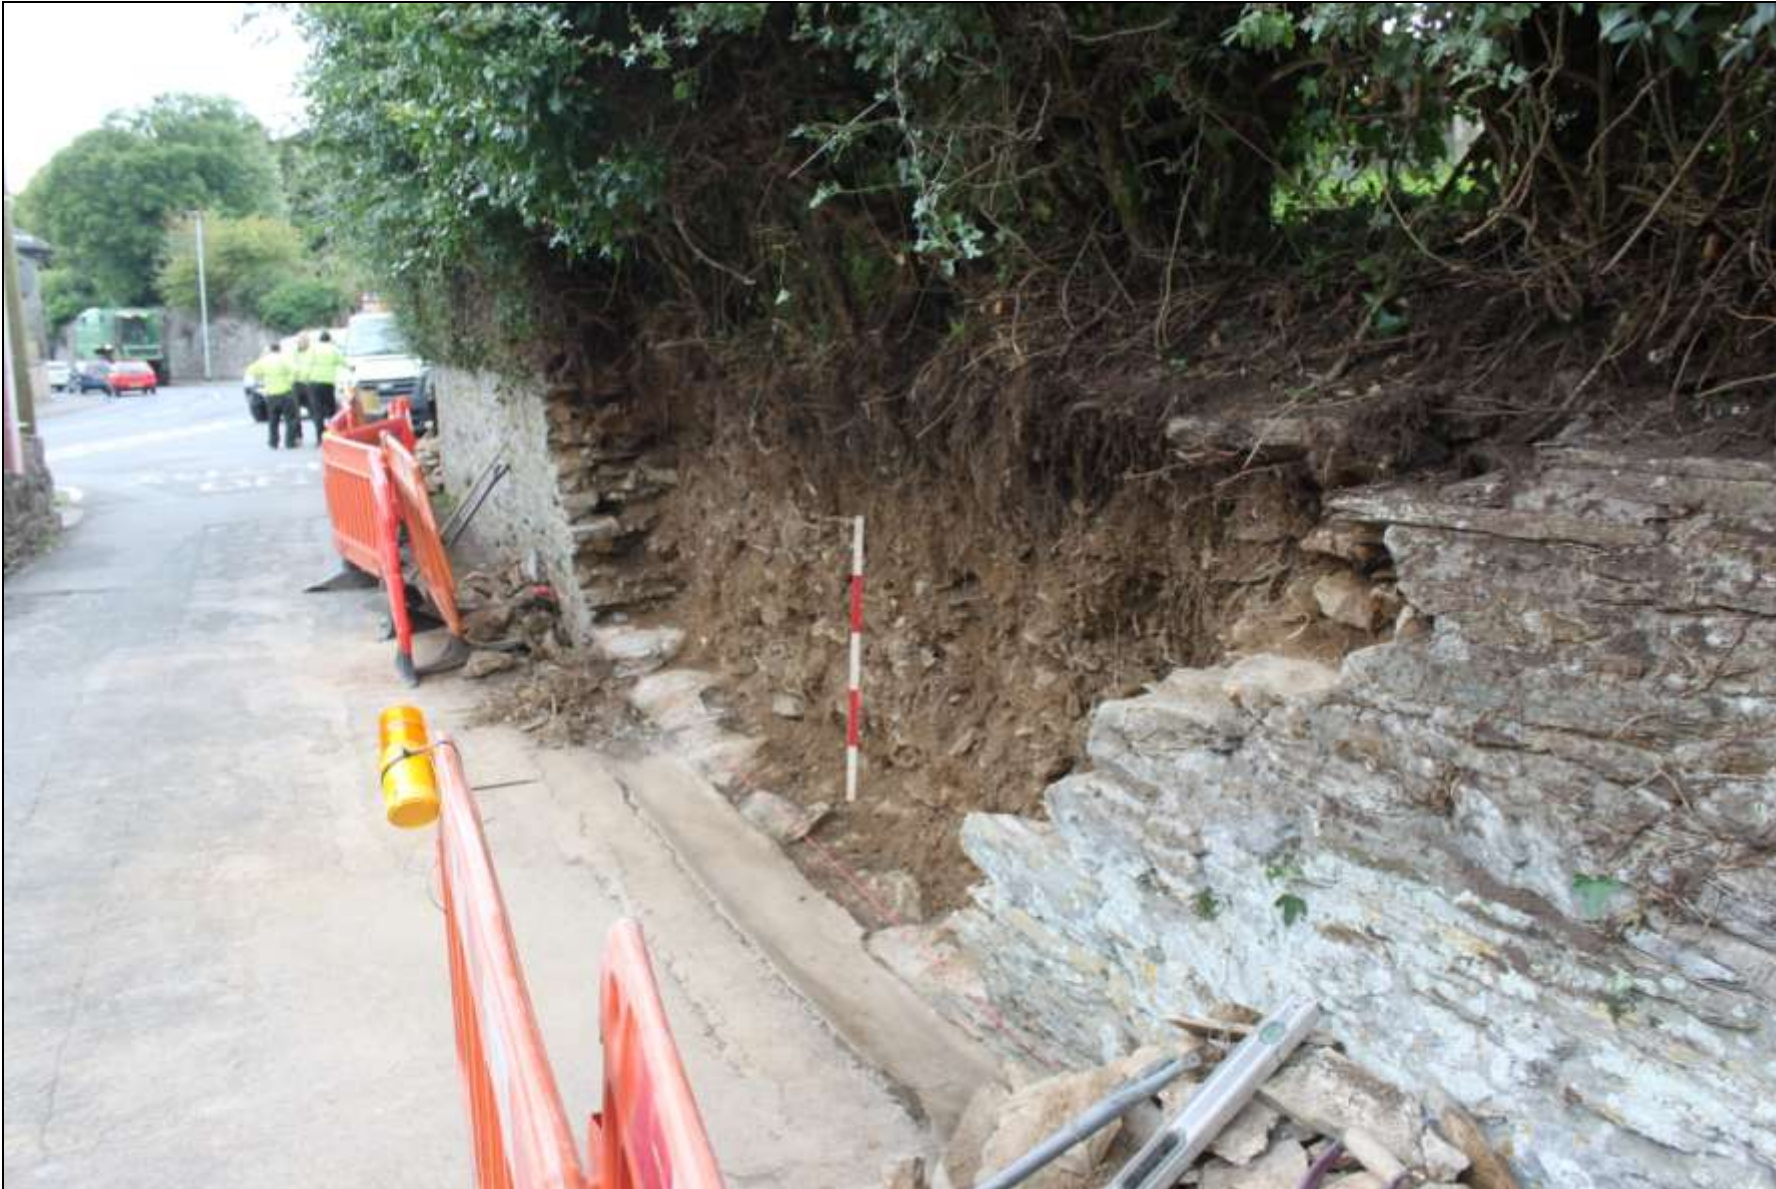
Figure 3: Full extent of wall removal, viewed from the south-east (1m scale).
