COOMBE FARM BRENDON AND COUNTISBURY EXMOOR DEVON

Historic Building Recording

Coombe Farm Barns, Brendon and Countisbury, Exmoor, Devon

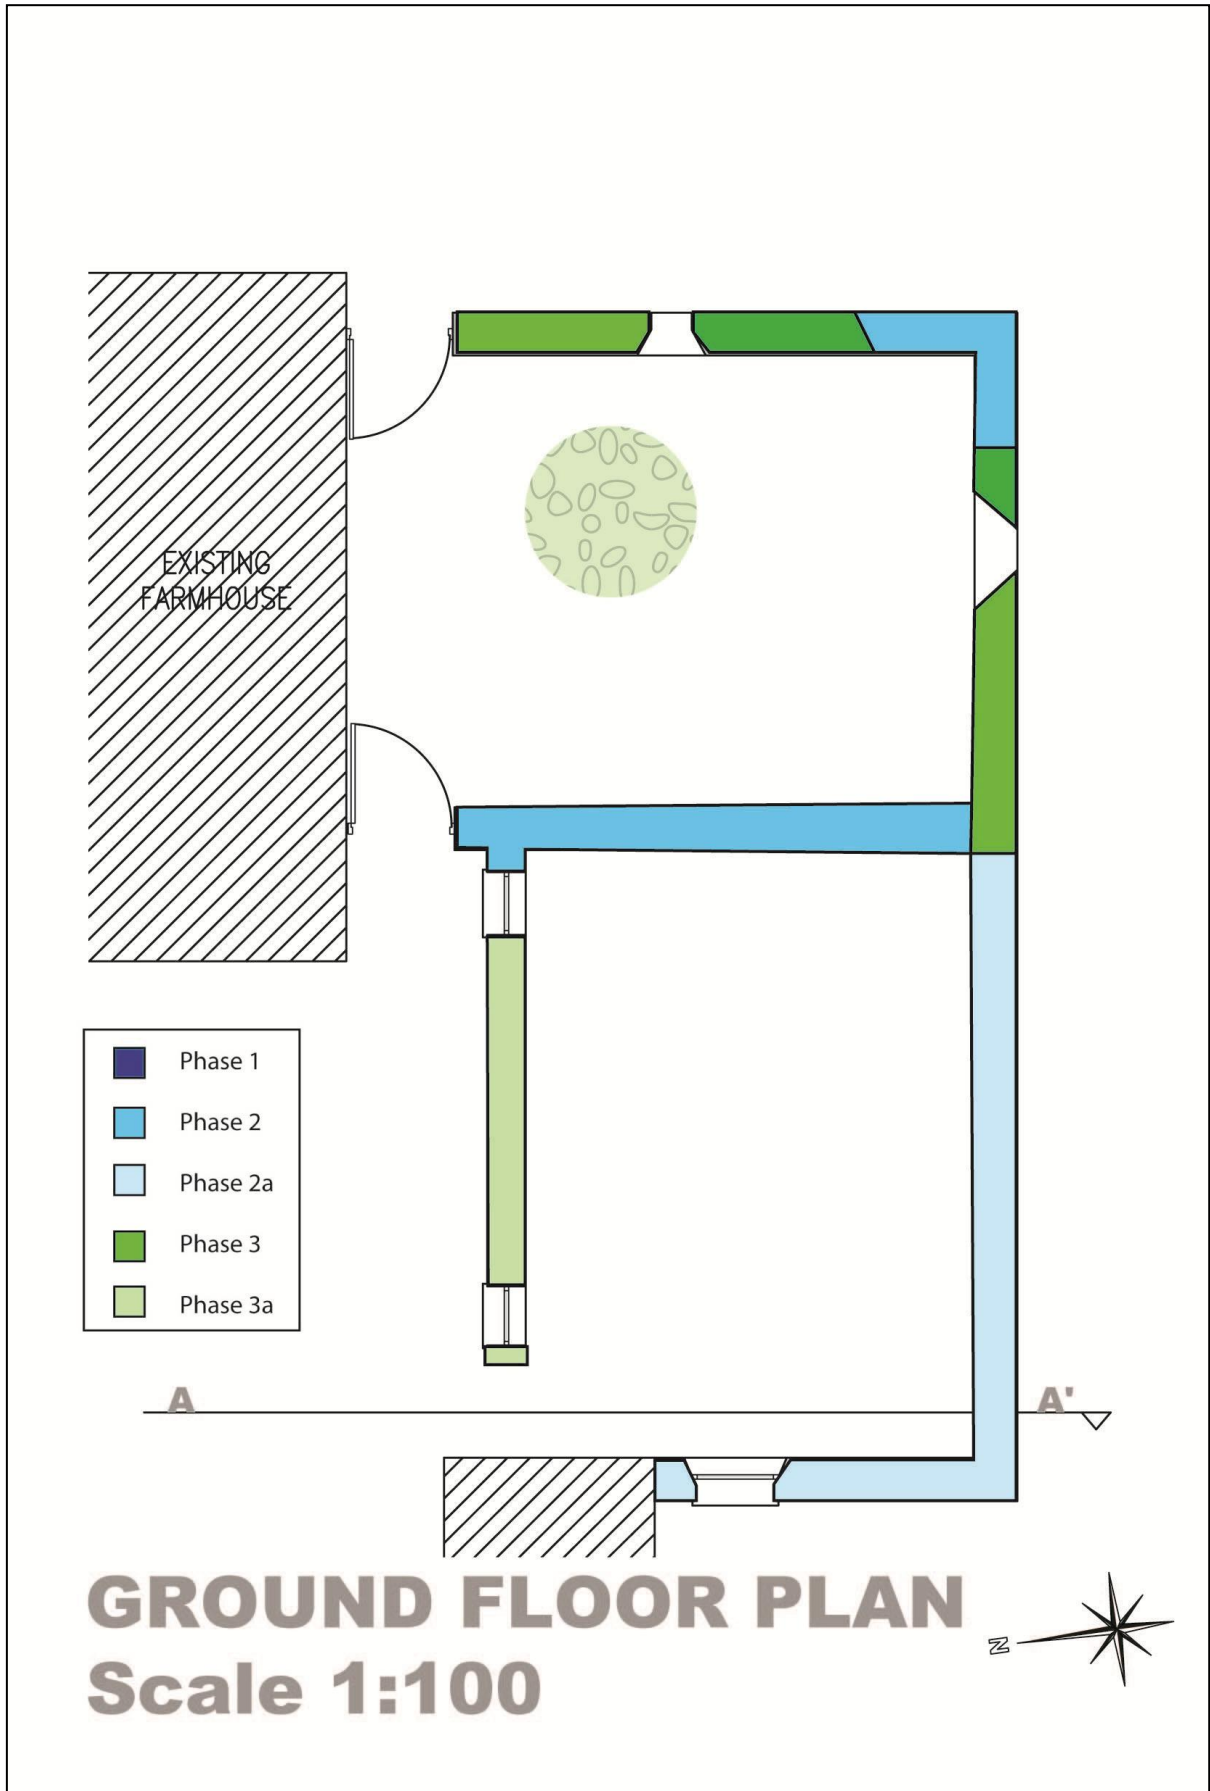
FIGURE 9: PHASING OF THE BARN; FLOOR PLAN.

Barn 1 is likely to be mid 19th century in date. There is the possibility that it is reworked from the southern end of the farmhouse depicted on the Tithe Map, but no evidence survives from this phase above ground. The barn was reworked again within a few years of its construction, likely in conjunction with the terracing of the field for drains, and this phase included the rebuilding of the south gable and probably the insertion of the cobbled floor and slate slab drain structure, which

dates the conversion to a cow byre. The loft appears to have been inserted at a similar time, the heavy beams and the name 'turf house' indicating its likely use being for the storage of peat cuttings.

Barn 2 also dates from the mid 19th century. It was significantly altered soon after construction, when the long, narrow west range was built abutting it and the north wall of the barn rebuilt at that point in poorer quality slate rubble, perhaps having been open fronted before. Its earlier function is unknown but it is unusually wide for such a short range. The roof has been replaced, probably in the early 20th century, when the heavy, good quality but relatively modern truss blades, purlins and rafters were installed. Barn 2 was then converted to form a cow byre.

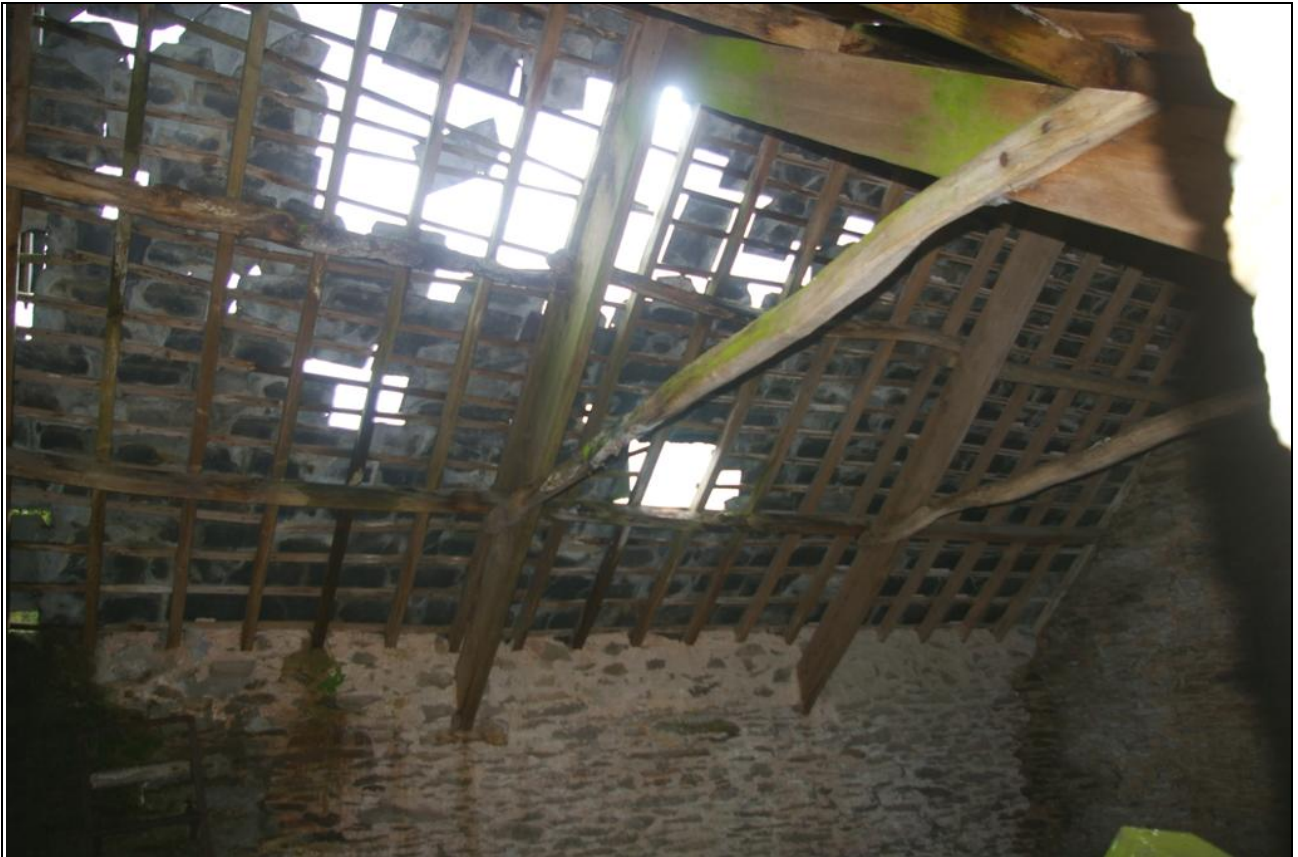
View of the roof structure over the two storey shippon (Barn 1) from the loading door; from the north-west.

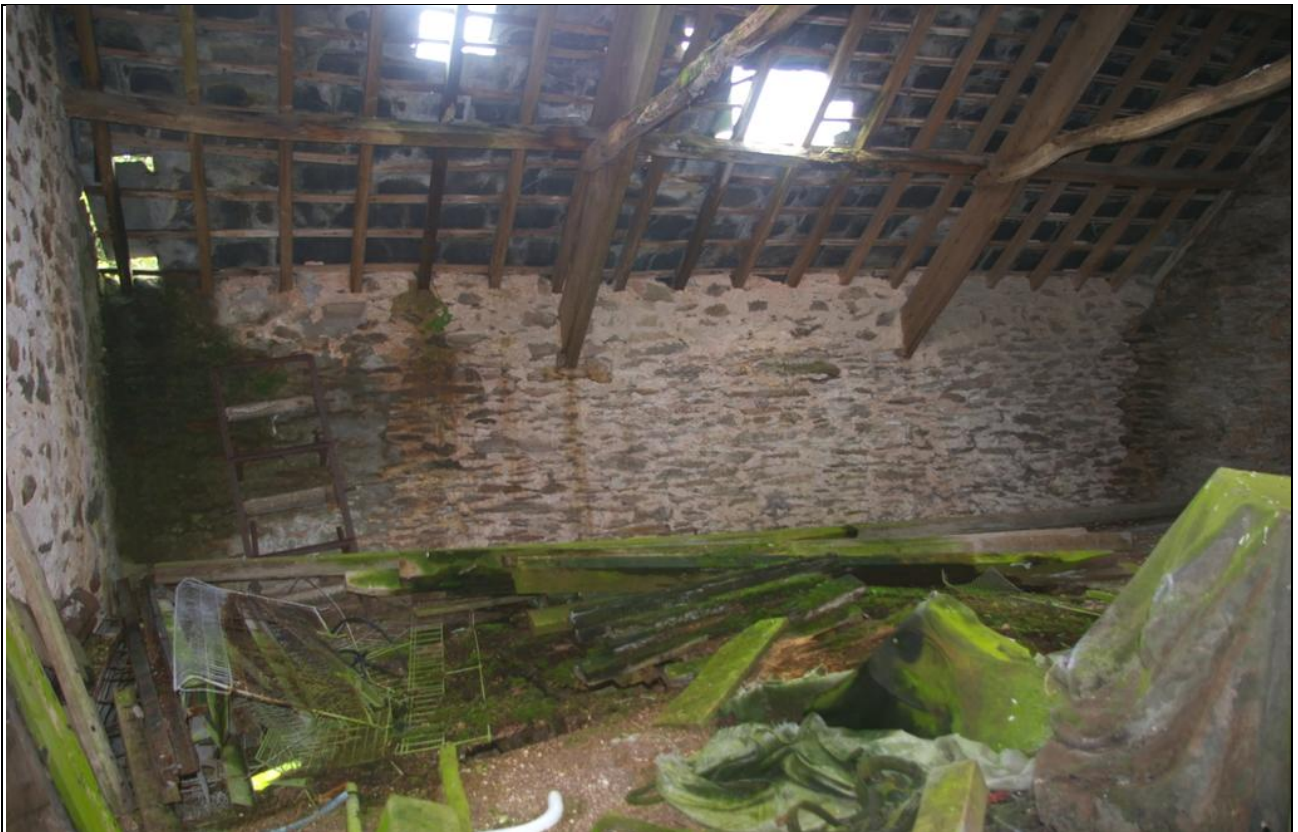
View of the upper part of the west wall of Barn 1, showing the upright at the eaves where the wall has been raised and the eaves enclosed during a later phase of alteration; from the loading door; north-west.

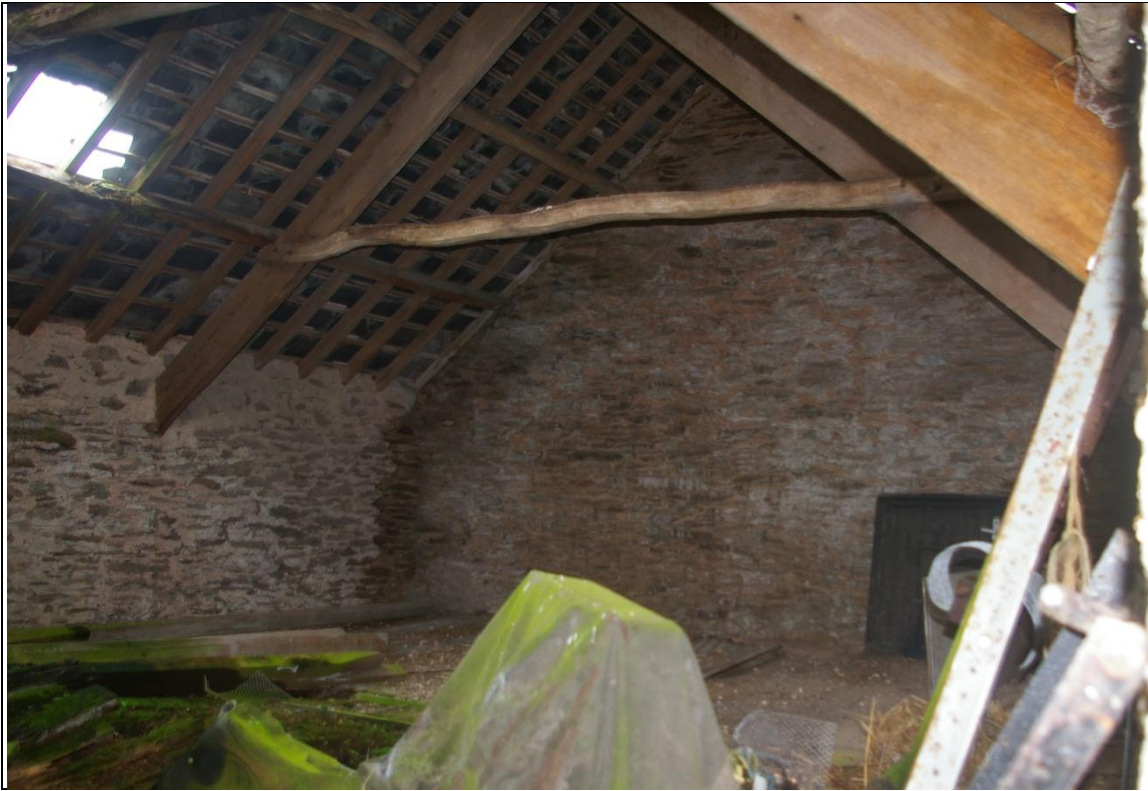
The south two storey gable end wall, which has clearly been rebuilt at a later stage in a markedly different mortar; from the north-west.

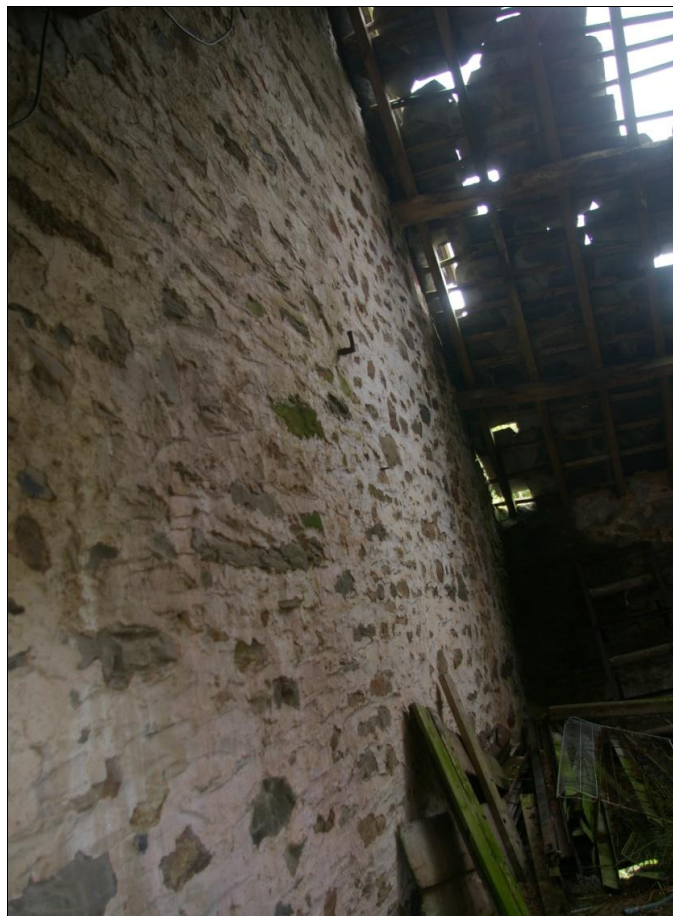
The upper part of the gable end of the house, as seen within the loft area of Barn 1; from the west.

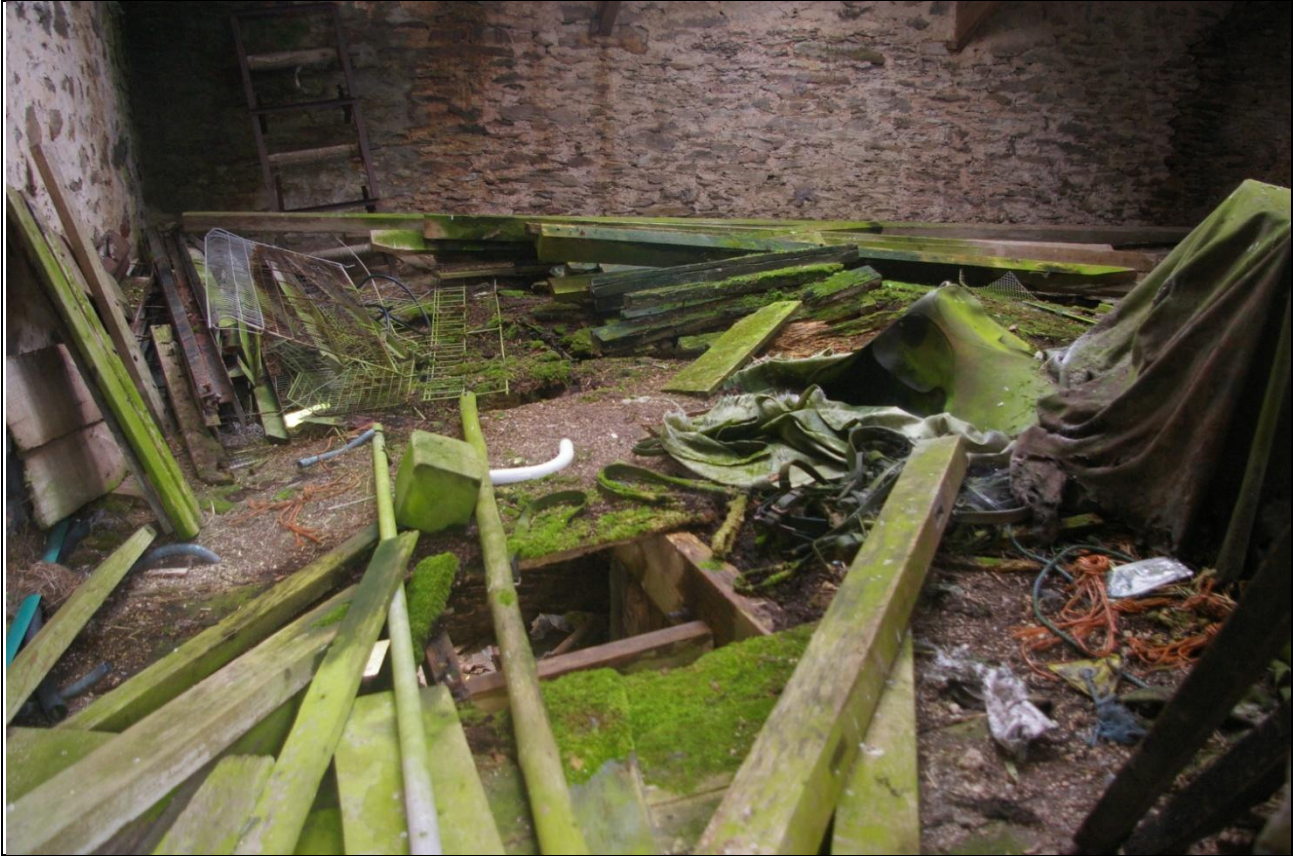
It must also be considered that this building has some structural and weather damage issues in the walls and roof respectively, as well as in the loft, which is no longer sound. The barn is also too small to be practical for modern farming, used only for occasional storage. The conversion will restore the structure, provide a sustainable use, and secure its survival as part of the wider complex.

The water damaged loft floor, showing large holes, Barn 1; from the west.

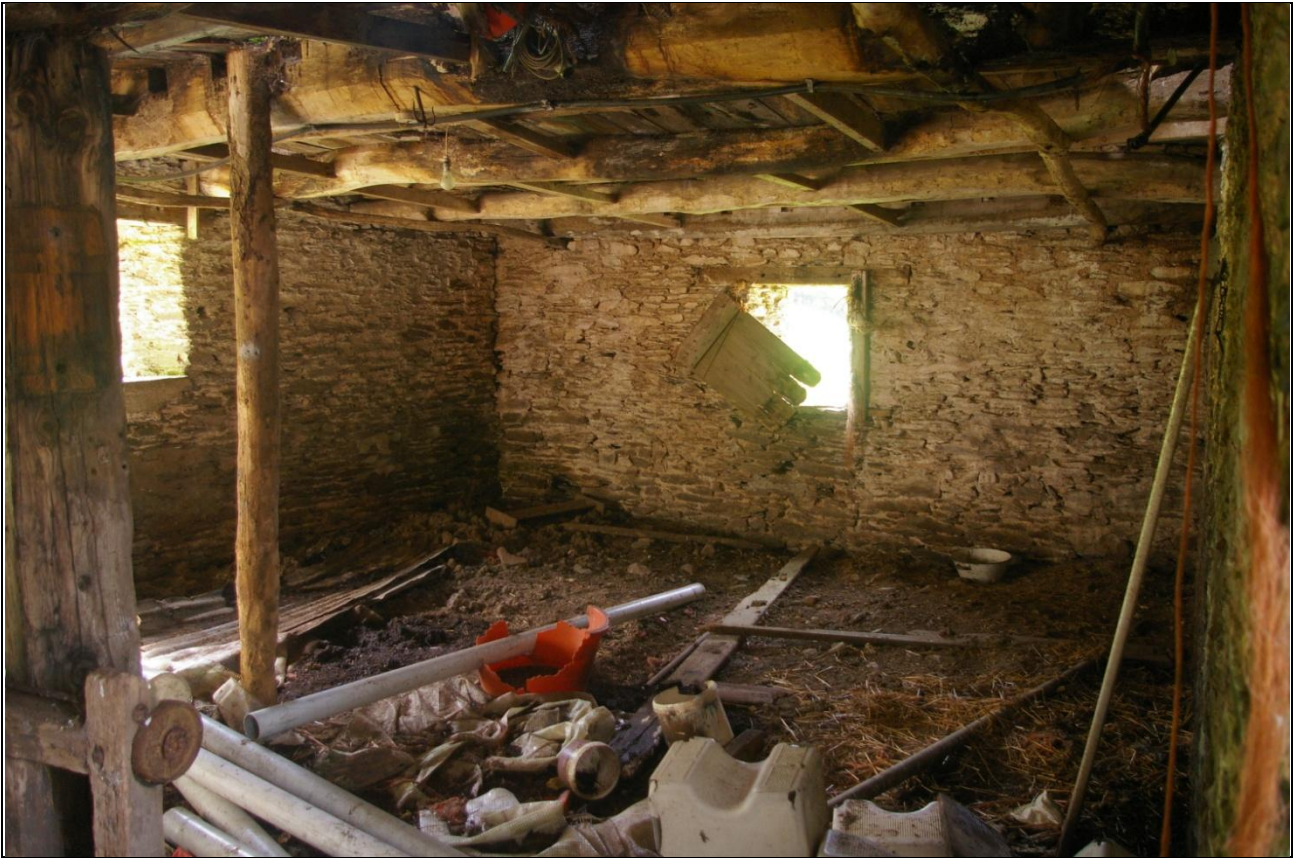
Ground floor south wall, Barn 1, with window; from the north-west doorway to the yard.

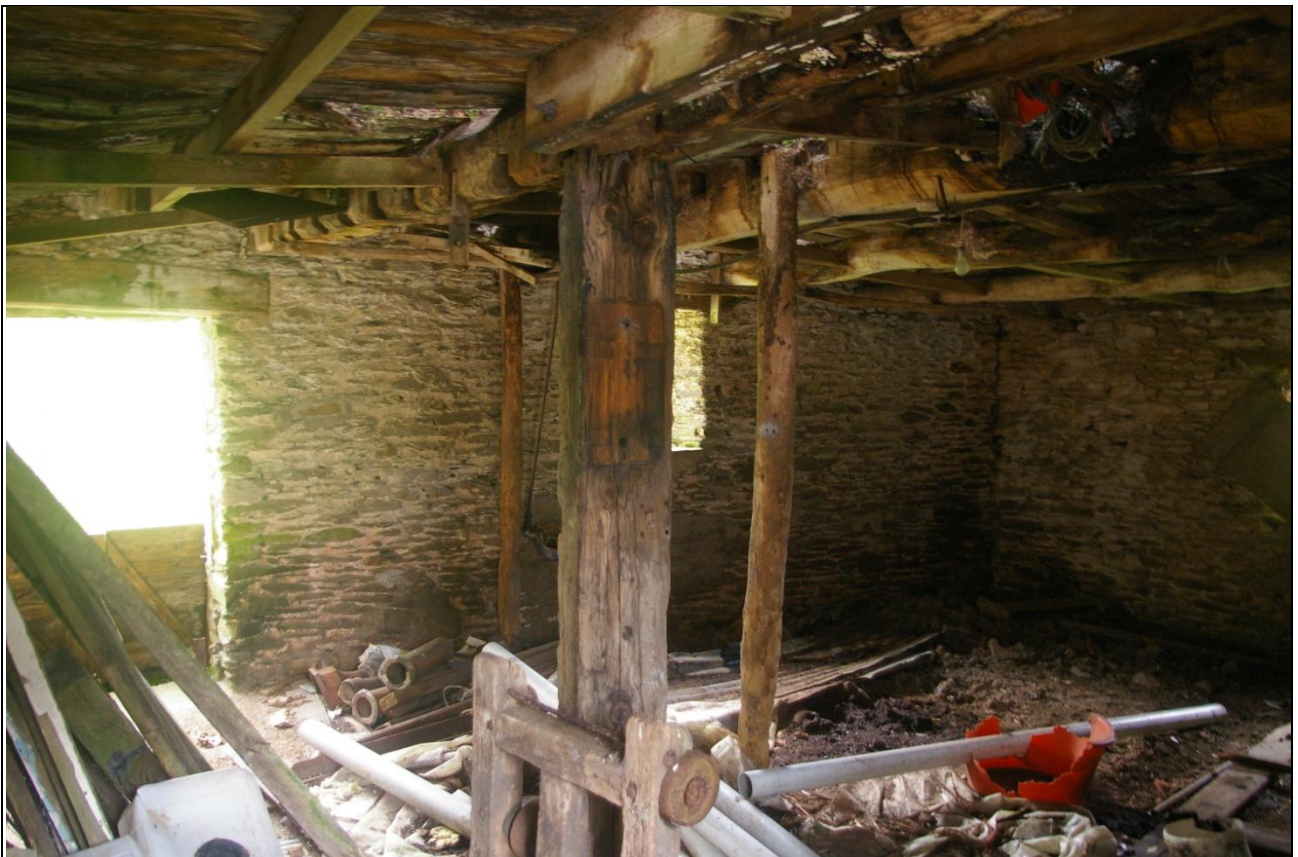
Ground floor east wall, Barn 1, with window and door to field; from the north-west.

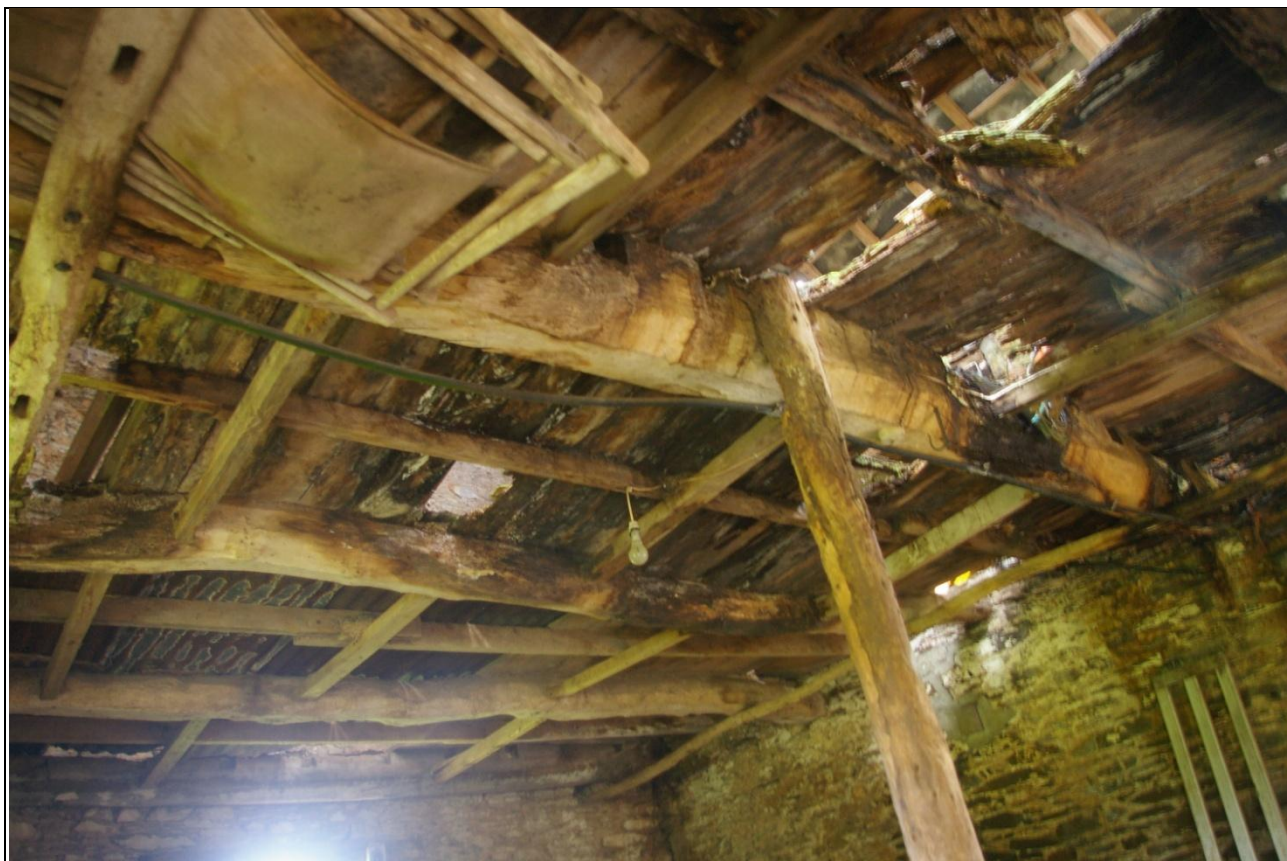
The loft floor in Barn 1, supported on massive reused timbers, possibly from the house; from the north-east corner of the barn.

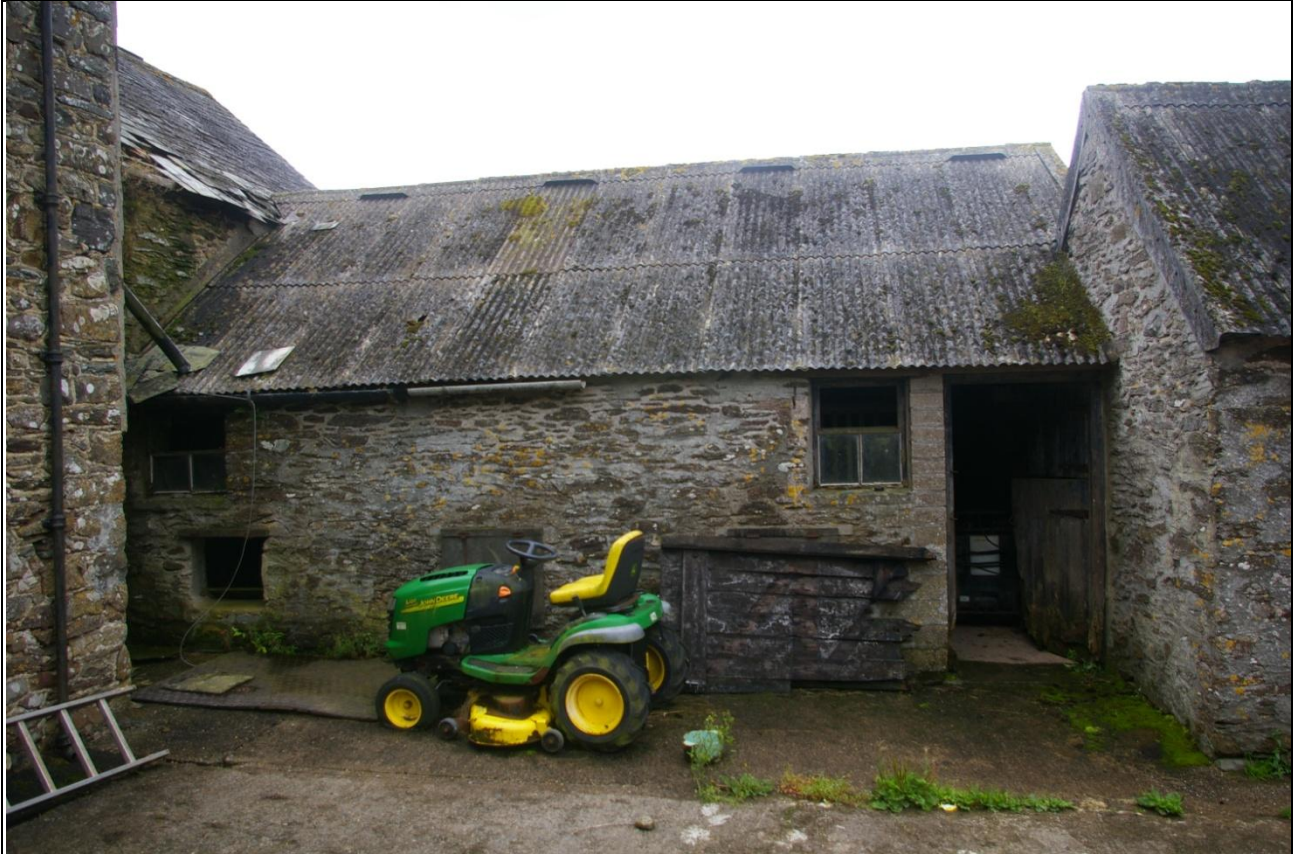
The north elevation of Barn 2, the single storey cow byre; from the north, north-west.

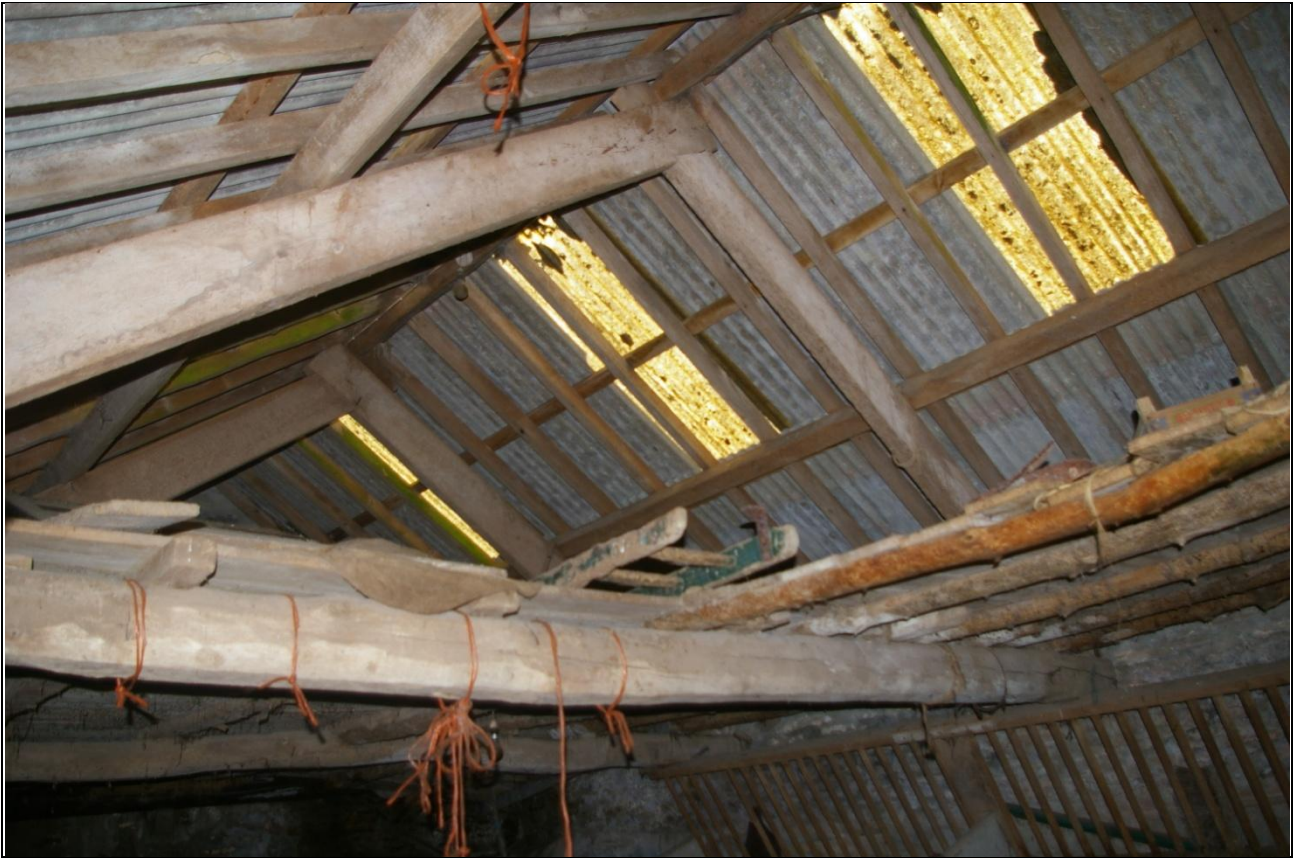
The roof structure in Barn 2, of the same form as that in Barn 1; from the north-west.

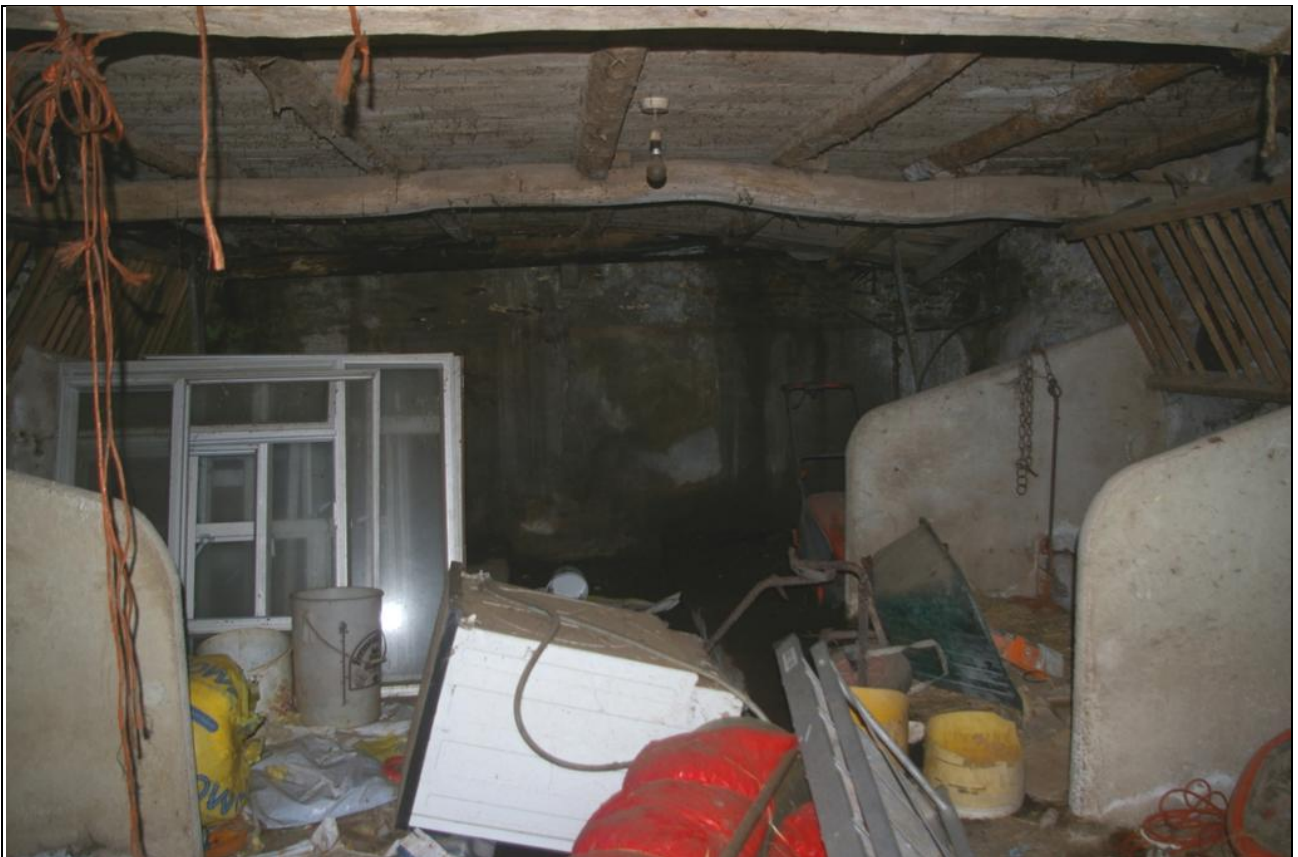
Comments		This building has been completely remodelled inside to provide 20 th century concrete cattle pens and retains no historic character or visible features. There is low potential for a cobbled floor to survive underneath the concrete slab.

The interior of Barn 2, with rendered walls and inserted concrete cattle pens, with loft carried on the tie beams of the roof; from the west, south-west.

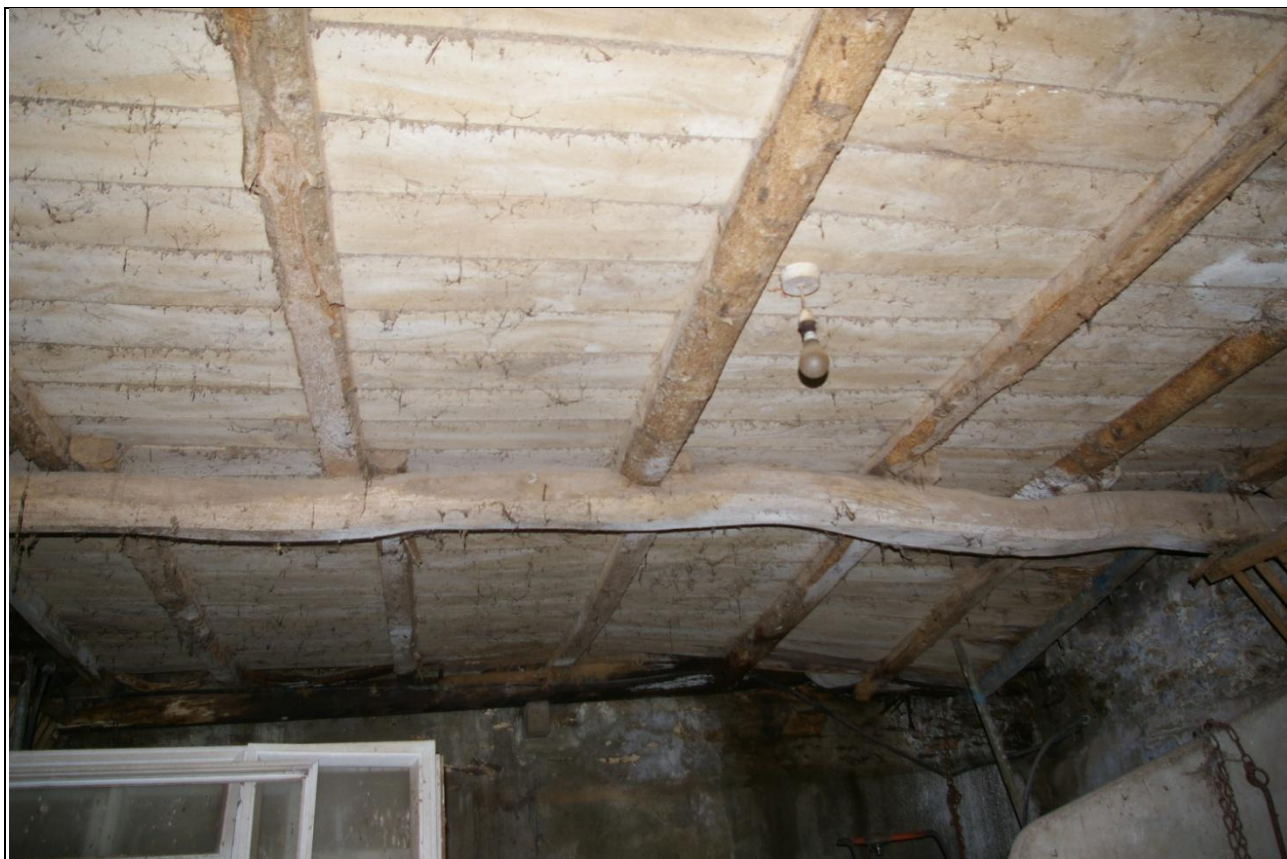
The loft structure in Barn 2: even width narrow but chunky plank boards on embarked irregular lightweight timbers, resting on the tie beams; from the west, south-west.

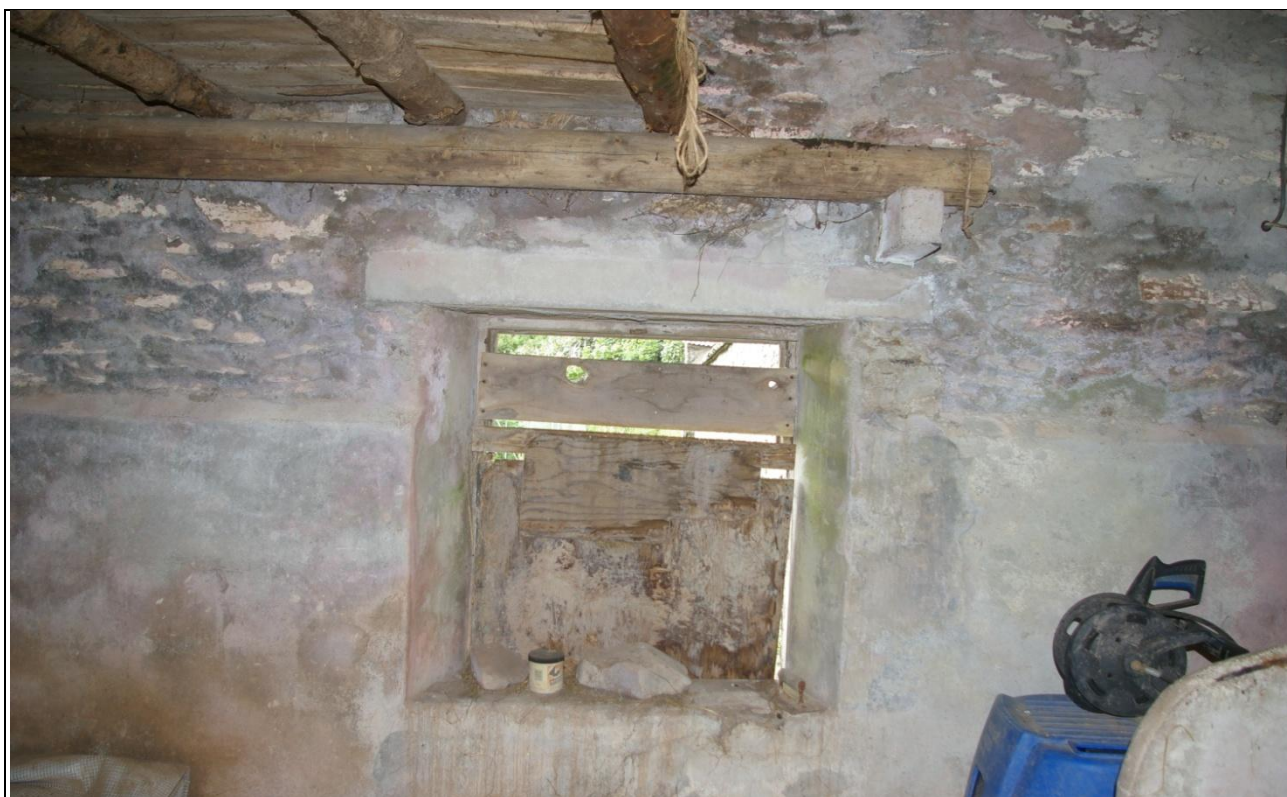
The window forced in the west gable end wall of Barn 2, with concrete lintel and rendered sides; from the east.

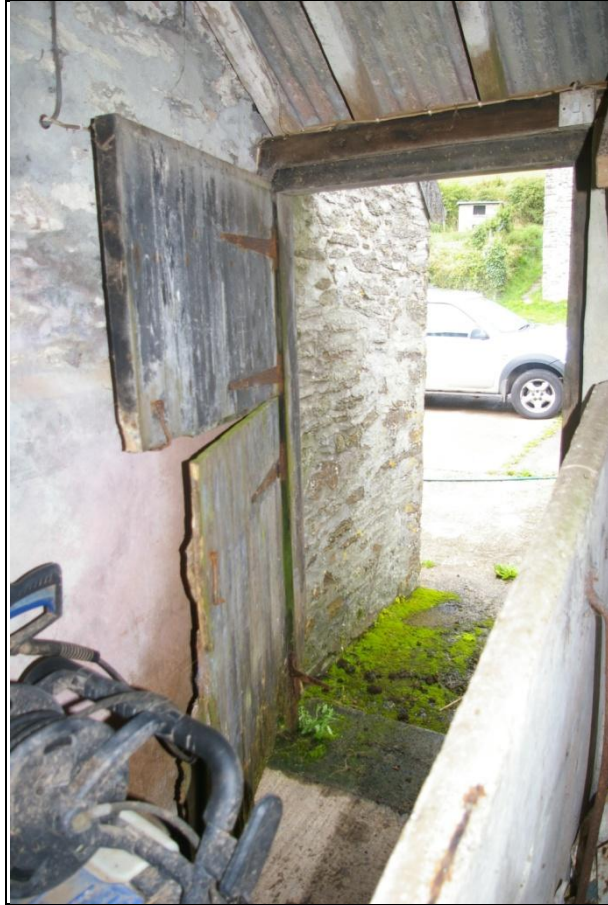
The yard door in Barn 2, with relatively modern plain timber frame and narrow plank stable door; from the south-east.

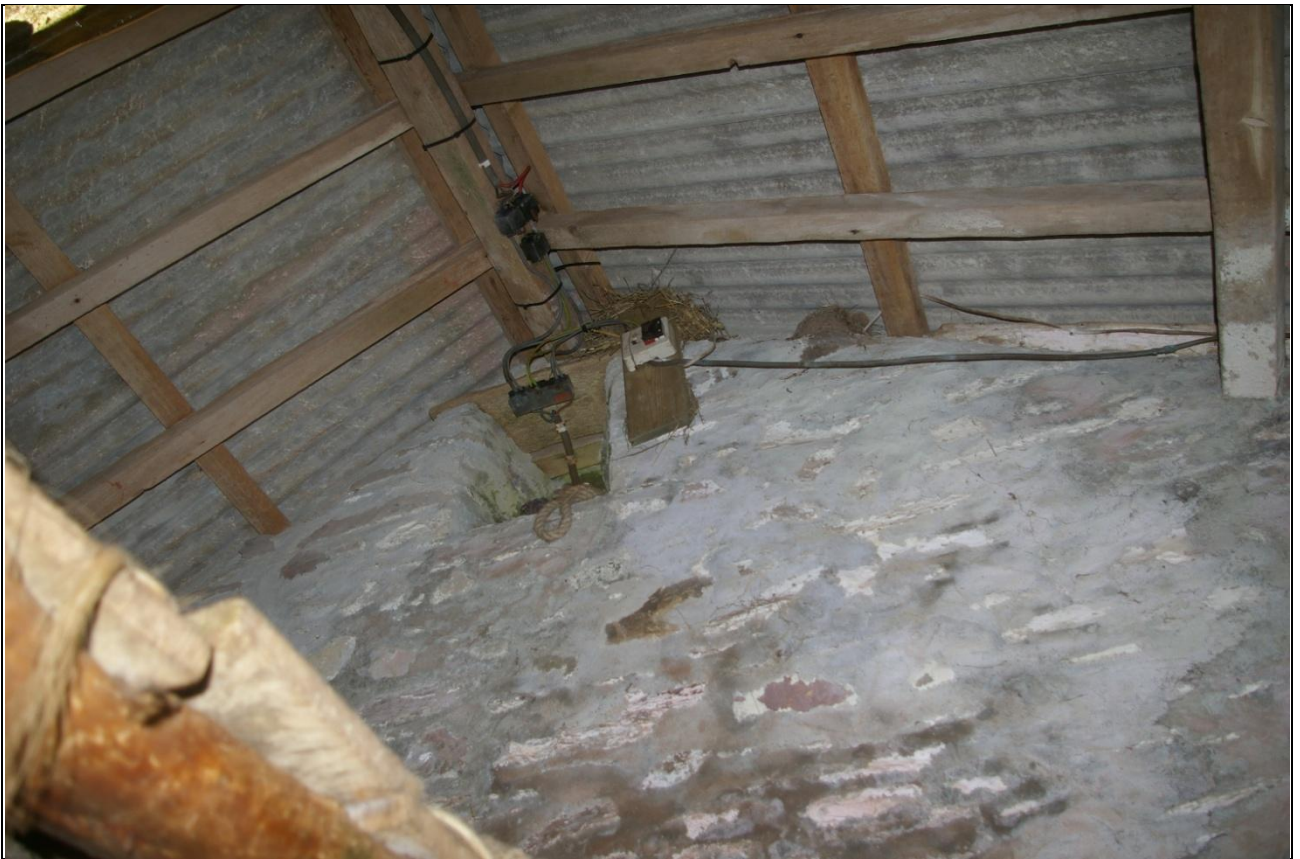
The small air vent in the apex of the gable of the west wall of Barn 2; from the east, north-east.

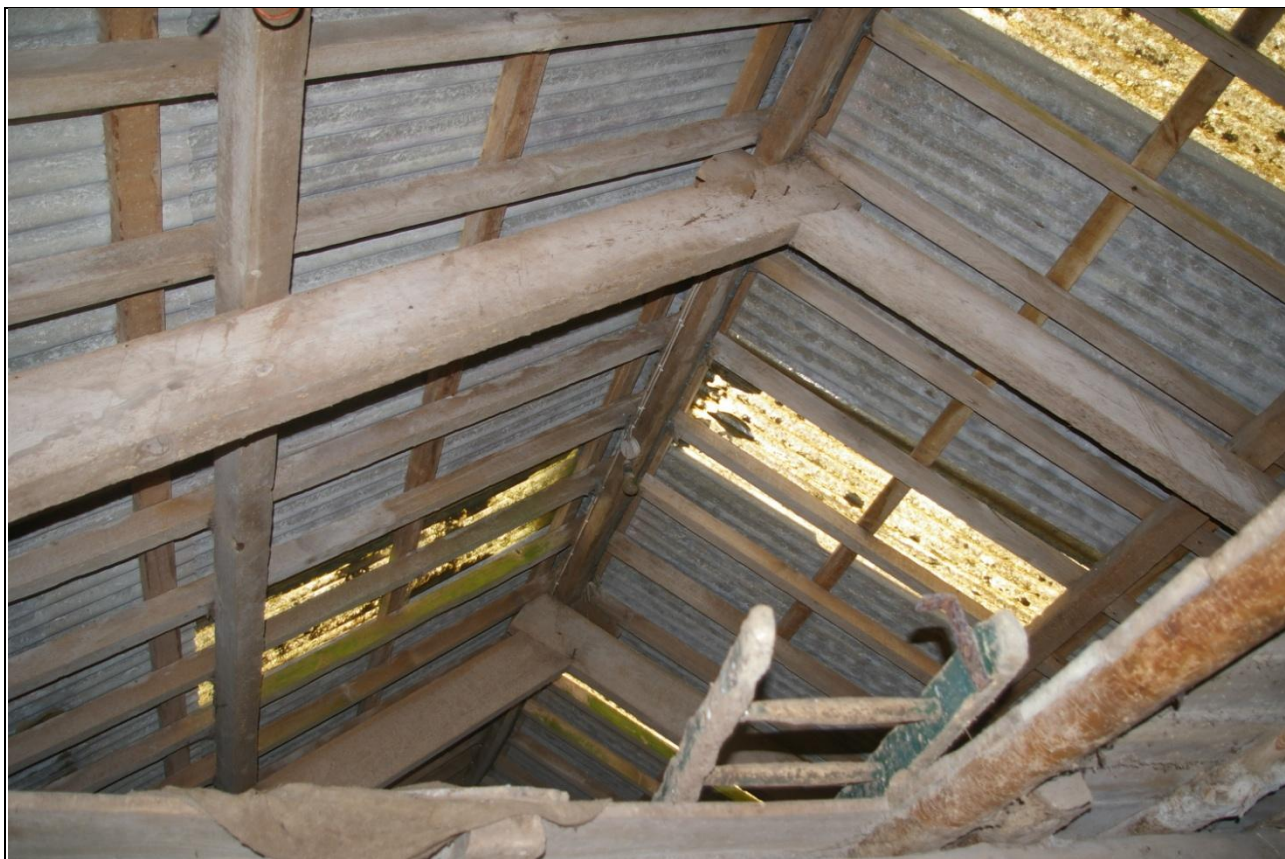
The ridge and relatively modern purlins and rafters of the roof over Barn 2, with corrugated asbestos sheeting; from the west, north-west.

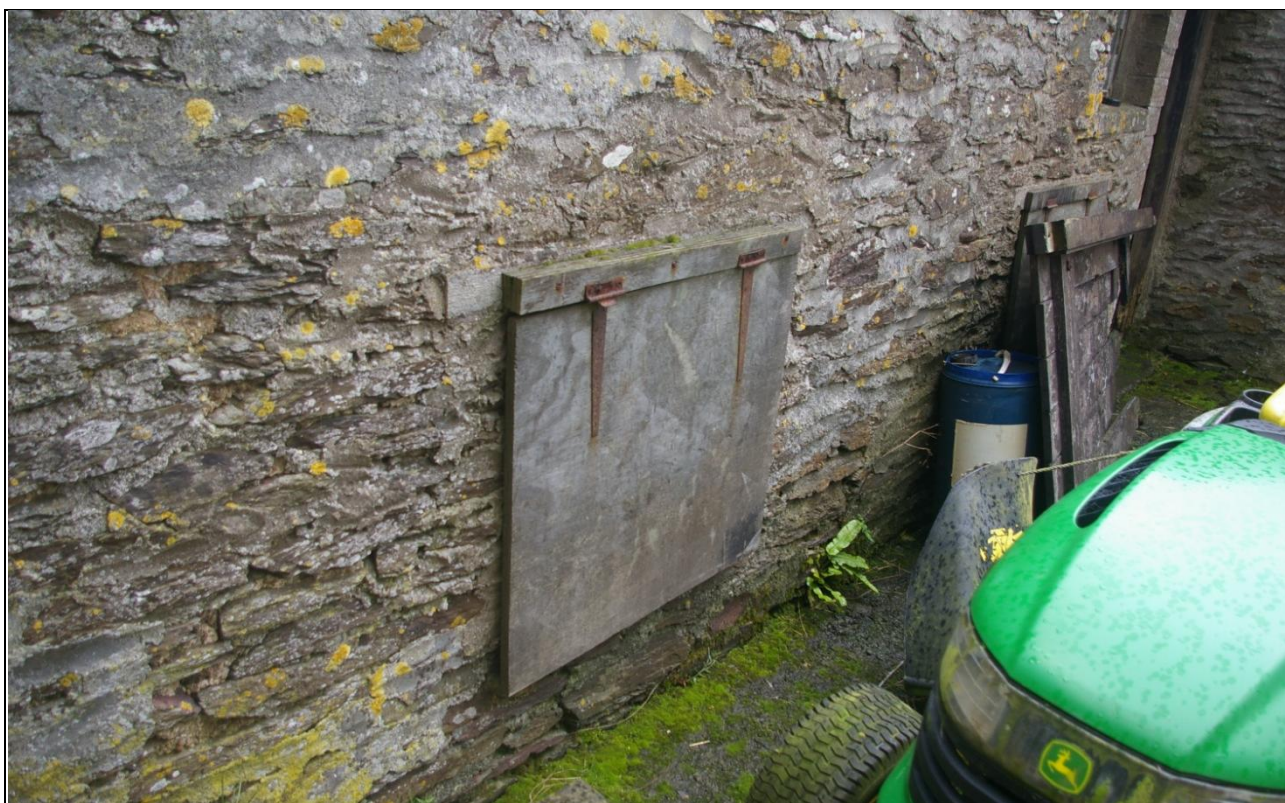
The forced feed openings in the north wall of Barn 2 at ground level, covered by MDF board awnings; from the north-east.

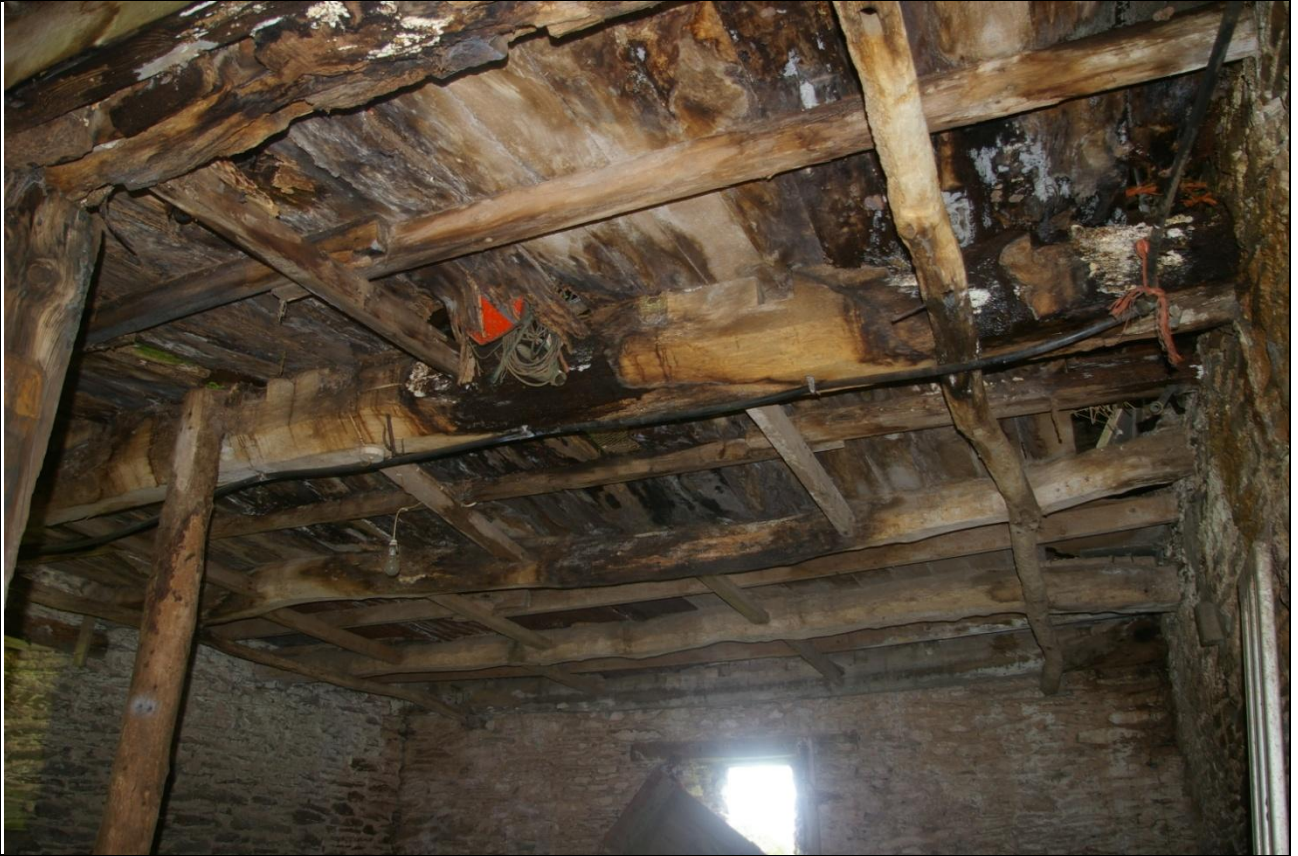
The loft structure in Barn 1, with flash, showing the massive chamfered beams which have been reused here; from the north-west.

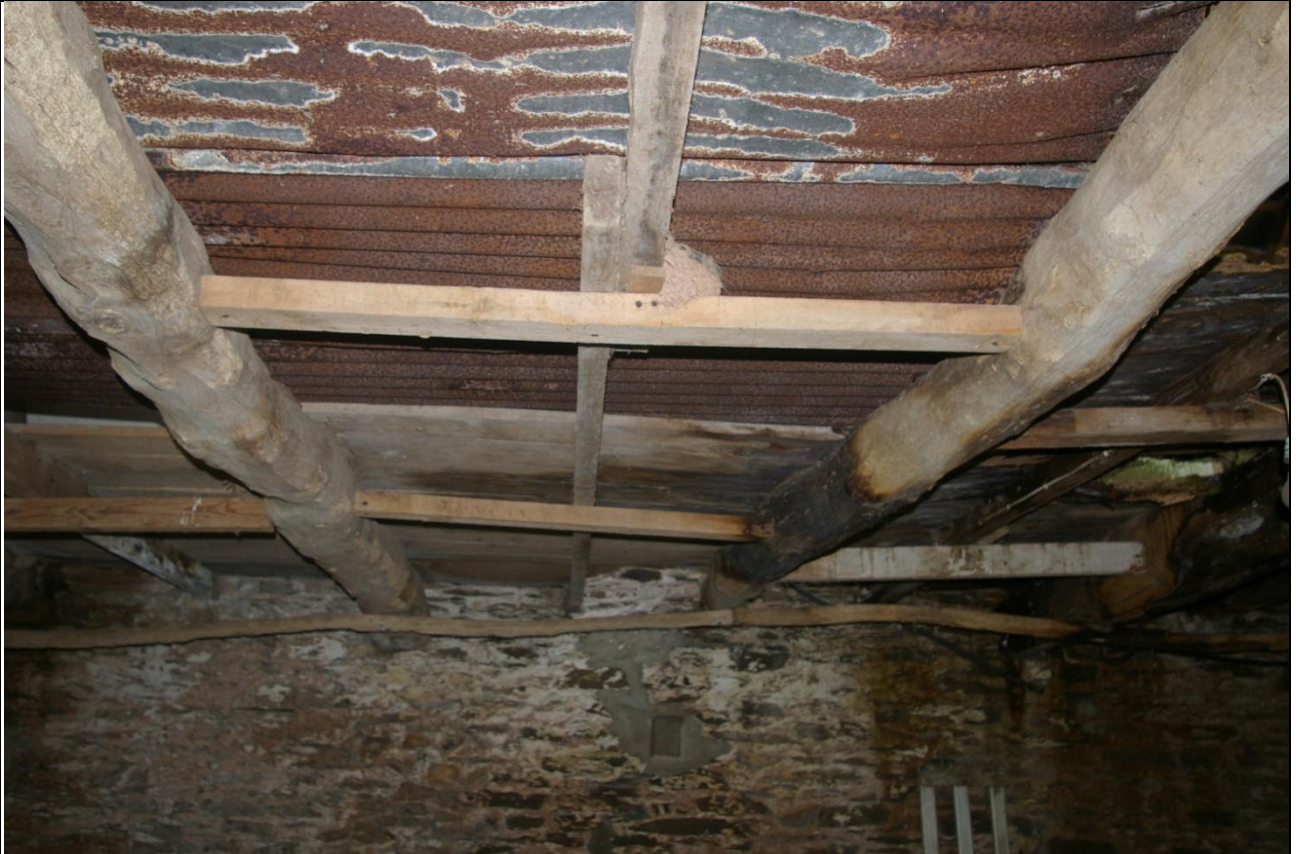
The two 19th century beams supporting the loft floor, roughly shaped trees, probably pine; from the east.
