COOMBE FARM BRENDON AND COUNTISBURY EXMOOR DEVON

Historic Building Recording

Coombe Farm Barns, Brendon and Countisbury, Exmoor, Devon

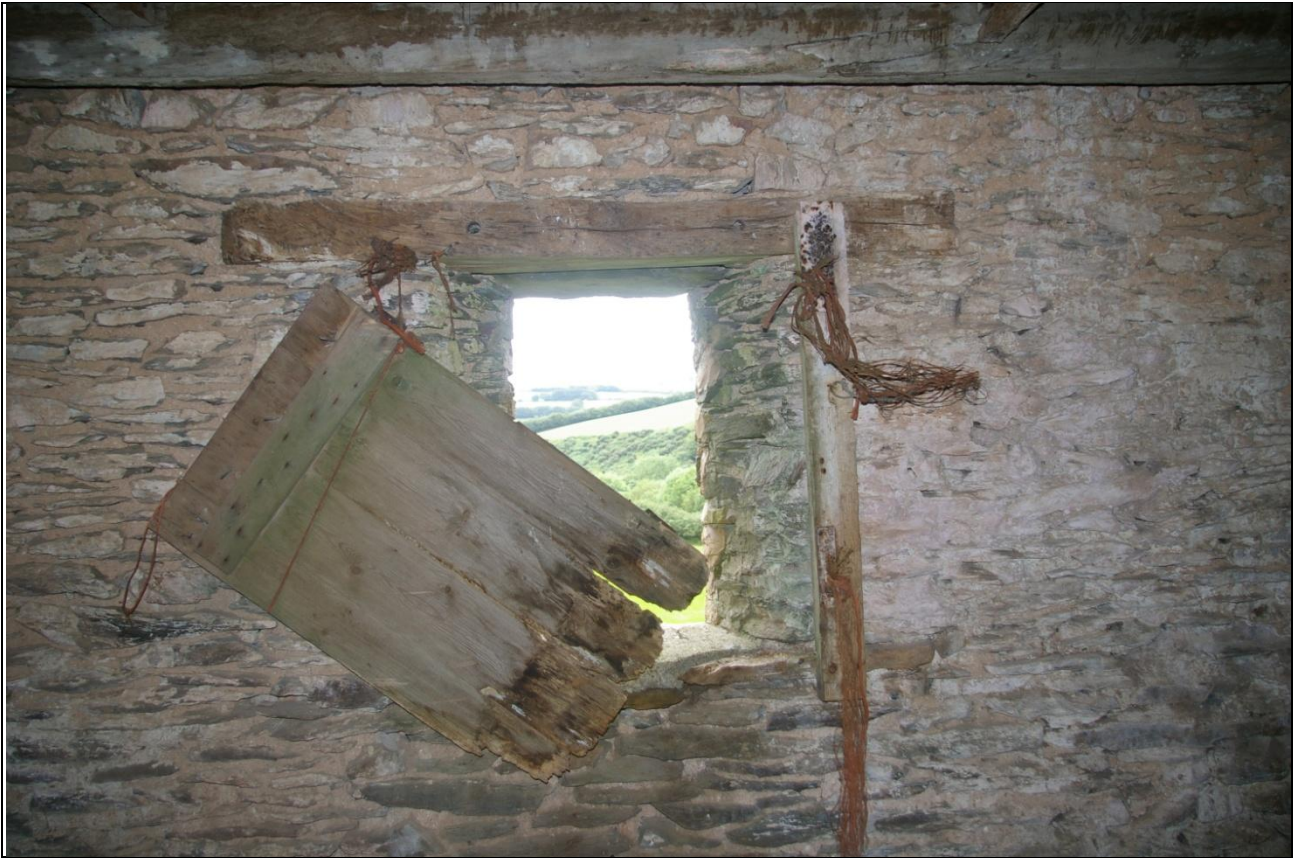
The south window in Barn 1, with hanging plank shutter; from the north.

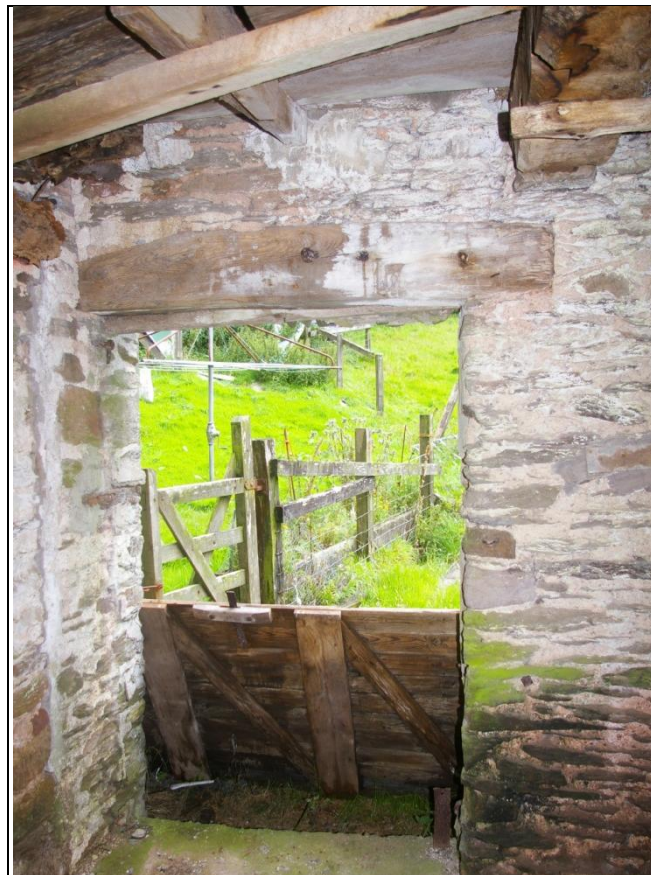
The door to the field, showing the large timber internal lintel, with pintles and peg holes, indicating its reuse; from the west-south-west.

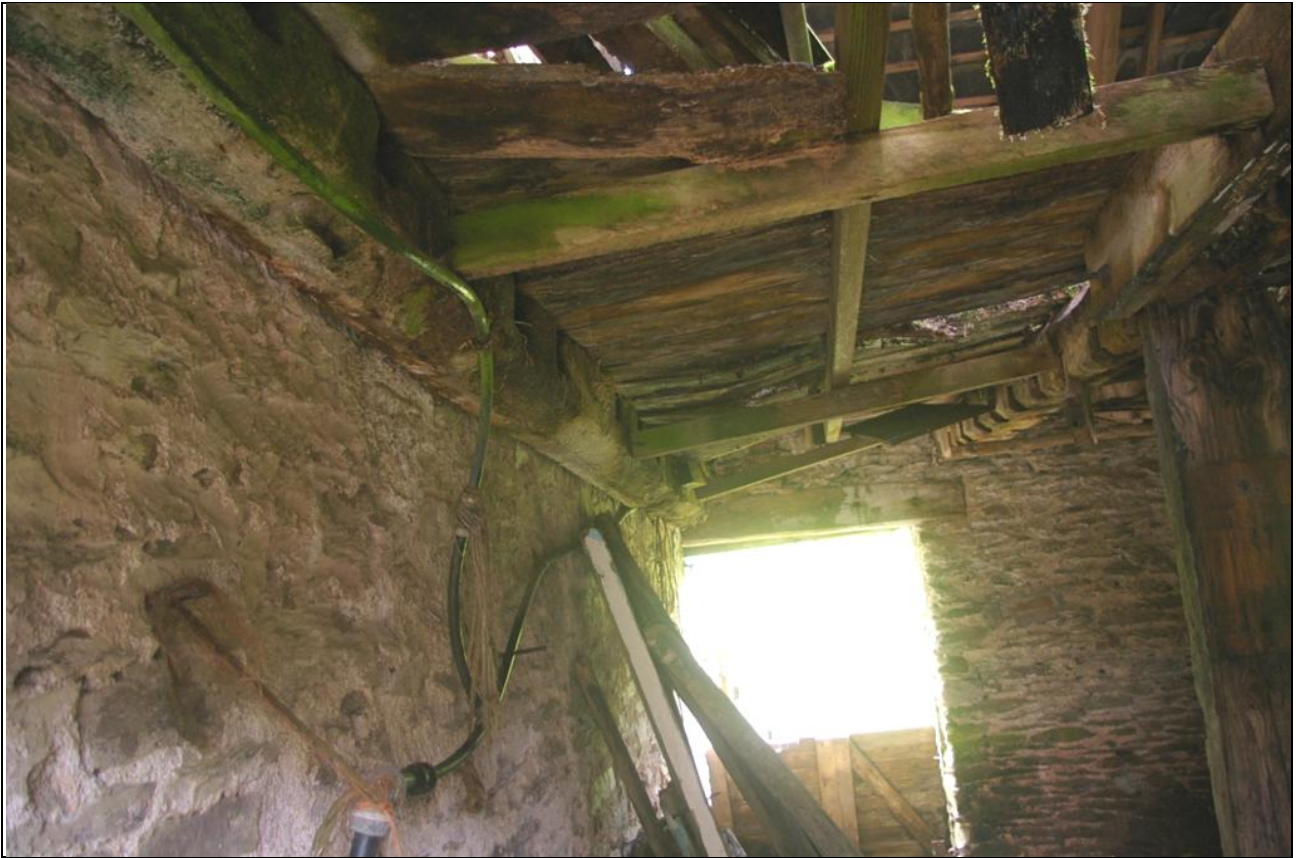
Detail of the profile of one of the large 17th century beams reused in the barn; from the west.

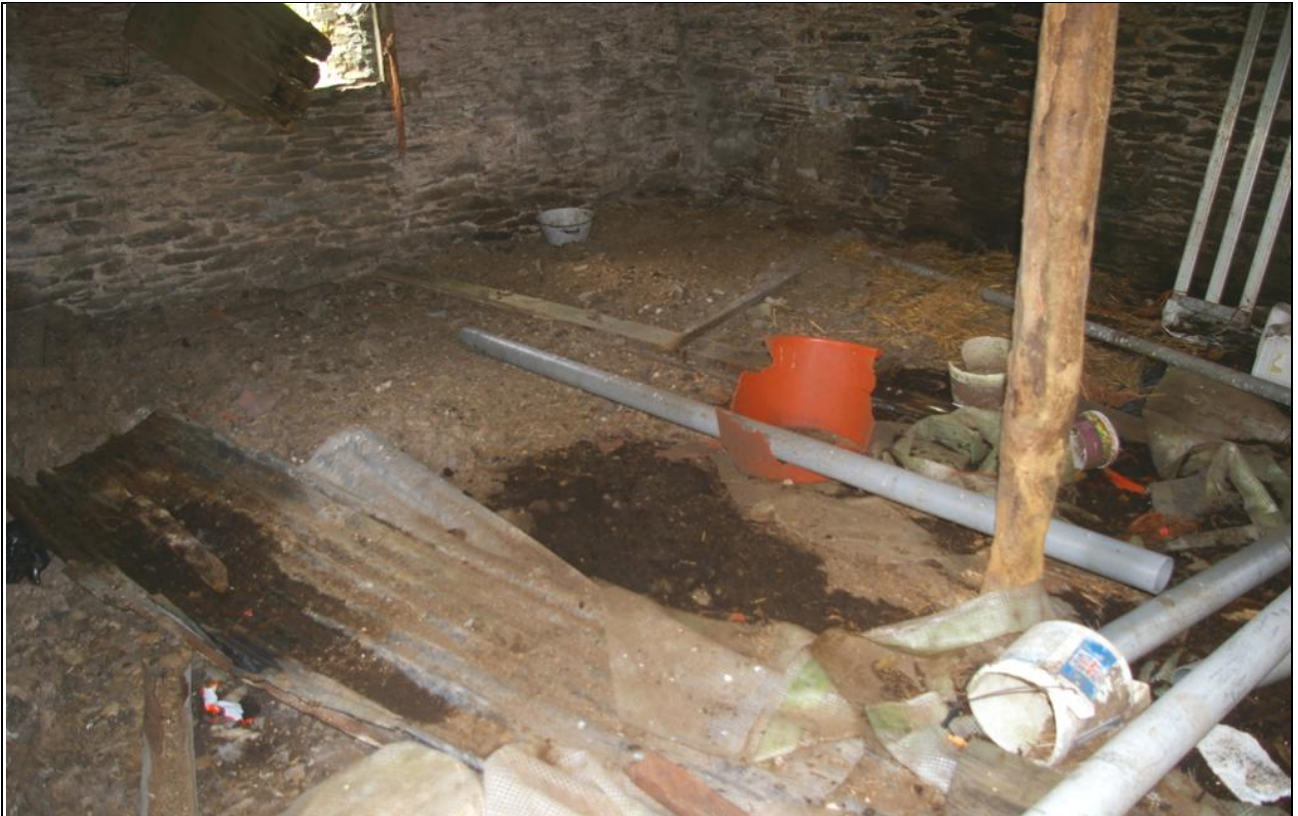
The south end of Barn 1, where the floor appears to be earth but is in fact cobbled beneath but much patched and altered, steeply sloping to a drain in the south wall; from the north-east.

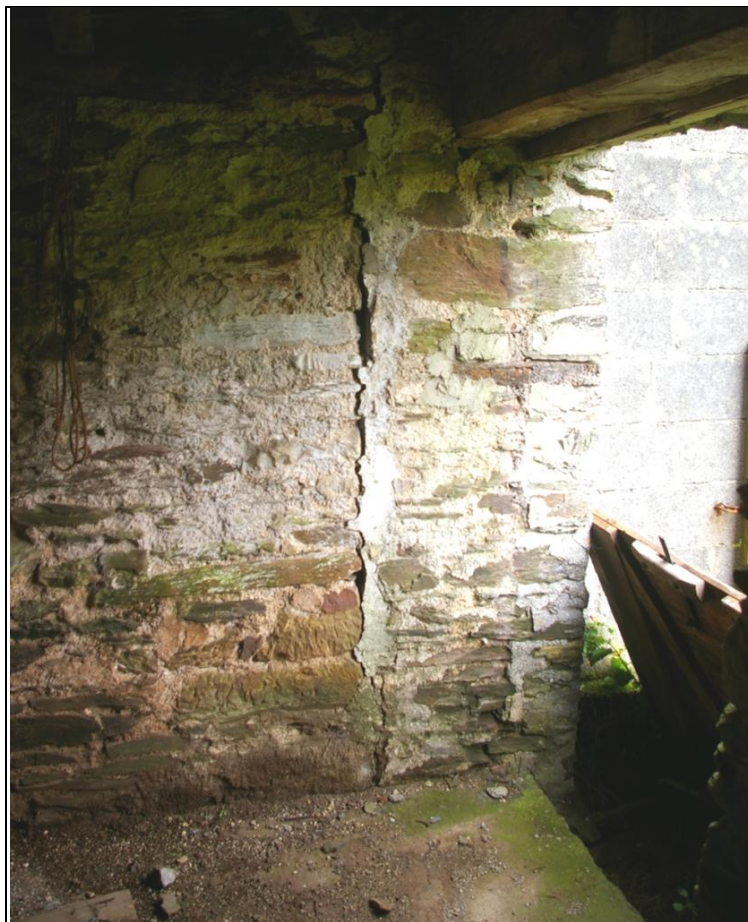
The quoin of the house, seen within Barn 1, with the small projecting section of slate and shale linking to the east wall of Barn 1, not tied in and now structurally failing; from the south, south-west.

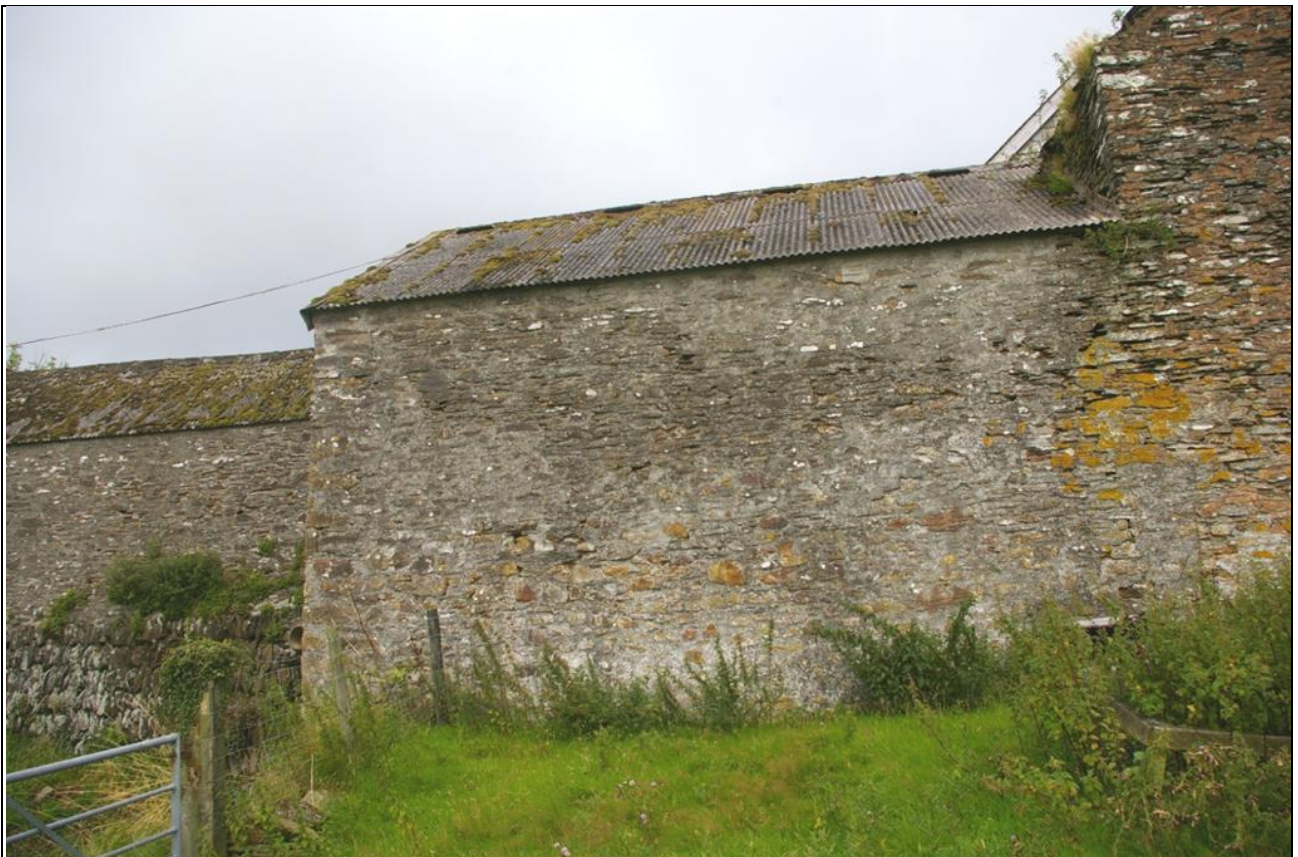
The different builds in Barn 2, heavier iron stone, sandstone and shale build to base, with slate and shale rubble above; from the south-east.

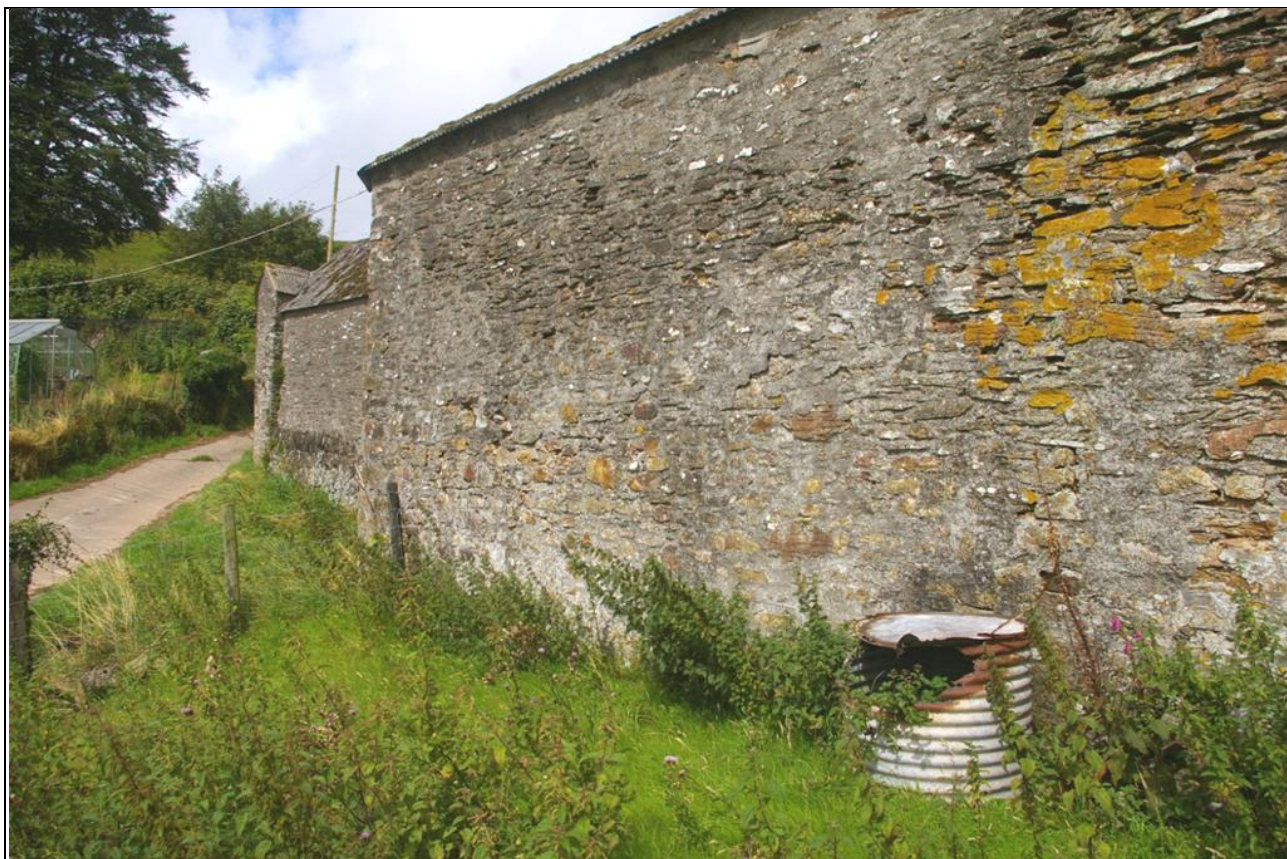
Detailed view of the different stonework to the base of the walls of Barn 2; from the east, south-east.

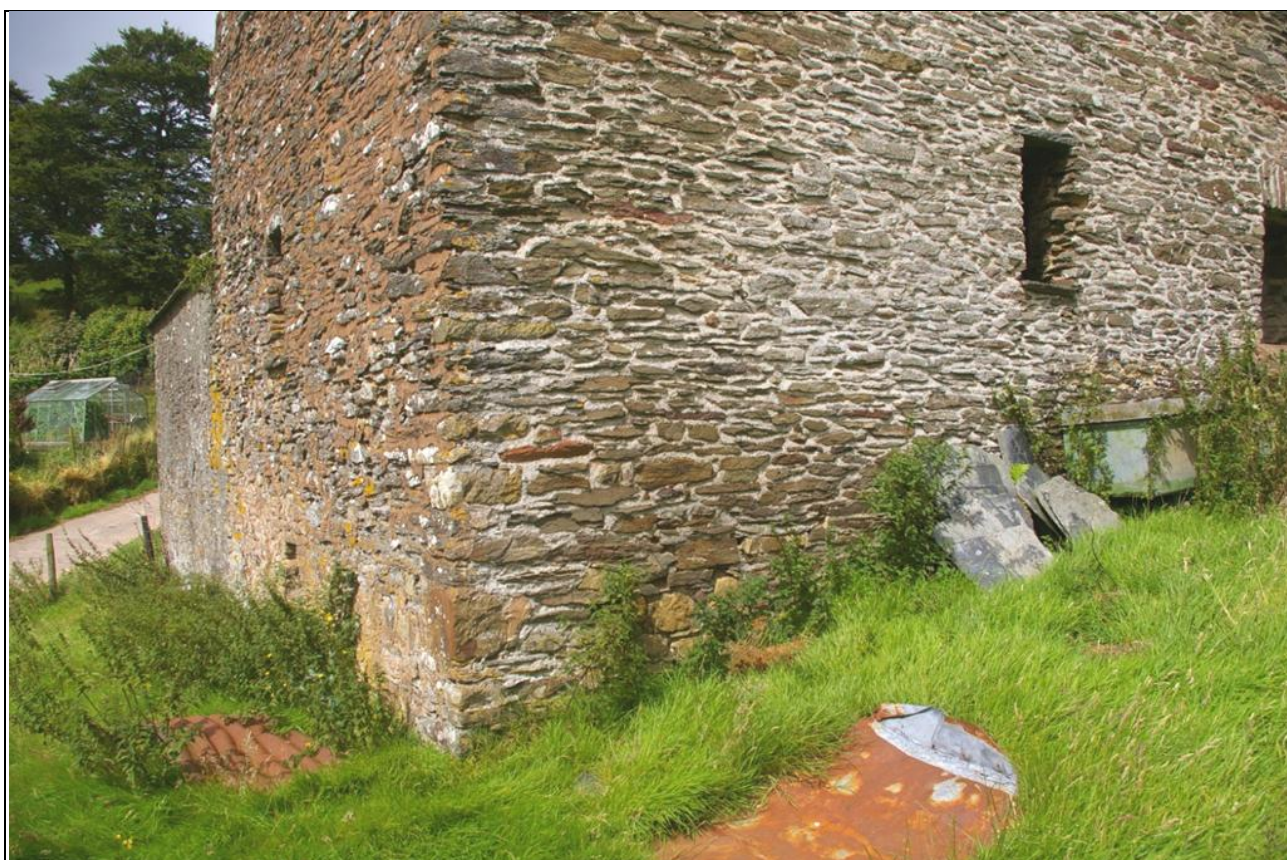
The different stonework seen in the base of the south and east walls of Barn 1, with more of the red and yellow sandstones and ironstone types, as well as heavier but softer blue purple shale, with harder slate rubble above; from the south-east.
