POLURRIAN VILLAS MULLION CORNWALL

Results of a Geophysical Survey

Polurrian Villas, Mullion, Cornwall Results of a Geophysical Survey

Work undertaken by SWARCH for Darren Healey of 3MS Construction (the Client)

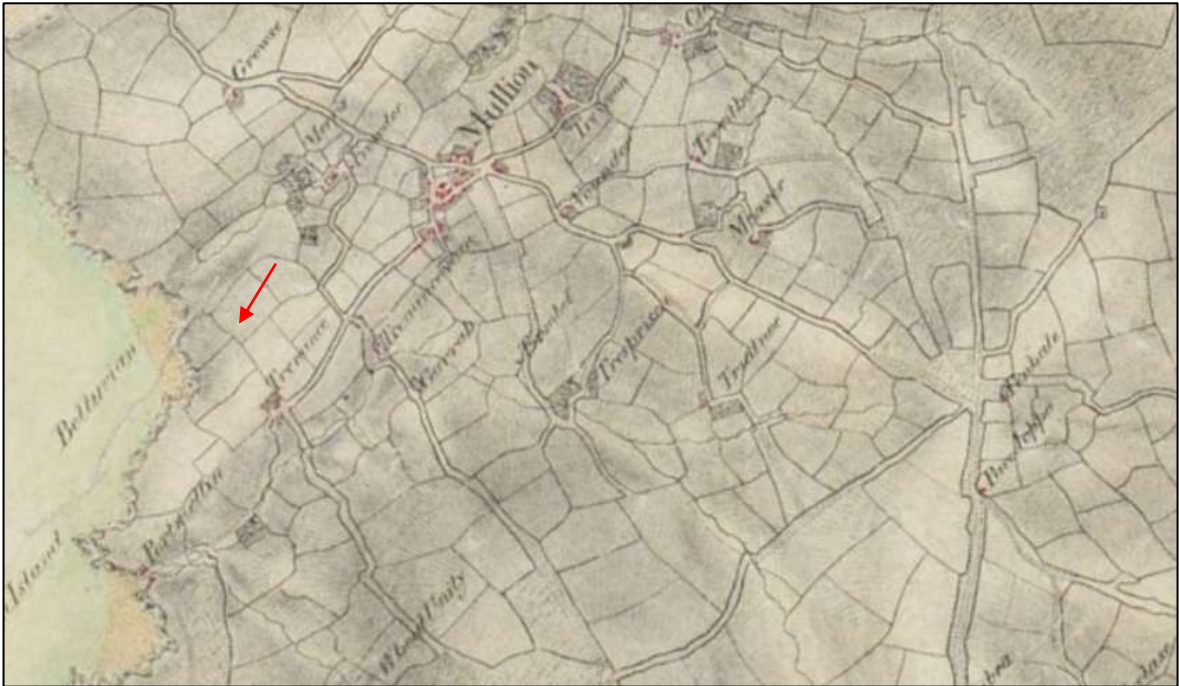
FIGURE 9: ORDNANCE SURVEY SURVEYOR'S DRAFT MAP FOR THE HELSTON AREA, 1811 (BL); THE APPROXIMATE LOCATION OF THE SITE IS INDICATED.

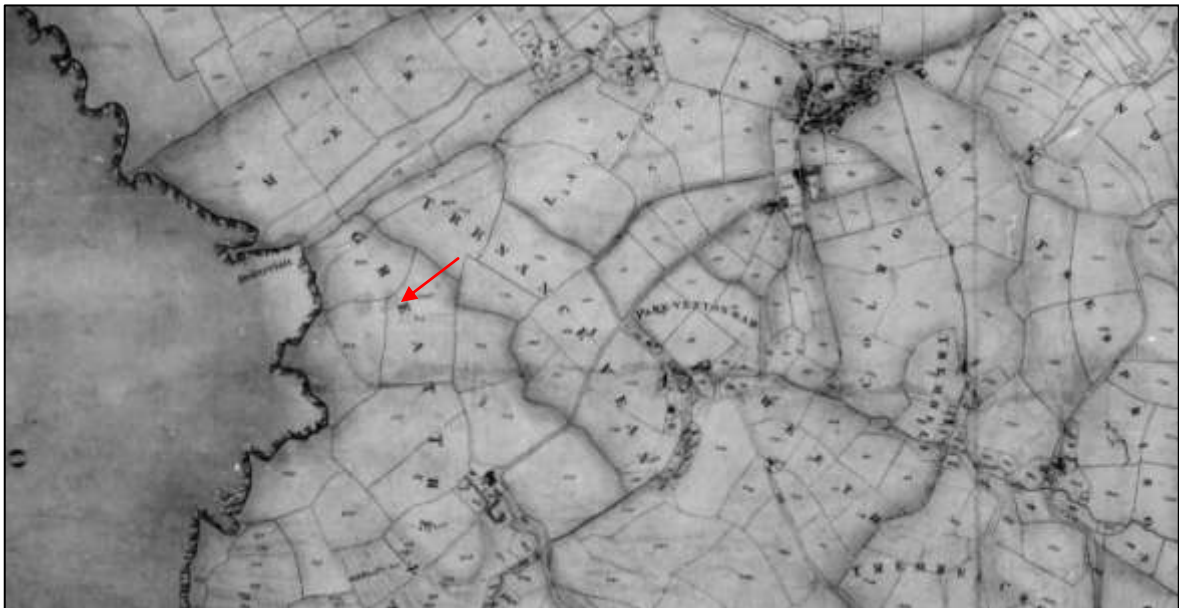
FIGURE 10: MULLION TITHE MAP, 1841 (CRO); THE APPROXIMATE LOCATION OF THE SITE IS INDICATED.

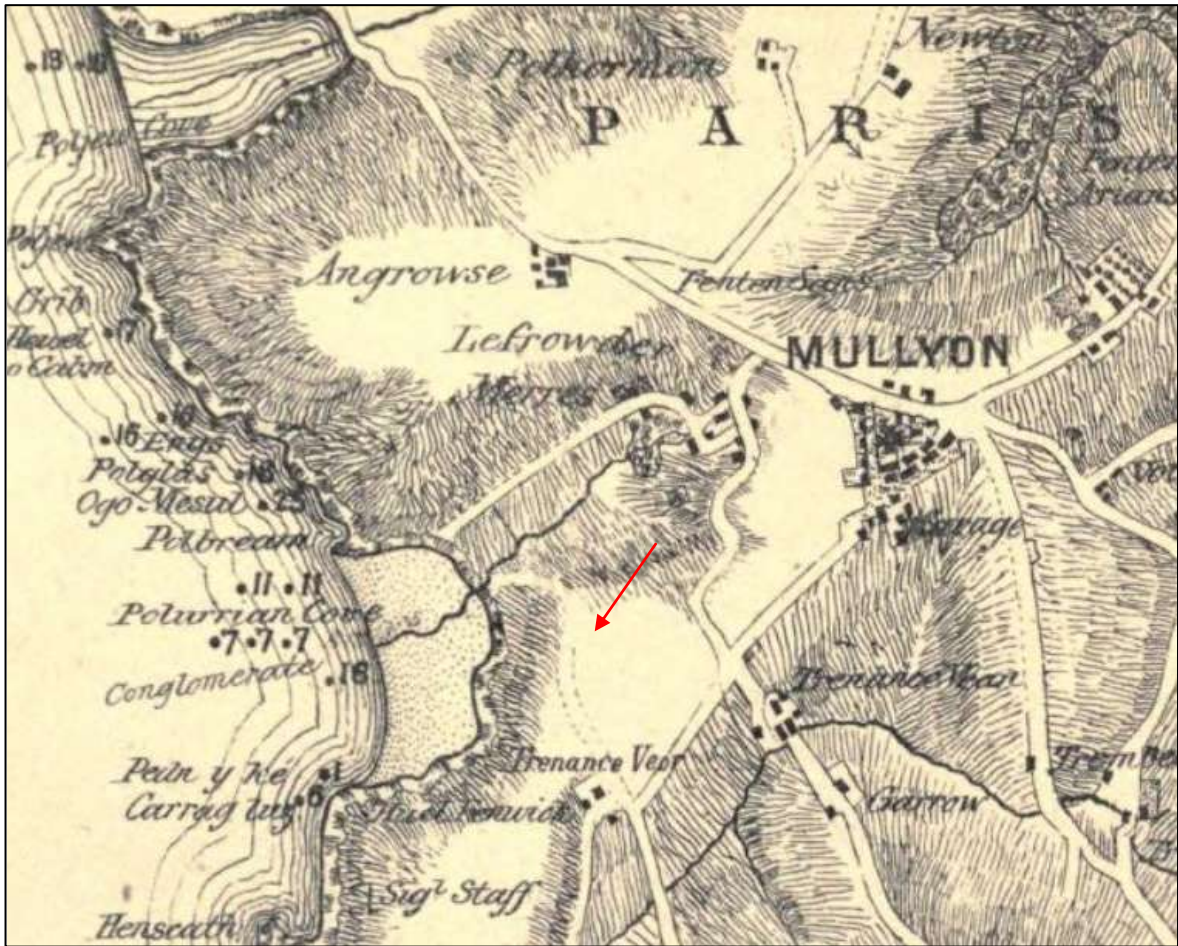
FIGURE 11: HARVEYS MAP, 1875 (HARVEY 1875); THE APPROXIMATE LOCATION OF THE SITE IS INDICATED.

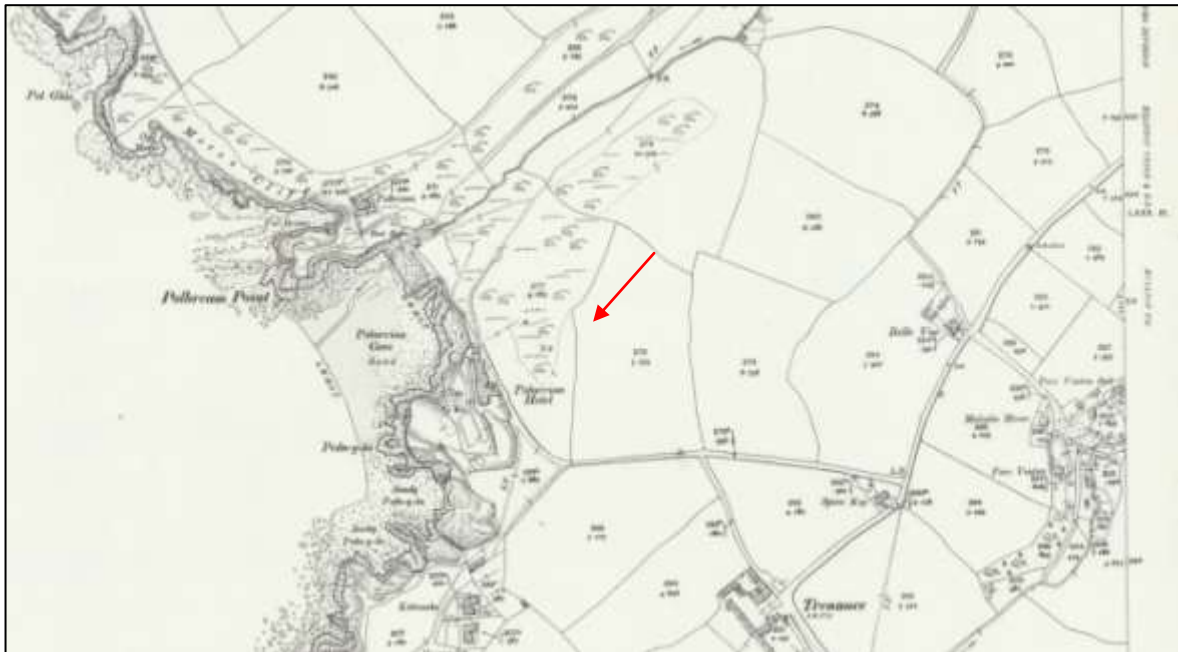
FIGURE 13: ORDNANCE SURVEY 2ND EDITION, 25 INCH SERIES, SURVEYED 1906, PUBLISHED 1907 (CRO);
THE APPROXIMATE LOCATION OF THE SITE IS INDICATED.
