GLENDORGAL PORTH NEWQUAY CORNWALL

Results of a Desk-Based Assessment and Historic Setting Assessment

South West Archaeology Ltd. report no. 161223

Work undertaken by SWARCH for Ivan Tomlin
on behalf of the Glendorgal Hotel

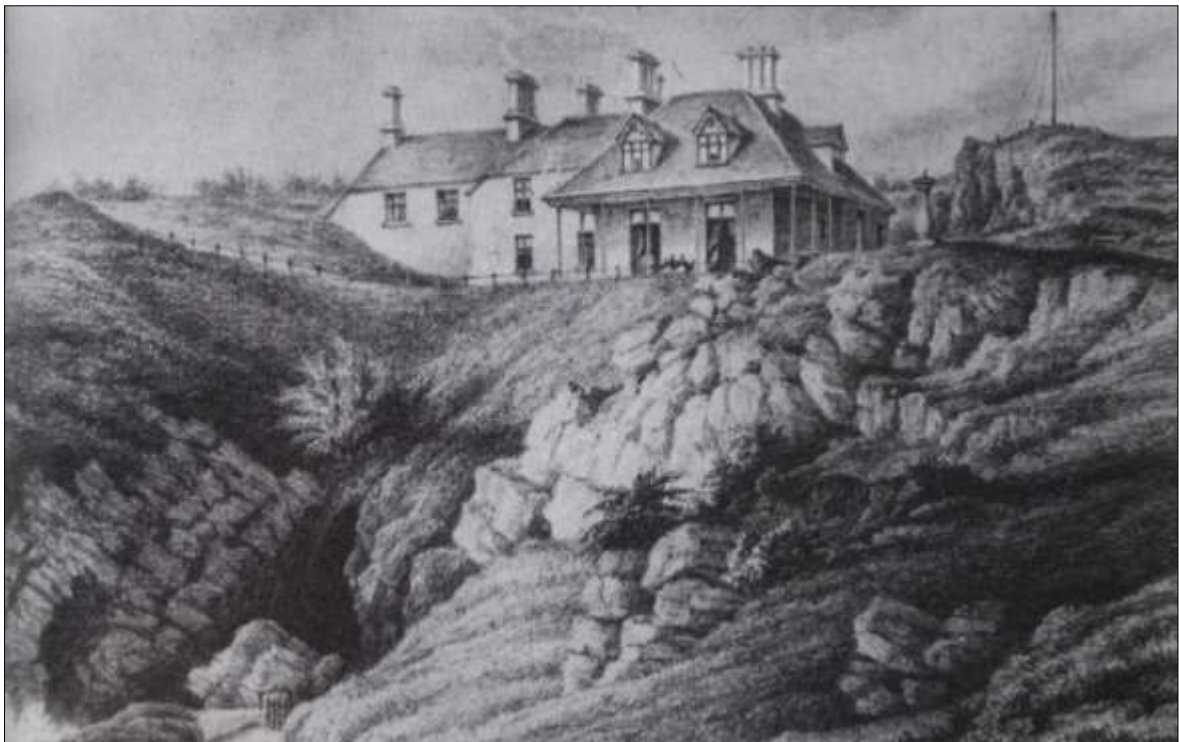
FIGURE 9: HISTORIC IMAGE OF GLENDORGAL (REPUTEDLY C.1875) REPRODUCED FROM TANGYE (1997). NOTE THE VERANDA AROUND THE HOUSE, THE FLAGPOLE, SUNDIAL (WITH GNOMON), AND STEPS LEADING DOWN TO THE CAVE, WITH GATED ENTRANCE. THIS MAY BE FROM A SALE CATALOGUE FOR THE PROPERTY.

The late 19th century romantic depiction of the building (Figure 9) shows steps leading down to a cave located below the house. This survives as a narrow path set with crude steps curving around the side of the slope, leading to a set of concrete steps protected by a narrow mortared stone wall. These steps drop down onto the solid rock at the base of the cliff where indistinct stone-cut steps can be discerned dropping down by stages to the sand. A second set of concrete steps ascends from this point to a narrow natural ledge halfway up the cliff; cast into these steps are stumps of iron posts for a handrail. This path appears to have been fashioned to provide access to the beach, and perhaps also the tall, narrow cave below the house, which may have been used as a grotto.

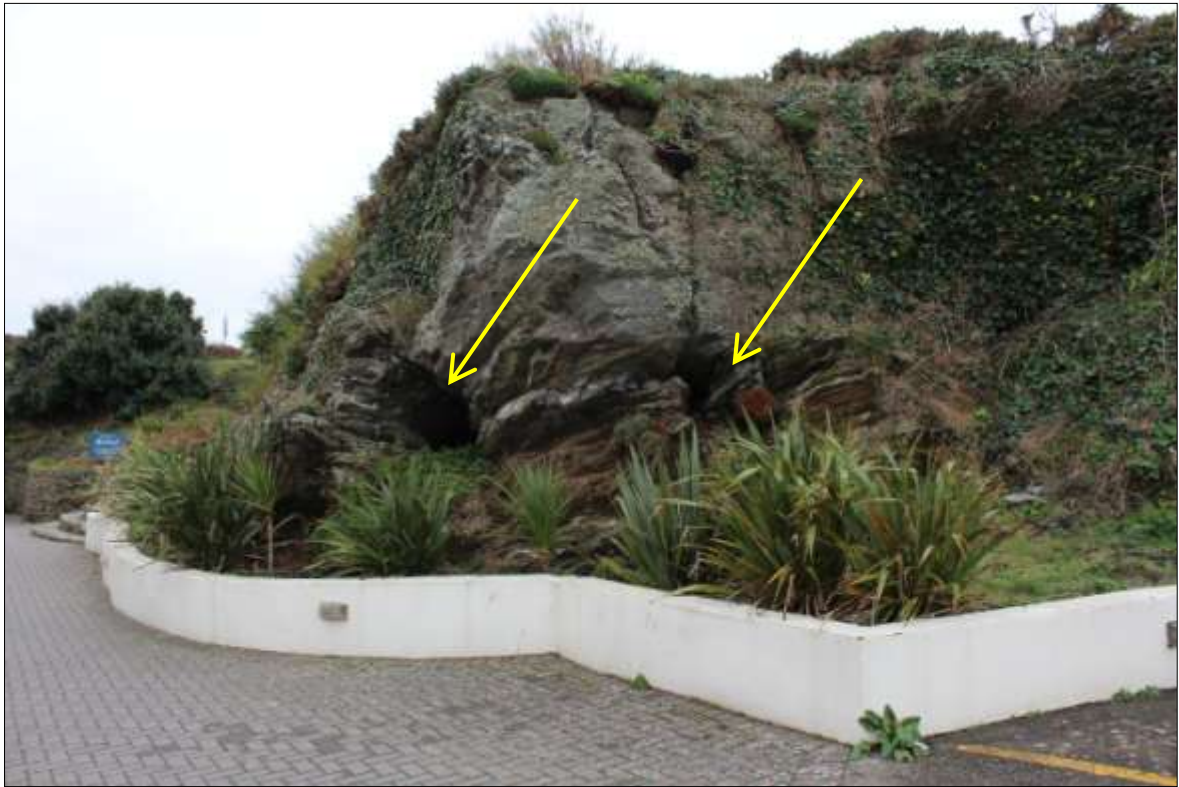
the north-east angle of the car park contains at least three irregular fissures that may be earlier cave openings (perhaps the eponymous *dorgals*, but caves are a feature of this coastline). Immediately to the north-west is a levelled platform cut back into the slope; this has the appearance of a fairly recent development, and readily-available aerial photographs indicate it has replaced a built levelled platform with access path, which in turn replaced a small levelled area and the original path down to the beach. On the edge of extant platform is a stone sundial base (as shown in Figure 9), now lacking the brass gnomon.

FIGURE 16: THE ROCKY OUTCROP CLOSE TO THE HOTEL, WITH FISSURES INDICATED; VIEWED FROM THE NORTH, LOOKING SOUTH.

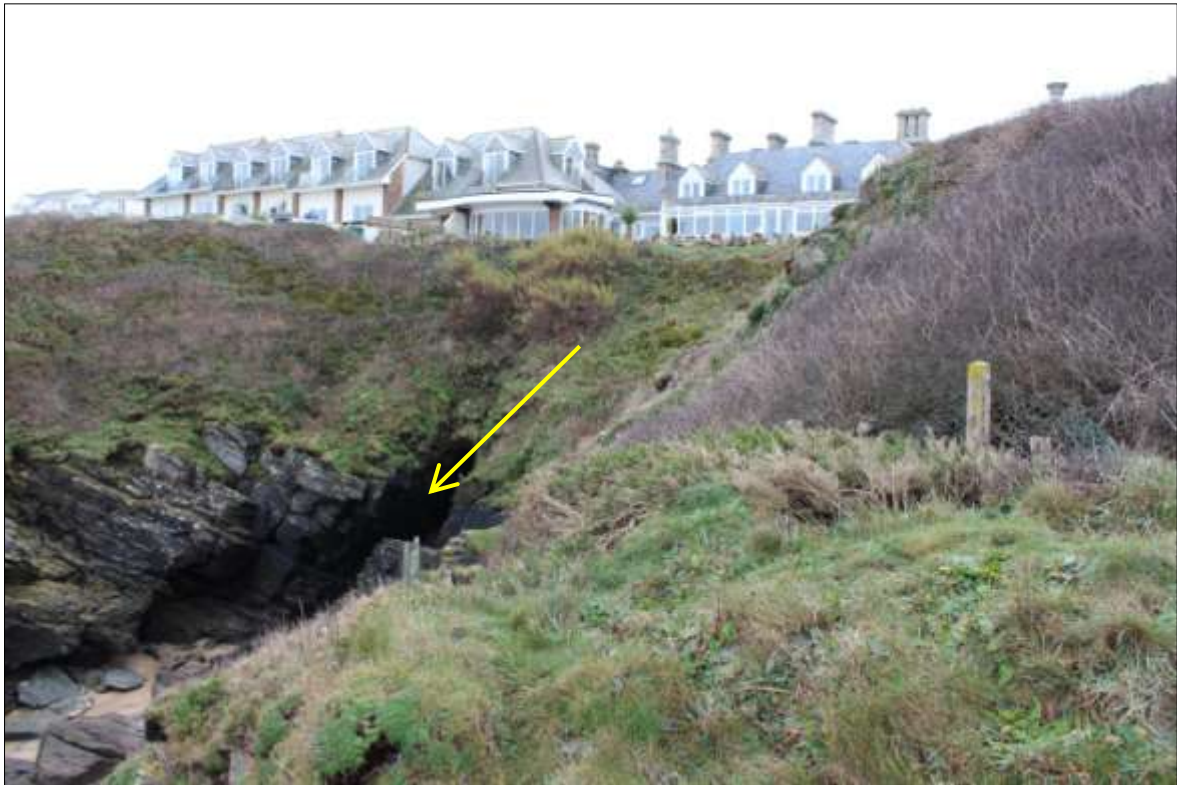
FIGURE 18: THE CAVE BELOW THE HOTEL; VIEWED FROM THE NORTH-WEST, LOOKING SOUTH-EAST.

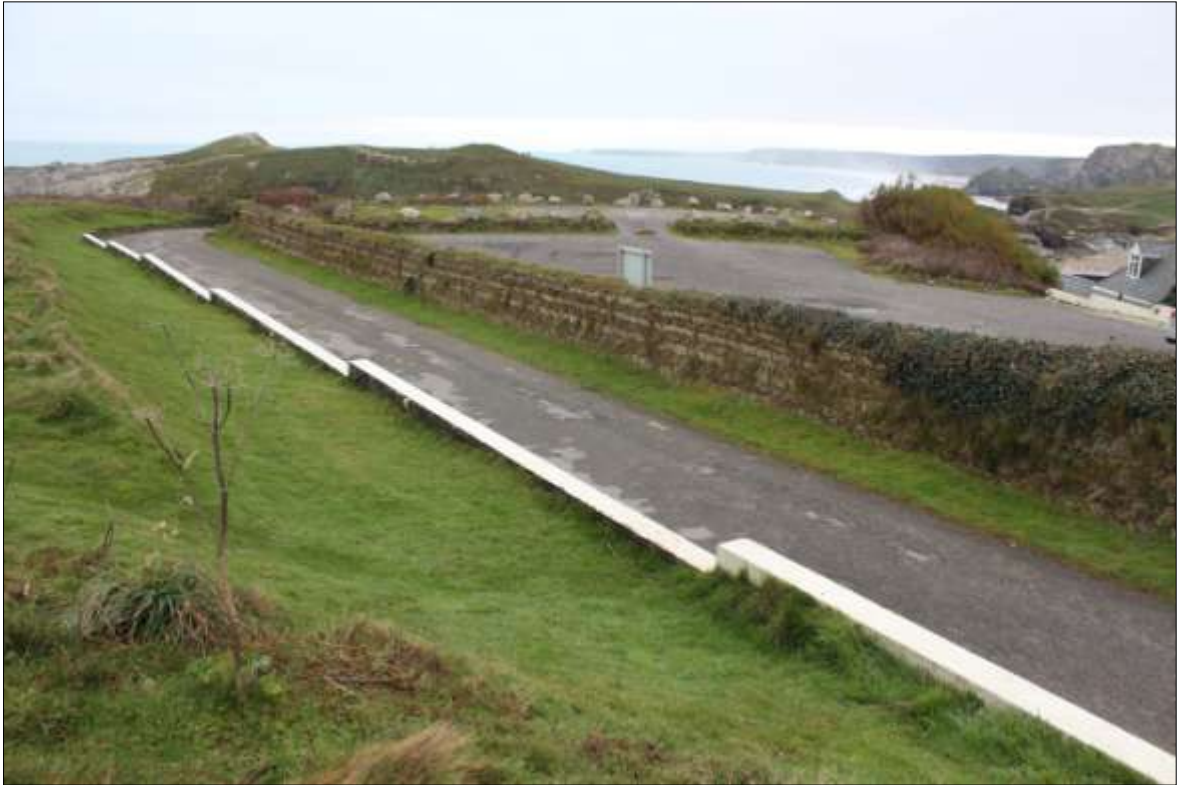
The car park is a sub-oval gravelled area bounded by a stone wall to the north and west. The build of this wall is particularly fine on its outer, western face, where it consists of small coursed narrow stones set in a herringbone pattern; Tangye (1997 14) notes it was constructed by Mr Luscombe of Quintrell Downs in 1954. The eastern face is much cruder, being of roughly-coursed slate slabs laid horizontally and was (presumably) never intended to be seen. The northern end of the car park steps up and is bounded by large granite boulders. On its eastern edge is an iron cage over the cist grave exposed in 1957; the cage bears a corroded brass plaque commemorating the event.

FIGURE 19: VIEW OF THE CAR PARK FROM THE SOUTH, SHOWING THE CAREFULLY-CONSTRUCTED STONE WALL; VIEWED FROM THE SOUTH, LOOKING NORTH.

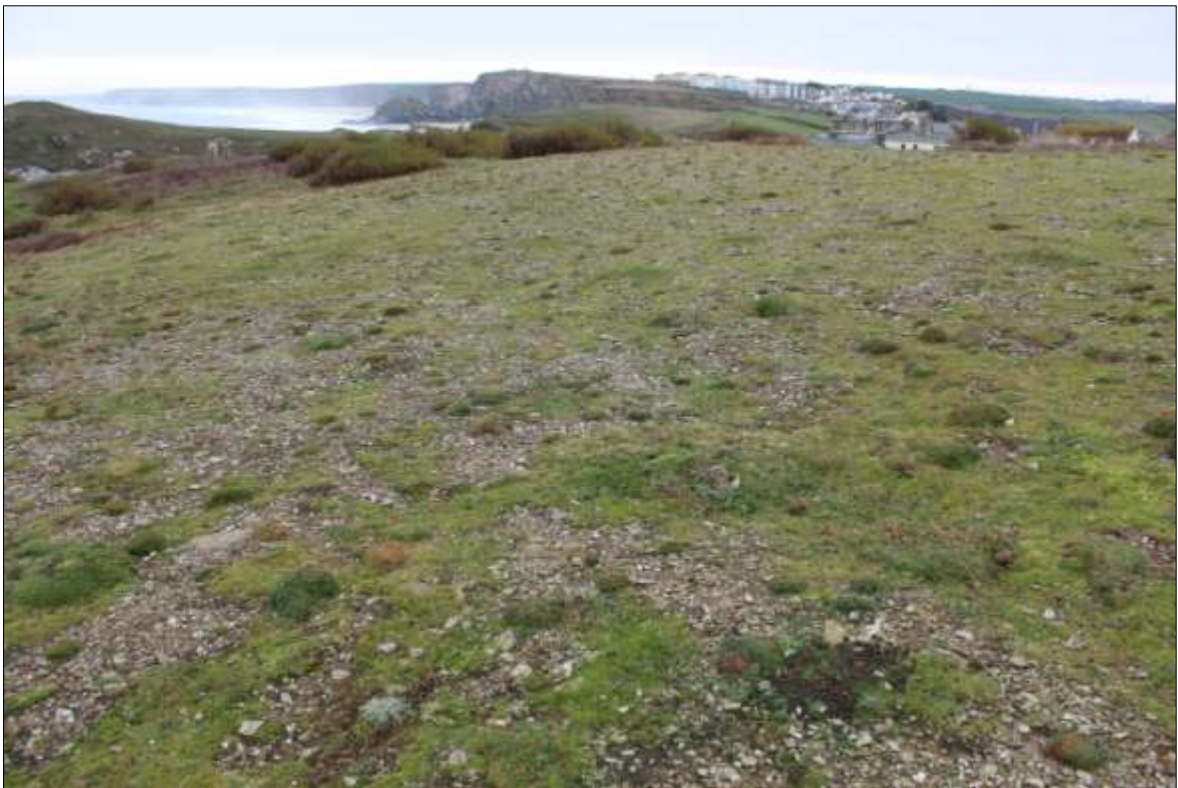
To the west of the car park is a broad area of disturbed ground. To the northern side this lies in piles where it was dumped and has been colonised by brambles. To the south it has been levelled out but has yet to grass over and the coarse stony nature of the material is evident, and aerial photographs would indicate it was dumped/levelled c.2005. As well as angular and sub-angular stone, this material also includes brick, tile and concrete. Tucked into the south-east corner of this area is a compound for garden waste and other waste materials. While some of the material here seems relatively recent, it may include material excavated during the construction of the house in c.1850. The access road leading to the hotel superficially appears to be set down into this material, but as the road lacks a historic boundary to the west to match that around the car park, it is more likely that the ground level has been raised during the 20th century and the original surface is buried below up to 1.5m of dumped material.

FIGURE 20: THE LEVELLED STONY MATERIAL TO THE WEST OF THE HOTEL; VIEWED FROM THE SOUTH, LOOKING NORTH.

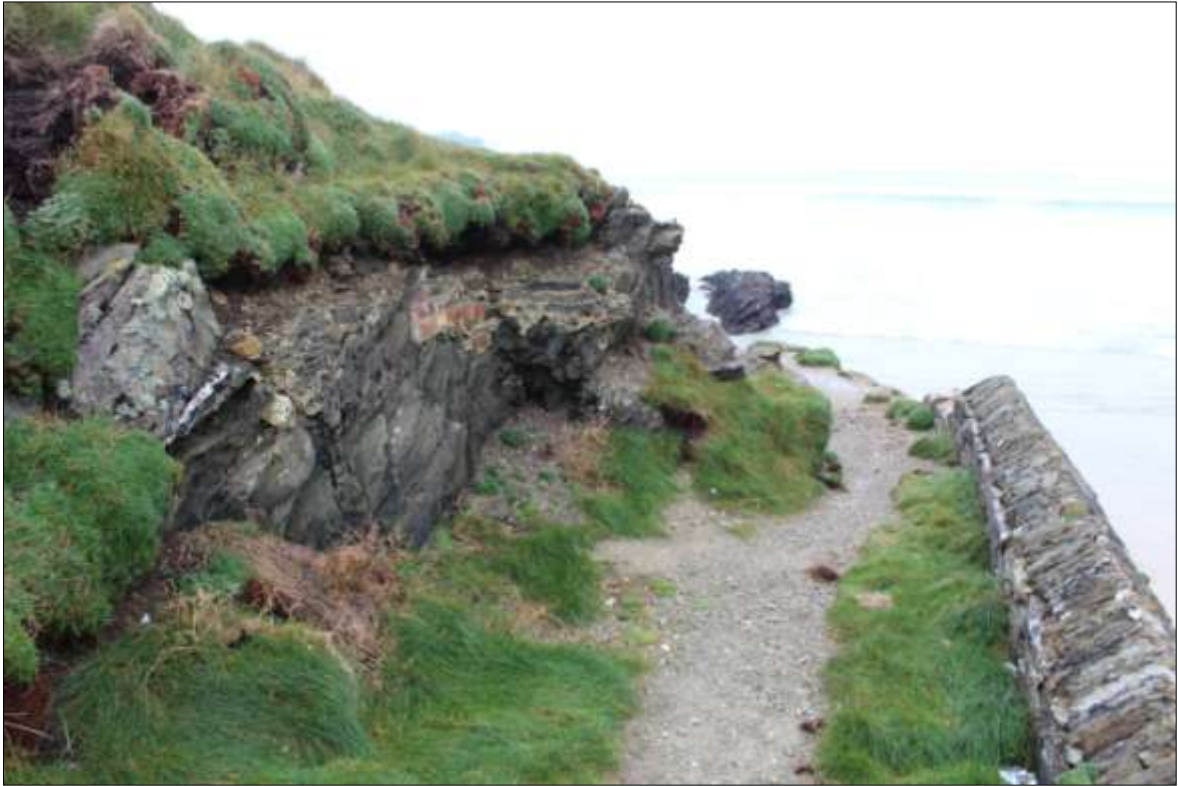
FIGURE 21: STRUCTURE #1, VIEWED FROM THE EAST, LOOKING WEST.

On the cliff edge and positioned above the entrance to Porth bay are the remains of two structures. Structure #1 is cut back into the rock of the cliff, with a floor of large squared stone slabs with a central drain, partly enclosed by a narrow mortared stone wall; the western part of this wall has been lost.

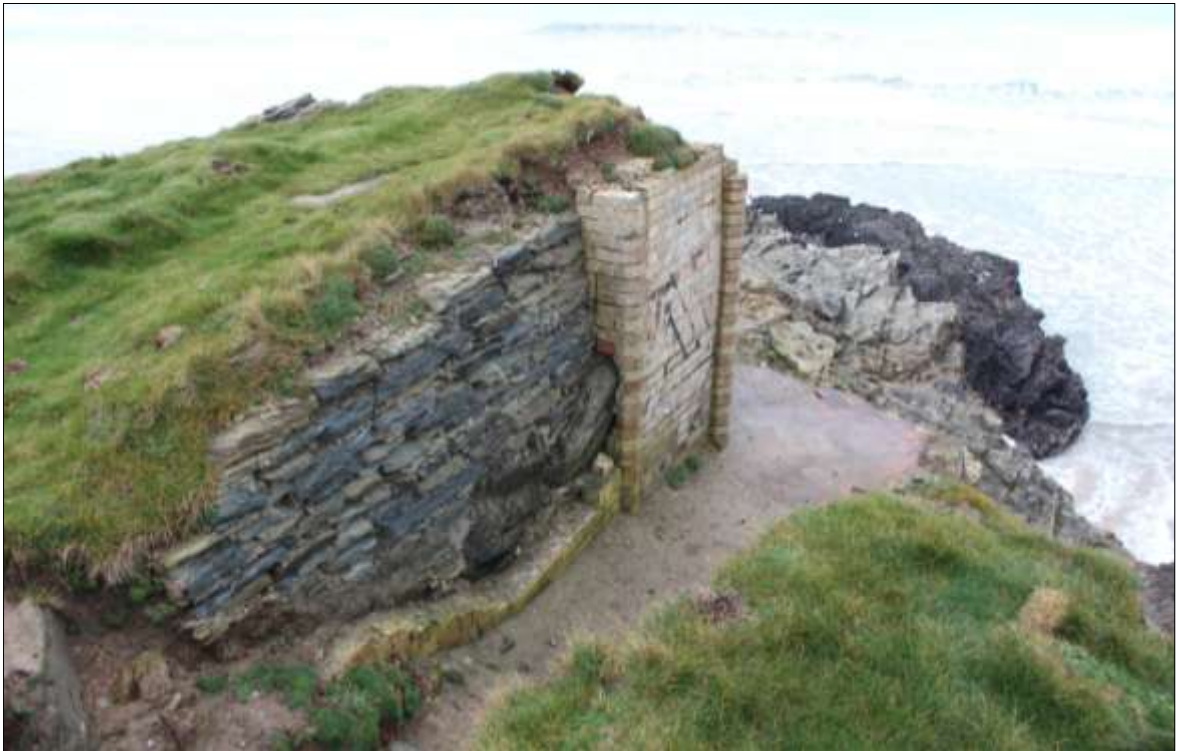
FIGURE 22: STRUCTURE #2 ('THE CABIN'), VIEWED FROM THE EAST, LOOKING WEST.

Structure #2 ('The Cabin') is located further to the west, and is also cut back into the rock, but is approached by a short flight of steps and is lined with mortared stone with yellow brick without frogs for decorative effect. The brickwork has timber lacing, perhaps for clothes hooks as the appearance of this structure is reminiscent of those built to accommodate bathers. As with the first structure, the wall facing the sea has been lost, as has part of the floor of small square red terracotta tiles. The south-western part of this structure is abutted by a stone wall of pitched stone, much like a typical Cornish hedgebank.

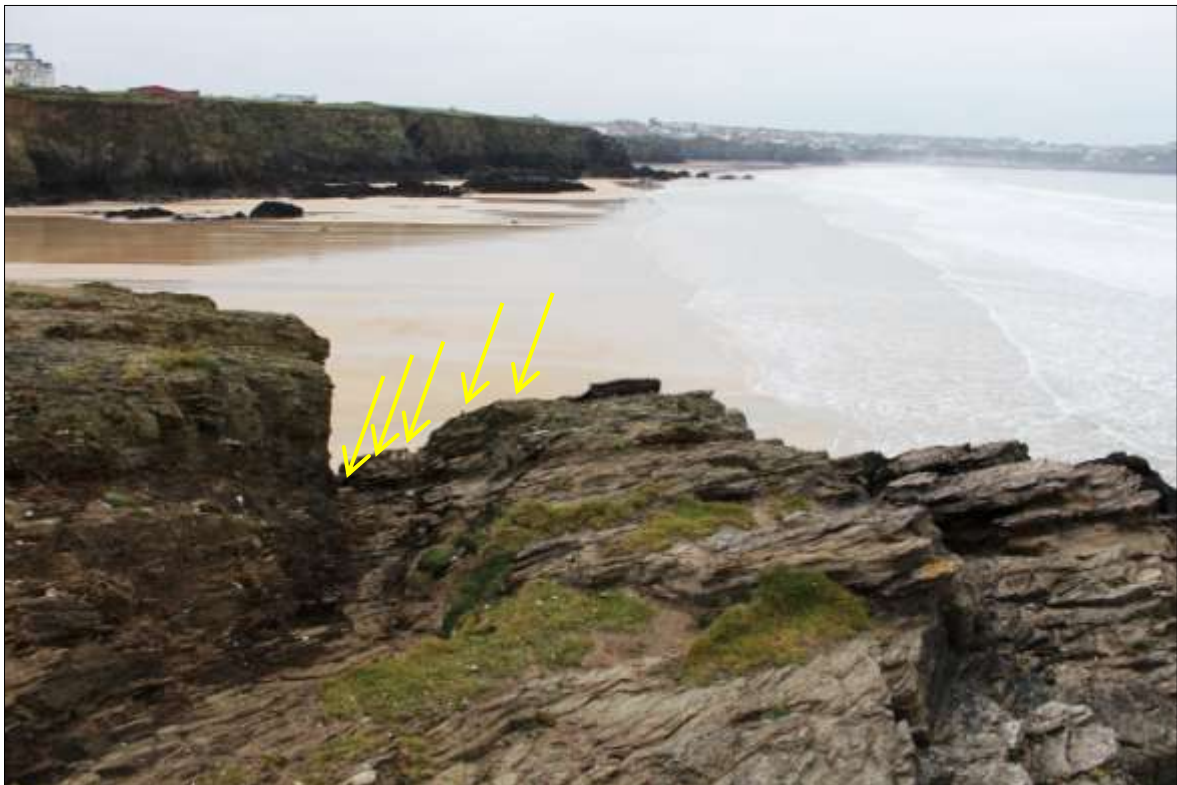
FIGURE 23: THE NORTHERN ROCK-CUT GULLEY, WITH IRON POSTS INDICATED; VIEWED FROM THE NORTH, LOOKING SOUTH.

Around the cliff towards Lusty Glaze Bay the cliff features a rock-cut channel that drops down the upper part of the cliff at 90° to the slope; at its southern end the stumps of iron posts are visible concreted into the stone, presumably for a handrail or possible fence. To the south, a second rock-cut gulley drops down onto the cliffs at Wind Cove via a steeply-incised set of crude steps cut back into the slope. As with the first, the cut is at 90° to the slope, and there are the stumps of iron posts here as well. There is also the base of a line of iron posts from an iron fence. This access to the beach is depicted on the OS 1:25" scale 1881 map (see above), and it might perhaps be related to the abortive Edyvean Canal.

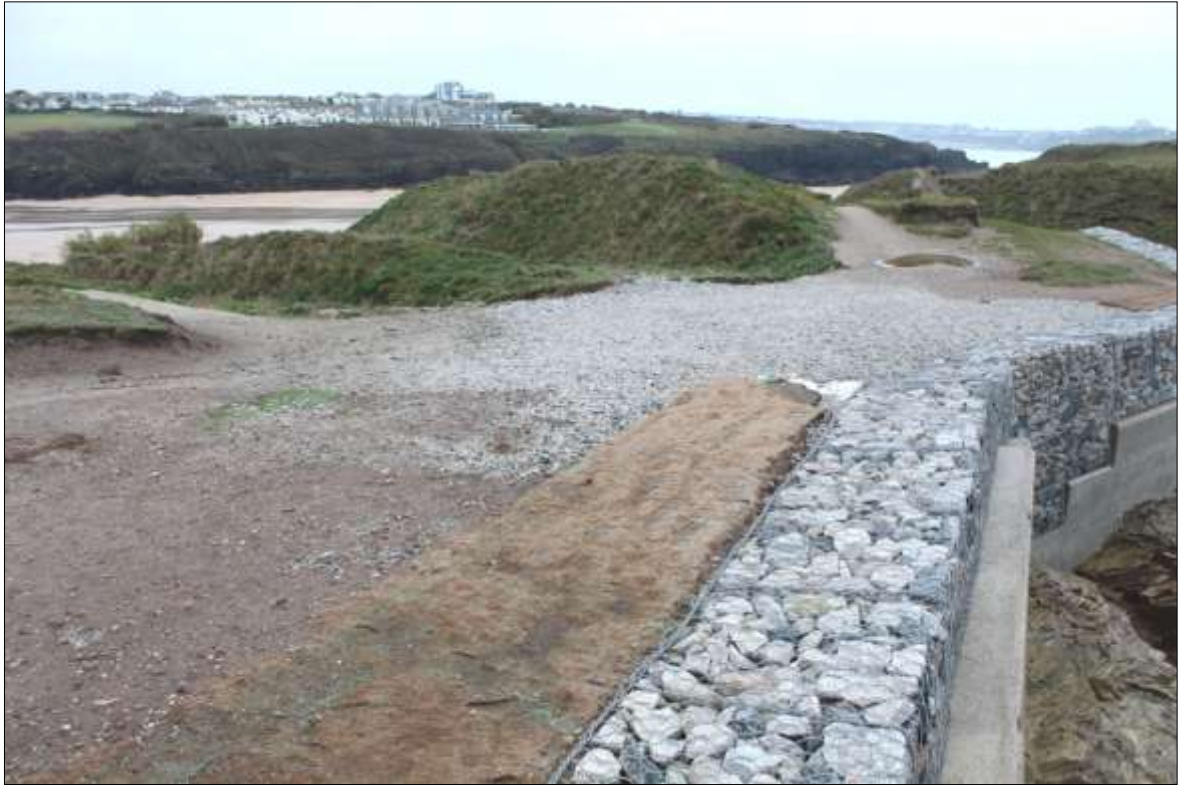
FIGURE 28: THE RAMPARTS AT TRELGULE HEAD, SHOWING THE RECENT STRENGTHENING WORKS, WITH GLENDORGAL IN THE BACKGROUND; VIEWED FROM THE NORTH, LOOKING SOUTH.

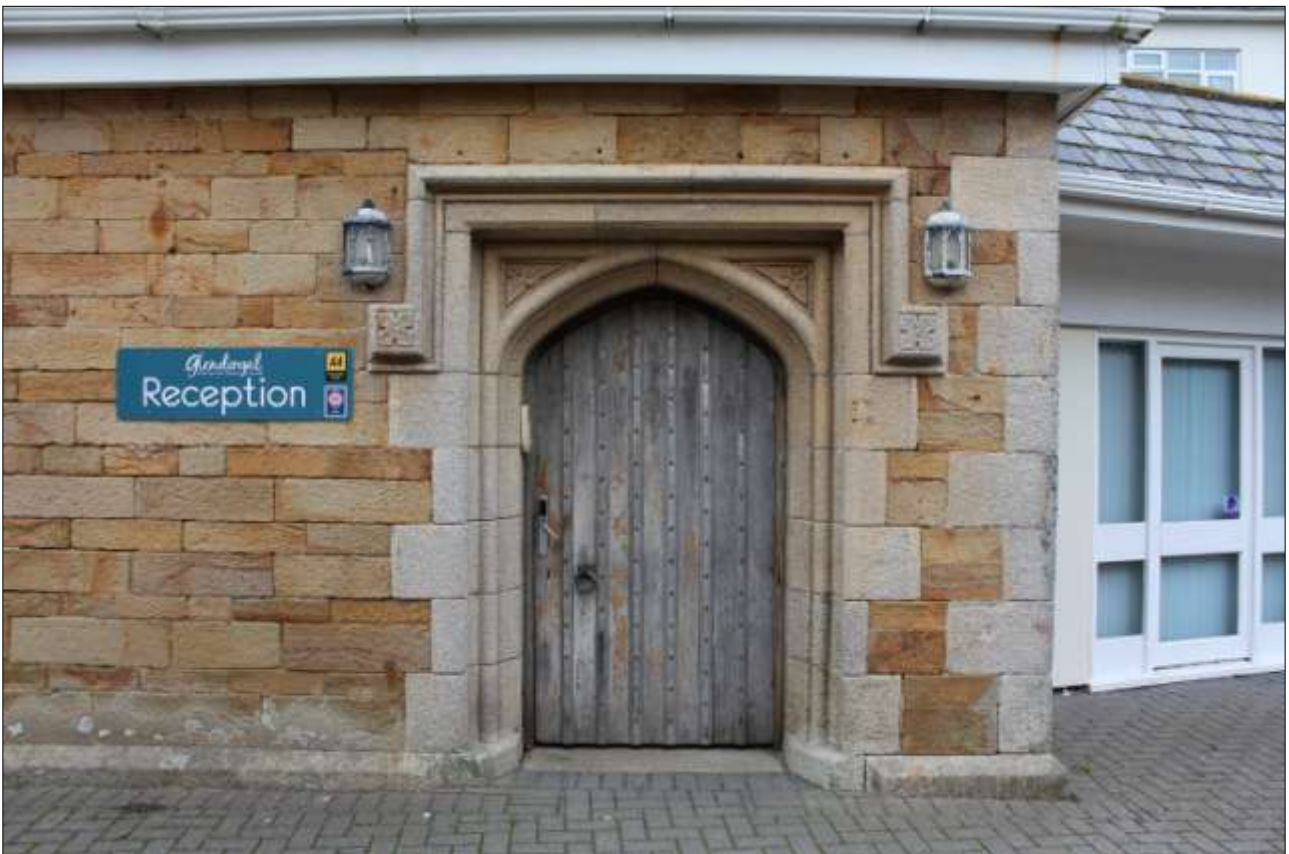
The fine c.1873x5 Gothic moulded granite doorway at the south-west corner of the Hotel; viewed from the west.

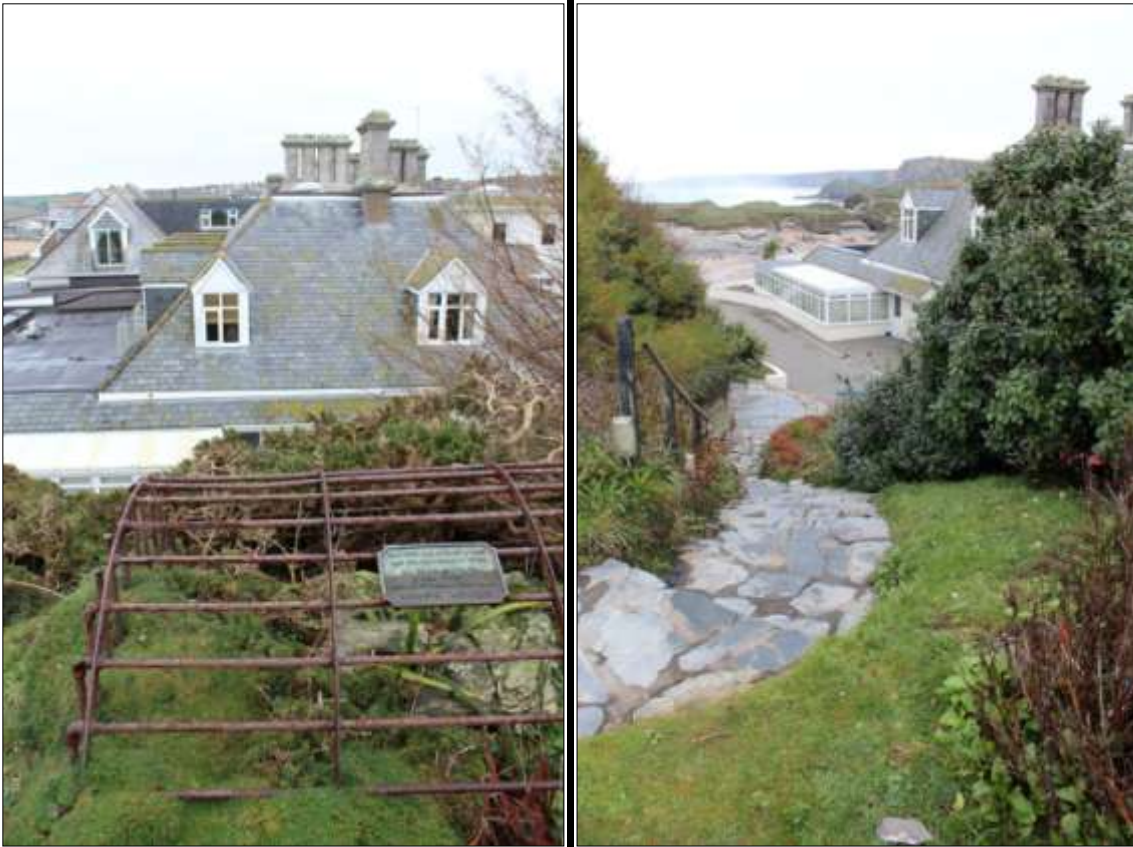
The cage with plaque erected over the BA grave, and the steps leading down from the car park.

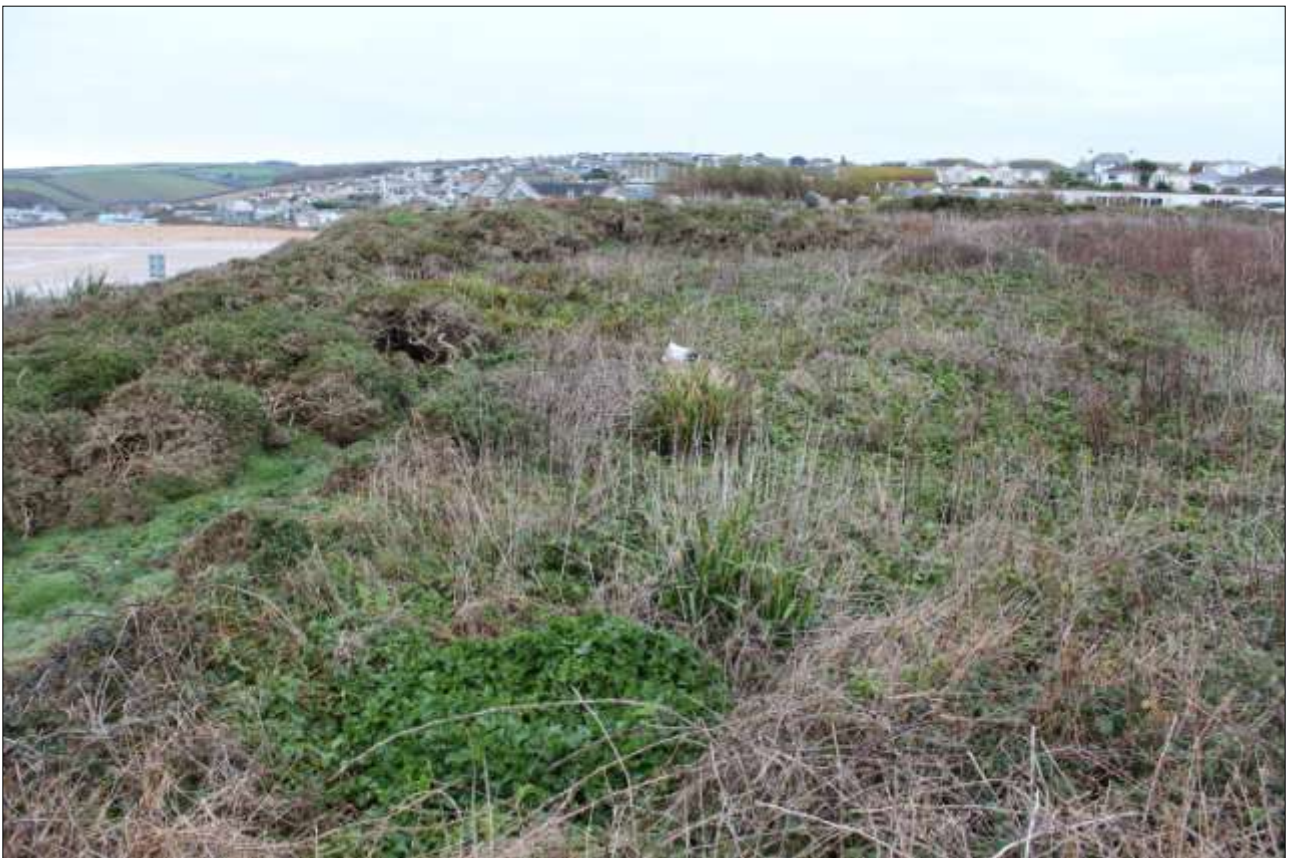
The scrub growing on dumped spoil west of the car park; viewed from the west, looking east.

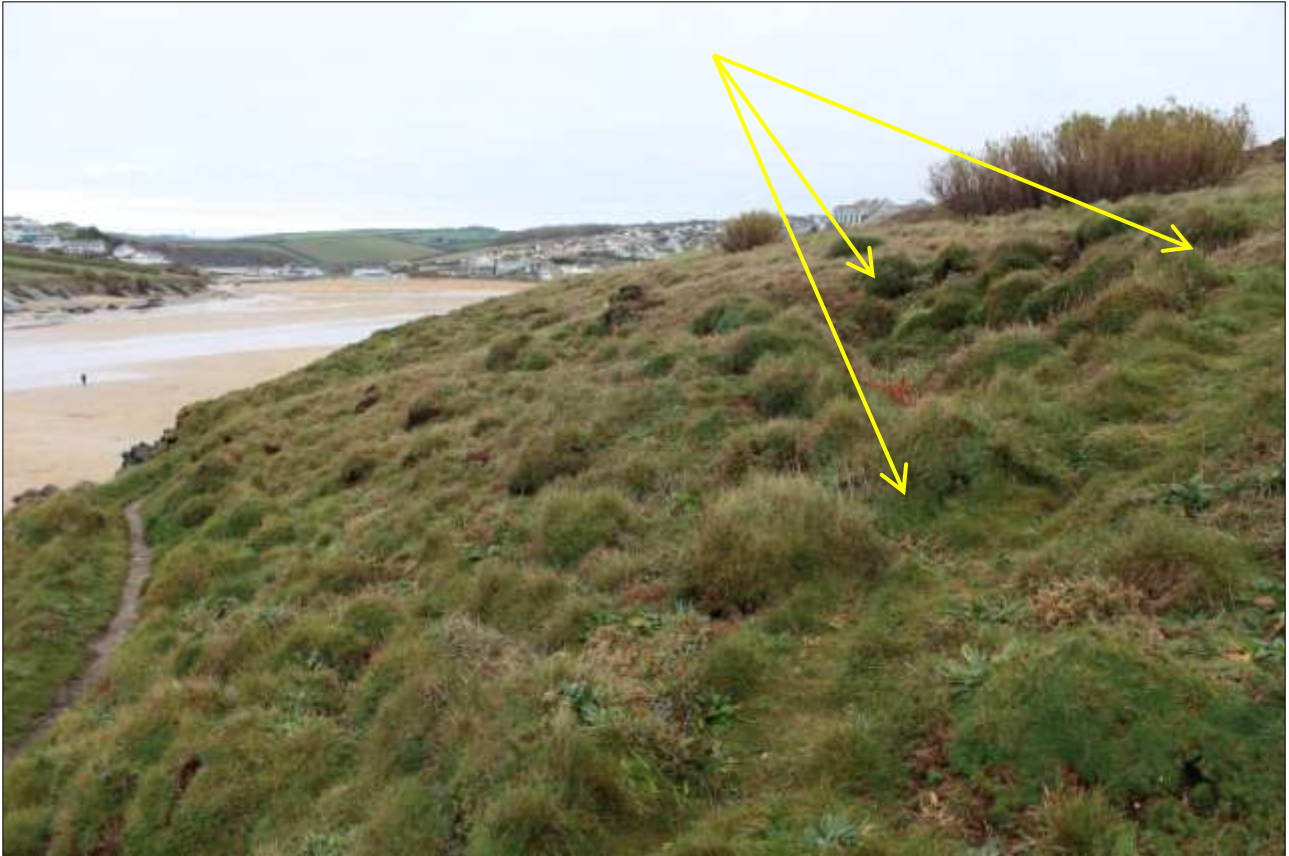
The possible shelter (linear hollow, indicated) above the north cliffs; viewed from the west, looking east.

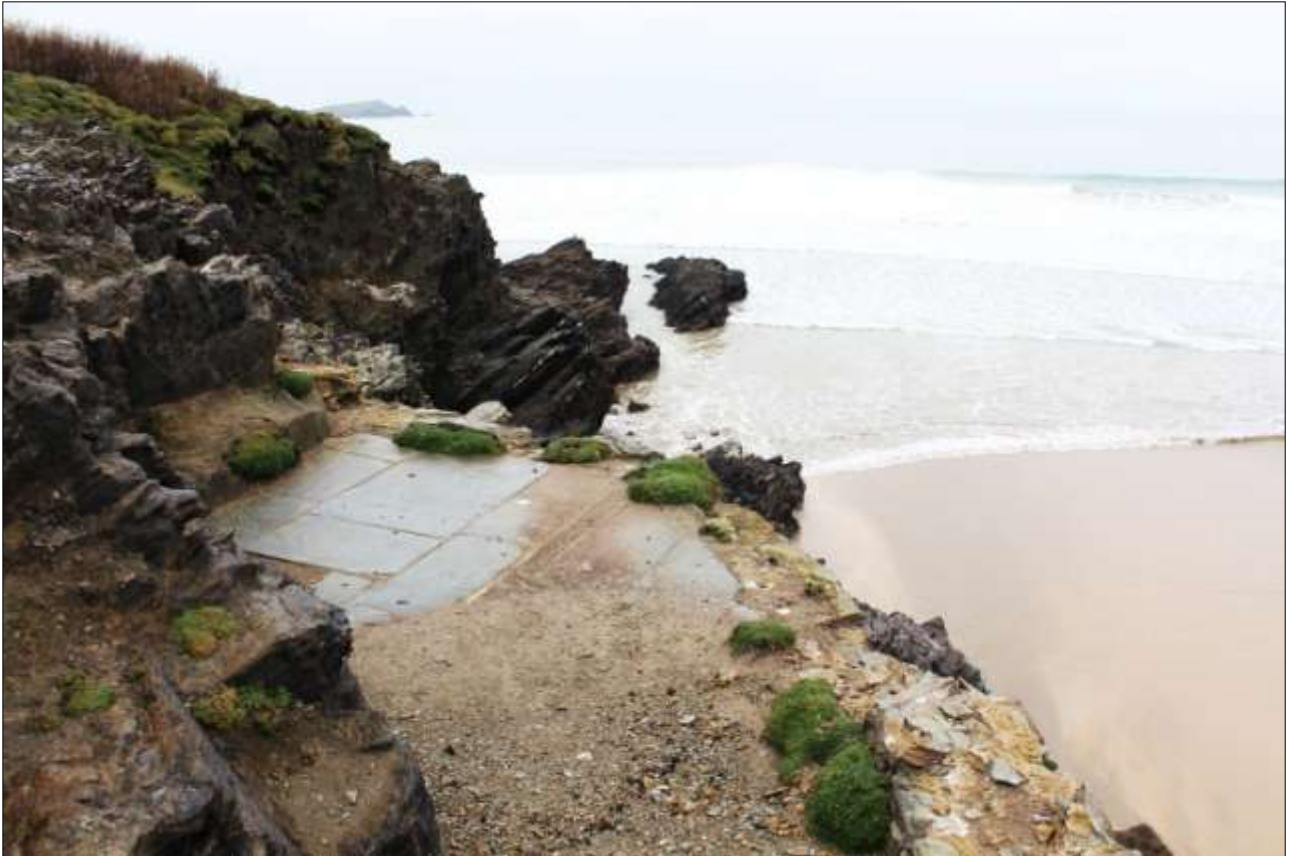
The floor of Structure #1; viewed from the east, looking west.

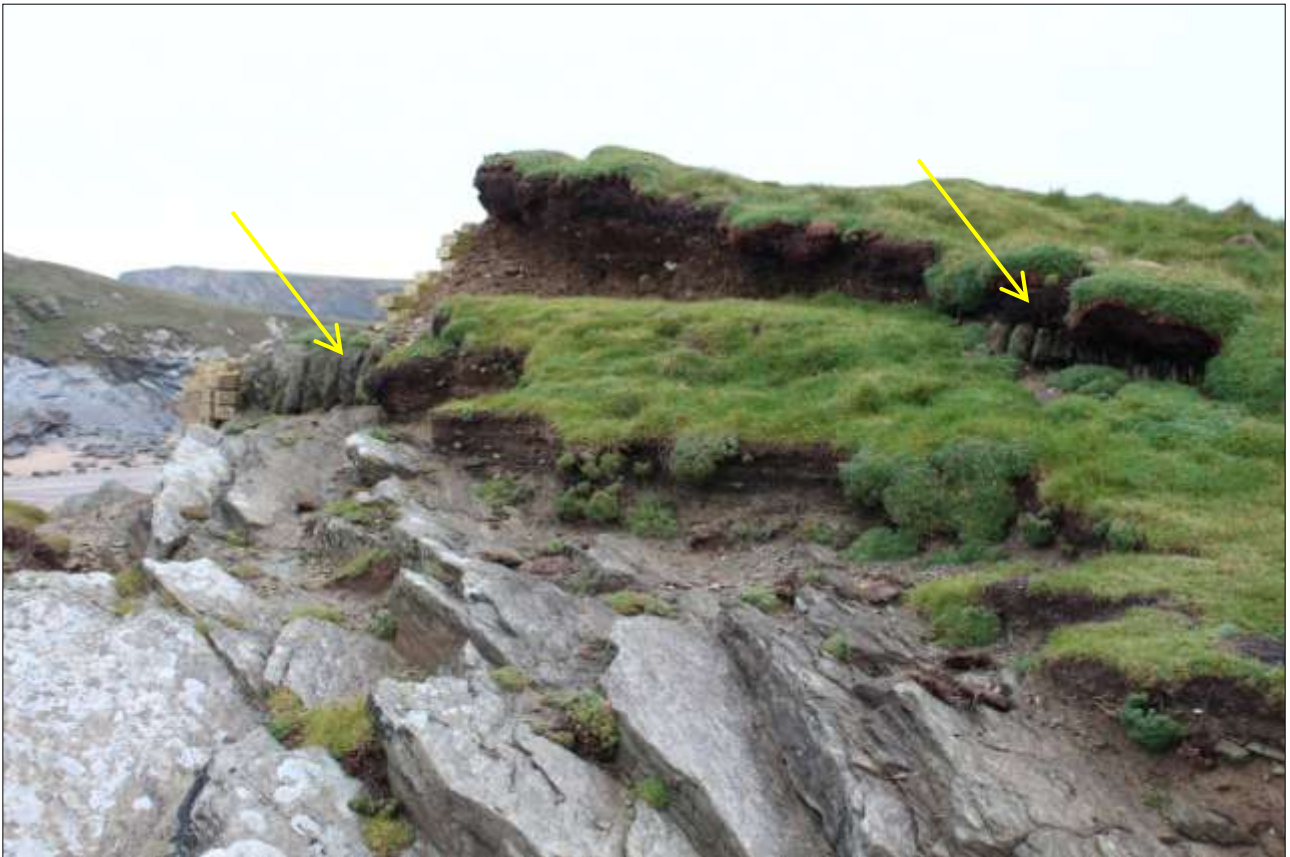
As above, showing the pitched stone 'hedgebank' (indicated).

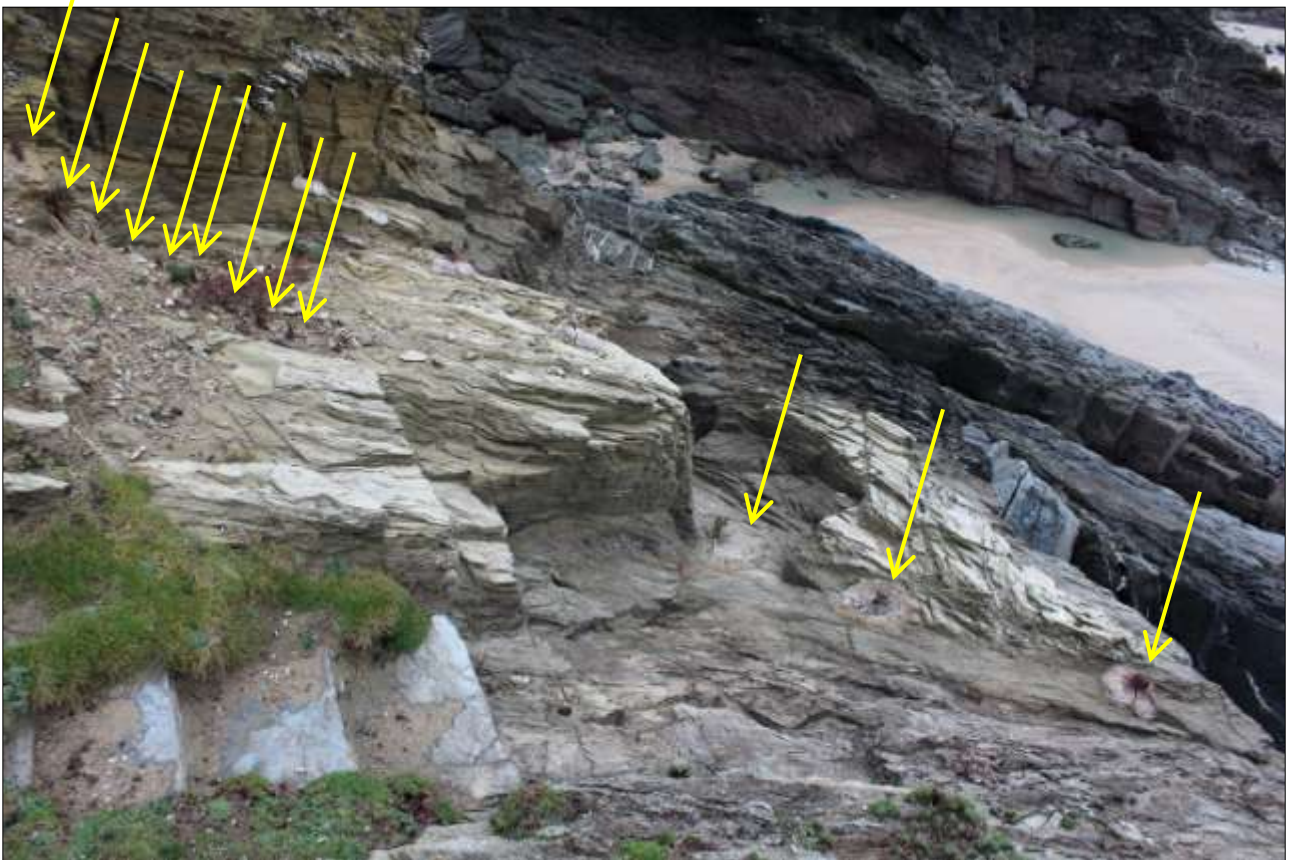
As above, with the stumps of iron posts indicated; viewed from the north, looking south.
