**LAND AT CHURCH HILL
HOLBETON
SOUTH HAMS
DEVON**

Results of an Archaeological Evaluation

South West Archaeology Ltd. report no. 171029

By J. Bampton
Report Version: FINAL
29th October 2017

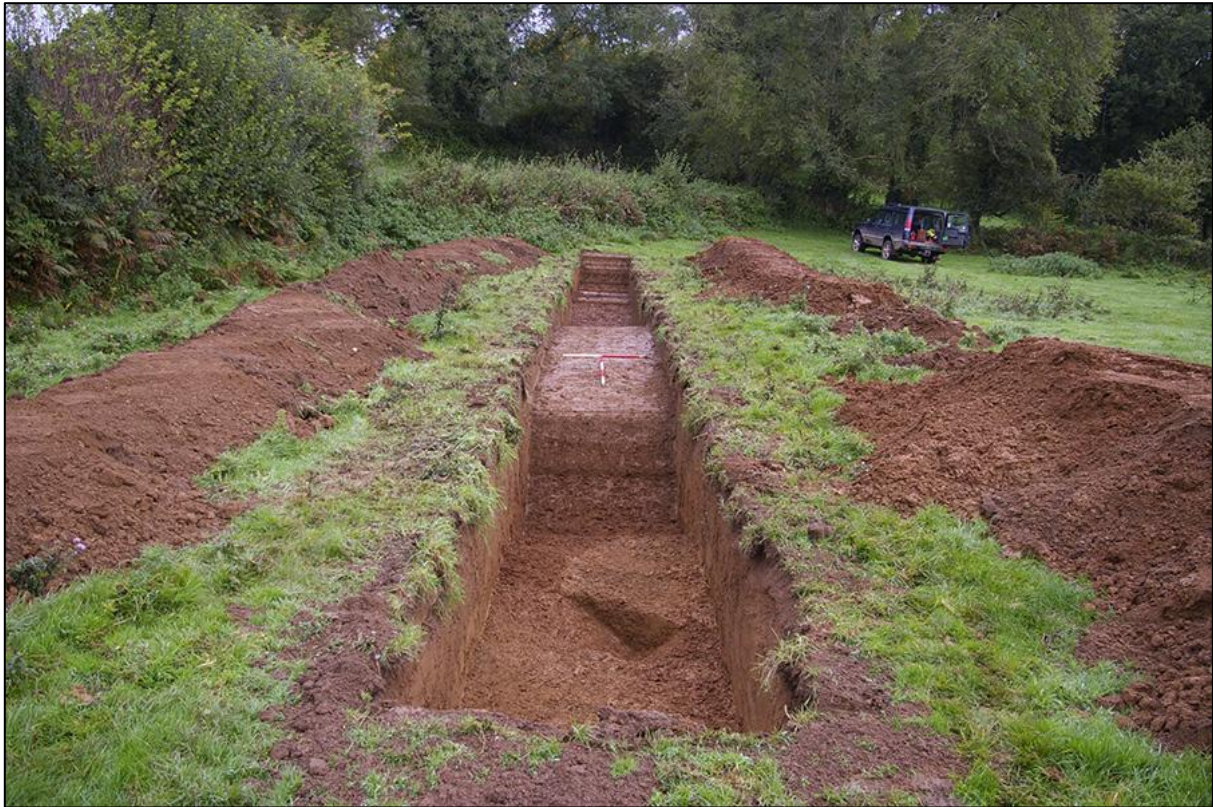
Ditch [505] (Figures 3, 9 and 12) was located at the south-west end of the trench. It was a linear ditch, c.1.36m wide, aligned east-west with moderate-steep sides and a pointed to gentle concave base. It contained a single fill: (506), which was a light grey-yellow, soft sandy-clay with gritty lenses and occasional charcoal flecks. It was overlaid by Subsoil (502). It contained no finds.

FIGURE 3: TRENCH 5, POST-EXCAVATION; VIEWED FROM THE SOUTH-WEST (1M AND 2M SCALES).

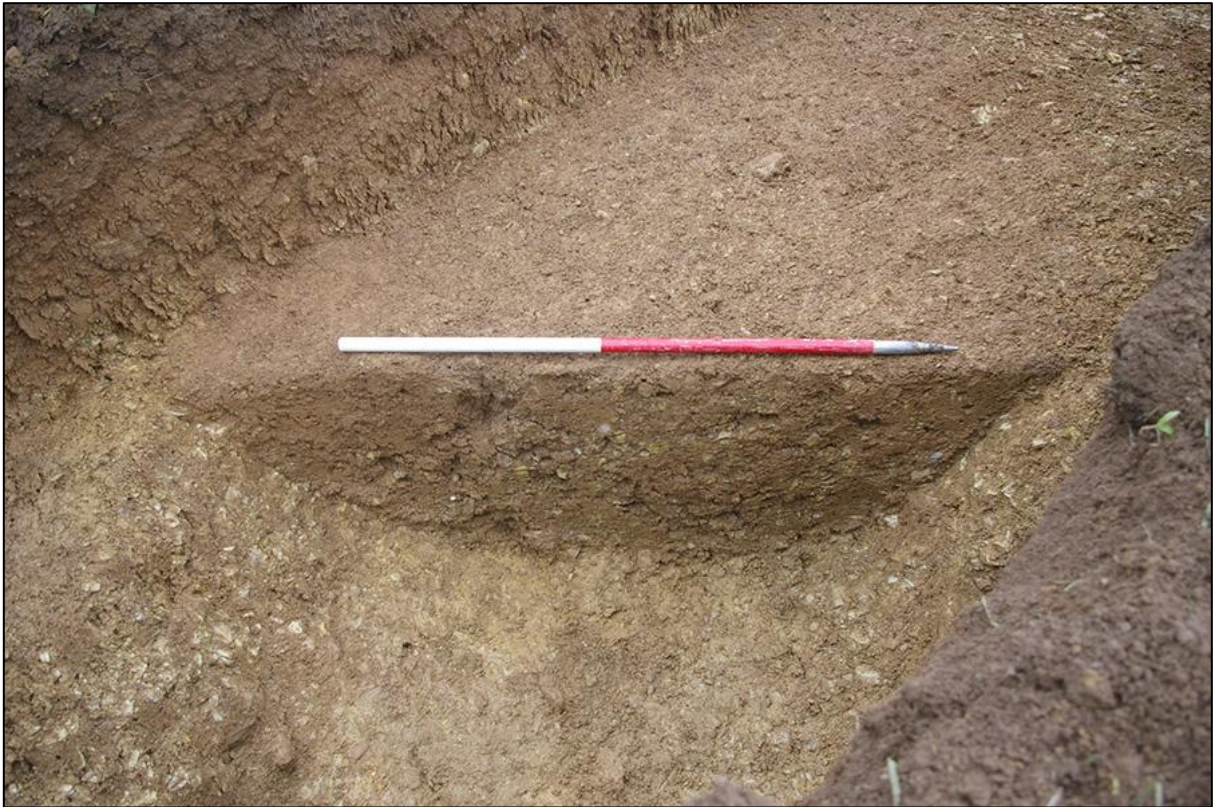
Ditch [706] (Figures 6, 9 and 14) was a linear ditch, 1.70m wide, aligned east-west with very steep sides and a concave base. It contained three fills: lowest fill (707), a light yellow-grey soft stony-clay; middle fill (708), which equated to Fill (609); and upper fill (709), which equated to Fill (610). None of these fills contained any finds, although fills (708) and (709) were sampled.

FIGURE 6: DITCH [706]; VIEWED FROM THE EAST (1M SCALE).

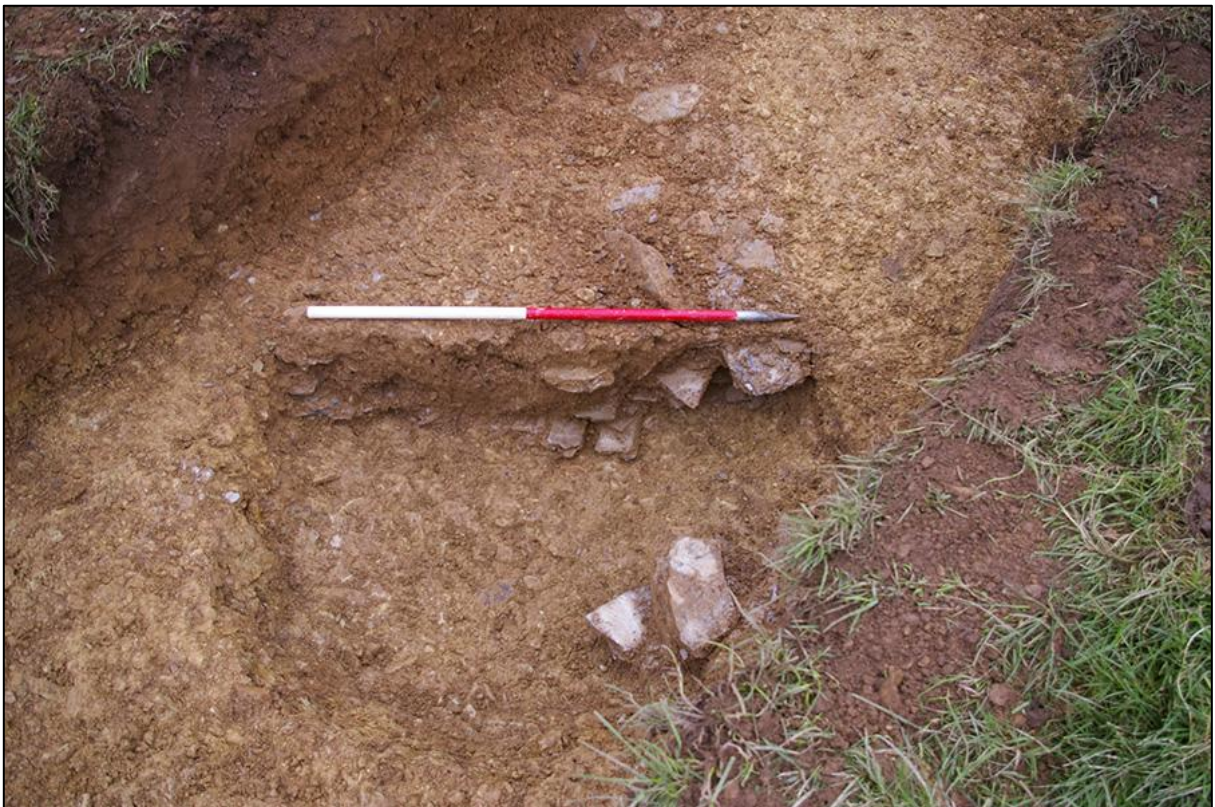
Construction Cut or Robber Cut [714] (Figures 7, 9 and 14) appeared similar to a sub-rectangular pit or the terminus of a linear feature that contained a stony fill and a silty-clayey fill. It was 1.34m wide and aligned approximately east-west. It had near vertical sides and a flat base and contained the remains of Wall {717} against its southern edge. Wall {717} was a thick slate/mudstone built wall with an earth bond surviving c.0.22m in height against the southern edge of the construction cut. It was overlain by demolition layer (715) a slate rubble layer in a light yellow-brown, soft silt-clay matrix, which contained ×4 fragments (17g) of animal bone. This was overlain by the made-ground/backfilling deposit (716), a mid-light yellow-brown, firm silt clay. The feature contained no finds.

FIGURE 7: DEMOLISHED WALL {717}; VIEWED FROM THE WEST (1M SCALE).

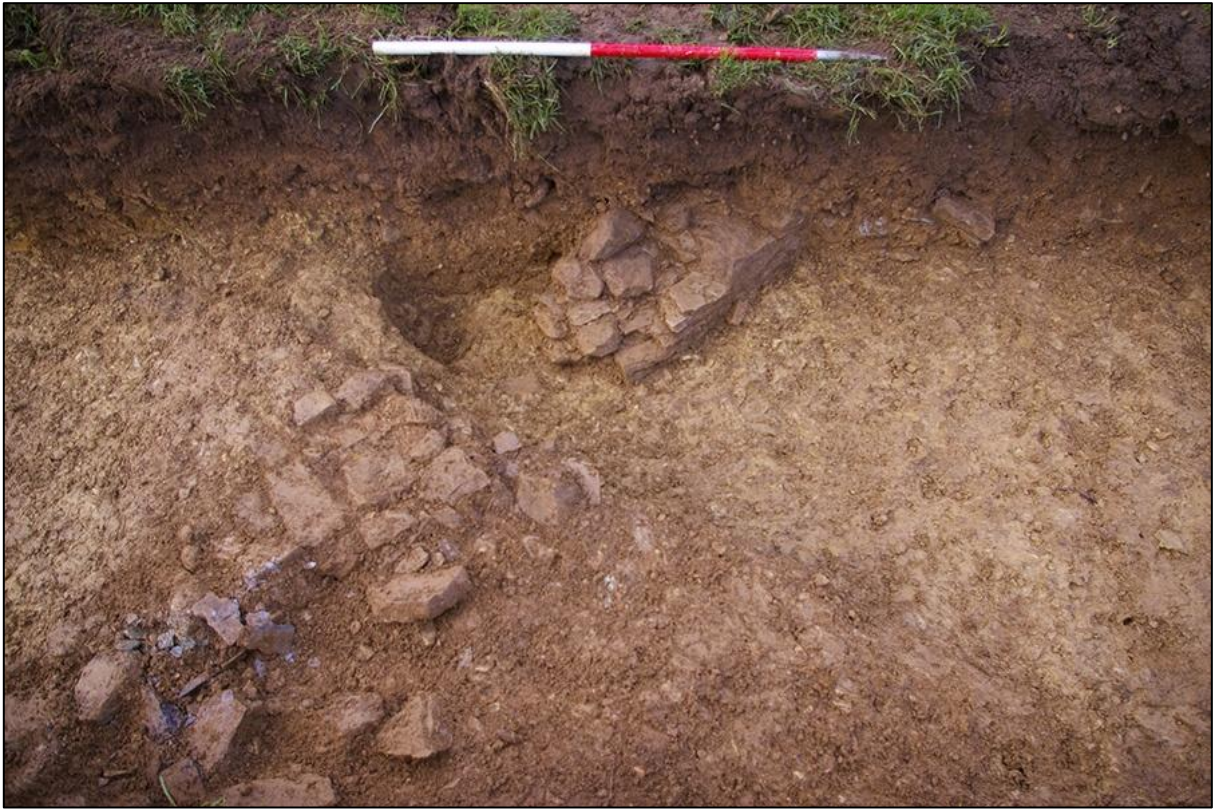
Construction/Platform Cut [718] (Figures 8, 9 and 14) was a linear cut, c.0.15m deep, aligned approximately east-west with a near vertical southern edge and a flat base/platform. Wall {719}, c.0.39m wide and c.0.20m deep, was built against the southern edge of the cut from slate/mudstone with an earth bond. It was overlain and abutted by demolition layer (720), similar to layer (715), which was spread across the platform on the north side of Wall {719}, which was in turn overlain by the subsoil. The feature contained no finds.

Pit/Posthole [721] (Figures 8, 9 and 14) was ovoid in plan and c.0.60m in diameter. It abutted cut [718] and contained a single fill, (722), which was identical to Subsoil (701). It may have been a supporting post associated with the wall or later feature backfilled with re-deposited subsoil.

FIGURE 8: WALL {719} AND PIT/POSTHOLE [721]; VIEWED FROM THE NORTH-EAST (1M SCALE).

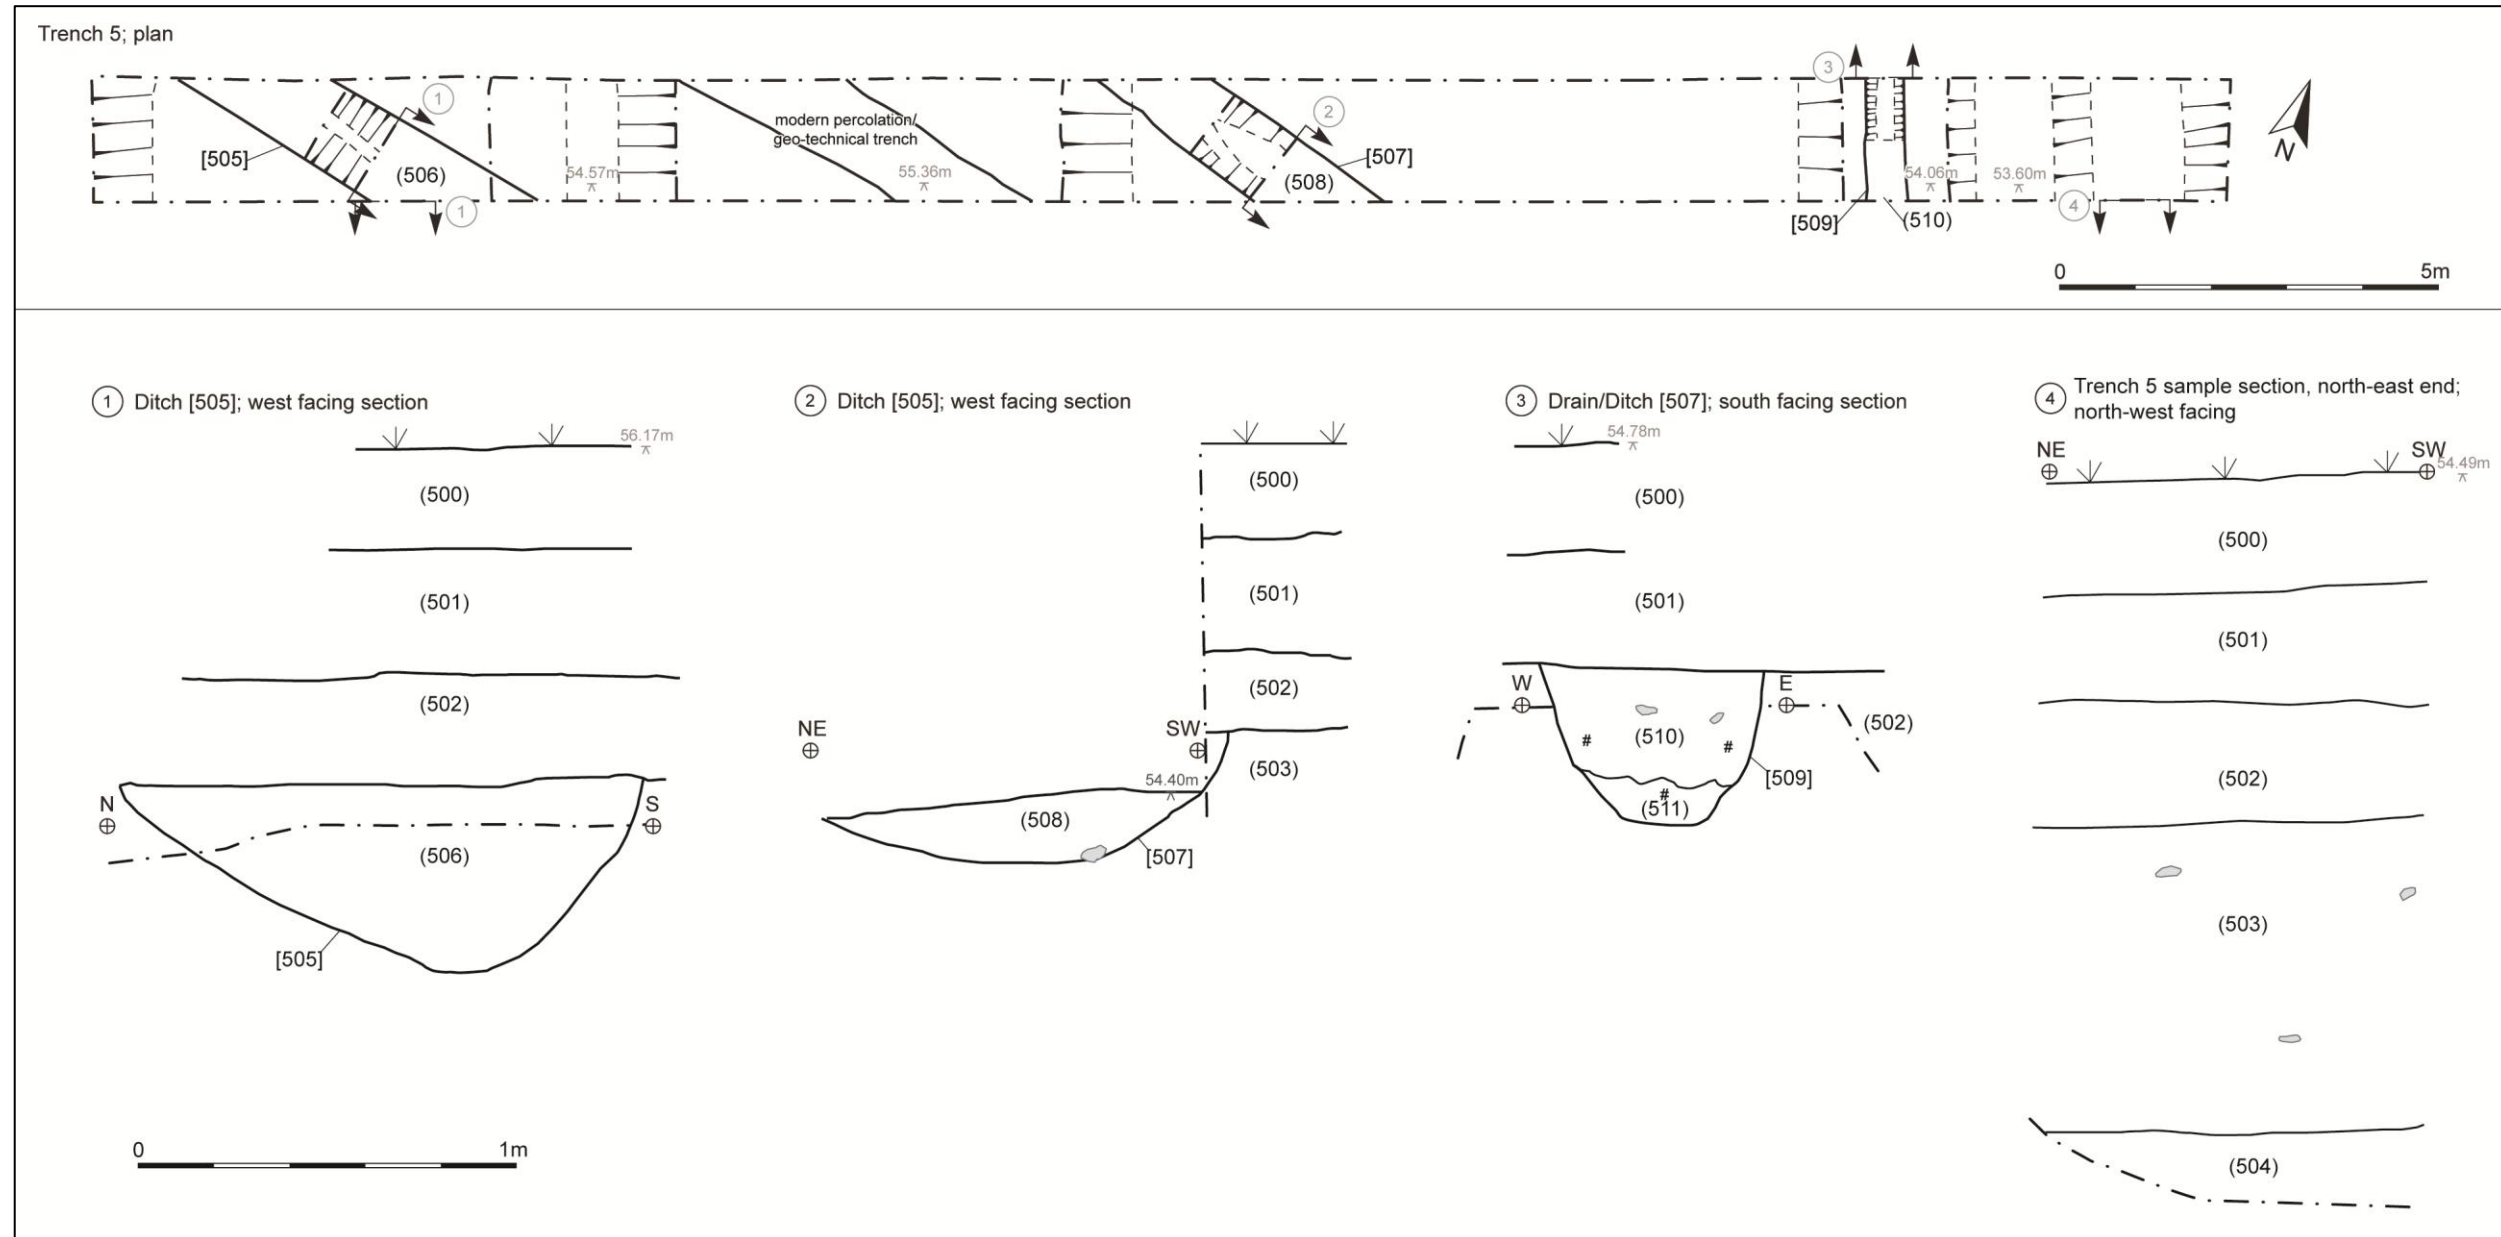
Ditch [507] (Figures 9 and 12) was parallel to Ditch [505] and almost identical in form and character, although 1.02m wide. It contained a single fill: (508), which was the same as Fill (506). It was overlaid by Subsoil (502). It contained no finds.

Drain [509] (Figures 9 and 12) was located at the north-east end of the trench. It was a linear drain, 0.58m wide, aligned north-west by south-east with near vertical sides and a flat base. It contained two fills; (510) and (511), upper and lower respectively. Fill (510) was charcoal rich and contained frequent slate fragments. It was overlain by Subsoil (501). Fill (511) was a soft-loose gravelly layer. Drain [509] contained no finds.

FIGURE 12: TRENCH 5; TRENCH PLAN AND FEATURE AND SAMPLE SECTIONS.

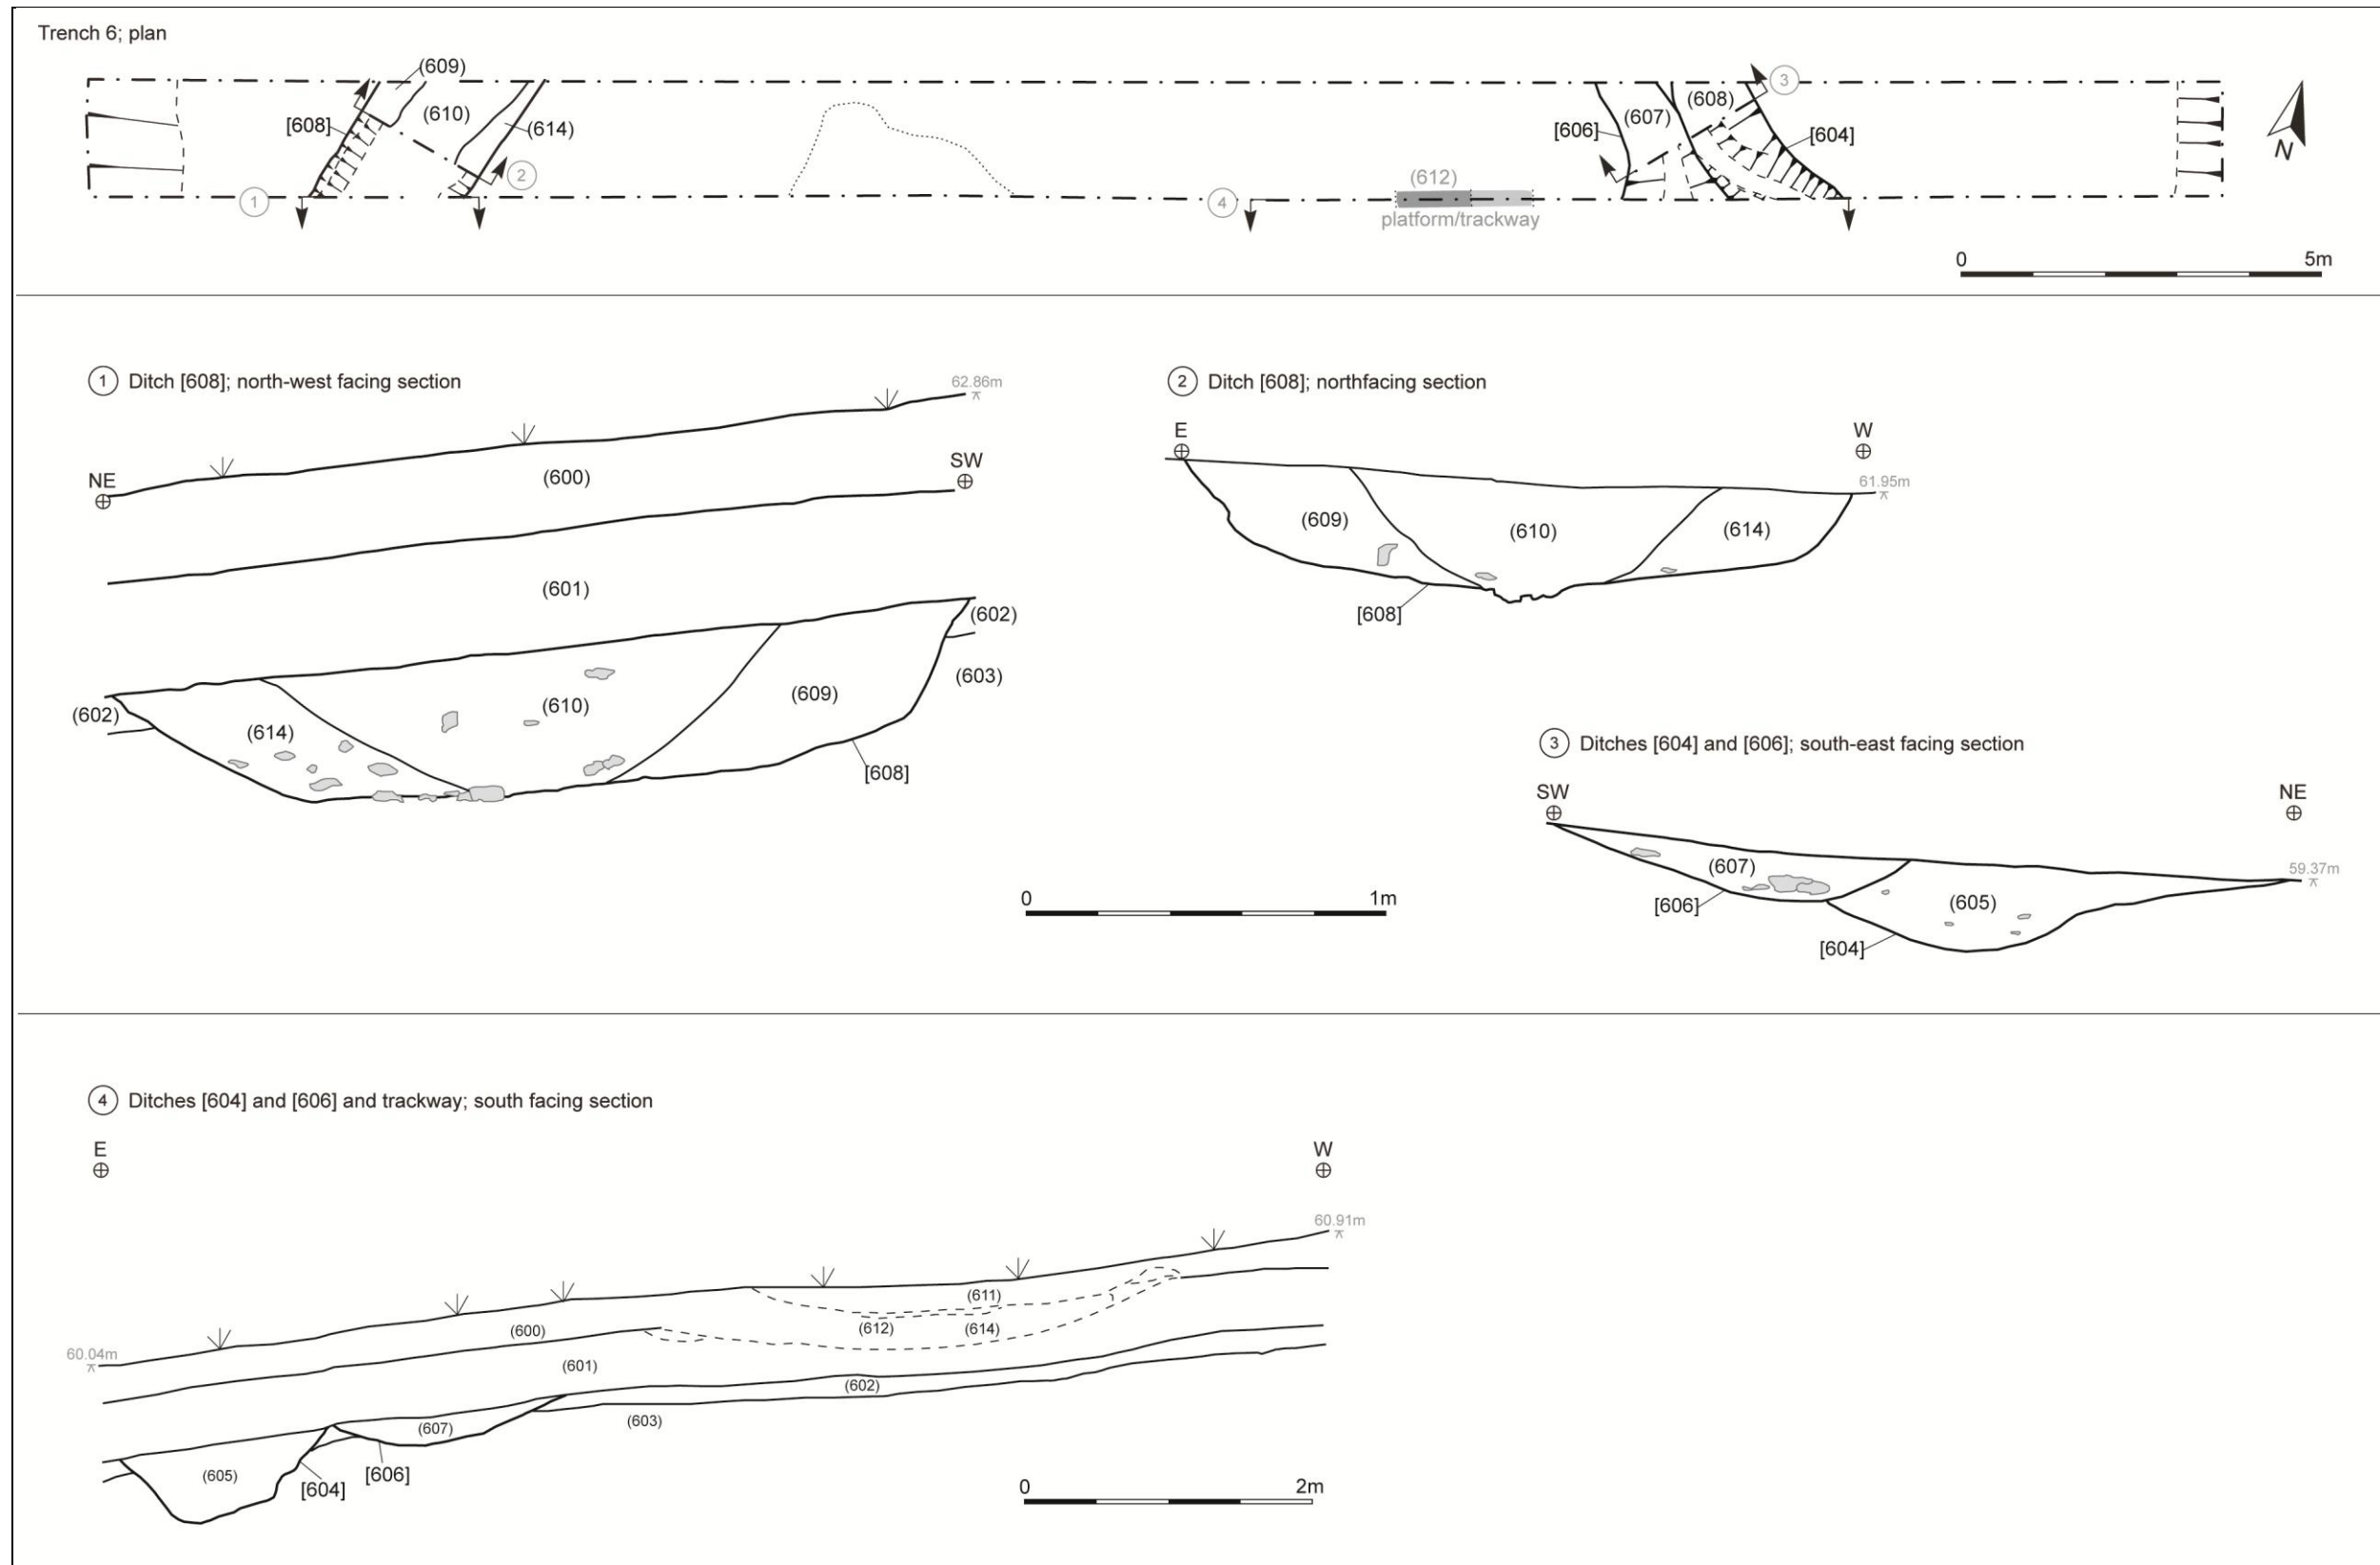
Ditch [604] (Figures 4, 9 and 13) was located at the north-east end of the trench. It was a linear ditch, c.1.40m wide, aligned north-west by south-east with a possible curve. It had steep sides and a gentle concave base. It contained a single fill: (605), which was a light yellow-grey, firm silt-clay with occasional charcoal flecks. It was cut by Ditch [606]. It contained no finds.

Ditch [606] (Figures 4, 9 and 13) was located at the north-east end of the trench and cut Fill (605). It was a linear ditch, c.1-1.55m wide, aligned north-west by south-east with a gentle concave profile. It contained a single fill: (607), which was similar to Fill (605). It contained no finds.

Ditch [608] (Figures 5, 9 and 13) was located at the south-west end of the trench. It was a linear ditch, c.1.86m wide, aligned north-south with very steep sides and a flat base. It contained two fills: lower fill (609), which was a mid red-brown, friable clay-silt and contained ×6 sherds (16g) of Iron Age/Romano-British pottery; and upper fill (610) which was a mid yellow brown, soft silt-clay. It is possible that the upper fill (610), represents a re-cut, but this was not clear in plan or during excavation.

A footpath/trackway was visible as an earthwork running from the south-east corner of the site to the north-west corner of the site. Other than Ditches [604] and [606], on the down-slope side of the trackway, the only archaeological evidence of the feature was a 0.75m wide lens of limestone chippings, c.0.02m thick which overlaid a compacted subsoil: (613), which was slightly more yellow and firm than the rest of the subsoil across the trench. The chippings, (612), were overlaid by a turf layer, (611), which may have built up over time or been purposefully reinstated. Chippings layer (612) contained a corroded iron nail.

FIGURE 13: TRENCH 6; TRENCH PLAN AND FEATURE AND SAMPLE SECTIONS.

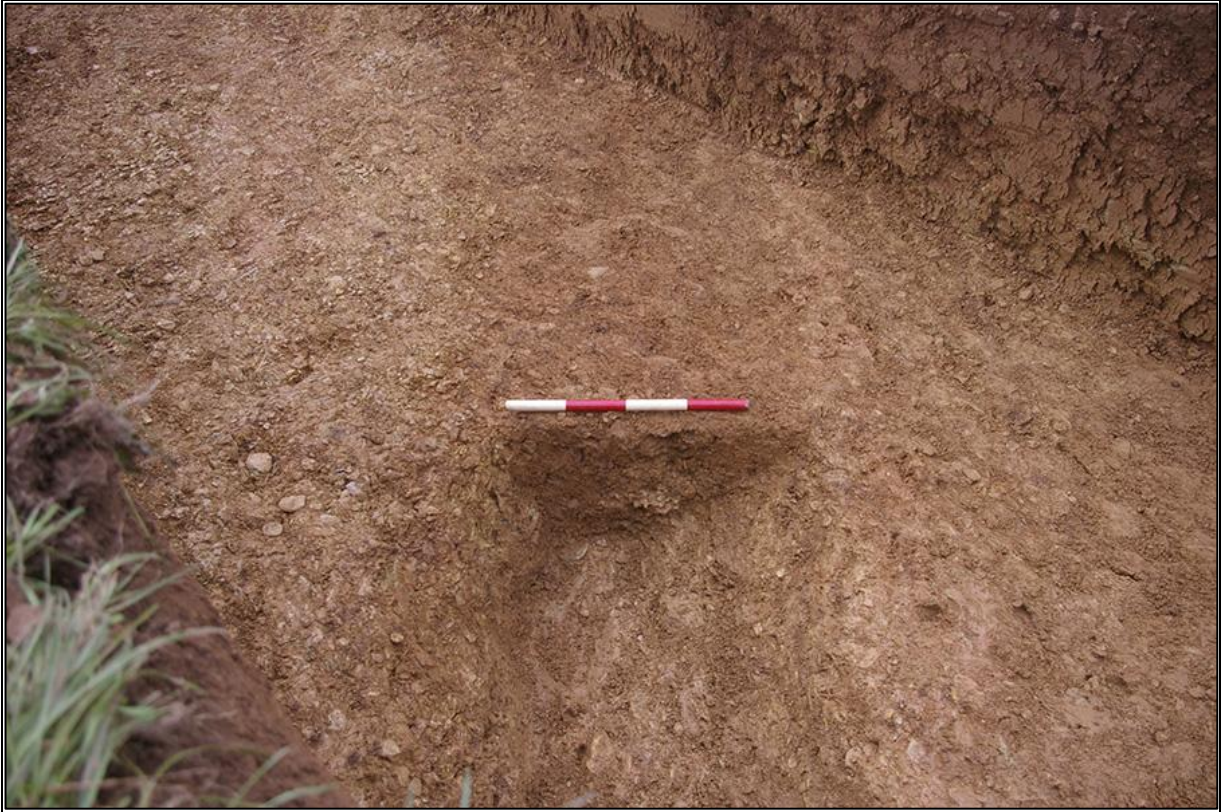
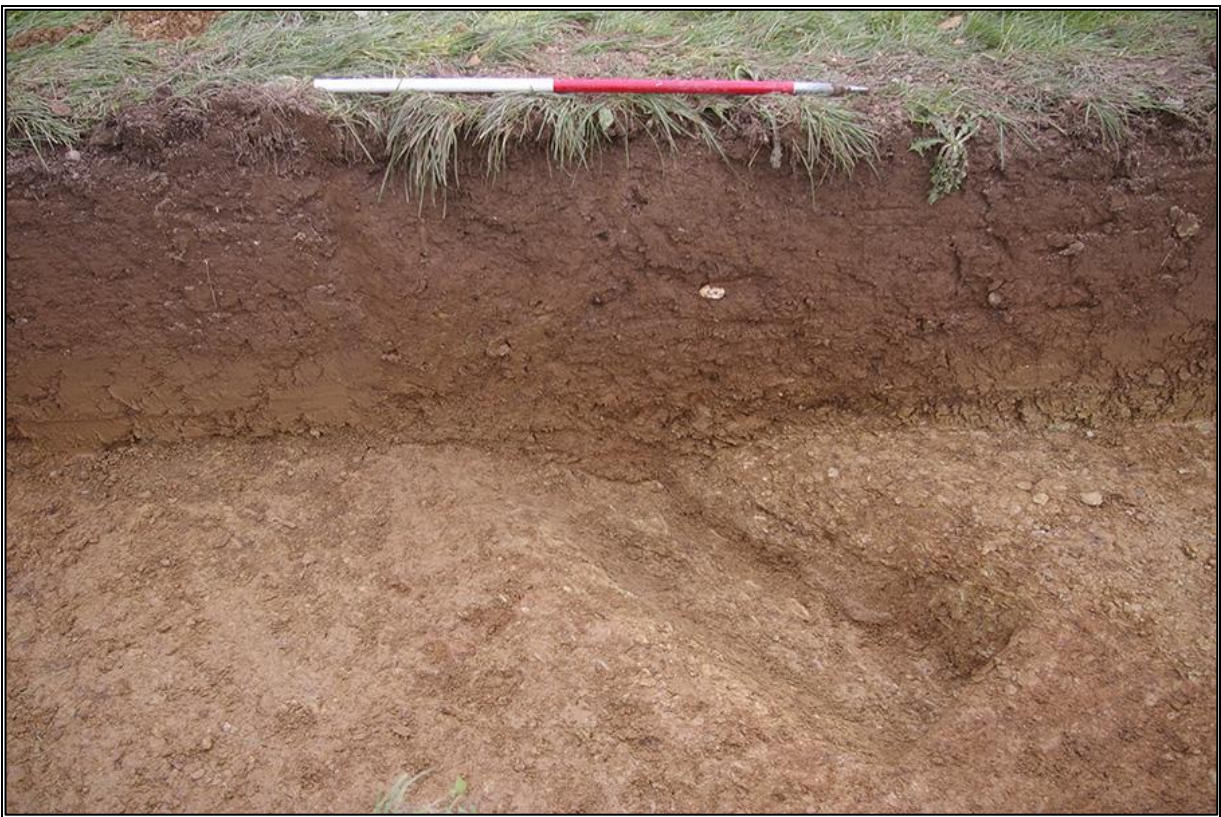
GULLY [103]; VIEWED FROM THE NORTH-EAST (0.40M SCALE).

GULLY [103] AND SAMPLE SECTION IN TRENCH 1; VIEWED FROM THE EAST (1M SCALE).

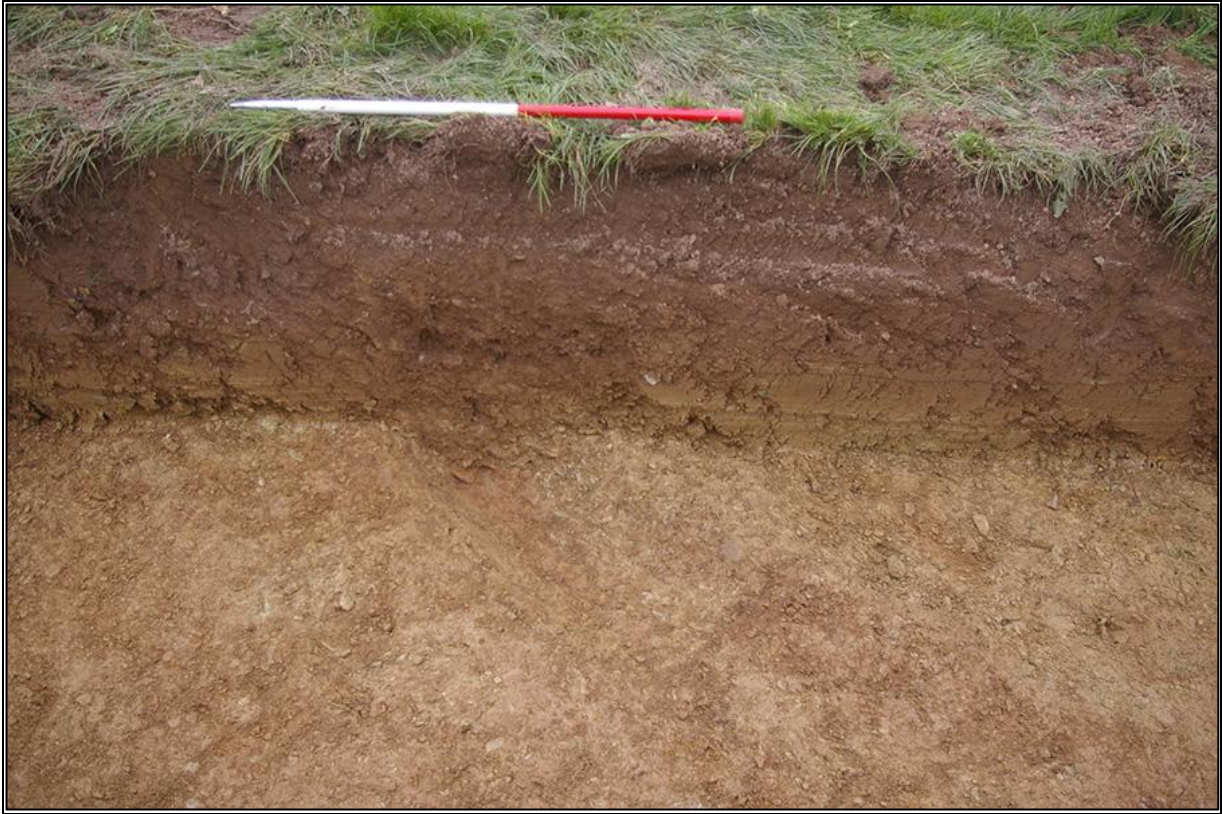
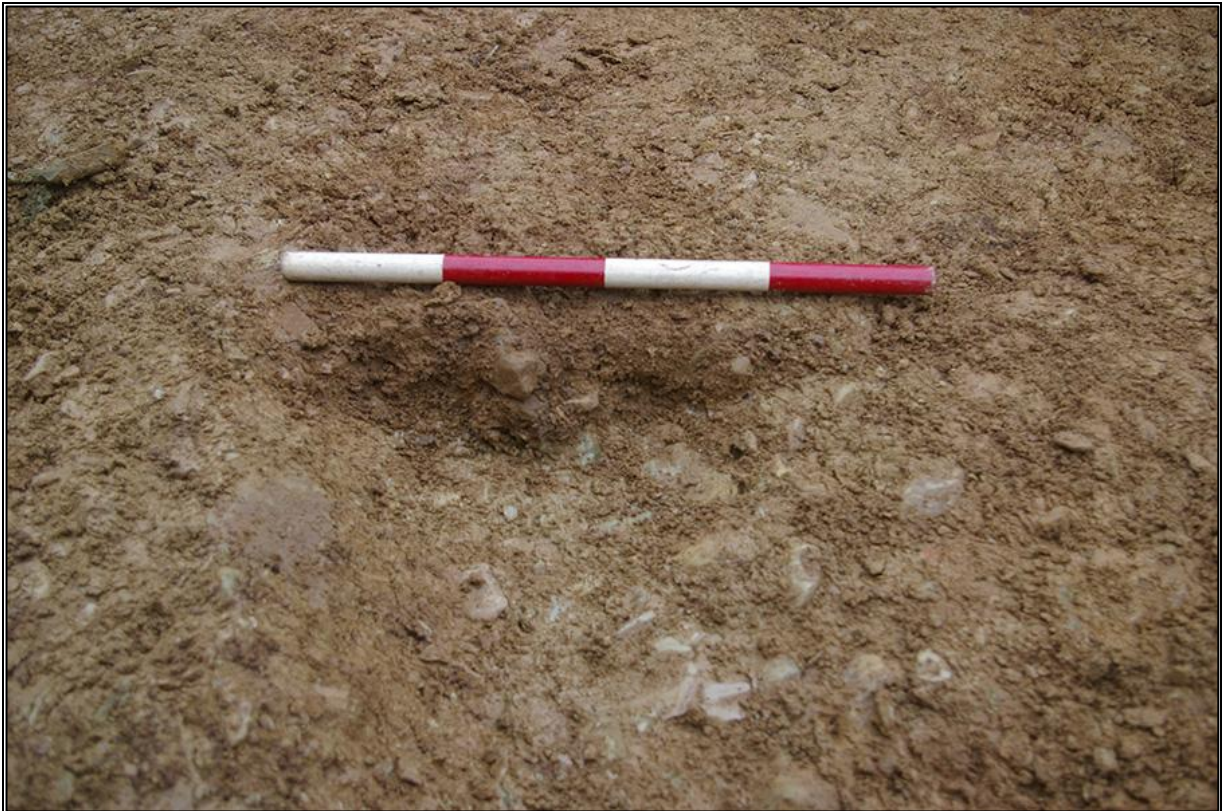
GULLY [104] AND SAMPLE SECTION IN TRENCH 1; VIEWED FROM THE EAST (1M SCALE).

GULLY [104]; VIEWED FROM THE NORTH-EAST (0.40M SCALE).

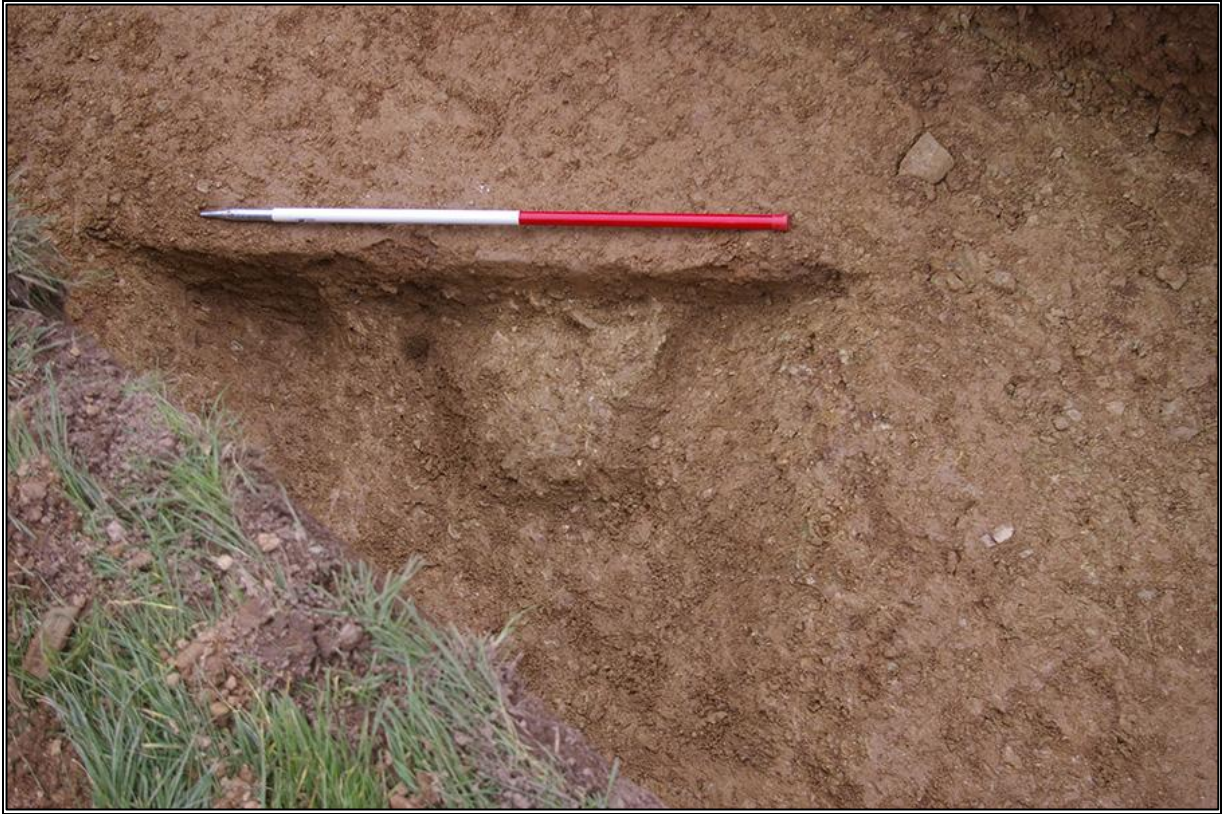
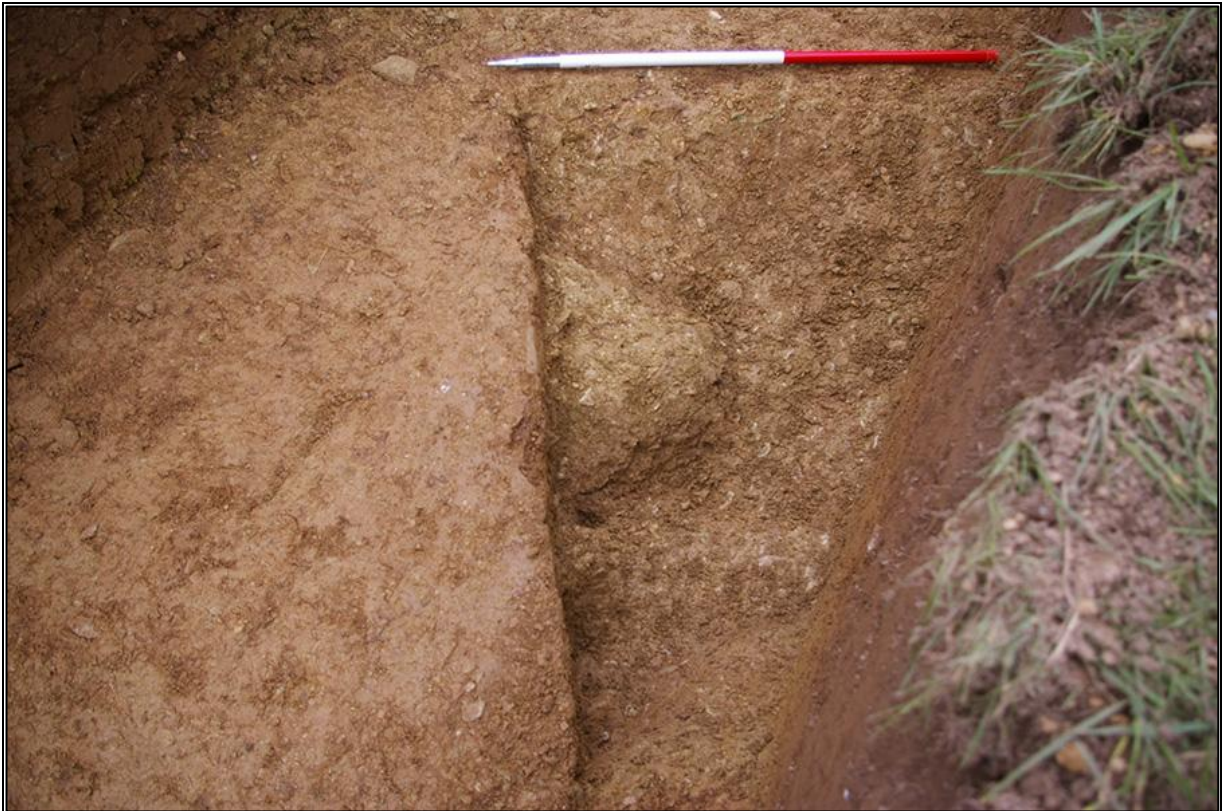
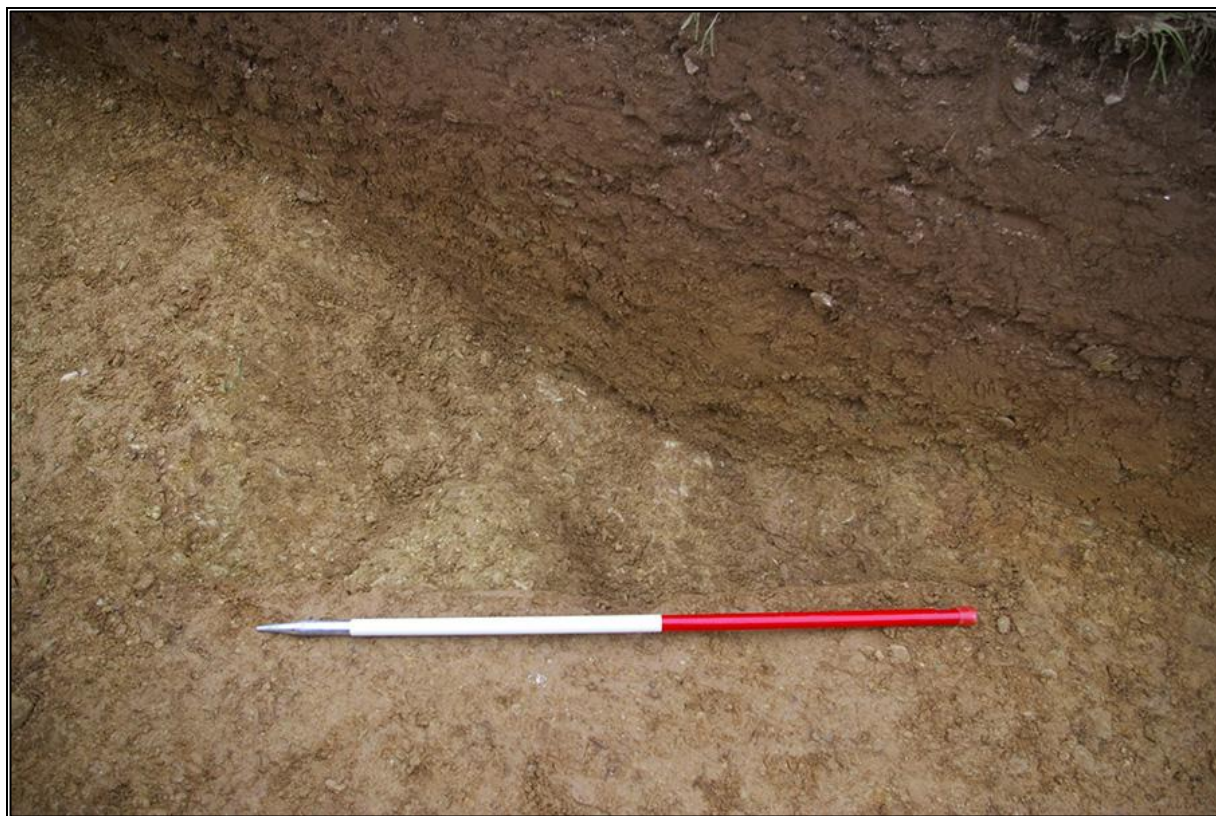
DITCH [105]; VIEWED FROM THE NORTH-EAST (1M SCALE).

DITCH [105]; VIEWED FROM THE SOUTH-EAST (1M SCALE).

DITCH [105]; VIEWED FROM THE SOUTH-WEST (1M SCALE).

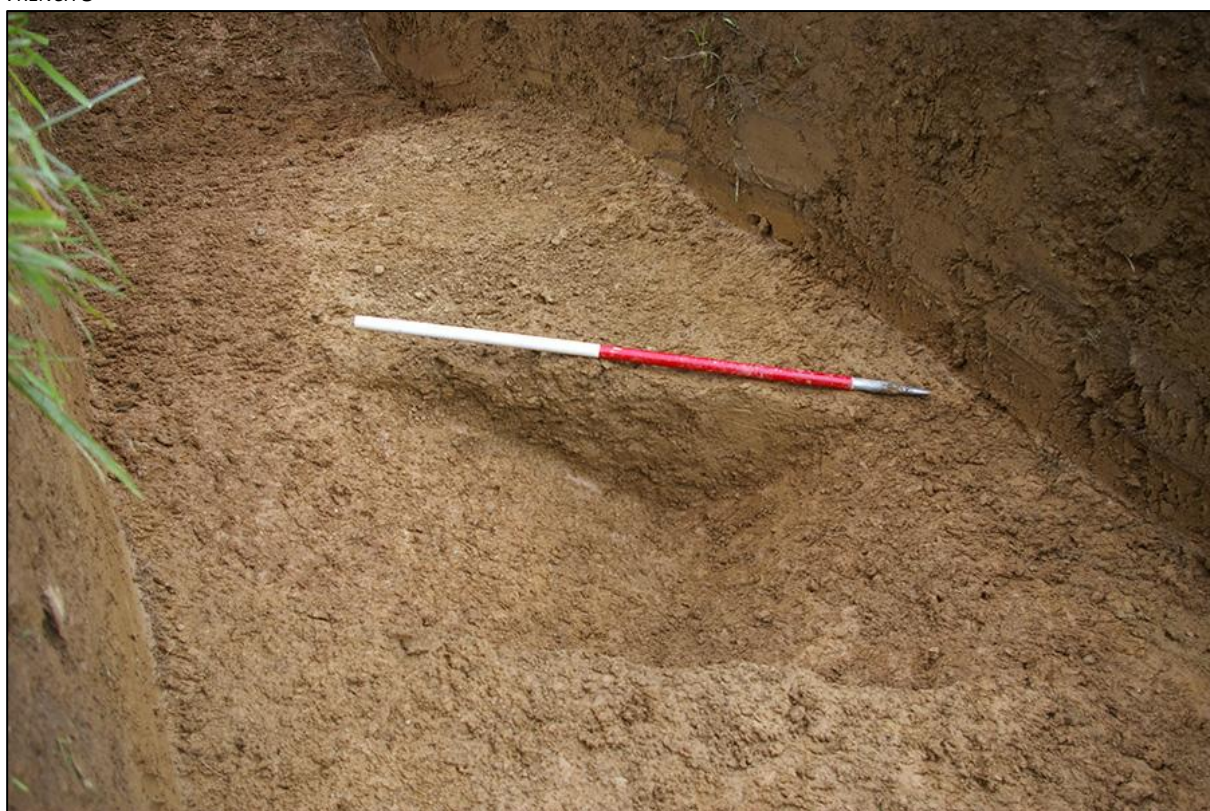
DITCH [505]; VIEWED FROM THE WEST (1M SCALE).

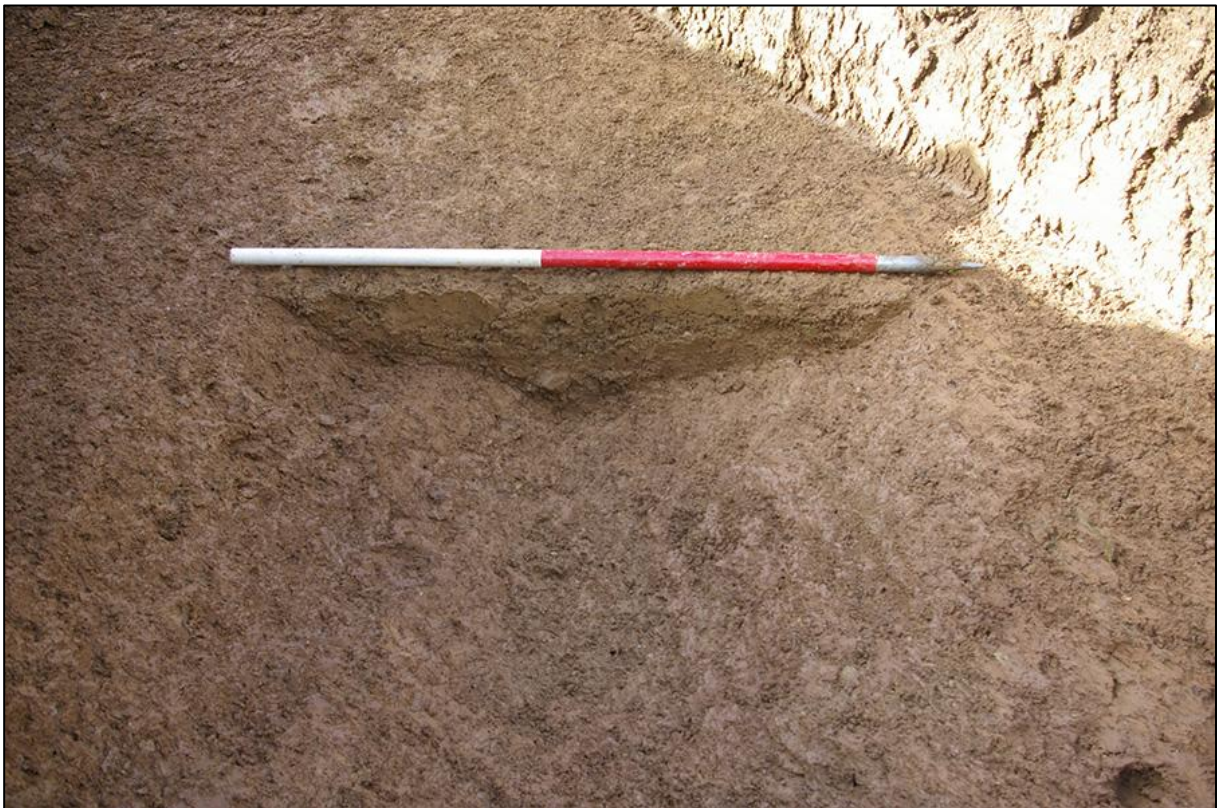
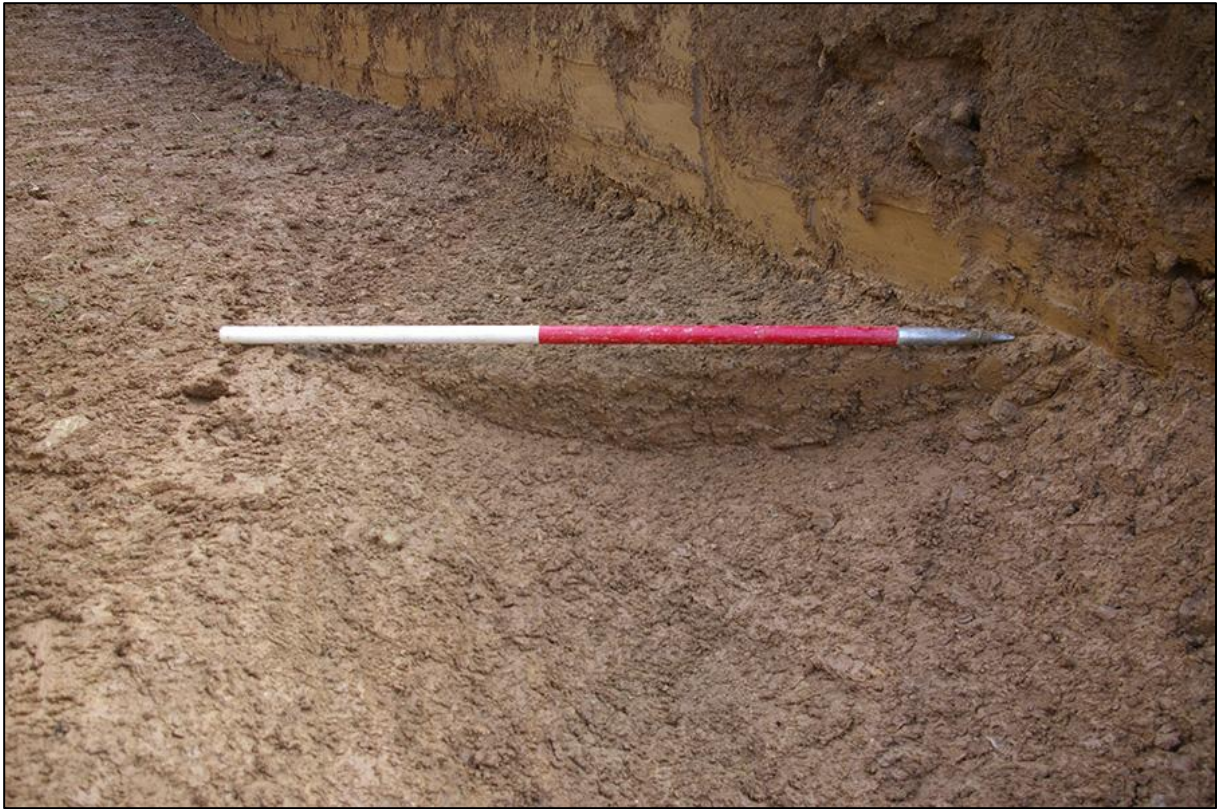
DITCH [507]; VIEWED FROM THE EAST (1M SCALE).

DITCH [507]; VIEWED FROM THE WEST (1M SCALE).
