**LAND AT CHURCH HILL
HOLBETON
SOUTH HAMS
DEVON**

Results of an Archaeological Evaluation

South West Archaeology Ltd. report no. 171029

By J. Bampton
Report Version: FINAL
29th October 2017

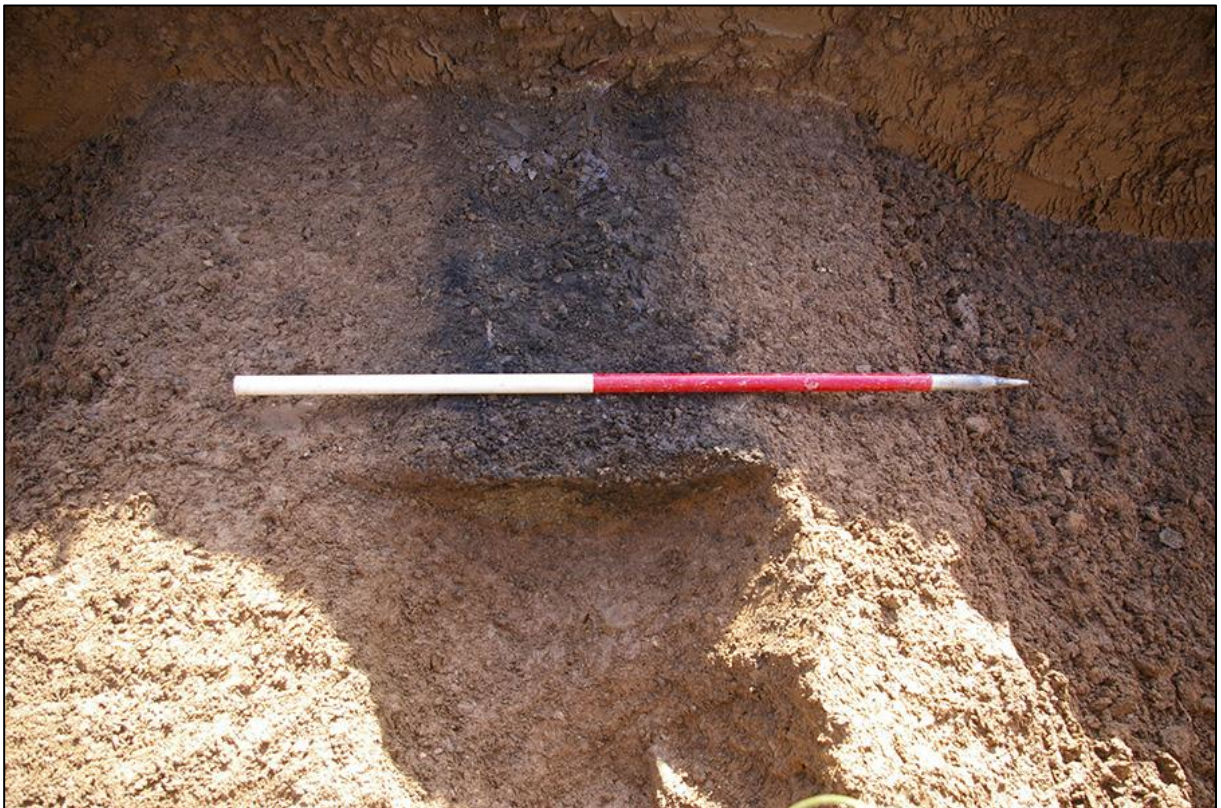
DRAIN/DITCH [509]; VIEWED FROM THE NORTH-WEST (1M SCALE).

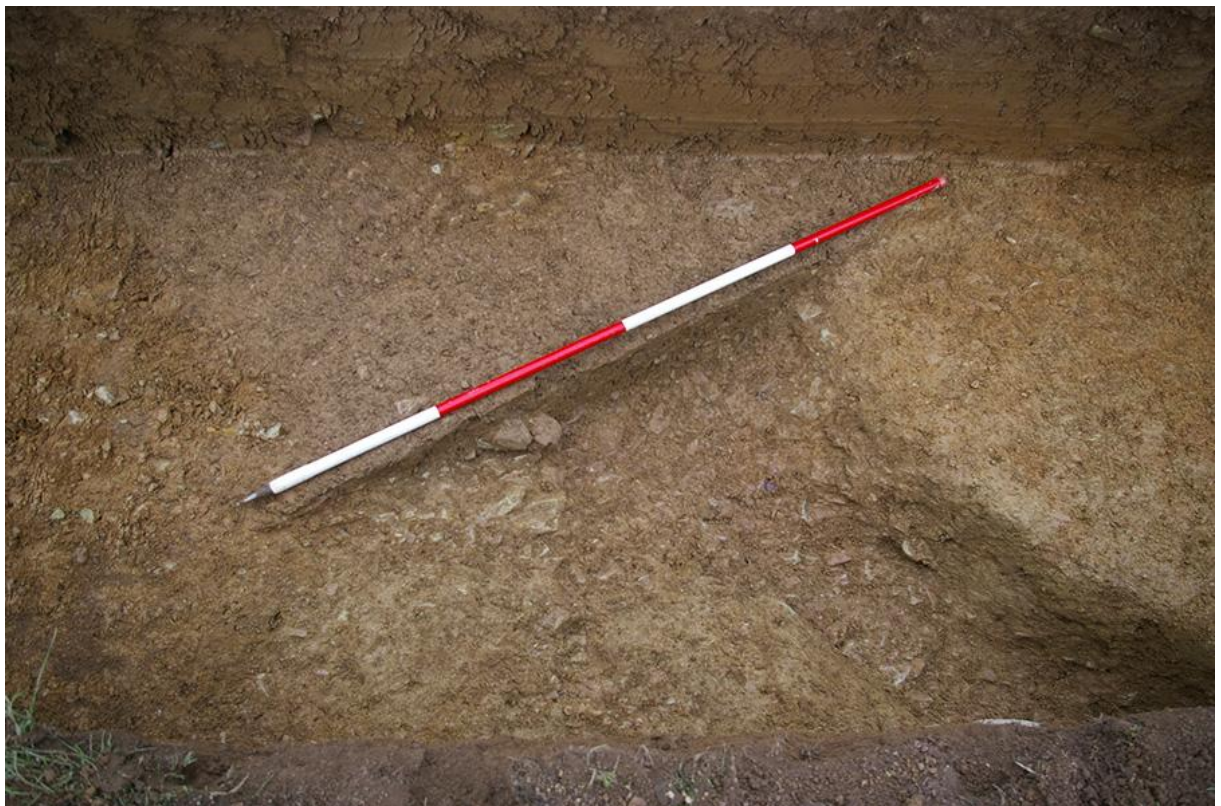
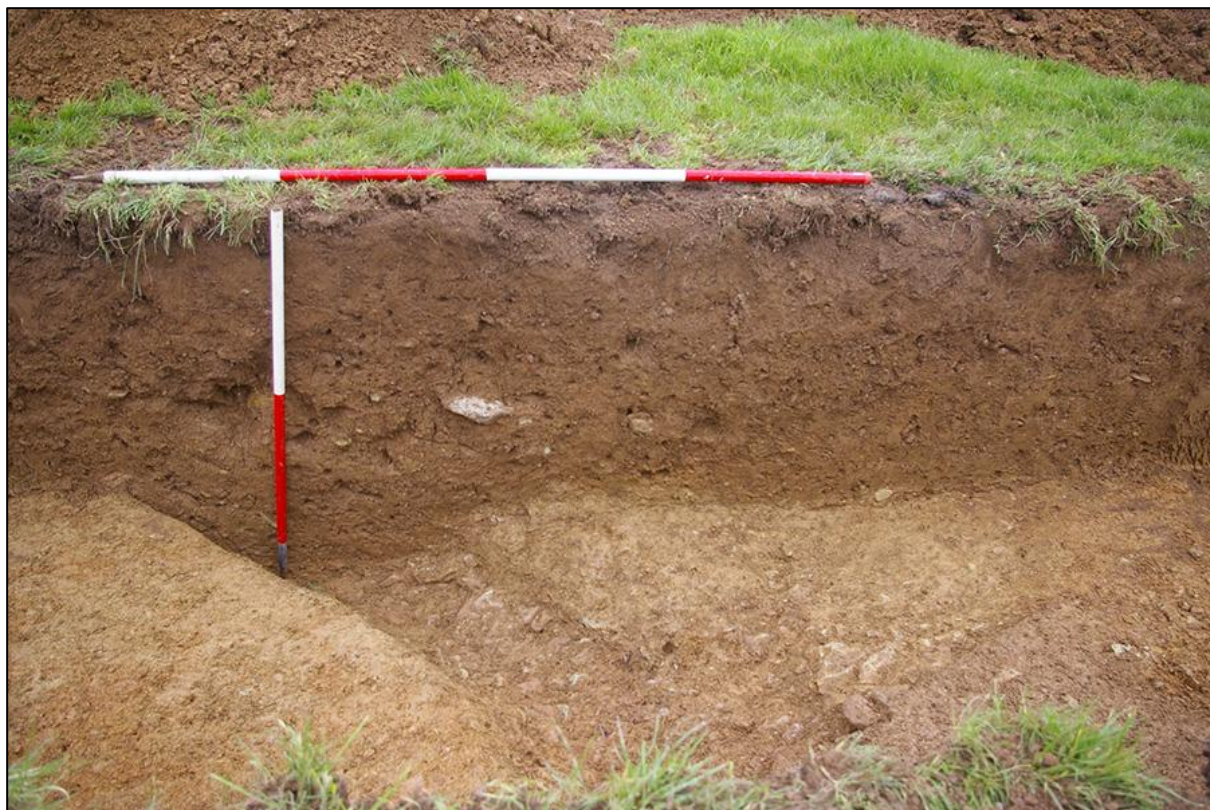
DITCHES [604] AND [606] FROM AN OBLIQUE ANGLE; VIEWED FROM THE SOUTH-EAST (2M SCALE).

DITCHES [604] AND [606]; VIEWED FROM THE NORTH-WEST (1M & 2M SCALE).

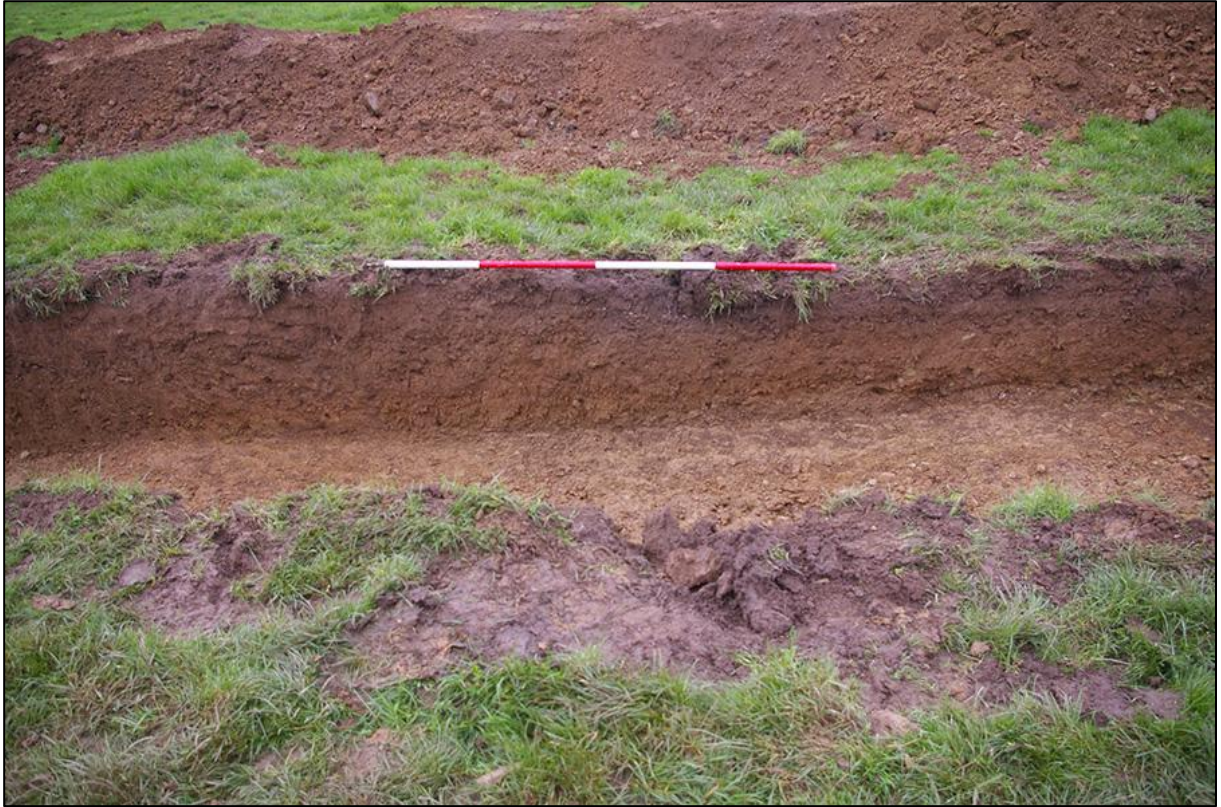
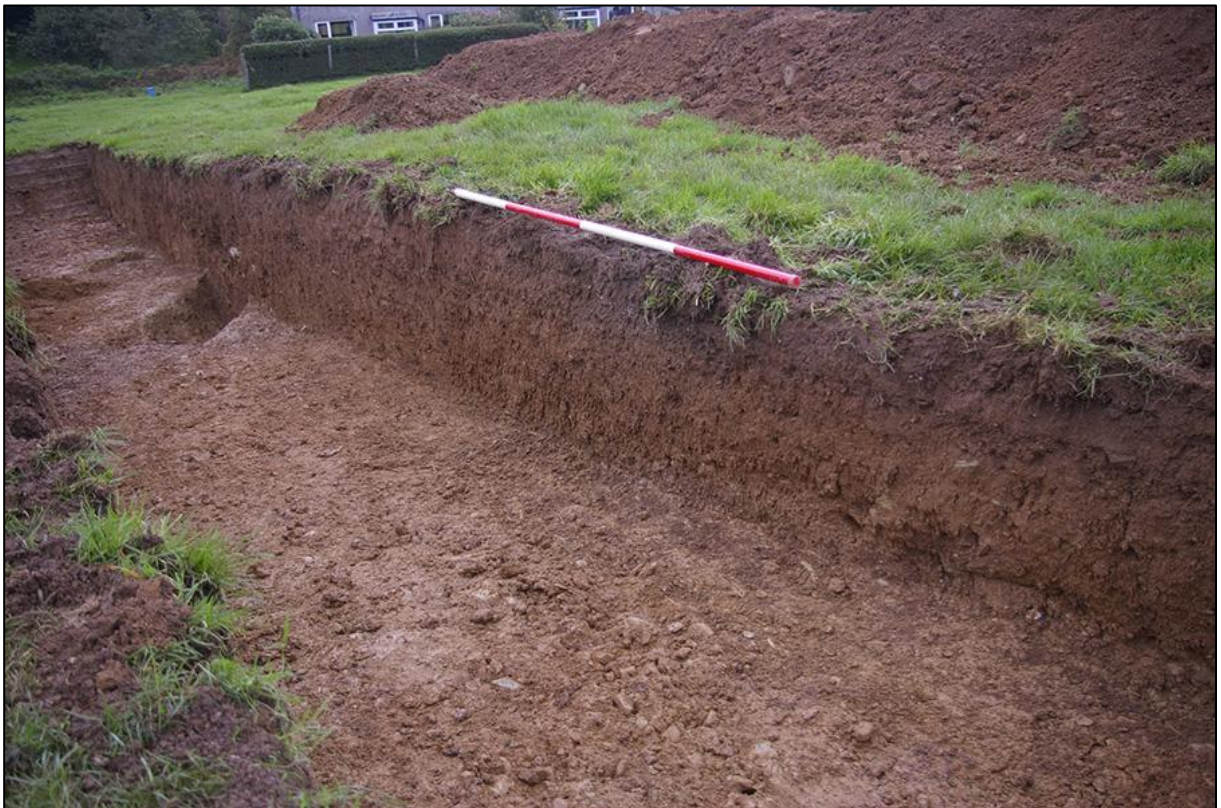
TRACKWAY IN TRENCH 6; VIEWED FROM THE NORTH-WEST (2M SCALE).

TRACKWAY IN TRENCH 6; VIEWED FROM THE WEST (2M SCALE).

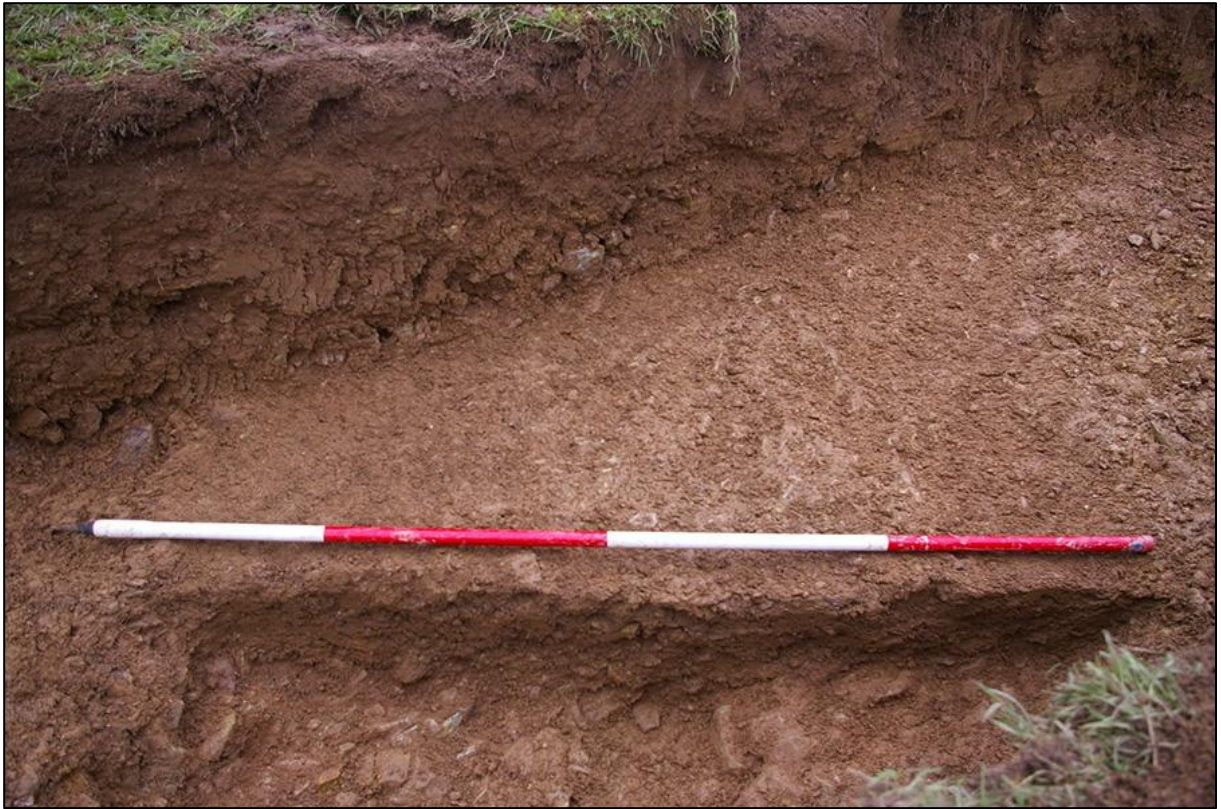
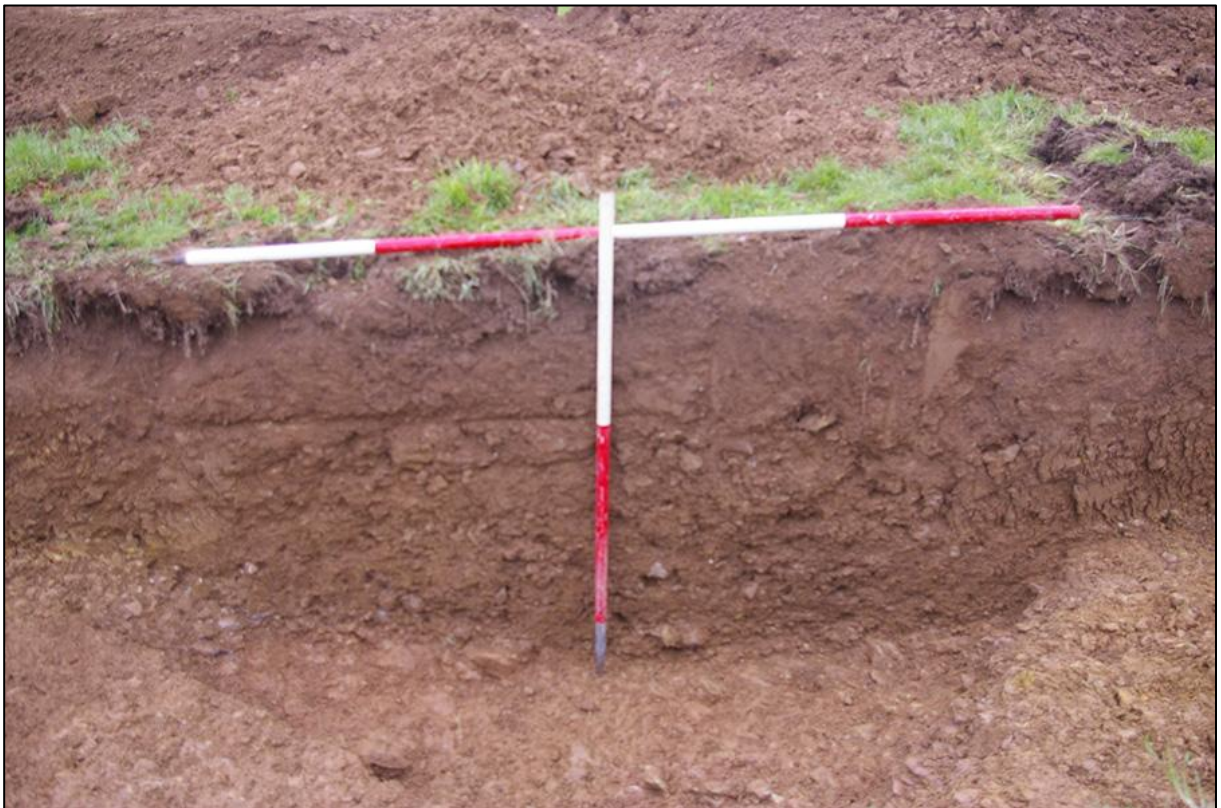
DITCH [608]; VIEWED FROM THE SOUTH (2M SCALE).

DITCH [608]; VIEWED FROM THE NORTH-WEST (1M & 2M SCALE).

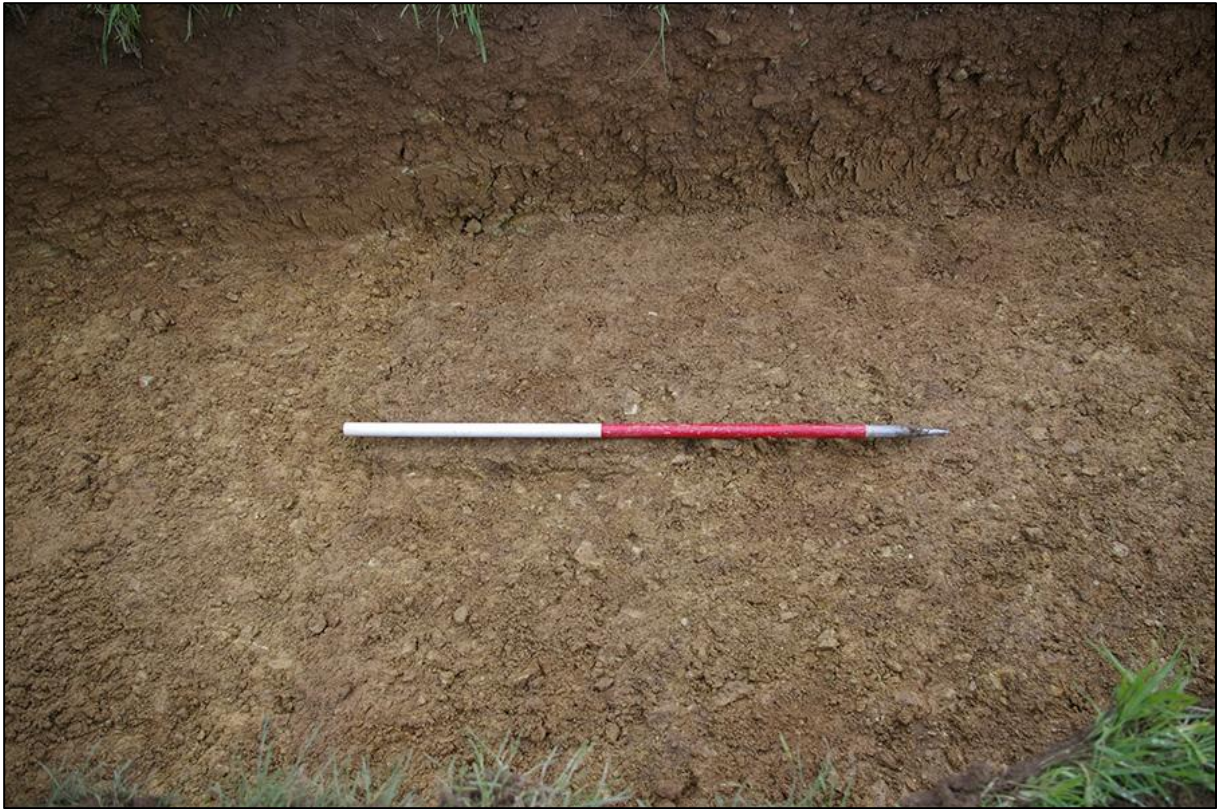
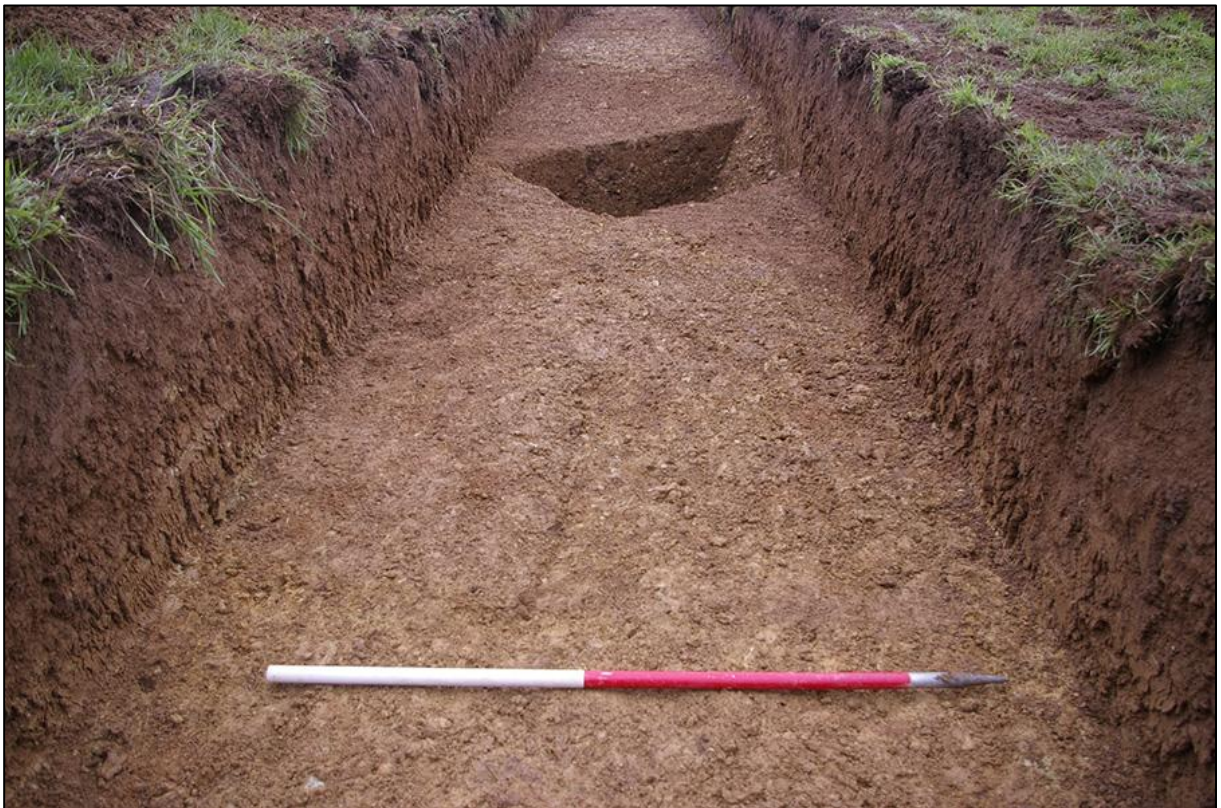
DITCH [704]; VIEWED FROM THE NORTH-EAST (1M SCALE).

DITCHES [704] AND [706]; VIEWED FROM THE SOUTH-EAST (1M SCALE).

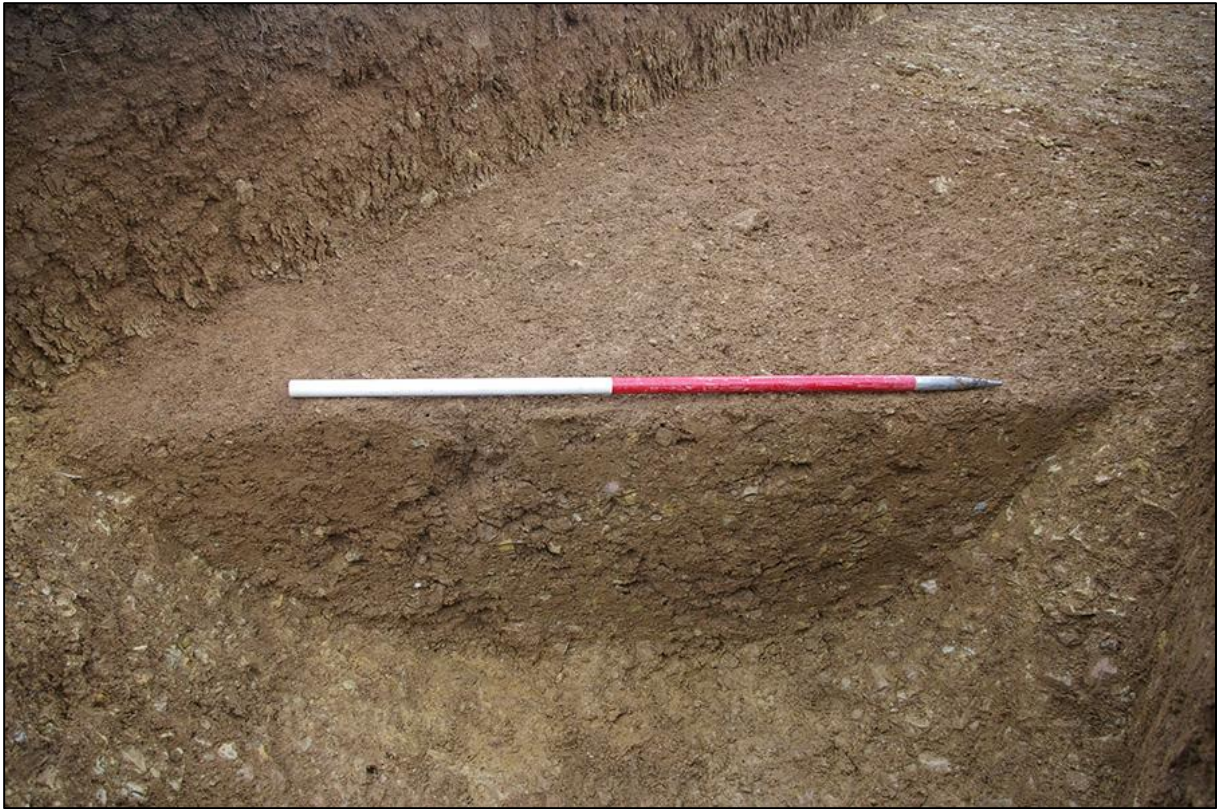
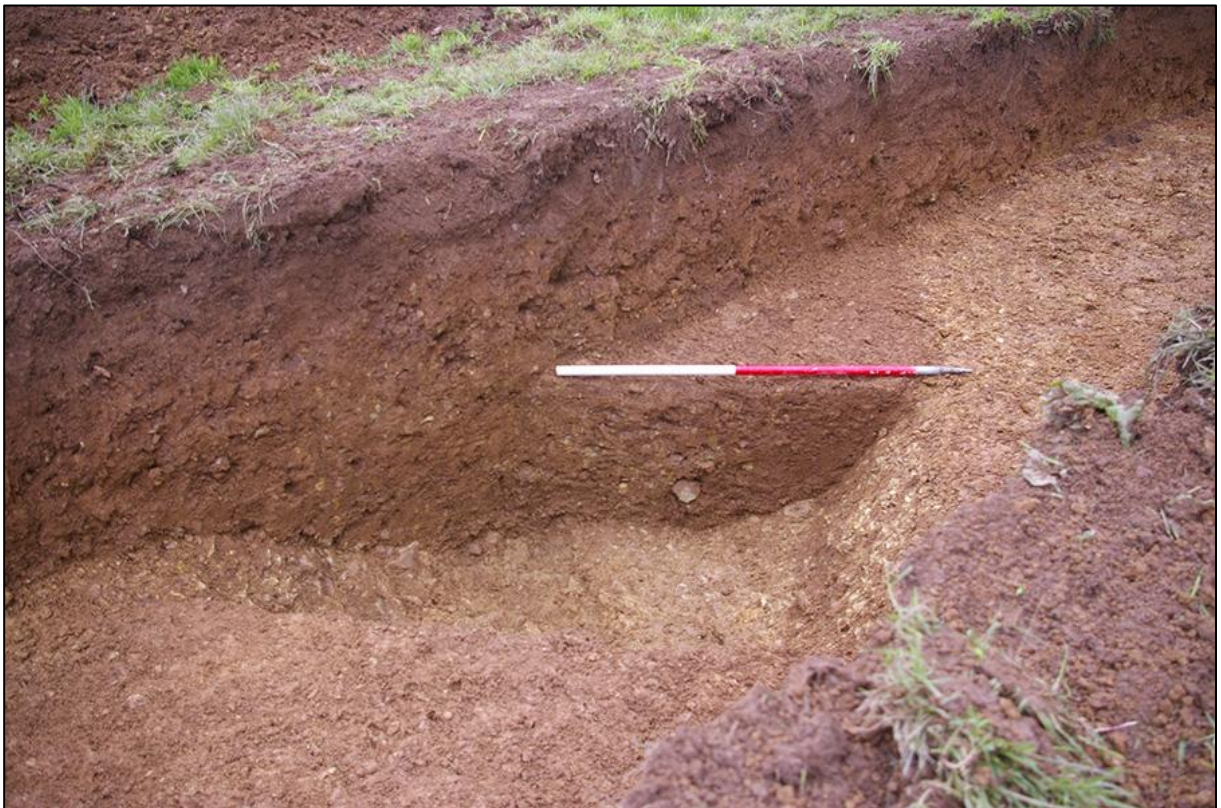
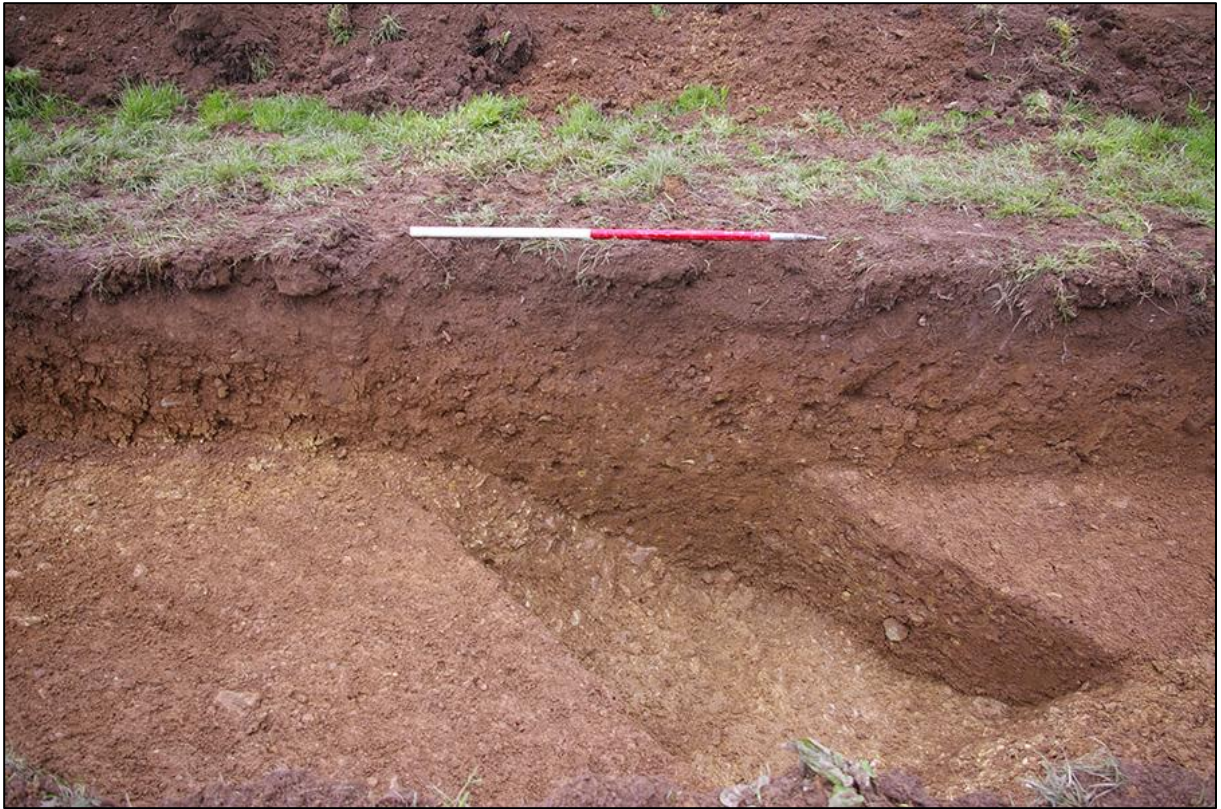
DITCH [706]; VIEWED FROM THE EAST (1M SCALE).

DITCH [706]; VIEWED FROM THE WEST (1M SCALE).

DITCH [706] AND SAMPLE SECTION; VIEWED FROM THE SOUTH-WEST (1M SCALE).

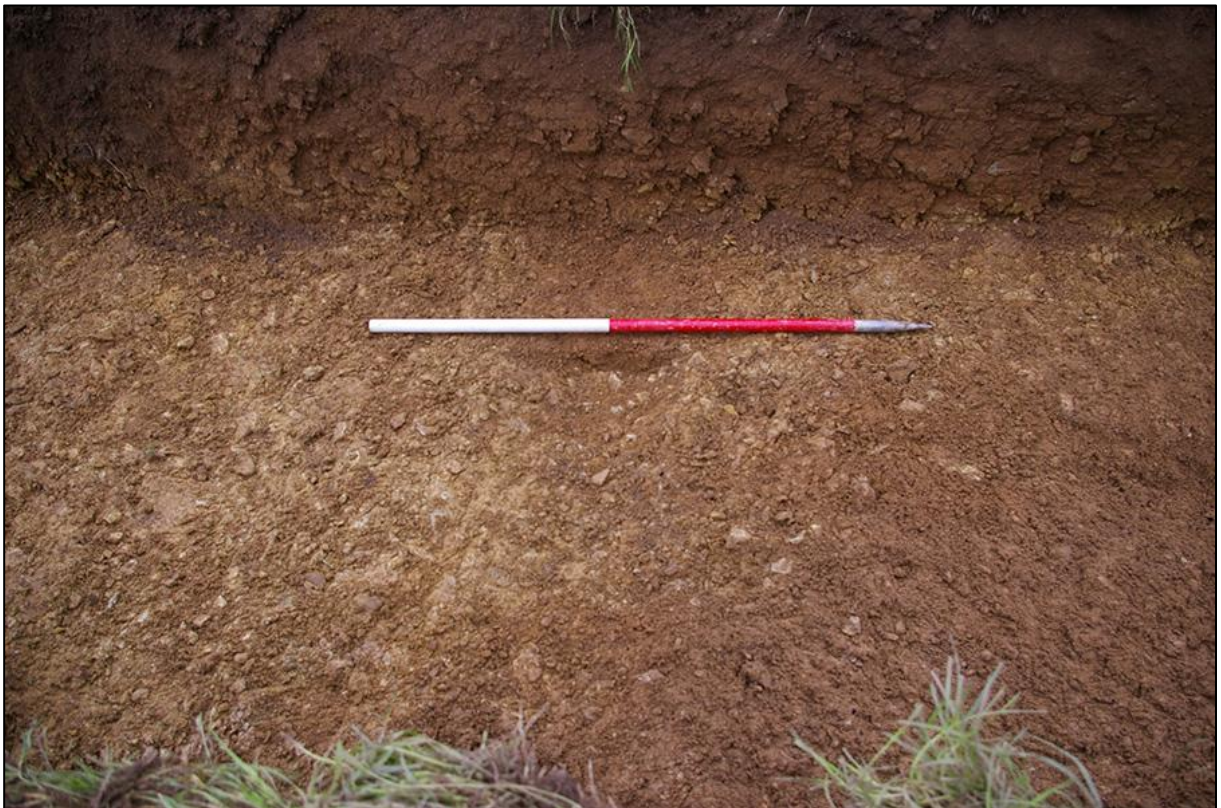
NATURAL GULLY [710]; VIEWED FROM THE SOUTH-WEST (1M SCALE).

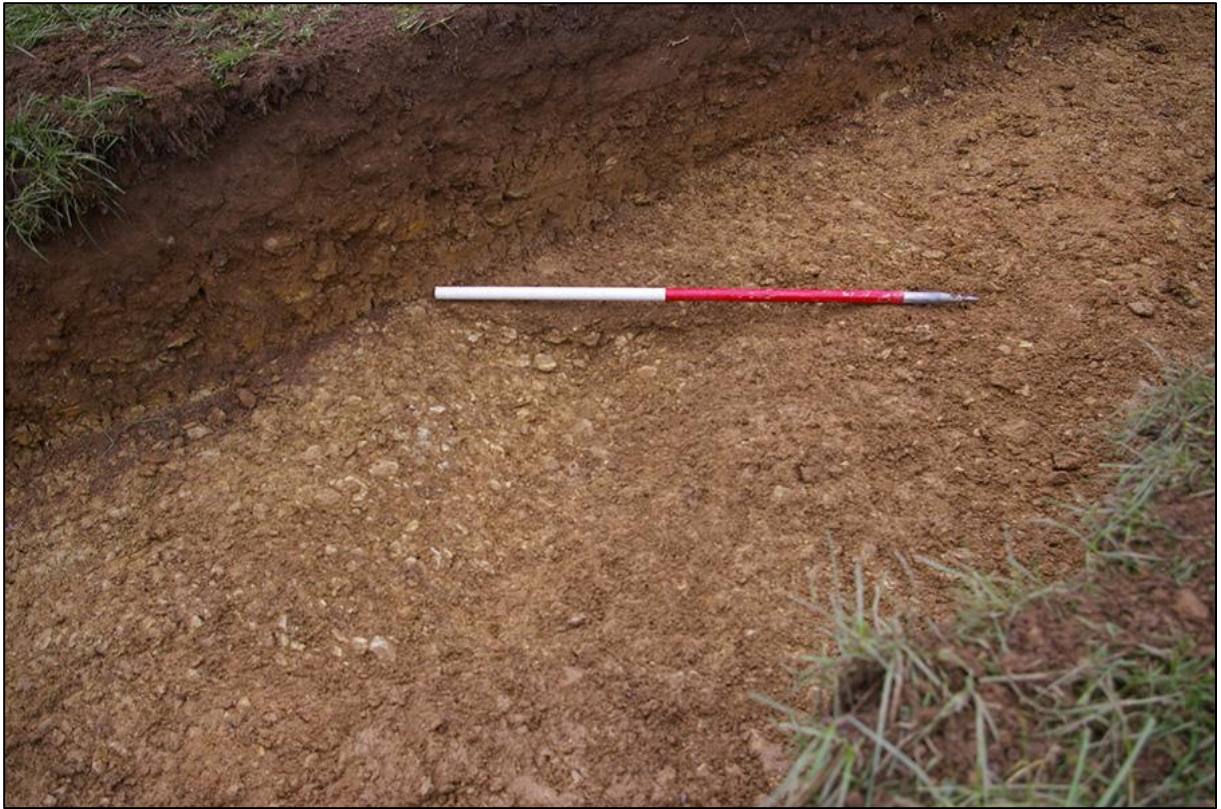
DITCH [712]; VIEWED FROM THE WEST (1M SCALE).

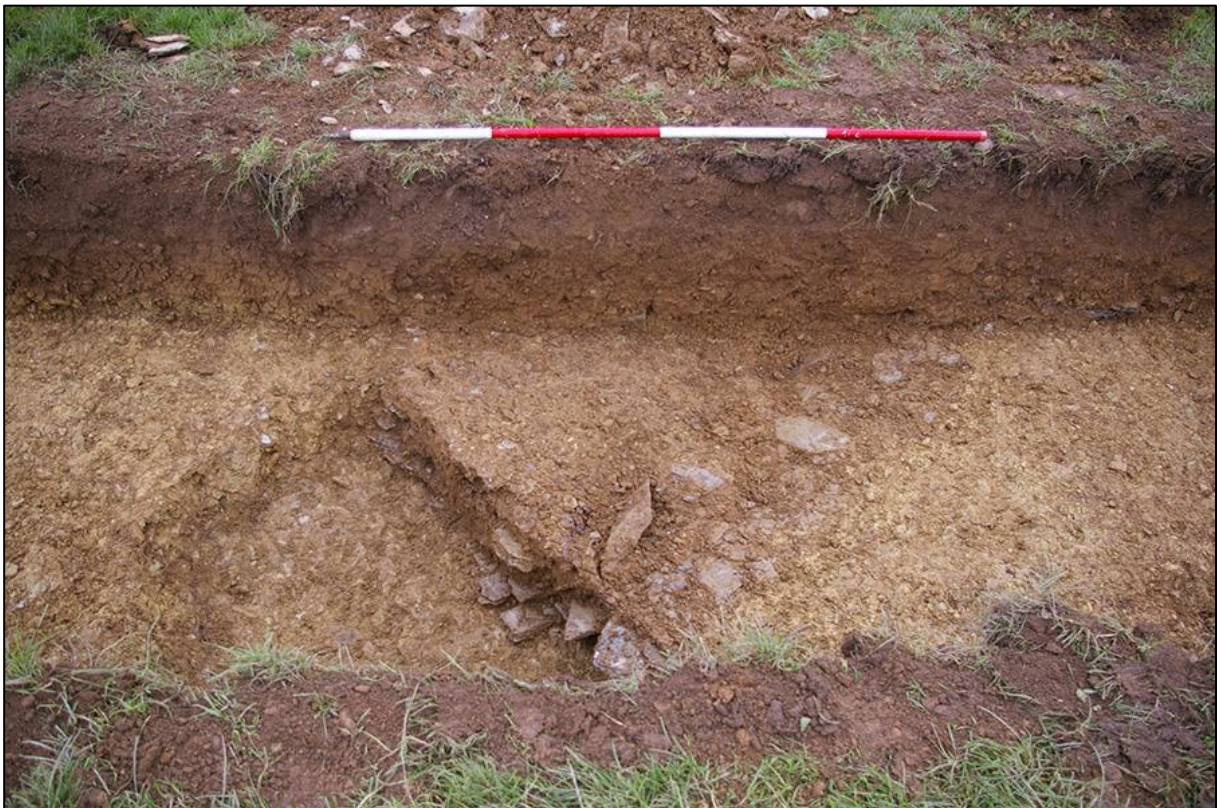
PIT [714]/WALL {717}; VIEWED FROM THE SOUTH-WEST (2M SCALE).

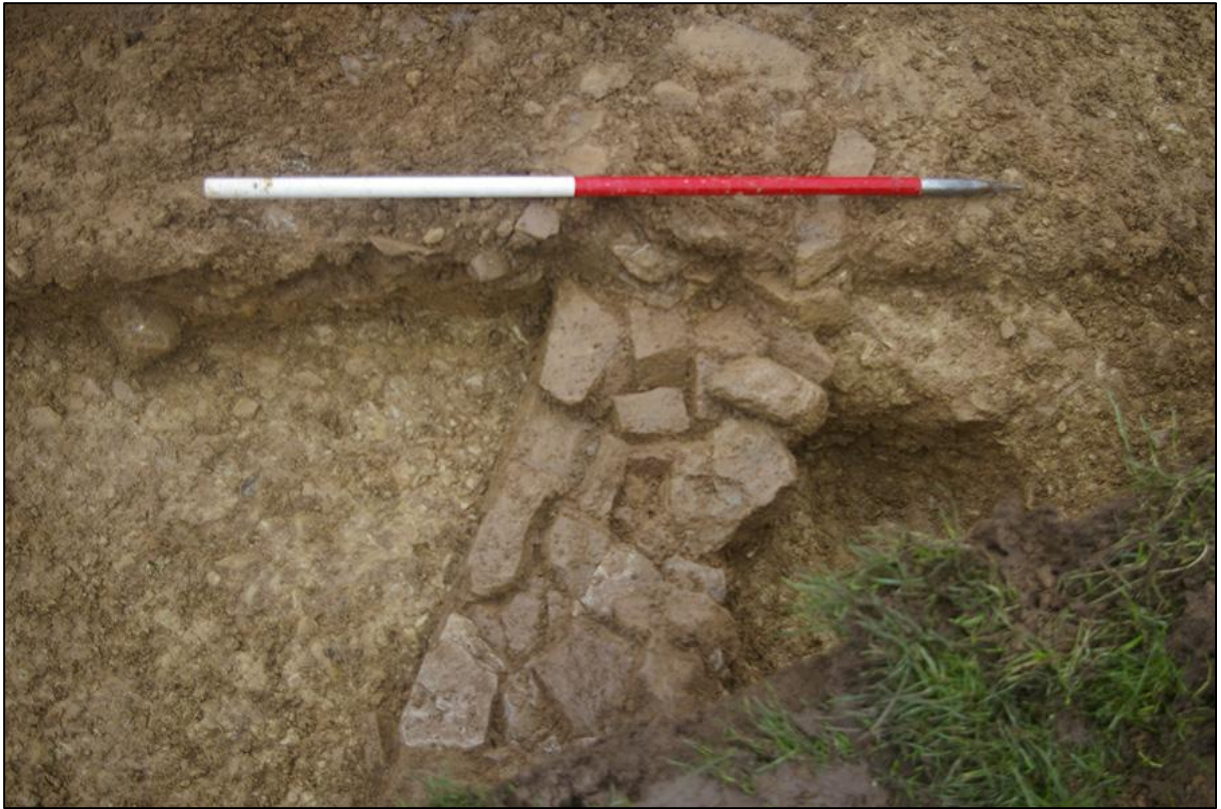
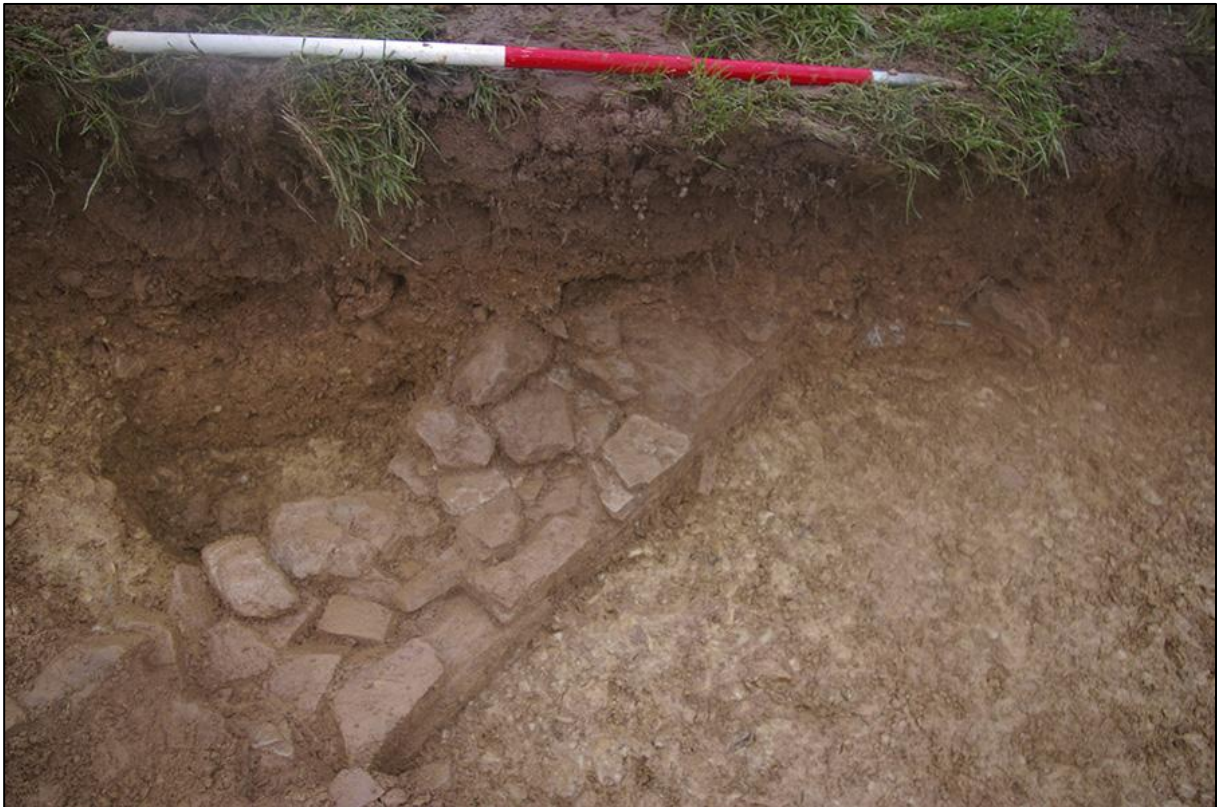
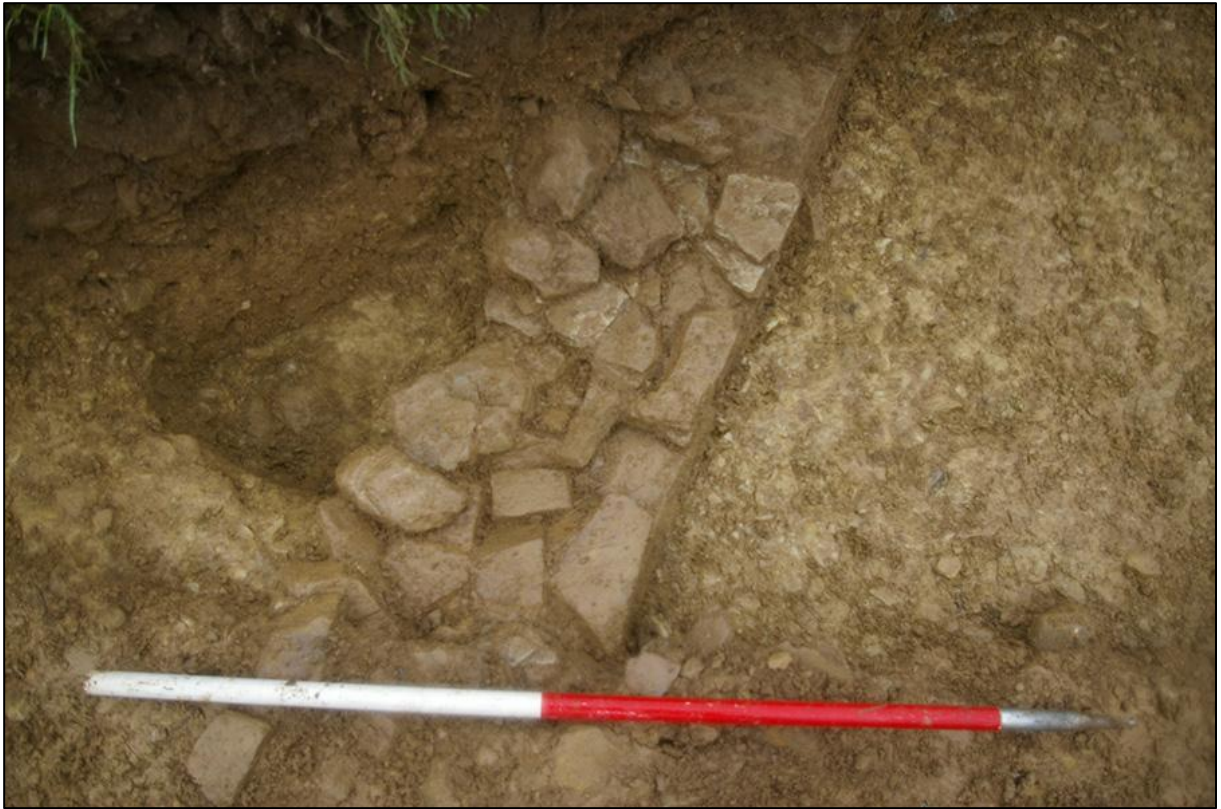
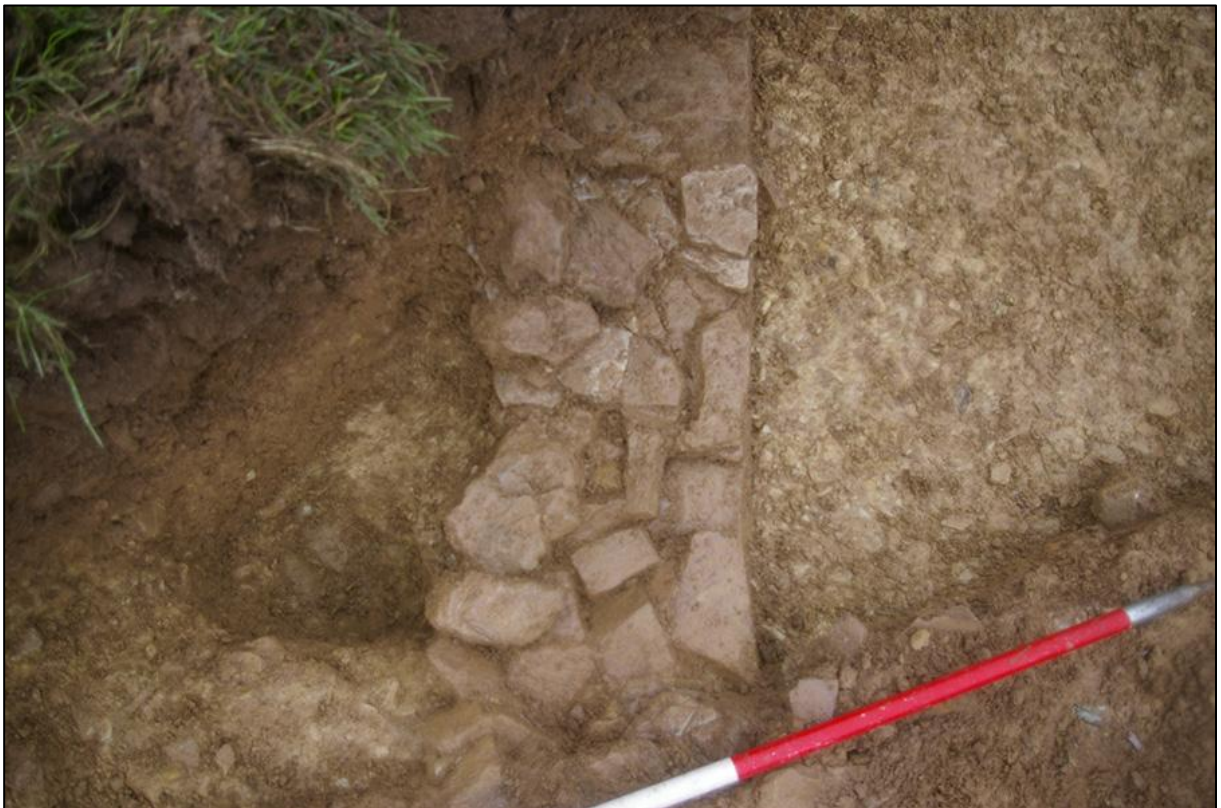
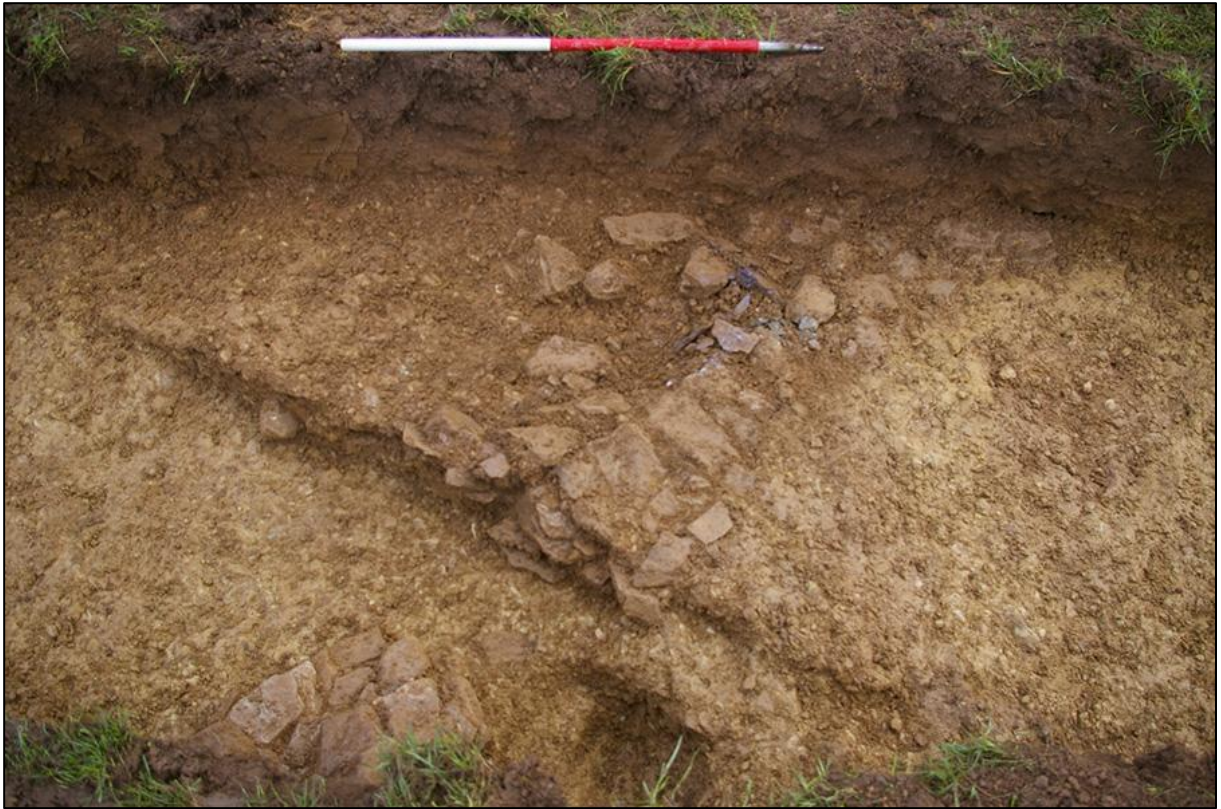
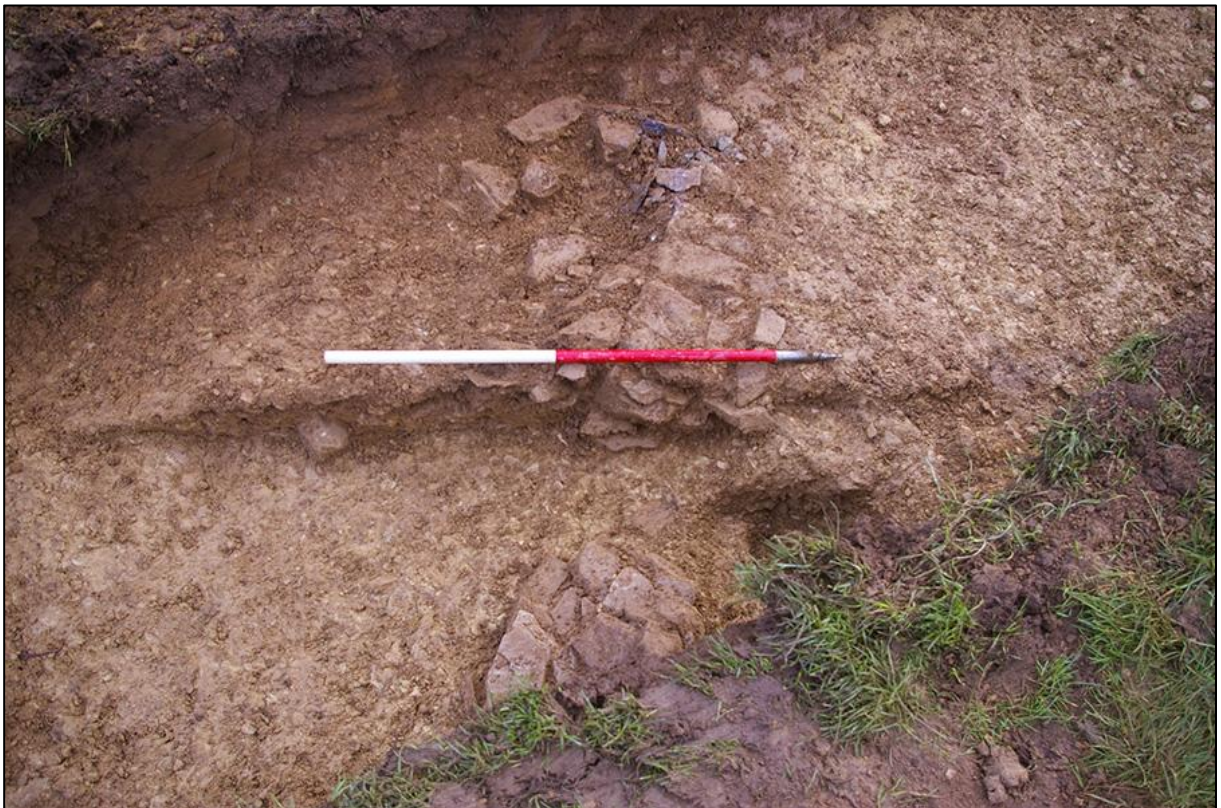
WALL {719}; VIEWED FROM THE WEST (1M SCALE).

WALL {719}; VIEWED FROM THE NORTH-EAST (1M SCALE).

WALL {719} AND PIT/POSTHOLE [721]; VIEWED FROM THE ENE (1M SCALE).

WALL {719} AND PIT/POSTHOLE [721]; VIEWED FROM THE EAST (1M SCALE, PARTIAL).

WALL {719}}; VIEWED FROM THE SOUTH-WEST (1M SCALE, PARTIAL).

WALL {719}}; VIEWED FROM THE WEST (1M SCALE, PARTIAL).
