# THE GUILDHALL BUTCHERS ROW BARNSTAPLE DEVON

Historic Building Recording

South West Archaeology Ltd. report no. 170830

By E. Wapshott & N. Boyd  
Report Version: FINAL  
7<sup>th</sup> September 2017

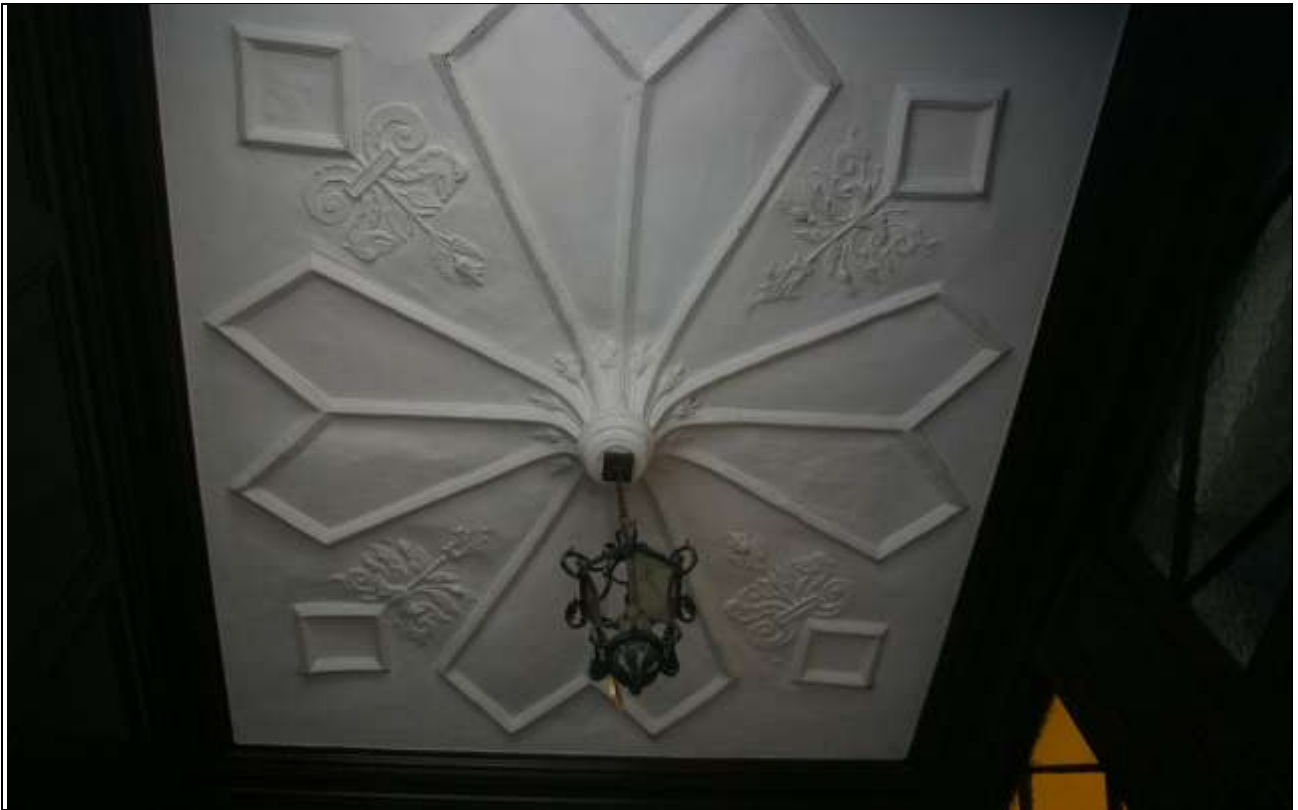
ROOM 15; FRAGMENT OF 17<sup>TH</sup> CENTURY PENDANT PLASTER ROOF, RESET AND REWORKED INTO A COPY CEILING; FROM THE SOUTH (BELOW).

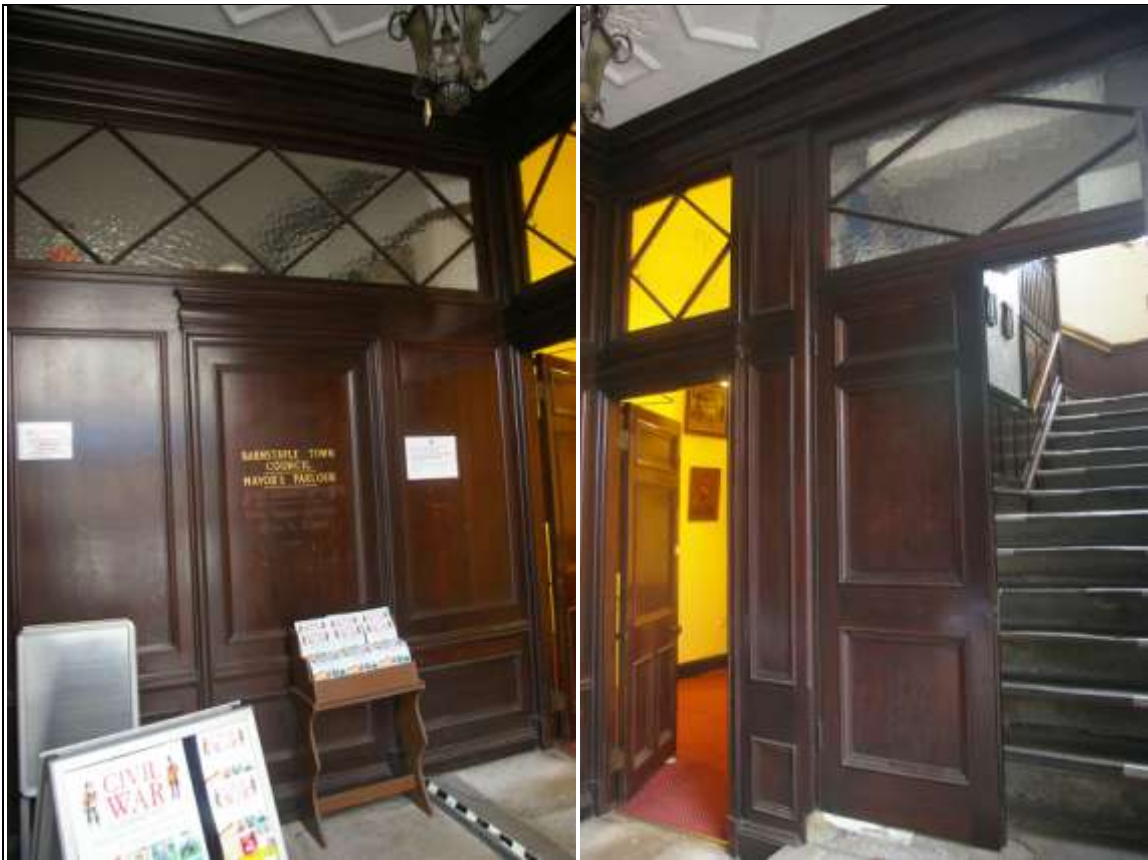
LEFT: ROOM 15; THE BLIND WINDOW STYLE NOTICEBOARD ANNOUNCING THE MAYOR'S PARLOUR; FROM THE SOUTH, SOUTH-WEST.

RIGHT: THE FINE PANELLED DOORS AND FANLIGHTS ABOVE THE OPENING TO THE WAITING ROOM; FROM THE SOUTH-WEST.

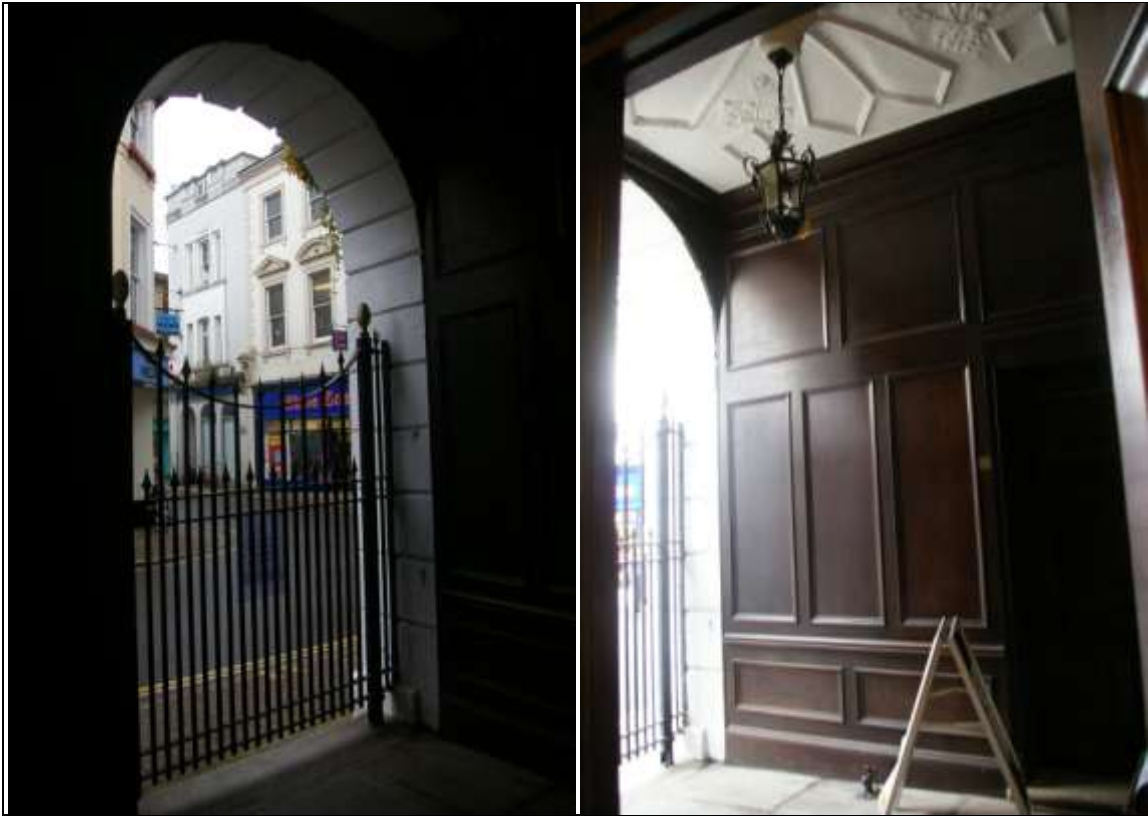
LEFT: ROOM 15; THE ROUND ARCHED BUTCHER'S ROW ENTRANCE IN THE SOUTH ELEVATION; FROM THE NORTH-EAST. RIGHT: 1920S PANELLING INSTALLED IN THE VESTIBULE, WITH A FRAGMENT OF A PENDANT 17<sup>TH</sup> CENTURY PLASTER CEILING FITTED ABOVE.

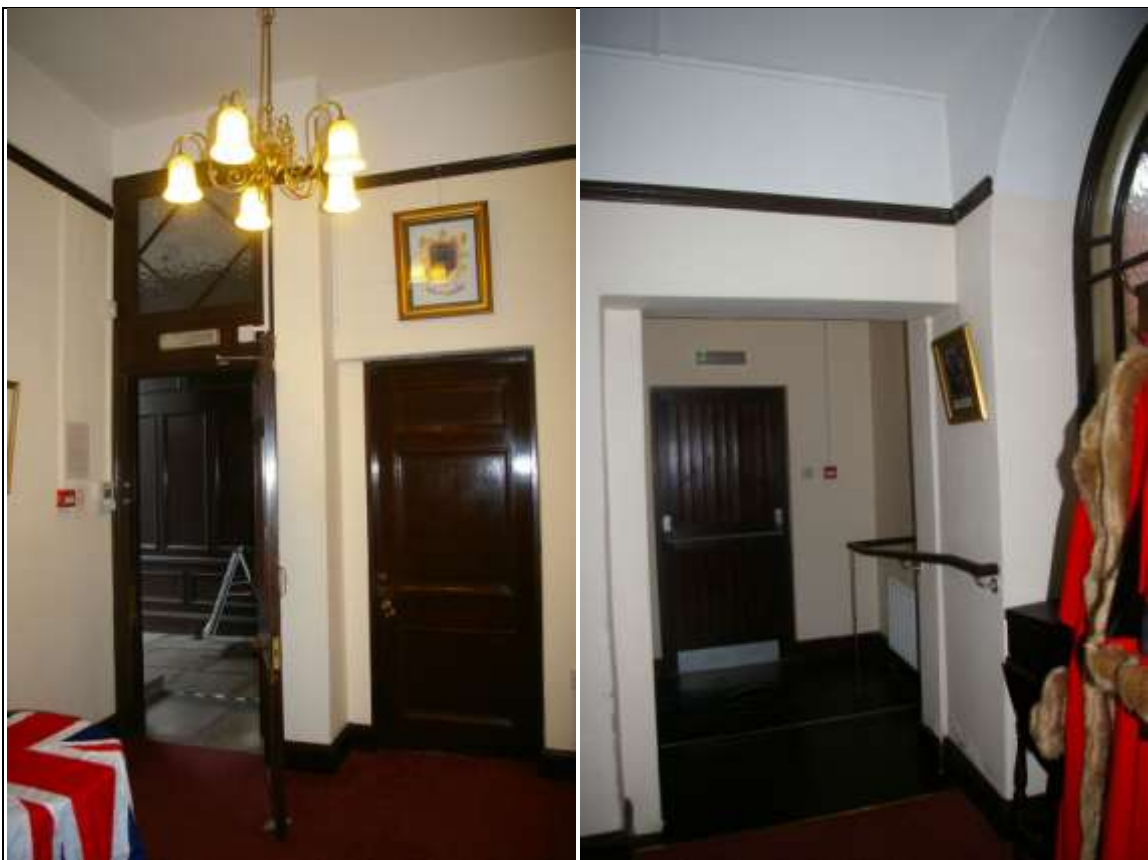
LEFT: THE 17<sup>TH</sup> CENTURY STYLE DOORWAY WITH GLAZED FANLIGHT TO THE OPEN VESTIBULE (ROOM 15) AND PANELLED DOOR TO MAYOR'S PARLOUR (ROOM 16); FROM THE EAST-NORTH-EAST. RIGHT: ROOM 18, LOOKING THROUGH THE FORCED WALL OPENING TO FIRE ESCAPE AND DISABLED TOILETS; FROM THE SOUTH-SOUTH-WEST.

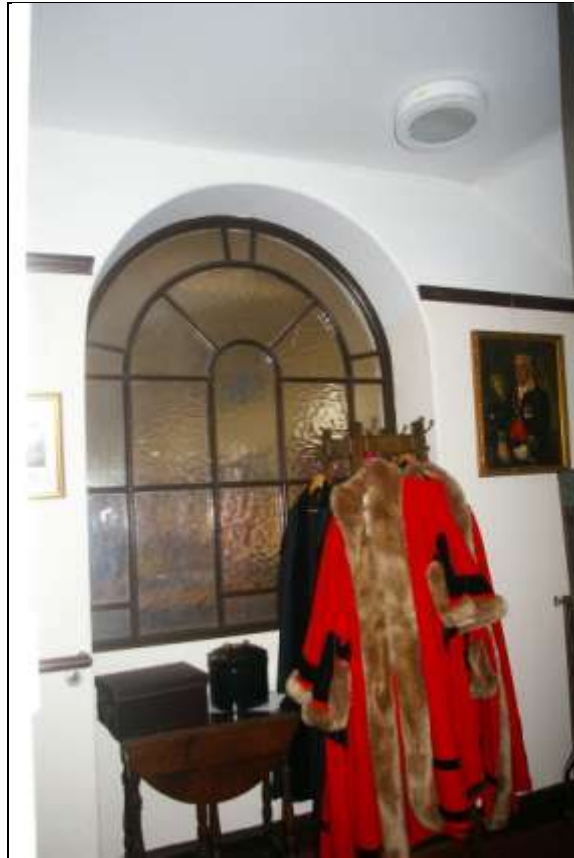
ROOM 18, WITH INSERTED LIFT AND 1920S FORCED GLAZED WINDOW, THIS AND ROOM 19 MAY HAVE BEEN THE CELLS, OR STORAGE FOR MERCHANTS, WITH VERY HIGH WINDOWS IN THE NORTH-EAST CORNER; FROM THE WEST-NORTH-WEST.

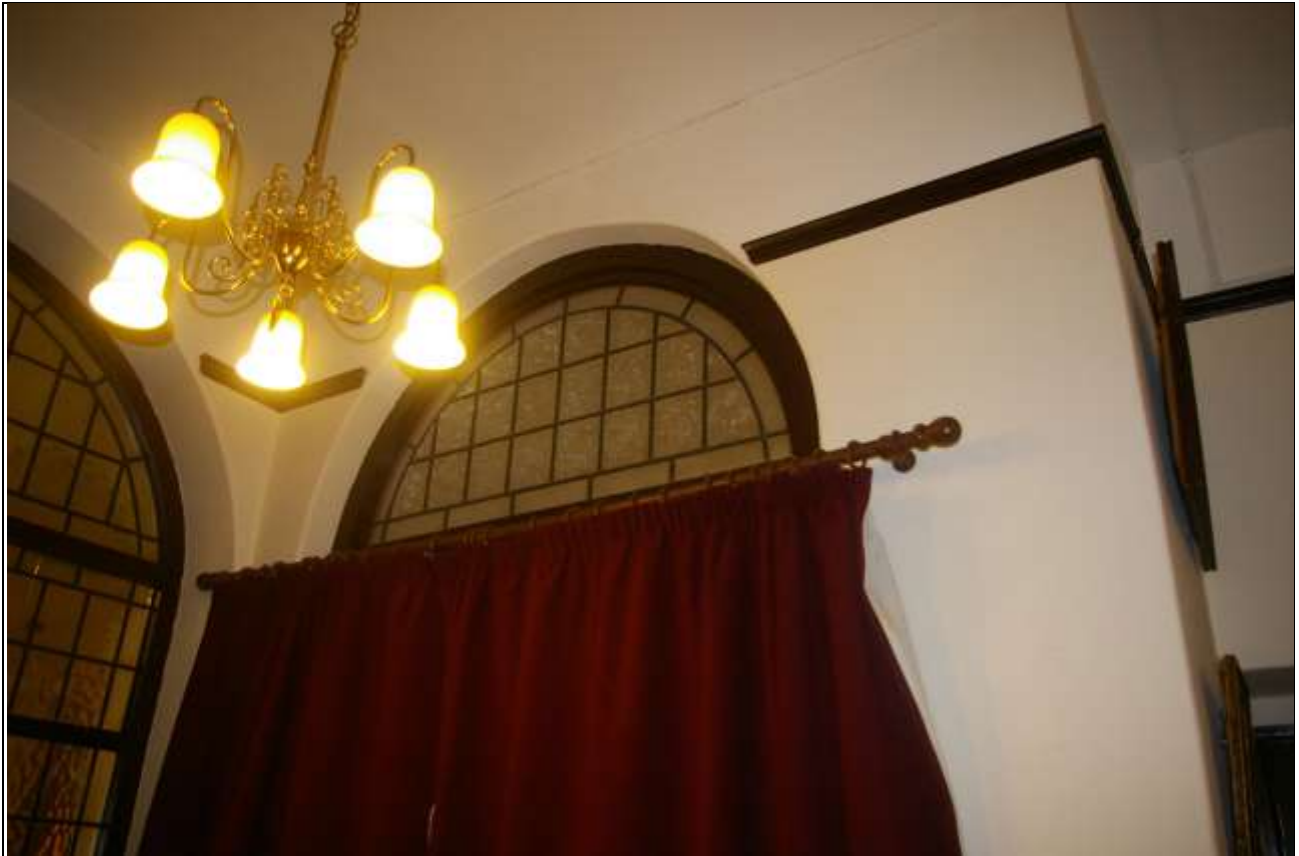
THE FANLIGHT ABOVE THE BLOCKED DOORWAY OFF THE WAITING ROOM (ROOM 17). THIS WOULD HAVE LED TO ROOM 19, FORMERLY TWO DISTINCT ROOMS WITH ROOM 18, POSSIBLY THE CELLS; FROM THE SOUTH-WEST.

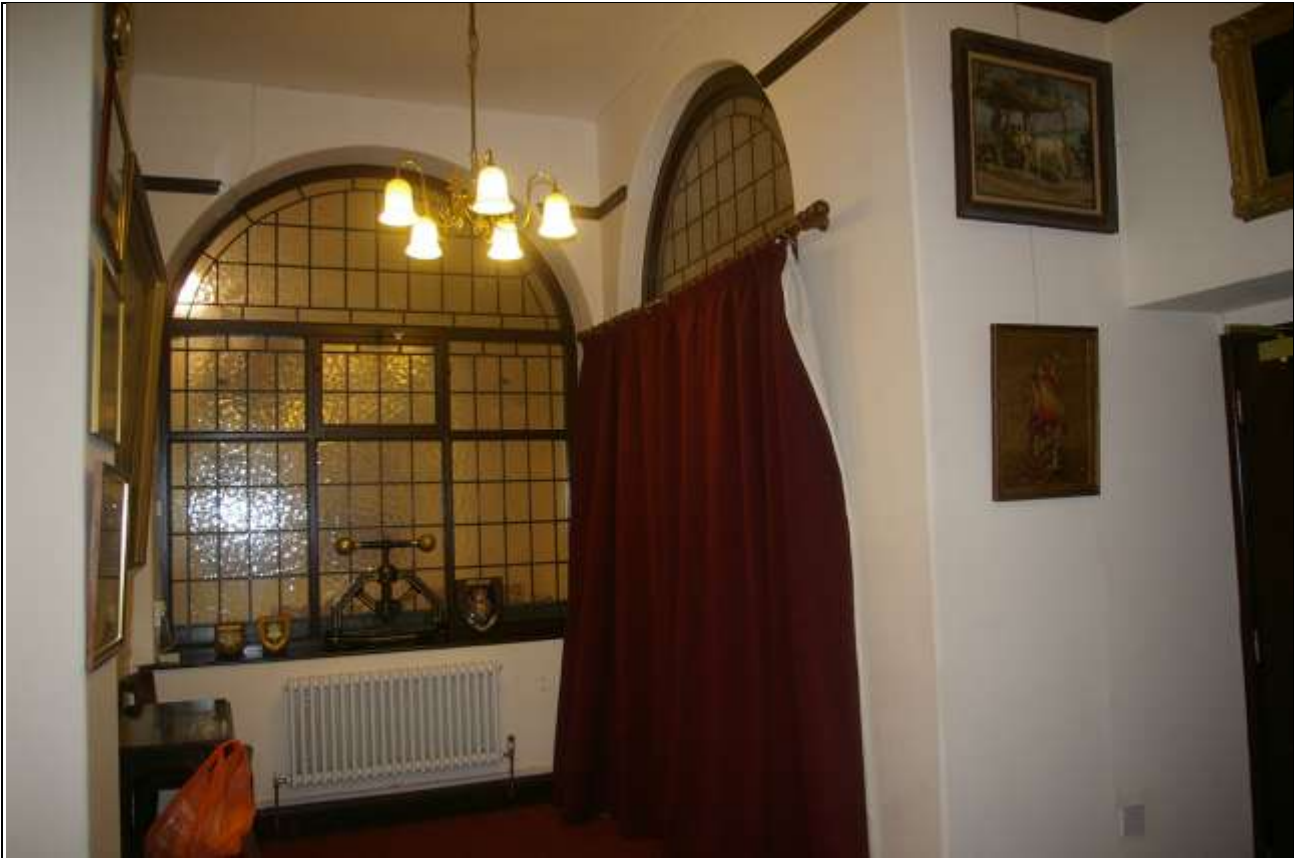
THE LOBBY/WAITING ROOM (ROOM 17) TO THE MAYOR'S PARLOUR, WITH LEADED GLAZED SCREEN IN THE BLOCKED ARCHED OPENING TO THE REST OF THE GROUND FLOOR AND SMALLER GLAZED LEADED FANLIGHT ABOVE A BLOCKED DOORWAY LEADING EAST; FROM THE SOUTH.

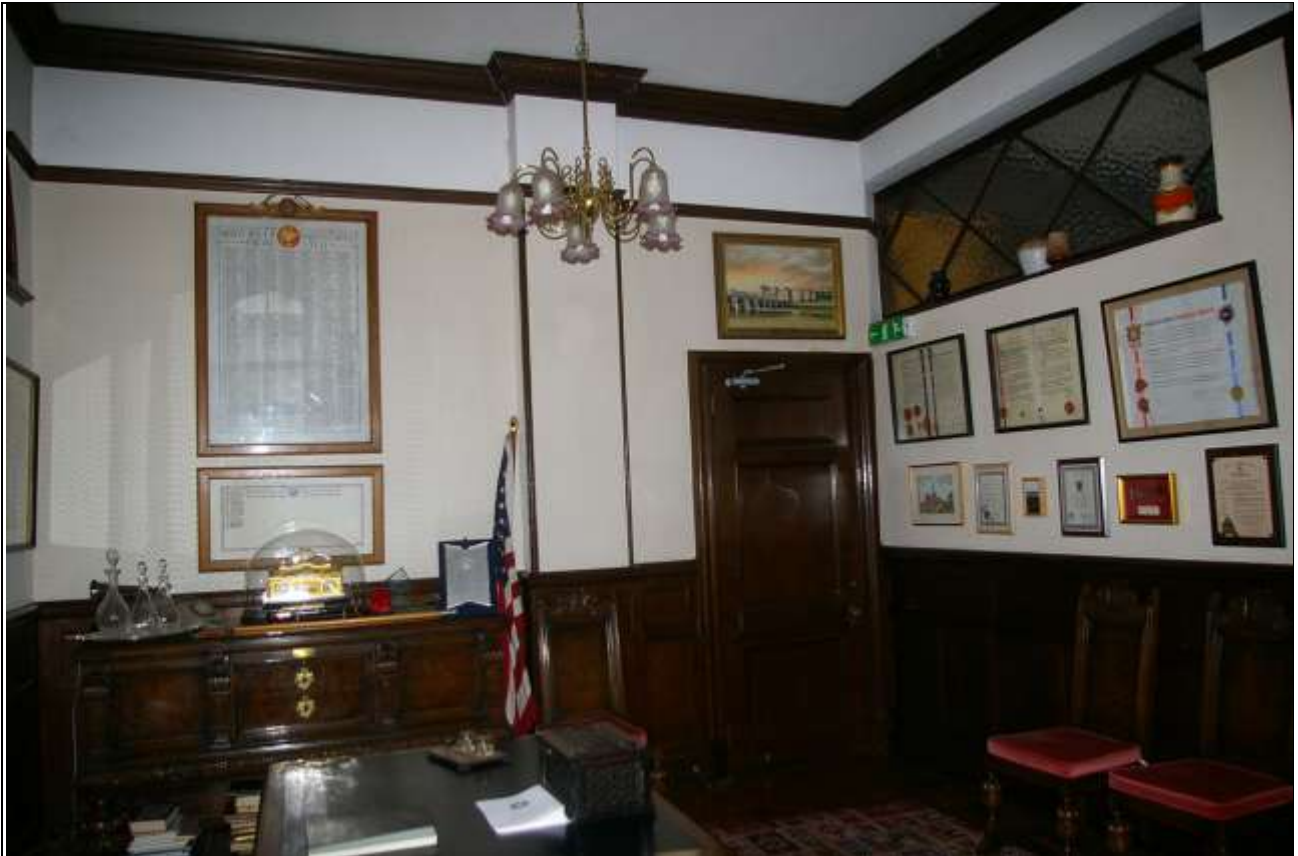
ROOM 16; THE GRAND MAYOR'S PARLOUR ON THE GROUND FLOOR, FORMED IN THE EARLY 20<sup>TH</sup> CENTURY, THE STYLE IS OF 17<sup>TH</sup> CENTURY INFLUENCE; FROM THE NORTH-WEST.

Room 16 is the Mayor's Parlour. This is an early 20<sup>th</sup> century parlour/office with elements of a mixture of historic styles, appearing cohesive due to the consistent use of oak. The room includes a 17<sup>th</sup> century style bolection mould fireplace surround with a mid 20<sup>th</sup> century projecting brick hearth, 19<sup>th</sup> century style ¼ height dado panelling echoing the panelling in the chamber above, 17<sup>th</sup> century style doors and doorframes, late Georgian/Regency arched sash windows and early 20<sup>th</sup> century block parquet flooring. The stained glass in the arches in the north wall may be 19<sup>th</sup> century, but their Arts & Crafts characters suggest they are more likely early 20<sup>th</sup> century. There is little flexibility for change in this room.

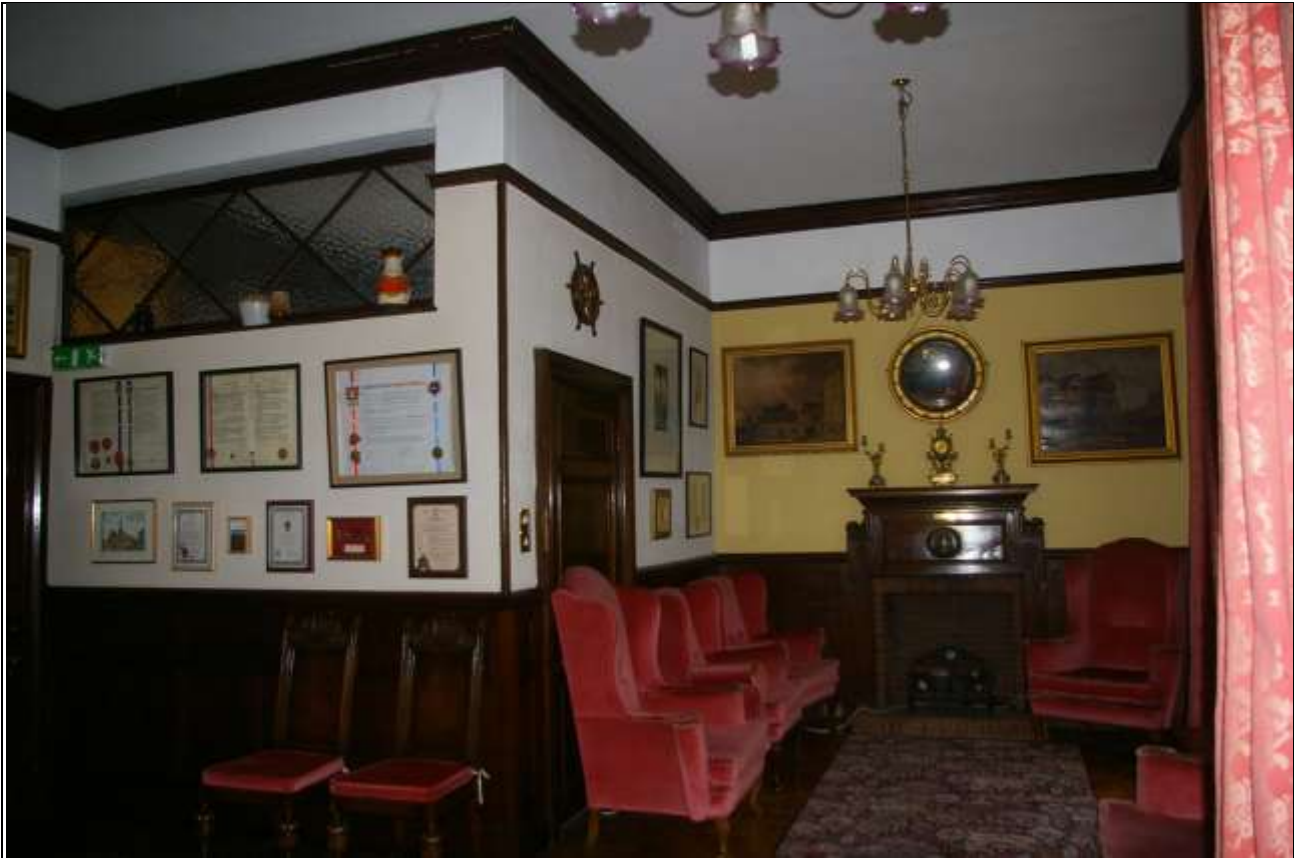
ROOM 16; THE GRAND MAYOR'S PARLOUR ON THE GROUND FLOOR, FORMED FROM THE FORMER CONSTABLE'S CHARGE ROOM AND CELL IN THE EARLY 20<sup>TH</sup> CENTURY, WITH FINE 1920S PANELLING; FROM THE NORTH-WEST.

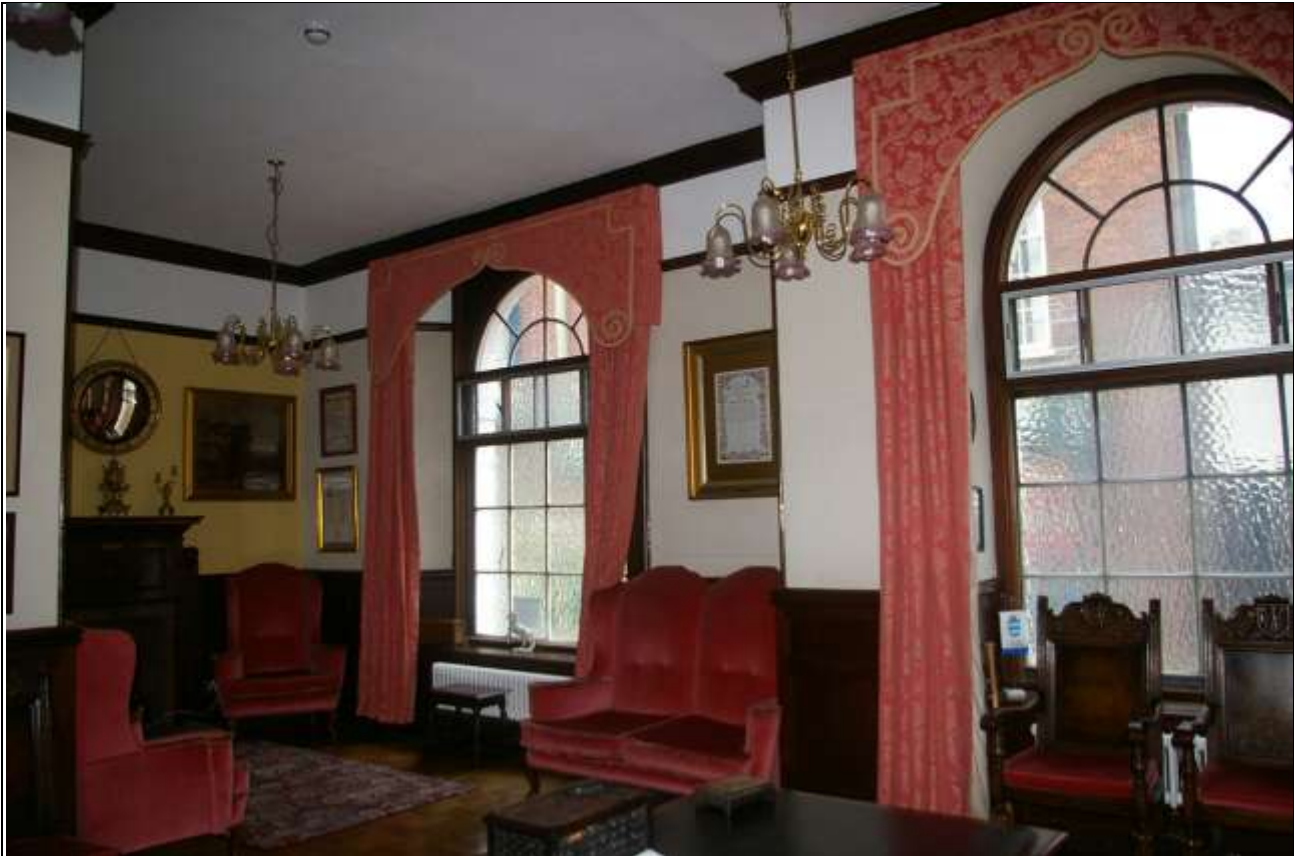
AS ABOVE; FROM THE NORTH-EAST.

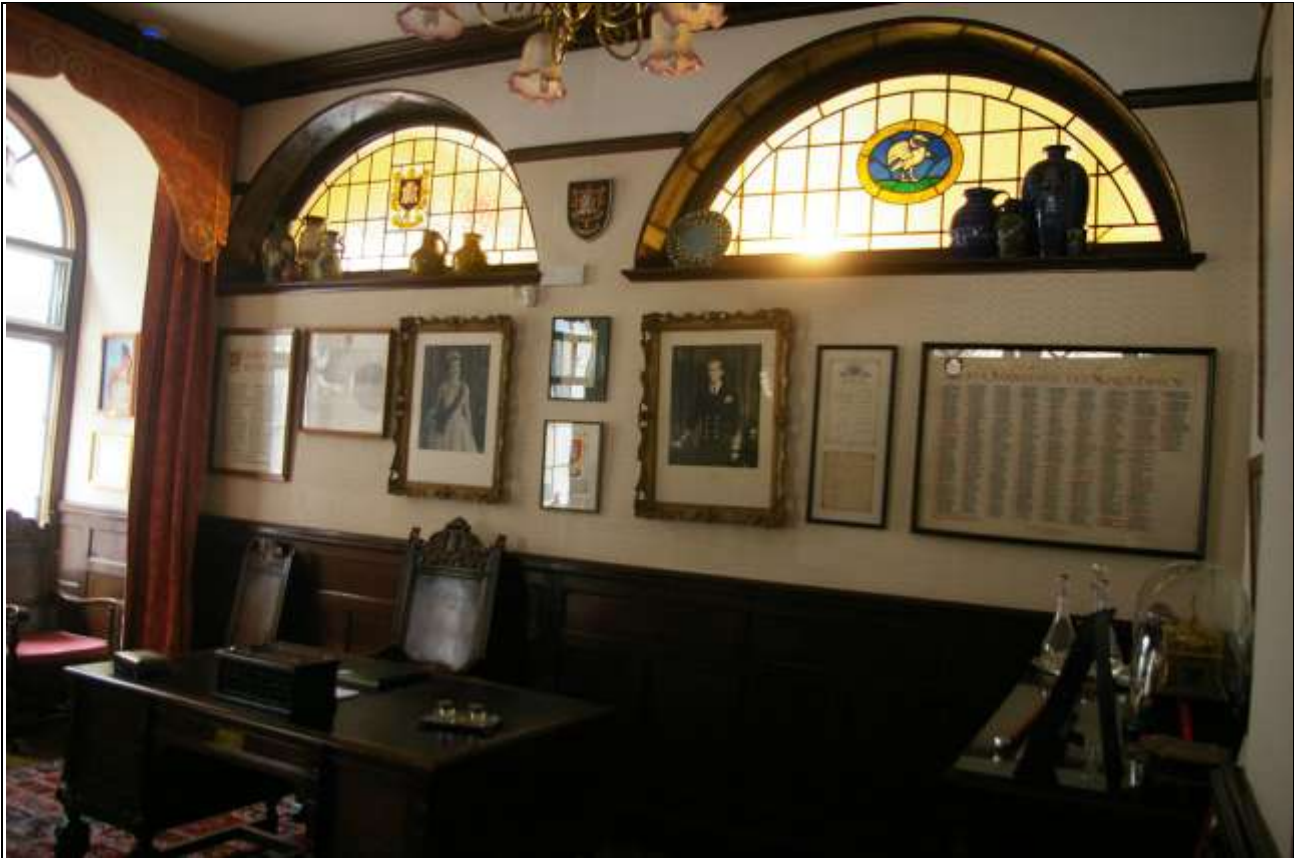
THE NORTH WALL OF THE MAYOR'S PARLOUR (ROOM 16), WITH LEADED STAINED GLASS FANLIGHTS, COMMEMORATING THE TOWN WITH THE CASTLE AND BARUM SWAN IMAGERY; FROM THE SOUTH-EAST.

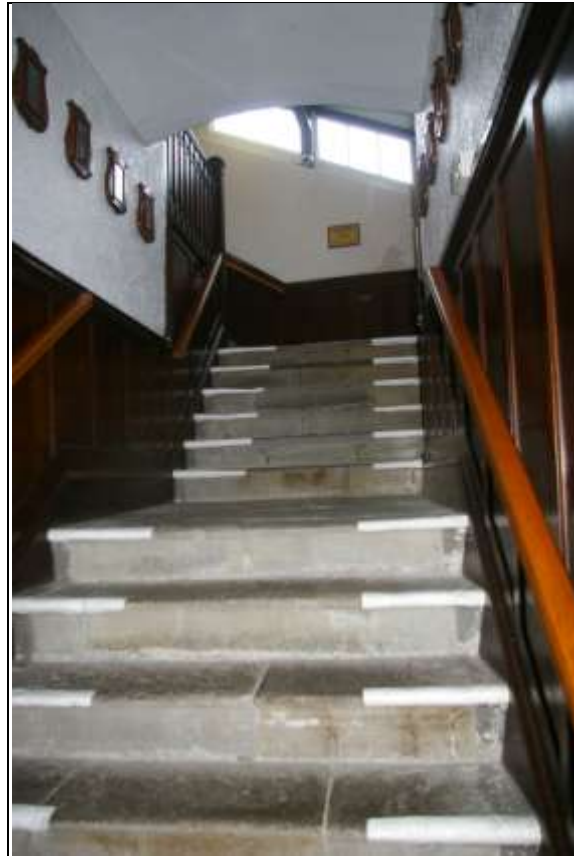
THE GRAND STONE STAIR WHICH RISES FROM THE BUTCHER'S ROW ENTRANCE OF THE BUILDING, BUT MAY HAVE BEEN RESET, WITH 1920S PANELLING TO SIDES; FROM THE WEST.

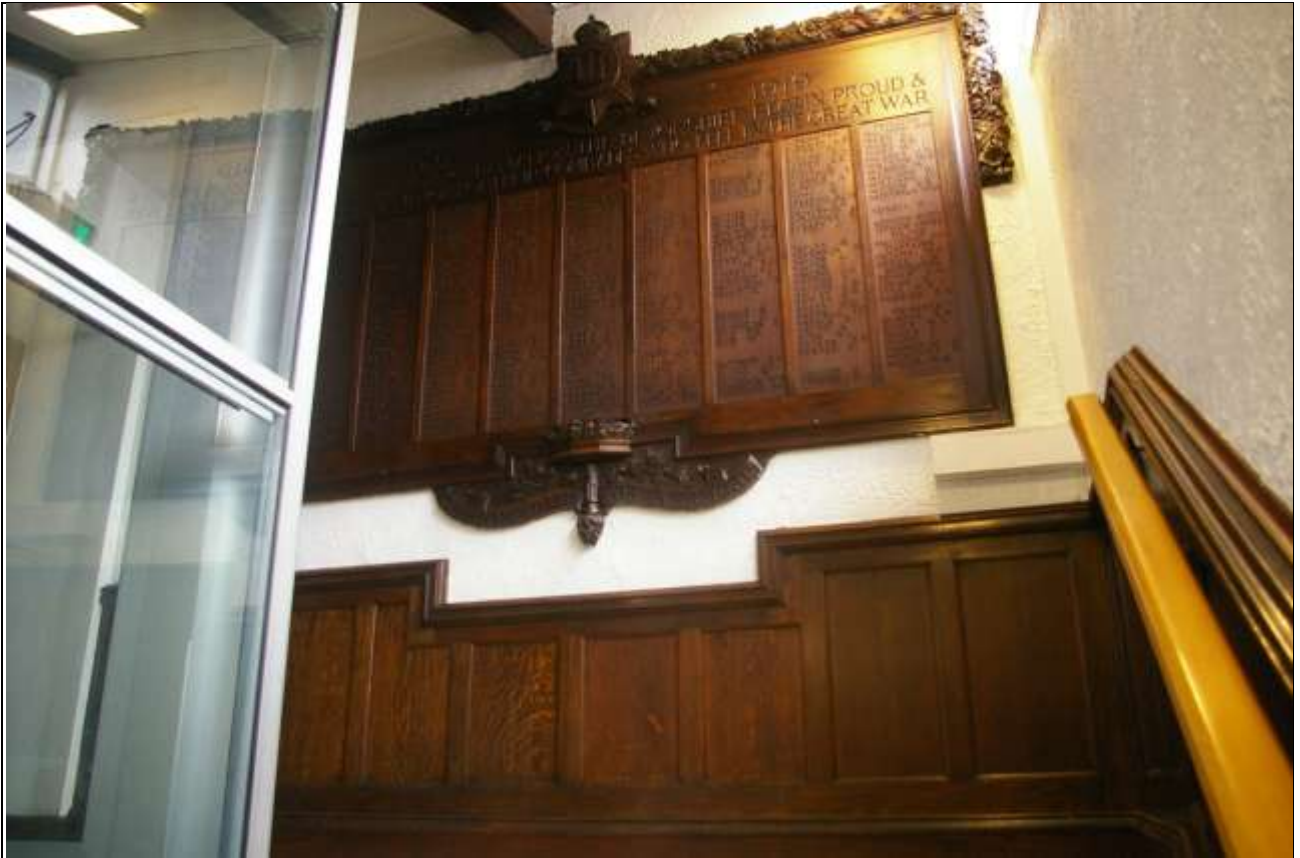
ONE OF THE FINE CARVED WAR MEMORIALS ON THE GRAND STAIR (ROOM 14); FROM THE SOUTH, SOUTH-EAST

along with the carved 20<sup>th</sup> century war memorials. This is the route which councillors and their guests enter the main chamber, and is therefore important for understanding the status divisions of the building. The 1920s bolection and 17<sup>th</sup> century style panelling is cohesive with rooms 15 and 16. A lift has been inserted into this stairwell and the short upper flight of stairs and first floor landing appear to have been remodelled. Sections of the panelling here have been replaced. There is capacity for change in this reworked area.

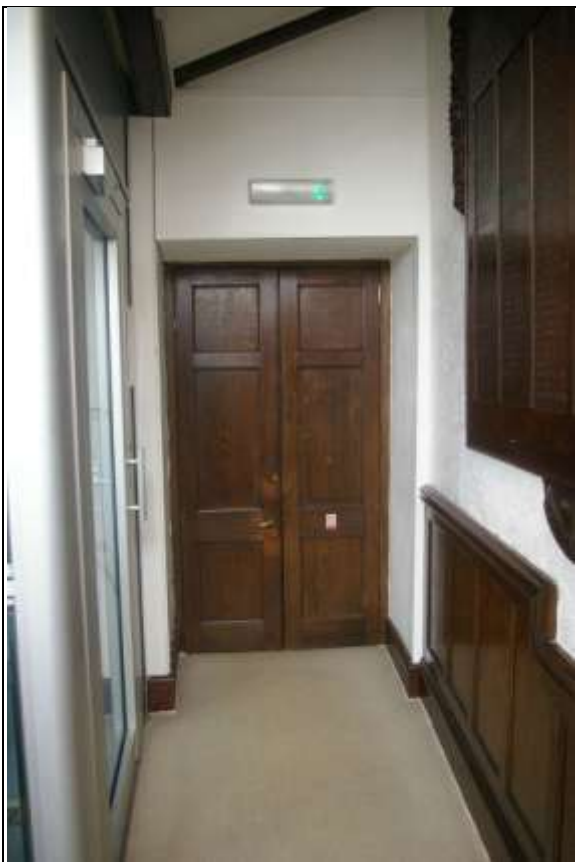
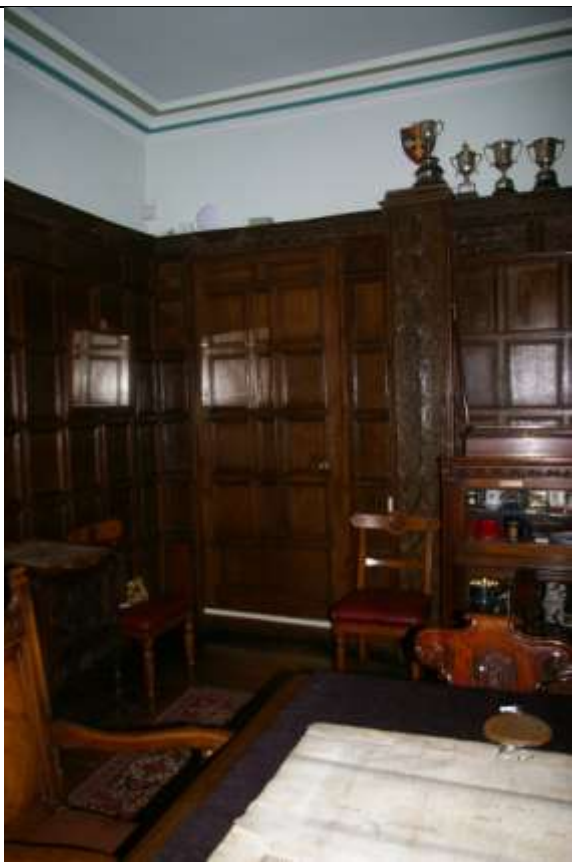
LEFT: THE MODERN DOORS ON THE FIRST FLOOR LANDING TO THE GRAND STAIR (ROOM 14), LEADING TO THE LOBBY ROOM 4; FROM THE EAST.  
RIGHT: ROOM 5; THE 17<sup>TH</sup> CENTURY RESET DOOR TO ROOM 5A, PART OF A DOUBLE DOOR SYSTEM TO SCREEN SOUND; FROM THE SOUTH-SOUTH-EAST.

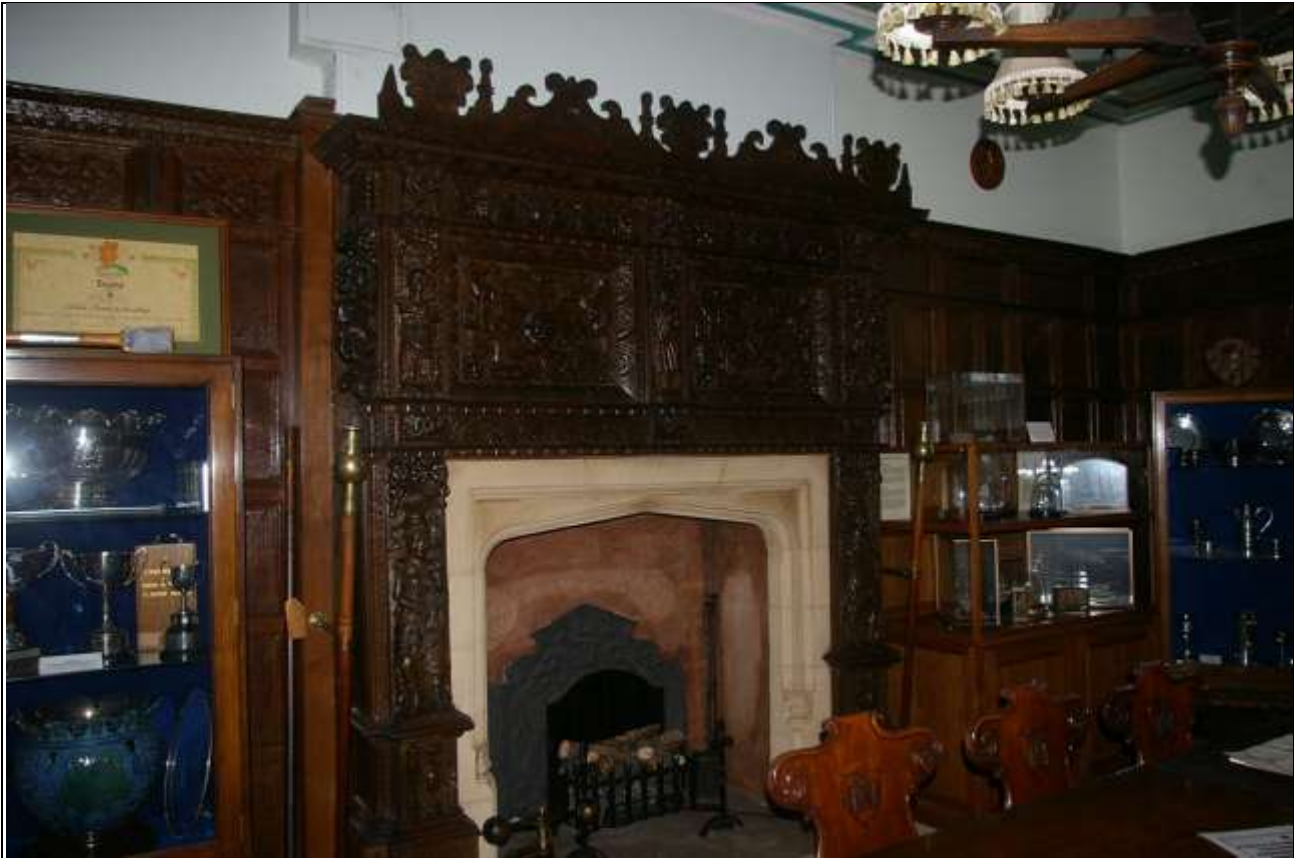
ROOM 5; THE ELABORATELY CARVED OVERMANTEL, FITTED TO A TYPICAL SHALLOW 19<sup>TH</sup> CENTURY STACK, WITH LATE 19<sup>TH</sup> OR EARLY 20<sup>TH</sup> CENTURY NEO-GOTHIC STONE COMPOSITE FIREPLACE; FROM THE NORTH-EAST.

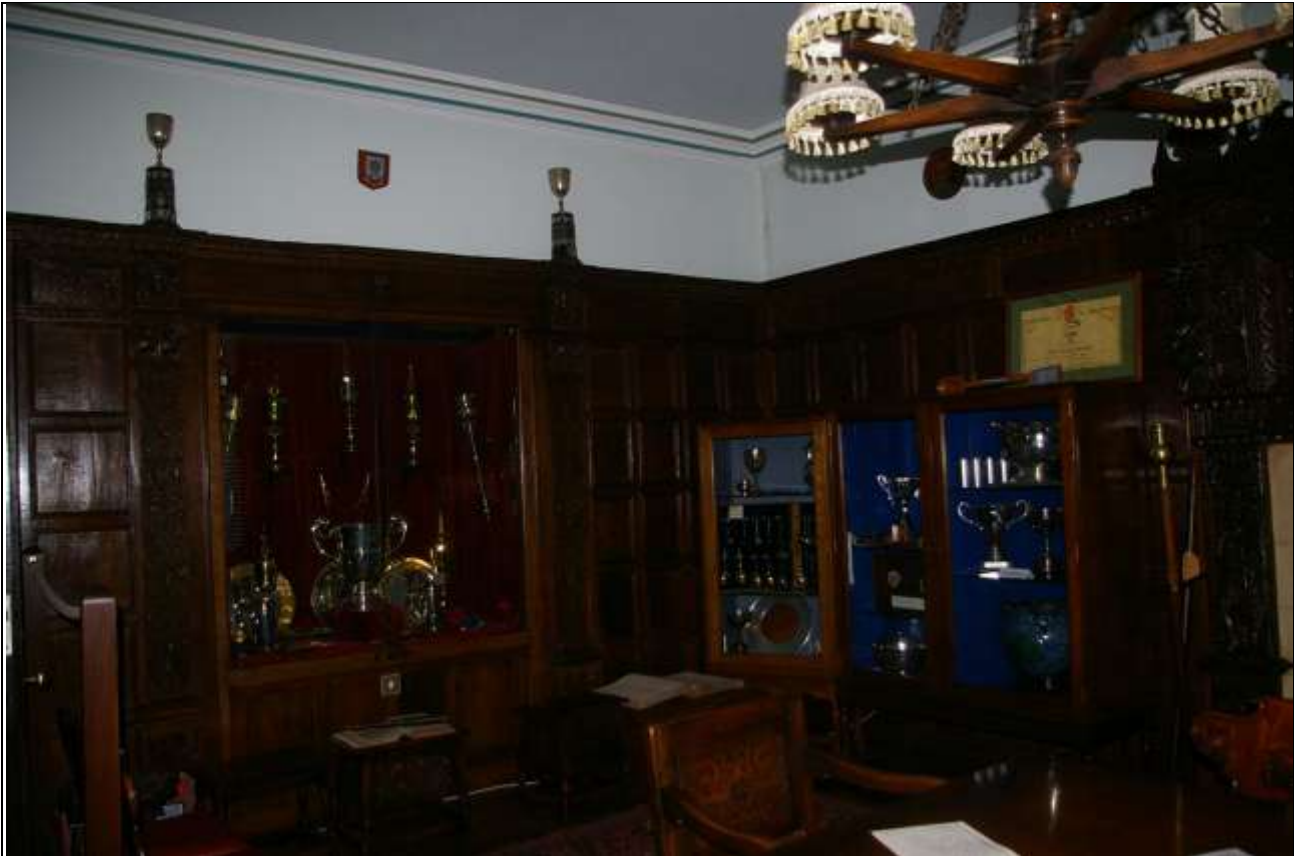
ROOM 5; THE EAST WALL OF THE DODDERIDGE ROOM WITH DEEP DISPLAY CASE AND DOOR TO THE FIRST FLOOR LOBBY; FROM THE WEST-NORTH-WEST.

<b>Room 5</b>		
Function:		Council meeting room/councillors dining room.
Walls:		Plastered and painted. The walls have been set with architectural salvage panelling from a house in Cross Street. Fine 17 <sup>th</sup> century panelling, with irregularly sized panels and carved pilasters. The panelling has been cut and reset to fit this room, mismatched at some joints. Inset panelled 17 <sup>th</sup> century door, very similar to panelling but not identical. Separate 16 <sup>th</sup> century fireplace overmantel and jambs, heavily carved. This feature is much altered and repaired in the later 19 <sup>th</sup> and probably 20 <sup>th</sup> centuries, when reset a couple of times. Window obscured by mock gothic/Jacobean stained glass internal shutters, probably early 20 <sup>th</sup> century, art nouveau style or similar, oak framing.
Floor:		Polished narrow even width boarded floor. Plain oak skirting fitted to bottom of panelling.

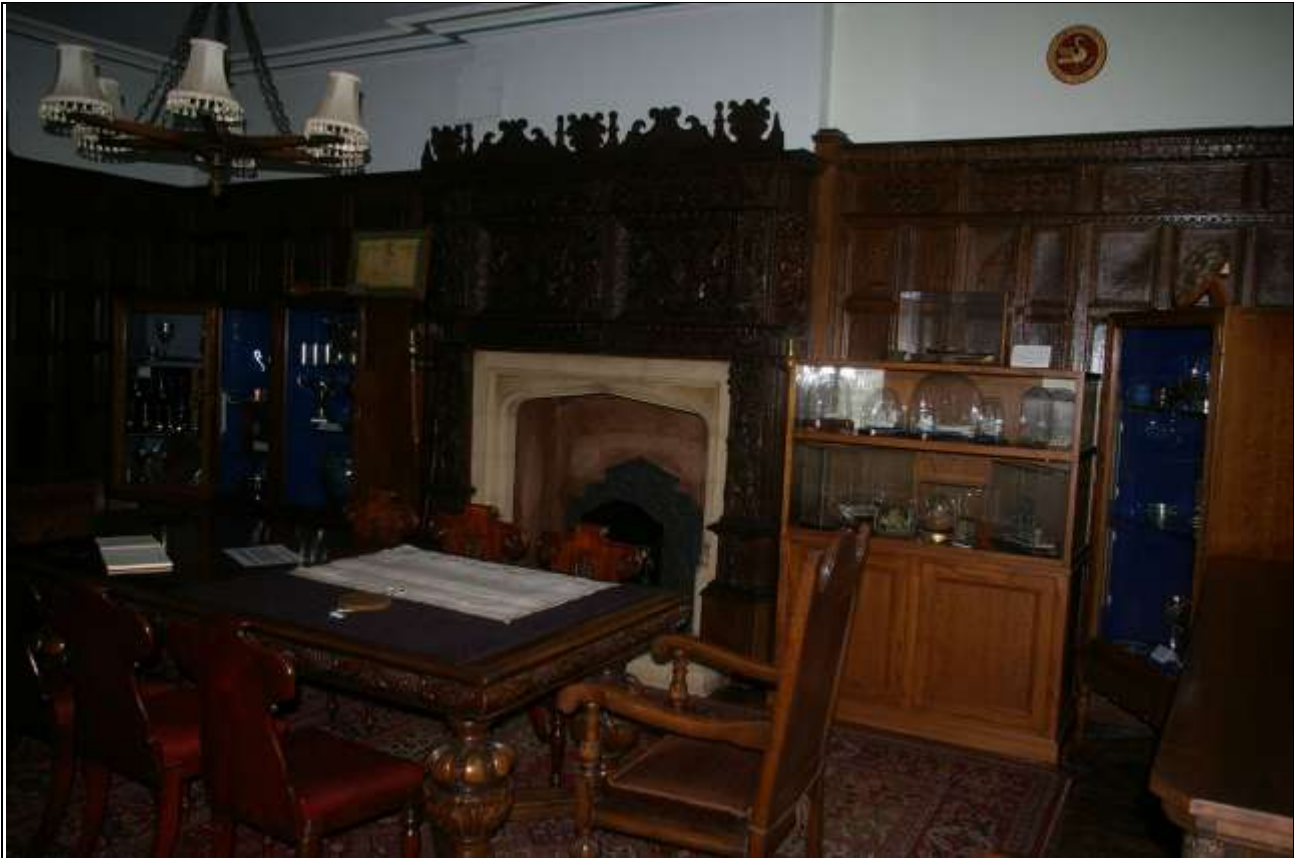
ROOM 5; THE SOUTH WALL OF THE MEETING ROOM, WITH SALVAGED RESET 17<sup>TH</sup> CENTURY PANELLING, CAVETTO SIMPLE PLASTER CORNICE, 19<sup>TH</sup> CENTURY AND FINE 16<sup>TH</sup> CENTURY SALVAGED CARVED OVERMANTEL; FROM THE NORTH-WEST.

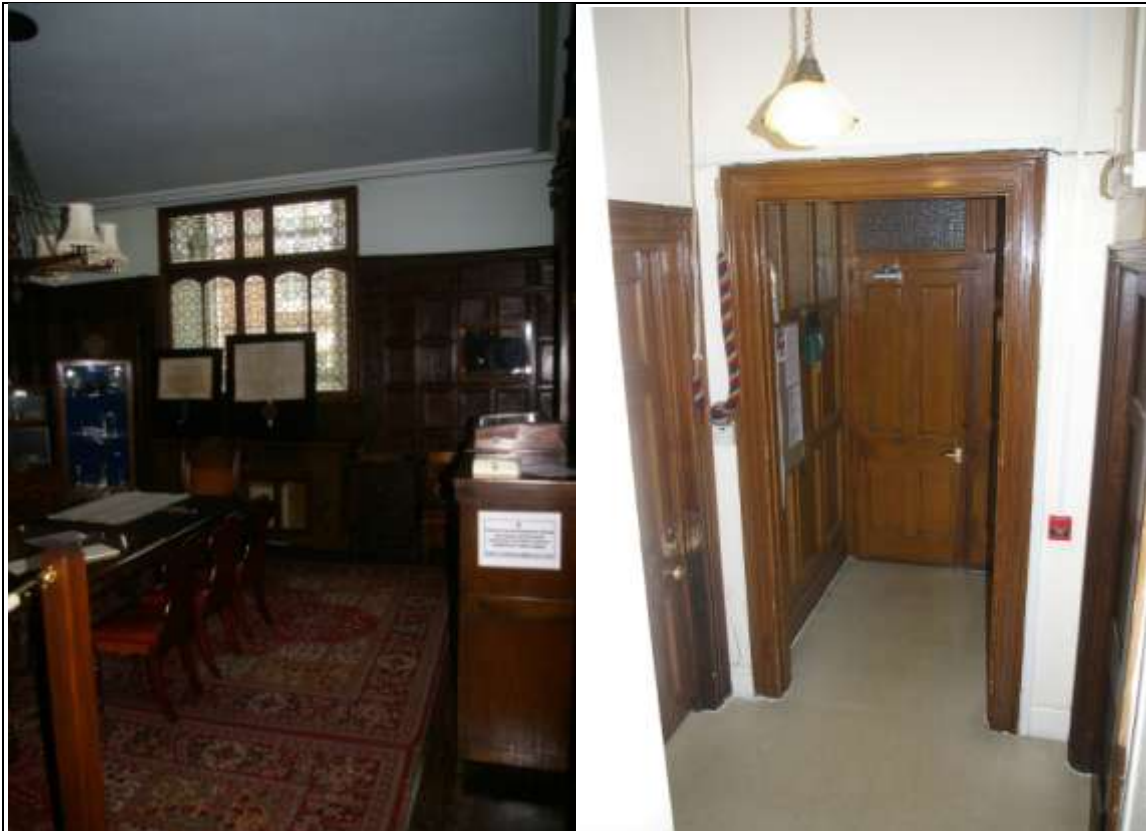
LEFT: ROOM 5; THE OAK LEADED SCREEN ACROSS THE CLASSICAL SASH WINDOW IN THE DODDERIDGE ROOM; FROM THE EAST-NORTH-EAST.  
RIGHT: ROOM 4; THE SMALL FIRST FLOOR LOBBY, LEADING OFF THE GRAND STONE STAIR, WITH DOORWAYS TO THE COUNCILLORS MEETING ROOM (ROOM 5) AND MAIN CHAMBER (ROOM 4A & 6); FROM THE SOUTH-EAST.

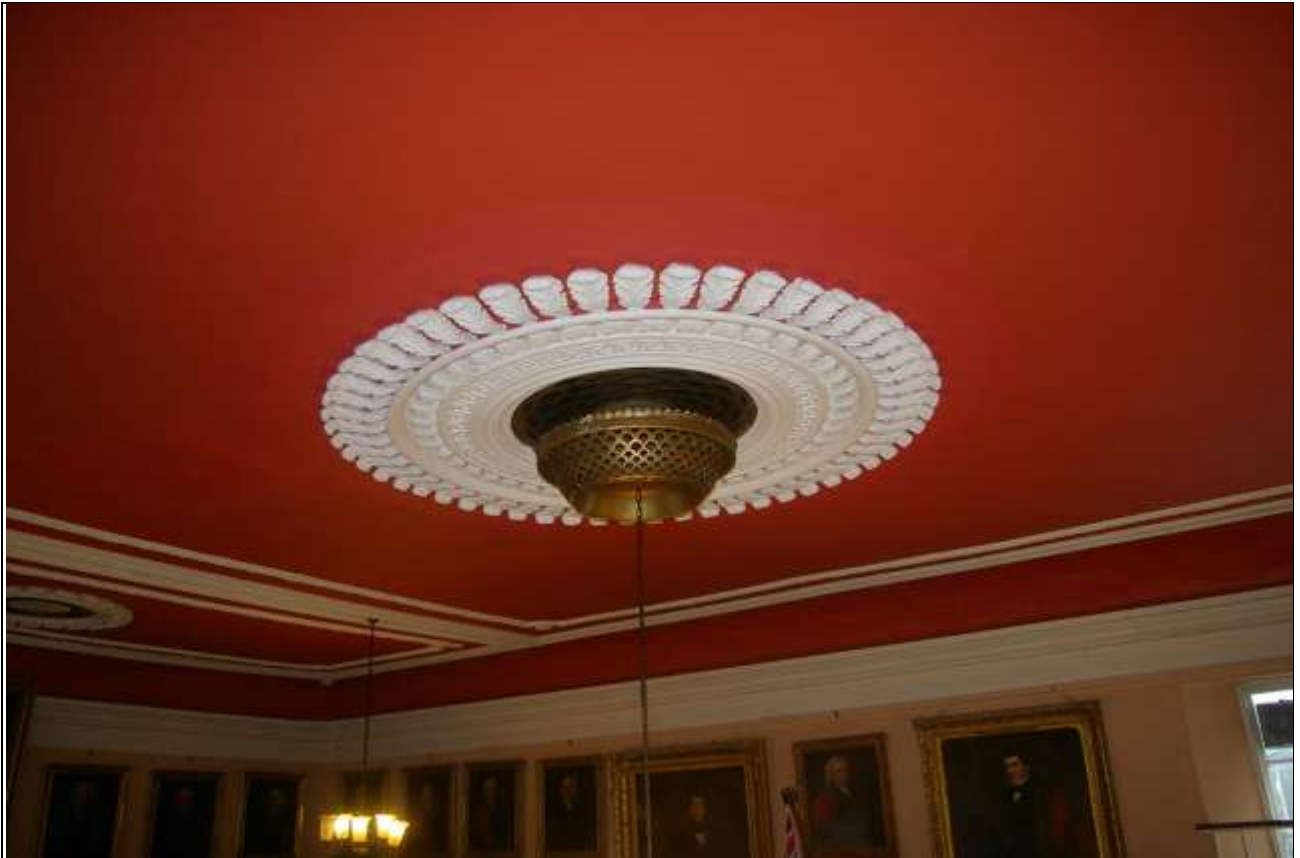
THE LARGEST OF THE TWO CEILING ROSES ON THE MAIN CHAMBER CEILING (ROOM 6), WHICH HAS BEEN RESTORED AFTER A COLLAPSE.

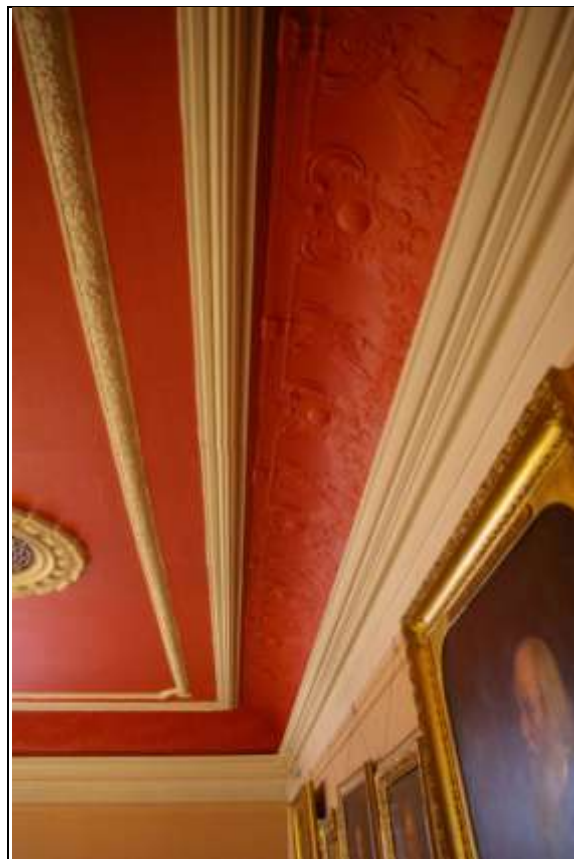
DETAIL OF THE ANAGLYPTA WALLPAPER APPLIED IN THE LATER 19<sup>TH</sup> CENTURY TO THE SIMPLE CAVETTO SIDES OF THE MOULDED PLASTER CEILING OF ROOM 6; FROM THE WEST.

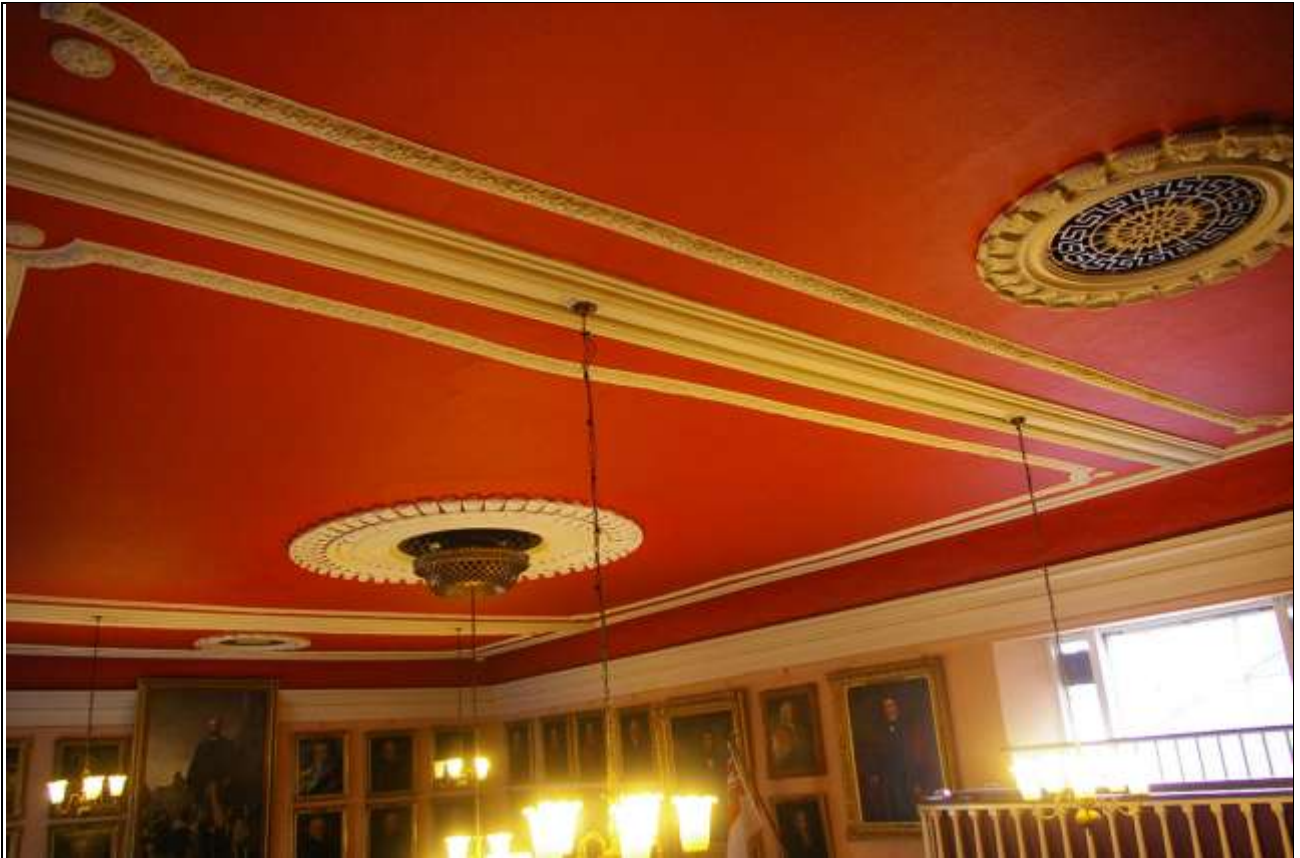
THE BEAUTIFUL PLASTER ROOF OF THE MAIN CHAMBER (ROOM 6); FROM THE SOUTH-WEST
